**NATIONAL BUREAU OF STANDARDS REPORT**

REPORT ON  
INSPECTION AND TESTS OF PLASTER  
ALASKA NATIVE SERVICE HOSPITAL AND QUARTERS BUILDINGS

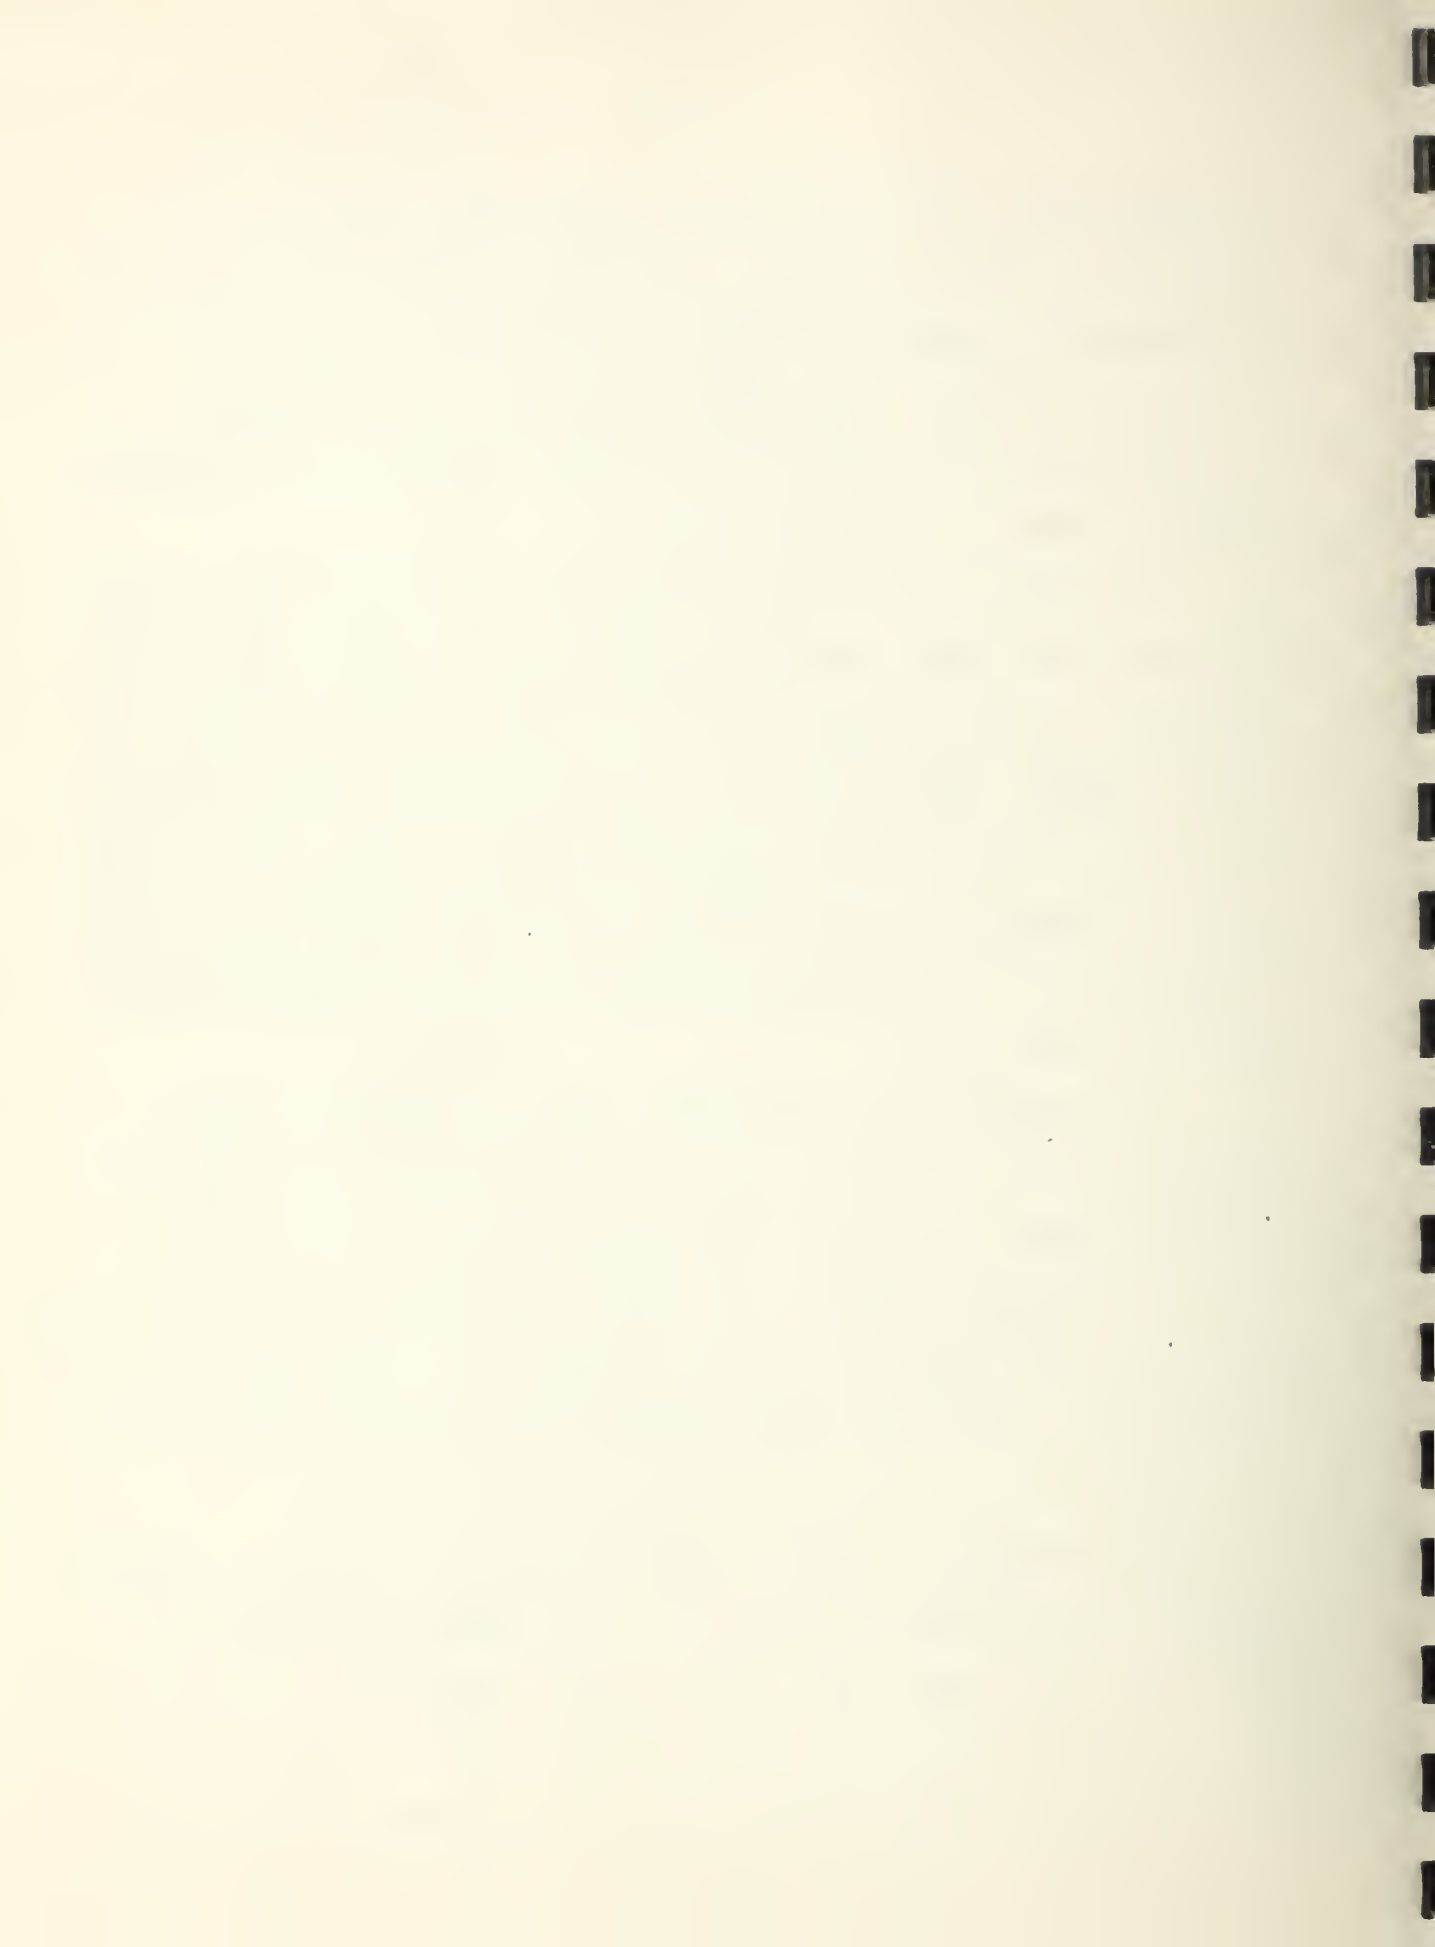
of sand to vermiculite aggregate was not in accordance with the specifications.

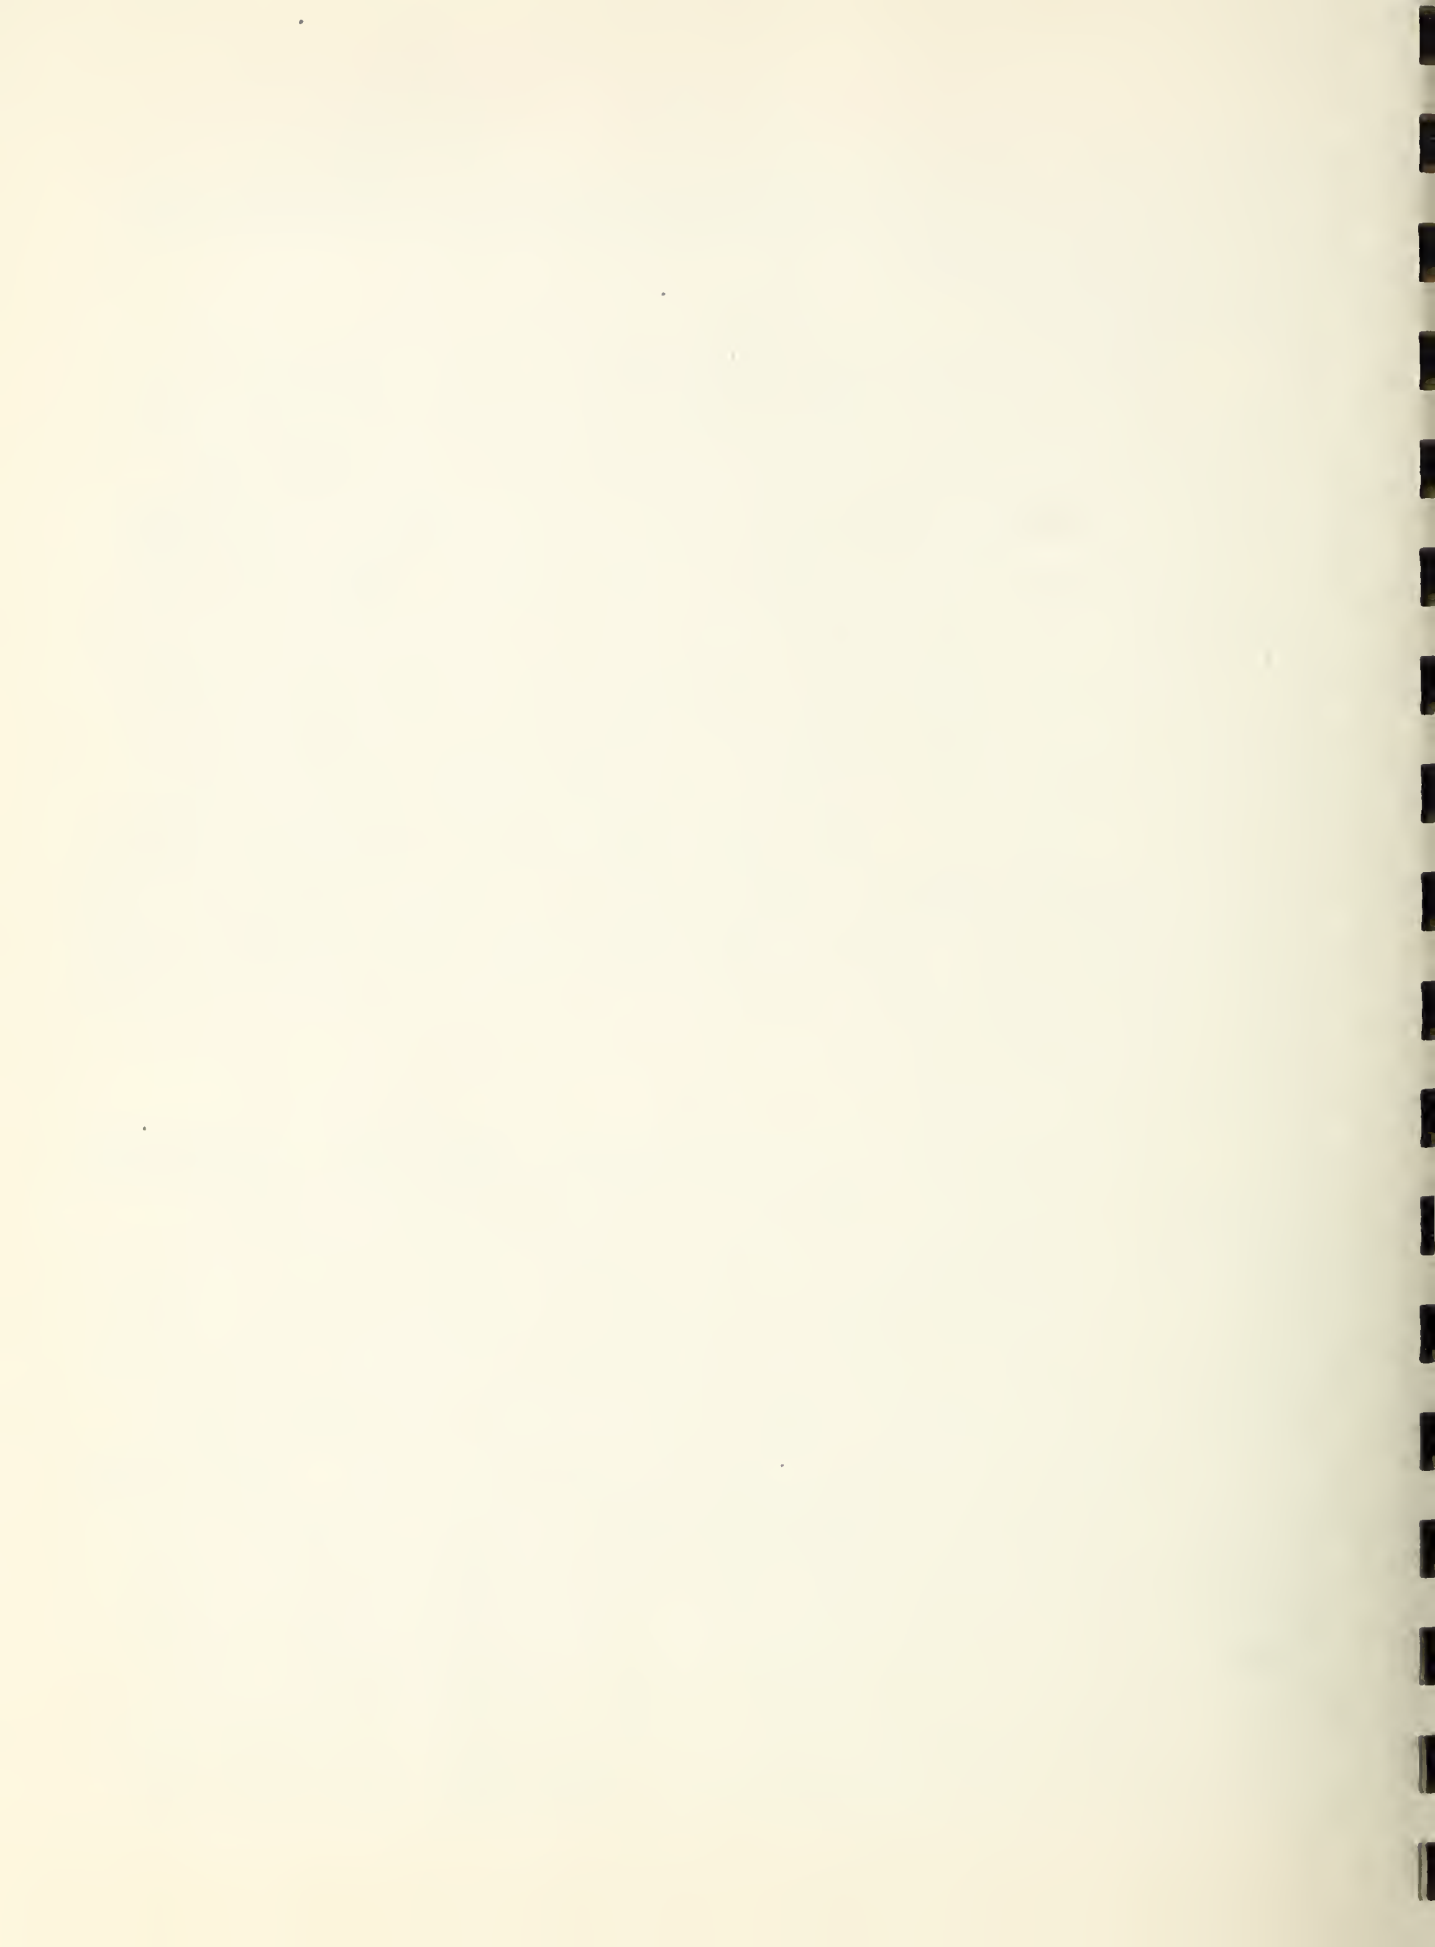
troweling is not done under proper conditions and at the proper time. Too rapid drying of white finish over wet base coat also tends to overstrain the surfacing material. It is possible that such causes were operating to some extent in both the hospital and quarters buildings to induce initiation of cracking.

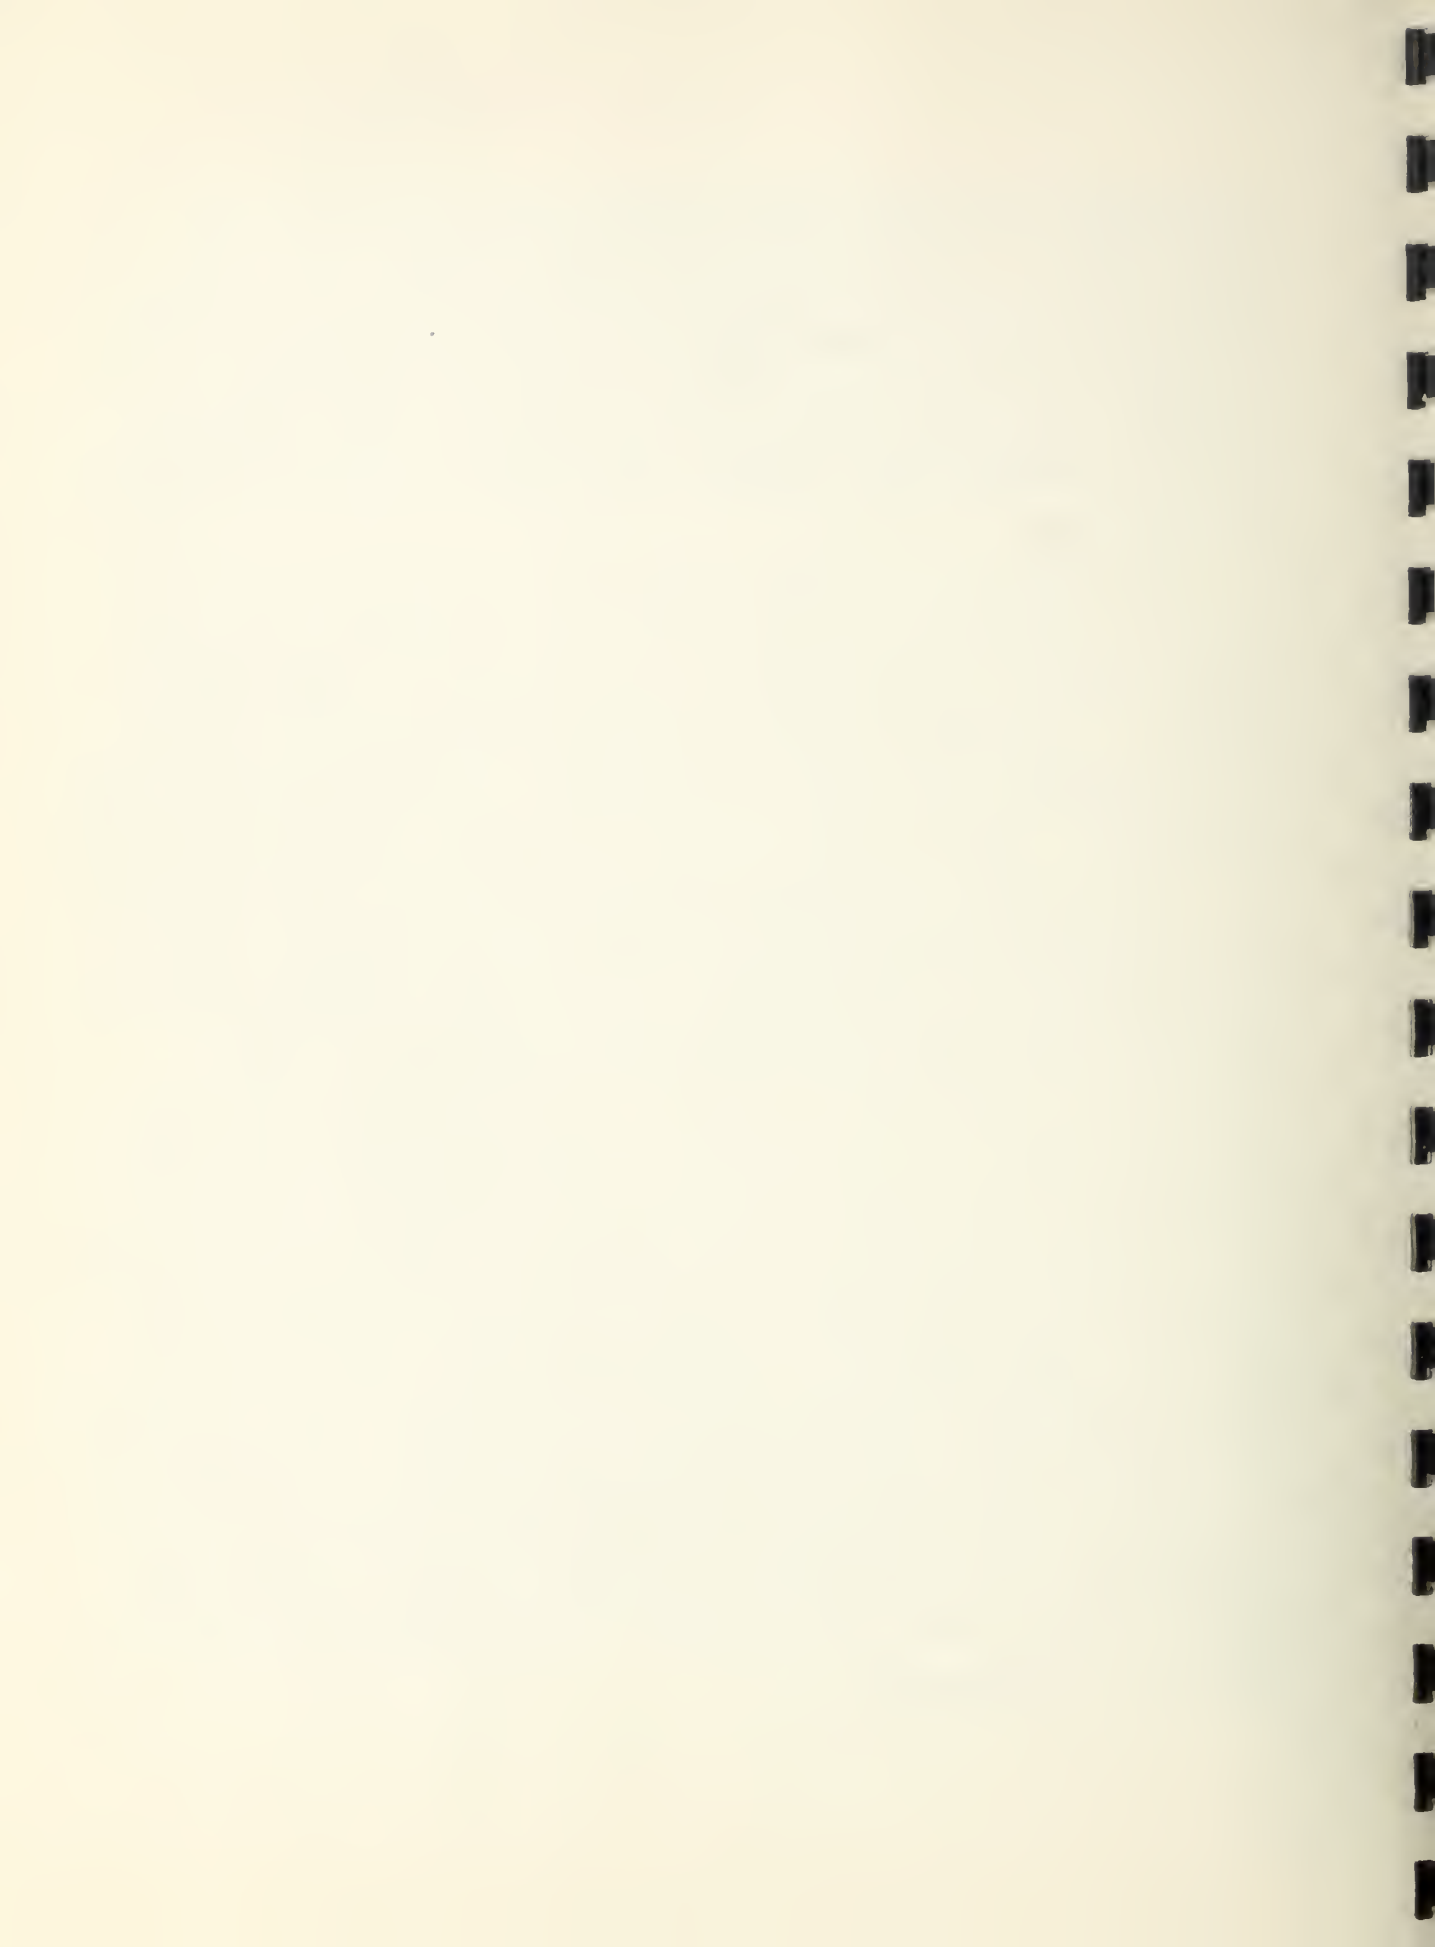
Expanded vermiculite aggregate, likewise, requires a large amount of water to secure workability. The water glaze on the plaster keys of some of the specimens of lath and plaster from the hospital building gave evidence that the vermiculite-sand gypsum plaster had been applied very wet. It is known that vermiculite gypsum plasters are low in strength and must be applied and cured under closely controlled conditions if cracking of white finish plaster is to be avoided. There are relatively few examples where good results have been achieved when the plaster base was expanded metal lath on furring channels or on metal studs. Vermiculite plasters are also susceptible to relatively large volumetric changes as the result of changes in the relative humidity of the atmosphere.

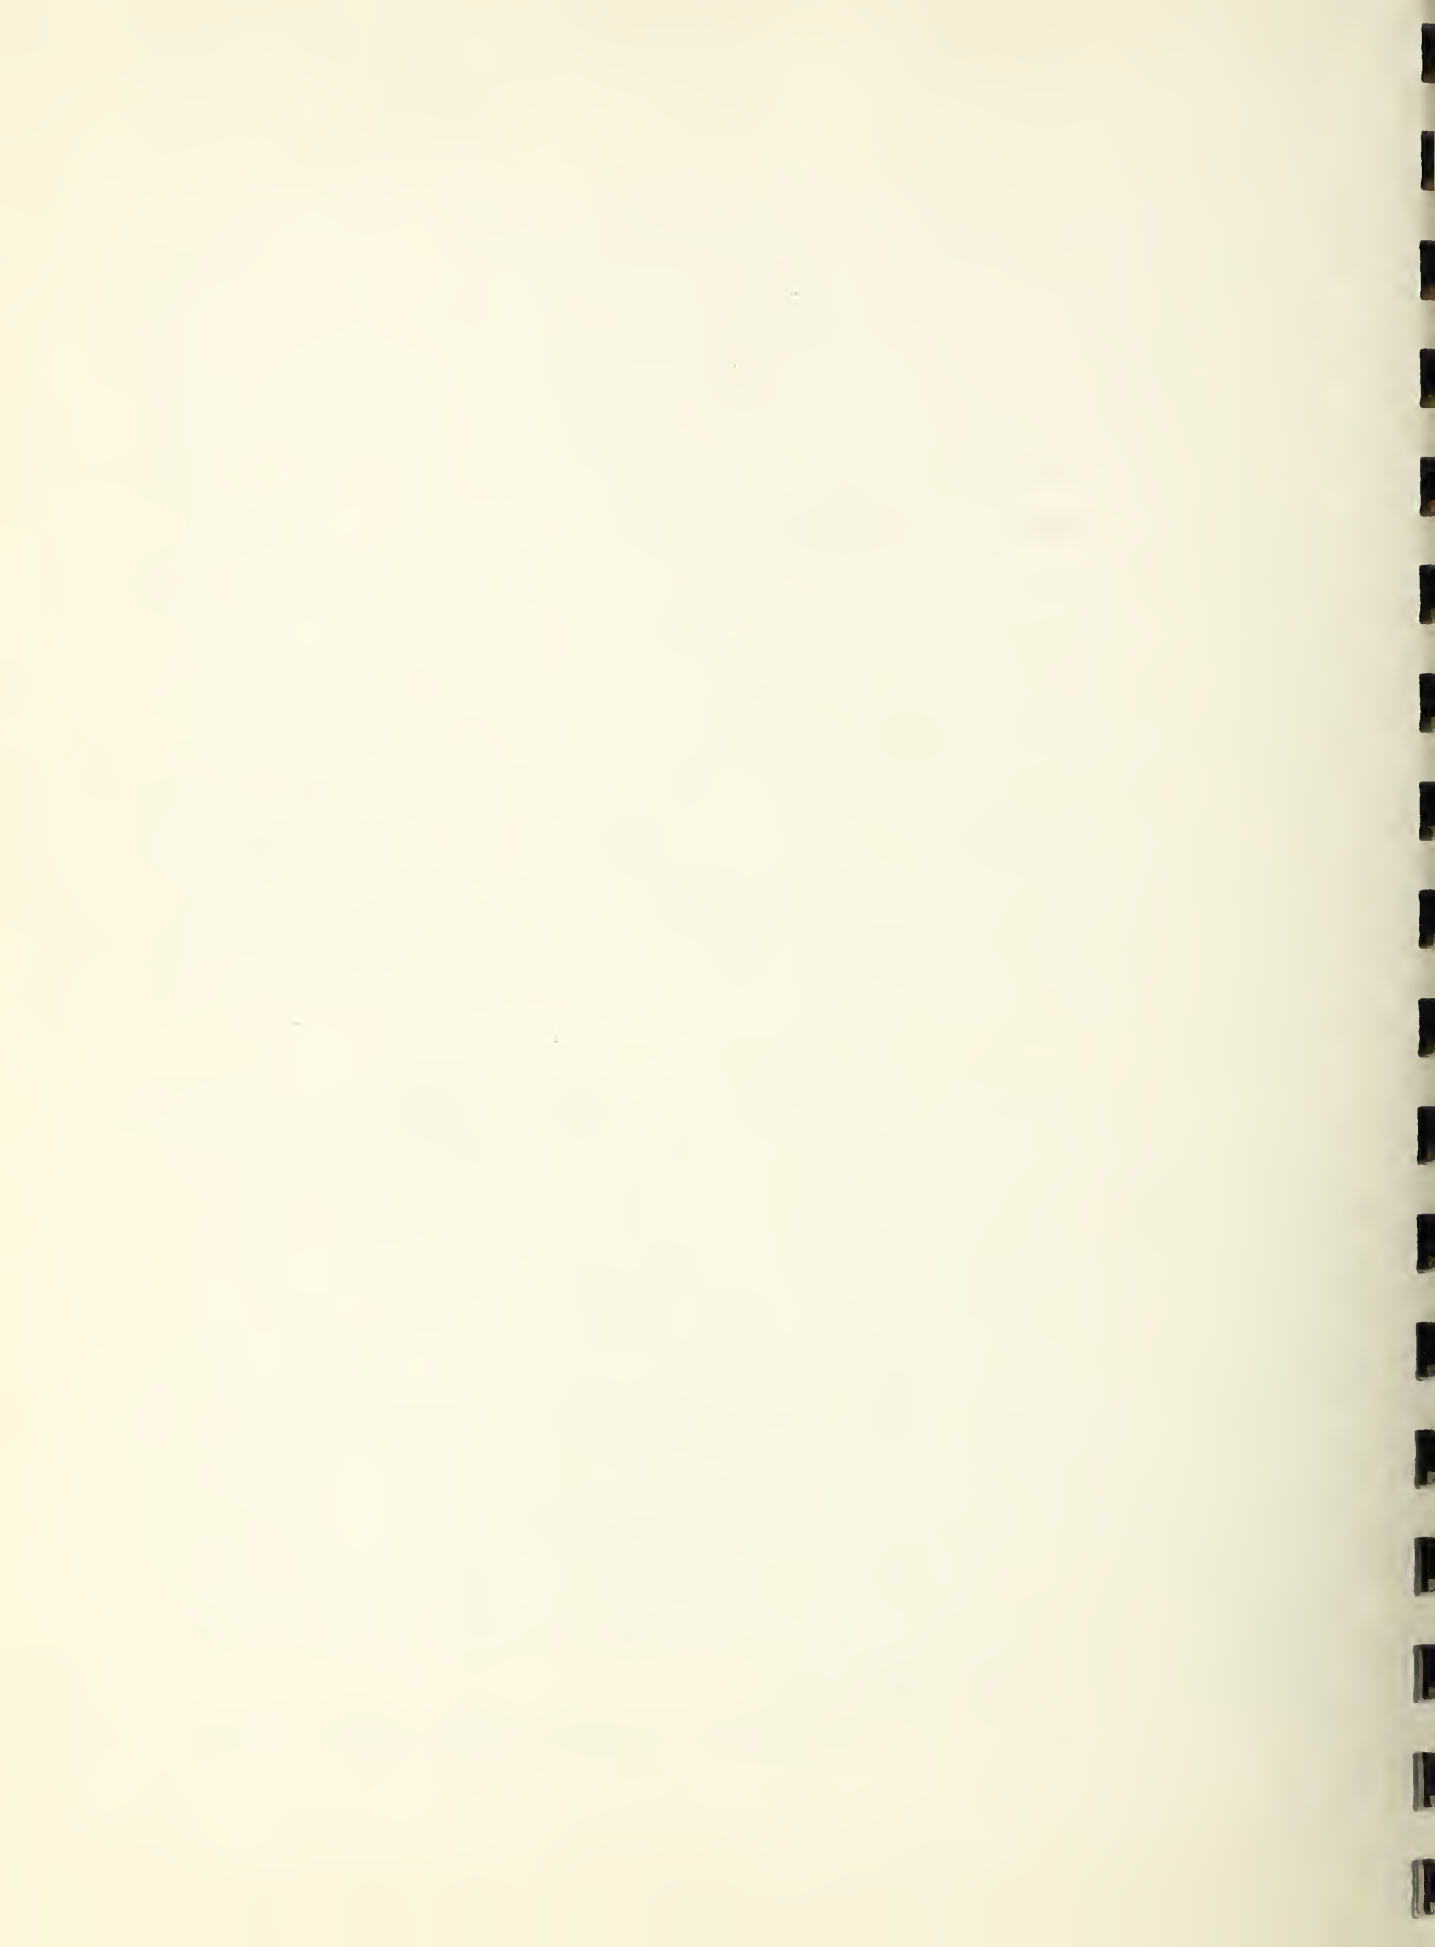
either lightweight metal studs or strip steel channels did not have sufficient rigidity to hold the weak base coat plaster in position when subjected to the shrinkage effects of both the base coat and the white finish plasters, especially after cracking of the white finish plaster had been initiated. In the hospital building, the measured thickness of plaster on metal lath was rather uniformly  $3/4$  in. as specified, but in many locations in the quarters building the thickness was not more than two-thirds the thickness specified.

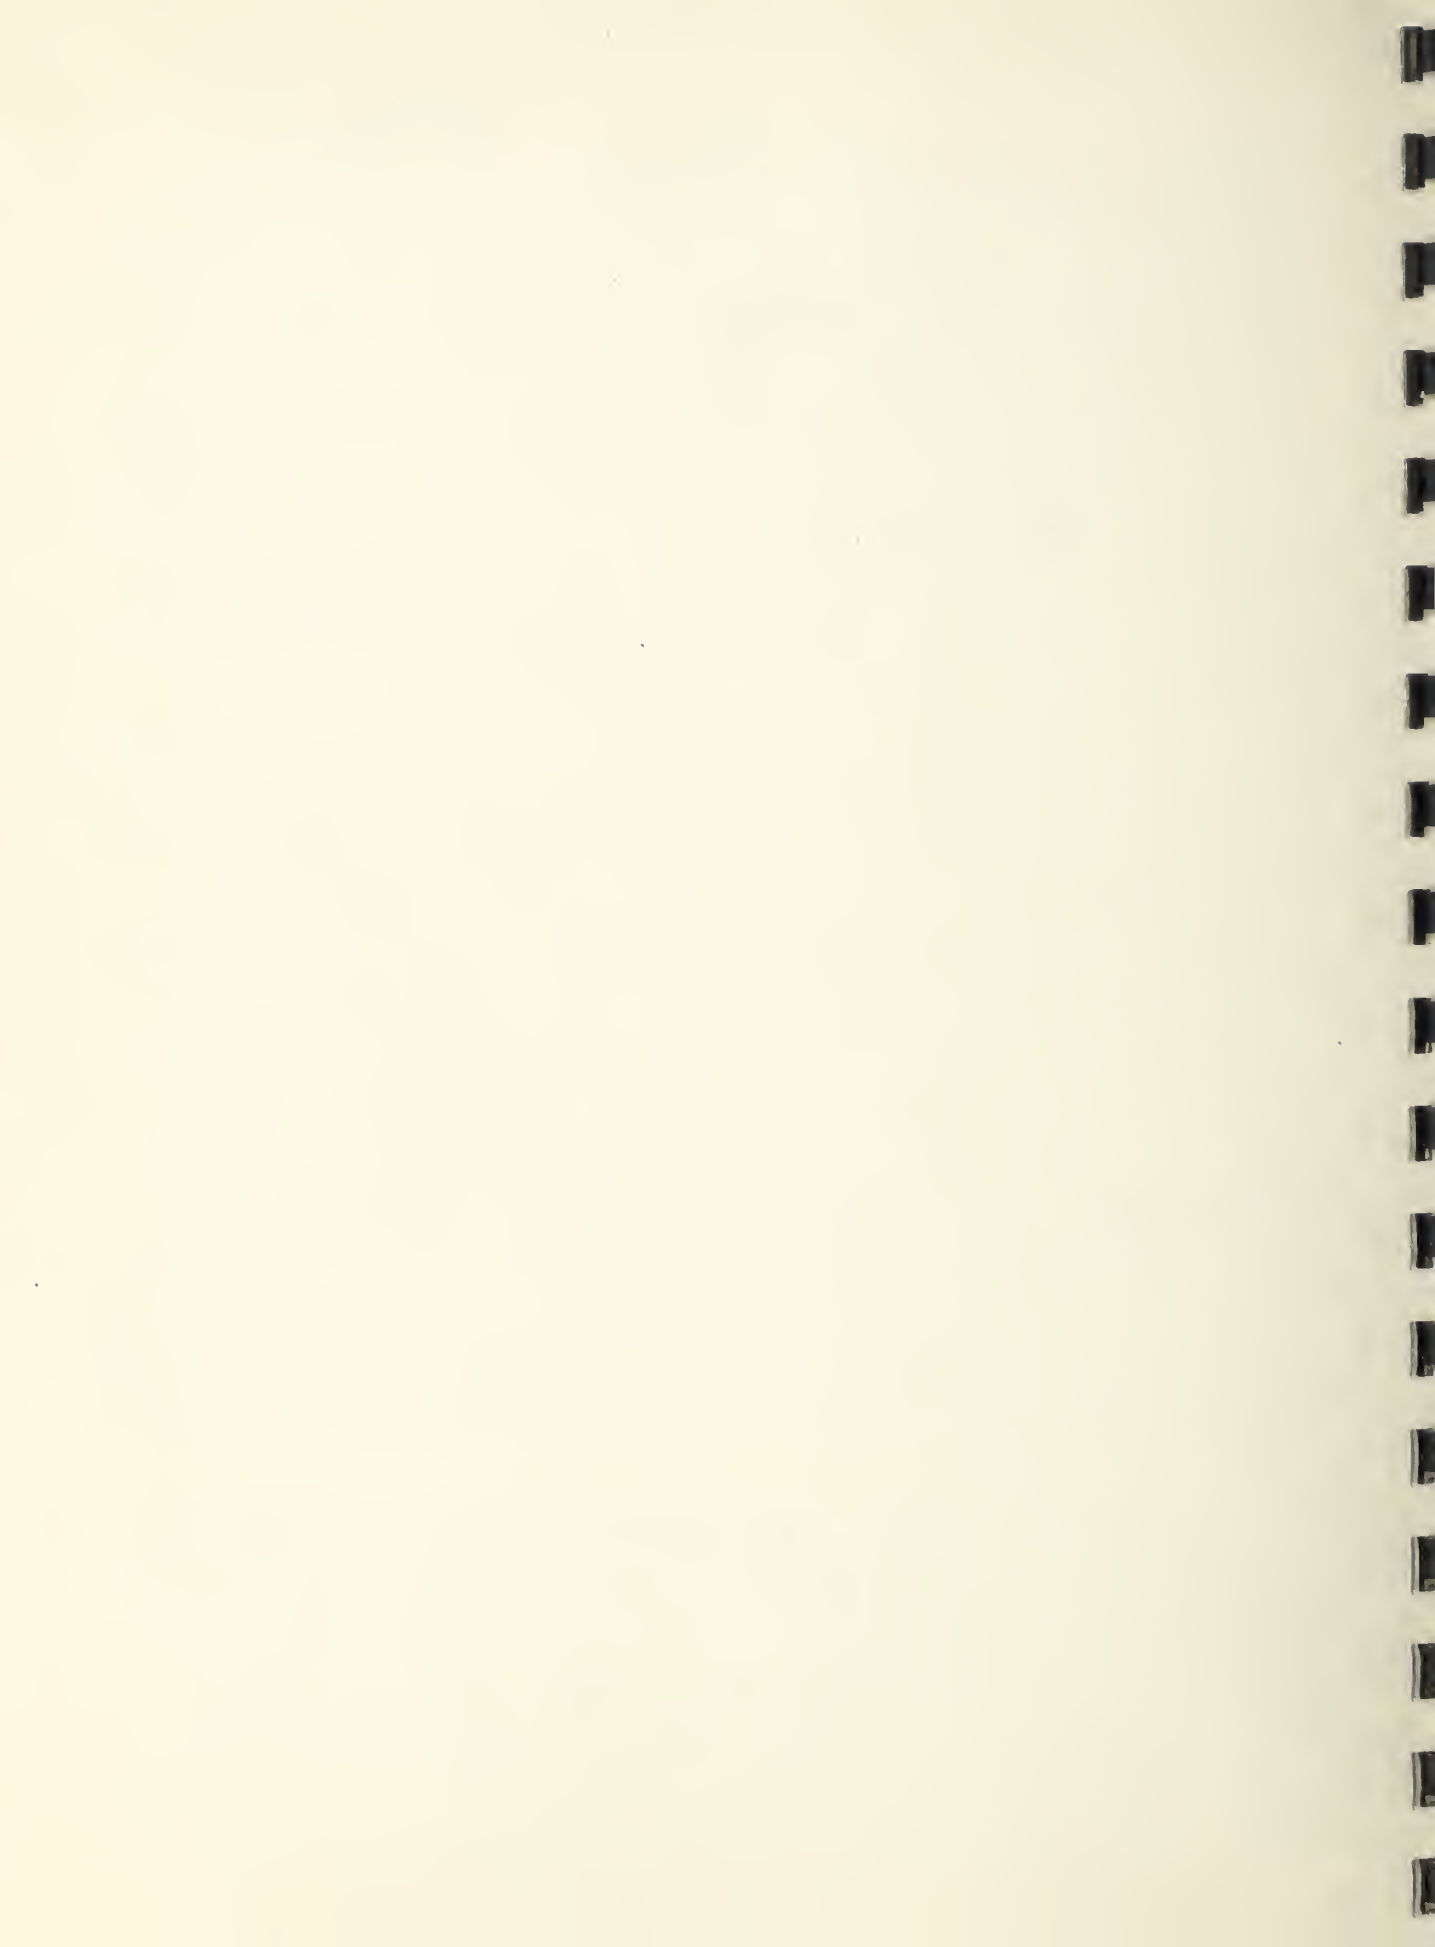
The two extremes of long-continued dampness of plaster in the hospital building and the rapid drying of plaster in the quarters building by means of forced circulation of hot air were both contrary to accepted good practice in plastering. It is not known to what extent the practices employed by the plastering contractor were influenced by the specification requirement:

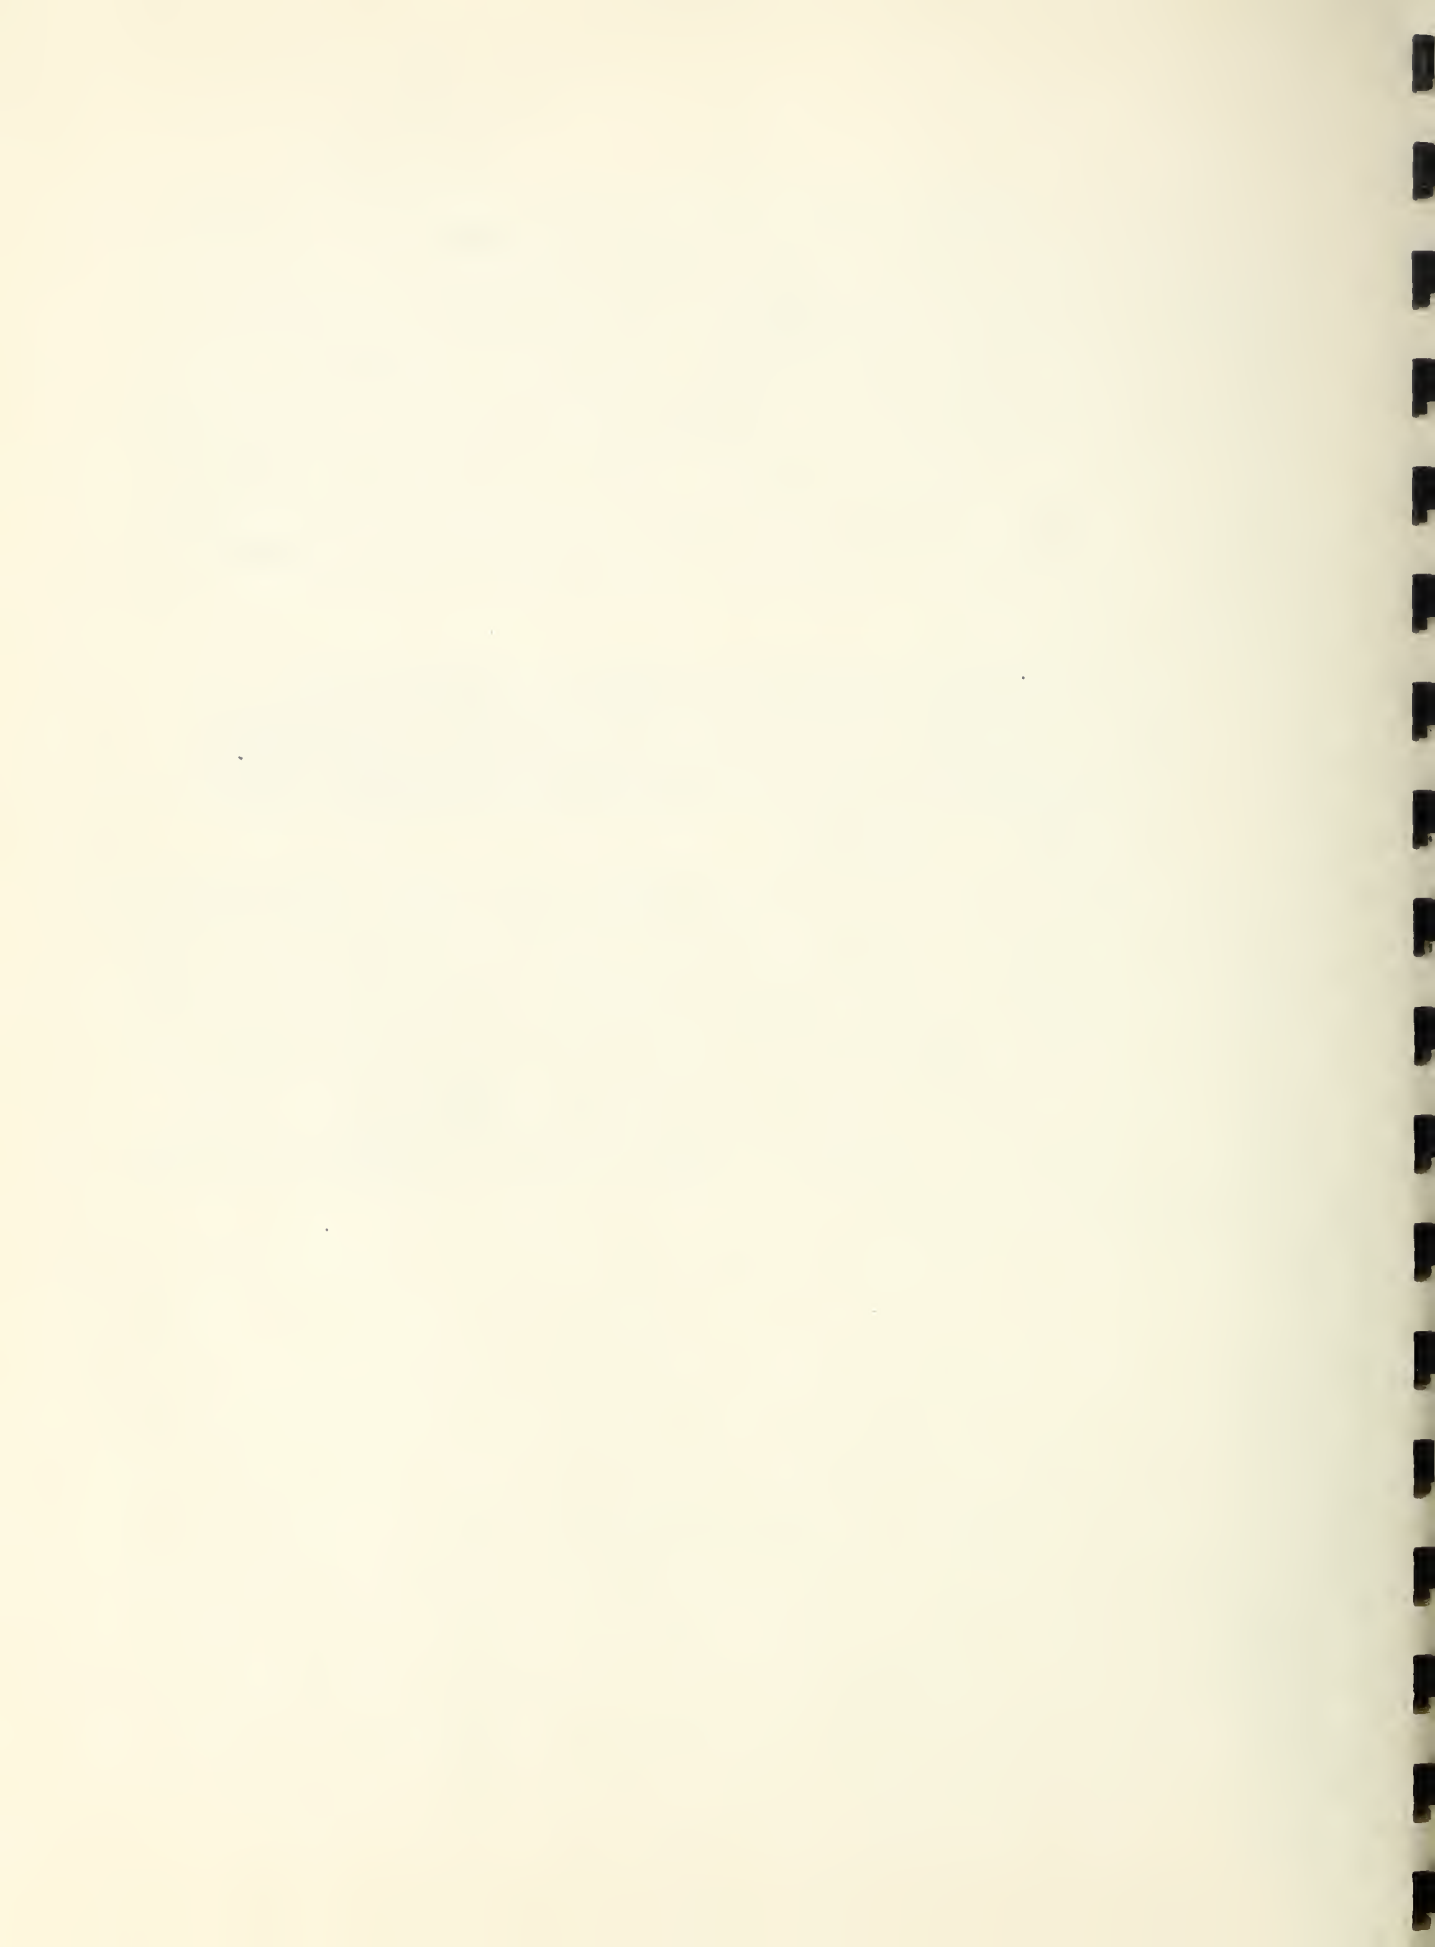
The specified precaution for spraying with water was doubtless inserted to guard against possible dry-outs or the too rapid drying of sanded gypsum plaster. This is not wholly compatible with the best practice when vermiculite aggregate is used, for that aggregate carries a large excess of water and holds it rather tenaciously.

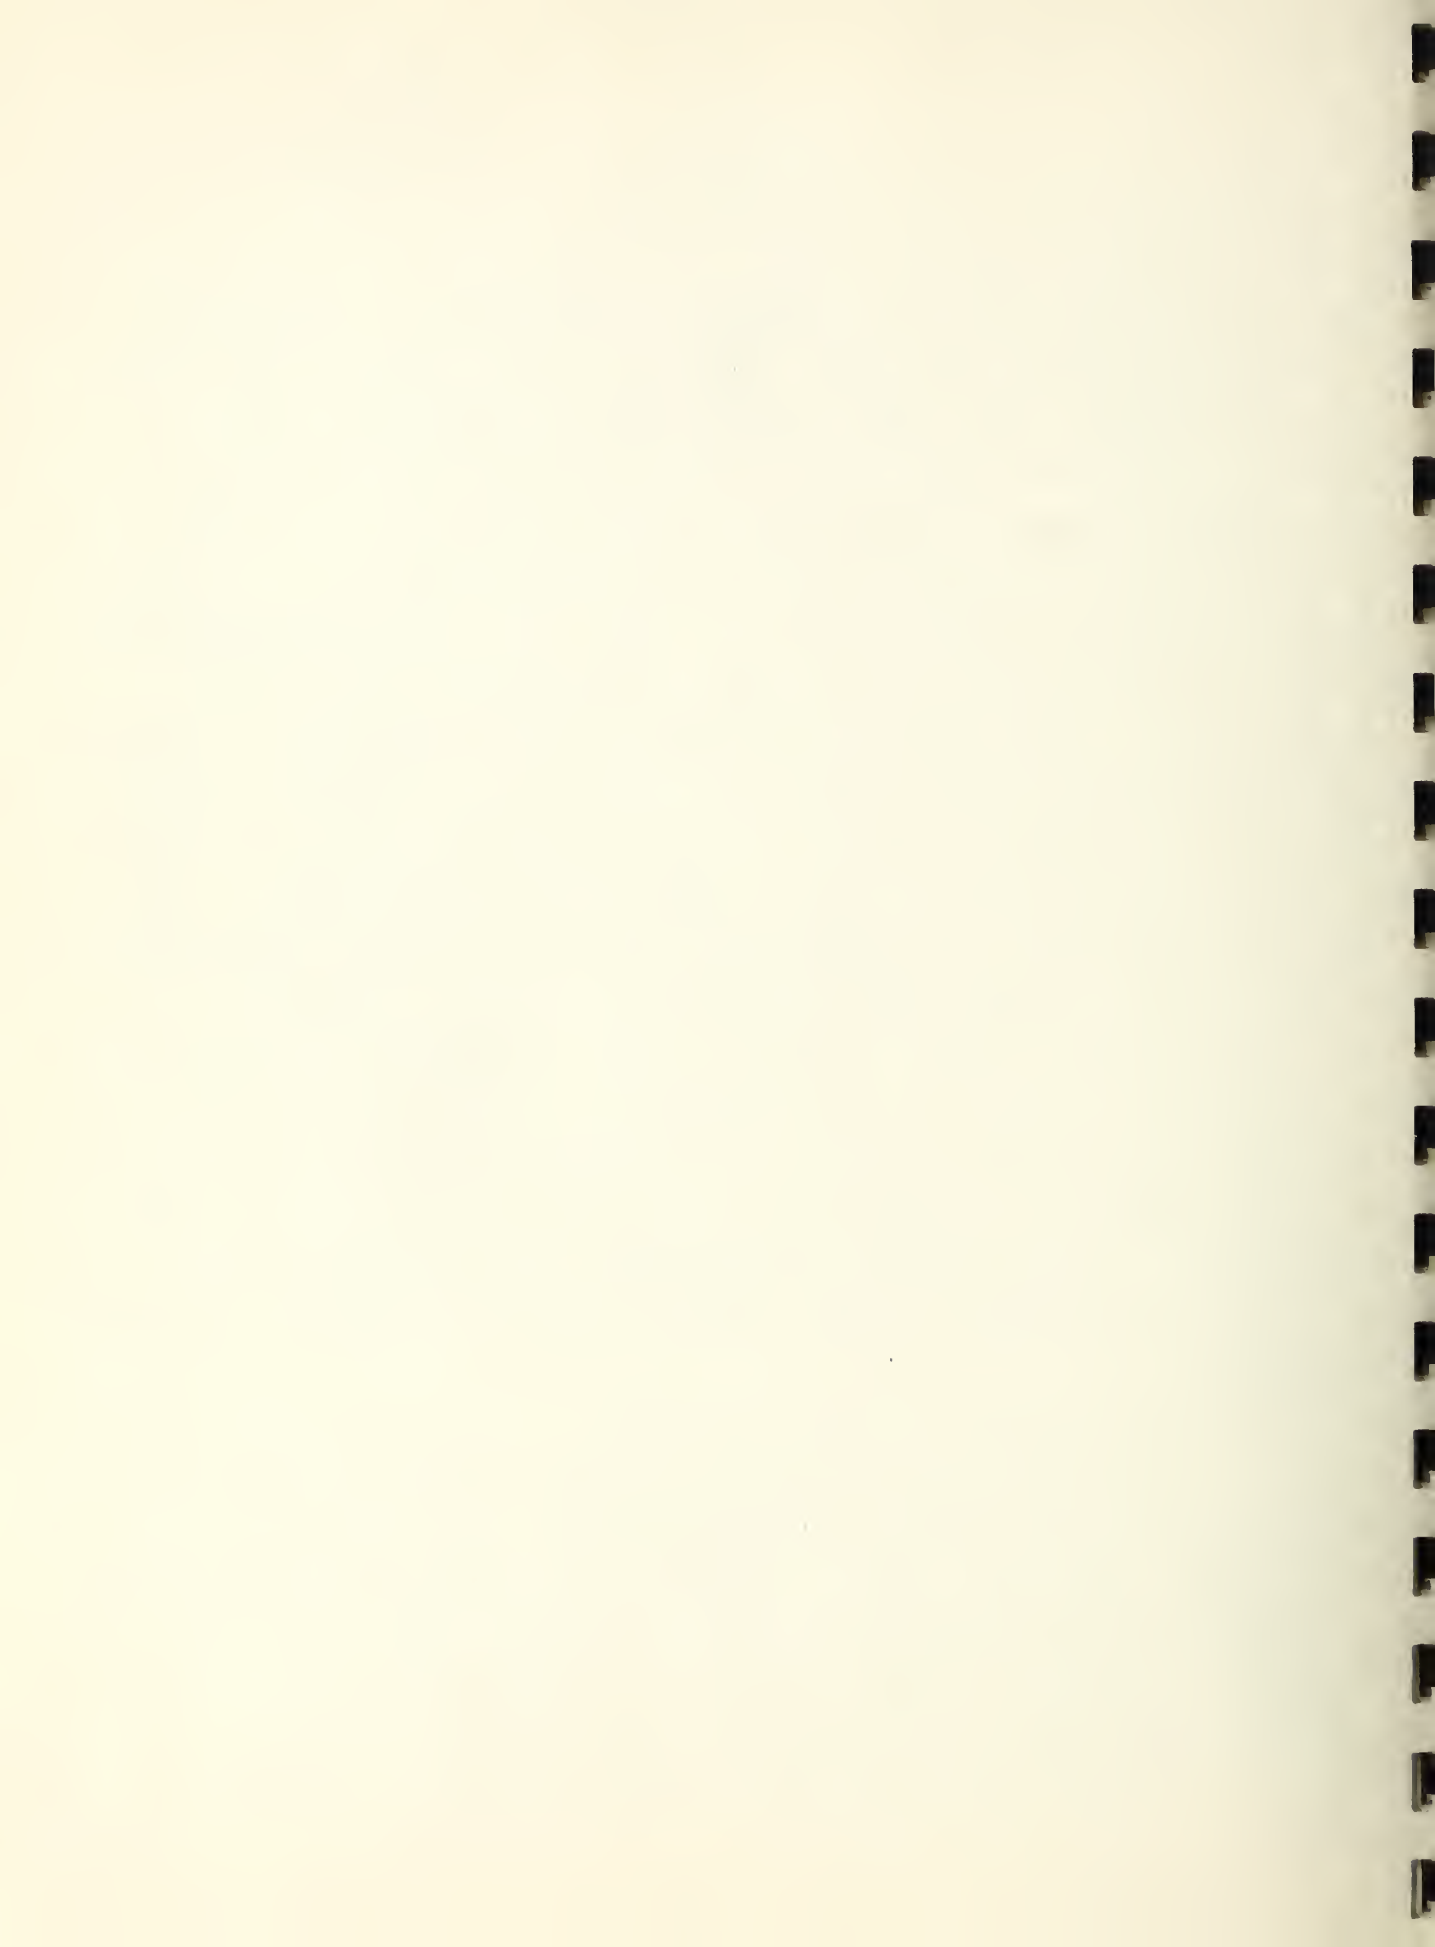
and proceeded at once to make the inspections requested and to take samples of lath and plaster from the walls of the hospital building (Project No. 501-228) and the quarters building (Project No. 501-228A). Containers of samples of the gypsum plaster and lime bearing the dates of approval were requested to be forwarded to the National Bureau of Standards for test.

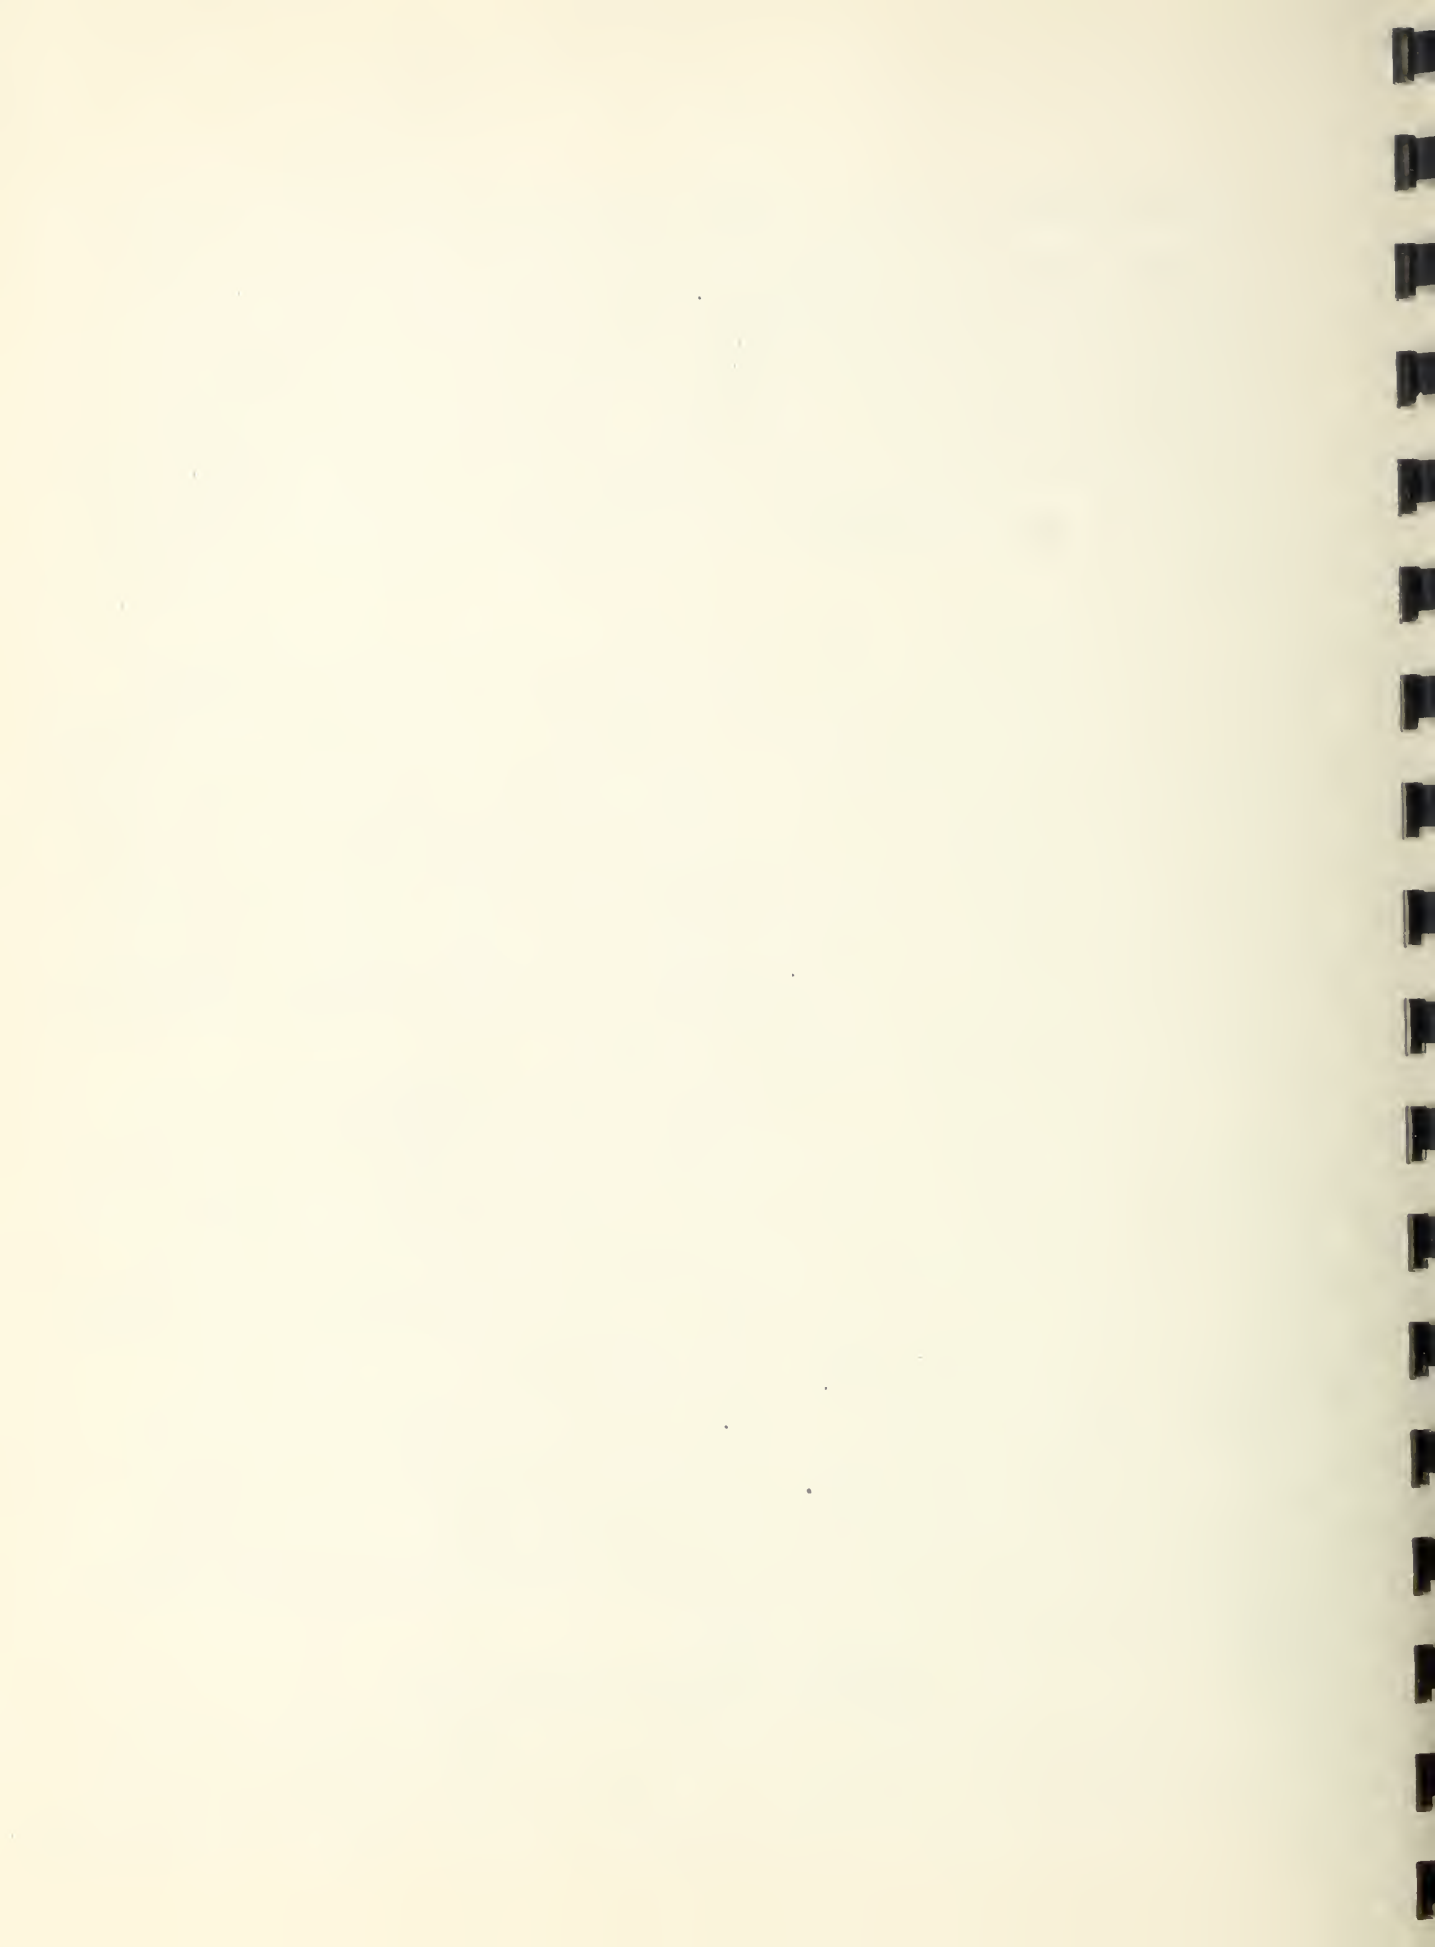
and Utilities; Harry Halvorson, Area Construction Engineer; V. P. Reimer, Project Engineer; J. C. Boespflug, representing Boespflug-Kiewit-Morrison, General Contractor; William Miller, Contractor's General Superintendent; Lansing S. Wells, Chief, Chemistry of Mineral Products Section, National Bureau of Standards; Melvin Quayle, Zonolite Company; and others inspected the plaster in various parts of the hospital building to observe its condition with respect to cracking. Dr. Wells reported on June 16, 1952, that:
