**NATIONAL BUREAU OF STANDARDS REPORT**

REPORT ON  
INSPECTION AND TESTS OF PLASTER  
ALASKA NATIVE SERVICE HOSPITAL AND QUARTERS BUILDINGS

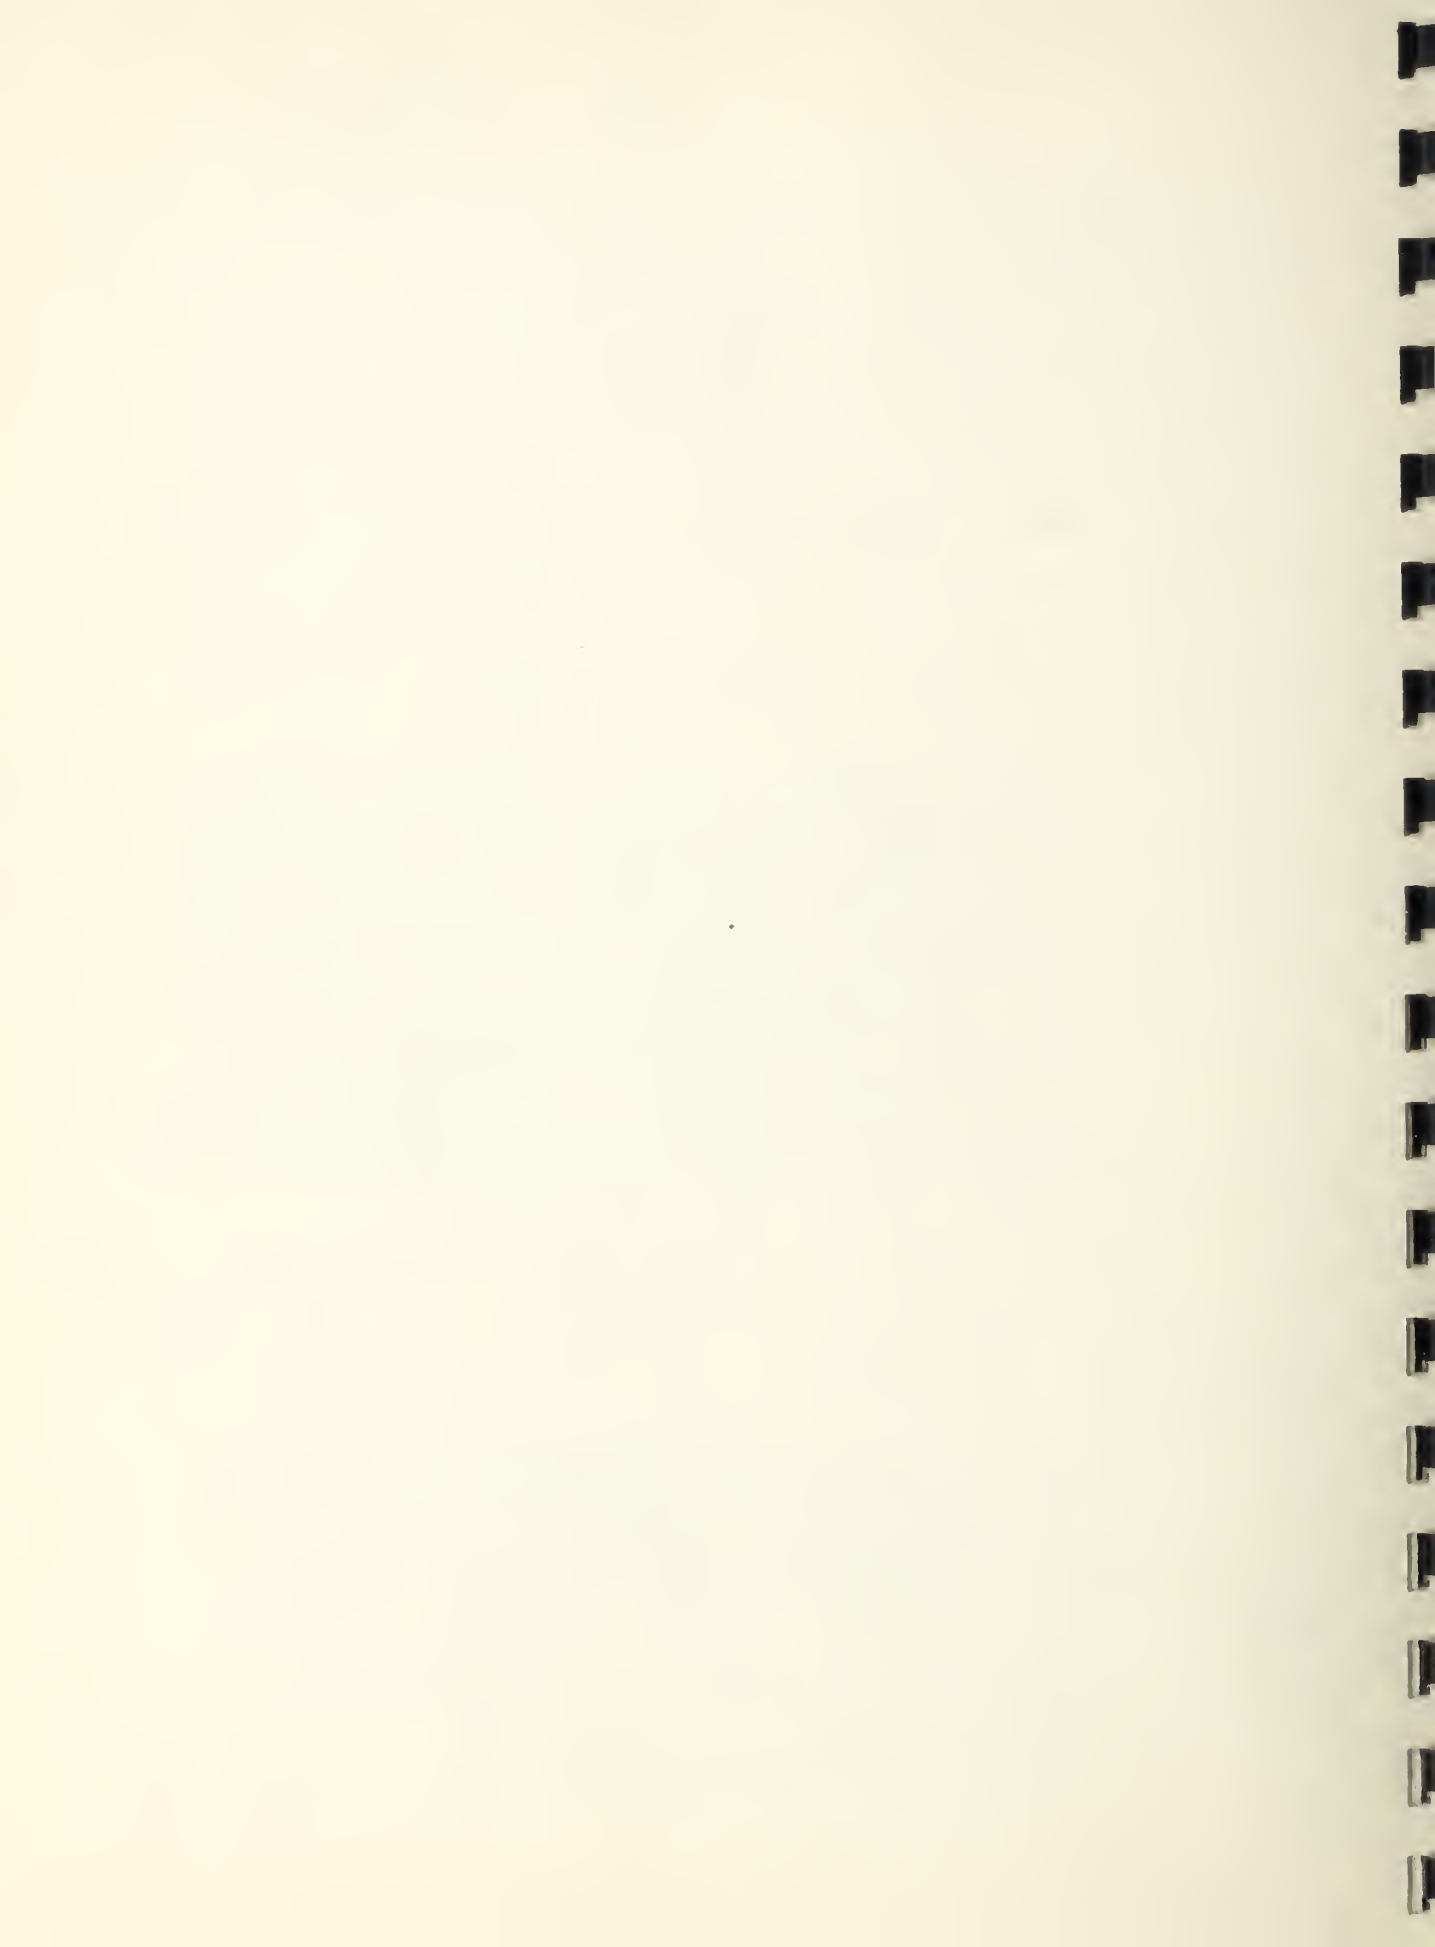
initially too much water had been added to the mix. Thus, the mix was a combination of gypsum plaster, vermiculite, sand, and, apparently, too much water. ....

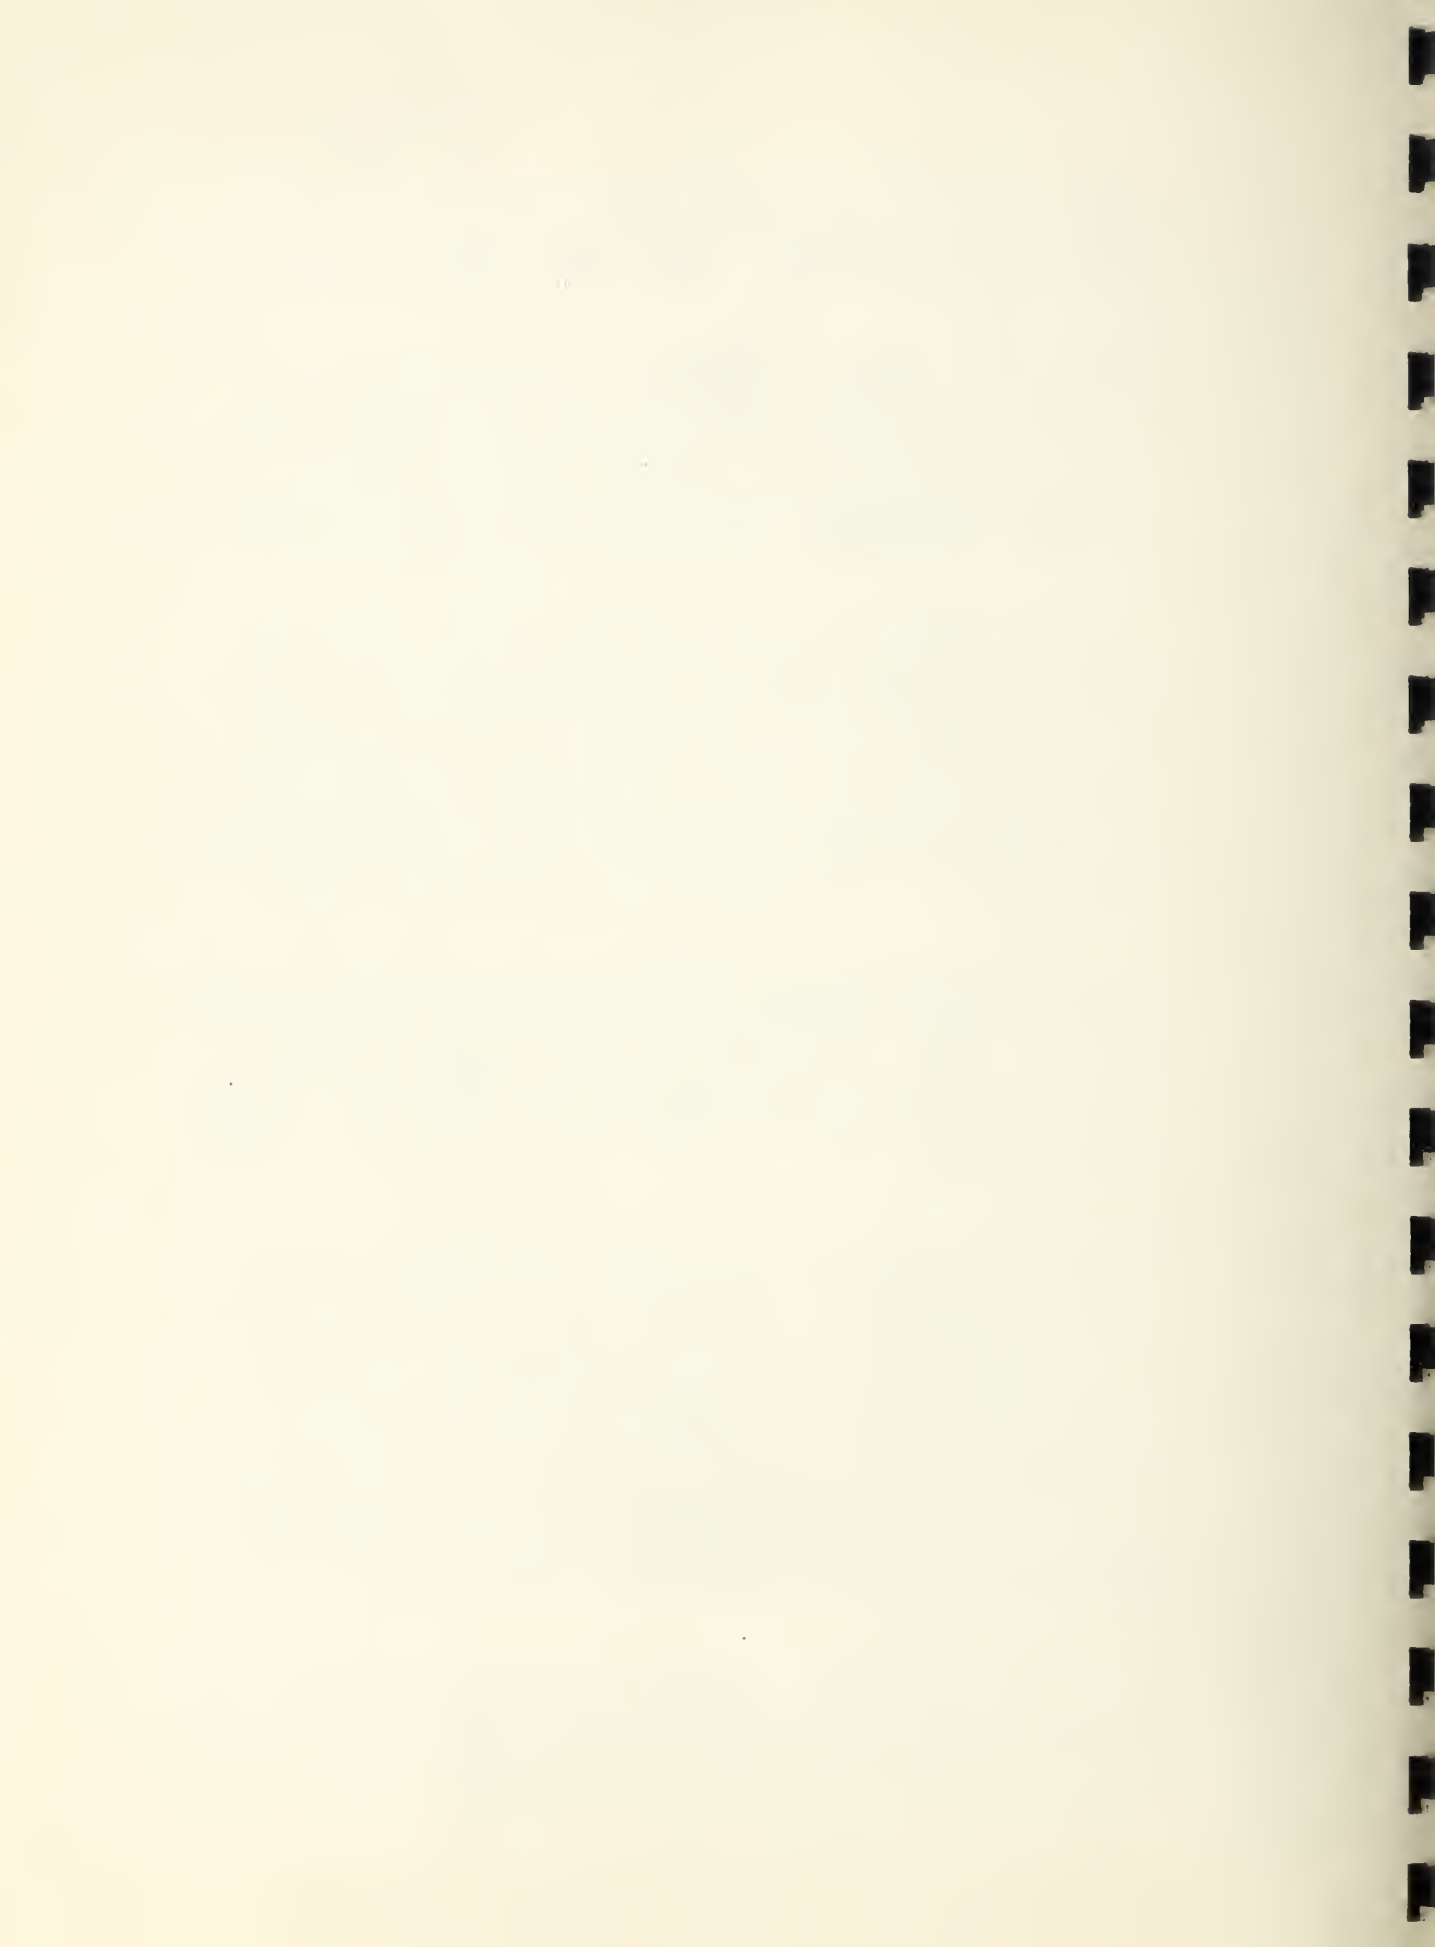
in the building had been poured for a considerable period of time before the plastering was undertaken, and that the concrete had dried well. It is suggested that the dry concrete absorbed enough water from the very wet plaster to reduce the moisture content of the plaster after it had been applied and before it had set to reduce the shrinkage on further drying very greatly. Furthermore, the probability of cracking would be reduced on a solid plaster base such as concrete, as compared with a more flexible base such as metal lath."

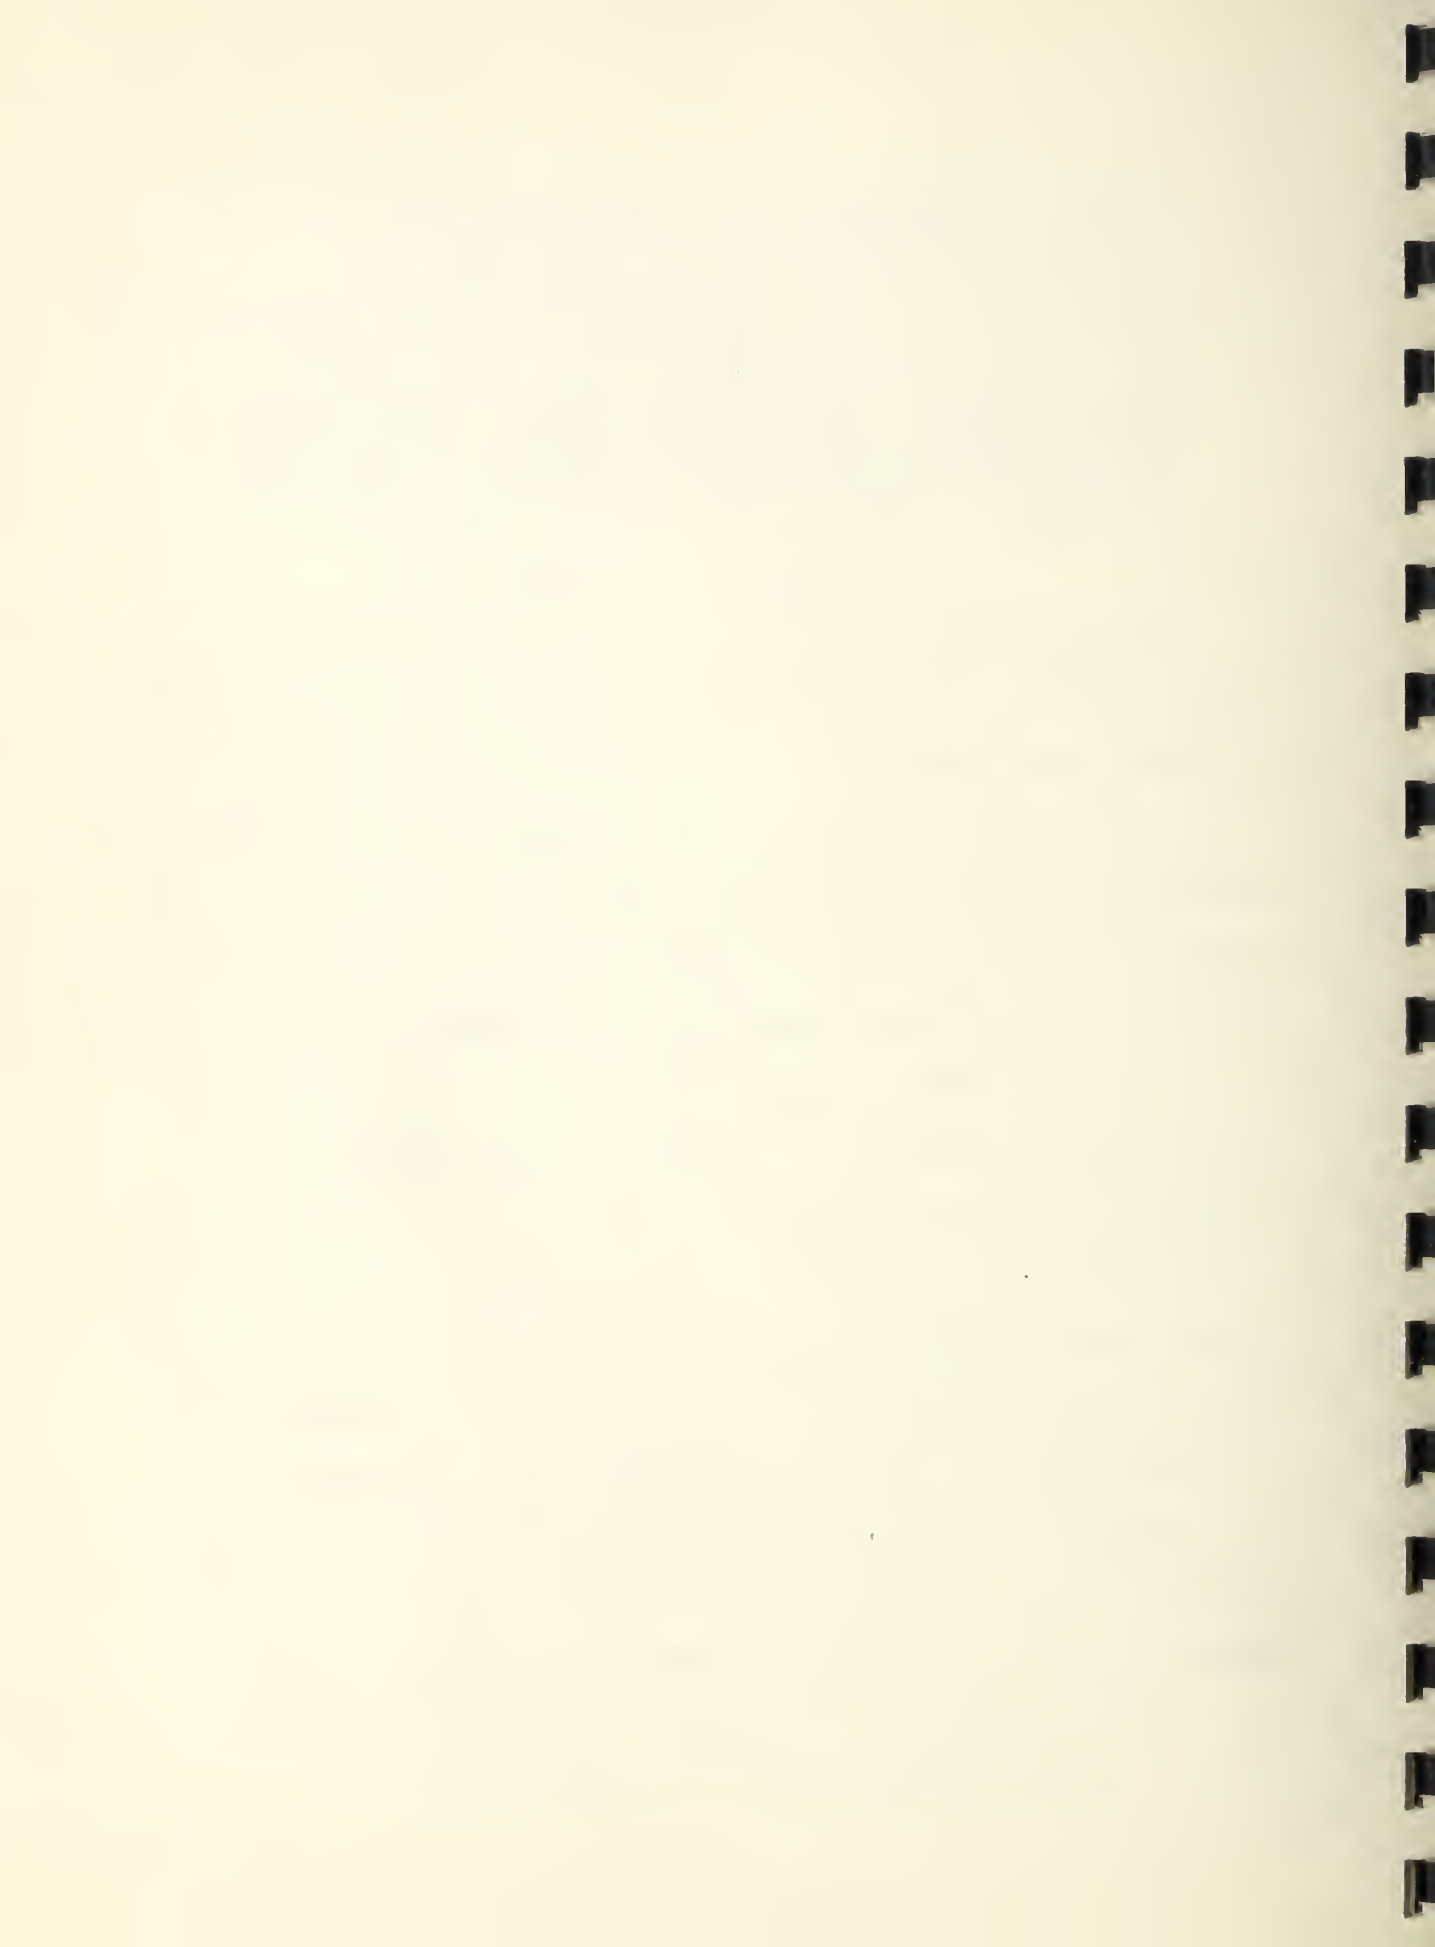
remained in a wet condition for an extended period, as was evident in the hospital building where streaks remained, indicating that water had condensed on the partition and coursed down the surface.

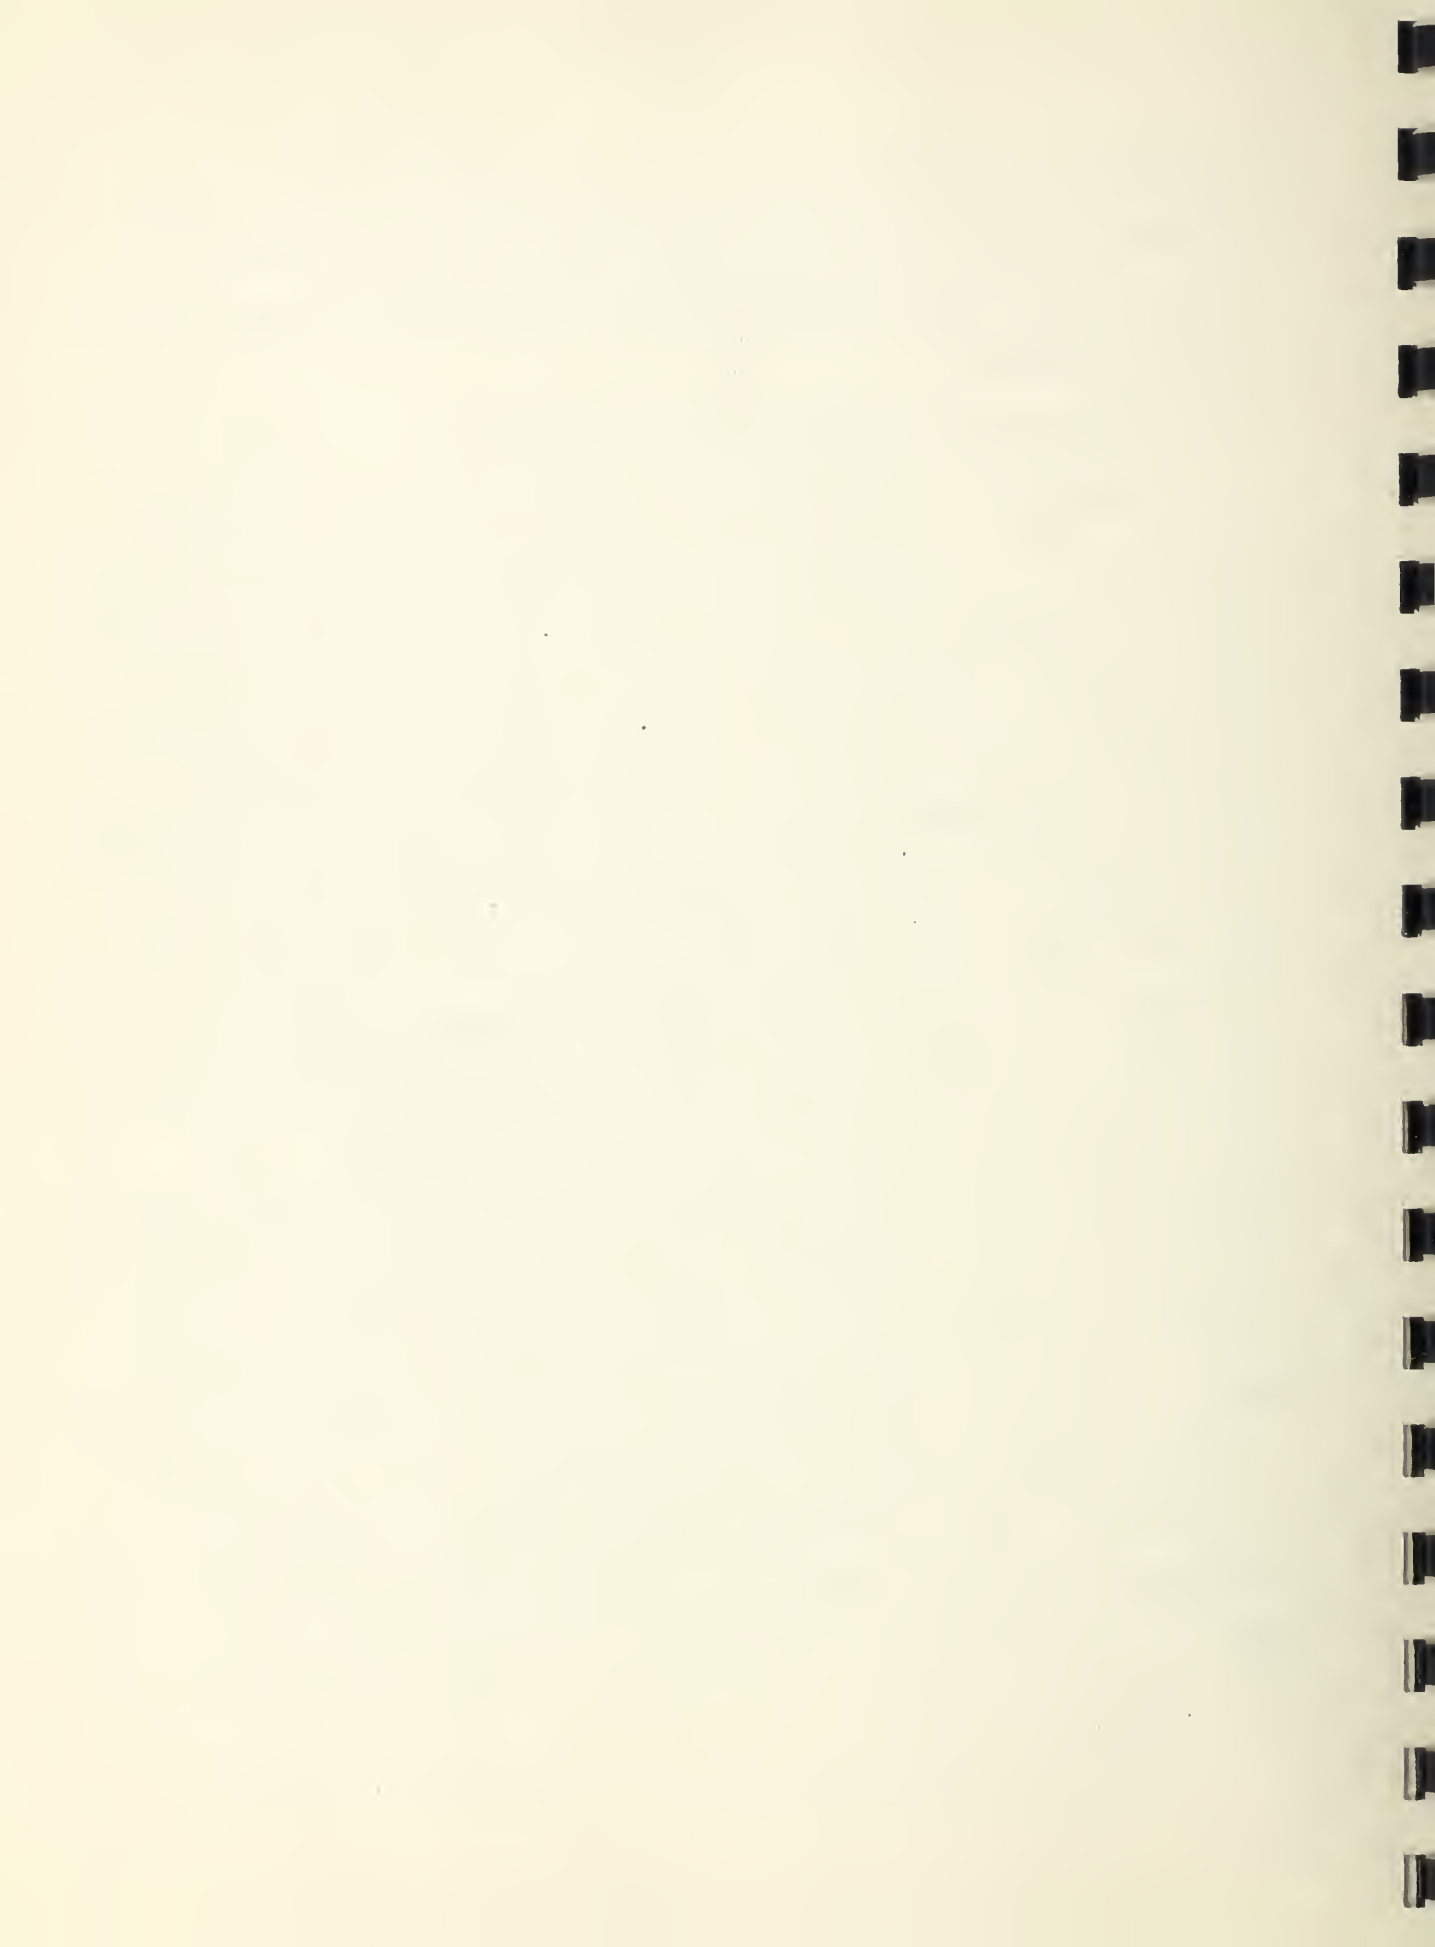
lath but a number of the ceramic tiles in the wainscots of bathrooms were found to be broken; and, in a number of places, wall tiles were found to be loose from the backing of portland cement plaster on metal lath. A tier of the wall tiles was removed from the wainscot in one location and three horizontal cracks in the cement plaster base were observed to be spaced about a foot apart in the height of the wainscot. These cracks extended through the neat cement setting mortar and the mortar base course made of portland cement and hydrated lime. The cracking of the base course of mortar for the tile wainscot was attributed to shrinkage.

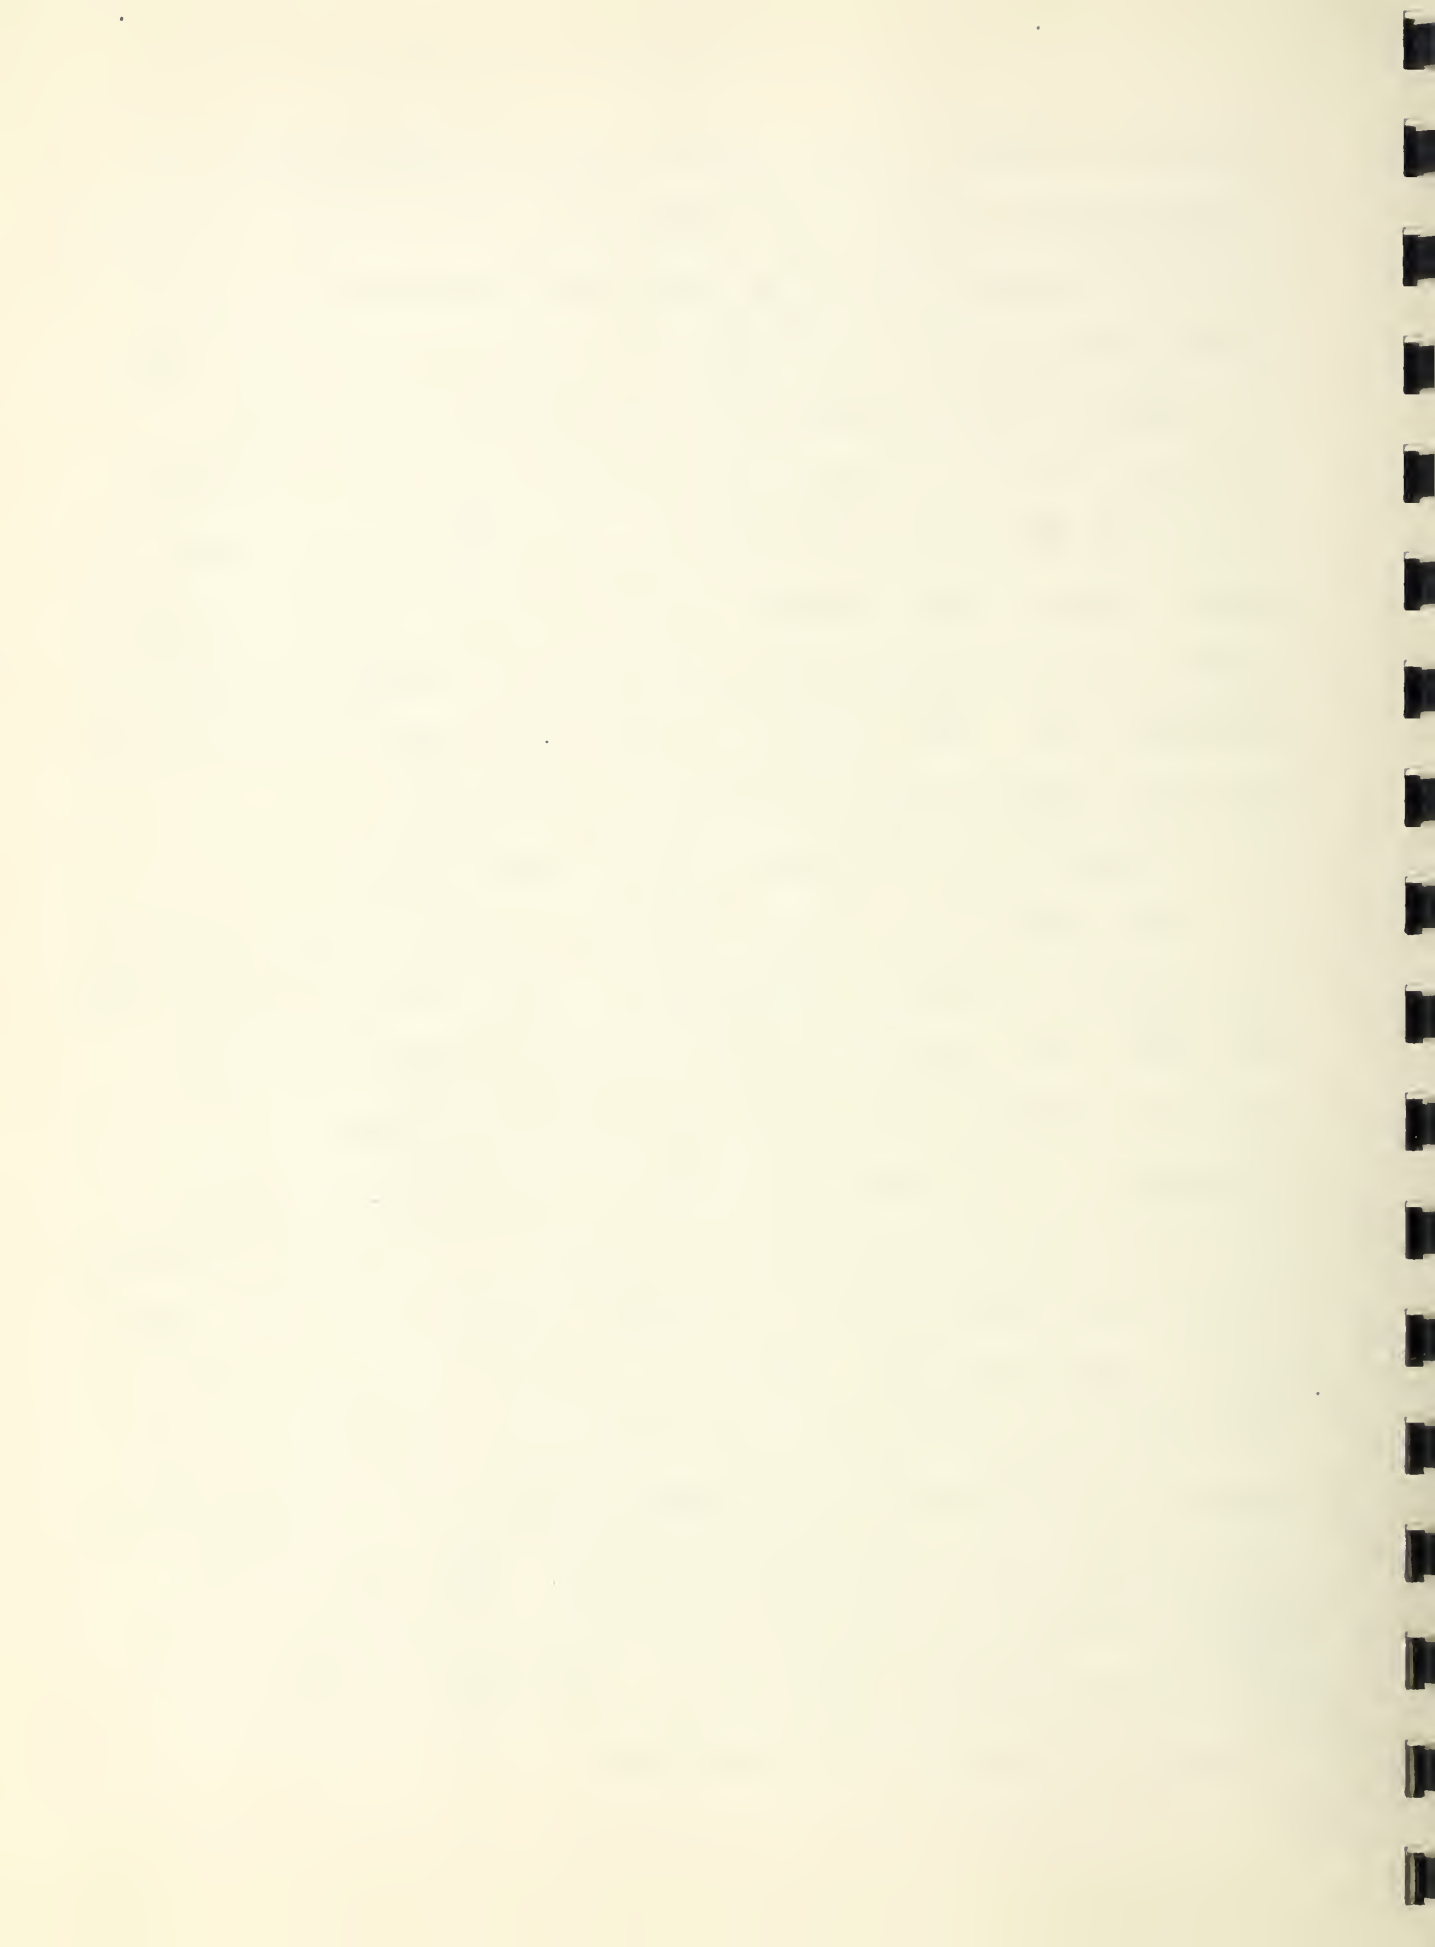
Approximately 60 percent of the rooms and all the corridors were visited. Cracks were found in almost all of the metal lath and plaster partitions inspected. There were also cracks in the lath and plaster furring for pipe spaces. A very large proportion of the plastered walls had been painted. In some instances, the painting had been done after the plaster had cracked. Many of the cracks, however, appeared to have occurred subsequent to the application of the paint, indicating that the cracking had been progressive.

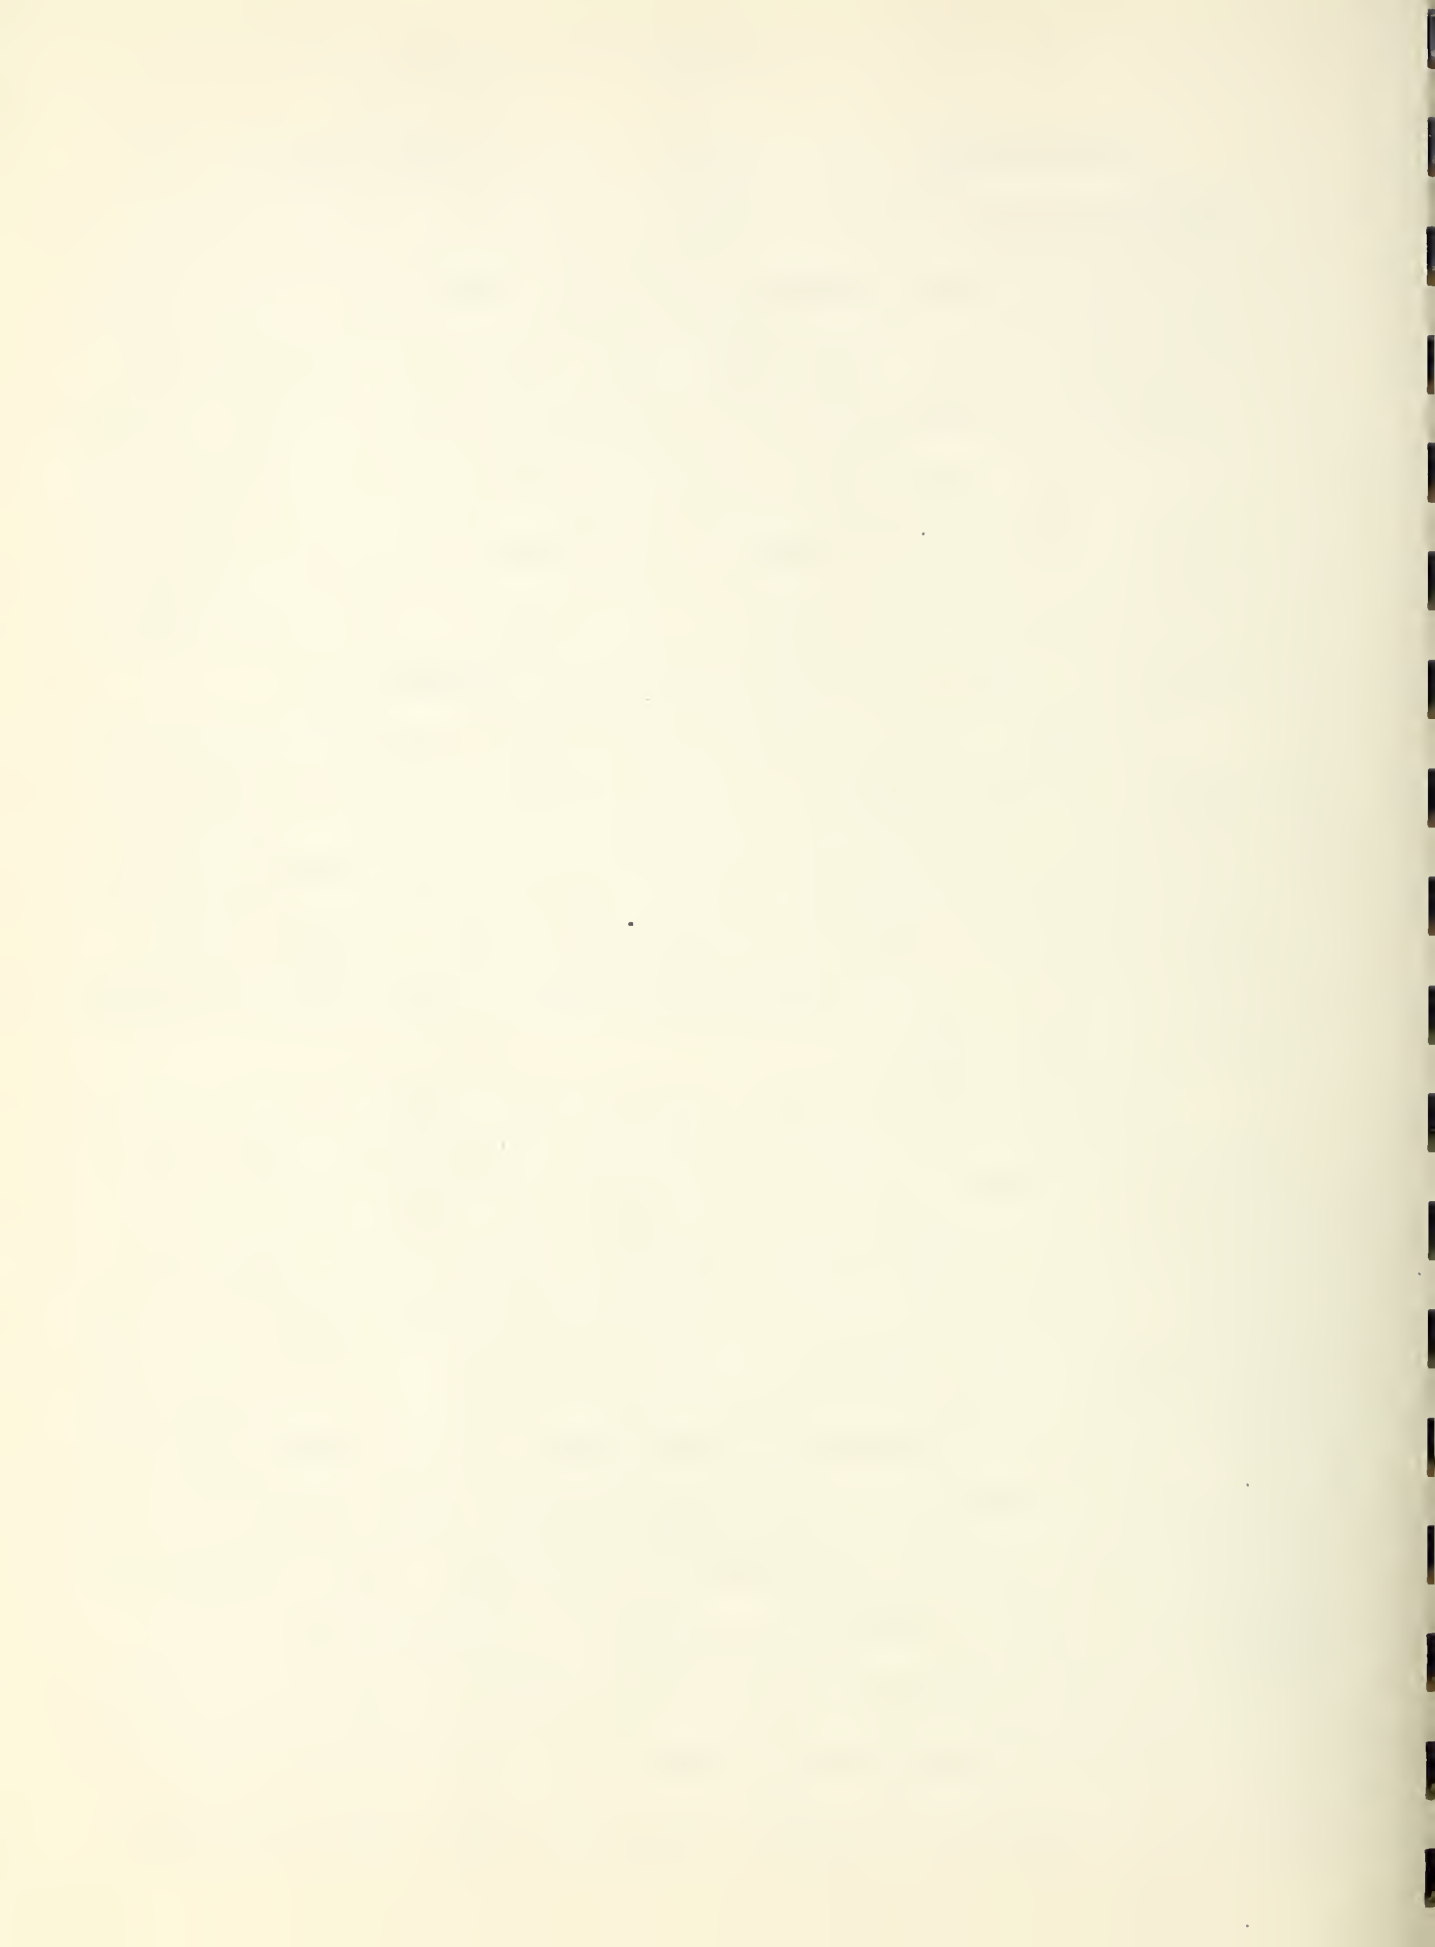
exposed in atmospheres having high or low humidity; and also how they were affected by changing from high to low humidity; and vice versa.

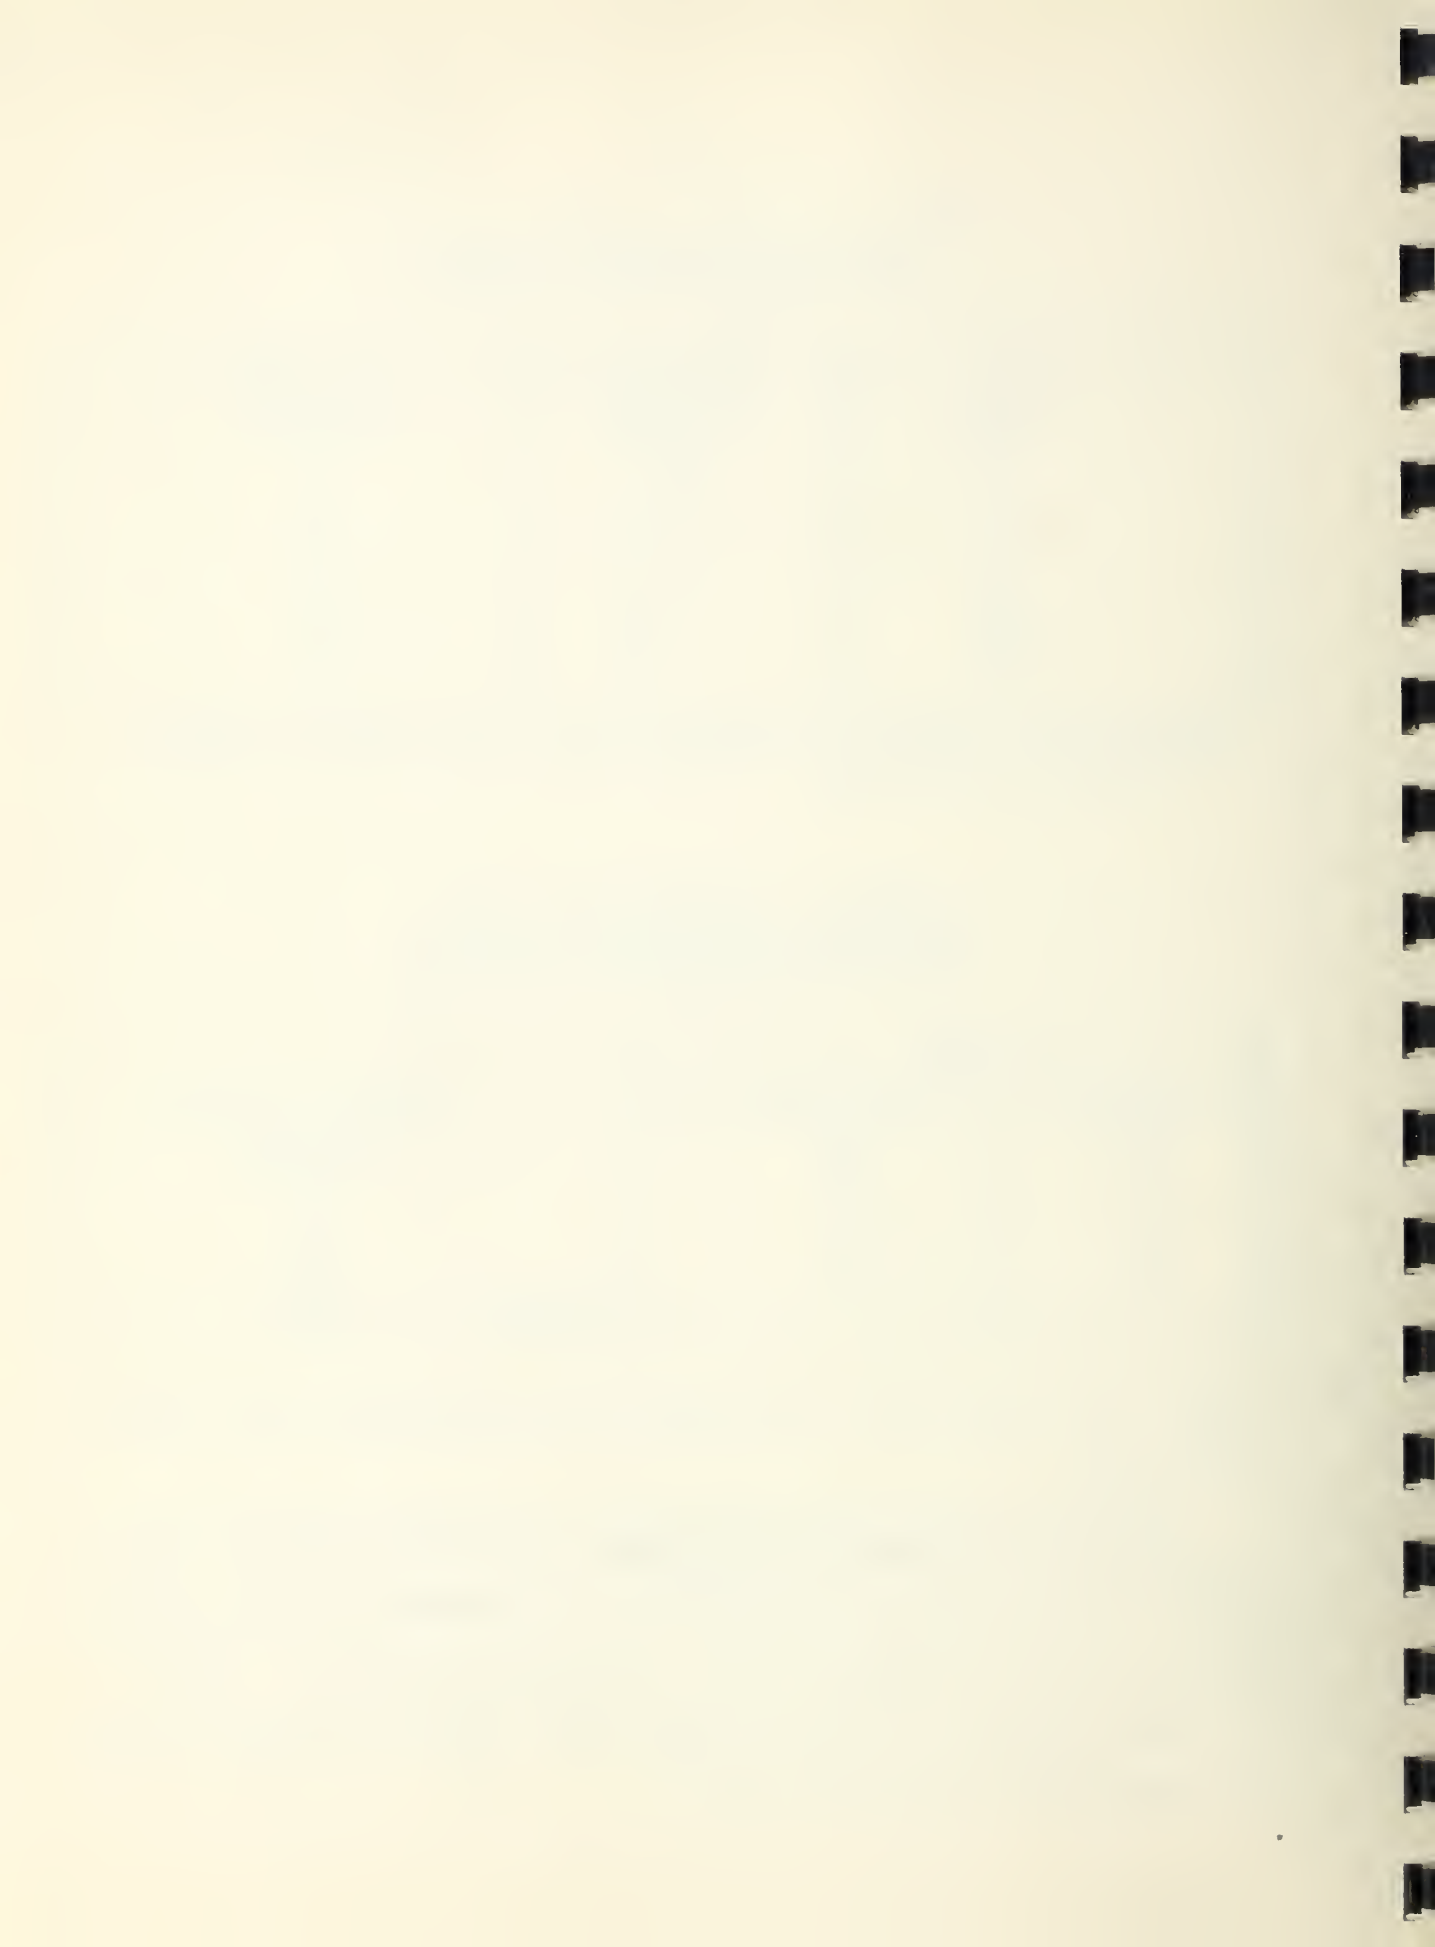
### 4.3 Hydrated Lime

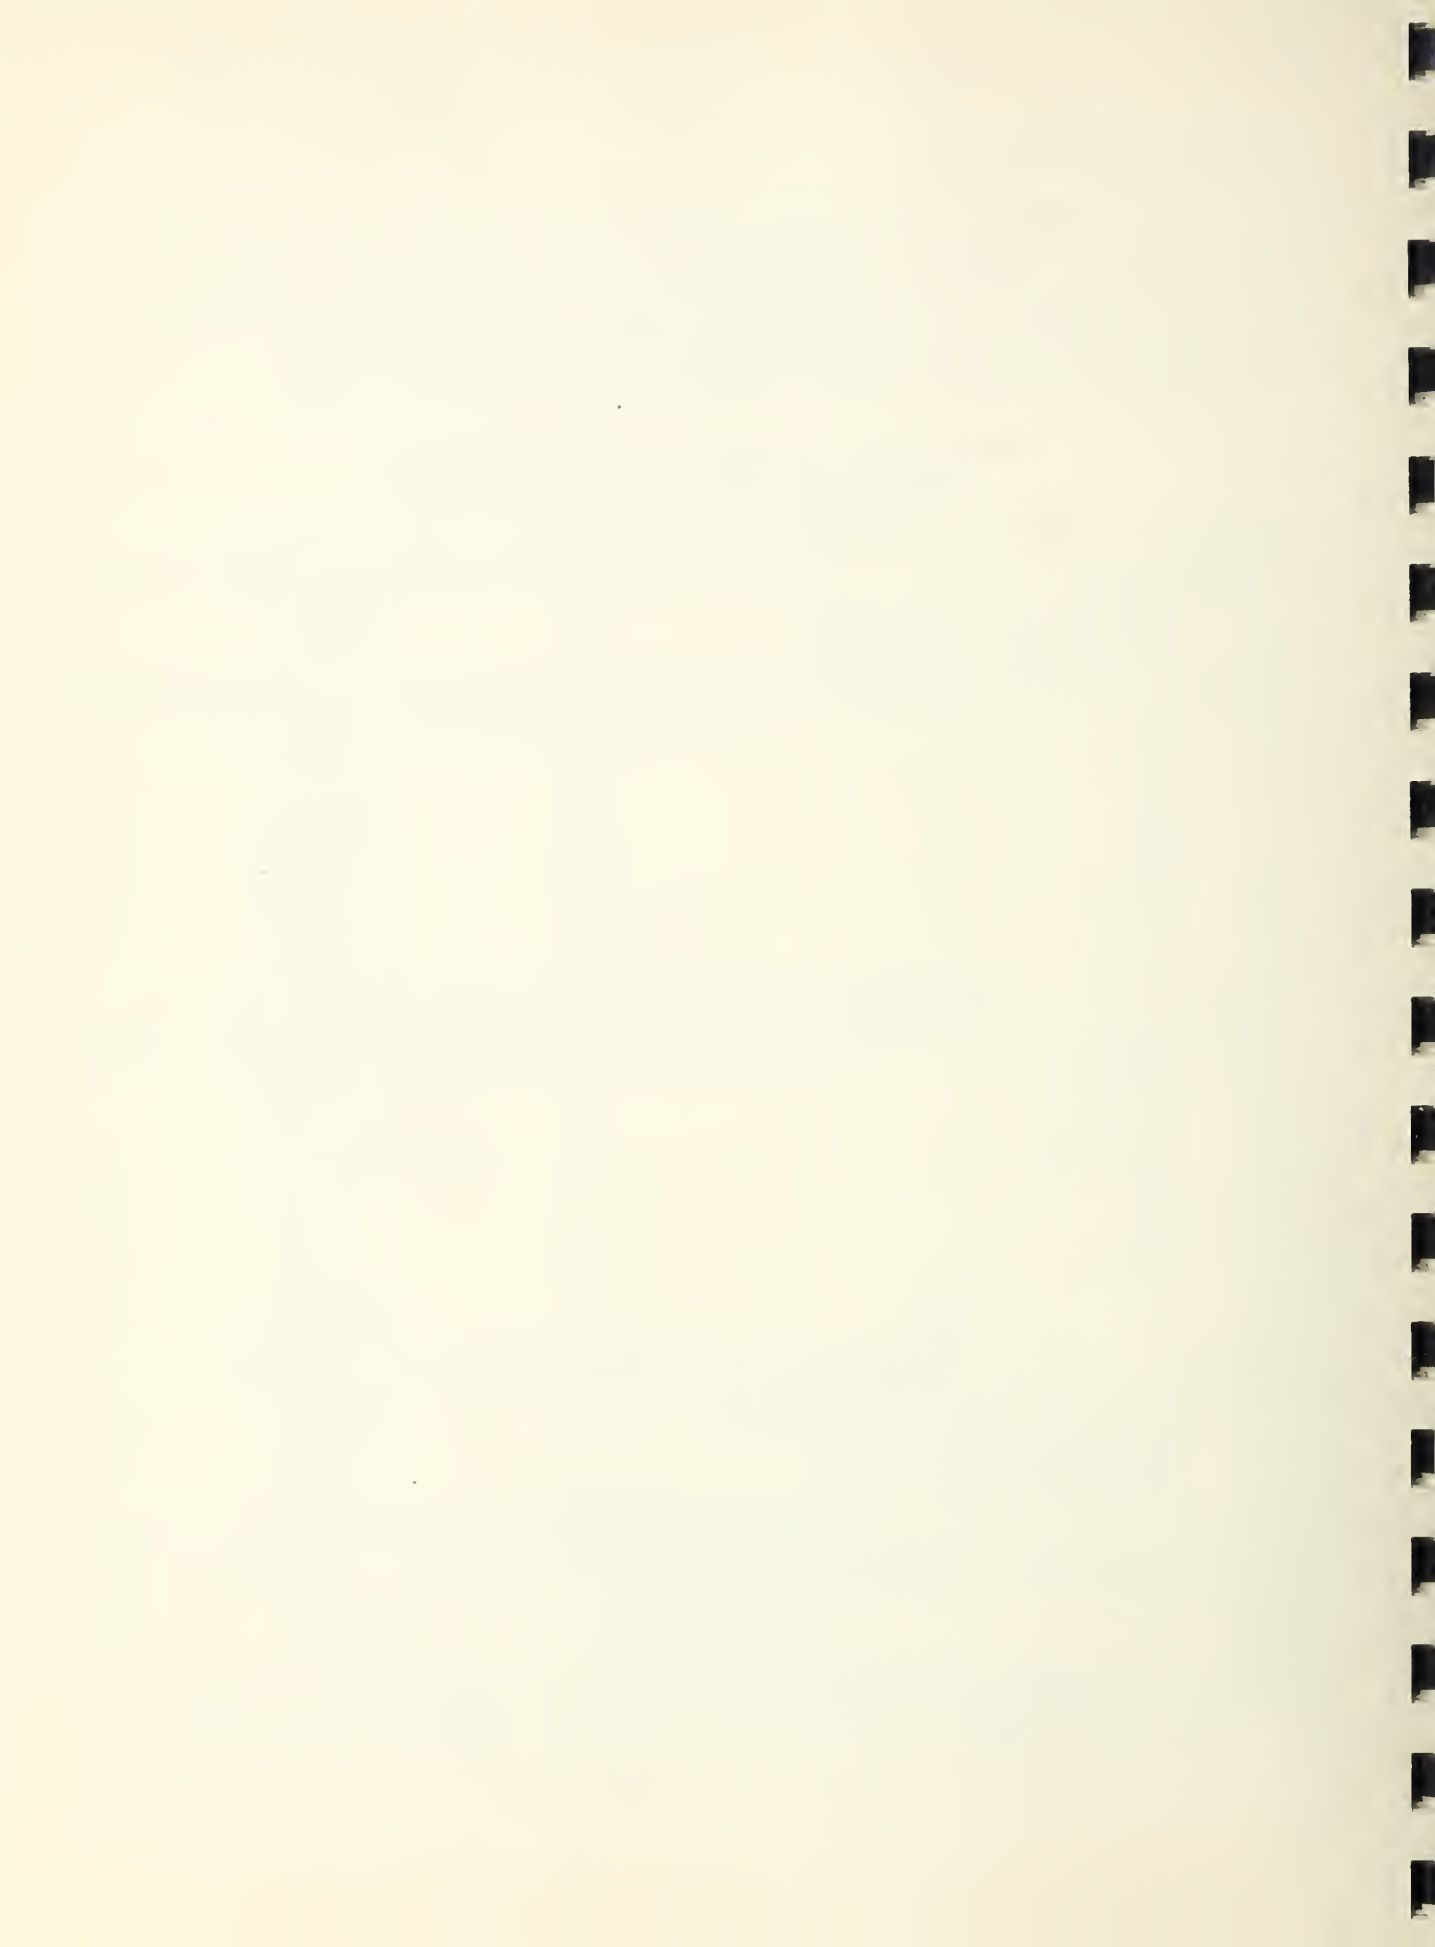
#### 4.4 Tests of Plaster Mixes
