**NATIONAL BUREAU OF STANDARDS REPORT**

REPORT ON  
INSPECTION AND TESTS OF PLASTER  
ALASKA NATIVE SERVICE HOSPITAL AND QUARTERS BUILDINGS

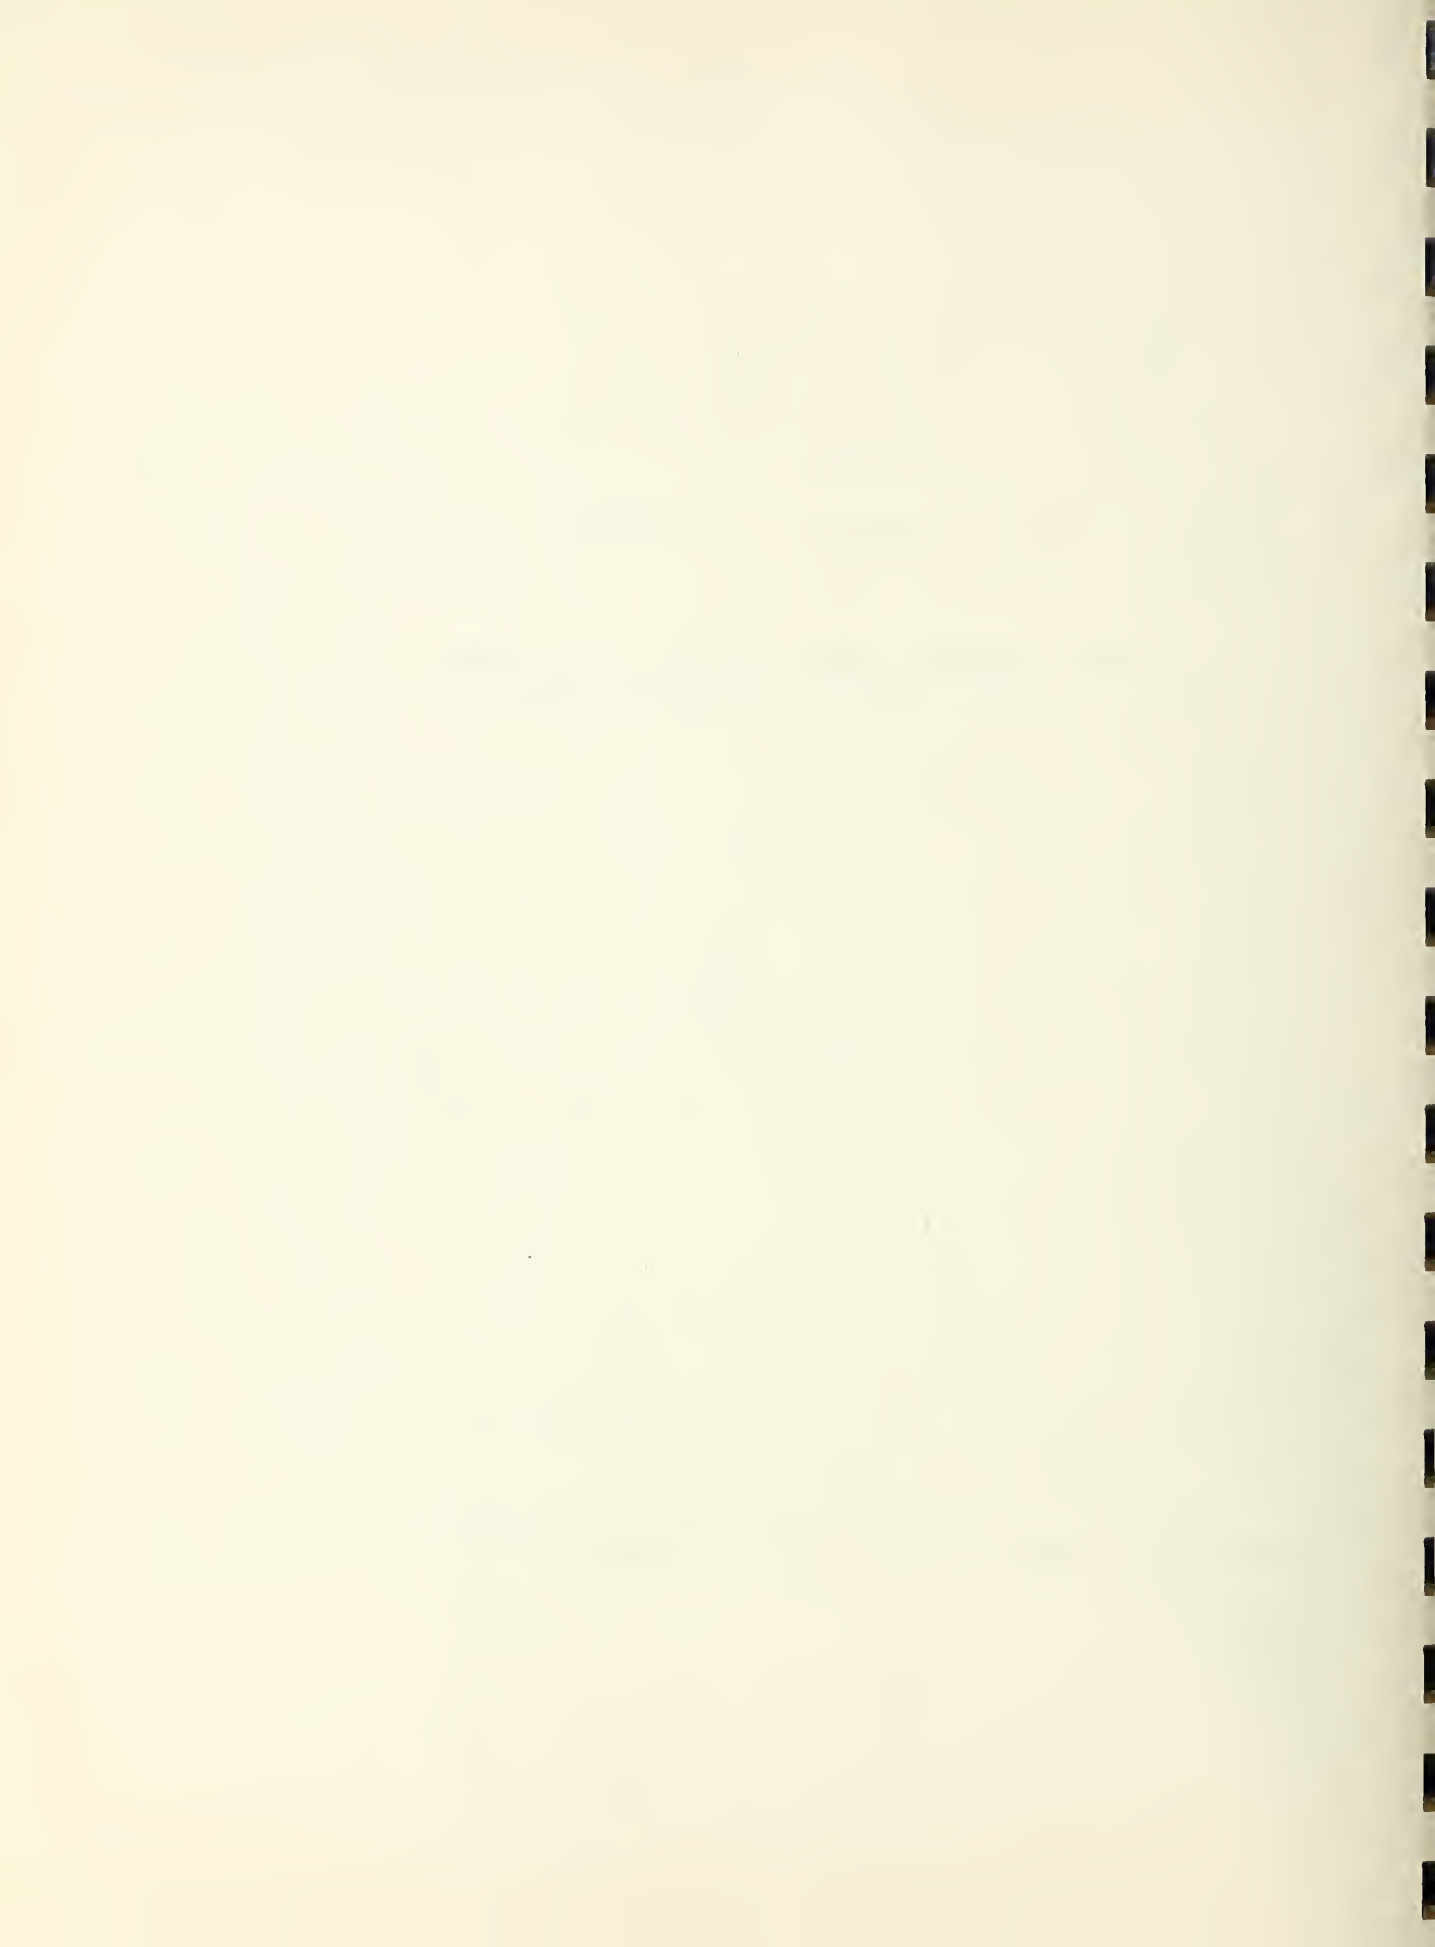
Table 6. Dimensional changes of set plaster specimen  
(Minus quantities indicate shrinkage)

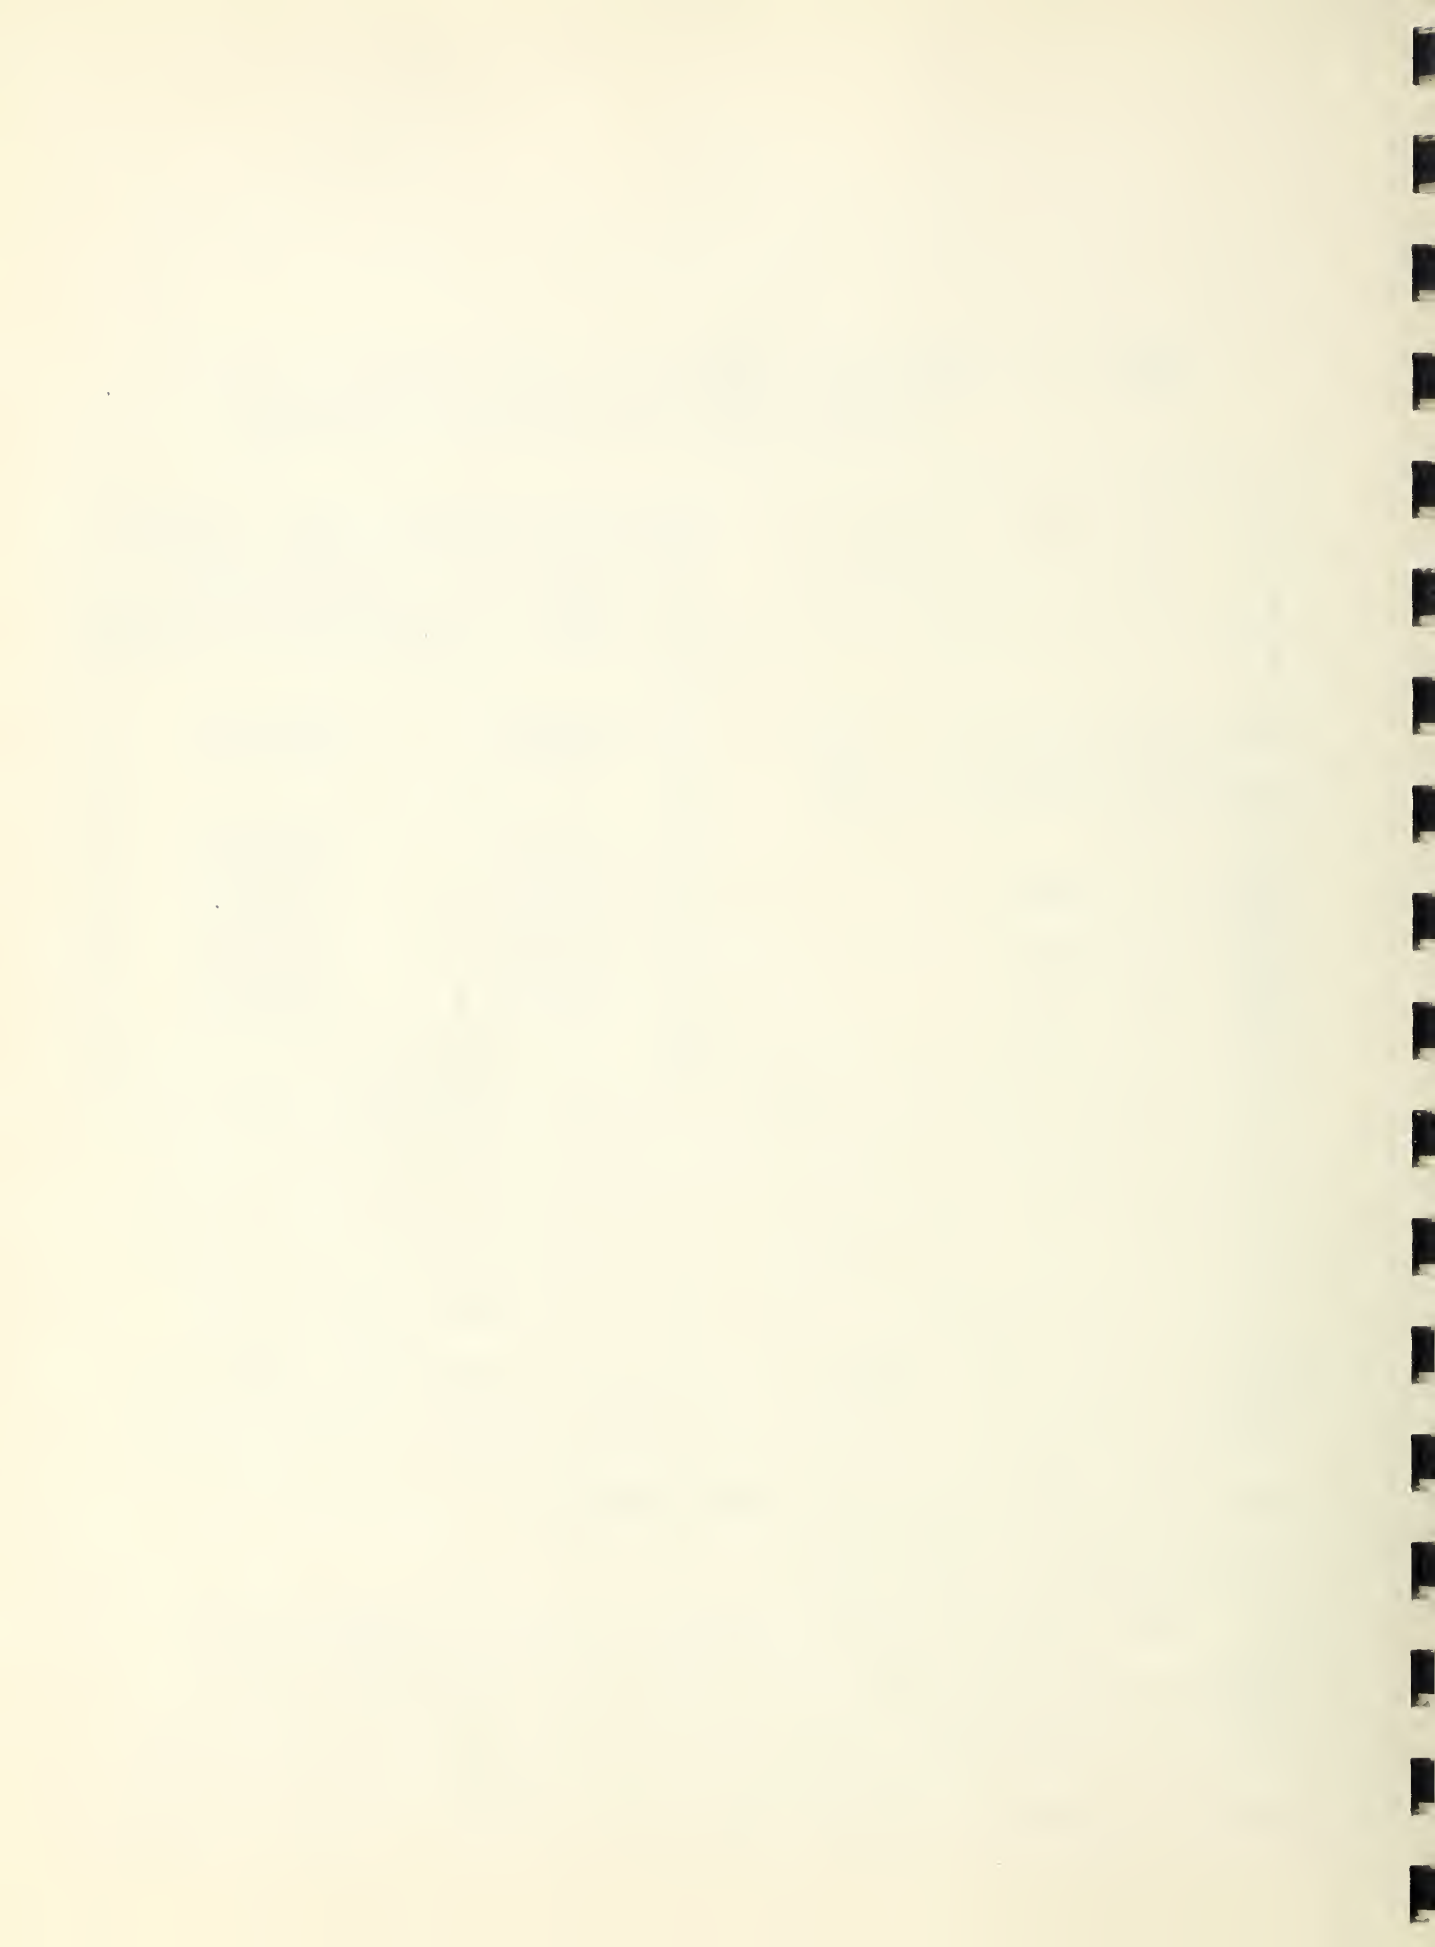
inset stainless steel reference points. The specimens were 1 in. square by 11 3/8 in. long with 10 in. length between the inner ends of the reference points. The barspecimens were measured as soon as removed from the molds and at intervals thereafter, as shown in table 7. They were stored in the laboratory maintained at 73°F (23°C) with relative humidity at 50 percent until the interval immediately preceding the last reading, in which latter interval the relative humidity of the container in which the bars were stored, was 30 percent, the temperature remaining 73°F (23°C).

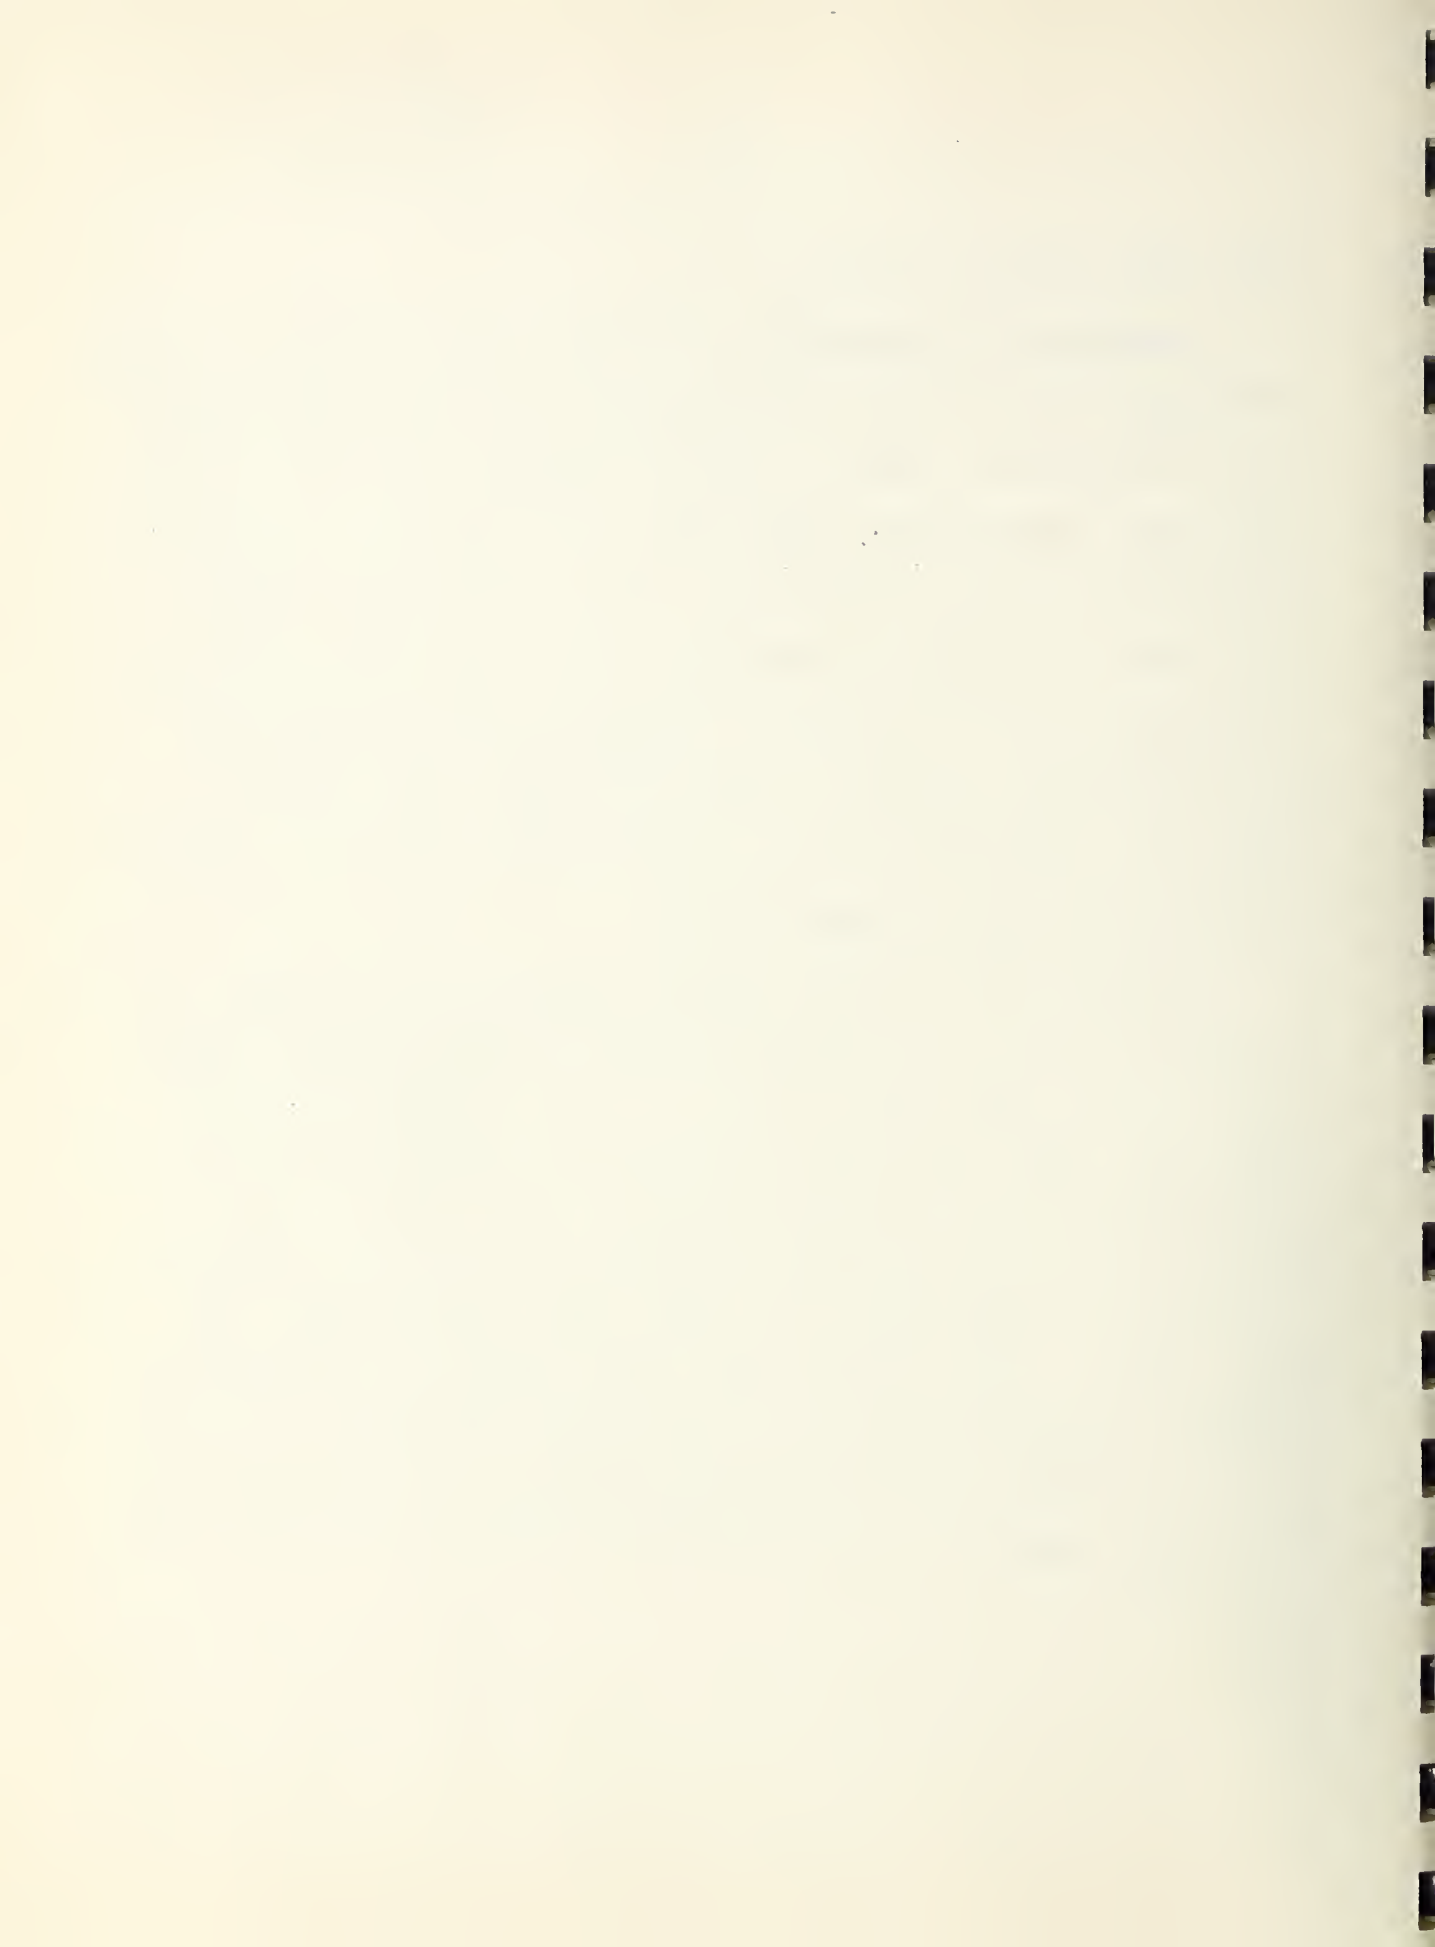
Table 12. Analysis of white finish plaster from hospital building  
(Basis, material dried at 45°C)

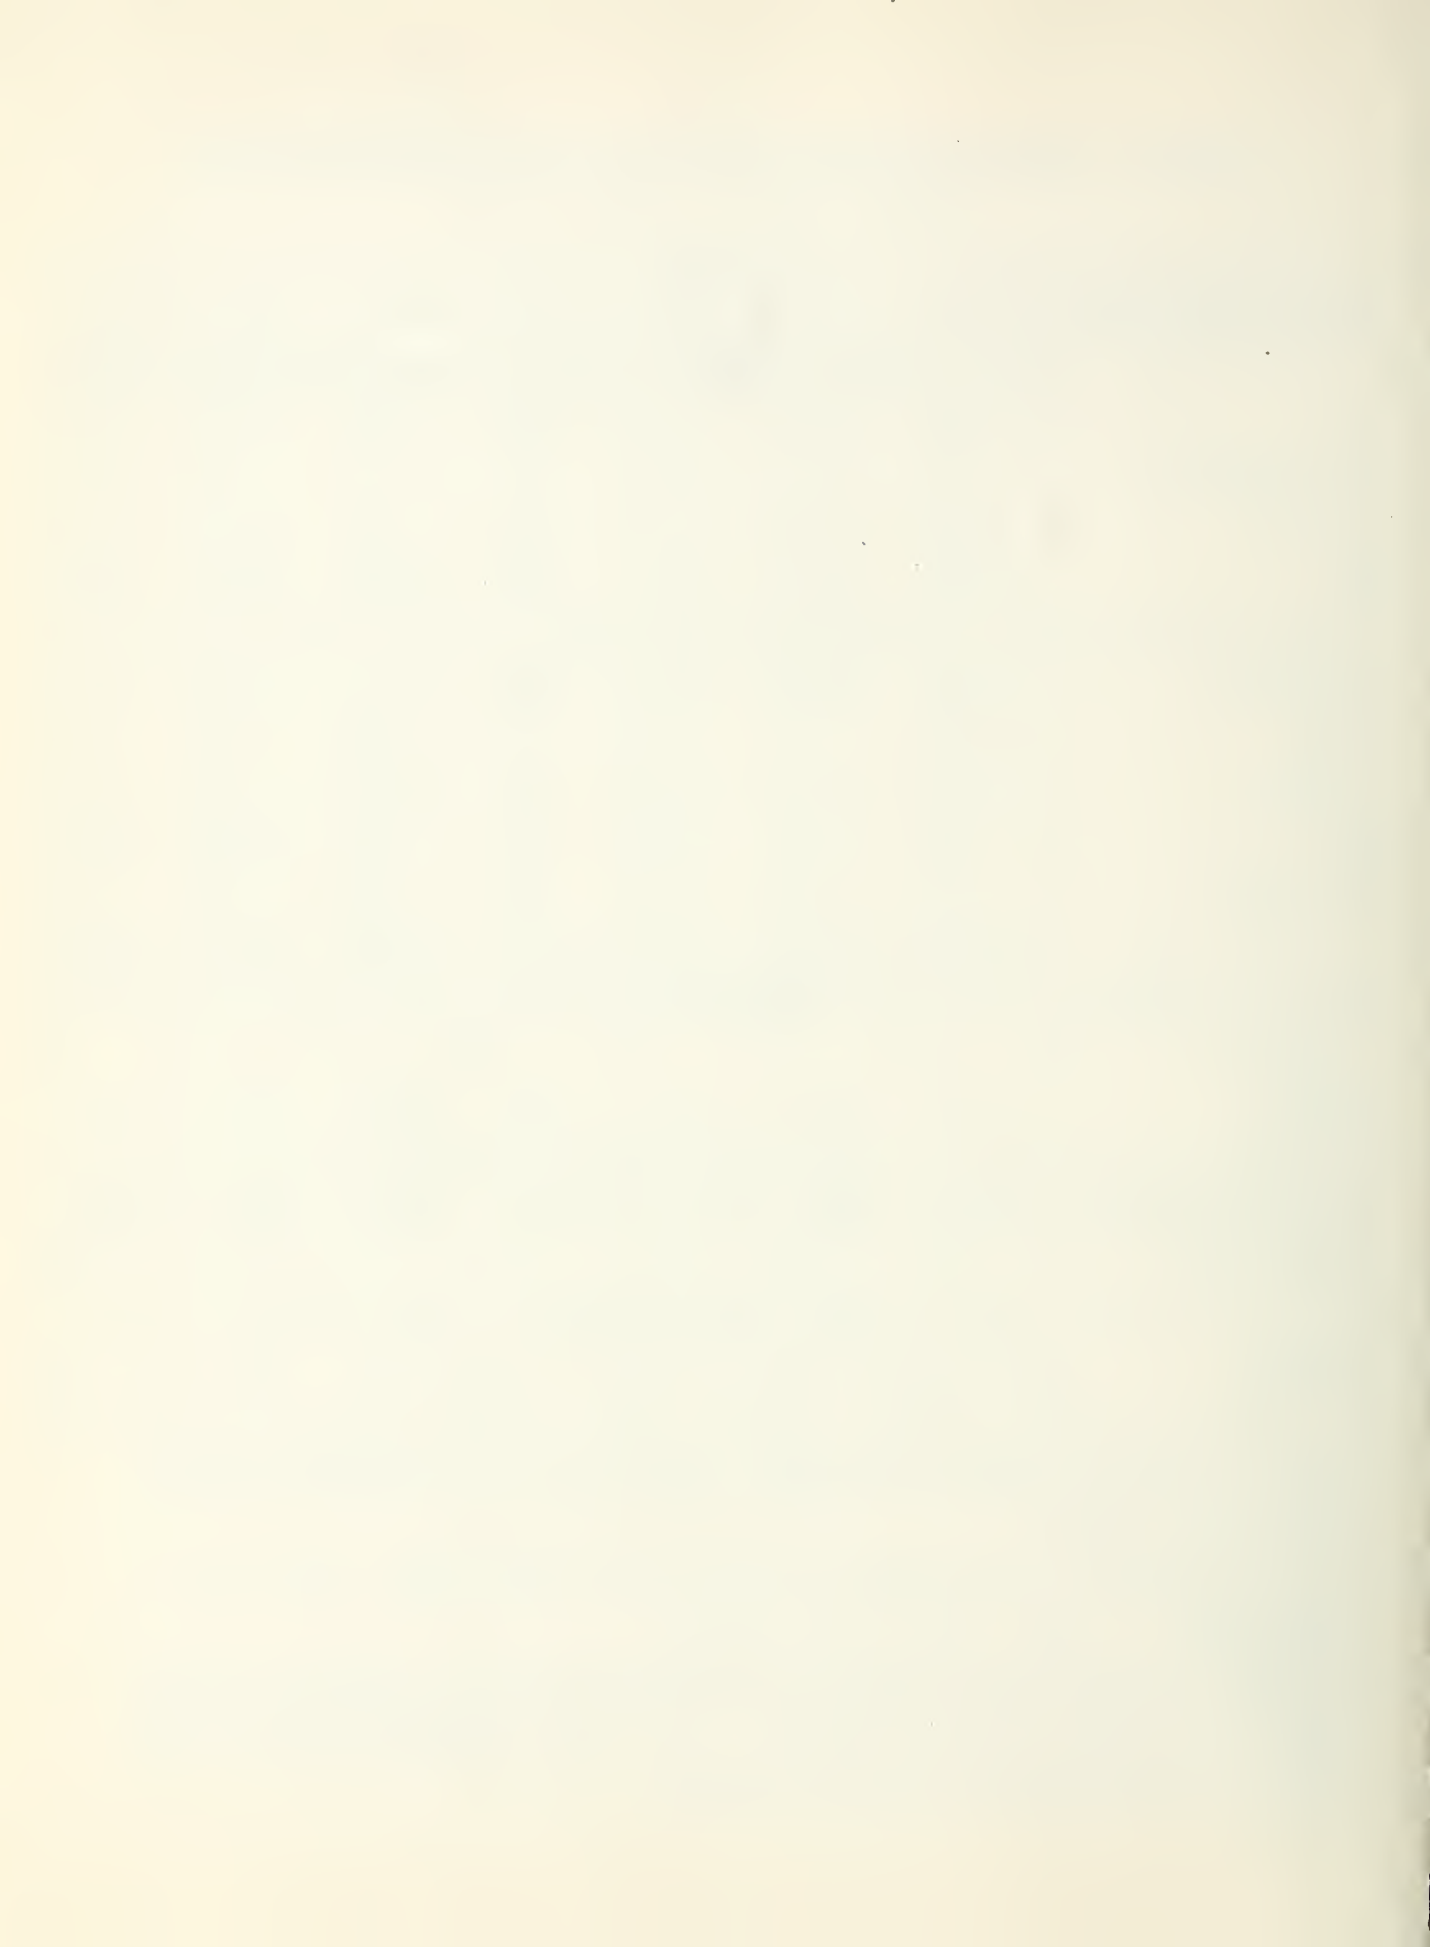
There is a high degree of probability that the same reactions had occurred in other stories of the building, but in the calculations of compositions the evidence is masked as long as any magnesium oxide (MgO) appears to remain unhydrated. This type of reaction would occur in the more favorable locations, rather than uniformly throughout the white finish plaster, and may account for initiation of cracking and the closer spacing of plaster cracks near the floors.

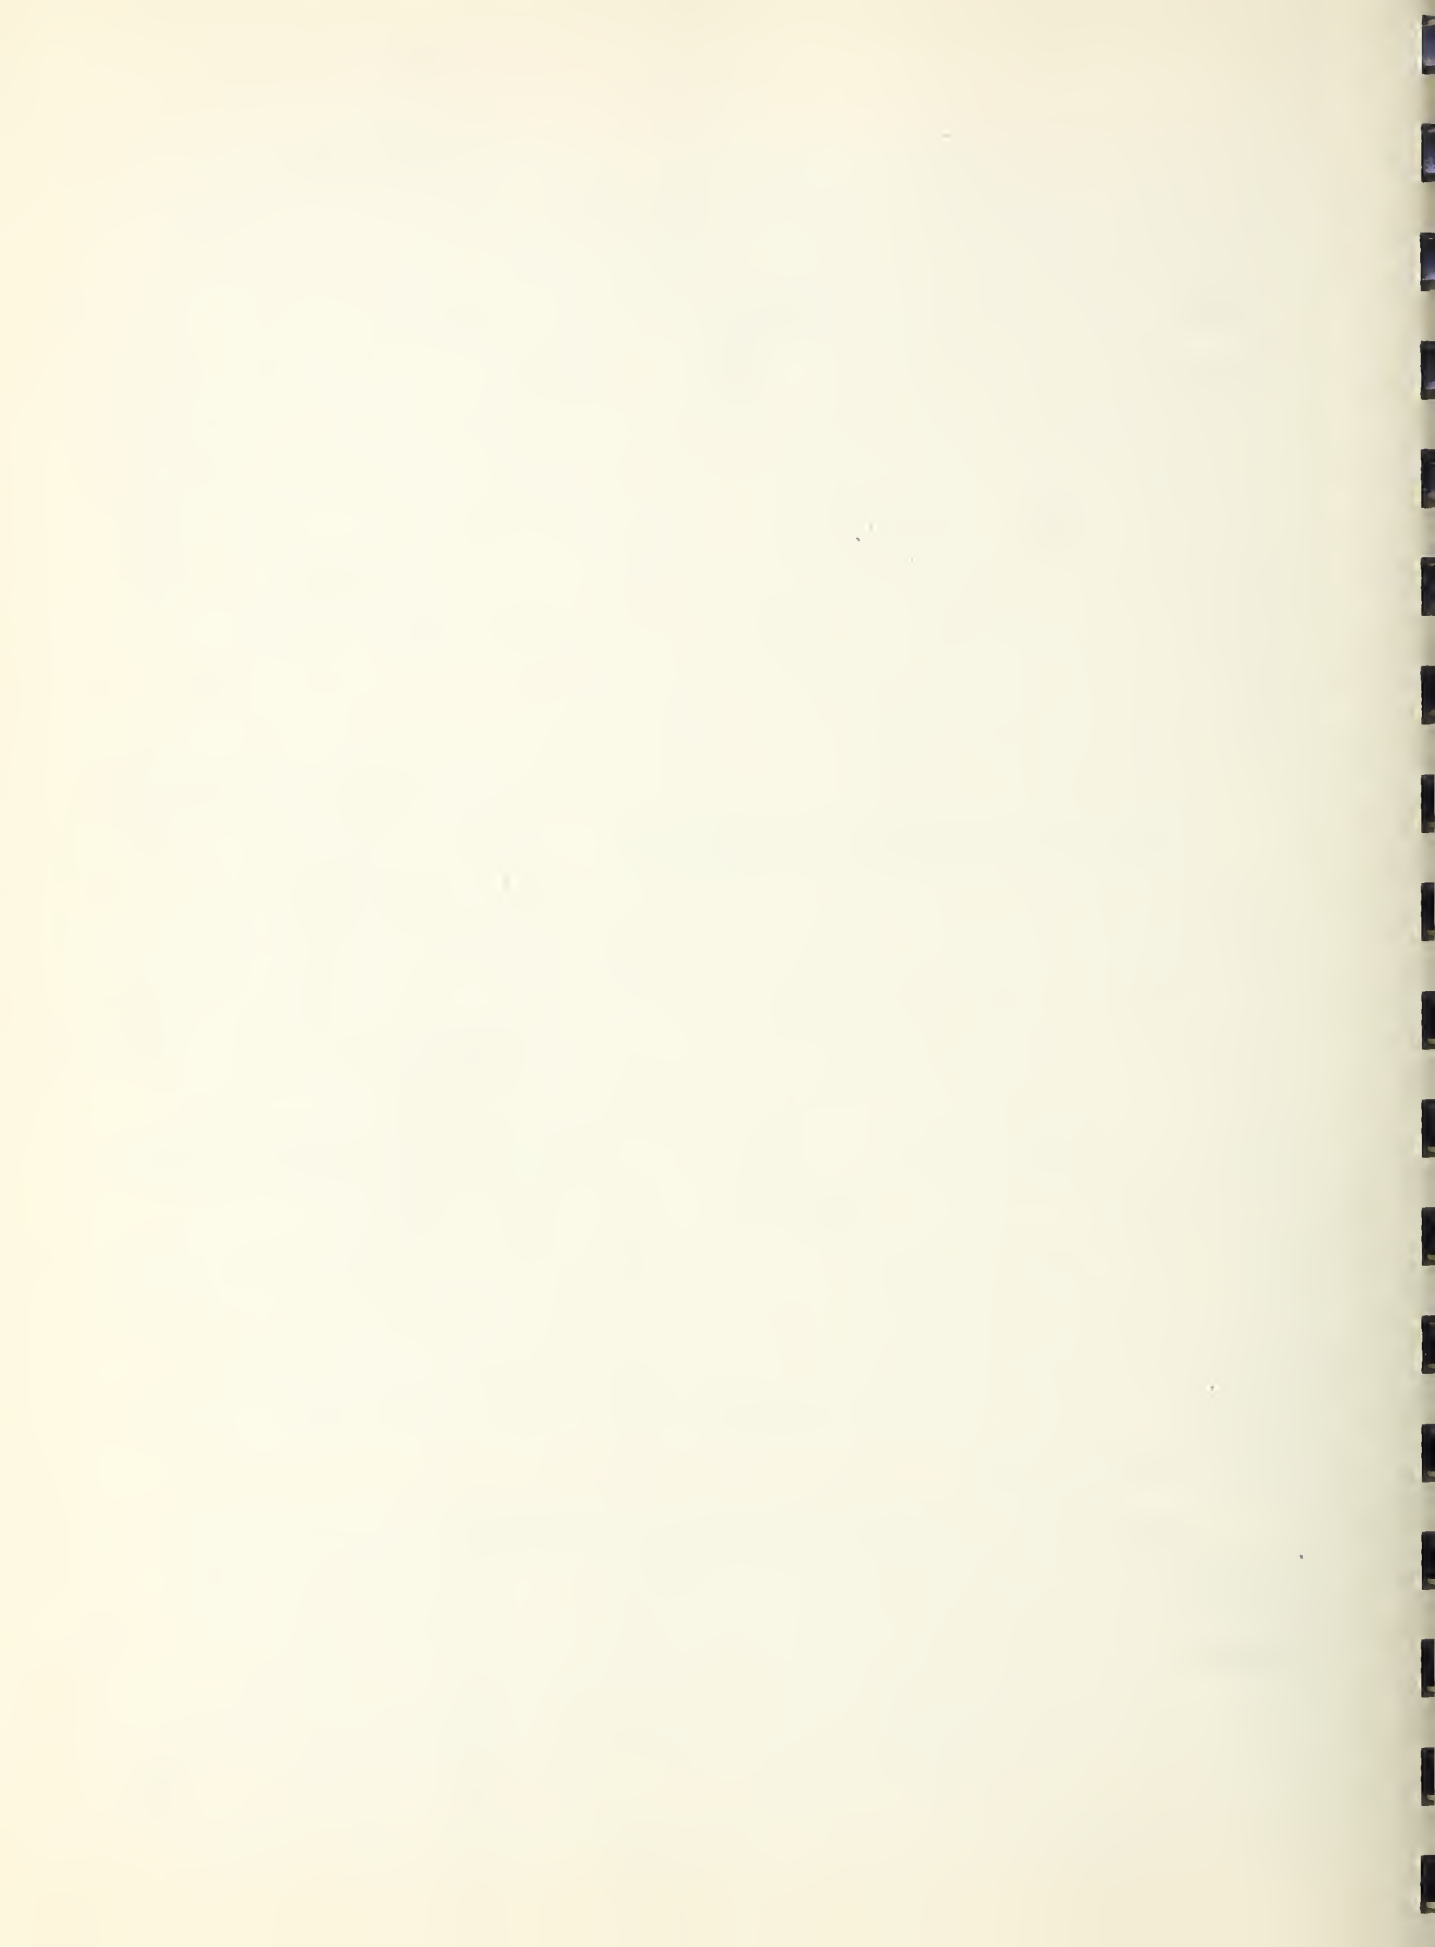
to reading are shown as percentages of the 10-in gage length.

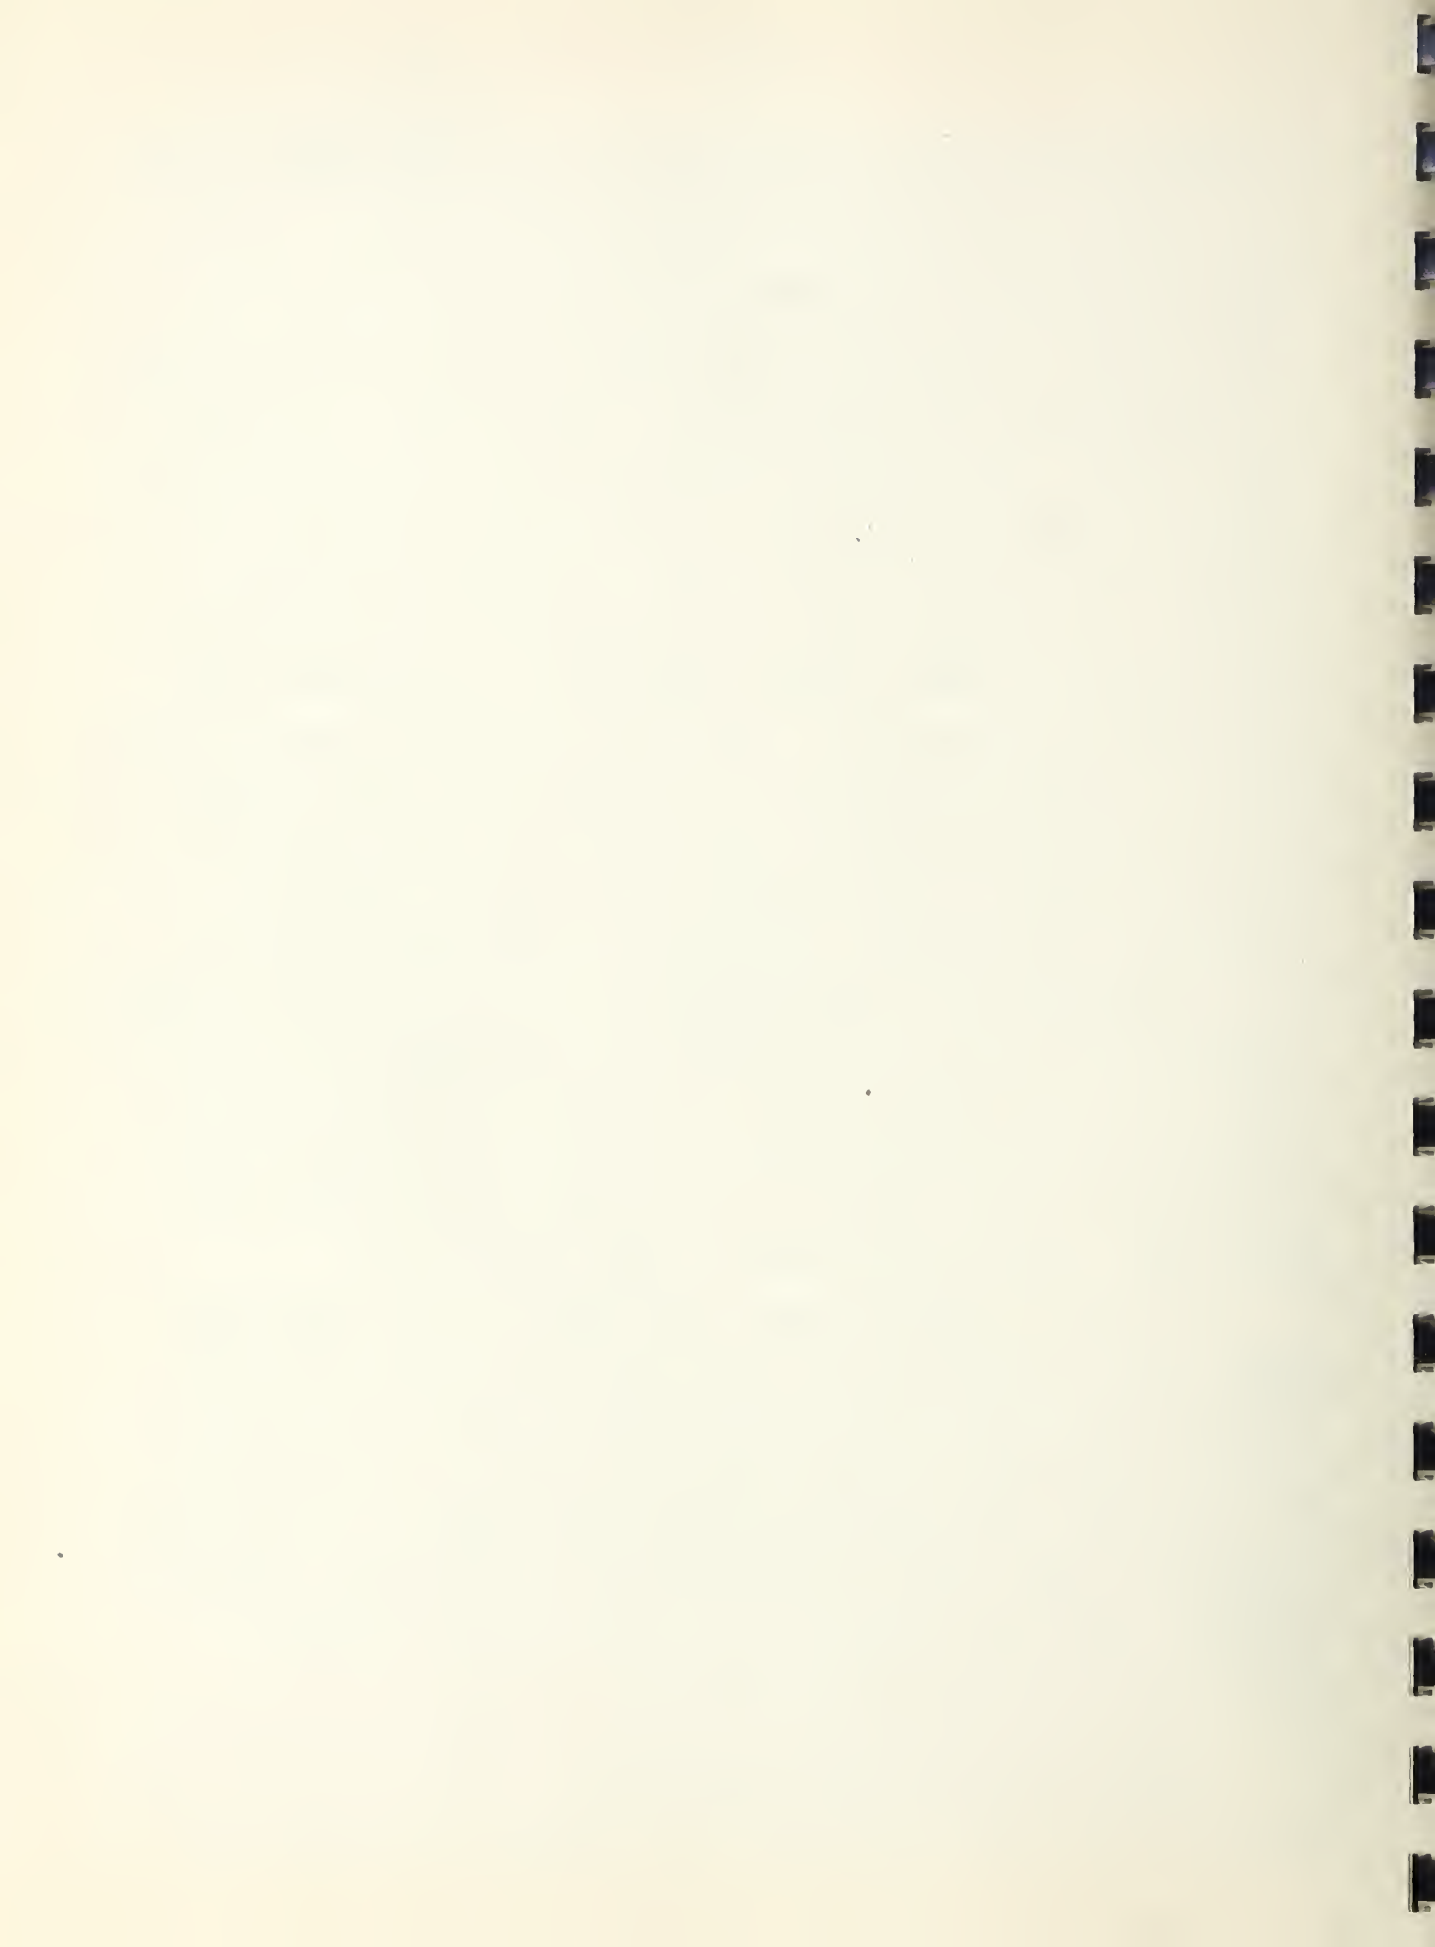
examined for friability and thickness of plaster as well as the condition of the lath. The plaster had been applied in three coats: scratch, brown, and finish coats. There were voids in the furrows in some parts of the scratch coat where the brown coat plaster had not filled the scratch furrows, and there appeared to be a plane of weakness in one specimen between the scratch and brown coats. The gypsum plaster seemed to be weak and somewhat more friable than is the case with the usual gypsum plaster as applied to metal lath. The white finish was decidedly stronger than the base coats.

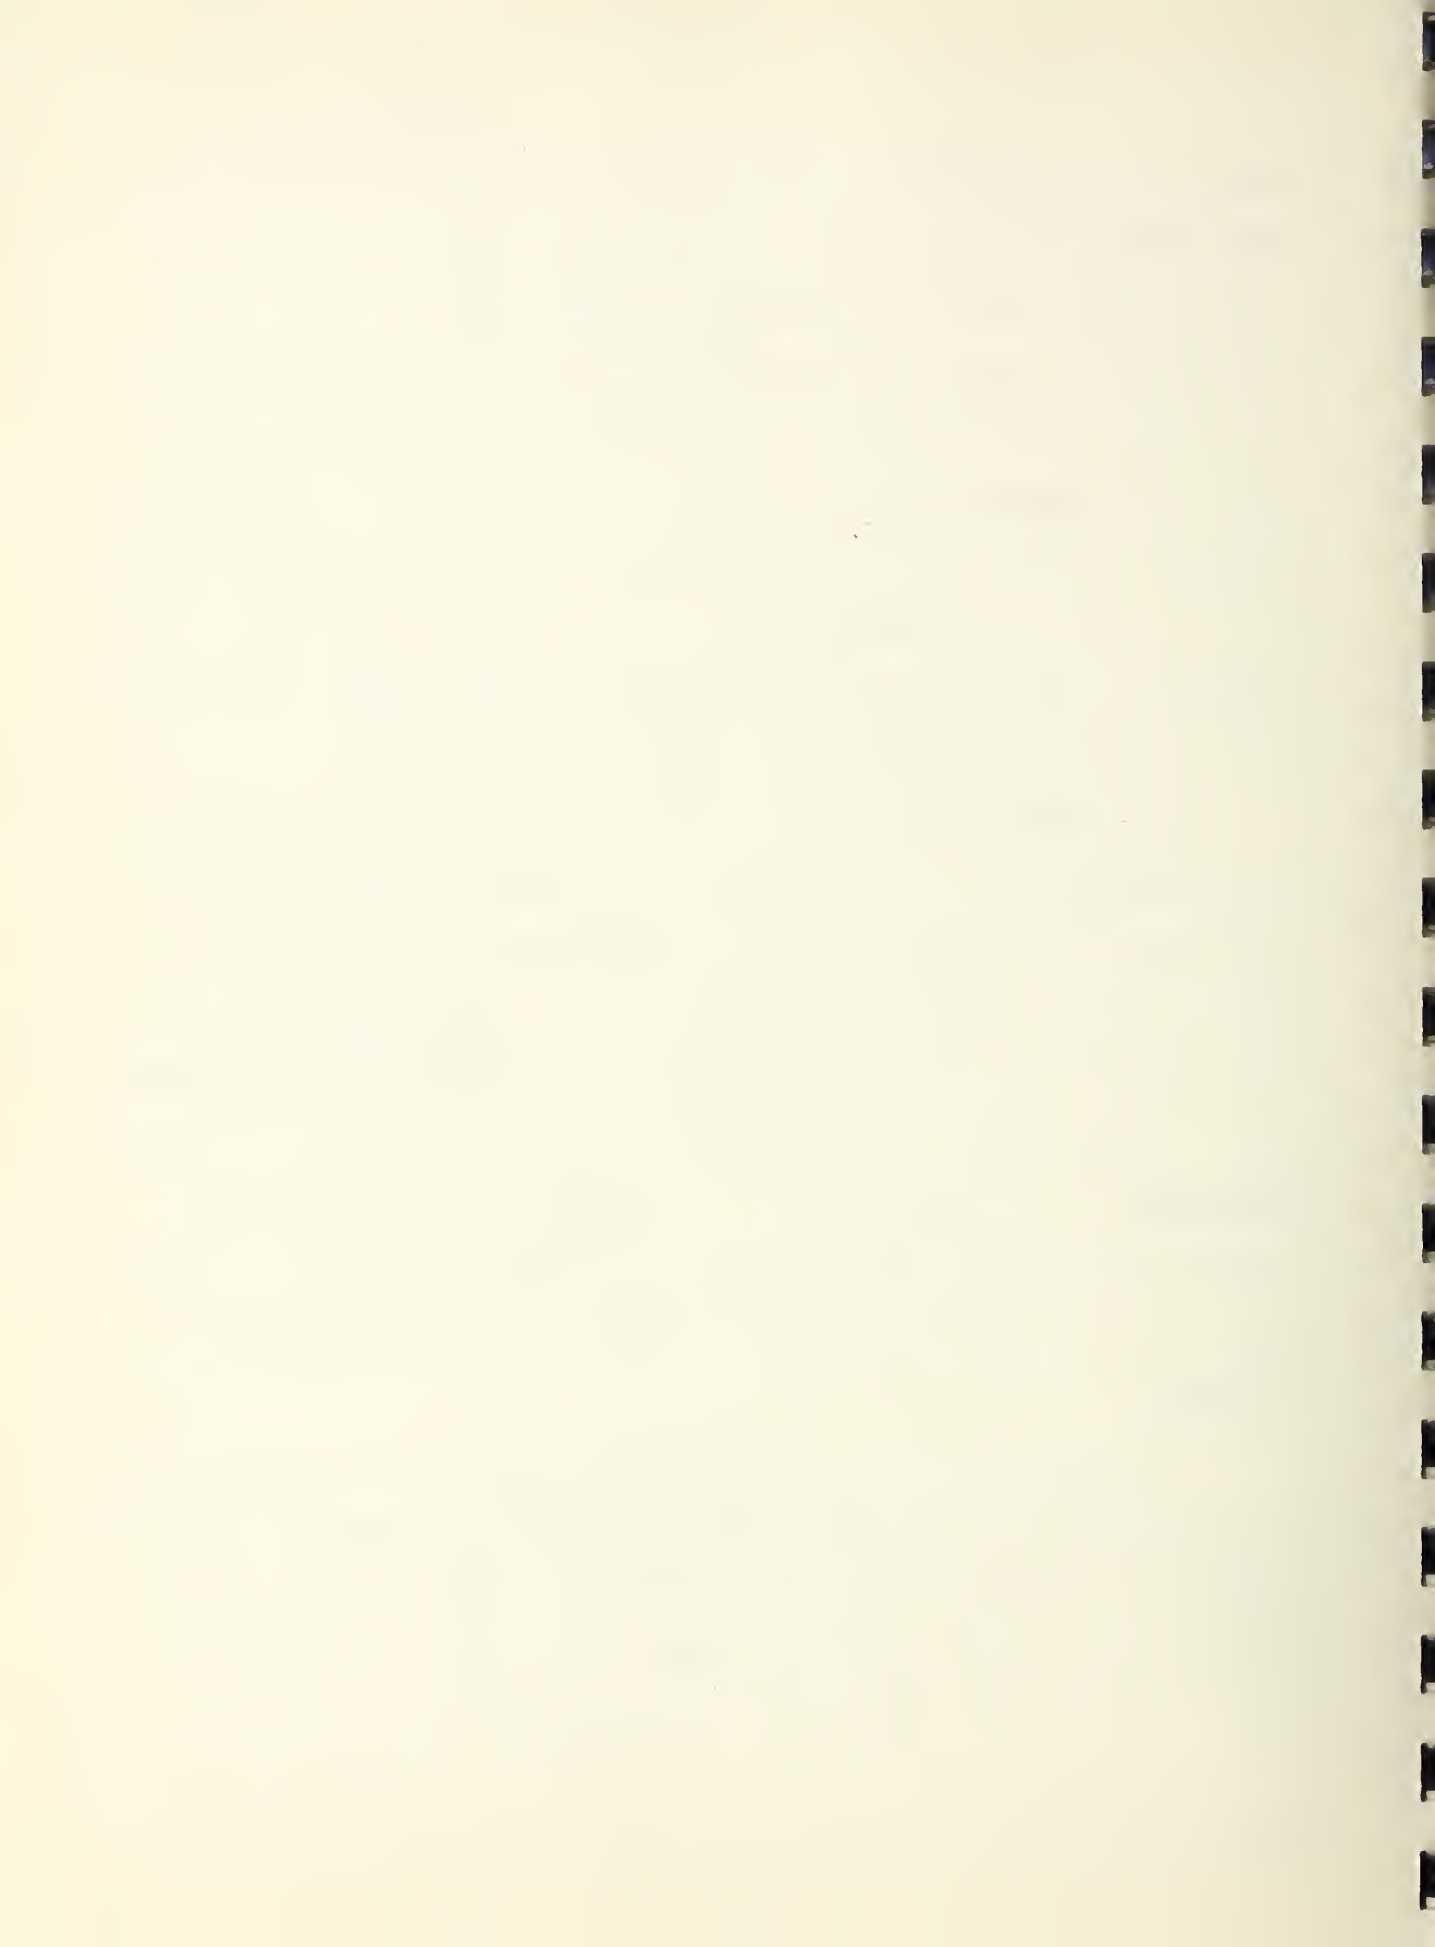
1 1/8 in., the average being 0.66 in. At 68 of the 101 points where the measurements were made, the depth from the surface to the lath was less than specified, and at 19 points it was in the range of 1/4 to 1/2 in., the average of the latter range being 0.44 in. Inasmuch as the strength of the plaster in resisting bending varies as the square of the thickness, it can be assumed without question that the deficiency in thickness was a factor in the development of the plaster cracks.

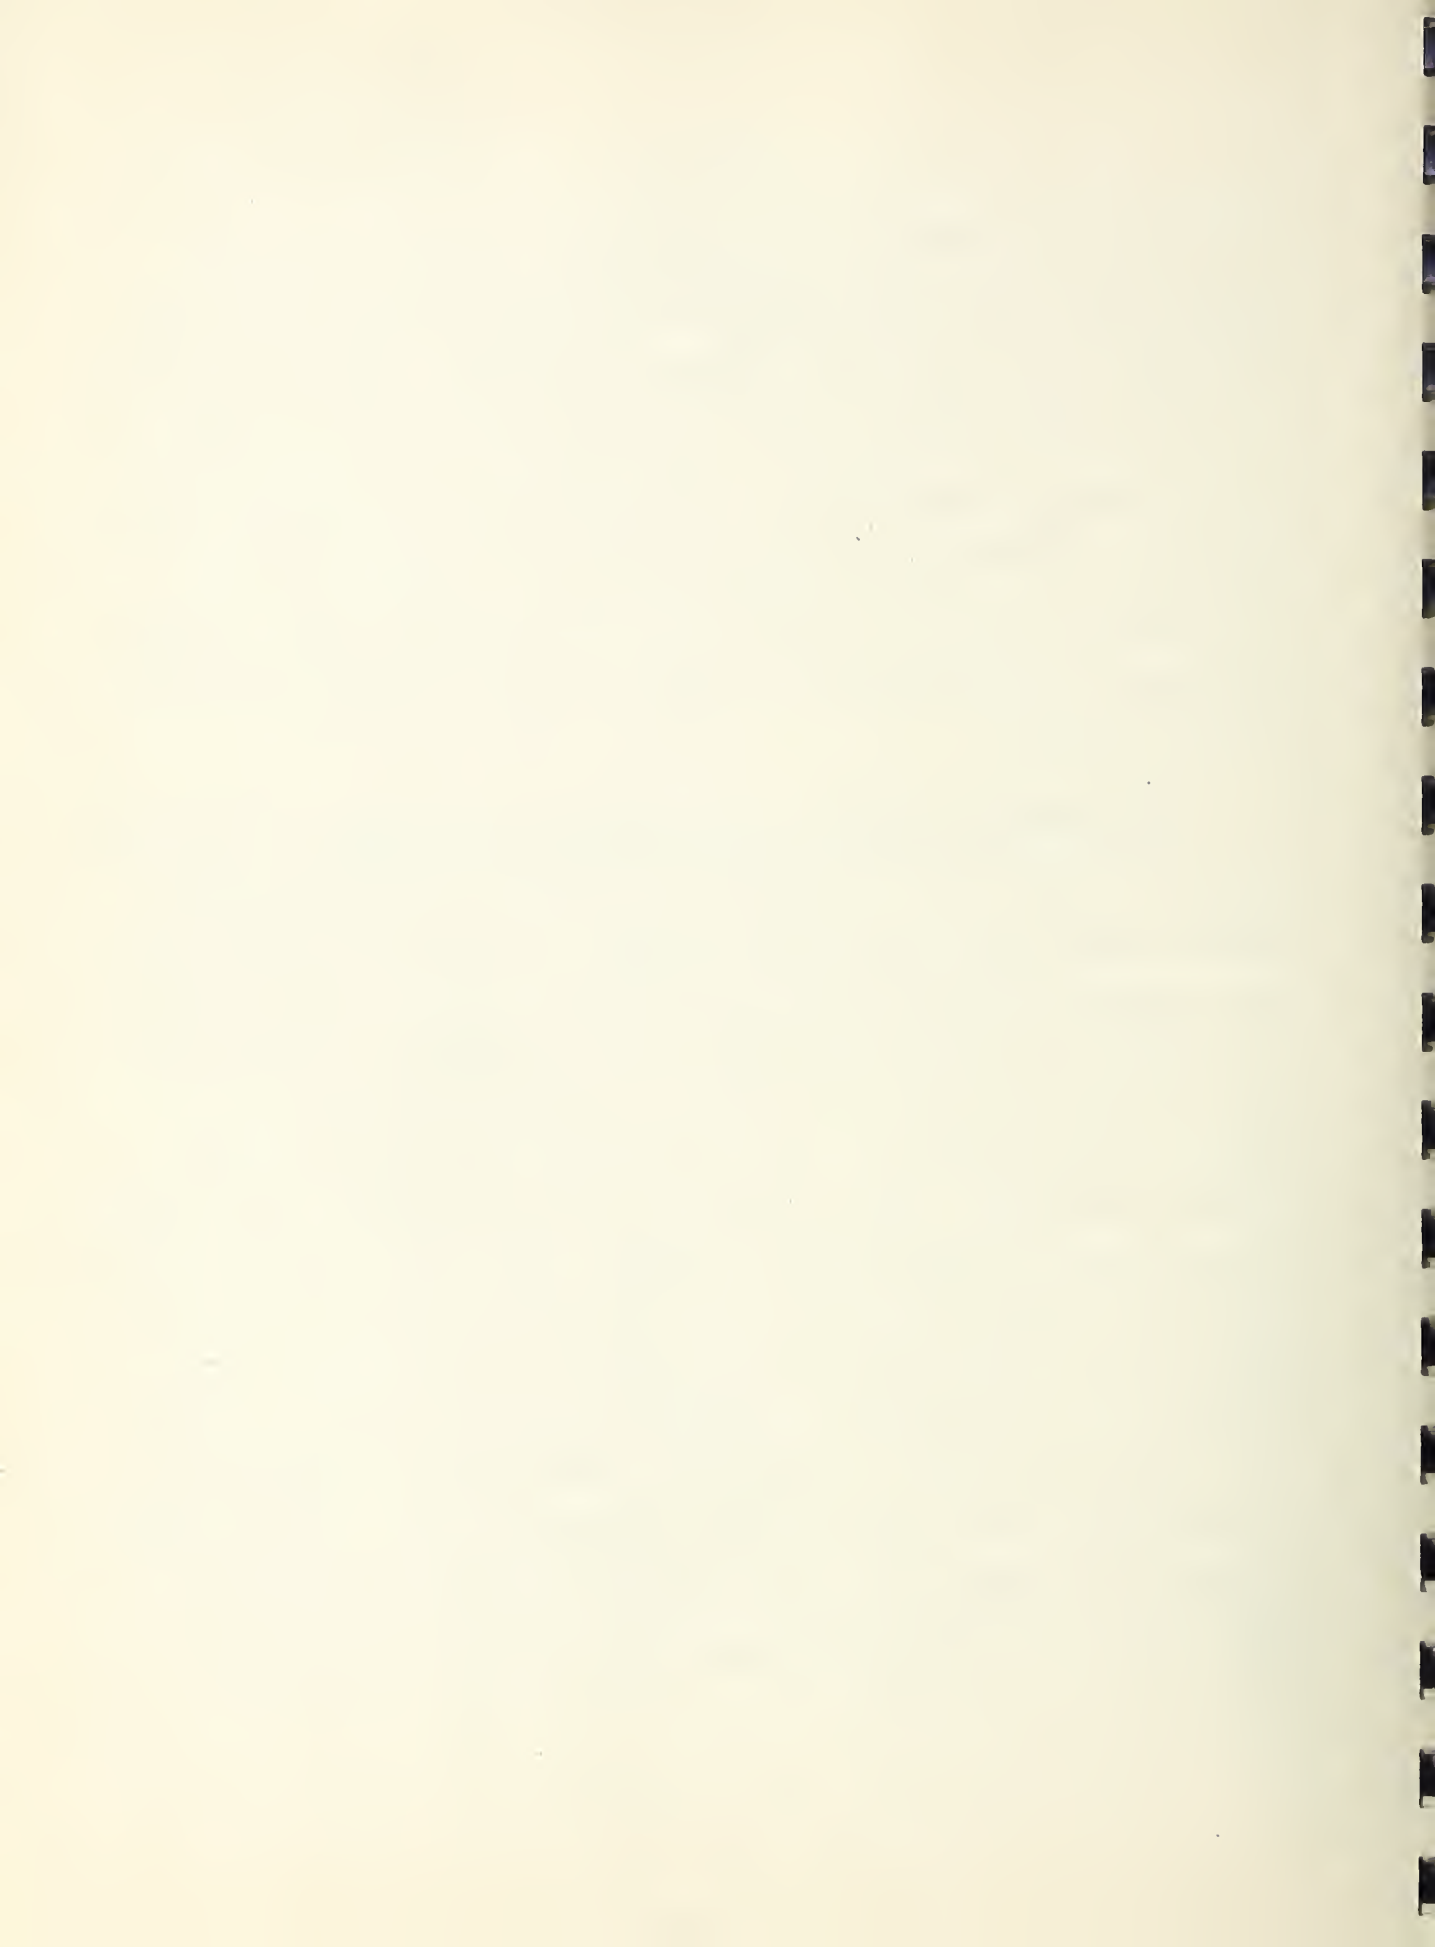
The ASTM Specification C35-52T states that:
