**NATIONAL BUREAU OF STANDARDS REPORT**

REPORT ON  
INSPECTION AND TESTS OF PLASTER  
ALASKA NATIVE SERVICE HOSPITAL AND QUARTERS BUILDINGS

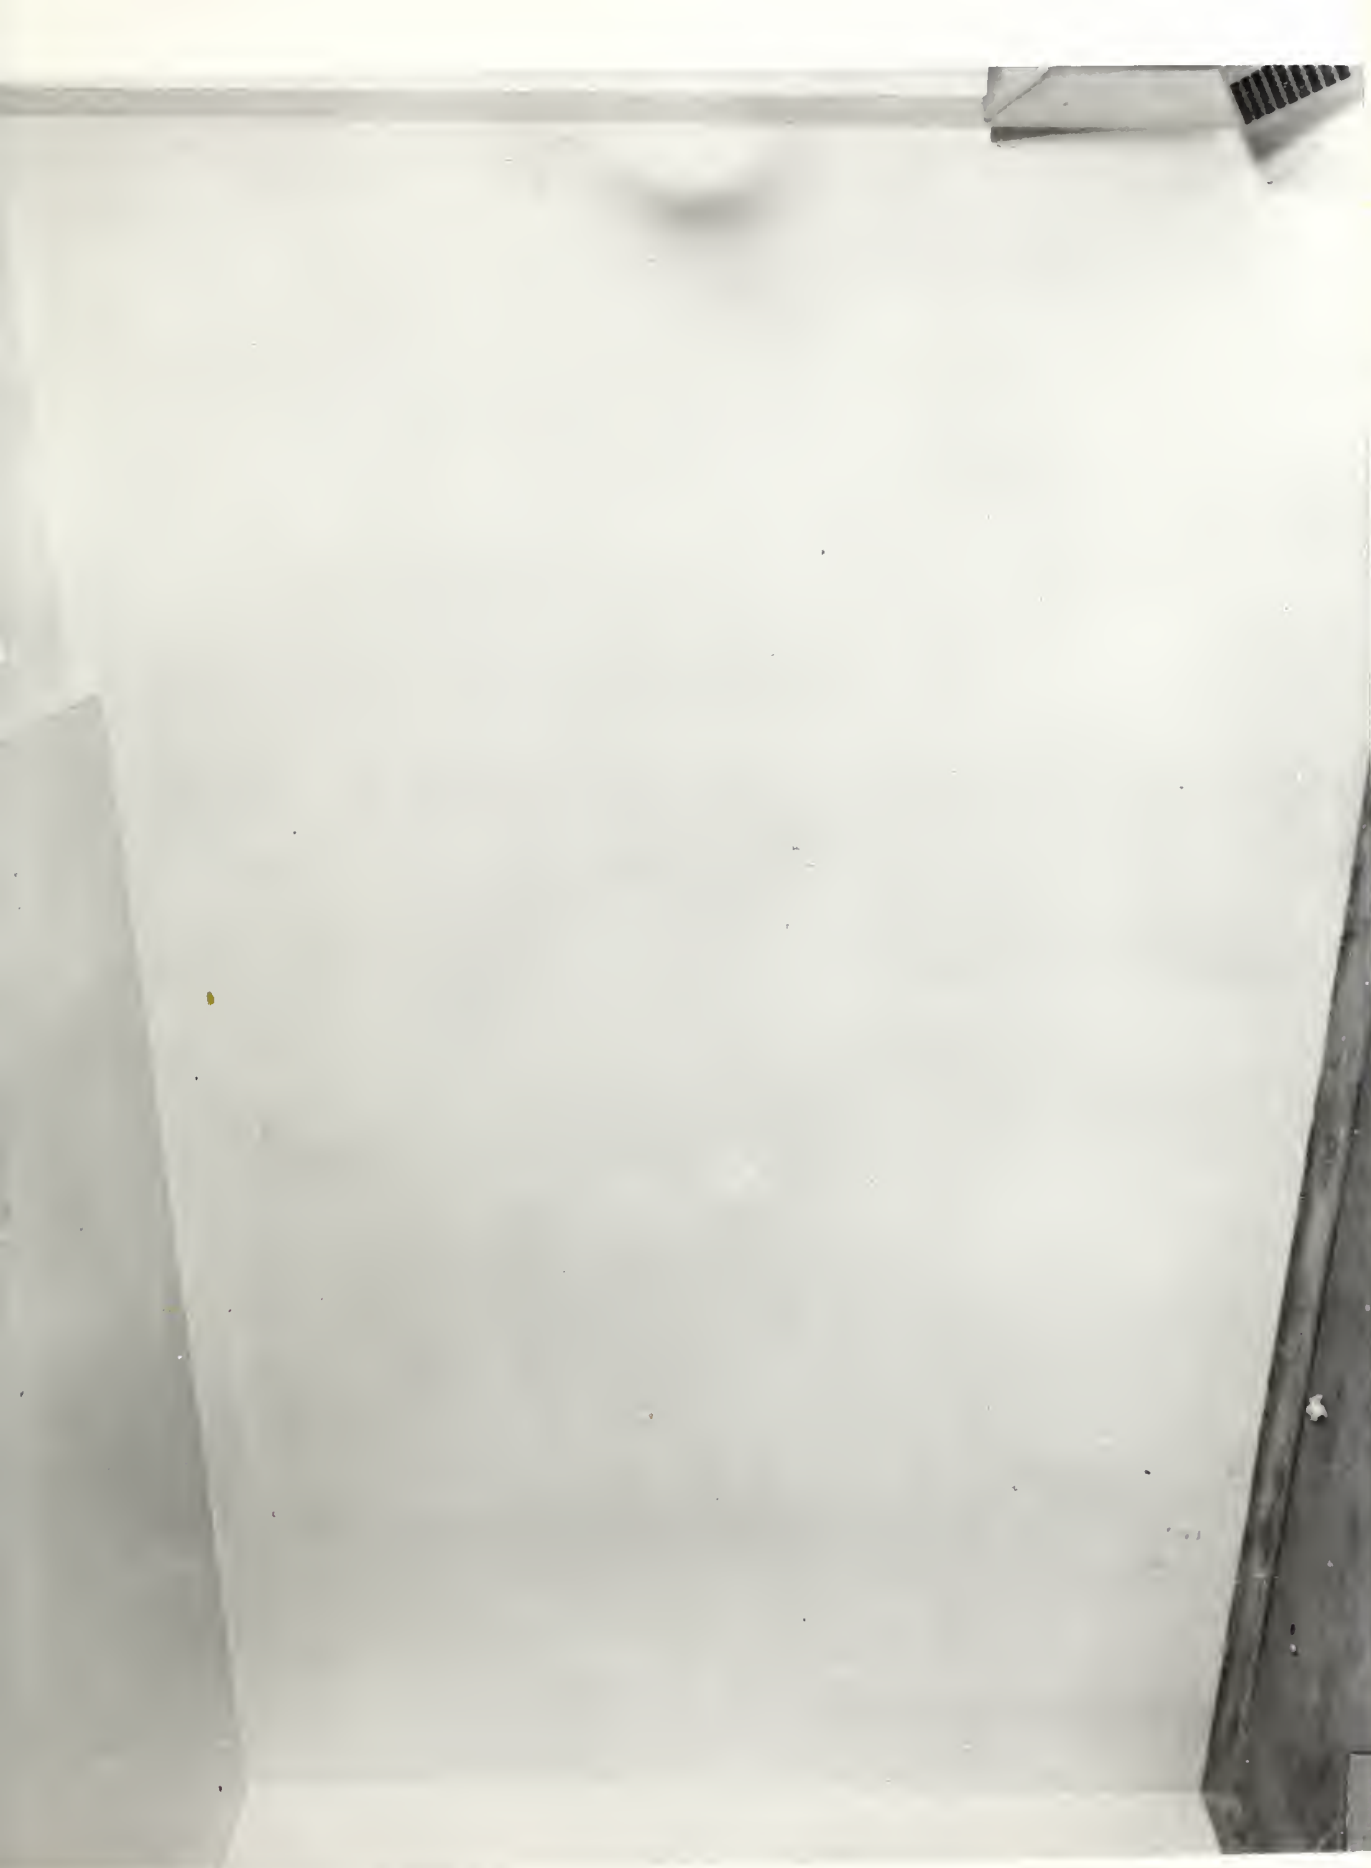
FIGURE 1. PROJECT 501-228. WALL SECTION OF ROOM N-125 (DINING ROOM). THE CRACK PATTERN IS TYPICAL OF STEEL-STUD WALLS AND HUNG CEILINGS IN THE FIRST STORY. THE 9-BY 15-FT. WALL AREA SHOWN REQUIRED 86 LIN. FT. OF REPAIR.

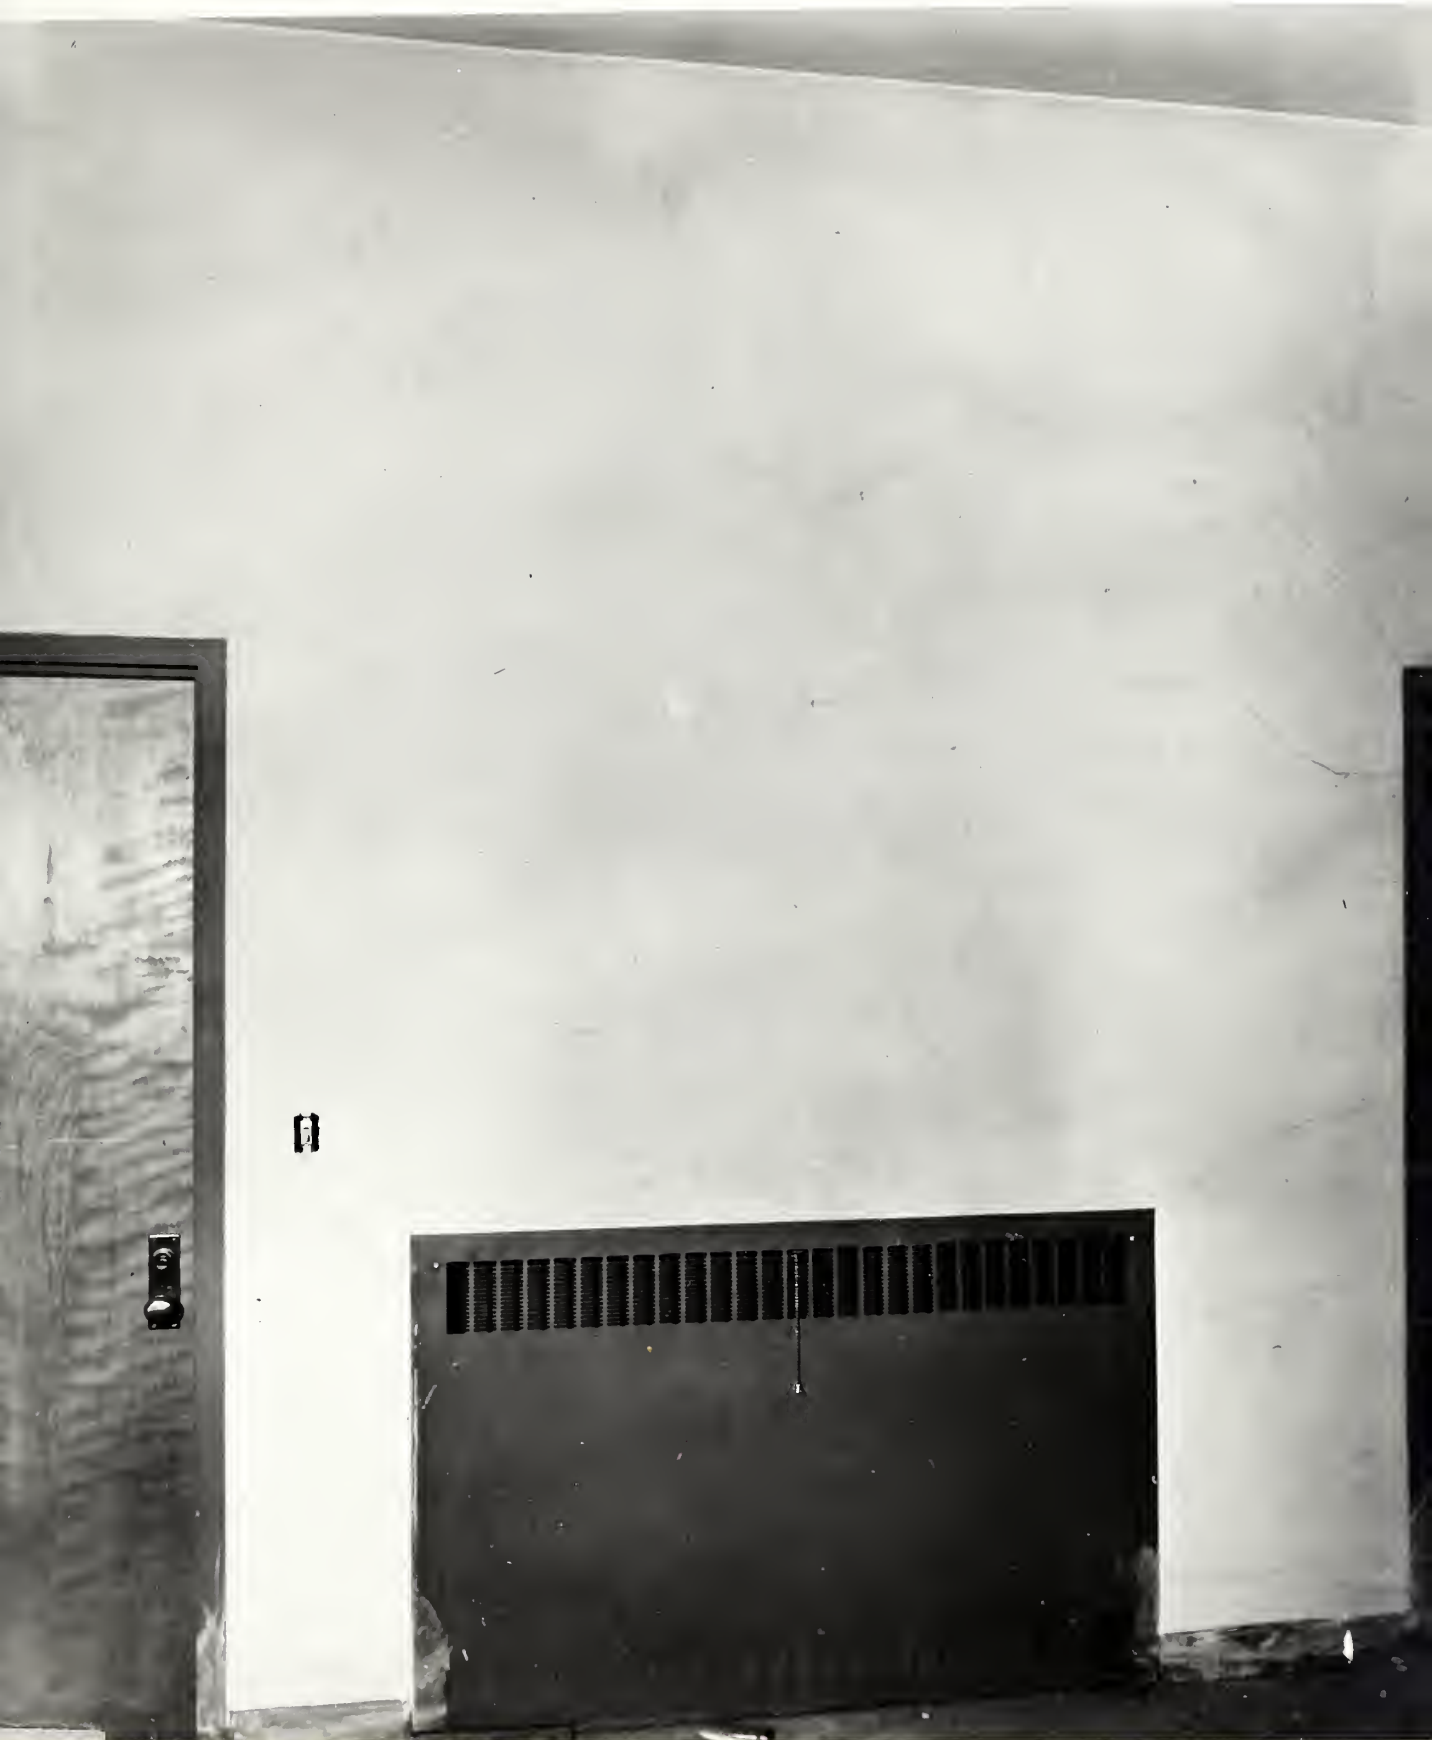
FIGURE 2. PROJECT 501-228. WALL OF ROOM W-149 (WAITING ROOM), A TYPICAL STEEL-STUD CONSTRUCTION, THE CRACK PATTERN OF WHICH WAS THE SAME AS IN OTHER AREAS. THE 11-BY 20-FT. AREA SHOWN REQUIRED 139 LIN. FT. OF REPAIR.

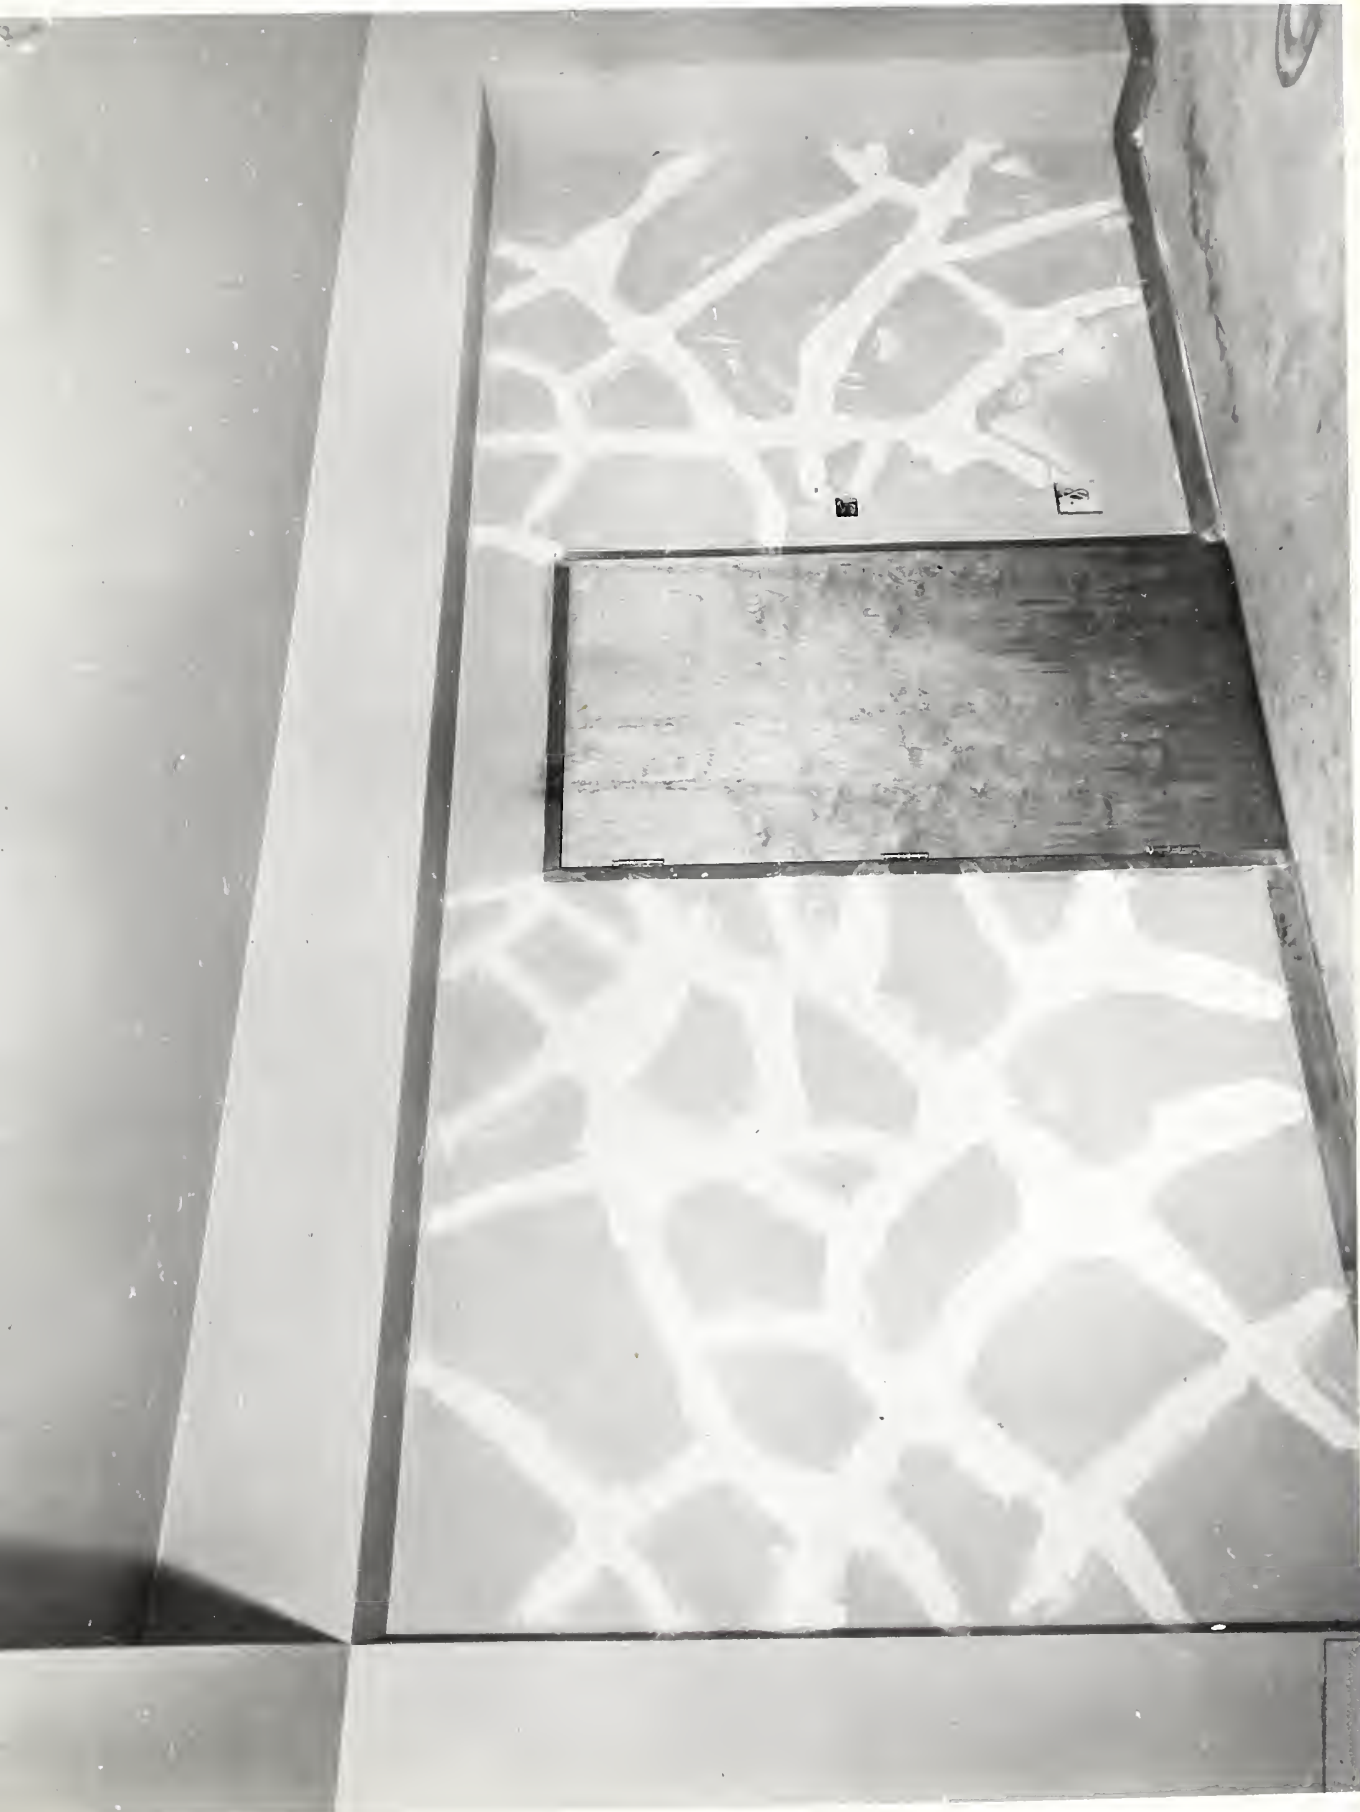
FIGURE 3. PROJECT 501-228. NORTH WALL OF ROOM E-202. CRACK PATTERN AND CONDITION TYPICAL OF ALL STEEL-STUD WALLS ON SECOND FLOOR. THIS WALL REQUIRED 90 LIN. FT. OF REPAIR FOR THE 8-BY 5-FT. SECTION SHOWN.

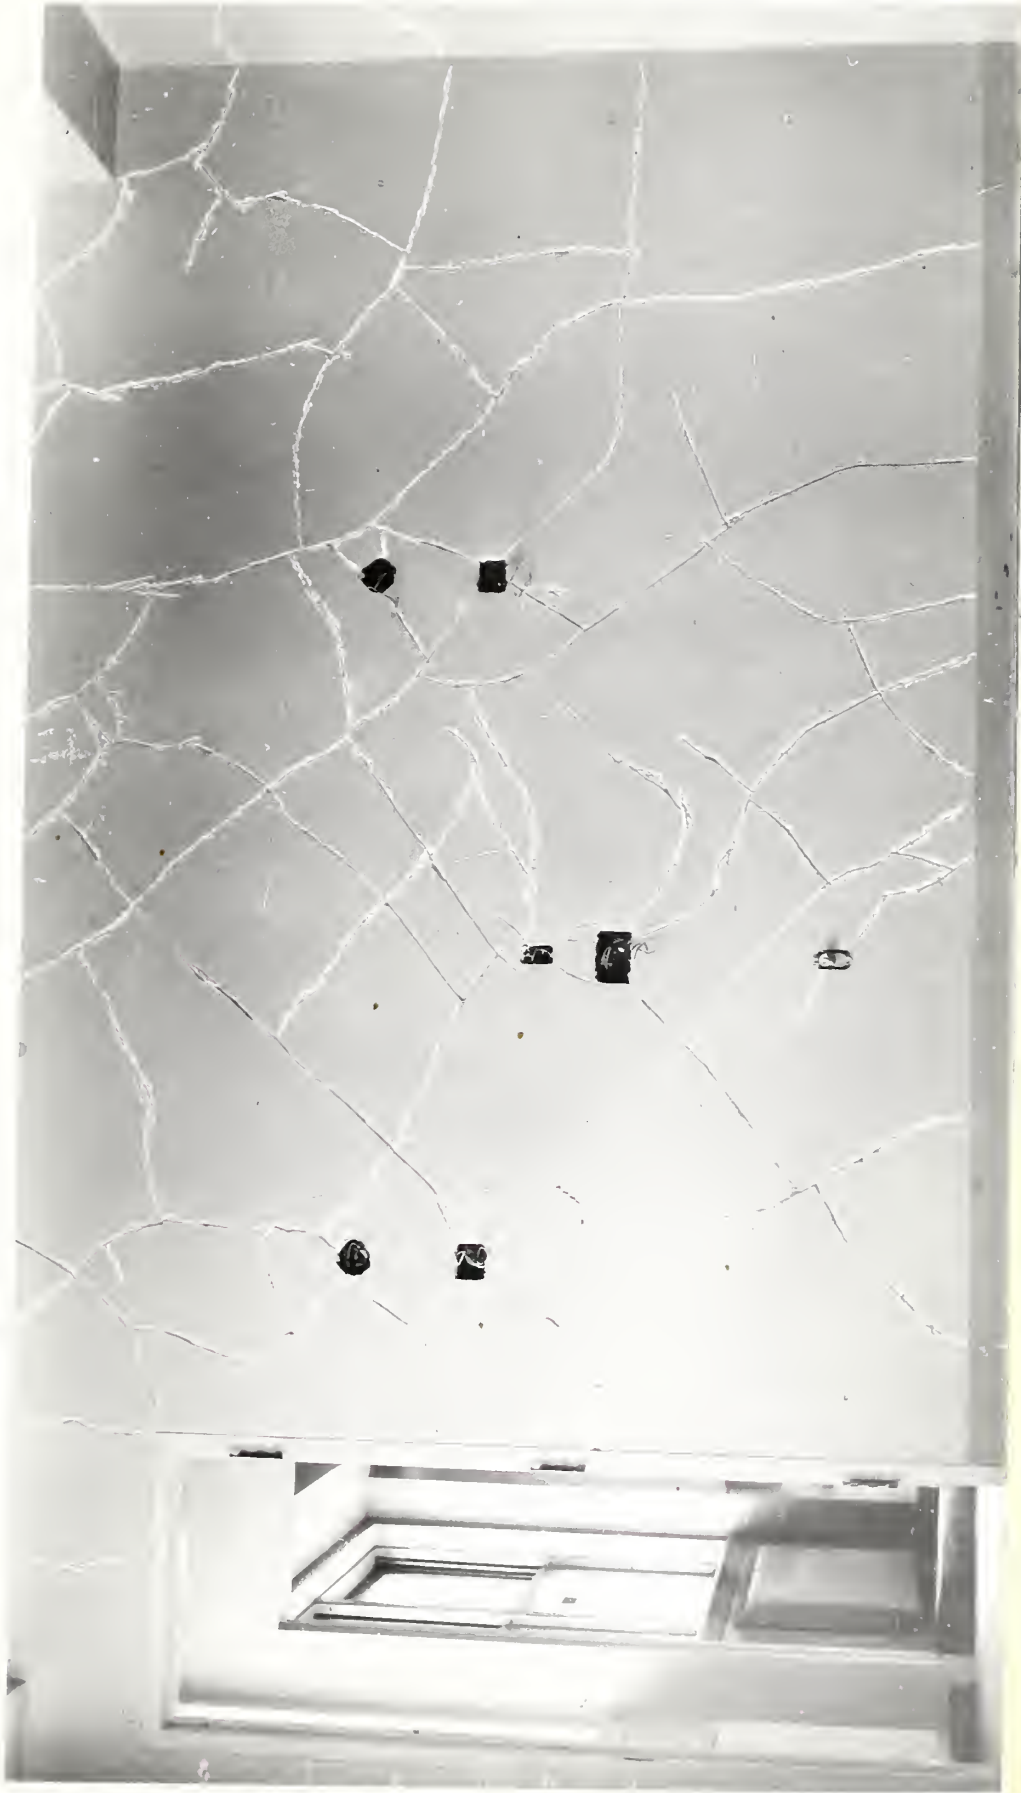
FIGURE 5. PROJECT 501-228. NORTH WALL OF ROOM N-518 (PRINTED REVERSED) SHOWING CRACKS GROOVED READY TO BE FILLED.

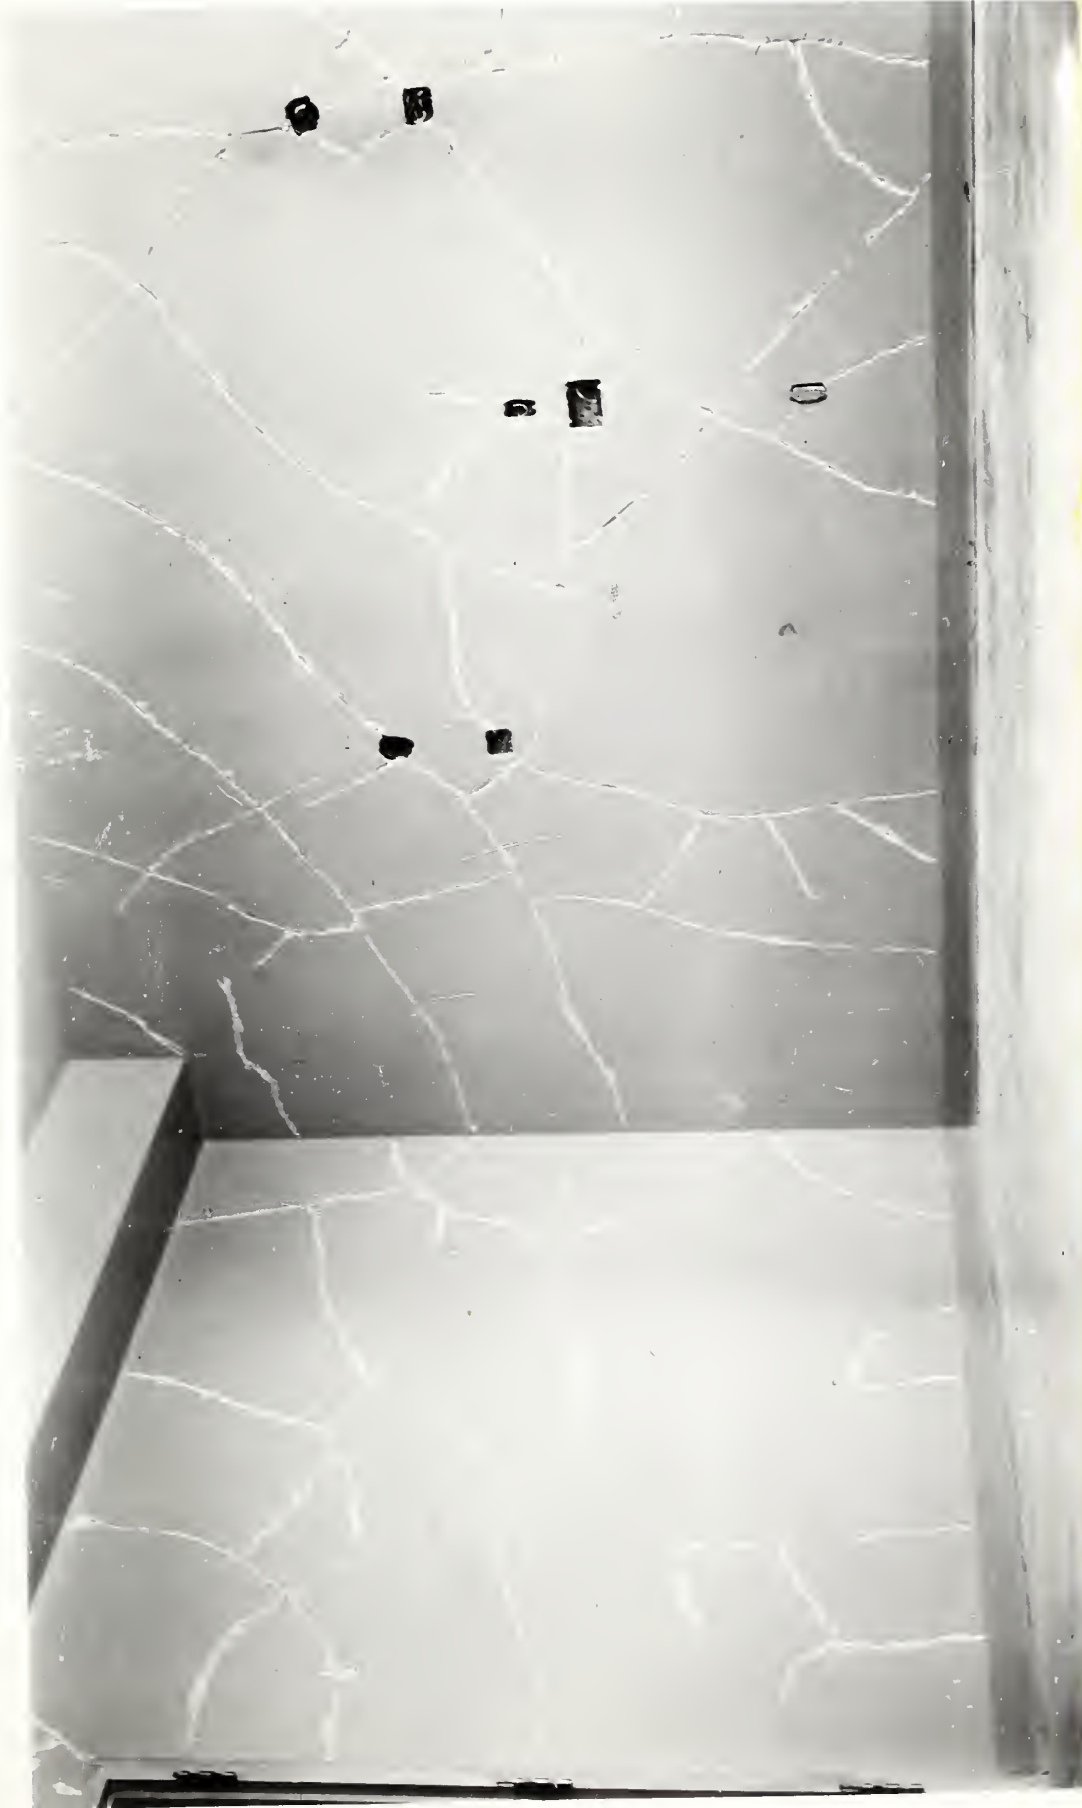
FIGURE 6. PROJECT 501-228. SOUTH AND CORRIDOR WALLS OF ROOM N-518 (PRINTED REVERSED) SHOWING CRACKS GROOVED READY TO BE FILLED.

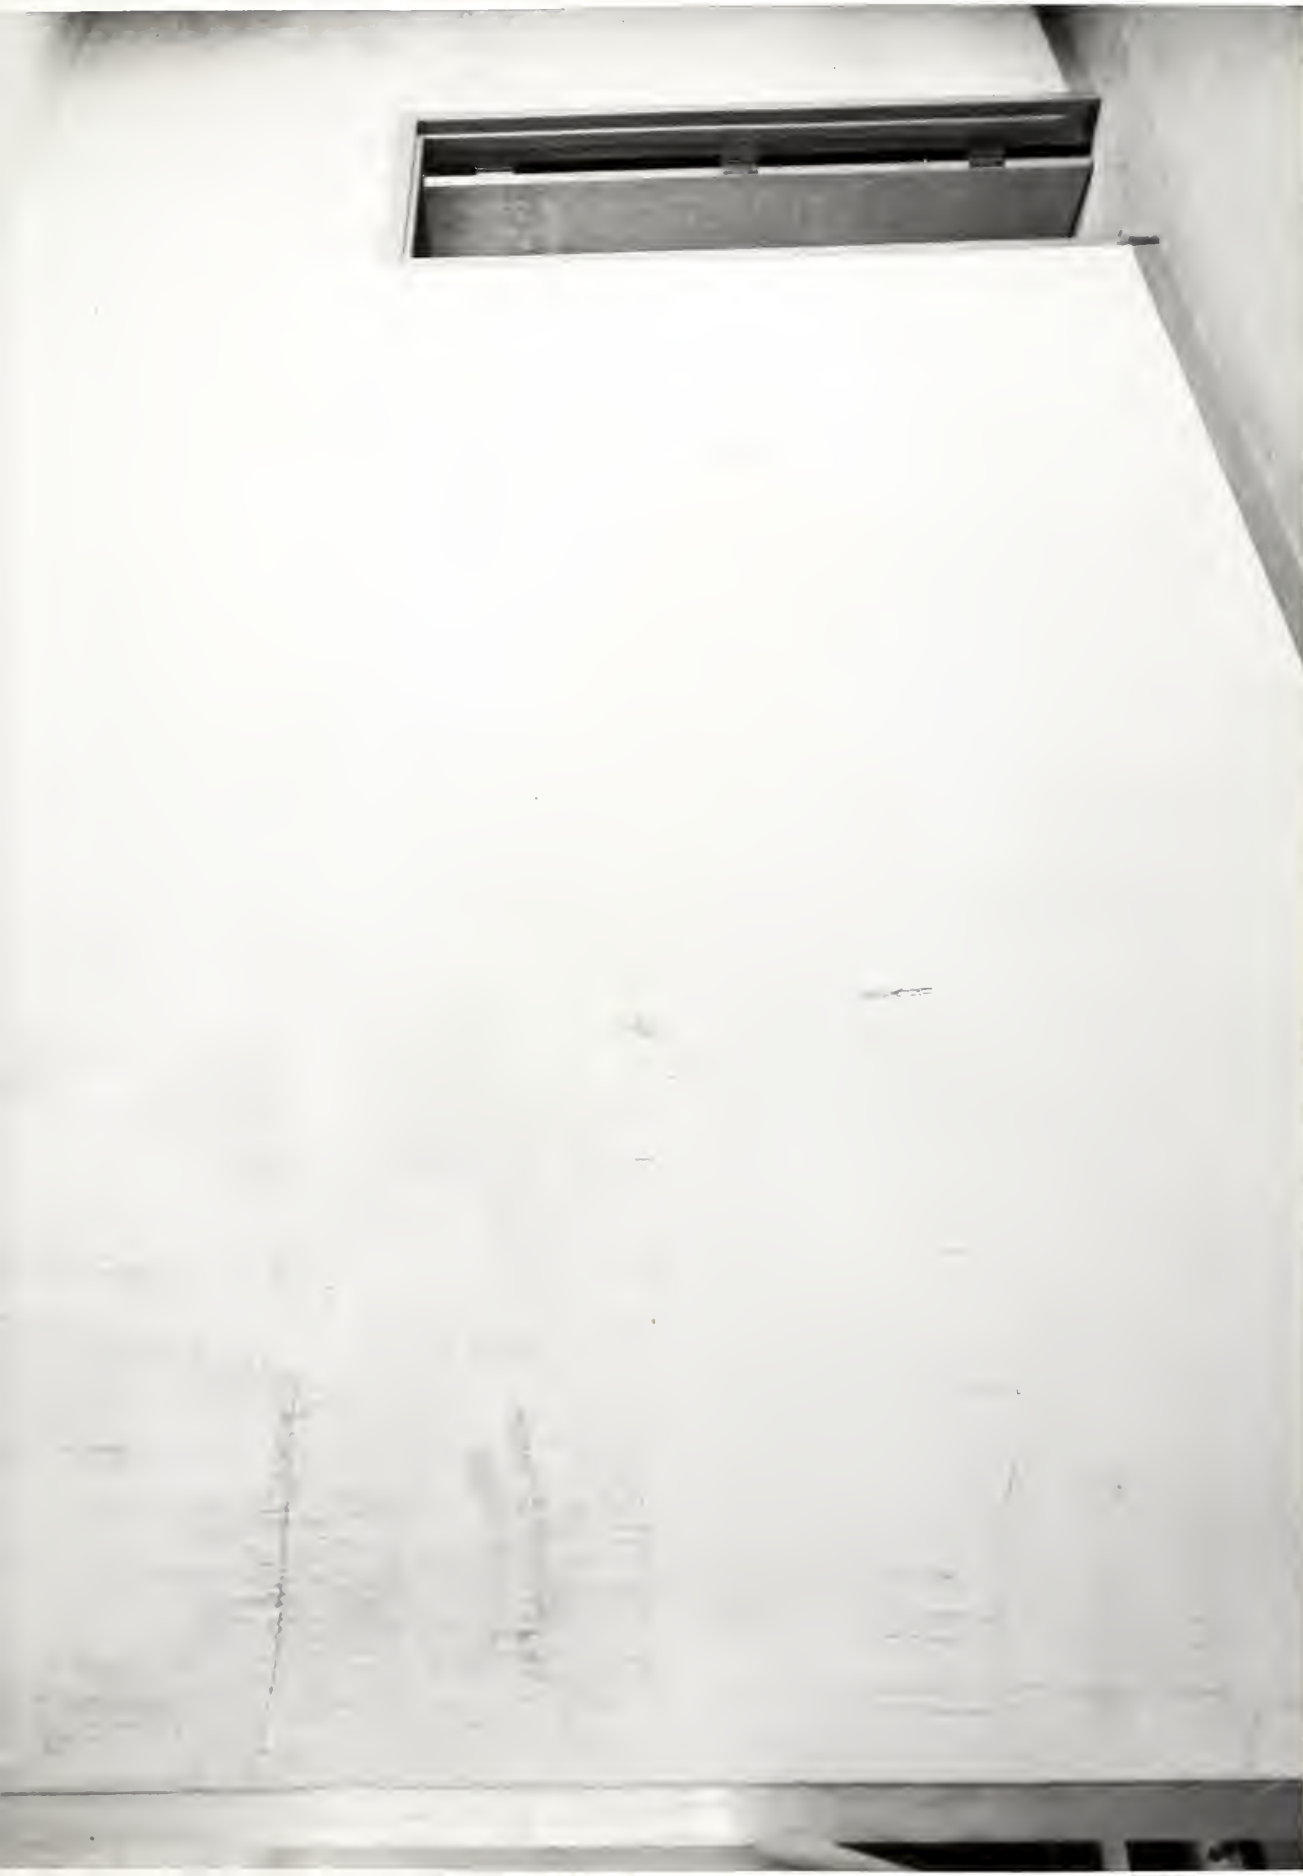
FIGURE 8. PROJECT 501-228. S-100, ( SOUTH CORRIDOR ) NEAR LAUNDRY ENTRANCE SHOWING CONDITION OF PLASTER ON OCTOBER 22, 1952.

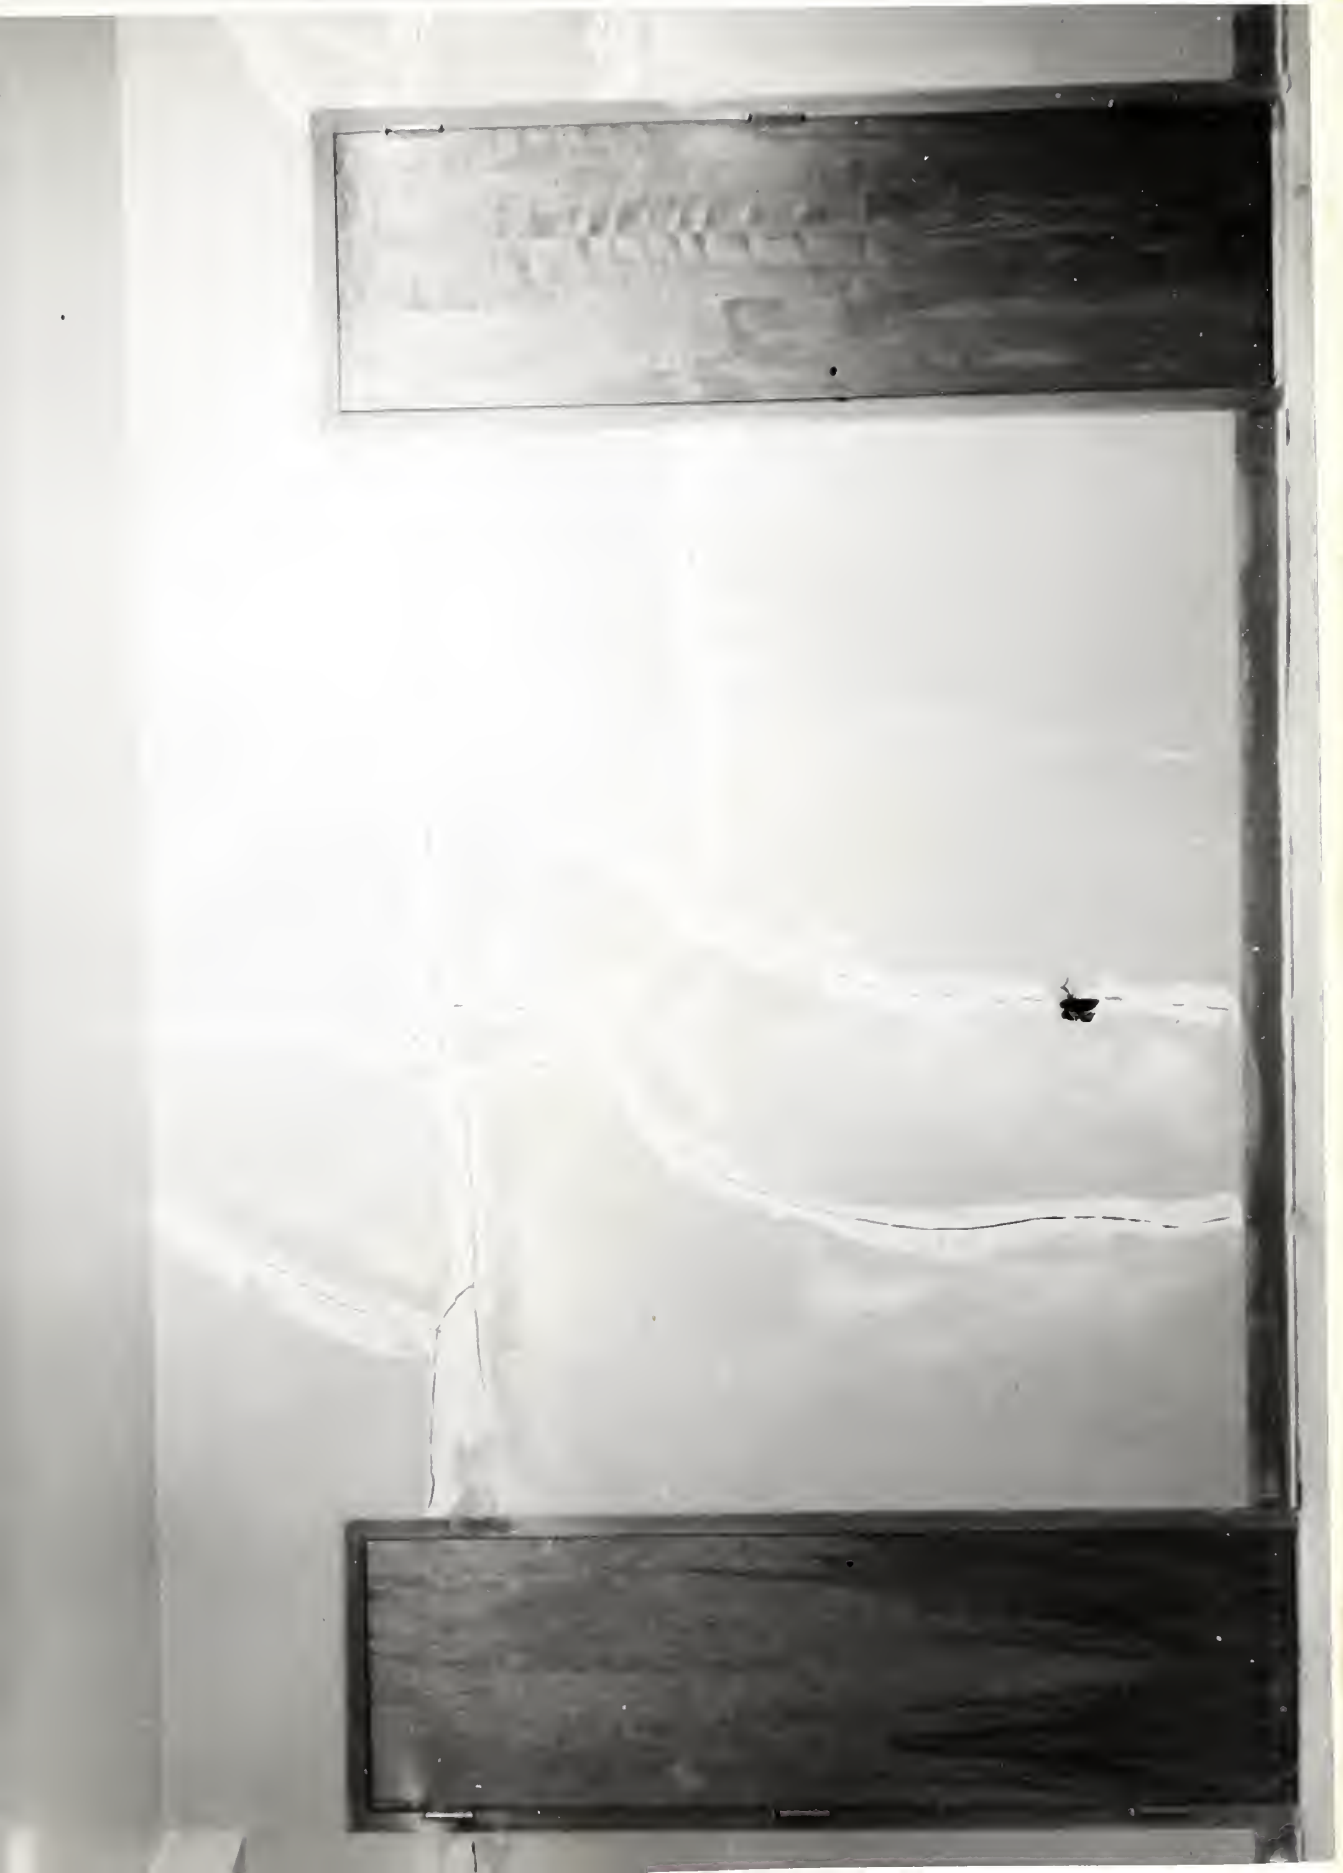
FIGURE 9. PROJECT 501-228A. PATTERN OF CRACKING, NORTH WALL OF ROOM E-240, QUARTERS BUILDING ON NOVEMBER 17, 1952.

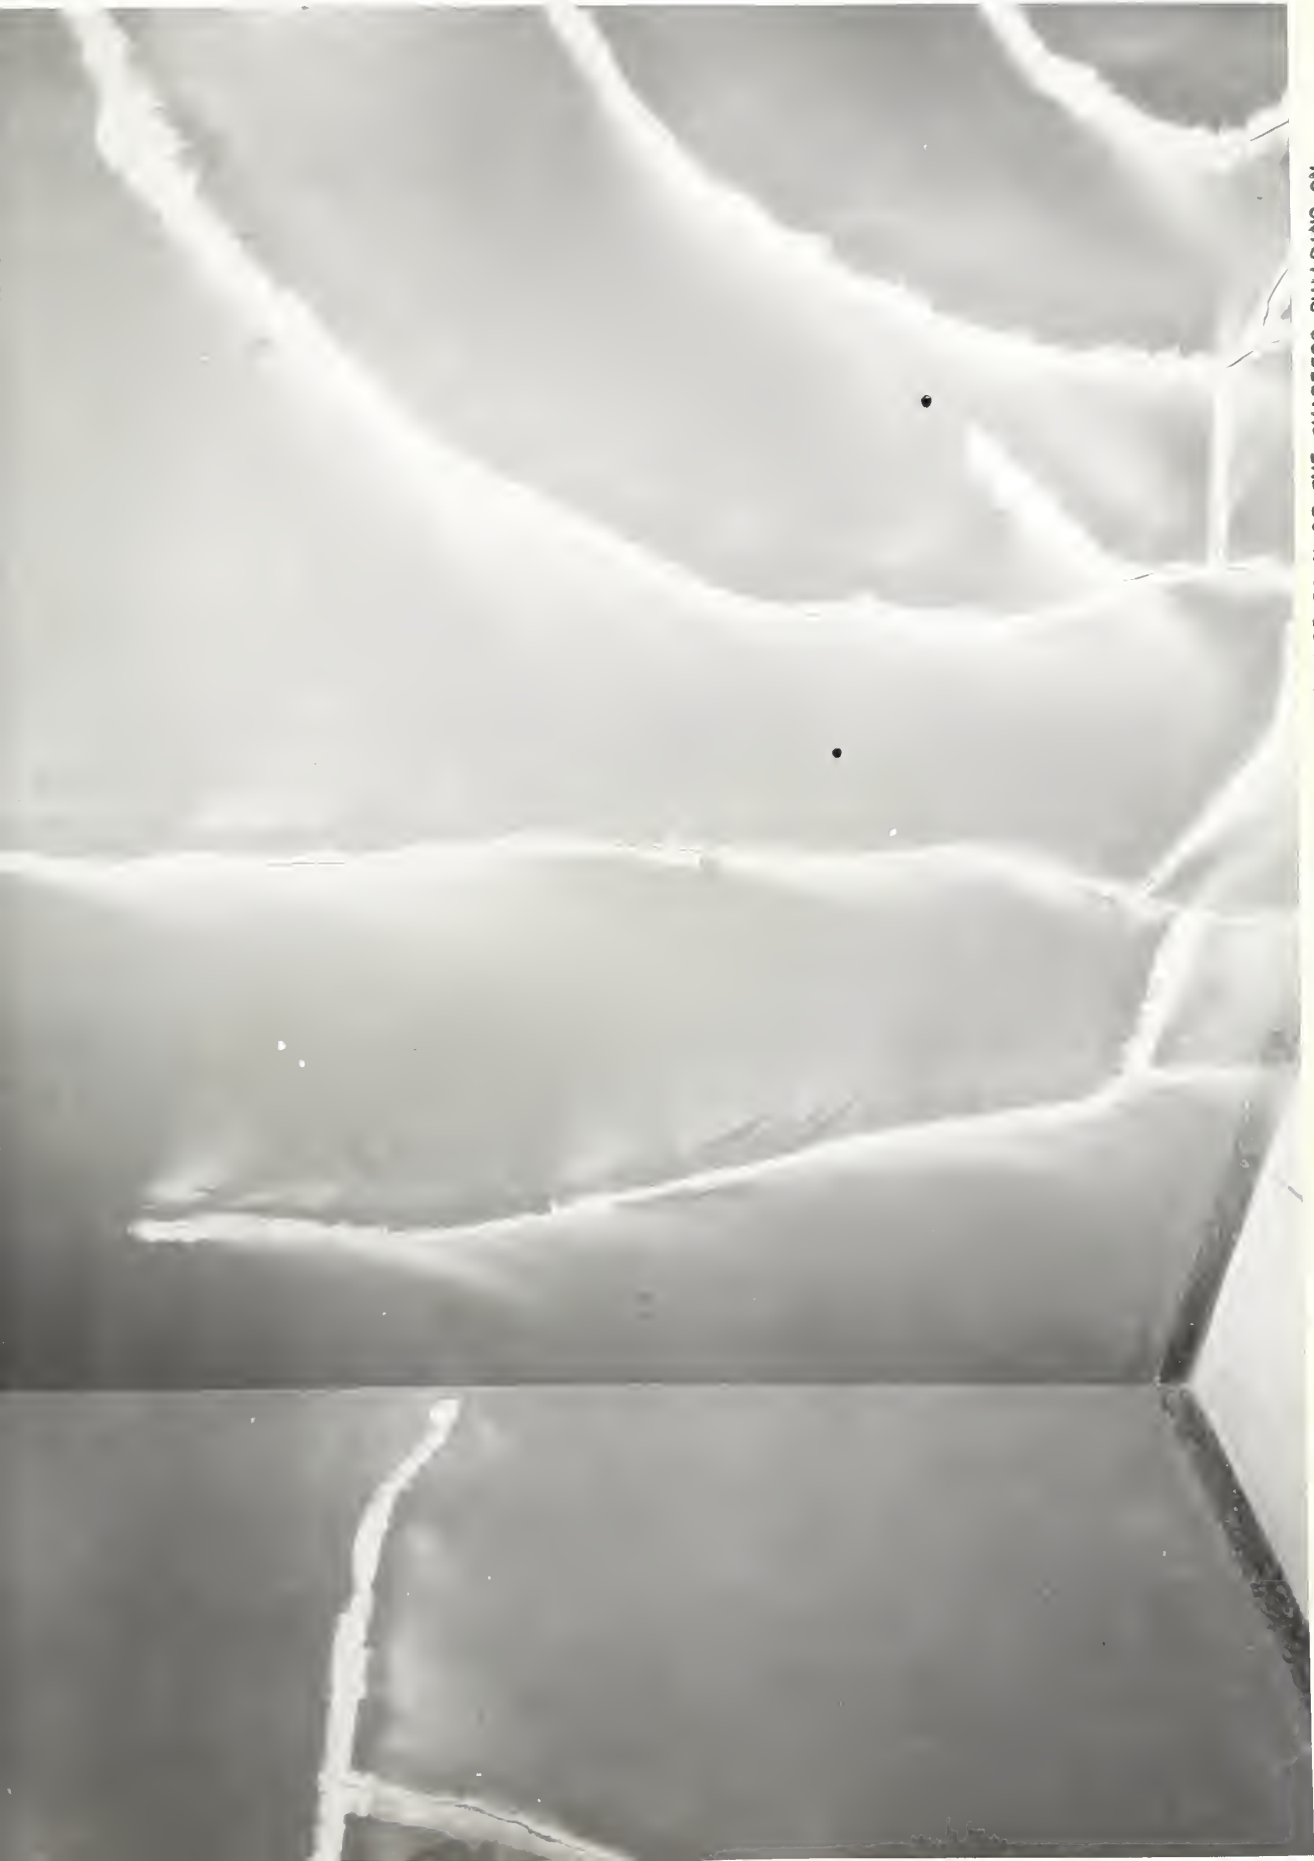
FIGURE 10. PROJECT 501-228A. PATTERN OF CRACKING OF PLASTER OF WALL, ENTRANCE ROOM OF THE QUARTERS BUILDING ON NOVEMBER 19, 1952. THE WARPED PLASTER AT MARGINS OF THE CRACKS HAD BEEN SANDED OFF IN PREPARATION FOR REPAIR. NOTE CLOSER SPACING OF THE CRACKS AT THE BOTTOM OF THE WALL.

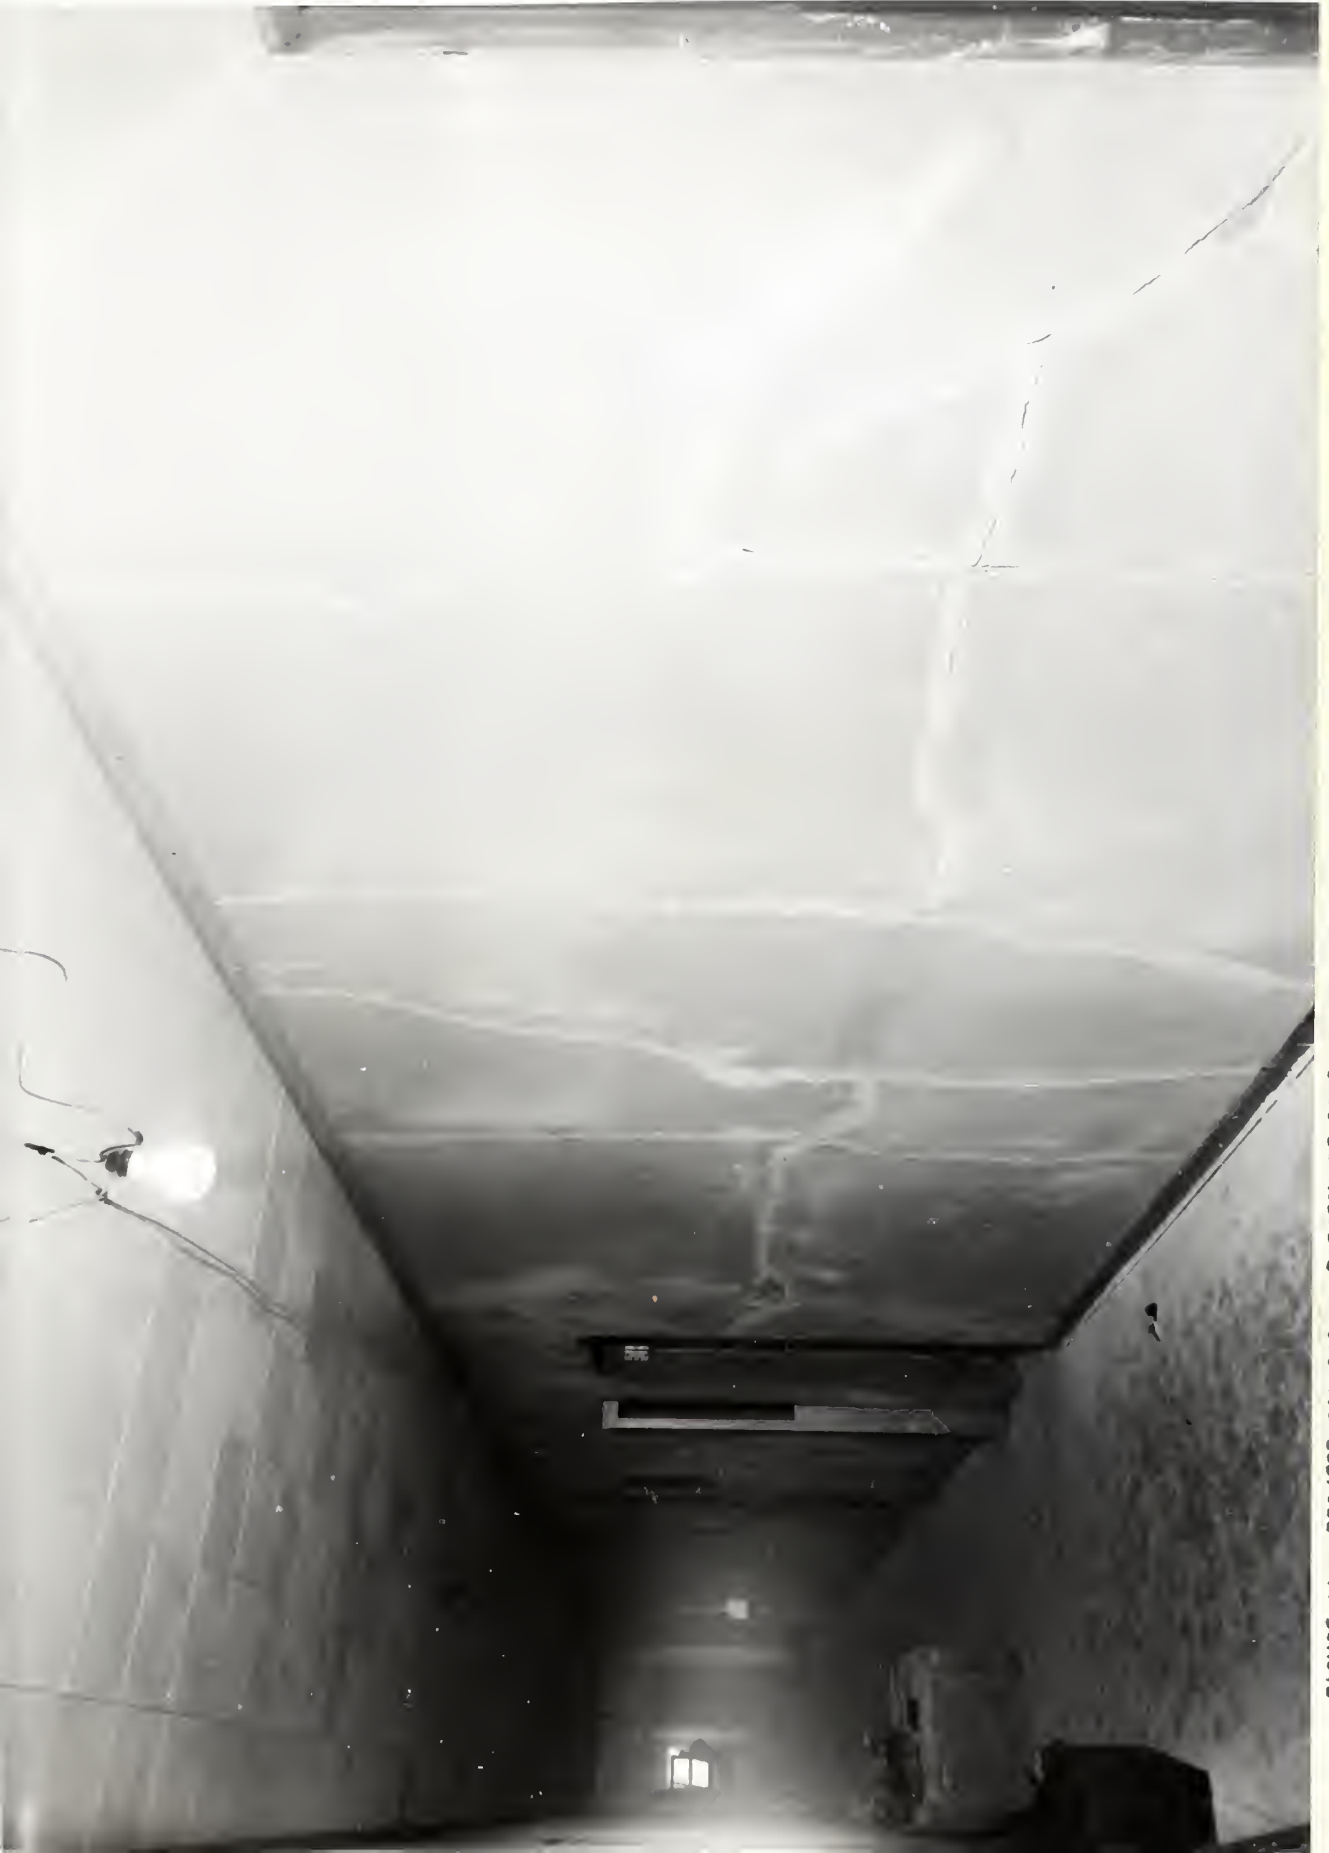
FIGURE 11. PROJECT 501-228A. PATTERN OF CRACKING IN THE WALL OF THE NORTH-WING CORRIDOR, SECOND FLOOR OF QUARTERS BUILDING ON NOVEMBER 17, 1952. THIS WAS TYPICAL OF CRACKS IN THE CORRIDOR PARTITIONS.

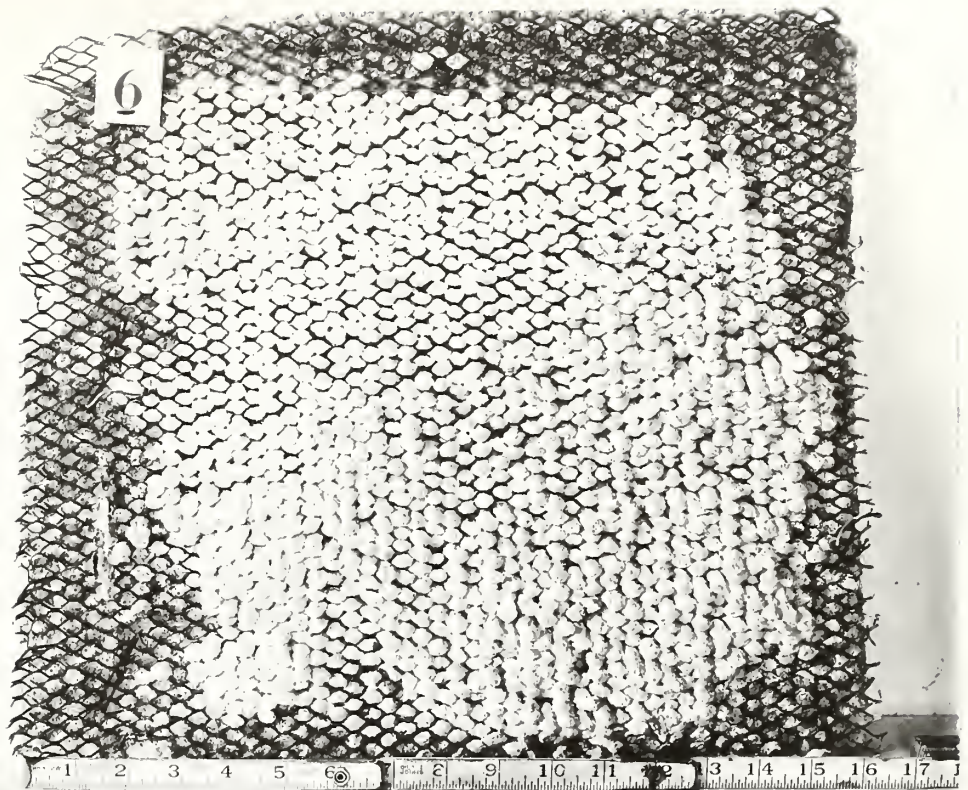
FIGURE 13. PROJECT 501-228. SPECIMEN OF LATH AND PLASTER TAKEN FROM WALL OF LINEN CLOSET N-308 SHOWING WHERE KEYS ARE BROKEN HOW RUST STAINS PENETRATE PLASTER KEYS.

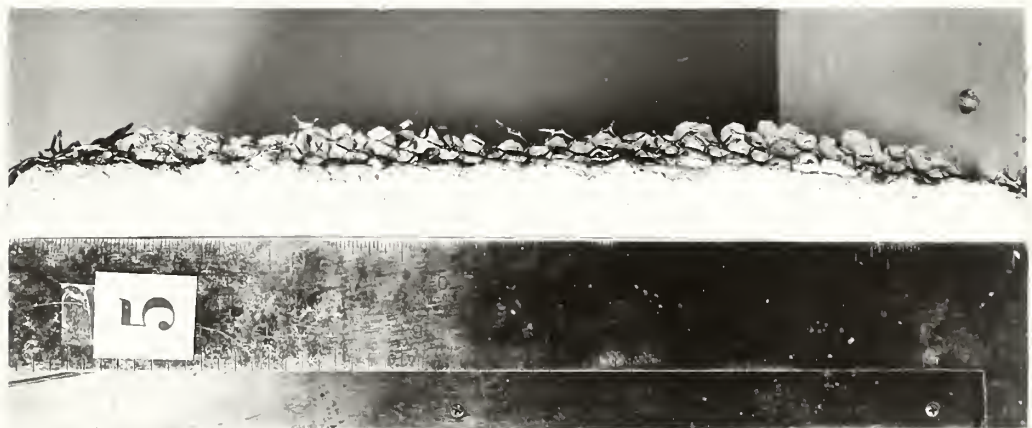
FIGURE 14. PROJECT 501-228. EDGE VIEW OF SPECIMEN FROM LINEN CLOSET SHOWING CURVATURE OF SURFACE AND THICKNESS OF PLASTER.
