**NATIONAL BUREAU OF STANDARDS REPORT**

REPORT ON  
INSPECTION AND TESTS OF PLASTER  
ALASKA NATIVE SERVICE HOSPITAL AND QUARTERS BUILDINGS

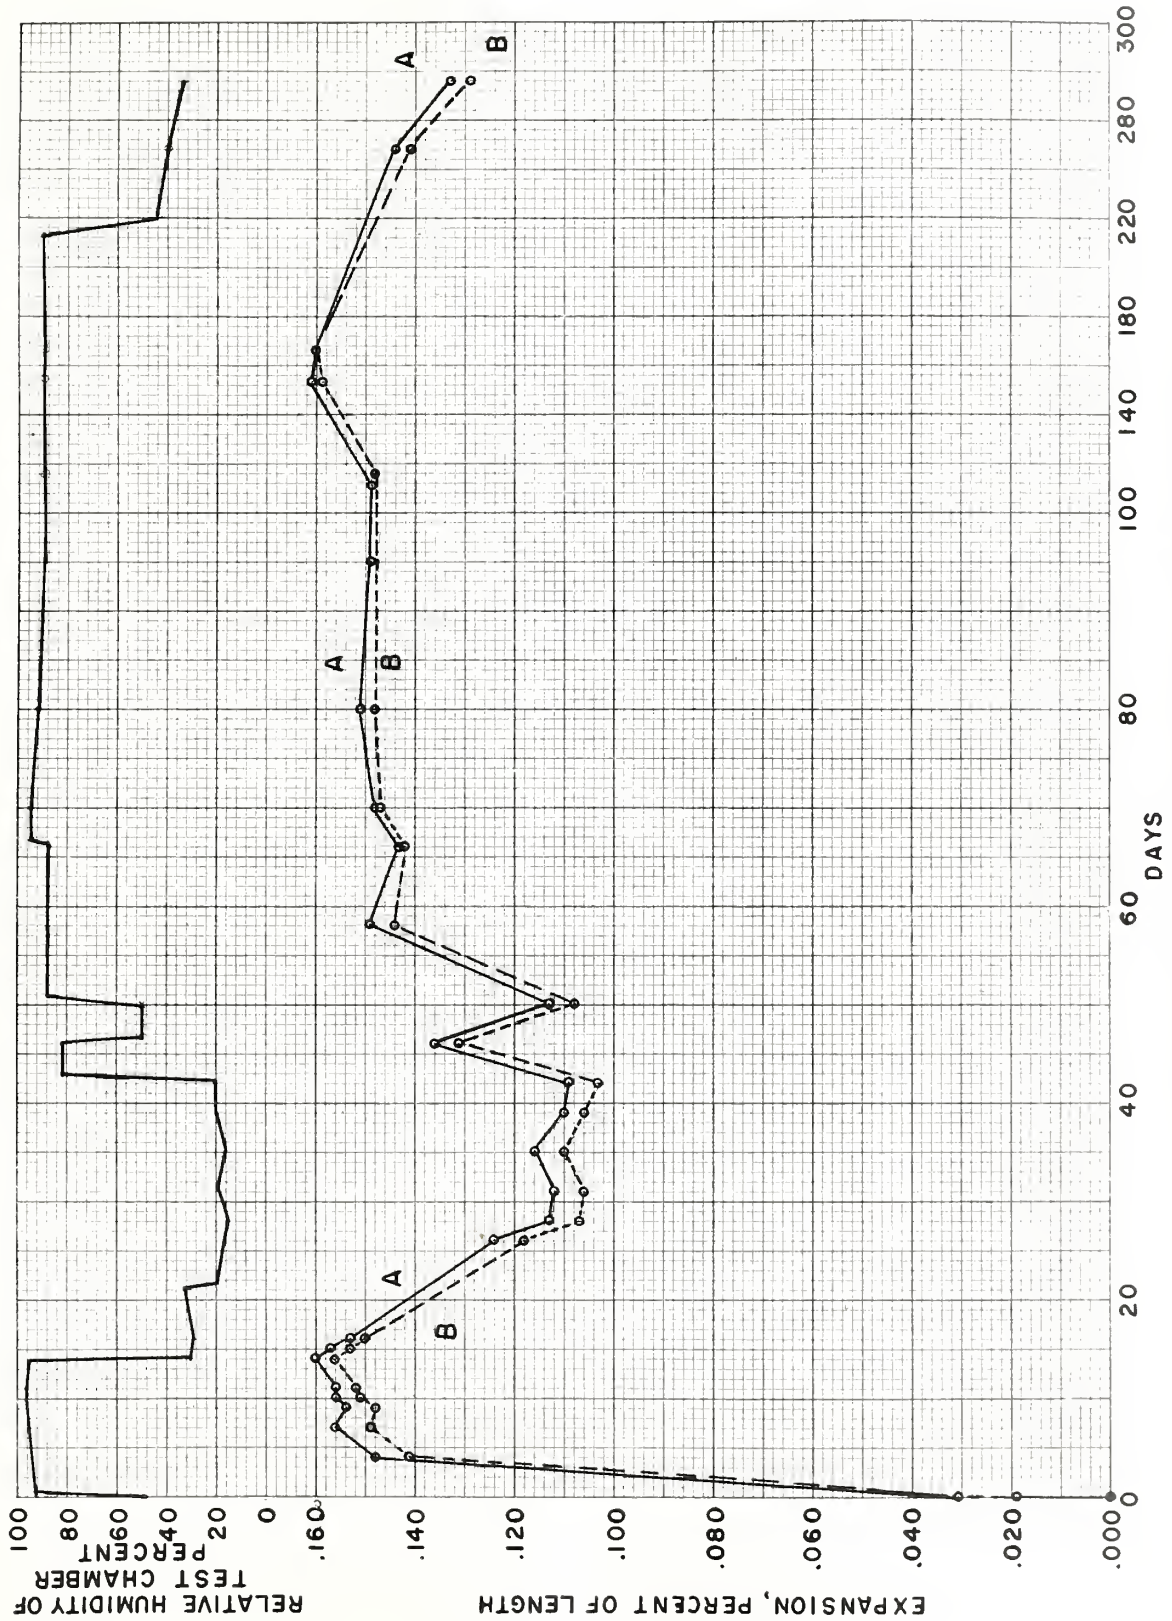
FIGURE 15. EXPANSION AND CONTRACTION OF BARS OF VERMICULITE-SAND-GYPSUM PLASTER WITH CHANGES IN THE HUMIDITY OF THE ATMOSPHERE OF THE STORAGE CHAMBER.

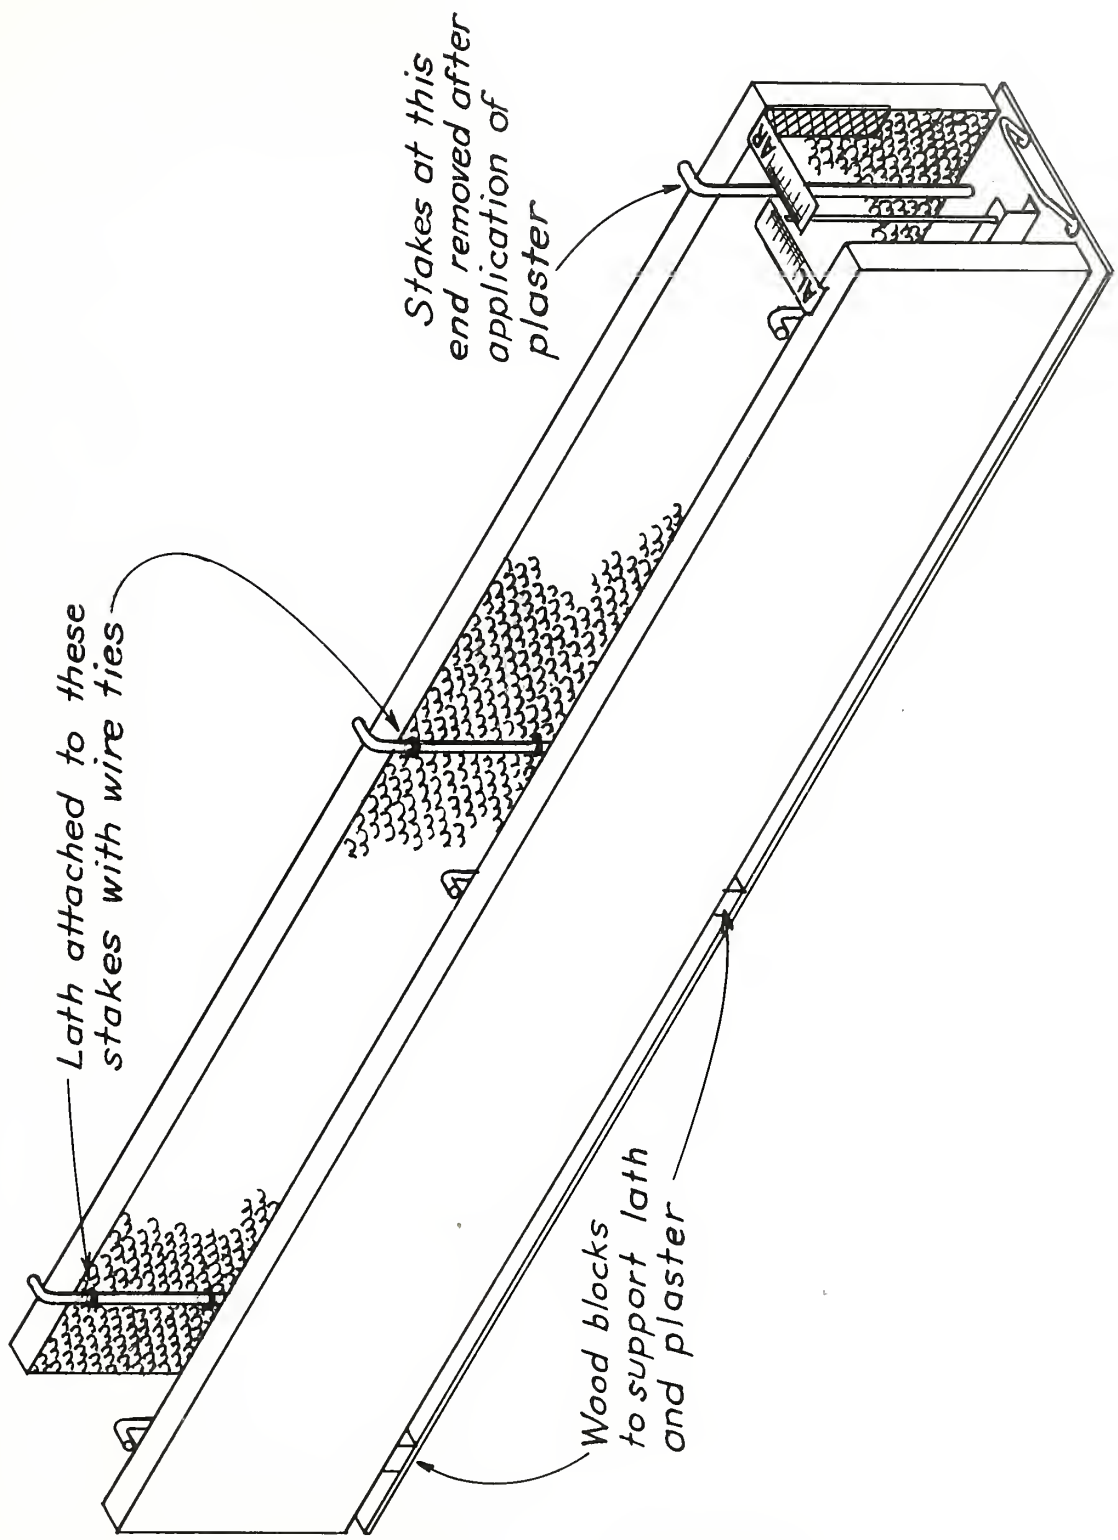
FIGURE 16. TEST SET-UP FOR MEASURING THE EFFECT OF HUMIDITY ON LATH AND PLASTER.

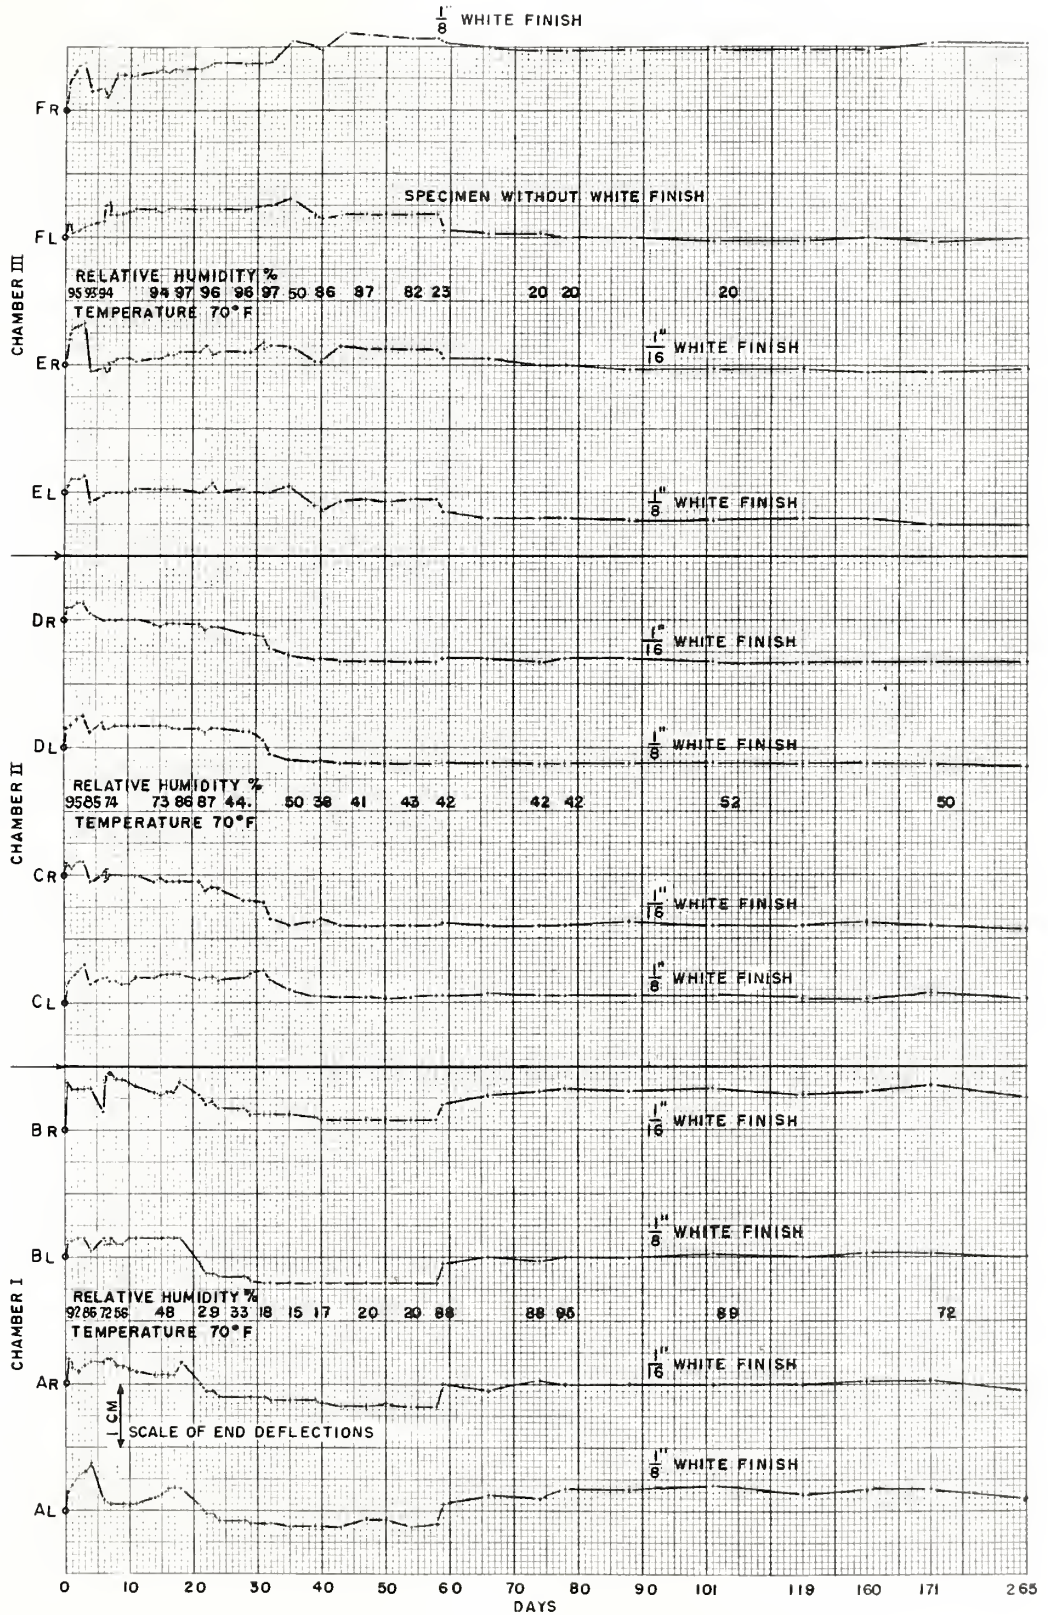
FIGURE 17. FLEXING OF LATH AND PLASTER SPECIMENS RESULTING FROM CHANGES IN THE RELATIVE HUMIDITY OF STORAGE CHAMBERS HELD AT 70°F. SEE FIGURE 16 FOR MOUNTING OF SPECIMENS.

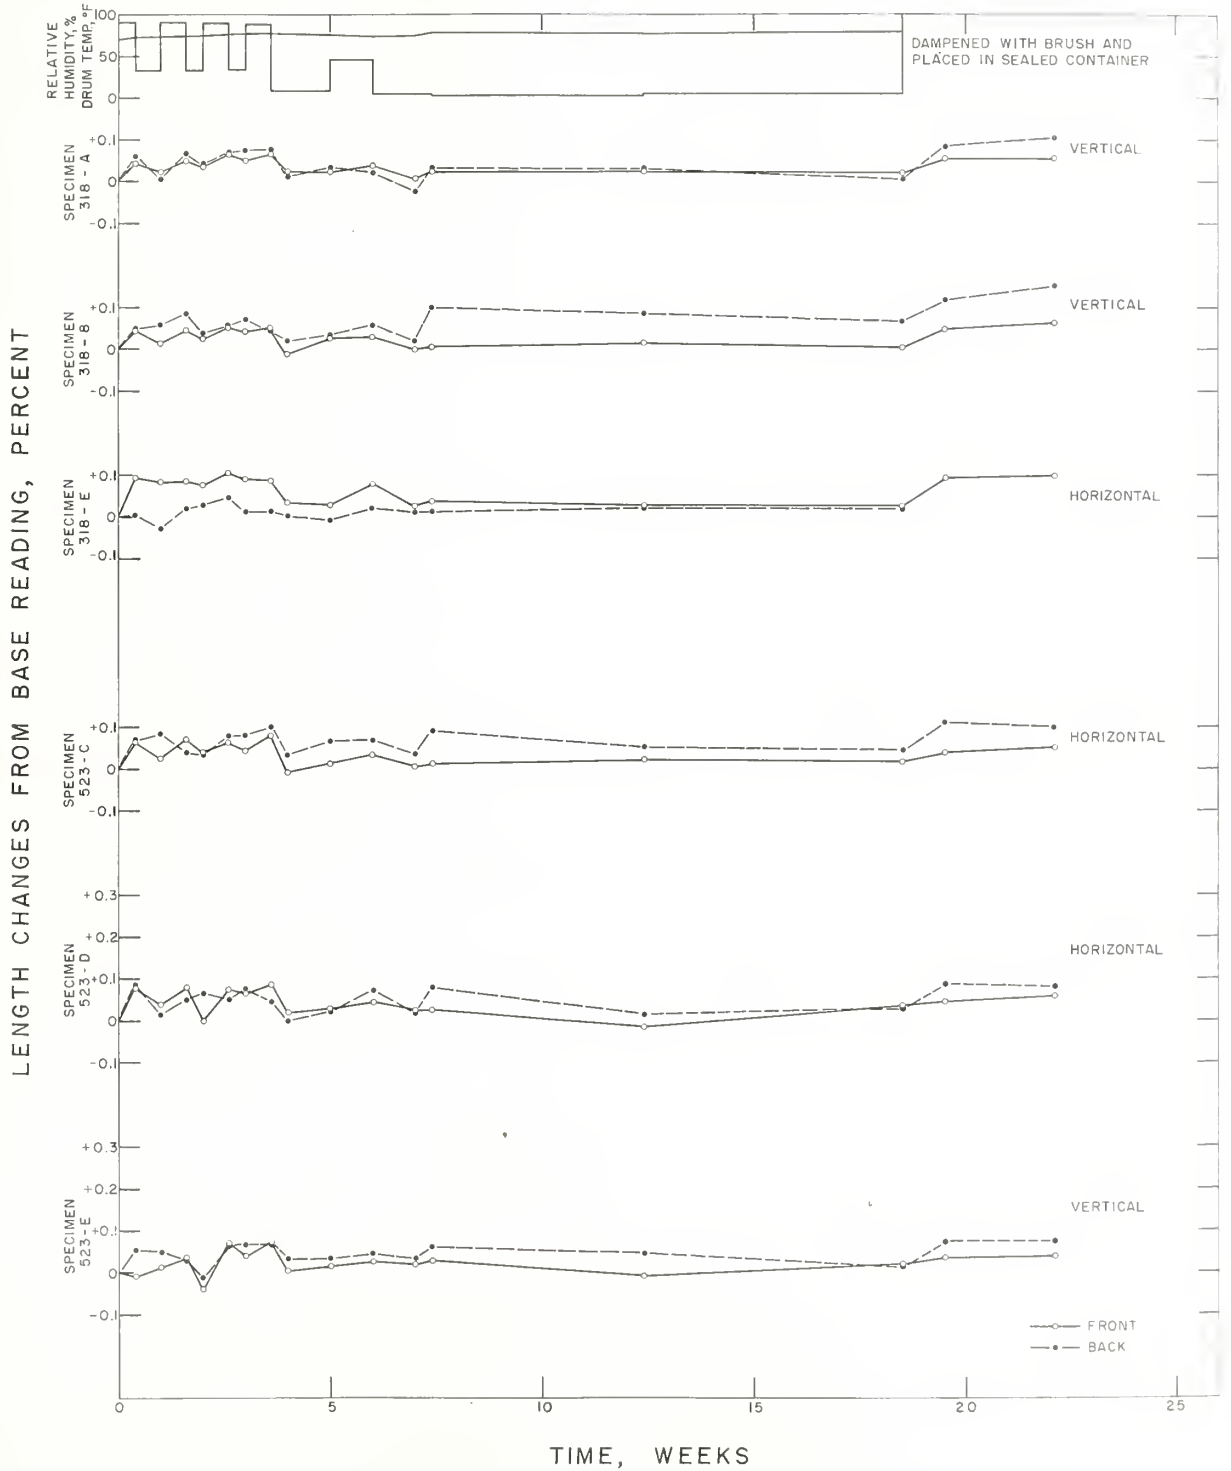
FIGURE 13. EXPANSION AND CONTRACTION OF LATH AND PLASTER SPECIMENS FROM HOSPITAL BUILDING AS THE RESULT OF CHANGE IN RELATIVE HUMIDITY AND DAMPENING. THE NUMBERS OF SPECIMENS CORRESPOND TO THE ROOM LOCATIONS SHOWN ON THE BUILDING PLAN.

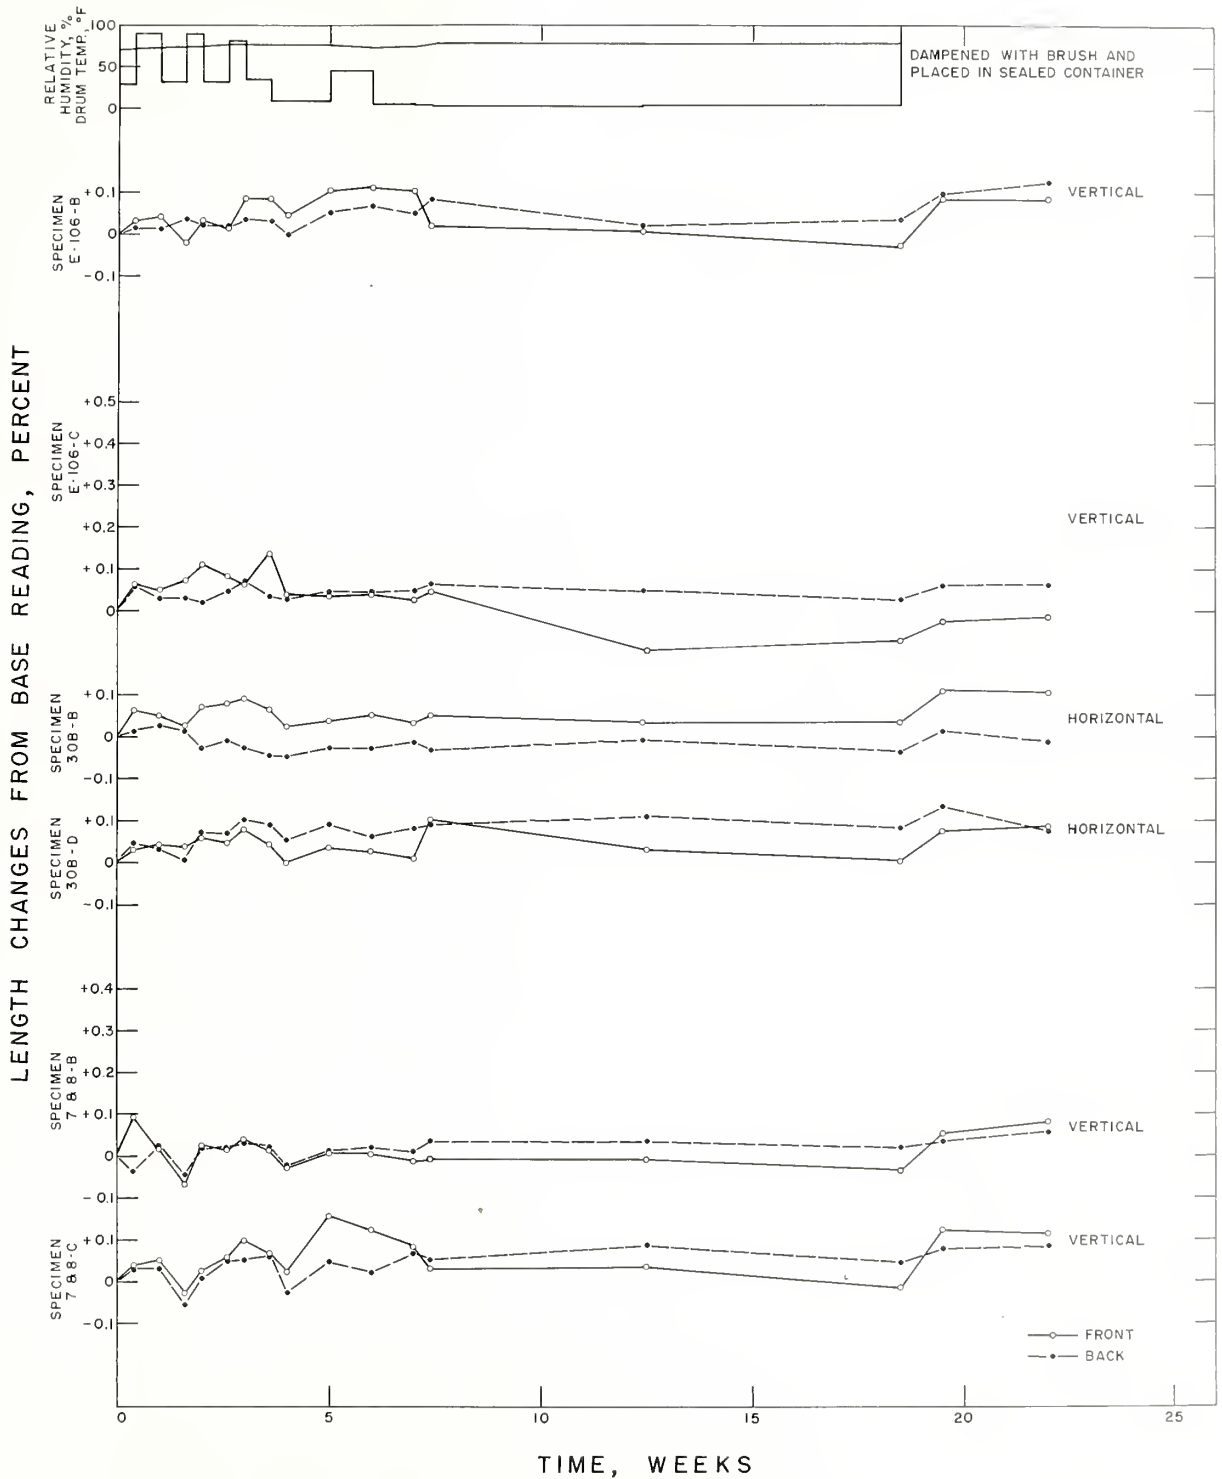
FIGURE 19. EXPANSION AND CONTRACTION OF LATH AND PLASTER SPECIMENS FROM HOSPITAL BUILDING AS THE RESULT OF CHANGES IN RELATIVE HUMIDITY AND DAMPENING. THE NUMBERS OF SPECIMENS CORRESPOND TO ROOM LOCATIONS SHOWN ON THE BUILDING PLAN. SPECIMENS MARKED 7 AND 9 WERE FROM THE BASEMENT CORRIDOR.
