WATER VAPOR TRANSMISSION THROUGH JOINTS AND BREAKER STRIPS OF INSULATED PANELS FOR REFRIGERATED WAREHOUSE, PANEL NO. 1

# January 9, 1956

P. R. Achenbach O. N. McDorman Heating and Air Conditioning Section Building Technology Division

Headquarters, Quartermaster Research & Development Command Natick, Mass.

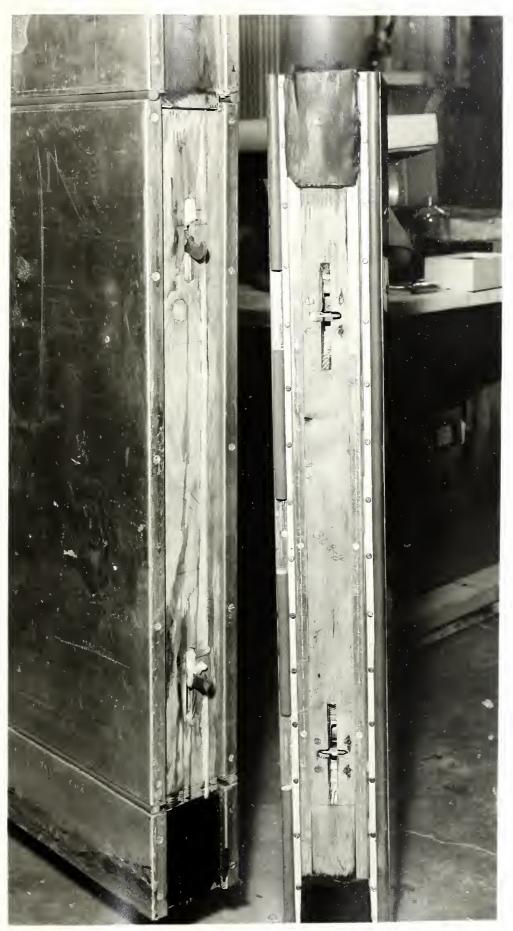
F1: . 3

with both gaskets in place, but with six two-inch slots in the gasket on the cold edge of the panel. Three of these slots were made in the horizontal gasket at the bottom of the center section and three were made in the corresponding positions at the top of the center section. The slotted gasket can be seen in Fig. 3 on the right hand border panel.

4. There was ice in the hook recesses of the two panel fasteners at the top of the center section. This ice is visible in Fig. 3.

5. There was a strip of ice from 1/2 inch to one inch wide for the full length of the joint at the top of the center section. This strip of ice was near the cold edge of the joint and can be seen clearly in Fig. 3.

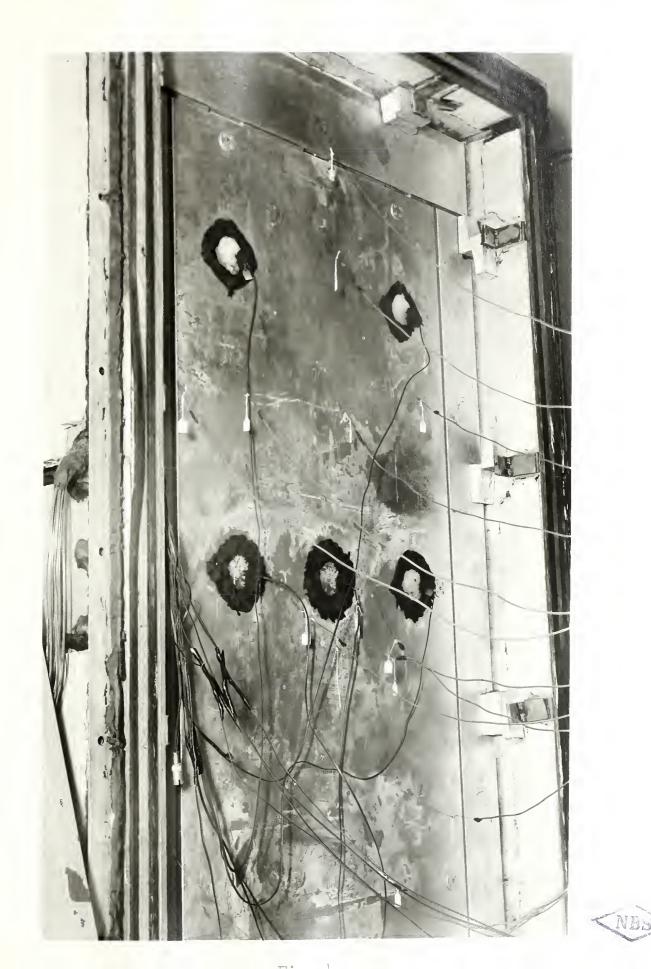
1. All five of the Plexiglas windows were covered with frost on the insulation side. See Fig. μ. Fig. 5 is a closeup view of two of the Plexiglas windows showing the frost accumulation.

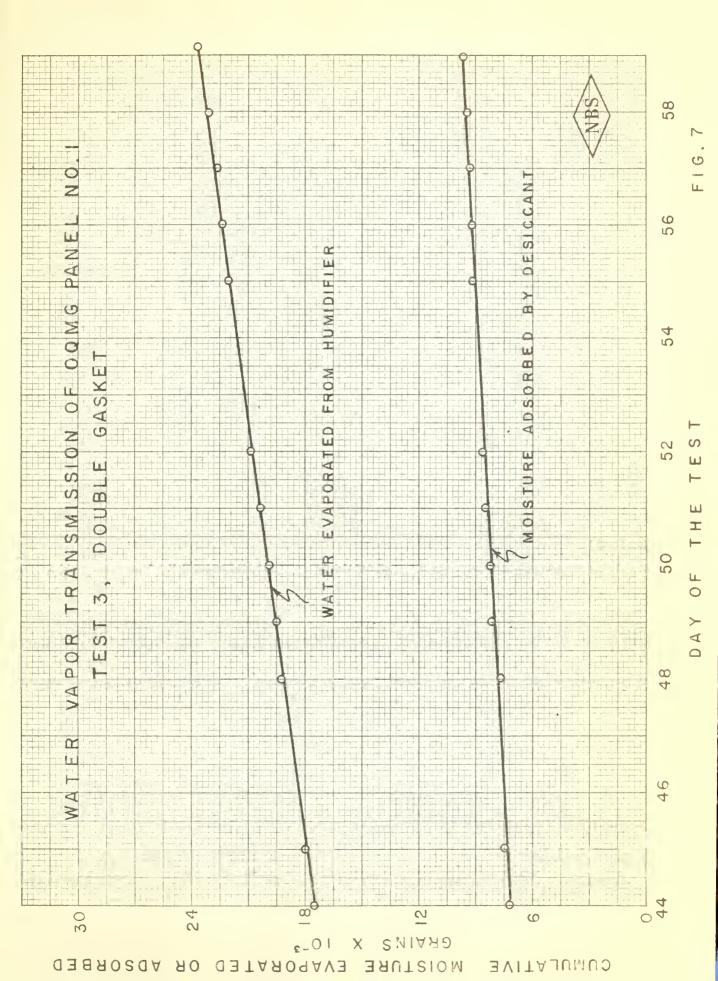
The test conditions and observed results for the four tests of the first panel are summarized in Table 2. Fig. 7 and 8 show the amount of water evaporated on the warm side and the amount of moisture adsorbed in the desiccant on the cold side on a cumulative basis for a period of several days during Tests 3 and 4, respectively.

Fig. 7 shows the rate of water evaporation on the warm side of the panel and the rate of moisture adsorption on the cold side of the panel on a cumulative basis for fifteen days during Test 3 when these rates were nearly steady. Conditions were not as steady for the entire 73 days as those shown in Fig. 7 because of difficulties in obtaining steady vapor generation in the humidifier. The rates of moisture transfer reported in Table 2 for Test 3 correspond to those plotted in Fig. 7. Fig. 8 shows corresponding water evaporation and moisture adsorption data for the entire duration of Test 4. This figure shows some change in water vapor transmission rates after the first eight days of the test, but nearly constant rates thereafter. The rates of moisture transfer reported in Table 2 for Test 4 correspond to those shown for the last eight days in Fig. 8.
