NATIONAL BUREAU OF STANDARDS REPORT

1002-30-10627

FIRE ENDURANCE TEST

TWO BULKHEAD ASSEMBLIES by

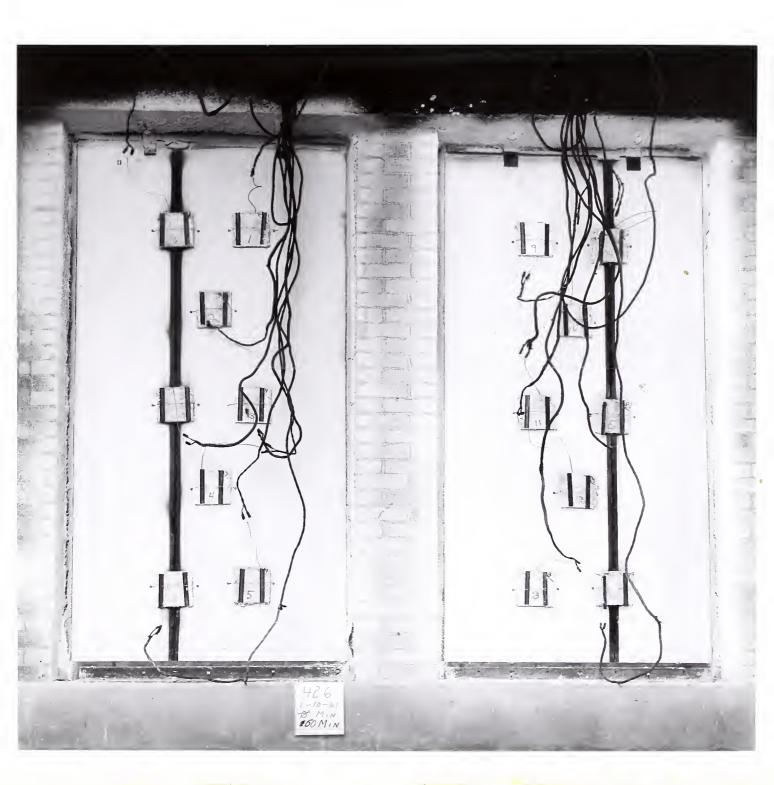
No cracks developed through either specimen during the test, although a diagonal flexure line near the bottom of the unexposed surface of the 30-lb specimen observed at 52 min corresponded to a crack in the exposed surface. The joint members bowed slightly toward the fire in the first few minutes but, after about 12 min, the joint members and marine boards bowed away from the fire. The test was stopped at 1 hr.

Figure 3. Unexposed surface at end of test.

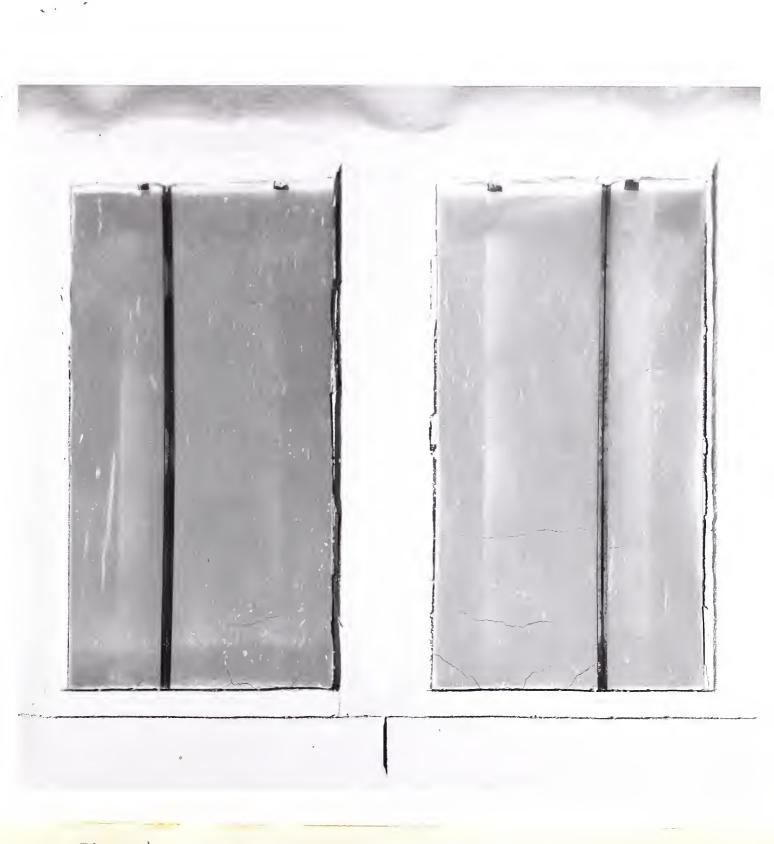
Figure 4. Exposed surface about 10 minutes after end of test.
