PROGRESS REPORT ON EXPOSURE OF NEW ROOFING SYSTEMS

Thomas H. Boone and William C. Cullen

31 July 1966

9381

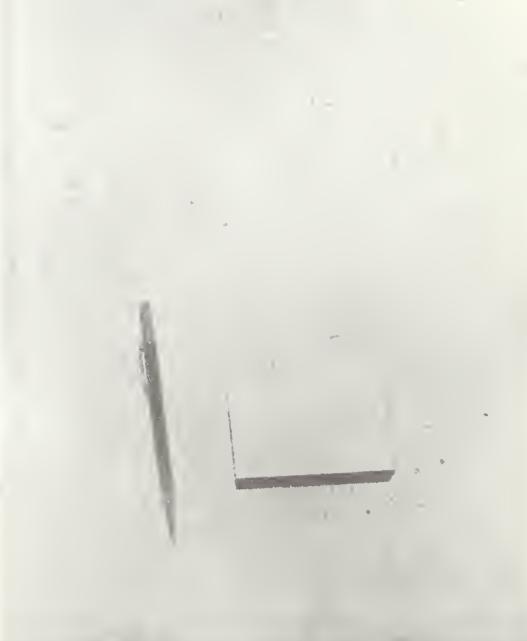
FIGURE 5. TYPICAL CRATER-LIKE SPOTS ON HYPALON TOP COAT.

Small crater-like spots appeared on the surface shortly after drying of the coating. Although these spots became more visible with time (see figure 5) there did not seem to be any break in the Hypalon coat.

The crater-like spots as seen on sample roof 3.1.3 were also noticeable on the roof (see figure 5). A slight color change which may have been caused by the black neoprene bleeding through the Hypalon was noted.

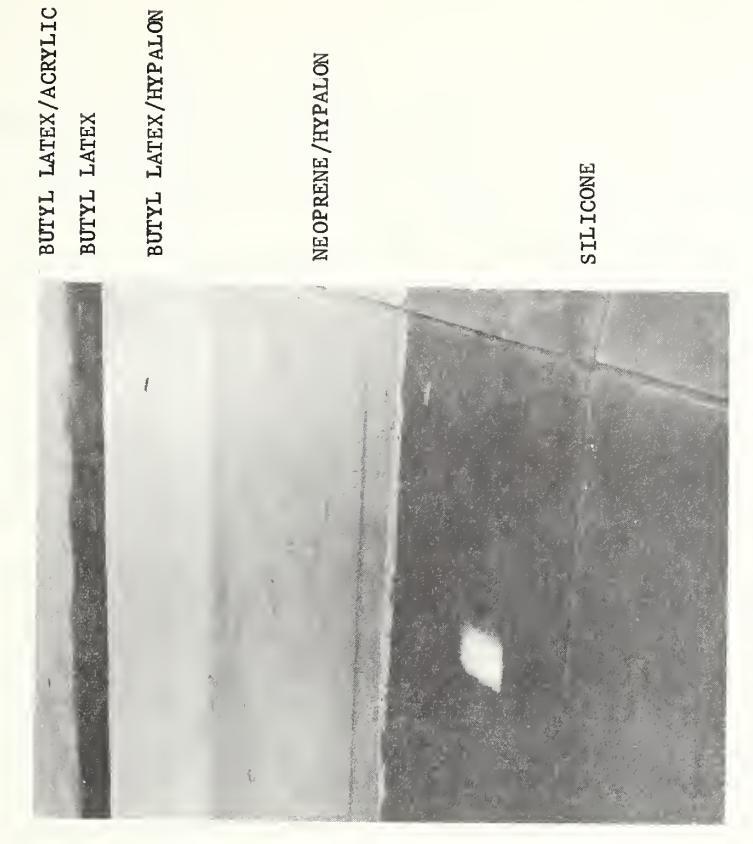
With the exception of dirt accumulation and darkening, the material showed no signs of deterioration. See figure 7 for comparison of darkening.

FIGURE 7. VIEW OF 5 ROJF SYSTEMS SHOWING VISUAL DIFFERENCES CAUSED BY AGE AND DIRT RETENTION AFTER 2 YEARS. ORIGINAL APPEARANCE OF ALL ROOF SYSTEMS WAS SNOW WHITE.

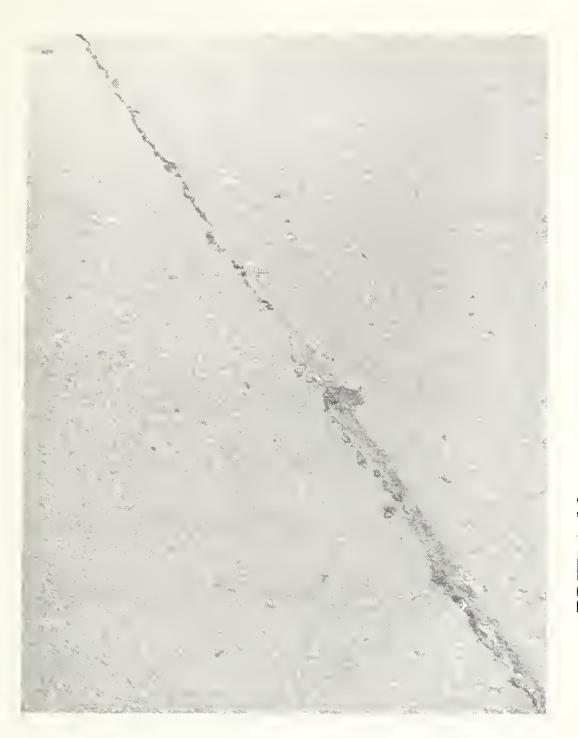
Exposure of the glass fibers was evident as in the butyl systems. The material cracked and separated between concrete panels. See figure 10. The coated base sheet separated from the concrete and blistered. See figure 11. 3.1.8

FIGURE 10. ASPHALT EMULSION- CHOPPED GLASS SHOWING CRACK IN 2 YEAR OLD COATING OVER A JOINT AND EXPOSURE OF FIBER GLASS.

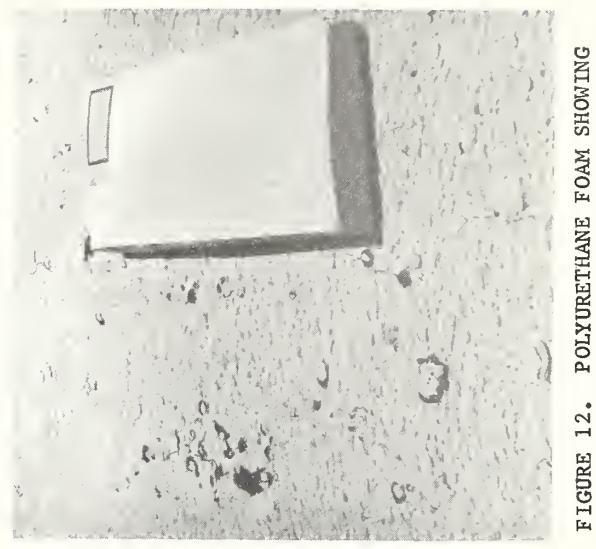
SURFACE DAMAGE OF TOP WEATHER COAT. UNEXPOSED PANEL IN UPPER LEFT CORNER.

On July 8, 1965 a hail storm with hail stones the size of marbles damaged the paint coating and exposed the brownish foam. With the exception of this slight surface damage the material is in good condition. See figure 12.

In the fluid-applied roofings the systems using the Hypalon as a top weather coating seem to maintain their original appearance and showed no visible signs of deterioration. The polyurethane foam roofing also seems to have excellent performance. This system serves as insulation as well as roofing. Recommendations have been made to the manufacturer to provide a more elastic and durable top weather coating on the polyurethane foam.

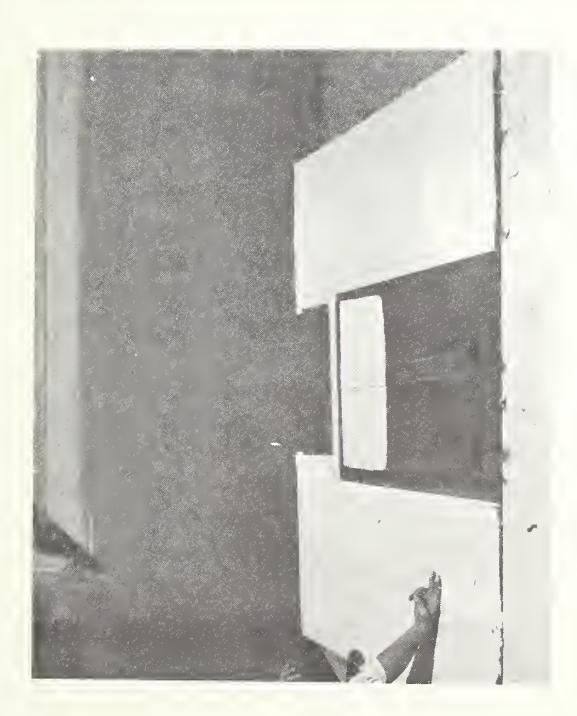
Within one month very noticeable brown stains appeared on the top surface. The stains could not be removed by scrub-washing. Chalking of the top surface was noticed after 8 months exposure. With the increasing chalking; the brown stains disappeared. See figure 13.

The black polyisobutylene surface and the coated surface have not changed from their original appearance in one year exposure. See figure 13. 3.2.3

After one year exposure there was no change in the visual appearance of the sheet material. See figure 13. Dimensional change or deck movement caused adhesive overlap of the tape.

FIGURE 13. SINGLE-PLY ROOFING SYSTEMS. LEFT TO RIGHT, HYPALON (NOTE CHALKING ON FINGERS) POLYISOBUTYLENE, AND TEPLAR.

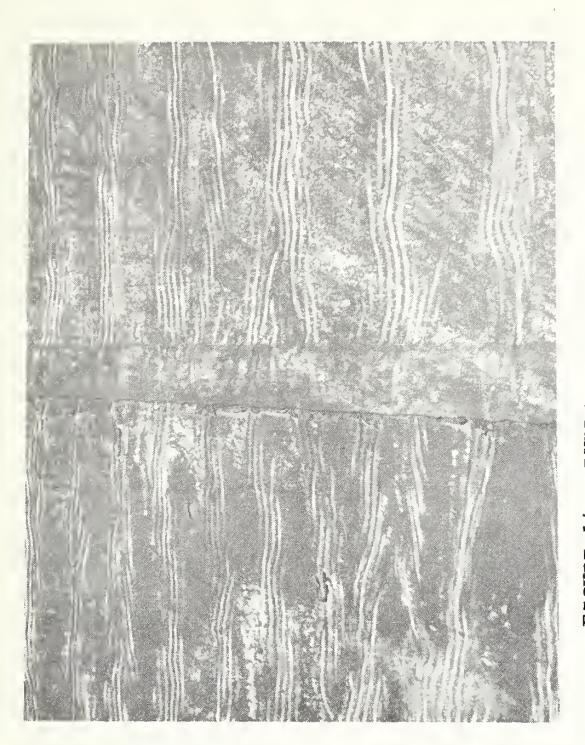
After seven months exposure there was no visible change. See figure 14.

FIGURE 14. RUBBERIZED-ASPHALT SHEET. THE WHITE WRINKLE APPEARANCE WAS INHERENT IN THE SAMPLE.

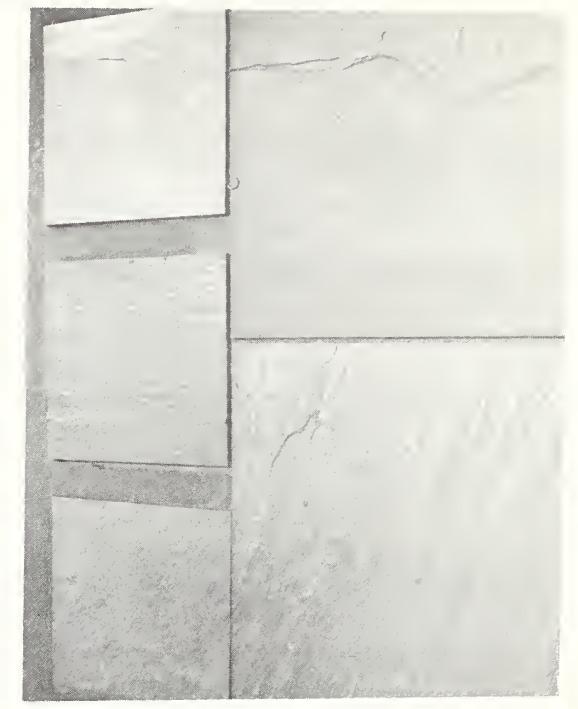
After one year exposure no visible change had occured. See figure 16. 3.3.2

FIGURE 16. FLEXIBLE TILE TRAFFIC DECK SHOWING SLATE-LIKE TEXTURE MOLDED ON THE SURFACE BY THE MANUFACTURER.
