FIRE ENDURANCE OF PARTITIONS AND ROOF DECKS

FIRE-RETARDANT TREATED AND UNTREATED WOOD

Harry Shoub

October 5, 1967

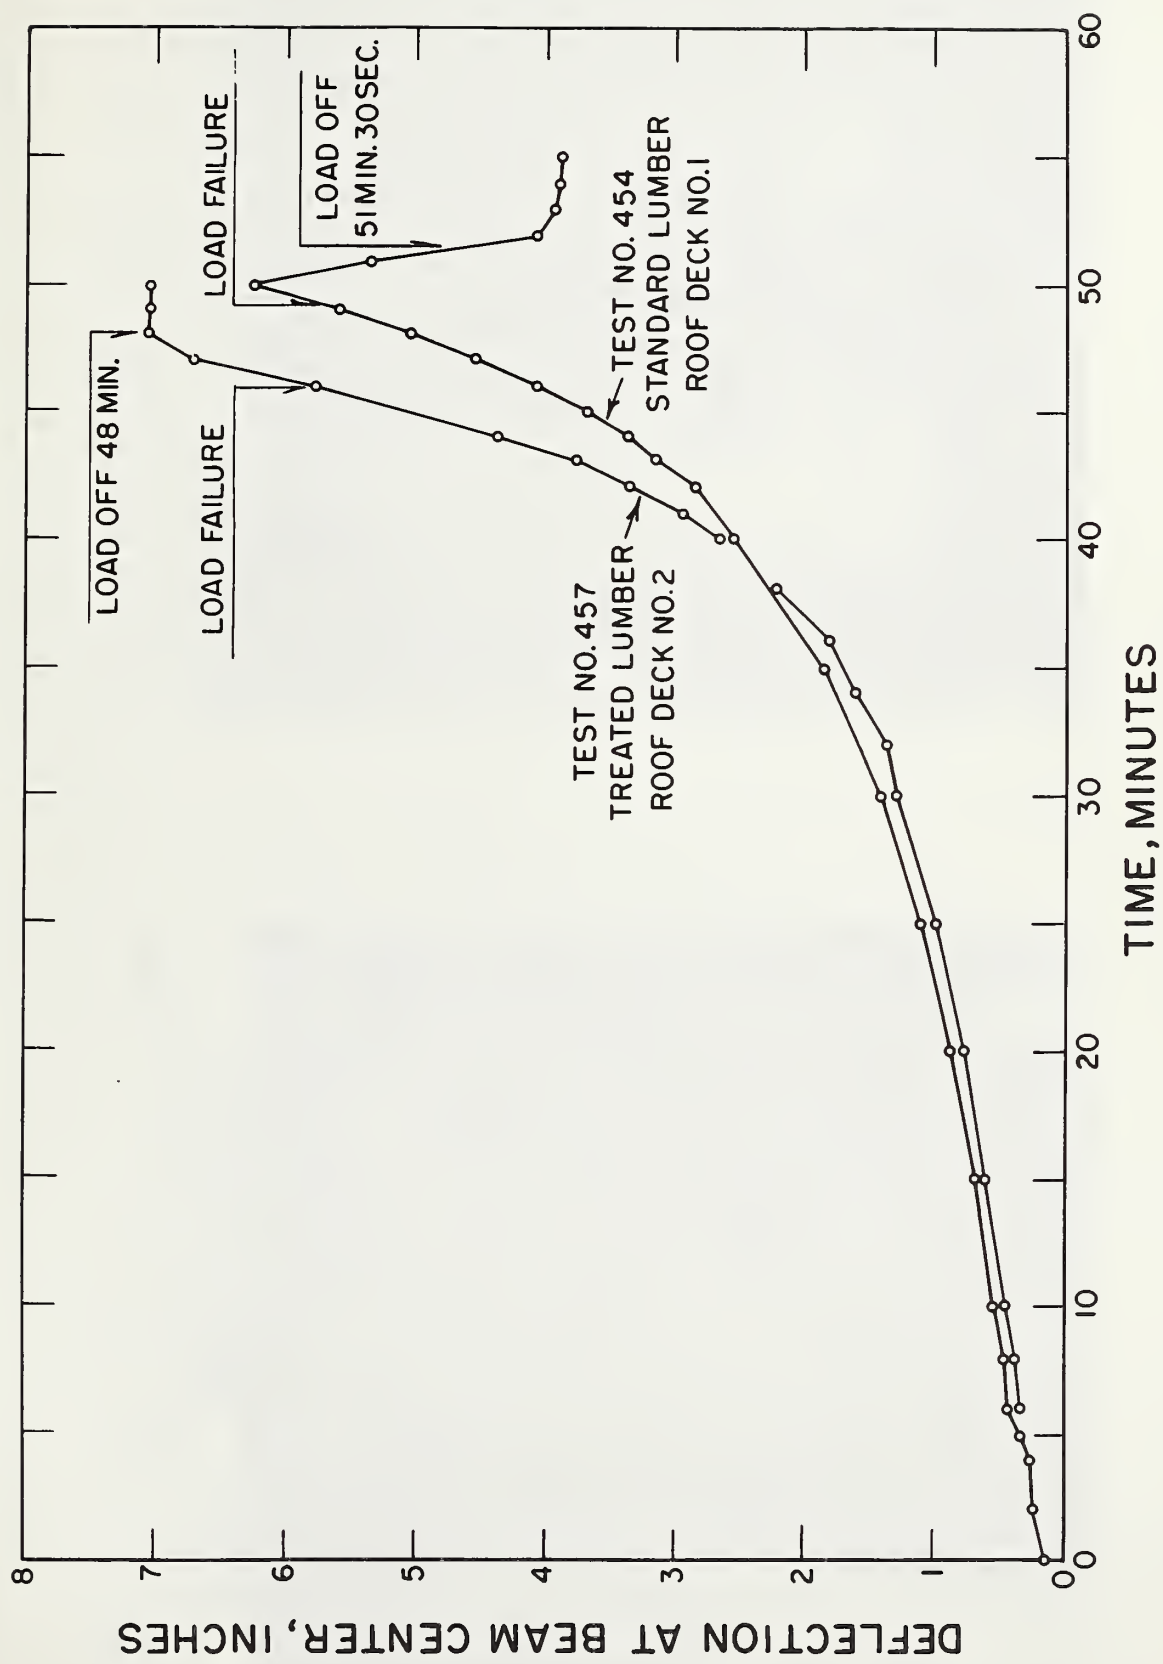
The considerable downward deflection of the decks resulted from loss of strength in their supporting beam from heating and reduction of cross section by charring, the extent of which in the treated beam, can be seen in Fig. 11. As measured at the center point, the deflection of the untreated wood deck was slightly greater than that of the treated wood specimen up to about 40 min fire exposure, at which time the rate of deflection of the treated structure increased beyond that of the first roof deck. Maximum deflections, just prior to load removal, were 6-1/4 in. for deck No. 1, and 7 in. for No. 2. After the load was removed, the beam on deck No. 1 showed some recovery, with a final deflection of about 4 in. This did not occur, however, on the roof deck of fire-retardant-treated wood. Deflections somewhat greater than those on the beams were noted at the deck measuring points. In part, these were attributable to the pulling away of the roof plank end supports from their attachment to the furnace frame during the course of the tests.

In the absence of any definitive requirement in the standard fire test (ASTM E 119), the criterion of load failure, which was the determining factor in the endurance of the roof decks, has been taken as the time when both a limiting total deflection and hourly rate of deflection are achieved [10]. These are based on the span length and the depth of the supporting structural component. For the beams in these tests, the limits were a deflection of 5.7 in. and a rate of 30.5 in./hr. With both roof decks, the rate of deflection limit was reached before the allowable total deflection, occurring at approximately 49 min for deck No. 1 and 43 min for No. 2.

FIGURE 7. Deflections at the center of the roof decks.

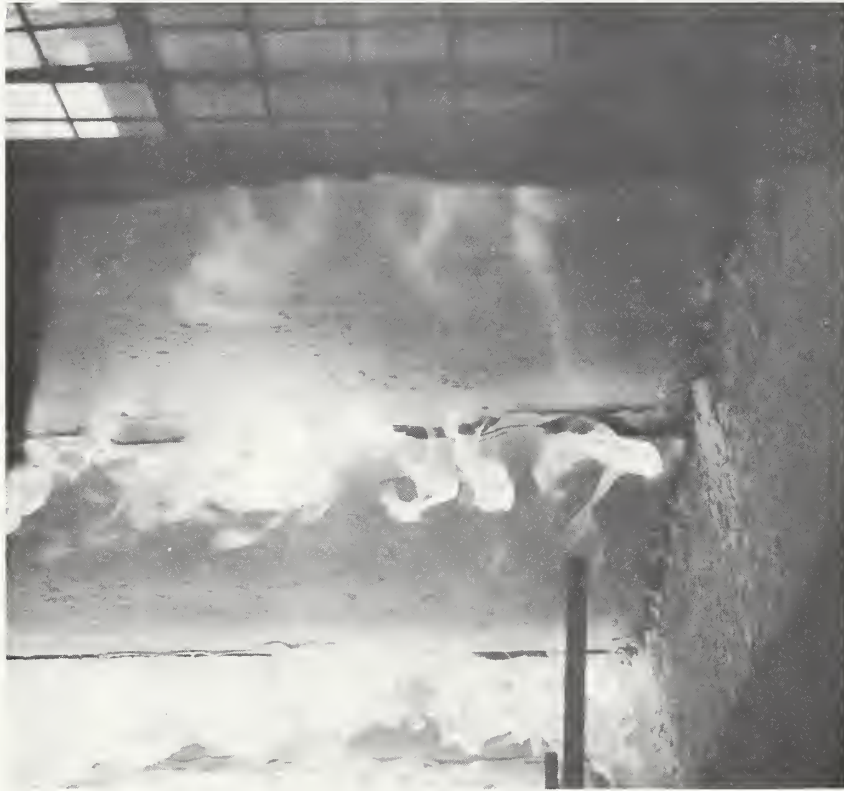
Initial flaming on the exposed sides of the structures was noted soon after the start of the tests, and represented the burning of the facing material on the gypsum panels. Flaming at the board joints, indicative of combustion of the studs, occurred before 30 min in partition No. 1 with untreated wood, and

was definitely established in the later stages of the tests of the two partitions with fire-retardant-treated framing. On these, the characteristic odor and crackling sound of burning wood had been noted earlier in the tests. Fig. 8 (at 57 min) and Fig. 9 (58 min) show the flaming at the gypsum board joints of partitions Nos. 1 and 3, respectively.

FIGURE 8. Exposed surface of partition No. 1 (Untreated framing). Flames from studs through gypsum board joints; time 57 min.

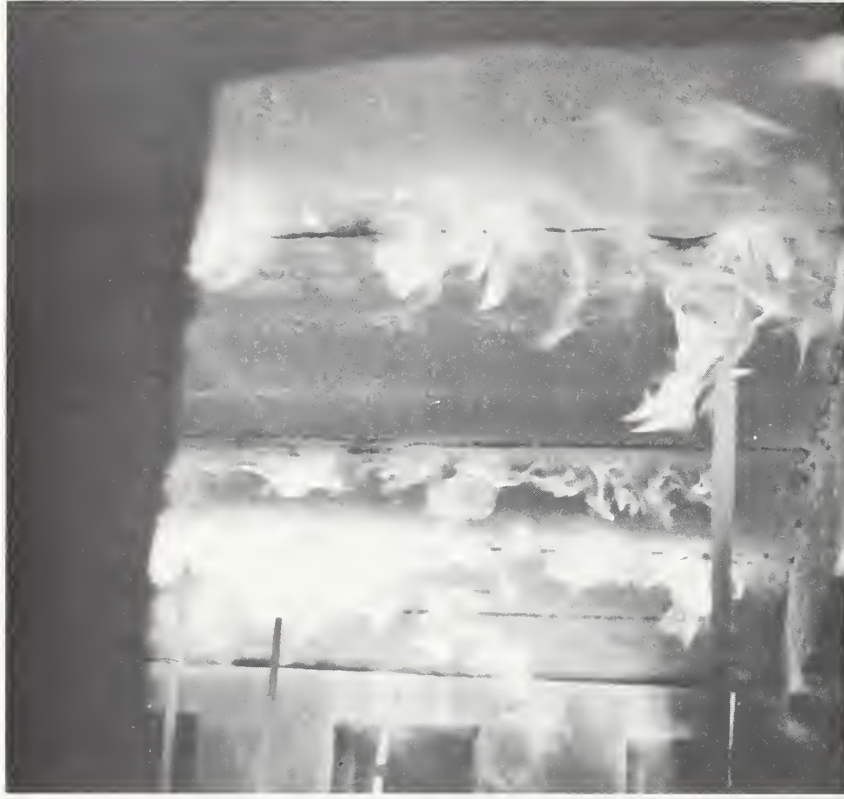
FIGURE 9. Exposed surface of partition No. 3 (fire-retardant treated framing). Studs burning at joints between gypsum boards, time 58 min.

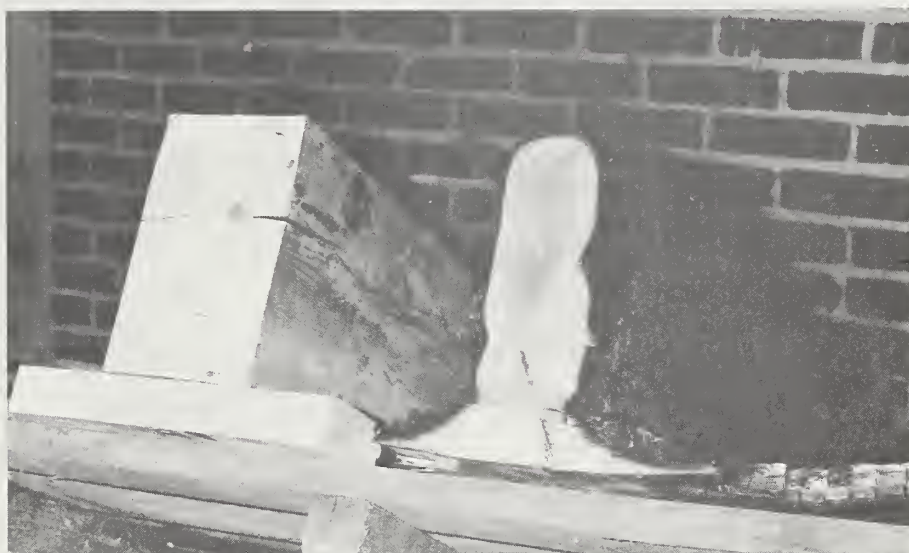
FIGURE 11. Cross section of fire-retardant treated beam and plank after test.
Unburned section shown for comparison.

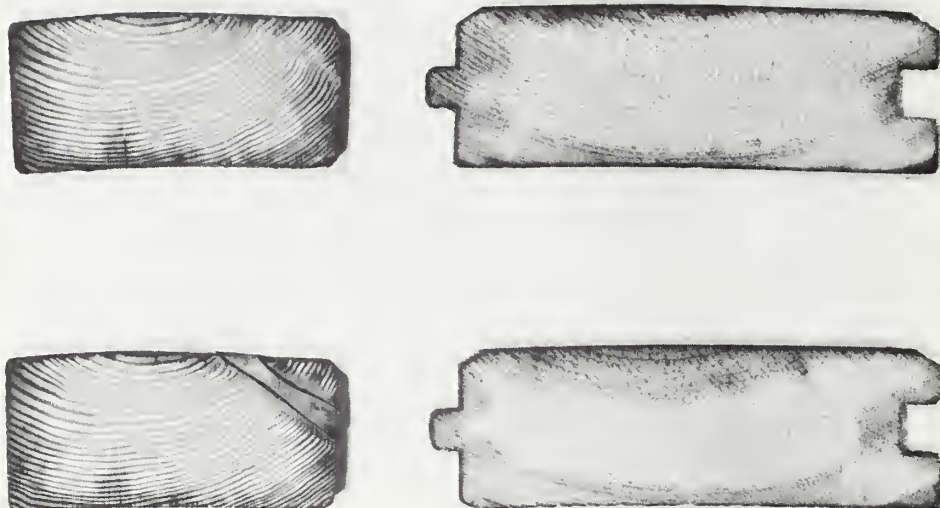
It has been established that fire-retardant treatment causes a greater production of charcoal in the wood and reduces the temperature at which char occurs. From this, it is possible to indicate the extent of treatment penetration by heating small thin sections of the wood to 220 °F for 20 min. Under these conditions char will have been produced in any treated portions while the untreated retains its normal appearance. The result of this simple investigation can be seen in Fig. 12. Note that the sections of both the 2- by 4 and roof deck lumber show hardly more than peripheral discoloration.

FIGURE 12. Sections of fire-retardant treated partition studs and roof deck planks heated to show extent of treatment penetration (charred areas).

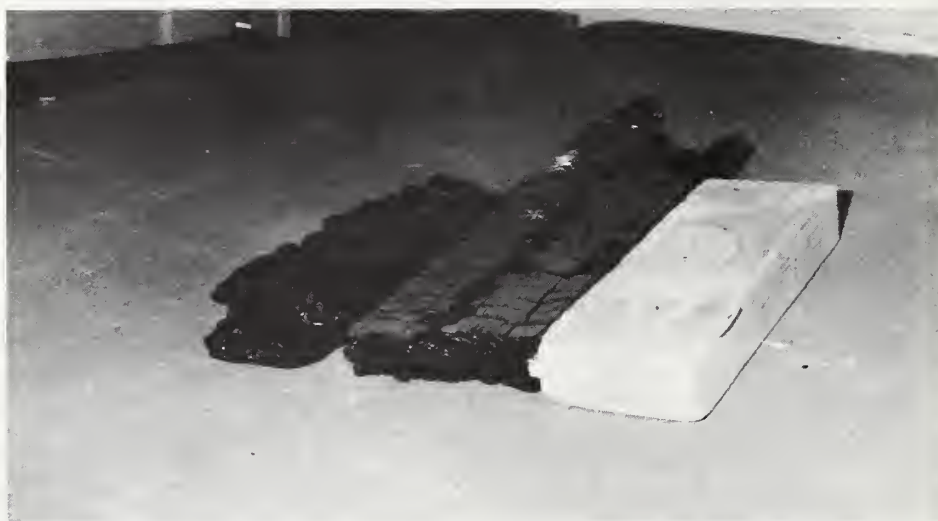
The failures of the roof decks by flames burning through to the unexposed surface occurred at single points. The whole of the decking, however, was involved, and an examination of the depth of char, the totality of which can be seen in Fig. 13, indicated that the fire soon would have broken through over much of the deck area. In the deck with treated wood, a second flame-through did take place 1-1/2 min after the first. At about this time the test was discontinued. Flaming continued on both decks after the fire exposure was stopped, and was extinguished only with considerable application of water.

FIGURE 13. Fire-retardant-treated roof decking after test. Unburned sample for comparison.
