NATIONAL BUREAU OF STANDARDS REPORT

9642

Howell-Bunger Valve No. 1 Summersville Dam, Gauley River, West Virginia

REPORT OF TEST Howell-Bunger Valve No. 1, Summersville Dam, Gauley River, West Virginia

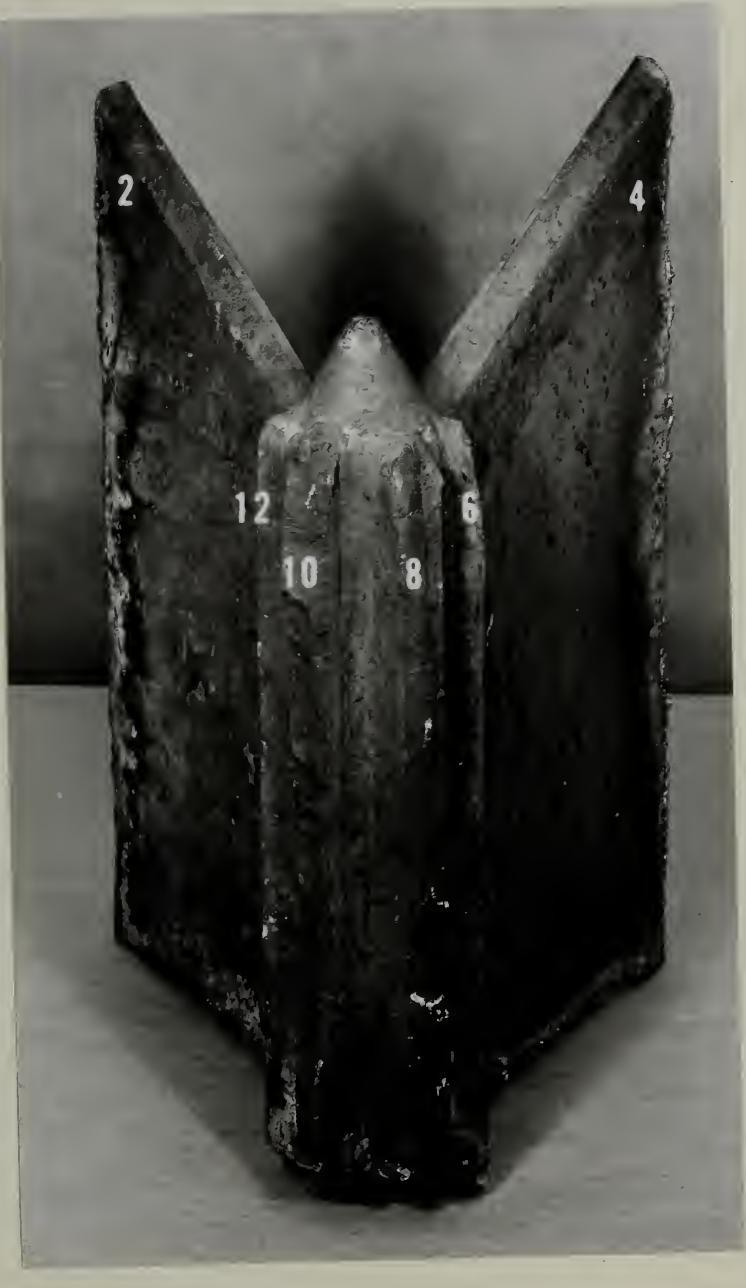
A portion of the upstream end of the valve consisting of part of the hub (approximately 18 inches in length) and parts of both remaining vanes was designated to be cut out and shipped to NBS for examination (figure 1).

Figure 1. Portion of Howell-Bunger Valve No. 1 as received at NBS. Vane numbers are shown. X 1/4 . .

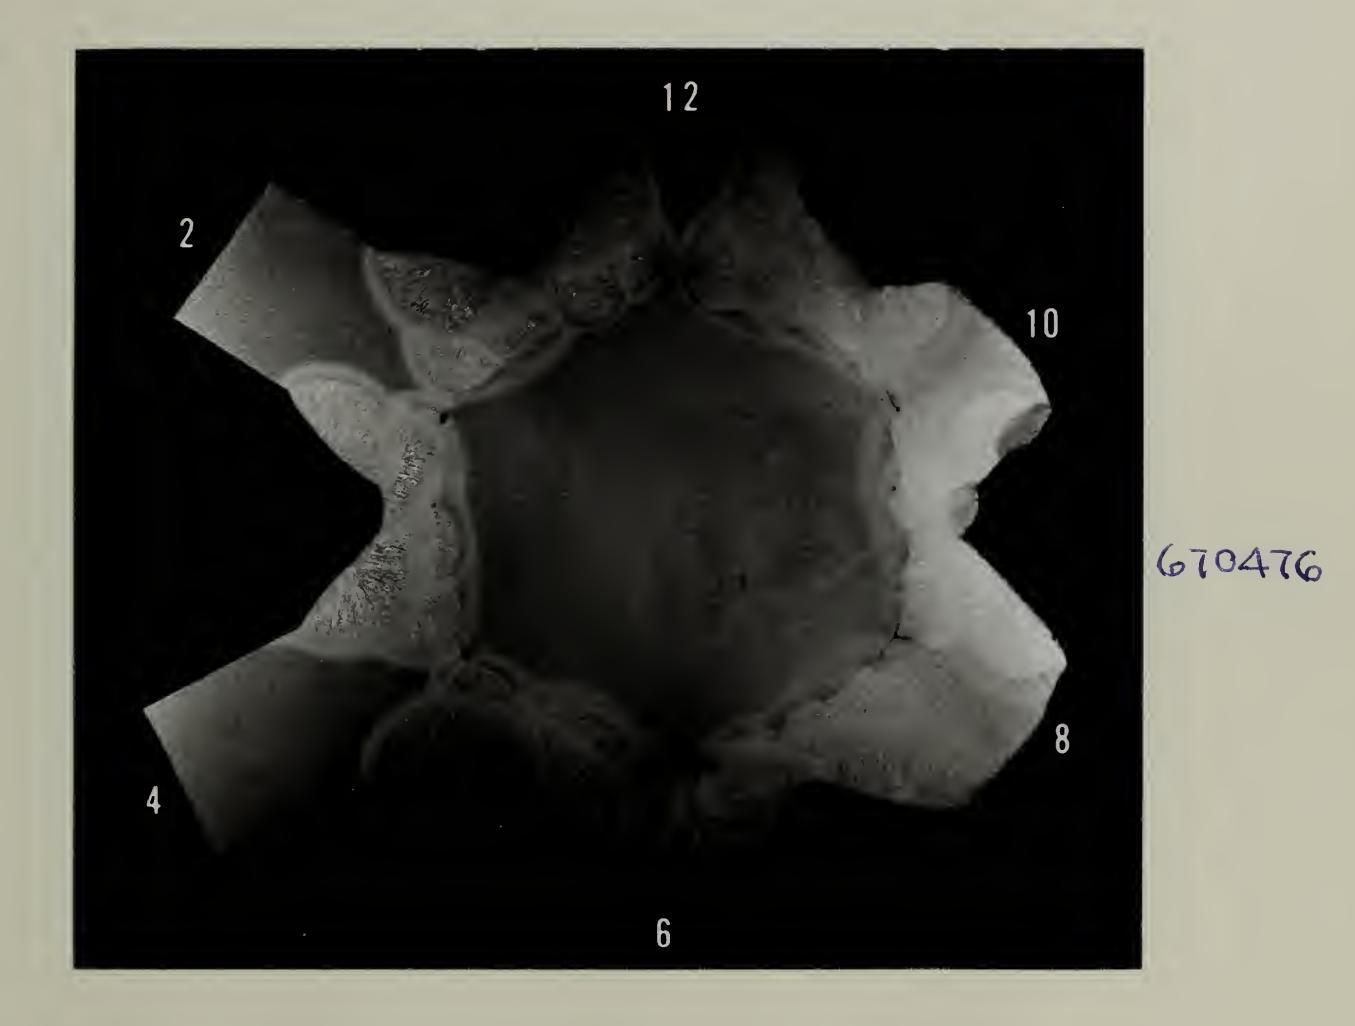
A transverse slice through the hub and parts of each vane about 12 inches from the upstream end of the valve is shown in figure 2. This section has been etched to show the configuration of the weld material and heat affected zones in relation to the hub and vanes. Most of vanes 2 and 4 have been cut off. Each of the fractures began in the region where the weld material meets the heat affected zone of the vane.

It is to be noted from figure 2 that there are somewhat sharp reentrant angles at the junction between weld material and the heat affected zone in the segments of the two vanes which had not failed. These re-entrant angles act as notches or stress concentrators which are very undesirable and can be quite detrimental. The crack in vane 4 occurred at such a place, and while it is difficult to establish the severity of the angle between the weld and vane for the four fractured vanes, the fractures occurred in the regions of these angles. It is quite likely that the same undesirable re-entrant angles existed for these vanes also.

In some areas between the hub and the vanes where there is a lack of welding (figure 2), the surface of the hub exhibits some decarburization (figure 7) which would tend to weaken the material, but this has not contributed to the failure.

Figure 2. Transverse slice through hub and part of each vane. Vane numbers are shown. 5% Nital etch. X 3/4

This condition can be corrected by grinding these angles to provide a smooth transition from the weld to the vane. The failure would definitely be postponed by the elimination of these re-entrant angles, but there is no assurance, however, that eventual failure in these areas would not occur. The cyclic stresses are quite high, as mentioned earlier, and this investigator is not aware of any valve assembly in operation with the re-entrant angles ground smooth so that a comparison can be made.

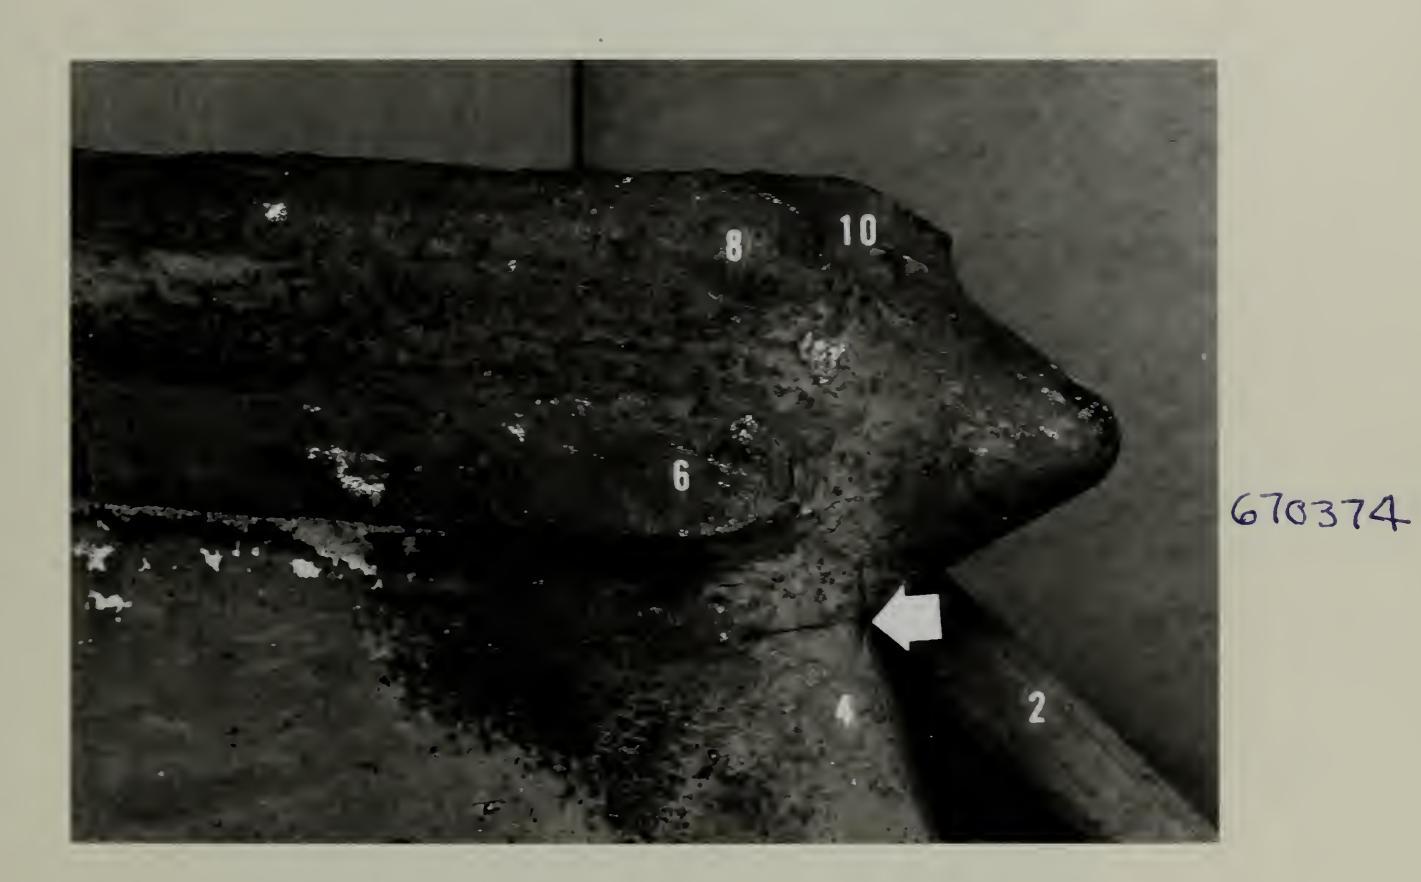
In addition to the four fractured vanes, a crack about five inches long was found in the upstream end of vane 4 in the same relative location as the other fractures (figure 3). The crack was opened and the exposed fracture surface is shown in figures 4 and 5. The fracture consists of two series of cracks, each of which has many sources, which propagated in fatigue. One series originated on either side of the vane and propagated transversely (in figures 4 and 5, one: series propagated upward and one downward) toward the center of the vane. The junction of the two series is characterized by the longitudinal ridge near the fracture center.

Figure 3. Upstream portion of Howell-Bunger Valve No. 1 showing crack in vane 4. Vane numbers are shown. X 1/2

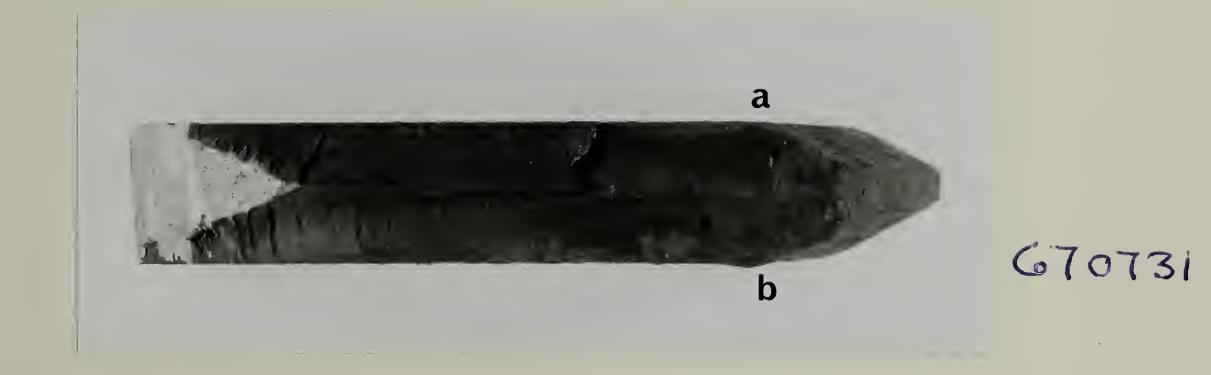
The exact starting points of the cracks could not be determined from the fracture surface, but the most probable locations are at "a" and "b" (figure 4) because the cyclic stress due to bending of the vane would have been greatest there.

On some of the transverse ridges, striations are visible (not clearly evident in the photographs). The spacing of these striations indicates that the fatigue cracks were probably propagating at a fairly high rate, which in turn indicates that the cyclic stress was much higher than the fatigue limit of this material.

Figure 4. Fracture surface of vane 4. Upstream end is at right. X 3/4

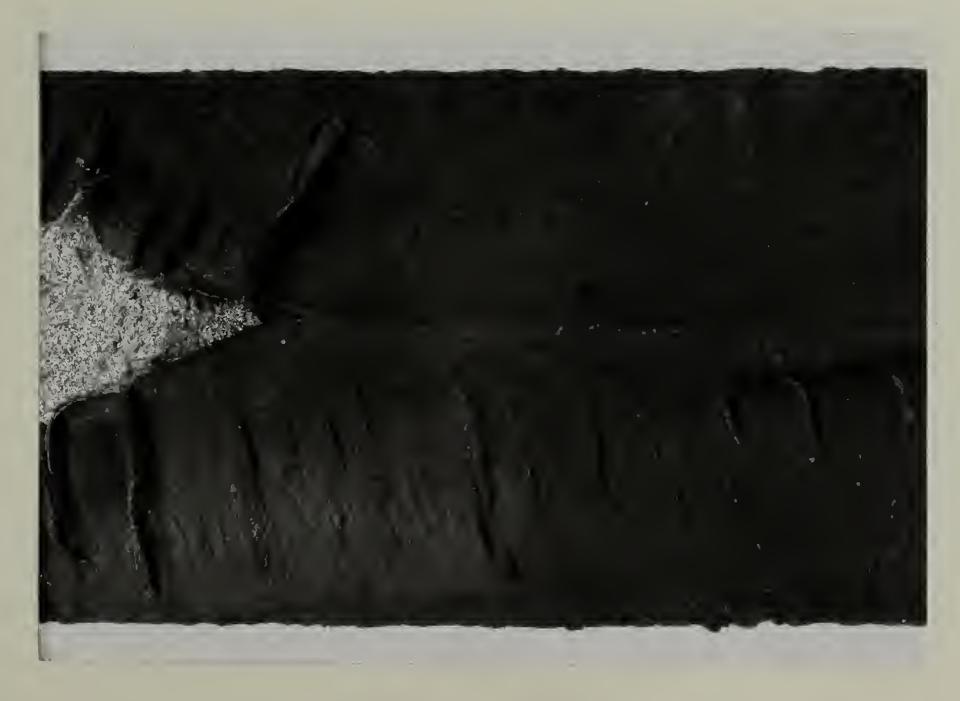
Figure 5. Fracture surface of vane 4. Upstream end is beyond right side of picture. X 3 ·

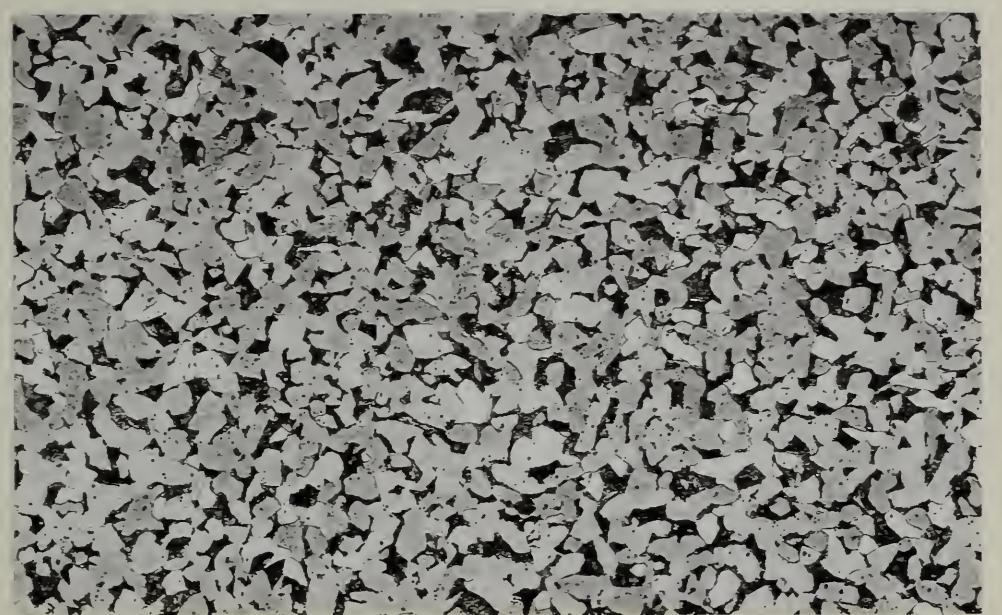
The microstructure of the hub (figure 6) consists primarily of ferrite and pearlite with a reasonably fine grain size. This structure is considered to be satisfactory.

Figure 6. Microstructure of hub. 1% Nital etch. X 100

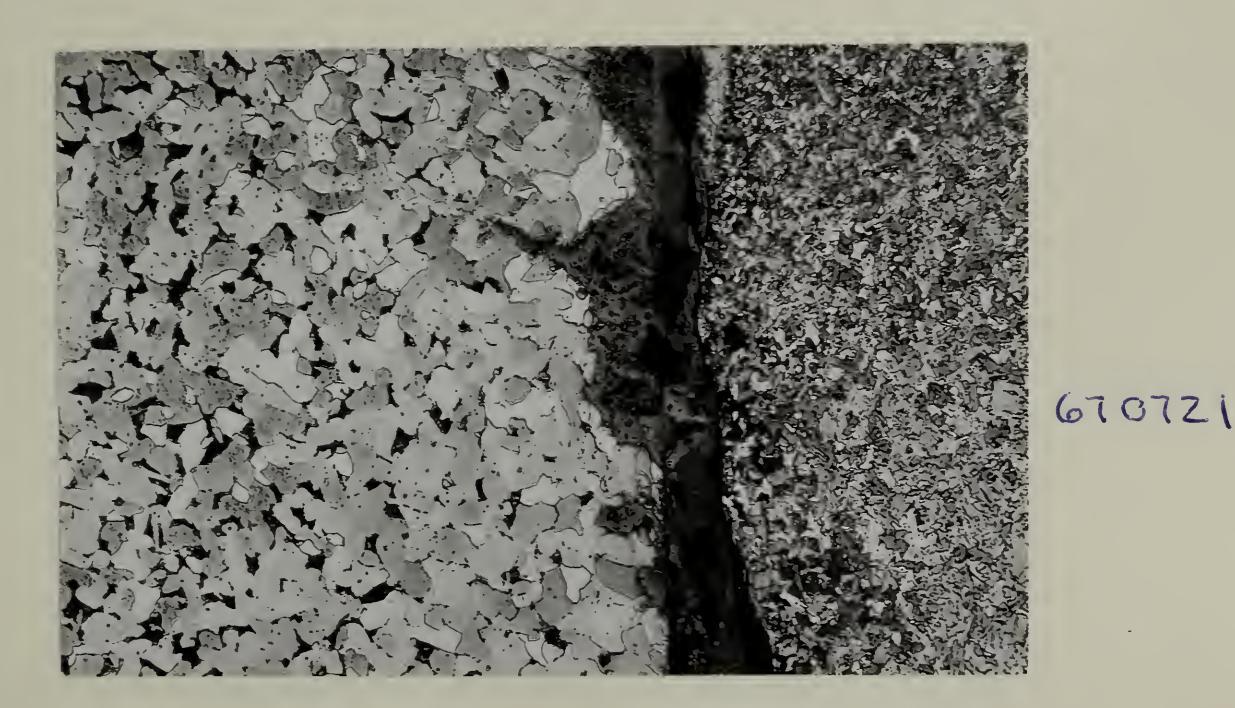
Figure 7. From left to right: hub microstructure, area of lack of welding, and heat affected zone of vane. Note decarburization near surface of hub. 1% Nital etch. X 100

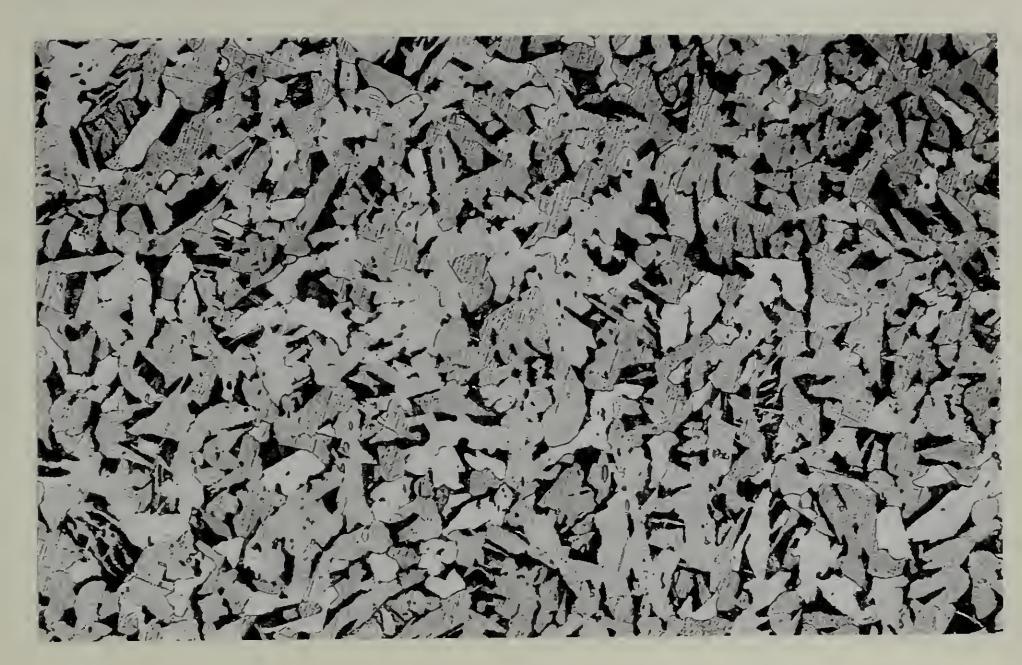
Vane 4, which had partially fractured, exhibits some evidence of an undesirable Widmannstatten structure (figure 8). The microstructure of fractured vane 6 (figure 9) is coarse and exhibits a Widmannstatten structure to a greater degree. Prior austenite grains are visible. The structure of vane 6 is poorer than that of vane 4, but both structures indicate too high a rolling temperature for the steel.

Figure 8. Microstructure of vane 4. 1% Nital etch. X 100

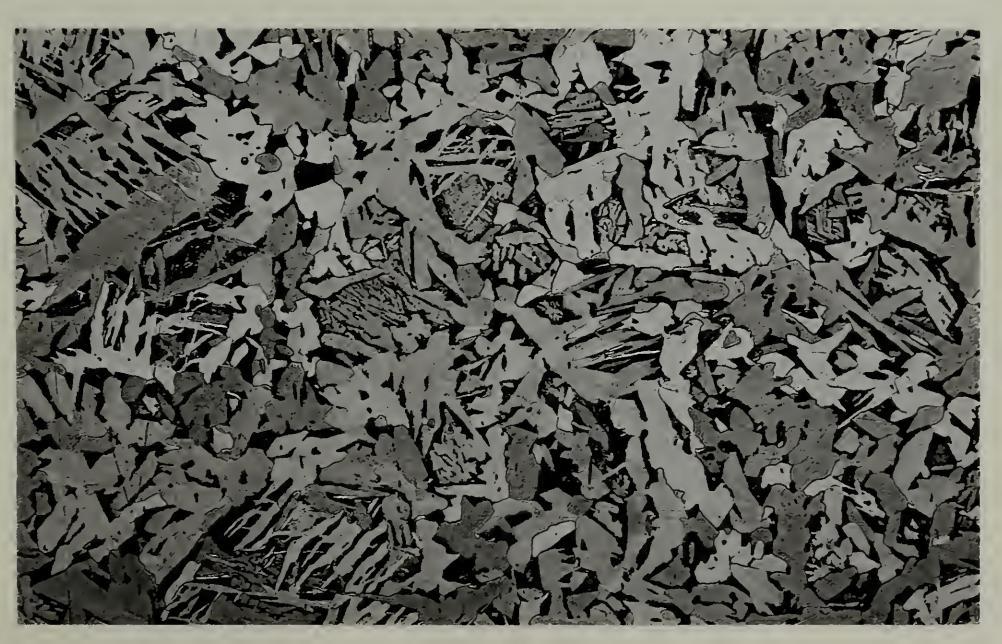
Figure 9. Microstructure of vane 6. 1% Nital etch. X 100

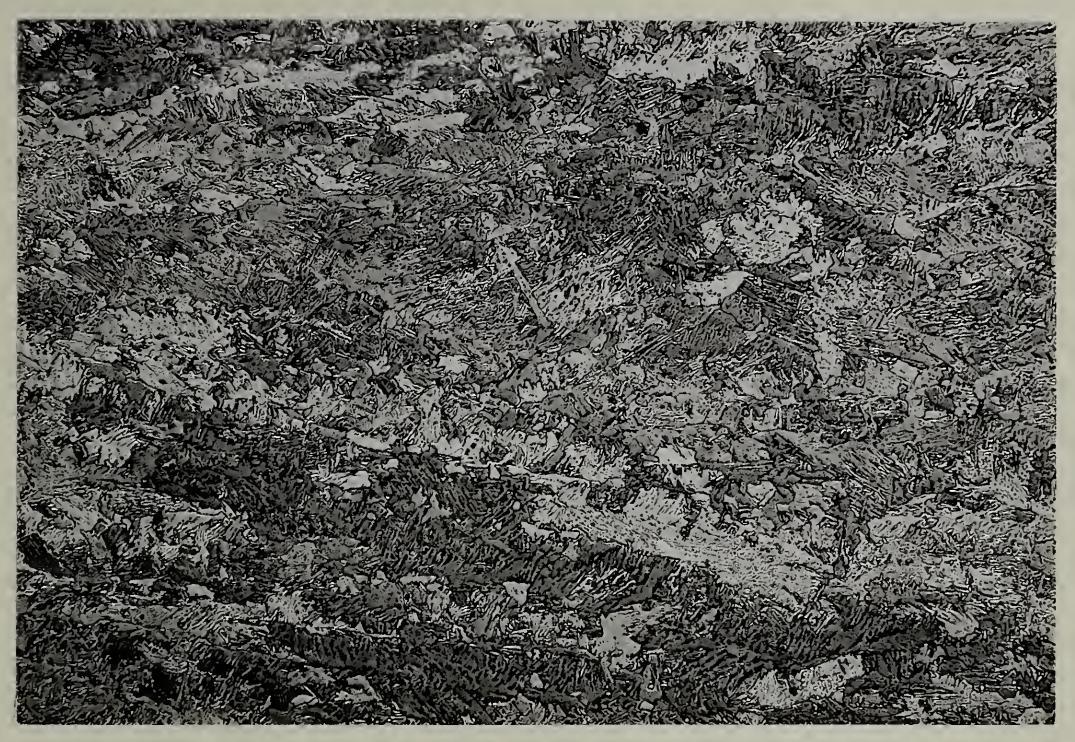
The microstructures of the weld material and the associated heat affected zones (figures 10 and 11) are satisfactory.

Figure 10. Microstructure of weld material. 1% Nital etch. X 100

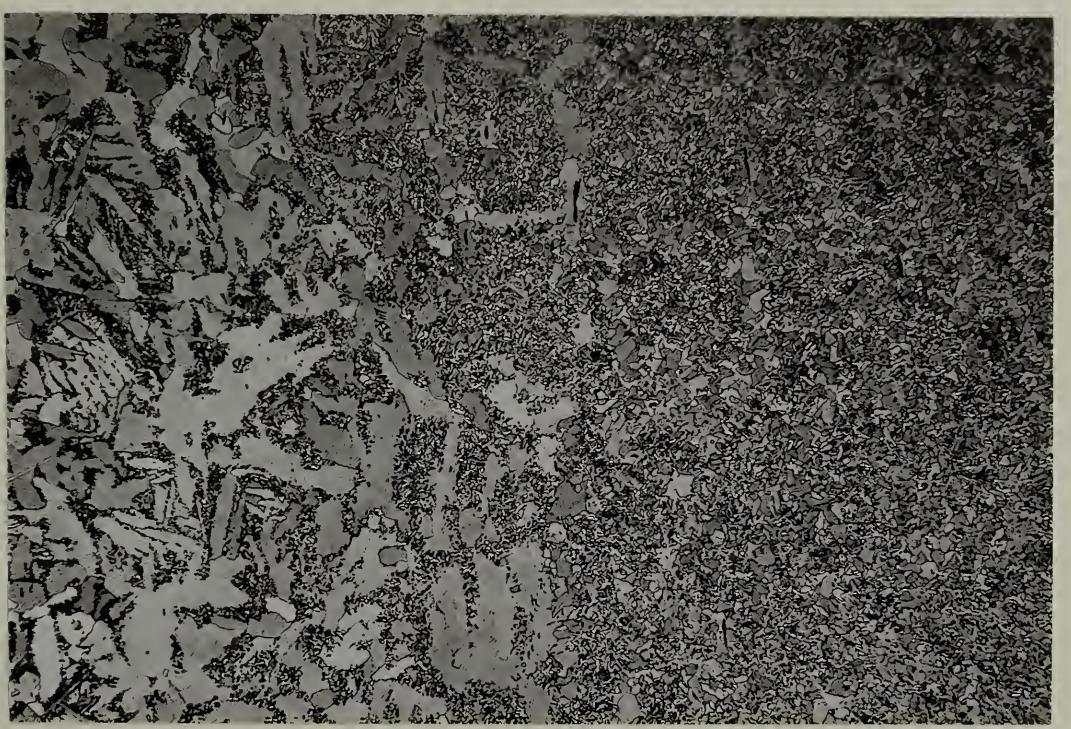
Figure 11. Transition from microstructure of vane (left) to heat affected zone (right). 1% Nital etch. X 100
