NBS TECHNICAL NOTE 569

Hurricane Camille-August 1969

HURRICANE CAMILLE - AUGUST 1969* A Survey of Structural Damage Along the Mississippi Gulf Coast by Robert D. Dikkers, Richard D. Marshall

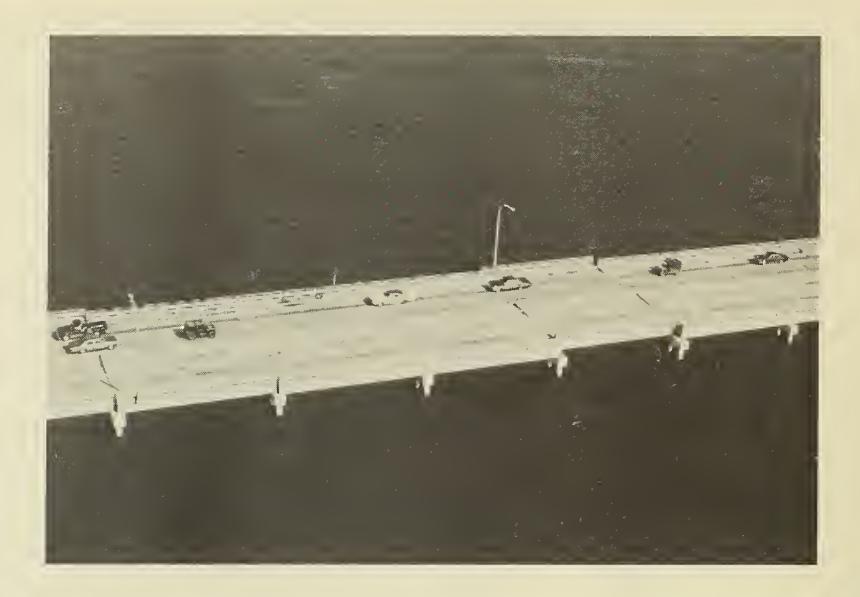
Figure 6. Biloxi Bay Bridge, Biloxi, Mississippi.

As indicated in figure 3, maximum wind speeds and surge heights in the Biloxi area were approximately 105 mph and 18 ft respectively. Precast concrete deck slabs of the Biloxi Bay Bridge (fig. 6) were moved longitudinally on their pile bents by surge-borne waves. Some slabs were displaced as much as 3 to 4 ft and considerable debris was lodged in the bridge railing. The ground floor of the Buena Vista Motel (fig. 7) was completely gutted by waves and extensive wind damage to the roofing was observed. Note the proximity of the structure to the water.

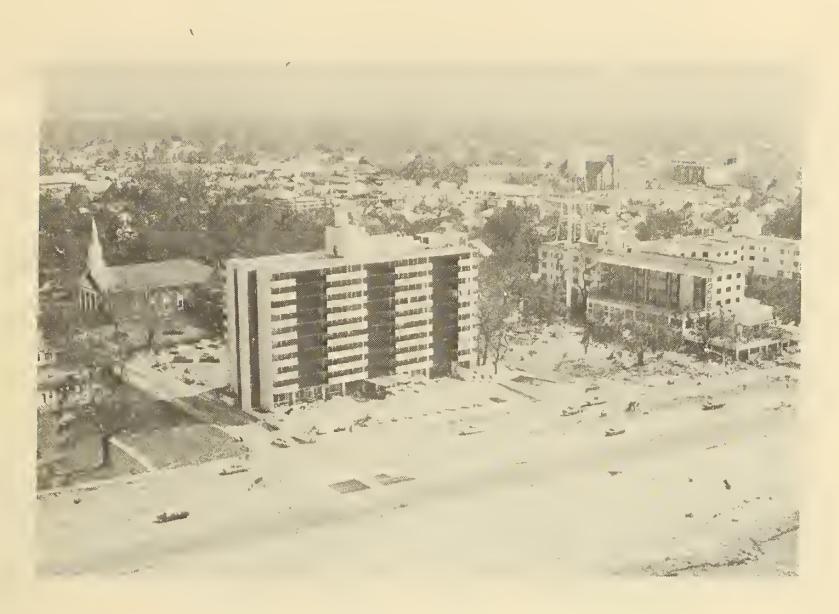
Figure 8. Coastal area, Biloxi, Mississippi.

Structures on slightly higher ground fared much better even though their ground floors and basements were flooded (fig. 8). Generally, surge damage was limited to those areas within two blocks of the beach.

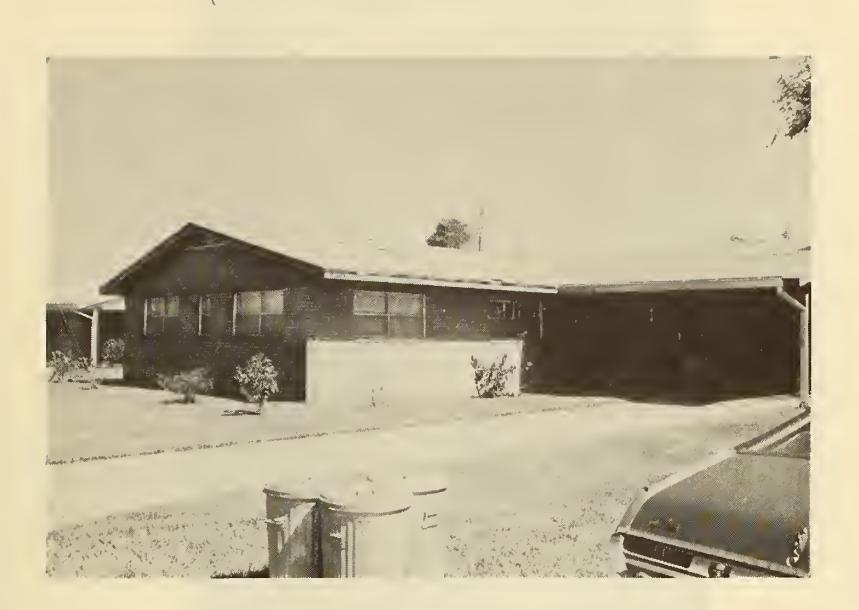
Figure 10. Single-family residence, Keesler Air Force Base.

Keesler Air Force Base - Damage to buildings was limited to loss of cladding and roofing with some flooding occurring in housing developments located along the back bay. The chapel shown in figure 9 suffered the most serious damage with the loss of copper roofing and subsequent water damage to the interior furnishings. Single-family dwellings with wind-resistant shingles exhibited very little damage (fig. 10).

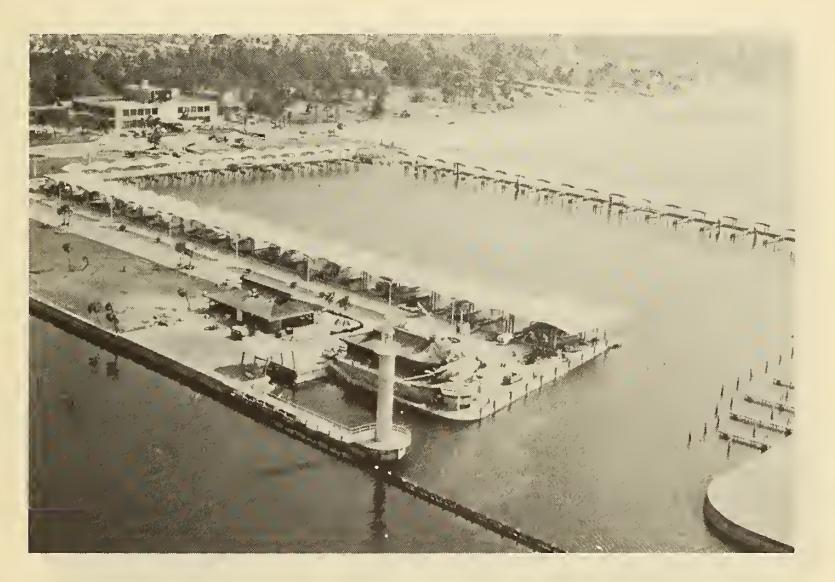
Figure 11. Broadwater Beach Marina between Biloxi and Gulfport, Mississippi.

Broadwater Beach Marina - This marina (fig. 11) near Biloxi consists of reinforced concrete columns and double-T roof members over the boat slips. Although some of the roof members were damaged (fig. 12), the overall performance of the structure was very good considering that it was completely inundated by the storm surge. Surge height in this area (approximately half way between Biloxi and Gulfport) was about 20 ft.

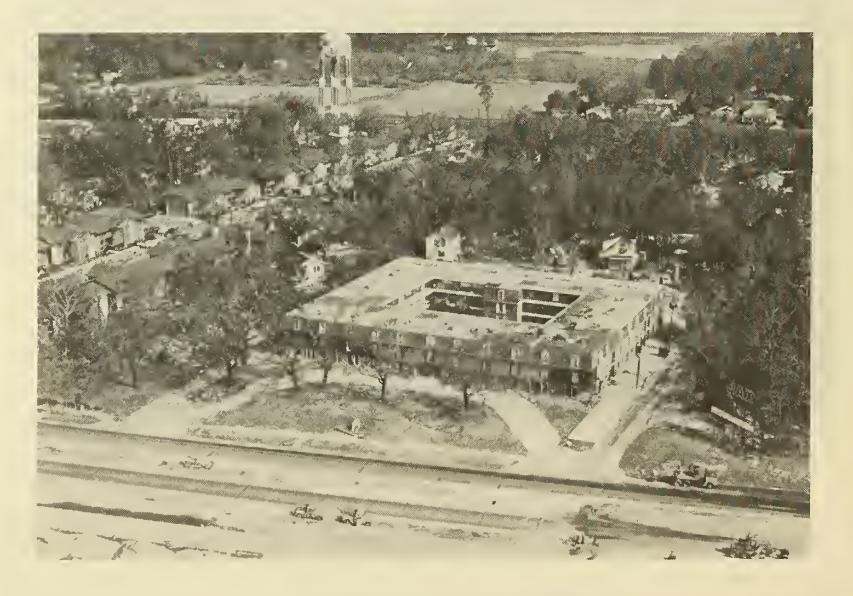
Figure 13. Residential area between Biloxi and Gulfport, Mississippi.

The building shown in figure 13 suffered heavy damage due to wave action and wind. Note the damage to roofing near the windward corner of the building. This type of damage is typical of flat-roofed structures investigated by the team. Although the seawall generally suffered light damage, considerable erosion was observed behind the wall and under the adjacent pavement slabs of U.S. 90 as indicated in figure 14.

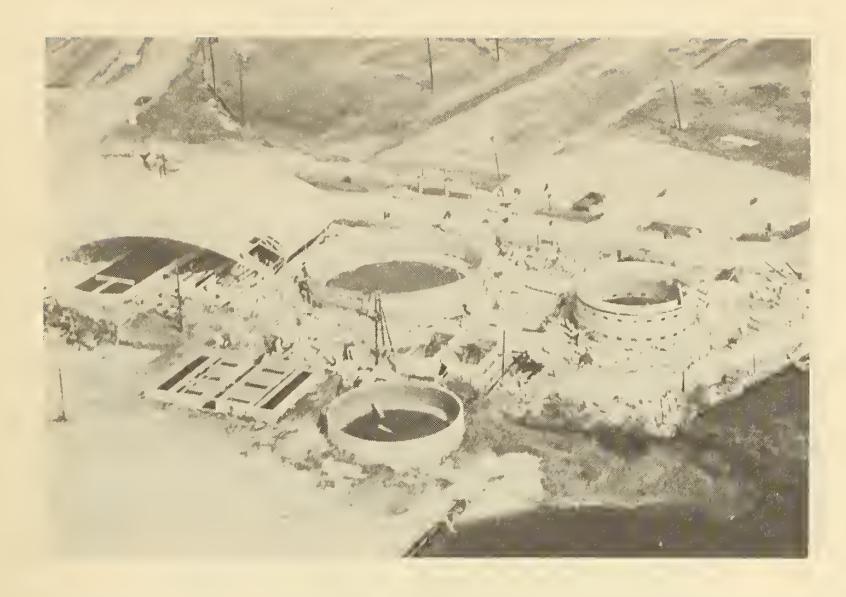
Figure 16. Marine Life Aquarium, Gulfport.

20-ft storm surge. One group of buildings in this area comprised the Marine Life Aquarium (fig. 16). The large steel-arched building at the left provided shelter for a display tank and a concrete seating area. Detailed description of the damage to these structures has been reported by another survey team [10].

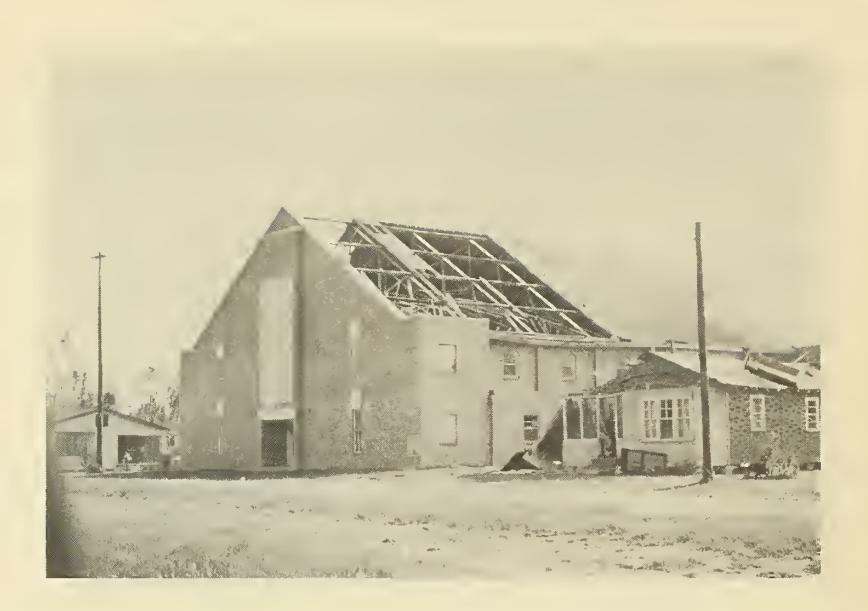
Figure 18. Church located in northern part of Gulfport.

The effect of building geometry on local wind pressures is demonstrated by the church in figure 18. This structure is located approximately 3 miles inland and probably experienced peak gusts when the wind was blowing from left to right. Strong vortex flows can develop along the eaves of the gable end, resulting in extremely high suctions. Failure of this roof structure is quite similar to that depicted in figure 9.

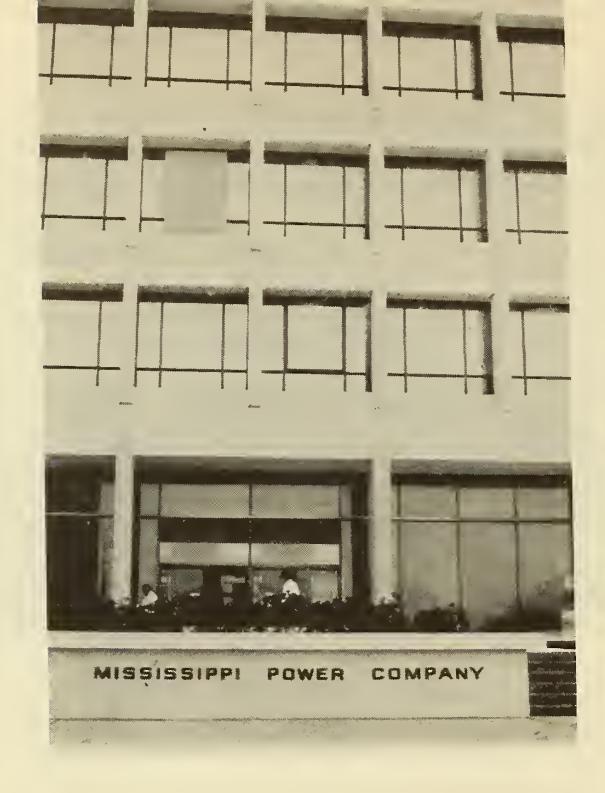
through seventh floors (fig. 20) [11]. The large first-floor windows were protected from flying or floating debris by a wire fabric screen which was erected just prior to the storm. The windows consist of one-inch thick panels of insulating reflective glass set in bronze anodized aluminum framing with neoprene gaskets. The neoprene gaskets provide a resilient mounting for the glass and prevented metal-to-glass contact and minimized breakage. After the storm, it was reported that, out of more than 500 windows, a total of 13 lights had to be replaced [11].

- Figure 20. Close-up view of Mississippi Power Company building.
 - Figure 21. Enclosure structure on roof of Mississippi Power Company building, Gulfport, MIssissippi.

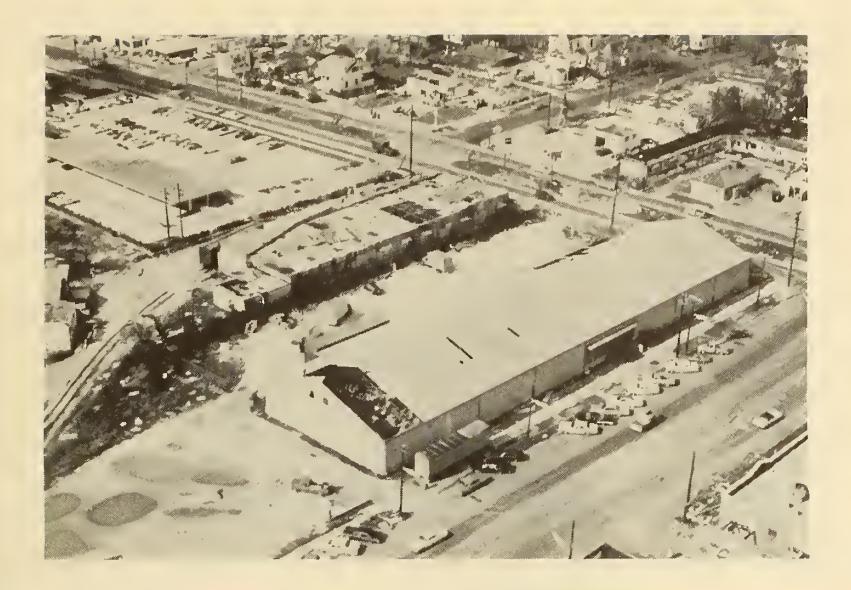
Figure 22. Area directly north of Mississippi Power Company building.

Figures 22 through 24 indicate the general level of damage in the area surrounding the Mississippi Power Company. The prefabricated metal building in figure 22 again points up the importance of local wind effects when designing roof elements. The random distribution of damage shown in figure 23 is typical of the entire area covered by the survey. Failures of roofing are usually progressive as is indicated in figure 24. Gravel from this built-up roof contributed considerably to the flying debris.

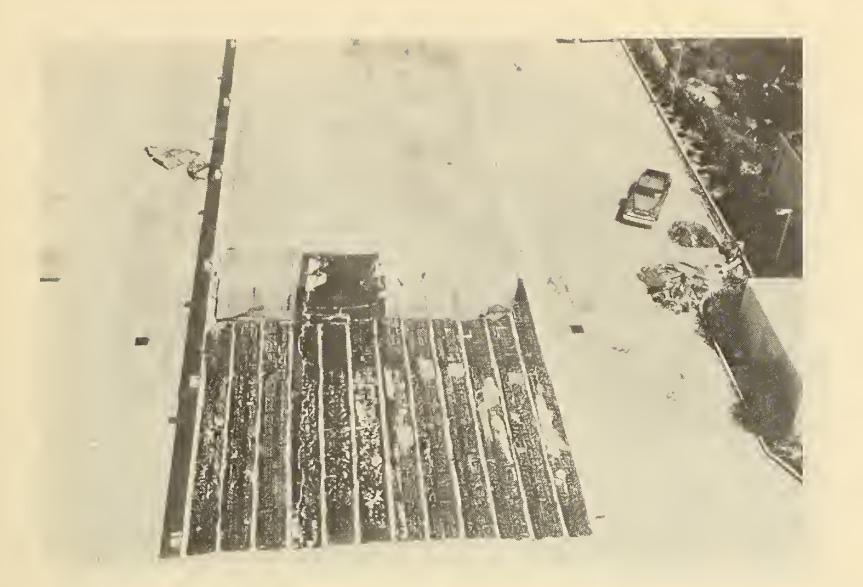
Figure 24. Roofing damage on building adjacent to north side of Mississippi Power Company building.

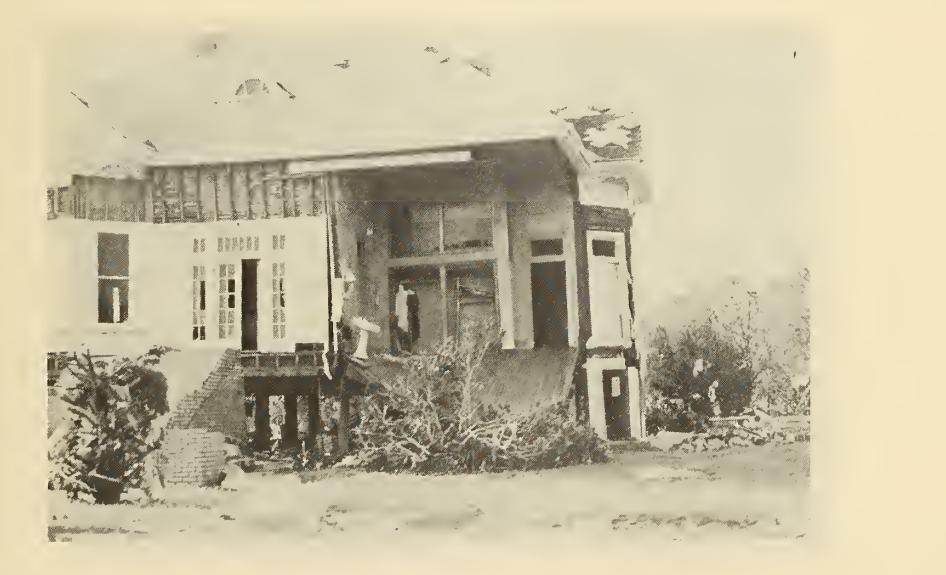
Wooden frame houses suffered relatively little wind damage, most damage being caused by wind-driven missiles and falling trees. The house shown in figure 25 was subjected to the direct action of waves and was probably battered by water-borne debris. The oil storage tank in figure 26 was carried inland on the surge from its original location on a pier in the port complex. The large dent indicates a collision with other structures while being driven ashore.

Figure 25. Wood-frame residence damaged by waves, Gulfport, Mississippi.

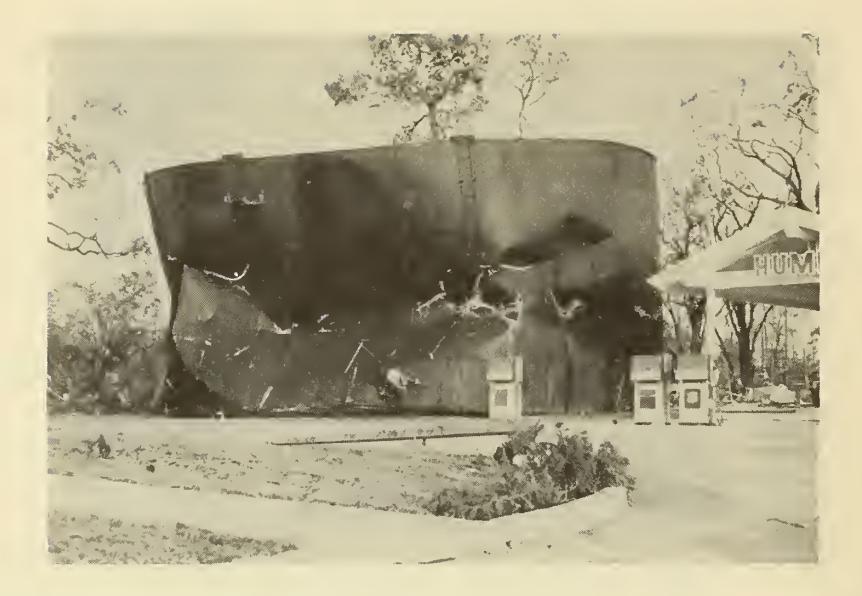
Figure 26. Tank washed ashore by storm surge, Gulfport.

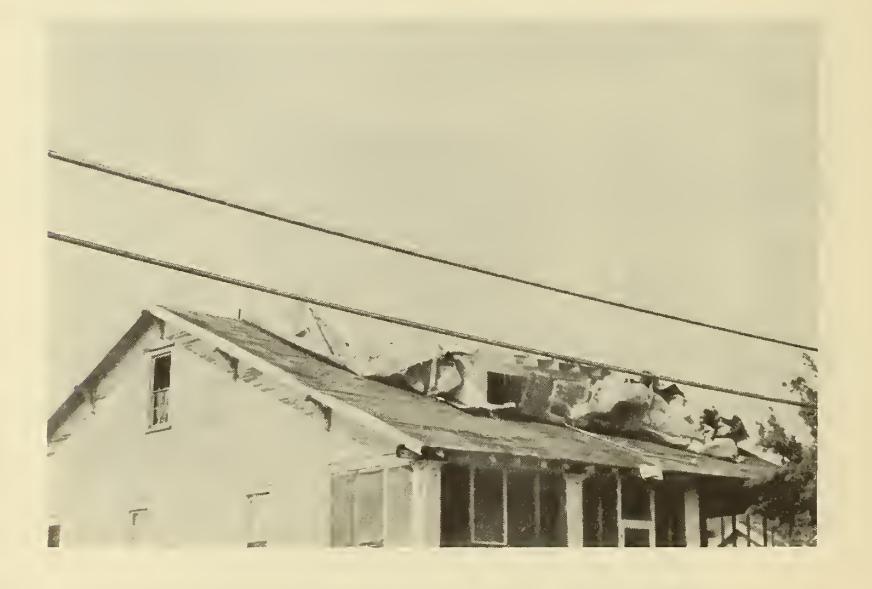
An old wood-frame house (fig. 27) escaped major damage except for its metal roof covering.

Figure 27. Metal roofing damage, Gulfport, Mississippi.

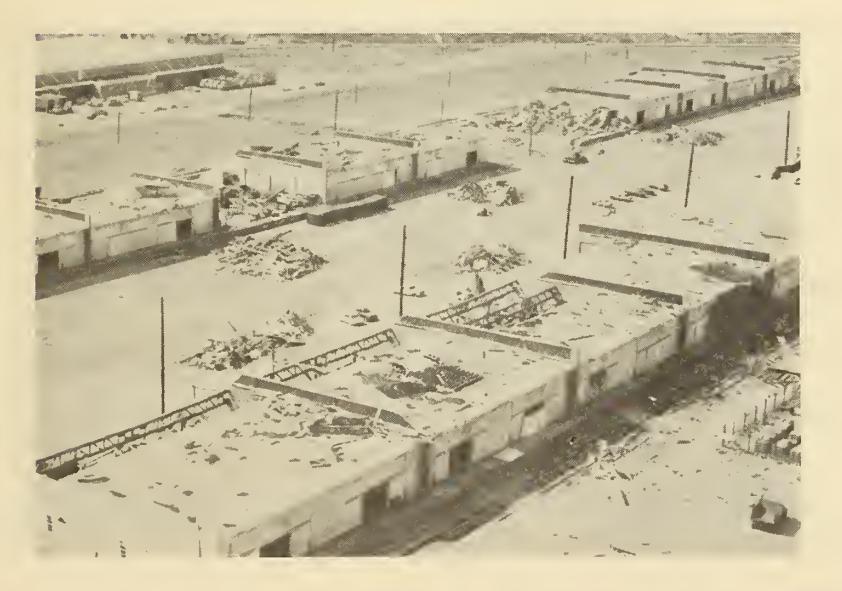
Figure 29. Damaged warehouses, U.S. Naval Construction Battalion Center, Gulfport, Mississippi.

An aerial view of the damaged warehouses is shown in figure 29. These wood-frame buildings were built during World War II and were still in daily use. The major damage to these structures occurred on the windward side. As shown in figure 29, the warehouse units were constructed with brick fire walls between each section. The roofs were supported by timber trusses and the front and back walls were of wood-frame construction. Close-up views illustrating the collapsed wood-frame walls, damaged brick fire walls and dislodged roof trusses are shown in figures 30 and 31.

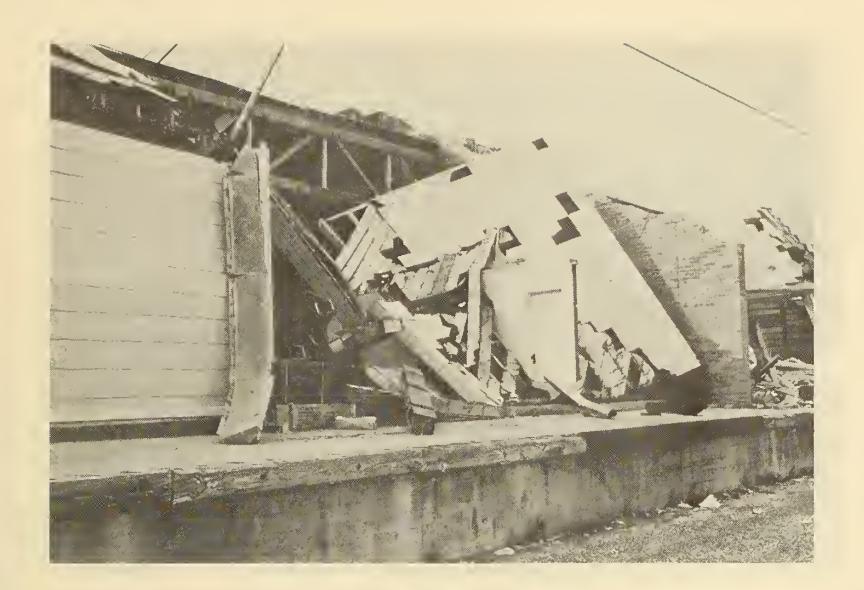
Figure 30. Close-up view of damaged warehouse shown in figure 29.

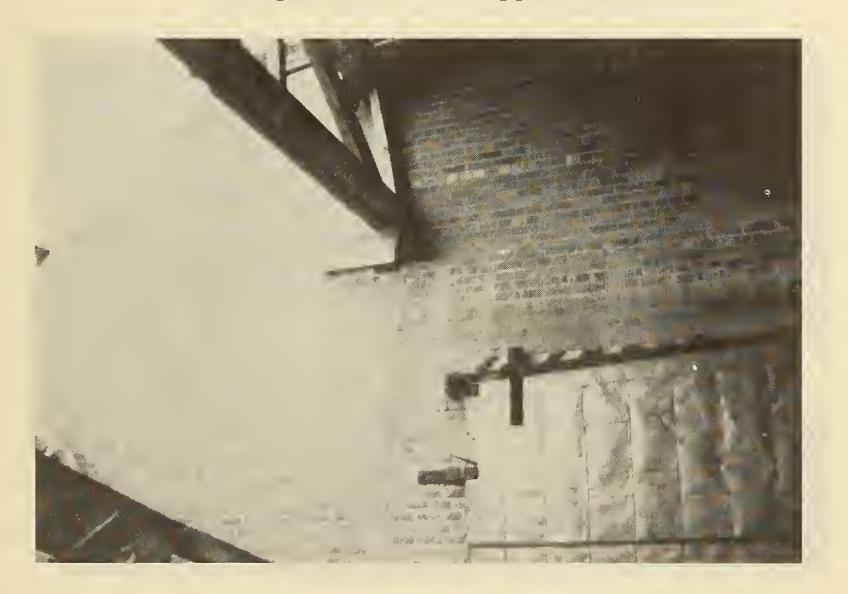
Figure 31. Damaged warehouse roof and fire wall, U.S. Naval C. B. Center, Gulfport, Mississippi.

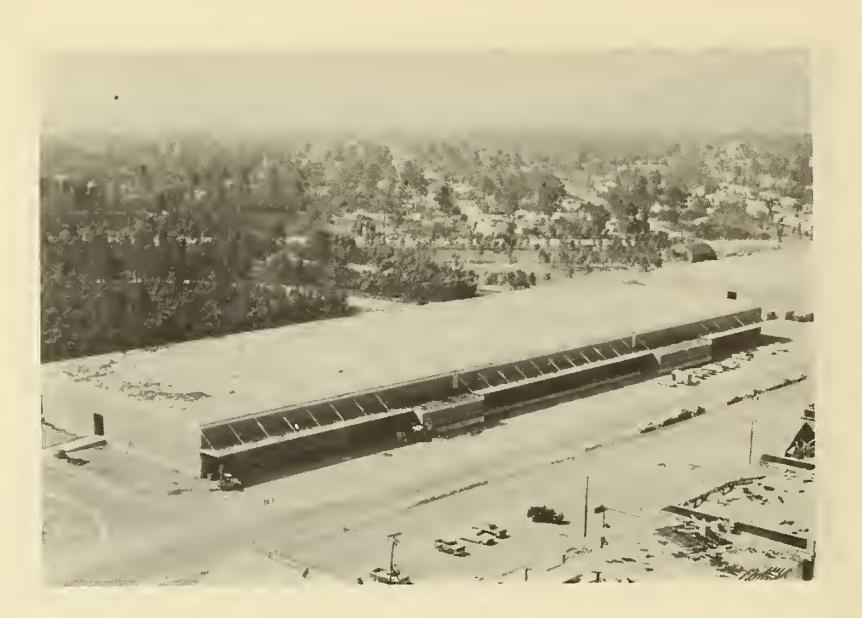
Figure 32. Reinforced concrete and masonry warehouse, U.S. Naval C. B. Center, Gulfport.

Comparatively minor damage was suffered by three reinforced concretemasonry warehouses (fig. 32) which were built during or since 1950. These warehouses were located near the older wood-frame warehouses (see upper left of fig. 29). As shown in figure 33, these structures lost some 2-ft wide by 8-ft long precast concrete roof panels along the perimeter of the roof. It was observed that all roof panels were securely anchored at interior points by steel clips but no anchorage was provided for the perimeter panels, the location where peak uplift usually occurs. Prior to the passage of Hurricane Camille, it was reported to the NBS survey team that hundreds of civilian dependents left their homes to take refuge in these concrete-masonry warehouses.

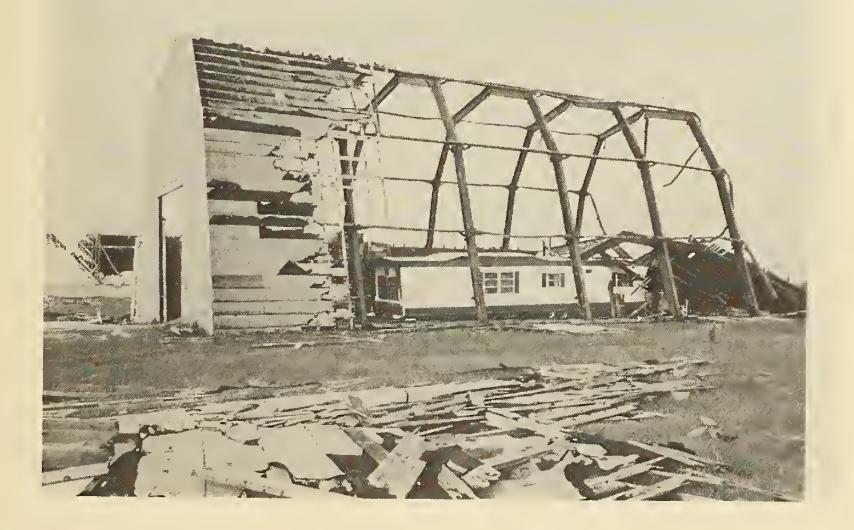
Figure 38. Masonry wall damage, U.S. Naval C. B. Center, Gulfport.

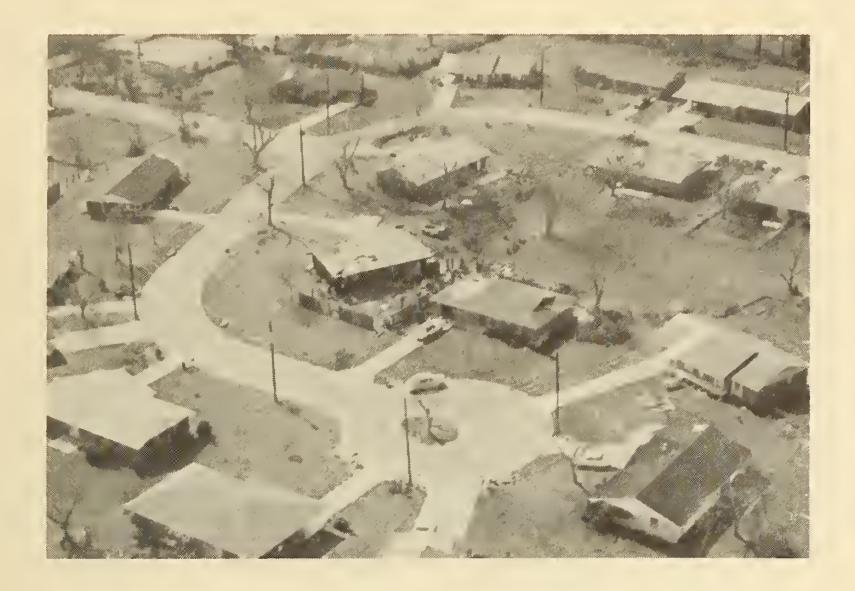
Figure 40. Residential area west of Gulfport.

Figures 40 and 41 indicate the sporadic nature of wind damage in the area west of the U.S. Naval Center and north of Long Beach. Failures were usually initiated by loss of carport roofs or large roof overhangs which often led to removal of the complete roof structure.

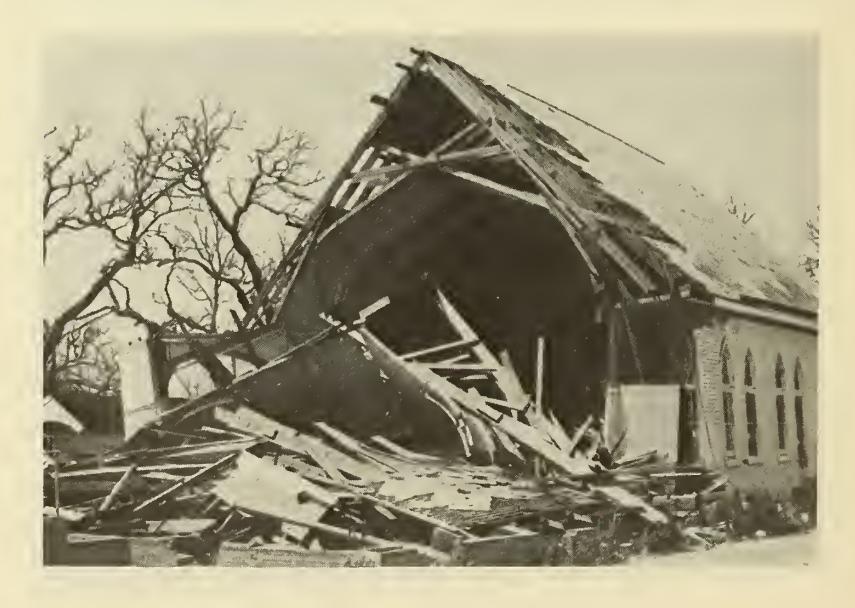
Figure 43. Saint Thomas Catholic Church, Long Beach, Mississippi.

Figure 43 shows a wood-frame church which was badly damaged by wave action. Commercial buildings located in a shopping center on U.S. Highway 90 are shown in figures 44-46. A small store constructed with masonry walls and located on the coastal side from the supermarket shown in figures 45 and 46 was completely destroyed. The church building shown in the center background of figure 45 had considerable storm surge damage to its interior although its exterior walls and roof were only slightly damaged.

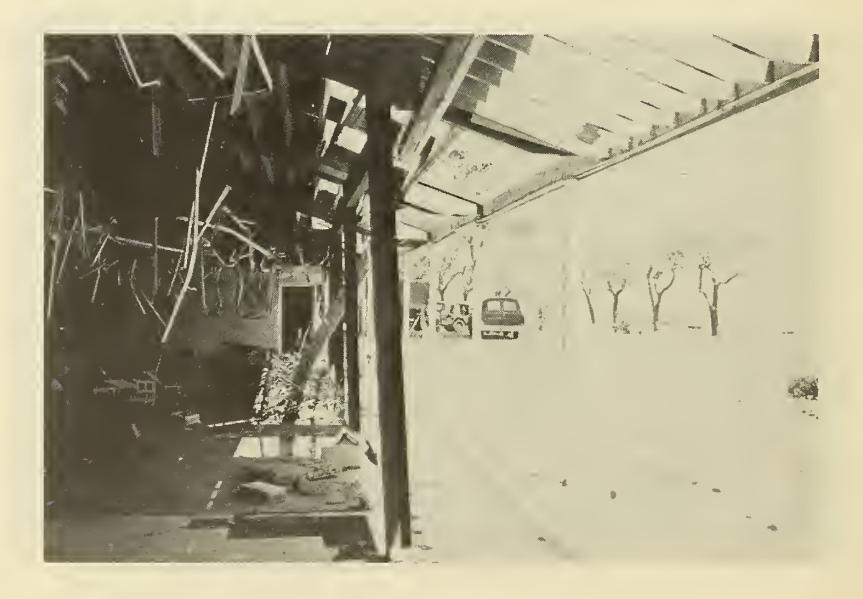
Figure 49. Restaurant area on west end of main building, Ramada Inn, Long Beach.

the restaurant area (fig. 49) experienced extensive water damage. On the east end of the main building, the top-story portion of a masonry wall had collapsed (fig. 50). An inspection of this brick and block wall indicated it contained some vertical reinforcement; however, the block cells containing this reinforcement did not contain any grout or concrete (fig. 51).

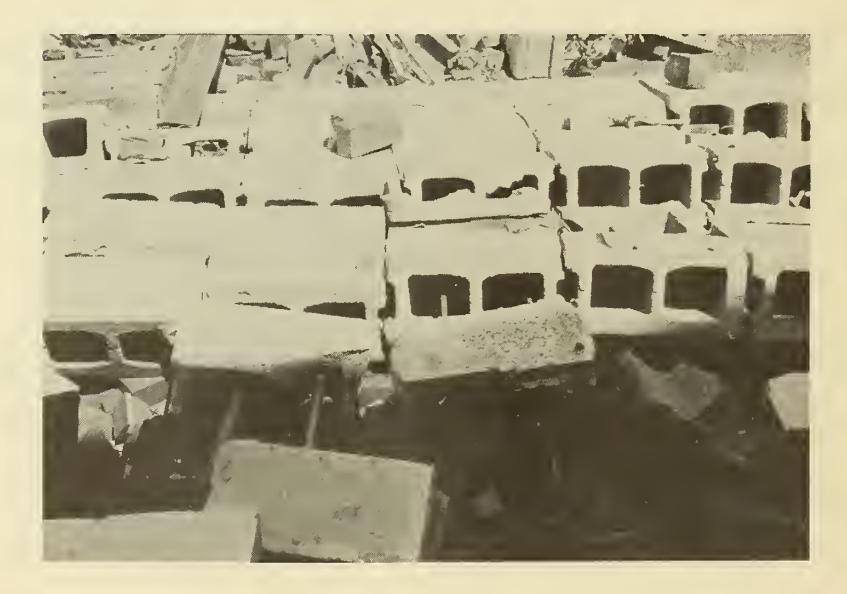
- Figure 50. Damaged masonry wall on east end of main building, Ramada Inn.
- Figure 51. Damaged masonry wall, Ramada Inn; block cells containing vertical reinforcement were not grouted.

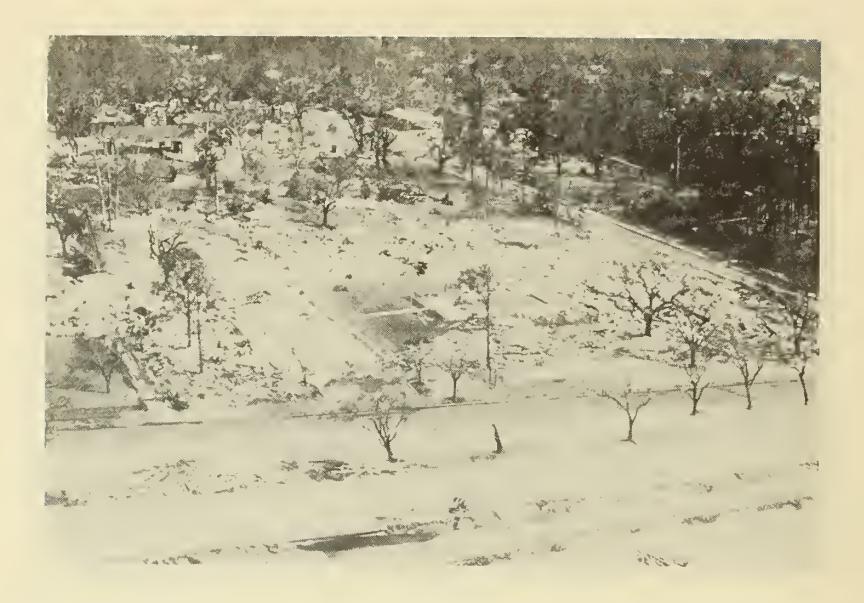
Figure 54. Richelieu Apartments, Pass Christian.

Along the coastal area in Pass Christian, several apartment buildings were totally destroyed by wave action. One of these buildings was the Richelieu Apartments (fig. 54) where 23 persons were killed because they failed to heed warnings to evacuate. A close-up view of the remains of the Richelieu Apartments, a three-story brick veneer and wood-frame building is shown in figure 55.

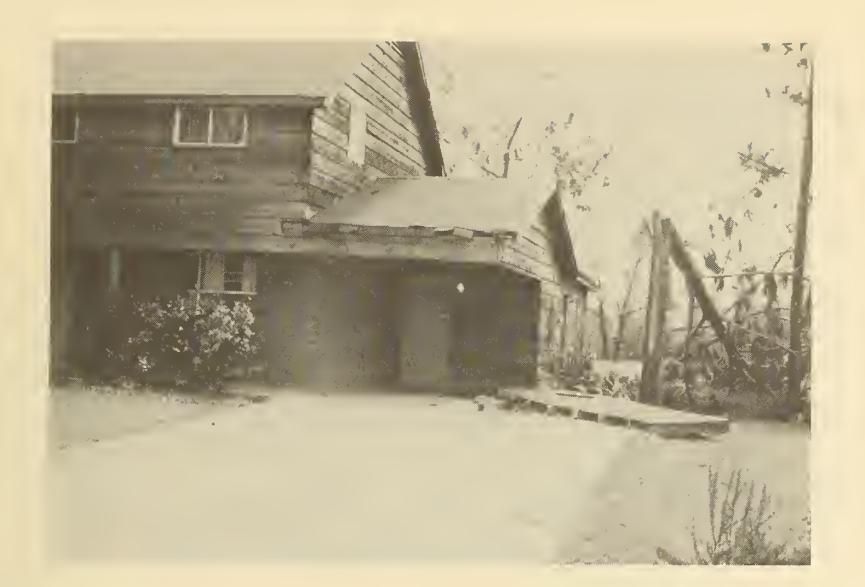
Figure 67. Single-family residence, Waveland, Mississippi.

A residence and a bank building, which were struck by waves, are illustrated in figures 67 and 68. The residential building lost most of its exterior and interior wall coverings but the good anchorage of the woodstud walls to the concrete slab foundation and to the timber roof prevented total destruction. As shown in figure 68, the bank building was completely destroyed except for the reinforced concrete vault and building frame.

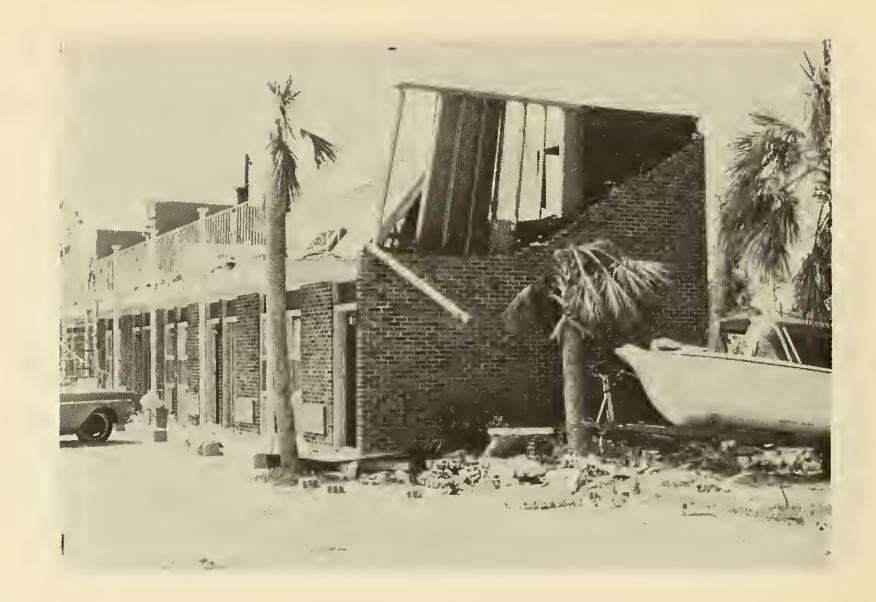
Figure 71. Motel, U.S. Highway 90 near Waveland, Mississippi.

Across the highway from the small motel is a larger two-story motel, which has a flat concrete roof overhanging the second-story balcony (fig. 71). In this building the roof structure was apparently heavy enough and anchored satisfactorily to resist the uplift forces. The only damage observed was to the built-up roofing and underlying insulation.

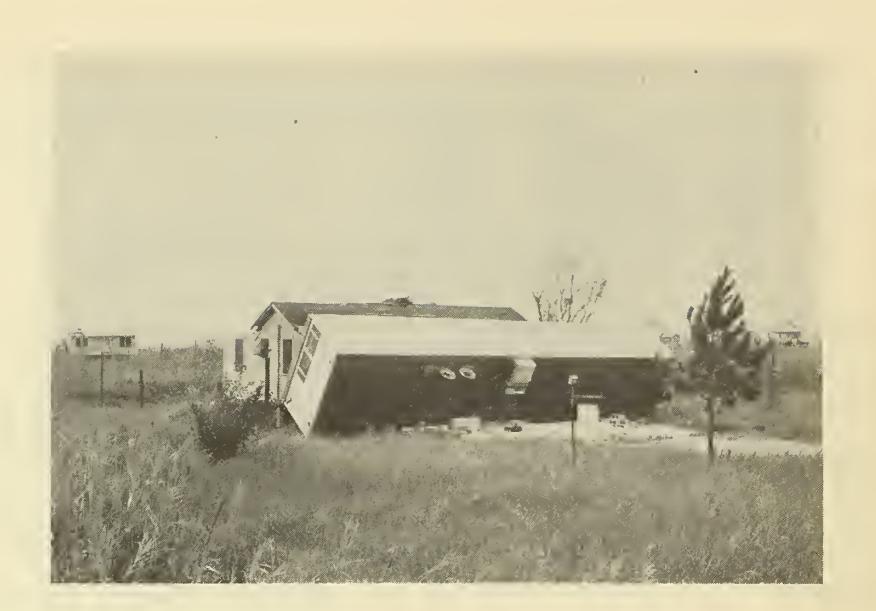
One of the many mobile homes which were overturned is shown in figure 72. This particular mobile home was located in Louisiana on U.S. Route 90 just west of Pearlington, Mississippi.

Figure 72. Damaged mobile home, U.S. Highway 90 near Pearlington, Mississippi.

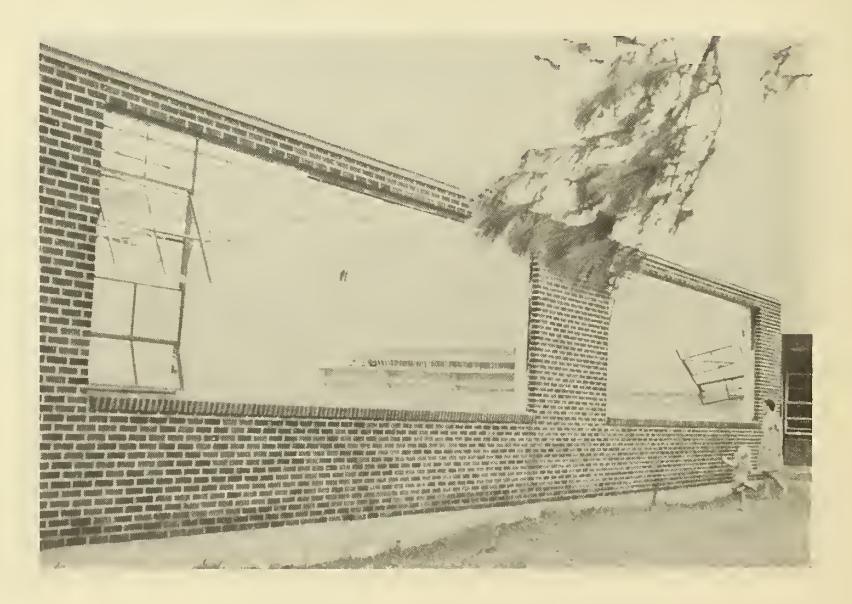
Figure 73. North Central High School between Waveland and Poplarville, Mississippi.

North Central High School is located on County Road 603 about 15 miles north of Waveland, Mississippi. The main school buildings are constructed with brick and block walls and a steel joist roof system. As shown in figure 73, the roof covering and insulation were stripped from the buildings and the windows were badly damaged. This exterior damage also resulted in extensive rain damage to the interior and contents of the buildings.

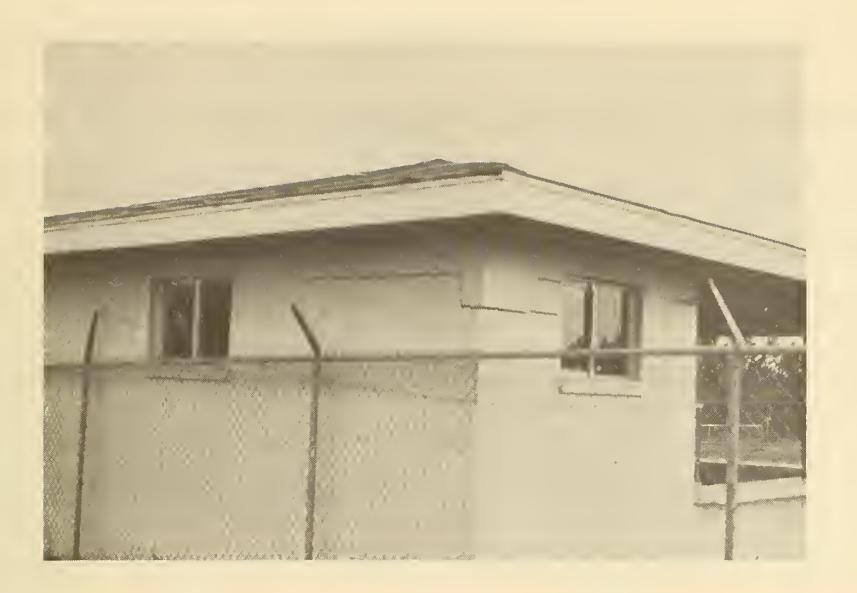
Figure 76. Small concrete block building, North Central High School.

A small concrete block building (fig. 76) near the other school buildings had a wood-frame roof which was adequately anchored to the walls. Wind uplift on the roof did produce some major tensile cracks in the horizontal mortar joints of the walls.

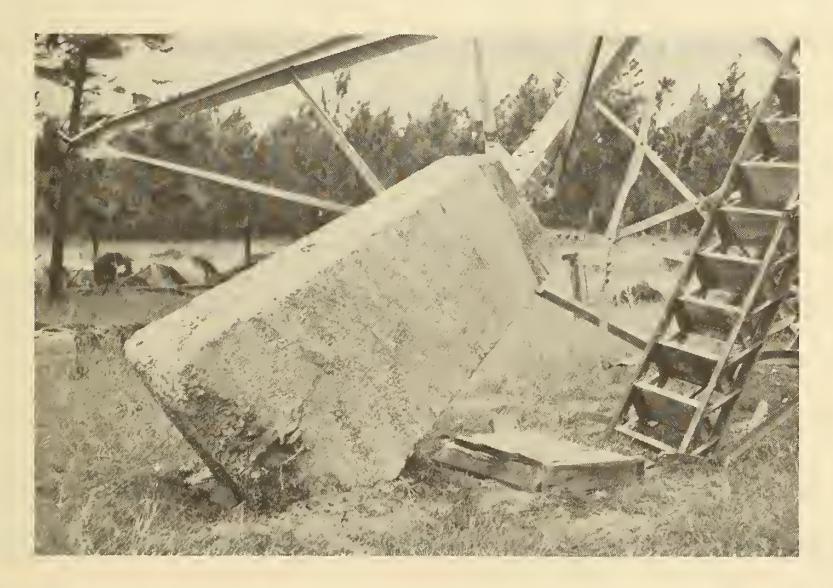
Figure 77. Steel observation tower near North Central High School.

About five miles north of the North Central High School, a tall steel observation tower was toppled by the strong winds. One leg of the tower was sufficiently anchored to a concrete footing (fig. 77) to pull the footing from the ground and drag it about 15 ft when the tower overturned.
