NIST Technical Note 2055

Compartment Fire Experiments on Long-Span Composite-Beams with Simple Shear Connections Part 2: Test Results

November 2019

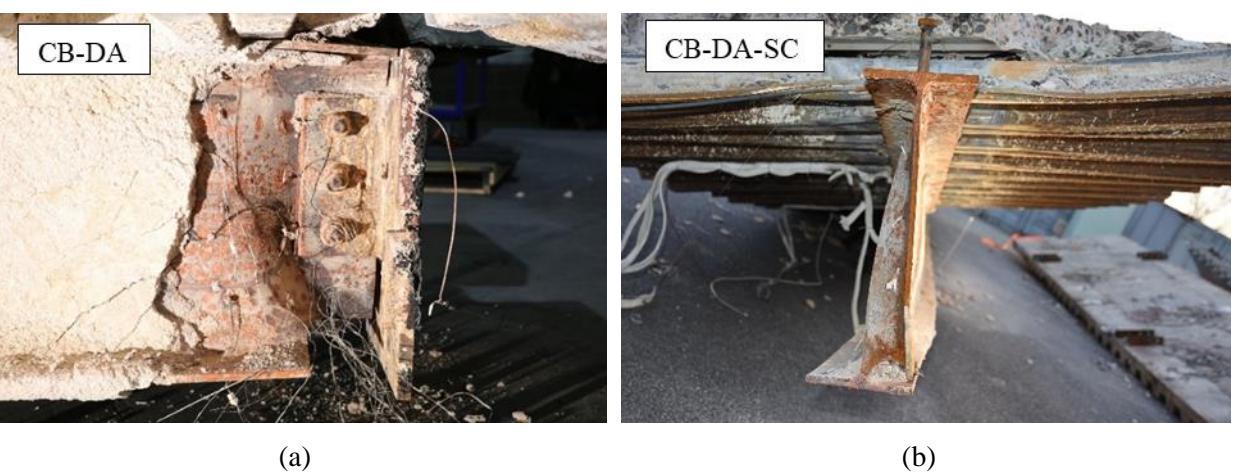
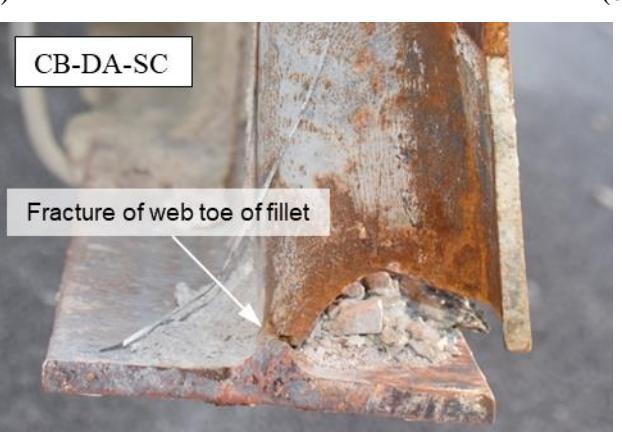
Figure 43 Photographs of locally buckled ends of the W18×35 steel beam: (a) CB-DA, (b) CB-DA-SC, and (c) fracture of bottom web toe of fillet (CB-DA-SC)
Figure 44 Photographs of locally buckled ends of the W18×35 steel beam: (a) CB-SP, and (b) CB-SP-SC.
Figure 45 Photographs of west end of (a) CB-DA-AMB after removal of concrete slab, and (b) CB-SP-SC after removal of SFRM and concrete slab
Figure 46 Photographs of deflected shape of (a) CB-DA-AMB and (b) CB-DA-SC
Figure 47 Photographs of deflected concrete slab of (a) CB-SP (side view), and (b) CB-SP-SC (top view).
Figure 48 Photographs of concrete cracks of (a) CB-DA-SC, and (b) CB-SP-SC near the west end after cool-down
Figure 49 Photographs of beam-to-column connections after cool-down: (a) CB-DA (prying of angles at west end), (b) CB-DA-SC (weld fracture of east angle connection), (c) CB-SP (weld fracture of east shear tab), (d) CB-SP (weld fracture on a sacrificial plate connected to east column), (e) CB-SP-SC (east shear tab), and (e) CB-SP-SC (fracture of bolts used in east shear tab)

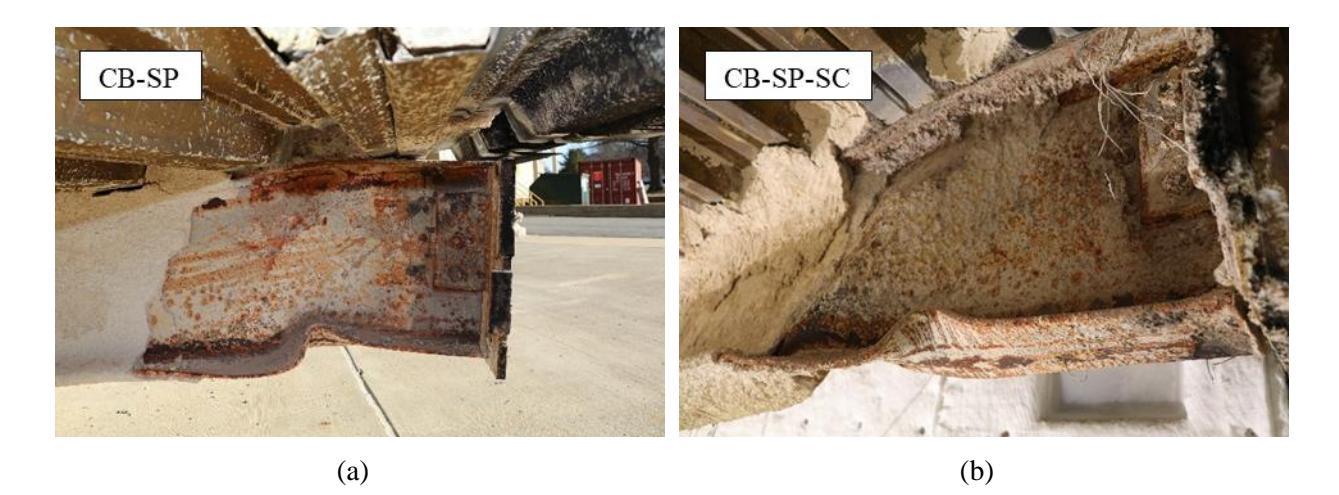
Figure 44 Photographs of locally buckled ends of the W18×35 steel beam: (a) CB-SP, and (b) CB-SP-SC.

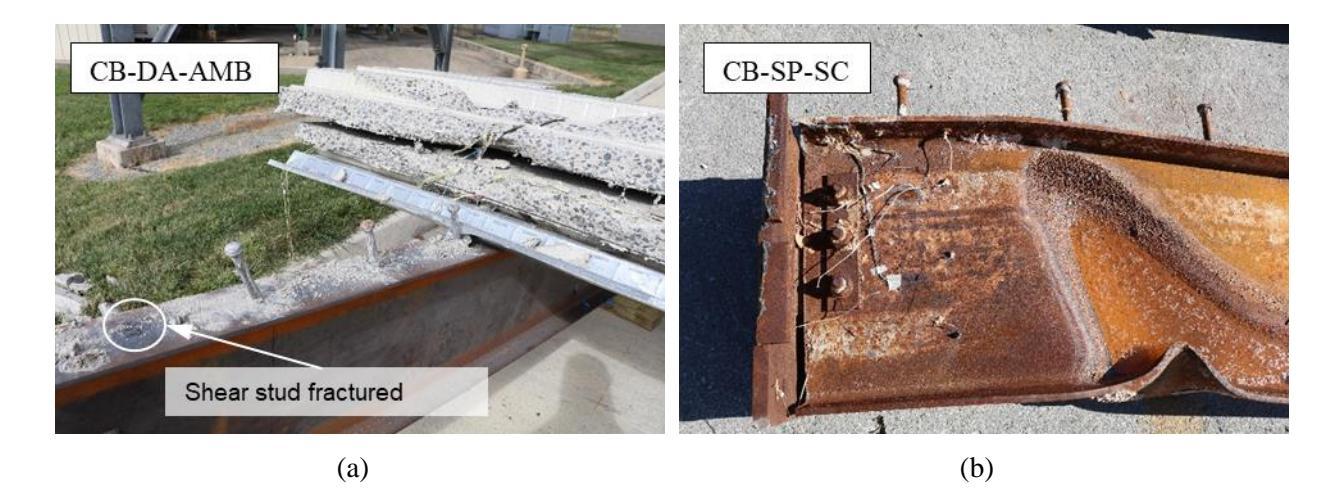
Figure 45 Photographs of west end of (a) CB-DA-AMB after removal of concrete slab, and (b) CB-SP-SC after removal of SFRM and concrete slab.

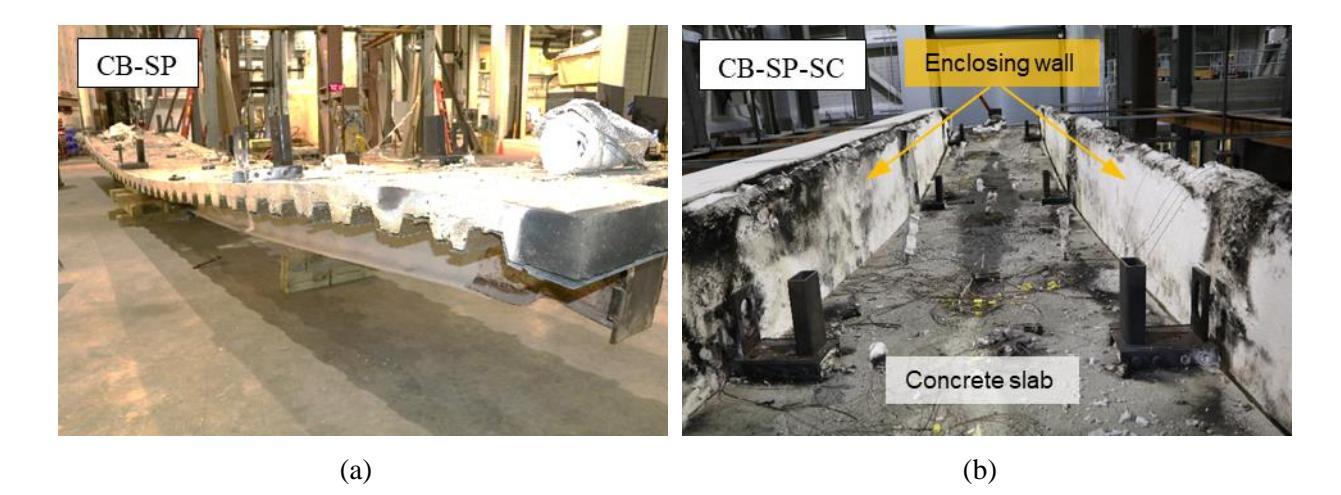
Figure 47 Photographs of deflected concrete slab of (a) CB-SP (side view), and (b) CB-SP-SC (top view).

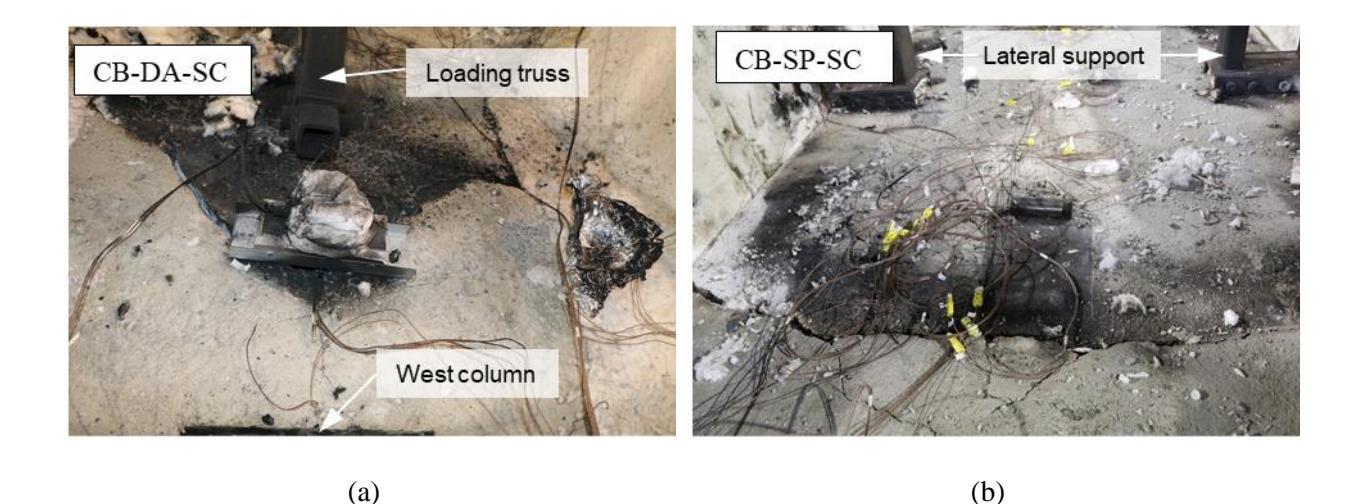
Figure 48 Photographs of concrete cracks of (a) CB-DA-SC, and (b) CB-SP-SC near the west end after cooldown.

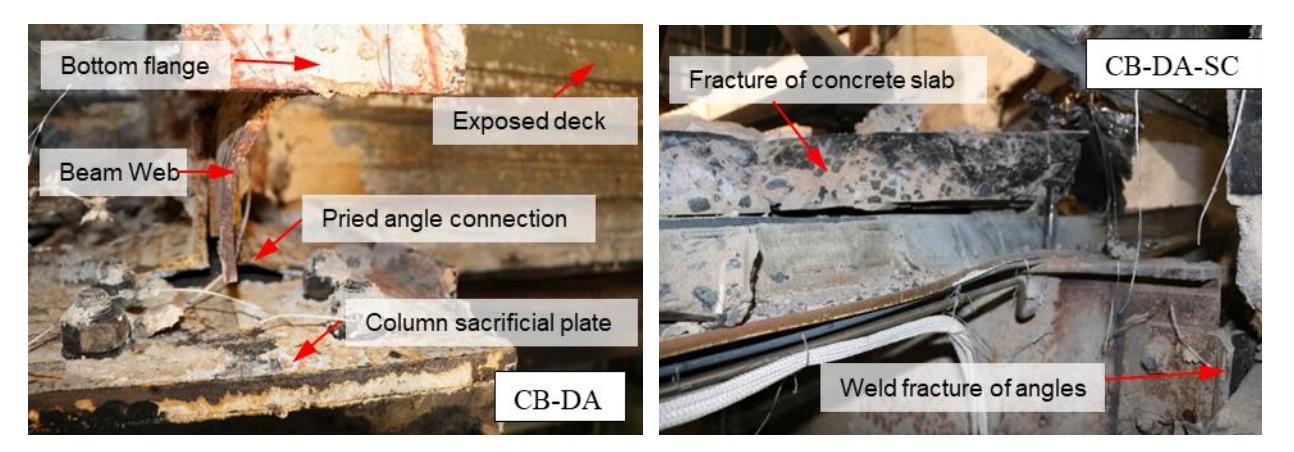
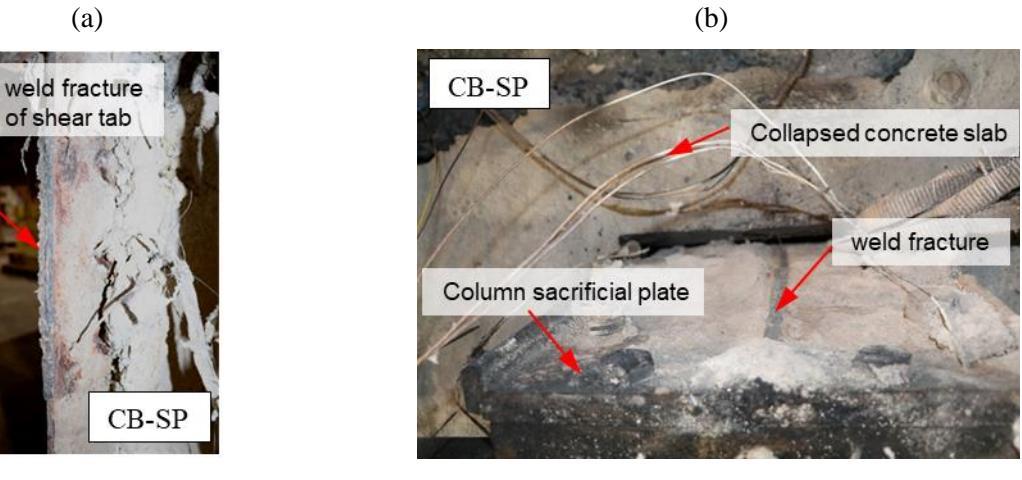
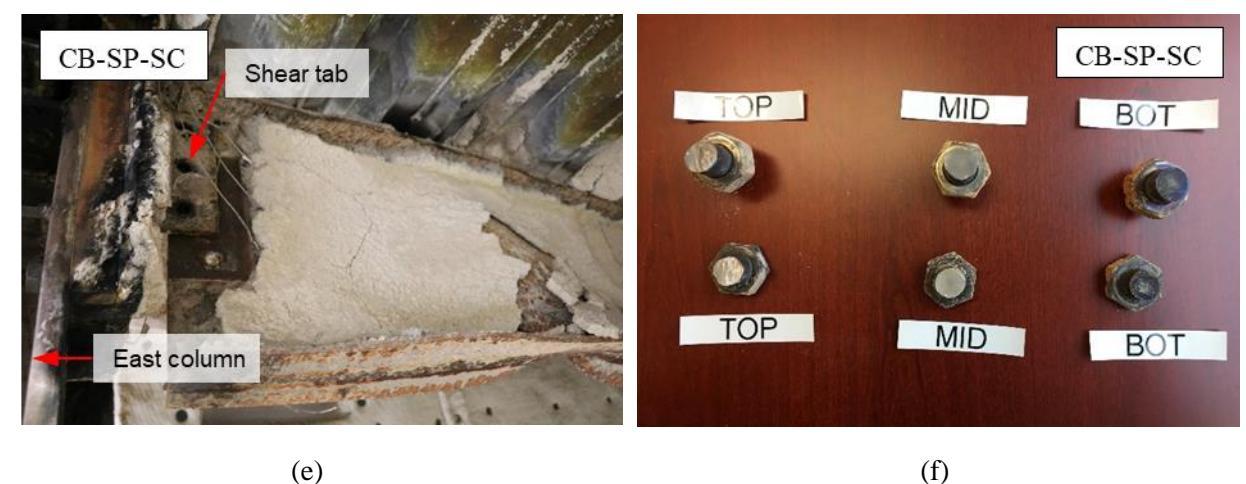
Figure 49 Photographs of beam-to-column connections after cool-down: (a) CB-DA (prying of angles at west end), (b) CB-DA-SC (weld fracture of east angle connection), (c) CB-SP (weld fracture of east shear tab),
(d) CB-SP (weld fracture on a sacrificial plate connected to east column), (e) CB-SP-SC (east shear tab), and (e) CB-SP-SC (fracture of bolts used in east shear tab).

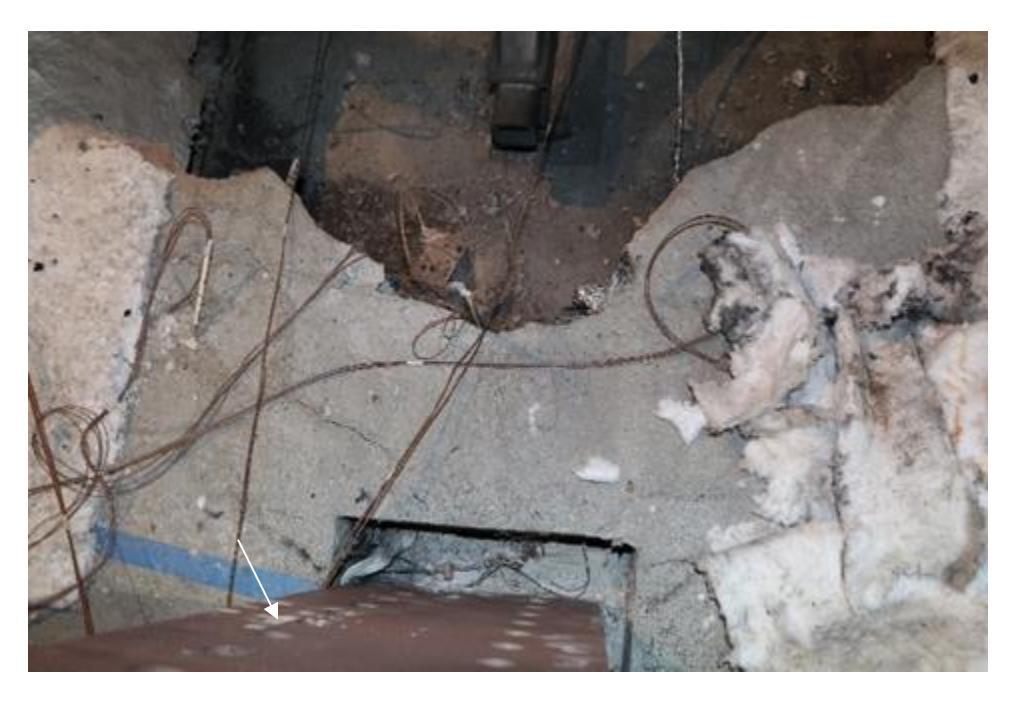
Figure 71 Photograph of concrete fracture and separation near the east column after the angle connection failed during cooling (CB-DA-SC).

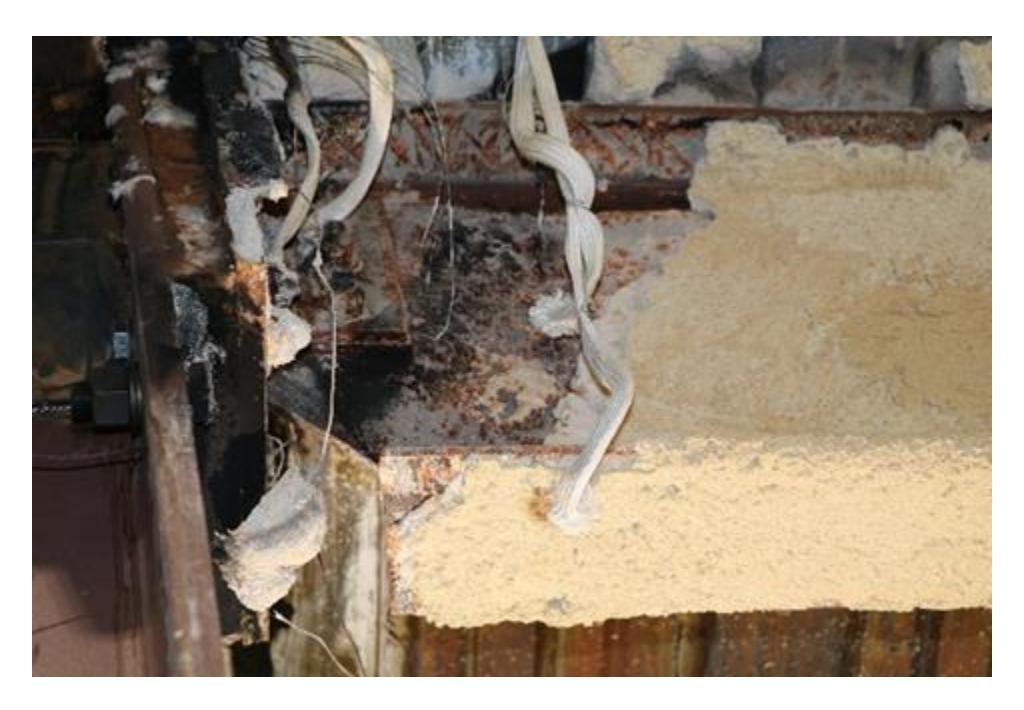
Figure 72 Photograph of local web buckling of the steel beam connected to the west column after cooling (CB-DA-SC).

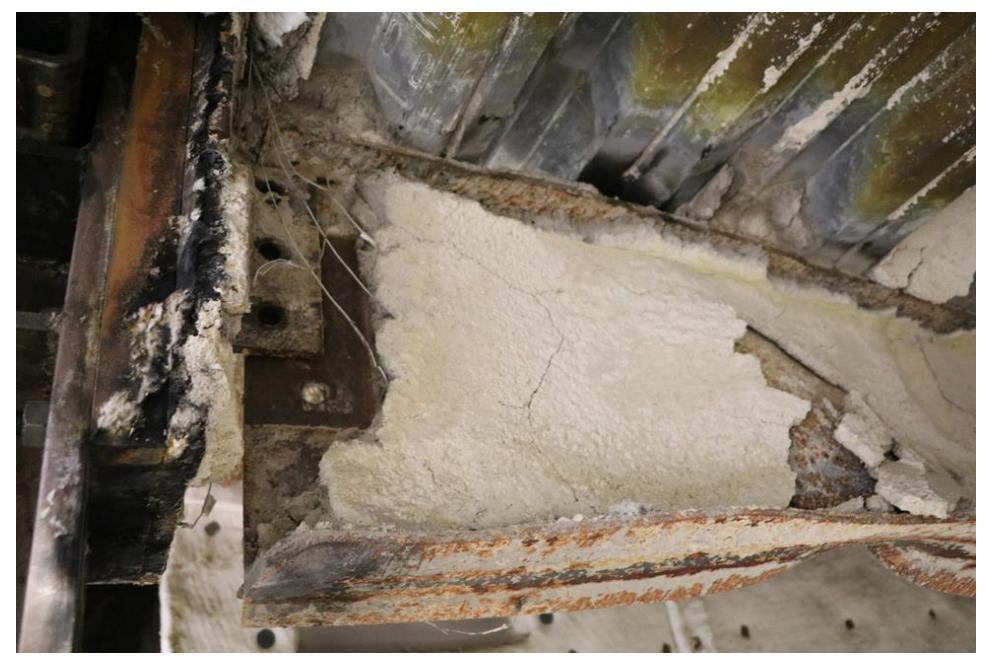
Figure 99 Photographs of CB-SP-SC after cooling: (a) the west shear tab connected to the column and (b) east connection region where three bolts connecting the shear tab fractured.

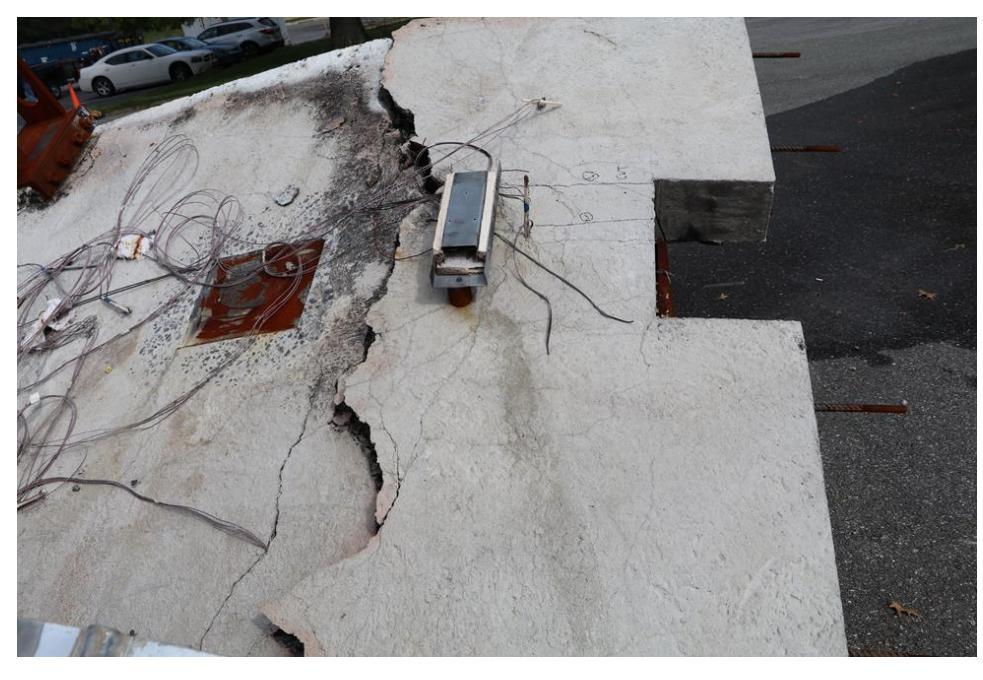
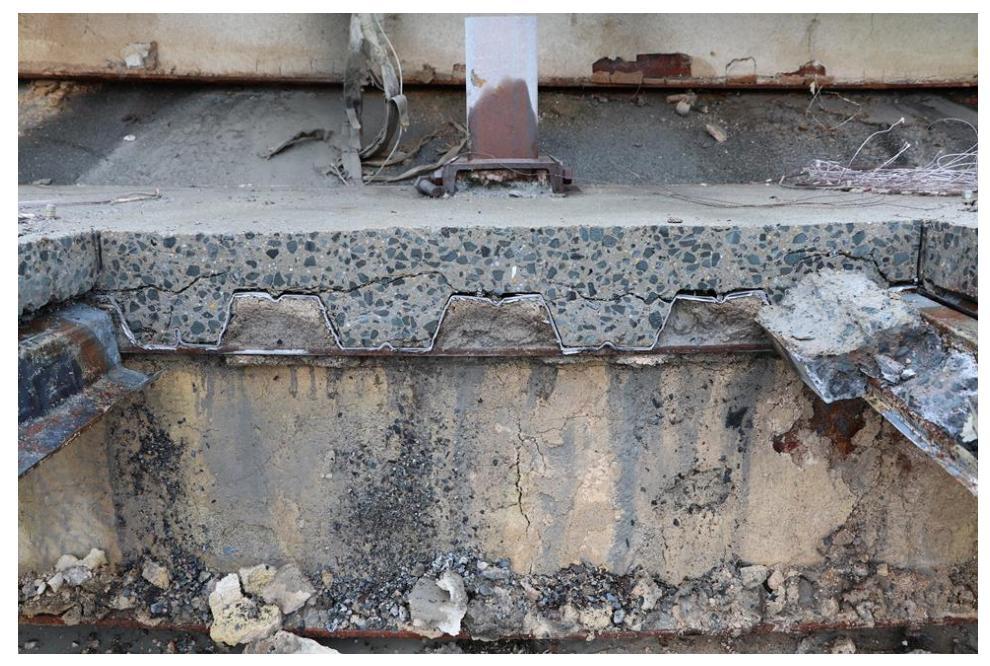
Figure 100 Photographs of CB-SP-SC after cooling: (a) concrete fracture at east end and (b) cut section of the concrete slab at midspan above the steel beam.
