NIST GCR 18-018

Structures Ignited by Virginia WUI Fires 2/2015 – 2/2017

David D. Evans Lavern R. Scott William D. Walton Home Safety Foundation Chevy Chase, Maryland 20815-4206

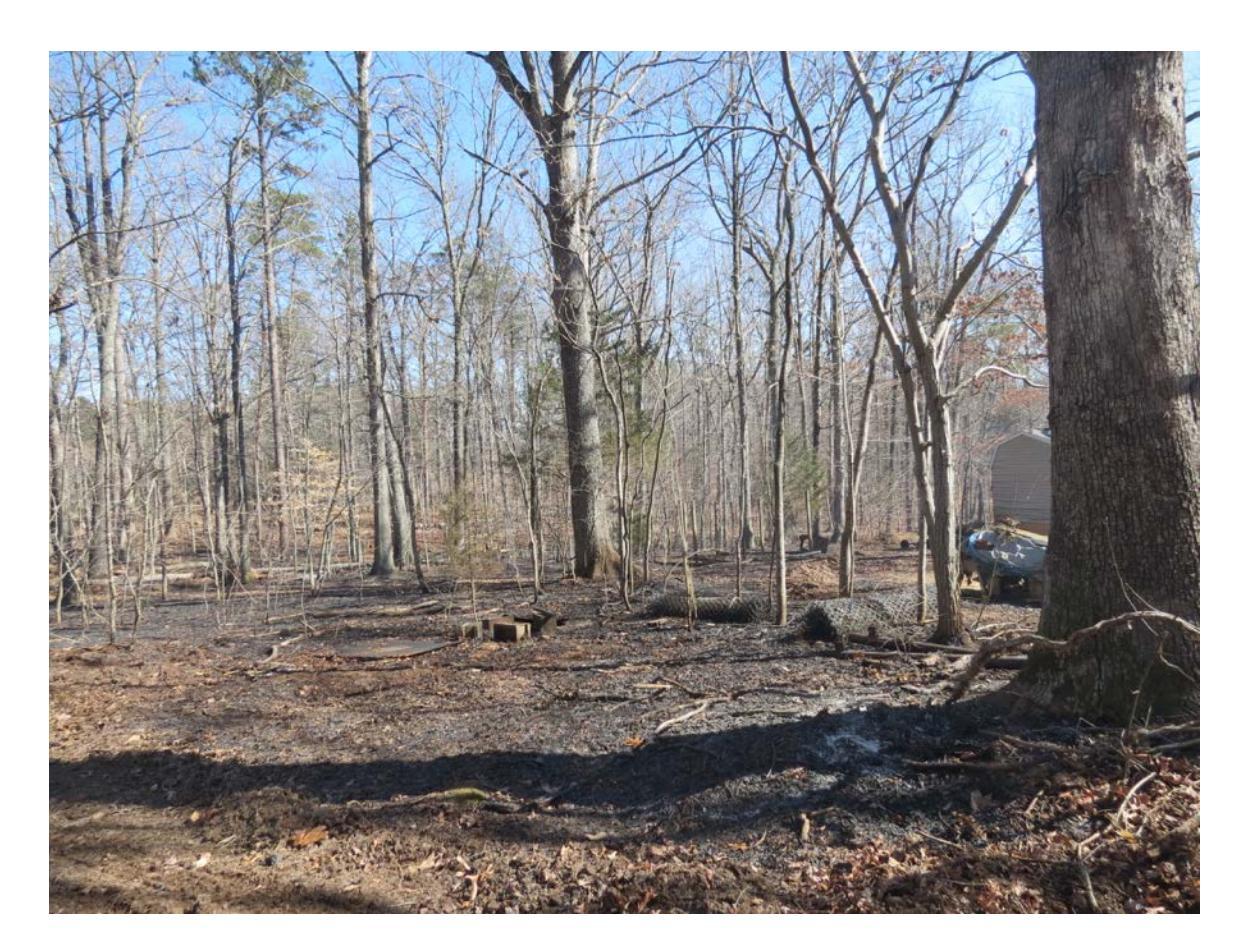
Fig. S1-1. Photo provided by the owner shows the path the fire took through the woodland toward the utility building in the distance on the right.

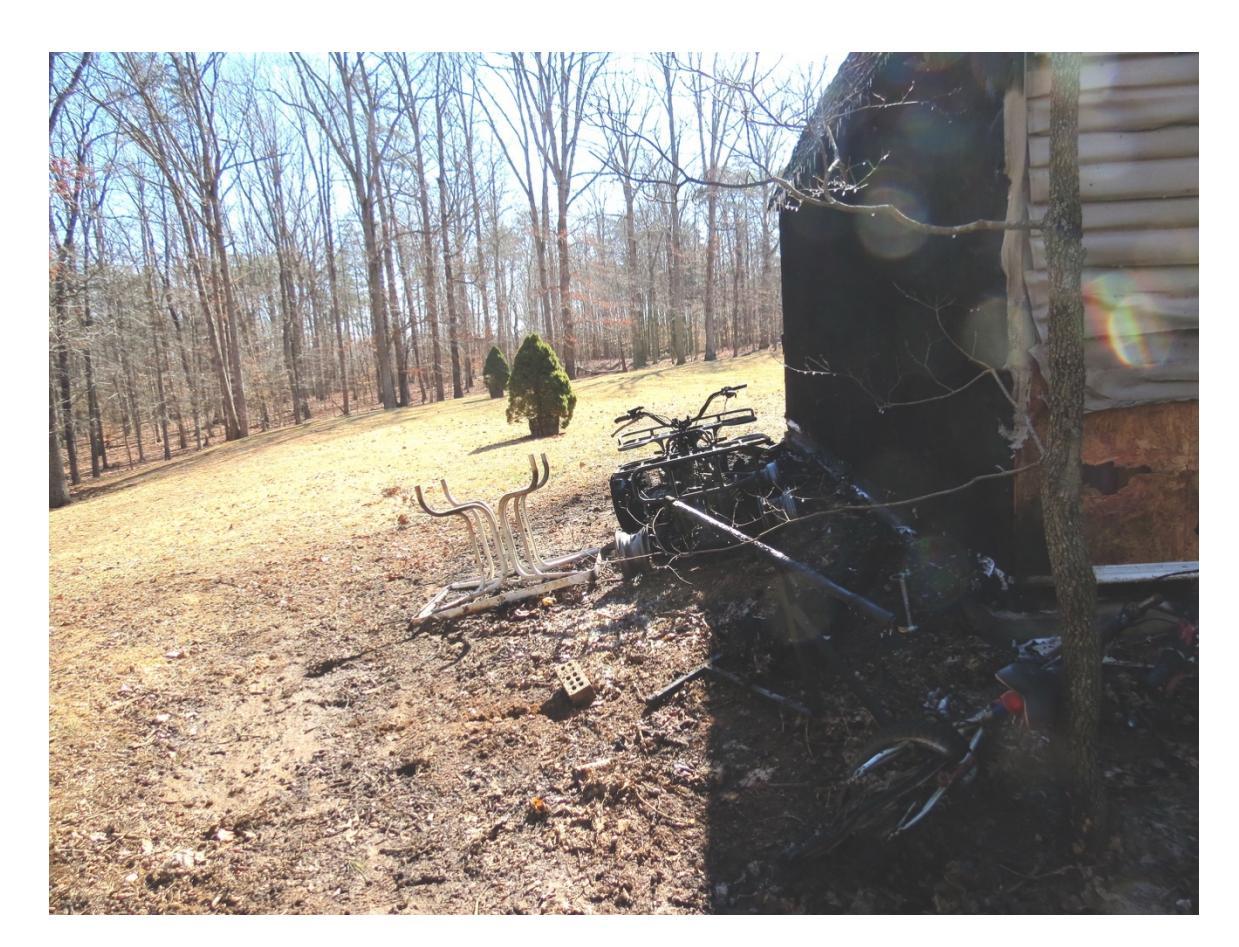
Fig. S1-2. Photo provided by the owner shows a close-up of the burn pattern on the ground where the surface fire approached and passed the utility building. The metal items in the photo were next to the utility building on side C.

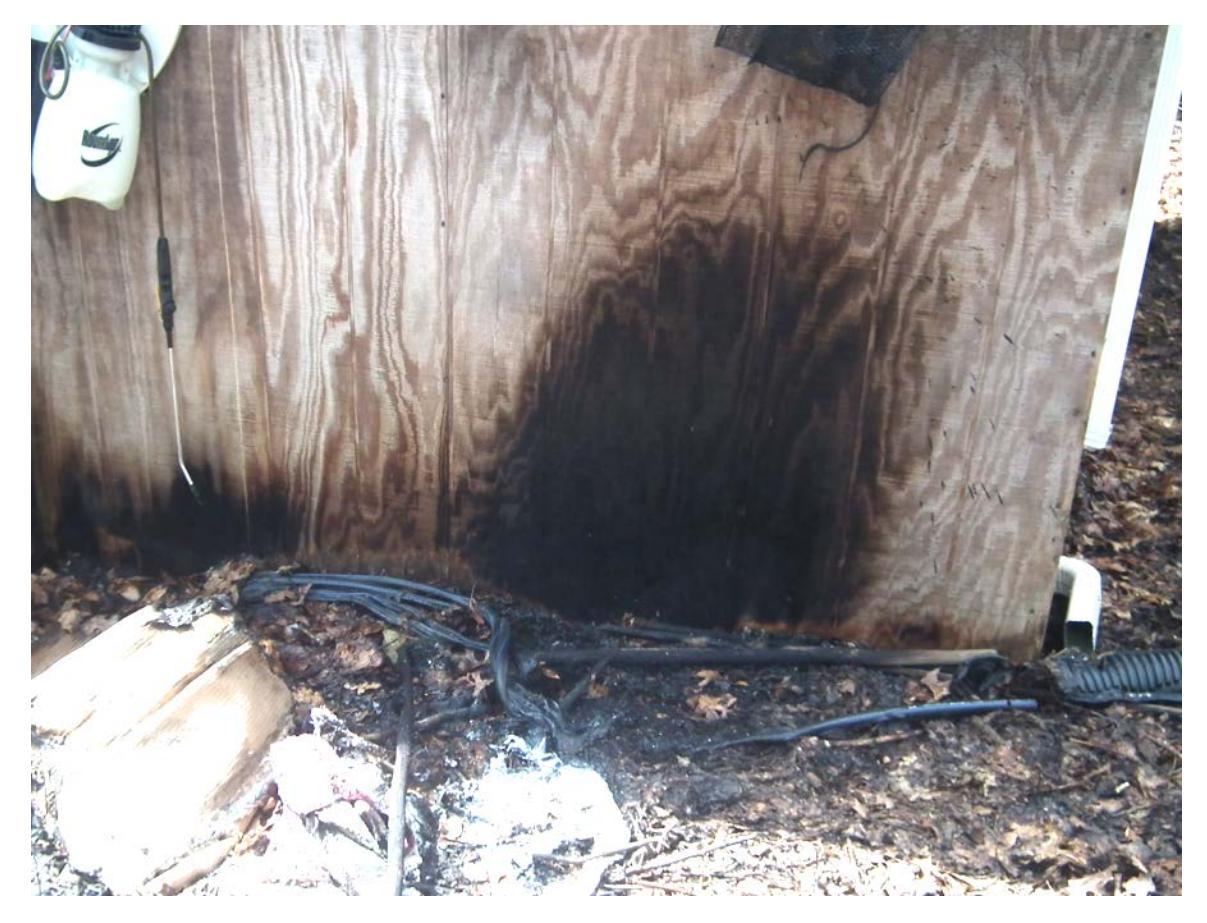
Fig. S3-2. Photo shows close-up view of fire damage to exterior T1-11 siding on side D near the corner with side C. The bottom edge of the exterior siding was the item first ignited by a creeping surface fire burning in leaves reaching the base of the building. Other combustibles ignited next to the building contributed to the large blackened area.

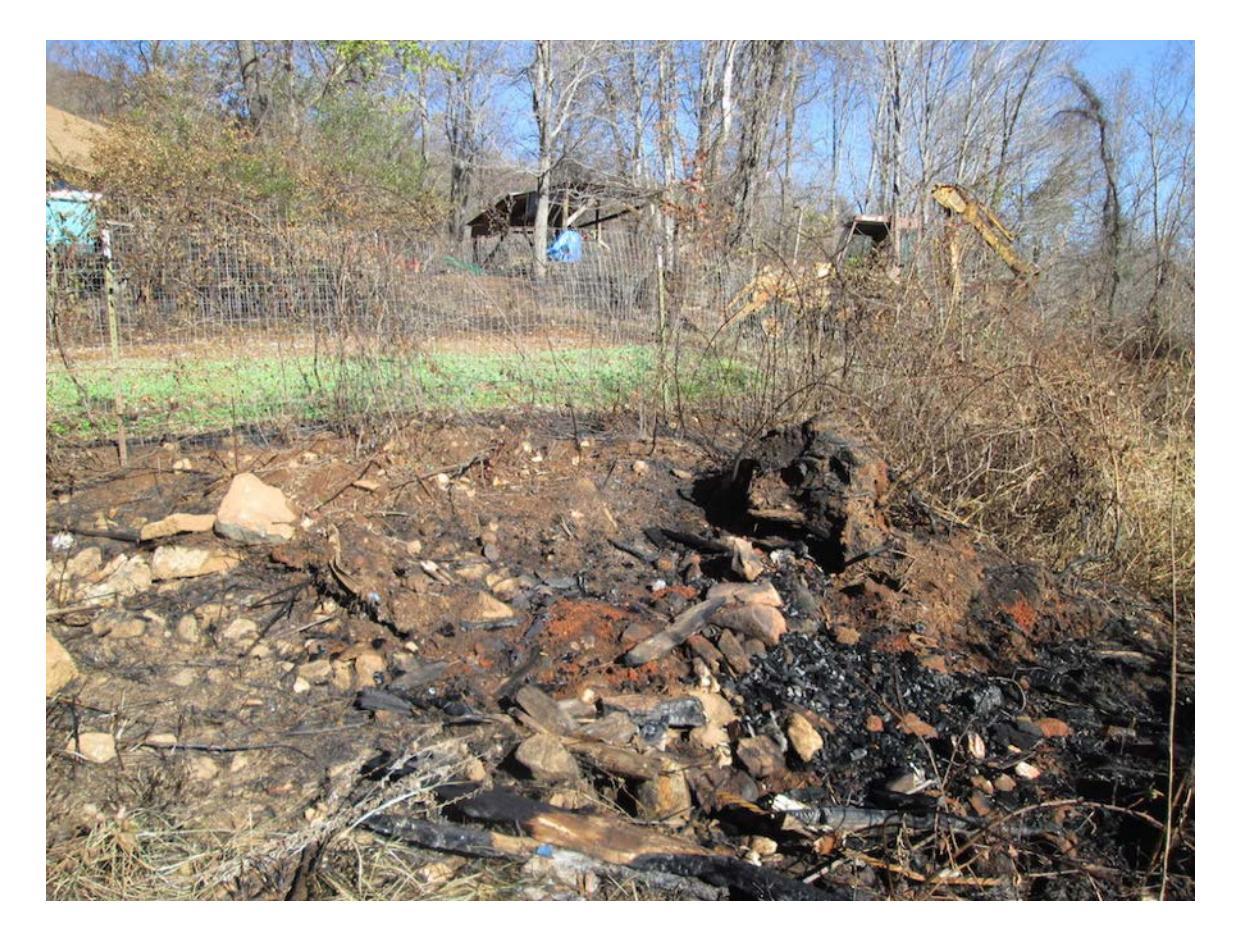
Fig. S4-1. Photo shows the burn pit, where the owner was burning debris, located below the damaged building. Fire escaped to the east (right side of the photo) and burned uphill 31 m (102 ft) to the pole building to the left of the backhoe.

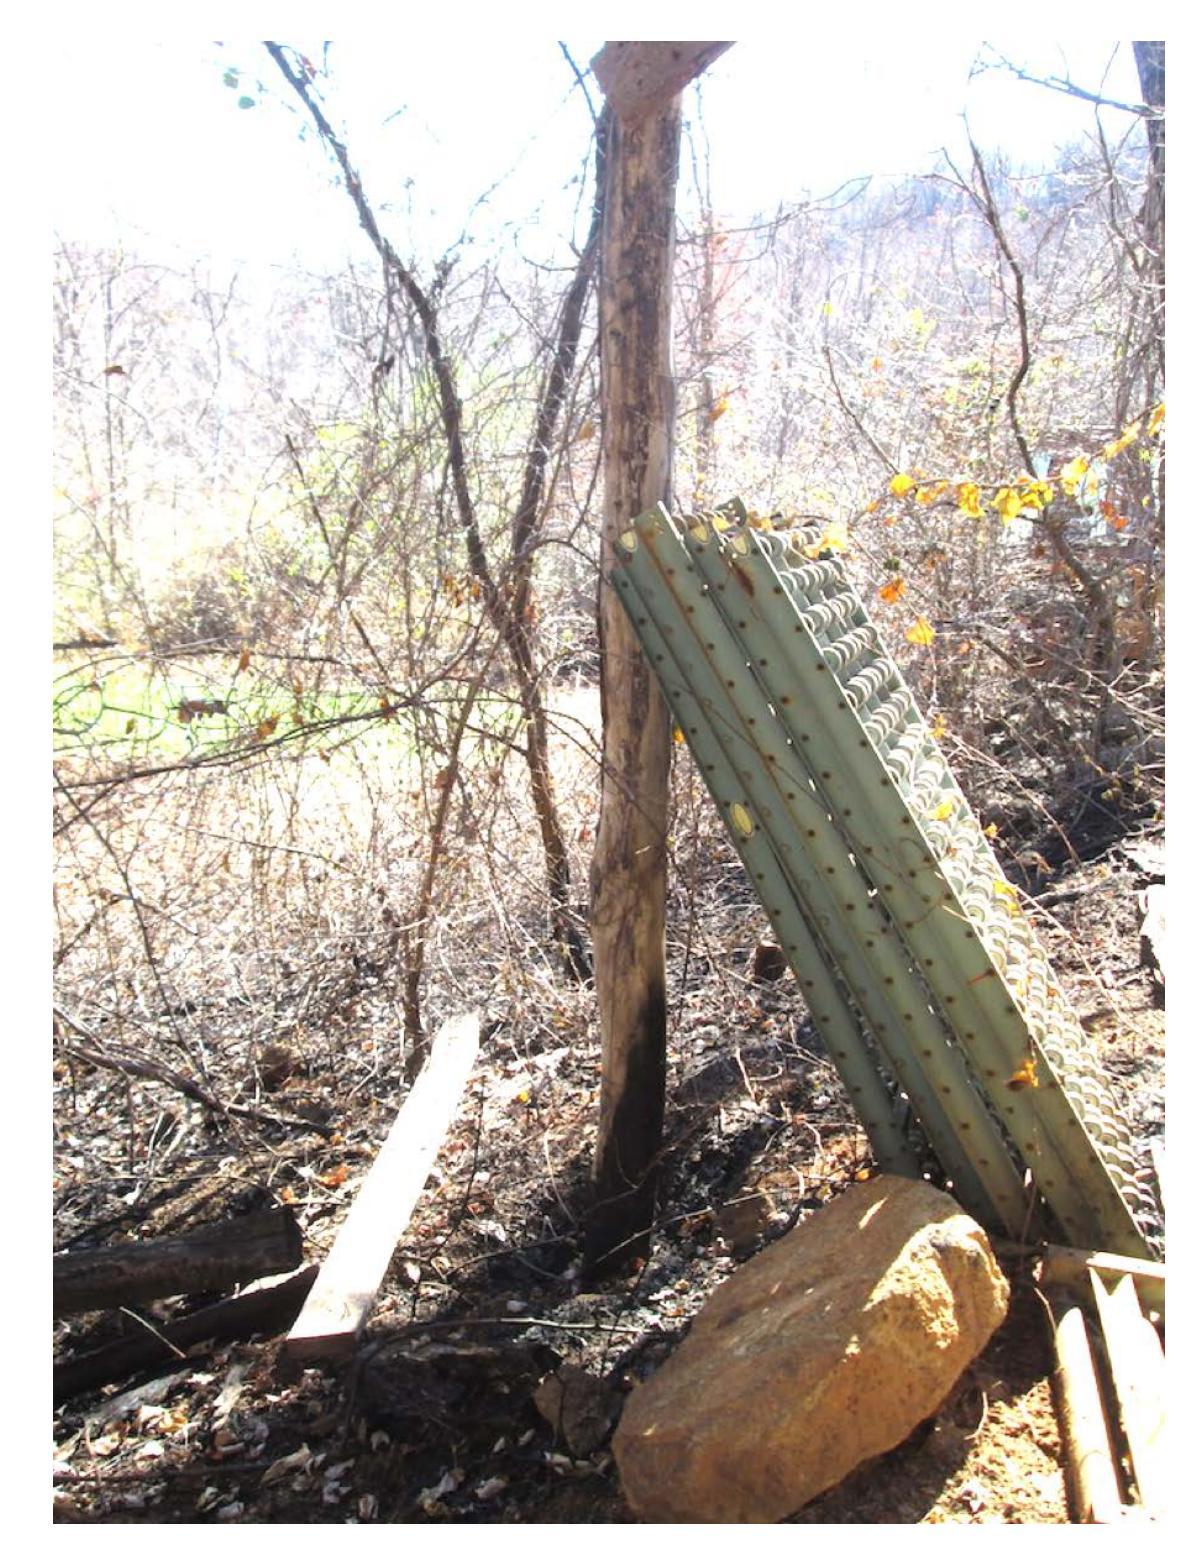
Fig. S4-3. Photo shows the column that was the first building component damaged. This column was a 15 cm (6 in) diameter locust log (debarked) set in a dug posthole at the corner of sides C and D.

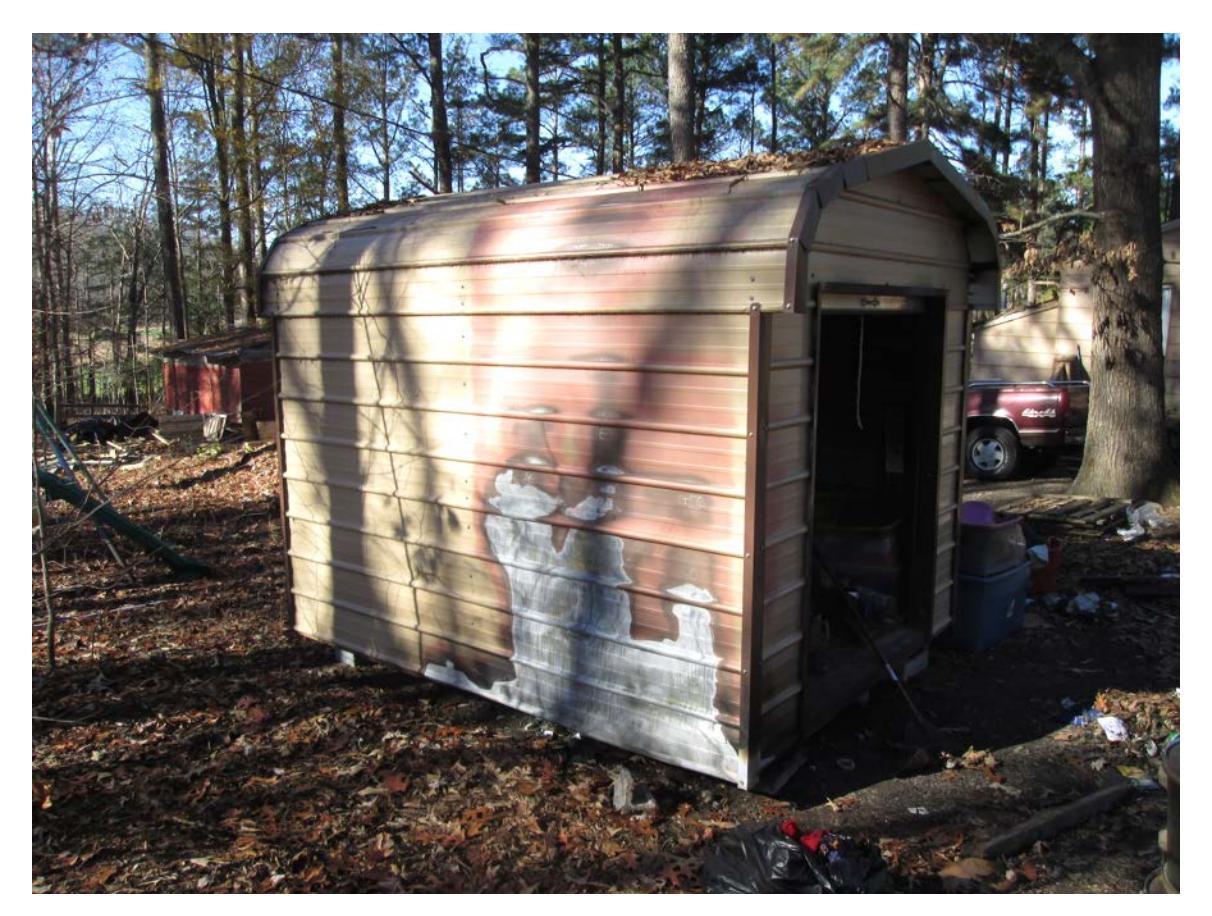
Fig. S5-1. Photo shows overall view of the damaged building from the side A, B corner. Heat damage occurred from burning leaves along the base of the building and from the ignition of the underside of the wood floor joists and wood floor sheeting. The wood floor sheeting burned through and interior contents were ignited, causing more heat damage to the metal wall siding.

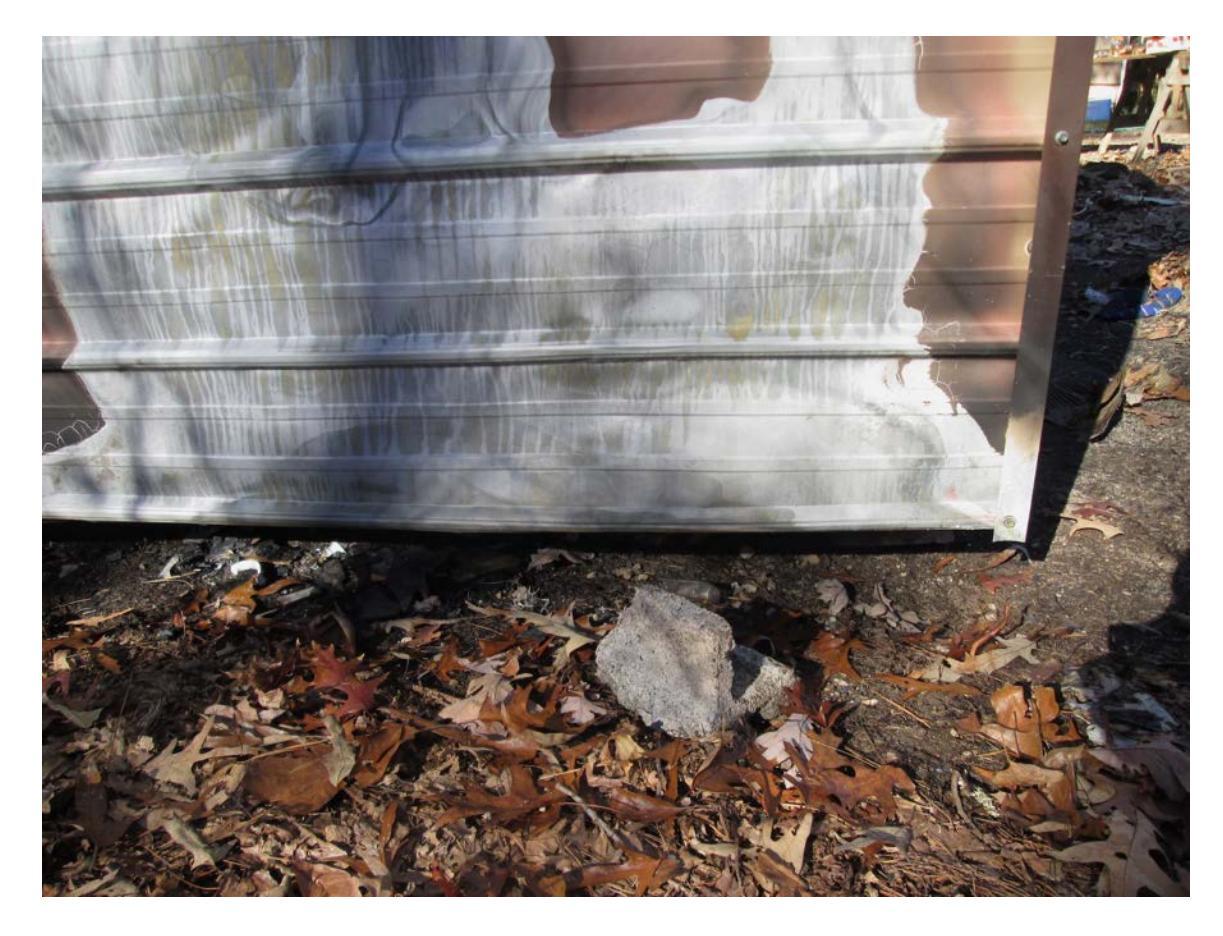
Fig. S5-2. Photo shows a close-up of the exterior damage on side B near the corner with side A. This is the area of most damage to the underside of the building and where the fire made entry into the building.

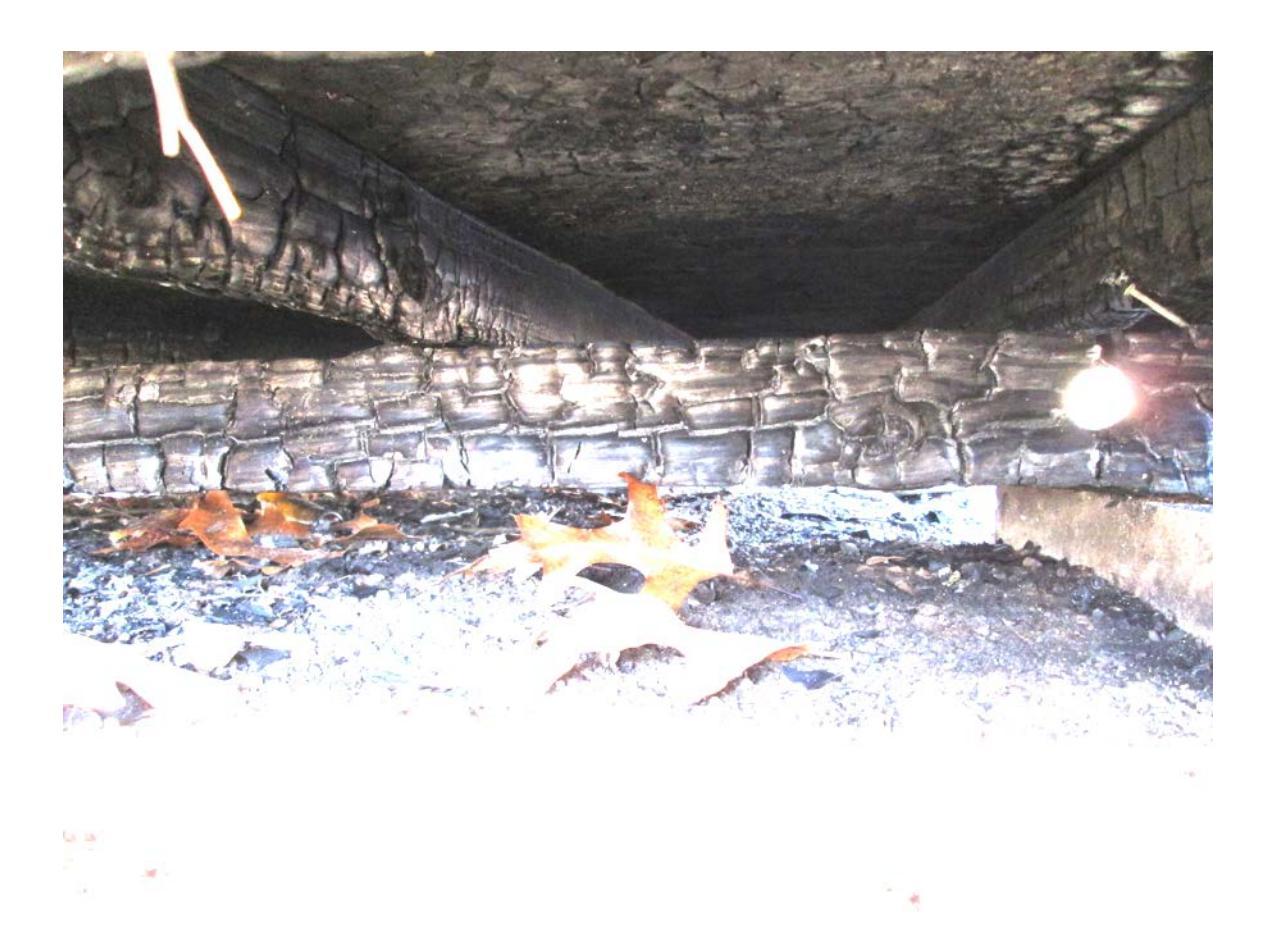
Fig. S5-3. Photo looking under the structure at ground level shows charring to the underside of floor sheeting and floor support structure. Post-fire leaf accumulation is present in the open area under the building.

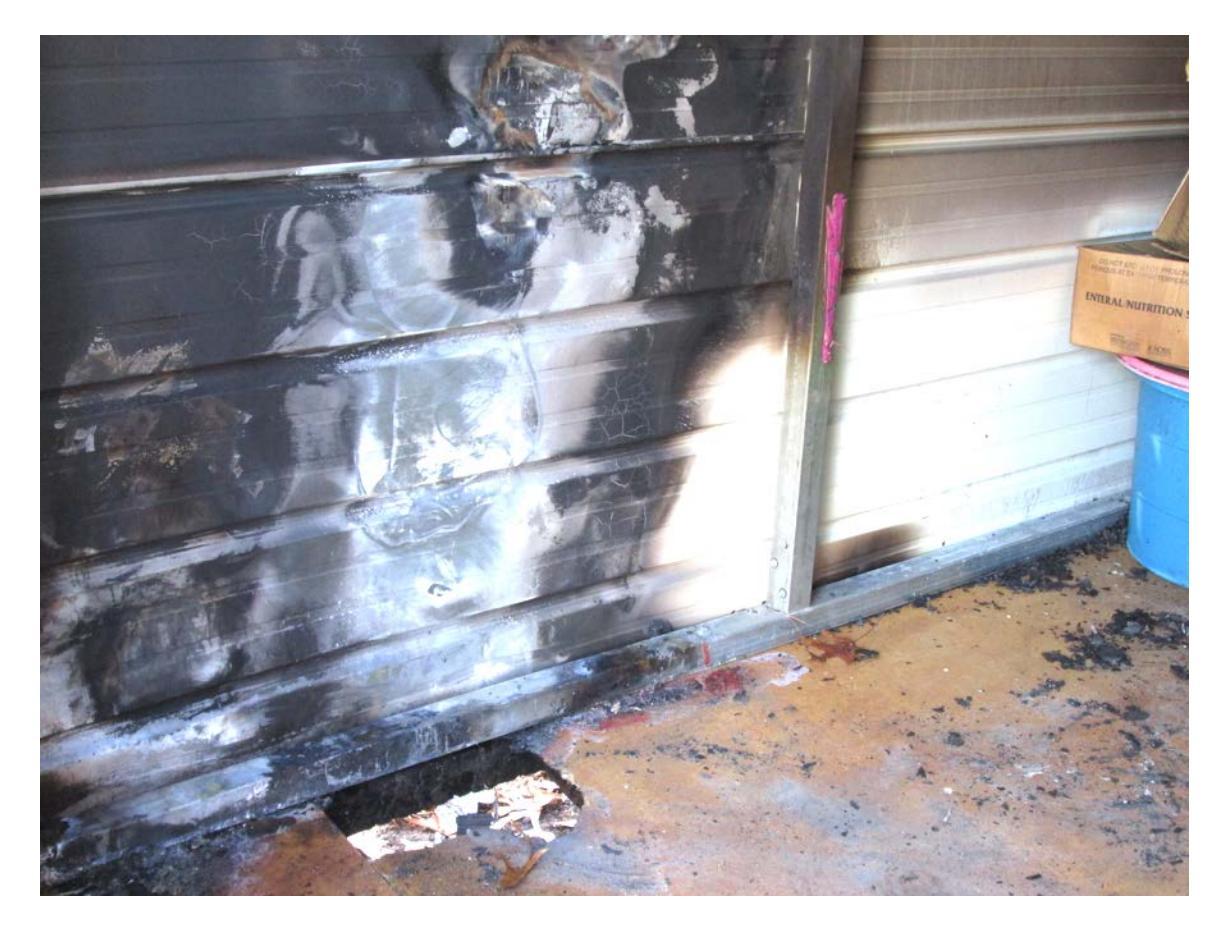
Fig. S5-4. Photo shows interior floor damage and burn pattern on the side B interior wall near the corner with side A. Burned interior contents were removed by firefighters.

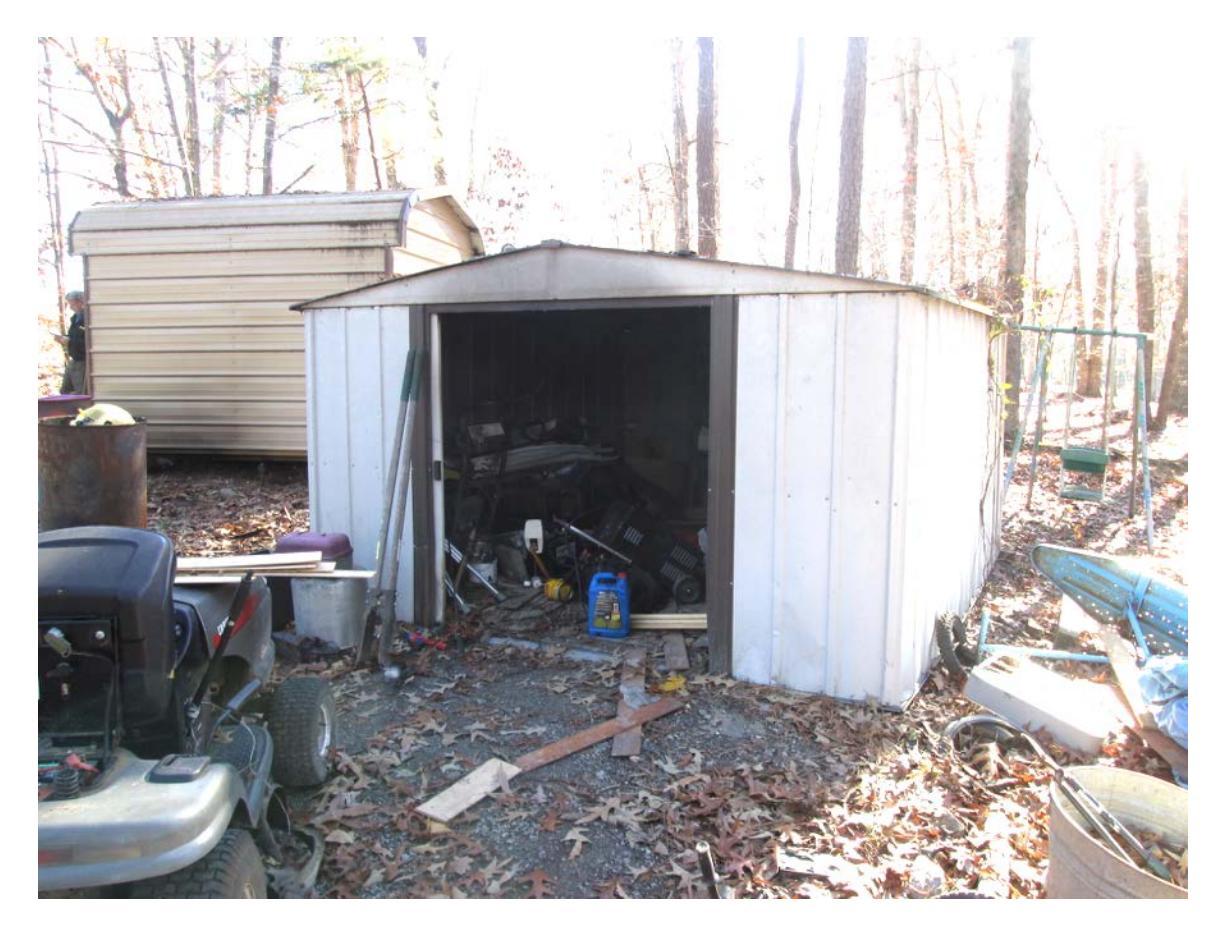
Fig. S6-1. Photo shows an overall view of building side A. The burn barrel (fire cause) can be seen at the center left of the photo.

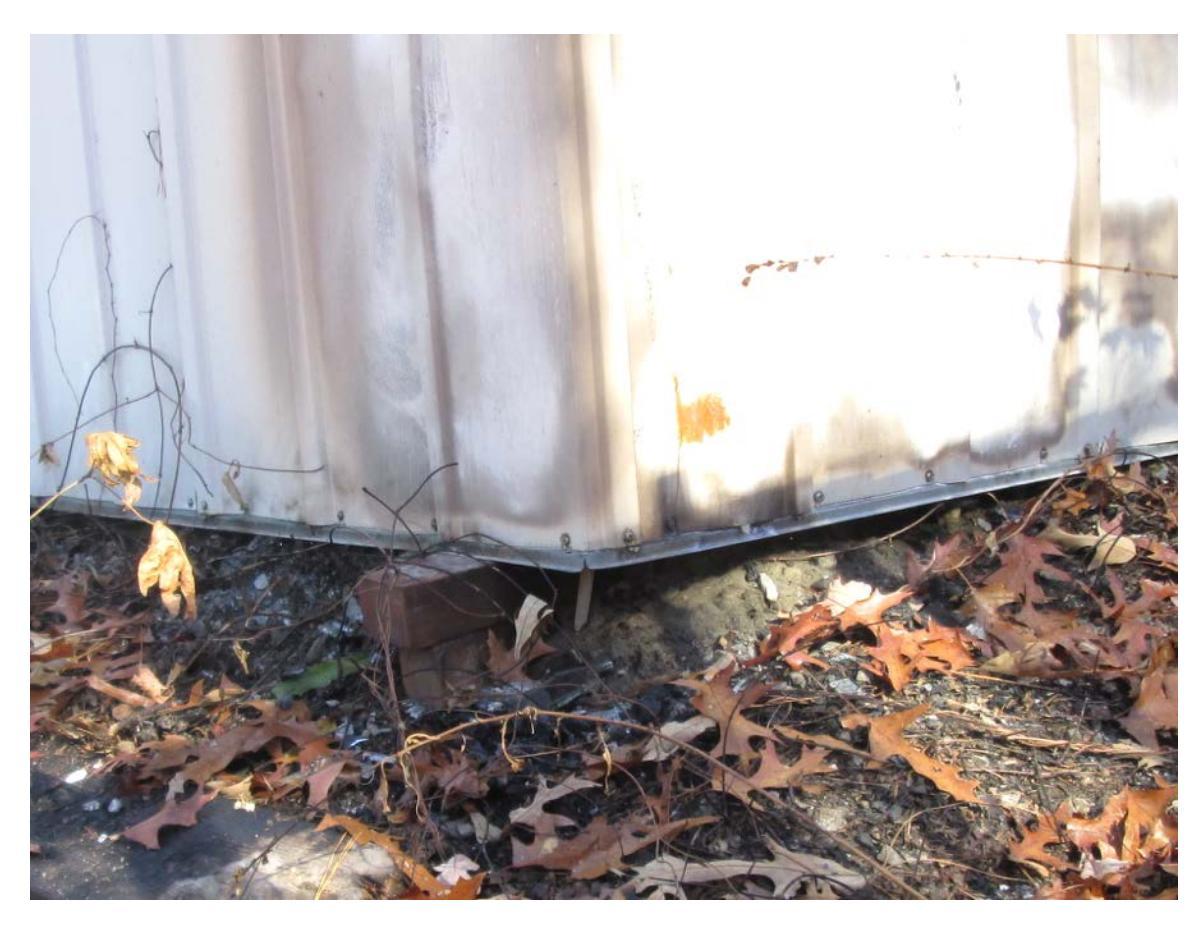
Fig. S6-3. Photo shows the erosion in floor materials on the exterior of side C at the corner with side D. This is where the surface fire made entry and ignited interior combustibles.

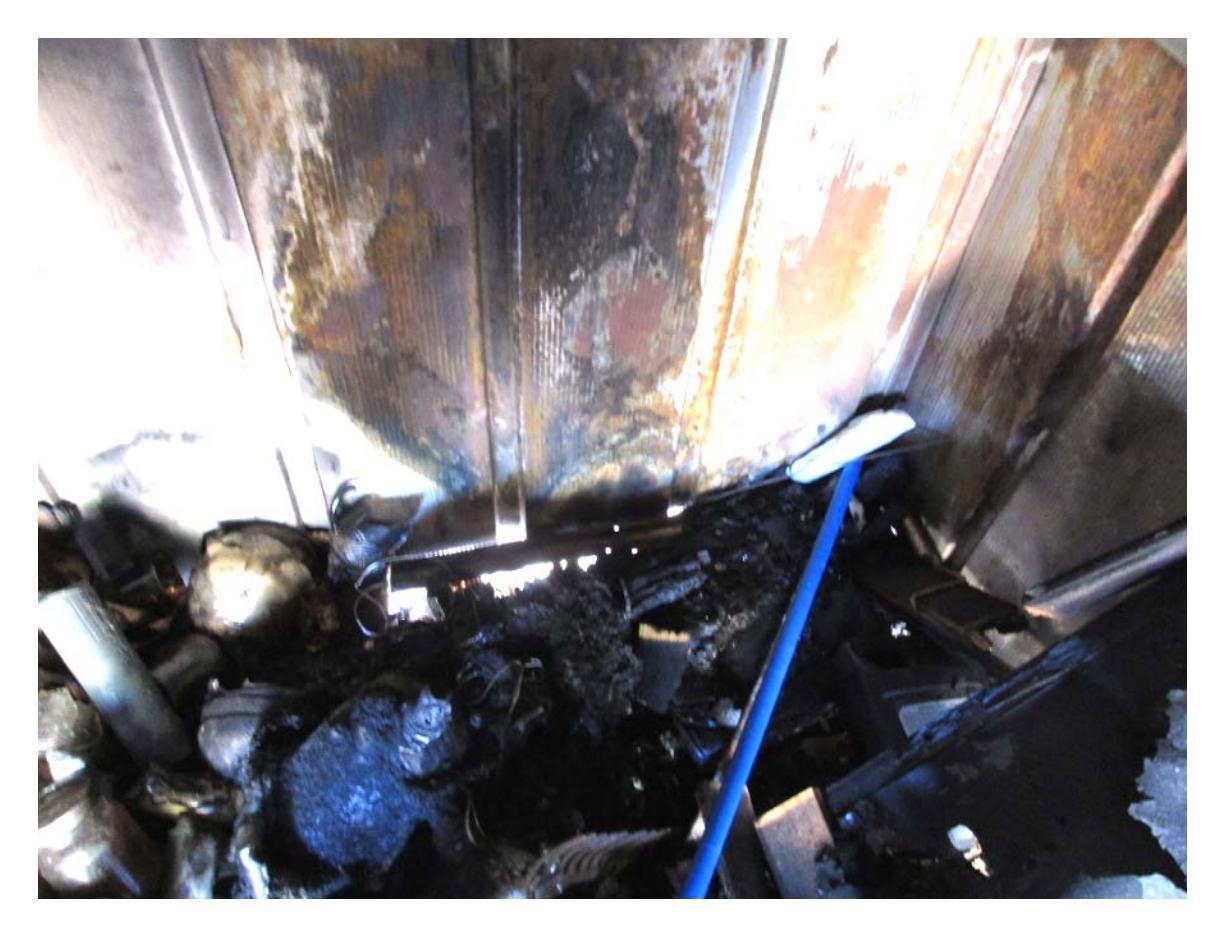
Fig. S6-4. Photo shows a close-up view of eroded floor openings at base of low burn pattern on the interior of the side C wall. This is where the surface fire of burning leaves entered the steel building, igniting interior combustibles.

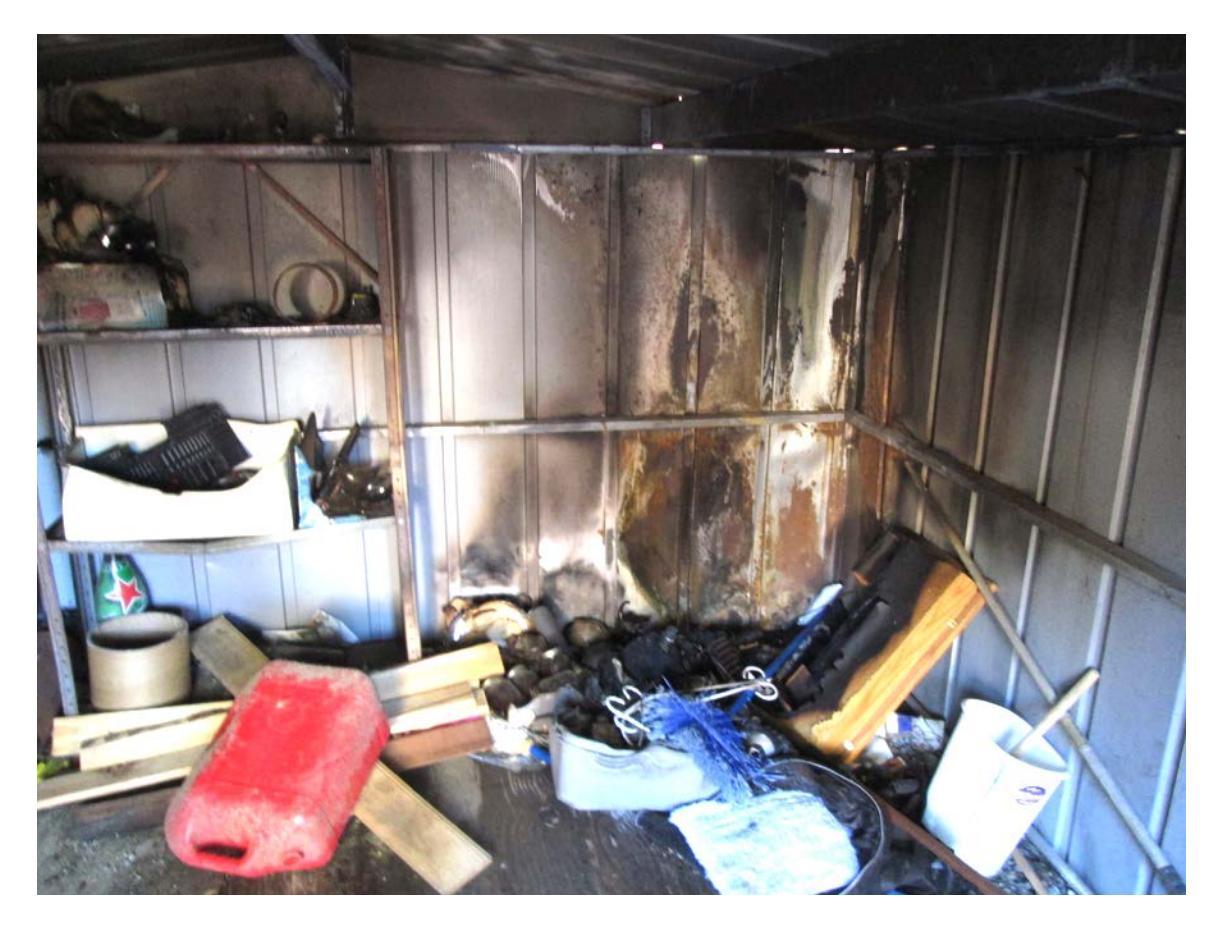
Fig. S6-5. Photo shows the burn pattern on side C interior wall at the corner with side D.

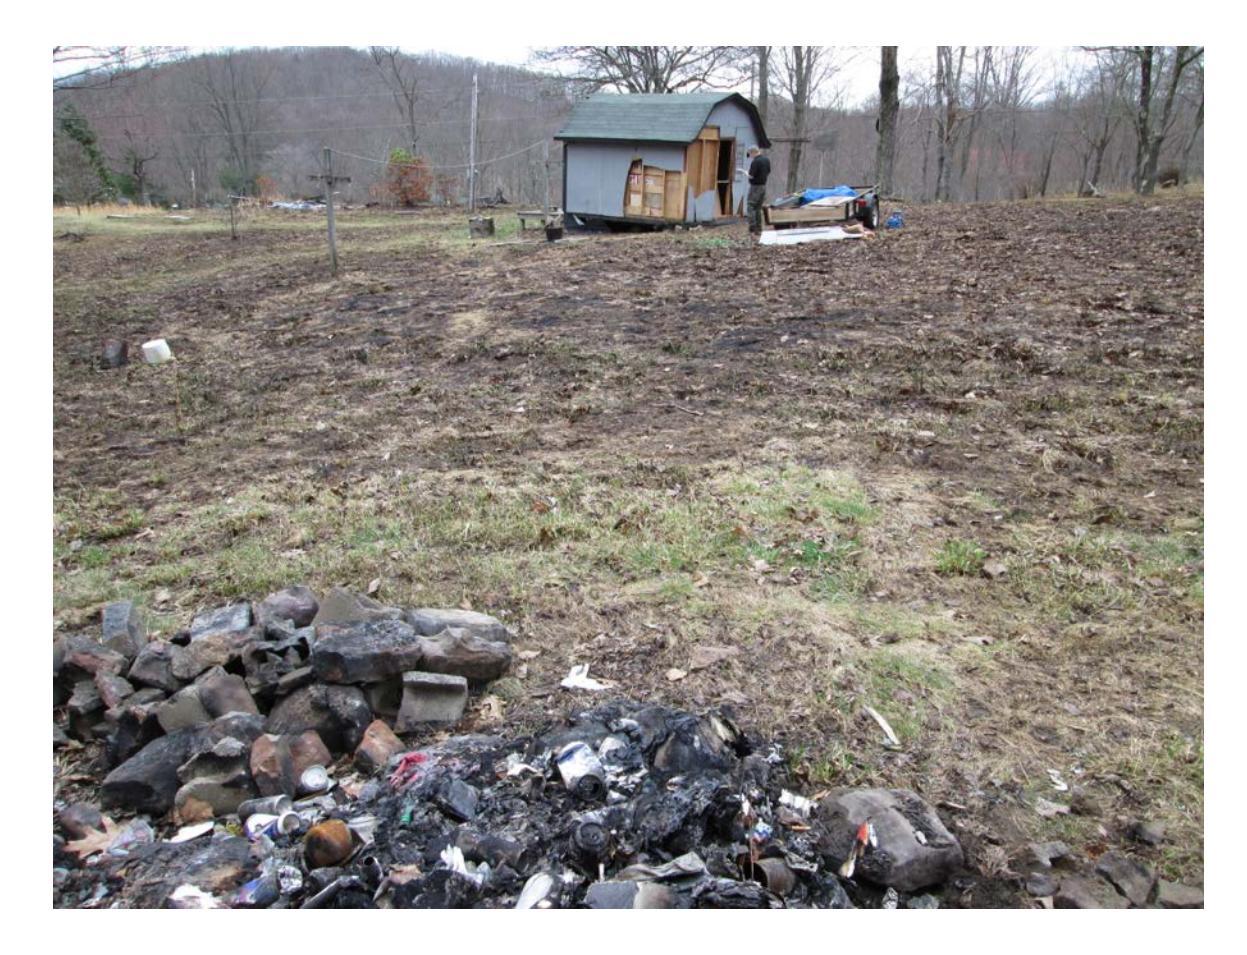
Fig. S8-1. Photo shows close-up view of the trash burn pit (rock circle) and the burned area leading to the damaged utility building 56.2 m (184.5 ft) away (Building sides C and D shown).

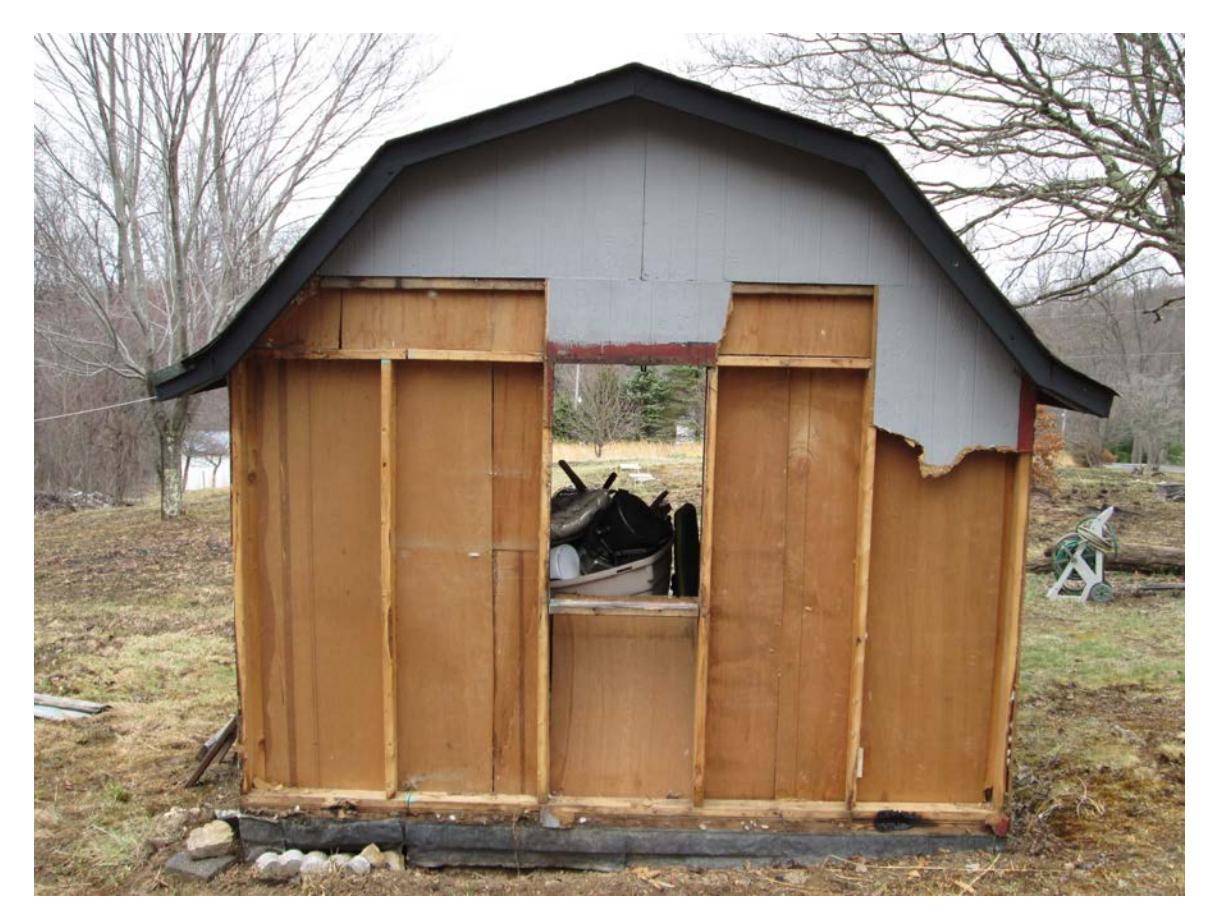
Fig. S8-2. Photo shows the view of side C where firefighters removed the fiberboard siding during fire suppression and overhaul operations. Fire damage to the sill plate can be seen at the lower right of the photo.

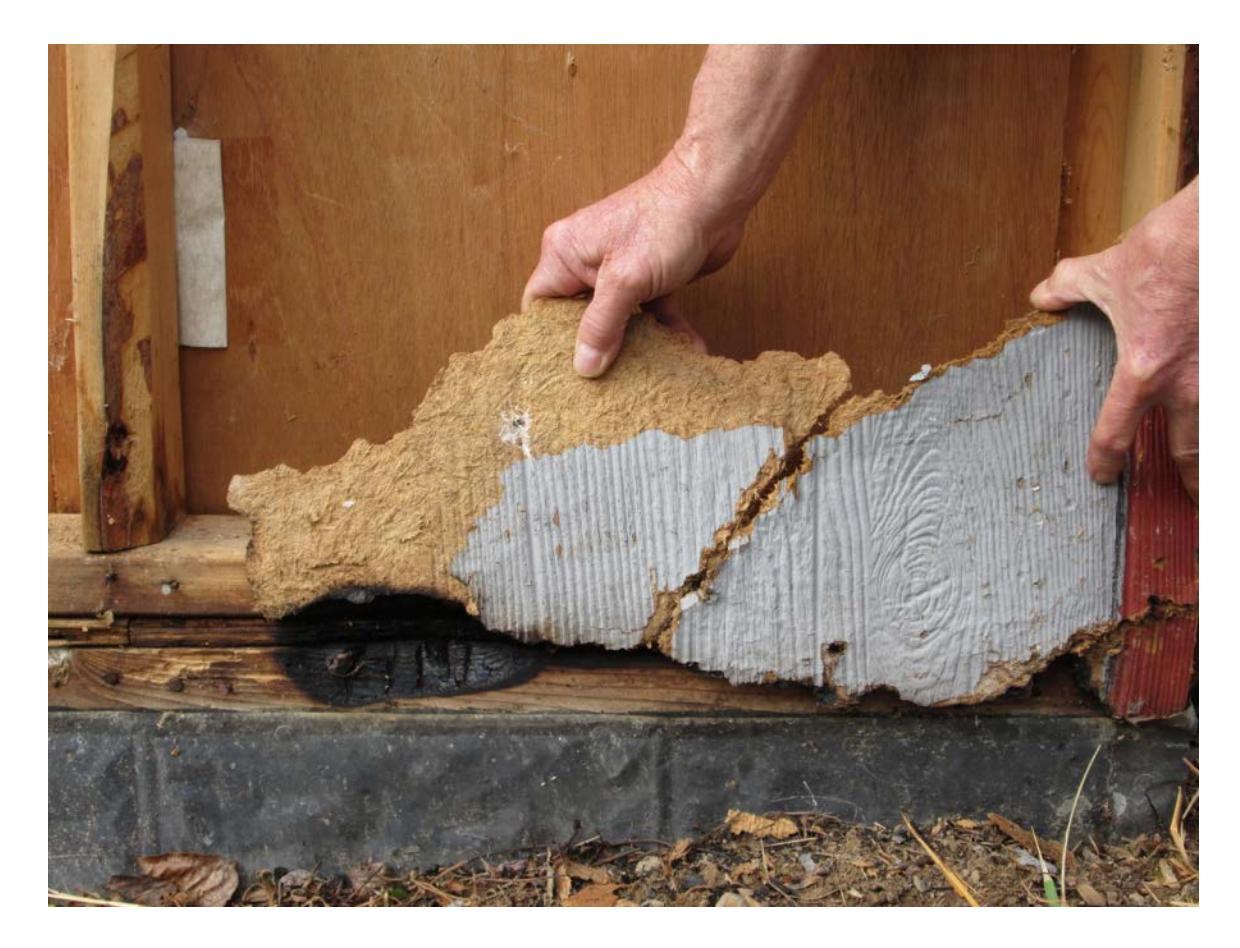
Fig. S8-3. Photo shows a view of the side C siding, placed in original position, showing damage at bottom edge.

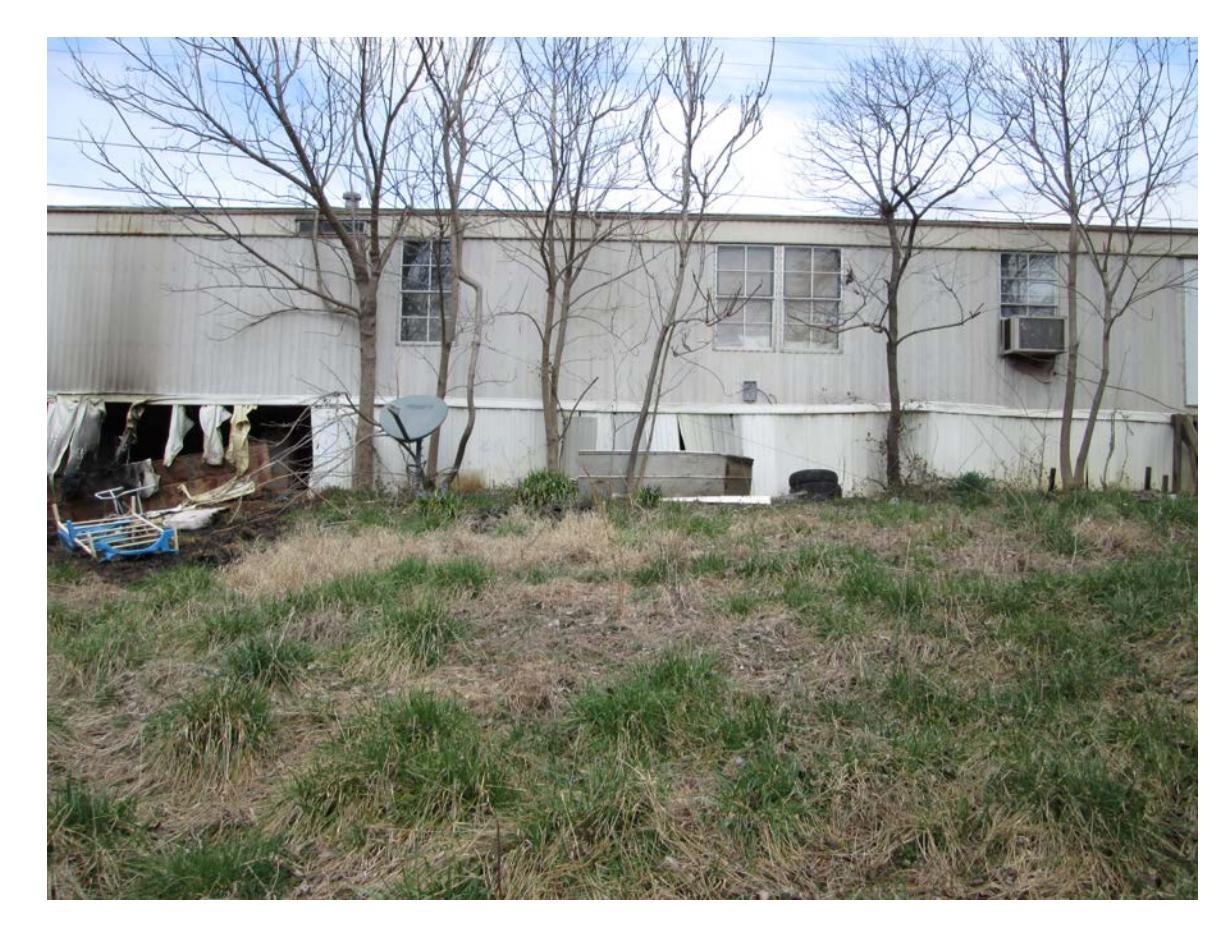
Fig. S9-1. Photo shows an overview of side C and fire damage.

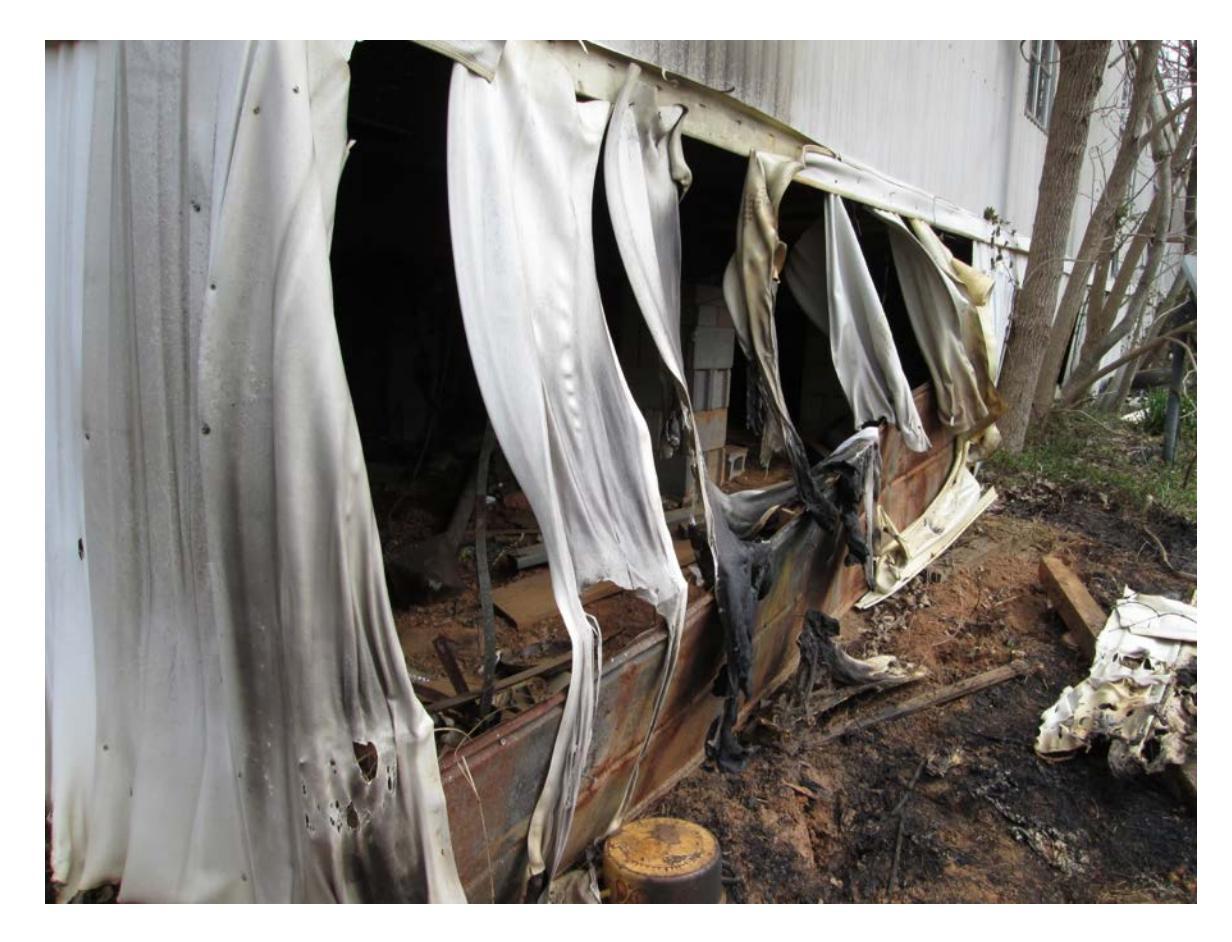
Fig. S9-3. Photo shows a close-up view of damaged vinyl siding on side C.
