NIST GCR 18-018

Structures Ignited by Virginia WUI Fires 2/2015 – 2/2017

David D. Evans Lavern R. Scott William D. Walton Home Safety Foundation Chevy Chase, Maryland 20815-4206

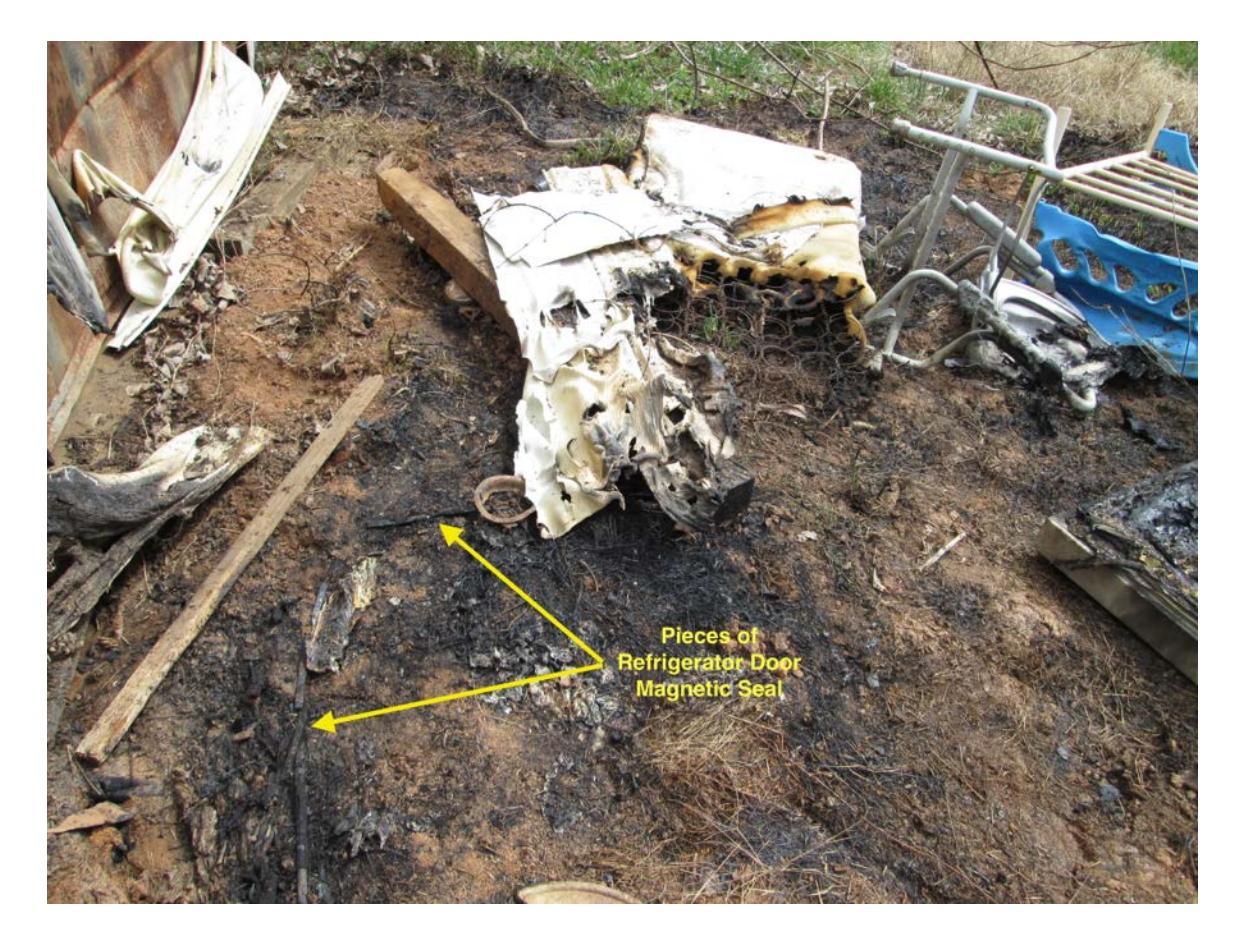
Fig. S9-4. Photo shows a close-up view of the ground burn pattern on side C. The remains of the refrigerator door magnetic seal indicate the location of refrigerator door at time of fire.

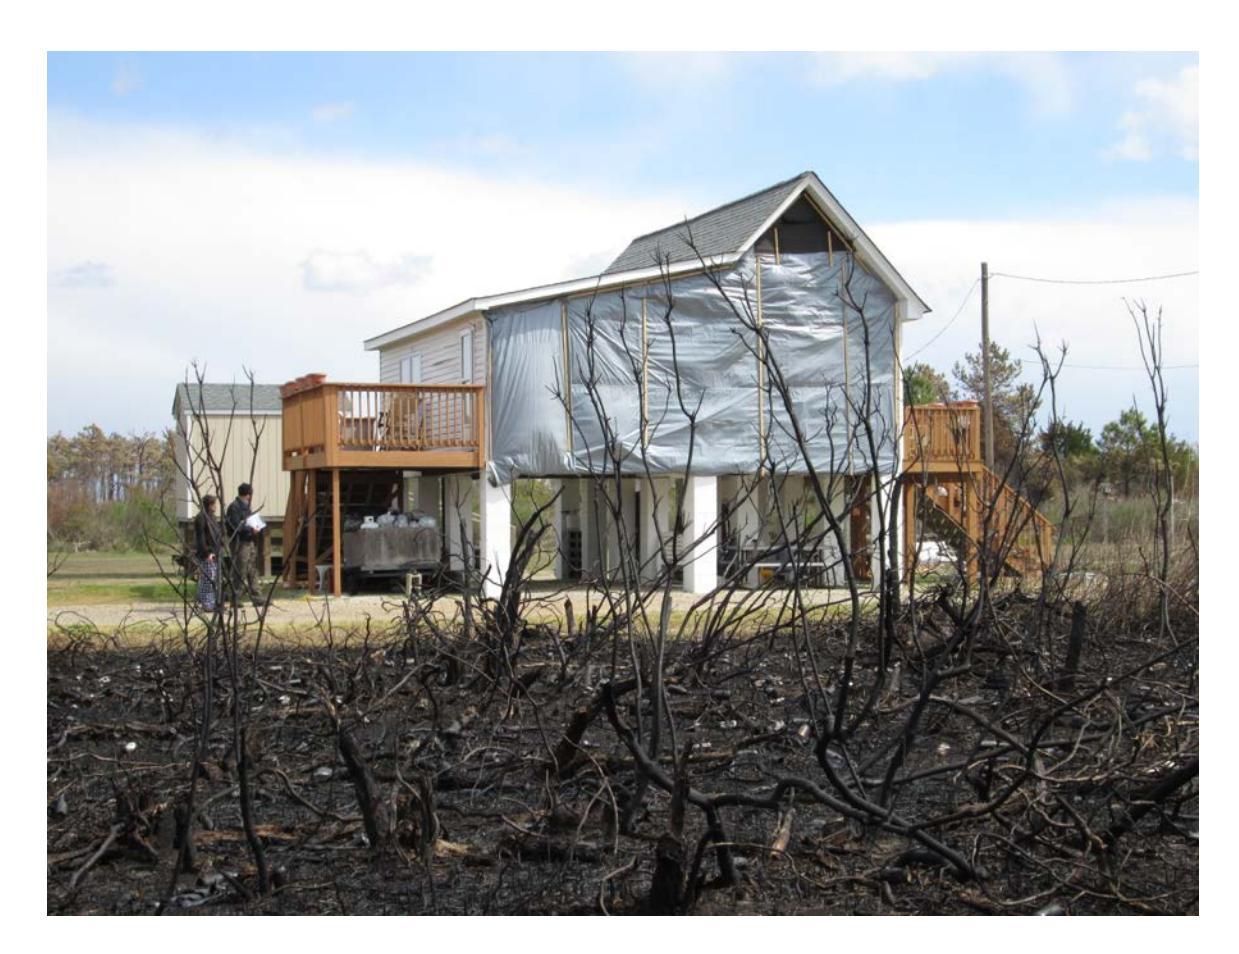
Fig. S10-1. Photo shows an overview of side B showing the damaged building weather protected with plastic sheeting. The wildfire burned to the edge of the recently mowed yard within 8.53 m (28 ft) of side B. The residence was defended by firefighters positioned in front of side A.

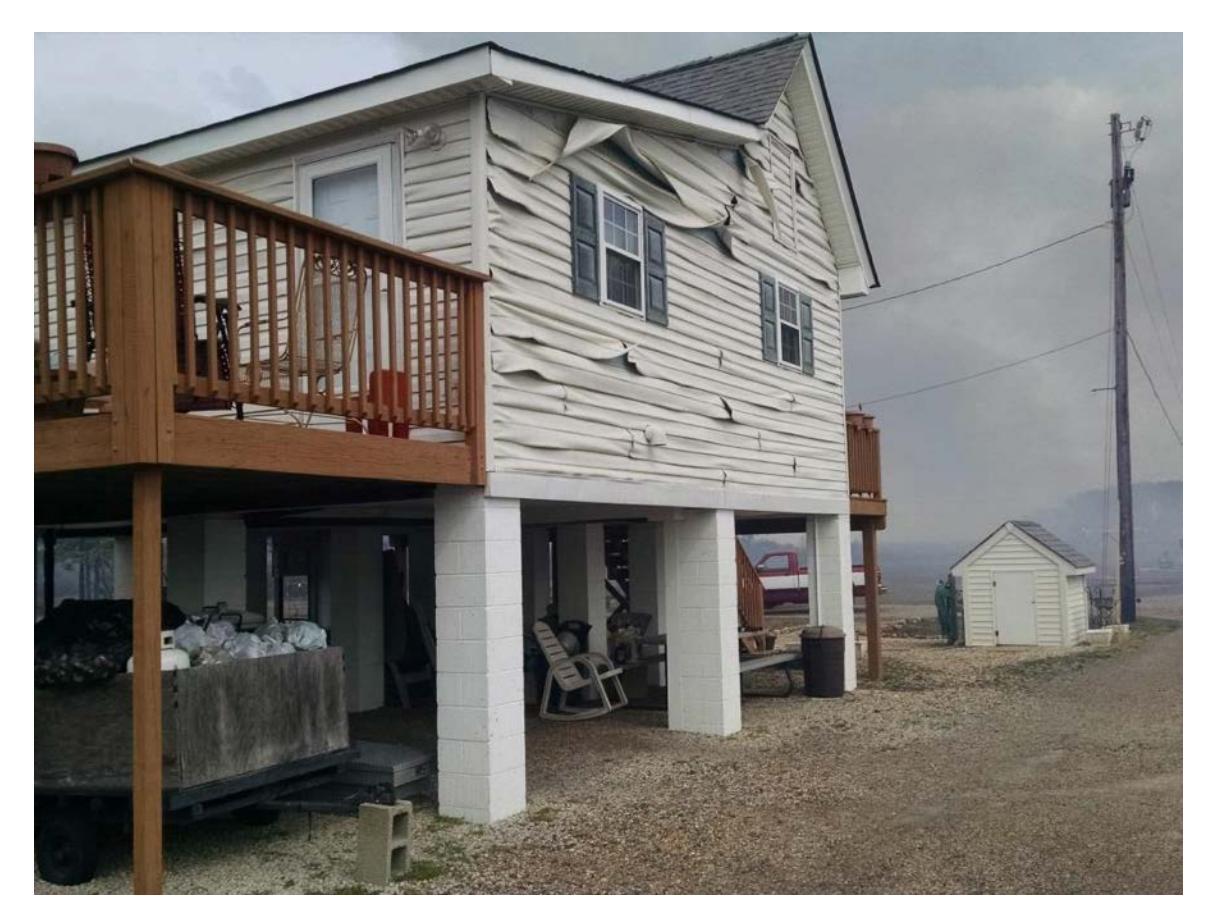
Fig. S10-2. Photo provided by the VDOF Incident Commander showing the damaged vinyl siding on side B.

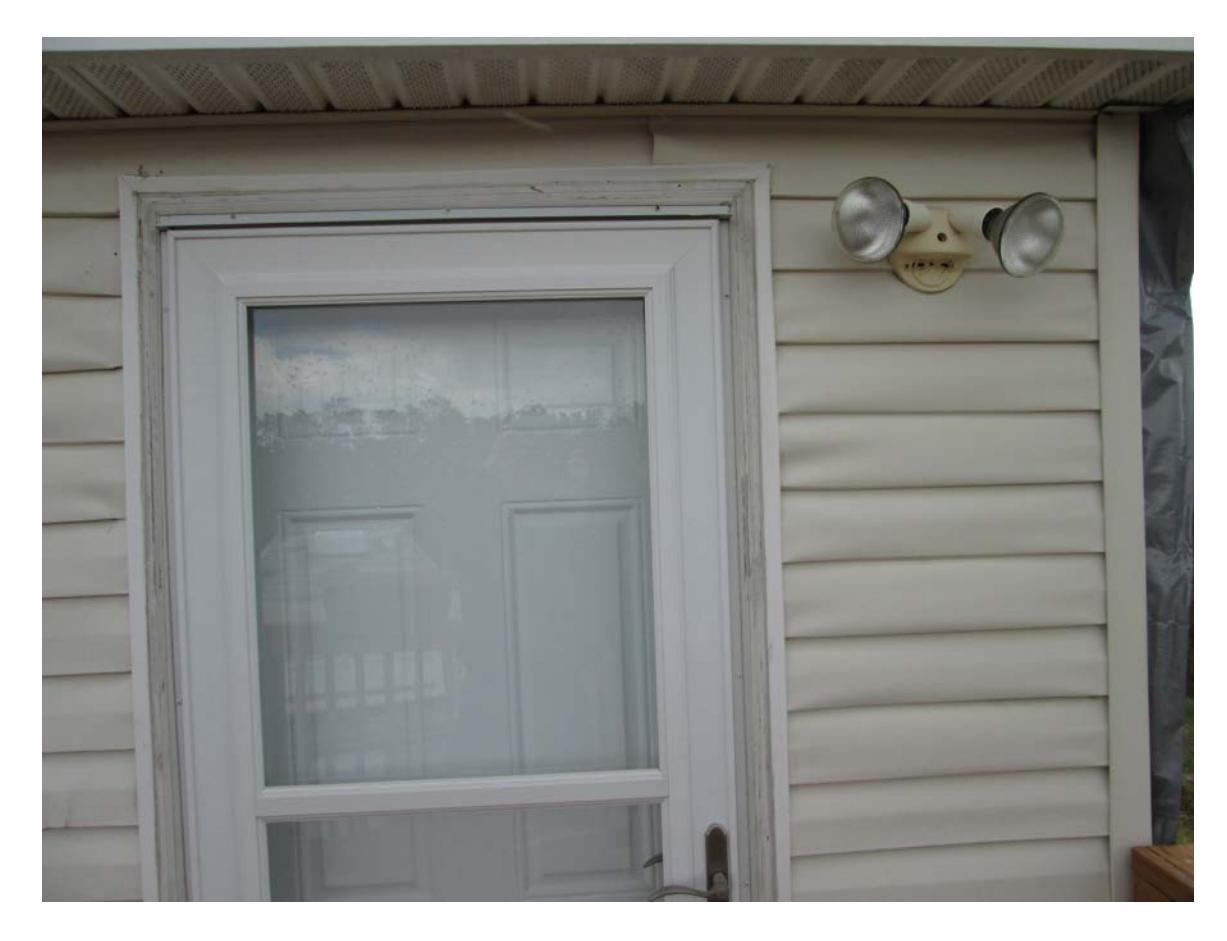
Fig. S10-3. Photo shows a close-up view of minor heat damage to vinyl siding on side C near the corner with side B.

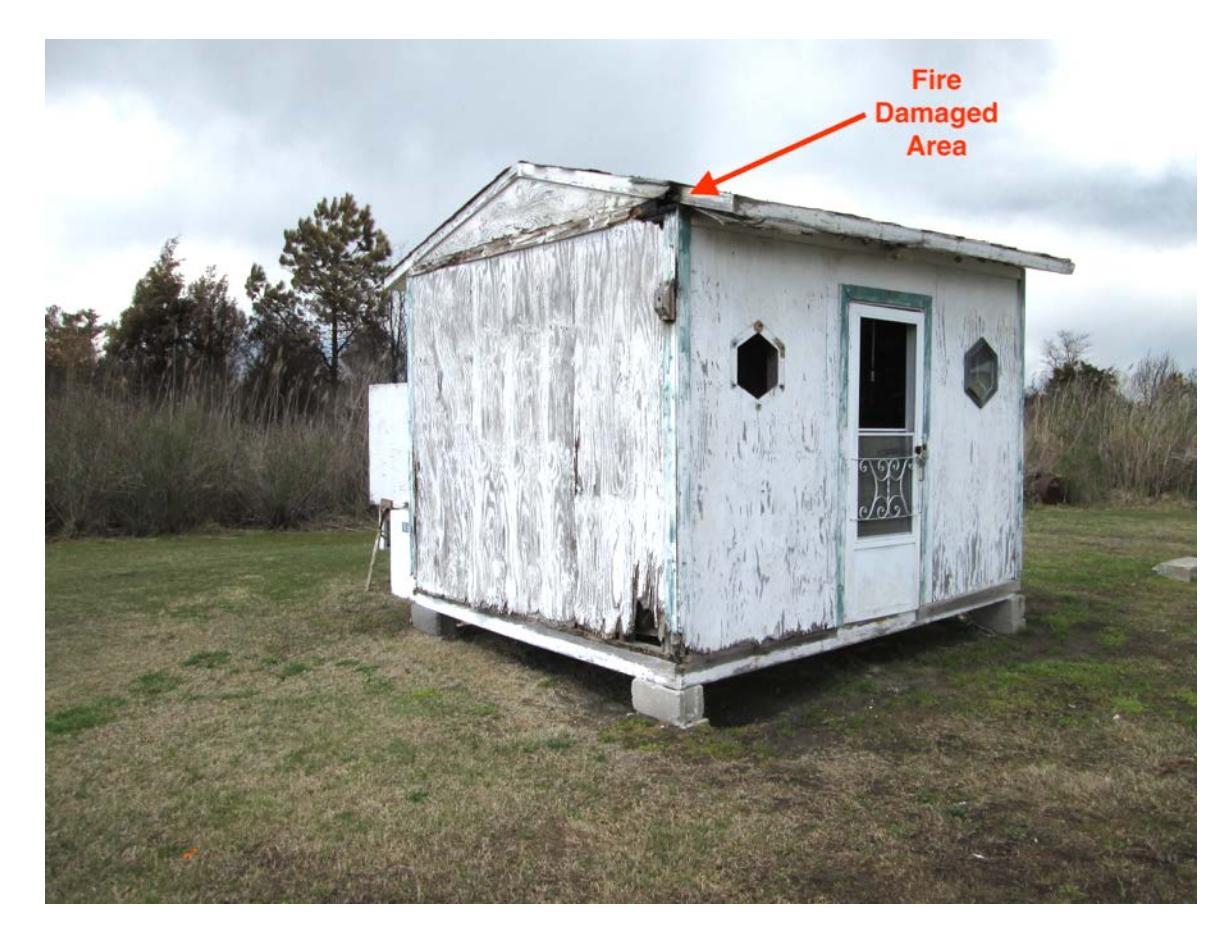
Fig. S11-1. Photo shows an overview of the utility building side A, B corner with fire damaged area indicated by arrow.

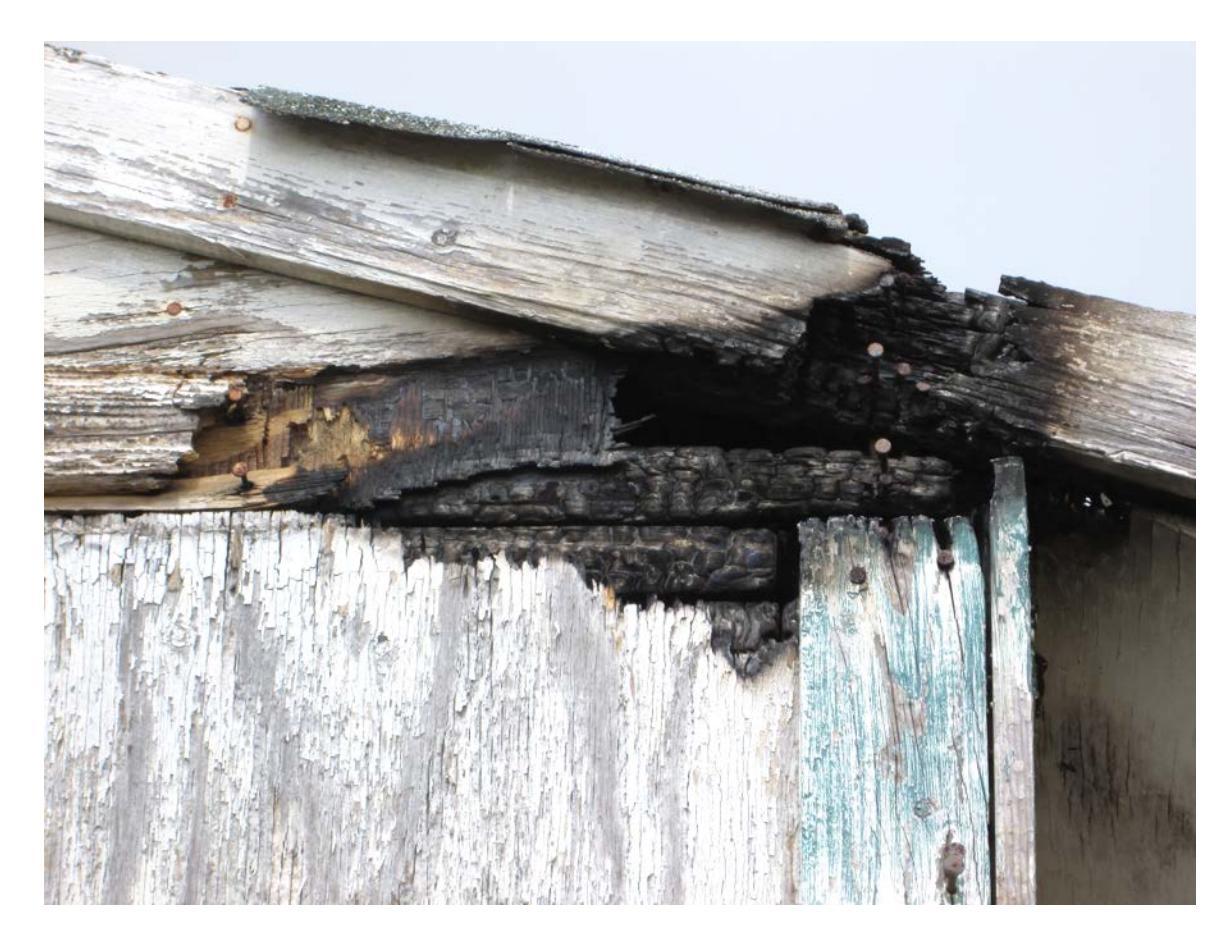
Fig. S11-2. Photo shows a close-up view of the fire damaged area.

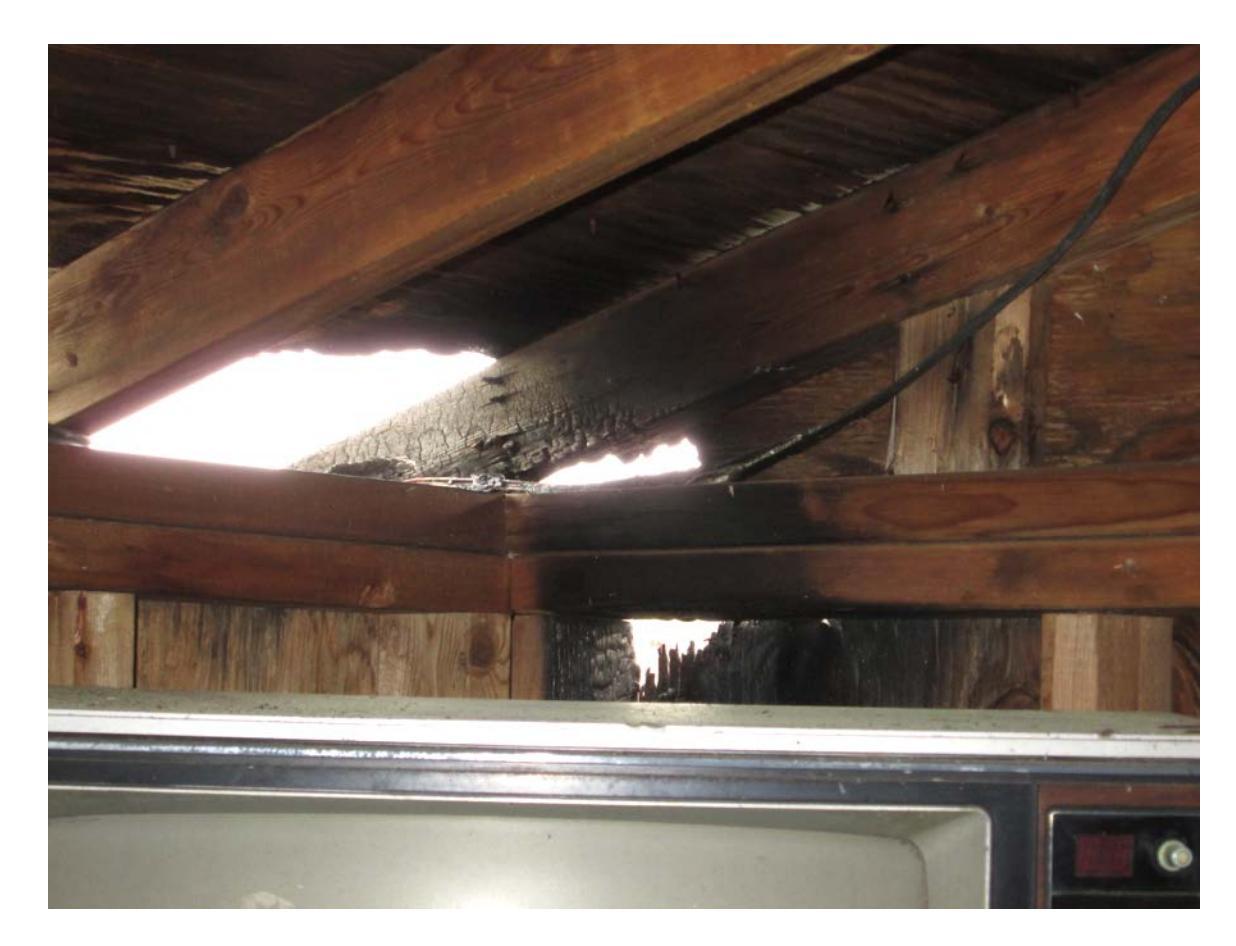
Fig. S11-3. Photo shows a close-up view of the inside of the utility building where fire burned through and made entry. This is the top inside corner of the side A, B walls.

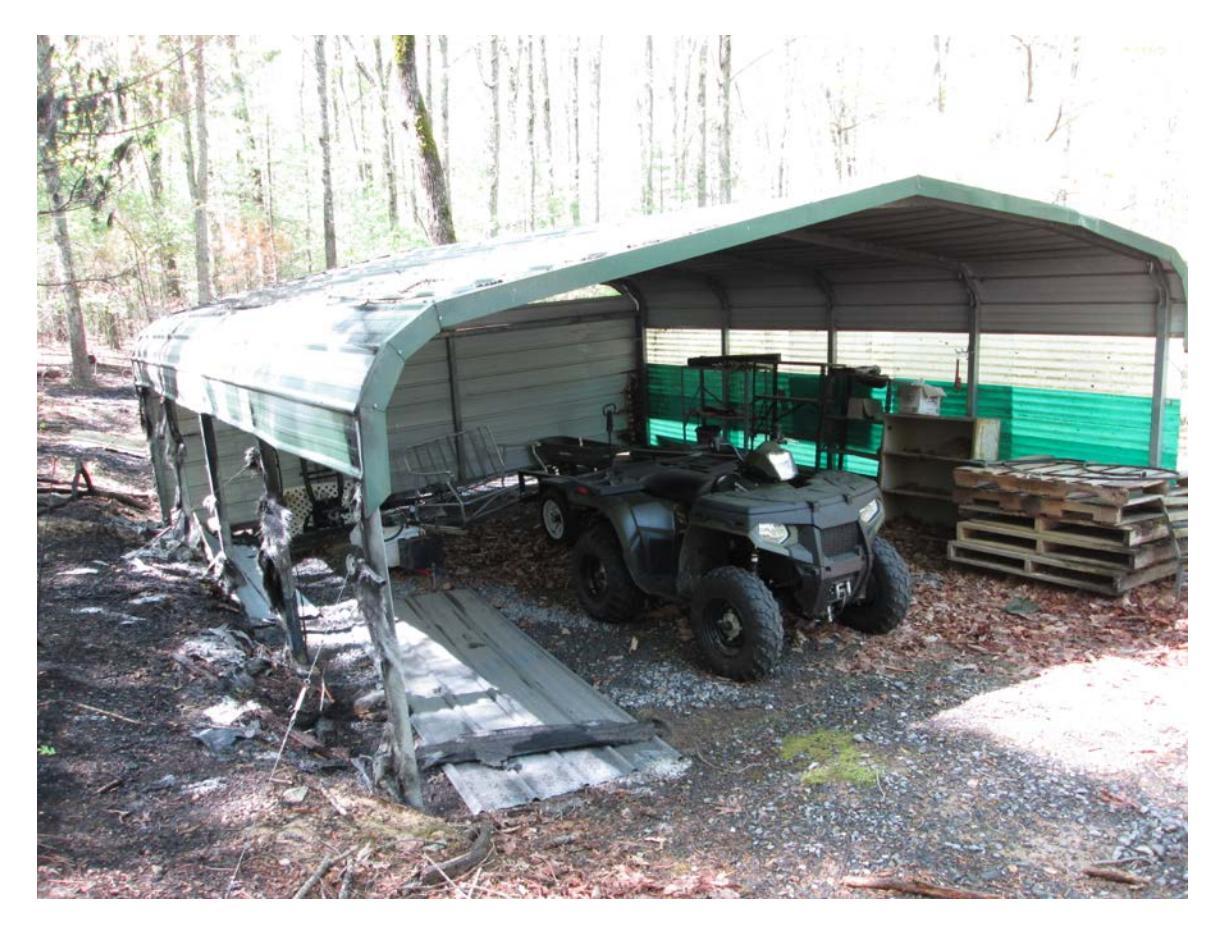
Fig. S12-1. Photo shows an overview of carport side A. Fire damage to the building can be seen on side B.

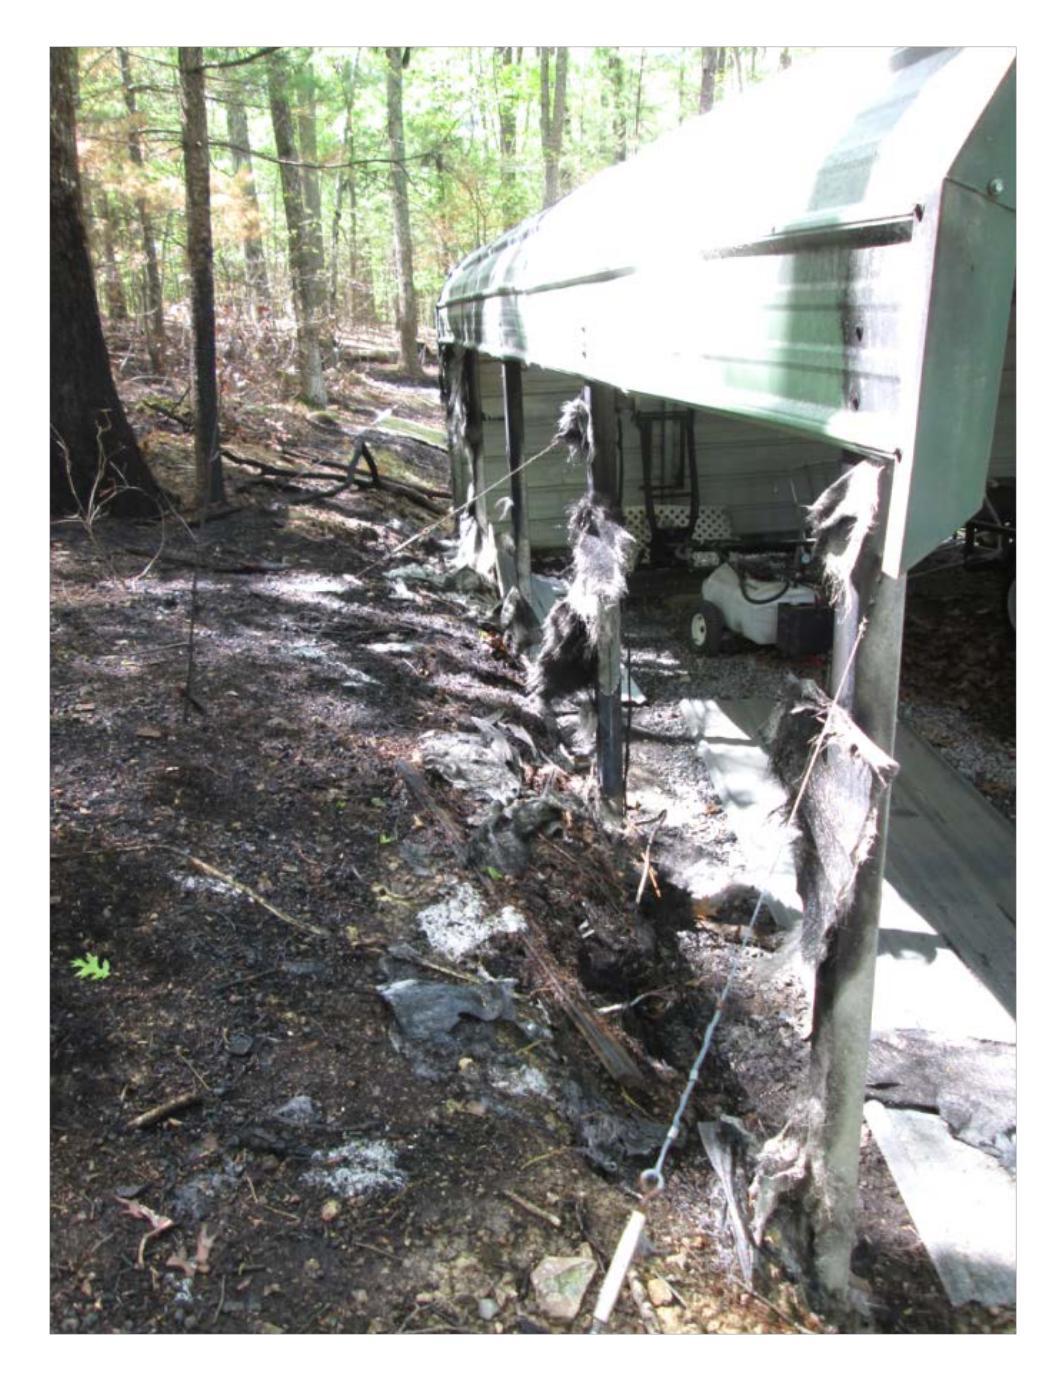
Fig. S12-2. Photo showing fire damage and roof to wall transition with corrugated metal.

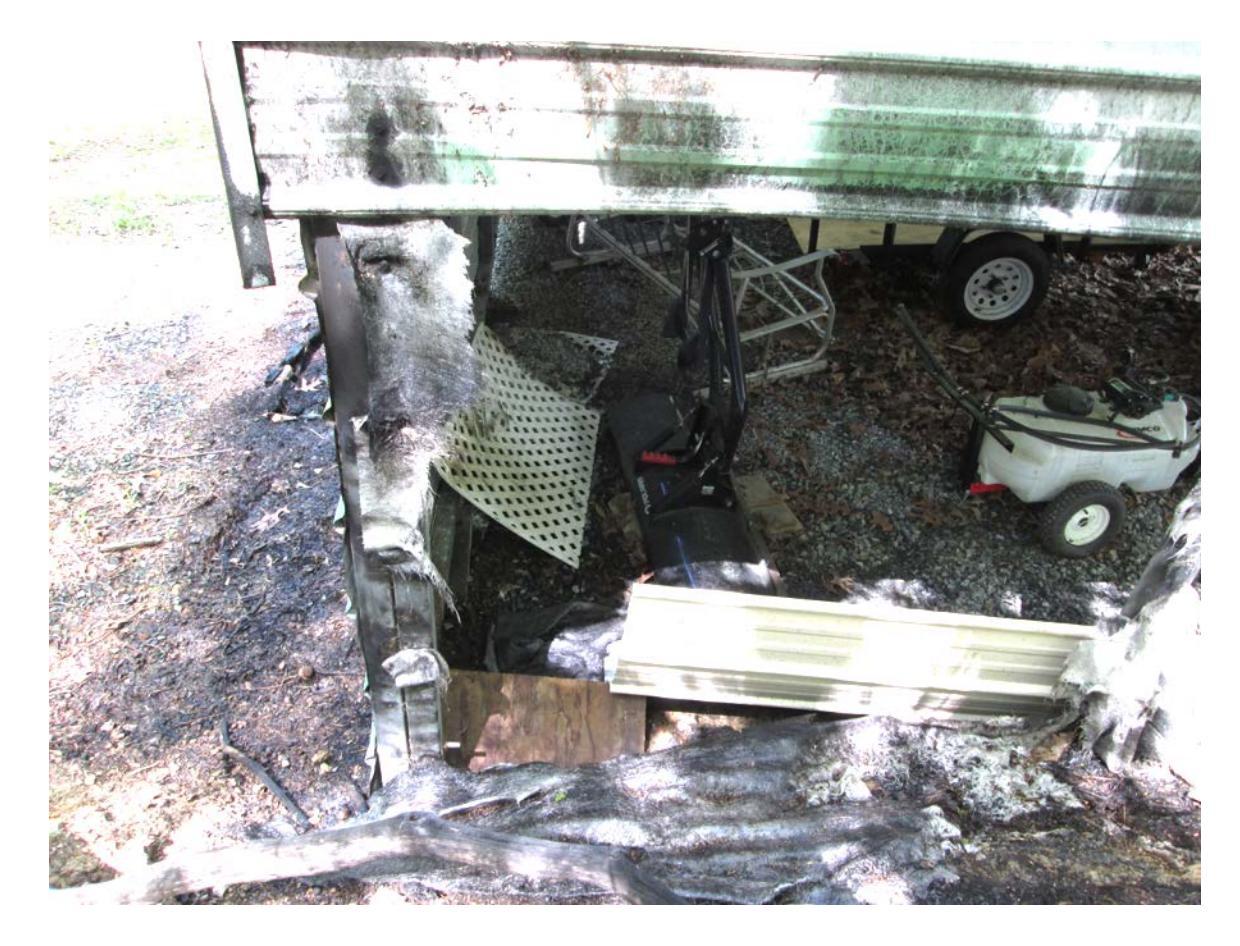
Fig. S12-3. Photo shows a close-up view of the wall side at the B and C corner where the surface fire ignited glass-fiber wall panels.

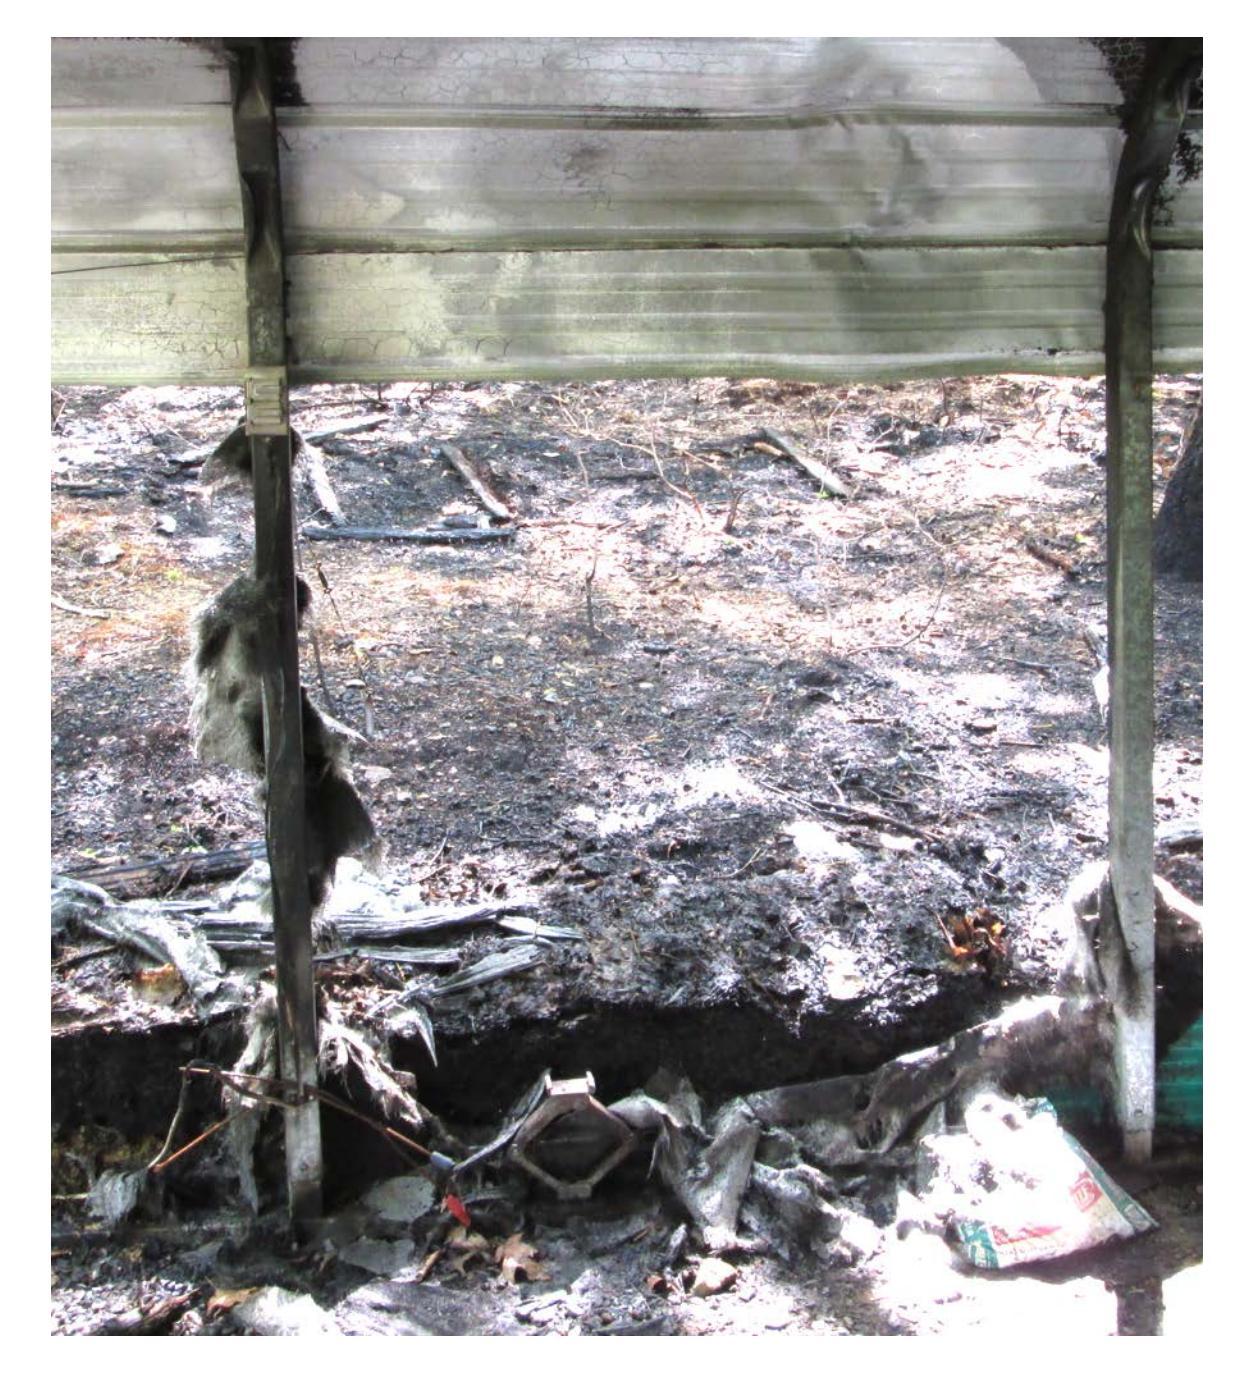
Fig. S12-4. Photo shows a close-up view of burned leaves next to wall on side B, as viewed from the interior of the carport.

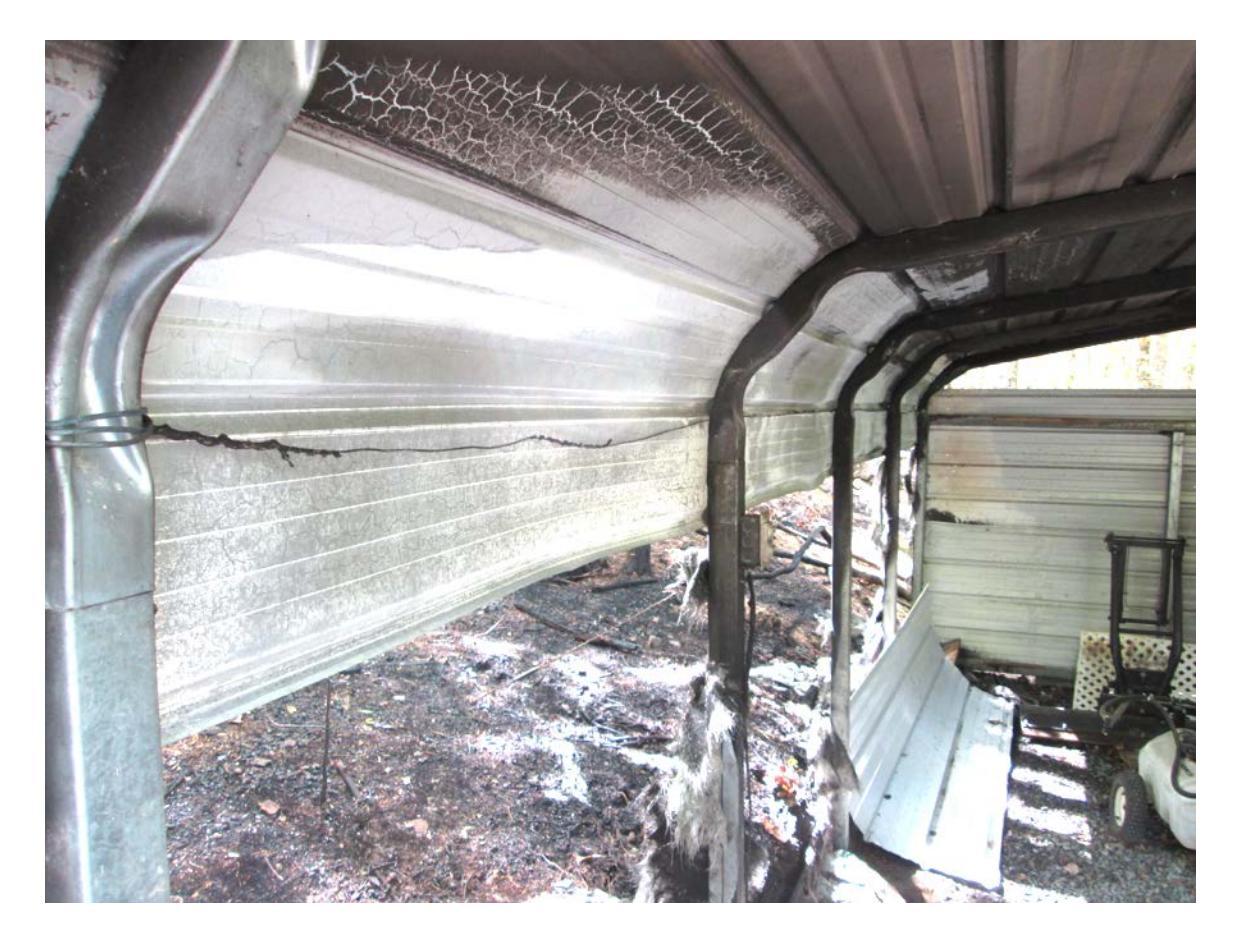
Fig. S12-5. Photo showing the interior fire damage to the carport caused by the burning glass fiber wall panels. The Incident Commander thought the electrical outlet box and wiring seen on wall support column (center of photo) was a suspect cause of the fire.

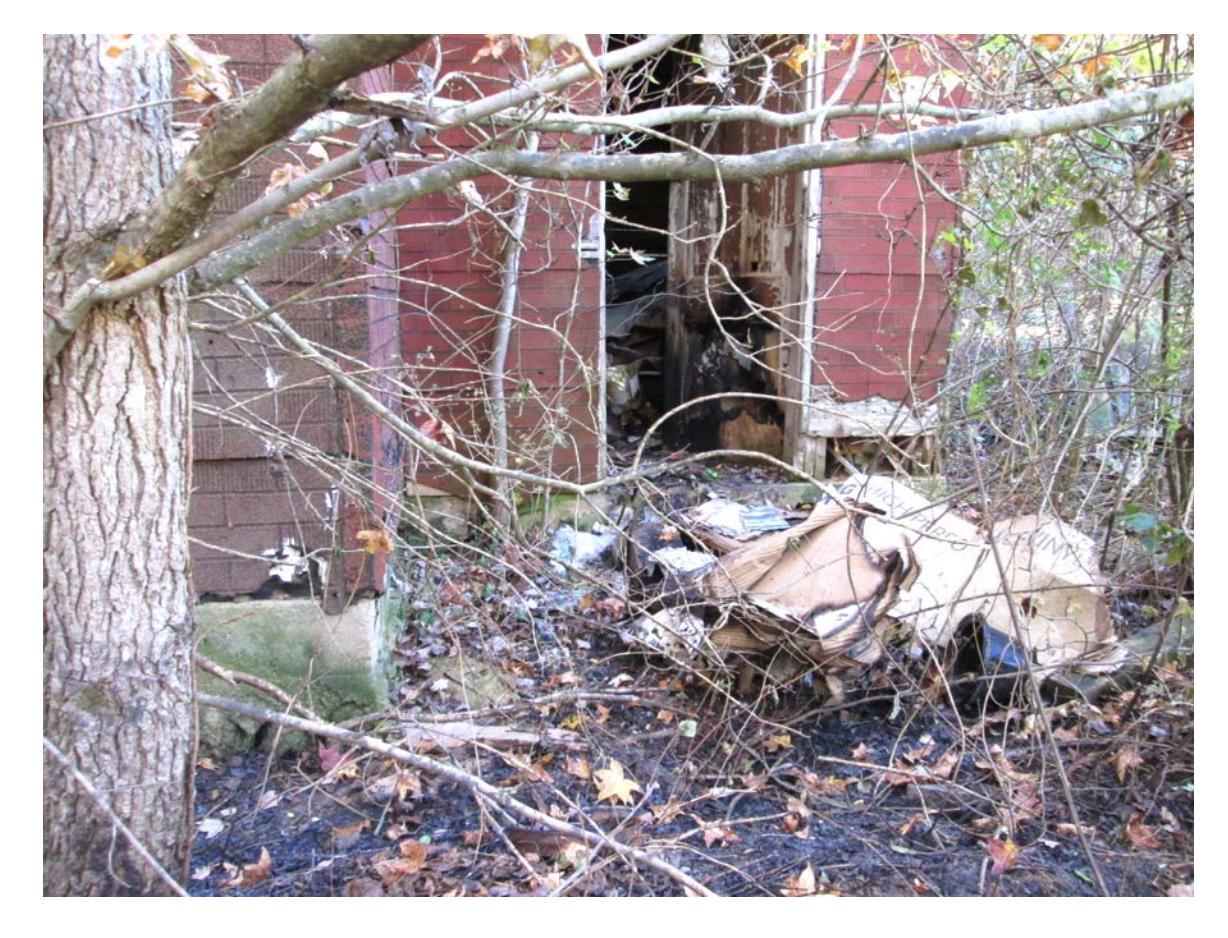
Fig. S13-2. Photo shows fire-damaged door on side B and combustible materials pulled from the interior by firefighters during overhaul operations.

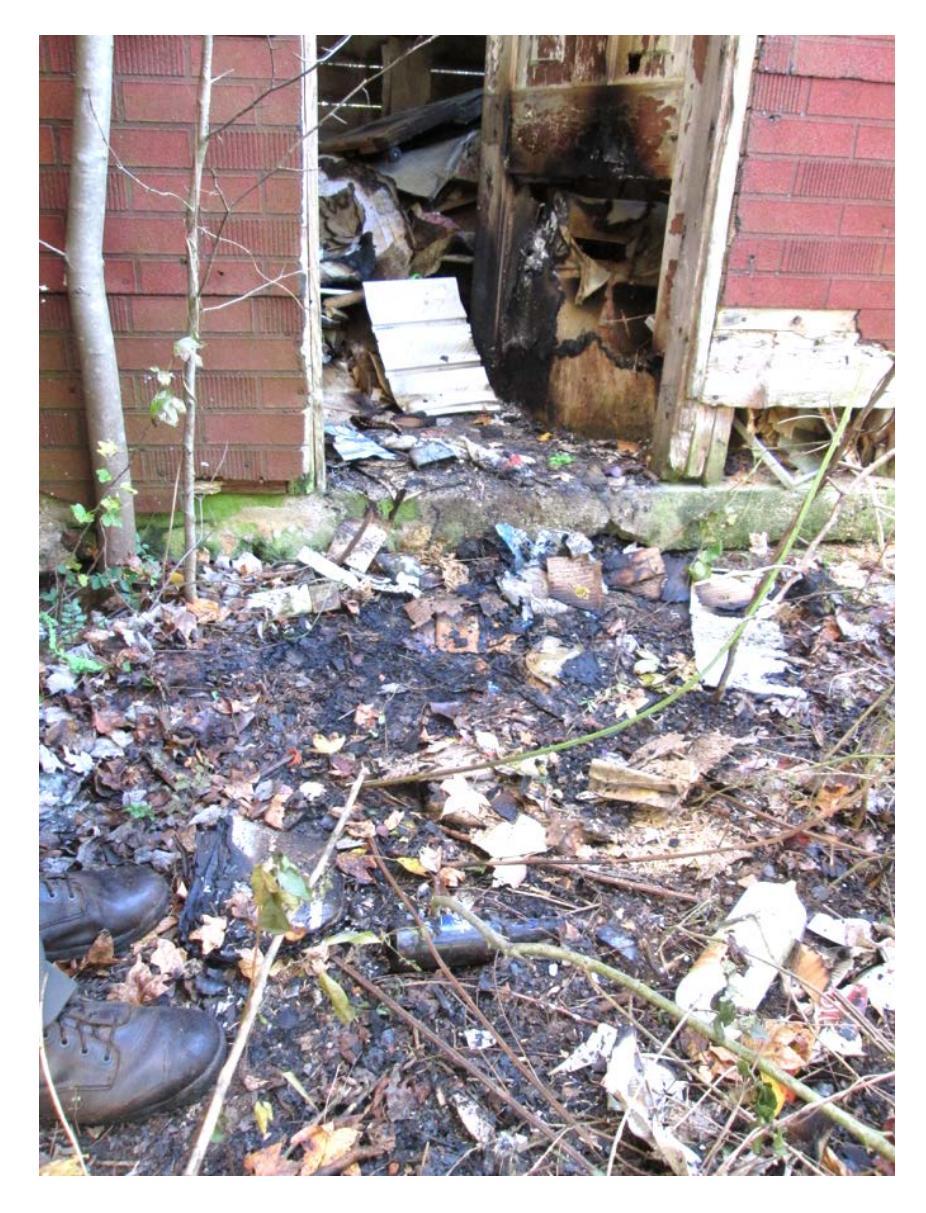
Fig. S13-3. Photo shows a close-up view of the burn pattern in the leaves leading to the front doorstep on side B. The debris placed in front of the door by firefighters during overhaul seen in Figure S13-2 were removed for this photo.

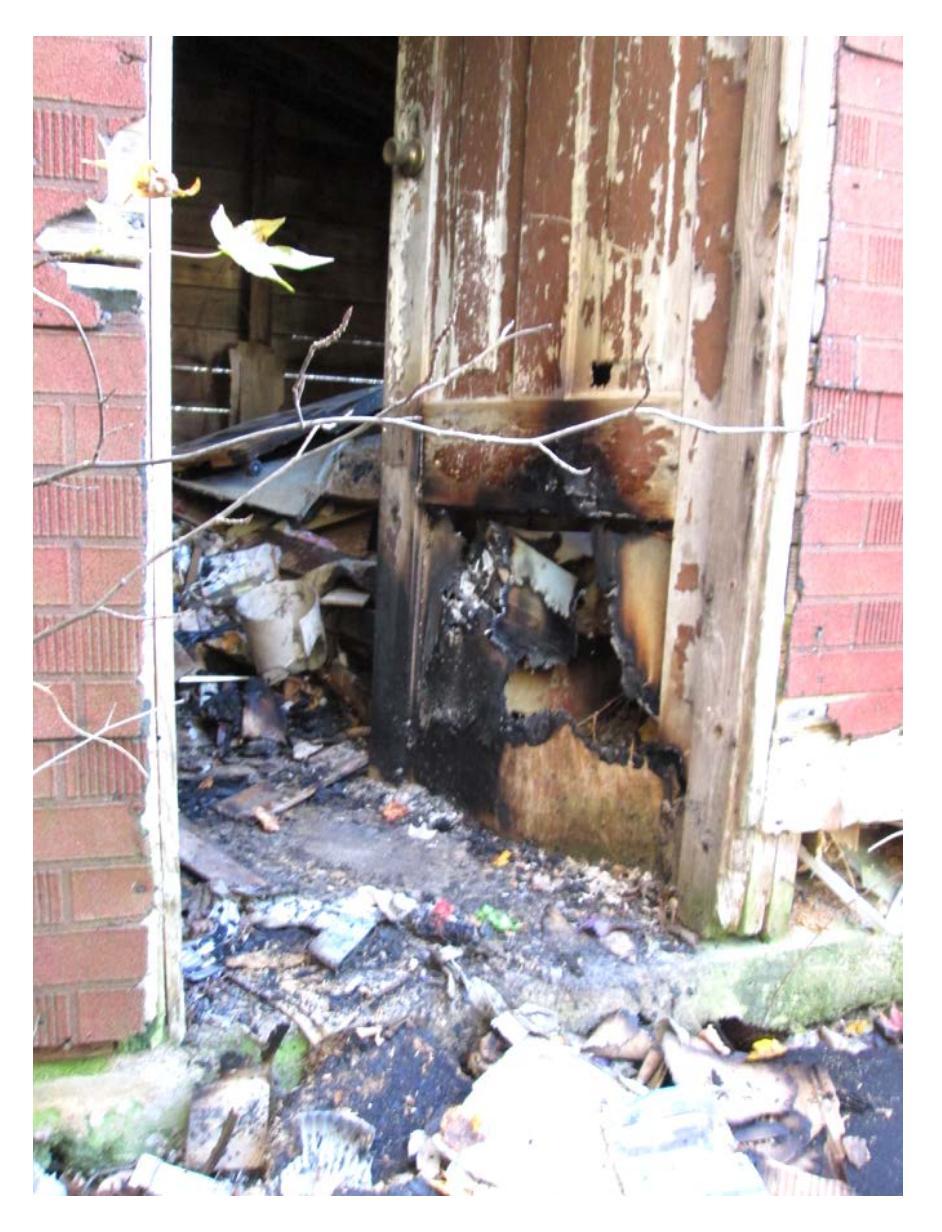
Fig. S13-4. Photo shows an overview of the damaged door on side B. The Incident Commander reported that the surface fire ignited combustibles lying in the open doorway. The burning combustibles in the doorway combined with leaves ignited the wood door's lower frame and panel.

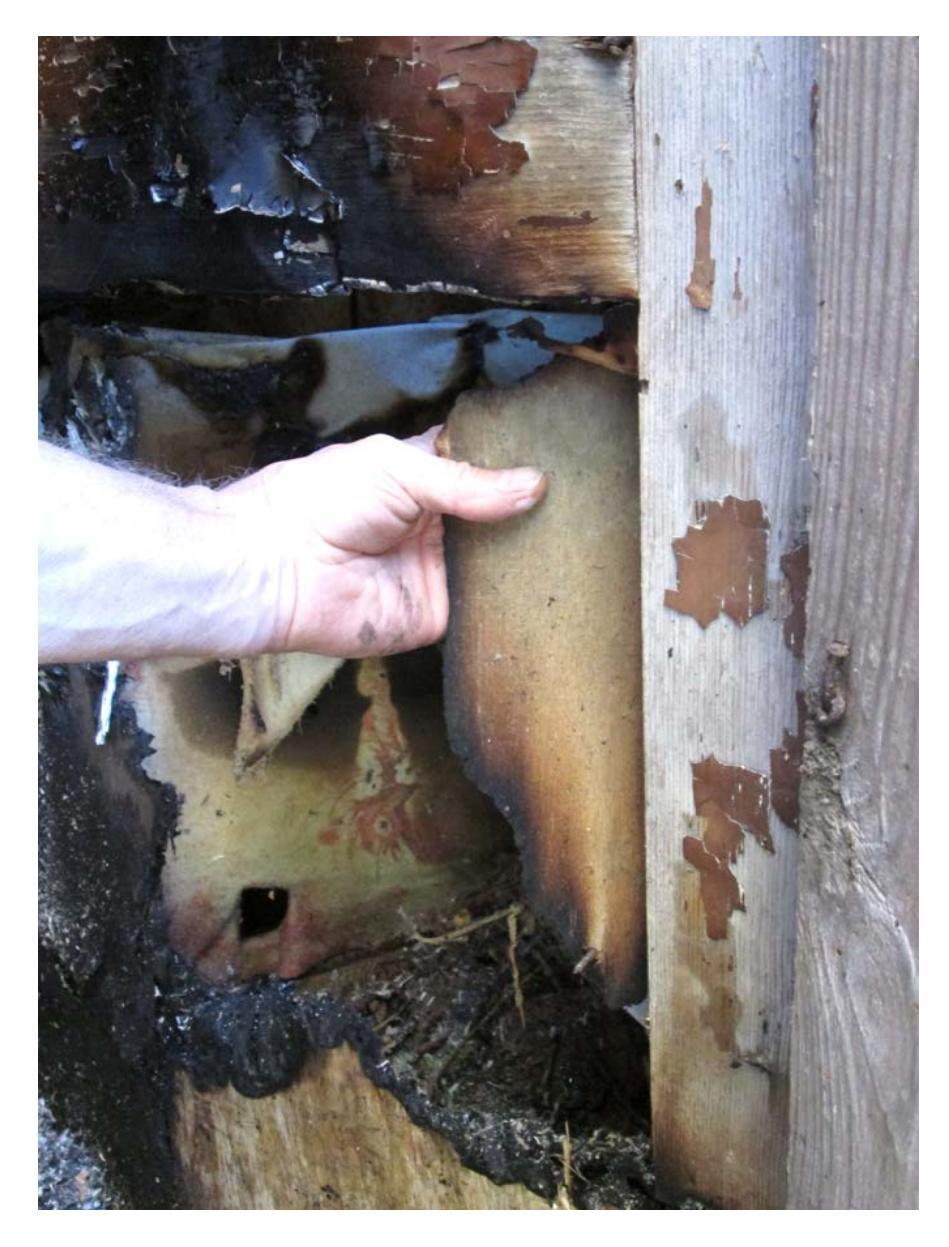
Fig. S13-5. Photo shows a close-up view of lower door panel damage and sample of panel being collected.

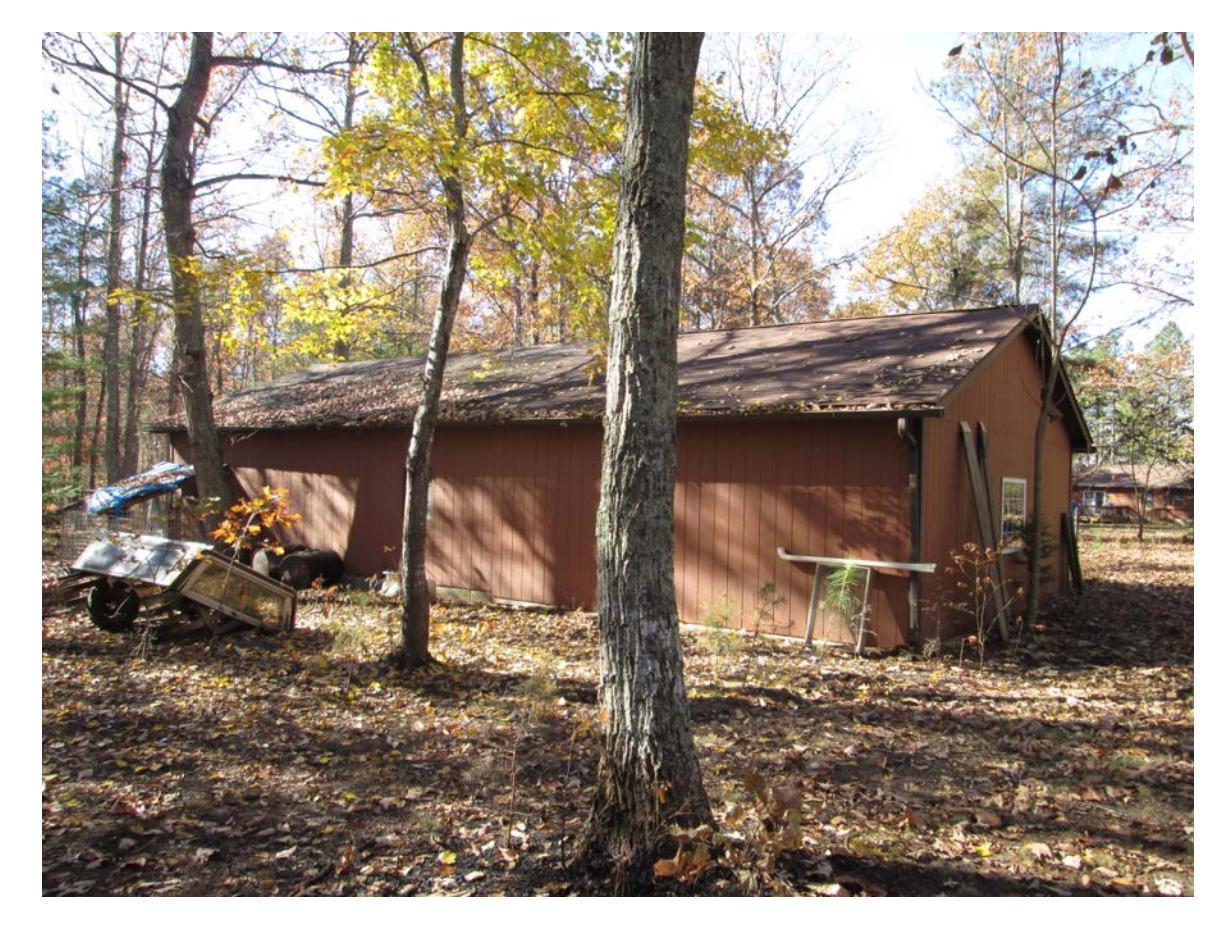
Fig. S14-1. Photo shows sides B and C of the building (fire damage located along the foundation wall on each side).

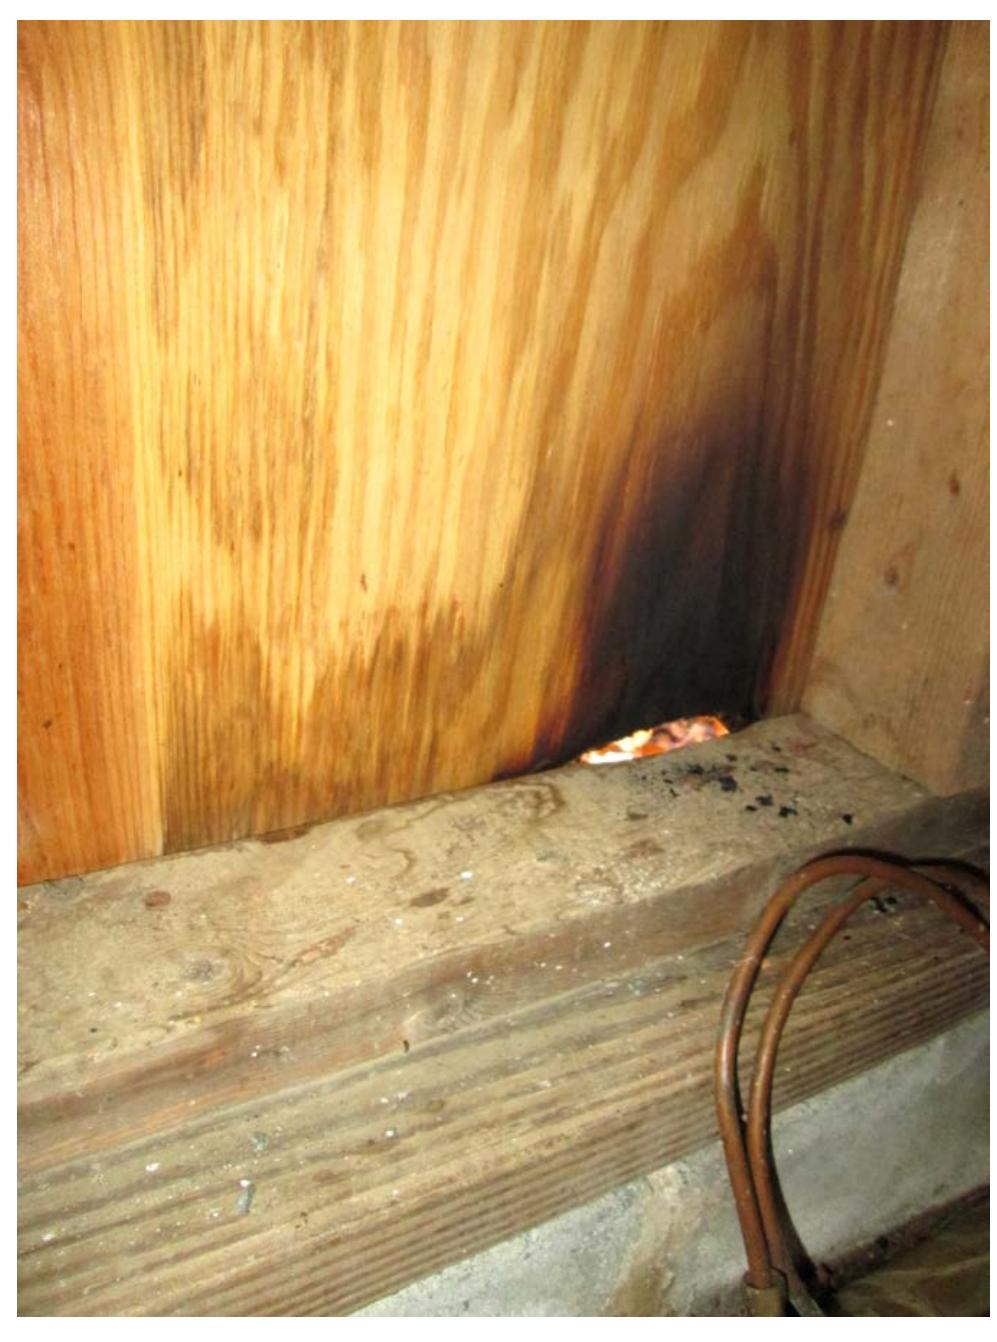
Fig. S14-3. Photo shows damage to interior wall cavity in area where fire penetrated to the interior of the building.
