NIST GCR 18-018

Structures Ignited by Virginia WUI Fires 2/2015 – 2/2017

David D. Evans Lavern R. Scott William D. Walton Home Safety Foundation Chevy Chase, Maryland 20815-4206

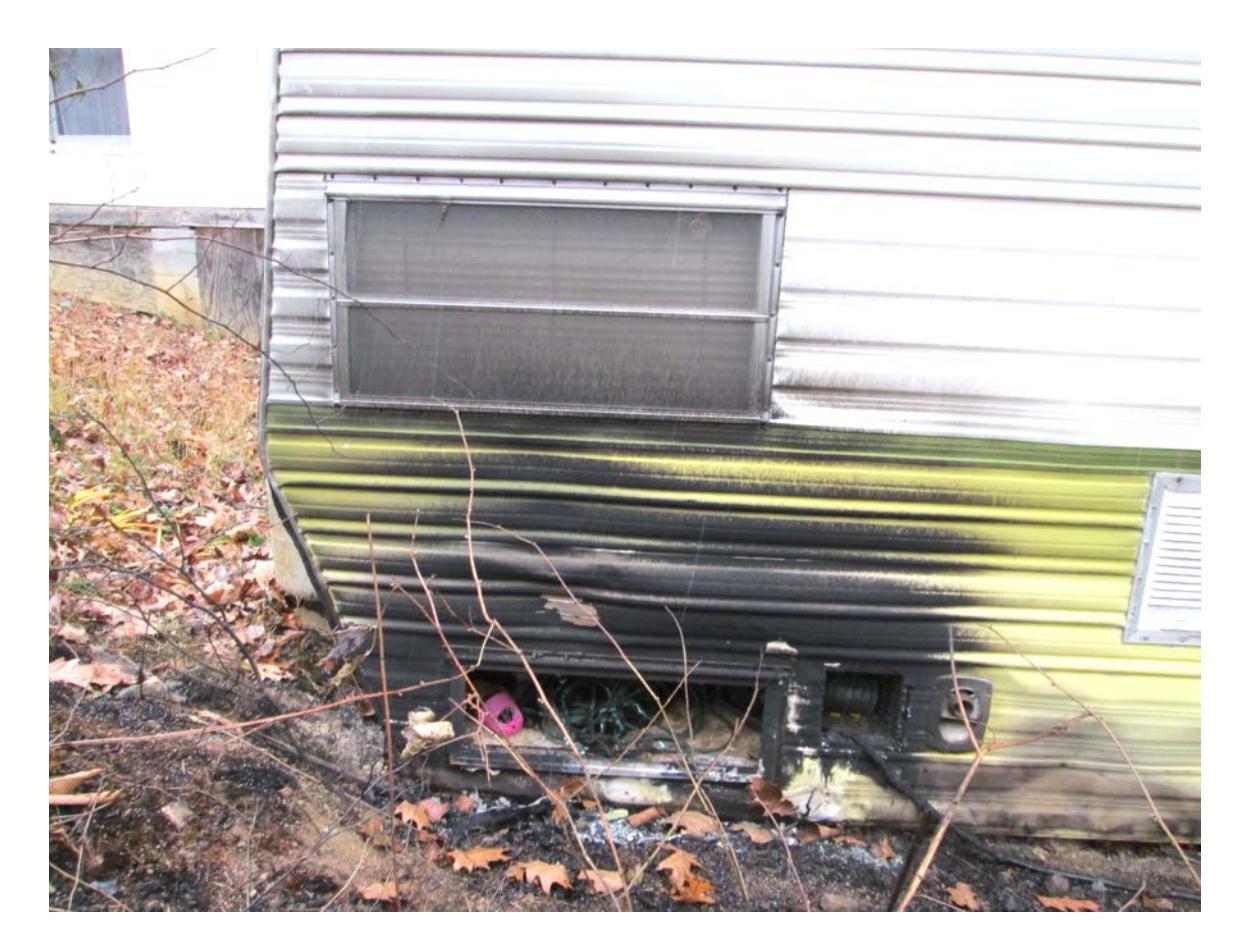
Fig. S15-2. Photo shows the damage to side C of the fixed mobile structure and to the storage compartment contents at the corner with side D.

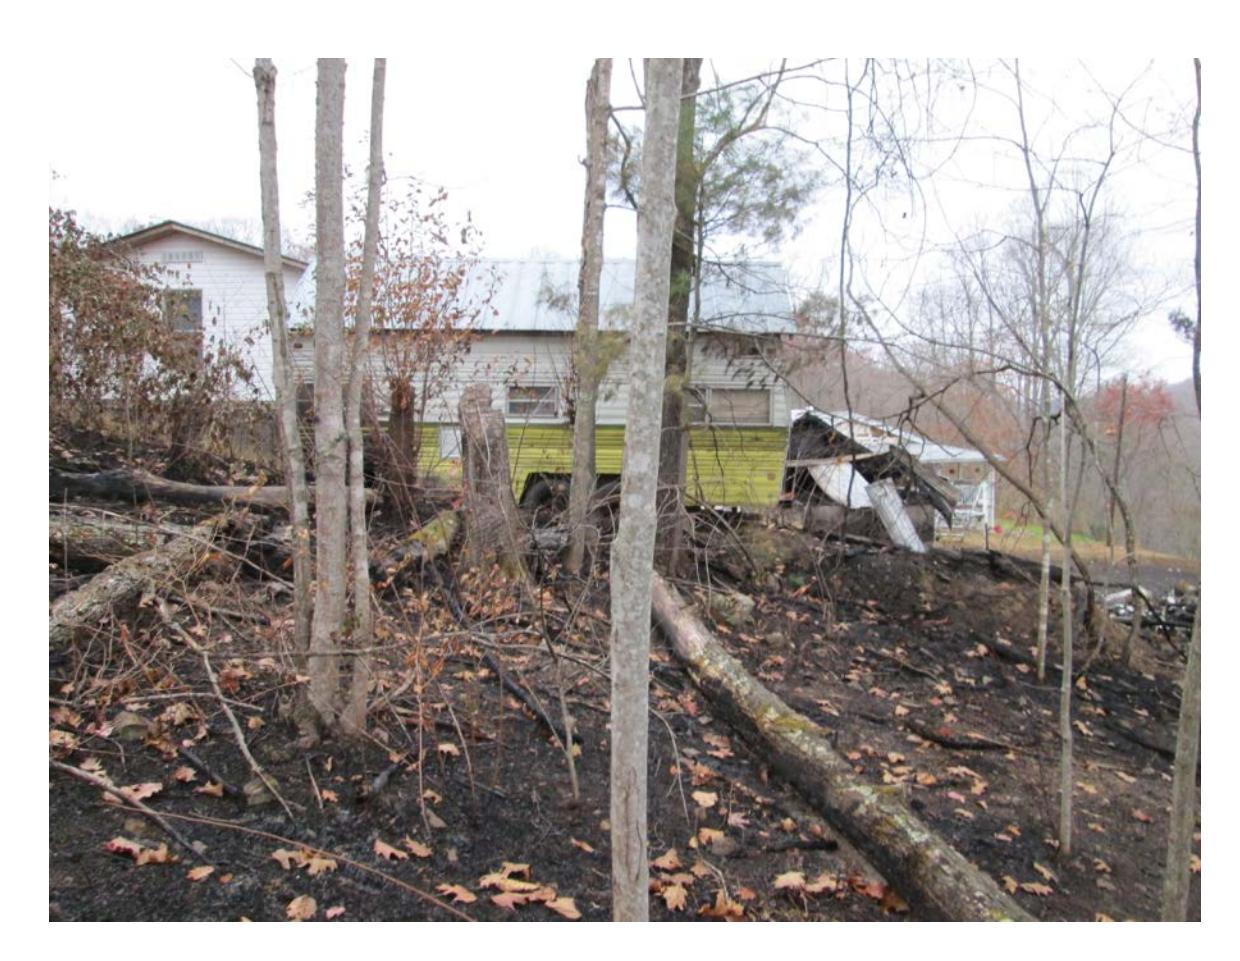
Fig. S15-3. Photo shows surface fire burn pattern leading to the fixed mobile structure's side C damage.

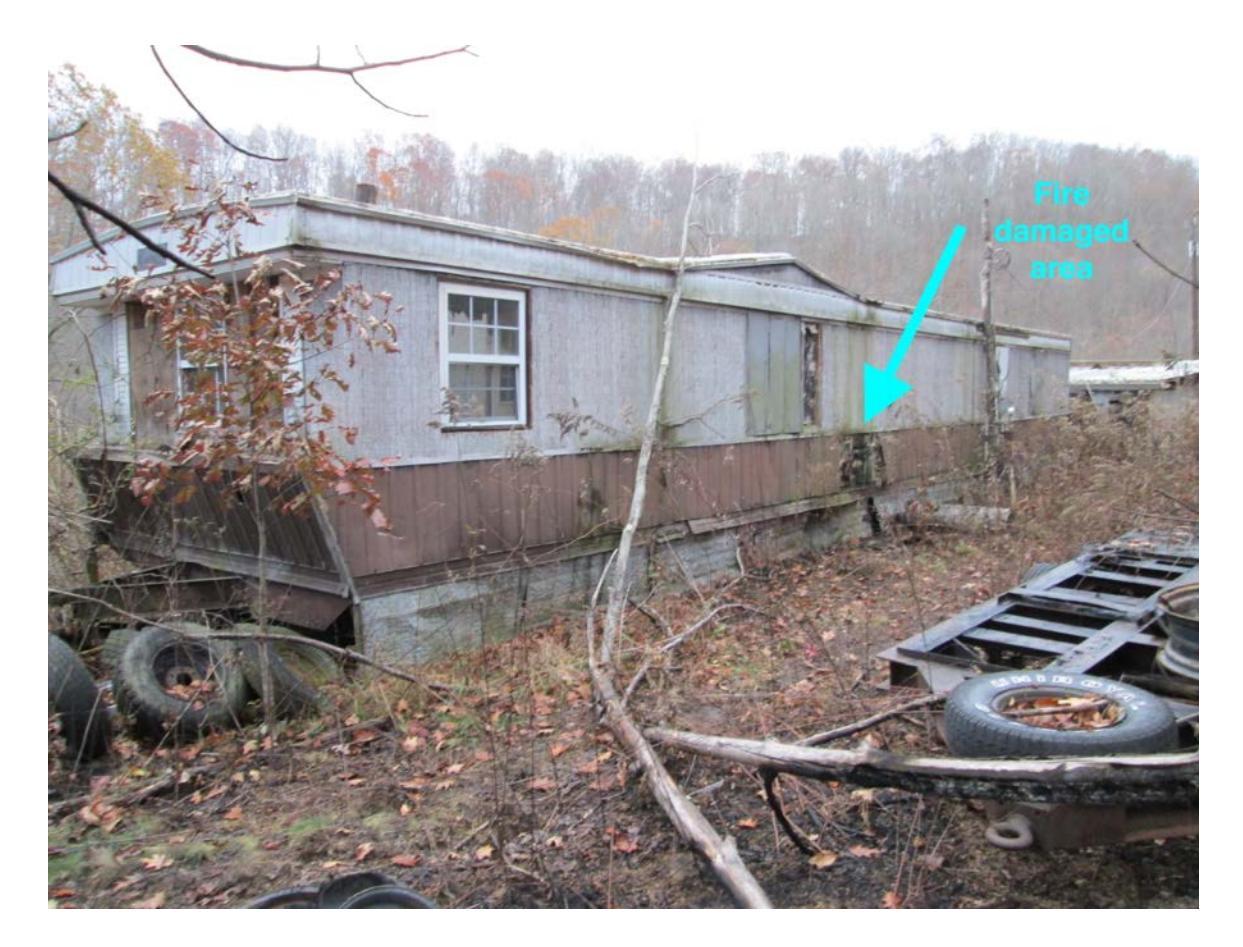
Fig. S16-1. Photo shows the damaged side C of the mobile home.

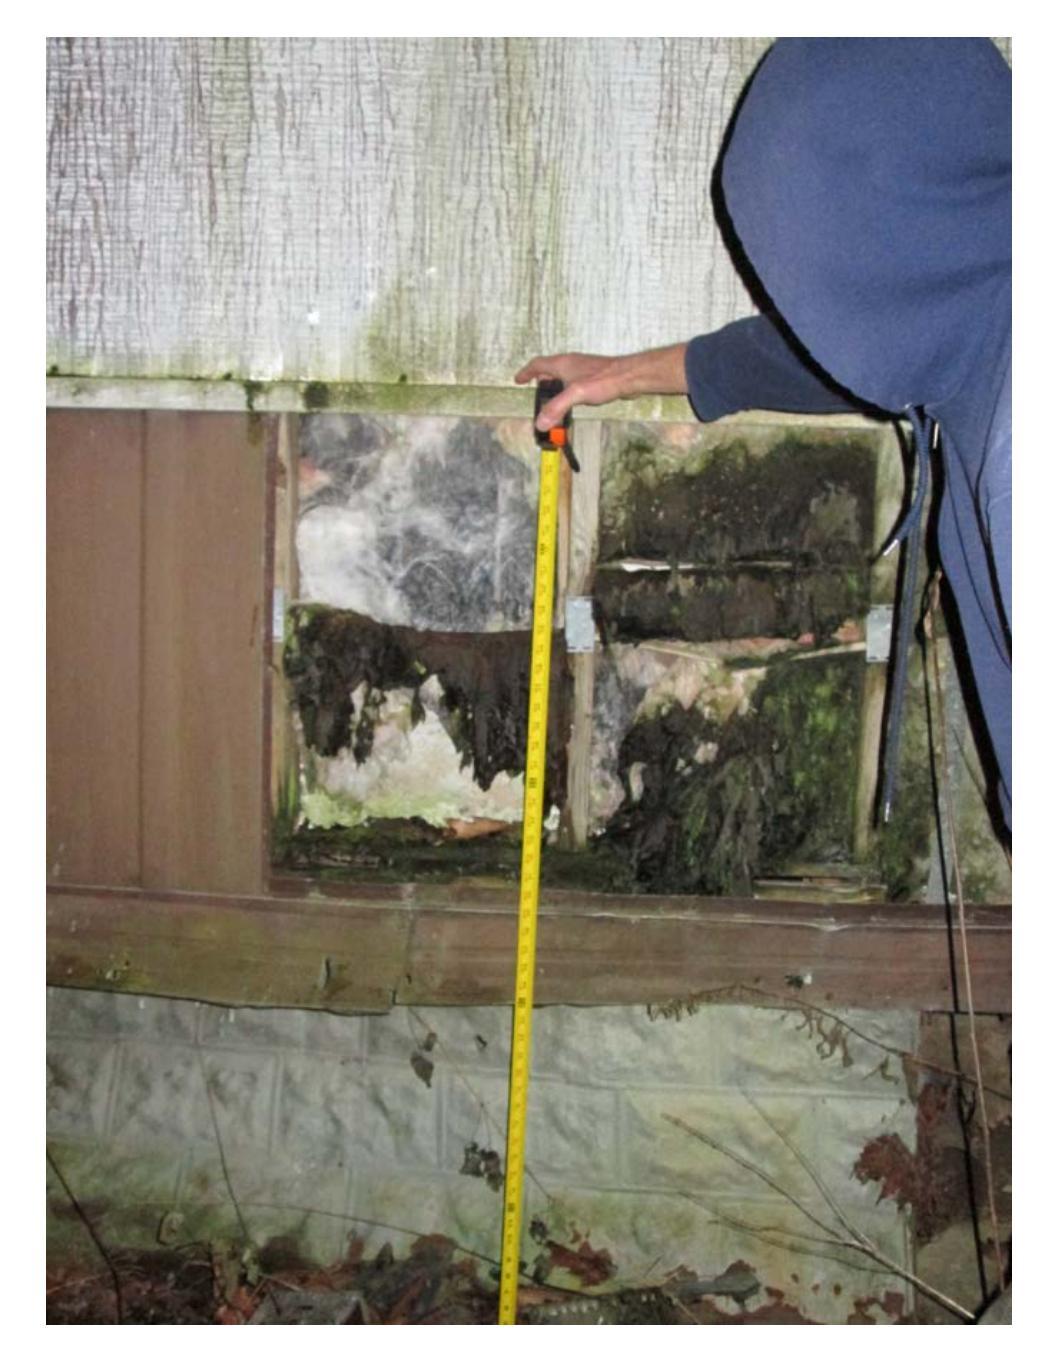
Fig. S16-3. Photo shows fire damage close-up with a ruler showing height of damaged area starting 76.2 cm (30 in) above the ground.

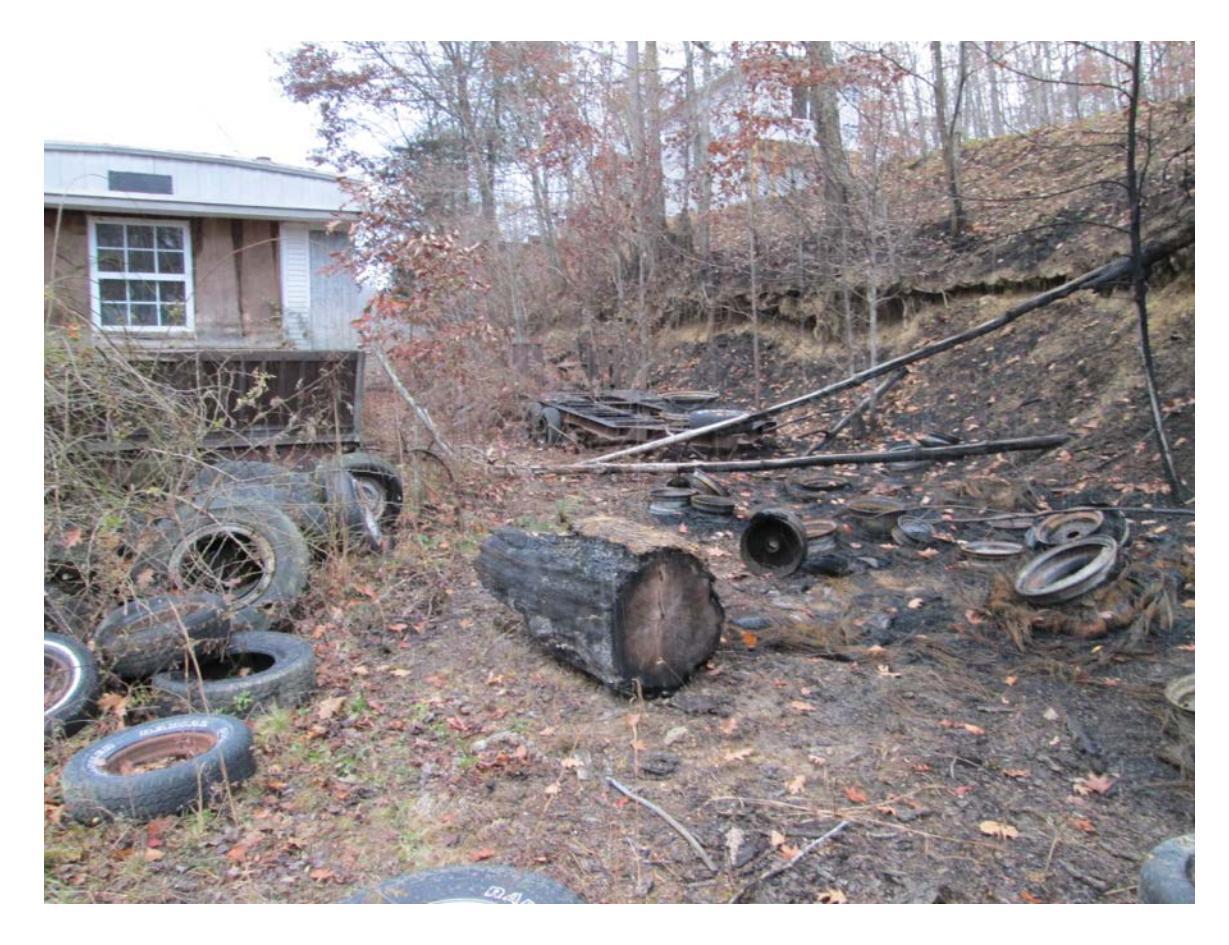
Fig. S16-4. Photo shows surface fire burn pattern from the tire pile (steel wheel rims center right) leading towards the point of damage on the mobile home side C.

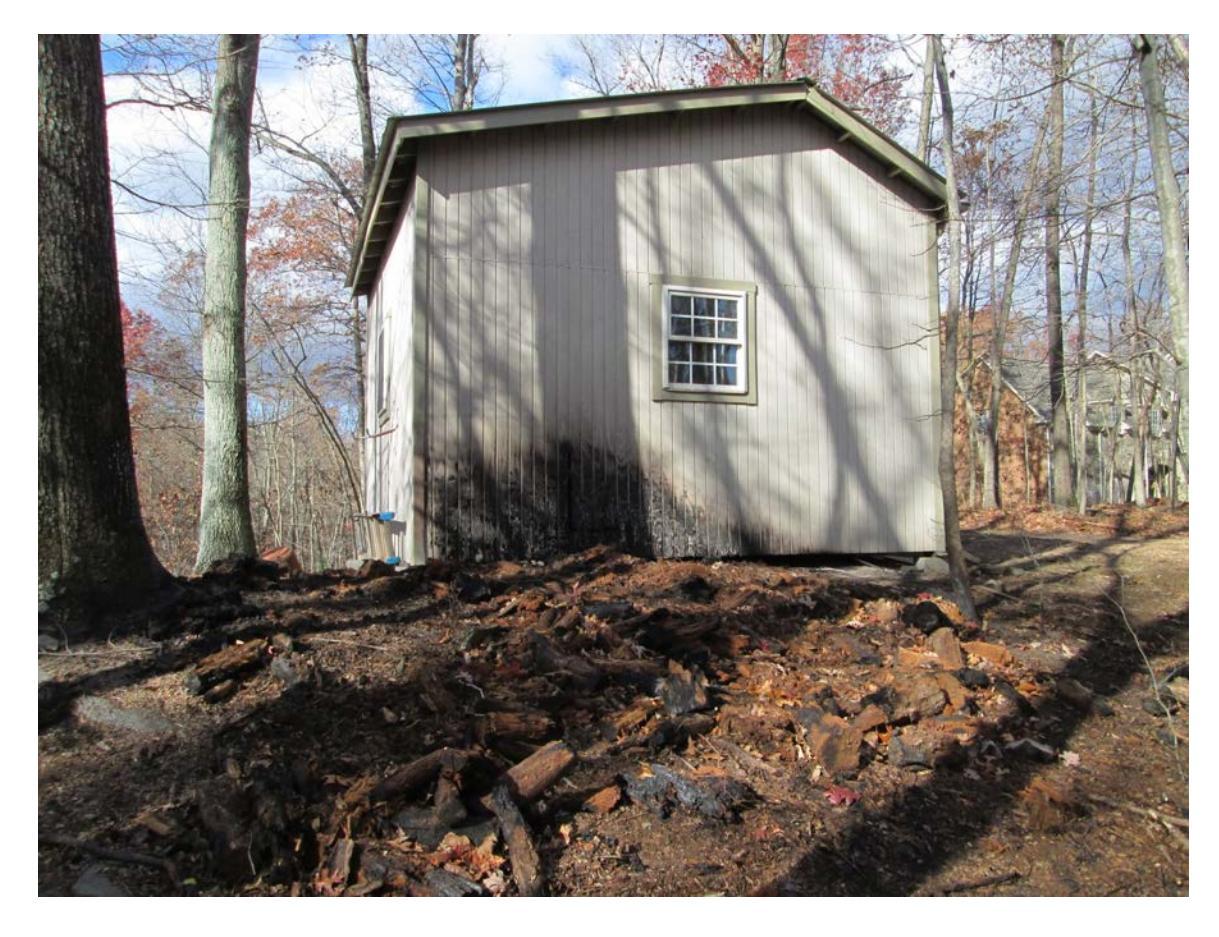
Fig. S17-2. Photo of the utility building on side B where the surface fire ignited the T1-11 siding, damaging the building. Sections of decayed but burned firewood can be seen scattered downhill in this picture. The decayed remains of a wood pile were about 1.8 m (6 ft) away from the side B wall.

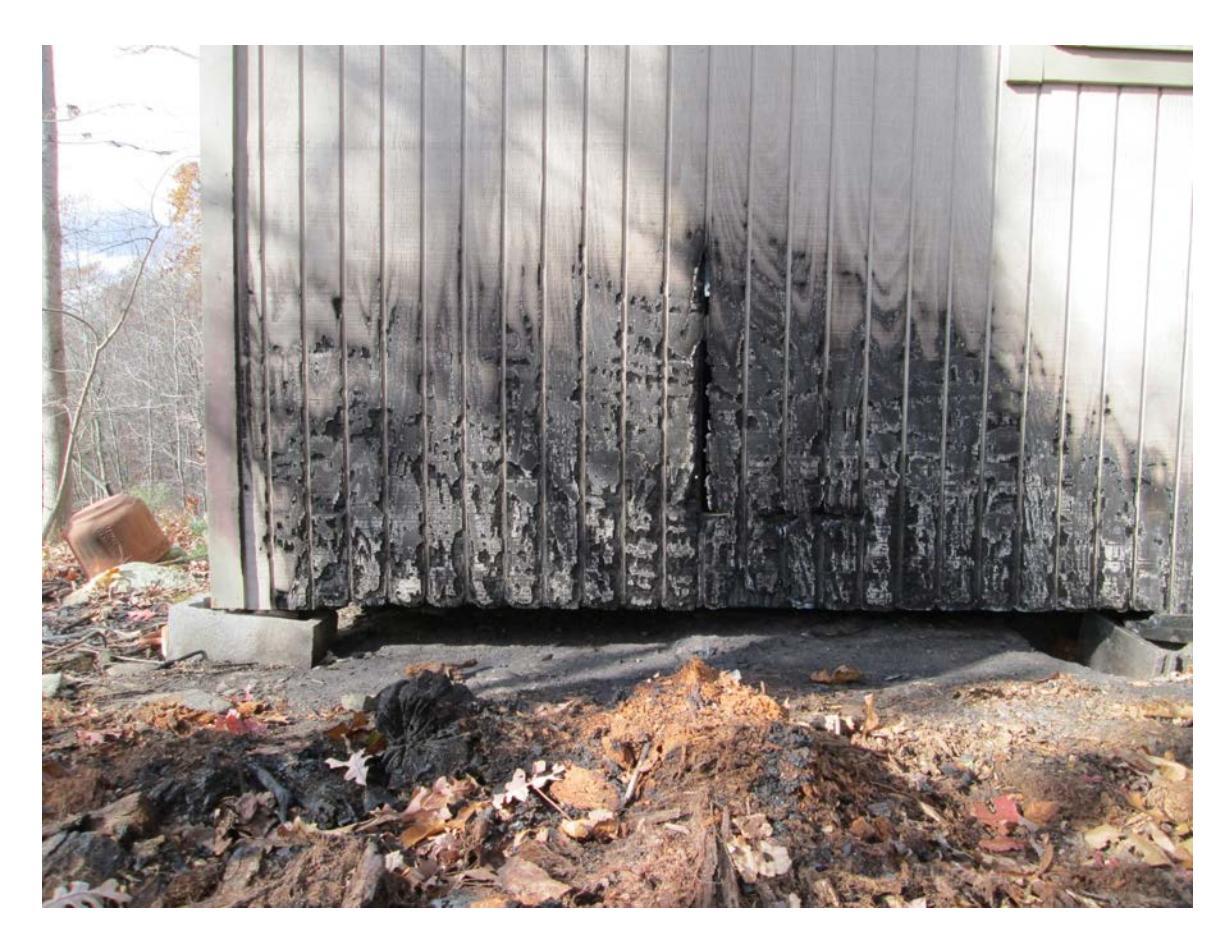
Fig. S17-3. Photo shows the damaged exterior on side B.

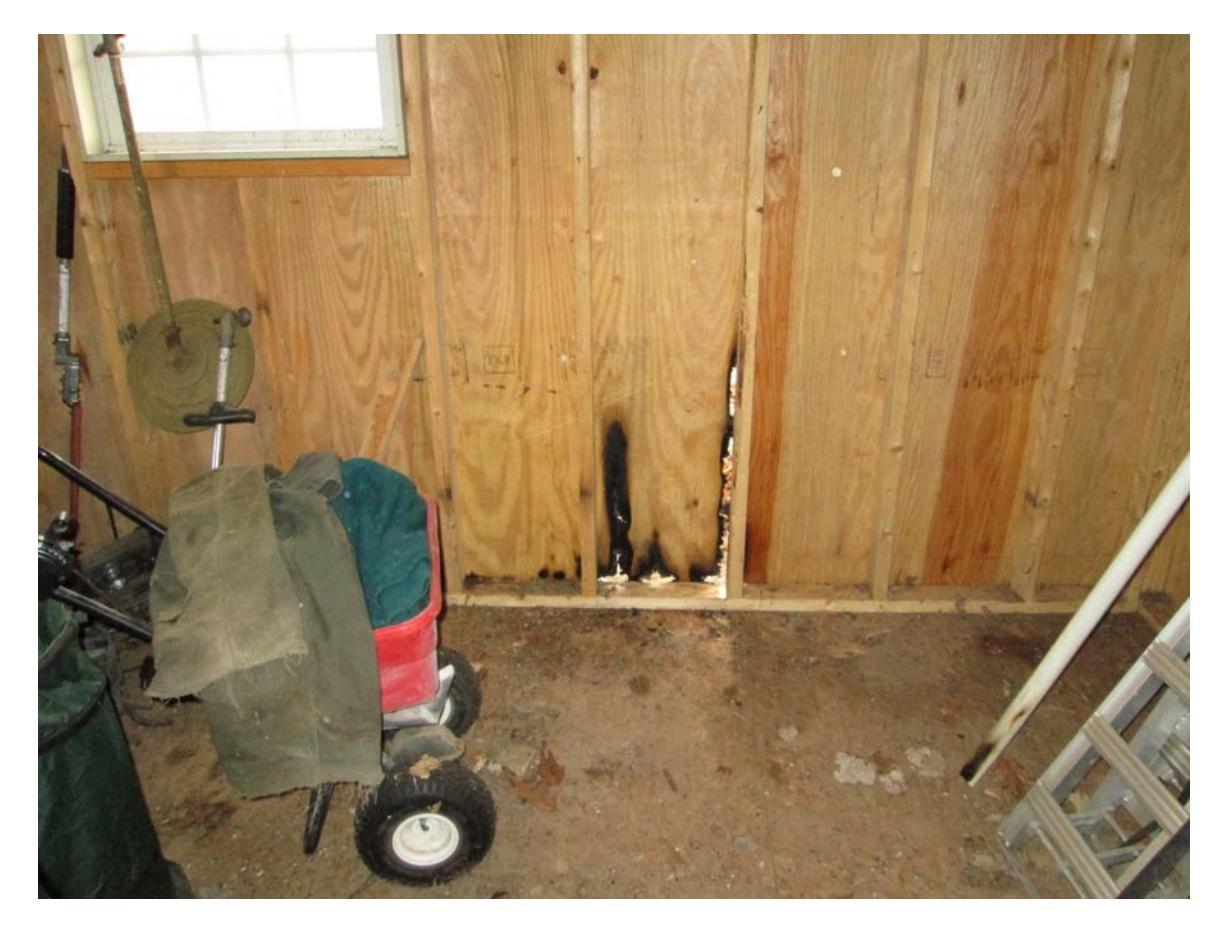
Fig. S17-4. Photo of the interior of side B wall opposite figure 17-3 shows the fire damage to the interior of the building. This was the area of fire entry.

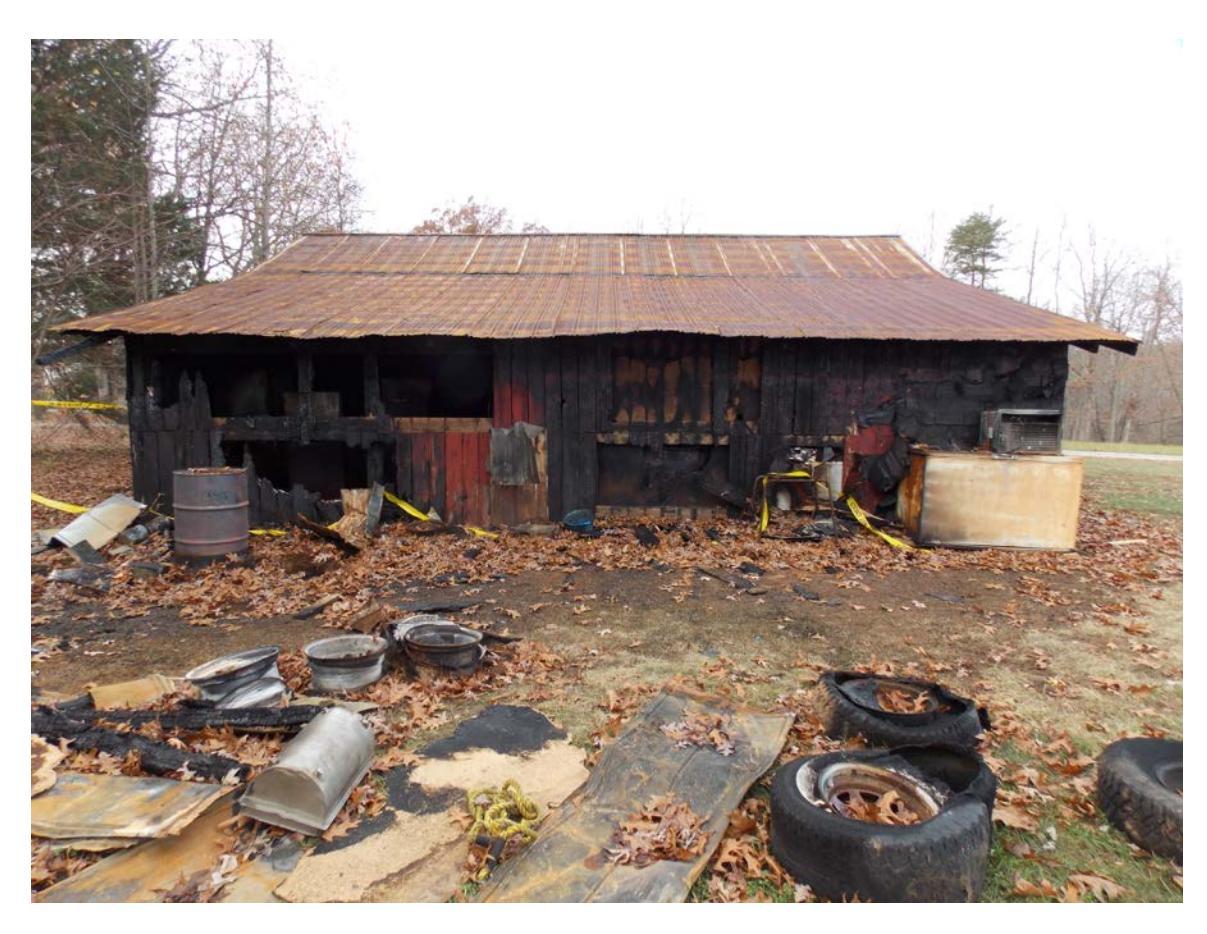
Fig. S18-2. Photo shows the damage to building side B caused by the surface fire.

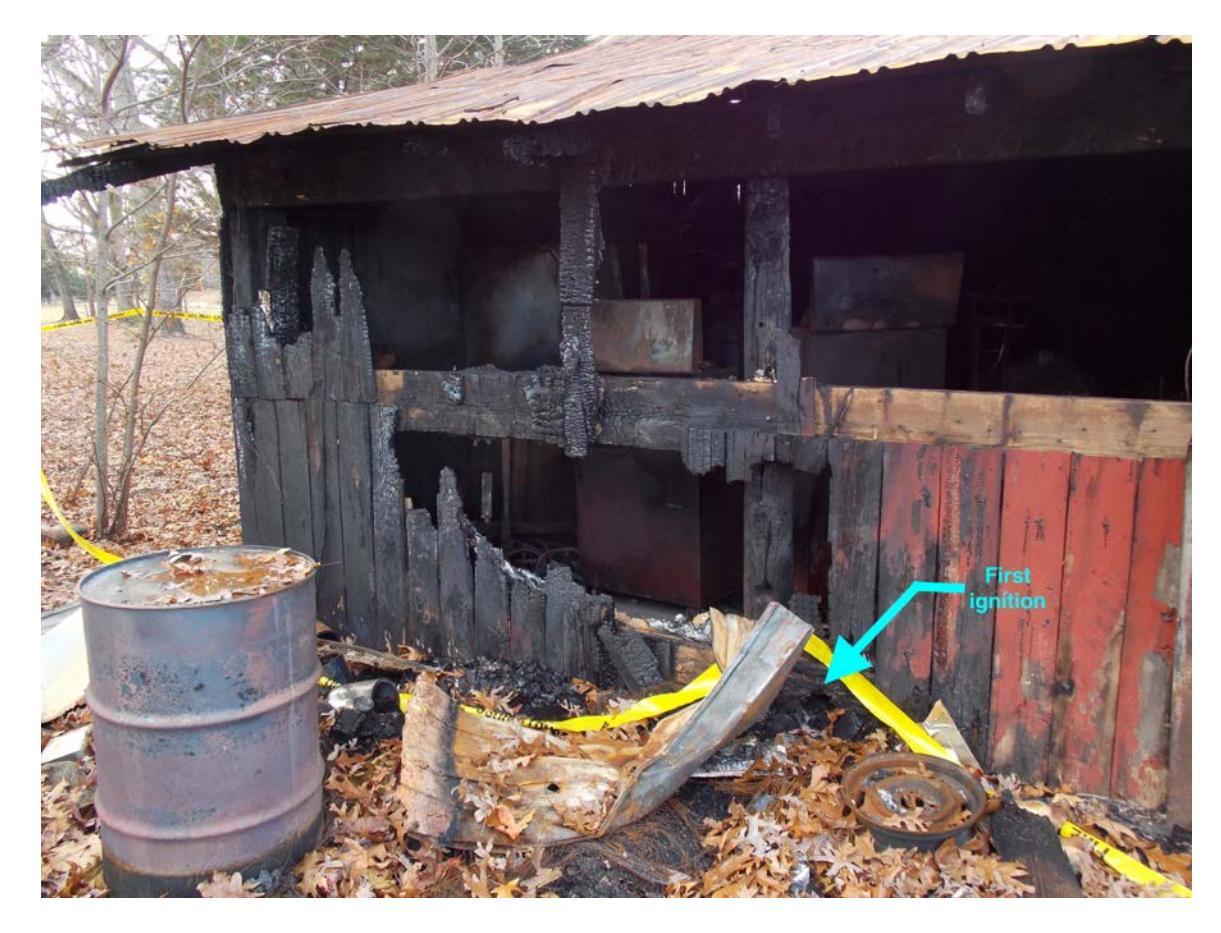
Fig. S18-3. Photo of the exterior of side B in the area where the tenant said the fire had reached and ignited the building. The lowest burn is at the first ignition point shown. This was also the inside corner where the bump out storage room connected to the side B wall. The storage room contained volatile combustibles including paints, thinners, glues and oils. Tires were also stored near the inside corner. A heat damaged steel wheel can be seen next to the first ignition arrow.

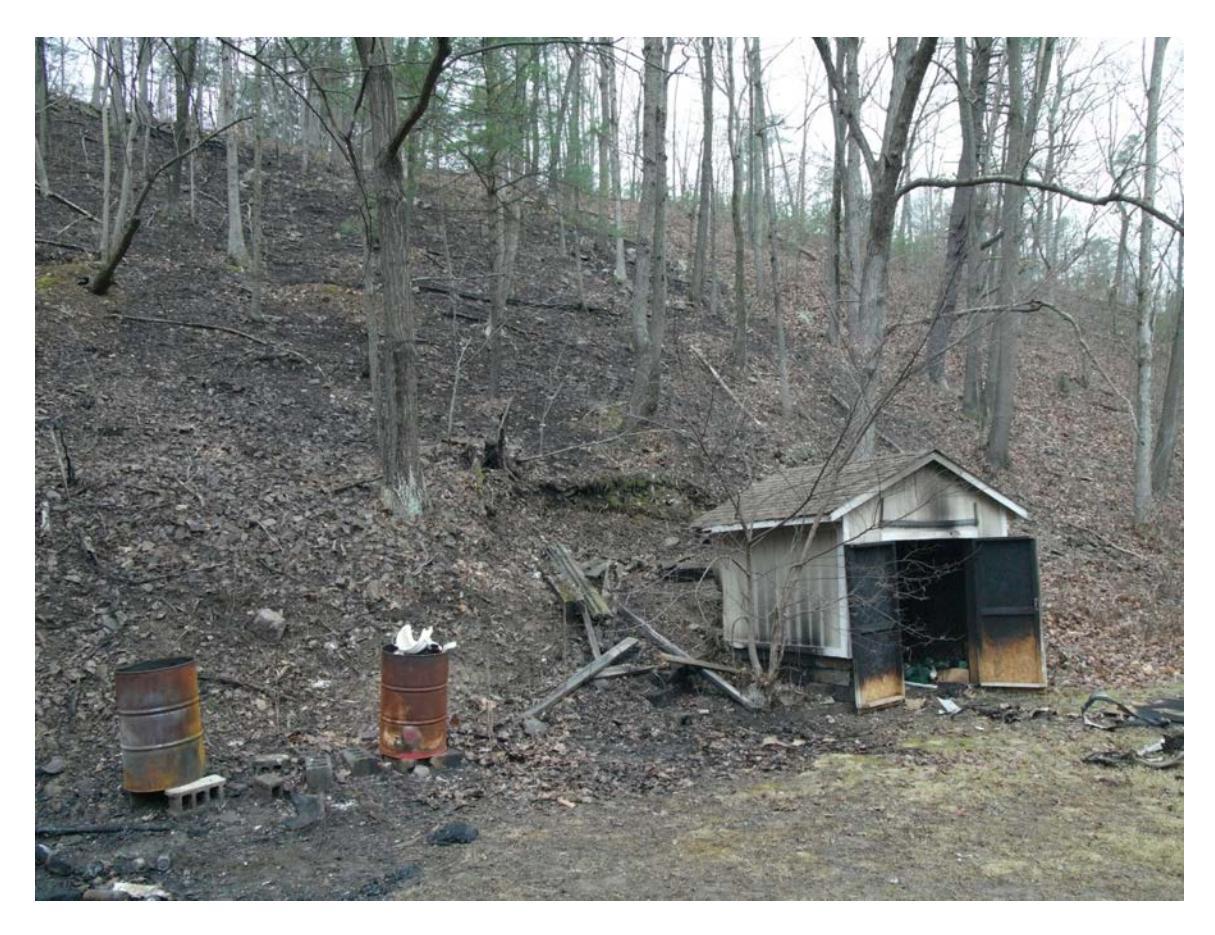
Fig. S19-1. Photo looking north showing burn barrels (the barrel on left was the point of origin) and the surface fire burn pattern leading to the damaged small shed.

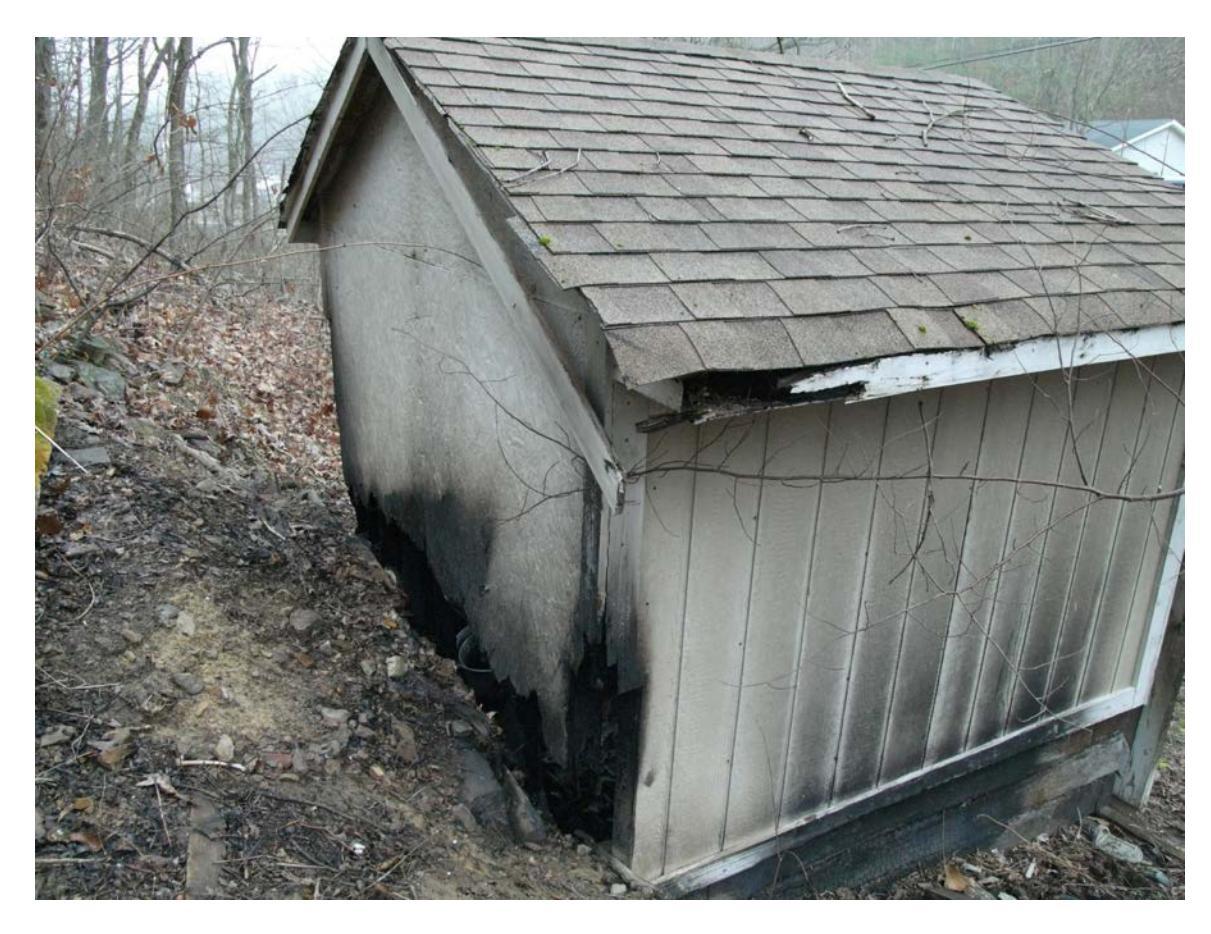
Fig. S19-2. Photo shows the fire damaged to the small shed at the side B, C corner. The OSB on side C was the first material ignited by a surface fire burning in leaves reaching the base of the side C wall. A second ignition by burning leaves occurred to the railroad tie foundation on side B.

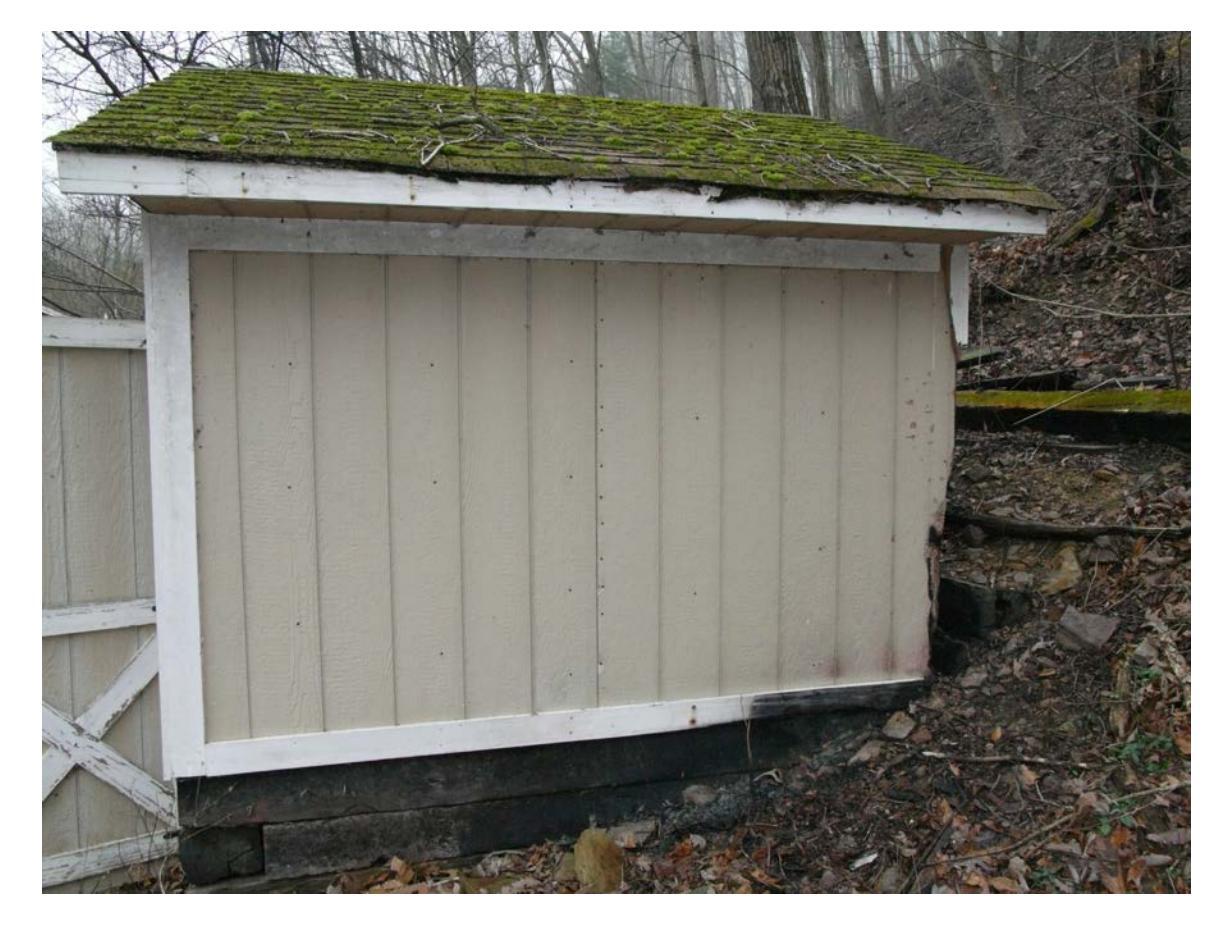
Fig. S19-3. Photo shows the third site of damage to siding and railroad tie foundation near the side D, C corner.

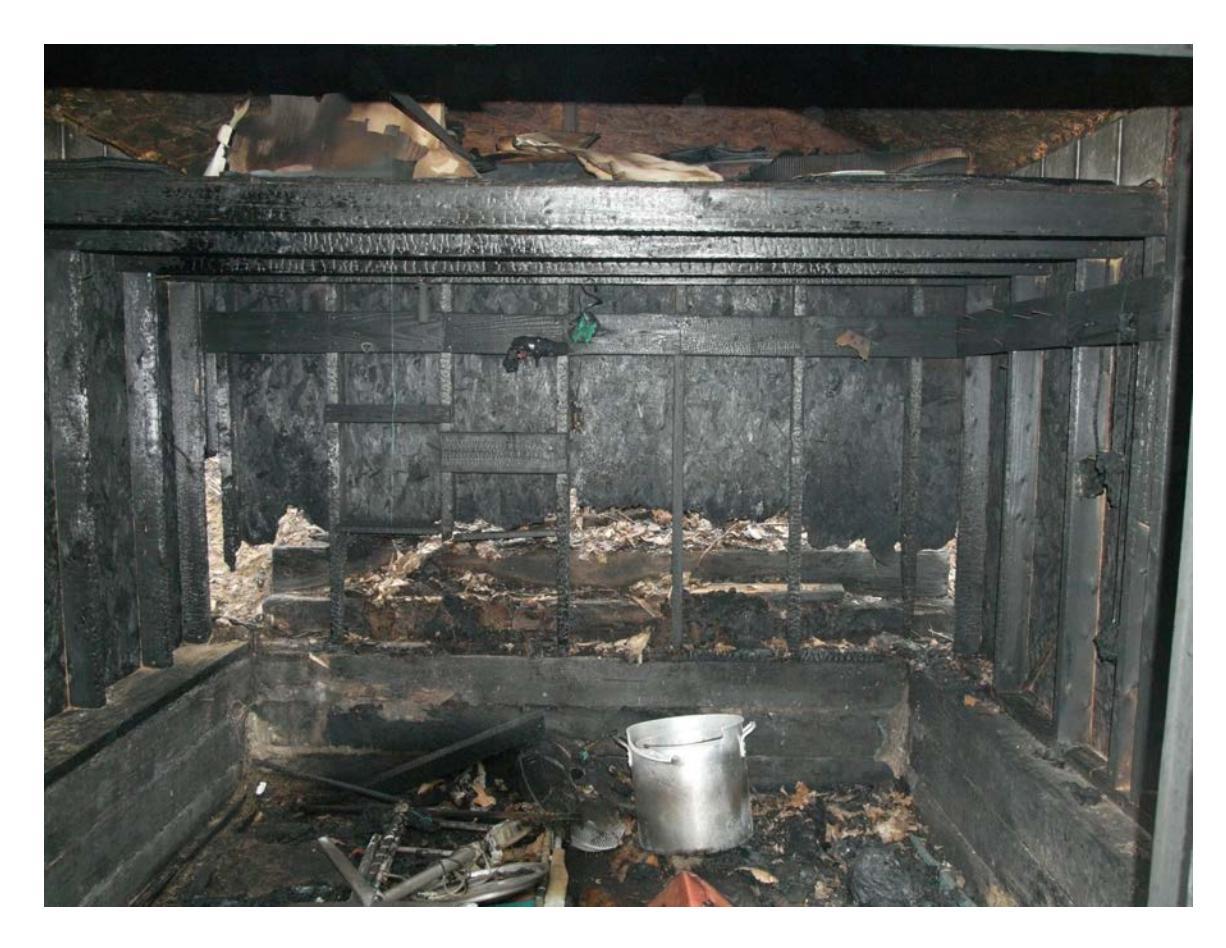
Fig. S19-4. Photo shows an interior view of the damage to the side C wall. The OSB sheeting is burned through along the base of side C. Railroad ties used for landscape retention can be seen through the burned out OSB.

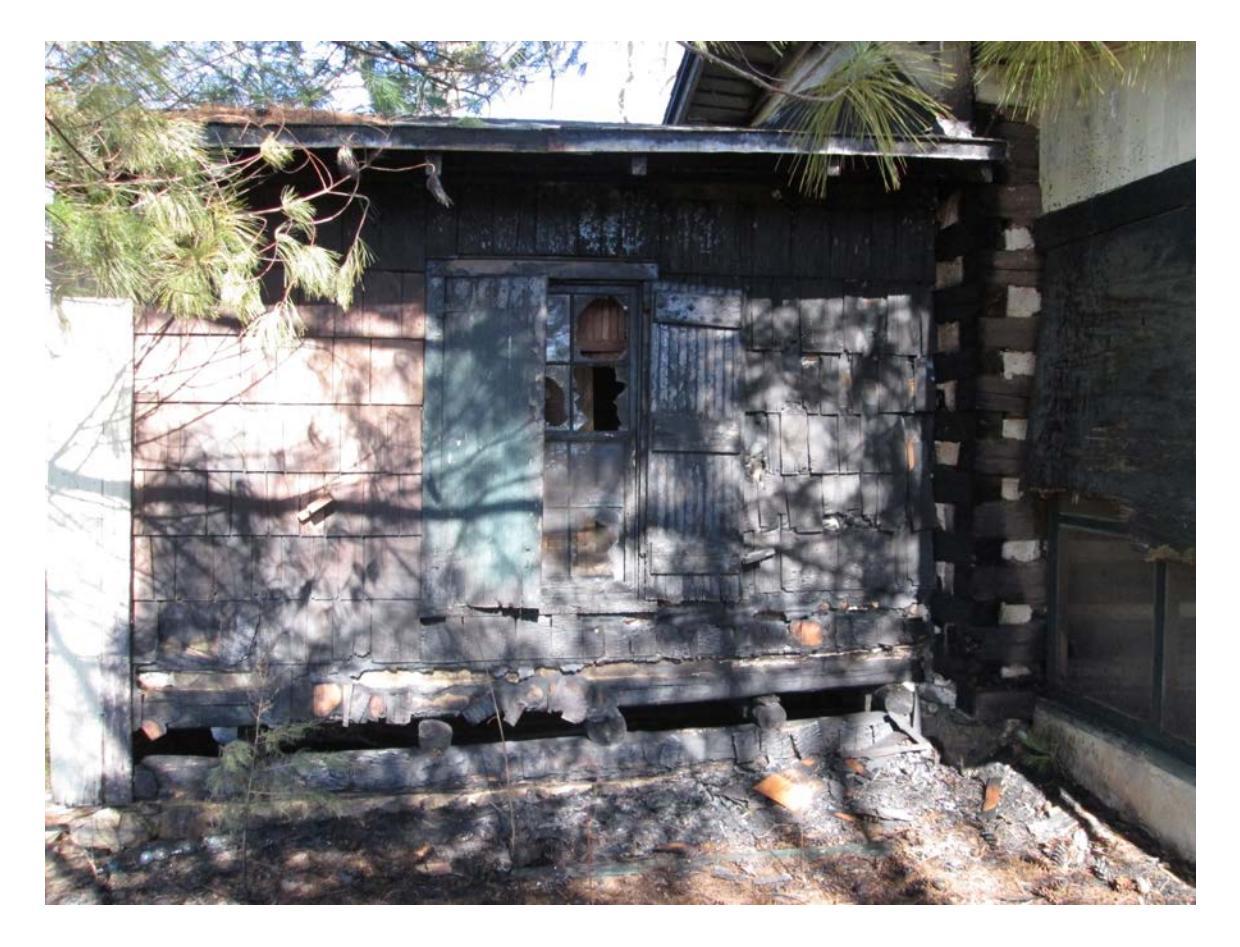
Fig. S20-1. Photo shows side A fire damage. The cedar shake siding was ignited by direct flame contact from a surface fire burning to the base of the wall in leaves, pine needles and grass.

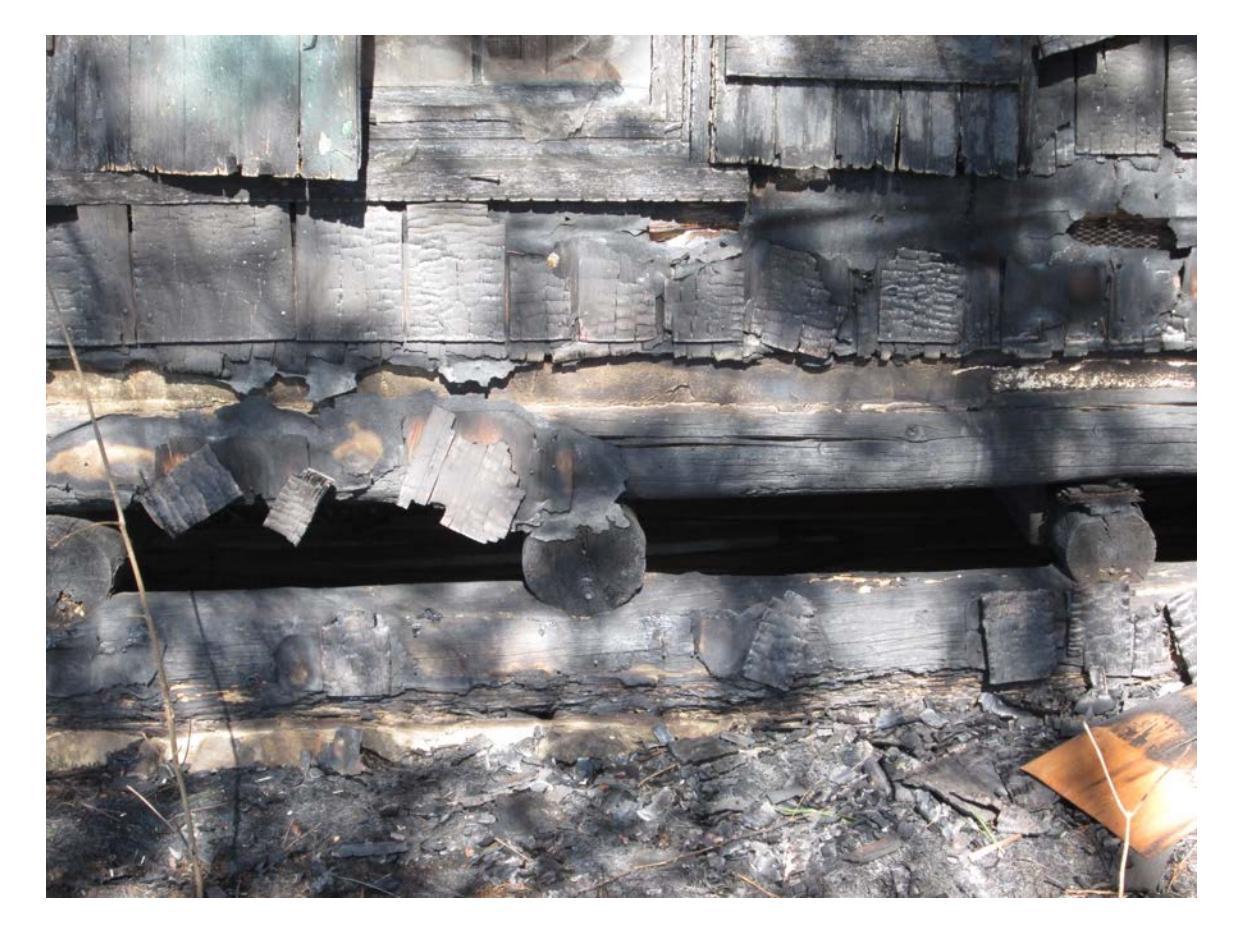
Fig. S20-2. Photo shows a close-up view of damage to the side A wall at its base. Cedar shake siding covered the exterior of the log wall.

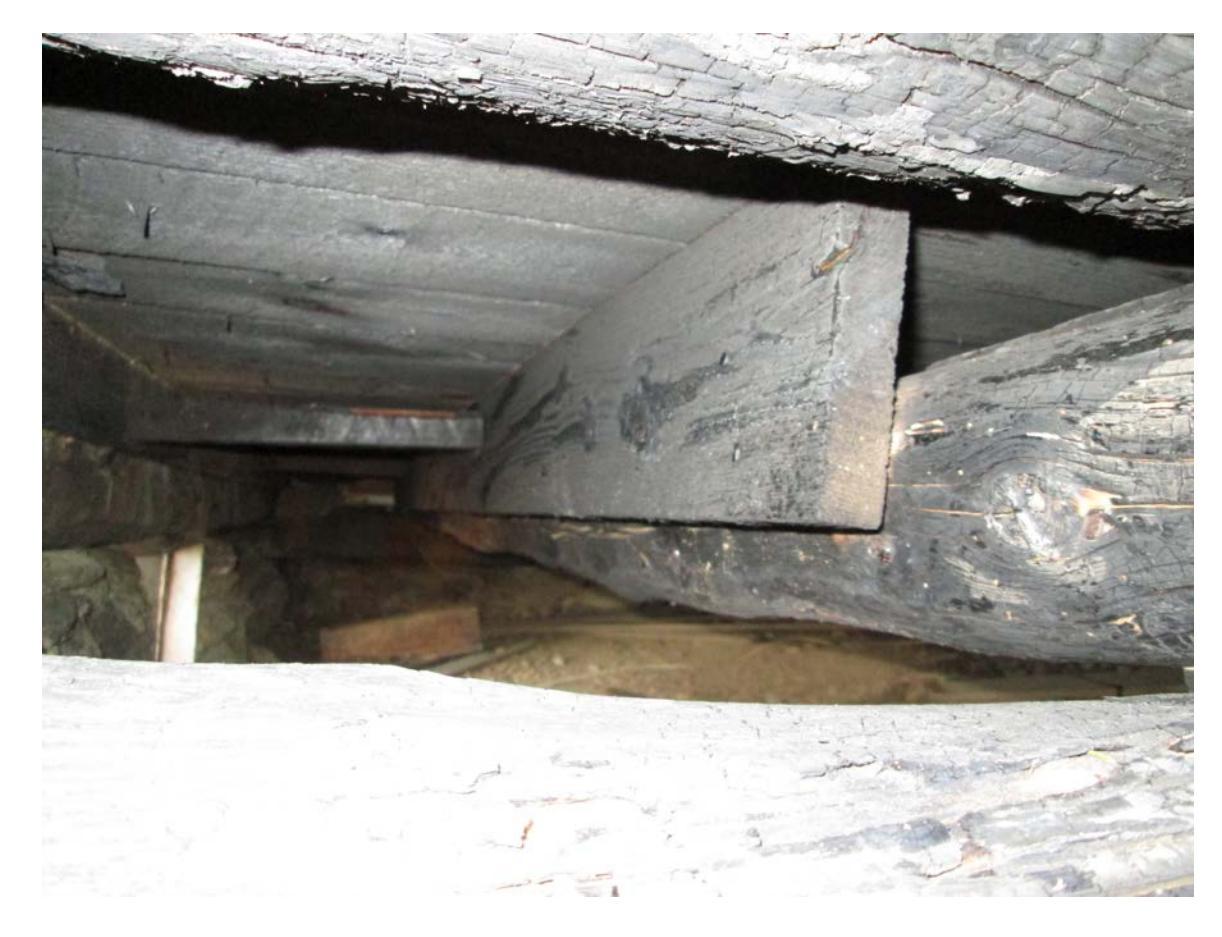
Fig. S20-3. Photo shows the damage to the joist space under the floor where the fire made entry.

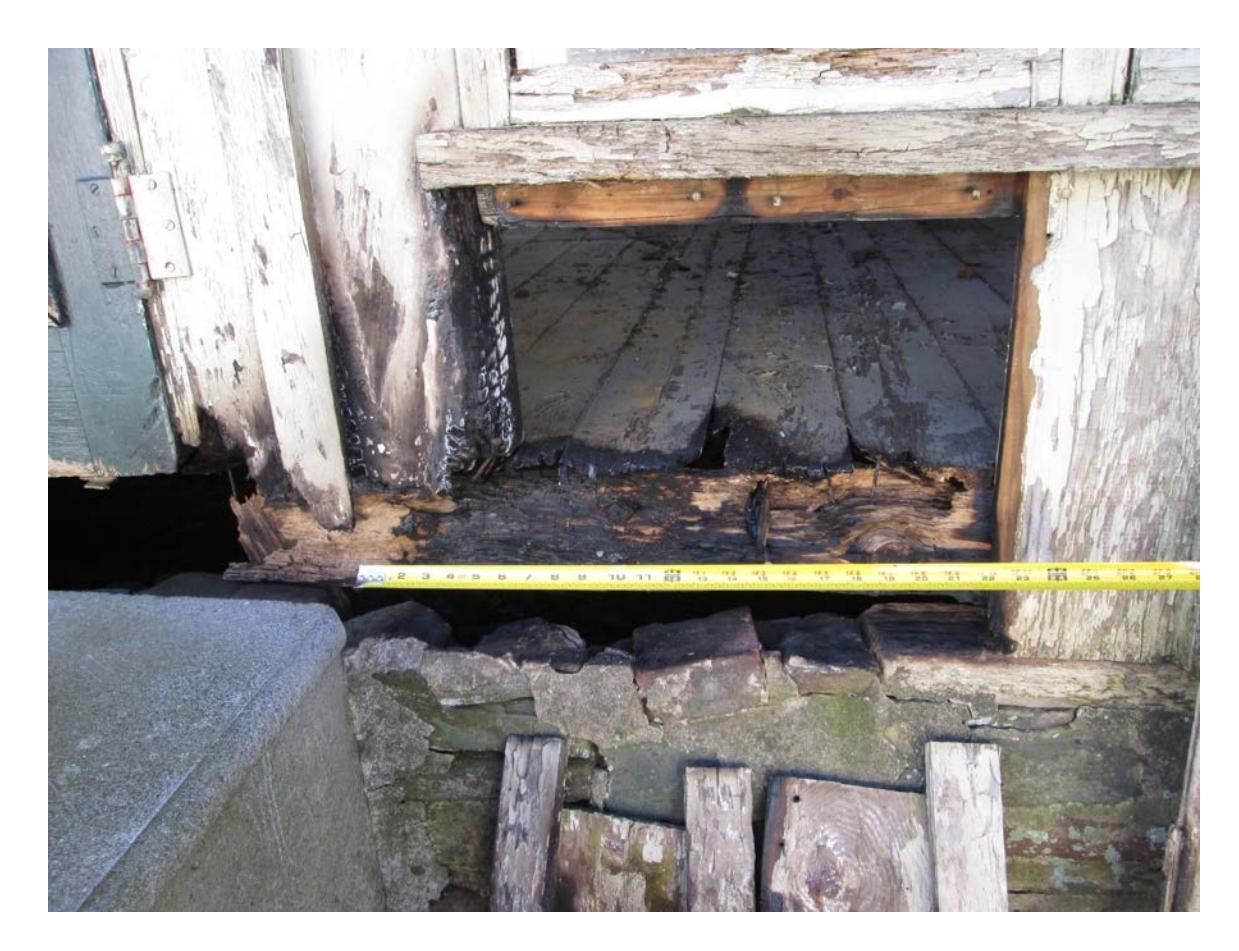
Fig. S20-4. Photo shows the fire damage to base of board and batten wood siding on side C. This was the second wall ignition on Cabin #1. Fire made entry into the joist space and ignited the wood porch floorboards.

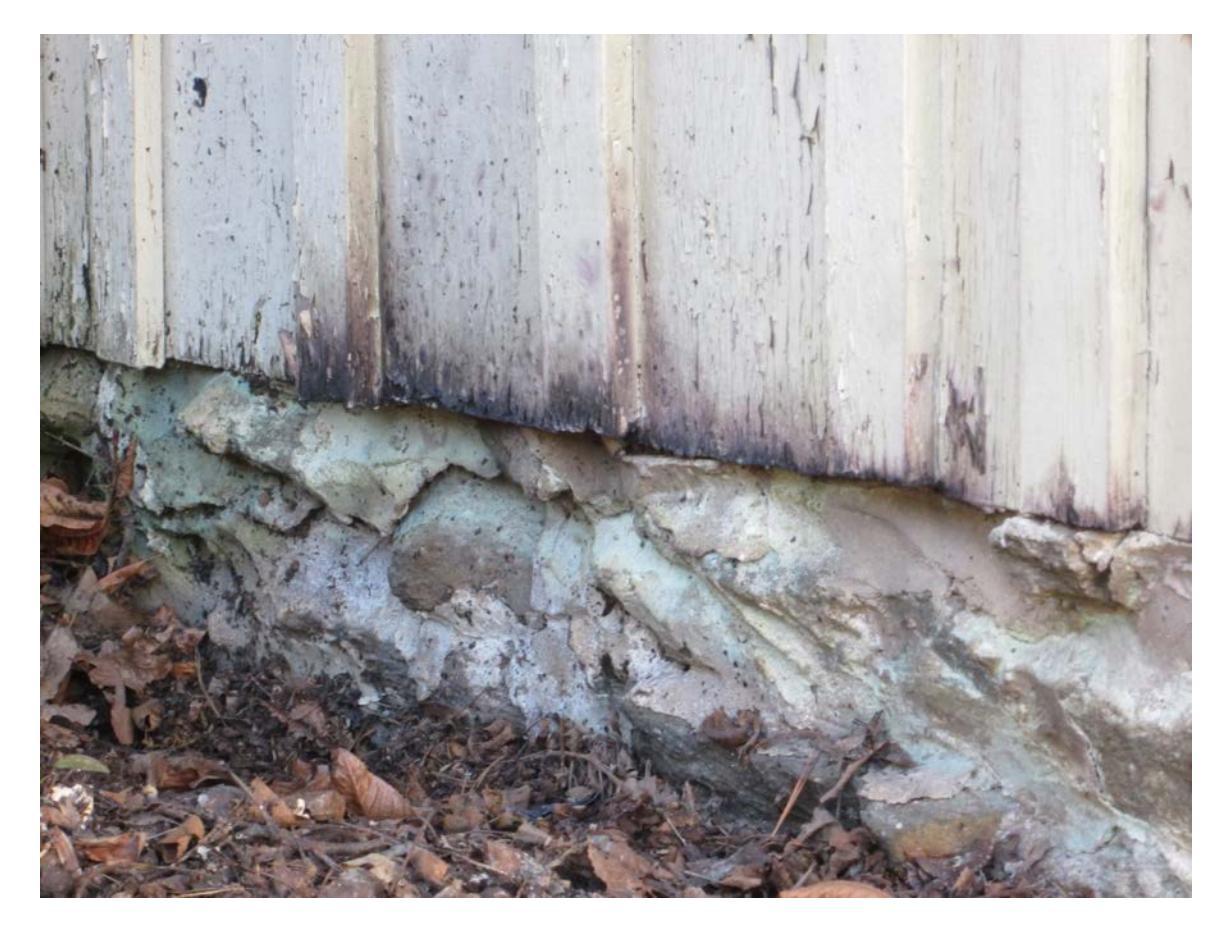
Fig. S20-5. Photo shows minor fire damage to base of wood board and batten siding on side D.
