NIST GCR 18-018

Structures Ignited by Virginia WUI Fires 2/2015 – 2/2017

David D. Evans Lavern R. Scott William D. Walton Home Safety Foundation Chevy Chase, Maryland 20815-4206

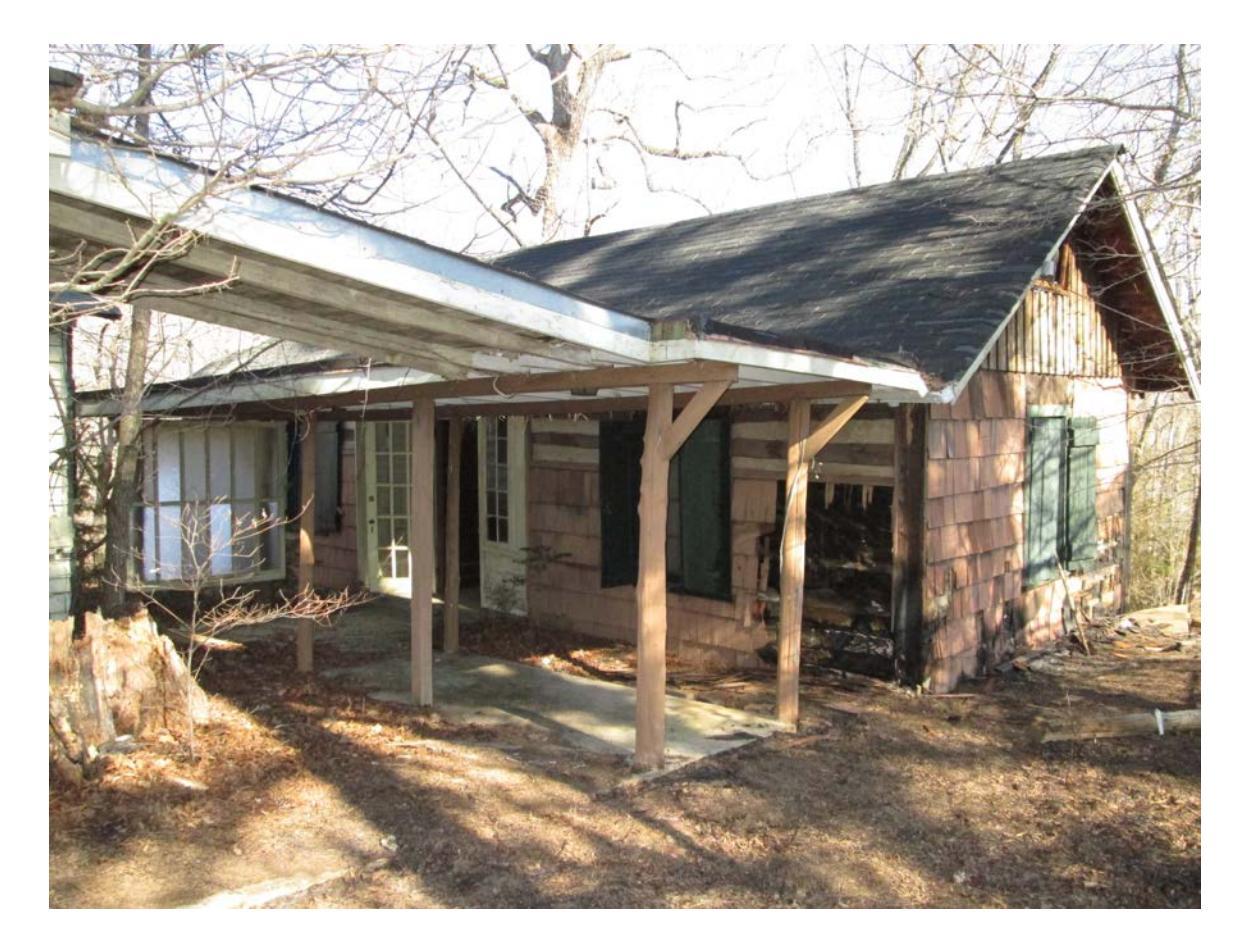
Fig. S21-1. Overall view of Cabin #2 from side A, D corner. Fire damage is visible on the side A exterior wall at the corner with side D.

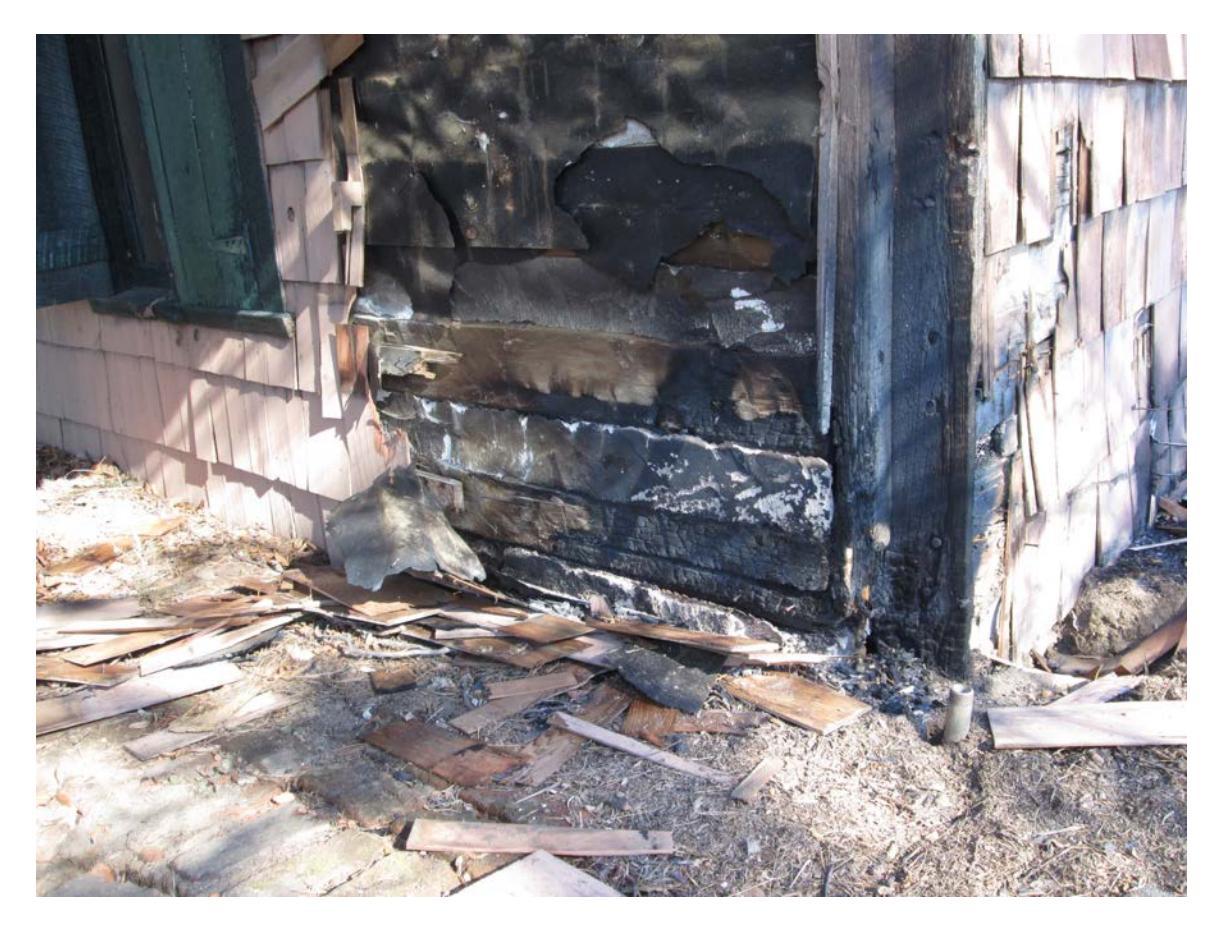
Fig. S21-2. Photo shows the fire damage on side A of Cabin #2. Surface fire ignited the cedar shakes at the base of the side A wall at the corner with side D.

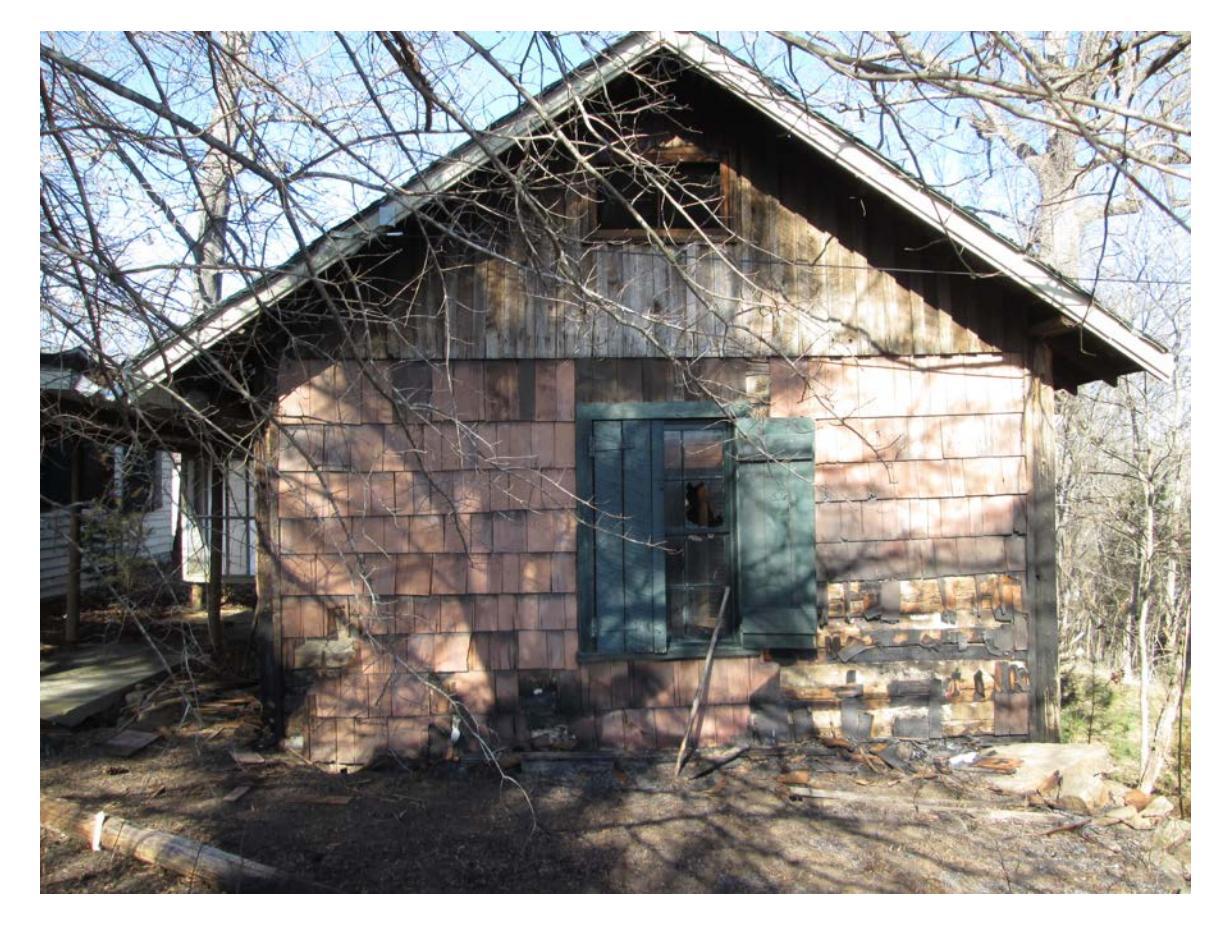
Fig. S21-3. Photo shows a view of fire damage on side D. Here two areas of ignition can be seen along the bottom edge of the shingled wall.

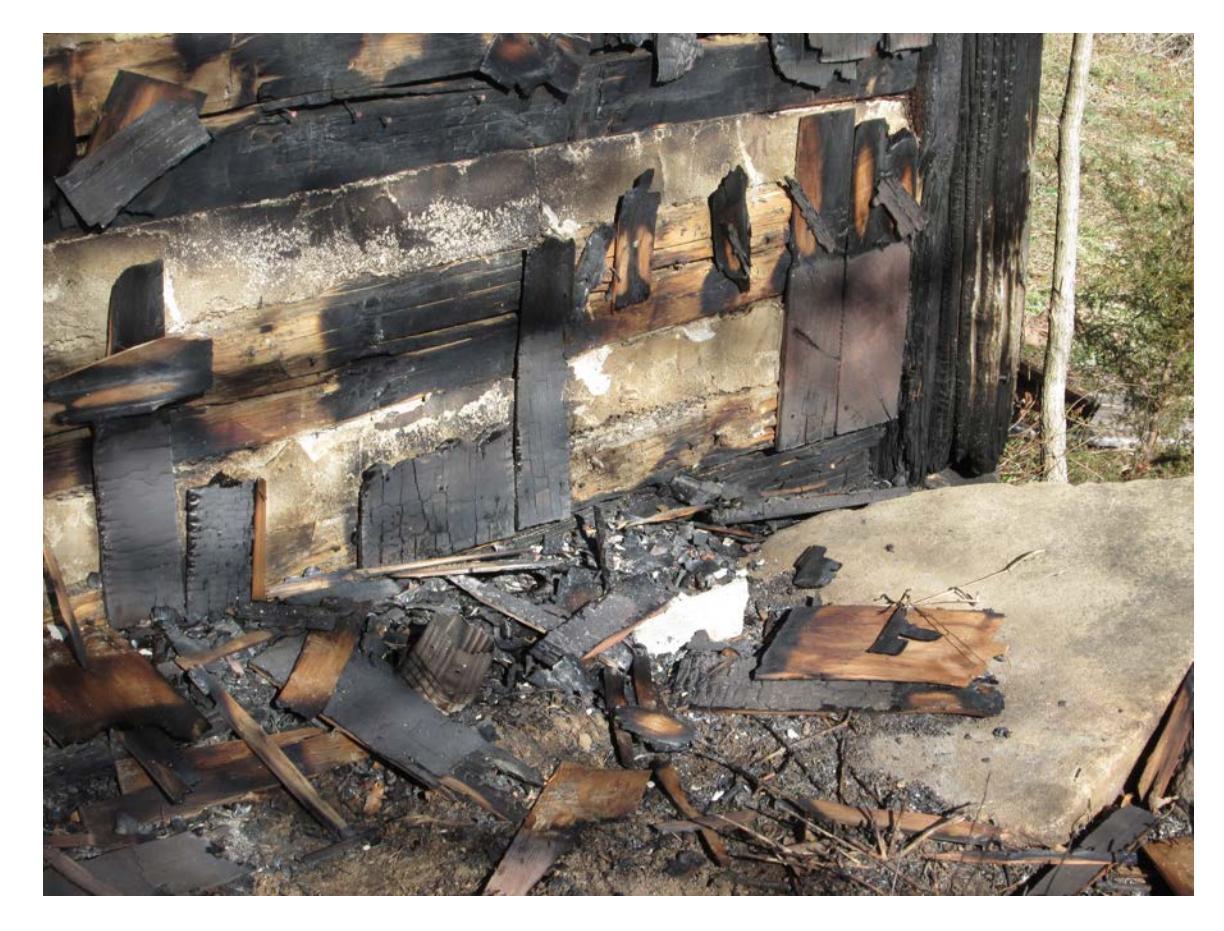
Fig. S21-4. Close-up photo shows fire damaged cedar shake siding at the base of the side D wall.

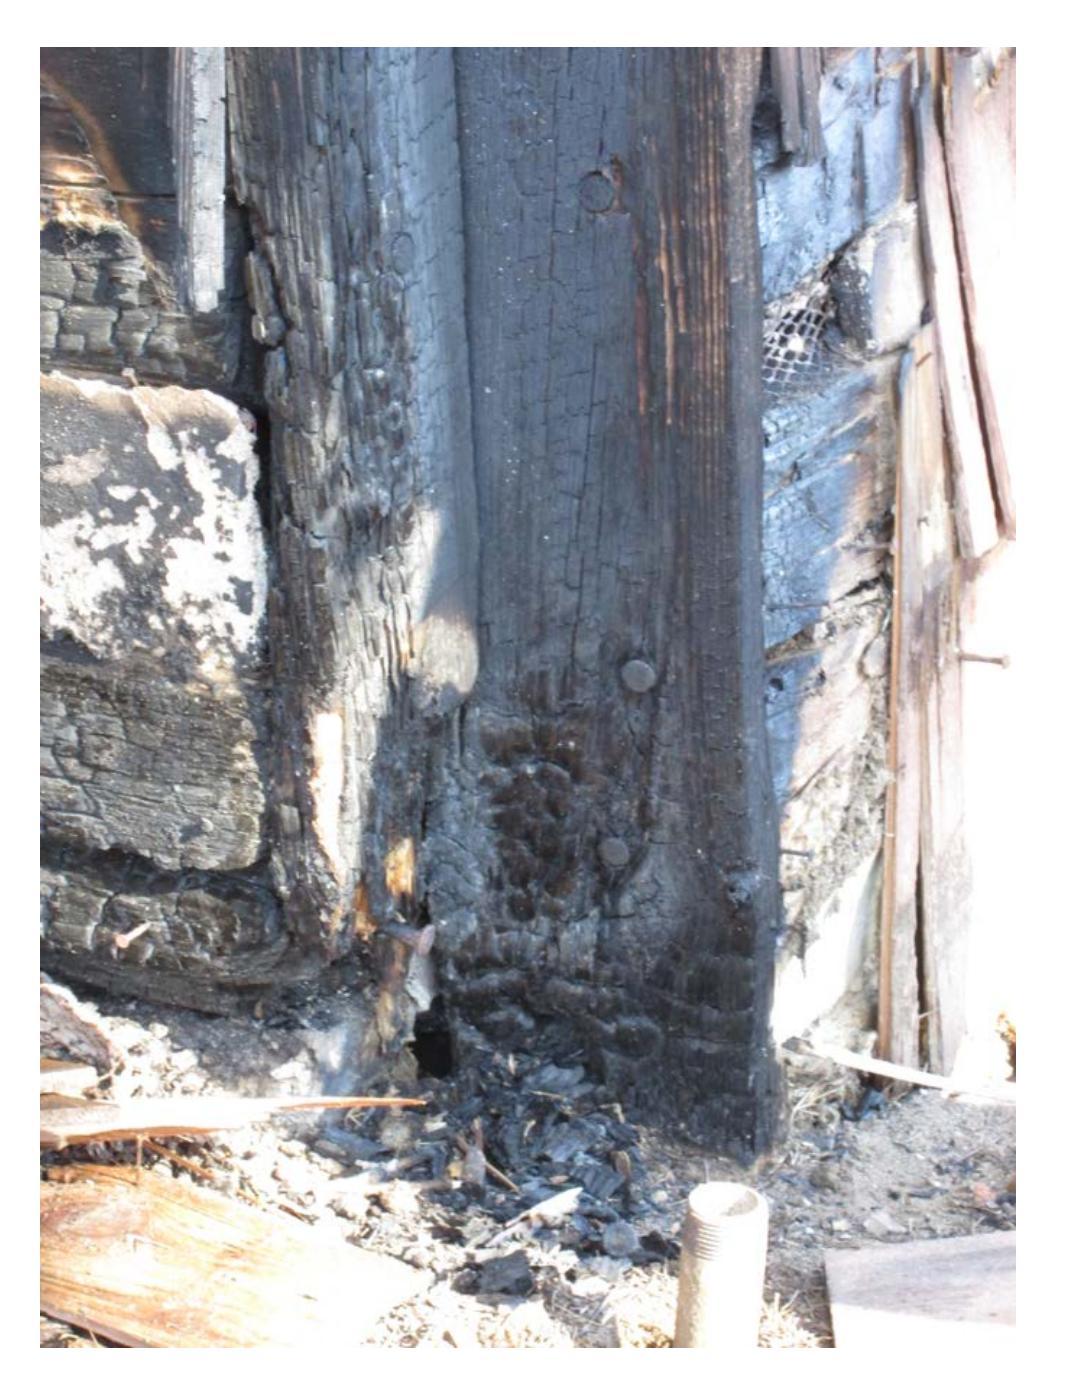
Fig. S21-5. Photo shows a close-up view of the deepest char at base of the corner of side A with side D. The fire made entry at the side A, D corner through gaps at the joints in the log wall construction.
