# **Development of In-Situ Techniques for the Detection and Measurement of Corrosion of Copper Concentric Neutrals in Underground Environments**

Annual Report

Annual Technical Report for Period January 15, 1976 to January 15, 1977

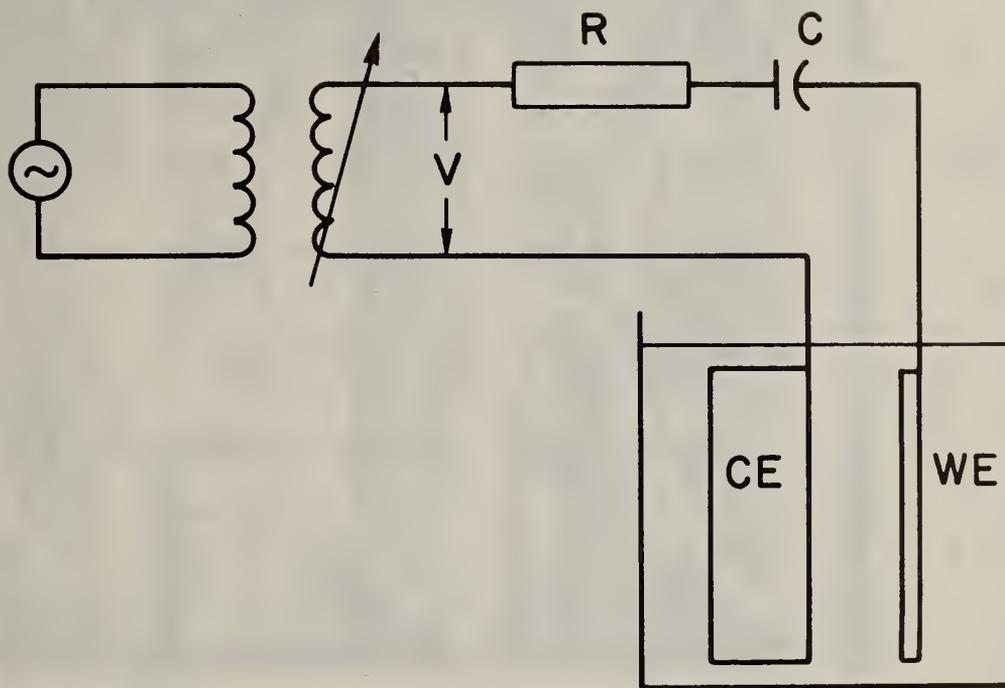
Fig. 1. Schematic circuit for corrosion tests with superimposed a.c.

d) Superimposed a.c. signal. In order to investigate the effect of a.c. current flowing between the wire and the soil, tests were performed where a 60 Hz a.c. signal was applied between the test specimen and a large surface area counterelectrode. In order to approximate a potentiostatic condition without entailing the use of a potentiostat for each test cell, a circuit scheme such as that of Fig. 1 was used. The resistance  $R$  is used to measure the current, and the capacitor  $C$  is inserted to prevent circulation of a d.c. current. In order to approximate a potentiostatic behavior, the voltage  $V$  supplied by the variable transformer should be as close as possible to the voltage between the electrode under study  $E$  and the solution in its immediate vicinity. In other words, all other voltage drops in the circuit should be as small as possible. In the practical case the resistance  $R$  was chosen as  $10 \Omega$ , and the capacitance was made by two  $220 \mu\text{F}$  electrolytic capacitors put in series so as to block all d.c. components. In separate experiments it was found that the d.c. resistance of the two capacitors at low voltages is greater than  $1 \text{ G} \Omega$ . The impedance of the two capacitors is of the order of  $24 \Omega$  at 60 Hz. The counterelectrode  $CE$  is made of a stainless steel sheet of large surface area ( $75 \text{ cm}^2$  compared with about  $2 \text{ cm}^2$  for the working electrode). In a number of experiments it was found that 60 to 80% of the total impedance was found between  $E$  and the adjacent solution (the measurement was carried out by means of a third electrode inserted in the cell).

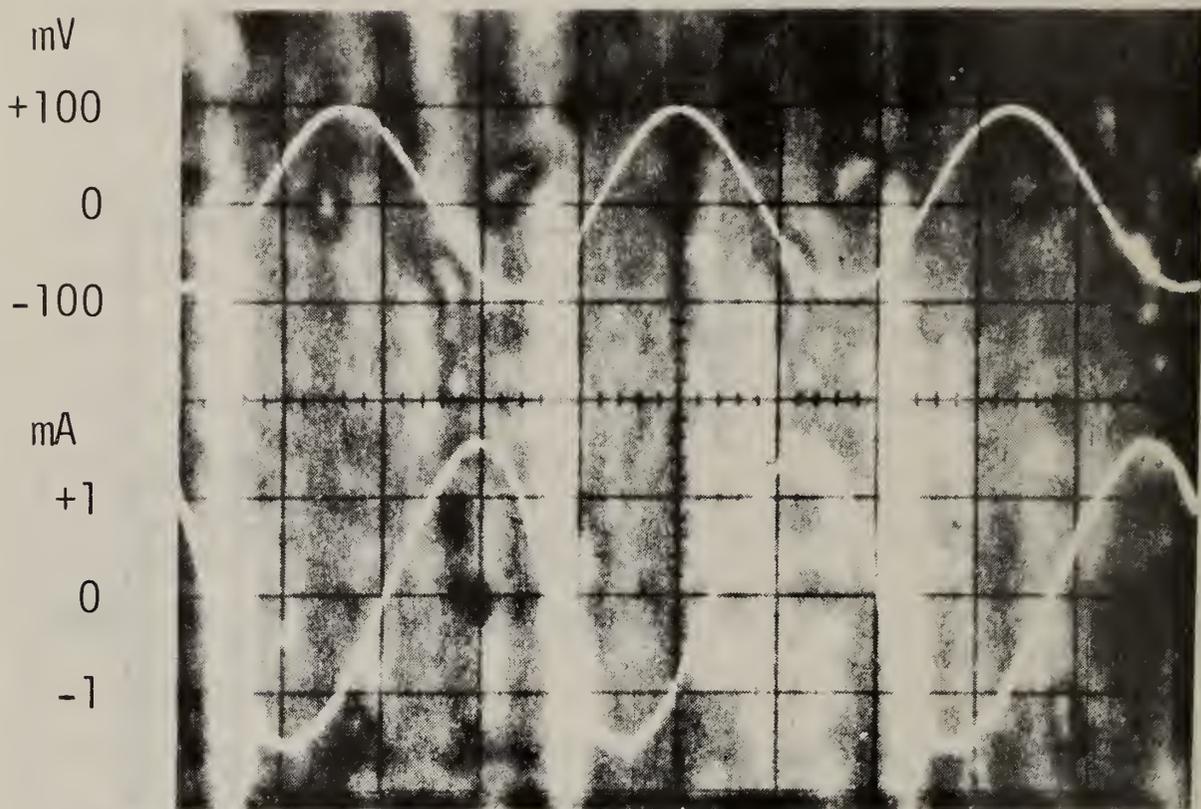
Fig. 2. Voltage signal (upper trace) and current signal (lower trace) for Cu in 2%  $\text{Na}_2\text{SO}_4$ .

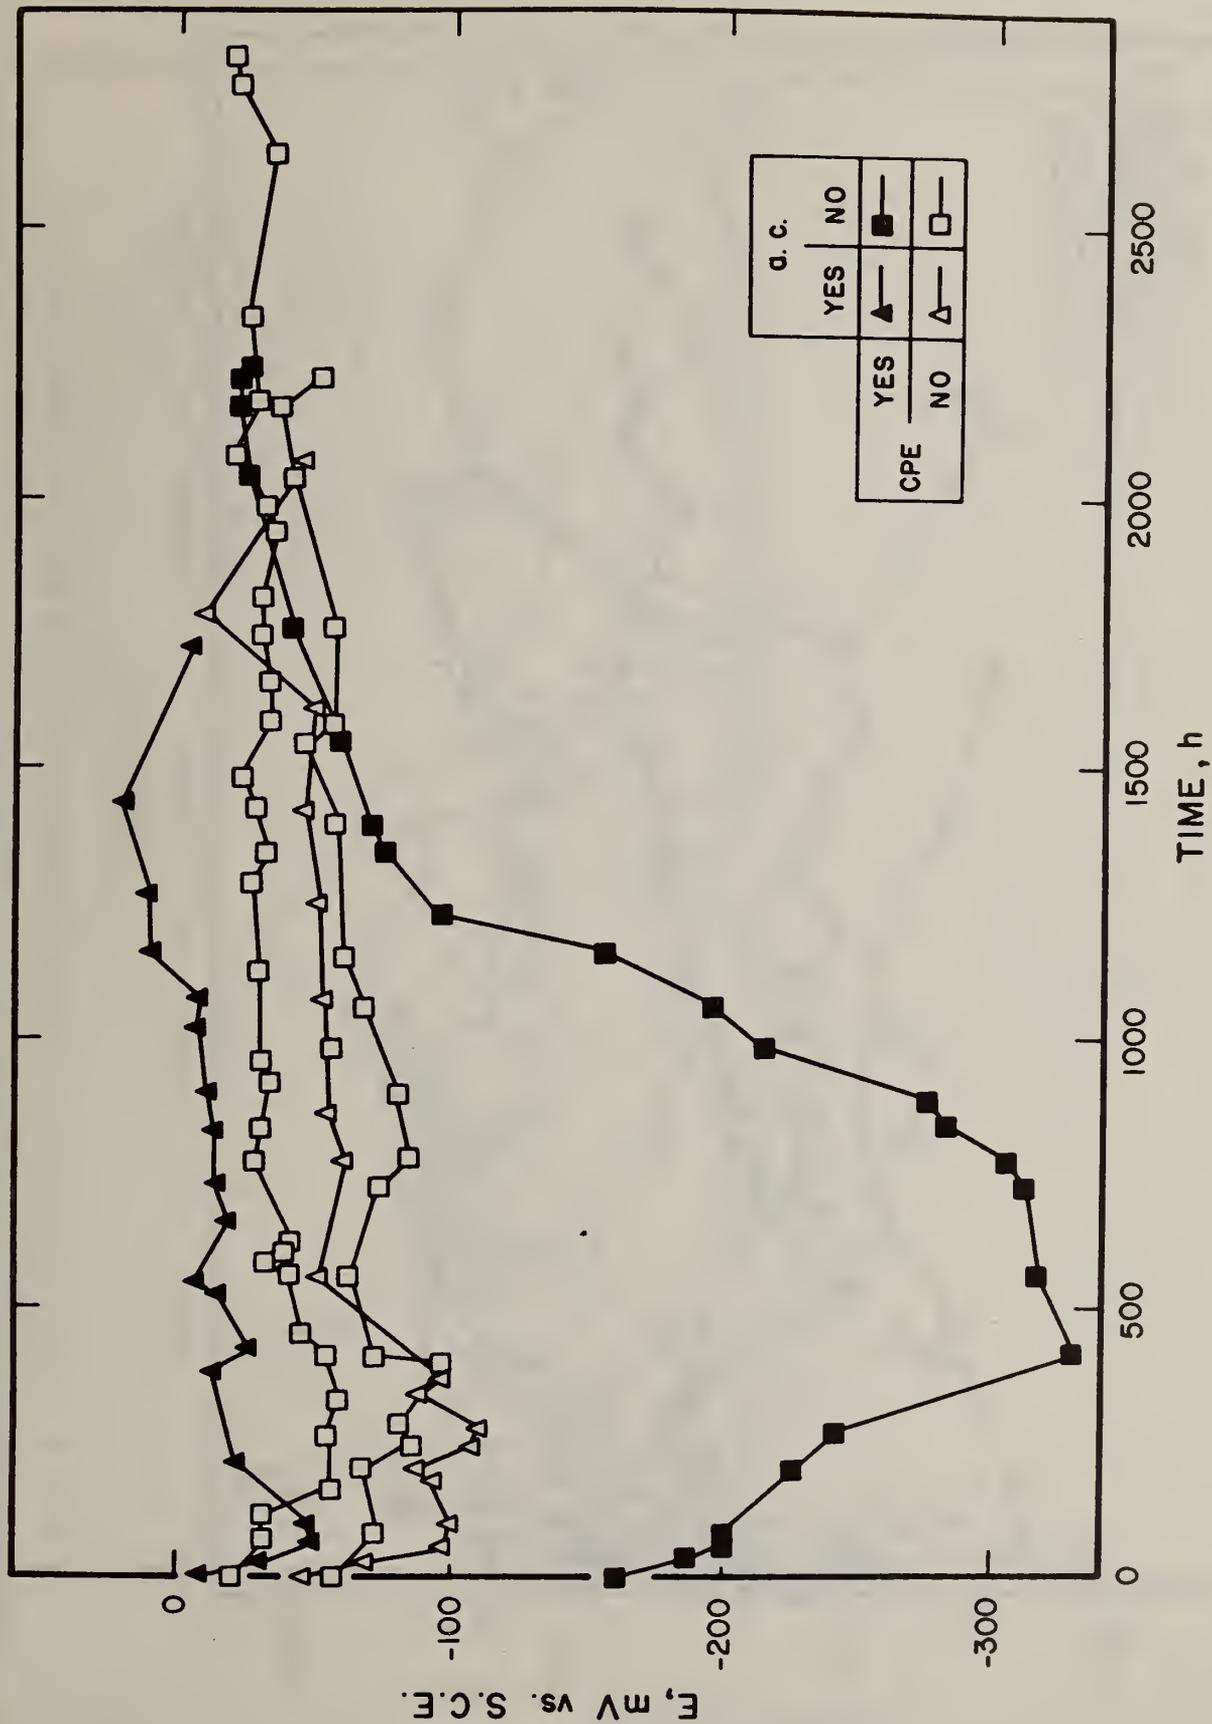
Fig. 3. Electrode potential vs. time for tinned Cu wire in 2%  $\text{Na}_2\text{SO}_4$ .  $\text{N}_2$  atmosphere.

The results obtained from the corrosion tests are presented as follows: Figs. 3, 4, 5, and 6 give the potential of the tinned CCN wire vs. SCE in solutions containing Na<sub>2</sub>SO<sub>4</sub> with and without NaCl and under an O<sub>2</sub> or N<sub>2</sub> atmosphere. Figs. 7, 8, 9, and 10 are the analogous graphs for solutions containing NaClO<sub>4</sub>. Also, Tables I-VIII summarize the results by giving average values of the electrode potential, of the a.c. resistance and of the short circuit current density between specimen and CPE when appropriate, as well as a description of the appearance of the wire after the test as obtained by visual inspection.

Under a nitrogen atmosphere the rate of corrosion is slower than in the presence of oxygen. The electrode potentials, as a consequence, tend to be more negative; if the tinning coat is continuous, the potential can remain at low voltages, -400 to -500 vs. SCE for fairly long periods of time, as it had been found in preliminary experiments. The tinning coat on the CCN wire in use now always presents many small flaws, and very low potentials have never been maintained for long times. The steady state values obtained on this wire (see Figs. 3, 4, 7, and 8) are higher in the absence of  $\text{Cl}^-$  ions (about 0 mV in  $\text{NaClO}_4$  and -50 in  $\text{Na}_2\text{SO}_4$ ) than in their presence (from -130 to -220 mV in  $\text{Na}_2\text{SO}_4$  and from -100 to -200 mV in  $\text{NaClO}_4$ ). Potentials are shifted towards more positive values by oxygen, and they are higher in the absence of chlorides, where  $\text{NaClO}_4$  solutions show, as in  $\text{N}_2$ , higher values (+40 to 80 mV) than  $\text{Na}_2\text{SO}_4$  solutions (from 0 to +30 mV). When chlorides are present, the differences are much less pronounced, also because the spread is larger. In sulfate, the potential ranges from +30 to -60 mV and in perchlorate from +50 to -80 mV, with the solutions containing agar showing the lowest values because of the lower availability of oxygen.

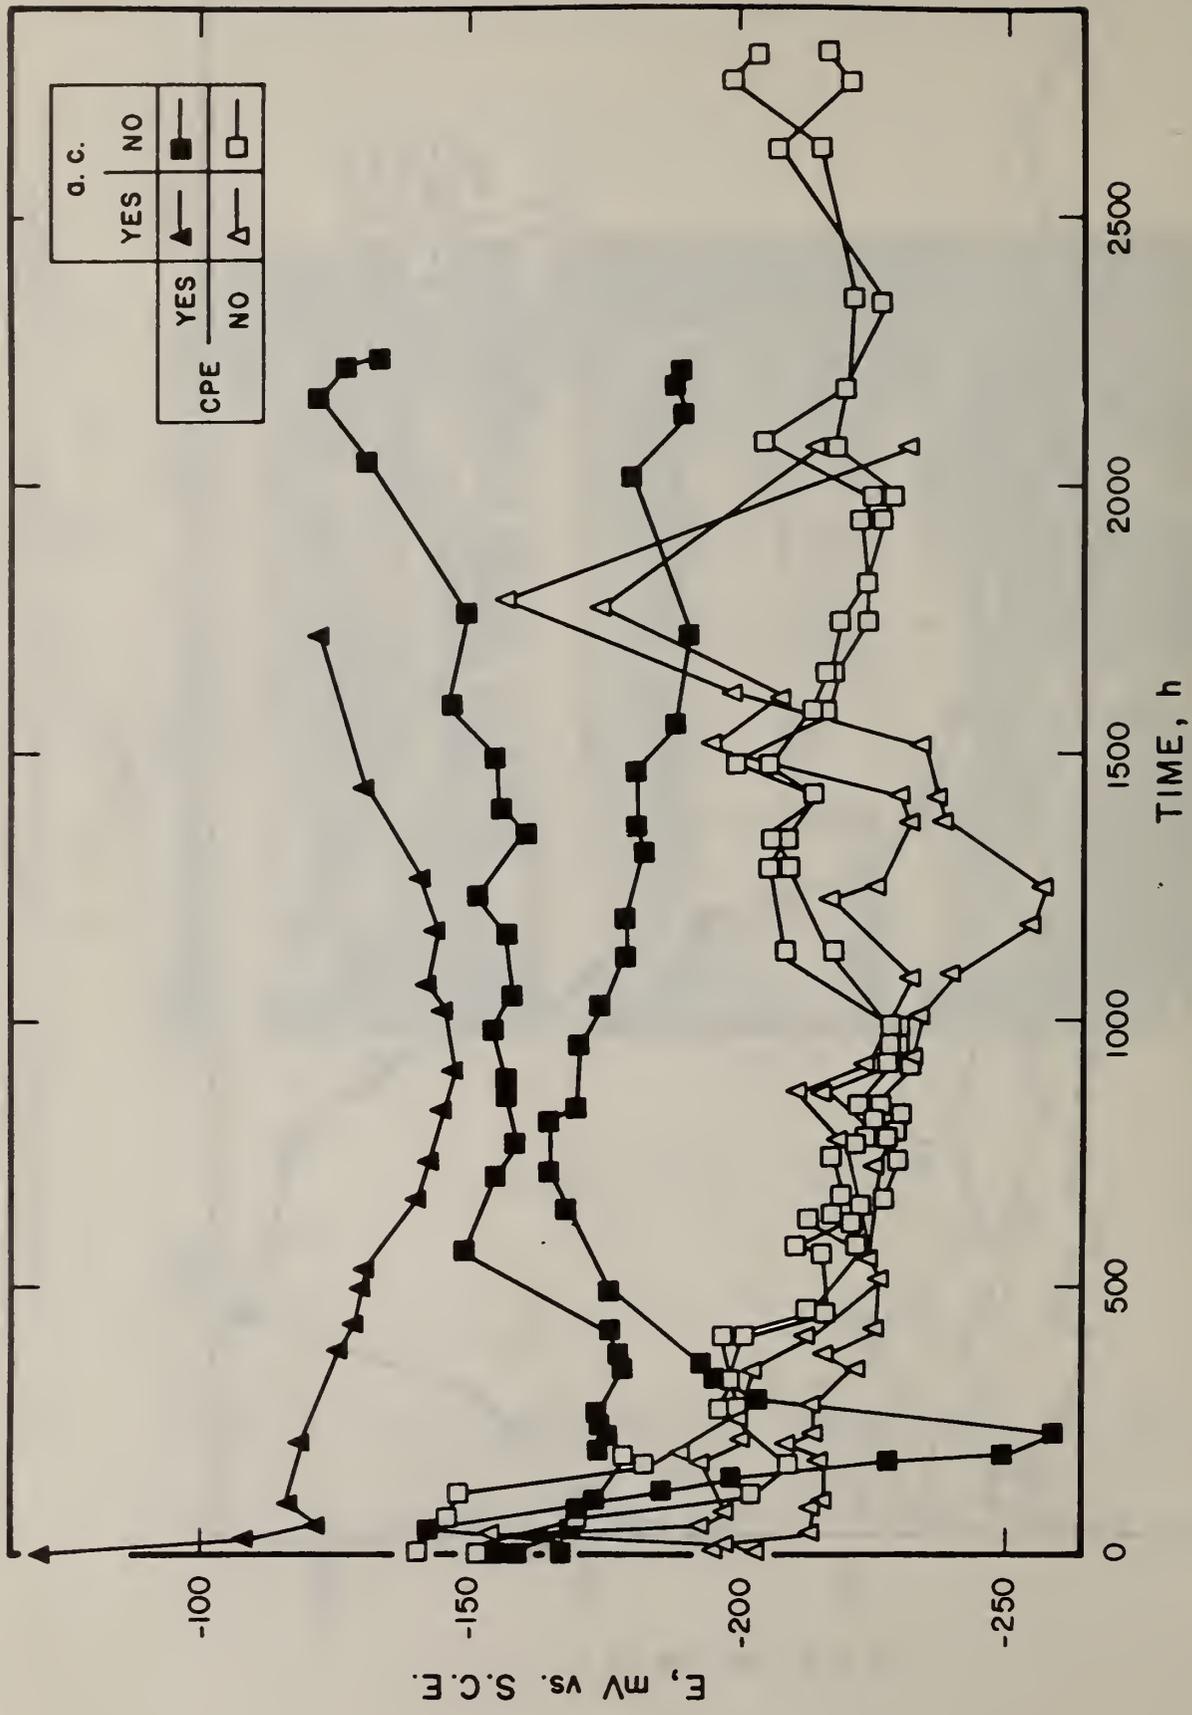
Fig. 4. Electrode potential vs. time for tinned Cu wire in 2% Na<sub>2</sub>SO<sub>4</sub> + 1% NaCl. N<sub>2</sub> atmosphere.

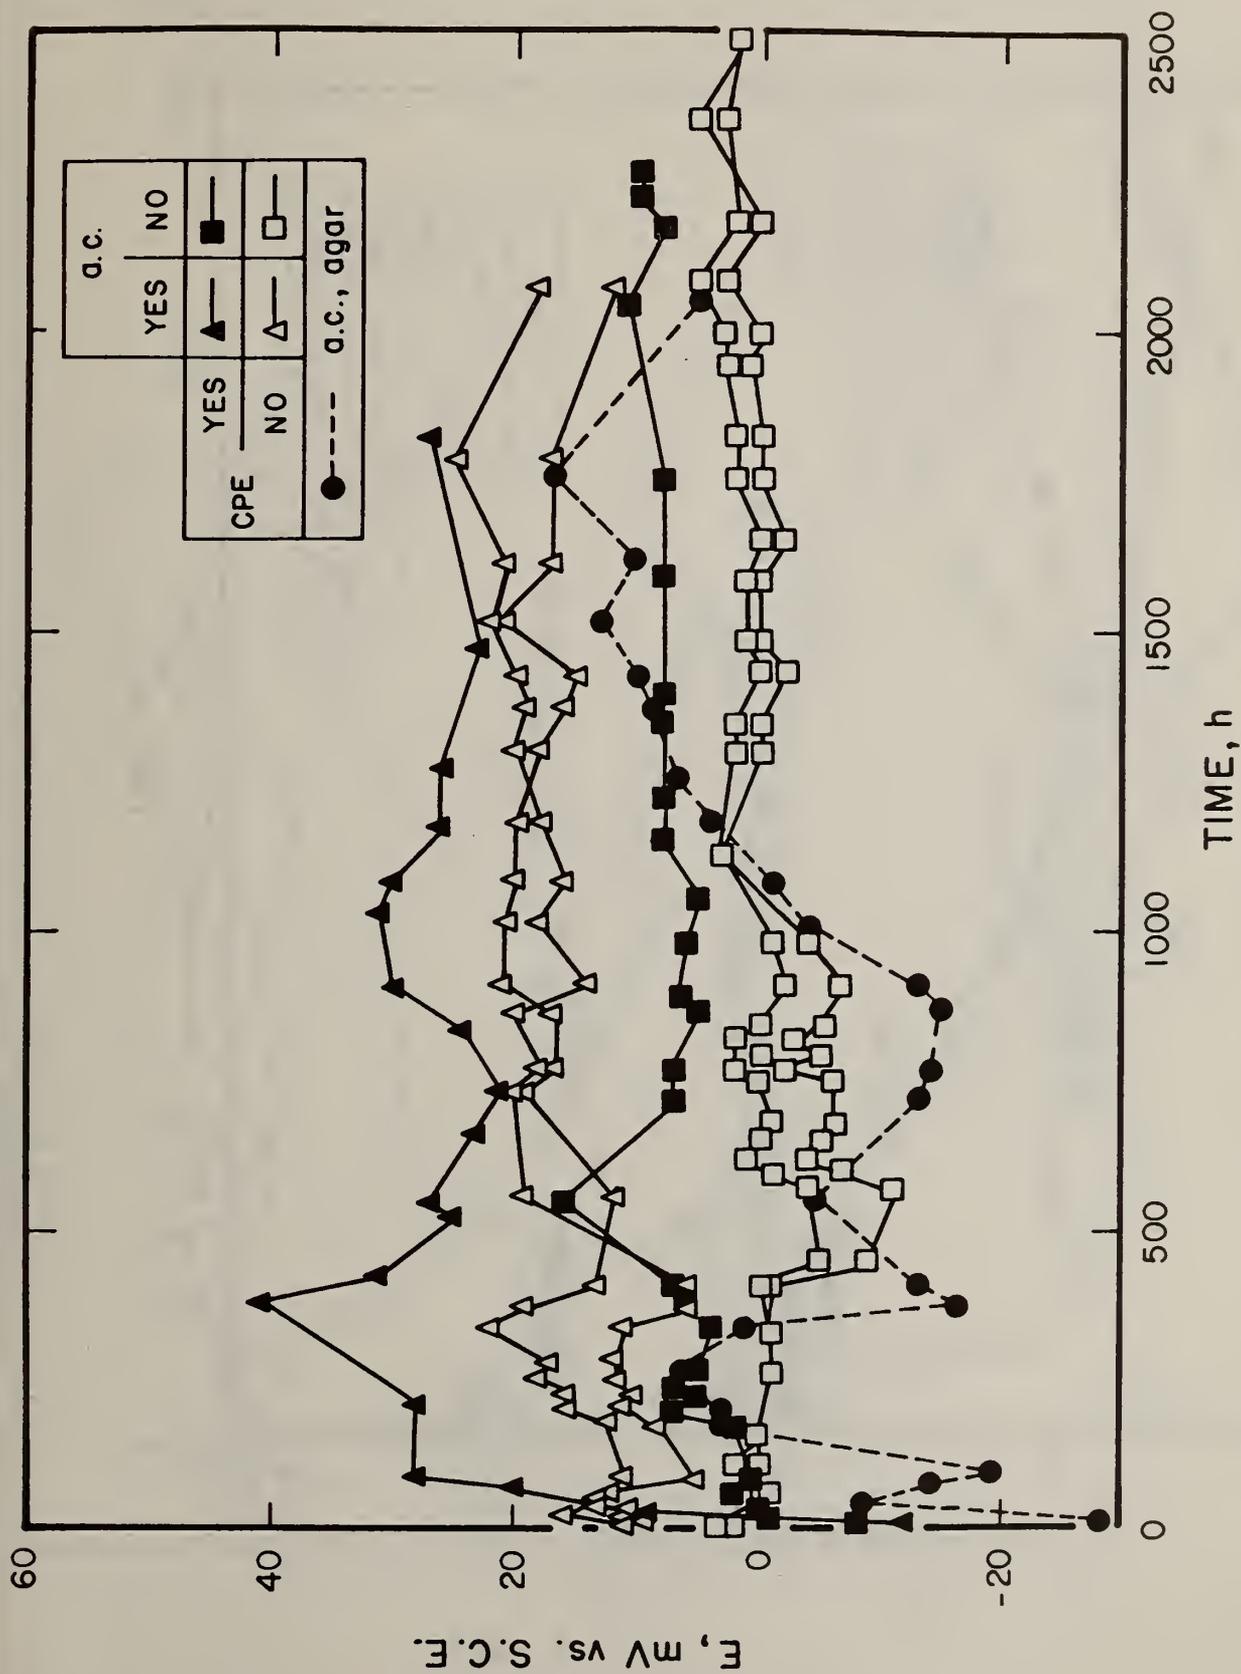
Fig. 5. Electrode potential vs. time for tinned Cu wire in 2%  $\text{Na}_2\text{SO}_4$ .  $\text{O}_2$  atmosphere.

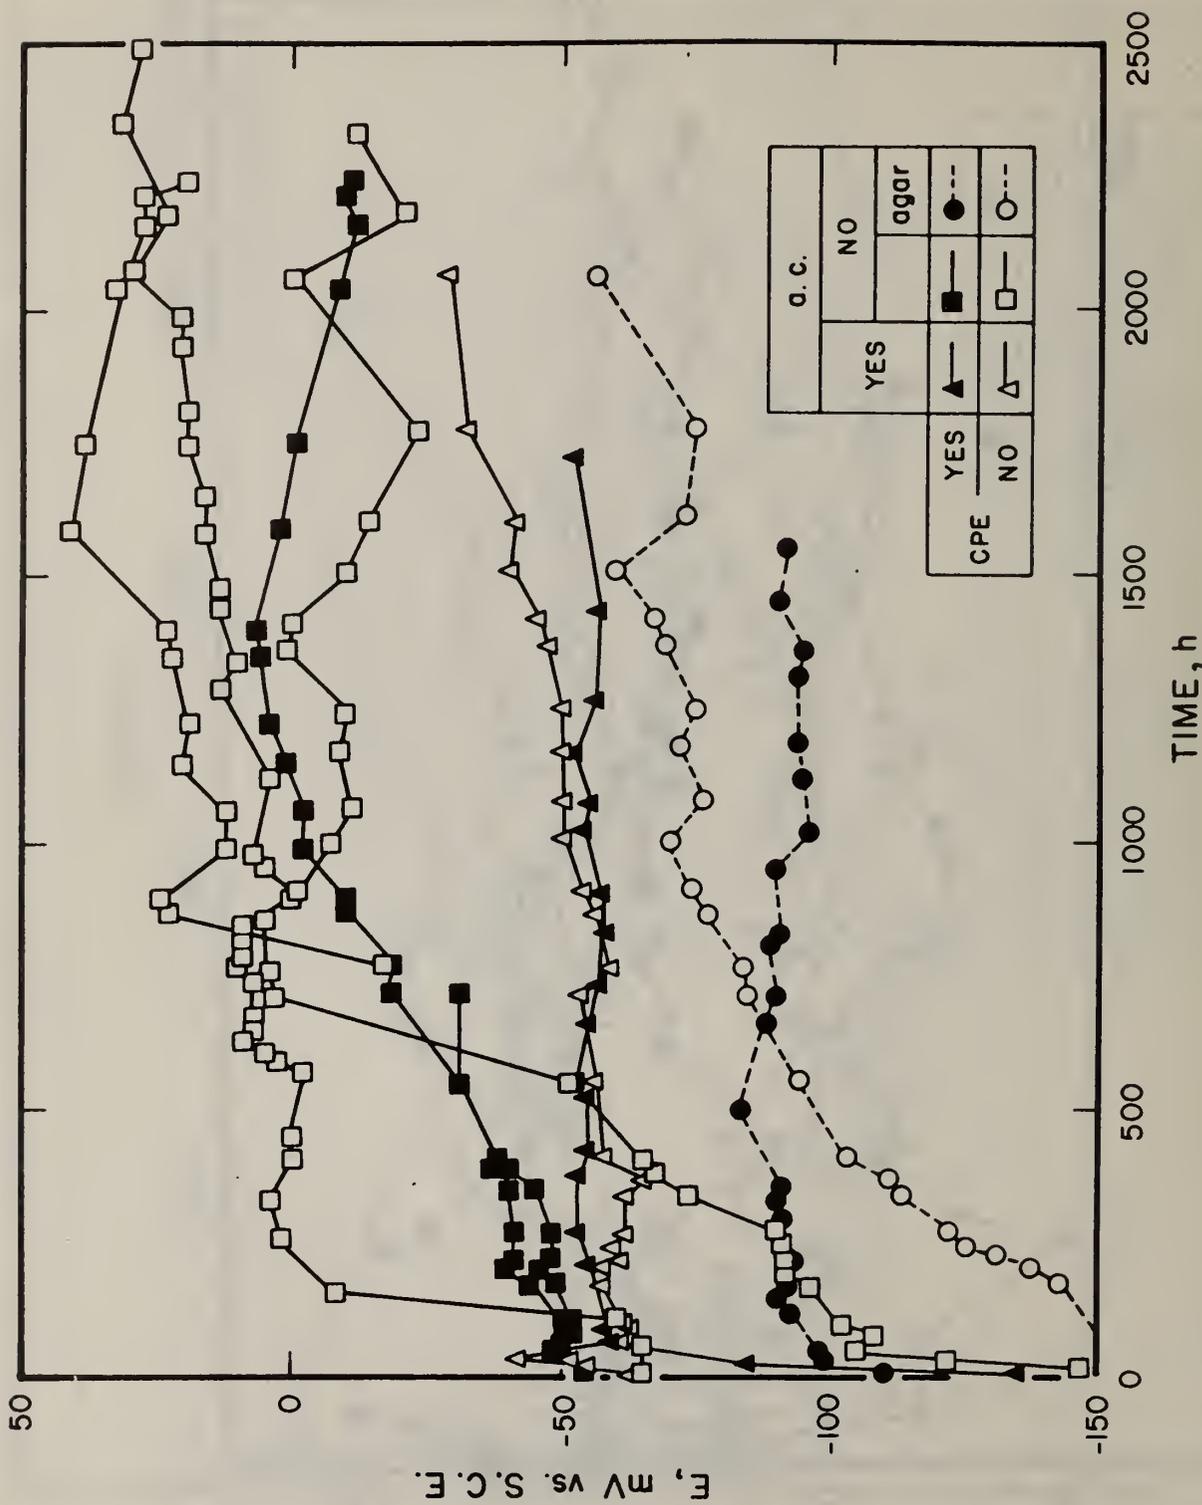
Fig. 6. Electrode potential vs. time for tinned Cu wire in 2% Na<sub>2</sub>SO<sub>4</sub> + 1% NaCl. O<sub>2</sub> atmosphere.

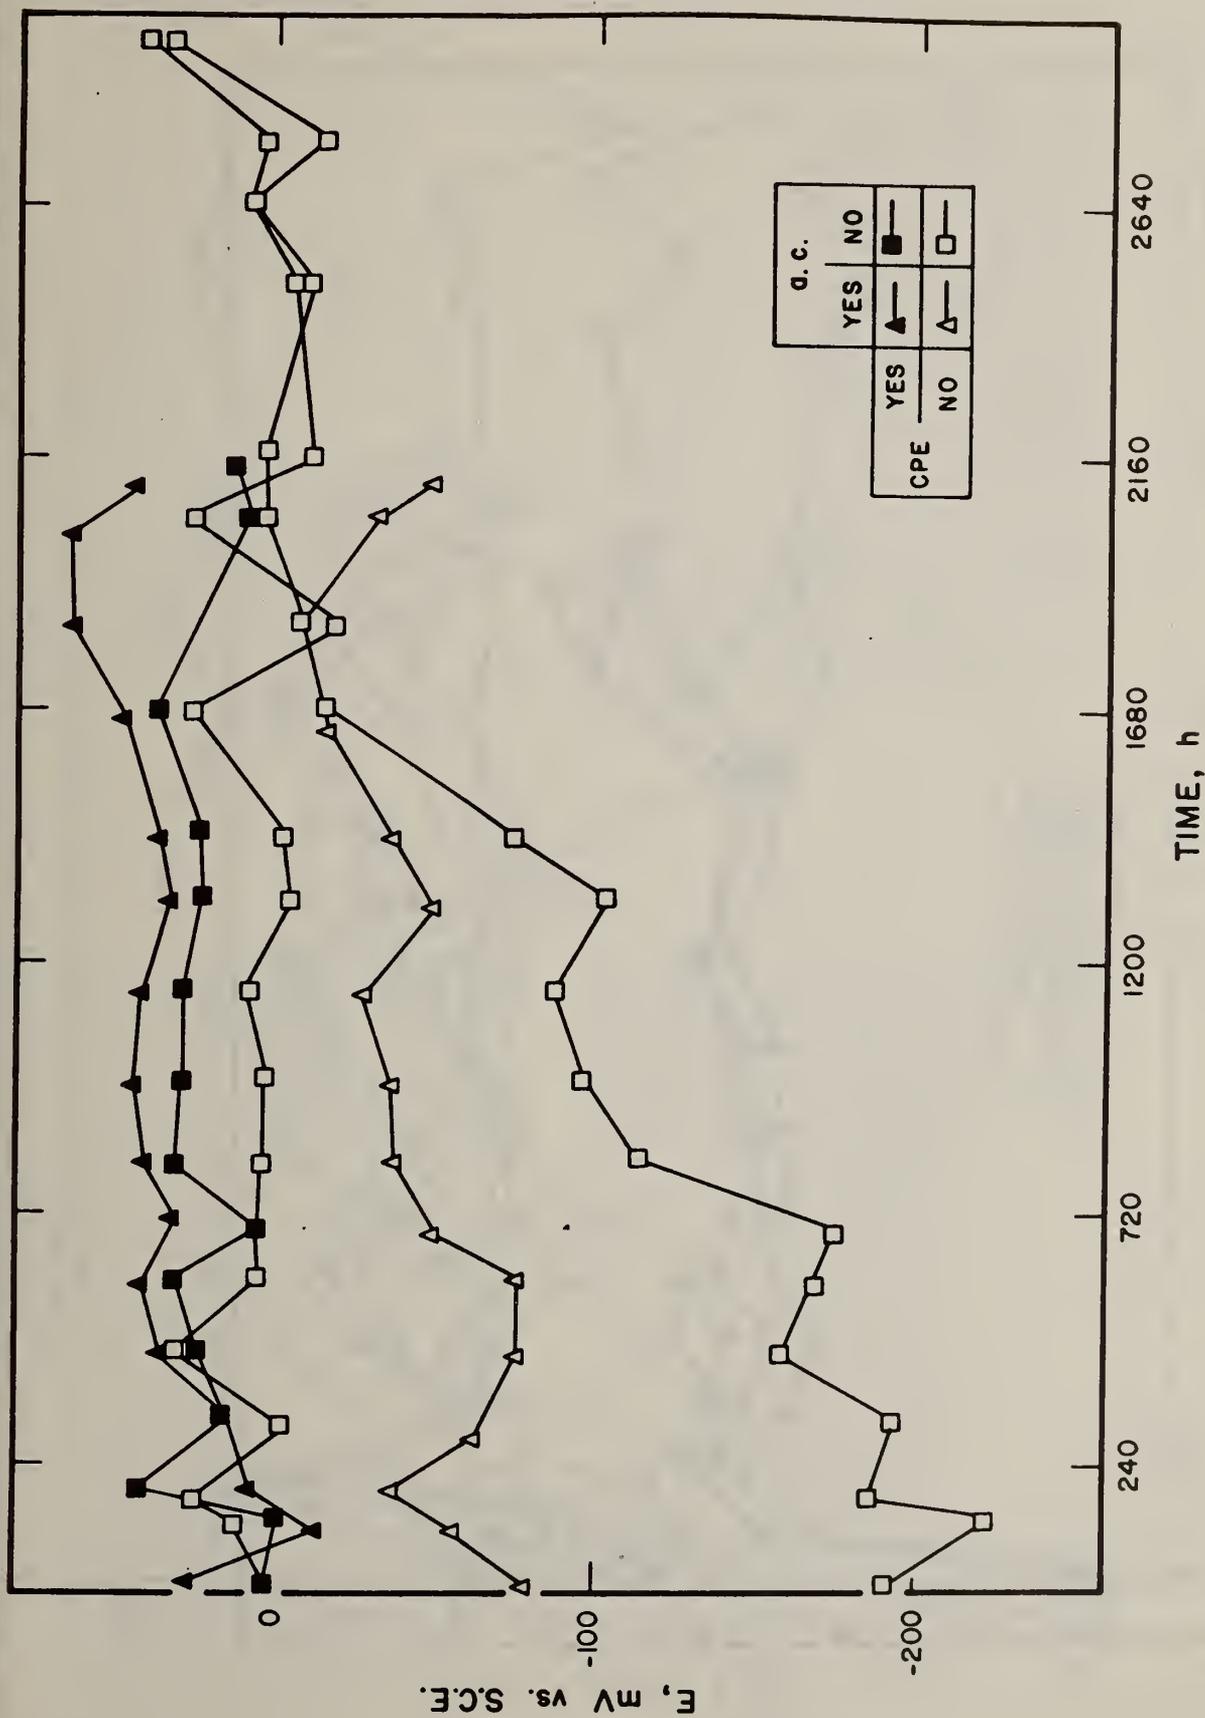
Fig. 7. Electrode potential vs. time for tinned Cu wire in 0.42 m NaClO<sub>4</sub>. N<sub>2</sub> atmosphere.

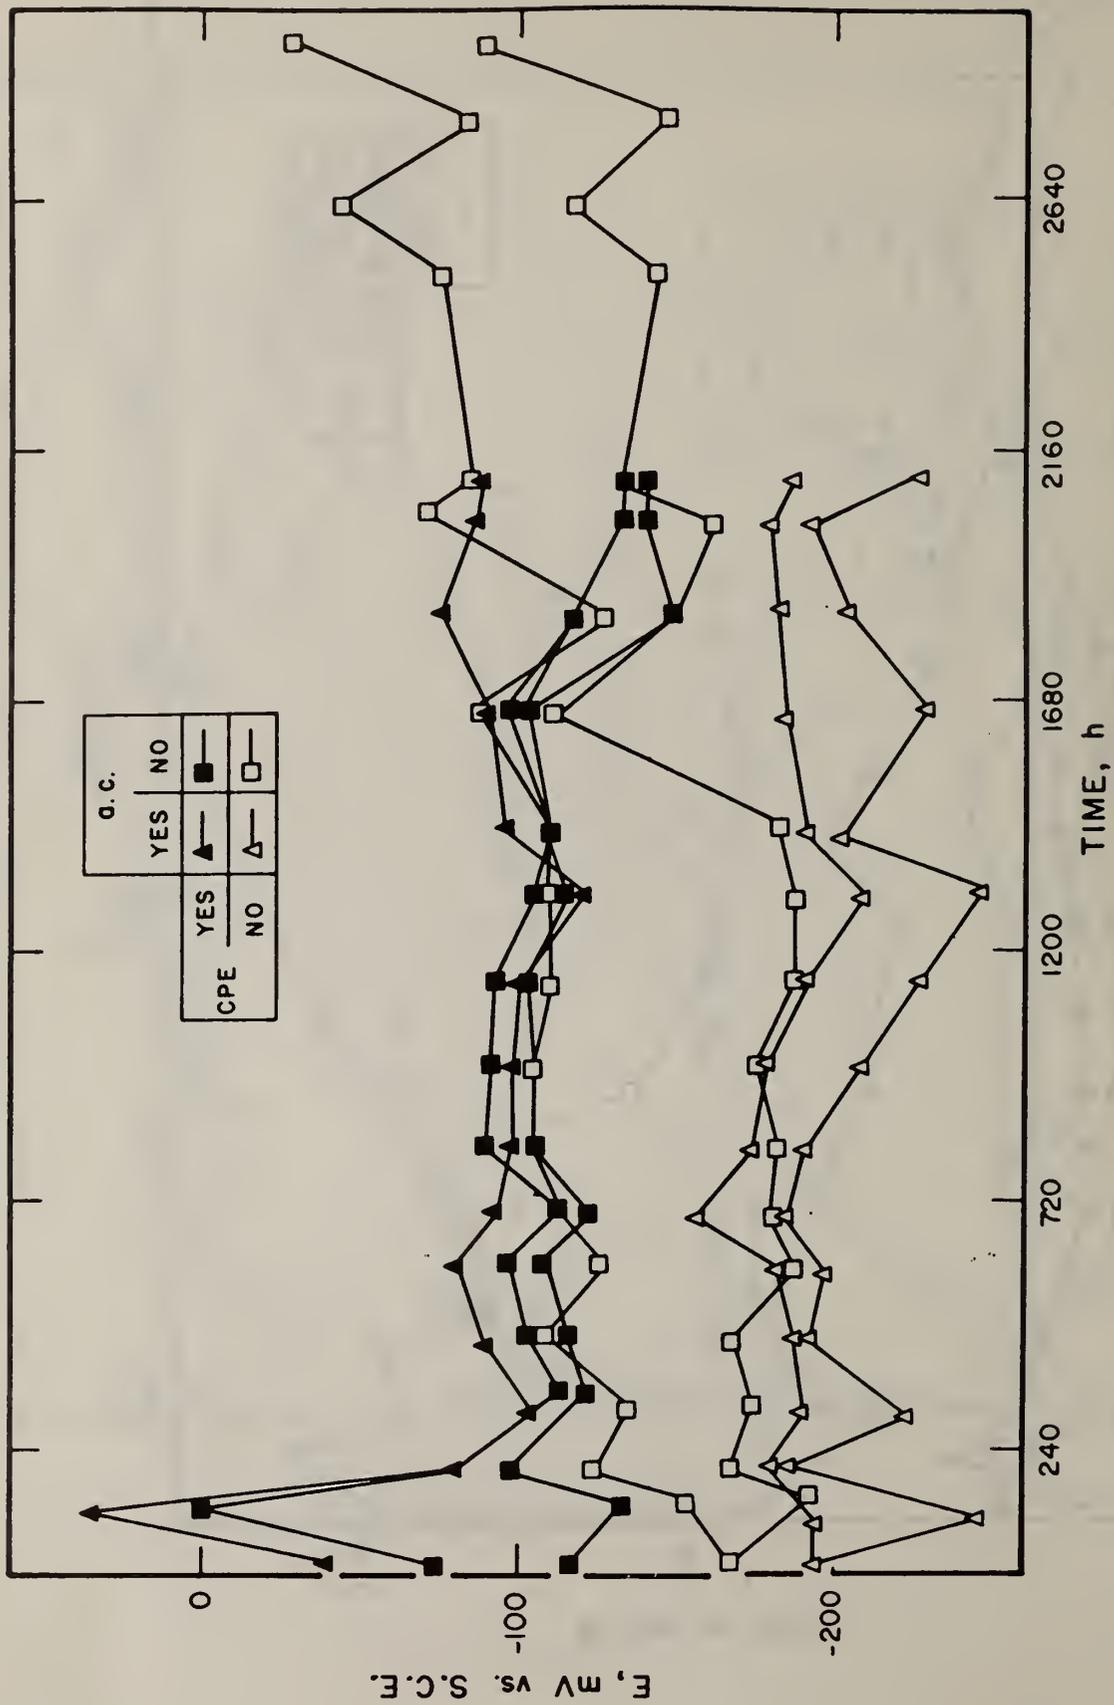
Fig. 8. Electrode potential vs. time for tinned Cu wire in 0.42 M NaClO<sub>4</sub> + 1% NaCl. N<sub>2</sub> atmosphere.

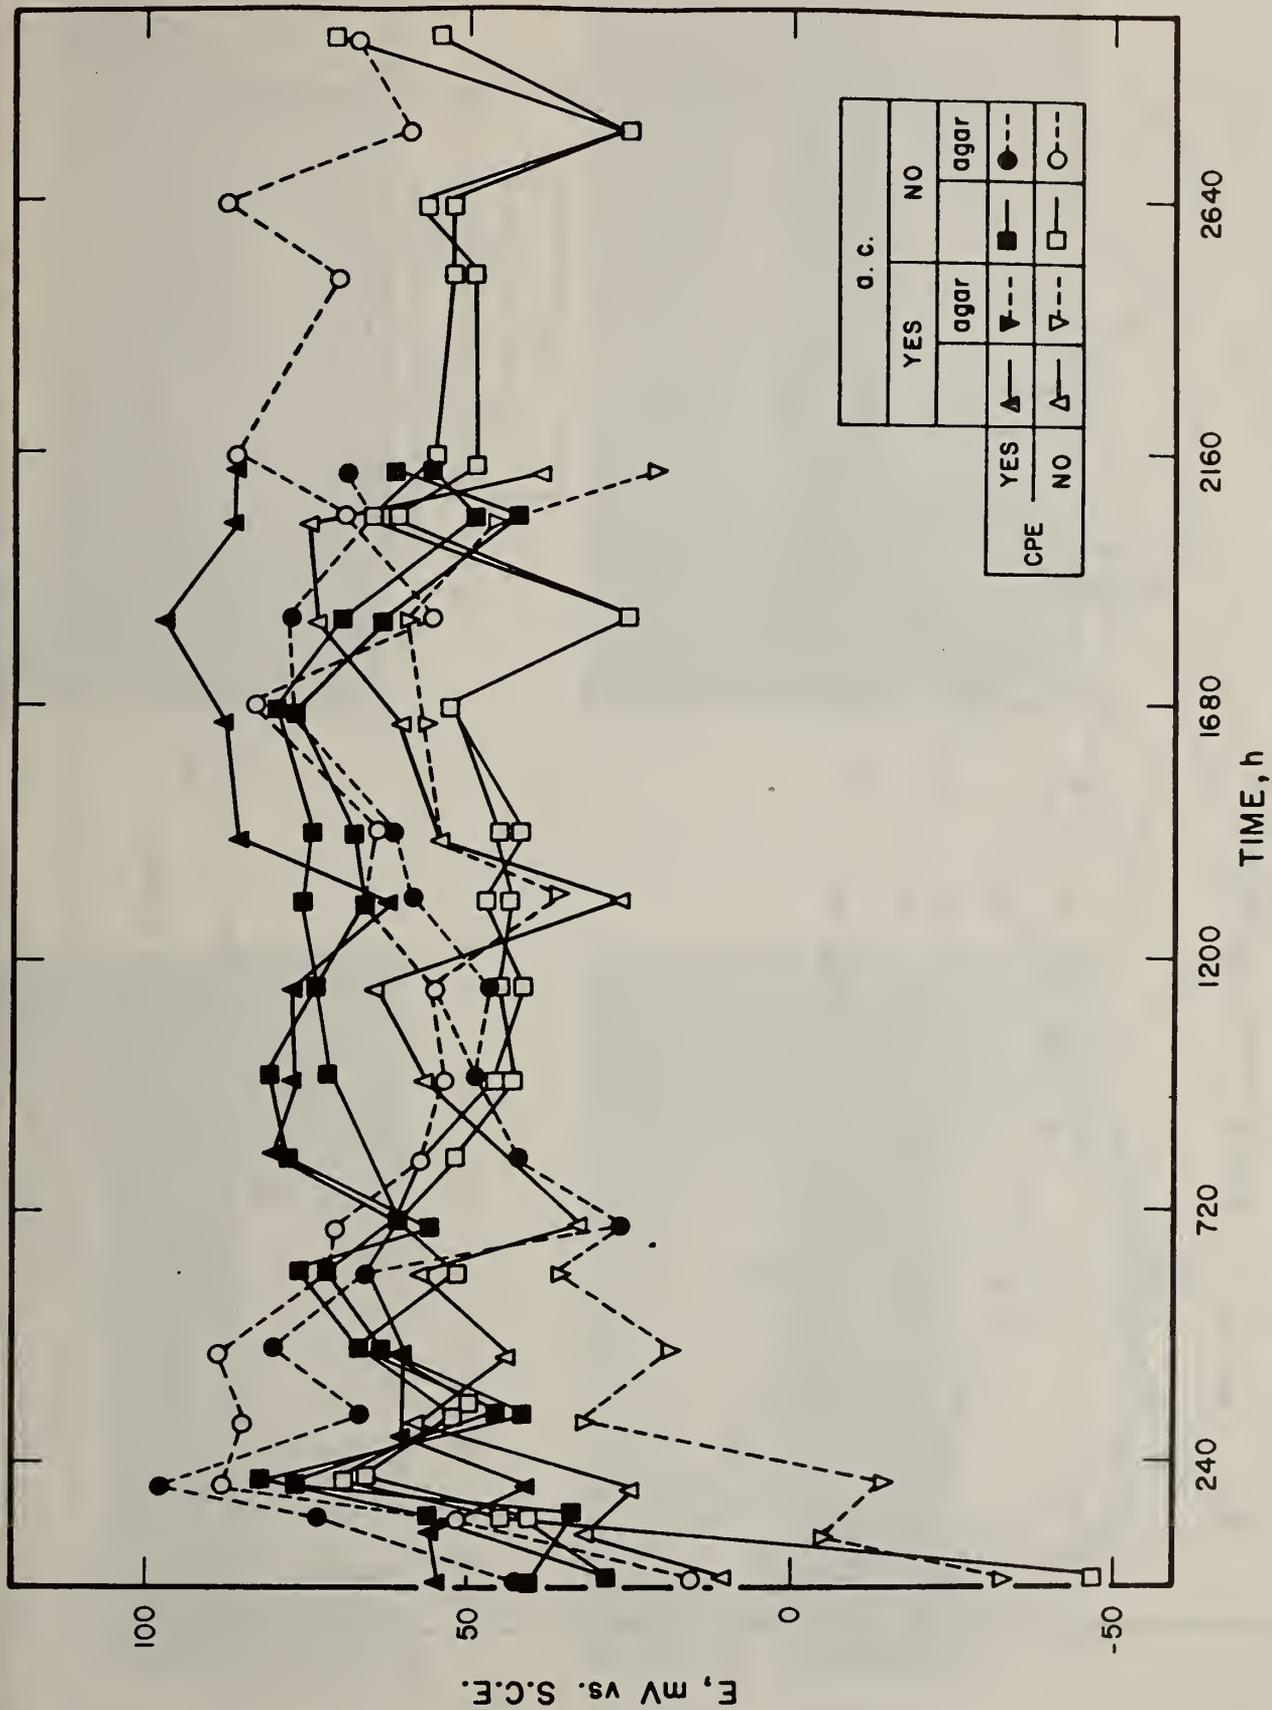
Fig. 9. Electrode potential vs. time for tinned Cu wire in 0.42 M NaClO<sub>4</sub>, 0<sub>2</sub> atmosphere.

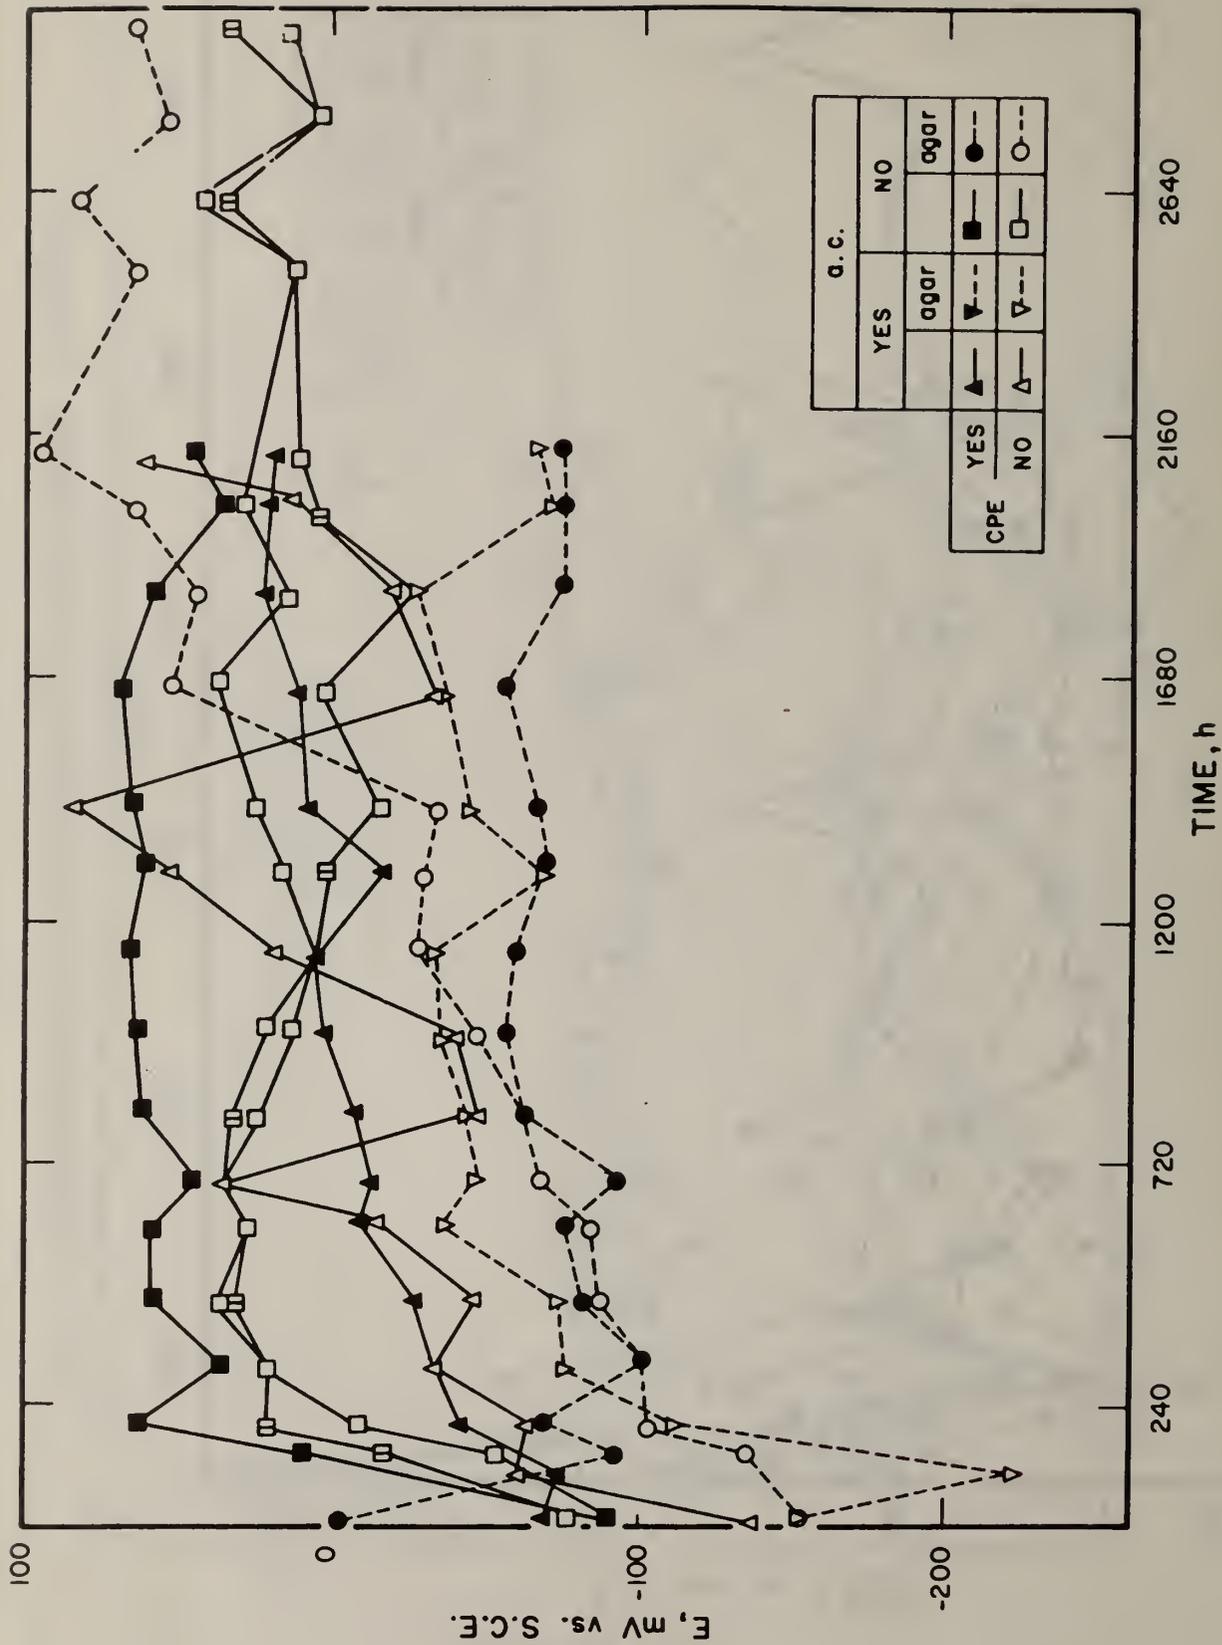
Fig. 10. Electrode potential vs. time for tinned Cu wire in 0.42 M NaClO<sub>4</sub> + 1% NaCl. O<sub>2</sub> atmosphere.

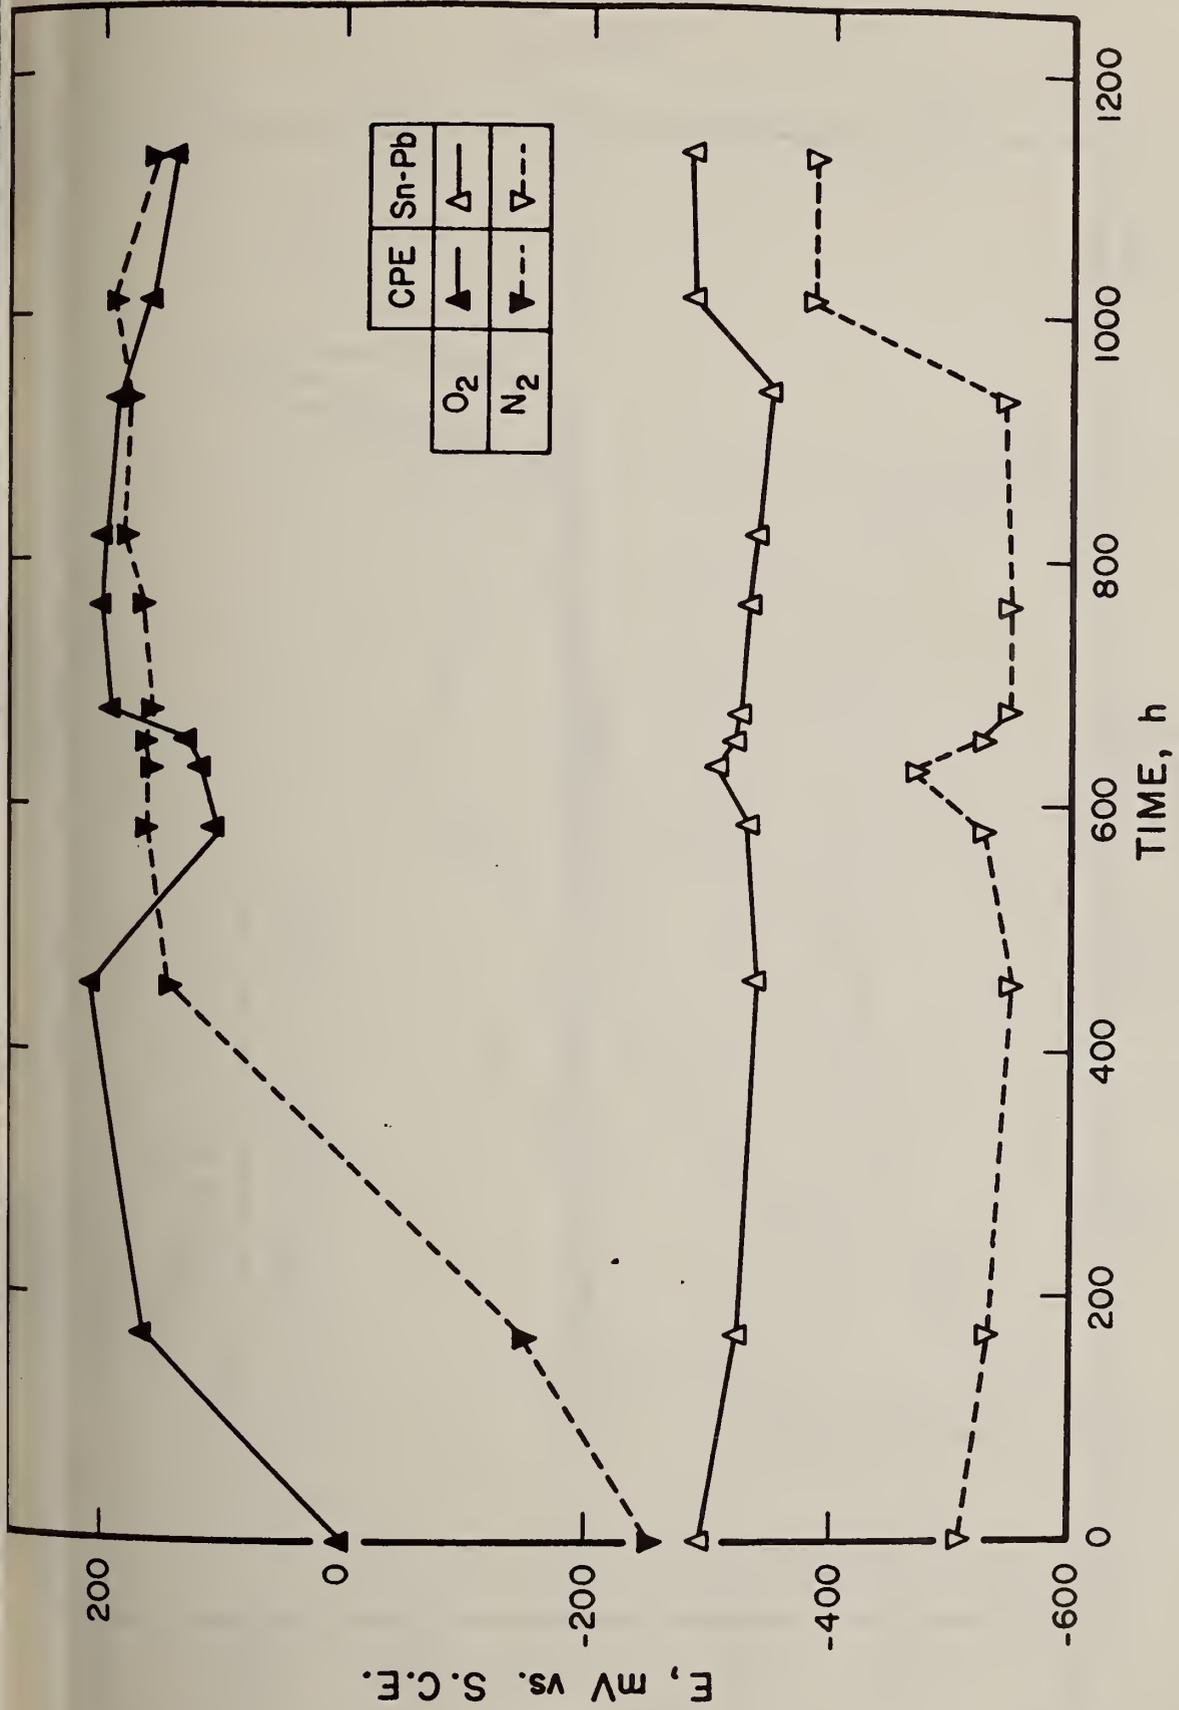
Fig. 16. Rest potentials vs. time of CPE and Pb-Sn alloy in 2% Na<sub>2</sub>SO<sub>4</sub> + 1% NaCl.
