# **Development of In-Situ Techniques for the Detection and Measurement of Corrosion of Copper Concentric Neutrals in Underground Environments**

Annual Report

Annual Technical Report for Period January 15, 1976 to January 15, 1977

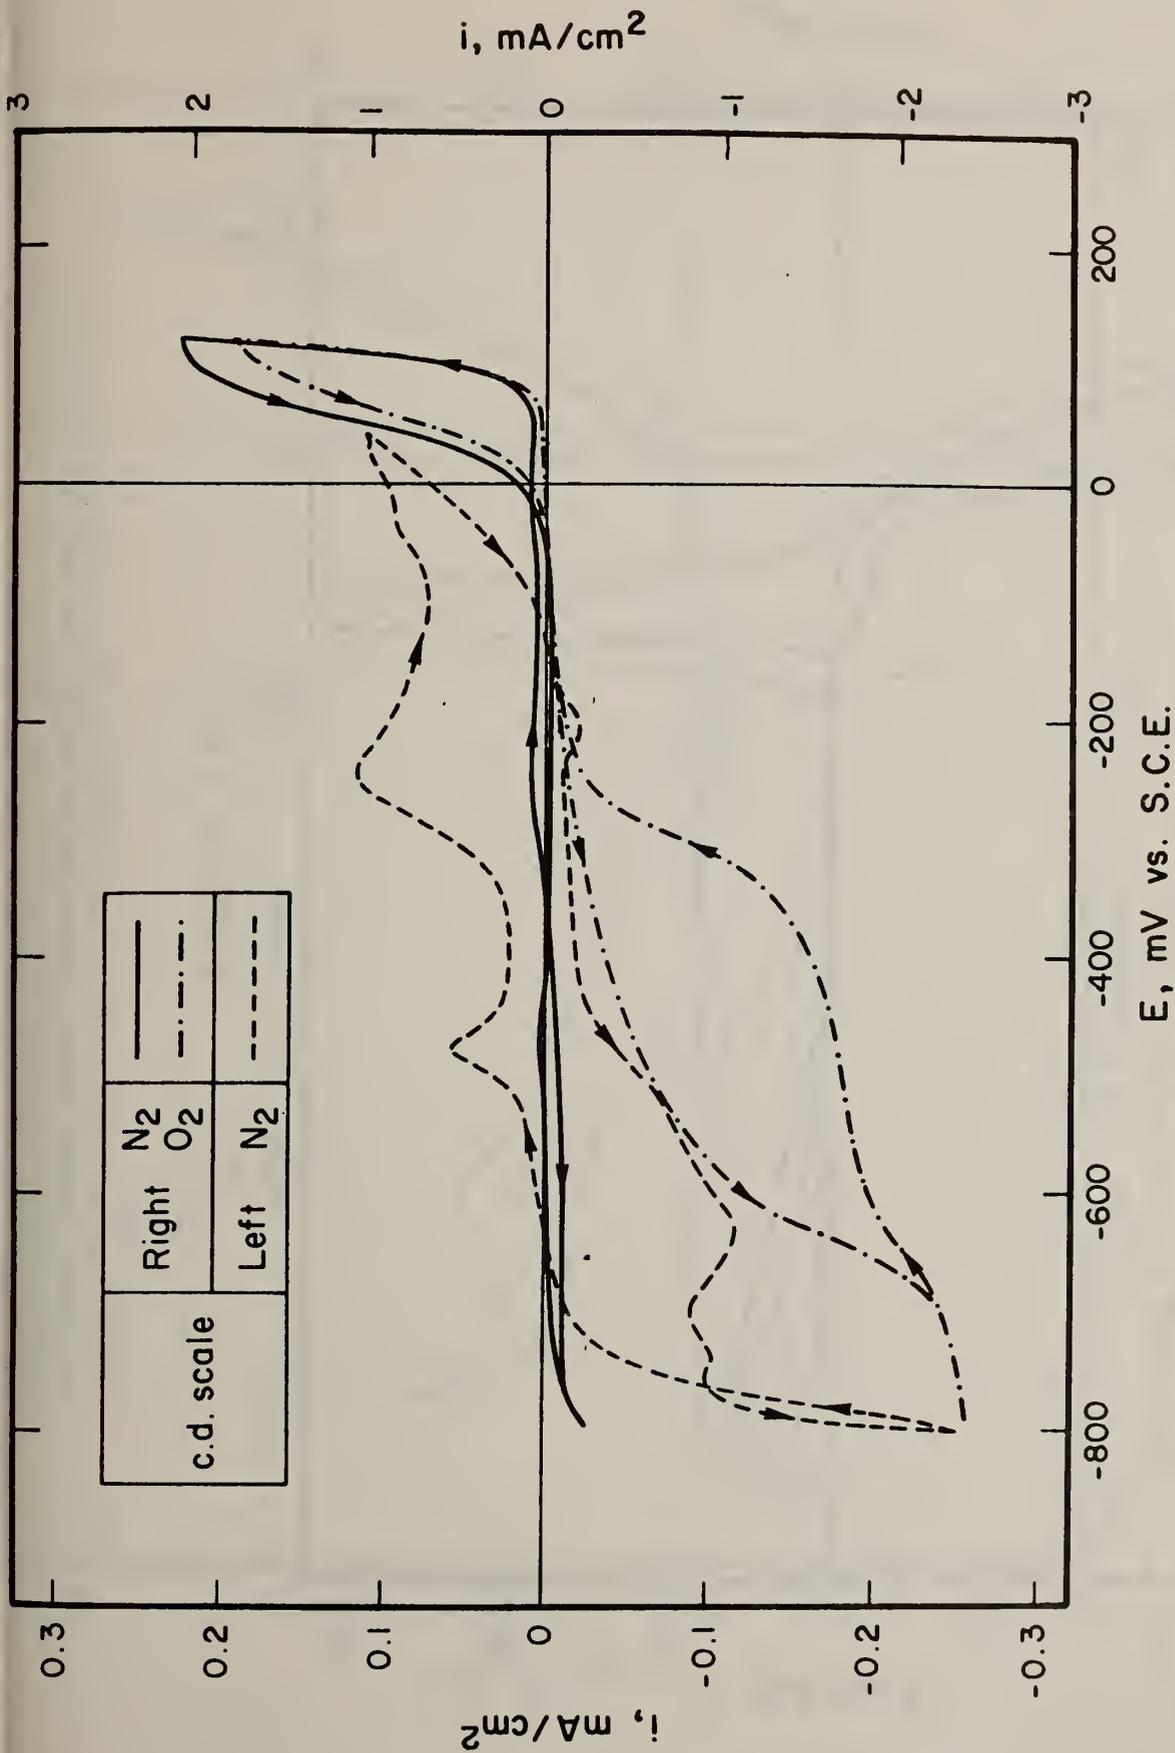
Fig. 17. Potentiodynamic scans for tinned Cu in 2% Na<sub>2</sub>SO<sub>4</sub>. Scan rate 4 mV/sec. Dashed curve is expansion of solid curve and refers to c.d. scale on left.

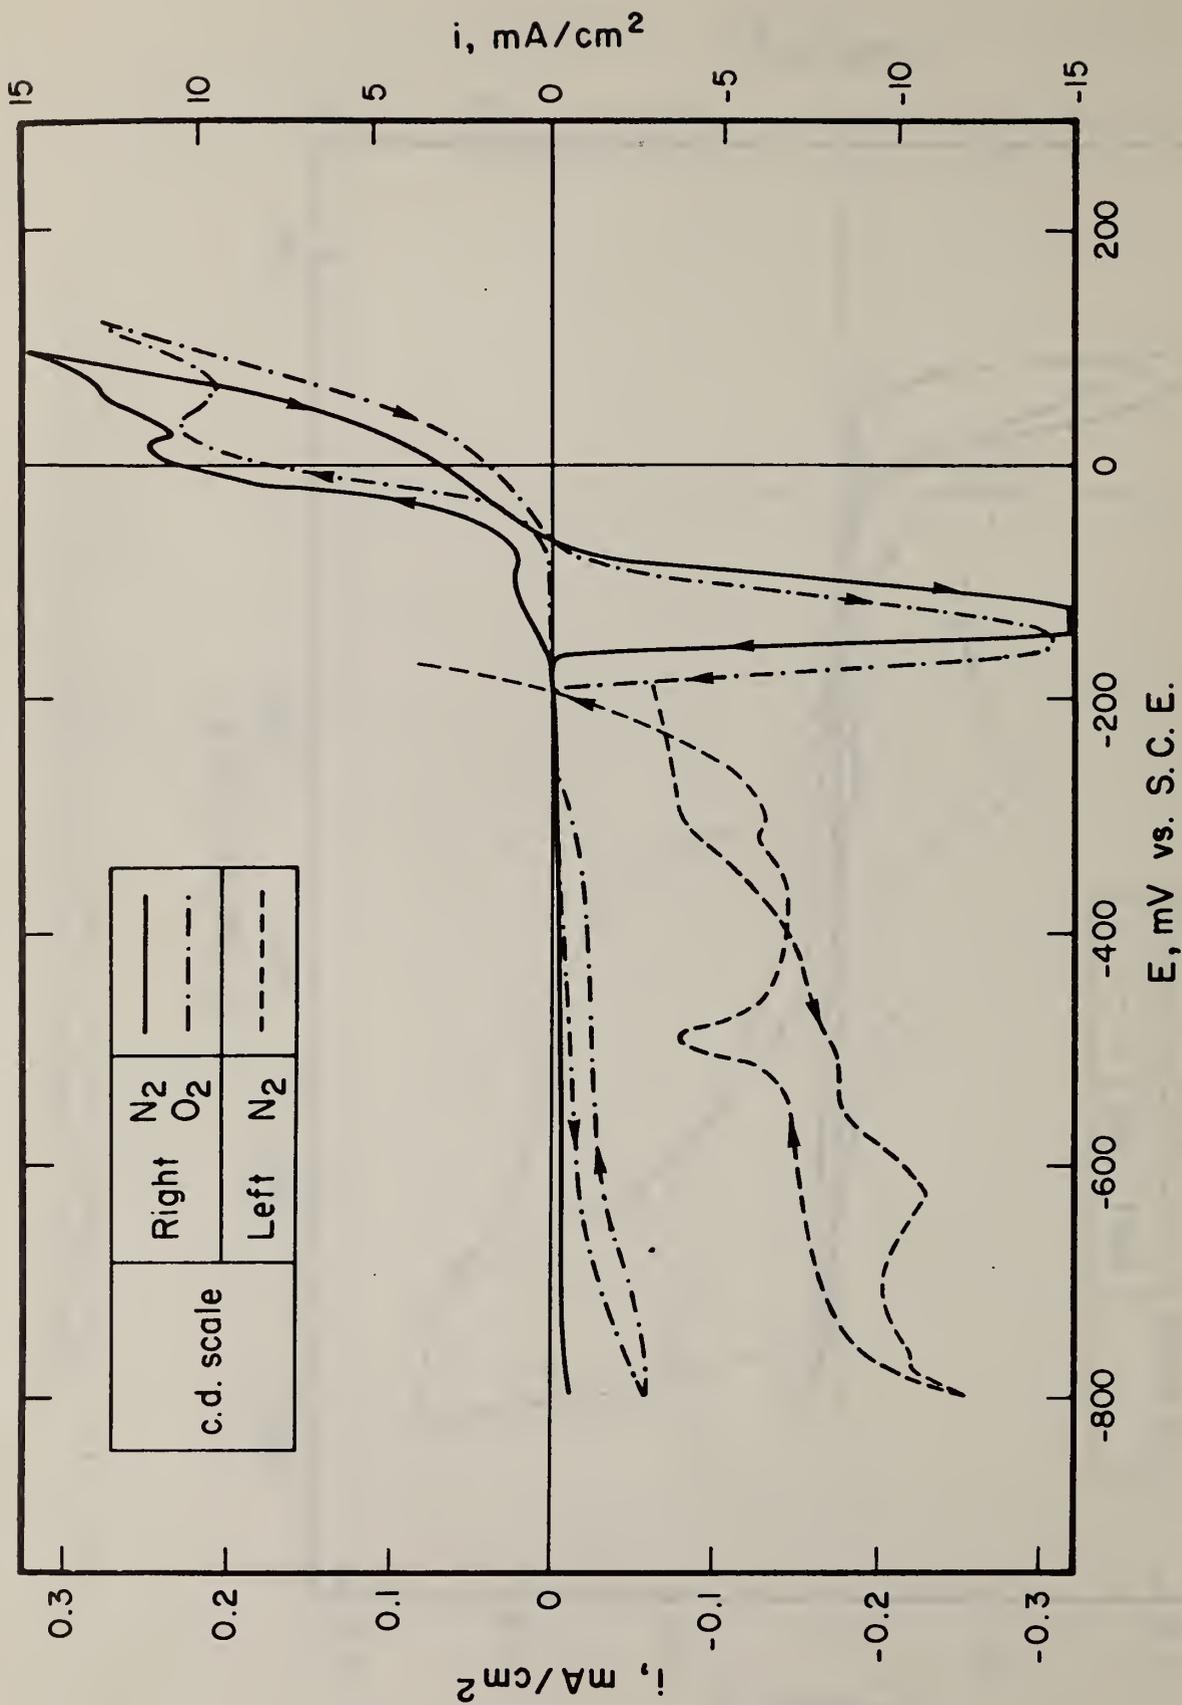
Fig. 18. Potentiodynamic scans for tinned Cu in 2% Na<sub>2</sub>SO<sub>4</sub> + 1% NaCl. Scan rate 4 mV/sec. Dashed curve is expansion of solid curve and refers to c.d. scale on left.

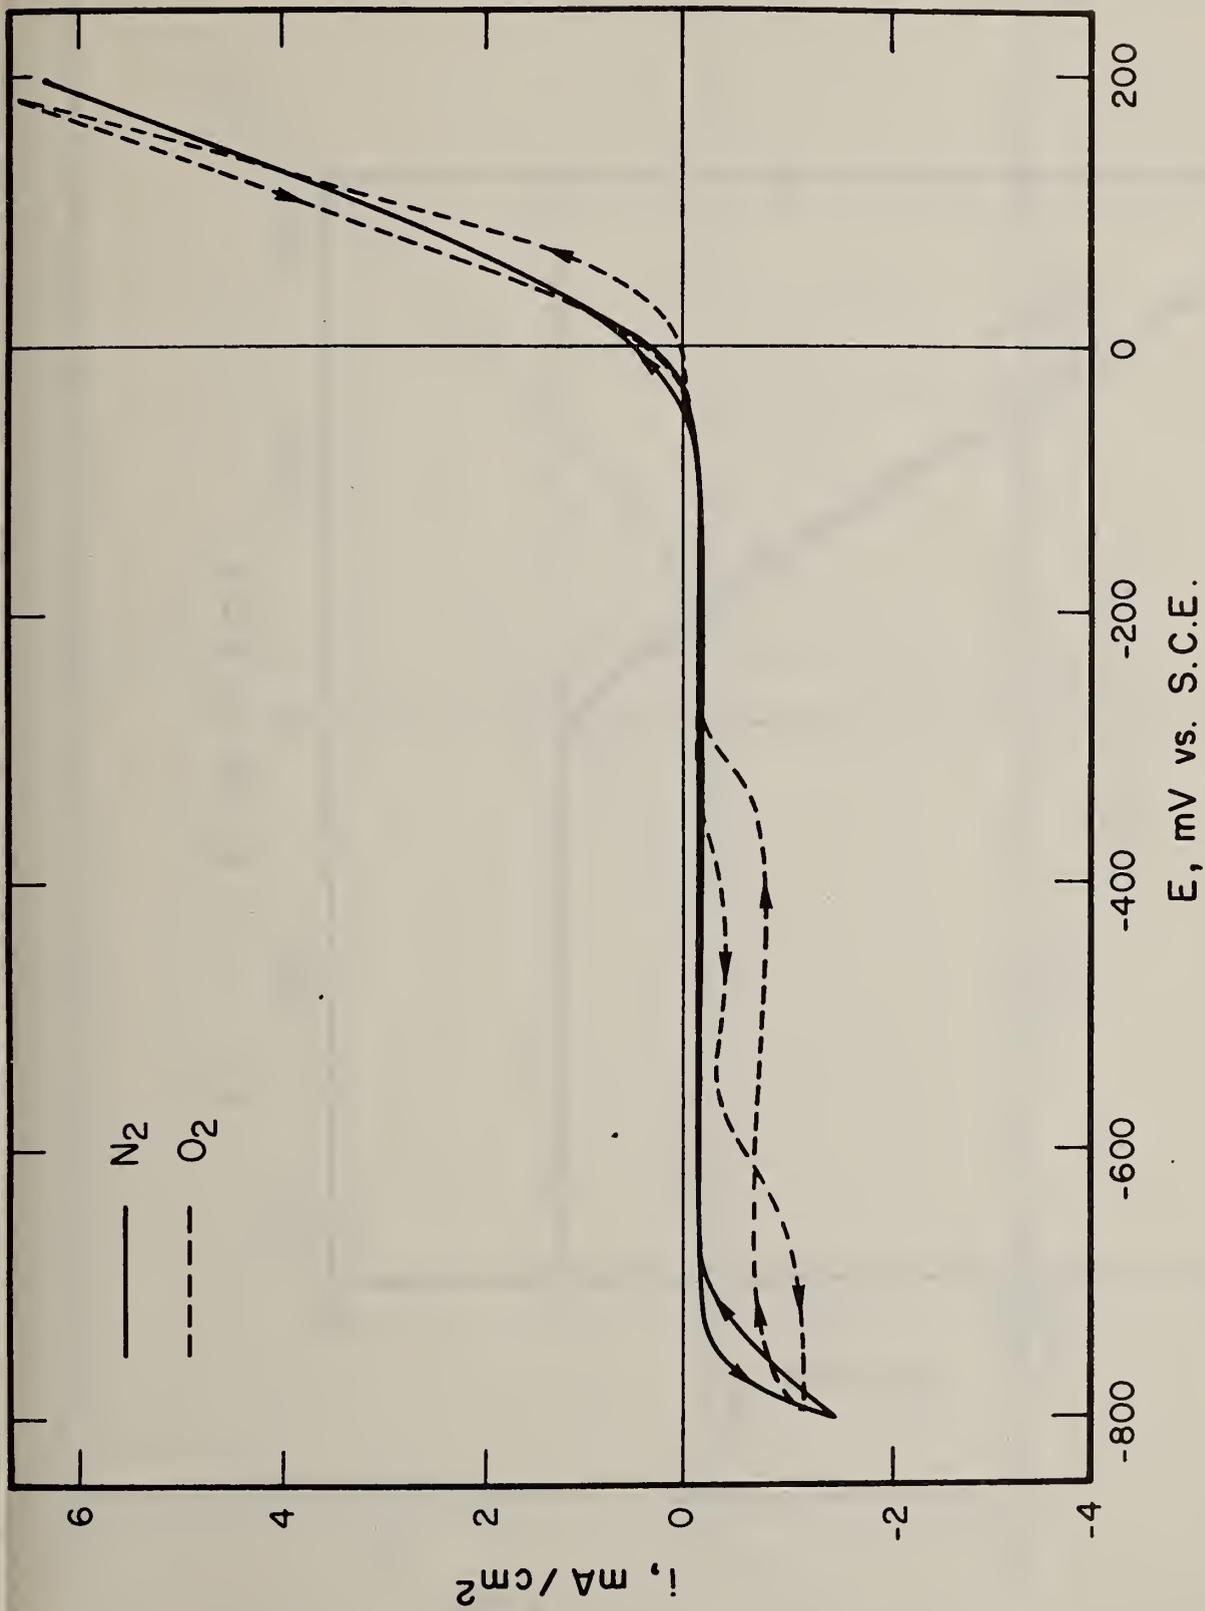
Fig. 19. Potentiodynamic scans for Cu in 2% Na<sub>2</sub>SO<sub>4</sub>. Scan rate 4 mV/sec.

The results obtained on pure copper are shown in Figs. 19 to 24. In the absence of chlorides no detectable formation of a passive, protecting film is observed, whether in  $\text{Na}_2\text{SO}_4$  or in  $\text{NaClO}_4$ . Fig. 19 shows the scans in sulfate in oxygen or in nitrogen over the scan range of greatest interest for our study from  $-800$  to  $+200$  mV vs. SCE. Fig. 20 shows the monotonic increase of anodic current with the extension of the range up to  $+800$  mV. The curve in Fig. 21 shows that the same behavior, with even larger current densities, is observed in perchlorate. From these data, and from visual observation of the solution in the cell, it is quite clear that the  $\text{Cu}^{++}$  ion produced anodically is precipitated as hydroxide away from the electrode surface and never forms any protective layer on the metal surface. As a consequence, no cathodic reduction takes place, in the absence of oxygen, until hydrogen can evolve during the cathodic sweep.

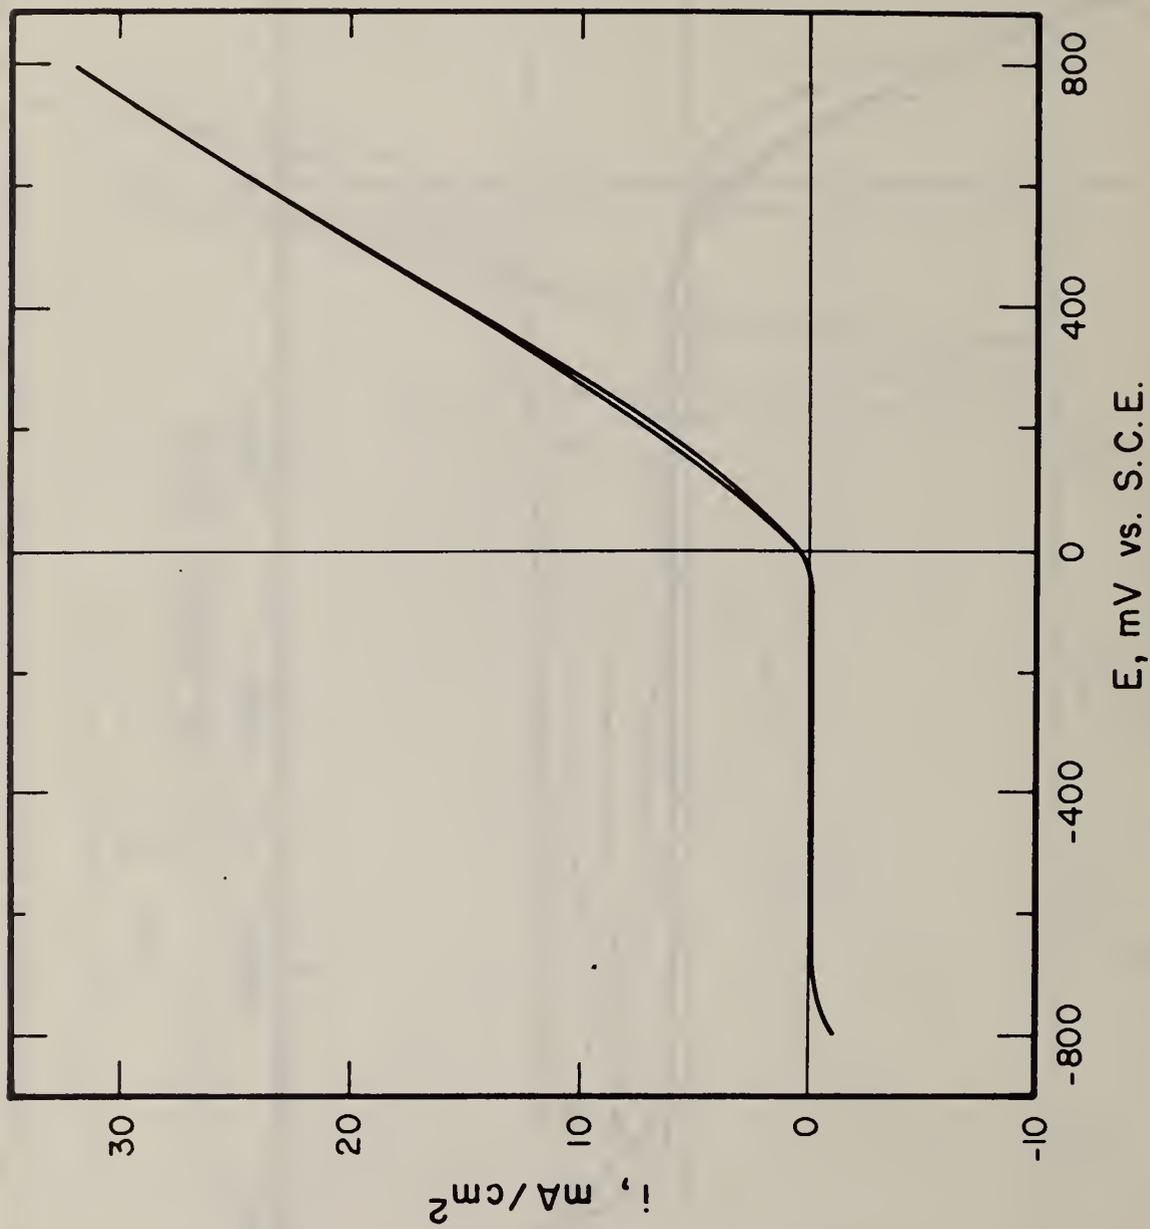
Fig. 20. Potentiodynamic scans for Cu in 2 M Na<sub>2</sub>SO<sub>4</sub> up to +800 mV. Scan rate 4 mV/sec.

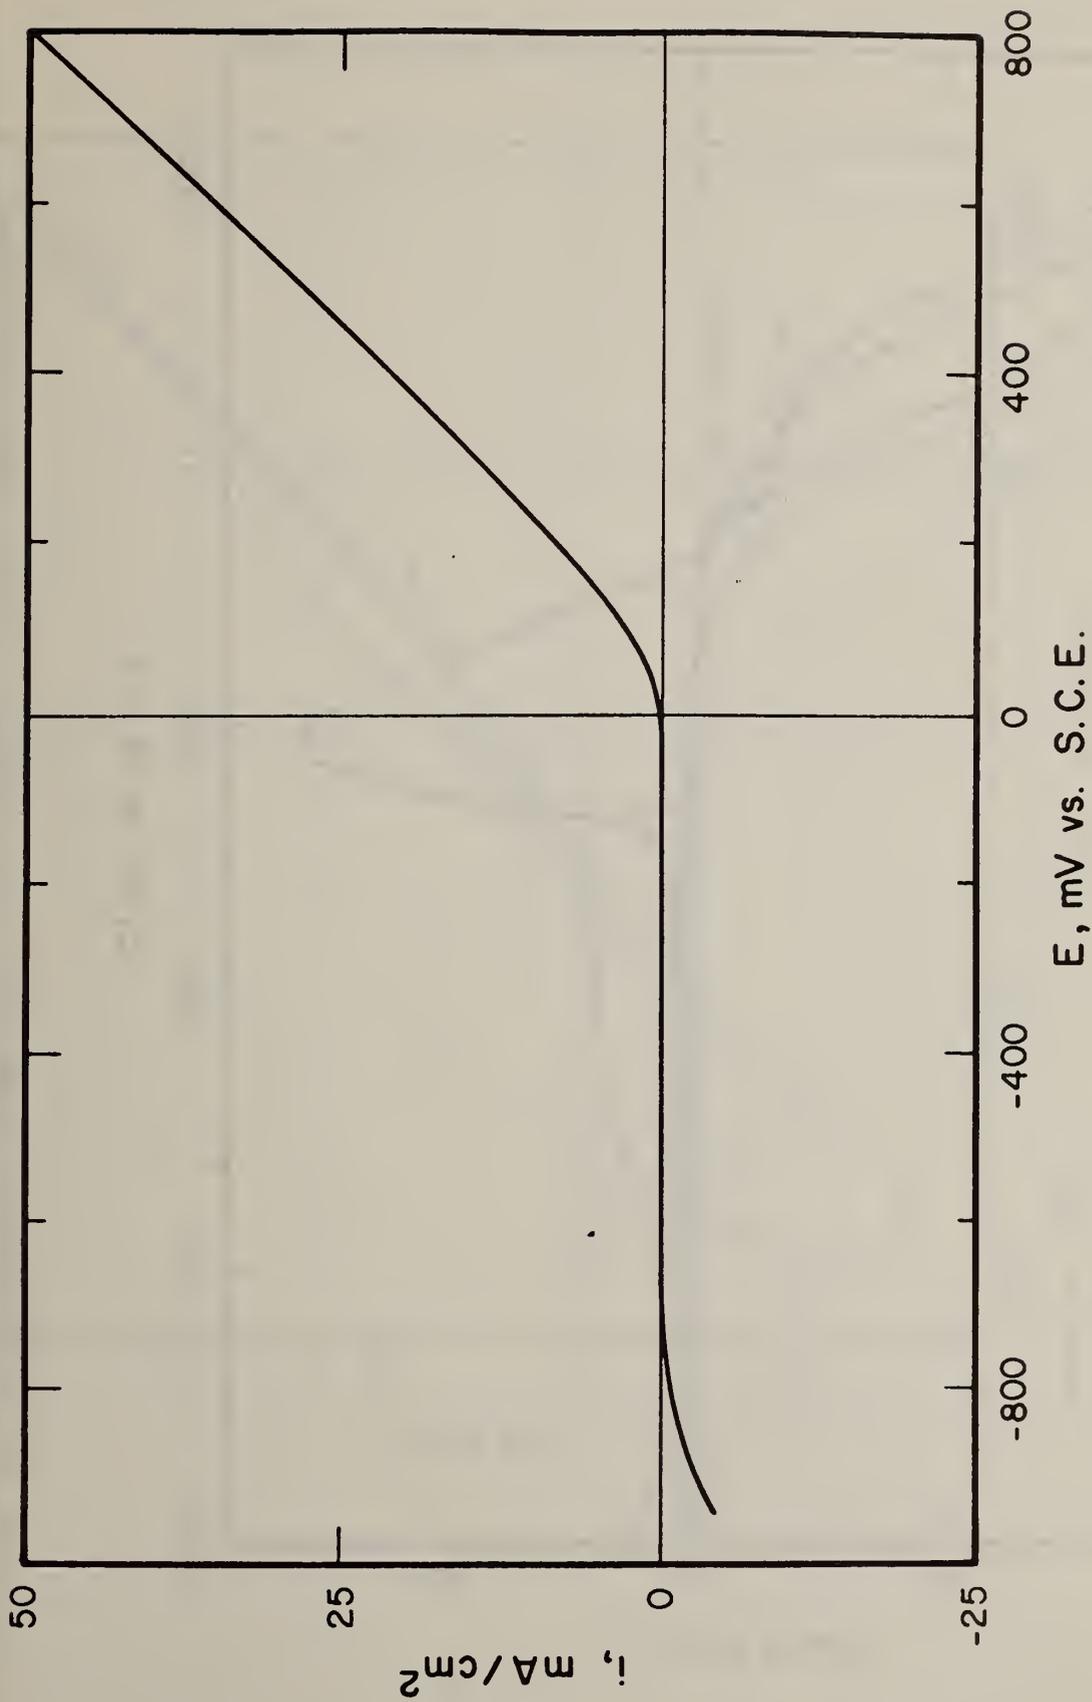
Fig. 21. Potentiodynamic scan for Cu in 0.42 M  $\text{NaClO}_4$ . Inert atmosphere.  
Scan rate 4  $\text{mV}/\text{sec}$ .

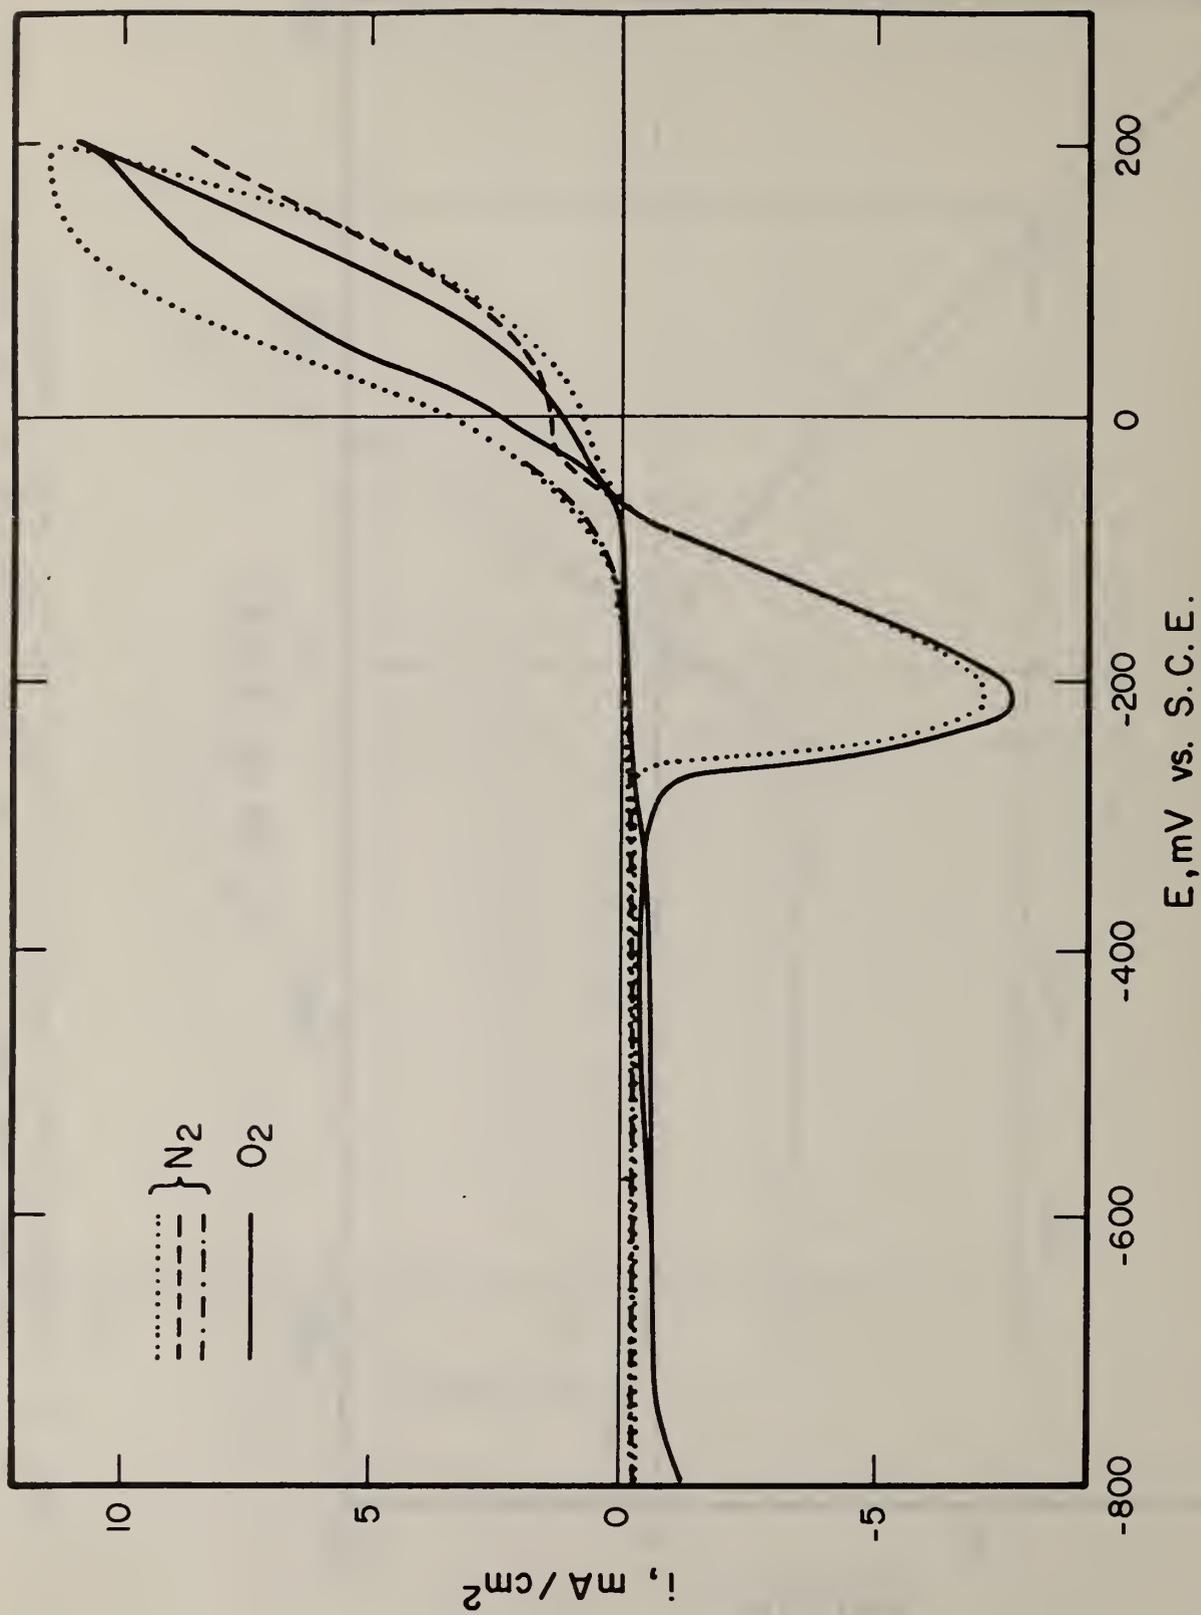
Fig. 22. Potentiodynamic scans for Cu in 2%  $\text{H}_2\text{SO}_4$  + 1%  $\text{NaCl}$ . Scan rate 4 mV/sec.

In the presence of chlorides in solution, a precipitate is formed during anodic attack, sufficiently adherent to produce a cathodic peak during the negative sweep. However, the precipitate is very ineffective in protecting the metal, and although causing some poorly reproducible peaks and inflections on the anodic branch, it fails to limit the anodic current density which can reach  $60 \text{ mA/cm}^2$  at  $+800$  mV as shown in Fig. 23. Comparison between Figs. 22, 23, and 24 shows that the position of the cathodic peak is shifted toward more negative values by extending the anodic range as well by increasing the scan rate. The anodic branch, on the contrary, is little affected by changes in scan rate indicating that the behavior is not a transient one.

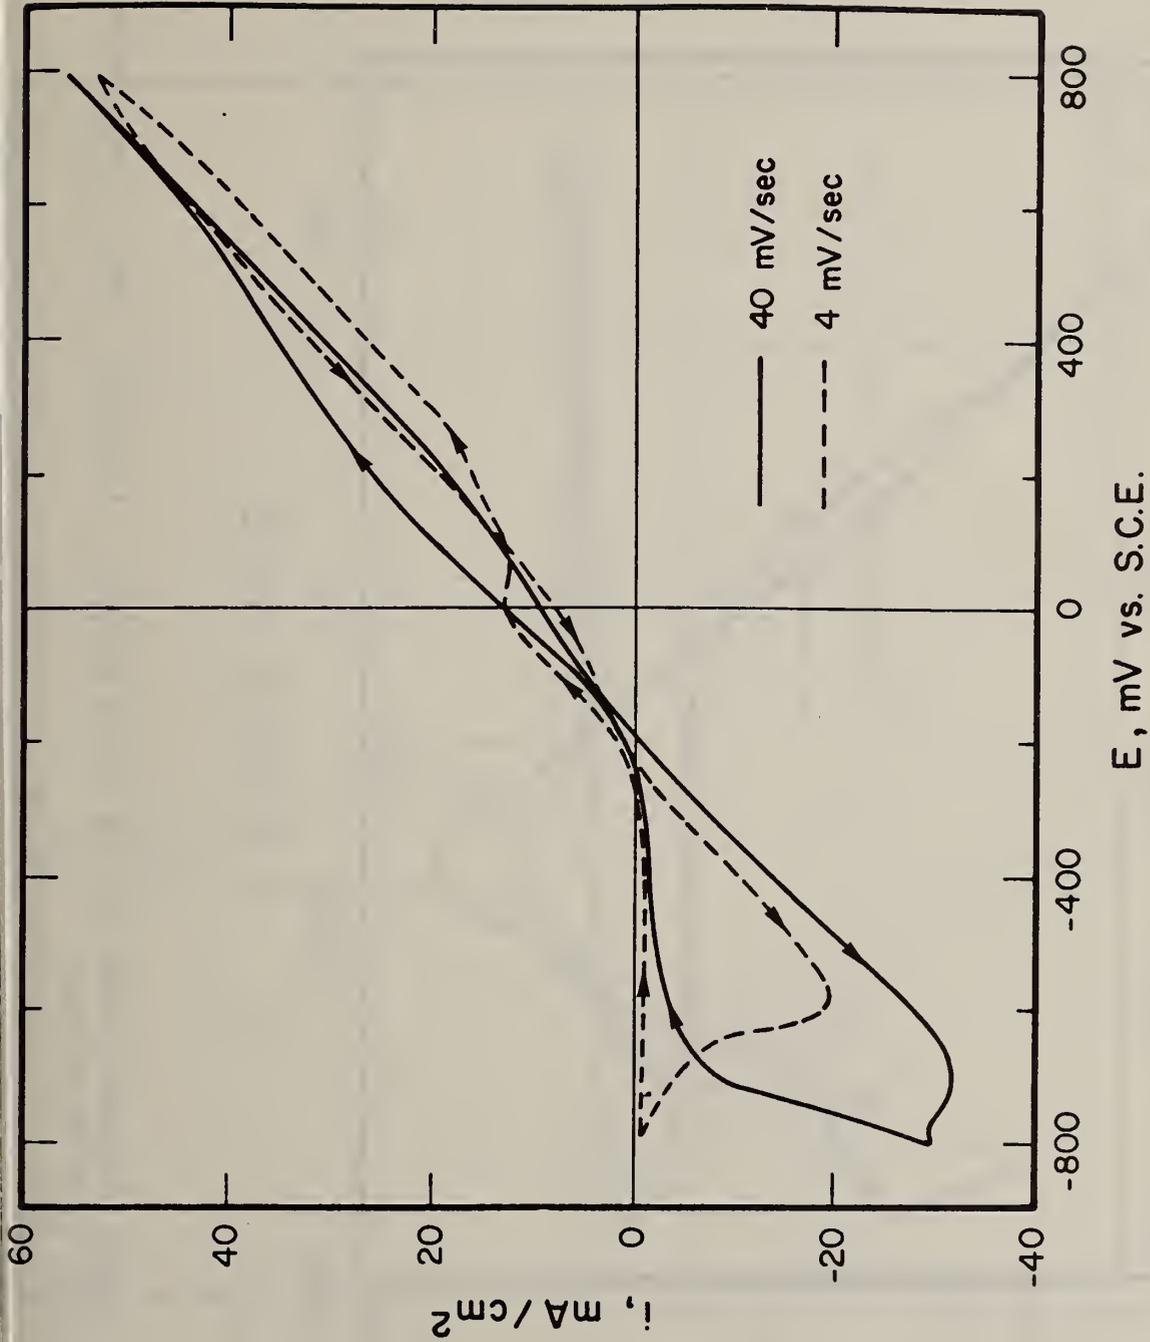
Fig. 23. Potentiodynamic scans for Cu in  $2.0 \text{ M H}_2\text{SO}_4 + 1\% \text{ NaCl}$ . Inert atmosphere.

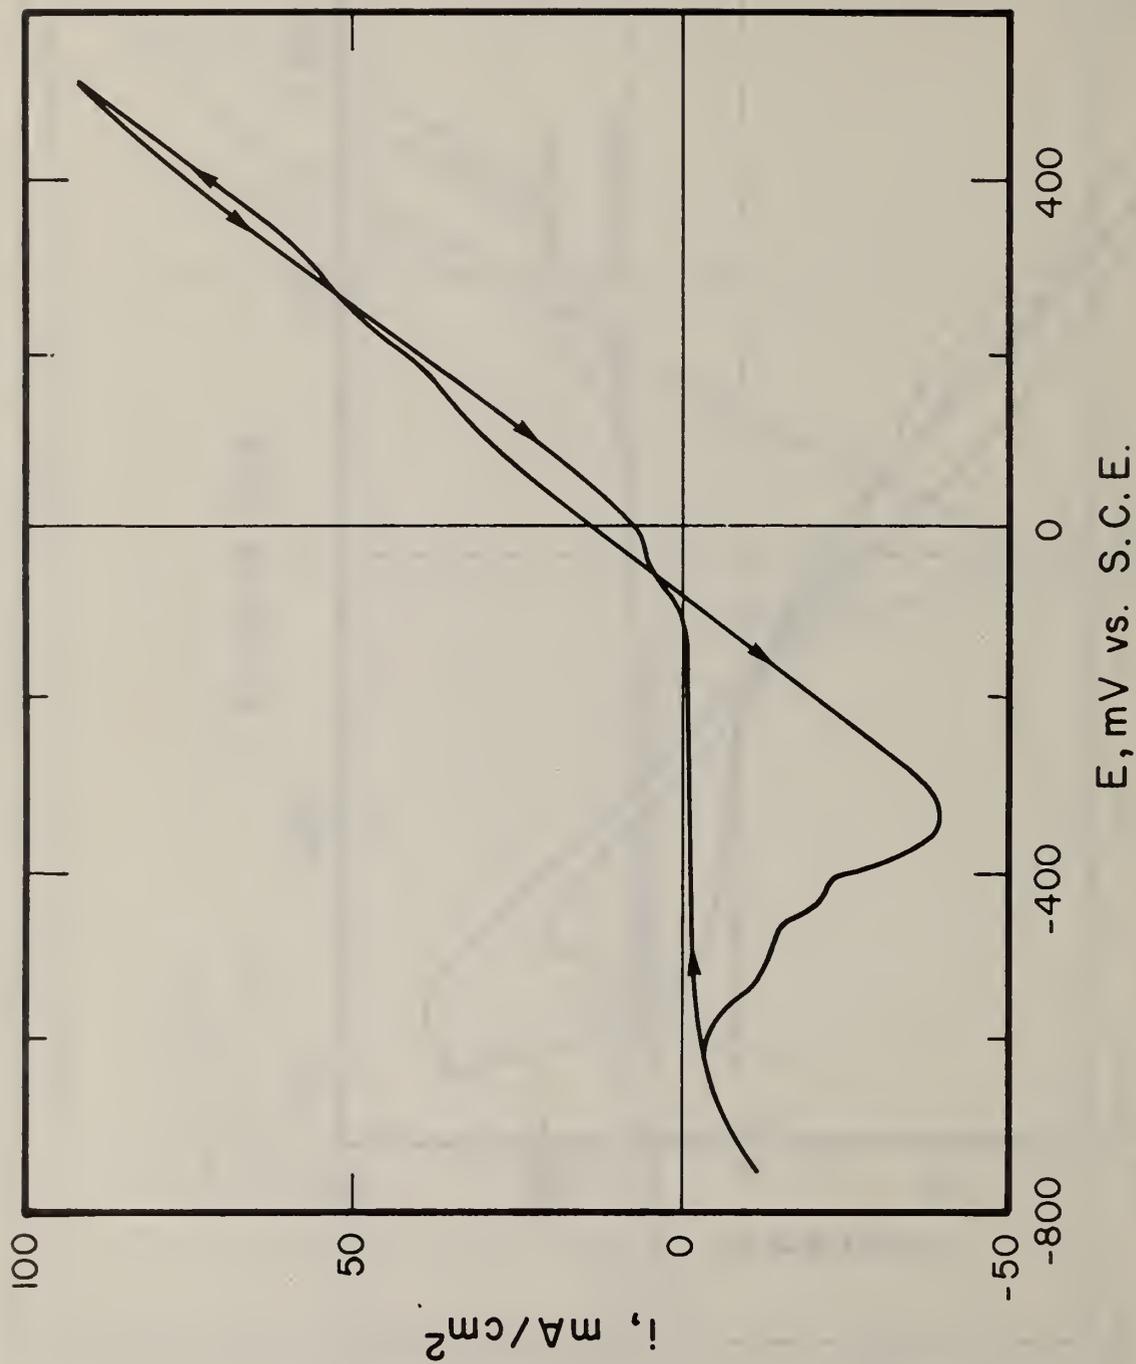
Fig. 24. Potentiodynamic scan for Cu in 2%  $\text{Na}_2\text{SO}_4$  + 1% NaCl. Inert atmosphere. Scan rate 40 mV/sec.

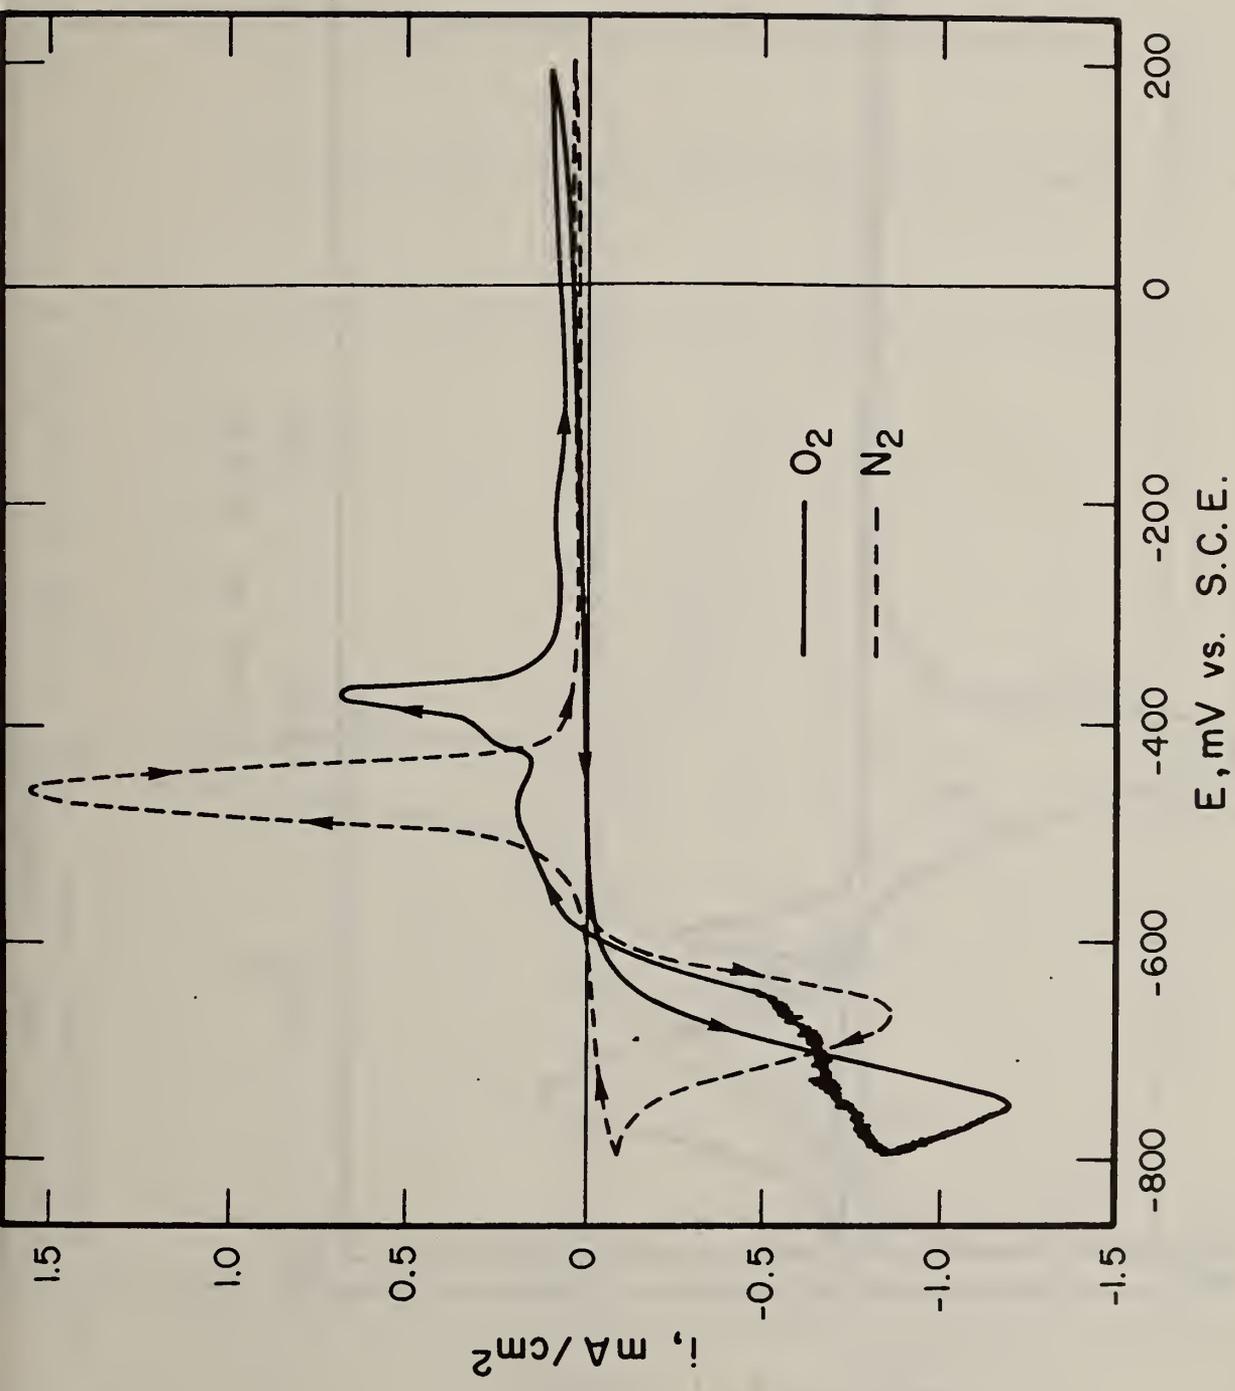
Fig. 25. Potentiodynamic scans for Pb-Sn alloy in 2M H<sub>2</sub>SO<sub>4</sub>. Scan rate 4 mV/sec.

The electrochemical behavior of the 90% Pb-10% Sn alloy, both in the absence and in the presence of chlorides, is described in Figs. 25, 26, and 27. Scans were carried out changing the range and the rate in chloride containing solutions. The results have confirmed that the more negative of the cathodic peaks corresponds to the anodic peak and is caused by the irreversible reduction of a  $\text{PbSO}_4$  film. The more positive of the cathodic peaks is absent if the scan does not exceed  $-200$  mV (see dashed curve in Fig. 27) and corresponds to an anodic oxidation occurring between  $-200$  mV and  $+200$  mV, probably the formation of lead chloride. The metal exhibits passive behavior up to  $800$  mV vs. SCE.

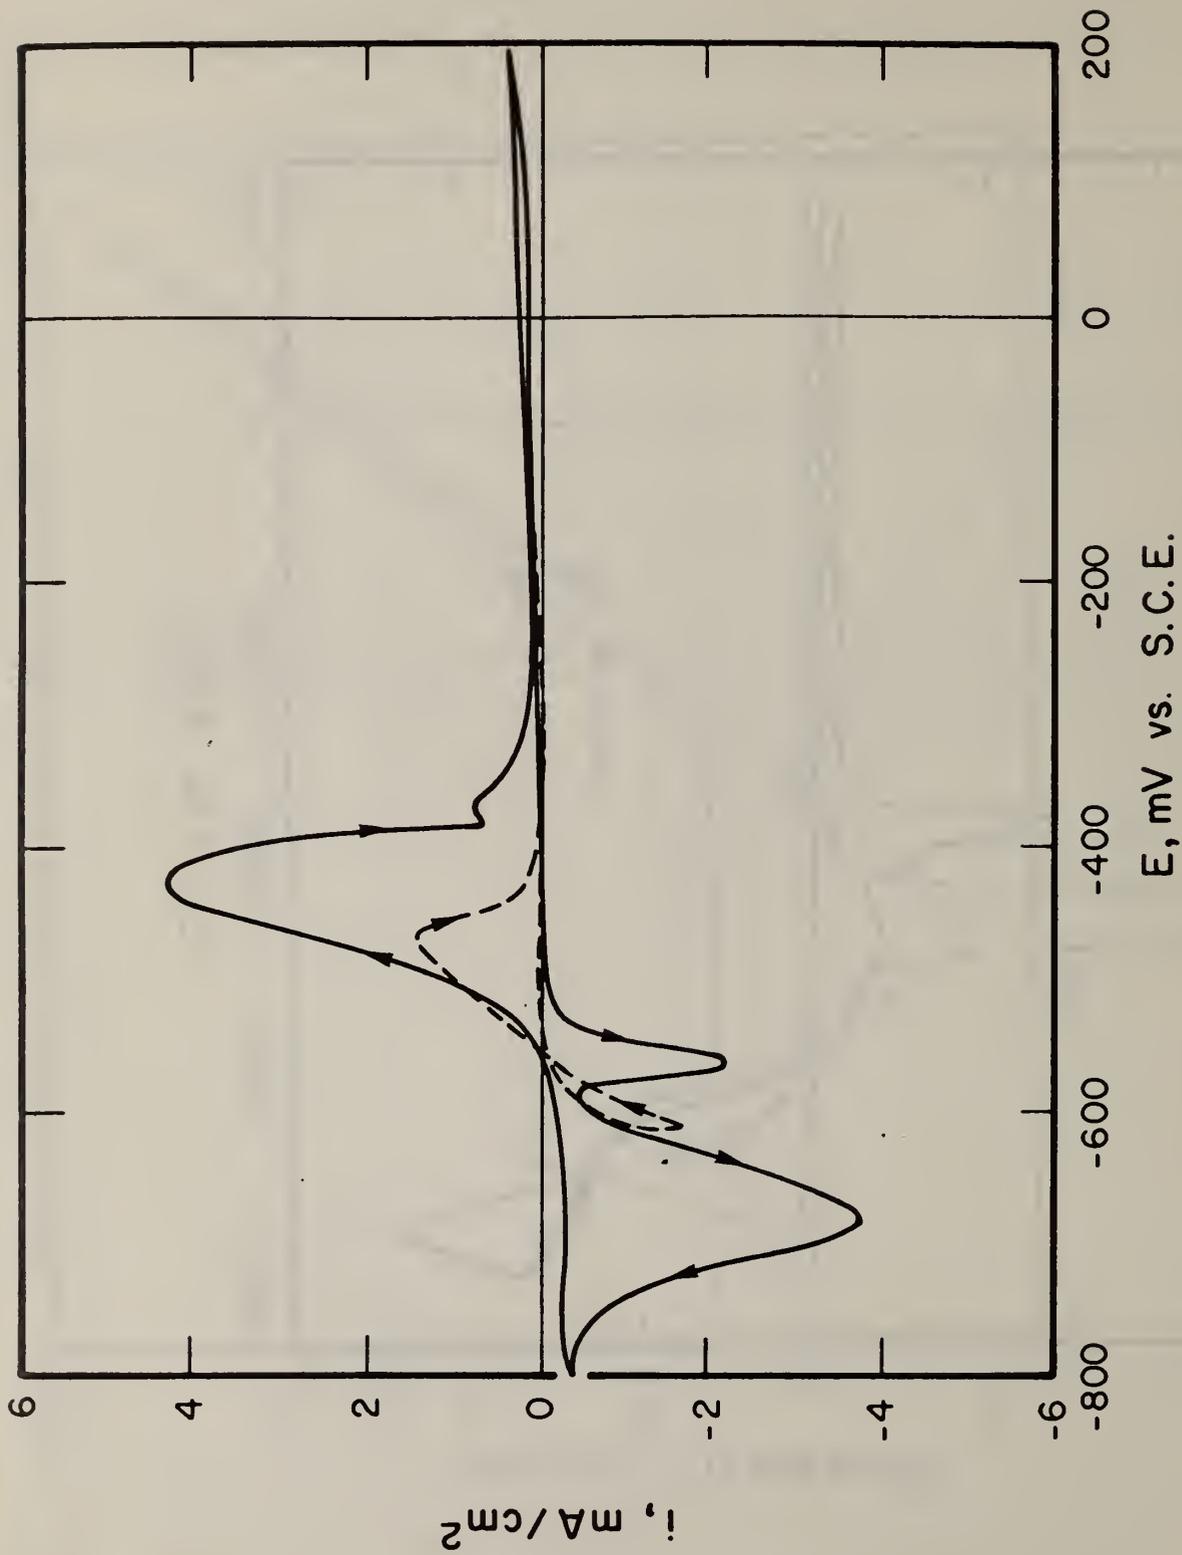
Fig. 26. Potentiodynamic scans for Pb-Sn alloy in 2%  $\text{H}_2\text{SO}_4$  + 1%  $\text{NaCl}$ . Scan rate 4 mV/sec. Inert atmosphere.

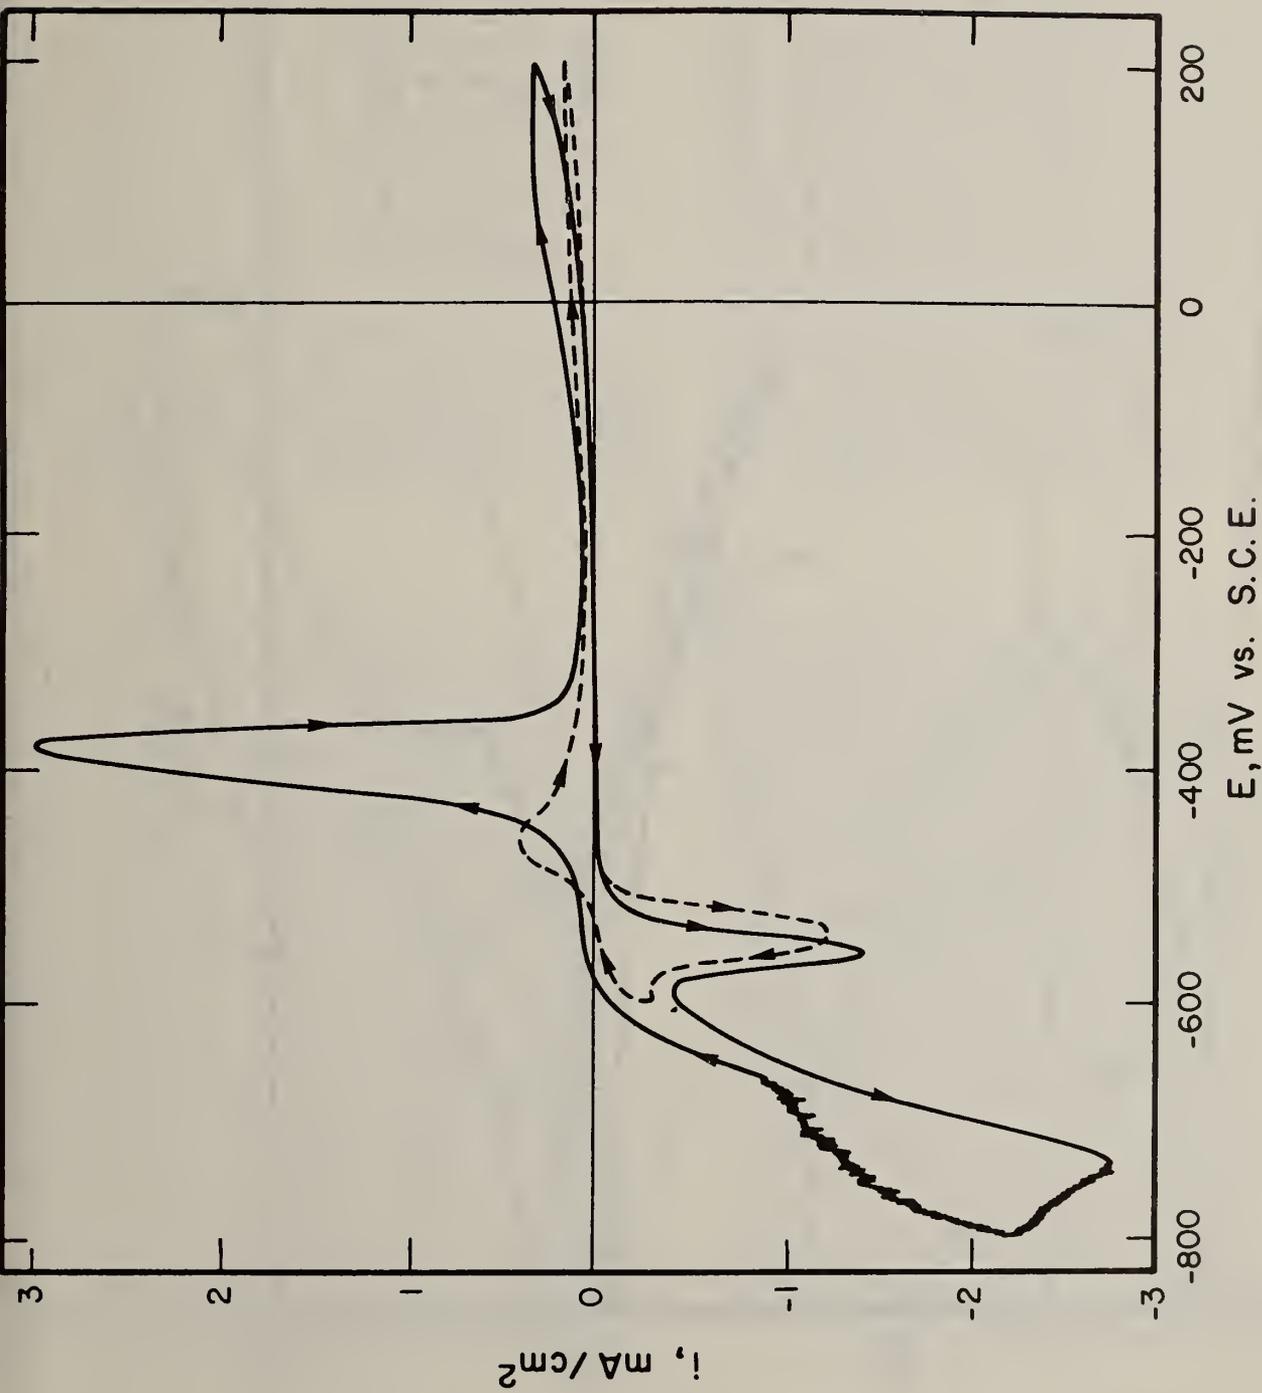
Fig. 27. Potentiodynamic scans for Pb-Sn alloy in 2%  $\text{H}_2\text{SO}_4$  + 1%  $\text{NaCl}$ . Oxygen atmosphere. Scan rate 4 mV/sec.

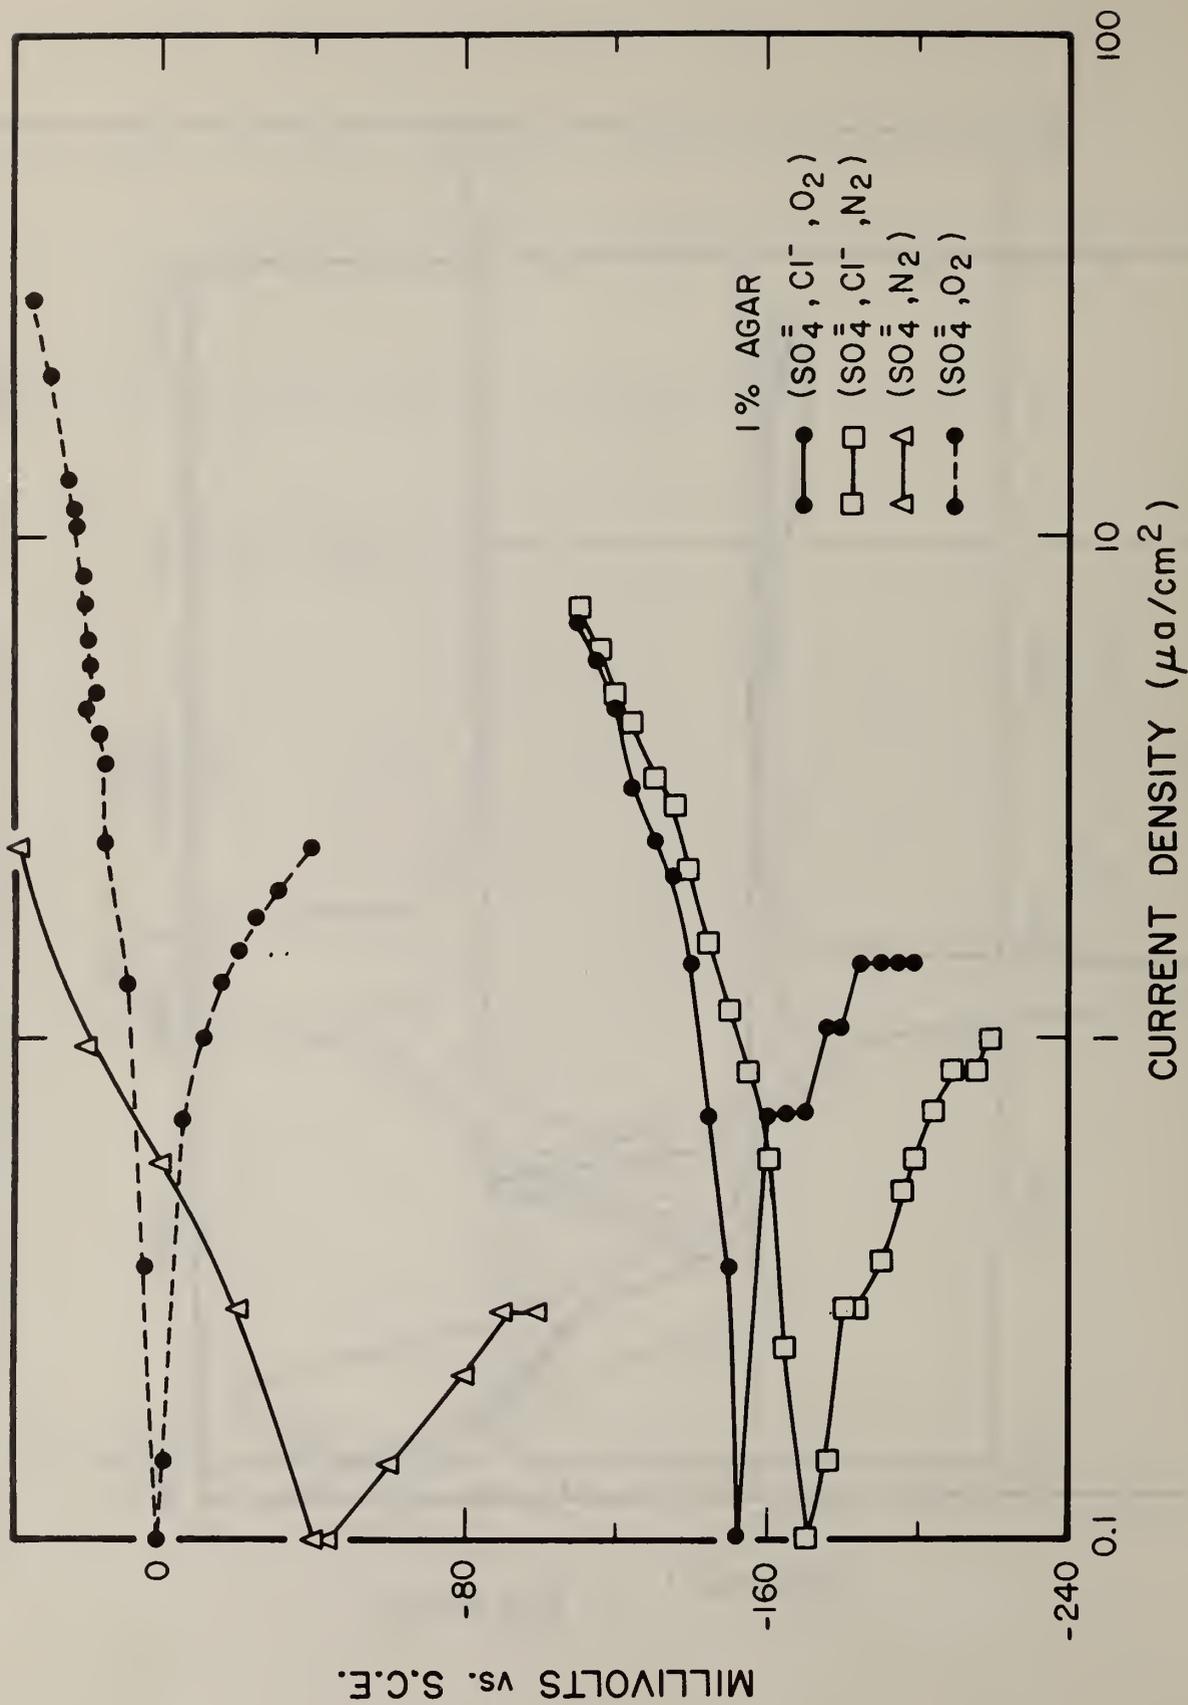
Fig. 28. Polarization curves for tinned Cu wire in 2% Na<sub>2</sub>SO<sub>4</sub>, taken in December 1976.

Values obtained in December 1976 are shown in Fig. 28 and those obtained in January 1977 in Fig. 29. For the moment the open circuit potentials have shifted somewhat, but there are not significant changes in the curves. The corrosion current densities, estimated roughly from the curves, are of the order of  $1 \mu\text{A}/\text{cm}^2$ .
