# **Development of In-Situ Techniques for the Detection and Measurement of Corrosion of Copper Concentric Neutrals in Underground Environments**

Annual Report

Annual Technical Report for Period January 15, 1976 to January 15, 1977

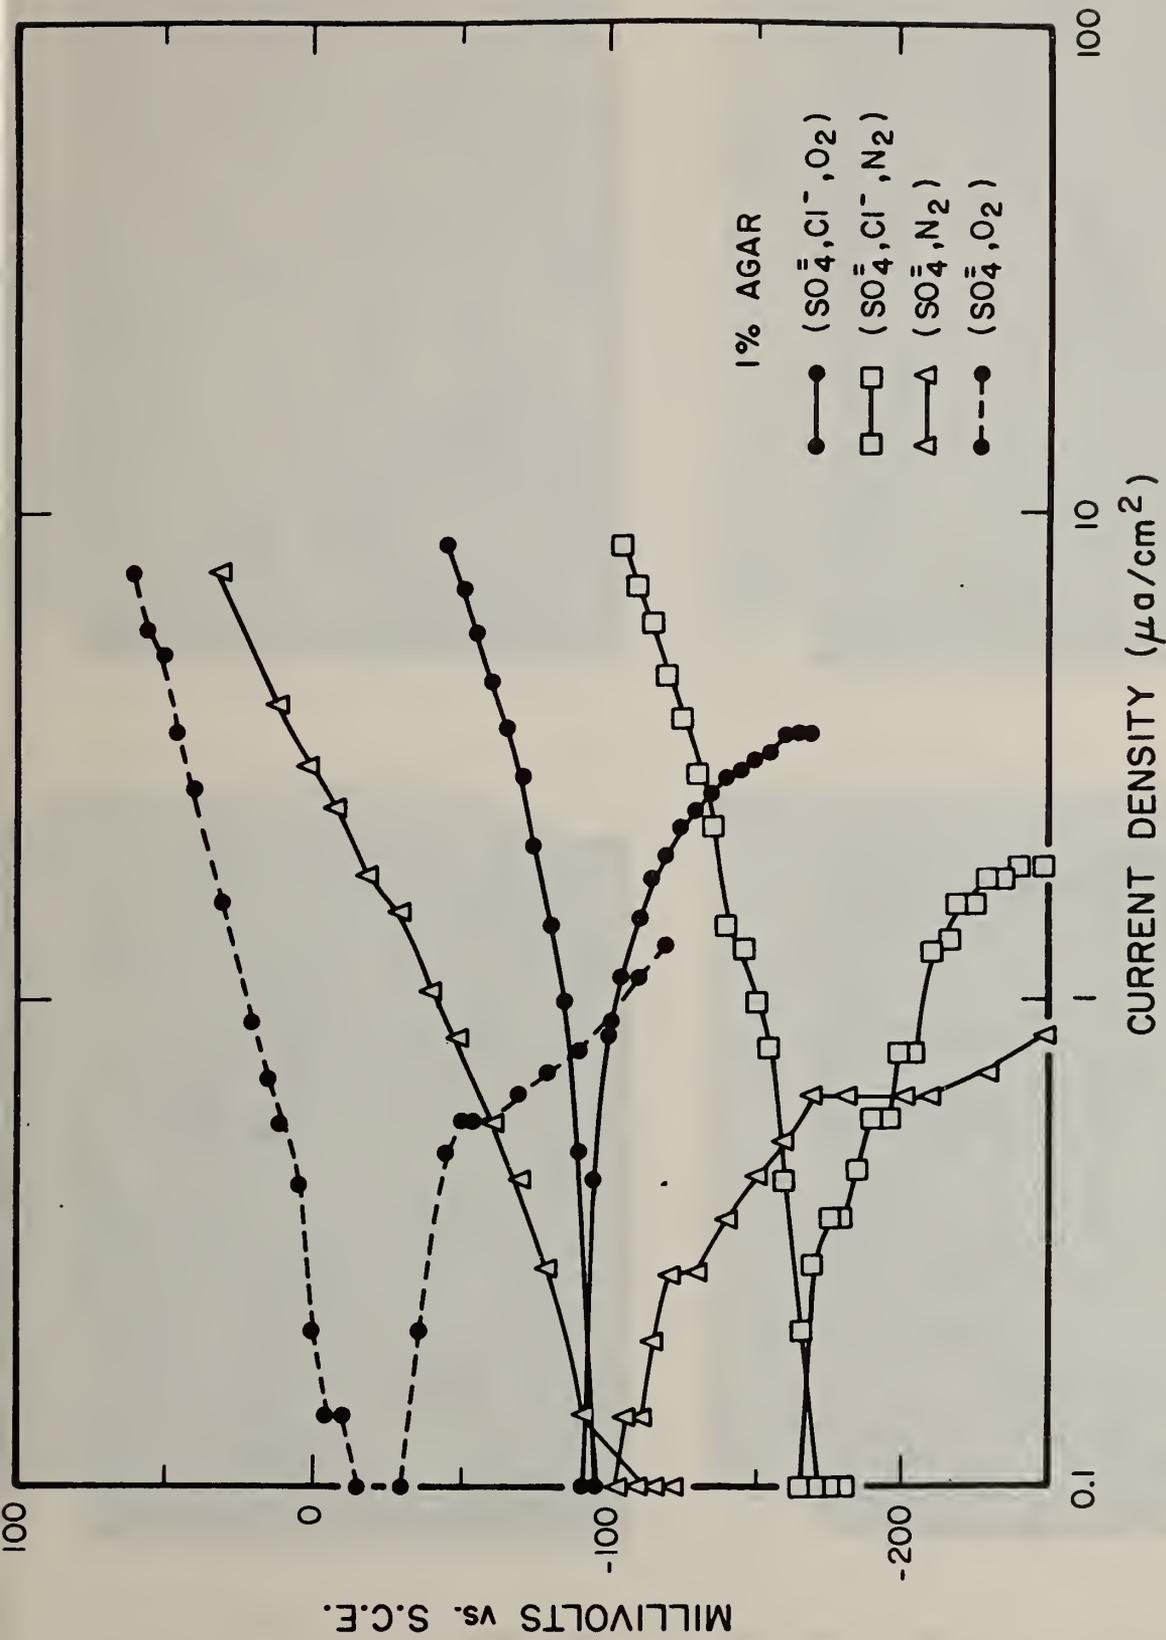
Fig. 29. Polarization curves for tinned Cu wire in 2%  $\text{H}_2\text{SO}_4$ , taken in January 1977.

Values obtained in December 1976 are shown in Fig. 28 and those obtained in January 1977 in Fig. 29. For the moment the open circuit potentials have shifted somewhat, but there are not significant changes in the curves. The corrosion current densities, estimated roughly from the curves, are of the order of  $1 \mu\text{A}/\text{cm}^2$ .

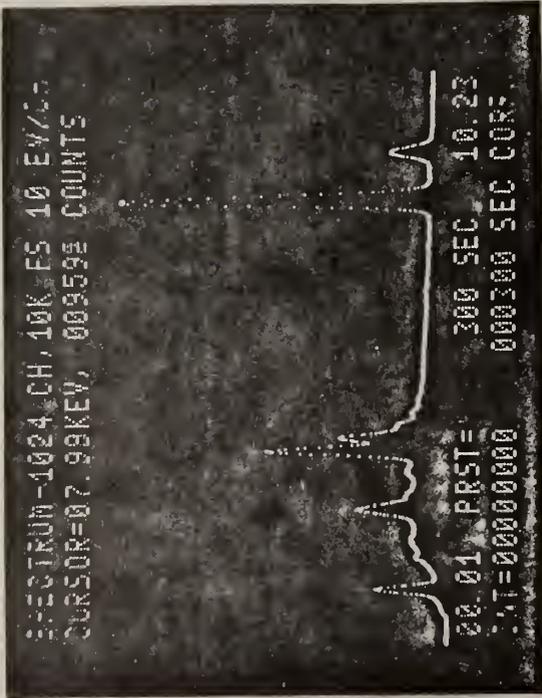
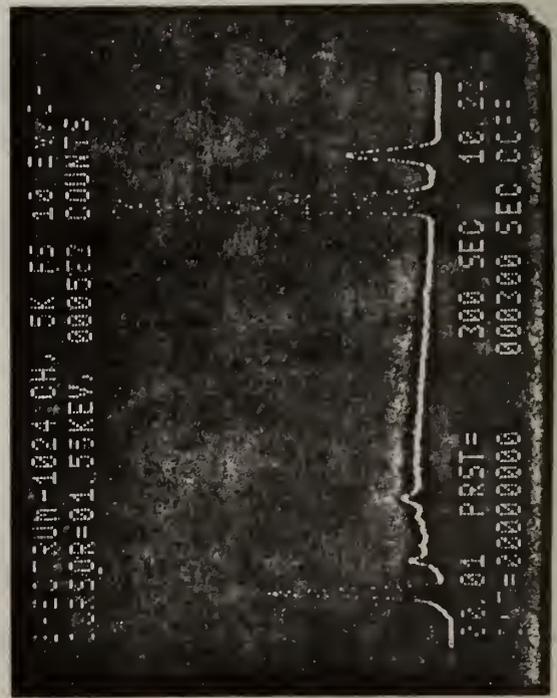
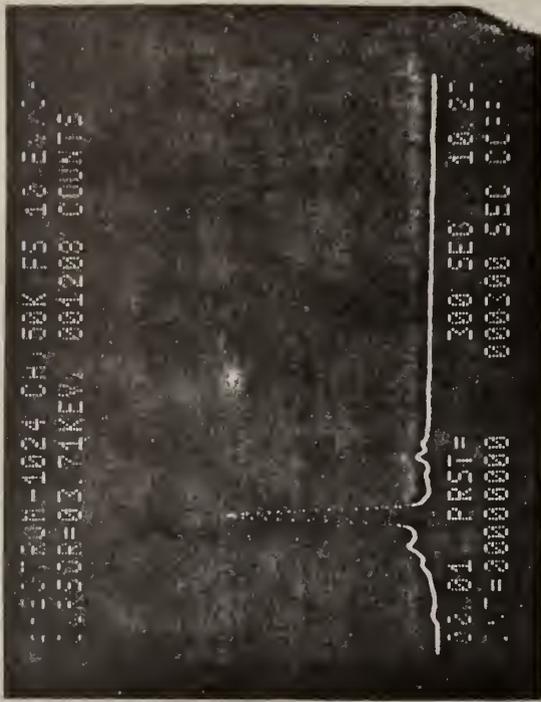
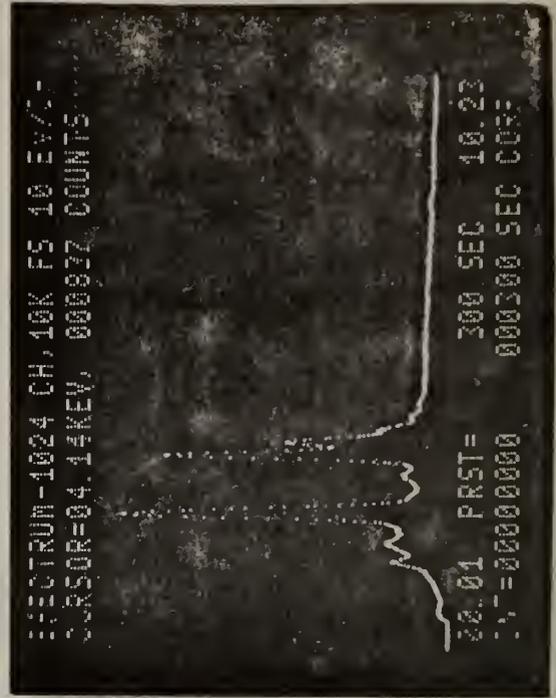
Fig. 30. X-ray spectra of various control specimens.

a) Concentric neutral wire as received

c) Pure copper wire

b) 90% Pb- 10% Sn alloy

d) 60% Sn- 40% Pb alloy

In Fig. 30 are the spectra of an untouched tinned wire as well as comparison spectra of copper and two compositions of Pb-Sn alloy. It is evident that on the tinned wire the Sn/Pb ratio is larger than in either one Pb-Sn alloy tested, 90% Pb-10% Sn being the composition of the tinning bath. The tinning layer, therefore, consists mainly of Sn with probably only 20 to 30% Pb. This is not surprising, since Sn forms intermetallic compounds with Cu, and it is taken up preferentially during the tinning process. Figs. 31 and 32 show spectra of corroded specimens, all of them after tests in sulfate solutions. Spectrum 31 a) was taken on specimen #1 (see Table III) where the surface was covered with a  $\text{Cu}_2\text{O}$  layer. No tinning was detected, although the tinning coat was still present in some areas. Spectrum 31 b) was taken on specimen #101 (see Table I). The only effect of the corrosion tests was some loss of Pb on the surface. Spectrum 31 c) was taken on specimen #5 (see Table III), exposed to conditions quite similar to 31 a), except that it was coupled with CPE. Its potential tended to be about 100 mV more positive than 31 a) throughout the tests. The analysis results show a significant amount of Sn still present as well as formation of  $\text{PbCl}_2$ , indicated by the presence of a small Cl peak. The tinning is still largely present on 31 d) (specimen #104, see Table III) where no a.c. was applied. Also no Cl peak can be seen. The wire whose

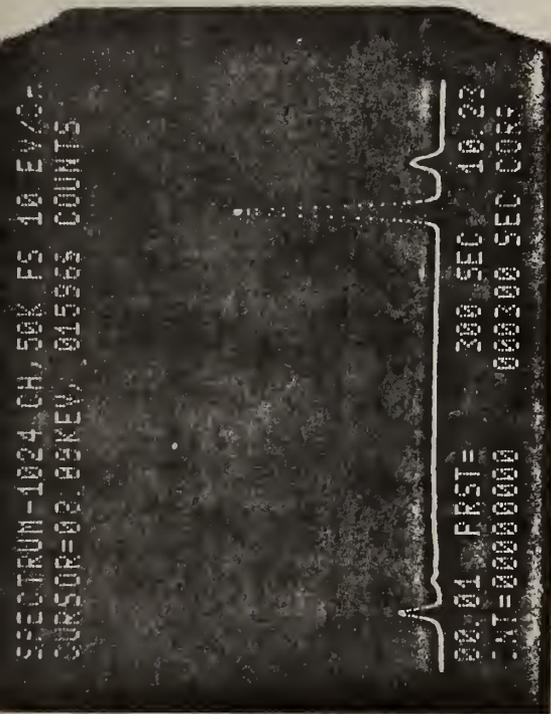
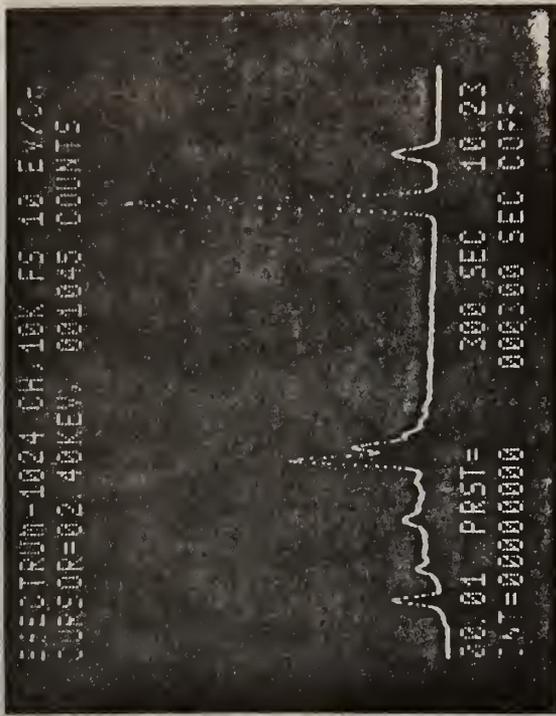
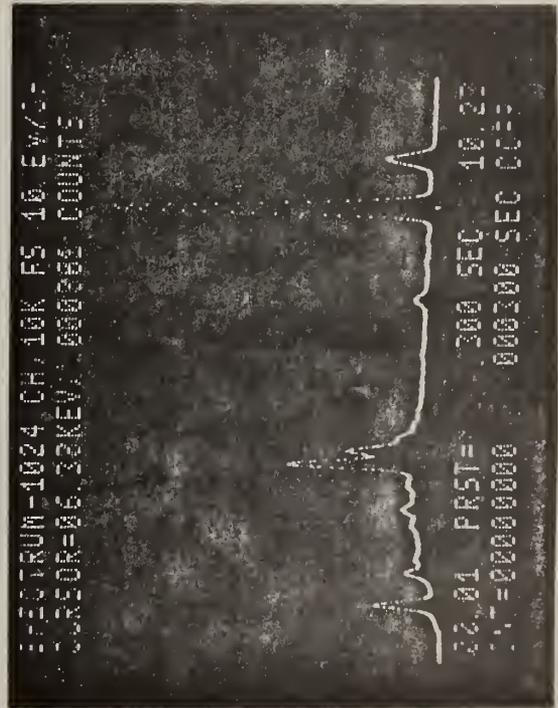
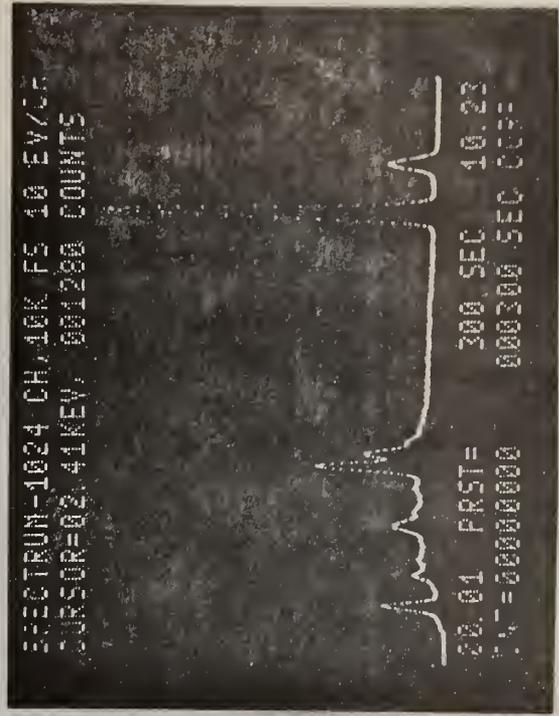
Fig. 31. X-ray spectra of corroded neutral wires.

a) # 1.  $\text{H}_2\text{SO}_4 + \text{HCl}$ .  $\text{H}_2$ . a.c. 2100 h.

b) #101.  $\text{H}_2\text{SO}_4$ .  $\text{H}_2$ . 2200 h.

c) # 5.  $\text{H}_2\text{SO}_4 + \text{HCl}$ .  $\text{H}_2$ . a.c. CPE. 1700 h.

d) #104.  $\text{H}_2\text{SO}_4 + \text{HCl}$ .  $\text{H}_2$ . 2900 h.

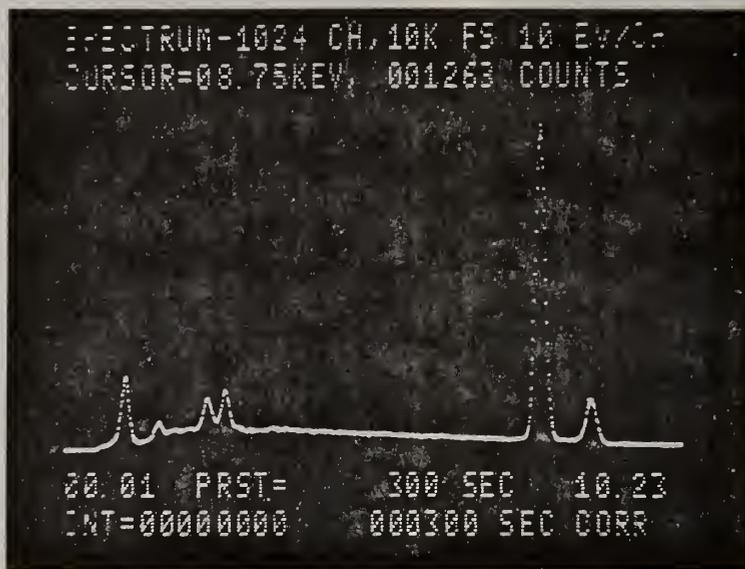
#119

Fig. 32. X-ray spectrum of corroded neutral wire. Solution  $\text{Na}_2\text{SO}_4 + \text{NaCl}$ .  $\text{O}_2$  atmosphere. CPE coupling. Agar. 1600 h.

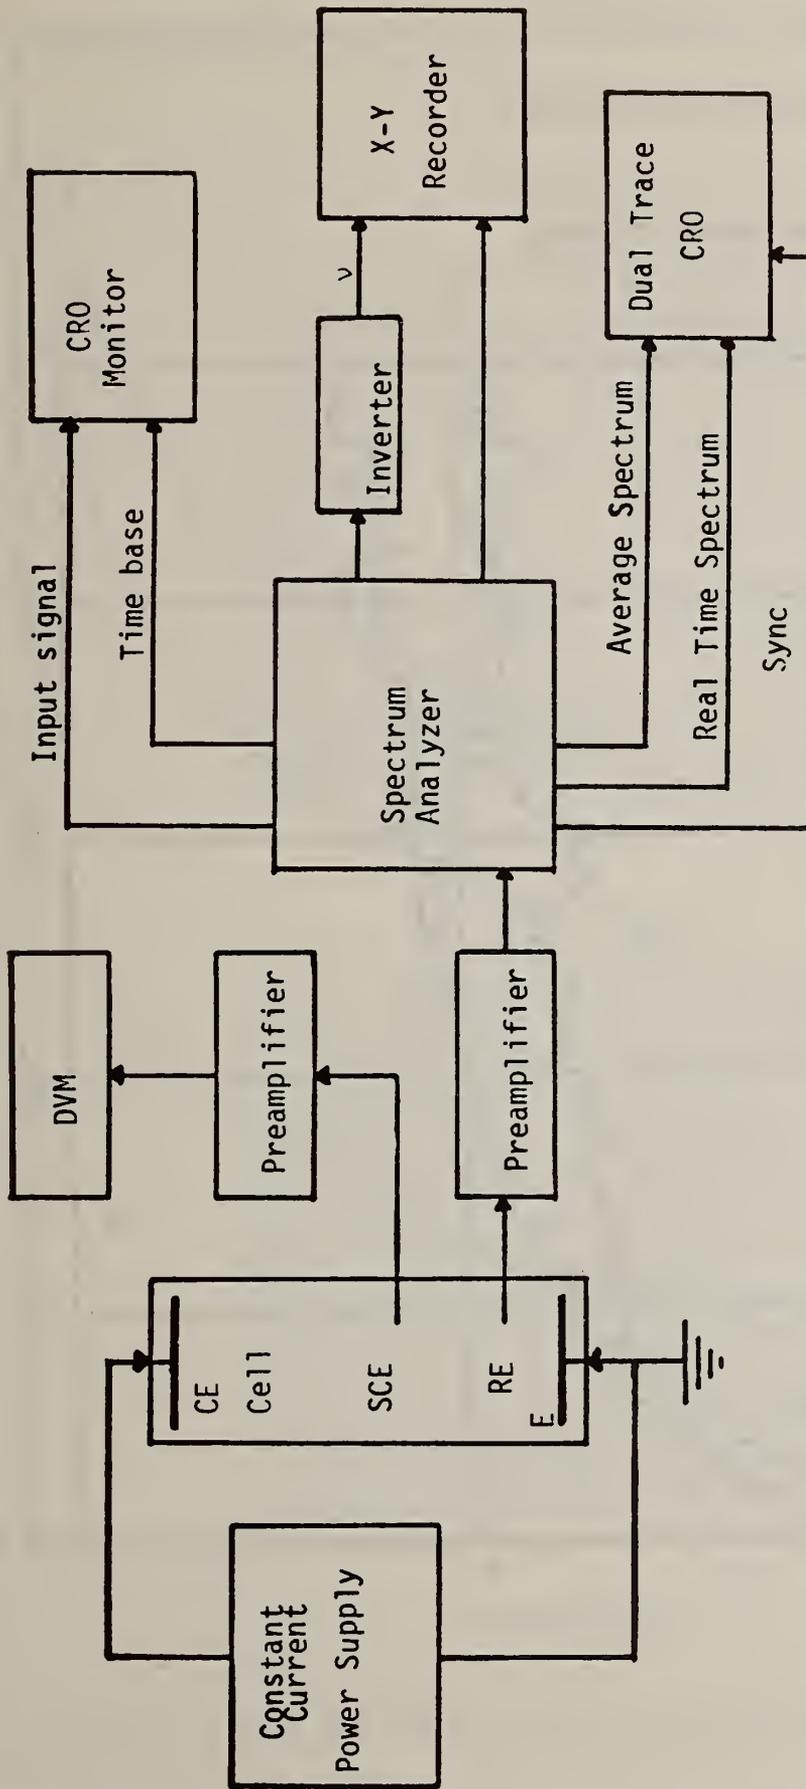
Fig.33. Schematic circuit for noise measurements.

During this year the equipment necessary for the measurement of noise by two methods has been assembled and tested. The first method is essentially based on using a spectrum analyzer. The schematic circuit is shown in Fig. 33. In this method the potential of the electrode is varied by applying a constant current. However, it would be better if the noise measurements could be carried out under potentiostatic conditions. For this purpose, a special low noise potentiostat is being developed and built at N&S and should shortly be ready for testing.

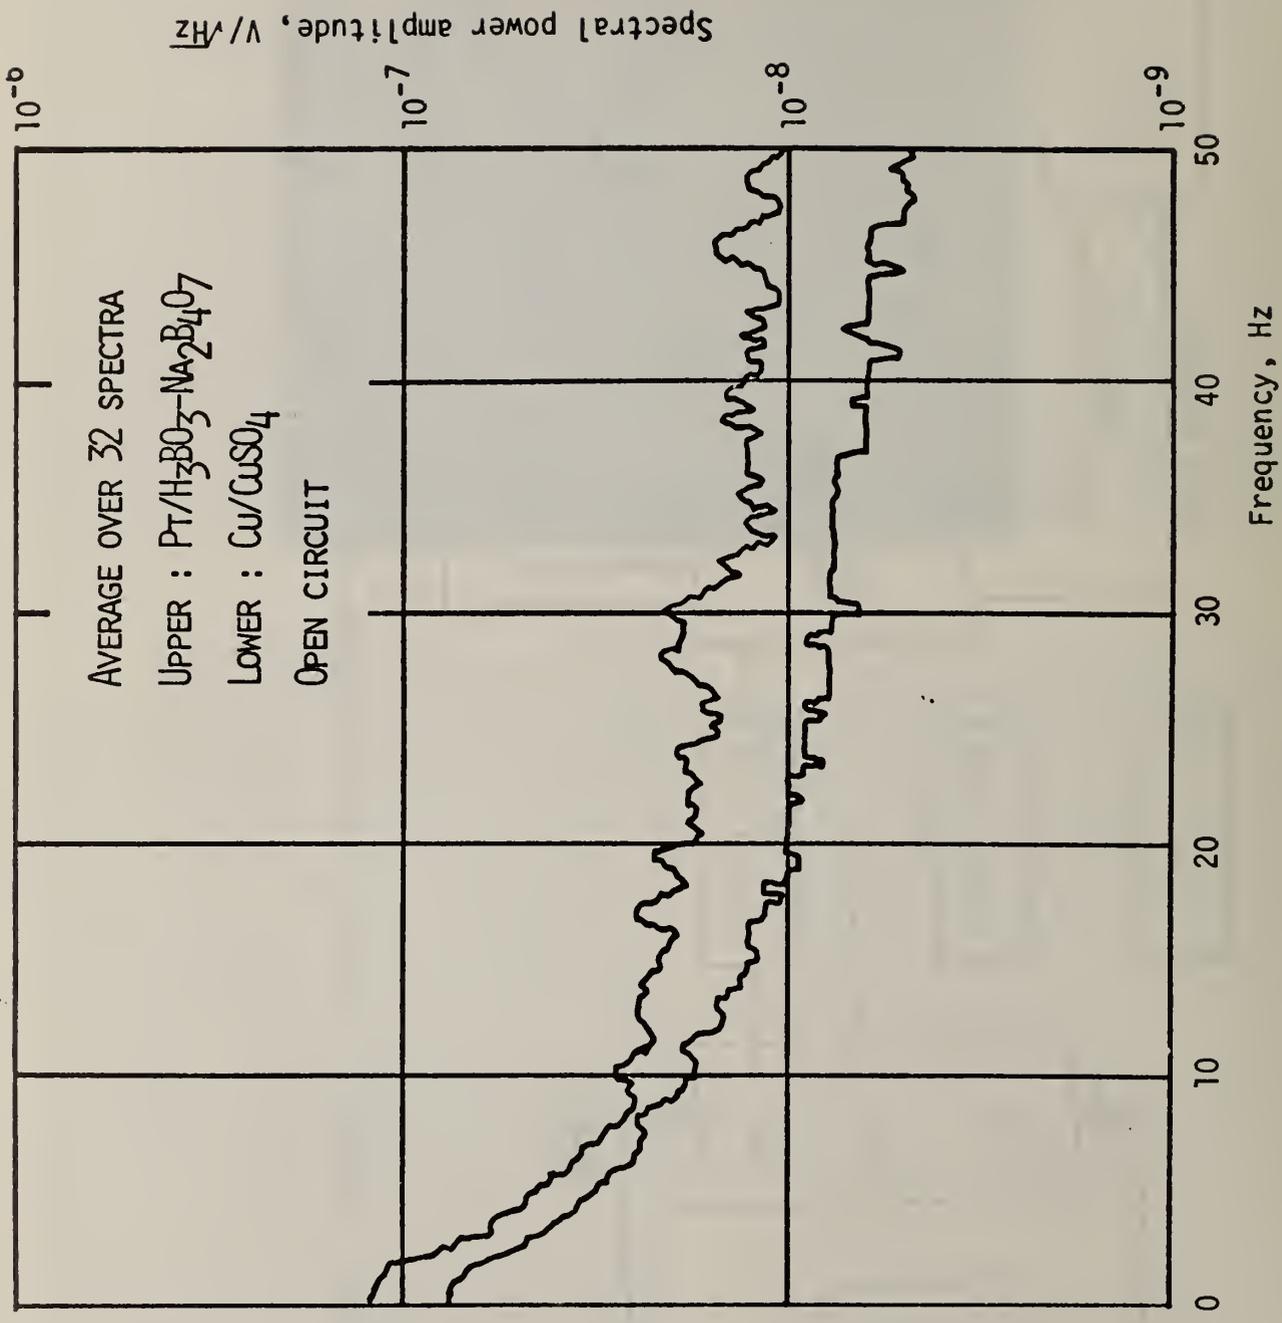
Fig.34. Noise spectrum at open circuit.

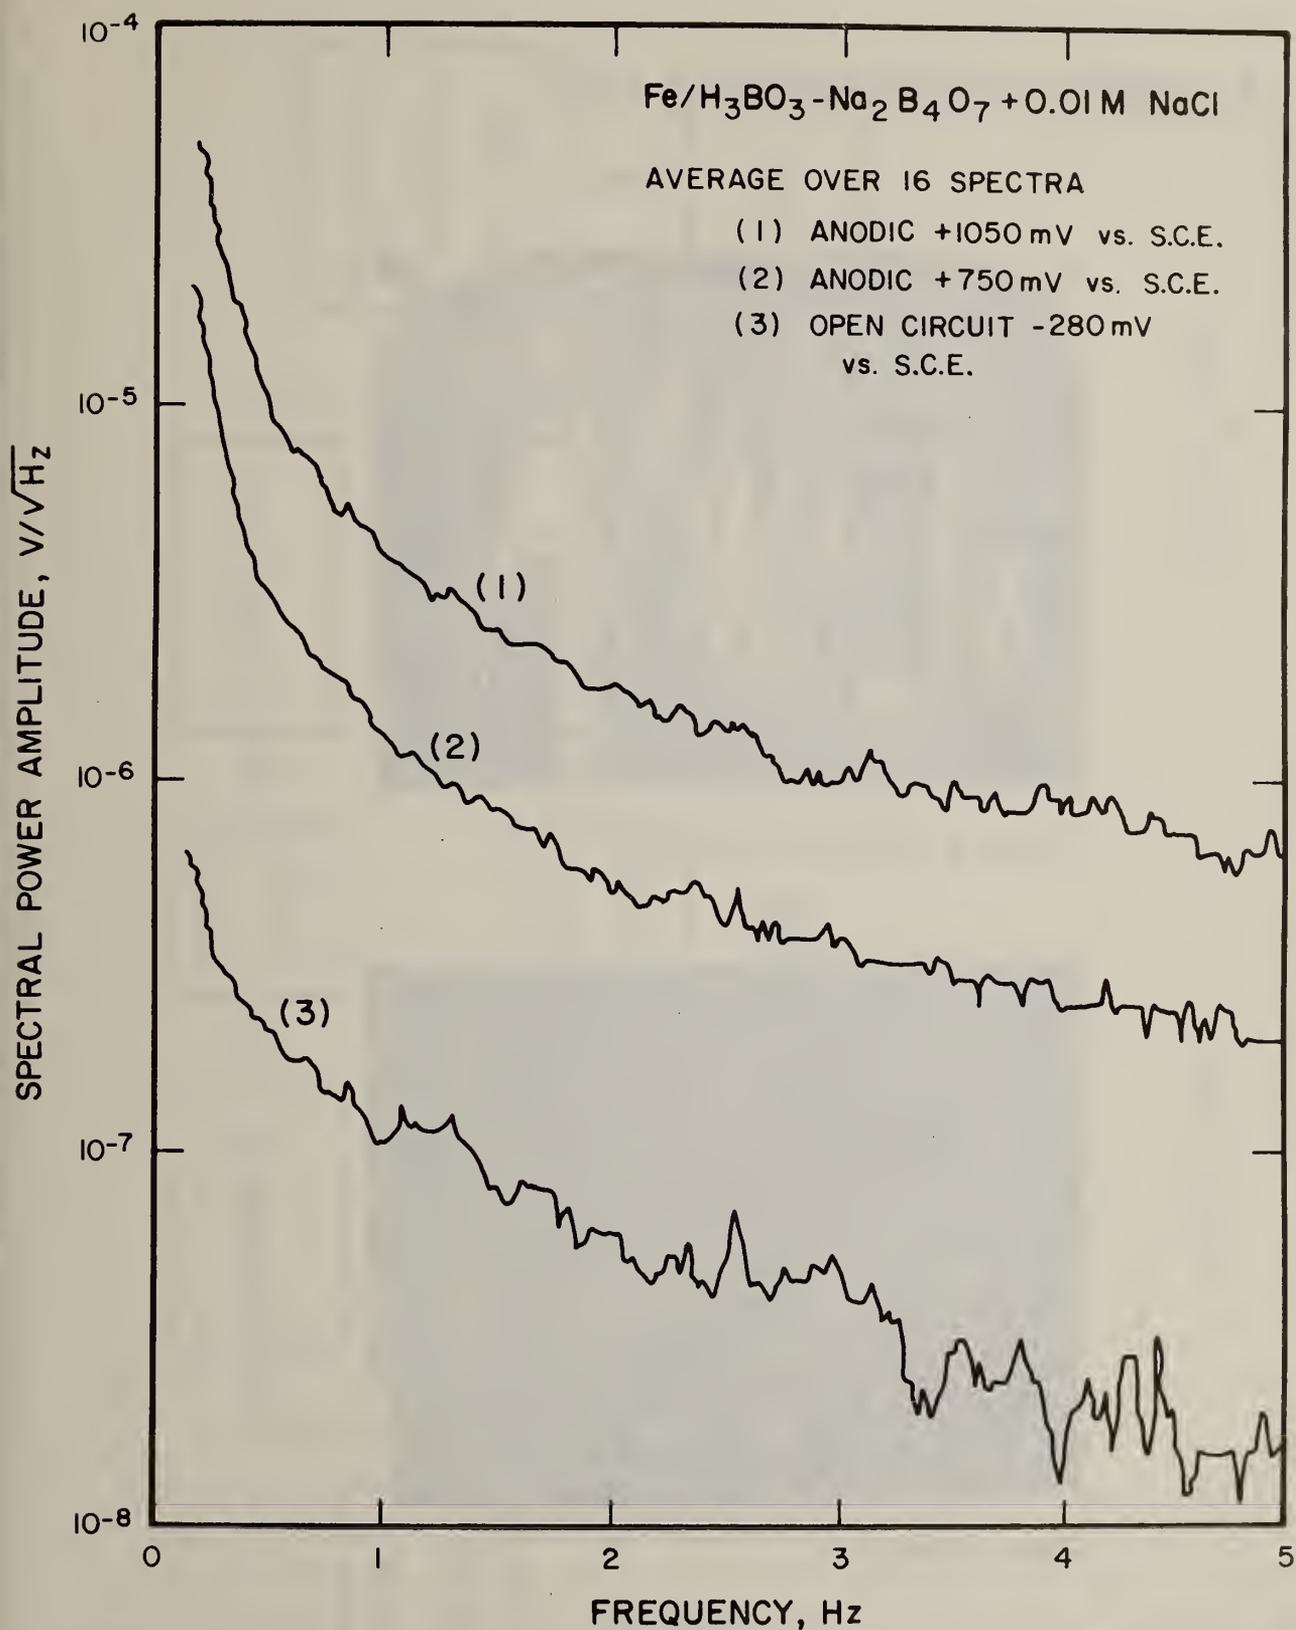
Fig. 35. Noise spectra of Fe in 1:1  $\text{H}_3\text{BO}_3\text{-Na}_2\text{B}_4\text{O}_7 + 0.01\text{ M NaCl}$  at various potentials.

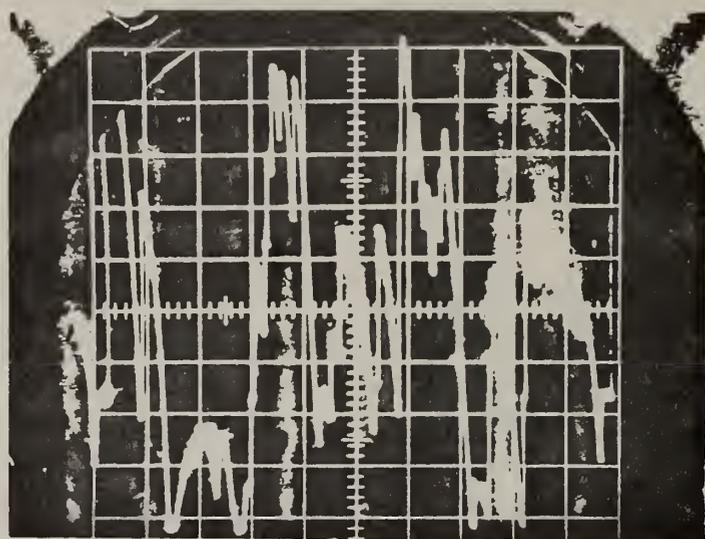
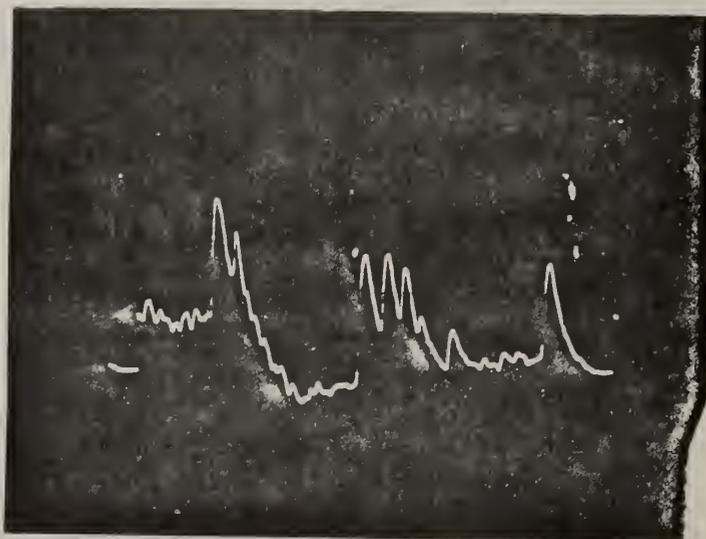
**Above Pitting Potential**

**Open Circuit**

Fig. 36. Oscillographic record of electrode potential of Fe in 1:1 H<sub>3</sub>BO<sub>3</sub>-Na<sub>2</sub>B<sub>4</sub>O<sub>7</sub>+0.01 m NaCl above and below the pitting potential.

Some measurements have been carried out on an iron electrode in a solution where pitting can occur. Under anodic polarization a significant increase of the noise was observed when the electrode potential was above the pitting potential. Fig. 35 shows the spectra obtained at different potentials, and Fig. 36 shows the time recordings of the electrode potential above and below the pitting potential.

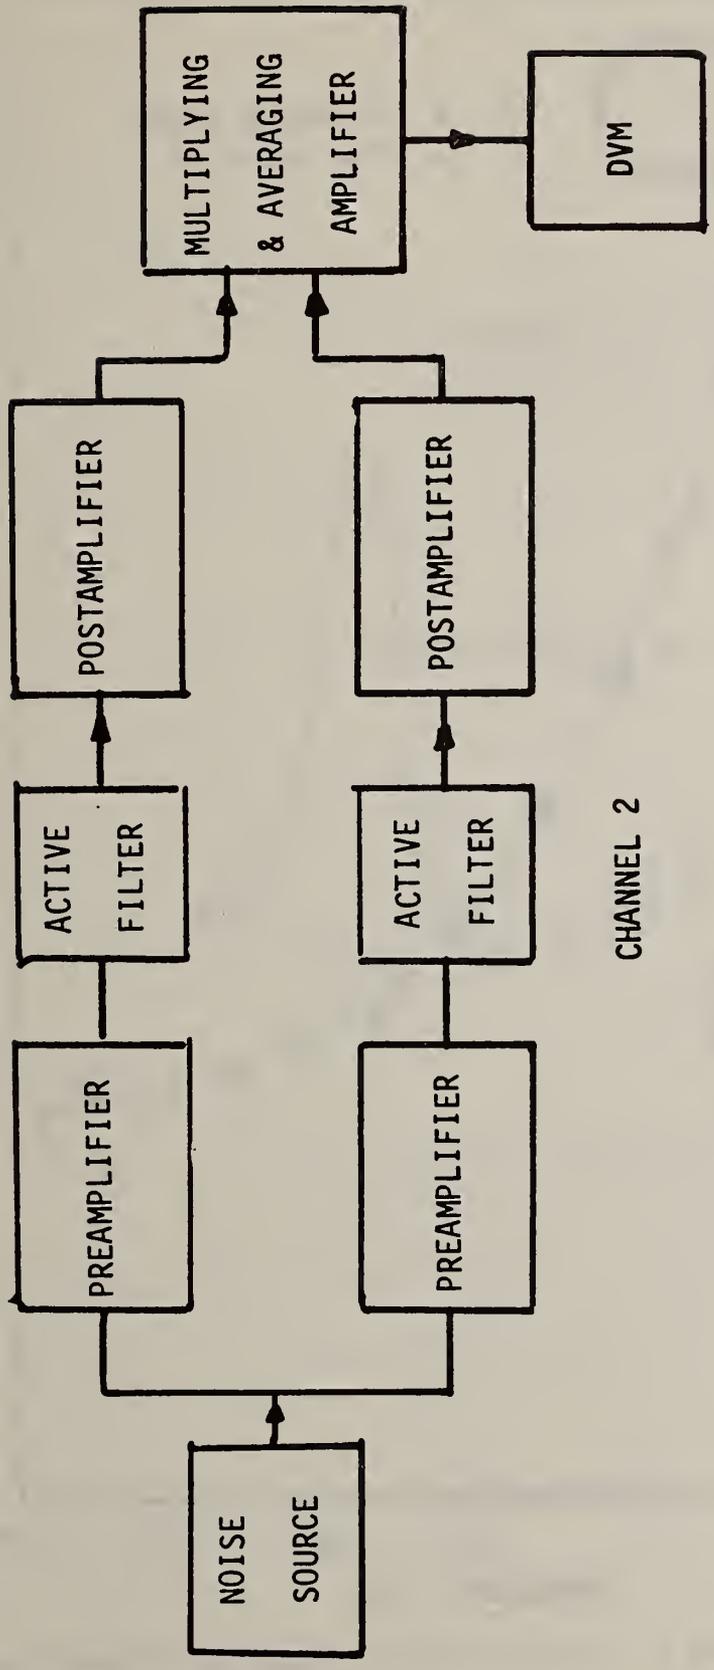
Fig.37. Noise measuring circuit.

37. Noise measuring circuit.
38. Spectral power amplitude vs. frequency. Noise generated by the instrumentation and by a 10 K $\Omega$  resistor.
39. a) Coated copper wire specimen.

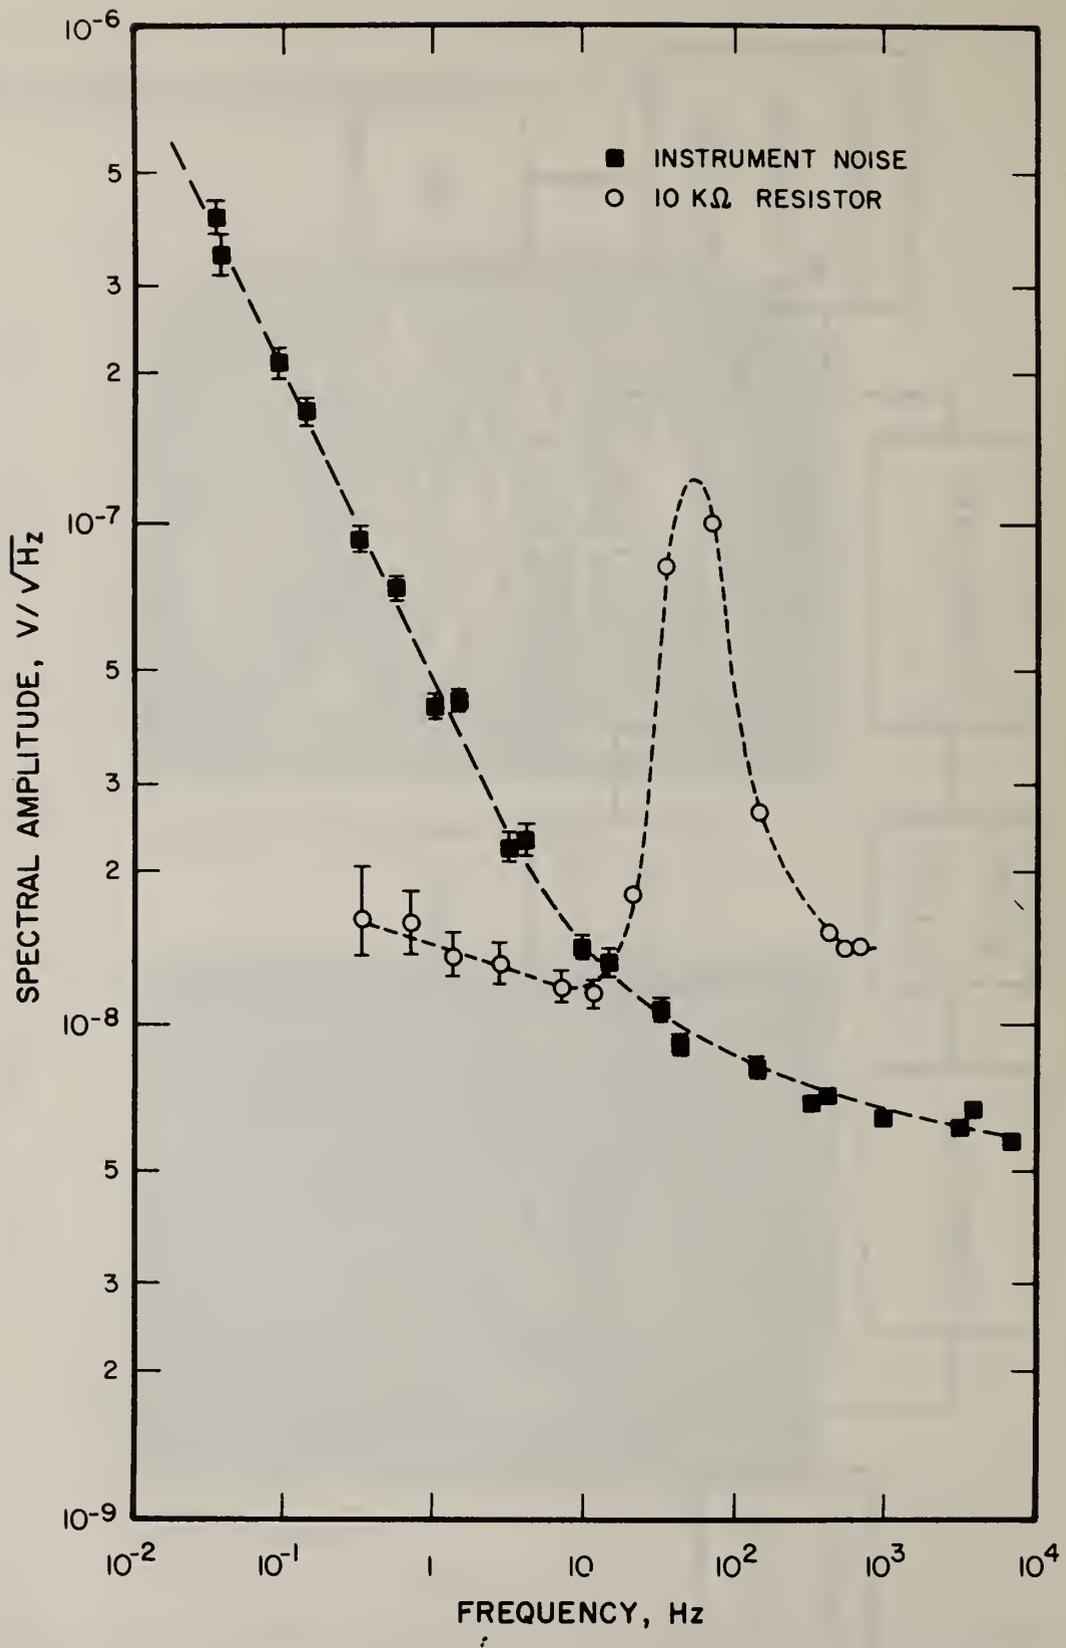
Fig. 38. Spectral power amplitude vs. frequency. Noise generated by the instrumentation and by a 10 k $\Omega$  resistor.

Fig. 30 shows some results of preliminary tests. On it is reported the instrument noise as well as the noise generated by a 10 K $\Omega$  resistor. At high frequencies, the thermal noise of the resistor is, as expected, higher than the instrumental noise. The larger peak is caused by some 60 Hz pickup, but from approximately 10 Hz down, the noise is lower than the instrument noise. This method is expected to be usable above 0.2 Hz.

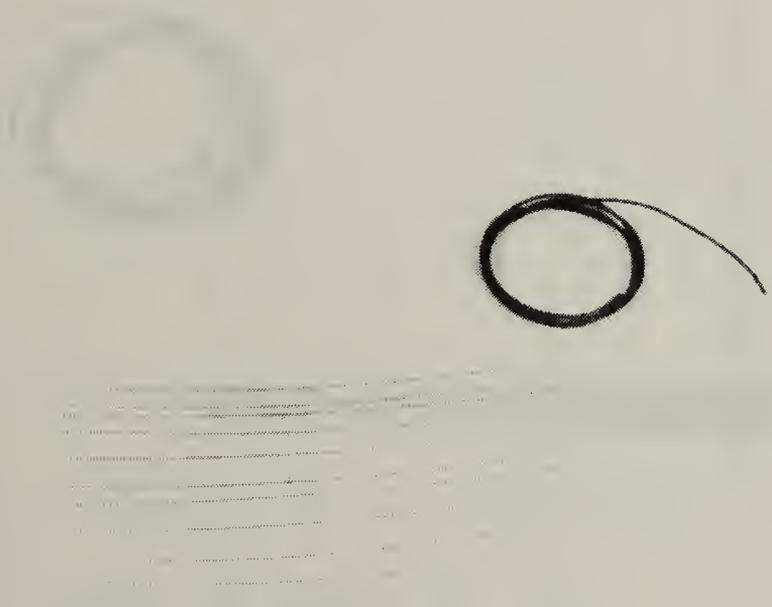
FIGURE 39

A) COATED COPPER WIRE

B) BARE COPPER WIRE

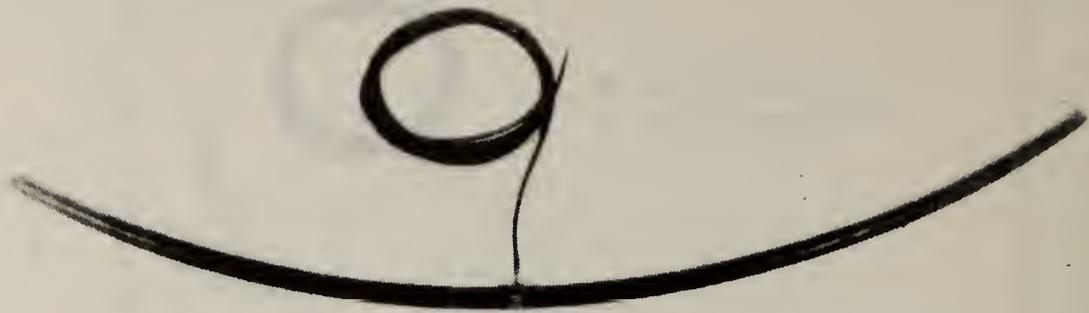
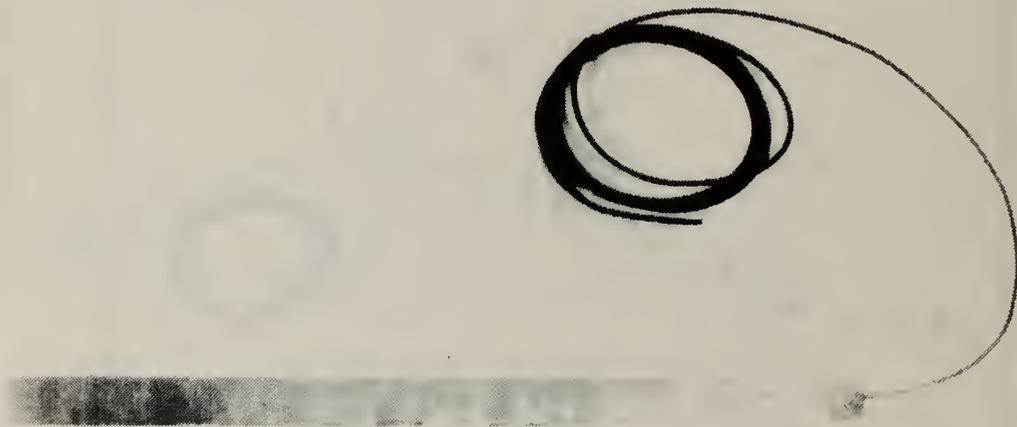
FIGURE 40

A) CONDUCTING POLYETHYLENE (CPE)

B) COATING ALLOY SHEET

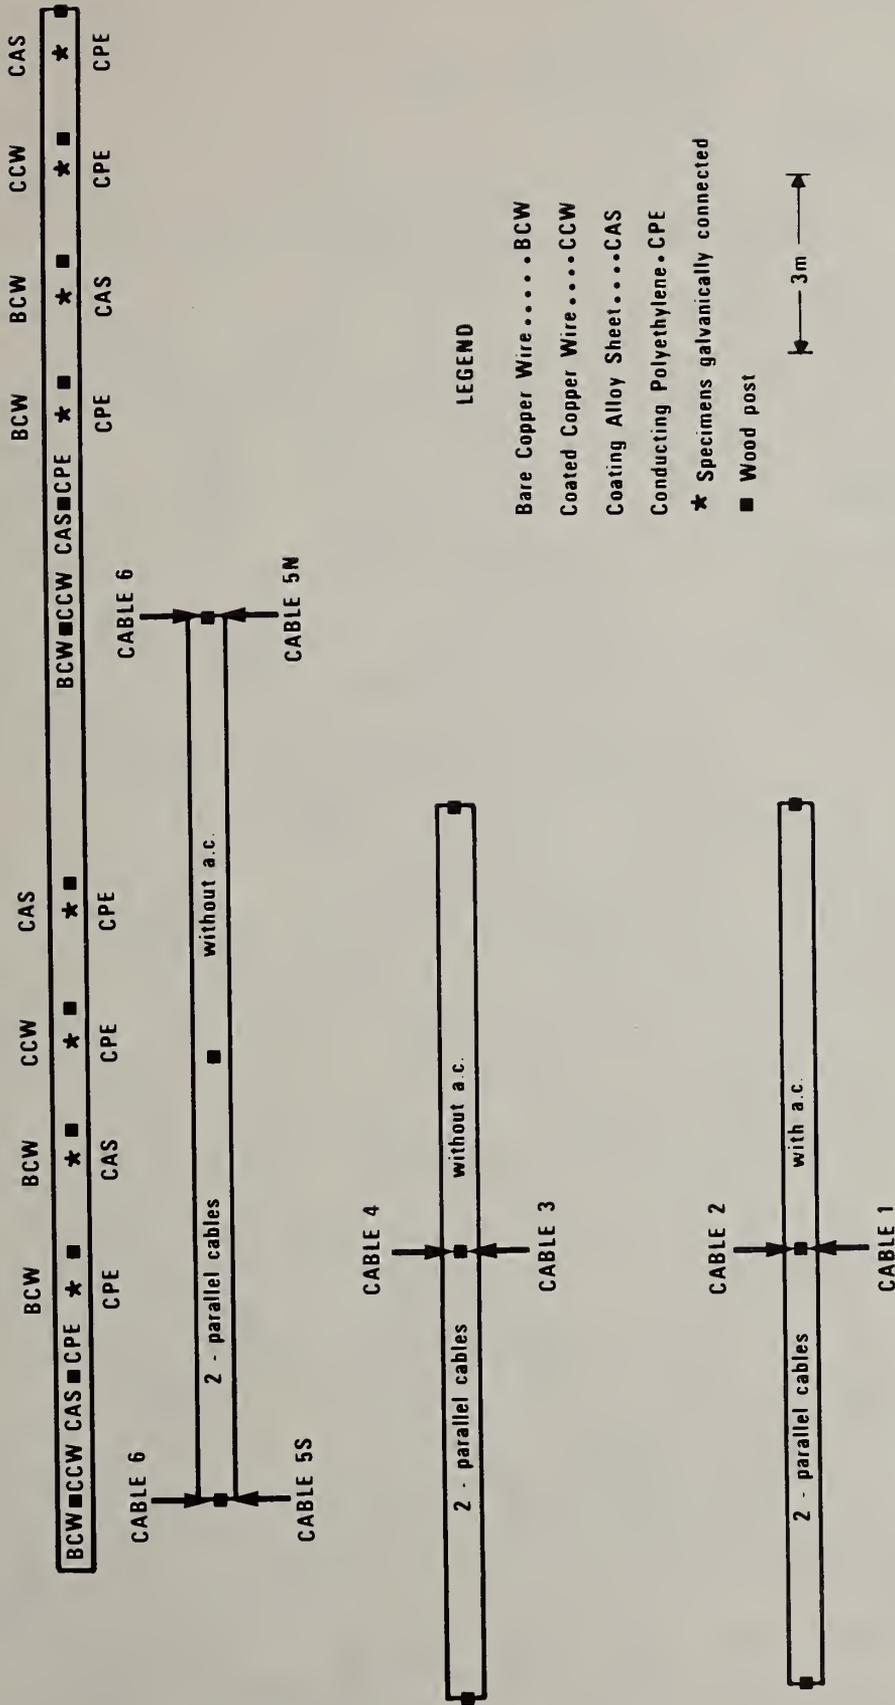
Fig 41

NBS UNDERGROUND CORROSION TEST SITE
