ALL106 048470

**NBSIR 85-3147**

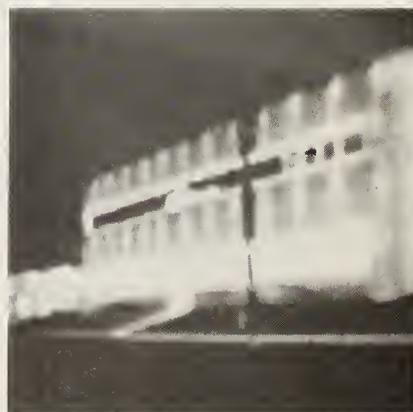
3.2-4  
West face of the  
A module

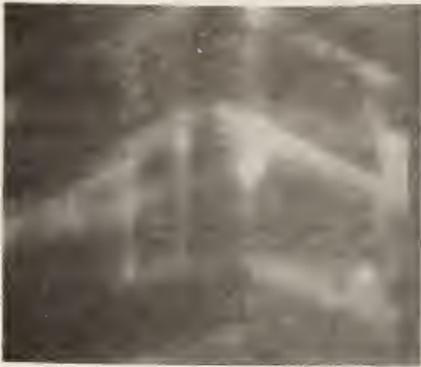
3.4-1  
Middle two floors  
of SW corner

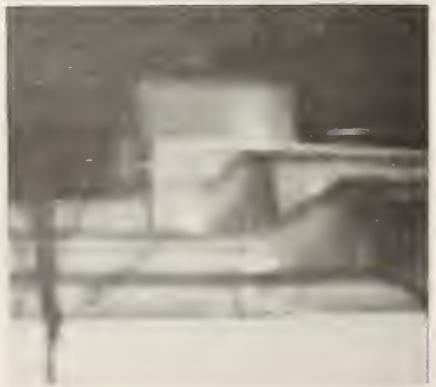
3.4-6  
N face above and to  
the left of the front  
entrance

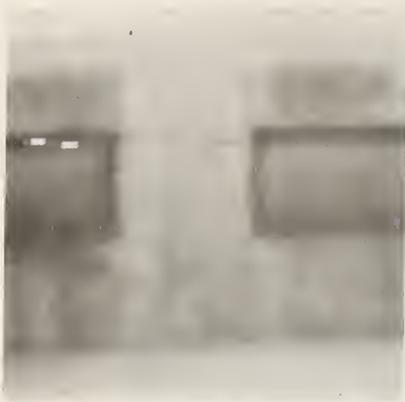
3.6-1  
N wall on the fourth  
floor of the tower  
(interior)

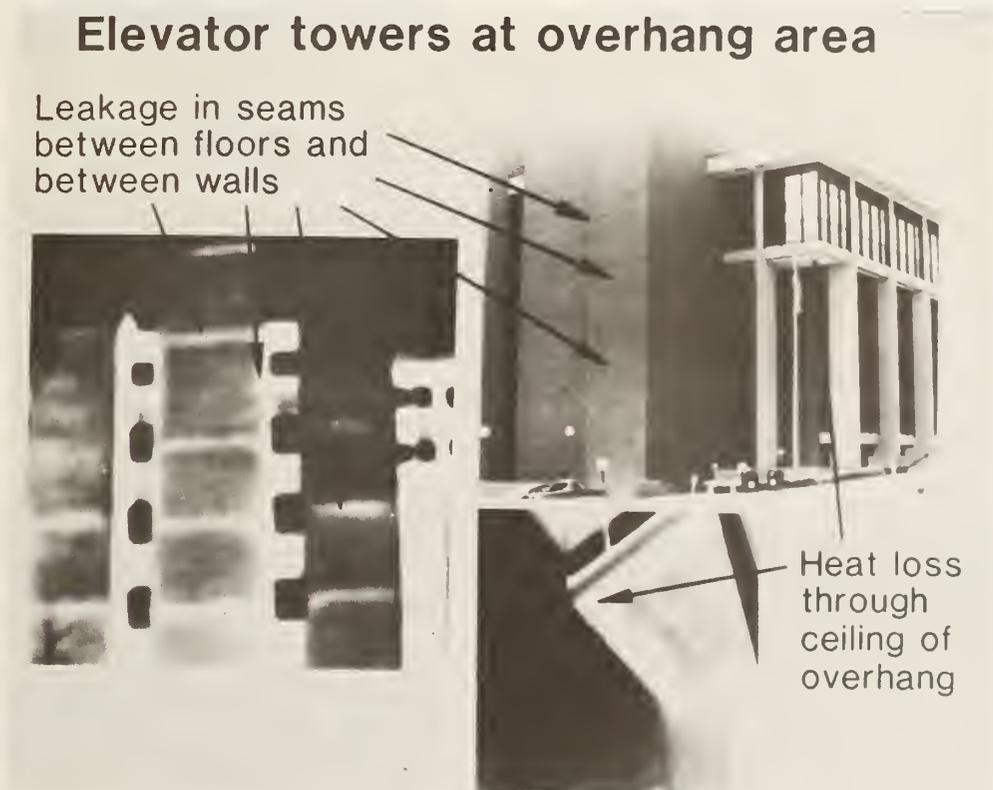
Figure 3.7 Sample Defects Observed in the Fayetteville Building

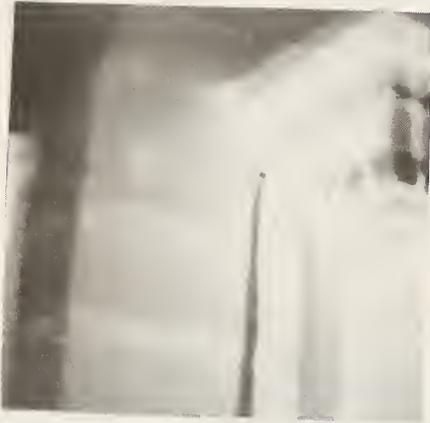
3.8-1  
NE corner with one  
east face tower

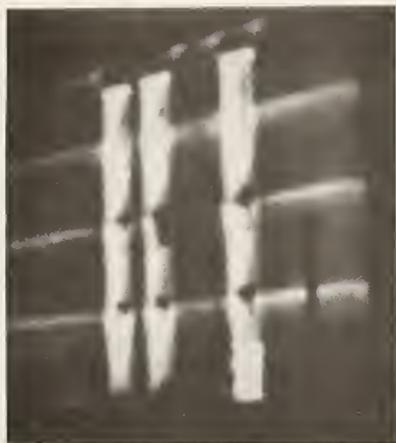
3.10-1  
E wall with NE  
entrance off to right

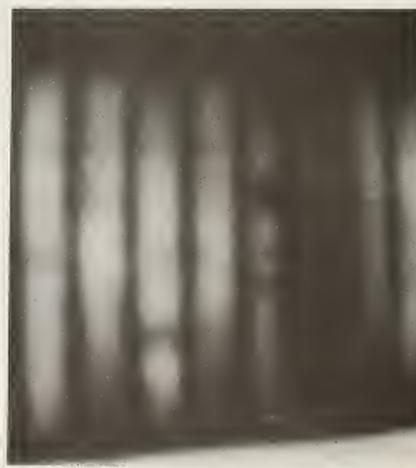
3.10-4  
Fourth floor interior  
N wall of the E wing

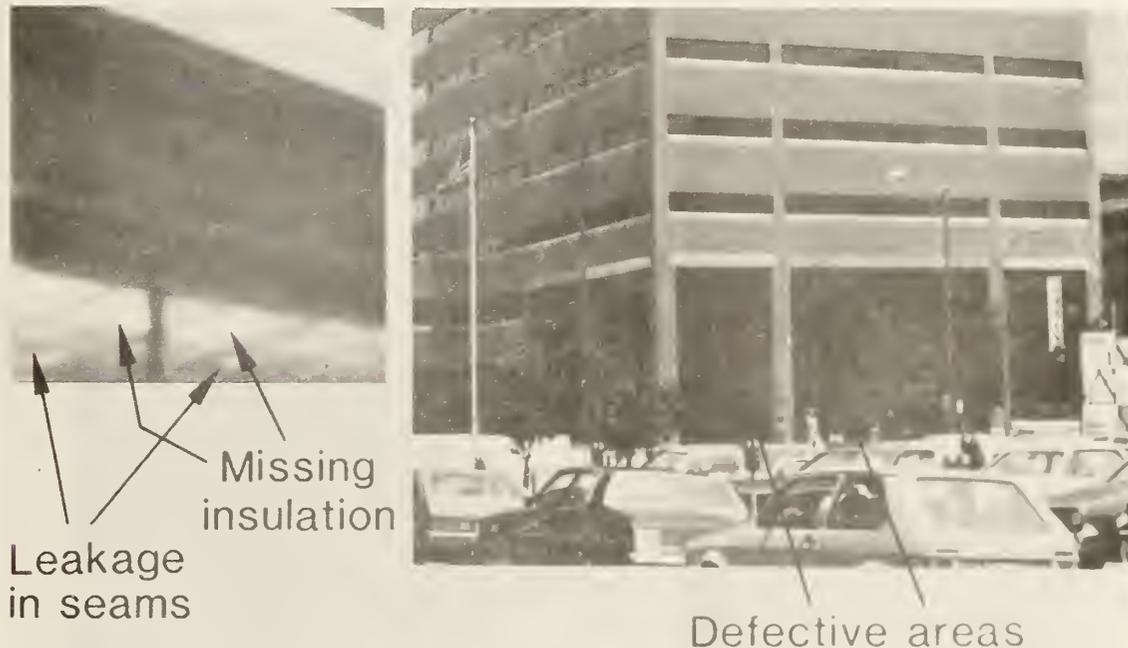
Figure 3.11 Sample Defects Observed in the Norfolk Federal Building

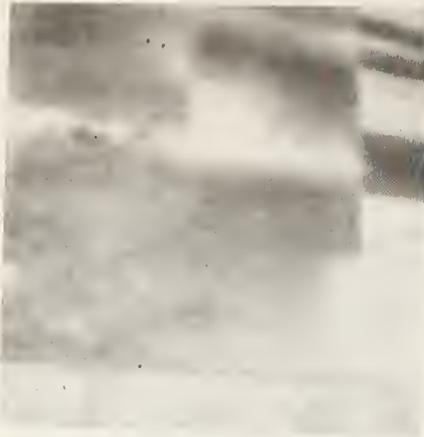
3.12-1  
Lower wall section  
of E wall

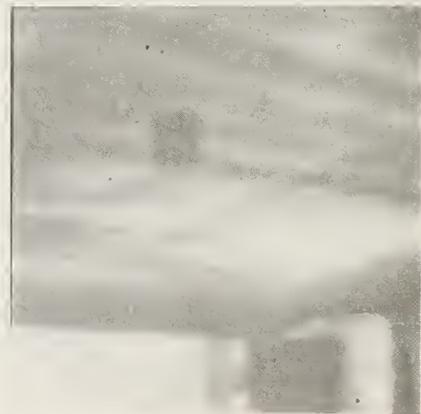
3.12-6  
NE overhang of second  
floor over garage

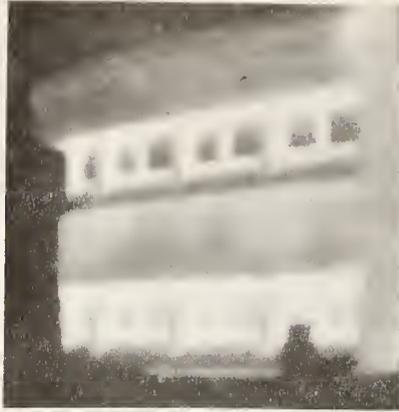
3.14-1  
S end of E wall  
(exterior)

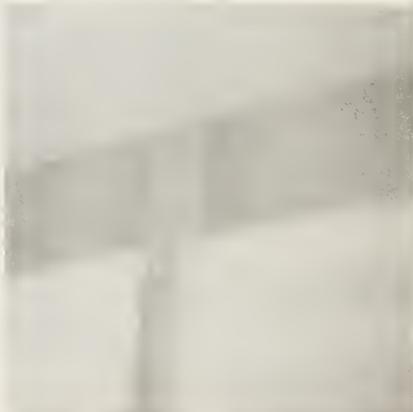
3.14-6  
Wall-post seams on E  
wall first floor  
(interior)

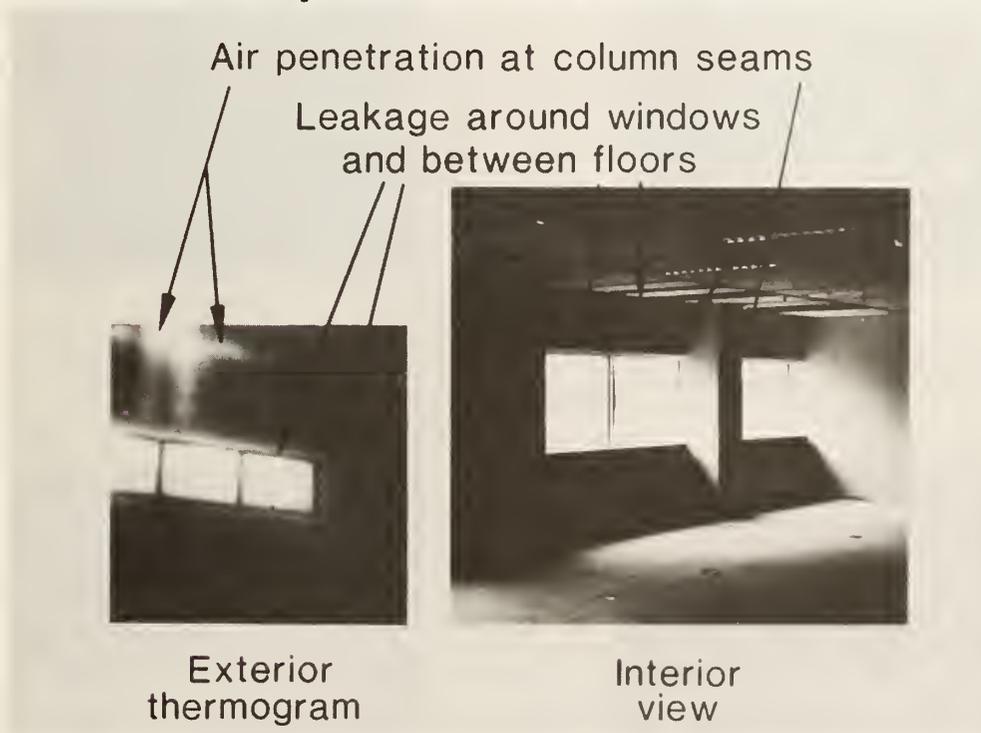
Figure 3.15 Sample Defects Observed in the Springfield Federal Building

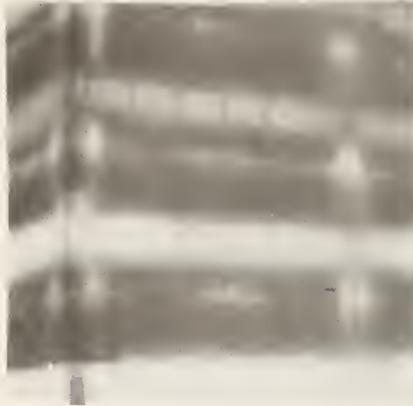
3.16-1  
SE corner of  
the N wing

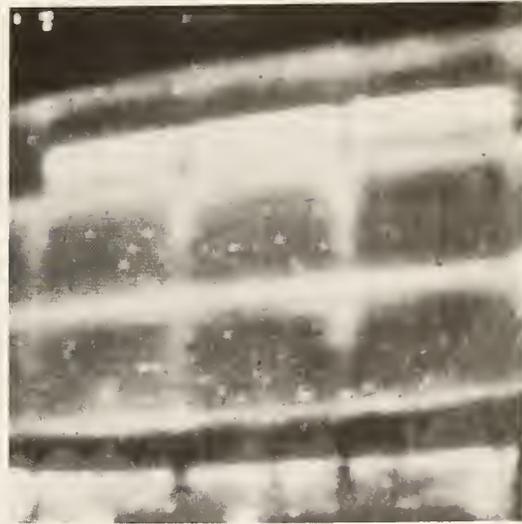
Figure 9.2 Thermal Bridge Occurring in the Ann Arbor Building

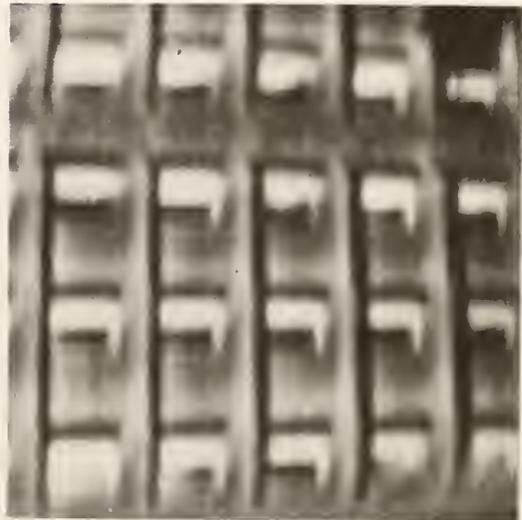
Figure 9.4 Thermal Bridges Occurring in the Columbia Building
