NISTIR 7468

Evaluating Positive Pressure Ventilation In Large Structures: High-Rise Fire Experiments

Stephen Kerber
Daniel Madrzykowski

November 2007

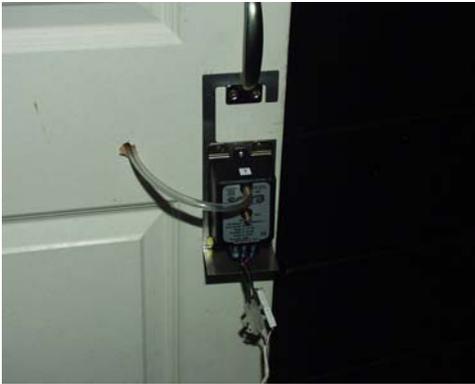
Figure 21. Pressure transducer

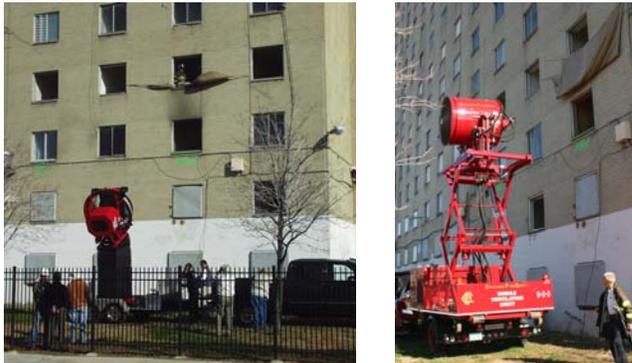
Figure 30. Trailer and truck mounted fans in position to create simulated wind

During the experiments on the third floor, apartment 303 and apartment 304, the larger mounted fans were used to simulate a wind condition by blowing in through an apartment window (Figure 30). Air velocity measurements were made with a hand-held anemometer from inside the window prior to each experiment. Both fans were throttled up to the engine speed that created an average velocity of approximately 11 m/s (25 mi/h). The same engine speed was utilized during each of the experiments. A fire blanket was also deployed during the experiment in apartment 303 to determine its effect on the wind and fire conditions.

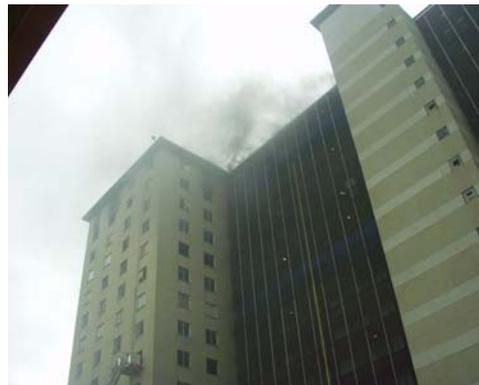
Figure 32. 1503 – Smoke from hallway leaks

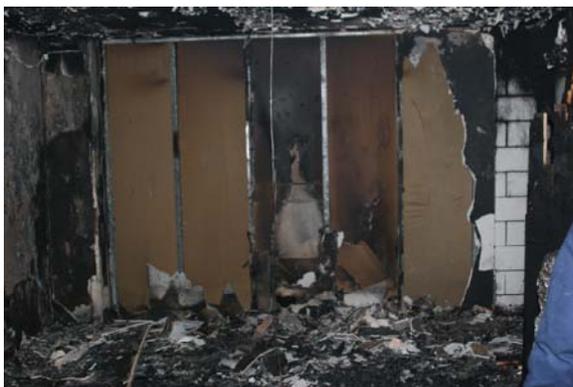
Figure 33. 1503 – Post test (Same view as figure 31)

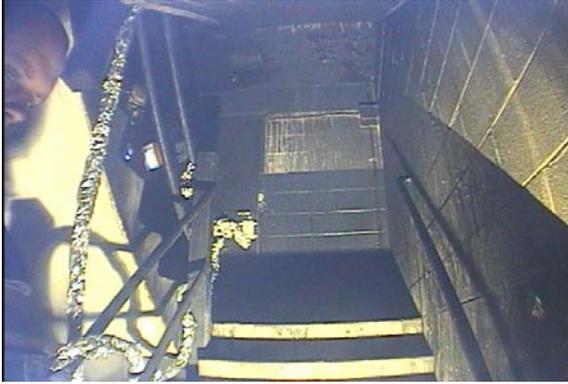
Figure 74-a

The video frame captured in the south stairwell before ignition of the experiment in apartment 1505 is in Figure 74-a. Smoke leaked around the door with one 0.7 m (27 in) fan placed at the base of the stairwell (Figure 74-b). A second 0.7 m (27 in) fan was added at the 13th floor and the smoke was vented out of the 16th floor doorway (Figure 74-c). Figure 74-d shows that with two portable fans running the smoke was kept out of the stairwell with the fire floor door open 0.08 m (3 in). The door was then opened completely and the smoke was still kept out of the stairwell. The wall of smoke at the doorway is shown in fire 74-e. The door to floor 14 was opened and a little bit of smoke can be seen intermittently flowing into the stairwell (Figure 74-f). The smoke flow into the stairwell seen in Figure 74-g is a result of turning both fans off. Figure 74-h was captured 20 seconds after the fan on floor 13 was turned back on. The fan was turned off and the stairwell quickly filled with smoke again (Figure 74-i). Both fans were turned back on and the smoke was pushed back into the fire floor (Figure 74-j).

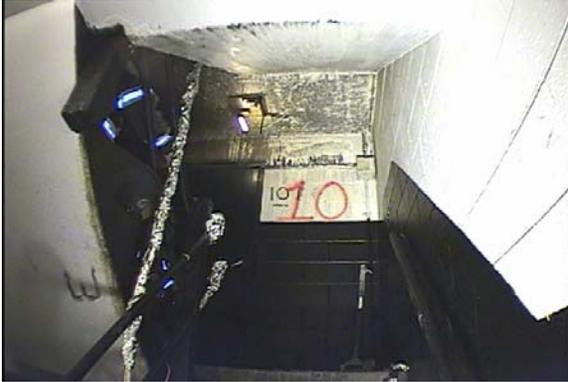
Figure 75-a shows the doorway to the fire floor prior to ignition of the experiment in apartment 1003. After ignition but prior to the door being opened, the smoke enters the stairwell around the cracks of the door and a layer begins to form (Figure 75-b). The door on floor 10 was opened and the black smoke quickly began to fill the stairwell (Figure 75-c). The 16th floor door was opened and two 0.7 m (27 in) fans were turned on at floors 1 and 8. After less than 60 s, the stairwell was cleared of any smoke (Figure 75-d). The fans were turned off (Figure 75-e) and the smoke entered the stairwell. The fans were turned back on and the smoke was vented again. After ventilation the 16th floor door was closed, the fans were able to maintain a stairwell free of smoke (Figure 75-f).

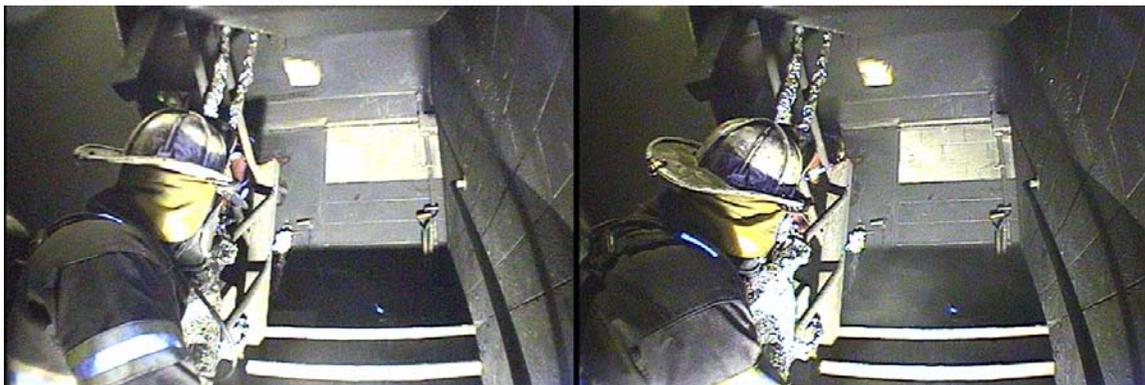
Figure 78-a

Figure 78-e was captured from the thermal imaging camera prior to ignition. Figure 78-f shows the heat being forced around the cracks of the doorway once the simulated wind was started. The door was opened slightly for one second and the heat poured into the stairwell (Figure 78-g). Ten seconds later the heat is flowing into the stairwell and the door jamb temperature increased from 55 °C (131 °F) to 145 °C (293 °F) (Figure 78h). Figure 78-i was captured seconds before the door was closed and Figure 78-j was captured seconds after the door was closed. This showed the importance of controlling the stairwell door under wind driven conditions in order to keep smoke and heat from entering the stairwell. Once the stairwell door was closed, the SVU was turned on at the front of the building and was able to keep the heat from the wind driven fire out of the stairwell (Figure 78-k).
