A STUDY OF THE PROPERTIES OF THE  
U.S. CAPITOL SANDSTONE

Arthur Hockman and D. W. Kessler

Report to the  
Architect of the Capitol

January 8, 1957

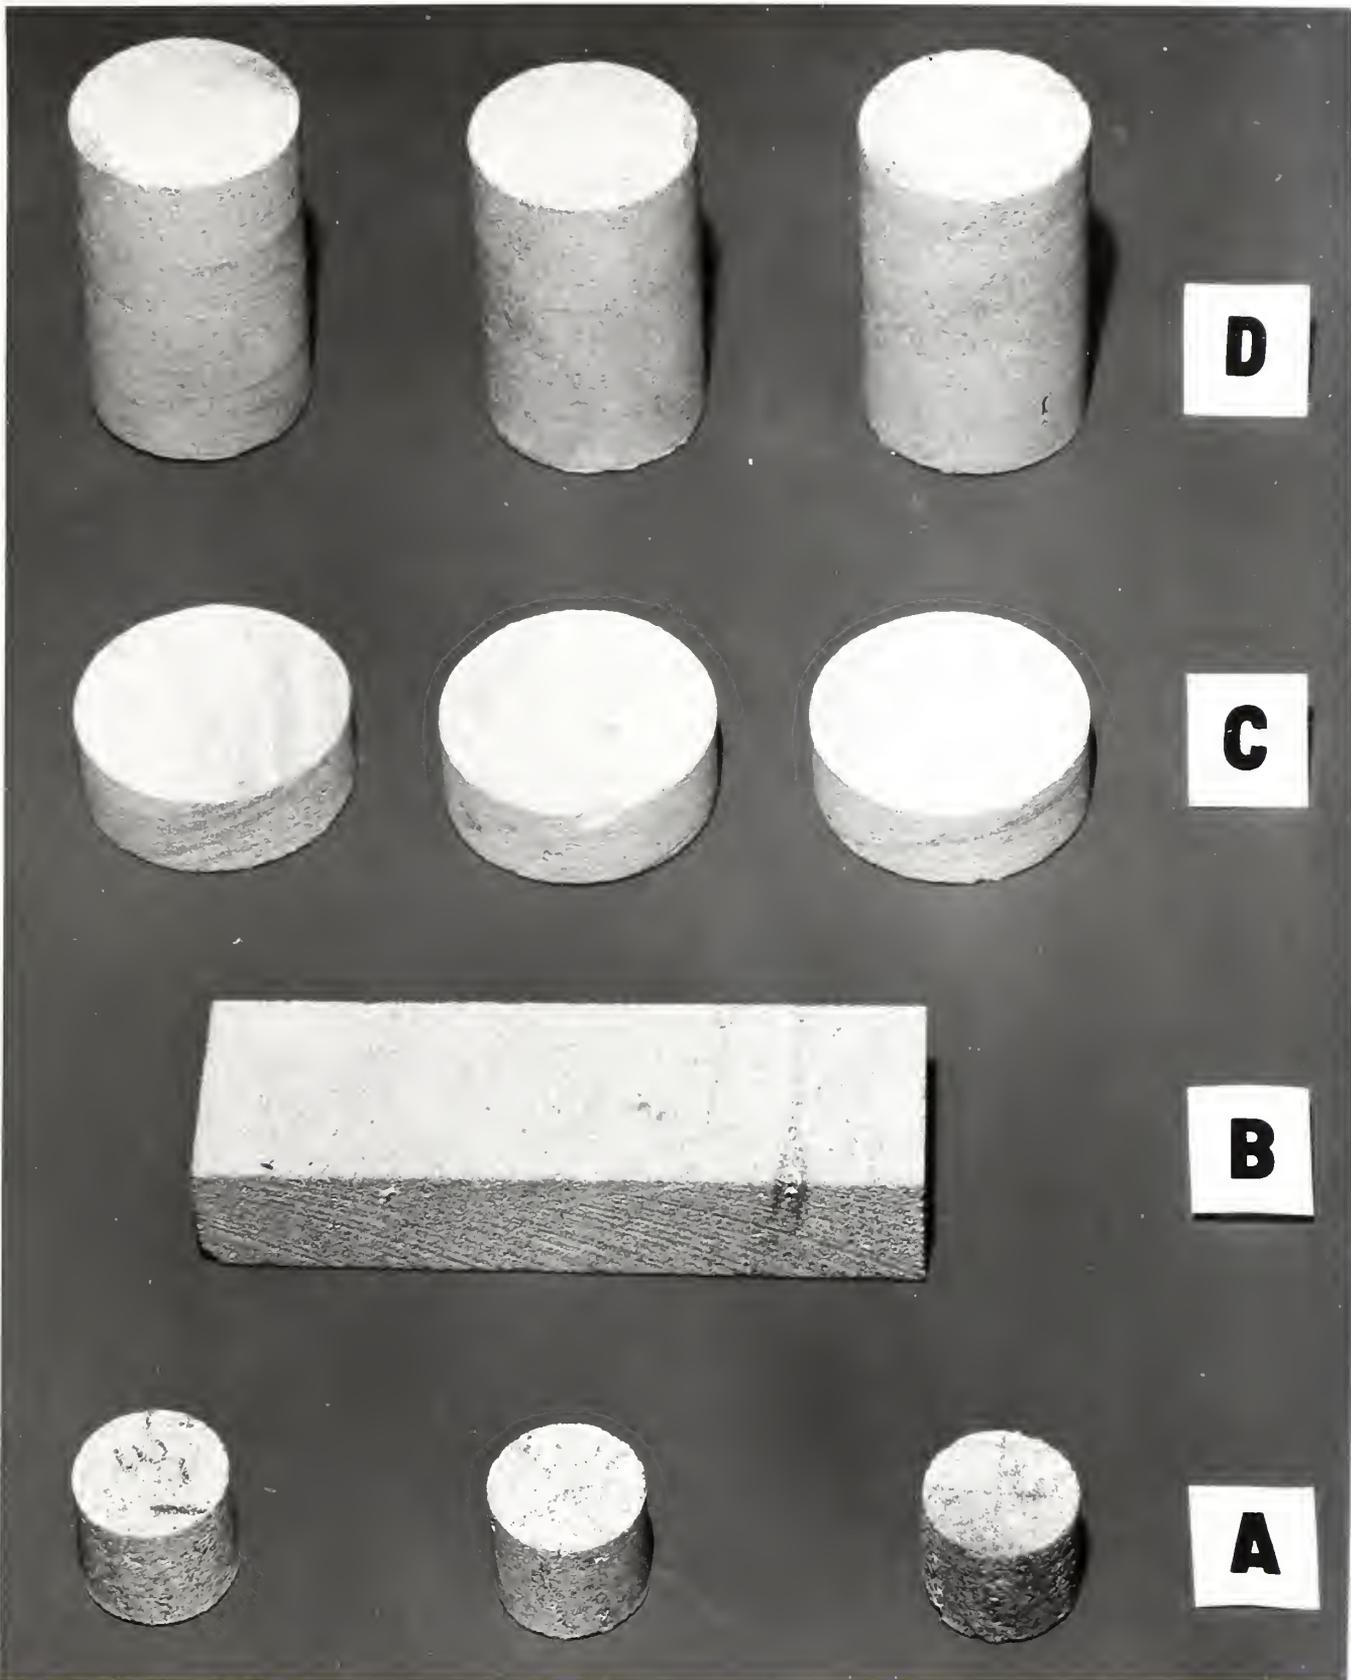
Fig. 1. Test specimens used in the determination of the physical properties of the U. S. Capitol sandstone:  
(A) Compression, absorption, specific gravity, toughness.  
(B) Shearing strength.  
(C) Abrasive hardness, absorption, specific gravity.  
(D) Elasticity, capillarity, freezing cycles.

The dynamic modulus of elasticity by sonic methods was determined for six of the nine samples submitted for test. The specimens were in the form of cylinders, approximately 2 1/2 in. long and 1 3/4 in. in diameter (figure 1-D). This property was determined wherever possible on specimens taken near the painted and back ends of each core tested. The specimens were first tested in an oven-dried condition, and later four of the six samples were tested after 10 and 20 cycles of freezing and thawing.

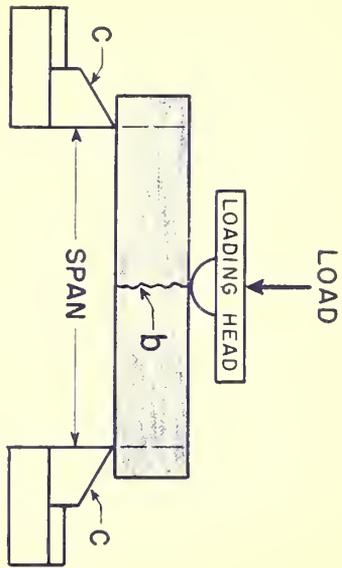
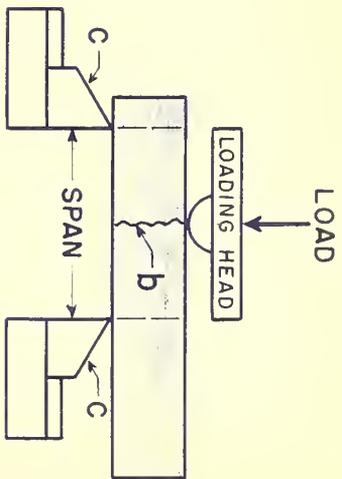
(A) LOADING AT CENTER OF SPAN

LOADING OFF-CENTER ON SHORT SPAN TO OBTAIN TWO TESTS FOR ONE SAMPLE.

- d - CROSS SECTION OF CYLINDRICAL SPECIMEN SHOWING BEDDING OF STONE.
- b - LOCATION OF BREAK.
- c - SUPPORTING KNIFE EDGE.

FIGURE 2. DIAGRAM SHOWING METHOD OF LOADING CYLINDRICAL TEST SPECIMENS IN FLEXURAL STRENGTH TEST.

After the specimens were dried for 24 hr at 105 deg C and cooled to room temperature, they were tested in a Baldwin-Southwark 60,000-lb capacity hydraulic testing machine. The cylindrical specimen was laid on supporting knife edges with the bedding of the stone perpendicular to the direction of loading. The load was applied at approximately 1000 lb per min until failure occurred. A similar test method is described in ASTM Standard C99-52, Modulus of Rupture of Natural Building Stone.

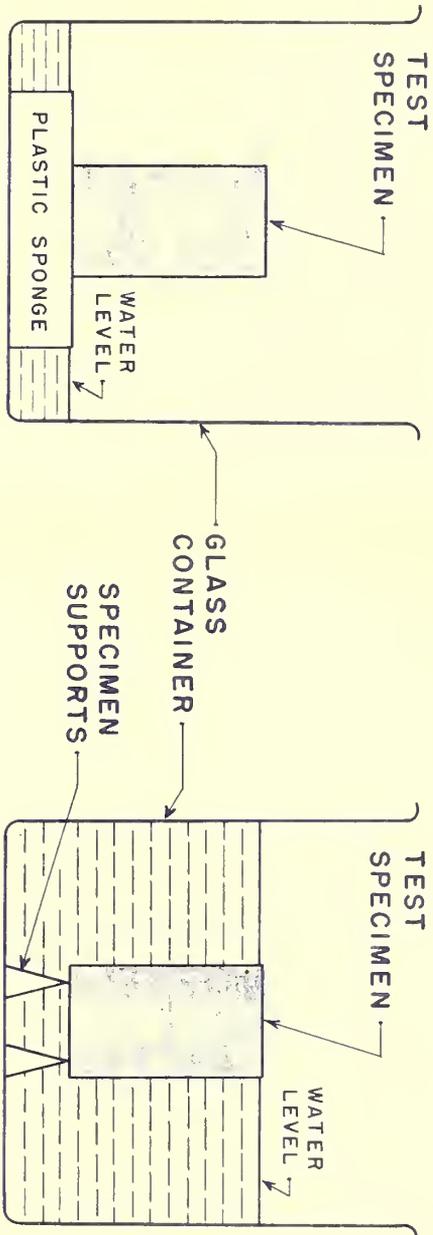
(ONLY ONE SURFACE OF SPECIMEN  
IN CONTACT WITH WATER).

(ALL BUT TOP SURFACE  
OF SPECIMEN IN CONTACT  
WITH WATER).

FIGURE 3. DIAGRAM SHOWING CONDITIONS OF TESTS A AND B IN THE DETERMINATION OF CAPILLARY PROPERTIES OF THE SANDSTONE SAMPLES.

The conditions of the tests are illustrated in figure 3, A and B. Test A determines the absorption when the specimen is standing on one end on a plastic sponge which is immersed in water nearly to the top. In test A absorption takes place entirely by capillary suction. Test B measures the absorption for the same period (one minute) when the specimen is in contact with water on bottom and sides, i.e., all faces except the top are immersed. The areas in contact with water in each case are determined for comparison with the absorption results.

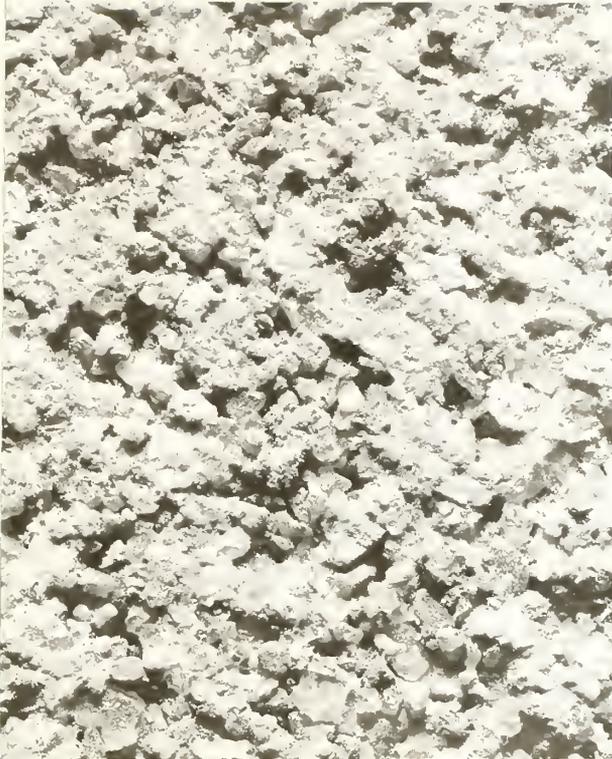
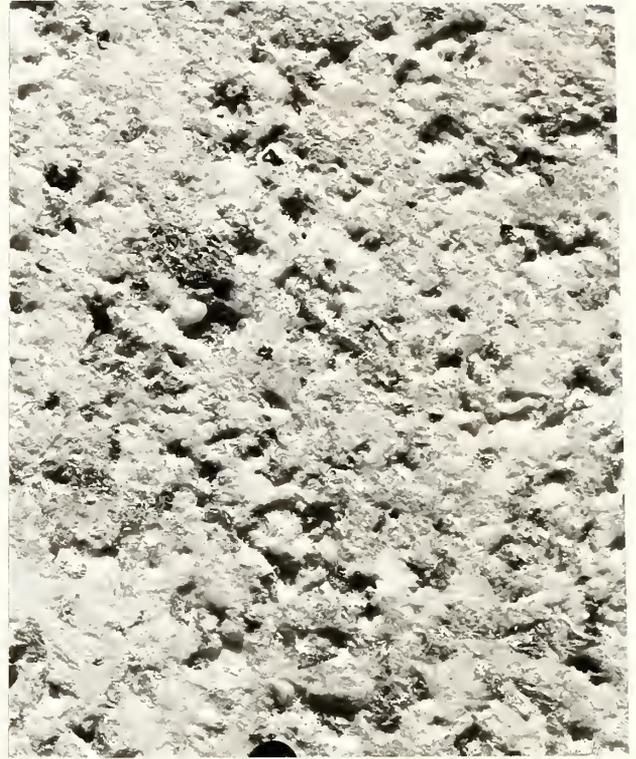
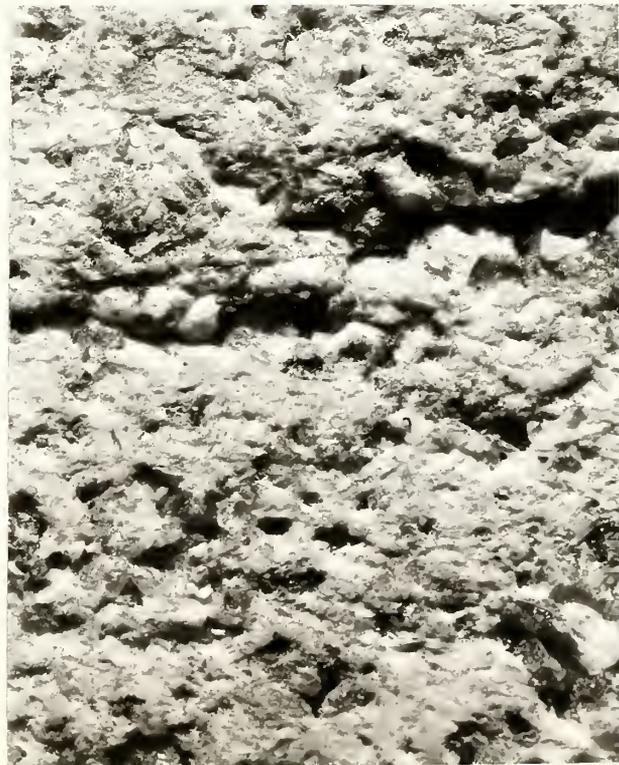
Fig. 4-A. Photographs of sections of samples C-1, C-2, and C-3, showing the variation in texture of the U. S. Capitol sandstone. (magnification, 10 X)

The nine samples submitted show considerable variations, both in composition and in texture. In general, the color of the specimens when observed on a fresh surface is light gray with occasional stains of brownish yellow. These stains were produced by the alteration of minerals containing iron, forming hydrous iron compounds. The variation in textures of the samples can be readily observed from the photographs of the nine specimens, magnified 10 times, representing each of the nine samples (figures 4-A, B and C). The difference in the textures of the specimens is due primarily to a difference in specimen porosity. In some specimens it appears that large voids were formed at the time of lithification of the deposit, as exemplified in figure 4-B (C-5). In other specimens many of the voids may be there as a result of leaching of soluble constituents after the sandstone had lithified as shown in figure 4-A (C-2).

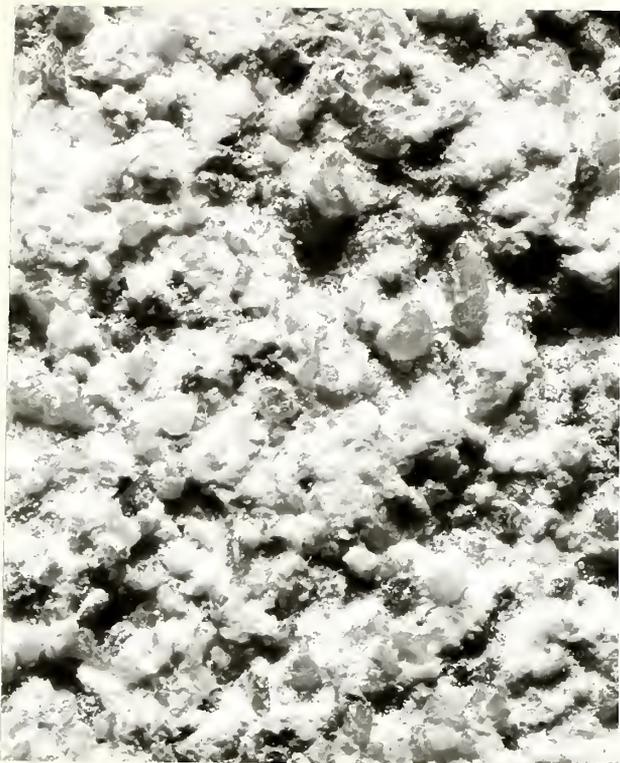
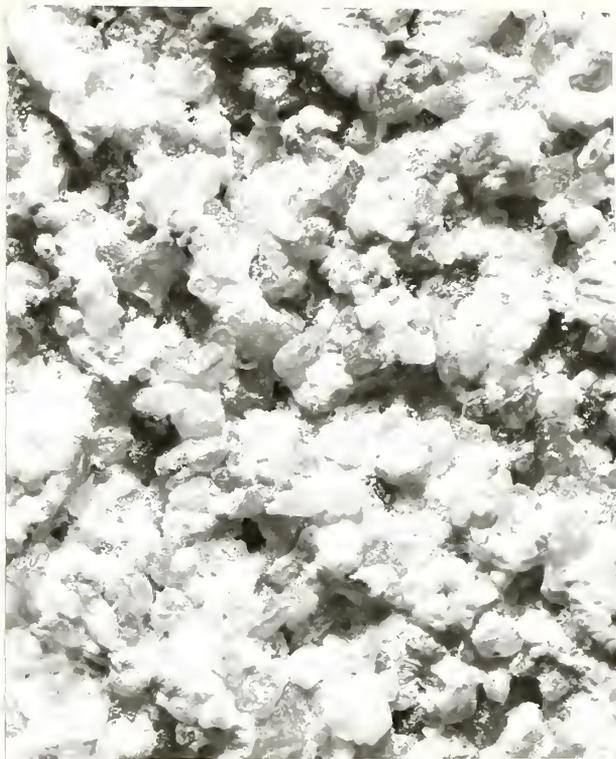
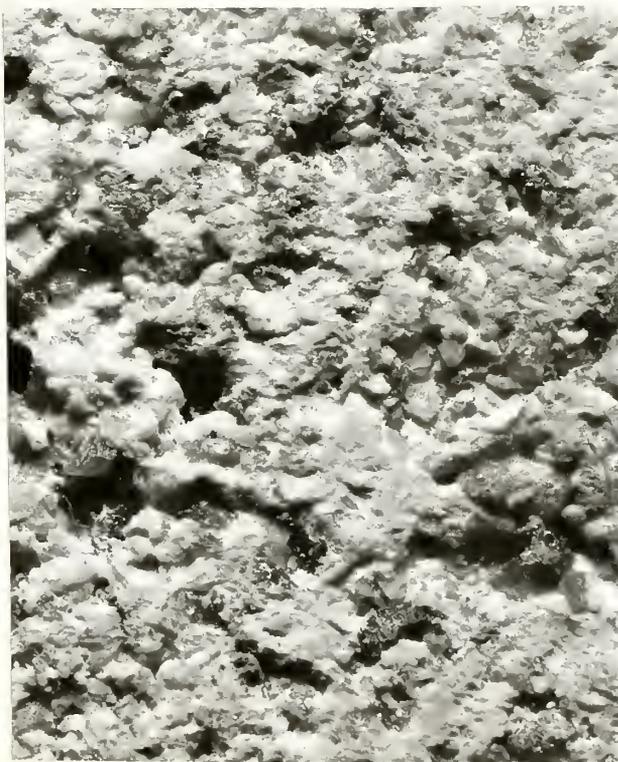
Fig. 4-B. Photographs of sections of samples C-4, C-5, and C-6, showing the variation in texture of the U. S. Capitol sandstone. (magnification, 10X)

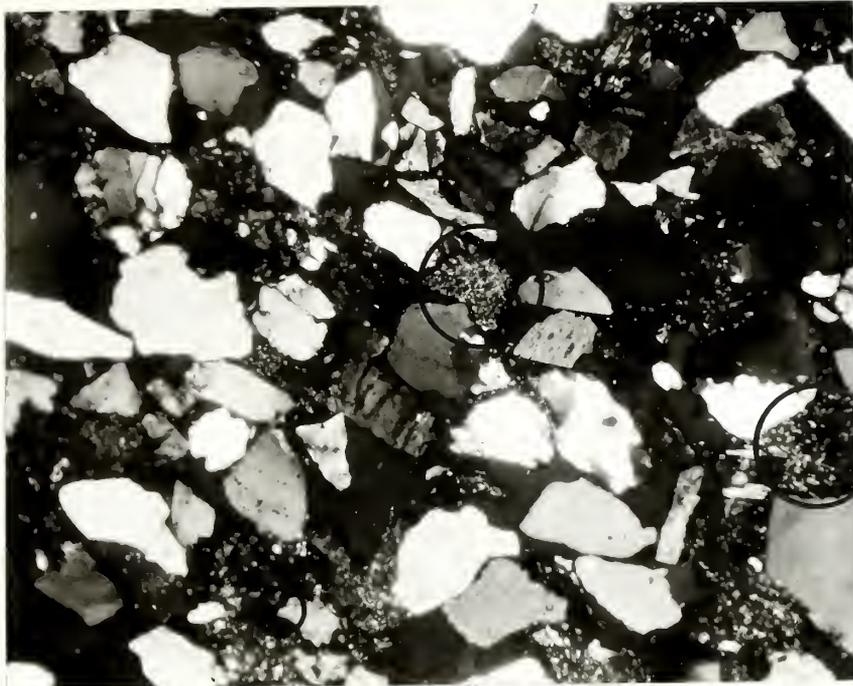
Fig. 5. Photograph of thin section of sample C-1 showing the decomposed feldspar areas as fine-grained birefringent crystals, exemplified in the two circled areas. (magnification 10 X)

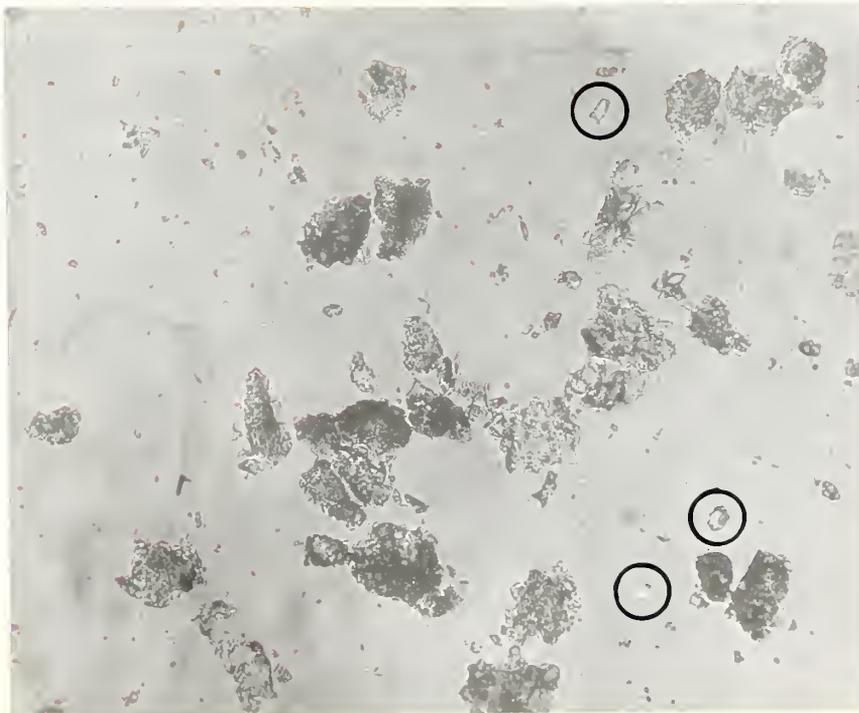
Fig. 6. Photograph of powdered specimen, representing material from samples of the Capitol sandstone, showing typical alteration products of the feldspar. Encircled clear grains are quartz; dark areas are kaolin. (magnification 200 X)

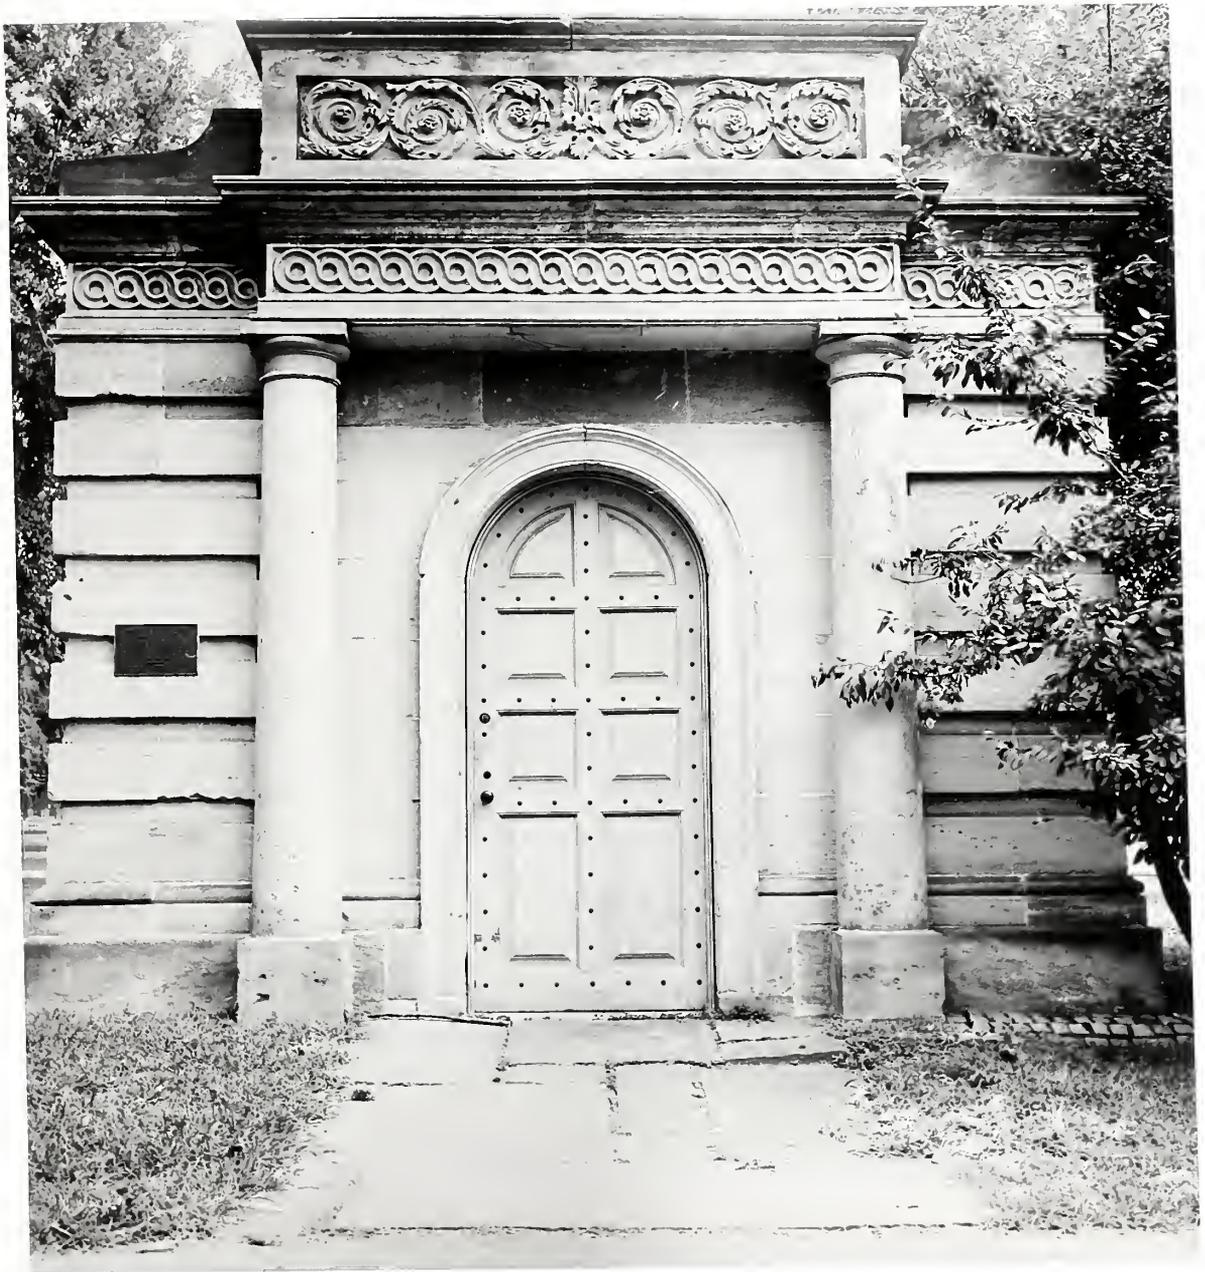
Fig. 7. View of Bulfinch gate house at Constitution Avenue and 17th Street, Washington, D. C. Photograph shows the excellent state of preservation of the unpainted Aquia Creek sandstone after about 125 years of exposure.

The Bulfinch gatehouses, formerly on the Capitol grounds and presently located on Constitution Avenue at 15th and at 17th Streets, are constructed of Aquia Creek sandstone. It is probable that these two buildings were never painted. Photographs were taken of them and reproduced here to illustrate the good condition of the stone (figures 7, 8 and 9). There is not much evidence of weathering except near the ground and at occasional small pits or vugs which may have been filled originally with friable, clayey material which was later removed by weathering.

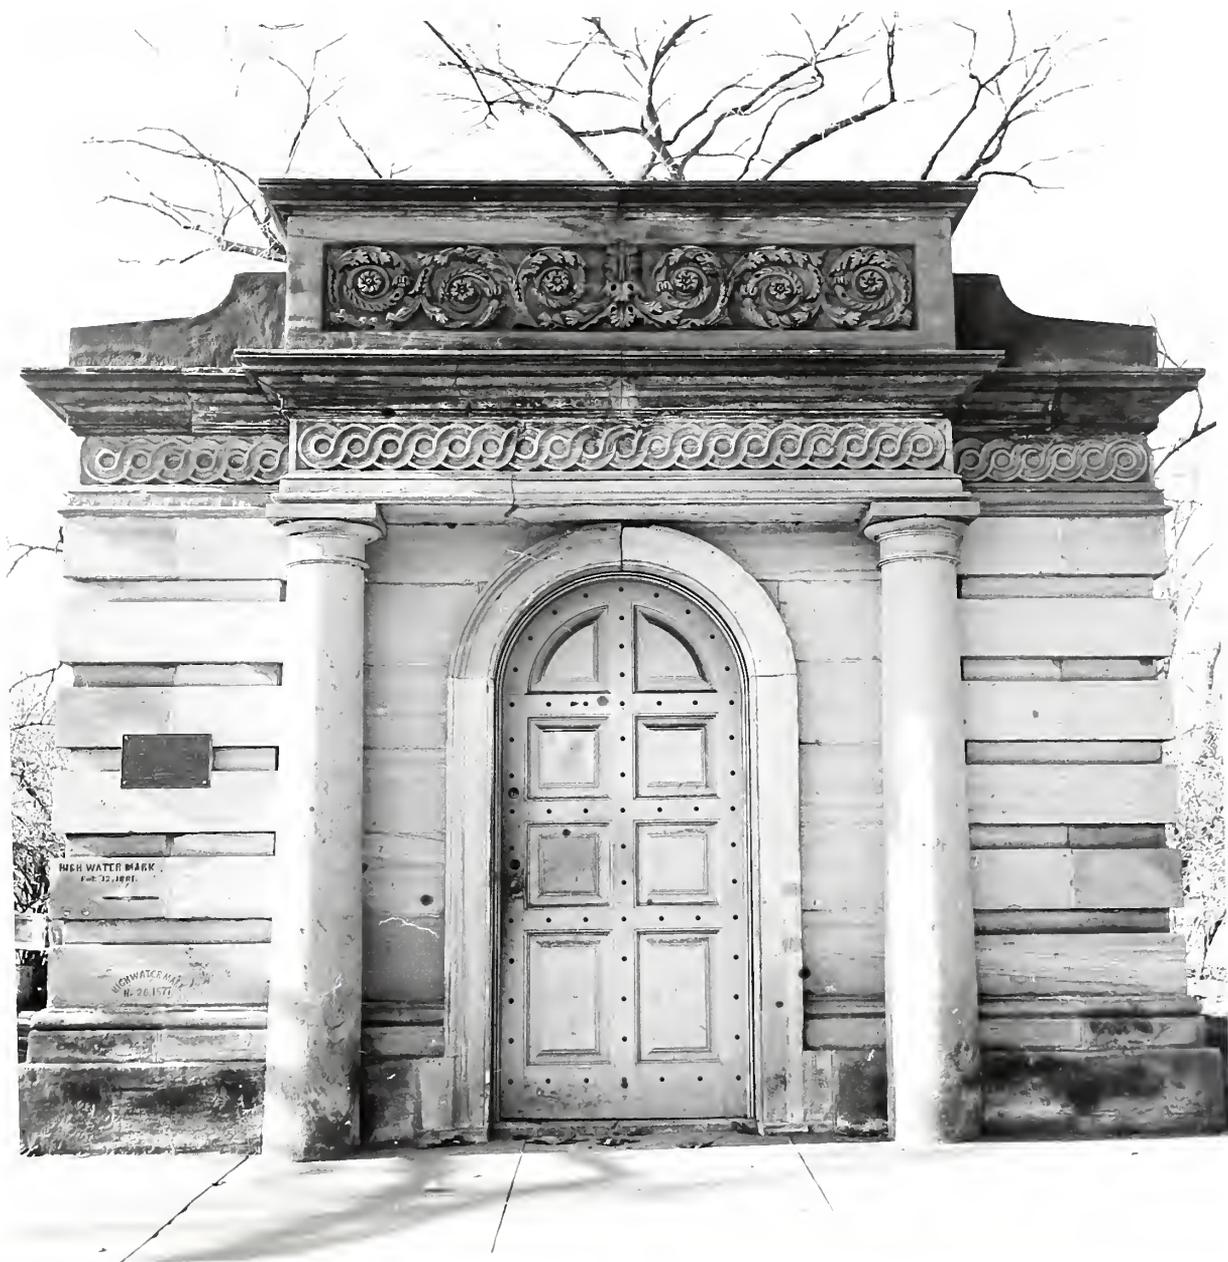
Fig. 8. View of Bulfinch gate house at Constitution Avenue and 15th Street, Washington, D. C. Photograph shows the excellent state of preservation of the unpainted Aquia Creek sandstone after about 125 years of exposure.

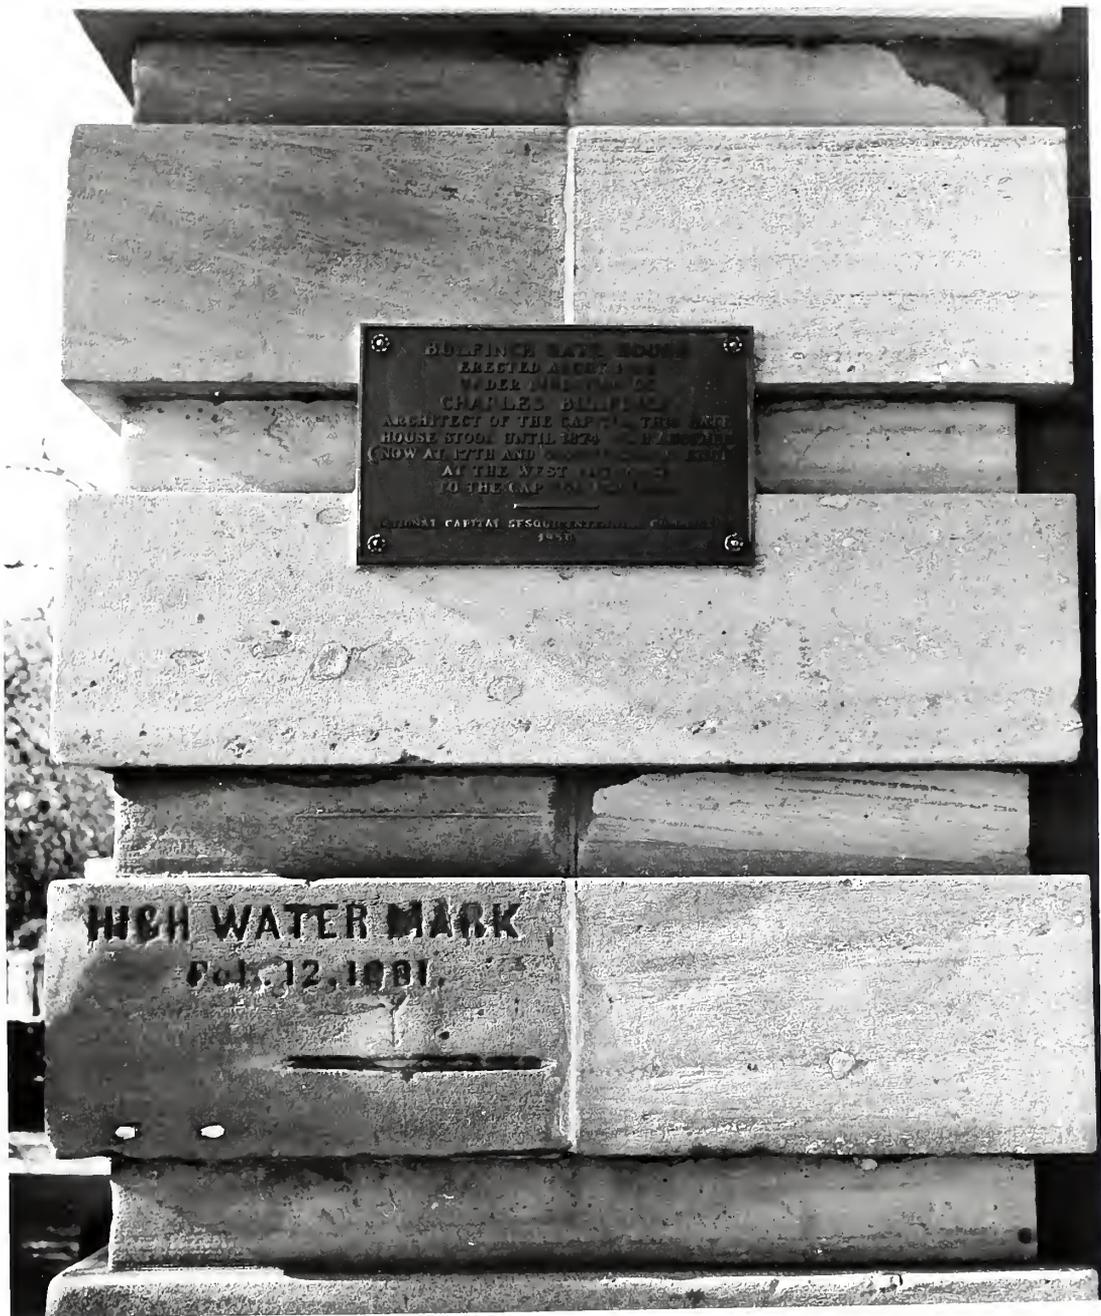
Fig. 9. Close-up view of a section of the east side of the gate house described in Fig. 8.

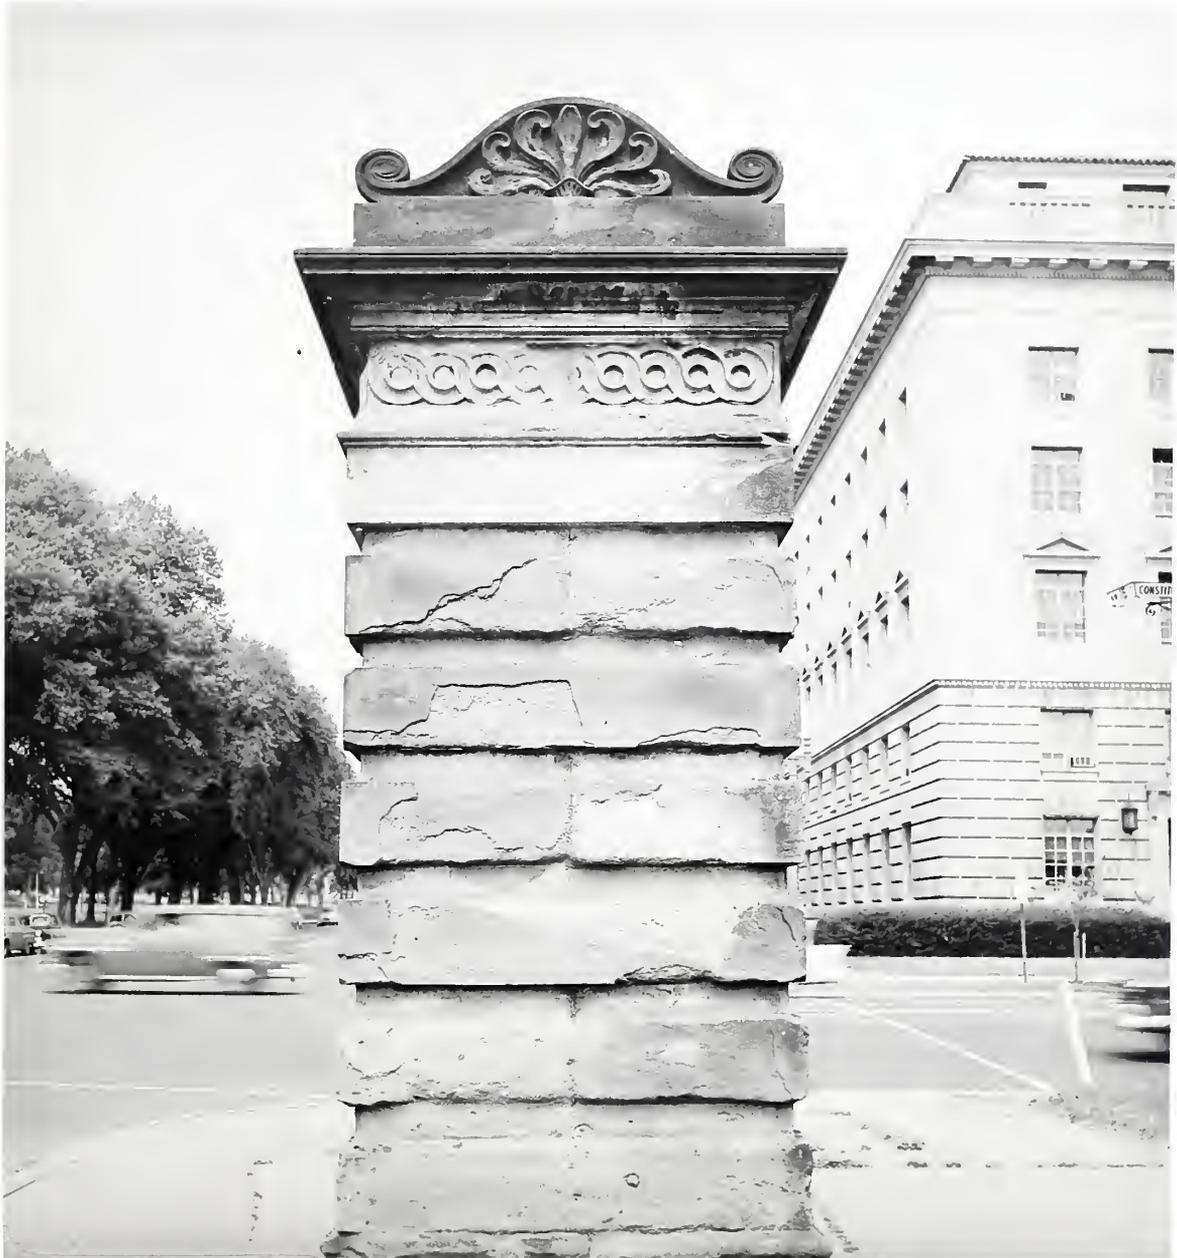
Fig. 10. View of gatepost at the southeast corner of Constitution Avenue and 15th Street, Washington, D. C. illustrating the advanced state of disintegration of unpainted Aquia Creek sandstone after about 125 years of exposure.

The gateposts once situated on the Capitol grounds and now located on 15th and Constitution, are examples of badly deteriorated Aquia Creek sandstone. Figures 10 and 11 illustrate this condition in two of the gateposts. Since some of the blocks in the Capitol have been shown by tests to be of inferior quality, it is likely that such blocks would have eroded very much like the gateposts if no painting had been done on the Capitol stone.

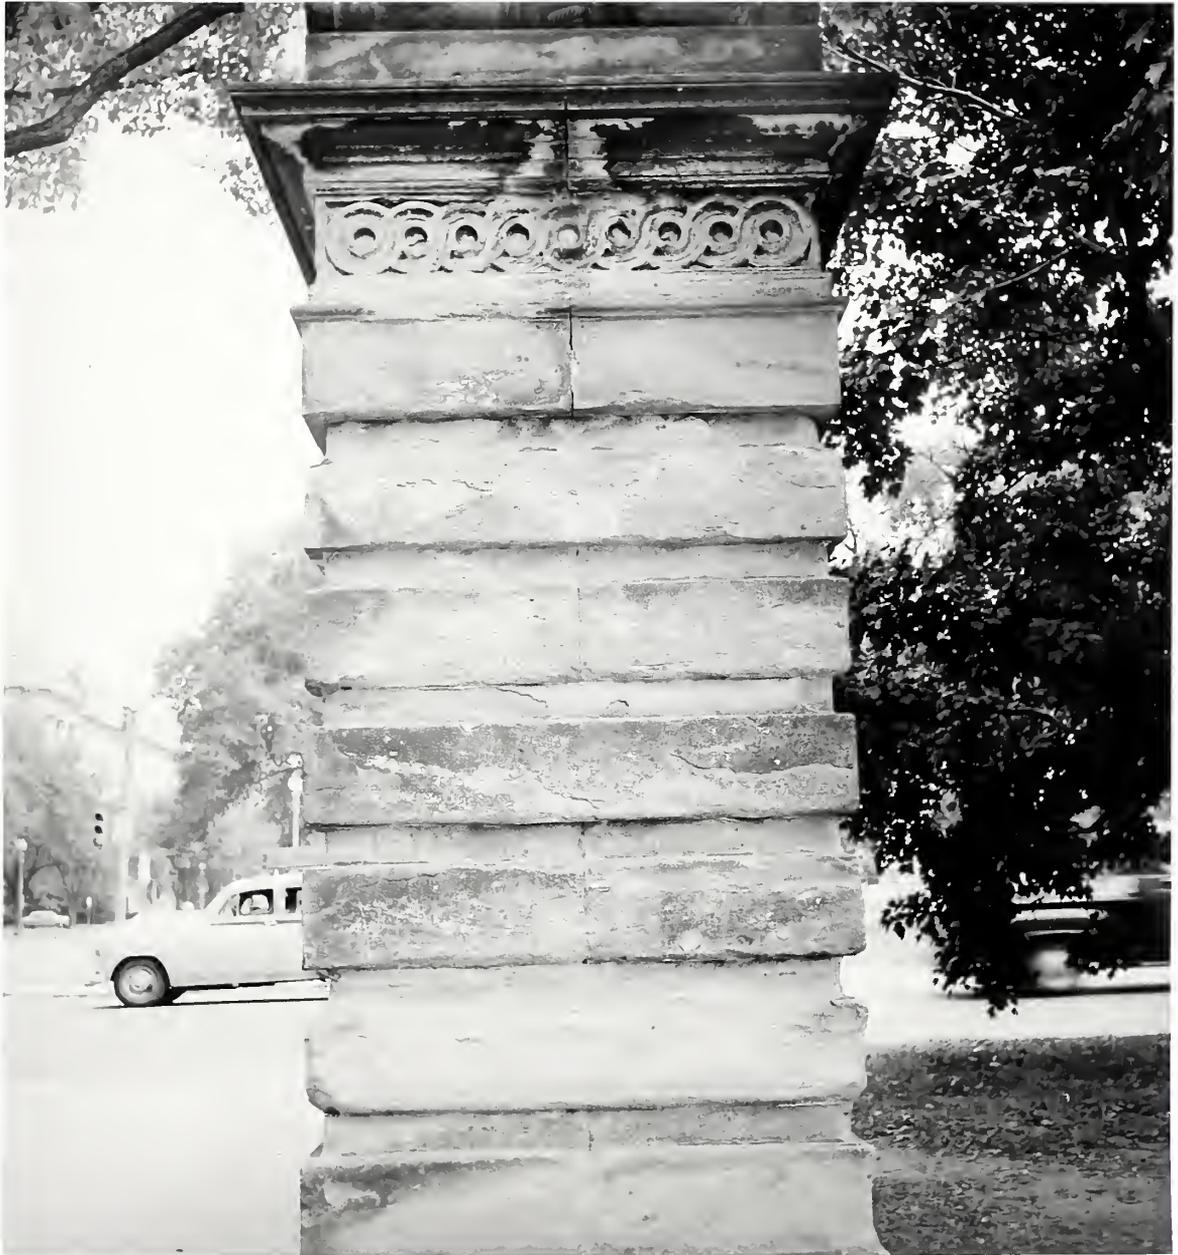
Fig. 11. View of gatepost at the southwest corner of Constitution Avenue and 15th Street, Washington, D. C. illustrating the advanced state of disintegration of unpainted Aquia Creek sandstone after about 125 years of exposure.
