CIRCULAR
OF THE
BUREAU OF STANDARDS

No. 113

STRUCTURE AND RELATED PROPERTIES
OF METALS

SEPTEMBER 7, 1921

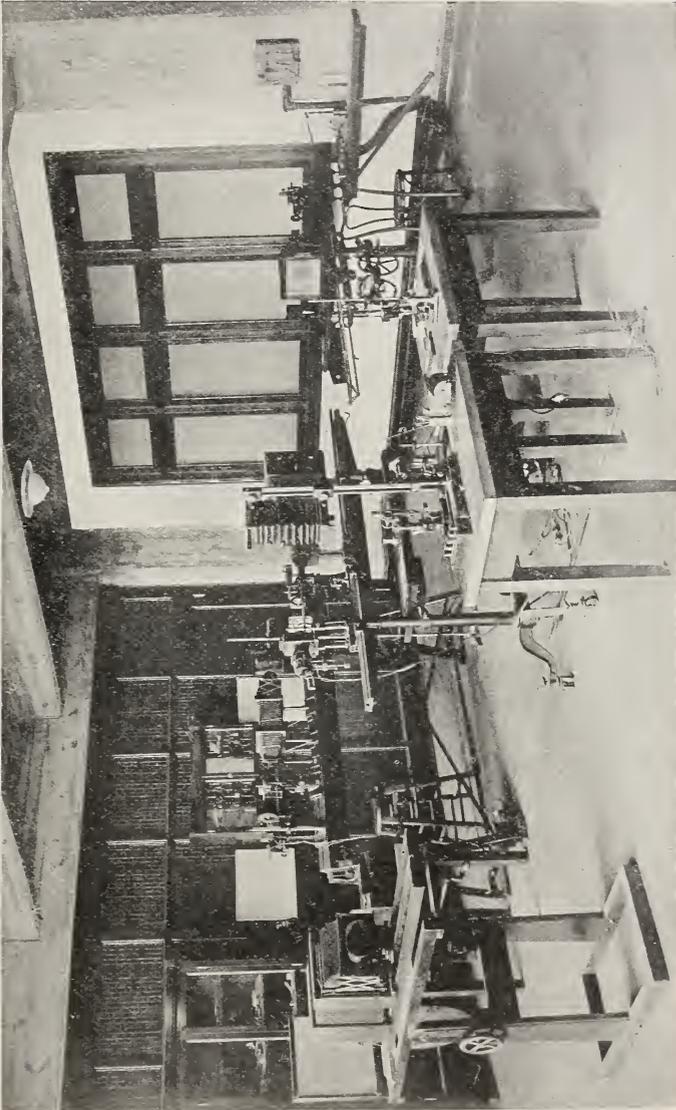
FIG. 1.—Laboratory for the microscopy of metals at the Bureau of Standards

metallographic testing for which the Bureau of Standards is equipped. A general view of the laboratory devoted to the study of the structure of metals is shown in Fig. 1.

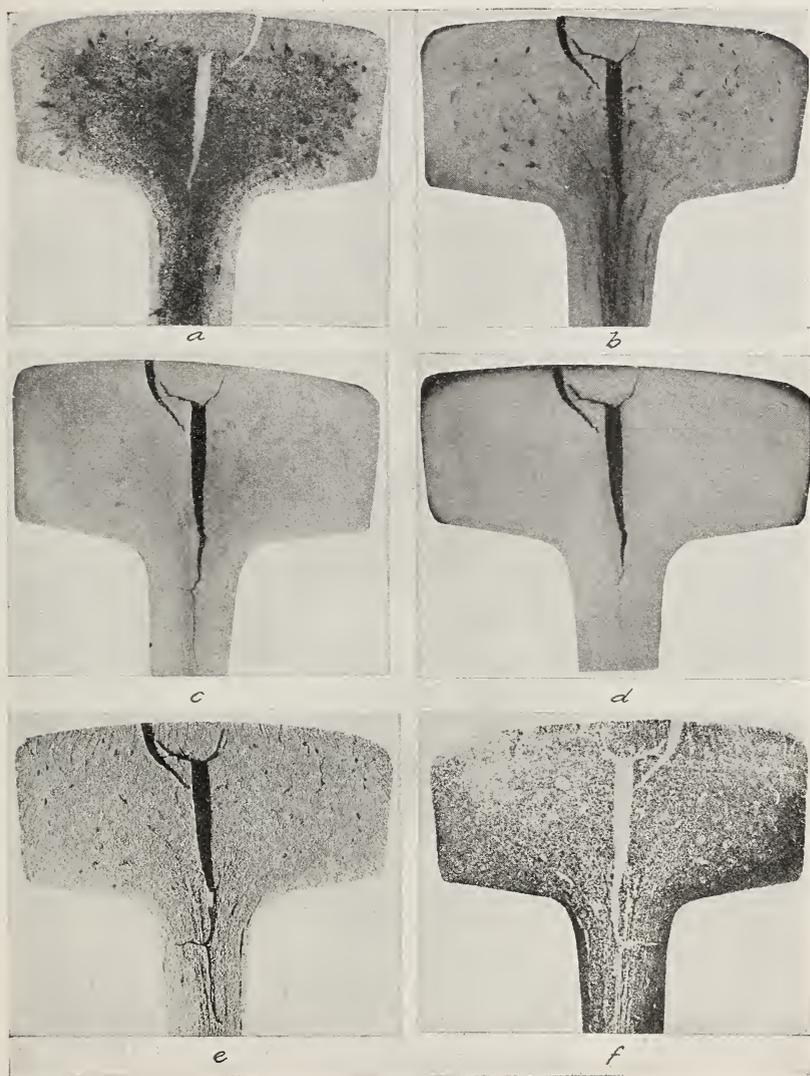
FIG. 2.—Macrostructure of the head of a segregated rail which failed in service, as revealed by various etching reagents. $\times 3/4$

Note that some of the reagents are much more effective than others in revealing the segregated center of the head. Although such metal should be regarded with suspicion, it is not to be inferred that segregation of the character shown will of necessity lead to failure of the rail. The character of the service is the decisive factor. Methods of etching: (a) Sulphur print, (b) aqueous solution of copper ammonium chloride (Heyn's reagent), (c) aqueous solution of iodine and potassium iodide, (d) acidulated alcoholic solution of cupric chloride (Stead's reagent), (e) hot concentrated hydrochloric acid, (f) print of the deeply etched surface of e

examination after failure in service in the track, illustrates the use of the various reagents described above. It is very evident that the results of chemical analyses of the rail shown by several analysts might differ very materially according to the location in the rail of the sample used for the analysis.

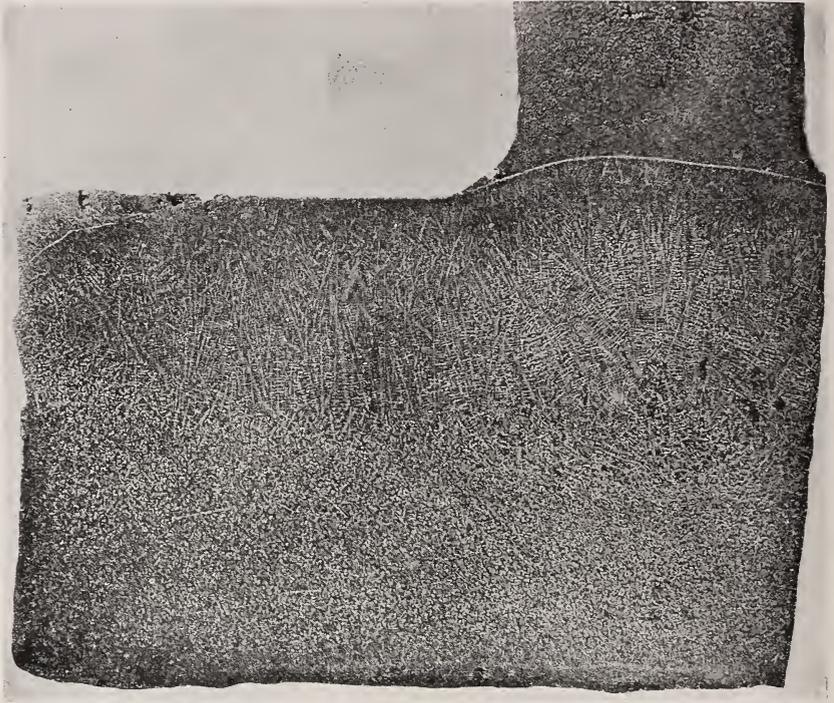
FIG. 3.—Macrostructure of a defective steel casting revealed by deeply etching with hot concentrated hydrochloric acid. $\times 1/2$

Fig. 3 shows the appearance of a specimen deeply etched with concentrated hydrochloric acid. The specimen was a portion of a large steel casting which broke during shipment. Although the

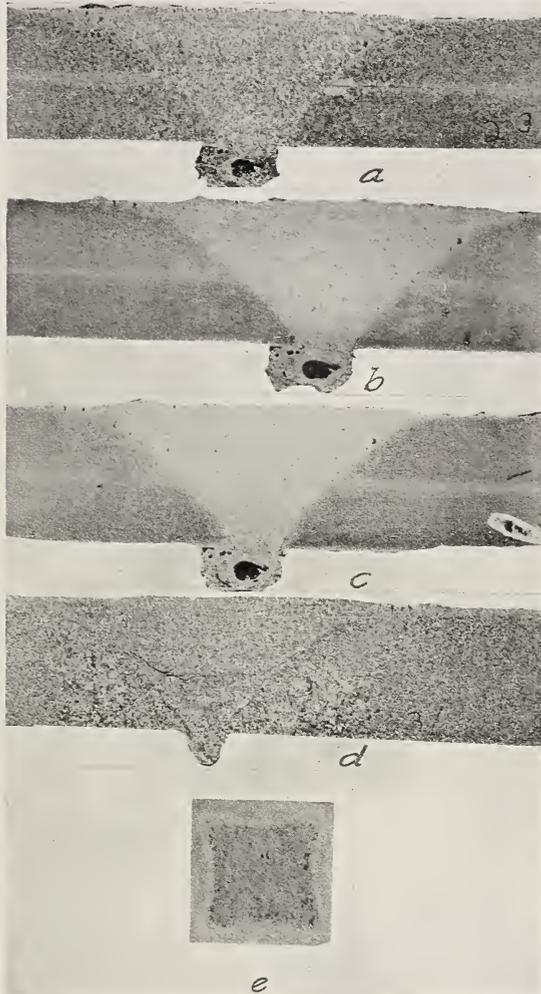
FIG. 4.—Macrostructure of fusion welds and of segregated steel, illustrating the advantages of ammonium persulphate as an etching reagent. $\times 1$

A coarsely crystalline condition is usually considered very undesirable in metals. Note that this condition is revealed most plainly by ammonium persulphate. (a) Specimen of oxyacetylene welded steel plate etched with aqueous solution of ammonium persulphate; (b) specimen a etched with aqueous solution of copper ammonium chloride; (c) specimen a etched with 2 per cent alcoholic nitric acid; (d) welded steel plate, similar to a, illustrating overheating of the plate, etched with ammonium persulphate; (e) cross section of bar of segregated steel, etched with ammonium persulphate

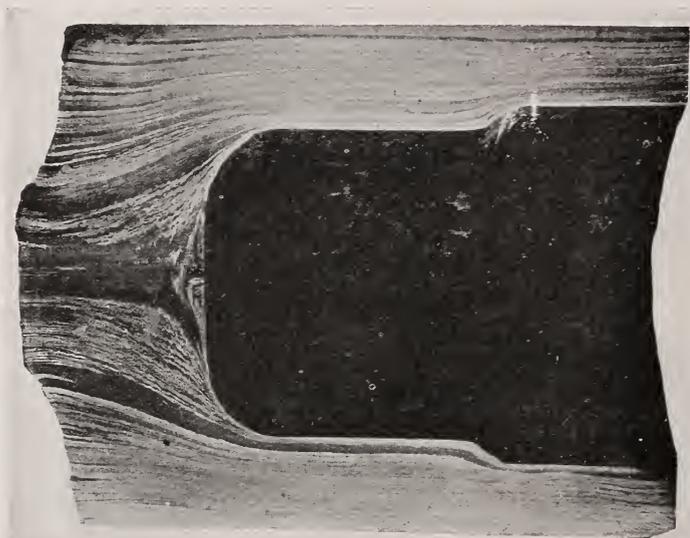
FIG. 5.—Macrostructure of forged steel (longitudinal section of the head of a shrapnel shell) revealed by etching with cupric chloride (Stead's reagent). $\times 4/5$

An acidulated alcoholic solution of copper chloride is often used to reveal the distribution of phosphorus. Various formulas for preparing this reagent have been recommended by different investigators. In general, however, the results obtained are very similar for all of them. The formula of Stead (copper chloride, 10 g; magnesium chloride, 40 g; concentrated hydrochloric acid, 20 cm³; and alcohol to make 1000 cm³) and that of LeChatelier (95 per cent alcohol, 100 cm³; water, 10 cm³; copper chloride, 1 g; picric acid, 0.5 g; and concentrated hydrochloric acid, from 1 to 3 cm³) may be cited as representative. After an immersion of about one minute, the previously polished and cleaned surface of the specimen will usually be found to be covered in certain portions with a firmly adhering film of copper. Other parts remain clear or uncoated. The copper-coated portions are generally considered to be of lower phosphorus content than the clear or slightly coated portions. Other elements in solid solution, however, such as nickel, may produce a similar differential precipitation of the copper, and the work of LeChatelier and Bogitch⁷ appears to indicate that the reagent is primarily useful for demonstrating the distribution of oxide within the steel, the other indications being only secondary ones. Fig. 5 shows a portion of a shrapnel shell which was etched with this reagent.

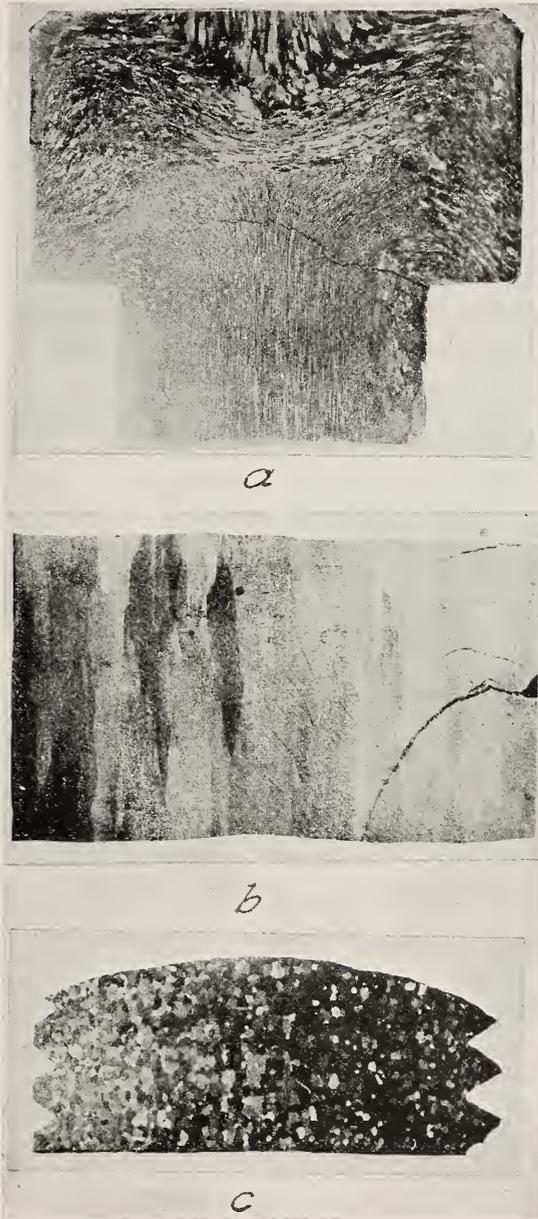
FIG. 6.—Macrostructure of a forged copper alloy, manganese bronze, revealed by etching with an ammoniacal solution of copper ammonium chloride

Note the cracks which occurred in service in the coarsely crystalline specimens, *a* and *b*; presumably this was largely the result of the crystalline condition of the material. (*a*) Longitudinal section of the head of a forged bolt which cracked in service ($\times 1\frac{1}{2}$); (*b*) longitudinal section of bolt which failed in service ($\times 3$); (*c*) longitudinal section of bolt ($\times 2$)

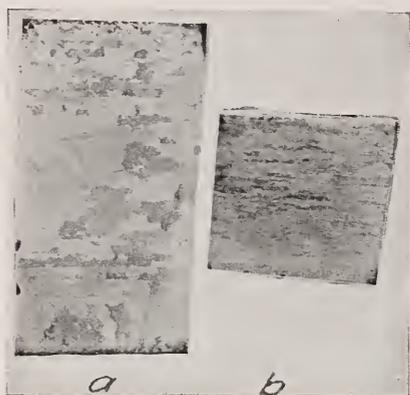
FIG. 7.—Macrostructure of a wrought aluminum alloy. $\times 2$

Fig. 7 shows specimens of an aluminum alloy, designated as "conducting aluminum" and of the approximate composition—silicon, 0.5 per cent; iron, 0.5 per cent; magnesium, 0.7 per cent; aluminum, remainder—etched so as to reveal the macrostructure.

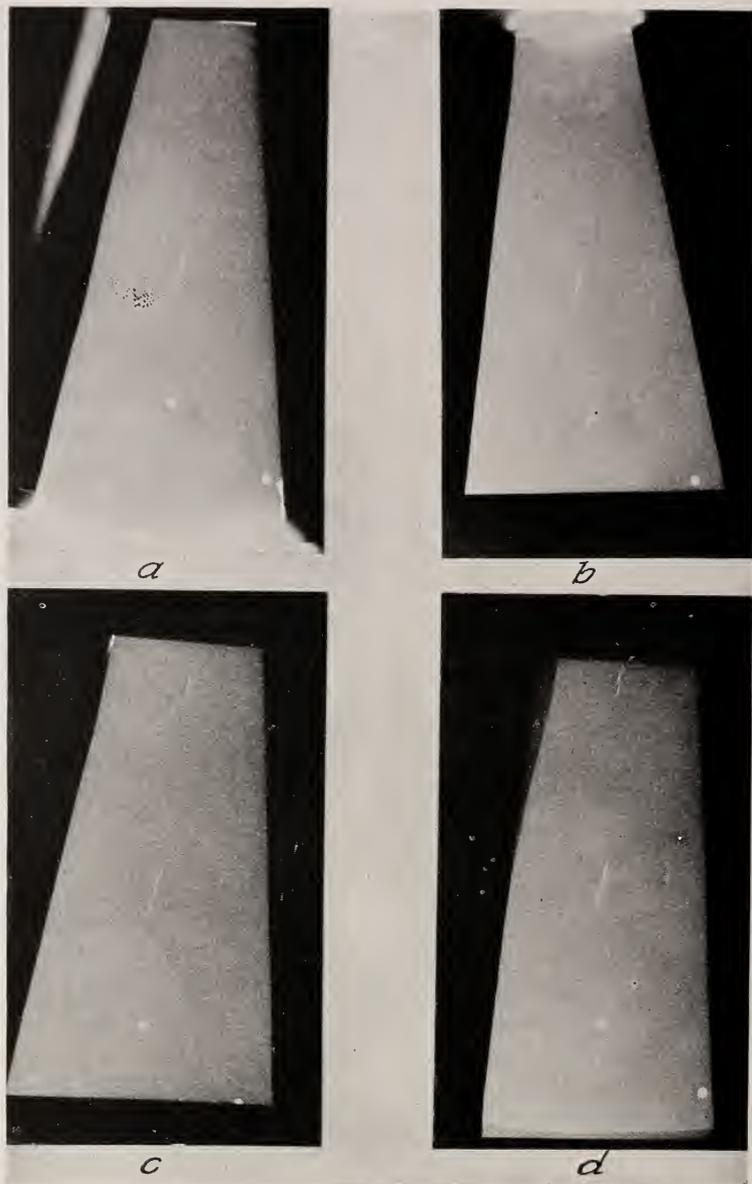
FIG. 8.—Defects, “flakes,” in forged gun steel revealed by radiographic examination.
Approximately $\times 1$

A radiograph of the specimen was taken after each of the treatments listed below. The steel plate $\frac{1}{4}$ inch thick, containing three holes (white spots in radiographs) drilled partly through for reference points, was placed so that the direction of the X-rays coincided with the plane of the defect. Each white line in the radiograph represents a “flake” or defect. Treatments: (a) Forging, as received, (b) specimen a after annealing 30 minutes at 900°C . furnace cooled, (c) specimen b heated 30 minutes at 900°C and quenched in oil, (d) specimen c heated 30 minutes at 1050°C and quenched in oil. The successive radiographs indicate the persistence of the defects after the thermal treatments given the material. Exposure, 9-inch spark, 2 milliamperes, 7 minutes

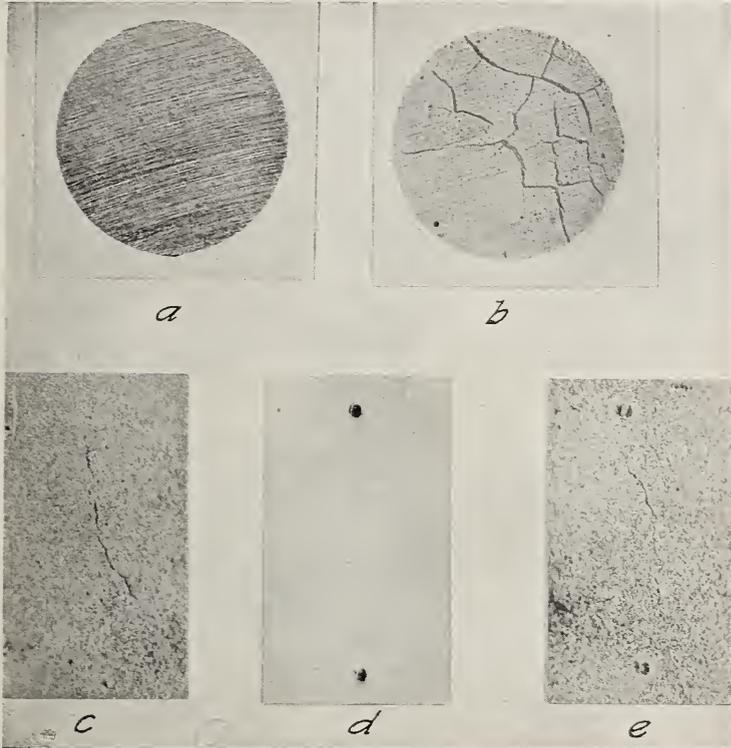
FIG. 9.—Physical unsoundness of steel revealed by magnetic examination

(a) Roughly polished surface of a precision gage block. $\times 1\frac{1}{2}$. (b) Same as a, magnetized and bathed in kerosene containing fine iron dust in suspension; note the network of fine "hardening" cracks revealed. $\times 1\frac{1}{2}$. (c) Section of steel from head of a rail containing internal fractures revealed by method of b. $\times 3$. (d) Same specimen as c after locating the defect by a punch mark at each end. After removing the iron dust no trace of the discontinuity could be seen. $\times 3$. (e) Same specimen as d, retreated as given in b. $\times 3$

internal fractures in wrought-steel parts.¹⁰ Fig. 9 shows specimens which have been treated in this manner.

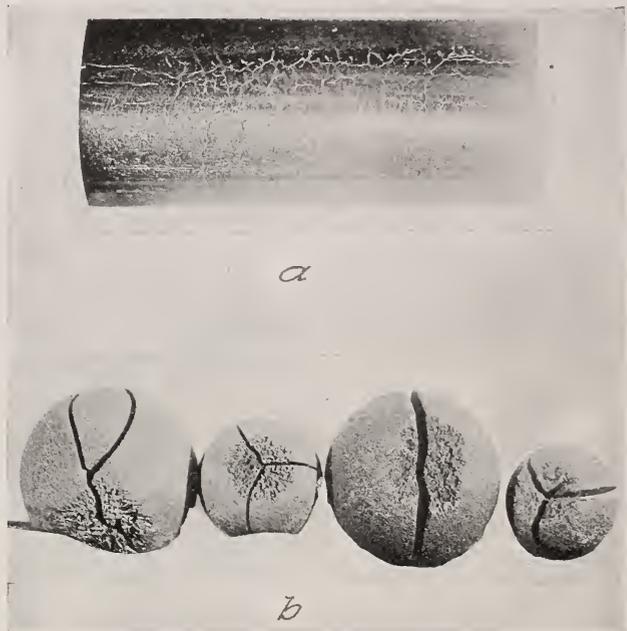
FIG. 10.—*Mechanical nonuniformity of wrought metals revealed by deep etching*

Cracks resembling those shown resulting from deep etching may be produced "spontaneously" in service in metals highly stressed internally. (a) Section of a 1-inch manganese bronze rod etched with an acidulated aqueous solution of mercurous nitrate (65 g mercurous nitrate, 15 cm³ nitric acid per liter). $\times 1$. (b) Hardened steel balls which split open when deeply etched with concentrated hydrochloric acid. $\times 2$

Fig. 10 a shows a portion of a cold-worked rod of manganese bronze which has been immersed in a solution of mercurous nitrate acidulated with nitric acid. The cracks which were formed by the action of this reagent may be taken as an indication of what would undoubtedly have occurred spontaneously later in service.¹¹

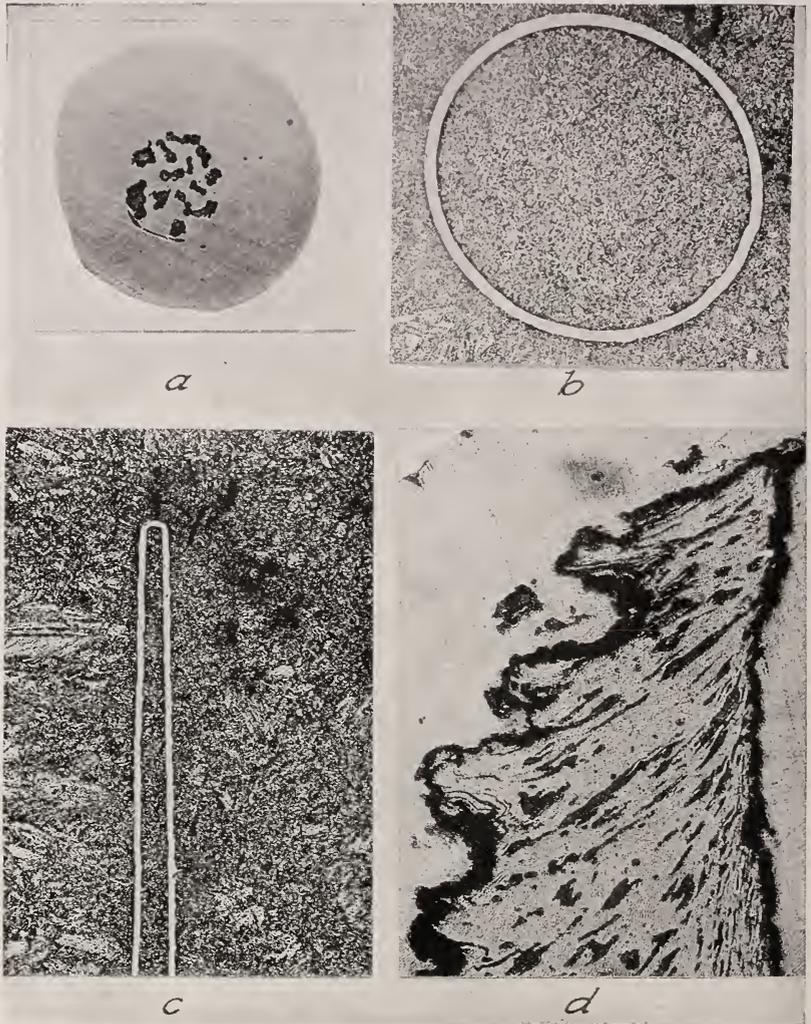
FIG. 11.—Illustrations of the proper method of mounting very small metallic specimens for microscopic examination

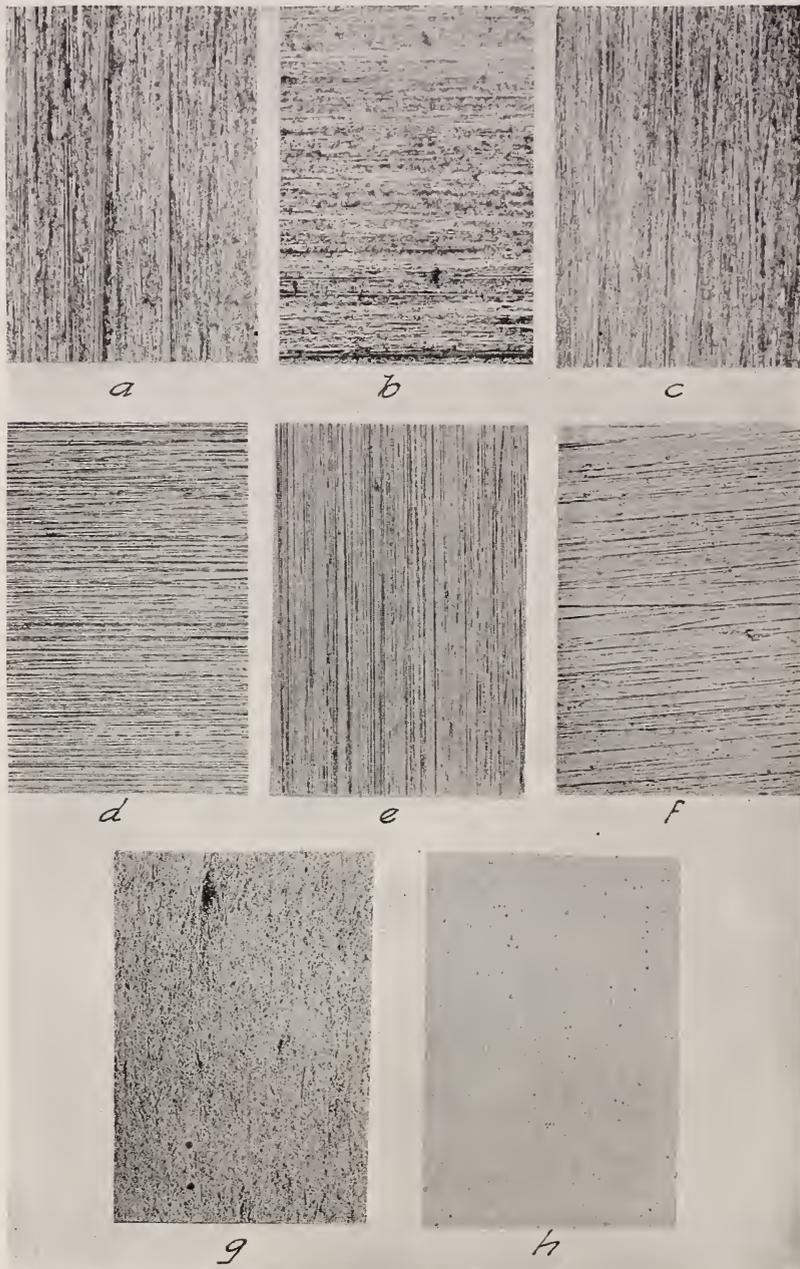
FIG. 12.—Appearance of the face of a specimen of mild steel in different stages of preparation for microscopic examination. $\times 100$

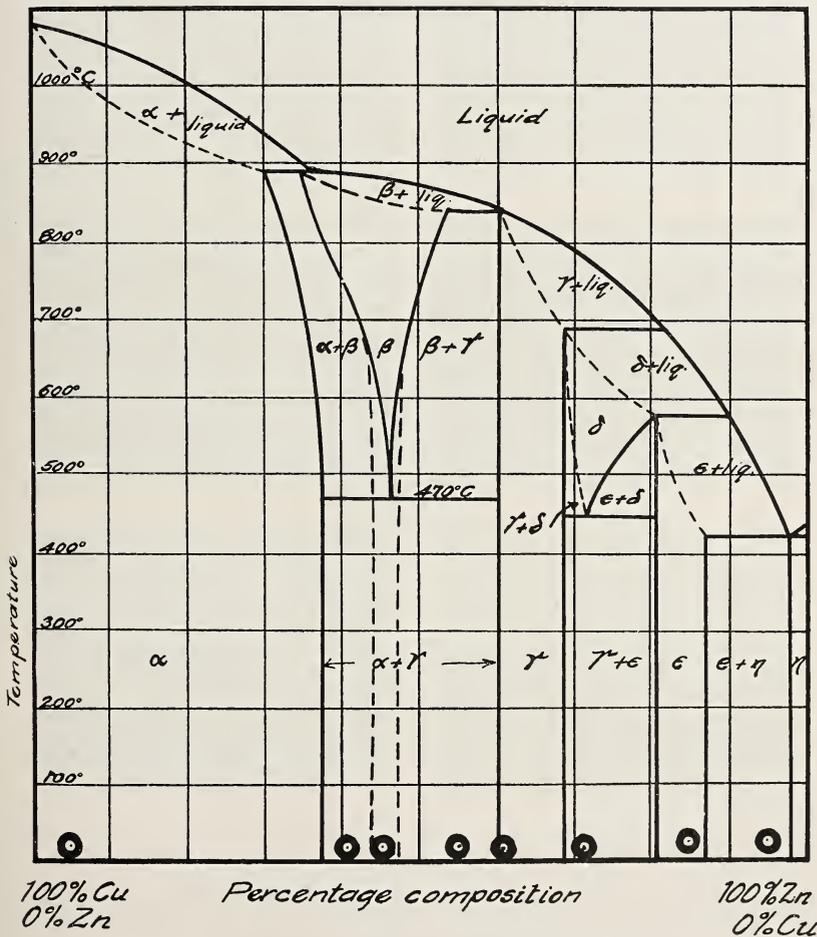
FIG. 13.—Constitutional diagram of the copper-zinc series of alloys

The microstructural features of the different types of alloys, the composition of which is indicated by the circles at the base of the diagram, are shown in Fig. 14

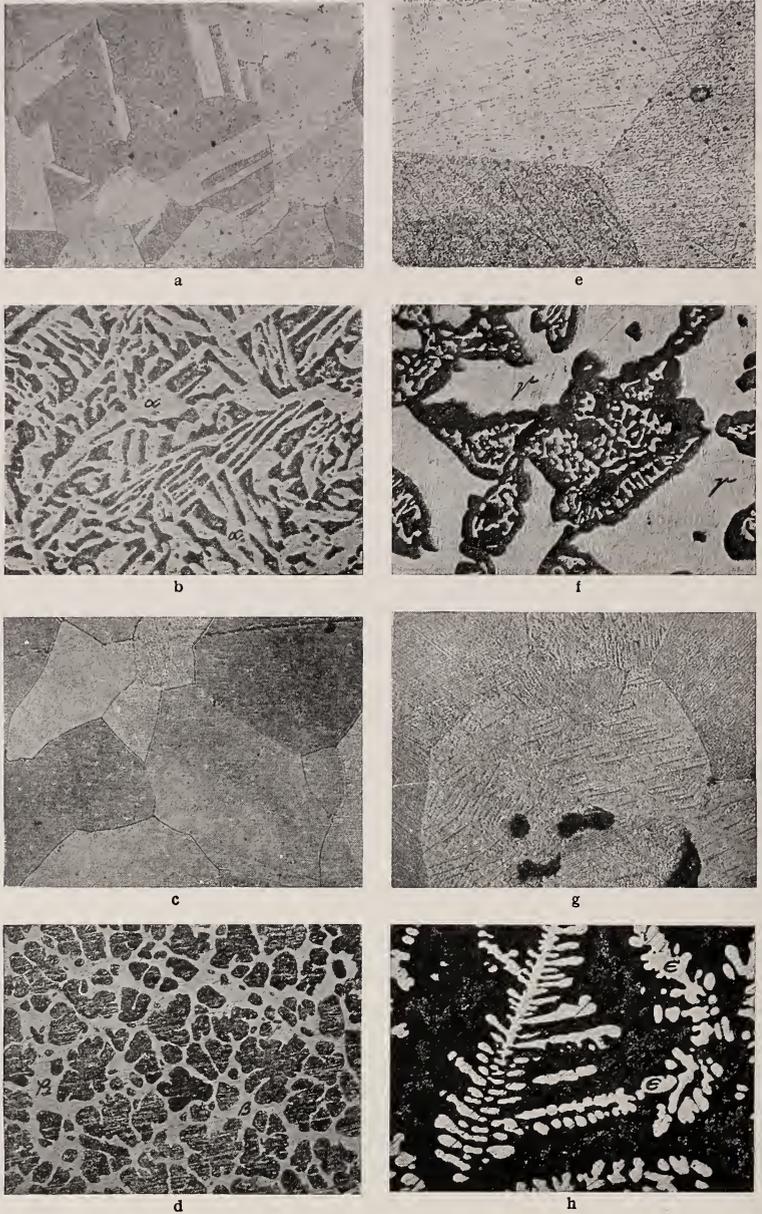
FIG. 14.—Microstructure of the principal types of brasses, that is, alloys of the copper-zinc series. $\times 100$

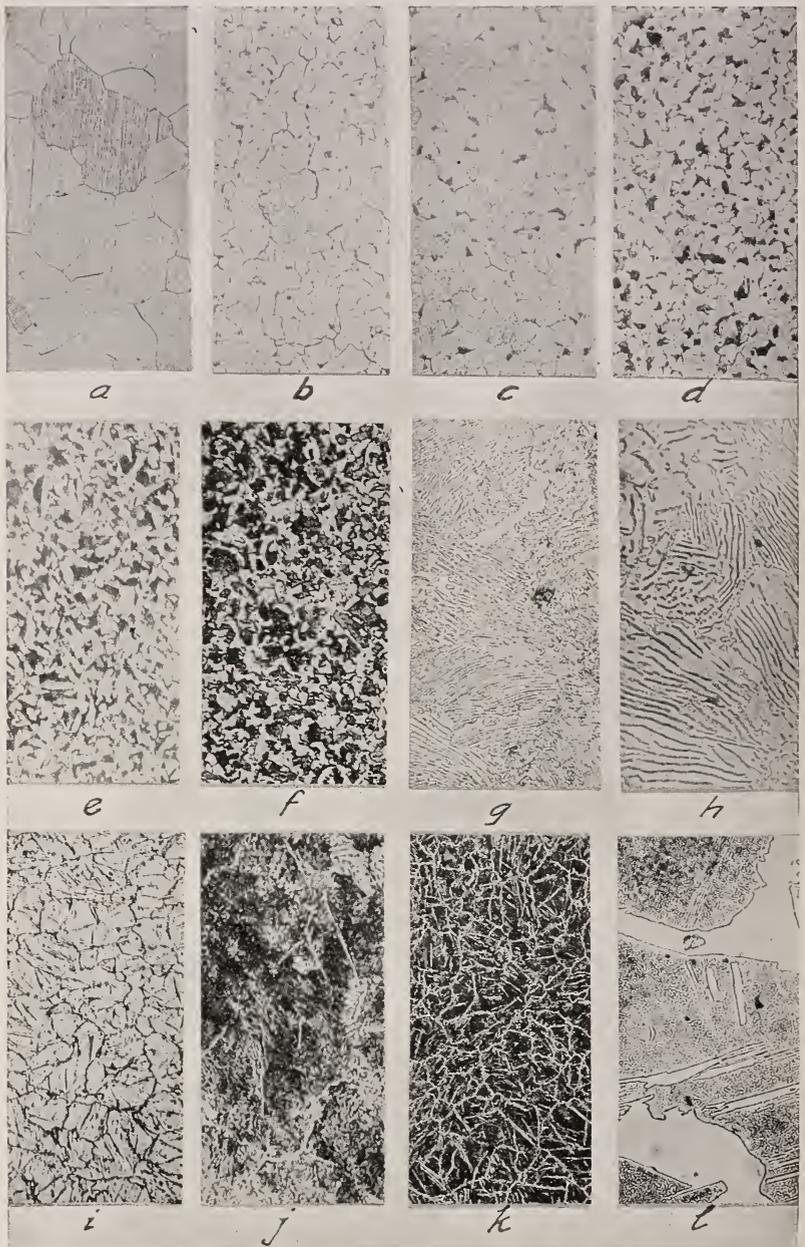
FIG. 15.—Microstructure of typical annealed iron-carbon alloys (steels) illustrating the effect of variations in carbon content upon structure

(a) Ferrite, electrolytic iron melted in vacuo. (b) to (g) Steels of ferrite-pearlite structure containing progressively increasing amounts of carbon as follows: b, 0.03 per cent; c, 0.07 per cent; d, 0.24 per cent; e, 0.32 per cent; f, 0.59 per cent; g, 0.68 per cent. (h) Eutectoid steel, 0.85 per cent carbon. (i) to (l) Steels of pearlite-cementite structure containing progressively increasing amounts of carbon as follows: i, 1.14 per cent; j, 1.14 per cent; k, 1.45 per cent; l, 1.70 per cent. $\times 100$, except g, h, and j, $\times 500$. Etching reagents, except for i, 2 per cent alcoholic solution of nitric acid, for i hot alkaline solution of sodium picrate

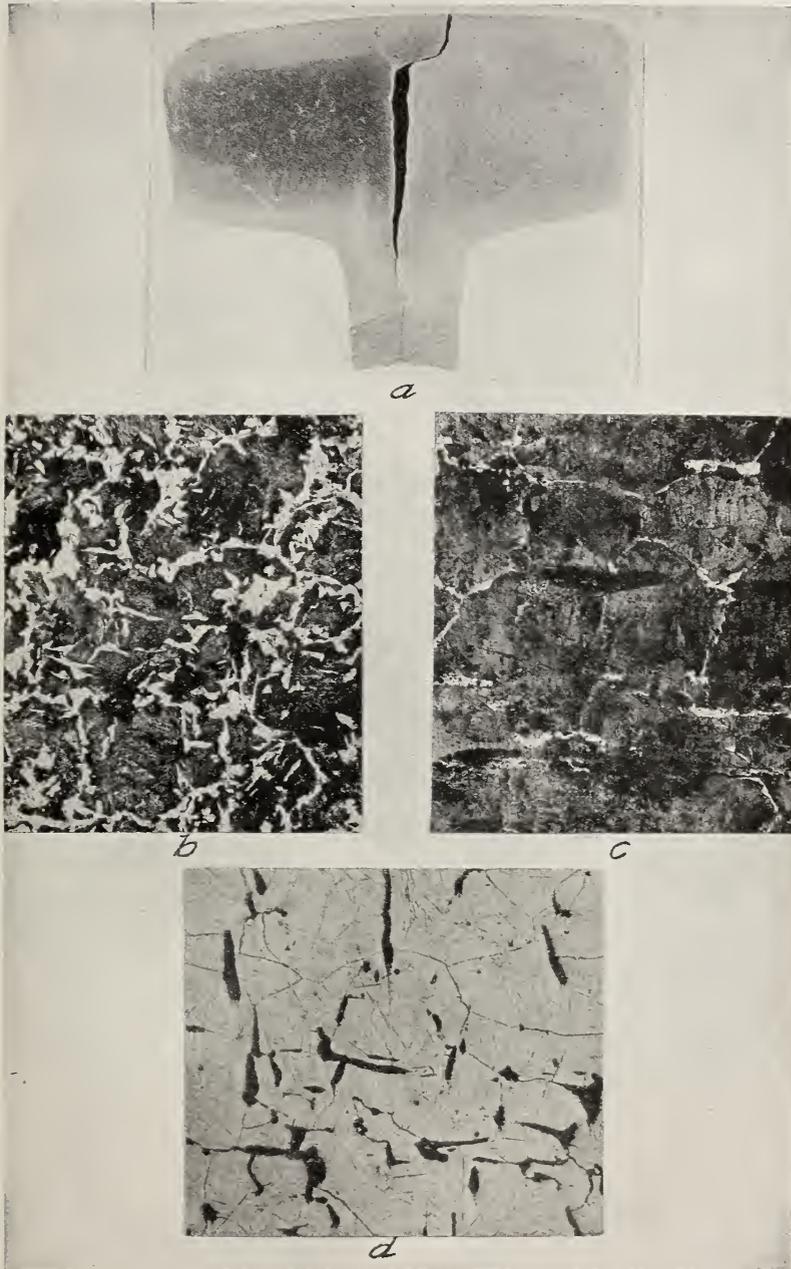
FIG. 16.—Variations in the microstructure of rail steel caused by segregation

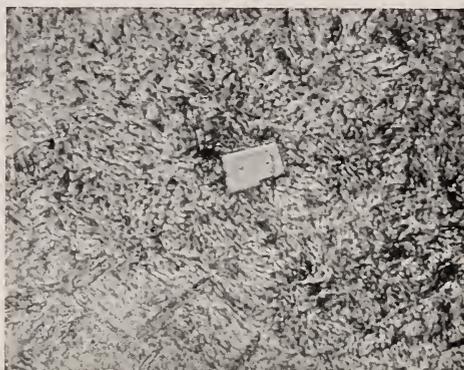
FIG. 17.—*Characteristic appearance of an inclusion caused by the addition of titanium to steel.*
 X 1000

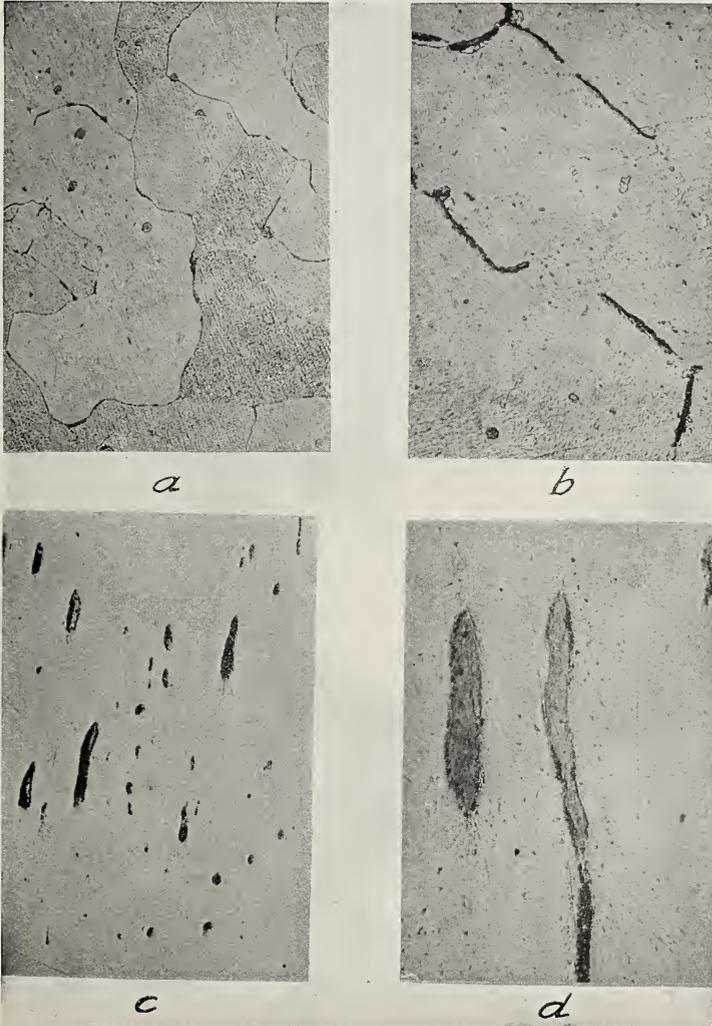
FIG. 18.—Microstructure of low carbon steel, illustrating the forms in which sulphur may occur

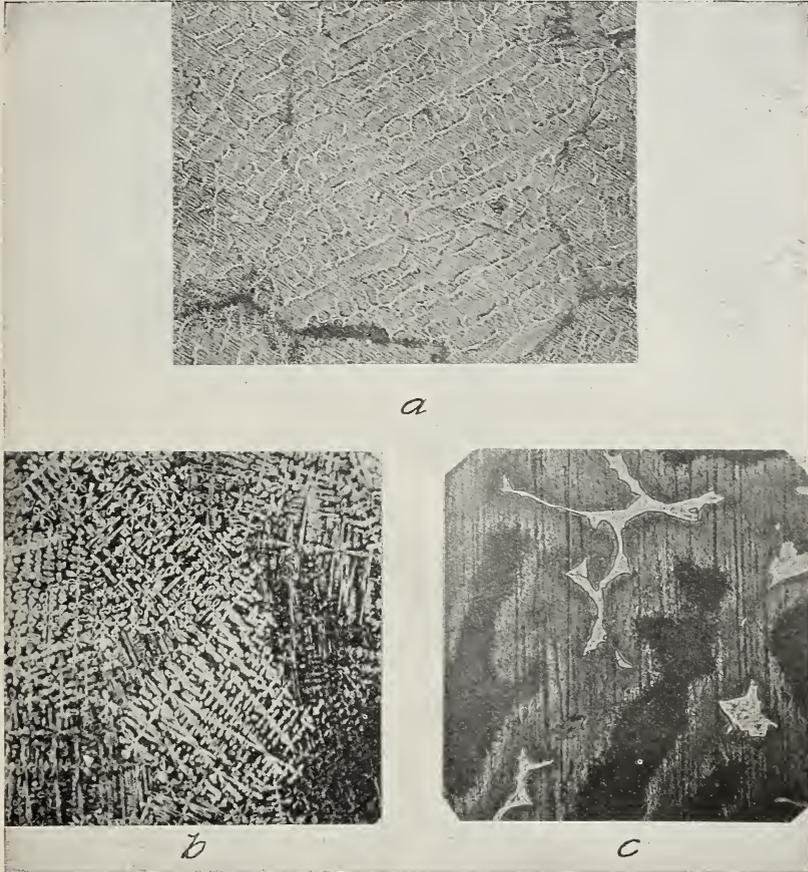
FIG. 19.—Characteristic appearance of cast alloys, showing a dendritic structure

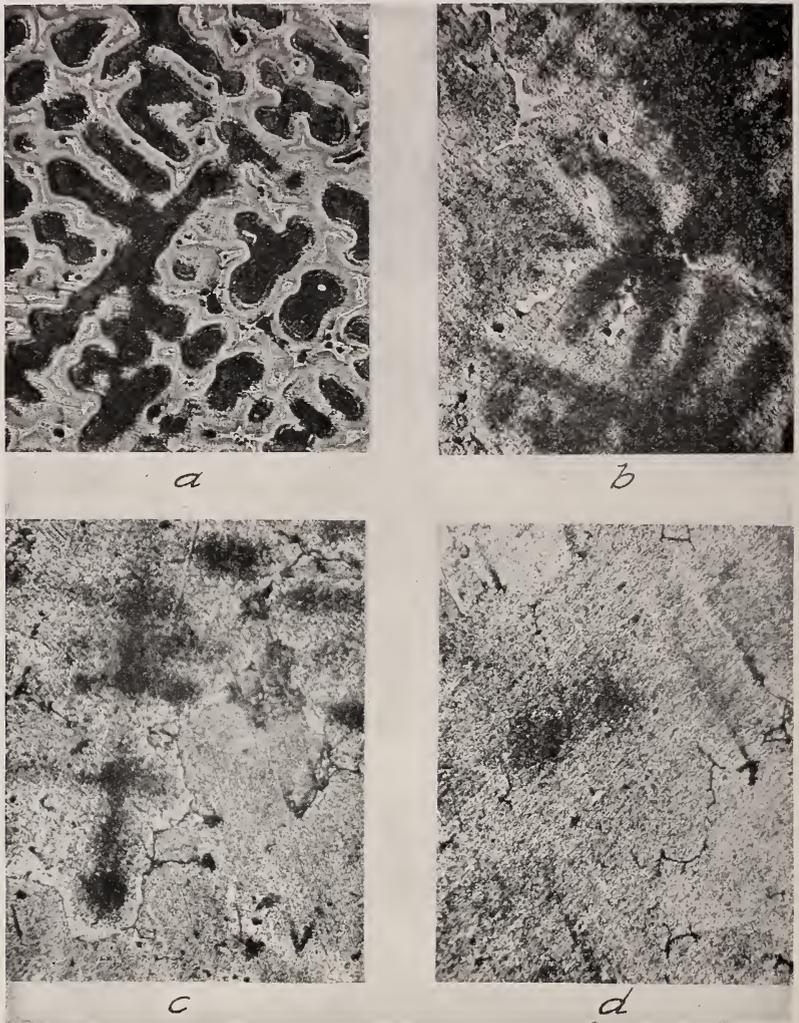
FIG. 20.—Microstructural changes in a cast alloy caused by prolonged heating. $\times 100$

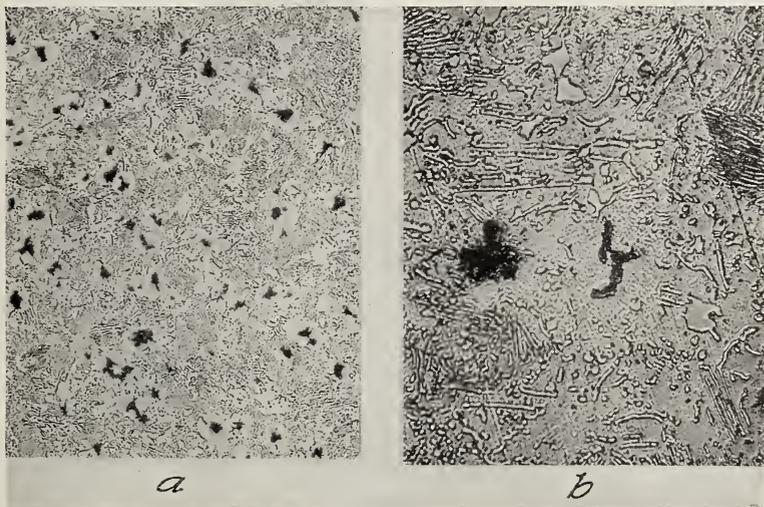
FIG. 21.—Microstructure of high-carbon steel in which graphitization has occurred

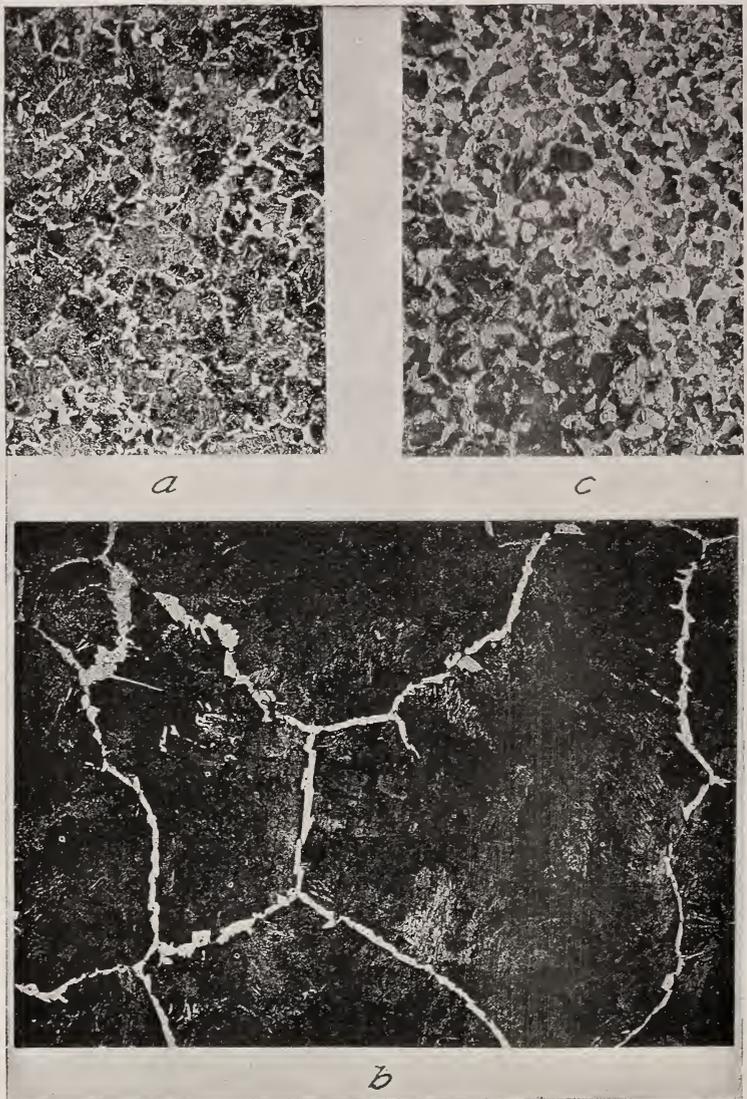
FIG. 22.—Microstructure of 0.47 per cent carbon steel illustrating the structural effect of overheating and of grain refinement. $\times 100$

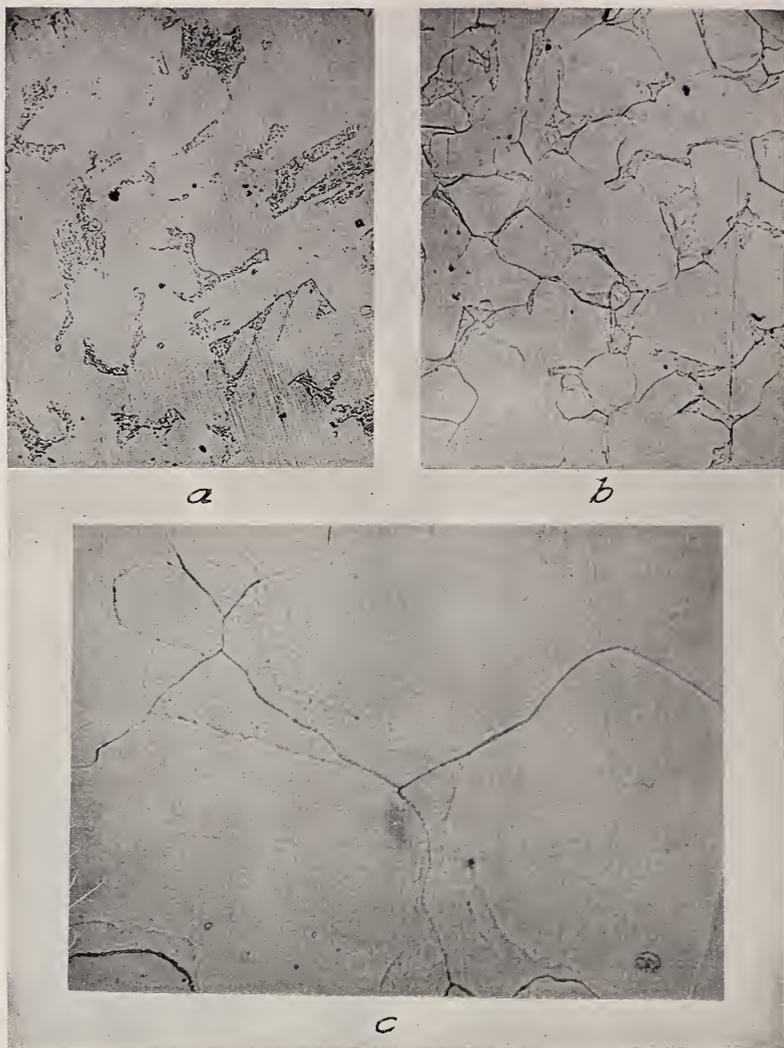
FIG. 23.—Microstructure of 0.18 per cent carbon steel as it exists at ordinary temperatures and at relatively high temperatures

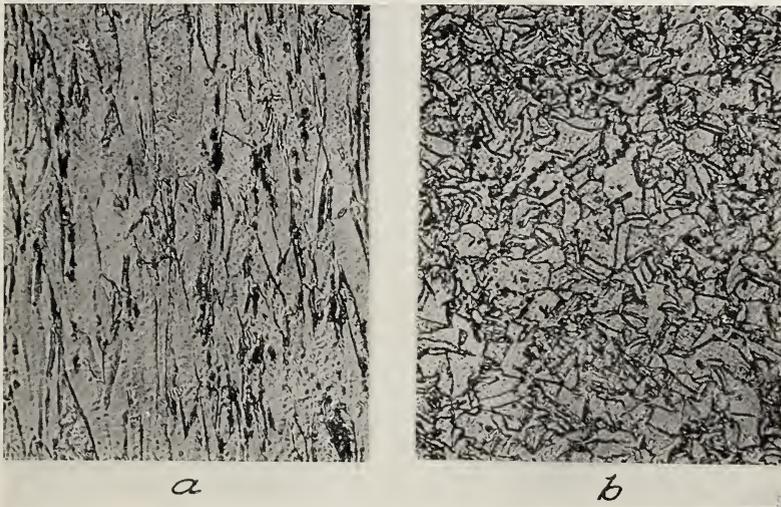
FIG. 24.—Microstructure of cold-drawn copper, showing the mechanical distortion as revealed by sections parallel to and perpendicular to the direction of working. $\times 250$

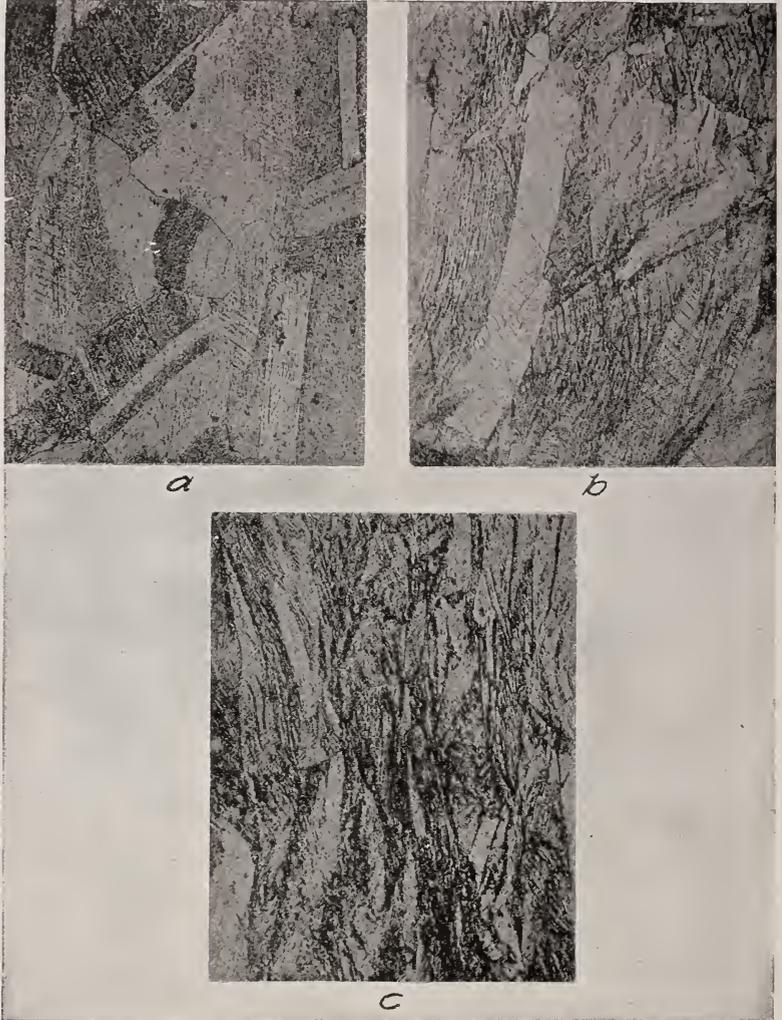
FIG. 25.—Microstructure of brass illustrating progressive stages in the crystalline distortion produced by cold-working $\times 100$

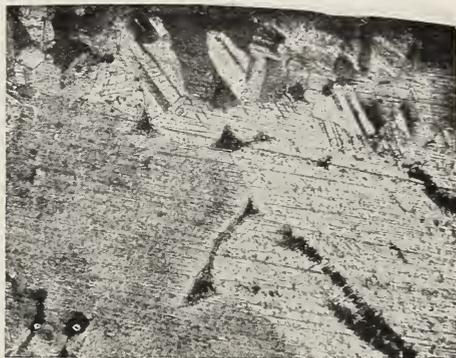
FIG. 26.—Microstructure of annealed cast bronze showing the thickness of the surface layer of cold-worked metal. $\times 100$

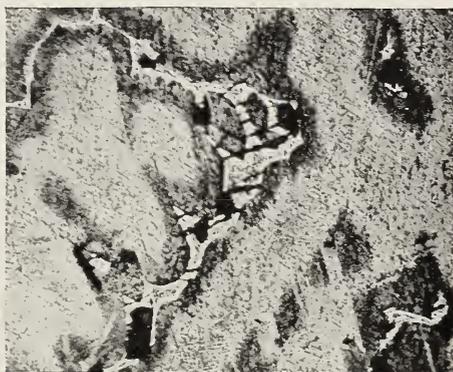
FIG. 27.—Microstructure of cast zinc bronze which has been stressed in tension. $\times 250$

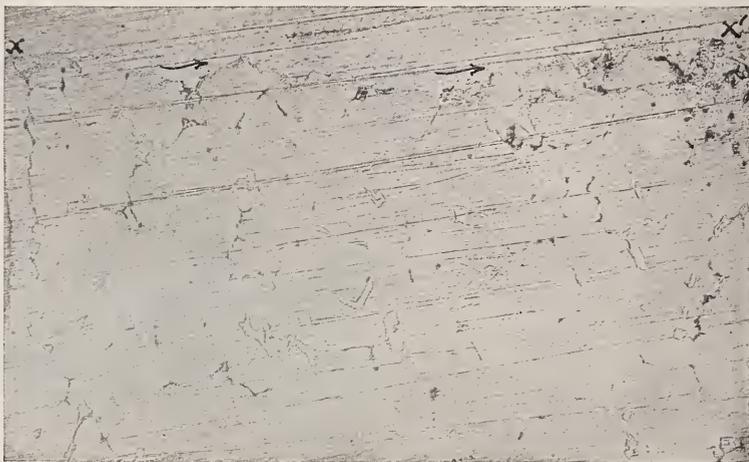
FIG. 28.—Microstructure of cast aluminum alloy showing the "path" of the fracture produced by a tensile stress. $\times 100$

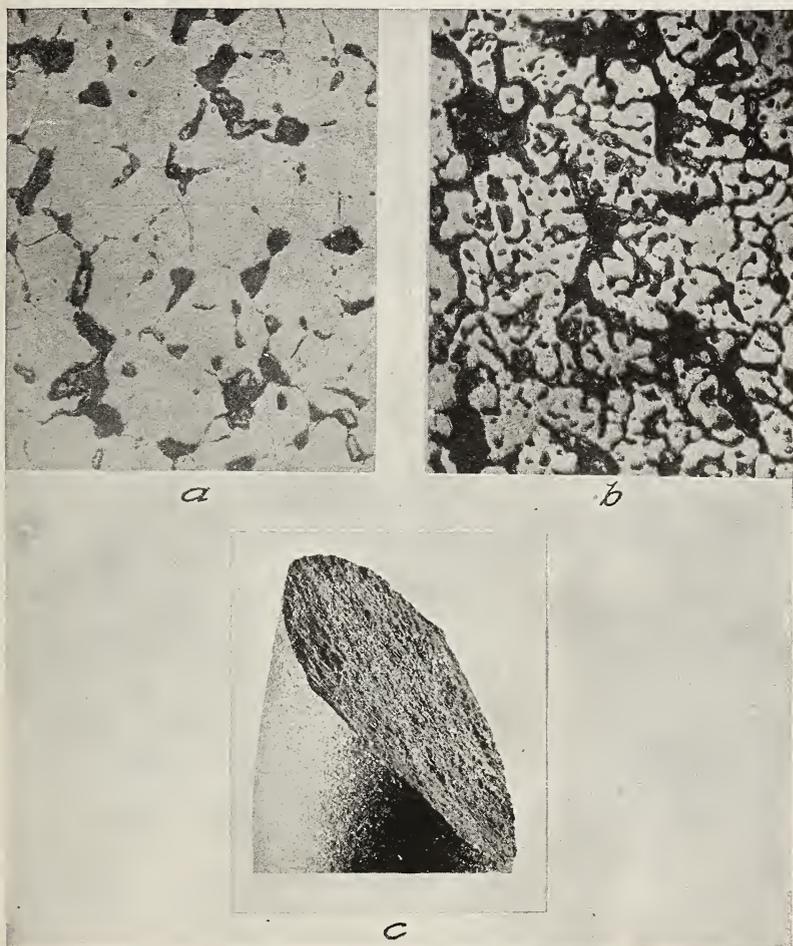
FIG. 29.—Microstructure of copper-lead alloys and appearance of a specimen of the same after testing in compression

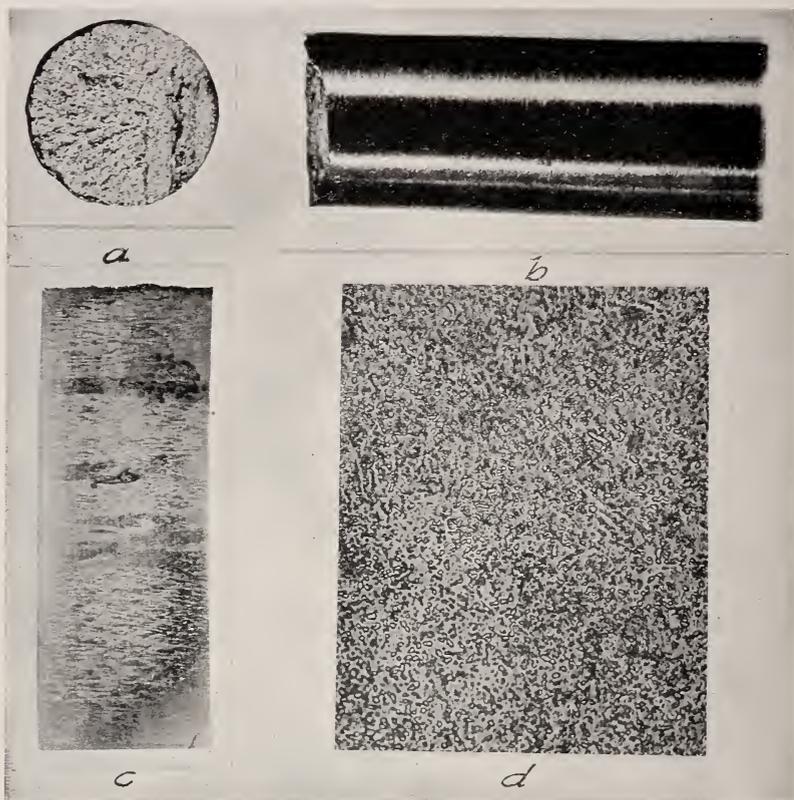
FIG. 30.—Characteristic fractures of gun steel tested in tension across the grain of the metal, together with structure of the same

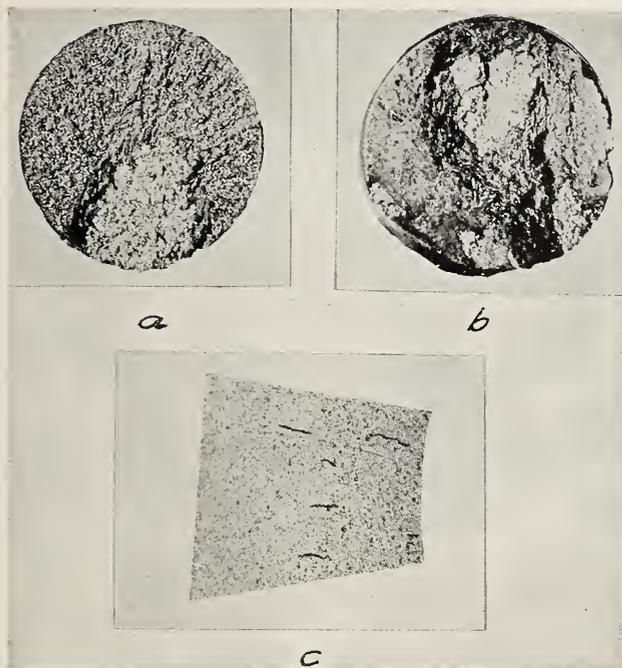
FIG. 31.—Characteristic appearance of "flakes" in gun steel revealed by tensile fractures and macroscopic appearance of flaky steel

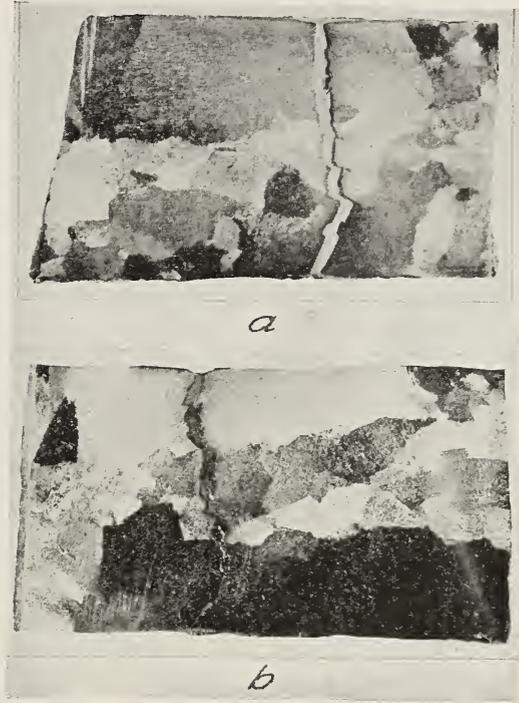
FIG. 32.—Macrostructure of tension specimens of cast zinc bronze showing the relation of the fracture produced to the crystalline structure. $\times 3$
