CIRCULAR
OF THE
BUREAU OF STANDARDS

No. 113

STRUCTURE AND RELATED PROPERTIES
OF METALS

SEPTEMBER 7, 1921

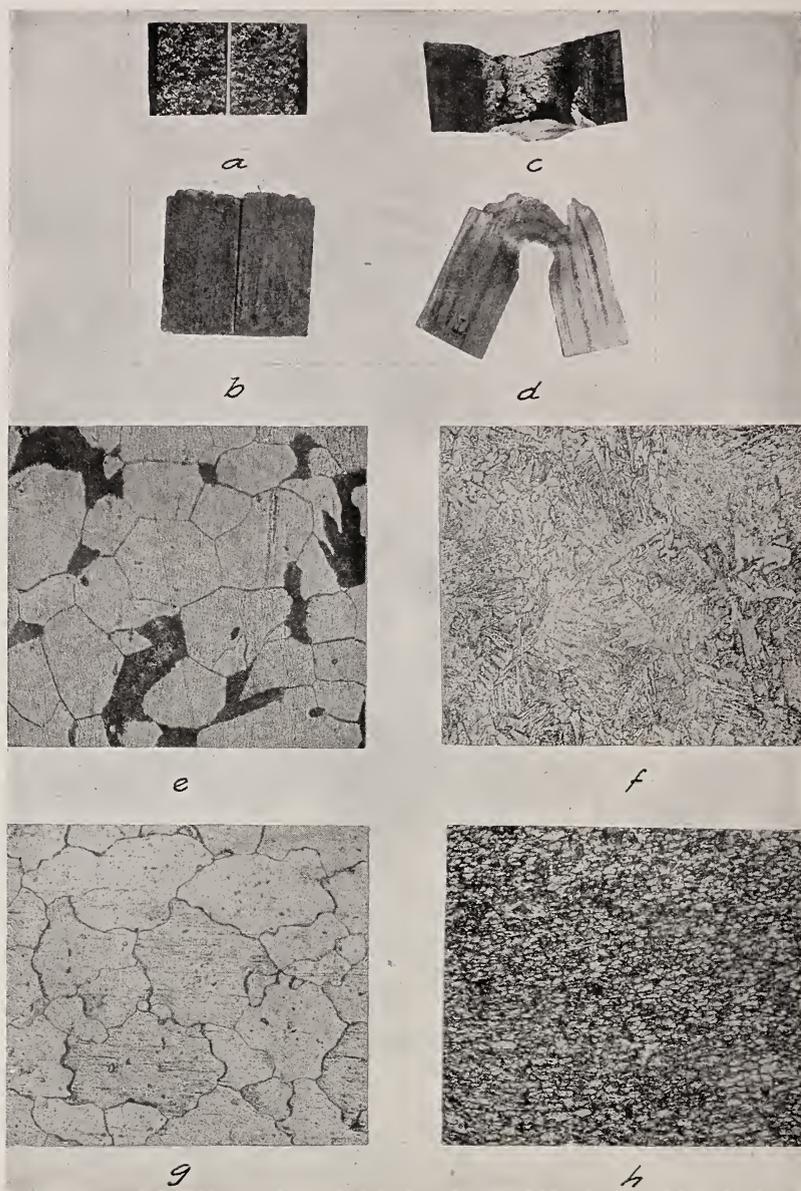
FIG. 33.—Appearance of specimens of low-carbon steel with different thermal treatments showing the relation of impact properties to the microstructure of the material

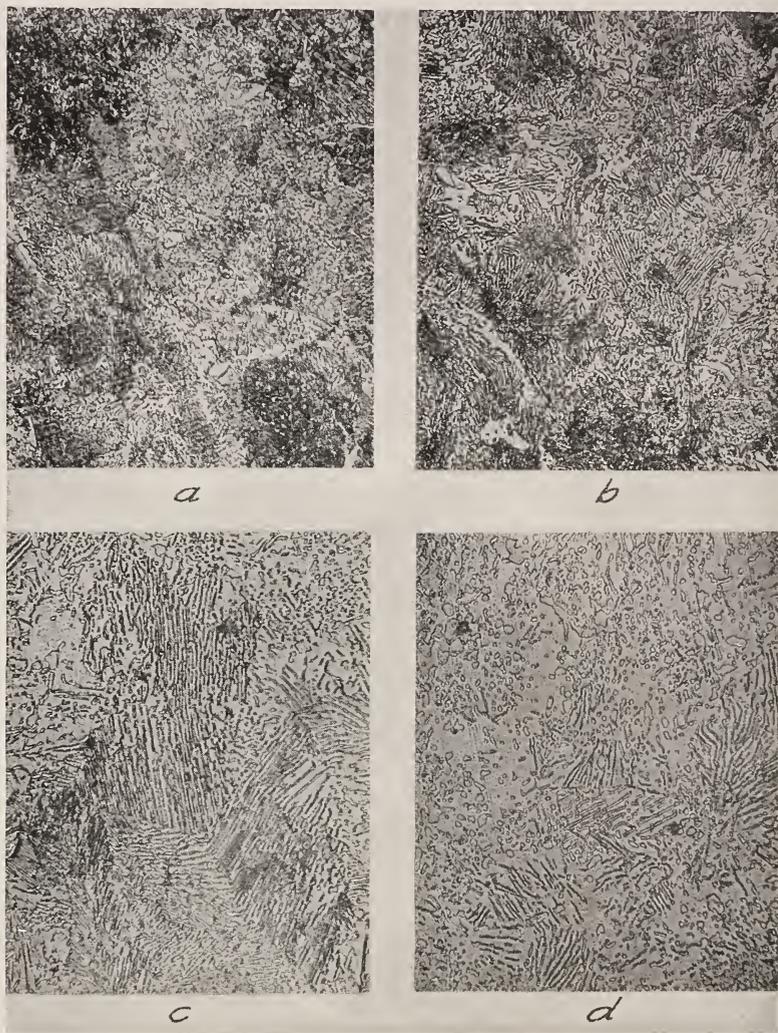
FIG. 34.—Microstructure of eutectoid carbon steel (0.85 per cent carbon) showing the effect of rate of cooling upon the physical state of the pearlite. $\times 500$

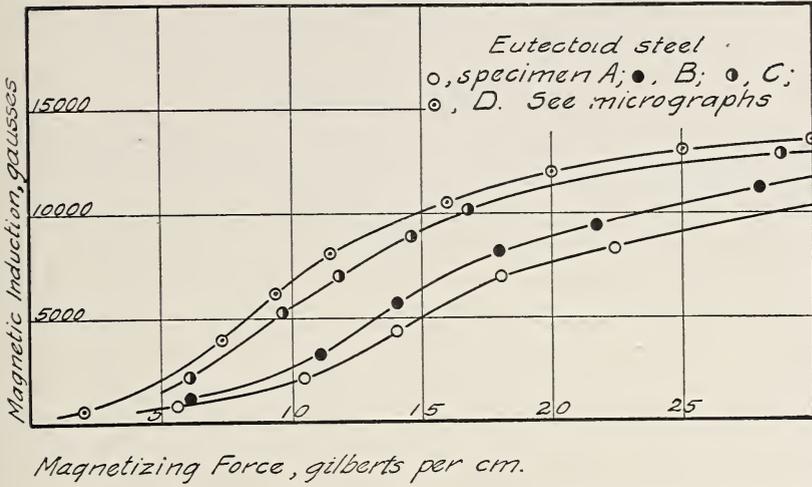
FIG. 35.—Magnetic properties (induction vs. magnetizing force) of eutectoid carbon steel after different annealing treatments

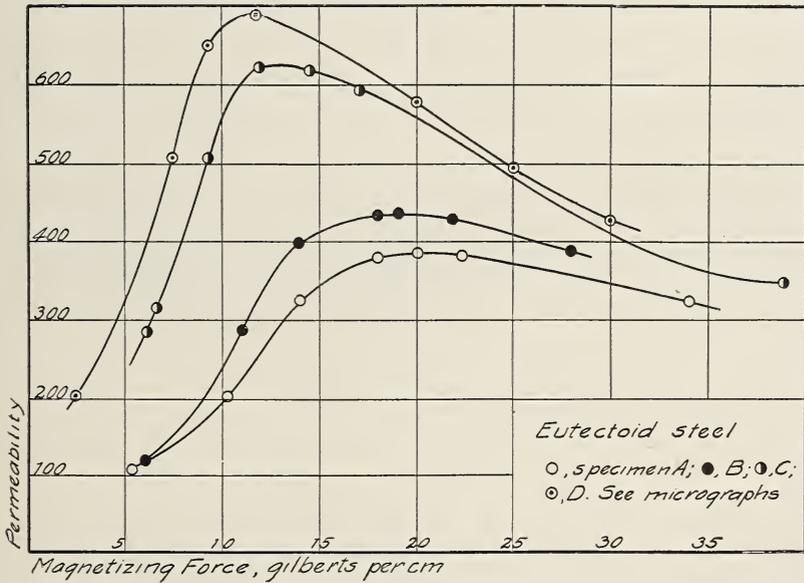
FIG. 36.—Magnetic properties (permeability vs. magnetizing force) of eutectoid carbon steel after different annealing treatments, replotted from Fig. 35

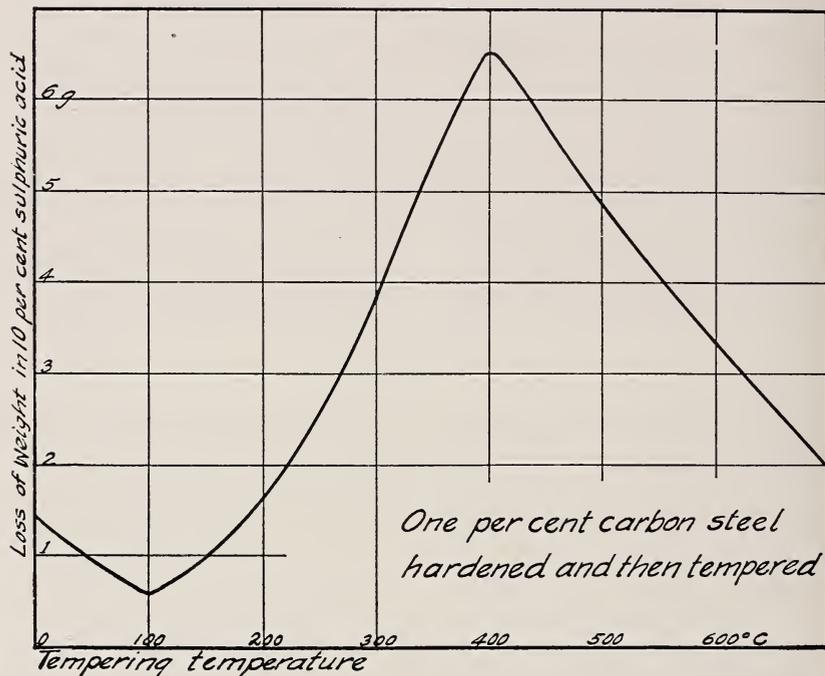
FIG. 37.—Variation in the solubility of 1 per cent carbon steel in dilute sulphuric acid, after hardening and tempering to different temperatures. (Hanemann)

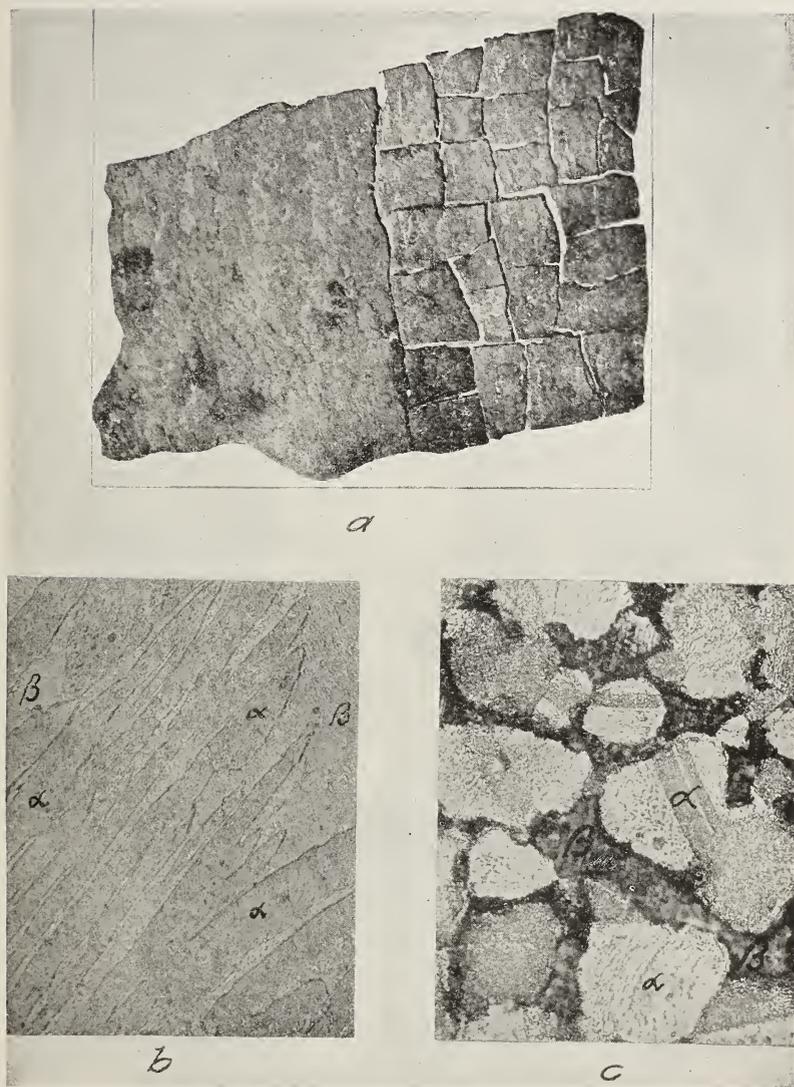
FIG. 39.—Appearance of a corroded brass sheet together with the microstructure of the unchanged and of the corroded metal

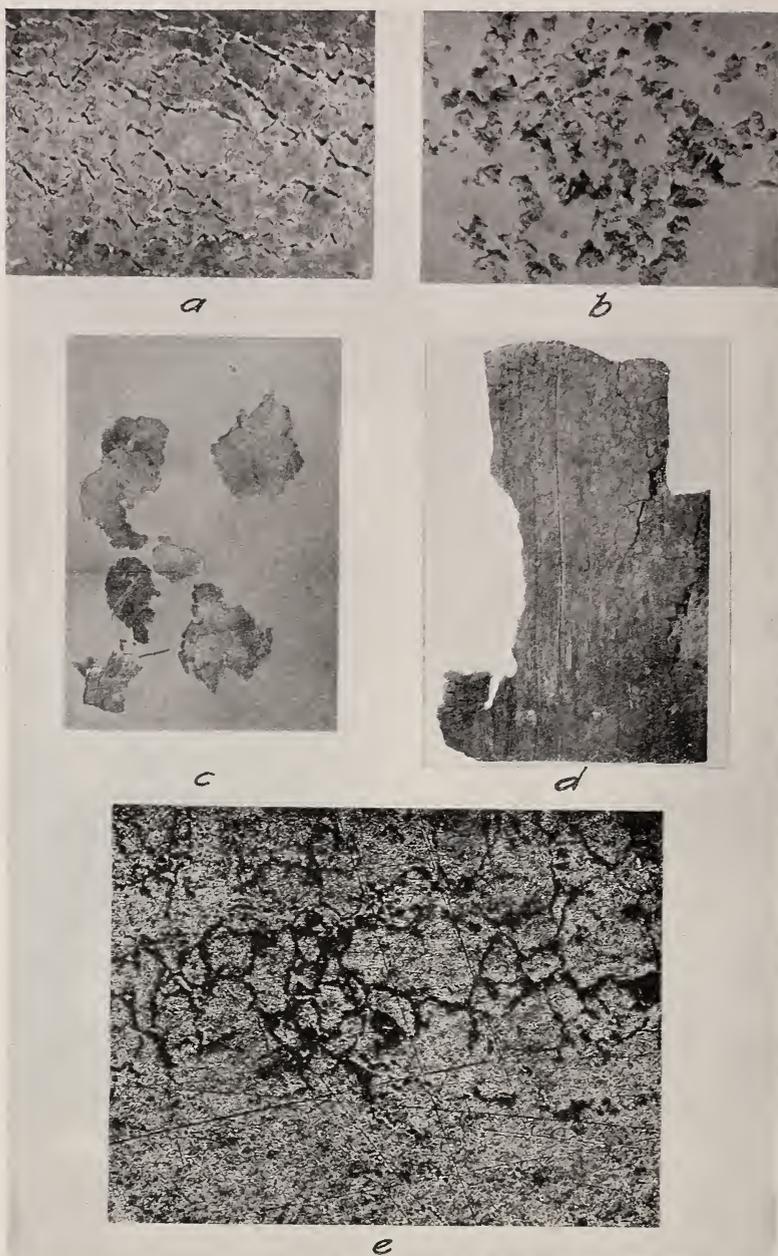
FIG. 40.—Appearance of lead after accelerated corrosion and of commercial lead which corroded in service

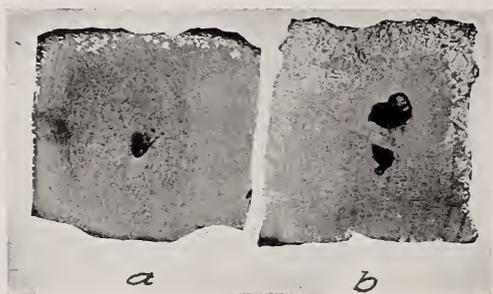
FIG. 41.—Chemical unhomogeneity of lead-antimony alloys caused by "liquation" during slow cooling. $\times 1$

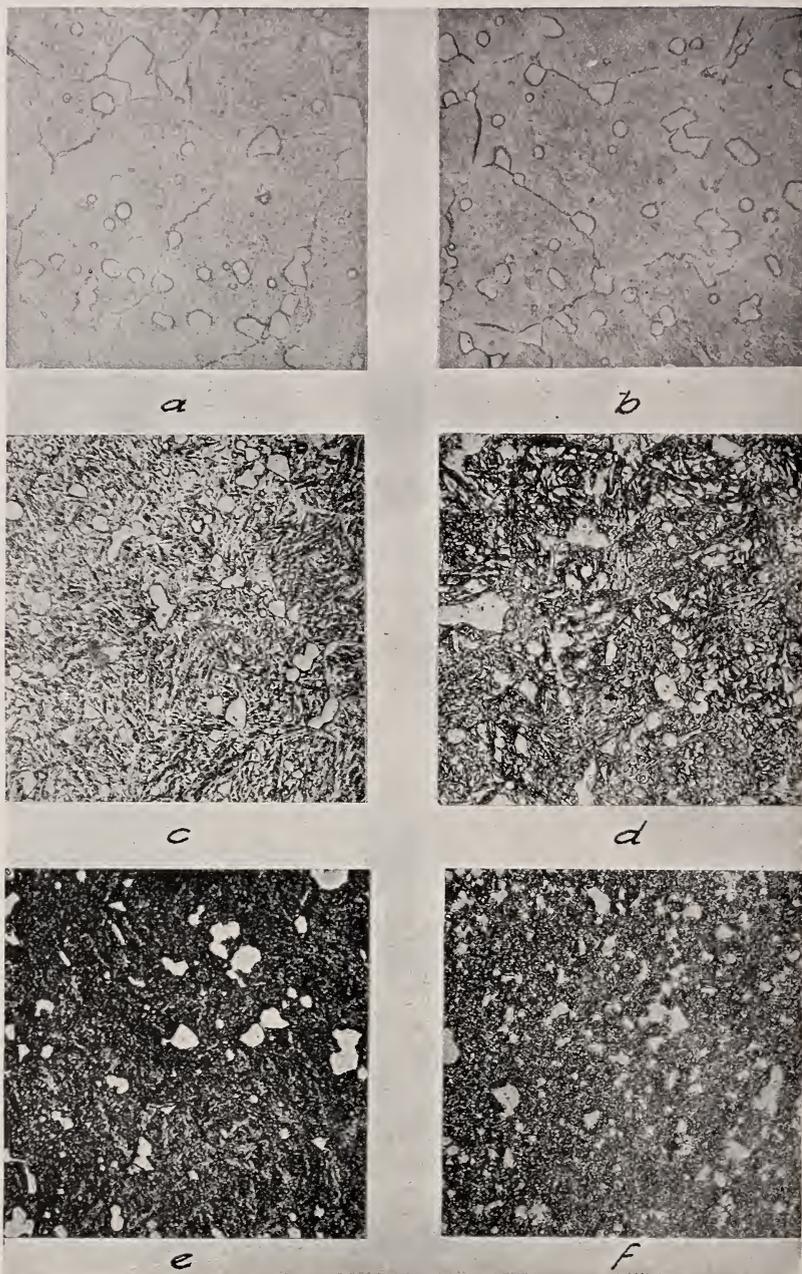
FIG. 42.—Microstructure of high-speed tool steel illustrating the effect upon structure of tempering the hardened steel at different temperatures. $\times 500$

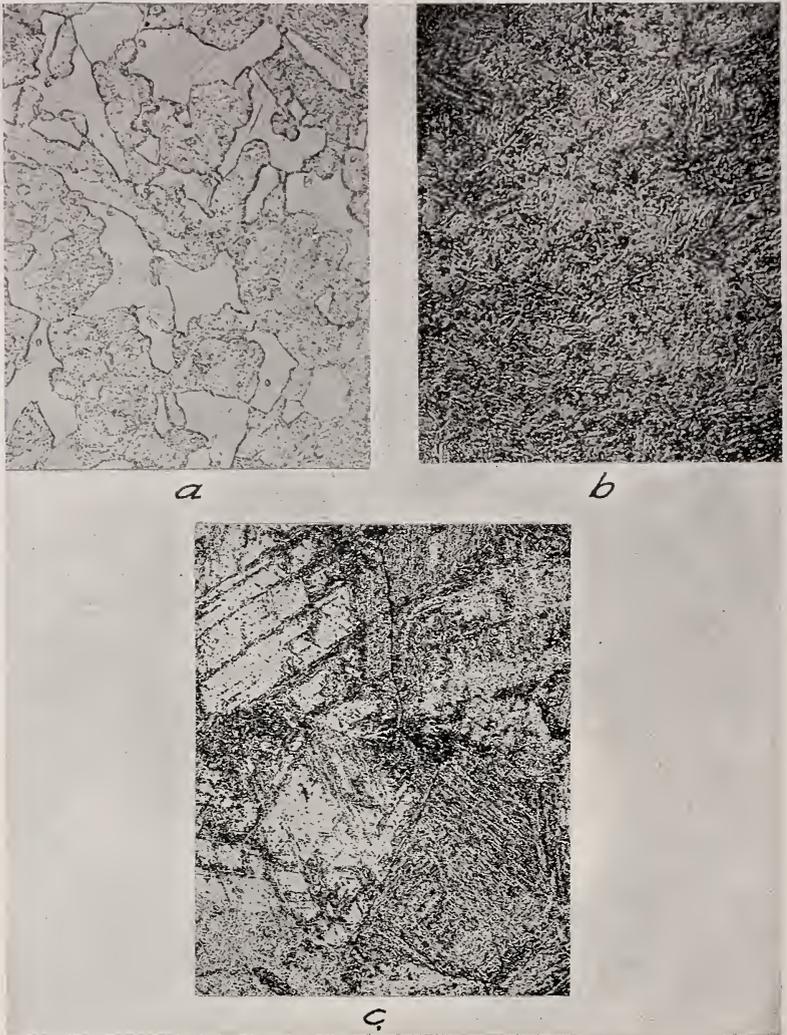
FIG. 43.—Microstructure of medium carbon steel after different hardening treatments

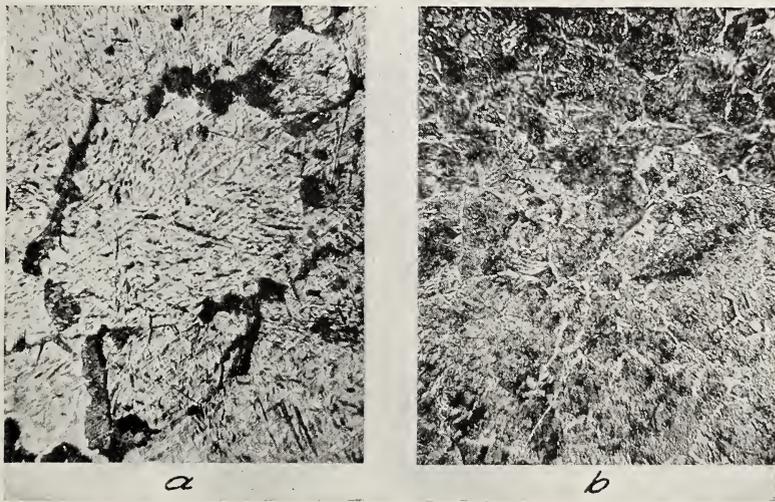
FIG. 44.—Microstructure of a heat-treated steel container for compressed gas which failed in service. $\times 250$

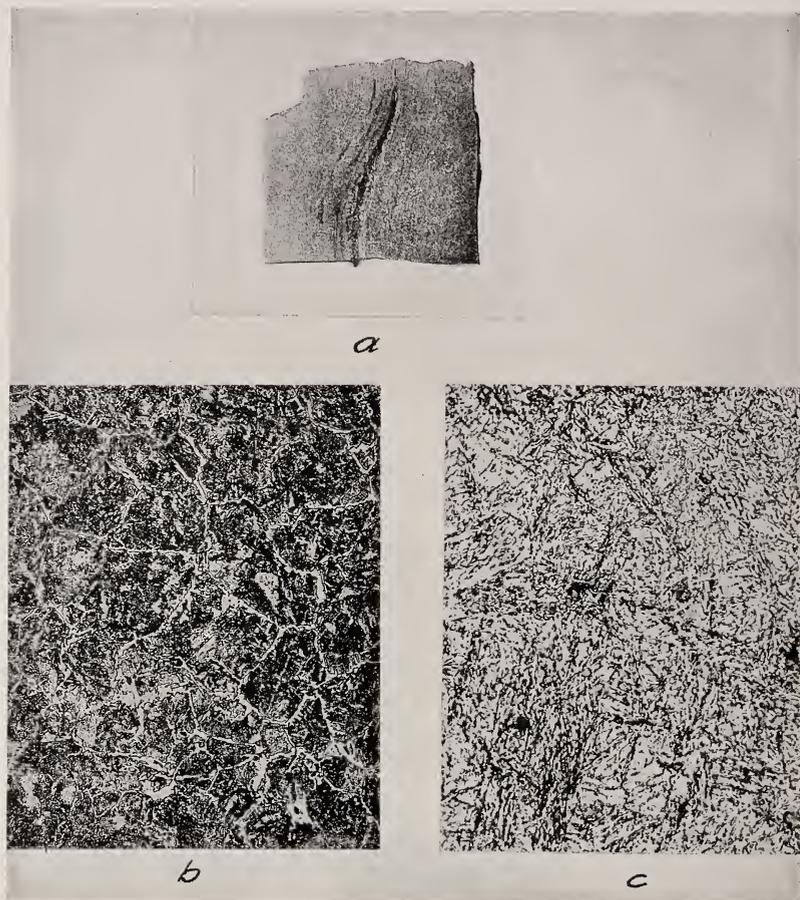
FIG. 45.—Structure of a defective nickel steel forging caused by improper melting practice

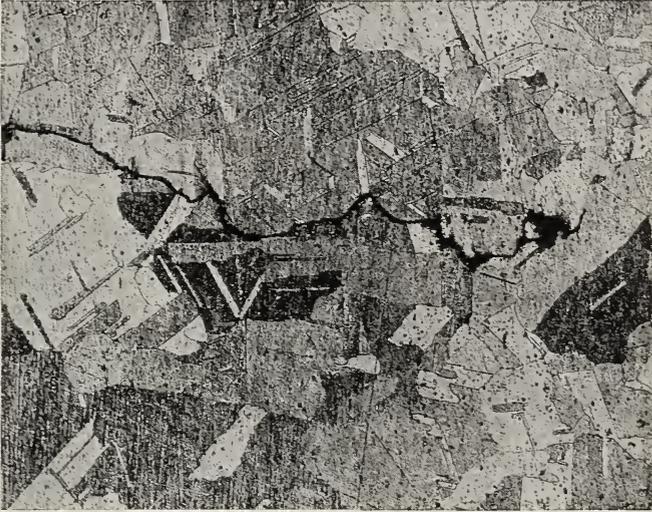
FIG. 46.—Microstructure of copper which was spoiled in annealing as a result of the nature of the surrounding atmosphere. $\times 100$

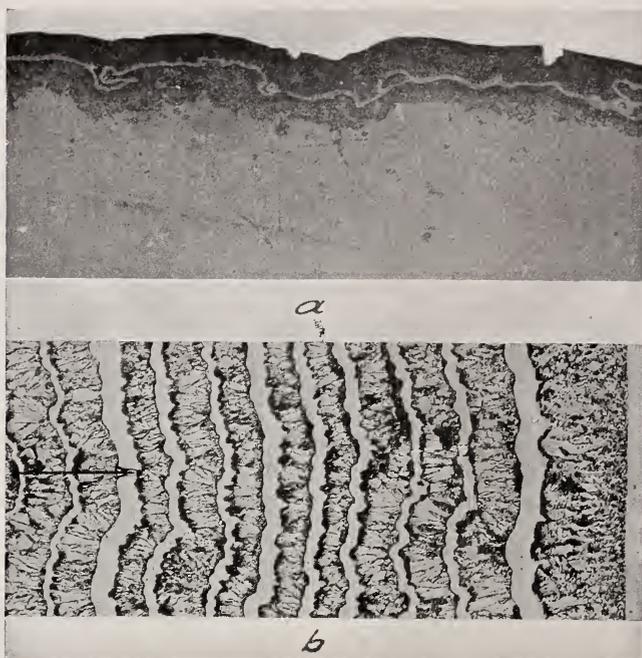
FIG. 47.—Microstructure of complex metallic coatings produced by electrolytic deposition

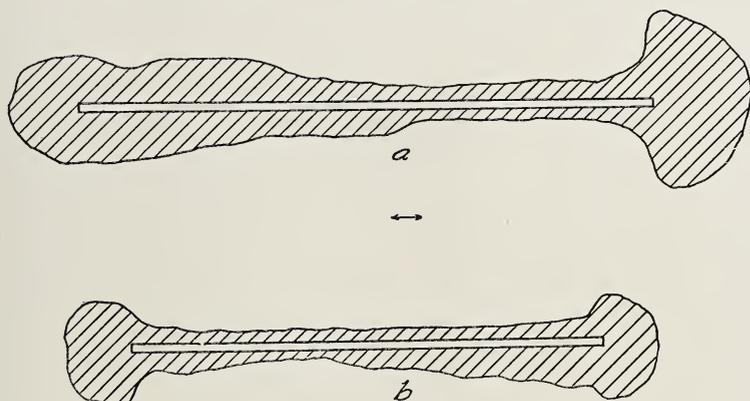
FIG. 48.—Variation in thickness of an electrolytic zinc coating such as may occur on flat sheets after plating, determined by microscopic measurements

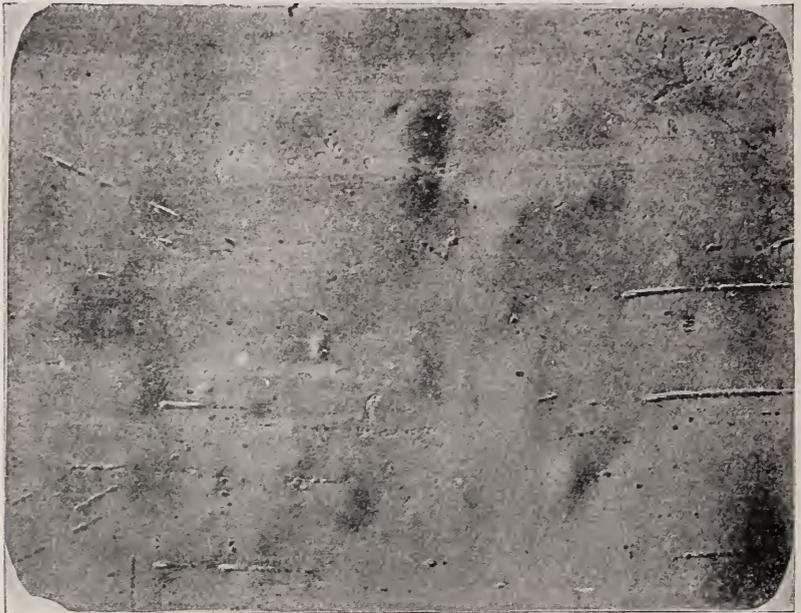
FIG. 49.—*Appearance of the exposed surface of corroded tinned copper sheathing used for roofing purposes. $\times 1$*

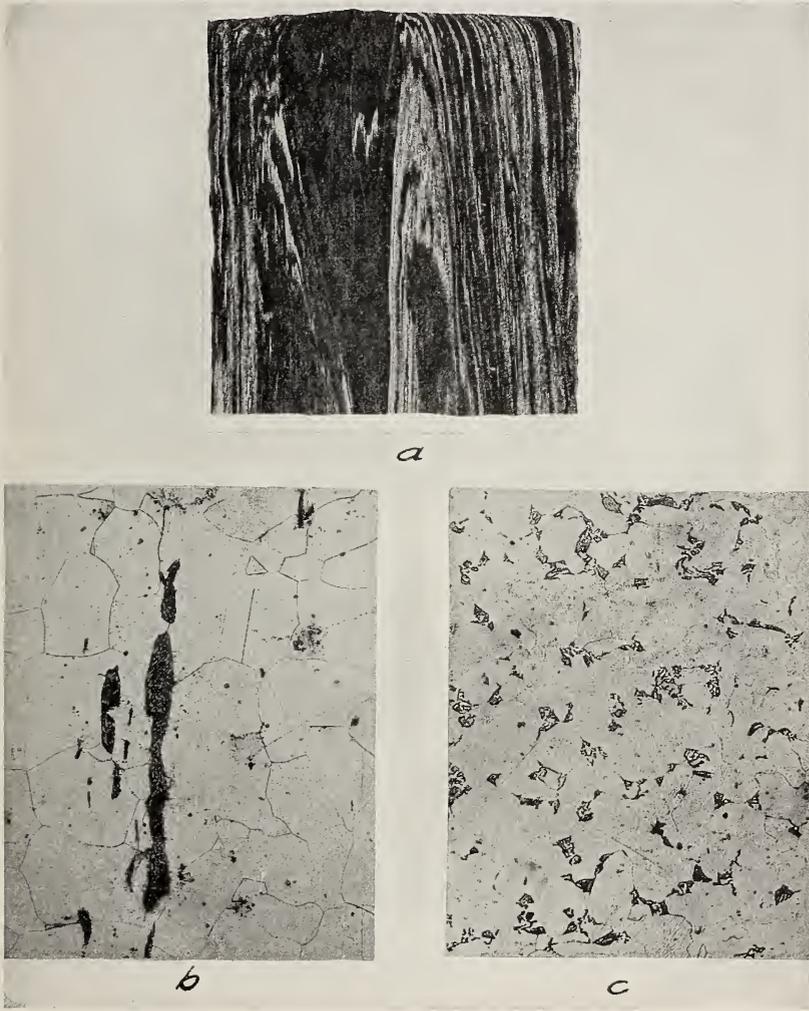
FIG. 50.—Structure of wrought iron to which additions of steel have been made

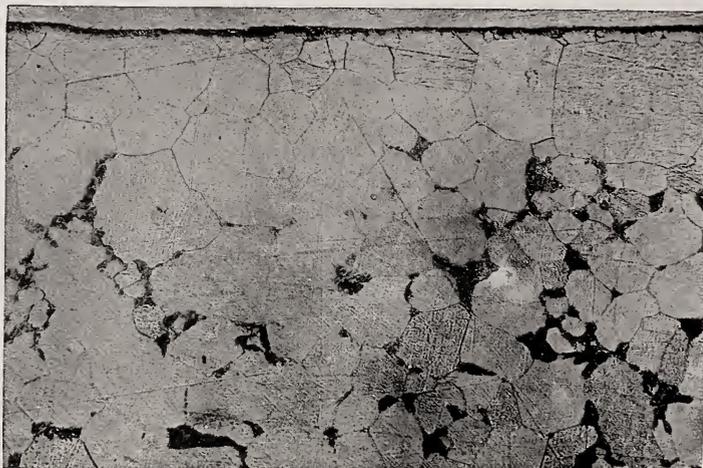
FIG. 51.—Microstructure of an iron-carbon alloy which was decarburized by heating in *vacuo*. $\times 100$

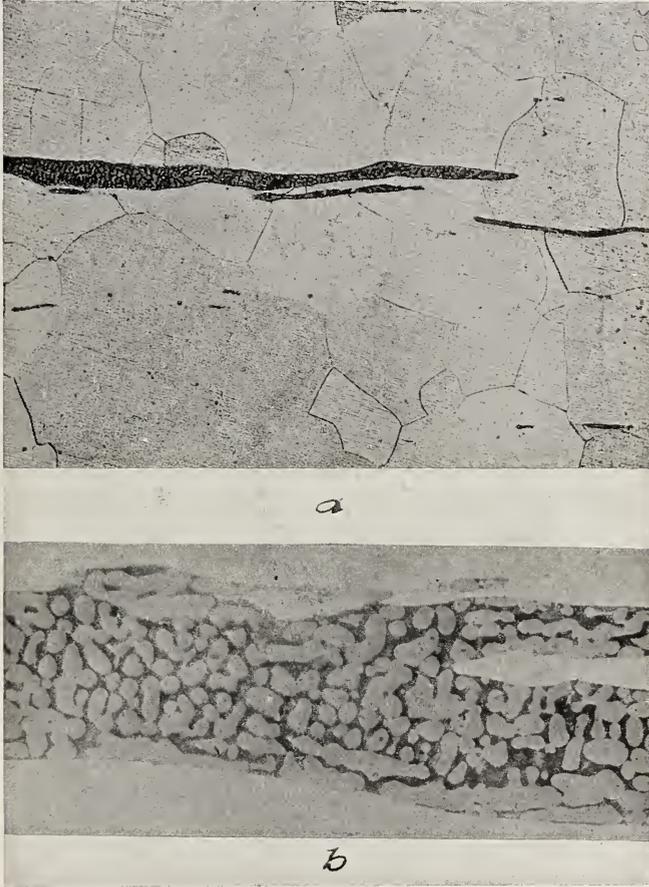
FIG. 52.—Microstructure of wrought iron showing the complex nature of the slag

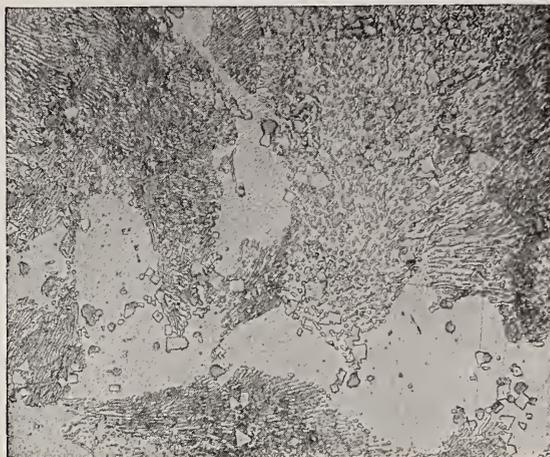
FIG. 53.—Microstructure of steel to which additions of zirconium have been made. $\times 500$

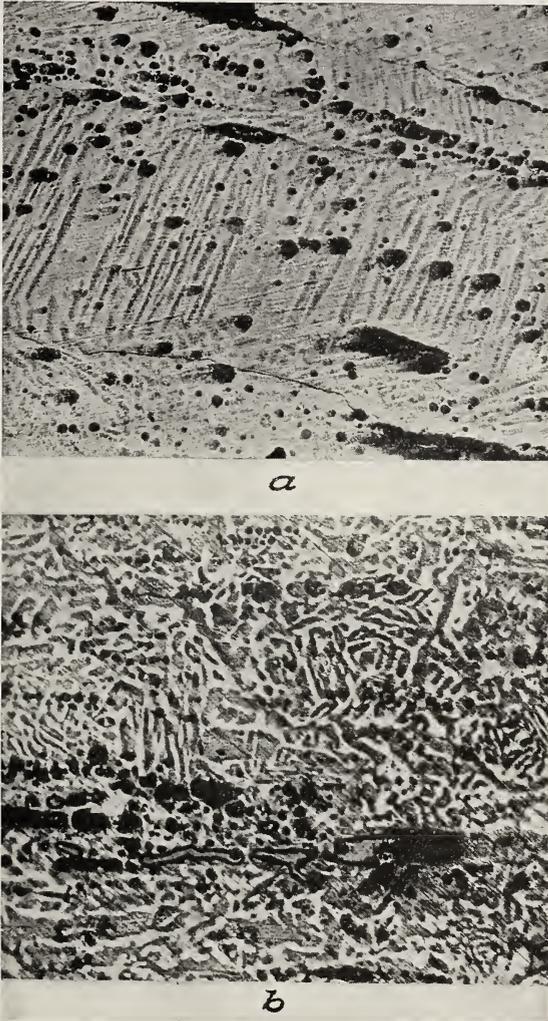
FIG. 54.—Microstructure of wrought iron of high phosphorus content, showing the lack of uniform distribution of this element even within the individual crystals. $\times 100$

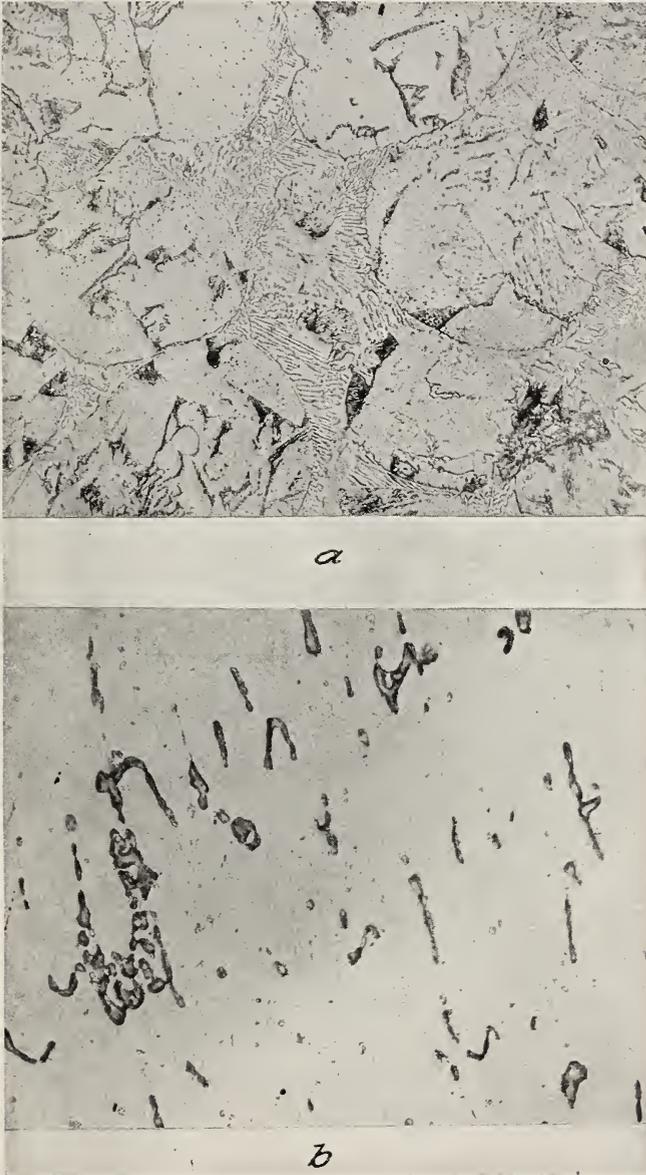
FIG. 55.—Microstructure of low carbon steels to which additions of boron have been made. $\times 500$

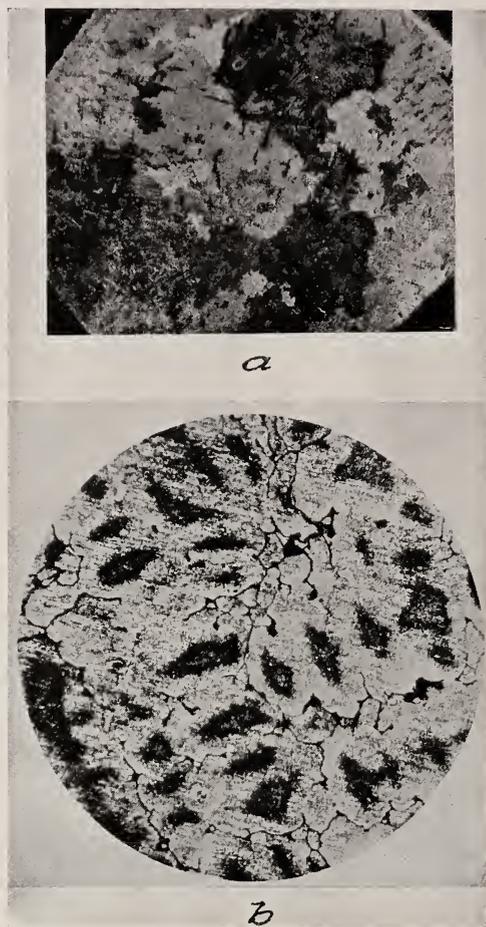
FIG. 56.—Structure of inferior zinc bronze castings showing defects caused by improper conditions of casting

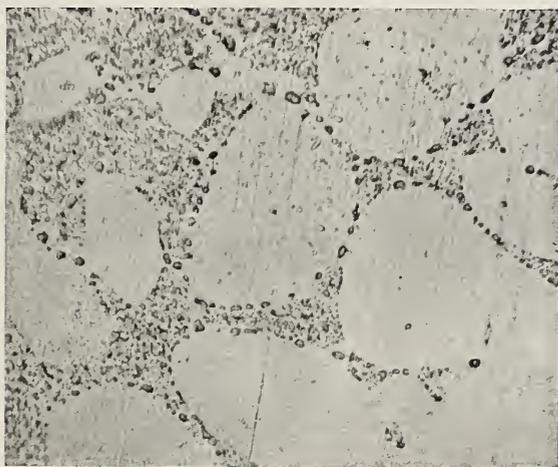
FIG. 57.—Microstructure of a proprietary copper alloy recommended by the "inventor" for purposes of deoxidation of various alloys. $\times 500$

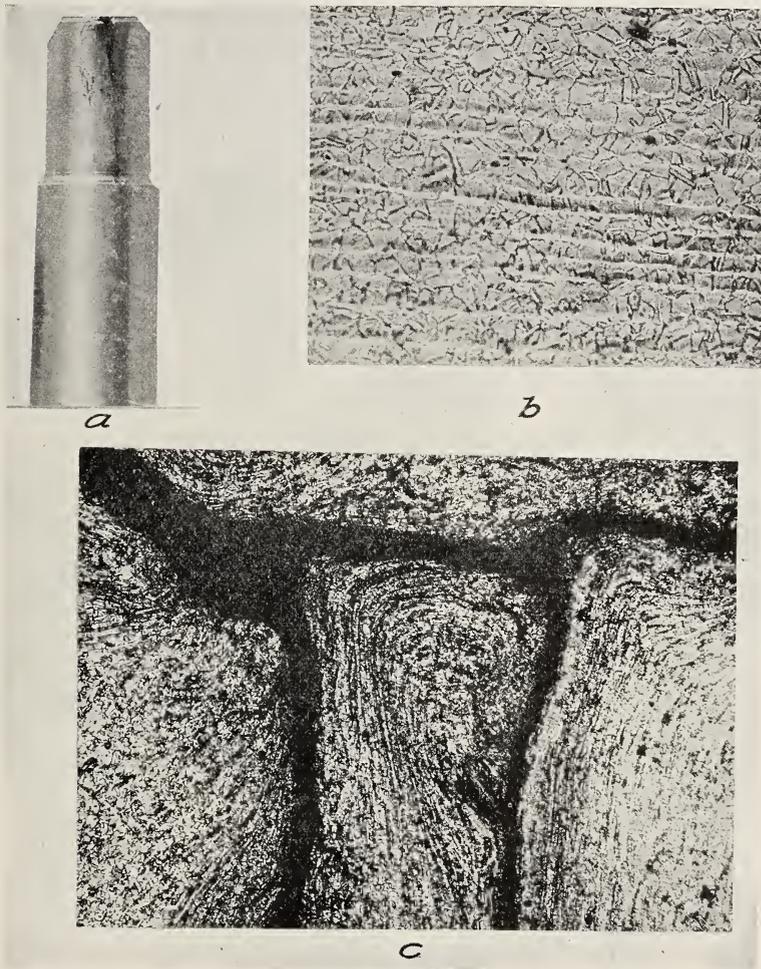
FIG. 59.—Structure of monel metal showing interior defects originating before the metal was rolled

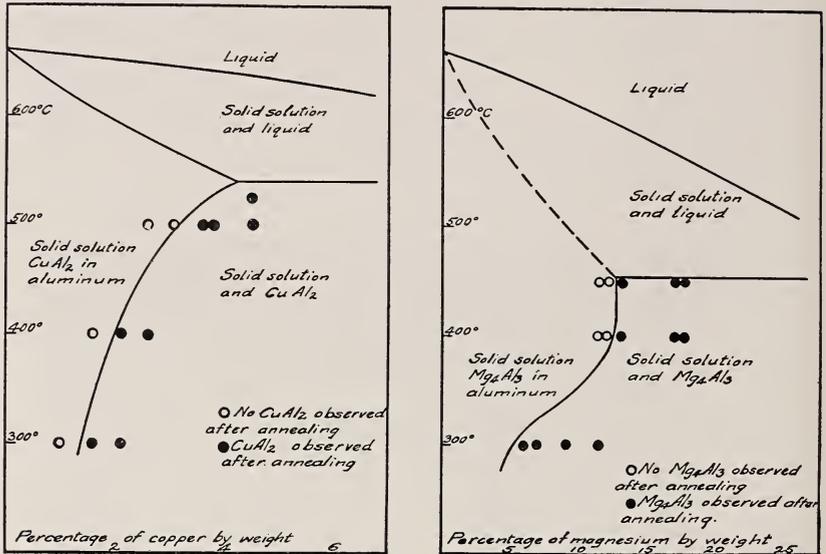
FIG. 60.—Portion of the constitutional diagram of the copper-aluminum and of the magnesium-aluminum alloy system illustrating the use of microscopic examinations in the preparation of such diagrams

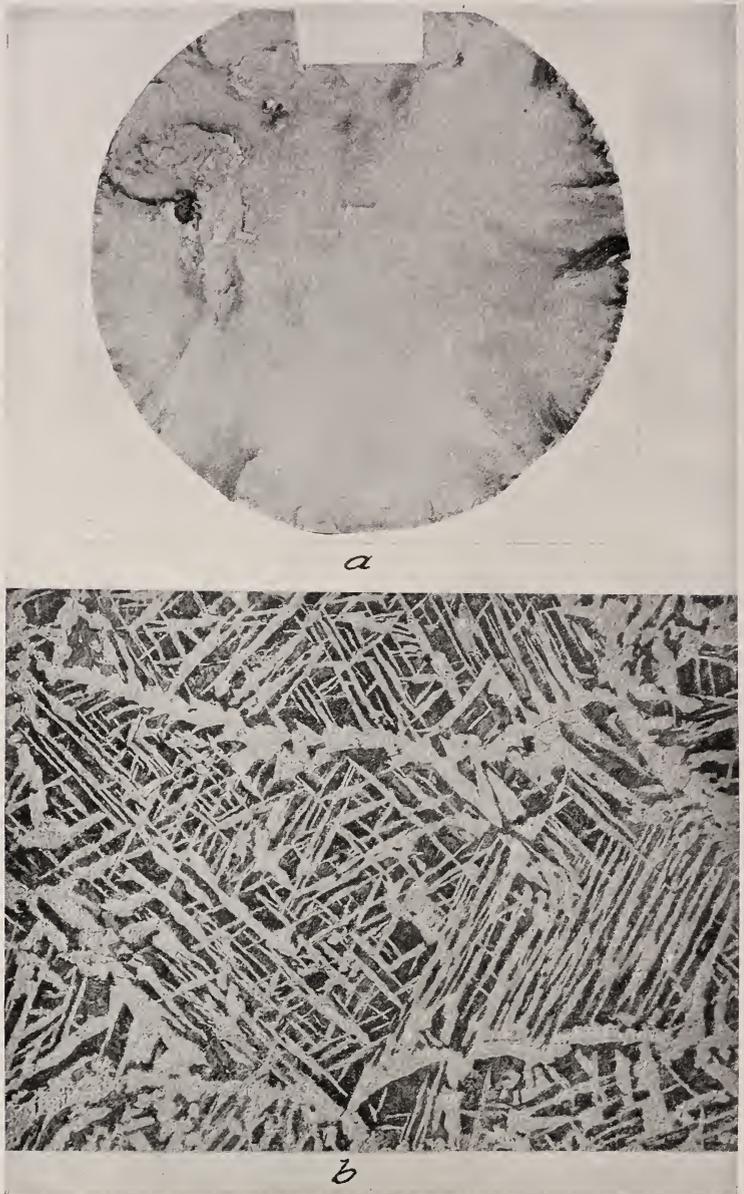
FIG. 61.—Structure of a steel shafting which failed in service by fatigue

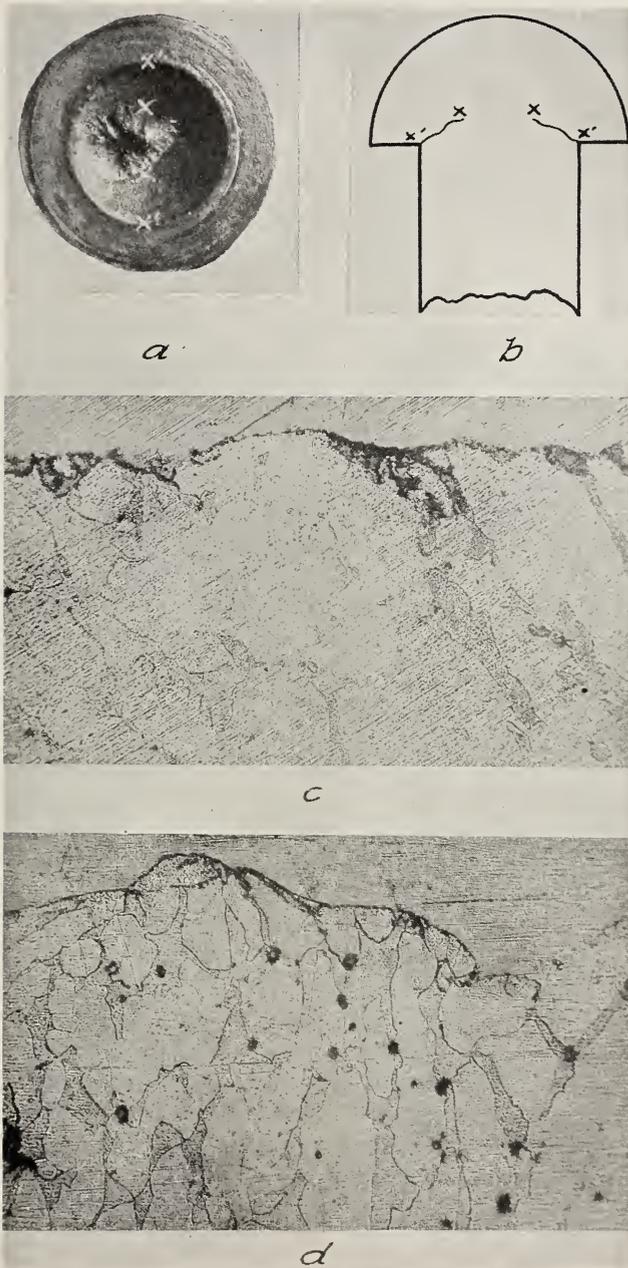
FIG. 62.—Structure of a brass (Muntz metal) bolt which failed in service, evidently by being corroded while stressed in tension

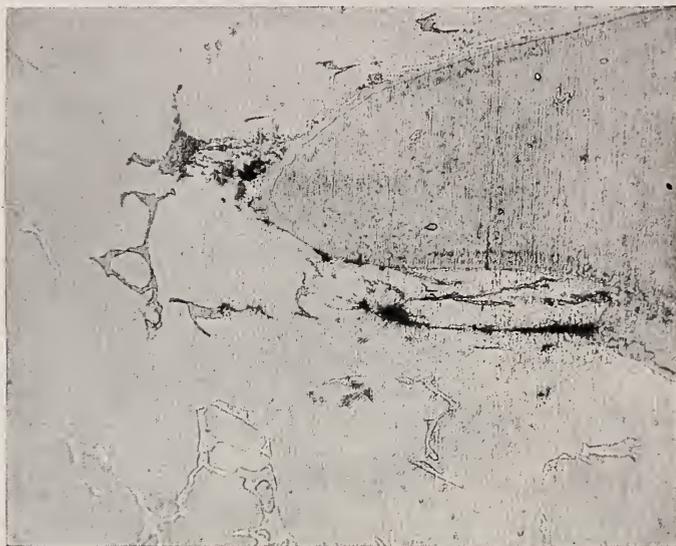
FIG. 63.—Microstructure of corroded Muntz metal, illustrating the effect of stress in localizing the corrosive action of this alloy. $\times 250$

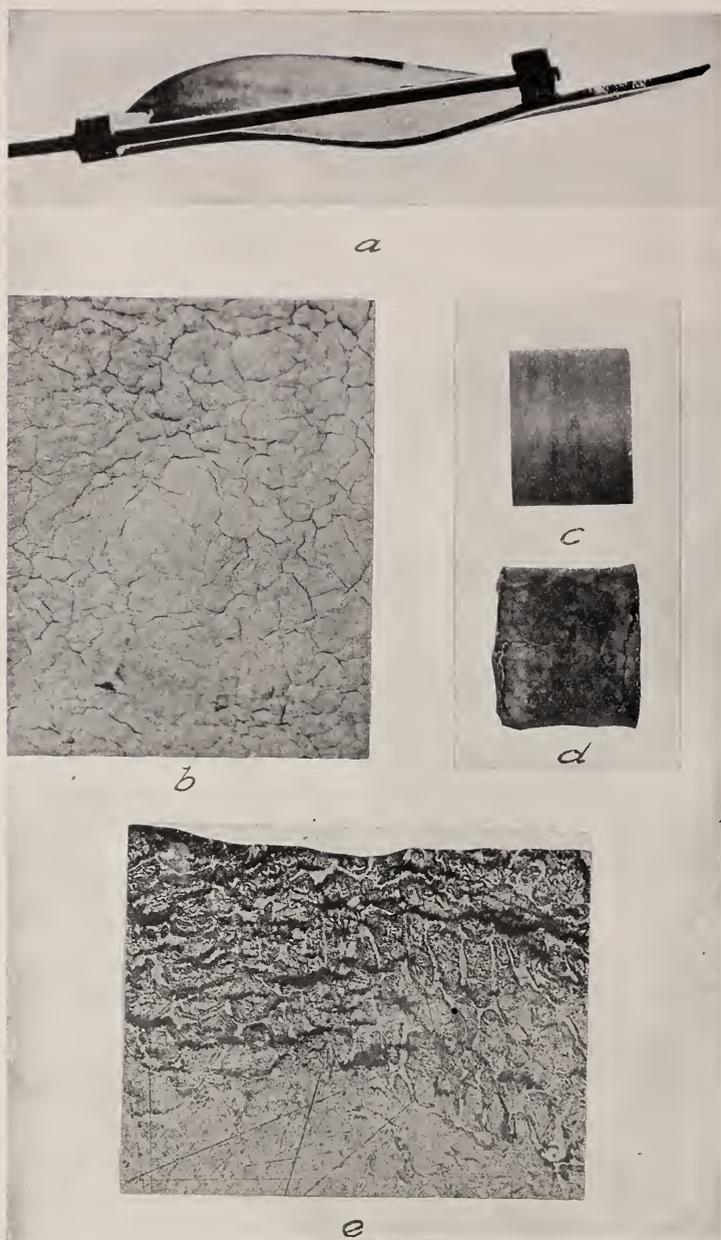
FIG. 64.—Appearance of certain aluminum alloys of high zinc content after deterioration

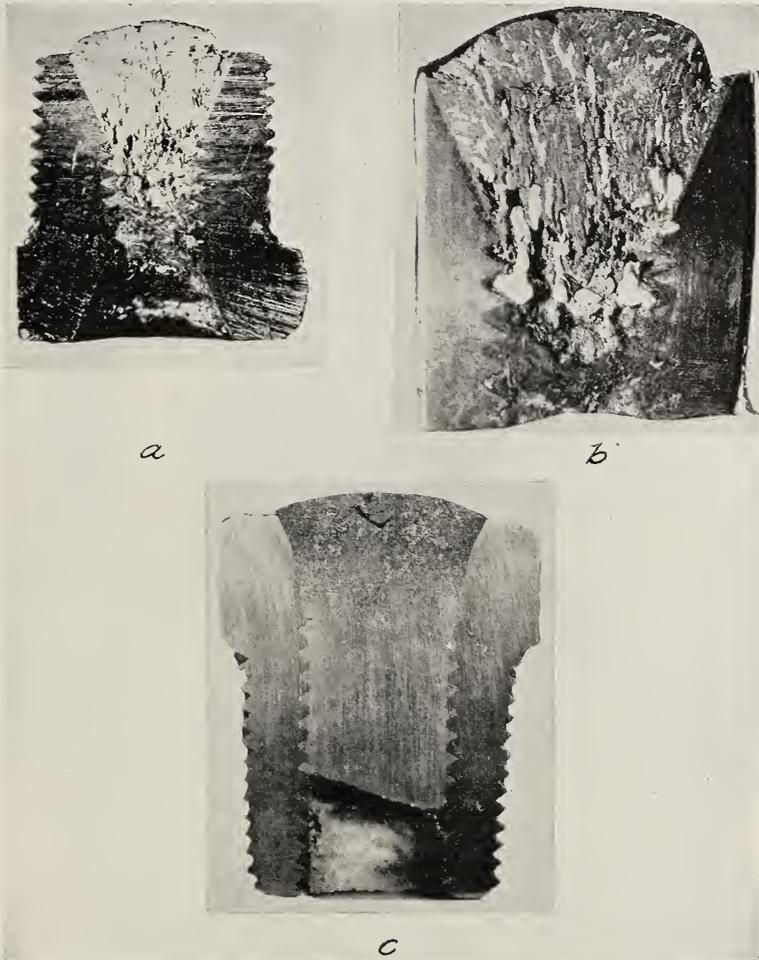
FIG. 65.—Structure of safety boiler plugs which deteriorated in service

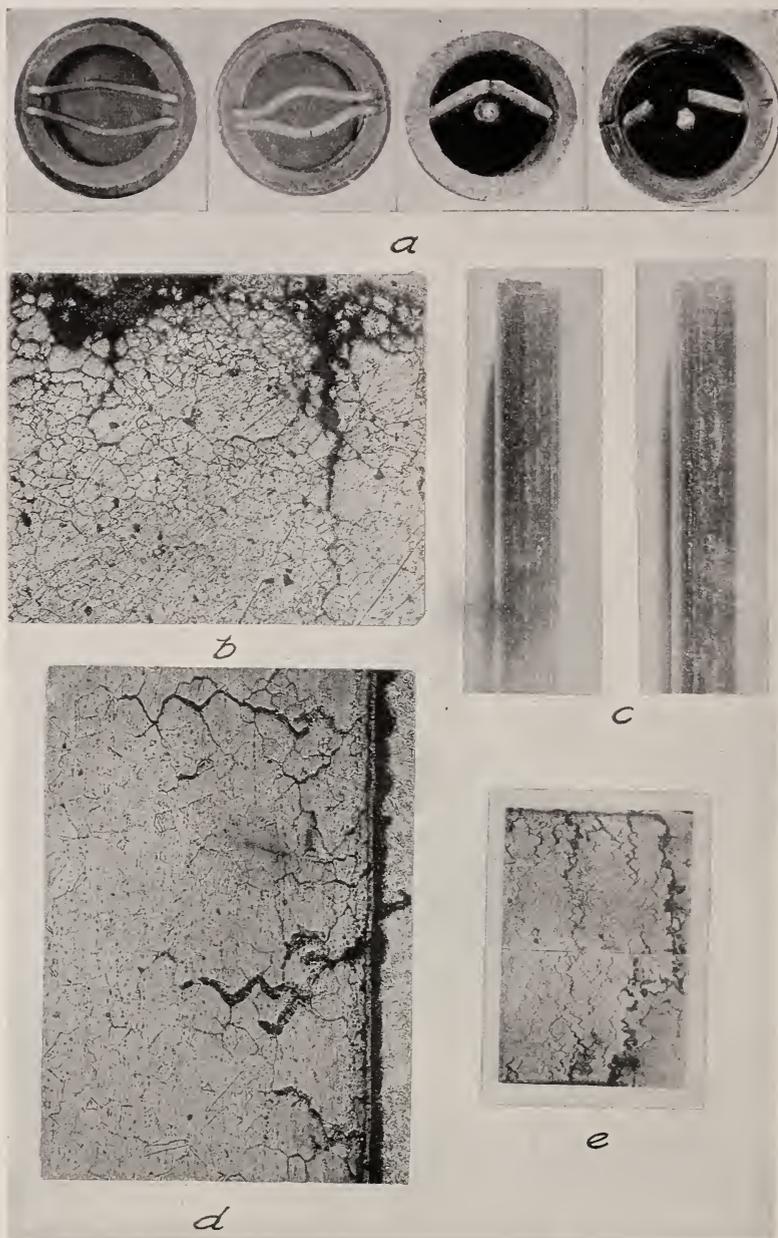
FIG. 66.—The appearance of deteriorated nickel wire and tension specimens of the same tested at a high temperature

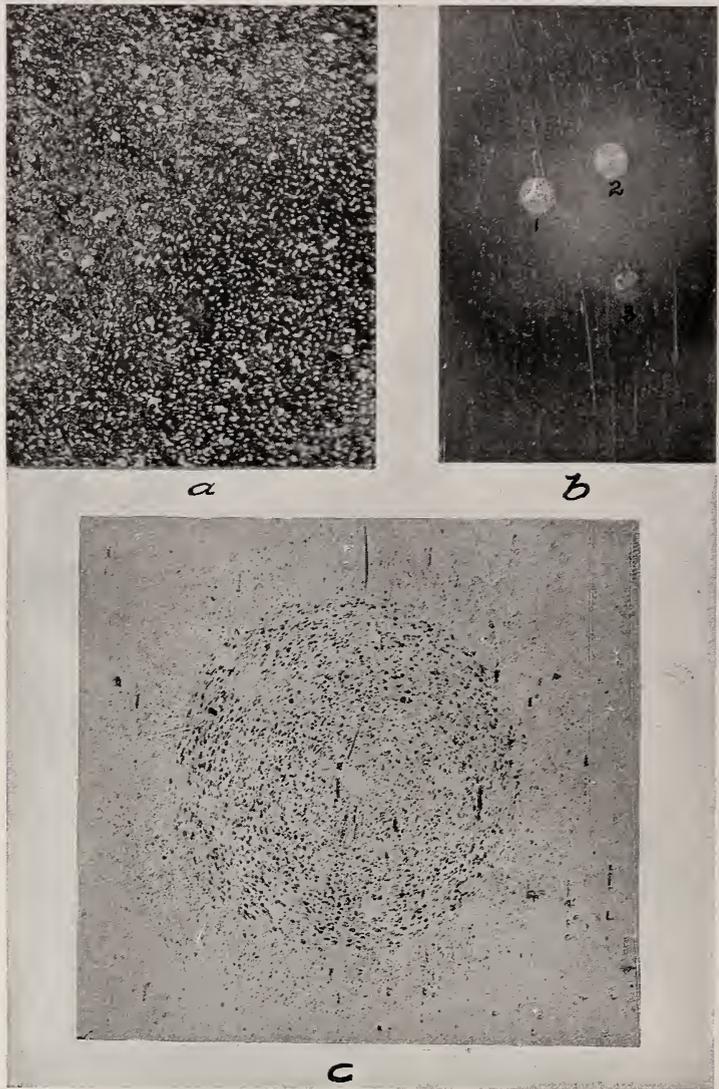
FIG. 67.—Structure of electrolytic copper before and after annealing

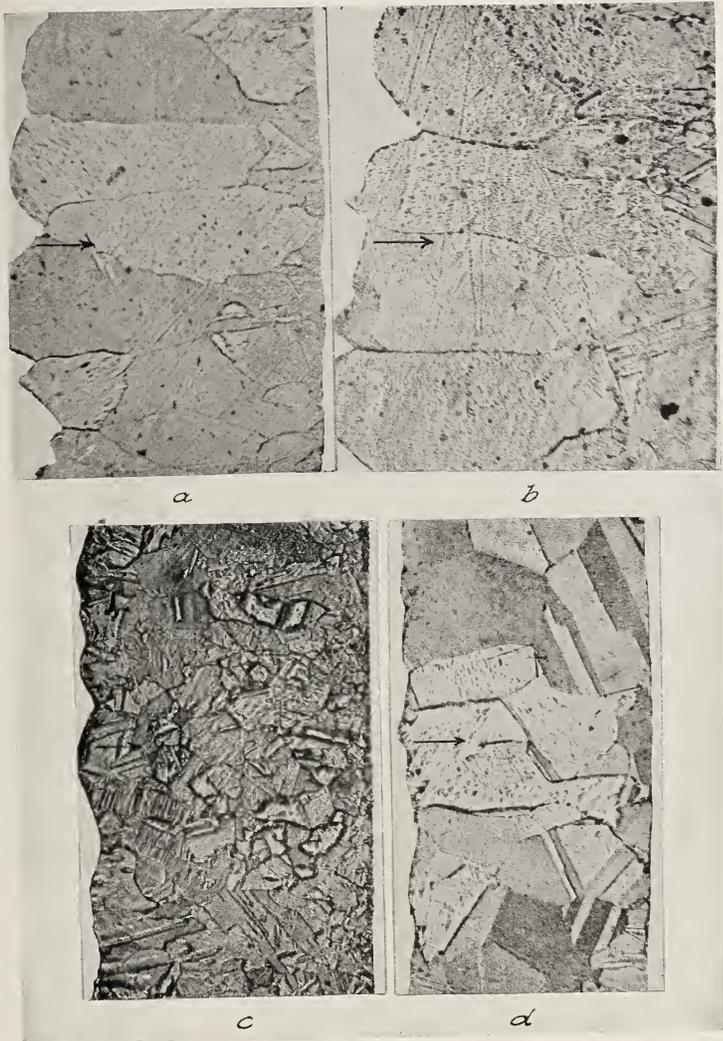
FIG. 68.—Appearance of the etched surface of a ball used in Brinell hardness determinations and the indentations produced

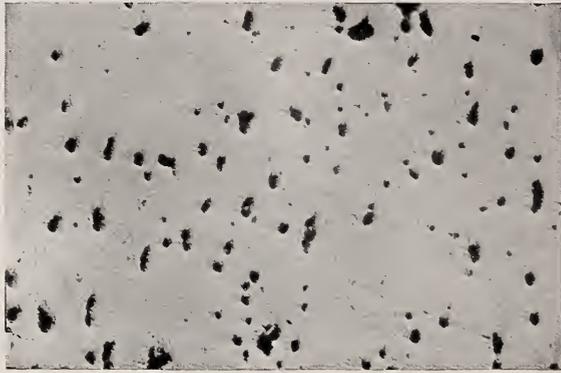
FIG. 69.—*Microstructure of leaded brass.* $\times 100$

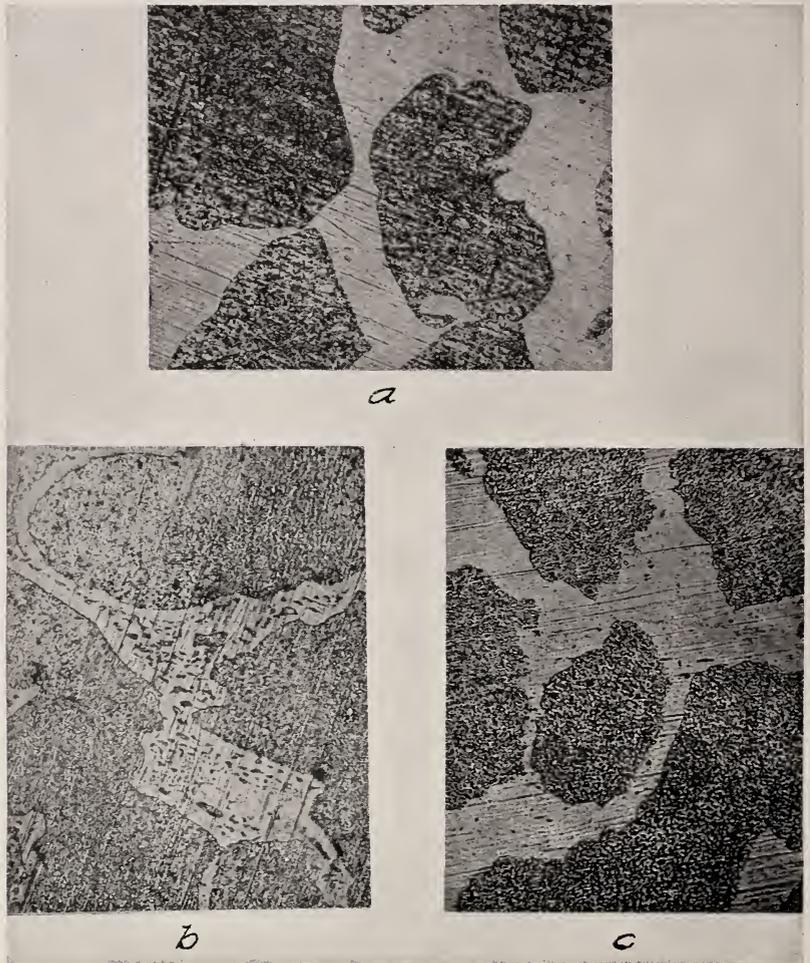
FIG. 71.—Microstructure of a bronze used for a bearing which became overheated in service.
X 500
