Underground Corrosion

U.S. Department of Commerce National Bureau of Standards Circular 579

Melvin Romanoff

National Bureau of Standards Circular 579 Issued April, 1957

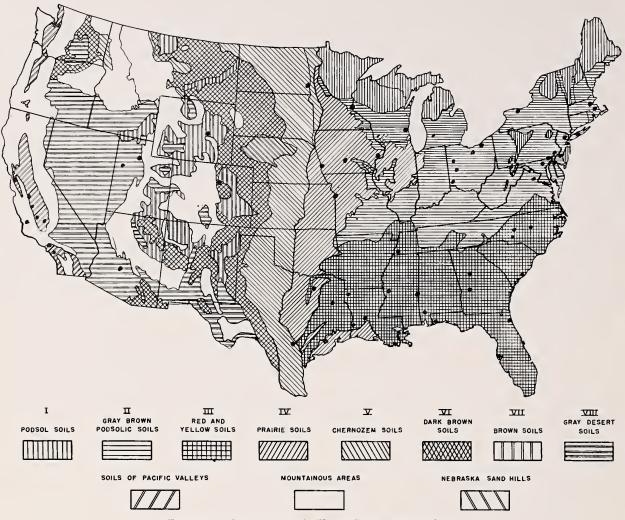
FIGURE 1. Soil groups of the United States. Marbut [60]. The dots show the location of the National Bureau of Standards test sites.

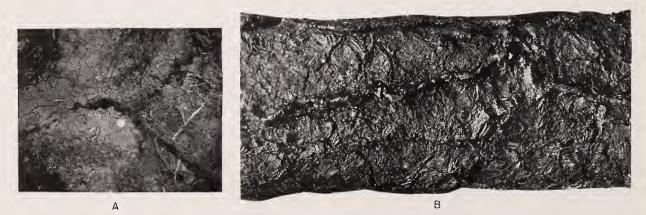
FIGURE 4. Soil cracking and its effect on a pipe coating. A, Cracks in Lake Charles clay. The white spot below the junction of the cracks is a 50-cent coin; B, rag-felt-reinforced asphalt pipe coating cracks. Note also cracks in the coating. Logan [4].

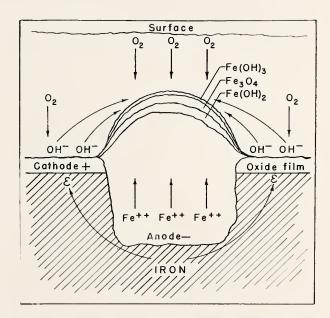
FIGURE 5. Development of a pit in a ferrous material. Denison [102].

Denison and Darniele [101] developed an explanation of pitting of iron in soils from results obtained from a laboratory corrosion cell, in which the corrosion products and processes could be observed. In the initial stages iron ions migrate into the electrolyte from a small area that is anodic for any of the reasons previously discussed. At the same time, negatively charged hydroxyl ions and acid ions, such as chloride, sulfate, nitrate, carbonate, etc., migrate from the cathode area in the electrolyte toward the anode. This condition will continue as long as the two electrodes maintain their respective potentials and the electrolyte continues to supply ions for conducting the current, but the rate at which current flows or corrosion occurs may be affected by reactions that occur within the electrolyte. Figure 5, from a presentation by I. A. Denison to the 1948 convention of the American Gas Assn. [102], illustrates a case where the main surface of the metal is cathodic because of the presence of a

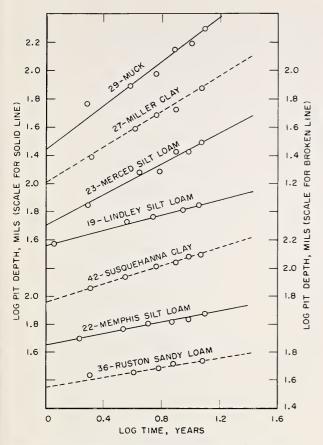
FIGURE 6. Relation of slopes of pit-depth-time curves for ferrous metals to aeration of soil [106].

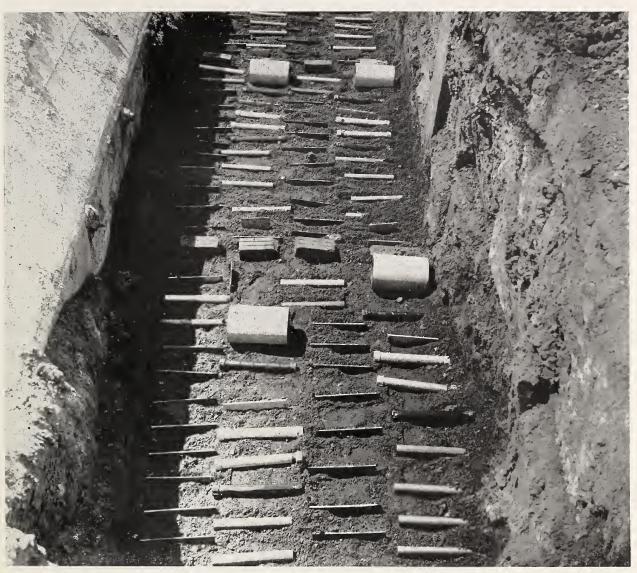
FIGURE 7. Arrangement of specimens buried in cinders at Milwaukee, Wis., in 1937.

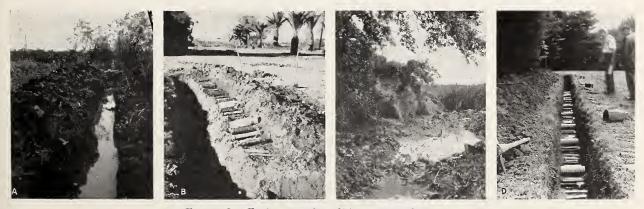
FIGURE 8. Environmental conditions at several test sites. A. Site 56, Lake Charles clay at El Vista, Texas; B, site 70, Merced silt loam at Buttonwillow, Calif.; C, site 63, tidal marsh at Charleston, S. C.; D, site 55, Hagerstown loam at Loch Raven, Md.

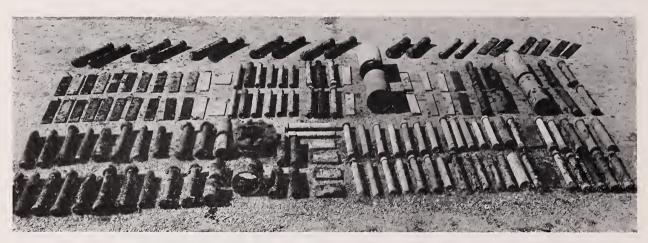
FIGURE 9. Specimen removed from Hagerstown loam at Loch Raven, Md. in 1946.

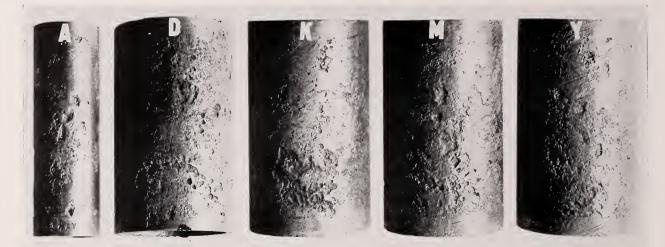
FIGURE 12. Different wrought materials exposed to Hempstead silt loam for approximately 12 years. Note similarity of corrosion patterns of the different metals. A, Open-hearth iron; D, wrought iron; K, open-hearth steel; M, Bessemer steel; Y, open-hearth steel with 0.2 percent of copper.

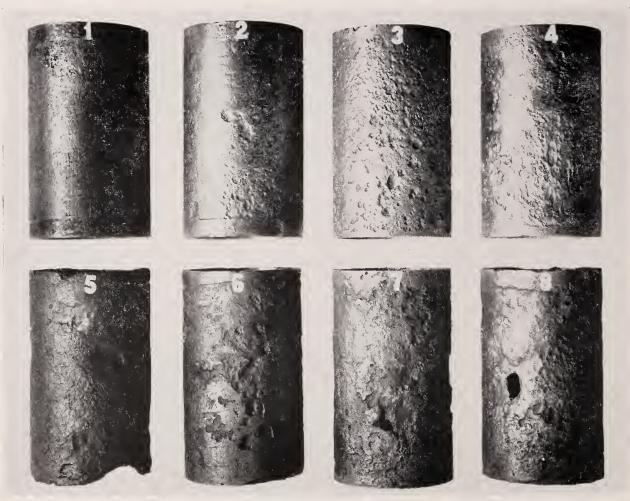
FIGURE 13. Open-hearth steel exposed for approximately 12 years to different soils. 1, A poorly drained silt loam; 2, Ontario loam; 3, Susquehanna clay; 4, tidal marsh; 5, muck; 6, Allis silt loam; 7, Montezuma clay adobe; 5, Merced silt loam containing alkali. Note the differences in the effects of the different soils on the same material.

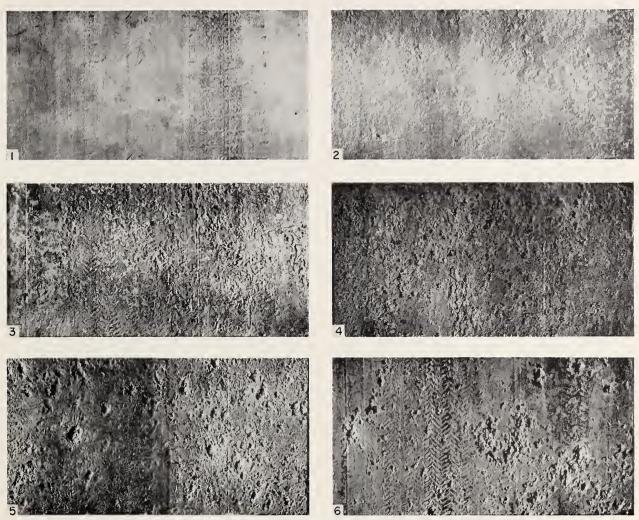
FIGURE 14. Types of corrosion shown by the same Bessemer steel specimens in various soils. See table 17 for identification of soils and corrosion data.

The variation in the type of corrosion on the same steel that may occur in soils is exhibited in figure 14, which illustrates corrosion patterns on Bessemer steel specimens, ranging from a uniform attack of the metal surface without pitting (14–1) to a highly localized attack in the form of deep,

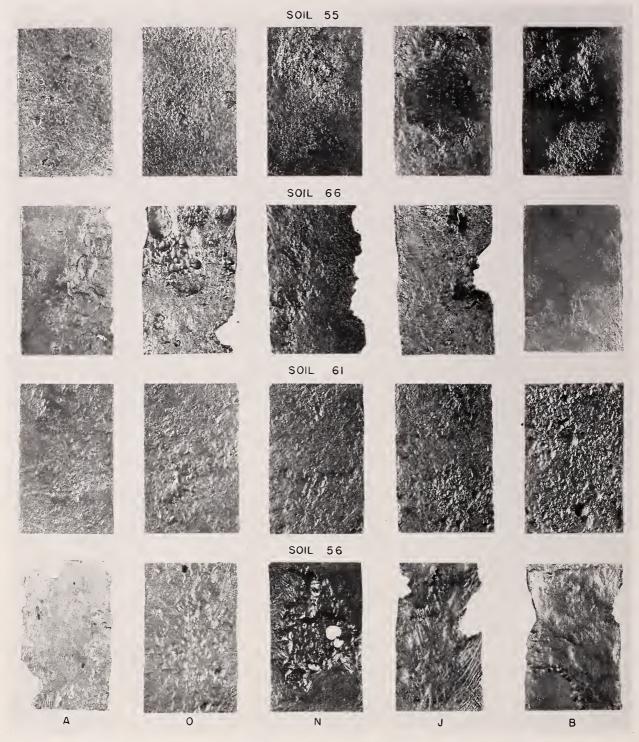
FIGURE 15. Corrosion of plain steel, copper-molybdenum open-hearth irons, and nickel-copper steels in several soil environments. A. Open-hearth iron, 0.5 f Cu, 0.07 Mo; N, openhearth iron, 0.5 f Cu, 0.13 Mo; J, steel, 0.95 Cu, 0.52 Ni; B, steel, 1.96 Ni, 1.01 Cu. Soil 55, well oxidized acid silt loam deficient in soluble salts; soil 66, fairly well aerated alkaline loam containing a high concentration of

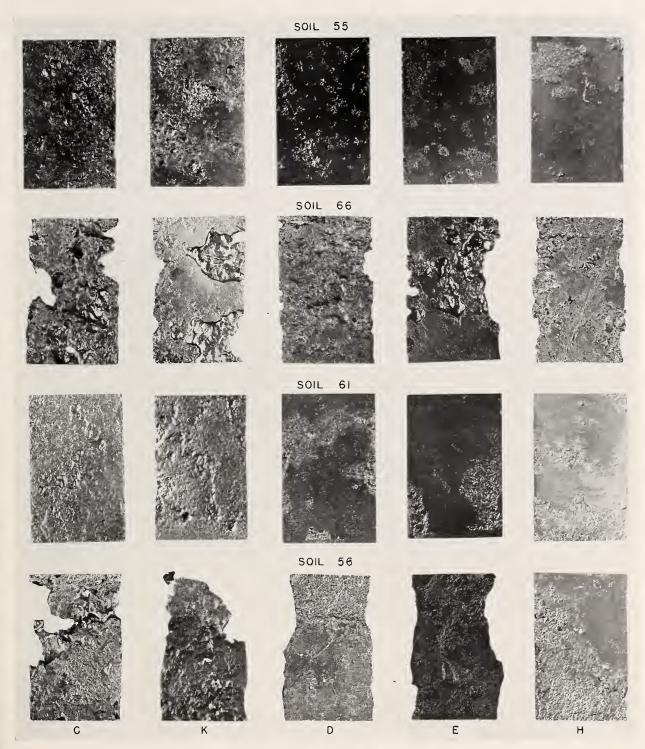
FIGURE 16. Corrosion of chromium-containing steels in several soil environments. C, Cr-Si-Cu-P steel, 1.02 Cr, 0.42 Cu; K, steel, 2.01 Cr, 0.57 Mo; D, steel, 5.02 Cr; E, steel, 4.67 Cr, 0.51 Mo; H, steel, 5.76 Cr, 0.43 Mo. Soil 55, well oxidized acid sil loam deficient in soluble satts; soil 66, fairly well aerated alkaline loam containing a high concentration of soluble material;

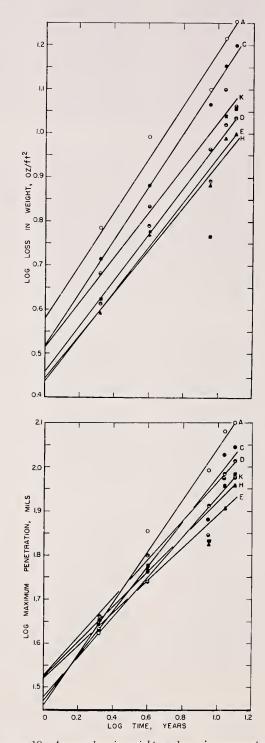
FIGURE 17. Average loss in weight- and maximum-penetrationtime curves for copper-molybdenum open-hearth irons and nickel-copper steels in 13 soils.

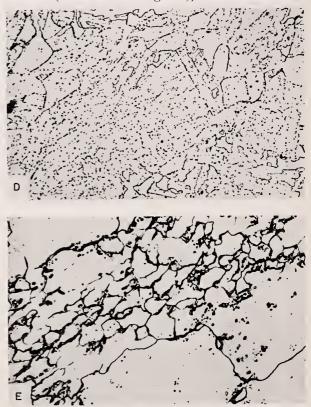
FIGURE 19. Longitudinal sections of 4- to 6-percent-chromiumsteel specimens.

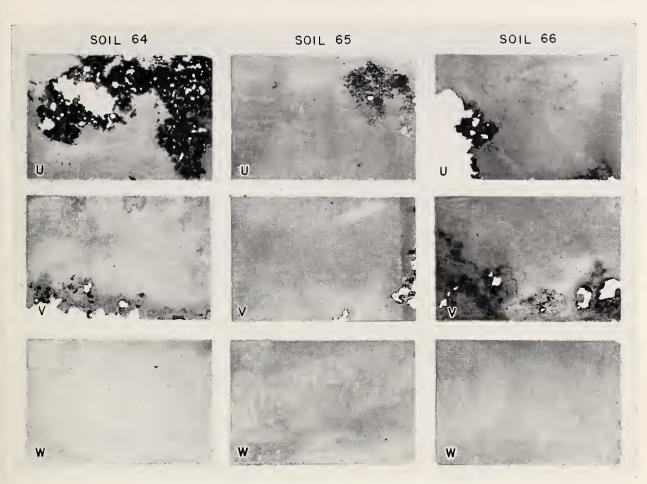
FIGURE 21. Specimens of high-alloy steels after exposure for 14 years. U, 12-percent chromium steel; V, 18-percent chromium steel; W, 18-percent chromium, 9-percent nickel steel.

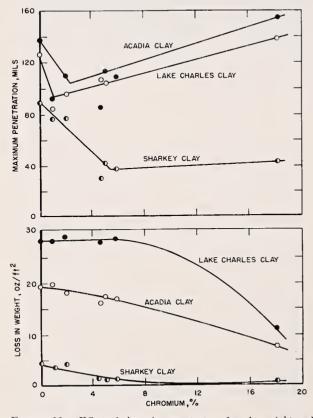
FIGURE 22. Effect of chromium content on loss in weight and pitting of steels in three poorly aerated soils, exposure 9 years.

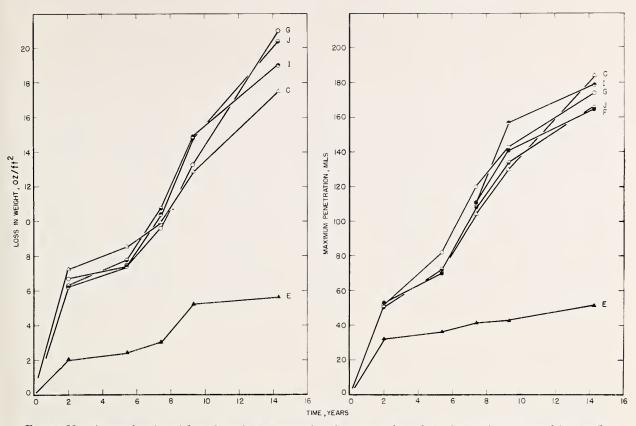
FIGURE 23. Average loss in weight and maximum-penetration-time curves of cast-iron pipe specimens exposed in 14 soils. G, Rattled cast iron; F, sand-coated cast iron; I, cast iron, 0.51-percent Cu, 0.28-percent Mn; J, cast iron, 0.62-percent Cu, 0.83-percent Mn; C, cast iron, 0.30-percent Cr, 0.15-percent Ni; E, cast iron, 15.0-percent Ni, 6.6-percent Cu, 2.6-percent Cr.

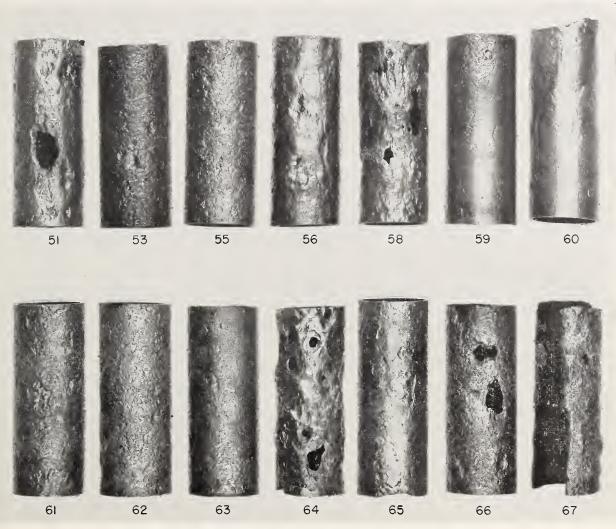
FIGURE 24. Corrosion of plain carbon steel N exposel 14 years at 14 test siles. See table 6 for identification of soils and table 10 for identification of steel N.

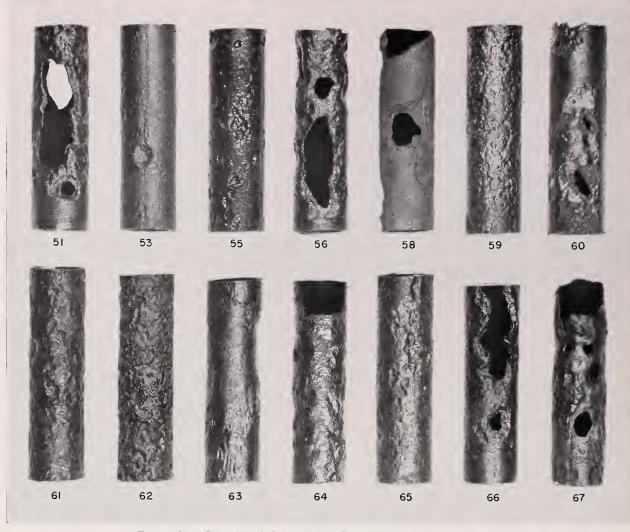
FIGURE 25. Corrosion of plain cast iron G exposed 14 years at 14 test sites. See table 6 for identification of soils and table 11 for identification of cast iron G.

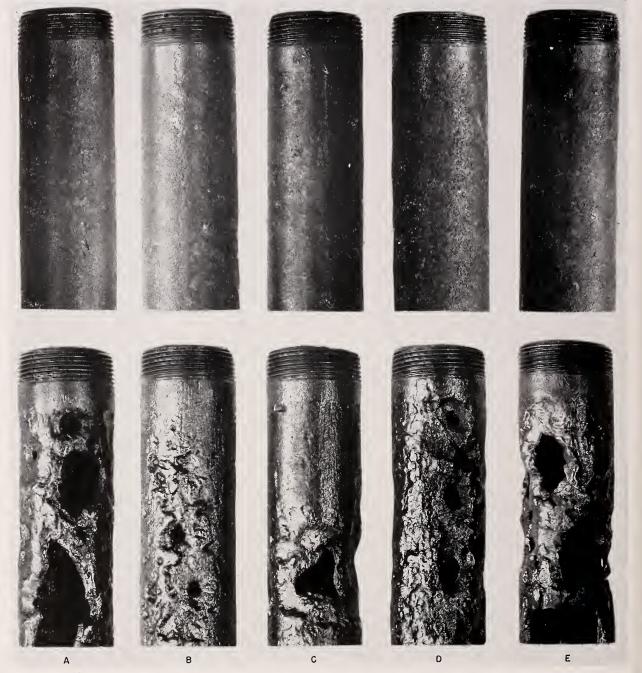
FIGURE 27. Condition of cast iron exposed for approximately 11 years to highly corrosive soils before (top row) and after (bottom row) removal of the corrosion products.
 A, Lake Charles clay, soil 56; B, muck, soil 58; C, tidal marsh, soil 63; D, Docas clay, soil 64; E, Merced silt loam, soil 70. For identification of soils see table 6.

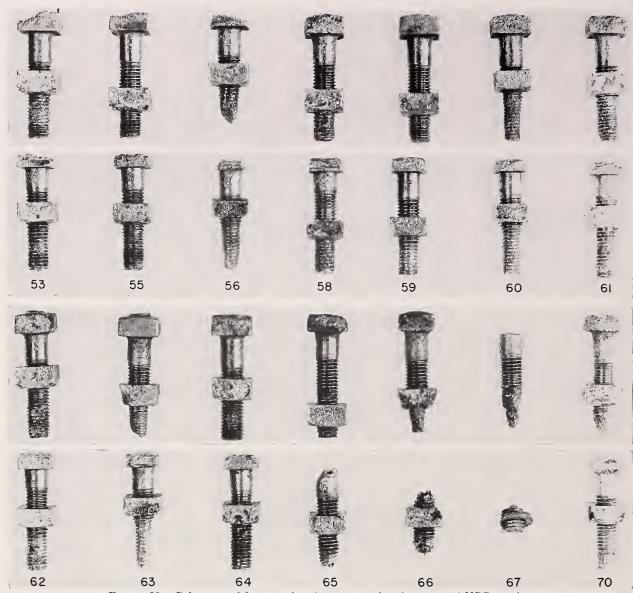
FIGURE 28. Bolts removed from couples after exposure for 13 years at 14 NBS test sites. A pair of bolts, cast iron (upper row) and steel (lower row), shown above the site numbers were components of a joint. Each pair of bolts (0.625 in.) joined two cast-iron plates (0.5 by 3.5 by 12 in.) that overlapped by 1.5 in.

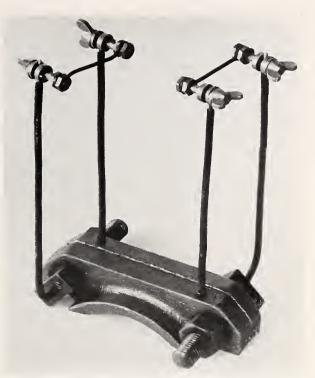
FIGURE 29. Couple of the type exposed to soil in the laboratory. Gland sections were cut from 4-in. cast-iron pipe glands. Bolts are 0.75 by 3.5 in.

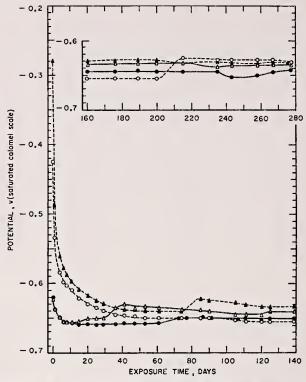
FIGURE 30. Potential relations between previously unexposed cast iron and graphitized cast iron in puddled soil.

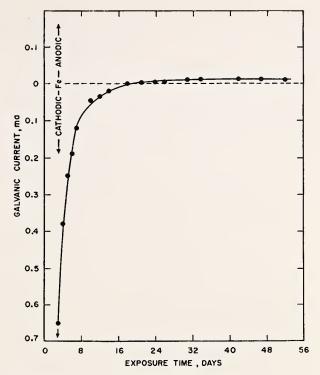
FIGURE 31. Effect of exposure time on the galvanic current of a galvanized iron-iron couple exposed to a 0.2-percent potassiumchloride solution at room temperature.

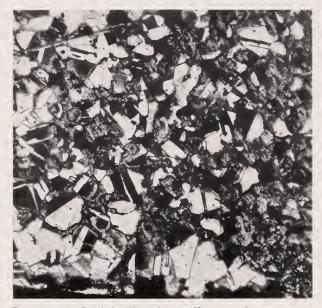
FIGURE 33. Leaded silicon brass (K) exposed 9.5 years to Sharkey clay, soil 61.

Transverse section showing partial dezincification. The dezincification is more severe at the left, as indicated by the dark, spongelike areas with irregular boundaries. Light grains of the alpha phase in dezincified areas show that the grains of the beta phase are dezincified first, $\times 250$.

The form and depth of dezincification on the specimens of high-zinc brass, B, H, K, J, and L, are given in table 51. No dezincification were observed in the specimens of red brass F and copper-nickelzinc alloy G at any of the test sites. A transverse section of a typical uniformly dezincified area of a Muntz metal specimen removed from Sharkey clay (soil 61) is shown in figure 32. The microstructures of a partially dezincified section of a leaded siliconbrass specimen removed from the same soil is shown in figure 33.

The microstructure of leaded silicon brass K, which contained approximately 40 percent of zinc, consisted of the alpha and beta phases (fig. 33). As the beta phase is higher in zinc than the alpha phase, it is more susceptible to dezincification, Dezincification of the two-phase copper-zinc alloys. K and L, was fairly general, and the specimens of these alloys showed evidence of dezincification in most of the soils (table 51). The much greater dezincification of these high-zinc brasses relative to that of the single-phase admiralty metal H was, of course, to be expected because the presence of 1 percent of tin in the alloy has been observed to inhibit dezincification appreciably in sea water [172]. The specimens of 60-40 Muntz metal L showed severe dezincification in 8 of the 14 soils to which they were exposed. However, the addition of 0.08 percent of arsenic to this alloy inhibited the dezincification reaction, and no dezincification was noted in any of the same soils up to 13 years in the 60-40 brass containing arsenic.

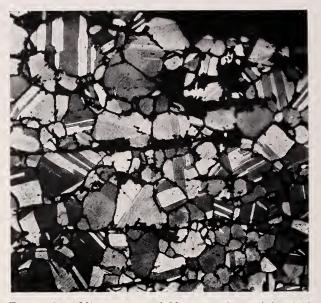
FIGURE 34. Microstructure of Muntz metal containing 0.08 percent of arsenic.

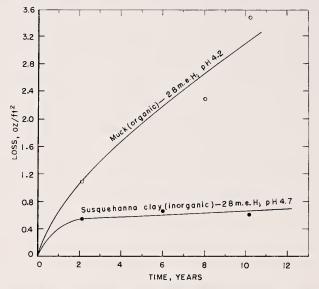
FIGURE 37. Effect of organic and inorganic acidity on the corrosion of lead.

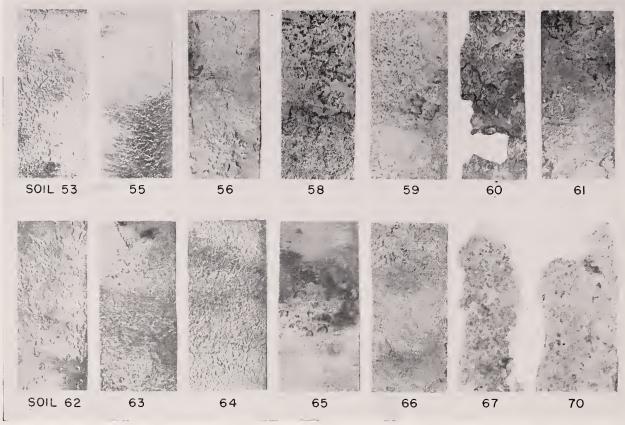
FIGURE 38. Condition of specimens of rolled commercial zinc after exposure for 13 years to 14 soils.

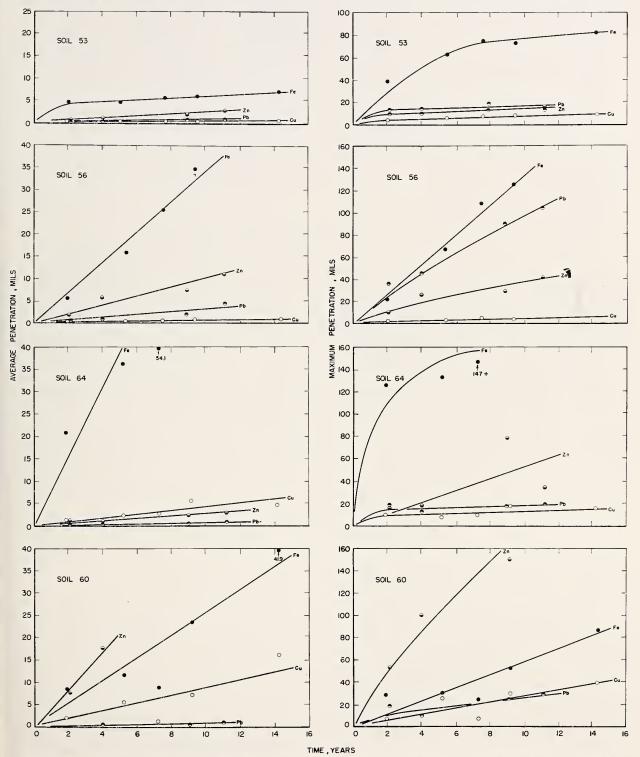
FIGURE 39. Average and maximum penetration-time curves of steel, copper, lead, and zinc in representative soil environments.

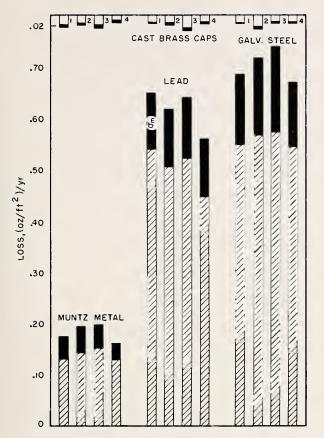
FIGURE 40. Average rates of corrosion of cast-brass fittings and attached nipples in 15 soils.

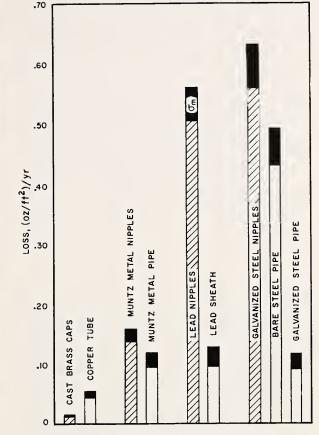
FIGURE 41. Effect of interconnecting different metals.

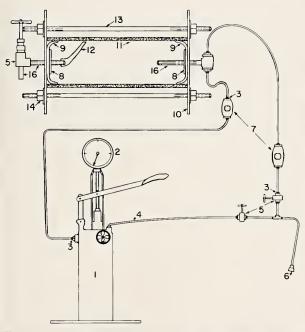
FIGURE 42. Arrangement of apparatus for hydrostatic bursting tests.

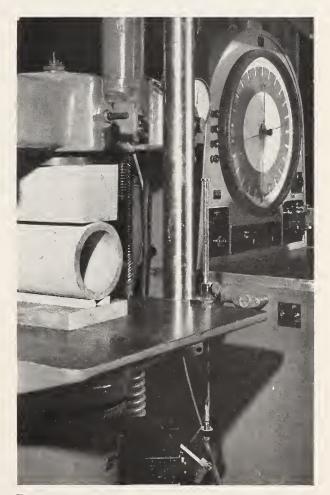
FIGURE 44. Determination of crushing strength of a section of asbestos-cement pipe.

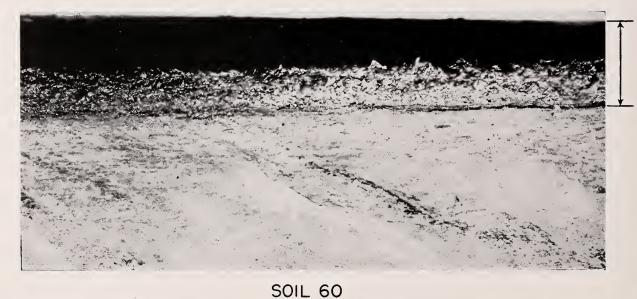
FIGURE 45. Cross sections of asbestos-cement pipe exposed in different soils for 13 years. ×3. The depth of softening is indicated by the thickness of the dark layers shown by the arrows.

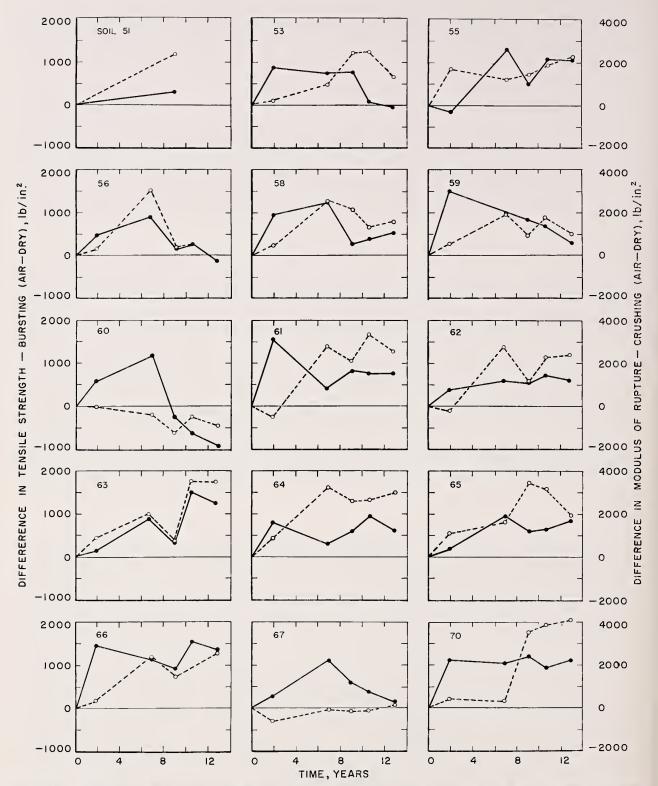
FIGURE 46. Differences in tensile strength and modulus of rupture between unexposed specimens of 4-in. pipe and similar specimens exposed underground for different periods.
 Tensile strength; O, modulus of rupture. The properties of the soils are given in table 6.

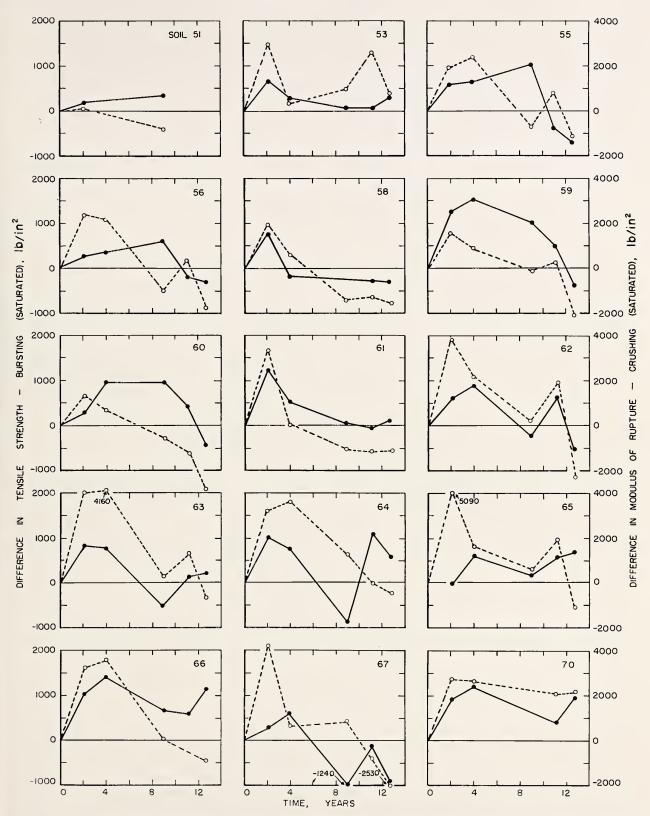
FIGURE 47. Differences in tensile strength and modulus of rupture between unexposed specimens of 6-in. pipe and similar specimens exposed underground for different periods.
 Tensile strength; O, modulus of rupture. The properties of the soils are given in table 6.

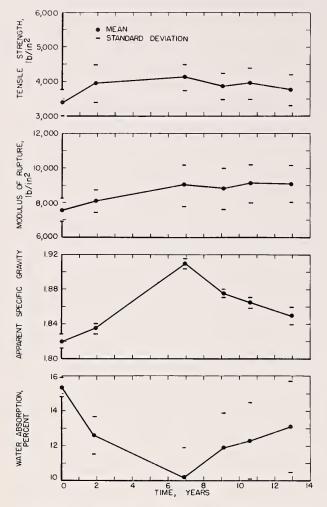
FIGURE 48. Average tensile strength, modulus of rupture, apparent specific gravity, and water absorption of 4-in. specimens in 14 soils for different periods of exposure. Data for the tensile strength and modulus of rupture adjusted to the saturated condition.

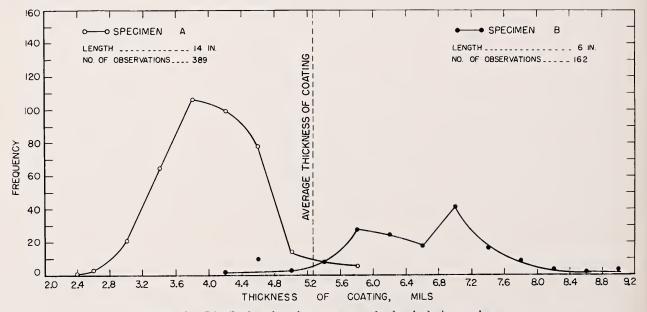
FIGURE 50. Distribution of coating on unexposed galvanized pipe specimens. Nominal weight of coating, 3.08 oz./ft.². This is the weight of coating on the exposed surface. Each ounce per square foot of coating is equivalent to 0.00172 in. in thickness.

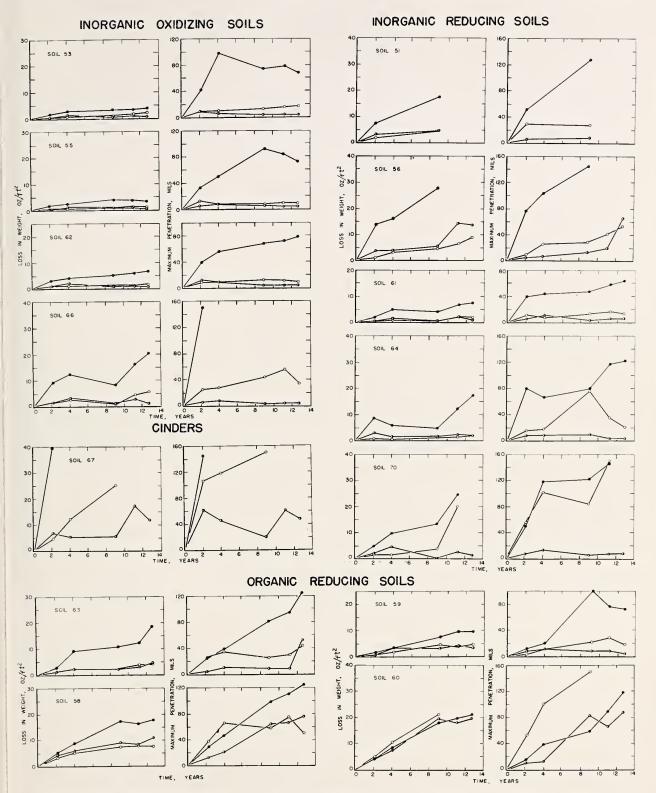
FIGURE 52. Weight loss and maximum penetration as a function of time for galvanized steel, bare steel, and zinc. •. Bare steel; •. zinc; •. galvanized steel.

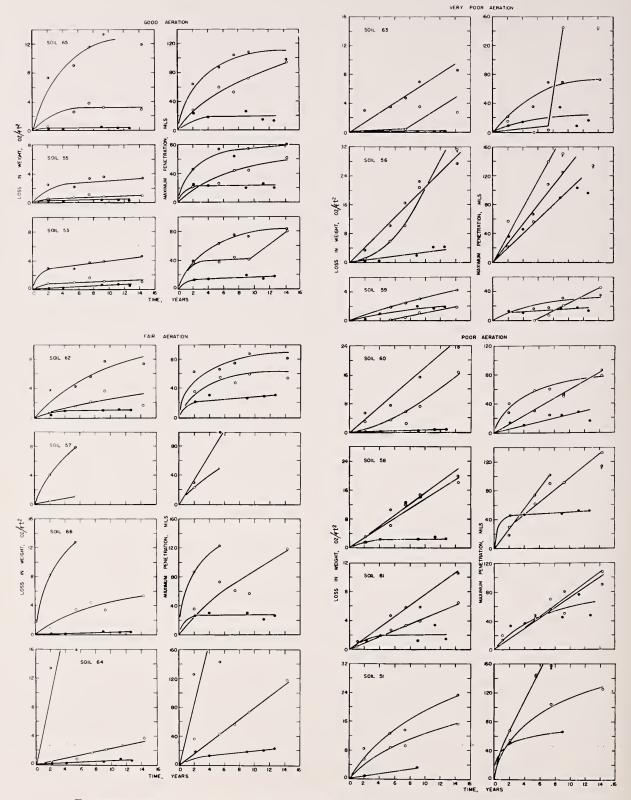
FIGURE 56. Weight-loss and pit-depth-time curves of lead-coated steel, bare iron and steel, and lead. •, Lead; O, lead-coated steel; •, bare iron and steel.

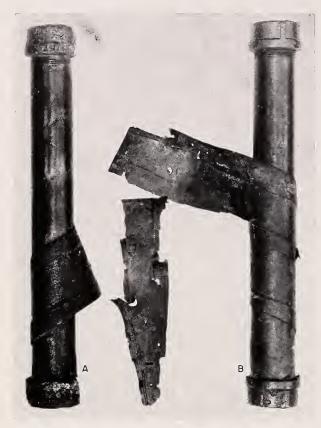
FIGURE 57. Condition of polyvinyl-chloride-treated fabric coating and the underlying steel pipe after exposure for approximately 13 years.

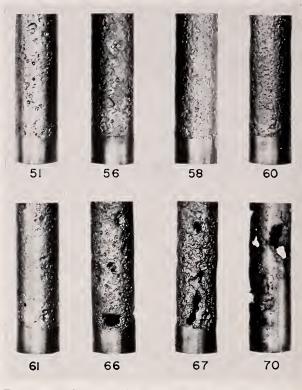
FIGURE 58. Condition of steel protected by soft rubber caps and bare steel exposed to different soils for 11 years.

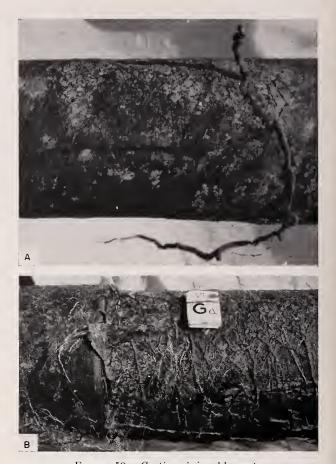
FIGURE 59. Coatings injured by roots. A. Root beneath a tar-felt-reinforced asphalt coating; B. grass roots in and beneath a 10-year-old asbestos-felt shielded coal-tar enamel coating on 1 pipeline.

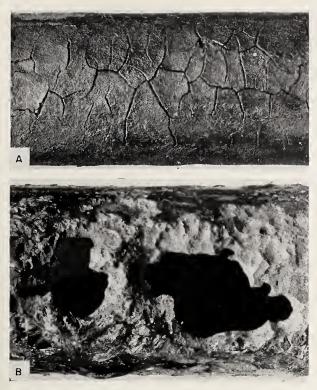
FIGURE 60. Examples of failure of pipe coatings in a tidal marsh soil.

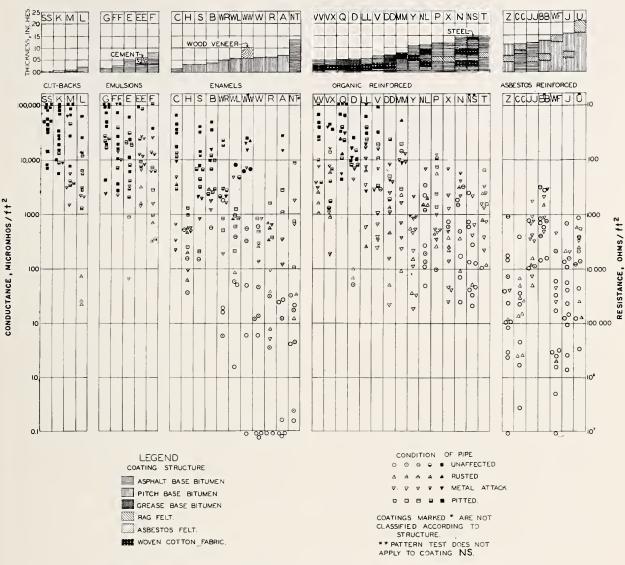
FIGURE 64. Results of inspections of NBS-AGA coatings after exposure for 5.5 years.

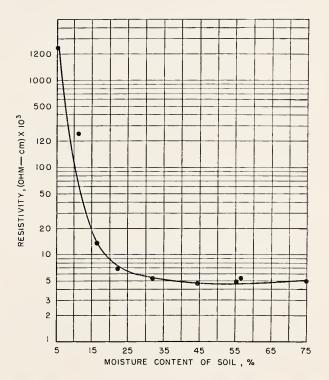
FIGURE 66. Effect of moisture content on resistivity of a clay soil.

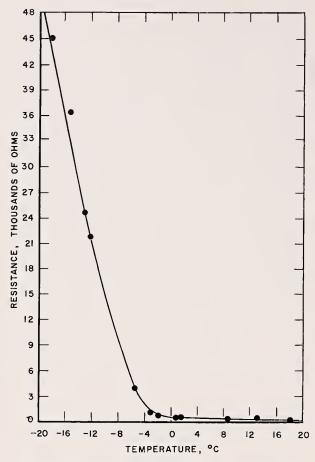
FIGURE 67. Effect of temperature on earth resistance [8].

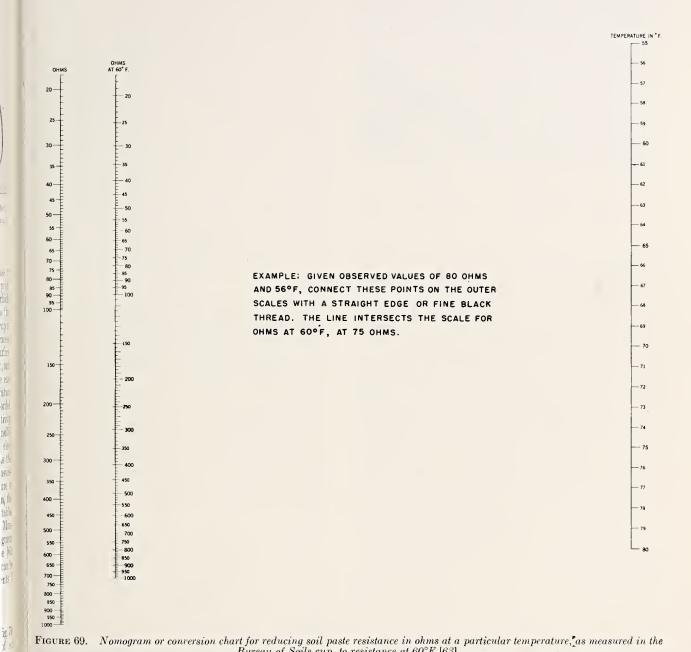
FIGURE 69. Nomogram or conversion chart for reducing soil paste resistance in ohms at a particular temperature, as measured in the Bureau of Soils cup, to resistance at 60°F [63].

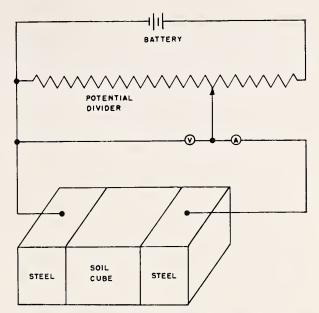
FIGURE 72. Modified Putman apparatus for testing for "potential corrosivity" [251].

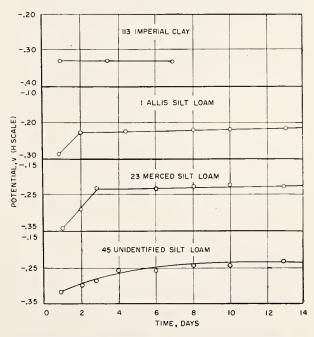
FIGURE 74. Relation between corrosion potential and time [133].

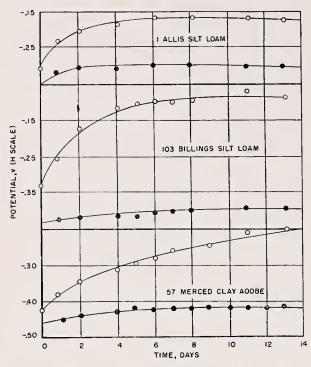
FIGURE 75. Potential-time curves for the anode and cathode [133]. ●, Anode; ○, cathode.

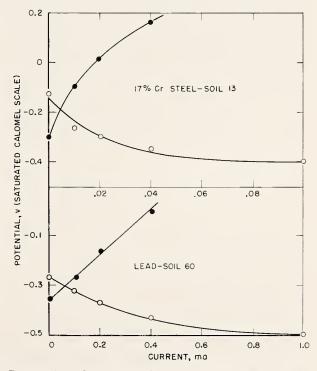
FIGURE 78. Current-potential curves illustrating corrosion under anodic control [134].
 Anode; O, cathode.

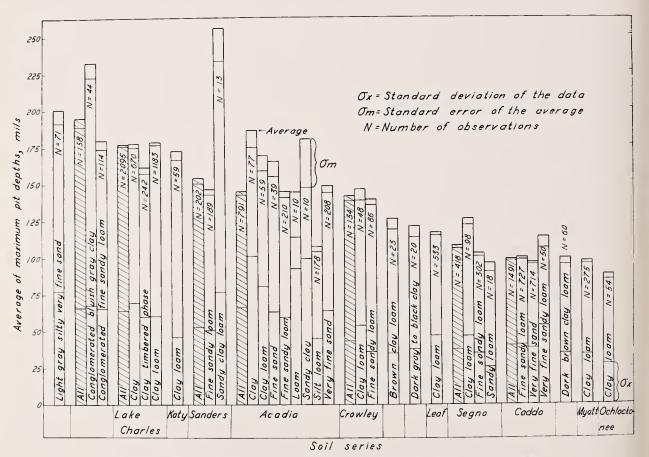
FIGURE 79. Maximum pit depths on sections of pipes exposed to different soil types [262].

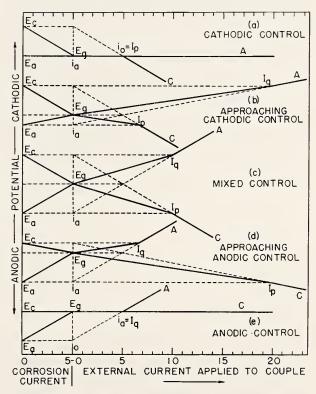
FIGURE 83. Hypothetical polarization diagrams for various types of control [142].

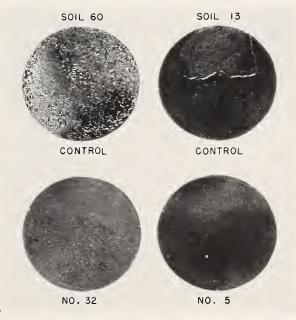
FIGURE 87. Unprotected (control) and protected steel electrodes in soil 60 (pH 2.9) and soil 13 (pH 9.5), exposure 60 days [136].

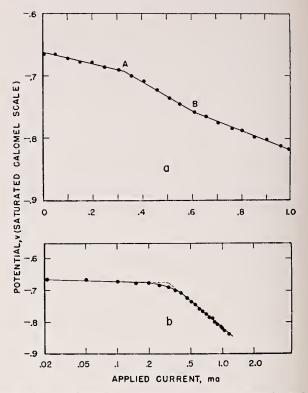
FIGURE 88. Cathodic polarization curves of a single steel electrode in a differential-aeration cell.

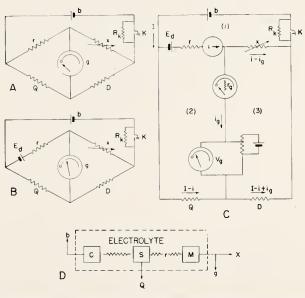
FIGURE 92. Holler's circuit for measuring potential and internal resistance.

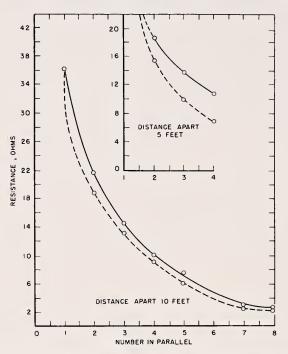
FIGURE 95. Effect of the number of 10-foot driven-pipe grounds in parallel on their resistance to earth [339]. _____, Observed values; _____, calculated values.

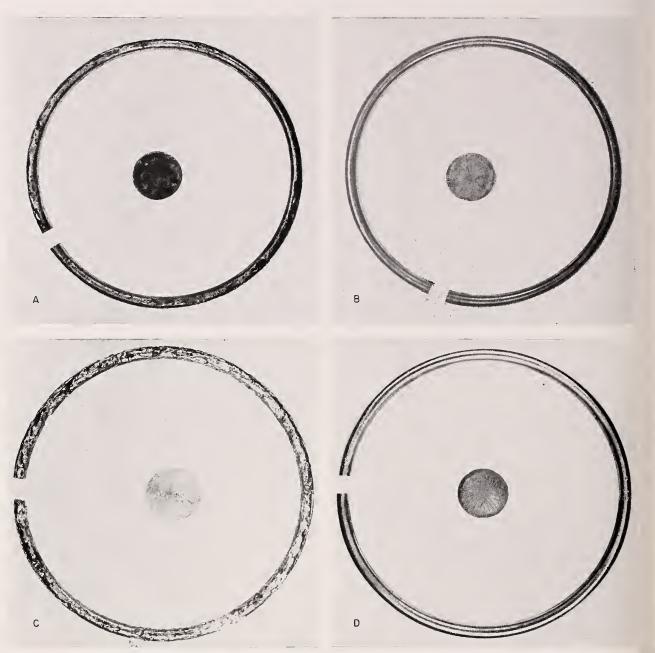
FIGURE 98. Condition of connected and unconnected steel cathodes and zinc anodes at two test sites [135]. A, Unprotected steel ring and zinc cylinder exposed at site 78 for 3.1 years; B, ring connected to zinc anode at site 78 for 3.1 years. Zn-Fe area ratio 1:20; C, unprotected steel ring and zinc cylinder exposed at site 75 for 5.8 years; D, ring connected to zinc anode at site 75 for 5.8 years. Zn-Fe area ratio 1:20.

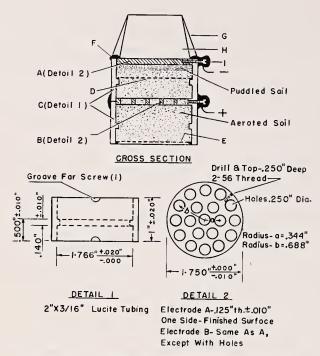
FIGURE 100. Modified Denison soil-corrosion cell [143].
