ACCELERATED LABORATORY CORROSION TEST METHODS FOR ZINC-COATED STEEL

By Edward C. Groesbeck and William A. Tucker

ABSTRACT

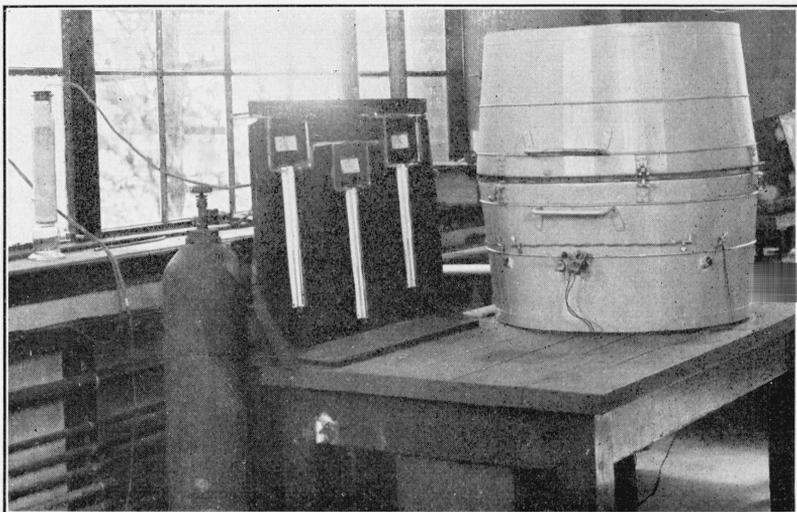
FIG. 1.—*Simulated atmospheric corrosion test apparatus, shown as assembled*

The apparatus employed in this work is shown in Figures 1, 2, and 3. The test was carried out in two wooden containers, K , one of which served as the "tank" and the other as the cover to the tank by being placed on top and in an inverted position. The containers were of cypress wood and of a variety which may be found in most any household-furnishings store. Their dimensions were $29\frac{1}{2}$ inches (750 mm) in diameter at the open end, $27\frac{1}{4}$ inches (692 mm) in diameter at the closed end, and $14\frac{1}{2}$ inches (368 mm) in height.

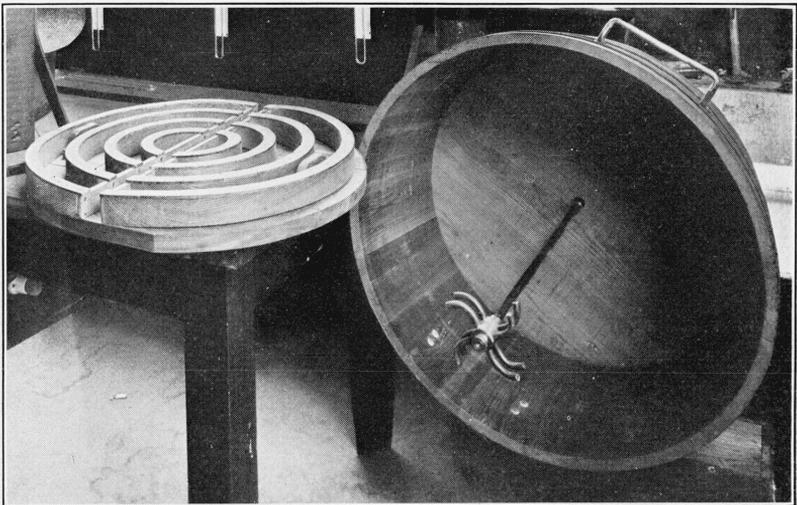
FIG. 3.—*Water-spraying arrangement and specimen racks for simulated atmospheric corrosion test apparatus*

At the start of the first stage of the test, the tank was filled with hot water up to a definite height. Next, a circular false bottom, F , 26 inches (660 mm) in diameter and made from a board $1\frac{1}{8}$ inches (29 mm) thick, was placed upon four $1\frac{1}{4}$ -inch (32 mm) square wooden uprights, U , being at a short distance above the water level when in position. A glass tube, serving as a gas inlet, was then placed in position as indicated in Figure 2. The specimen holder, SH , which was in two separate parts, each consisting of four wooden semi-annular rings held in position by a wooden strip extending along at approximately the diameter of the rings (see fig. 3), was next laid on

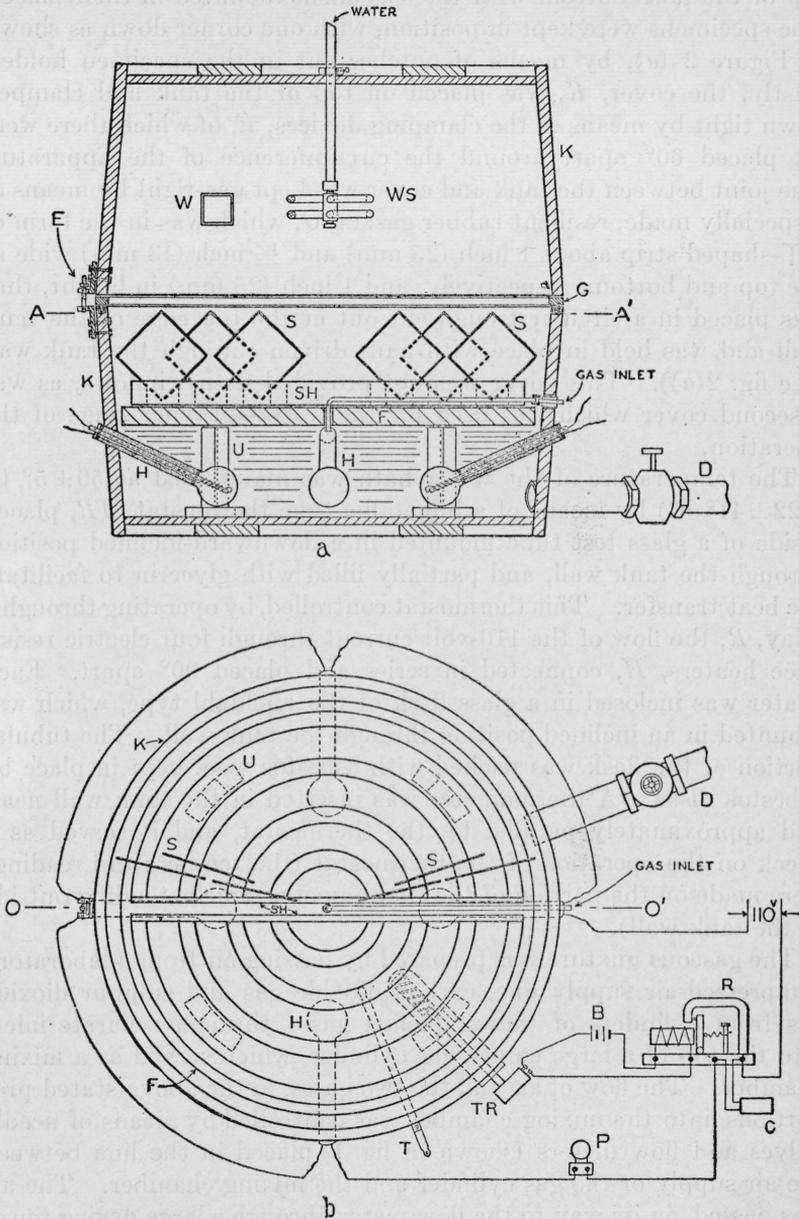
FIG. 2.—Details of simulated atmospheric corrosion test apparatus

a, vertical section at O-O'; the cover shown here was that used in the water-spraying stage of the operation; b, plan below horizontal plane A-A': The wiring arrangement is shown at lower right; WS, water sprinkler; W, window; S, specimens; SH, specimen holder; F, false bottom; H, electrical heater; D, drain pipe; U, supports for false bottom and specimen holders; T, thermometer; TR, thermoregulator; R, relay; P, pilot light; B, battery; C, condenser; K, wooden container; E, clamping arrangement; G, rubber gasket

the gas-inlet tube on the tank was situated beneath the false bottom, as shown in Figure 2 (a), so that the incoming stream of gaseous mixture would come directly upon the surface of the warm water and spread radially to the edge of the false bottom, upward along the tank walls and into the specimen chamber. Thus, the specimens were exposed to a corroding atmosphere under "muggy" conditions.

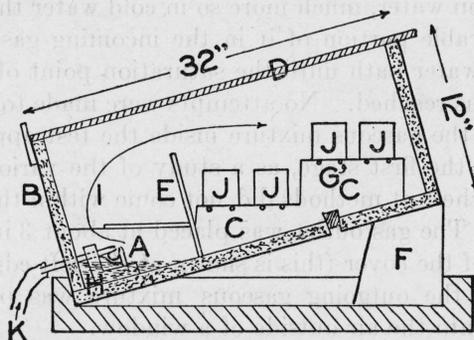
FIG. 4 (a).—Details of spray box

B, Alberene stone box; *A*, atomizer; *H*, corrosive solution; *K*, compressed air stream; *E*, baffle plates; *I*, course of spray; *D*, glass cover; *J*, specimens; *F*, support for box

The apparatus employed in the spray tests is shown in Figure 4(a). The outside dimensions of the two Alberene stone boxes were 32 by 16½ by 12 inches (813 by 419 by 305 mm) in height, and the walls were 1¼ inches (32 mm) thick. A piece of plate glass served as the top cover, *D*, and permitted ready observation of the progress of the test. The specimens were suspended from glass rods, extending across inside the box, by means of glass hooks passing through a hole, ⅛-inch (3 mm) diameter, at the middle of one edge of the specimen (these details are not shown in Figure 4 (a)). The corrodent was

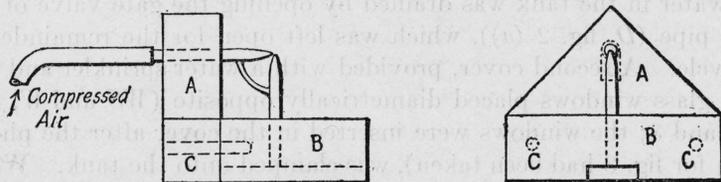
FIG. 4 (b).—Details of atomizer used in spray box (a)

The atomizer consists of two nipples, made from glass tubing and joined at right angles by a glass rib, and is mounted in an alberene stone frame. The corrosive solution is sucked up through the vertical nipple by the air stream

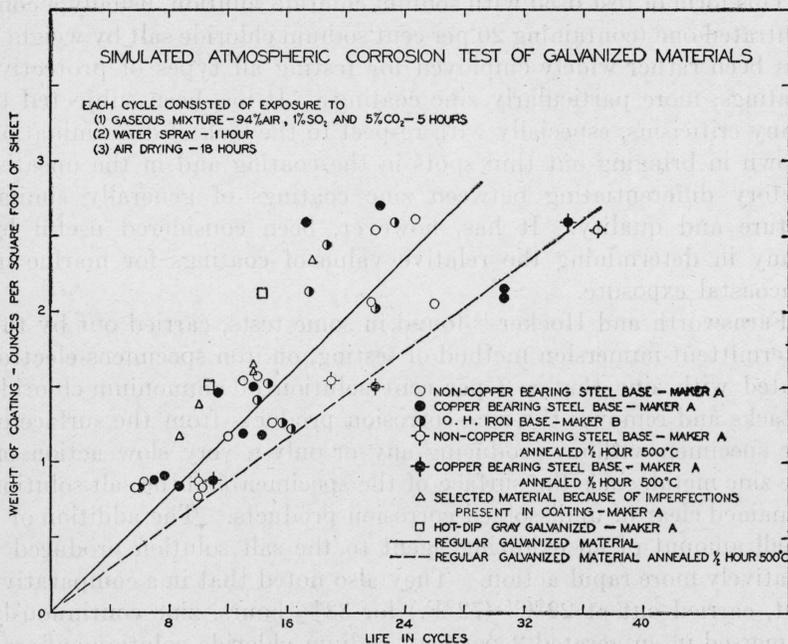
FIG. 5.—Results of simulated atmospheric corrosion tests

Each point plotted in the diagram is the average value of three determinations

The results for the simulated atmospheric corrosion test are tabulated in Table 3 and summarized in Figure 5 (Tables 3 and 4 have been included in this paper for the benefit of those desiring to make a more detailed analysis of the test data). There are given in this table

average values for the face (face No. 1) of the specimen, which first reached the failure point have been plotted in Figure 5 for the different test materials. Each point plotted represents the average of three determinations, which were made at the same time and under the same conditions. Although the plotted data show a considerable scattering, the solid line, which has been drawn in as nearly a mean position as practicable (with reference to all uncrossed circles), indicates the relation between the "life" of the coating, expressed in cycles, and the weight of the coating in oz./ft.² of sheet; for example, a coating of 2.0 oz./ft.² of sheet should require 20 or 21 cycles of exposure, under the conditions of the experiment, for the coating to break down.

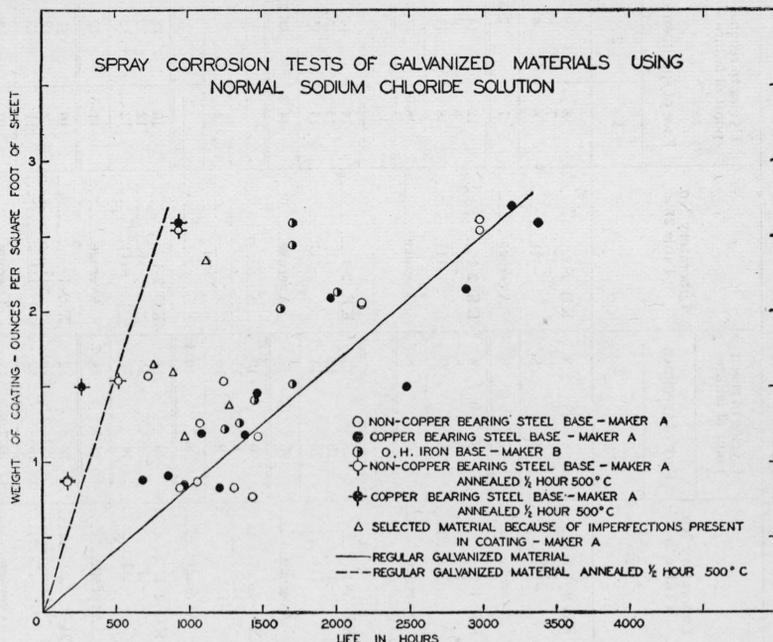
FIG. 6.—Results of spray tests with *N* sodium chloride solution
Each point plotted in the diagram is the average value of three determinations

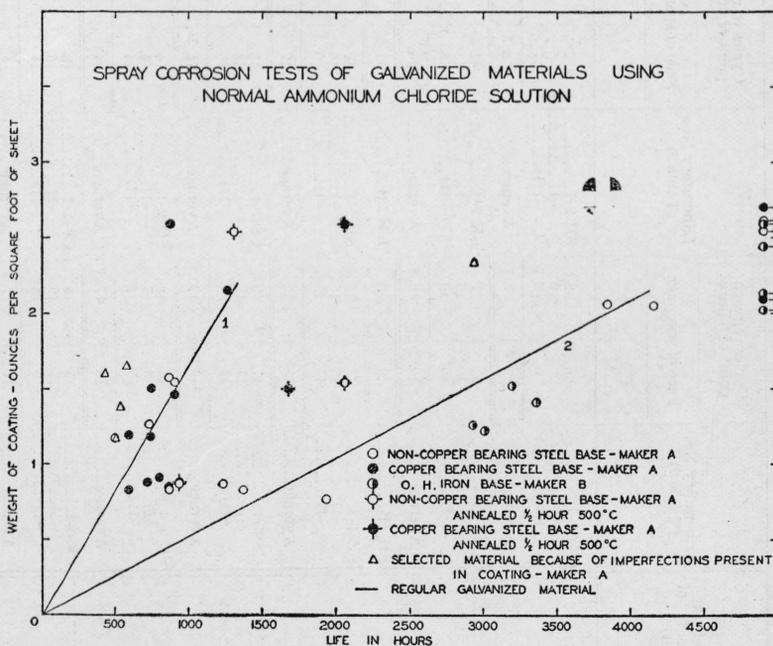
FIG. 7.—Results of spray tests with *N* ammonium chloride solution
Each point plotted in the diagram is the average value of three determinations. The results represented by curves 2 and 1 were influenced by the fact that the simulated atmospheric corrosion test was run, and was not run, respectively, simultaneously with and in close proximity to the spray test

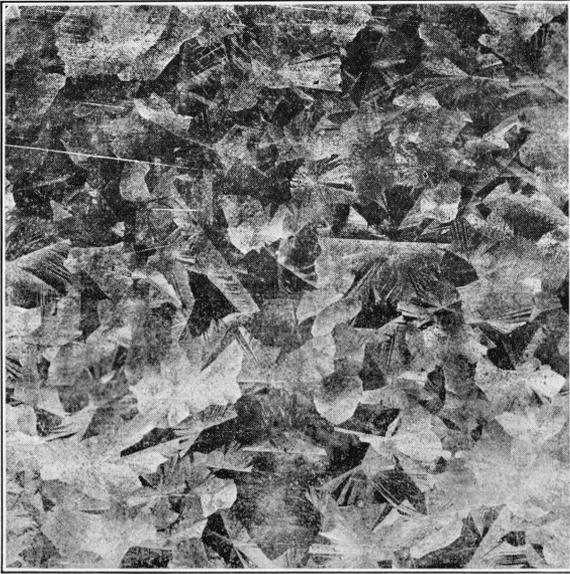
FIG. 8.—Appearance of an 0.9-ounce coating in the “as received” condition. (Material No. 4, Table 2.) $\times \frac{3}{4}$

This coat had a smooth surface with no ridges between the adjacent spangles standing out in relief

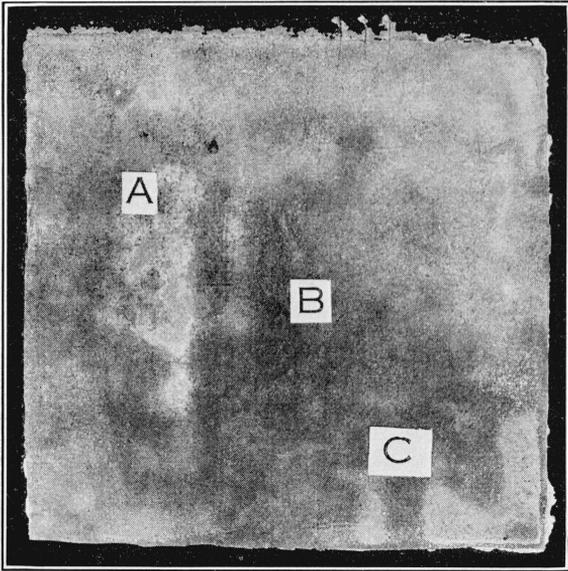
FIG. 9.—Change in appearance of an 0.8-ounce coating after 11 cycles' exposure in the simulated atmospheric corrosion test. (Material No. 21, specimen SK1-111, Table 2.) $\times \frac{3}{4}$

A, relics of zinc metal layer; B, outer iron-zinc alloy layer; C, inner iron-zinc alloy layer; the dark patch shown in the lower right corner of the L-shaped area is red-brown iron rust.

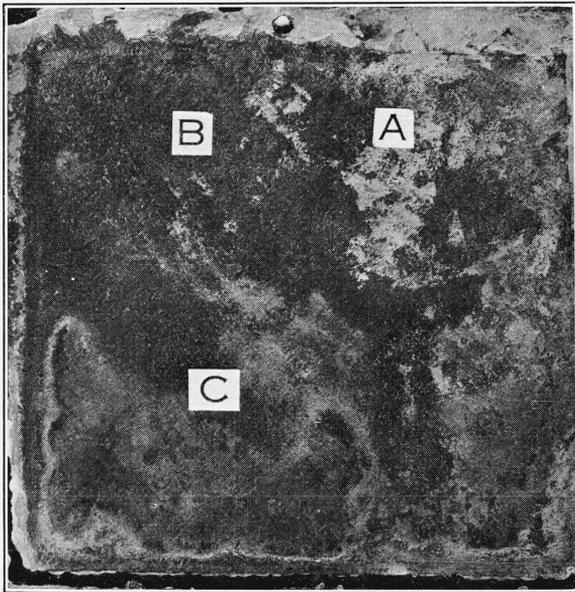
FIG. 10.—Change in appearance of a 2.2-ounce coating after 34 cycles' exposure in the simulated atmospheric corrosion test. (Material No. 15, specimen KB1-11, Table 2.) $\times \frac{3}{4}$

A, relics of zinc metal layer; B, outer iron-zinc alloy layer; C, inner iron-zinc alloy layer; the dark patches shown scattered through this area are red-brown iron rust

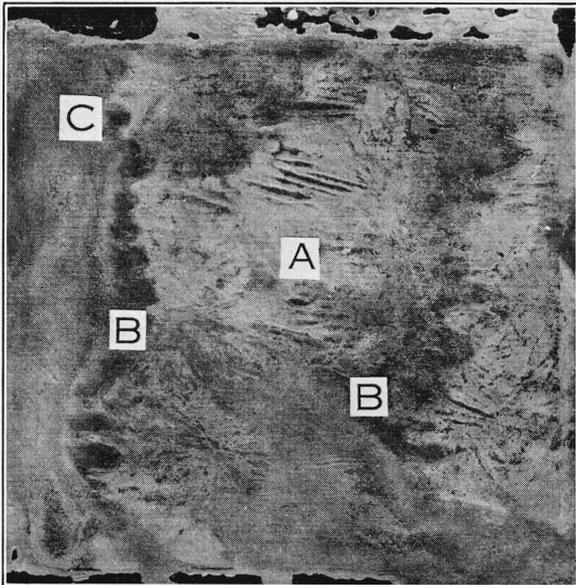
FIG. 11.—Change in appearance of a 2.1-ounce coating after 23 cycles' exposure in the simulated atmospheric corrosion test. (Material No. 30, specimen 883-11, Table 2.) $\times \frac{3}{4}$

A, relics of zinc metal layer; B, outer iron-zinc alloy layer; C, inner iron-zinc alloy layer; the dark patch shown at the lower end of this elongated area is red-brown iron rust

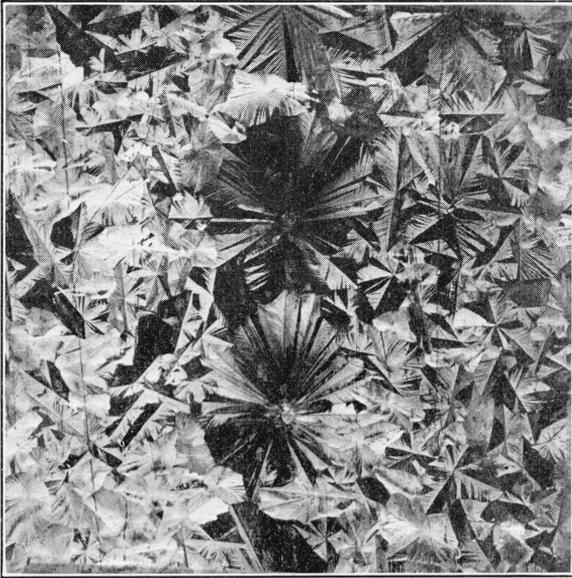
FIG. 12.—Appearance of a 2.6-ounce coating in the “as received” condition. (Material No. 18, Table 2.) $\times \frac{3}{4}$

Various portions of the surface, as along the boundaries between the spangles and also alongside some of the dendritic branches of the spangle, stood out in decided relief and the corroding through of the zinc metal layer usually occurred first at these places where the coating was thinnest. In the center of the two large adjacent spangles may be seen “chain conveyor marks.” Several materials having these marks, which were generally not deep-seated, showed no tendency for the failure point to occur first at these points

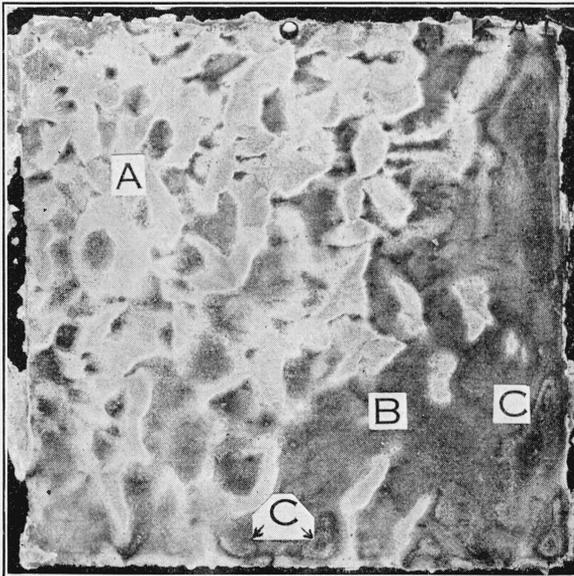
FIG. 13.—Change in appearance of a 2.7-ounce coating after 27 cycles' exposure in the simulated atmospheric corrosion test. (Material No. 19, specimen KA1-11, Table 2.) $\times \frac{3}{4}$

A, relics of the zinc metal layer; B, outer iron-zinc alloy layer; C, inner iron-zinc alloy layer; the darker portions of these areas are red-brown iron rust

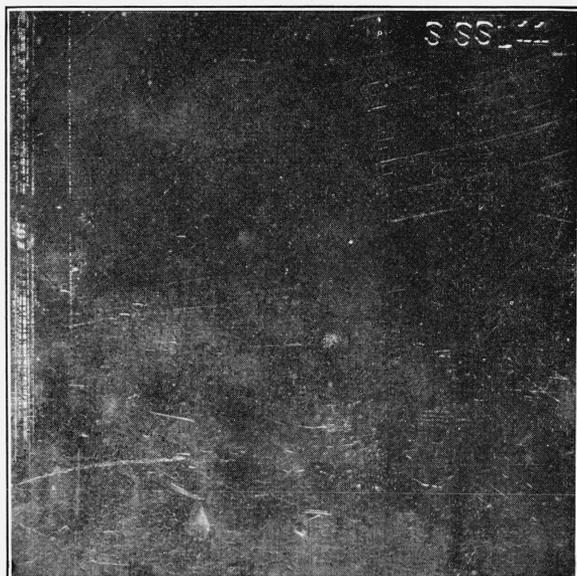
FIG. 14.—Appearance of a specimen of lead-coated material in the “as received” condition. (Material No. 35, Table 2.) $\times \frac{3}{4}$

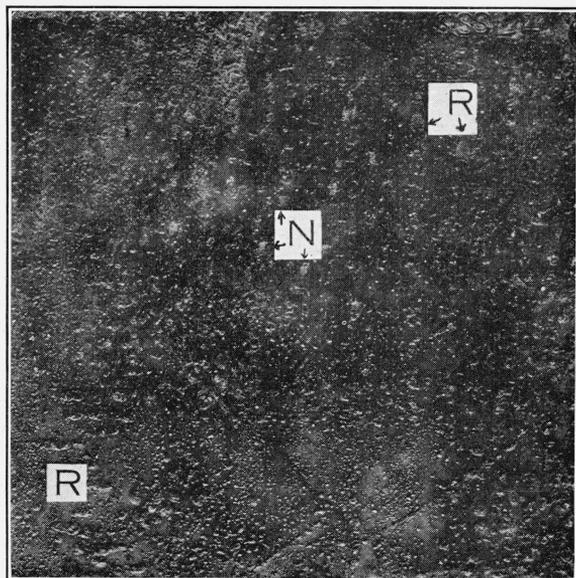
FIG. 15.—Change in appearance of a specimen of lead-coated material after 55 cycles' exposure in the simulated atmospheric corrosion test. (Material No. 35, specimen SSSL-1, Table 2.) $\times \frac{3}{4}$

The lead coat is badly roughened and many blisters have formed (compare with fig. 14). The underlying surface at some of the blisters is strongly rusted (*R*) while that at some of the other blisters show a gray-colored, matte appearance (*N*). This specimen had reached the “failure point” after 5 cycles, exposure

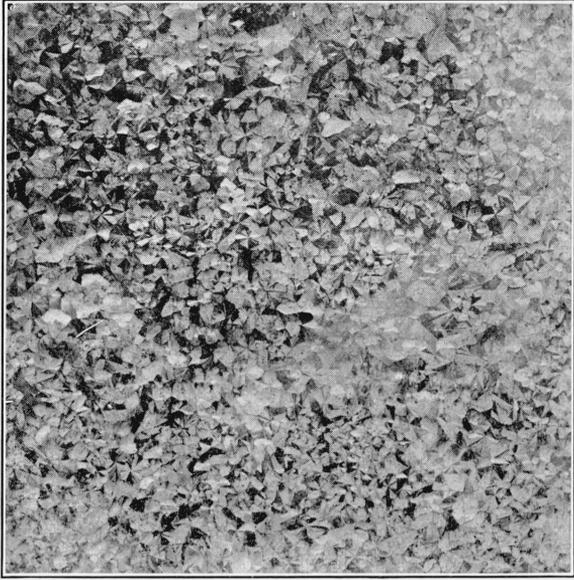
FIG. 16.—Appearance of a “gray galvanized” coating in the “as received” condition (1.6-ounce coating; material No. 46, Table 2.) $\times \frac{3}{4}$

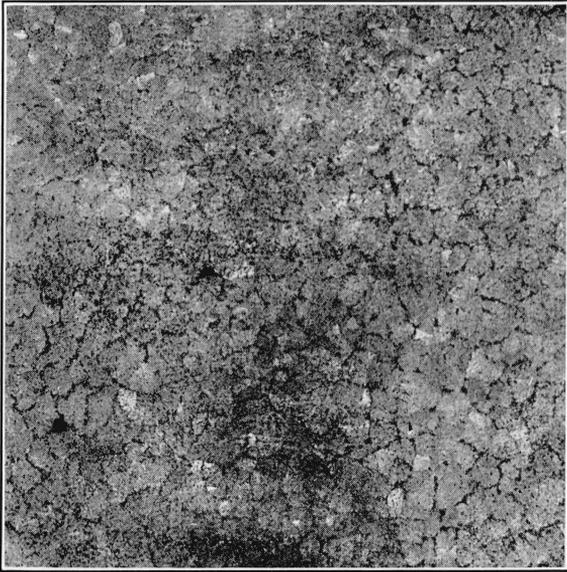
FIG. 17.—Change in appearance of the “gray galvanized” coating after 5 cycles' exposure in the simulated atmospheric corrosion test (1.6-ounce coating; material No. 46, specimen X5-1, Table 2.) $\times 1$

The corroding away of the “gray galvanized” coat has started along the grain boundaries

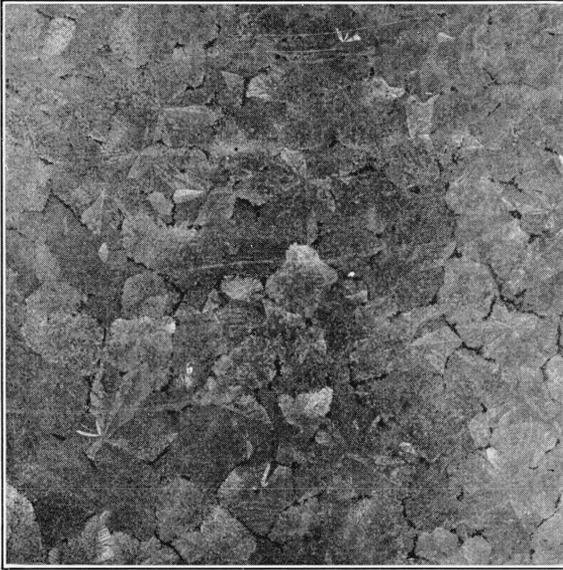
FIG. 18.—Change in appearance of a 1.7-ounce coating after 5 cycles' exposure in the simulated atmospheric corrosion test (Material No. 45, specimen X4-1, Table 2.) $\times 1$

The corroding away of the coating has started along the grain boundaries

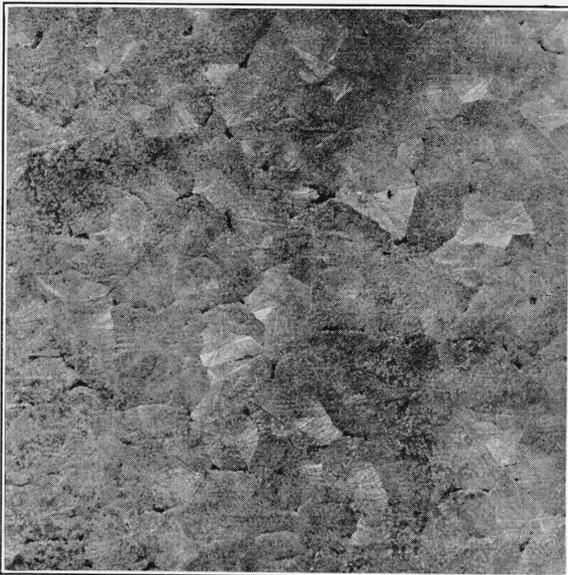
FIG. 19.—Change in appearance of a 2.7-ounce coating after 5 cycles' exposure in the simulated atmospheric corrosion test. (Material No. 19, specimen KA1-11, Table 2.) $\times 1$

The corroding away of the coating is starting at the junctions between the adjoining grains

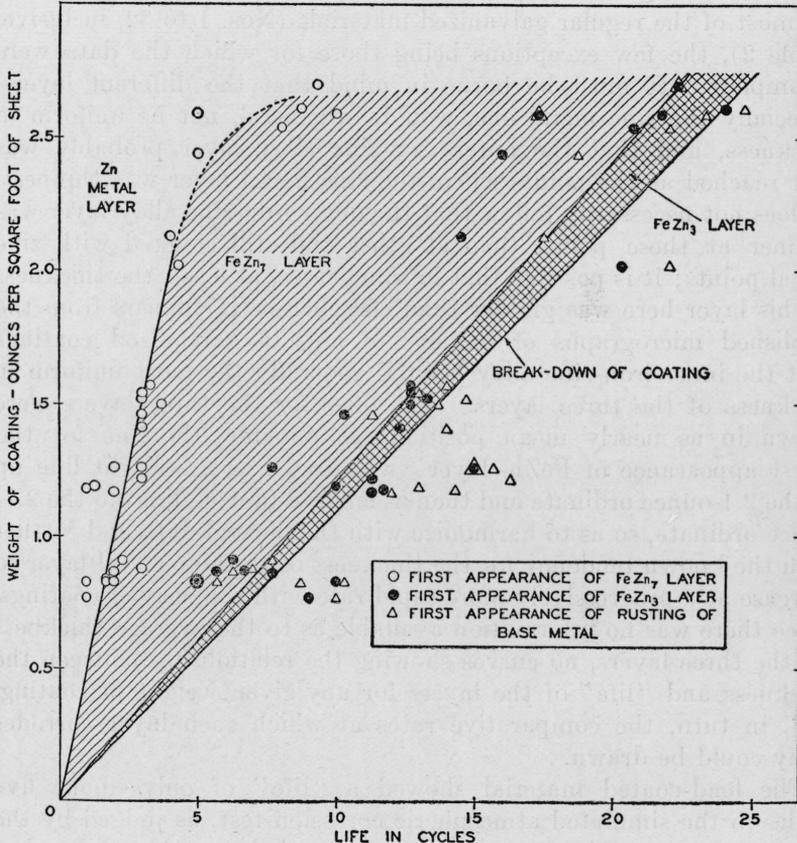
FIG. 20.—“Life” of the three layers constituting hot-dip zinc coatings, as determined by the first appearance of the inner two layers and base metal in the simulated atmospheric corrosion test

Each point plotted in this diagram is the average of three determinations

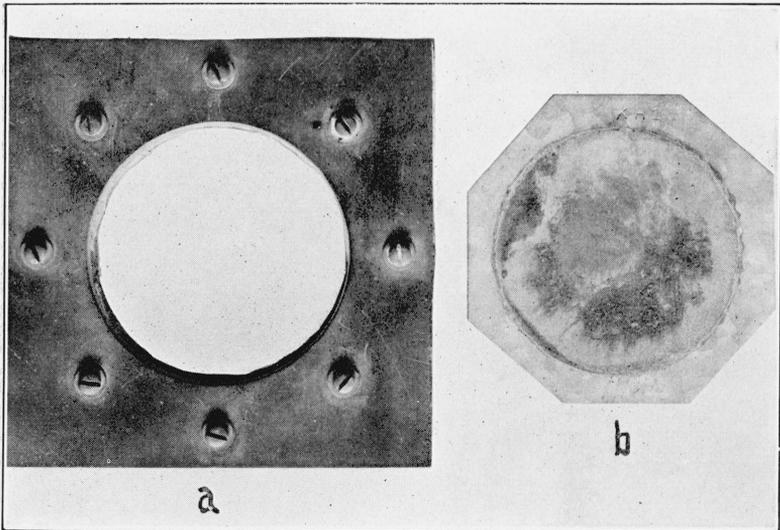
FIG. 21.—Clamping arrangement used for exposing a definite area of the specimen in the tests made to determine the rate of loss in weight of the zinc coating. $\times \frac{1}{2}$

a, clamping arrangement; *b*, specimen; the dark areas shown inside of the circular area on the face of the specimen are red-brown iron rust

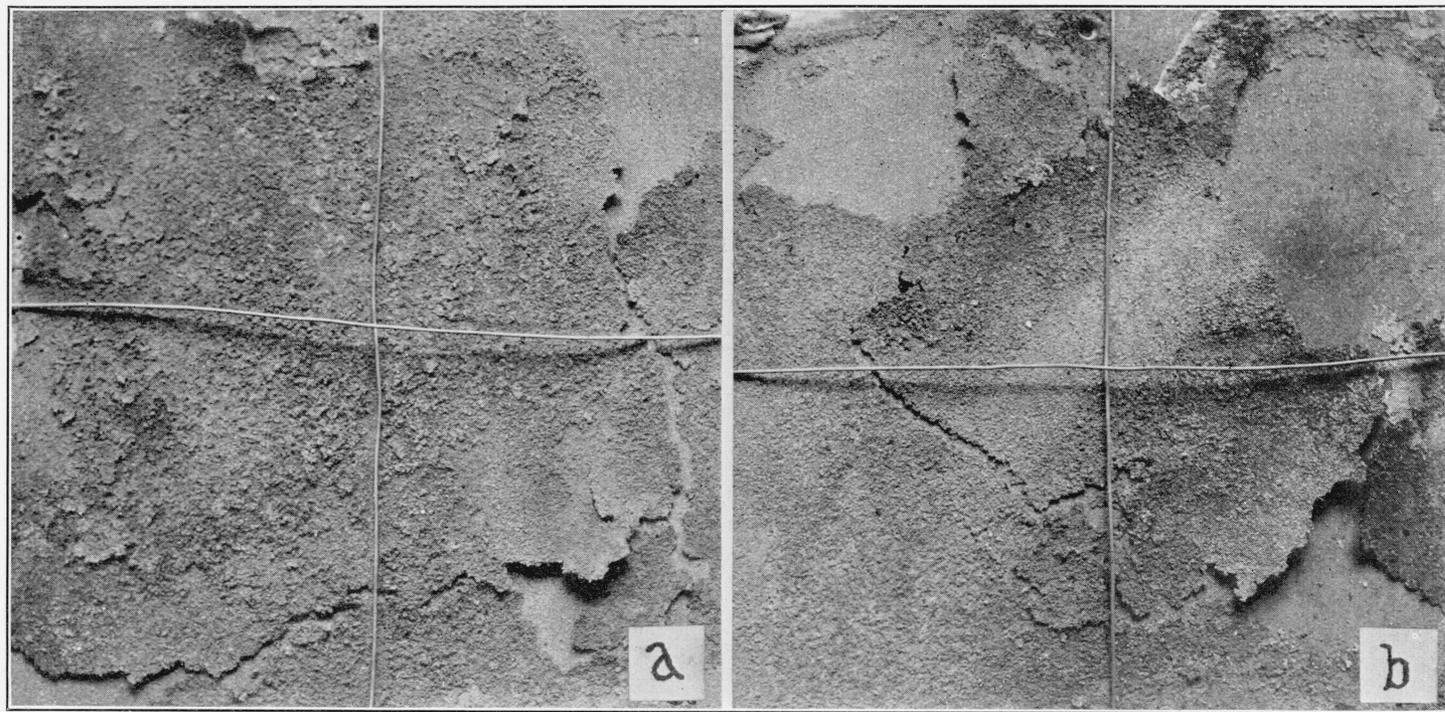
FIG. 22.—Comparison of the effect produced by the presence of copper in the base metal of hot-dipped galvanized sheets upon the coat of iron rust formed by prolonged exposure in the simulated atmospheric corrosion test. $\times 1$

a, copper-bearing steel base; weight of zinc coating, 1.50 oz./ft.² of sheet (No. 11, Table 1); b, noncopper-bearing steel base; weight of zinc coating, 2.54 oz./ft.² of sheet (No. 17, Table 1)

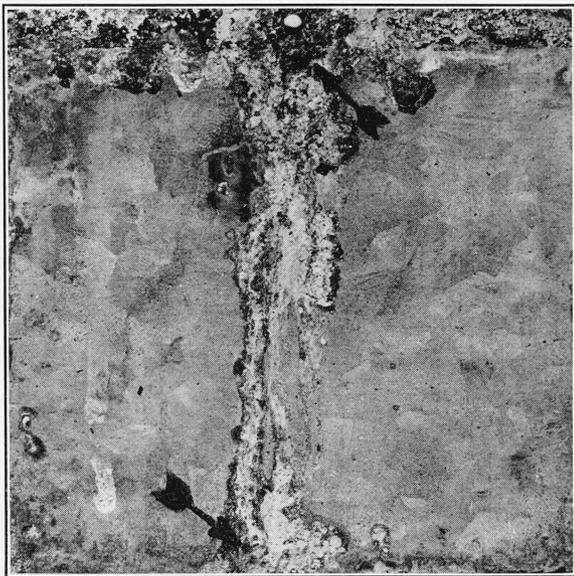
FIG. 23.—Change in appearance of a 0.9-ounce coating after 2,450 hours' exposure to sodium chloride spray. (Material No. 3, specimen KH1-1, Table 2.) $\times \frac{3}{4}$

One type of corrosive attack was the formation of streaks extending from the upper edge downward and generally to the bottom edge, while the zinc coating lying between the streaks remained little affected. The breakdown of the coating occurred in these streaky areas, as evidenced by the formation of red-brown rust areas and spots (in this photograph, at the top and bottom ends of the central vertical streak, where indicated by arrows)

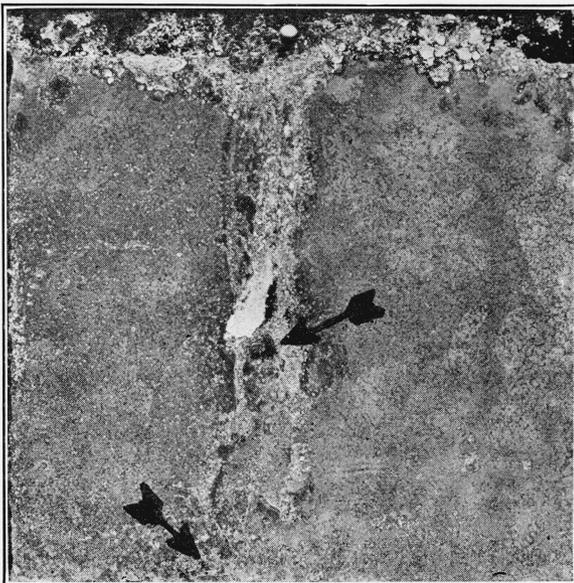
FIG. 24.—Same specimen as in Figure 23, but showing reverse side. $\times \frac{3}{4}$

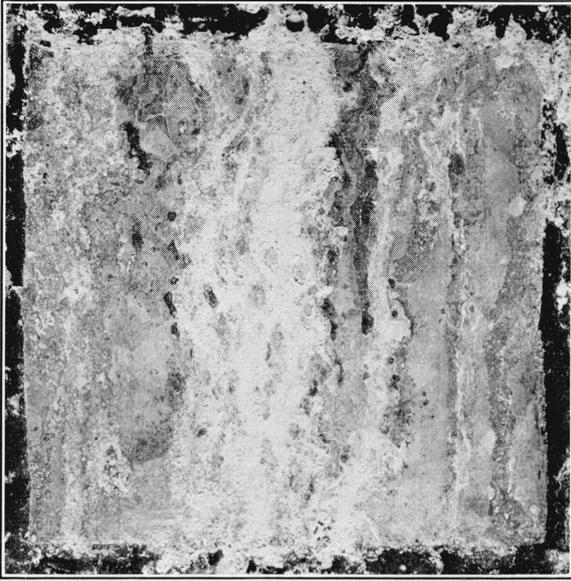
FIG. 25.—Change in appearance of a 2.0-ounce coating after 2,180 hours' exposure to sodium chloride spray. (Material No. 14, specimen SB2-11, Table 2.) $\times \frac{3}{4}$

A number of specimens were heavily corroded in a manner similar to that shown here. The central vertical streak was heavily encrusted with corrosion products, and several iron rust spots were present in this streak, thus indicating that the coating had broken down at these points (these rust spots are not brought out in this photograph in a well-contrasted manner)

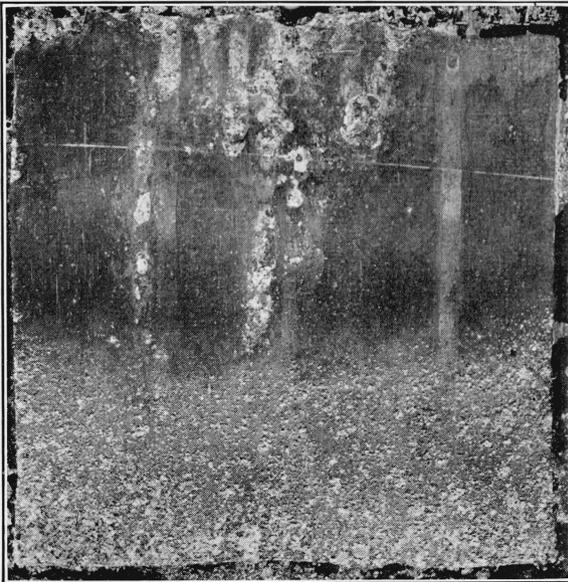
FIG. 26.—Change in appearance of a specimen of lead-coated material after 1,560 hours' exposure to sodium chloride spray. (Material No. 35, specimen SSSL-111, Table 2.) $\times \frac{3}{4}$

Both the streaky and generally corroded types of corrosive attack occurred on this face of the lead-coated specimen. Numerous small iron rust spots were scattered above the lower edge and in portions of the different vertical streaks. The lead coat was roughened in the generally corroded area and in part along the streaks, while it remained smooth in the portions lying between the streaks

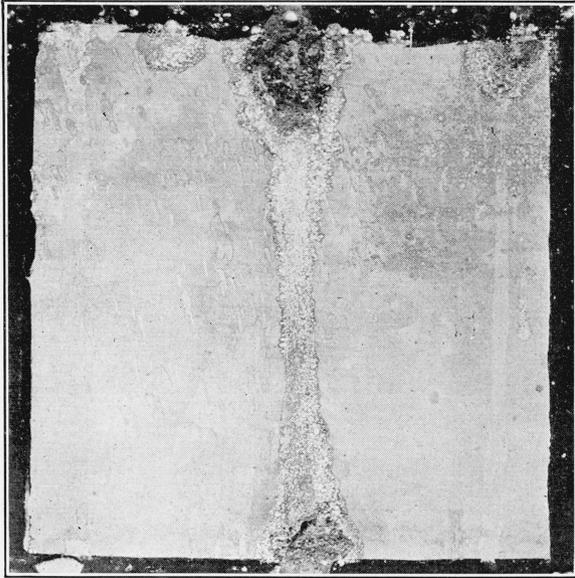
FIG. 27.—Change in appearance of a 0.9-ounce coating after 2,560 hours' exposure to ammonium chloride spray. (Material No. 2, specimen SH2-1, Table 2.) $\times \frac{3}{4}$

A heavy deposit of iron rust is present at the top and bottom ends of the central streak and at the top of the streak near the right edge

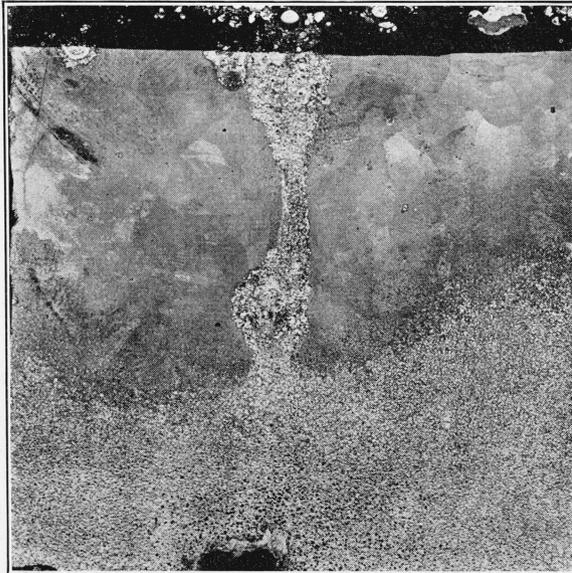
FIG. 28.—Change in appearance of an 0.8-ounce coating after 1,070 hours' exposure to ammonium chloride spray. (Material No. 23, specimen KK1-11, Table 2.) $\times \frac{3}{4}$

The vertical streak at the center had formed before the general corroding of the lower half had developed. Clusters of small iron rust spots had formed in the top and middle of the vertical streak, and a considerable part of the corroded area in the lower half was covered with a yellow-colored rust. At the bottom of the vertical streak the coating had been entirely removed, thus leaving bare a good-sized area of the base metal, part of which was covered with an adherent coat of iron rust (shown very dark in the photograph)

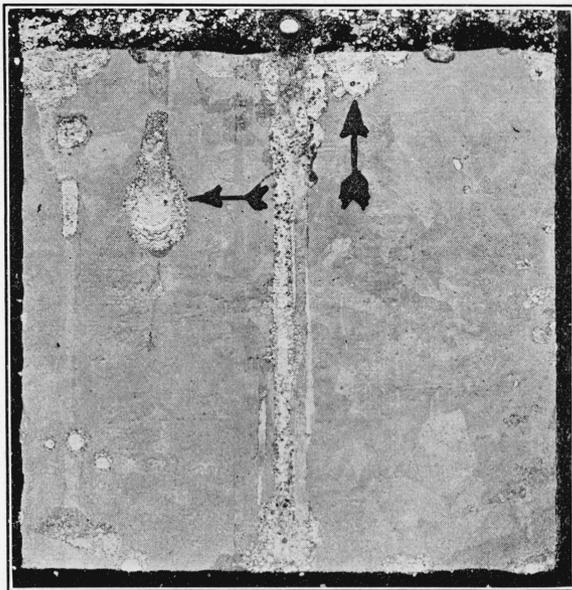
FIG. 29.—Change in appearance of a 1.5-ounce coating after 1,530 hours' exposure to ammonium chloride spray. (Material No. 12, specimen KC2-11, Table 2.) $\times \frac{3}{4}$

The coating had broken down on localized corroded areas, as was evidenced by the presence of single small rust spots at the places indicated in the photograph by the arrows. The base metal was laid bare in one fair sized and several small areas at the top of the central vertical streak by the complete removal of the coating; these areas of exposed base metal are fairly well brought out in the photograph

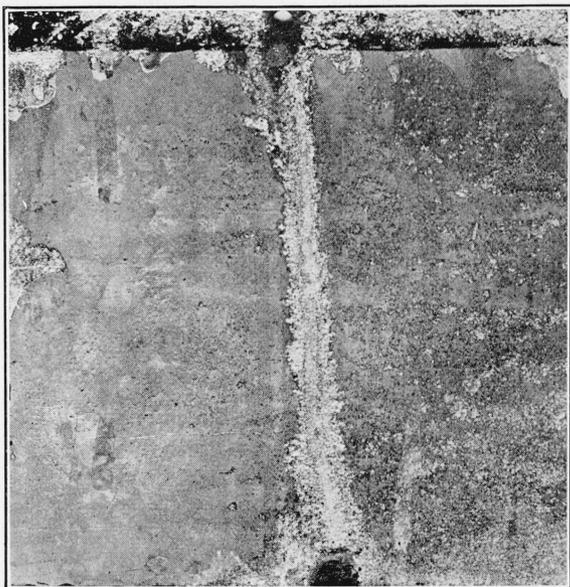
FIG. 30.—Change in appearance of 1.2-ounce coating after 1,070 hours' exposure to ammonium chloride spray. (Material No. 7, specimen KE1-1, Table 2.) $\times \frac{3}{4}$

Fairly good-sized areas of the base metal have been laid bare at the top and bottom of the central vertical streak by the complete removal of the coating. Iron rust was present at the borders of these base metal areas. The right half of the specimen was corroded in a general manner, although no evidence of the coating as having broken down anywhere in this portion was present

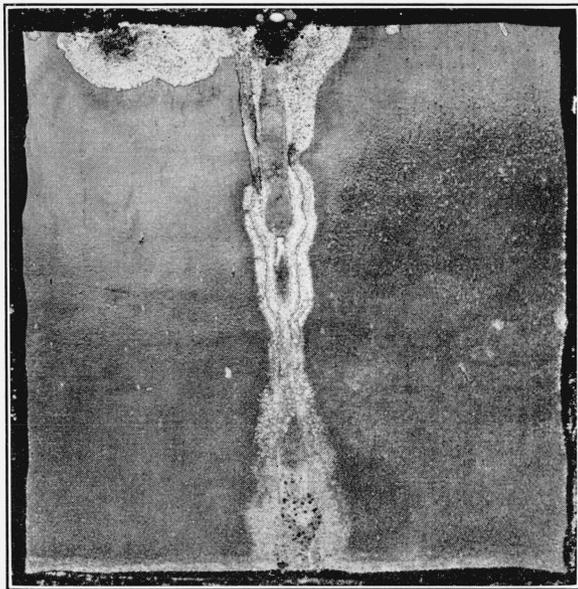
FIG. 31.—Change in appearance of specimen of “commercially heat-treated” material after 1,125 hours’ exposure to ammonium chloride spray. (Material No. 36, specimen SSSG-11, Table 2.) $\times \frac{3}{4}$
