TECHNOLOGIC PAPERS
OF THE
BUREAU OF STANDARDS

No. 156

**METALLOGRAPHIC FEATURES REVEALED
BY THE DEEP ETCHING OF STEEL**

H. S. RAWDON, Physicist

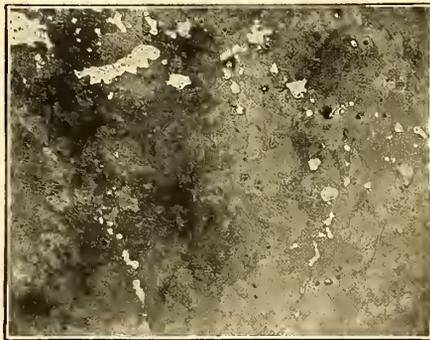
FIG. 3.—*Porous condition of cast steel*

Same material as Fig. 2, heat tinted. The white spots which are due to the exudation of alcohol and water used for washing from within the metal have prevented the uniform coloring of the surface. Each spot marks a spongy area. $\times 25$

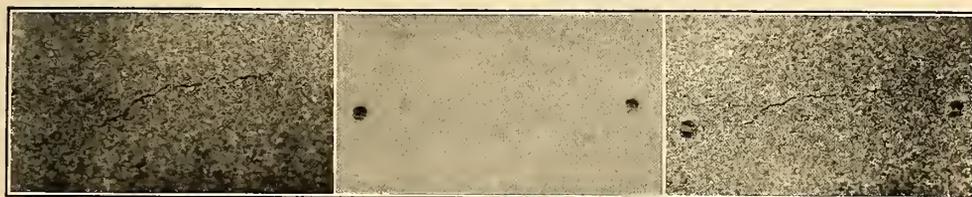
FIG. 11.—Interior cracks existing in rails of the transverse-fissure type

(a) Crack (b) of Fig. 10, a, viewed obliquely. \times_3
 (b) Same specimen as (a). The line of the crack shown in (a) was located by a punch mark at each end of the crack and the iron dust wiped off. No crack is visible. \times_3
 (c) Same specimen as (b), treated a second time with iron dust. Compare with (a). \times_3

The appearance of the cracks located by the magnetic method is more clearly shown in Fig. 11, somewhat magnified, in which the surface was viewed obliquely. Crack *b* (Fig. 10, *a*) was located by means of iron dust after magnetizing the specimen. Its position was then recorded by punch marks at each end of the crack. Fig. 11, *b*, shows the specimen after the iron dust was wiped off; no crack can be detected between the punch marks. Fig. 11, *c*, shows the same specimen after a second treatment with iron dust.

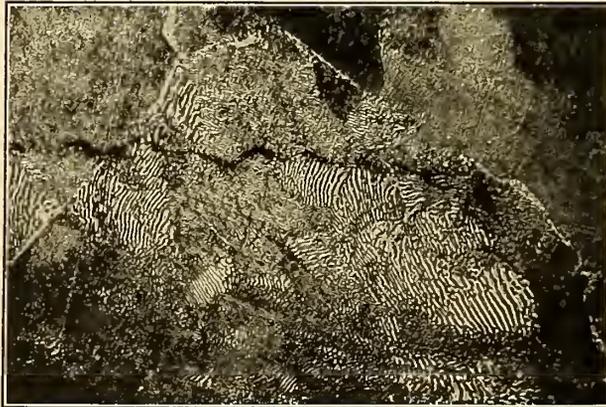
FIG. 15.—Microscopic nature of the interior defects found in rails of the transverse-fissure type

(a) Longitudinal section of rail No. 2 (Table 4) parallel to the tread. The interior cracks as they appear after slight etching with concentrated hydrochloric acid. $\times 1$

(b) Specimen (a) after slight etching in concentrated hydrochloric acid to widen the crack, repolished for microscopic examination. The crack is intracrystalline in its course. There is some evidence of banding due to phosphorus. Etching, 2 per cent alcoholic nitric acid. $\times 100$.

(c) Same material as (b). The intracrystalline nature of the crack is very evident. Etching, 2 per cent alcoholic nitric acid. $\times 500$

to be very suitable for this purpose. Fig. 15, *a*, shows a section of this rail after slight etching with concentrated hydrochloric acid. The interior cracks having been widened by the concentrated acid, the surface was ground down, repolished, and reetched for microscopic examination. In Fig. 15, *b* ($\times 100$), and Fig. 15, *c* ($\times 500$), a crack is shown passing through the grains and across the grain boundaries. The cracks are intracrystalline, in their course; that is, the break has occurred *through* the grains rather than *between* them.
