TECHNOLOGIC PAPERS
OF THE
BUREAU OF STANDARDS

No. 18
ELECTROLYSIS IN CONCRETE

E. B. ROSA, Chief Physicist
BURTON McCOLLUM, Associate Physicist, and
O. S. PETERS, Assistant Physicist

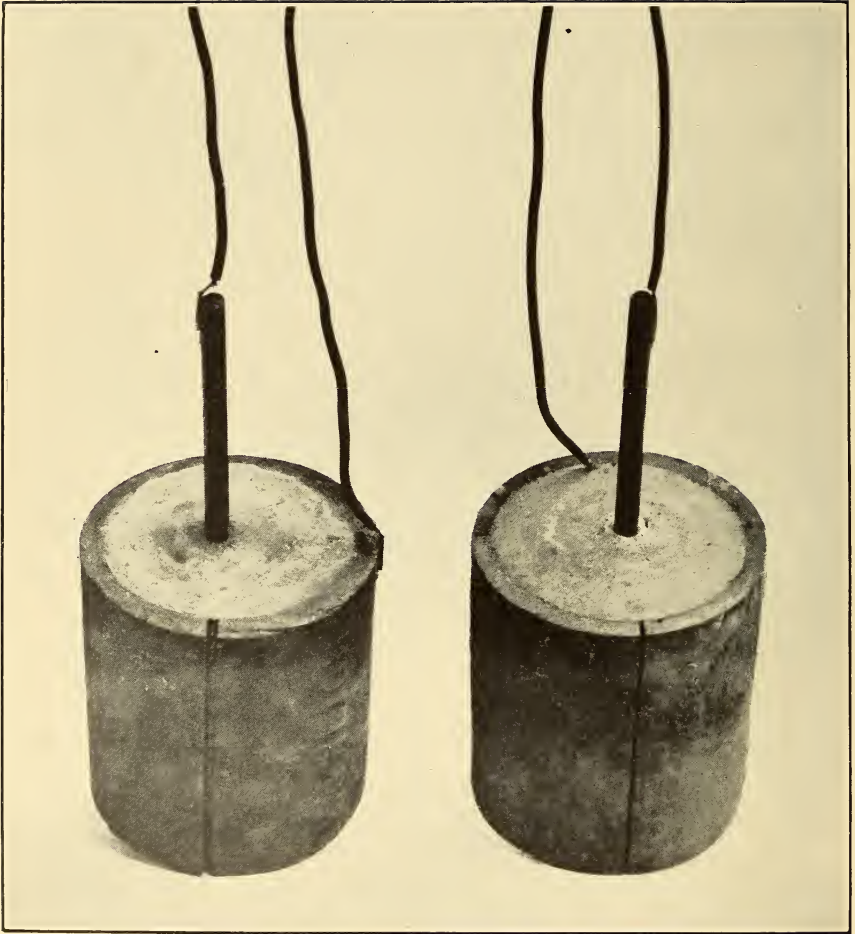
Fig. 11.—Specimens used in tests to determine the force produced by the corrosion of iron in concrete

In order to test this matter further two more specimens were made up with collapsible electrodes of the same material as the first, but with a curved strip of sheet iron covering the seam, as shown at *e*, in order to prevent binding of the edges by the concrete. These two specimens were placed in series on 115 volts and continued in circuit for three months. The current was never greater than 1 ampere nor less than 0.045 ampere during that time. There was evidence of a great deal of corrosion, but no cracks appeared in either of the specimens, although the voltage was about 60 to 70 volts for one specimen and 45 to 55 volts for the other.

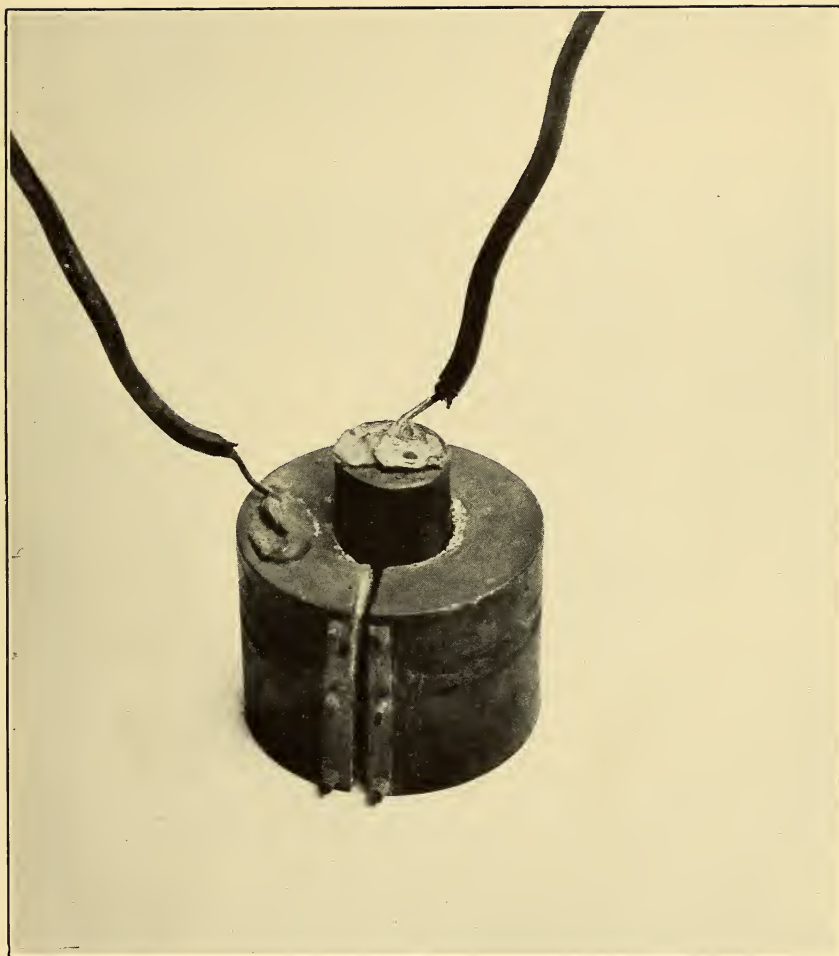
A three-fourths-inch solid iron cylinder was placed in the hole in the cast-iron cylinder and the space between them filled with 1:1 cement mortar made up with a 1 per cent NaCl solution. The object of adding the salt was to increase the rate of corrosion and shorten the time required to make the test. The bottom of the

Fig. 12.—*Specimen used in test to determine the force produced by the corrosion of iron in concrete*

specimen was covered with two layers of asphalt and felt to keep the current from shunting around the mortar while under test the test being made in a crystallizing dish filled to one-eighth inch from the top of the shell with lime water to prevent the mortar from drying out and at the same time keep the pins from rusting seriously.

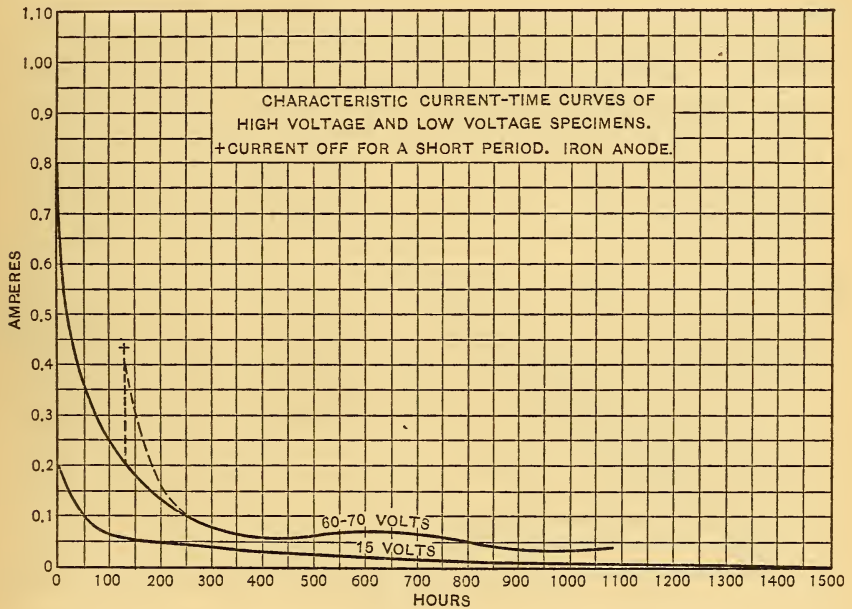
Fig. 17

the first 1000 hours of each test. It is seen that the greatest drop of current occurs during the first 200 hours. If the current is then discontinued for a considerable time the resistance decreases almost to its original value; this is partially shown in the curve of the high-voltage specimen at the point where the current is indicated as having been off for a short time—an hour or two at most. Beyond the 200-hour point the curves are both comparable with a straight line and nearly parallel. This is also shown to

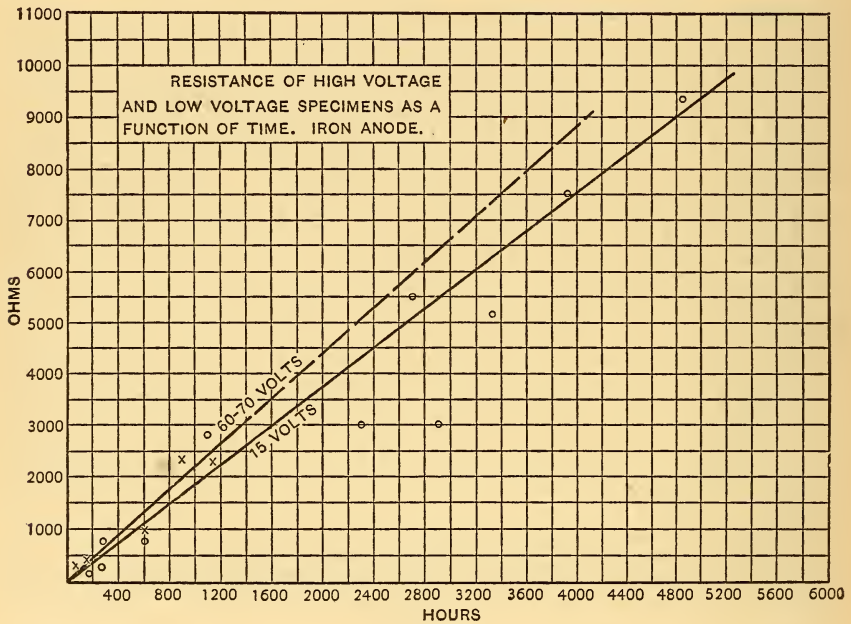
Fig. 18

some degree in the curves of Fig. 18. These show plots of resistance as a function of time for a high and a low voltage anode specimen, respectively. The high-voltage specimen was continued in circuit but a short time in comparison with the low-voltage specimen, but there is an indication that the curves would be very nearly parallel if they had both been continued in circuit indefinitely. Fig. 19 shows plots of increase of resistance as a function of ampere hours for high and low voltage specimens. If the continued increase of resistance after the initial rapid

increase were wholly an electrical effect and its rate of increase depended on the rate of ampere hour discharge we should expect the two last-named curves to practically coincide. There is a wide divergence, however, showing that the increase of resistance is not wholly an electrical effect. A much larger amount of electricity passes on the high voltage for a given rise of resistance than on the low voltage. It would thus appear that lapse of time is an important factor in the rise of resistance noted. As seen from
