# Fire Tests of Steel Columns Protected With Siliceous Aggregate Concrete

United States Department of Commerce  
National Bureau of Standards  
Building Materials and Structures Report 124

Nolan D. Mitchell

Issued May 25, 1951

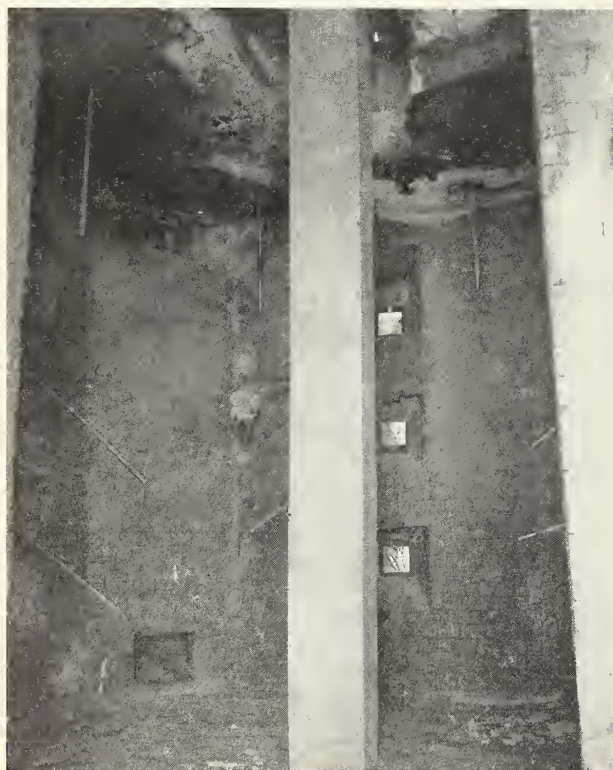
FIGURE 1. A test column in furnace after fire exposure.

The condition of the gravel aggregate concrete column protections after the fire test are shown in figures 1 and 7. Figure 8 shows the two columns after removal of the concrete encasement.

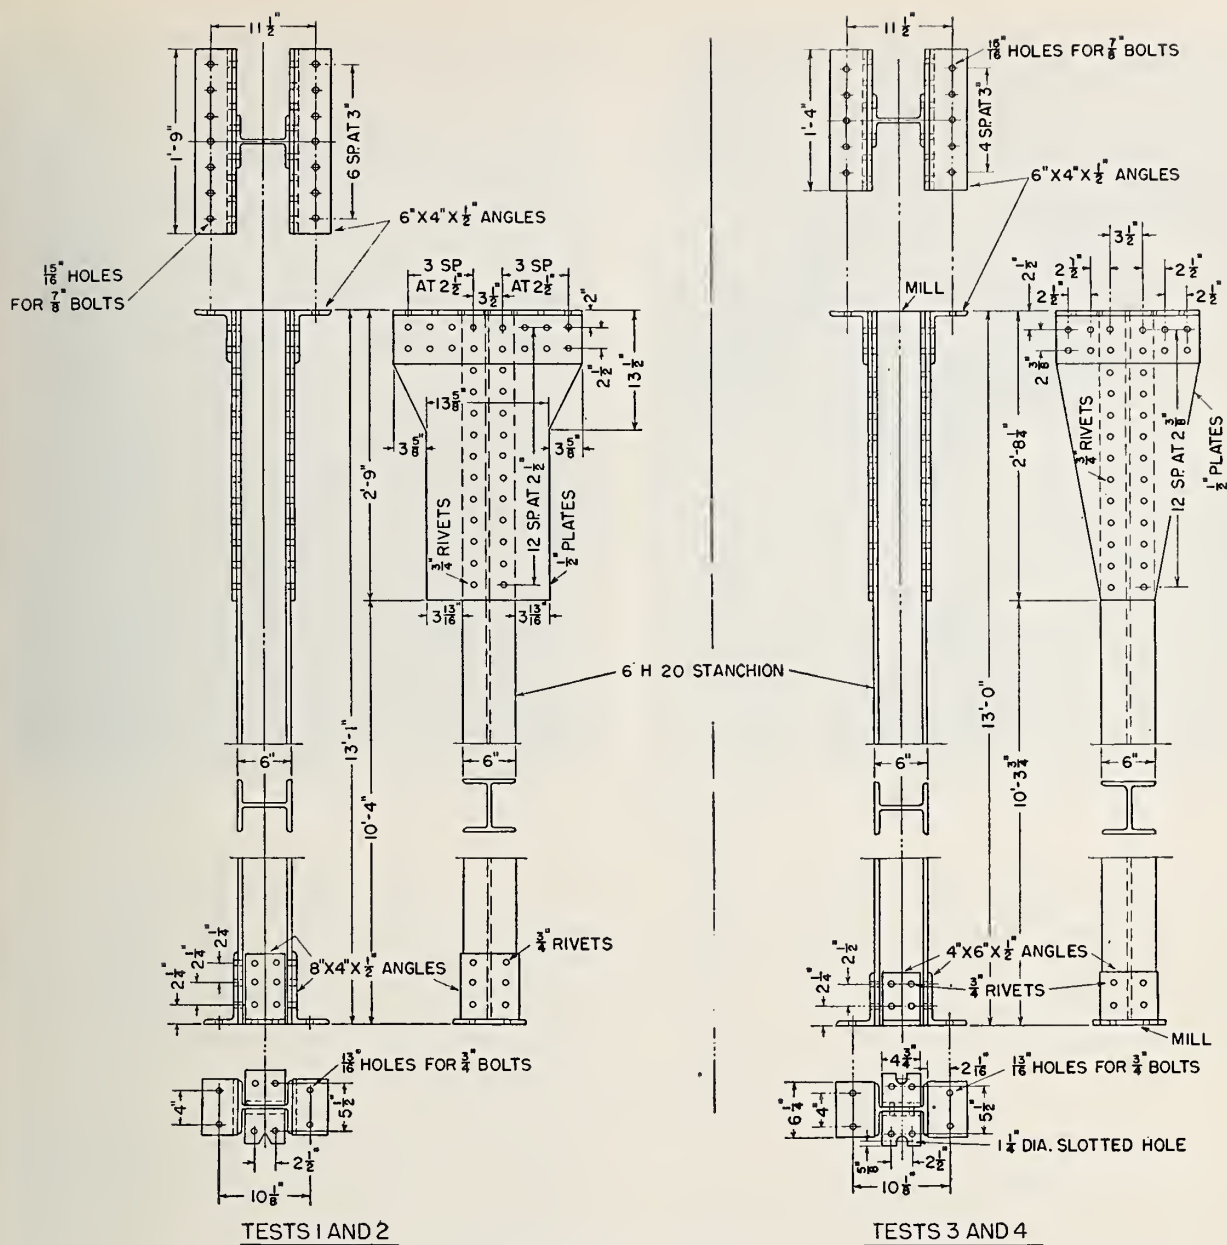
FIGURE 2. Details of columns.

The column shafts were fabricated from 6-in. 20-lb stanchion sections 5.97 in.<sup>2</sup> in area. The heads of the columns were restrained for 32 to 33 in. by ½-in. plates of two types, leaving an effective column length of 124 in. End fittings were so applied as to allow the milled ends of the column shafts to rest directly on the 1½-in.-thick planed steel bearing plates. The column fitting assemblies were made with hot rivets. The least radius of gyration of the columns was 1.5 in. and the  $l/r$  ratio was 82.67. Figure 1 shows a column in place after a fire test. The details of the column shafts are shown in figure 2.

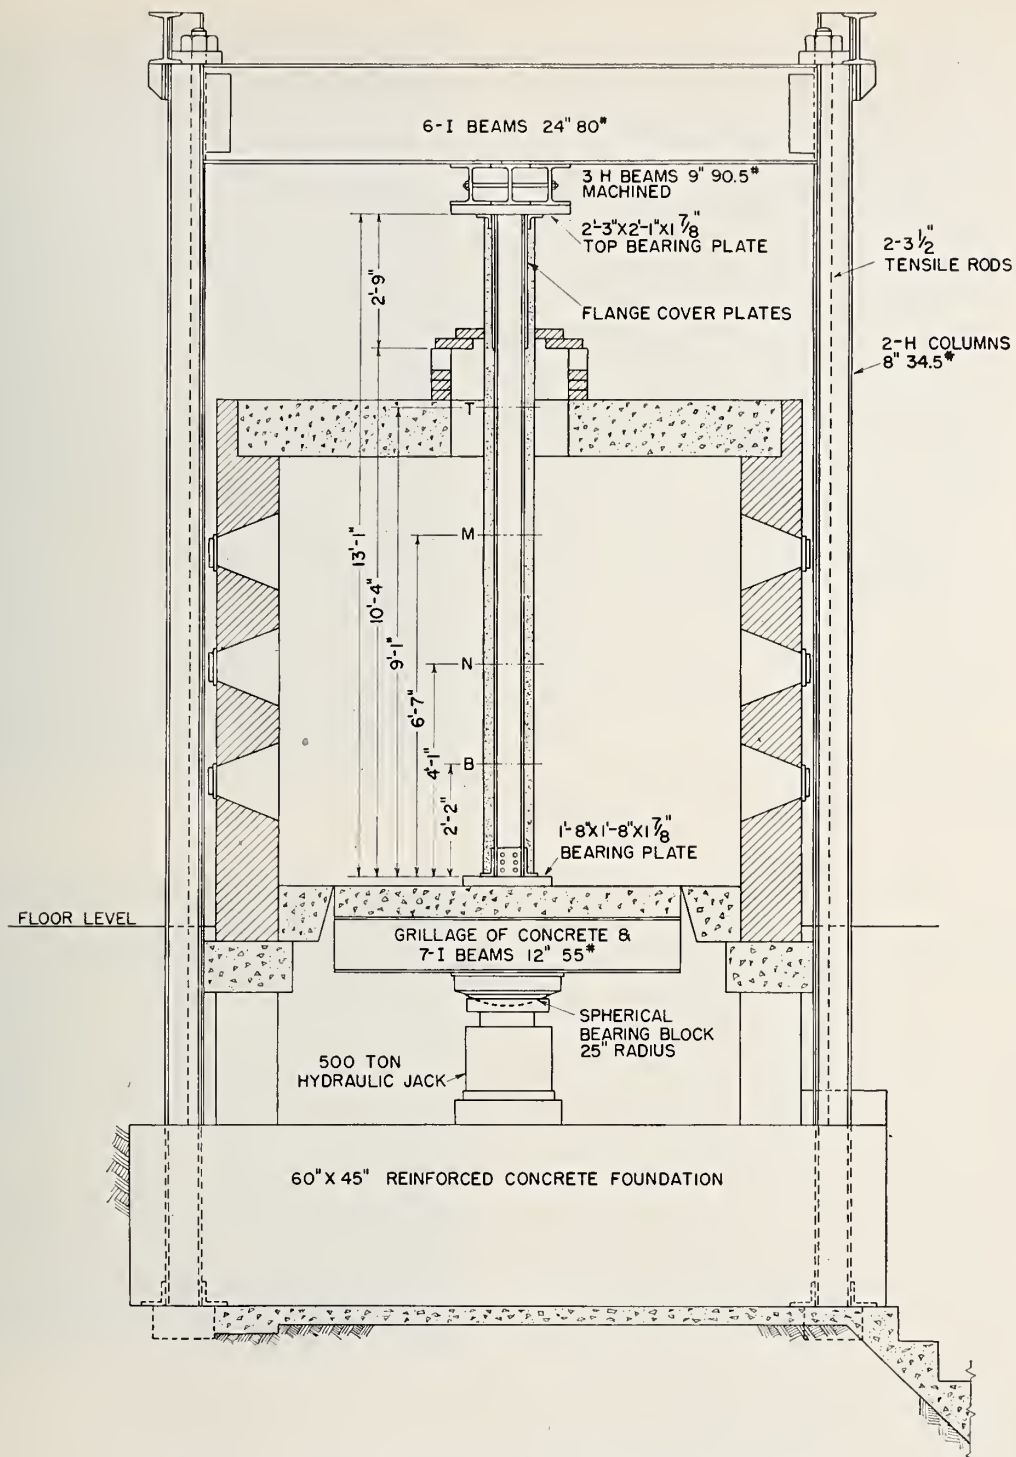
FIGURE 4. Furnace and loading equipment with typical column in place.

The tests were made in gas-fired furnaces equipped with hydraulic jacks for applying load. The furnace, loading equipment, and the column under test are shown in figure 4. The furnace, while not originally designed for columns, was modified by an increase in height to accommodate a column having an effective length of 124 in.

Temperatures at 12 locations in the furnace were measured with chromel-alumel thermocouples protected by iron tubes. The temperatures at 16 or more points on each column were also measured with similar thermocouples made of No. 18 AWG wires. The thermocouple junctions were formed by inserting carefully cleaned ends of the respective wires into 1.1-mm diameter paired holes spaced at  $\frac{1}{4}$  in. drilled into the column shaft. Steel was swaged around the holes to secure metal-to-metal contact with the wires. The thermocouples were disposed at each of four levels of the column shafts as indicated by the positions B, N, M, and T in figure 4.

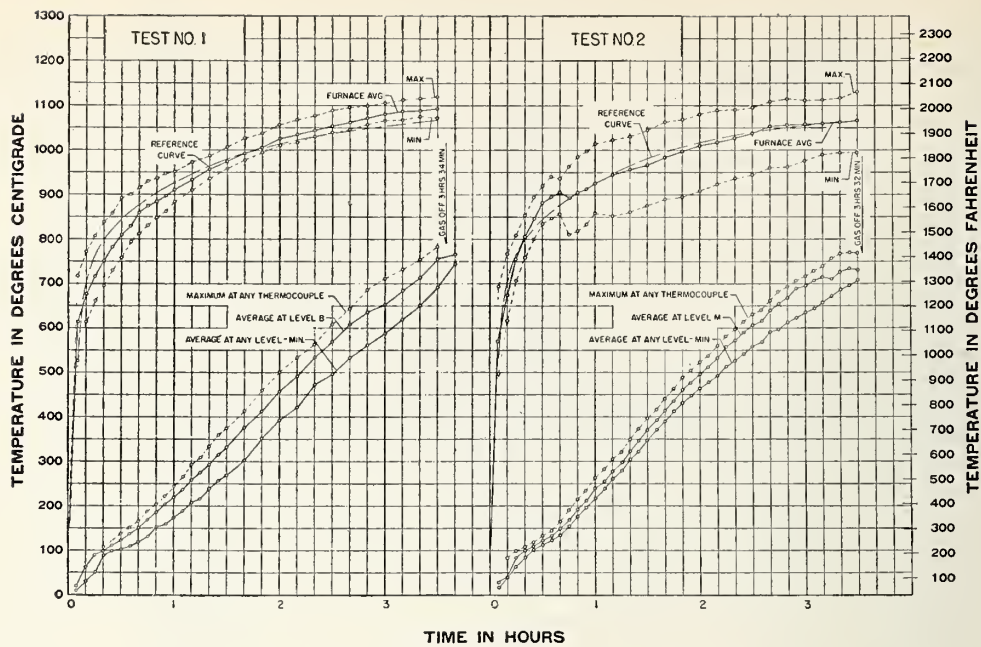
FIGURE 5. Furnace and column temperatures for columns with Potomac River gravel concrete—Tests 1 and 2.

The results of fire tests of columns protected with concrete made with Potomac River gravel aggregate are shown in figures 5 and 6.

Figure 5 shows the temperatures within the furnace and the standard furnace reference curve. Also shown are the maximum observed temperatures at any thermocouple, the temperatures at the level having the highest average most consistently, and the minimum level temperatures in a column. The average of temperatures for the several levels are arithmetical. They were not weighted in proportion to the areas involved as were those reported in previous tests.<sup>4</sup> It was considered that the greater temperature effects on the column strength at the edges of the flanges, as compared to the effects at the midpoint of the flange or web, compensated for the smaller cross-sectional area contributory to each thermocouple near the edges.

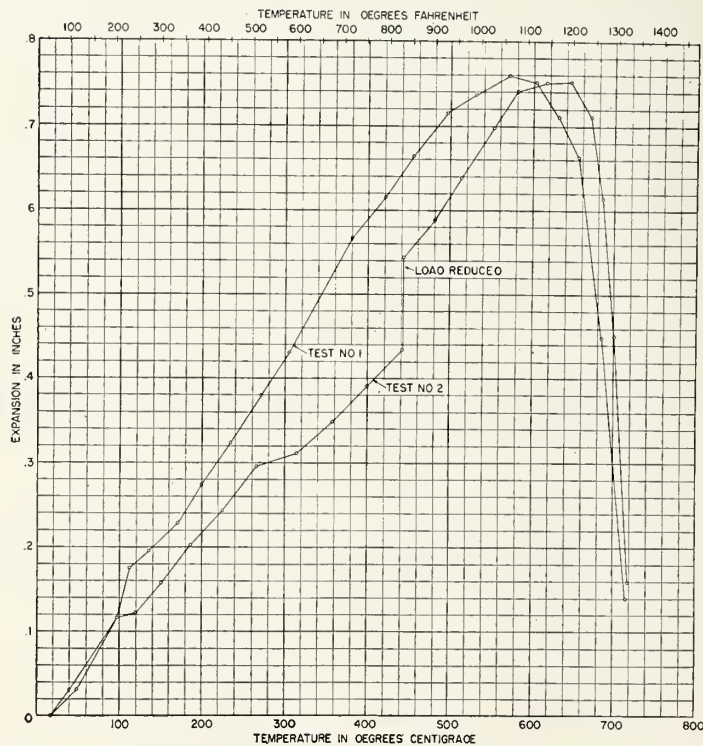
FIGURE 6. Expansion curves for columns with Potomac River gravel concrete—Tests 1 and 2.

The expansion of the columns with increases in the average temperatures of the steel shafts are shown in figure 6. Column 2 was subjected to double the load applied to column 1 until the average temperature in the shaft reached 445° C (833° F), after which the load was reduced to that of column 1.

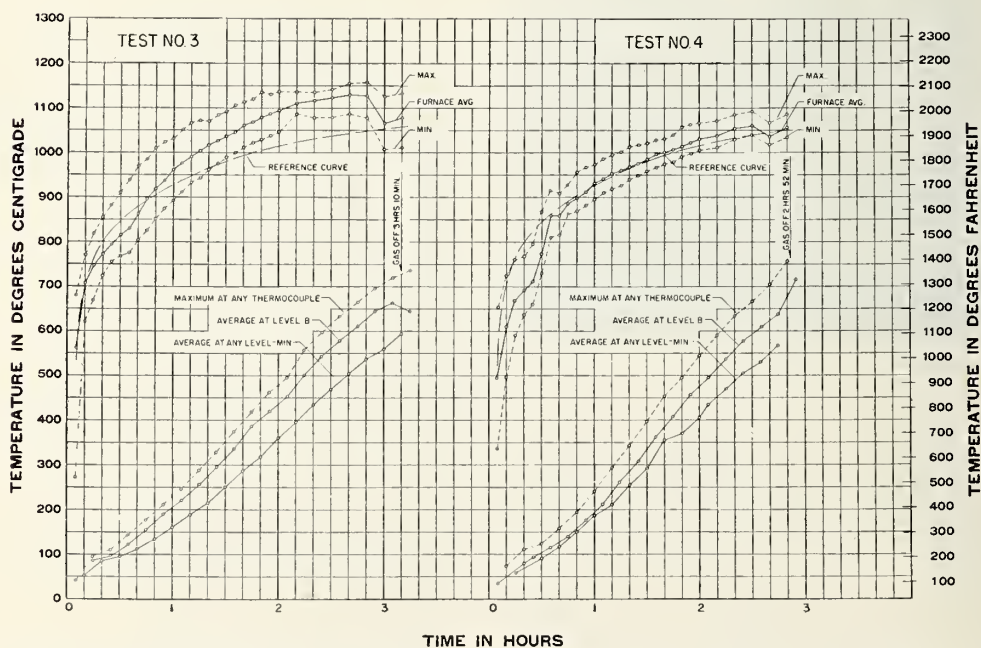
FIGURE 10. Furnace and column temperatures for columns with crushed quartz concrete—Tests 3 and 4.

Figures 10 and 11 show the results of fire tests on steel columns protected with crushed quartz aggregate concrete. Temperatures within the furnace and the standard reference curve are shown in figure 10, as well as the observed temperature at any thermocouple in a column, the temperature at the level having the highest average most consistently, and the minimum average temperature at one level. As was true for the first two columns, the averages are arithmetical and not weighted.

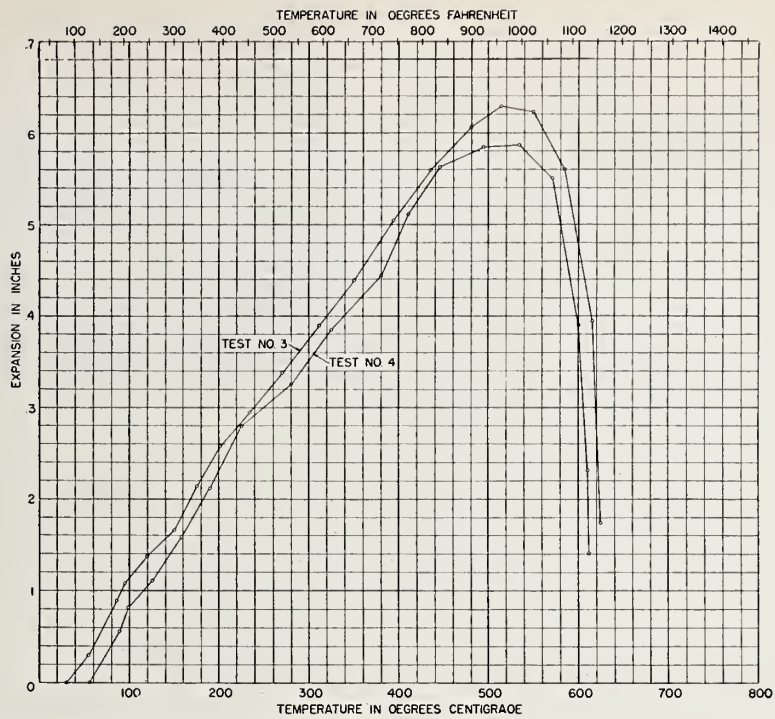
FIGURE 11. *Expansion curves for columns with crushed quartz aggregate concrete—Tests 3 and 4.*

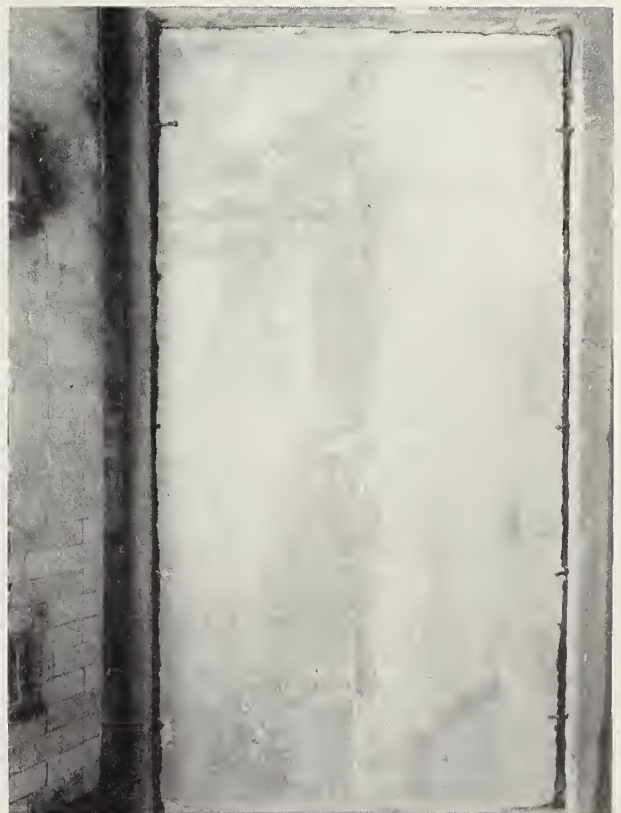
FIGURE 13. *Fire-exposed face of a crushed quartz concrete wall slab after 1½-hr test.*

The quartz aggregate concrete of a 4- by 8-ft wall slab 4 in. thick showed only a fine crack in the line of a pouring joint after a fire exposure of 1½ hr. The slab was poured in quarters from the same milky and clear quartz concrete batches used for columns 3 and 4, the sections with like aggregate being diagonally opposite. Figure 13 shows the fire-exposed face of the wall after removal from the furnace.

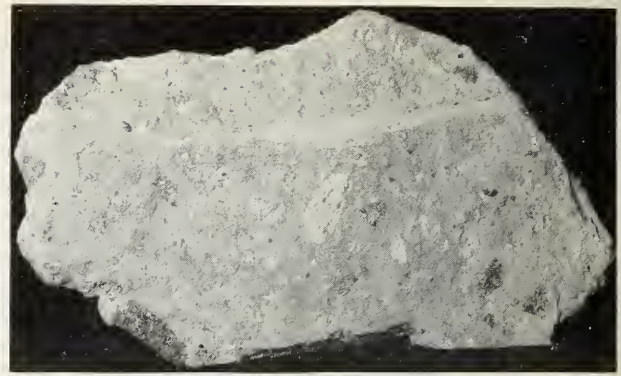
FIGURE 14. *Sample of firebrick aggregate concrete spalled from top of furnace.*

The resistance of a concrete to high temperatures is probably influenced by its density. The spalling caused by the explosion resulting from superheated water in a dense concrete was previously mentioned in connection with the failure of a floor slab made with siliceous aggregate concrete. Further evidence of this effect can be seen in figure 12, which shows failure of the concrete top of the furnace after the first fire-endurance test to which the concrete was subjected. The failure occurred with explosive force 34 min after a 3-hr 10-min fire exposure, at which time the furnace still retained considerable heat. Examination of the debris showed the concrete, made with carefully graded firebrick aggregate, to be extremely compact. The structure of the spalled material can be seen in the photograph of the sample in figure 14.
