Properties of Cavity Walls

United States Department of Commerce  
National Bureau of Standards  
Building Materials and Structures Report 136

# Properties of Cavity Walls

Building Materials and Structures Report 136

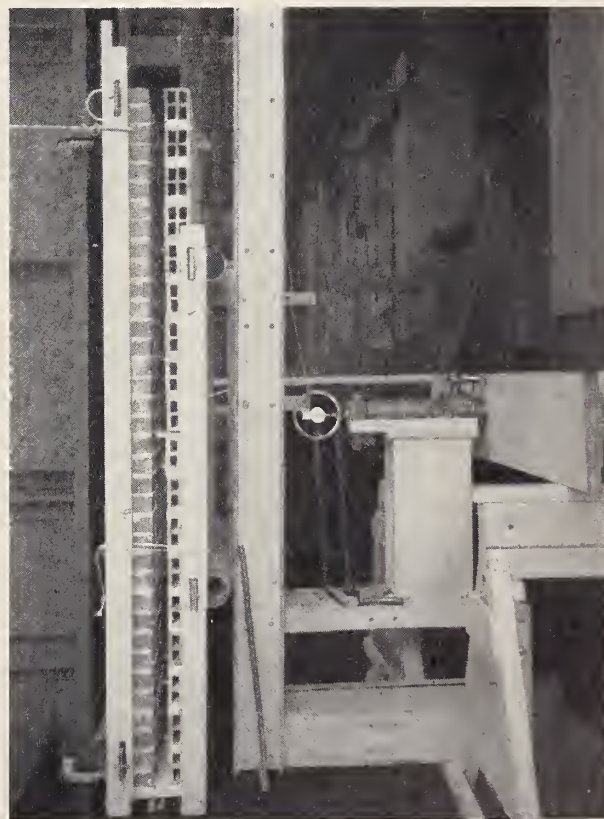
FIGURE 8. Brick-tile cavity wall under transverse load. Loading rollers at quarter span are shown to the right of the wall.

Three of the brick-tile cavity walls failed by rupture of the brick-mortar bond at midheight in the facing and by rupture of the bond between the

tile and the mortar at one or two bed joints at or between the loading rollers in the backing. For three other specimens, the bond between the tile and the mortar ruptured at a bed joint near mid-height in the backing, the bond rupture on the brick face occurring at a bed joint between the loading rollers in the facing.

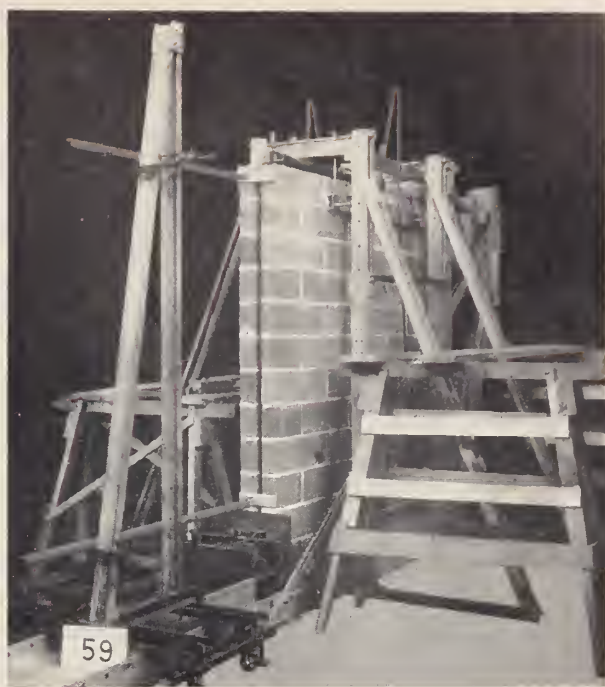
FIGURE 12. *Concrete-block cavity wall under racking load.*  
Ties at top restrict vertical motion.  
Compressometers measure horizontal deformation.

The test specimens were 8 by 8 ft, twice as large as any of the other walls for structural tests, and were braced on the lower corner to prevent horizontal sliding when thrust was applied. The loaded end was constrained from vertical movement by tie plates, but was allowed to move horizontally by a series of plates and rollers under the tie plates. The thrust was applied horizontally at the upper corner of the specimen and the

horizontal displacement relative to the fixed base measured at the other end of the wall (fig. 12). Test results are given in table 5.

One of the concrete-block walls failed by crushing of blocks in both the facing and the backing at the loaded corner. The other two failed by rupture of the blocks of both the face and back wythes approximately along a diagonal between the point of application of the load and the stop.

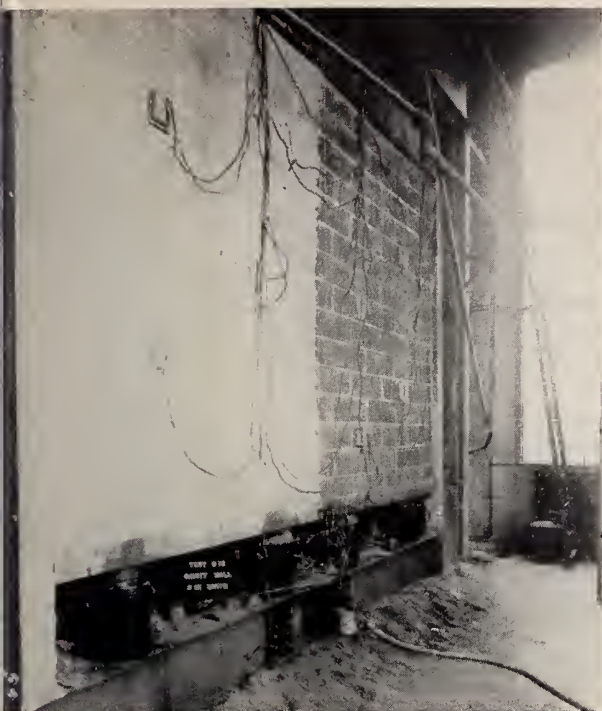
FIGURE 15. Concrete-masonry cavity wall in position for fire test.

One 8- by 11-ft section consisted of cinder-concrete units, the other of sand and gravel-concrete units
