REPORT BMS24

Structural Properties of a Reinforced-Brick Wall Construction and a Brick-Tile Cavity-Wall Construction Sponsored by the Structural Clay Products Institute

ISSUED AUGUST 24, 1939

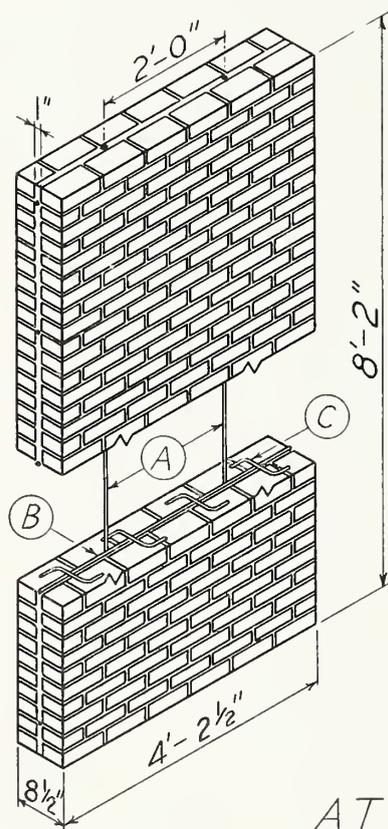
FIGURE 1.—Four-foot wall specimen AT, having 35 courses.

The wall specimens had either 35 or 36 courses of brick. The average height was 8 ft 2 in. for specimens with 35 courses and 8 ft 5 in. for specimens with 36 courses. The width was 4 ft  $2\frac{1}{2}$  in. and the thickness  $8\frac{1}{2}$  in. The wall was reinforced with two vertical reinforcement bars, *A*, shown in figure 1, and five horizontal reinforcement bars, *B*. The horizontal bars were spaced eight courses apart, the first bar being between the second and third

*A*, vertical reinforcement bars; *B*, horizontal reinforcement bars; *C*, wall ties.

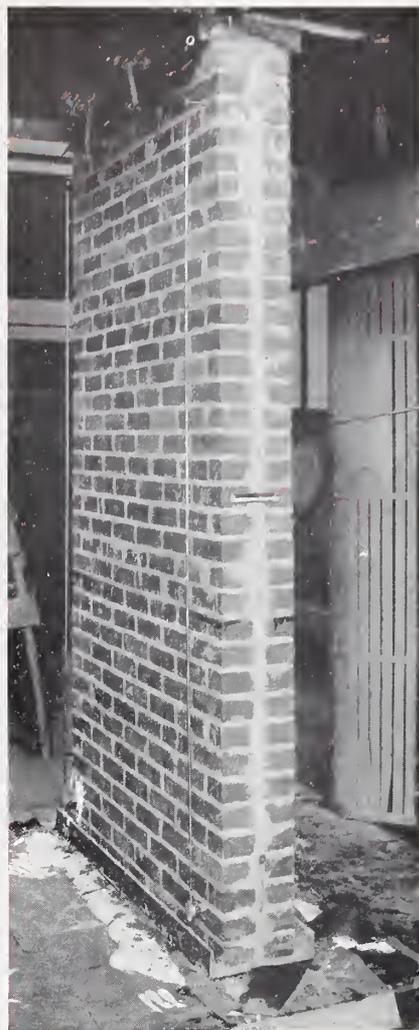
FIGURE 2.—*Wall specimen AT-C3 under compressive load*

The compressive loads were applied 2.83 in. from the inside face. The shortenings and sets shown in figure 3 for a height of 8 ft were computed from the values obtained from the compressometer readings. The gage length of the compressometers was 7 ft 3 in.

Specimens *C1* and *C2* failed by rupture of the collar joints at both edges of the specimens and crushing of bricks in several courses on the inside face. For specimen *C3* the lower third of the specimen completely collapsed.

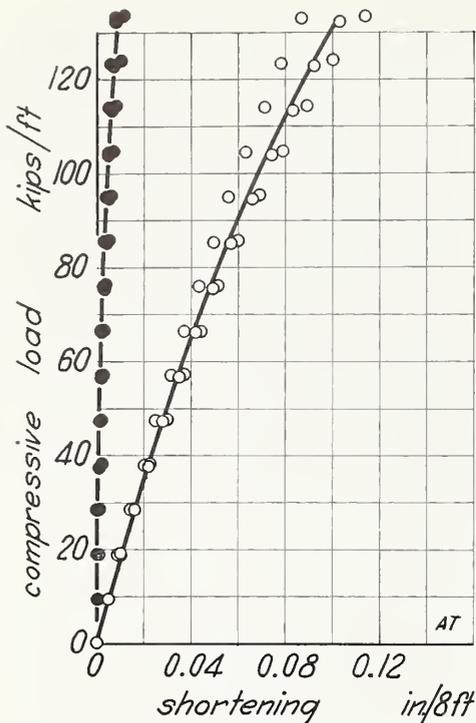
FIGURE 3.—Compressive load on wall AT.

Load-shortening (open circles) and load-set (solid circles) results for specimens AT-C1, C2, and C3. The load was applied 2.83 in. from the inside face. The loads are in kips per foot of actual width of specimen.

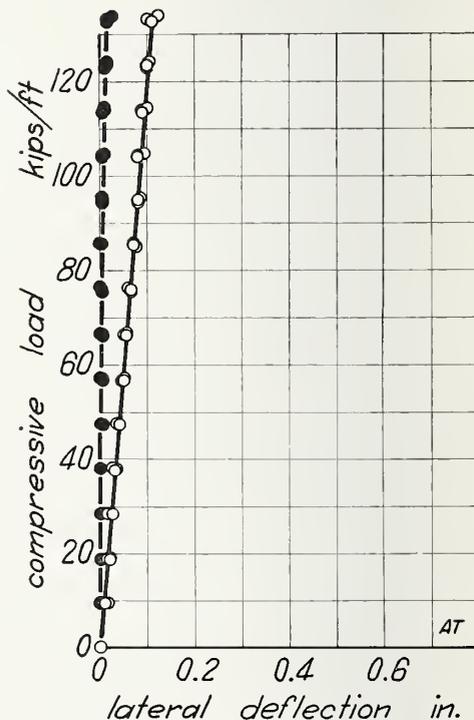
FIGURE 4.—Compressive load on wall AT.

Load-lateral deflection (open circles) and load-lateral set (solid circles) results for specimens AT-C1, C2, and C3. The load was applied 2.83 in. from the inside face. The loads are in kips per foot of actual width of specimen. The deflections and sets are for a gage length of 7 ft 3 in., the gage length of the deflectometers.

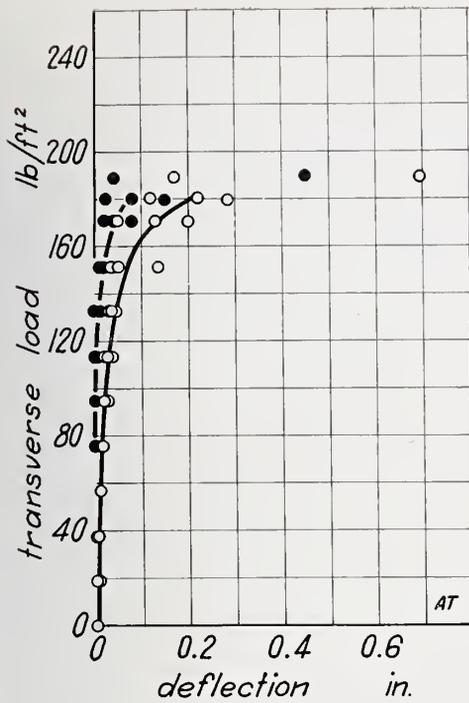
FIGURE 5.—Transverse load on wall AT.

Load-deflection (open circles) and load-set (solid circles) results for specimens AT-T1, T2, and T3 on the span 7 ft 6 in.

The results for wall specimens *AT-T1*, *T2*, and *T3* are shown in table 6 and in figure 5.

At loads of 190, 142, and 166 lb/ft<sup>2</sup> for specimens T1, T2, and T3, respectively, the bond between the brick and the mortar ruptured at one or more bed joints between the loading rollers. At the maximum loads these cracks opened further and new cracks developed. Each of the specimens failed by deflecting continuously under constant load.

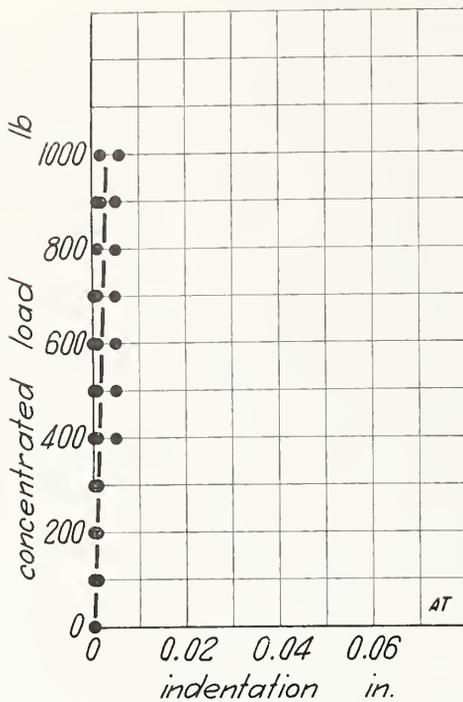
FIGURE 7.—Concentrated load on wall AT.

Load-indentation results for specimens AT-P1, P2, and P3.

The indentations after a load of 1,000 lb had been applied were 0.006, 0.002, and 0.002 in. for specimens P1, P2, and P3, respectively, and no other effect was observed.

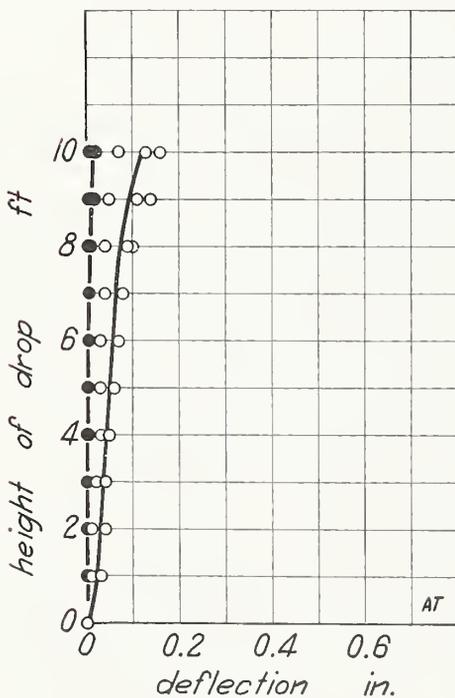
FIGURE 8.—Impact load on wall AT.

Height of drop-deflection (open circles) and height of drop-set (solid circles) results for specimens AT-I1, I2, and I3 on the span 7 ft 6 in.

The set after a drop of 10 ft was 0.020 in. for specimen I1, and there was a crack about 2 in. long between a brick and the mortar at one edge of the specimen in a bed joint near midspan. The sets after a drop of 10 ft were 0.007 and 0.015 in. for specimens I2 and I3, respectively, and no other effect was observed.

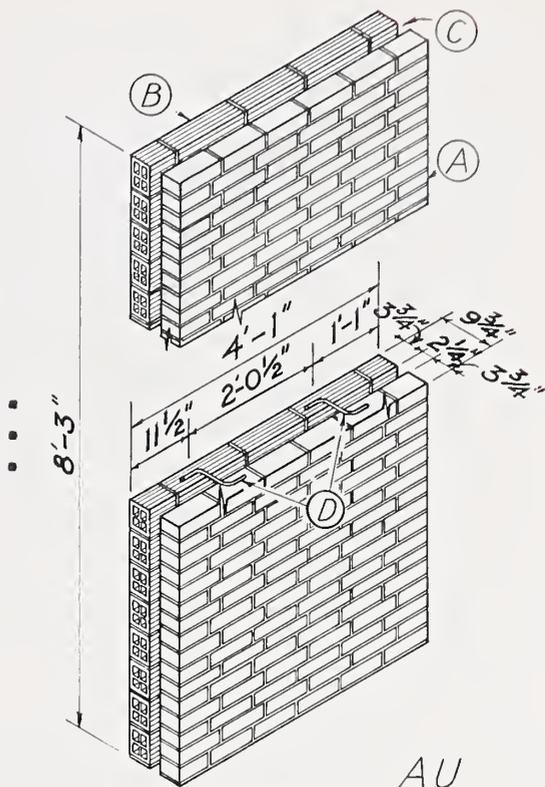
FIGURE 10.—Four-foot wall specimen AU.

A, facing; B, backing; C, air space; D, wall ties.

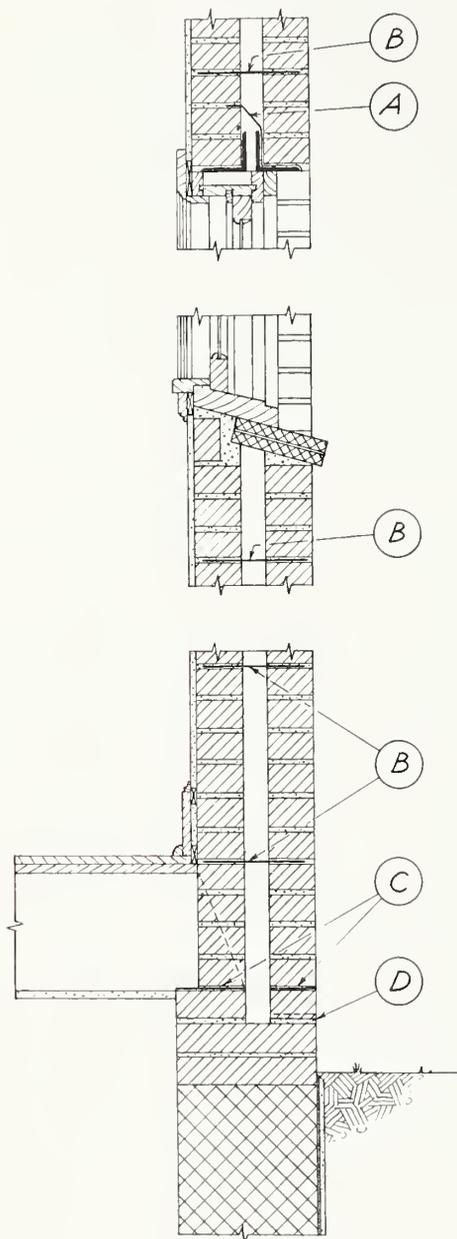
FIGURE 11.—Lintel flashing and damp check for cavity walls.

A, flashing; B, wall ties; C, damp check; and D, weep hole.

In a house, the cavity wall extends from the top of the foundation wall to the eaves or to the base of the parapet wall. The bottom of the cavity should be below the damp-proofed course,

The cavity may be either closed (except for weep holes) or ventilated. If closed, the upper and lower ends are sealed. If ventilated, the entire wall or only the upper or lower portion may be ventilated. The closed cavity has better thermal insulation, while the ventilated cavity will allow moisture to evaporate more quickly, if any penetrates the facing.

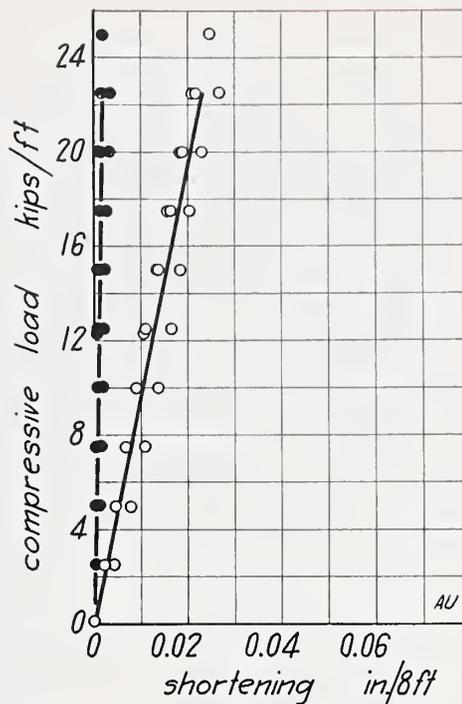
FIGURE 12.—Compressive load on wall *AU*.

Load-shortening (open circles) and load-set (solid circles) results for specimens *AU-C1*, *C2*, and *C3*. The load was applied 3.25 in. from the inside face. The loads are in kips per foot of actual width of specimen.

Each of the specimens failed by breaking of the tile in the upper two or three courses. No failure of the brick facing was observed.

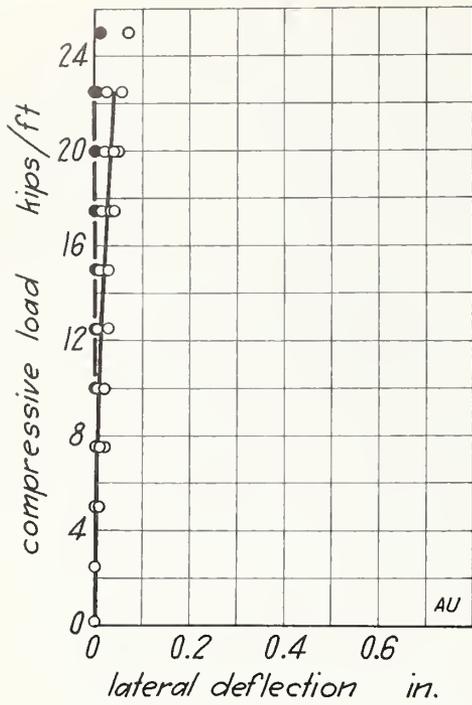
FIGURE 13.—Compressive load on wall AU.

Load-lateral deflection (open circles) and load-lateral set (solid circles) results for specimens AU-C1, C2, and C3. The load was applied 3.25 in. from the inside face. The loads are in kips per foot of actual width of specimen. The deflections and sets are for a gage length of 7 ft 4 in., the gage length of the deflectometers.

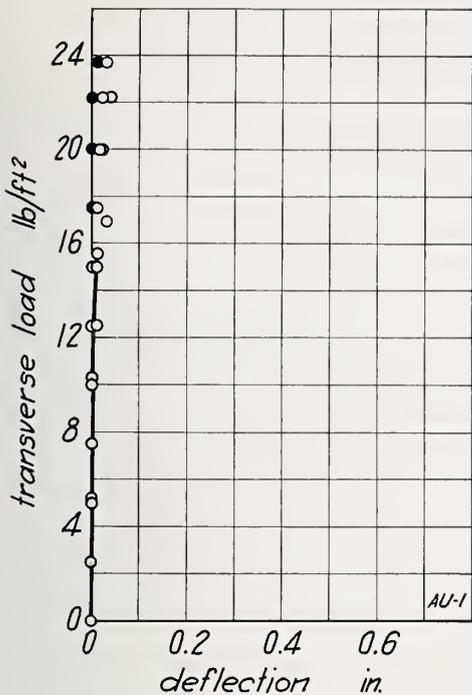
FIGURE 15.—Transverse load on wall AU, load applied to inside face.

Load-deflection (open circles) and load-set (solid circles) results for specimens AU-T1, T2, and T3 on the span 7 ft 6 in. The deflections and sets are for a gage length of 7 ft 4 in., the gage length of the deflectometers.

Each of the specimens *T1*, *T2*, and *T3* failed by rupture of the bond between the brick and the mortar at a bed joint at midspan in the facing, and rupture of the bond between the tile and the mortar at one or two bed joints at or between the loading rollers in the backing. In each case the failures in the tile backing occurred at joints having ties.

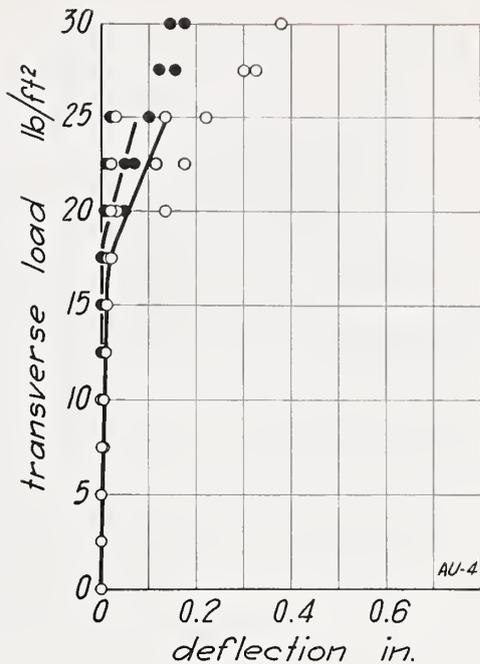
FIGURE 16.—Transverse load on wall AU, load applied to outside face.

Load-deflection (open circles) and load-set (solid circles) results for specimens AU-T4, T5, and T6 on the span 7 ft 6 in. The deflections and sets are for a gage length of 7 ft 4 in., the gage length of the deflectometers.

For specimens *T4*, *T5*, and *T6* at loads of 27.5, 17.2, and 15 lb/ft<sup>2</sup>, respectively, the bond between the tile and the mortar ruptured at a bed joint near midspan in the backing. At the maximum load each of the specimens failed by

rupture of the bond between the brick and the mortar at a bed joint between the loading rollers in the facing. For specimens *T4* and *T5* the failure of the brick facing occurred at joints having ties.

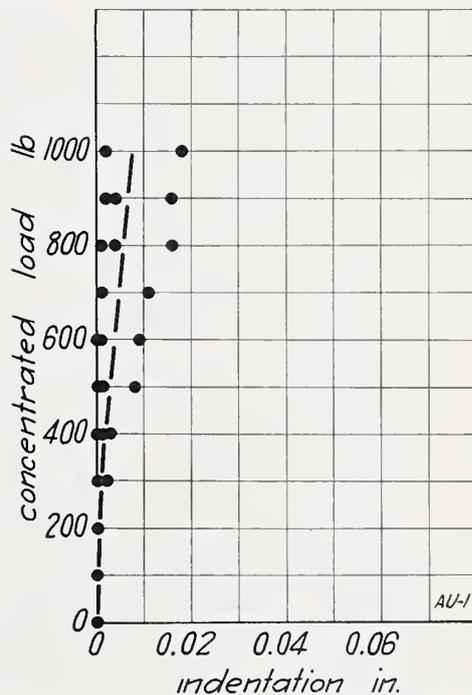
FIGURE 17.—Concentrated load on wall AU, load applied to inside face.

Load-indentation results for specimens AU-P1, P2, and P3.

The concentrated loads were applied to the faces of the specimens at midwidth and midway between ties. The indentations after a load of 1,000 lb had been applied were 0.002, 0.018, 0.002, 0.001, 0.001, and 0.004 in. for specimens *P1*, *P2*, *P3*, *P4*, *P5*, and *P6*, respectively, and no other effect was observed.

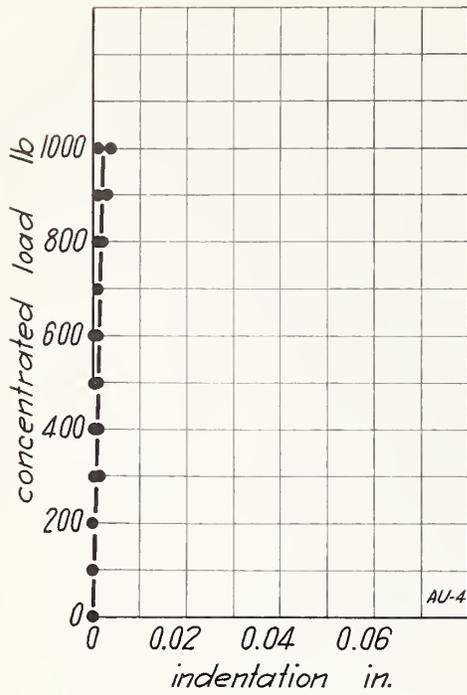
FIGURE 18.—Concentrated load on wall AU, load applied to outside face.

Load-indentation results for specimens AU-P4, P5, and P6.

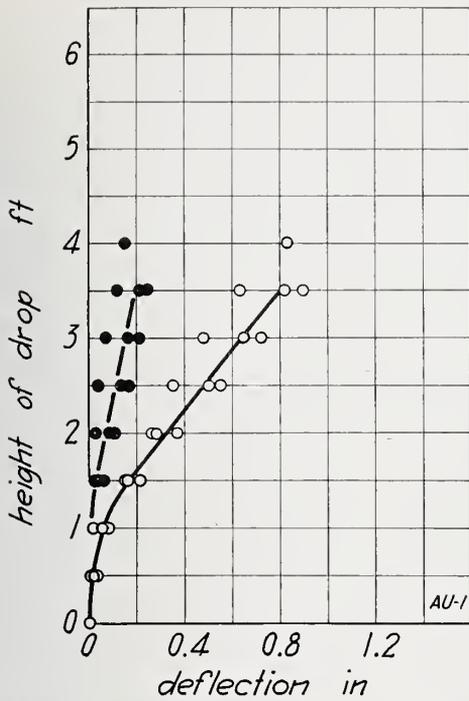
FIGURE 20.—Impact load on wall AU, load applied to inside face.

Height of drop-deflection (open circles) and height of drop-set (solid circles) results for specimens AU-11, 12, and 13 on the span 7 ft 6 in.

shown in table 10 and in figure 20 for wall specimens AU-I1, I2, and I3, loaded on the inside face, and in figure 21 for wall specimens AU-I4, I5, and I6, loaded on the outside face.

The impact loads were applied to the center of the inside face of specimens I1, I2, and I3, the sandbag striking the tile backing at mid-span, one tile course below the nearest joint with ties. For each of the specimens I1, I2, and I3 at drops of 2, 2, and 3 ft, respectively, the bond between the brick and the mortar in the facing ruptured transversely (across the specimen) near midspan. For specimens I1 and I3 the breaks occurred at joints with ties. At drops of 2, 2.5, and 3 ft for specimens I1, I2, and I3, respectively, the bond between the tile and the mortar in the backing ruptured transversely (across the specimen) near midspan. The rupture in specimen I1 occurred at a joint with ties. At higher drops both the backing and the facing failed by opening of these cracks or by the formation of new cracks. In all cases the tile backing failed first, followed by the failure of the brick facing at the next drop.

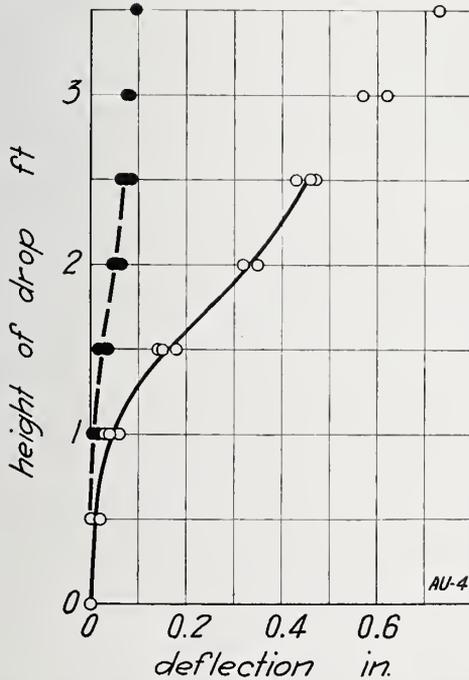
FIGURE 21.—Impact load on wall AU, load applied to outside face.

Height of drop-deflection (open circles) and height of drop-set (solid circles) results for specimens AU-14, 15, and 16 on the span 7 ft 6 in.

The impact loads were applied to the center of the outside face of specimens *I4*, *I5*, and *I6*, the sandbag striking the brick facing at midspan, between joints with ties. For each of the specimens *I4*, *I5*, and *I6* at drops of 1.5, 2, and 2 ft, respectively, the bond between the tile and the mortar in the backing ruptured transversely (across the specimen) at or above midspan. For specimen *I6* the break occurred at a joint with ties. At drops of 2, 2, and 3 ft for specimens *I4*, *I5*, and *I6*, respectively, the bond between the brick and the mortar in the facing ruptured transversely (across the specimen) at or above midspan. The breaks in specimens *I4* and *I5* occurred at joints with ties. At higher drops both the backing and the facing failed by opening of these cracks or by the formation of a new crack in the tile backing. For specimens *I4* and *I6* both the backing and the facing failed at the same drop. For specimen *I5* the tile backing failed first, followed by failure of the brick facing at the next drop.

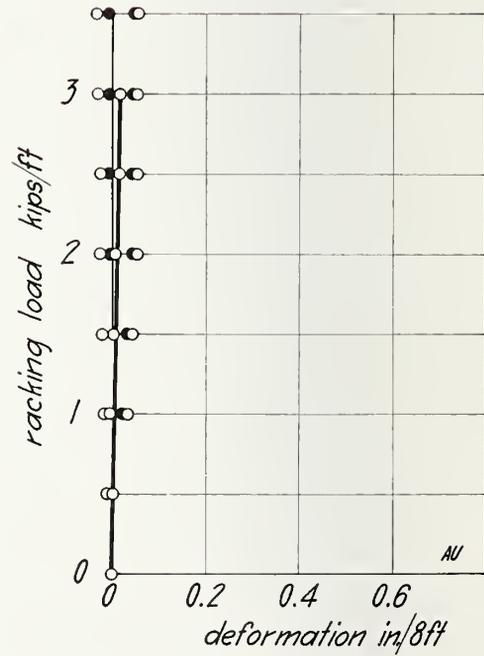
FIGURE 23.—Racking load on wall AU.  
Load-deformation (open circles) and load-set (solid circles) results for specimens AU-R1 and R3. The loads are in kips per foot of actual width of specimen.

At loads of 2.92, 4.75, and 3.75 kips/ft for specimens *R1*, *R2*, and *R3*, respectively, the tile backing of each specimen cracked in the bed and head joints, along the diagonal from the load to the stop. In addition a few tile were broken. At the maximum load the facing and the backing of specimen *R1* and the backing of specimens *R2* and *R3* failed by rupture of

the bond between the masonry units and the mortar in the bed and head joints, along the diagonal from the load to the stop. The facings of specimens *R2* and *R3* did not fail.
