**BUILDING
MATERIALS
AND
STRUCTURES**

REPORT BMS29

Survey of Roofing Materials
in the
Northeastern States

by
HUBERT R. SNOKE
and LEO J. WALDRON

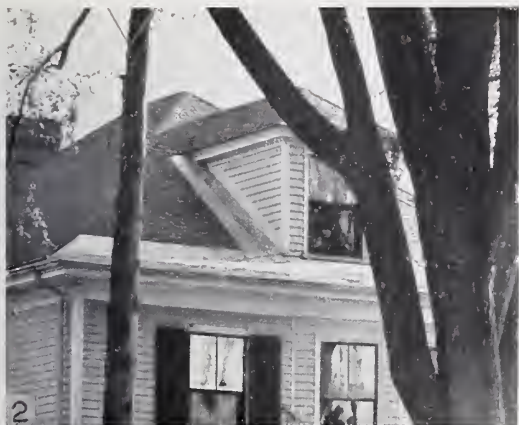
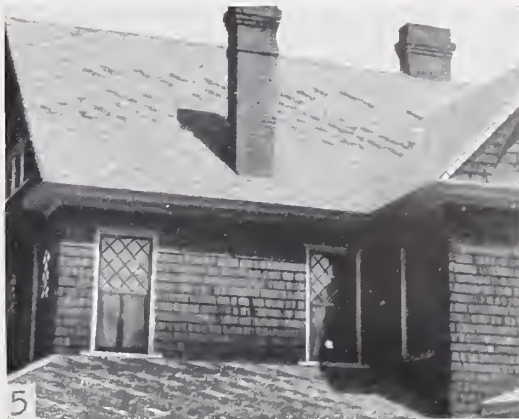
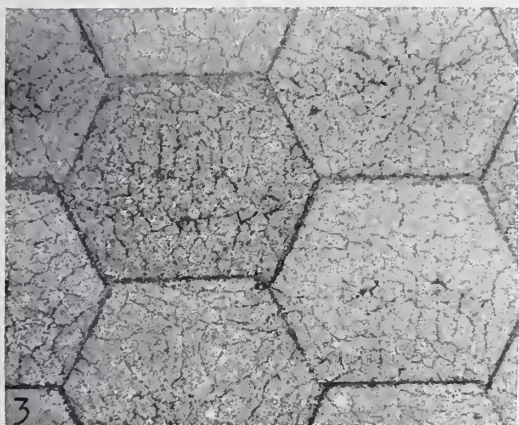
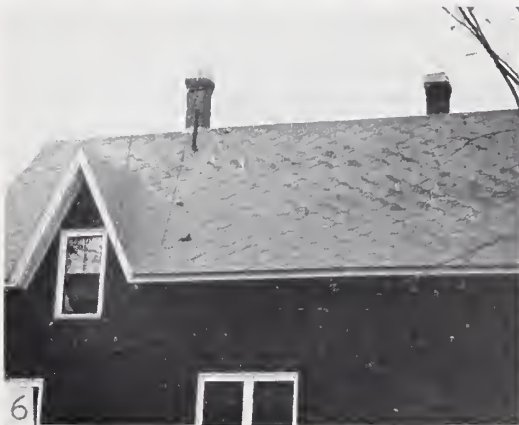
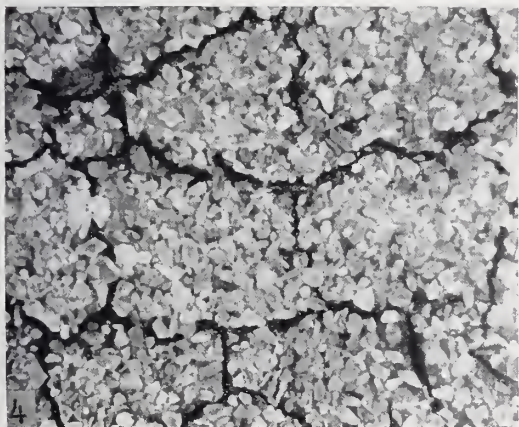
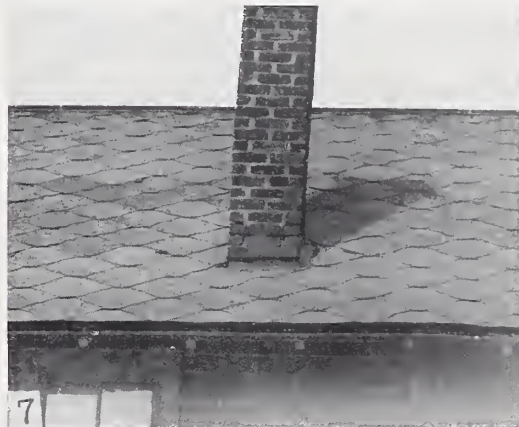
FIGURES 2 to 7.—*Asphalt shingles*

Figure 2, wide metal eaves strip and dormer flashing, 3 and 4, severe alligatoring, heavyweight asphalt shingles exposed 12 years in Wilmington, Del.; 5, 6, and 7, re-cover asphalt shingles; 5, exposed 7 years in Greensboro, N. C.; 6, exposed 15 years in Manchester, N. H.; 7, exposed 10 years in Albany, N. Y.

Considerable so-called "alligatoring" of asphalt coating was observed, most noticeable on shingles with thick coatings. Figure 3 shows this condition on heavyweight asphalt shingles after 12 years of exposure in Wilmington, Del. Figure 4 is a close-up of a section of one of these shingles.

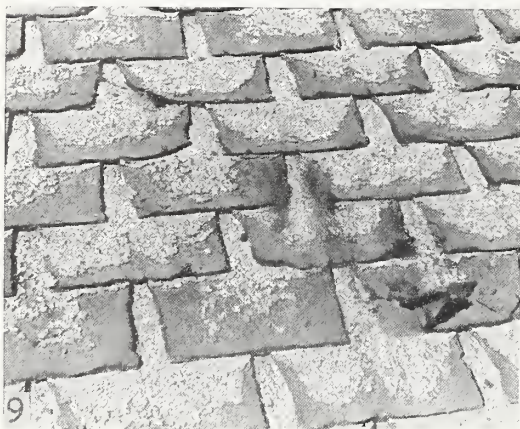
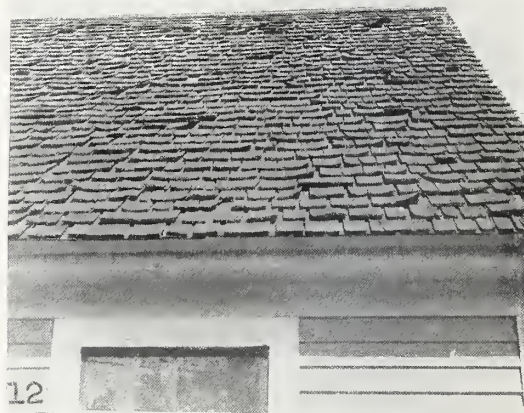
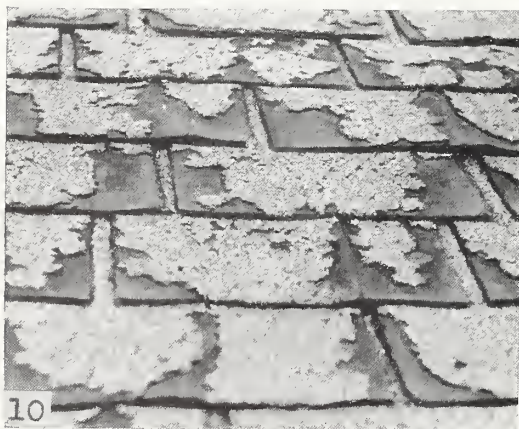
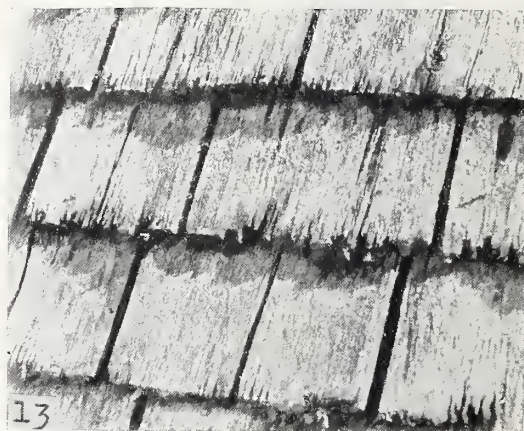
FIGURES 8 to 13.—*Asphalt and wood shingles*

Figures 8, 9, and 10, individual asphalt shingles, southern exposures; 8, after 13 years in Savannah, Ga.; 9, after 22 years in Syracuse, N. Y.; 10, after 21 years in Portland, Maine; 11, asphalt shingles exposed 18 years near Boston, Mass.; 12, wood shingles on tight sheathing exposed 15 years in Manchester, N. H.; 13, wood shingles more than 40 years old near Hillsboro, N. H.

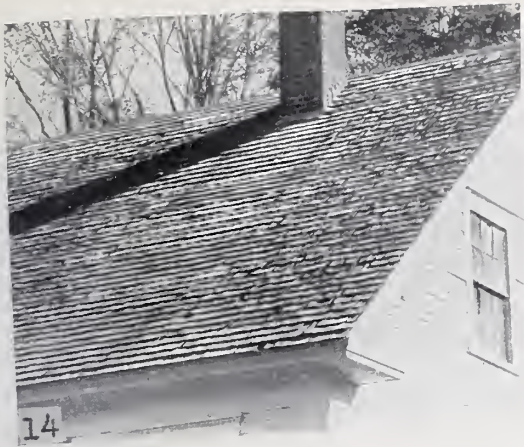
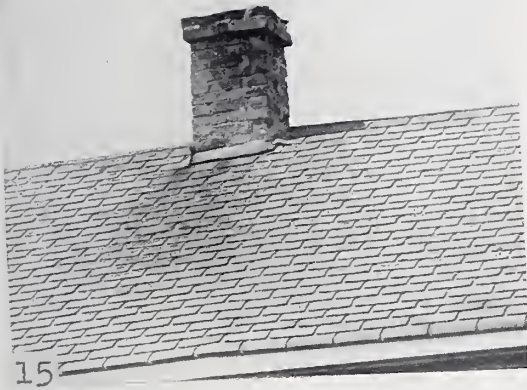
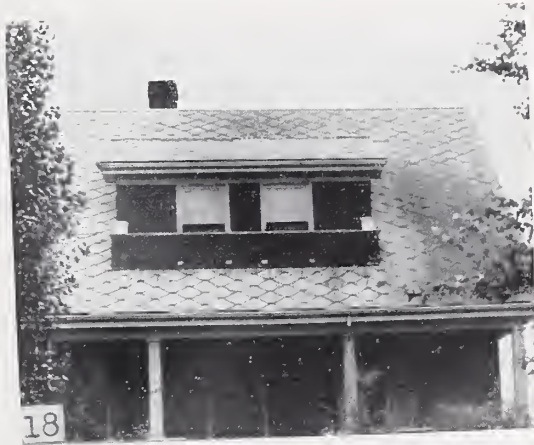
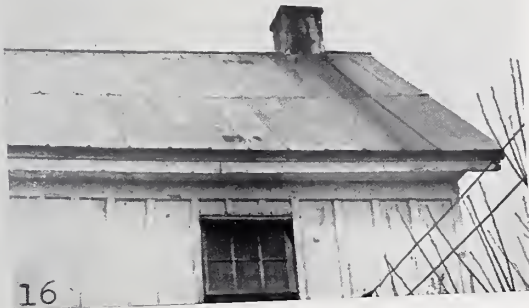
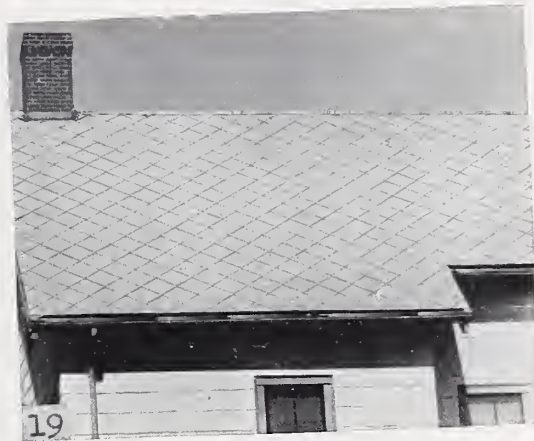
FIGURES 14 to 19.—Wood, asphalt, and cement-asbestos shingles; galvanized sheet metal

Figure 14, wood shingles preserved below chimney, larger section of roof shown in figure 13; 15 and 16, deterioration of asphalt shingles and galvanized sheet metal below chimney; 17, treated wood shingles exposed 20 years in Portland, Maine; 18, cement-asbestos shingles exposed 18 years in Portland, Maine; 19, cement-asbestos shingles exposed 18 years in Boston, Mass.

Wood shingles are applied on spaced sheathing (shingle lath) or on tight sheathing. This latter practice is quite common in some sections, no doubt, due to the fact that snow may filter through a wood-shingle roof laid on shingle lath. Wood shingles absorb a considerable amount of moisture in long-continued rains, and when laid on tight sheathing, have less opportunity to dry thoroughly than those laid on open decks. Figure 12 shows a roof of wood shingles laid on tight sheathing after 15 years' exposure in Manchester, N. H. These shingles had been stained originally. Figure 13 illustrates the extreme weathering of untreated wood shingles that had been exposed more than 40 years near Hillsboro, N. H. These shingles were laid on shingle lath. A larger section of this roof is shown in figure 14. The shingles directly beneath the chimney show less curling and general weathering than those in other sections of the roof. This condition is characteristic of hundreds of wood-shingle roofs observed. Many cases were observed where sections of asphalt and galvanized-iron roofs beneath chimneys were weathered more severely than others. See figures 15 and 16.

Menhaden oil, colloquially Pogy oil, was used formerly in certain sections of Maine for preserving wood shingles. Figure 17 shows a roof so treated after 20 years of exposure in Portland, Maine. Except for slight curling and cracking of a few shingles, this roof showed practically no weathering. The oil treatments had made these shingles quite dark in color. Shingles on this roof were laid on 6-in. sheathing spaced 2 to 3 in.

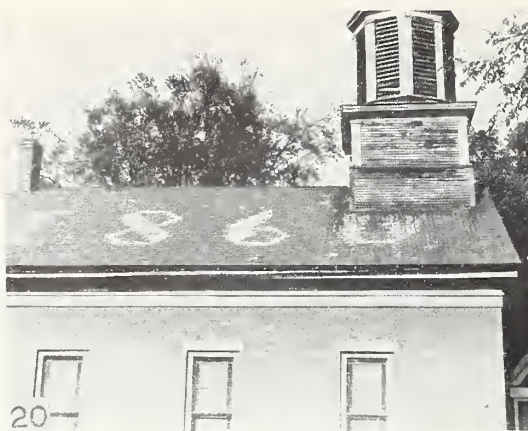
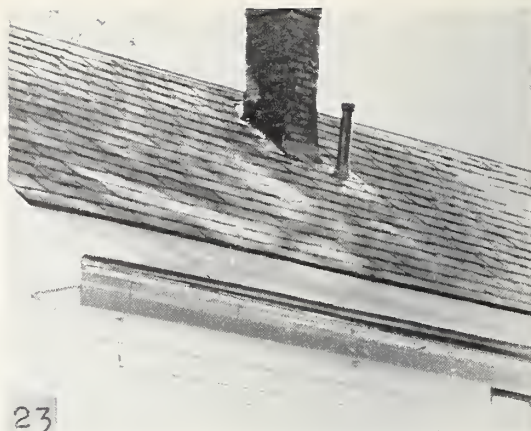
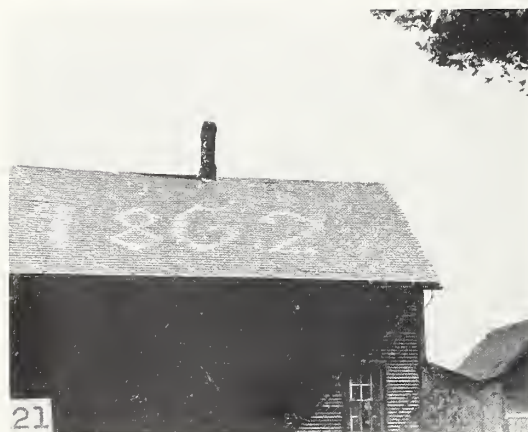
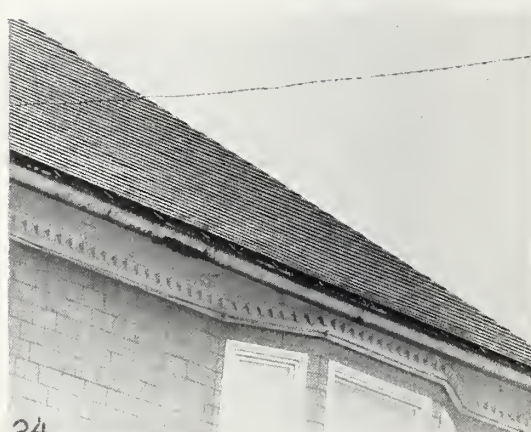
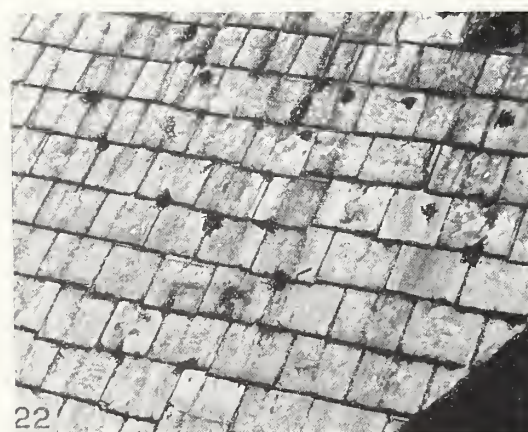
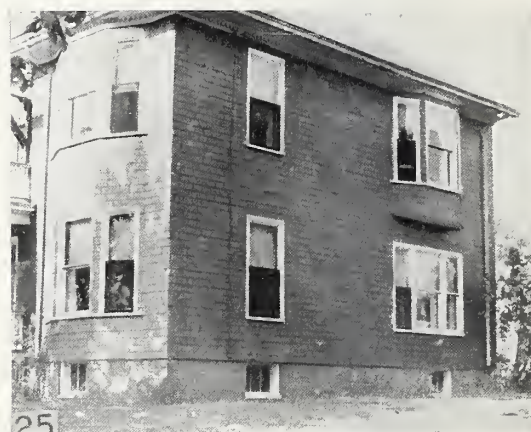
FIGURES 20 to 25.—*Slate*

Figures 20 and 21, purple Vermont slate with numerals of unfading green in and near Fair Haven, Vt.; 22, roof of fading green Vermont slate in Rutland, Vt., approximately 75 years old; 23, red slate roof in Rutland, Vt., more than 50 years old; 24 and 25, Maine slate, roofing and siding exposed 38 to 40 years in Portland, Maine.

The fading green (sea-green) Vermont slates are also extremely durable, as evidenced by the roof shown in figure 22, reported to be more than 75 years old. These have weathered to a light brown and some have begun to disintegrate by scaling. This roof is failing principally through failure of the nails used to

Areas in Maine where roofing slate has been produced were not visited. In Portland, however, a number of roofs were inspected which were said to be of Maine slate. These slates were of a very dark color, almost black, and would certainly be classed as unfading. Figure 24 shows a section of one of these roofs after 38 to 40 years of exposure. Similar slates were used as a siding material on this dwelling with excellent workmanship throughout. See figure 25.

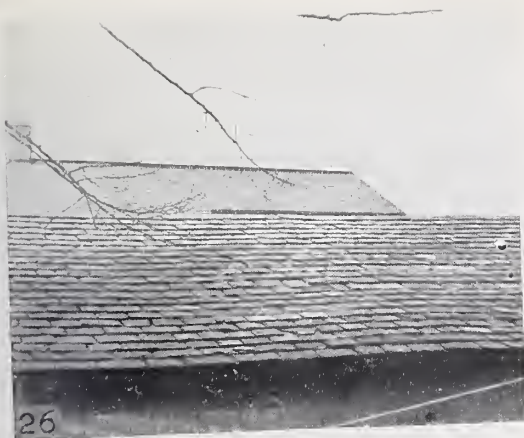
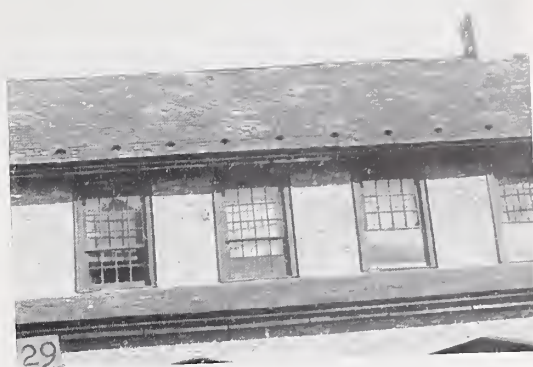
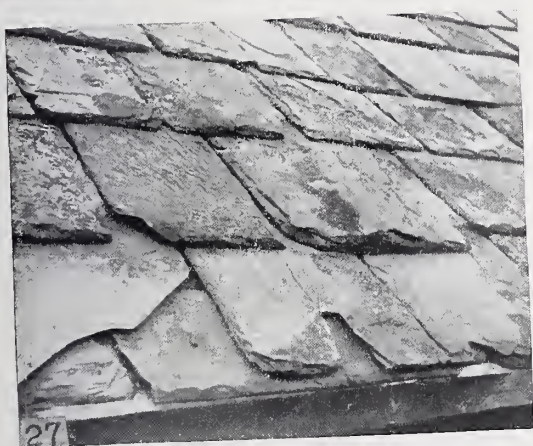
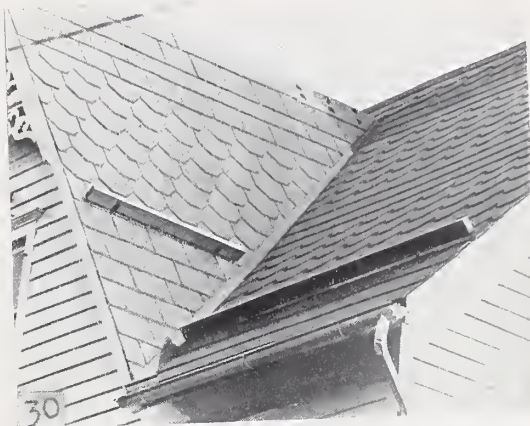
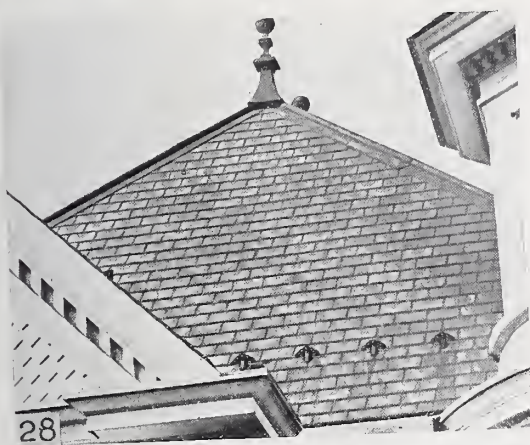
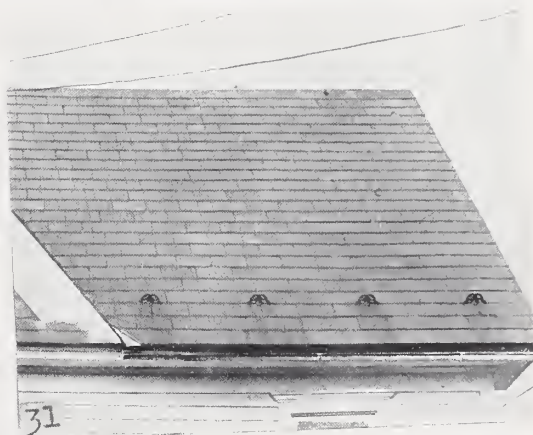
FIGURES 26 to 31.—Slate.

Figure 26, Peach Bottom slate applied recently in Delta, Pa., after about 130 years exposure on another structure; 27, heavy Peach Bottom slate exposed more than 100 years near Delta, Pa.; 28 and 29, roofs in Slatington, Pa.: 28, 35 years old; 29, about 60 years old; 30, roof in Pen Argyl, Pa., 37 years old; 31, slates laid on slats, exposed 25 years in Wind Gap, Pa.

on a number of buildings over a period of about 200 years show slight evidence of rust on the surface. Figure 27 shows a very old slate roof of heavy Peach Bottom slate. The slate that has been produced in the Peach Bottom district represents but a small proportion of the total slate production in this country.

All of the illustrations mentioned show roofs 25 or more years old and all are in good condition except the one in figure 29. Roofs of slate from this section may require considerable repair or even replacement in less than 25 years. Figure 32 illustrates a roof that was replaced after 20 years of exposure, and which had required extensive repairs for a number of years. These were ribbon slates,⁵ though most of them would be described by producers as "No. 1 Ribbon," since the ribbons were mainly in the unexposed portions of the slates. "No. 2 Ribbon" slates are those with ribbons in the section that is exposed to the weather, and "clear" slates are those without ribbons. A number of roofs of ribbon slate have been observed where the ribbons in the unexposed portions show disintegration as great if not greater than those in the exposed section. The authors are convinced that much of the soft-vein ribbon slate should not be used for roofing purposes.

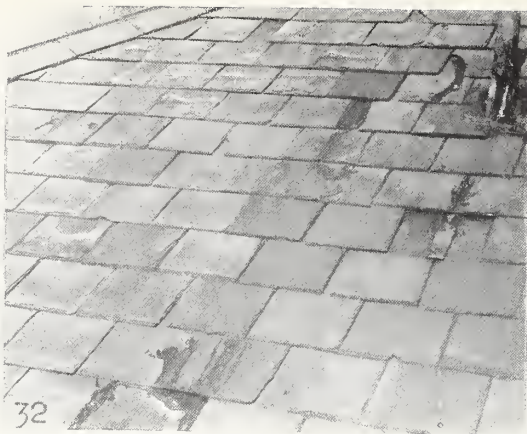
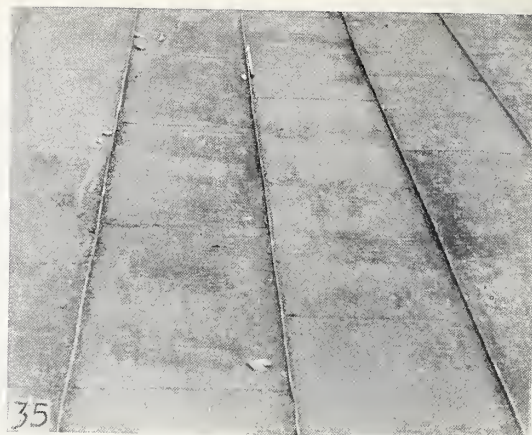
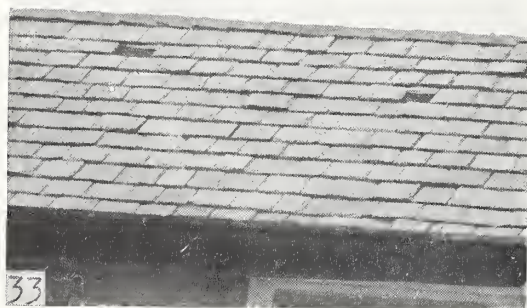
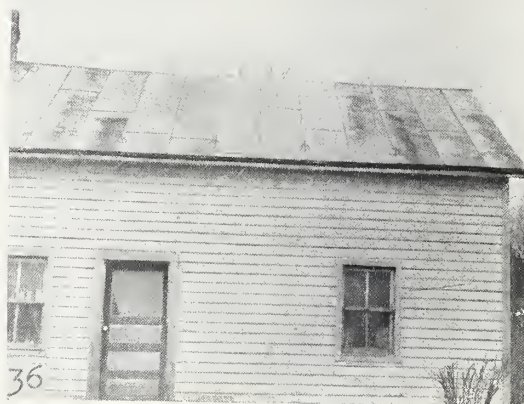
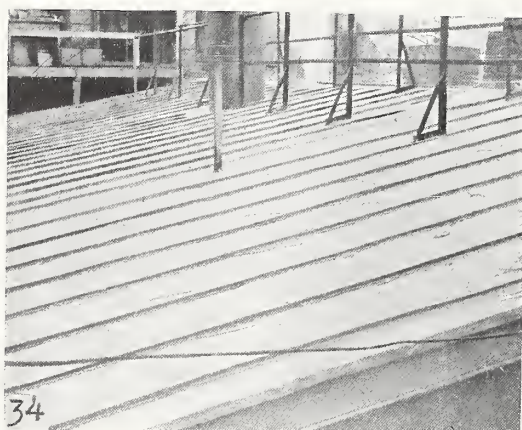
FIGURES 32 to 37.—*Slate and sheet metal.*

Figure 32, ribbon slates, exposed 20 years in Washington, D. C.; 33, Vermont slate laid with alternate courses of saturated felt after exposure of less than 1 year in Scarsdale, N. Y.; 34, standing-seam tin roof more than 80 years old in Reading, Pa.; 35, old standing-seam tin roof in Portland, Maine, showing lack of proper maintenance in recent years; 36, galvanized sheet-metal roof 8 to 9 years old, near Thurmont, Md.; 37, copper roof on Christ Church, Philadelphia, Pa., applied in 1749.

Roofing tin when properly protected by painting gives long service. Many of these roofs are still in good condition after 40 or more years of exposure. The oldest roof of this kind of known history that was observed was more than 80 years old and had been painted regularly for more than 60 years by the same person (see fig. 34). Another standing-seam tin roof that was in good condition after 73 years of exposure was observed. The underside of the metal was unpainted and showed no rust or other evidence of corrosion. Much shorter life results if roofs of this type are not adequately maintained. Roofs covered with roofing tin are usually either good or poor; they are either well maintained and present a good appearance, even though they may have considerable age (fig. 34), or are in a poor condition due to improper maintenance (fig. 35).

It is frequently observed, with galvanized roofs, that some sheets are rusted severely, whereas others show little or no rust, a condition indicating a lack of uniformity in the sheets. Figure 36 illustrates this condition. Information obtained from other sources indicates that this behavior prevails in other sections of the country.

The oldest metal roof (fig. 37) that was observed was the copper roof on Christ Church in Philadelphia, Pa., which dates from 1749.

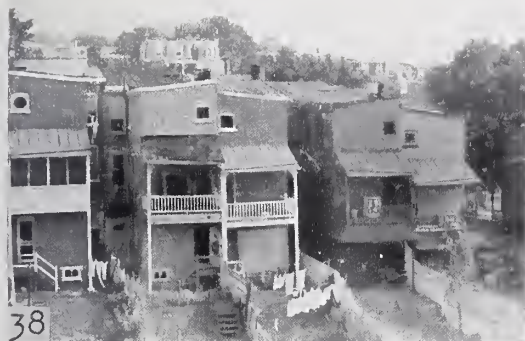
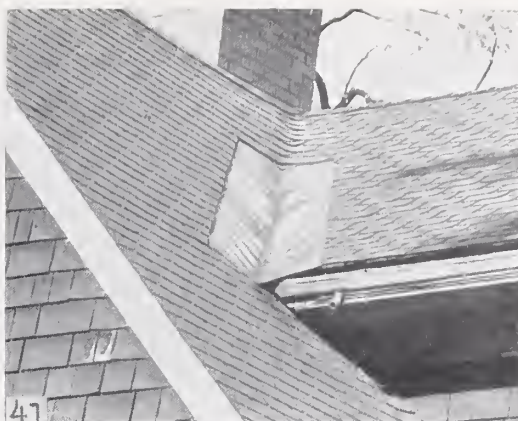
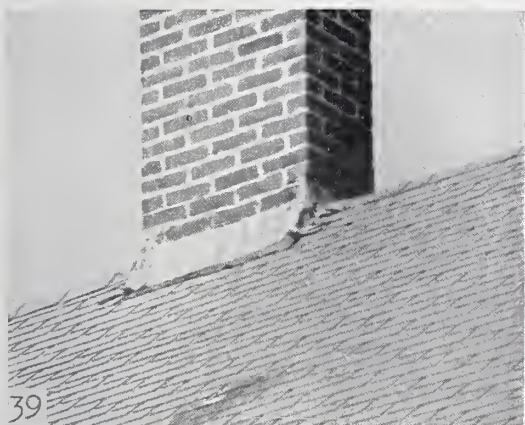
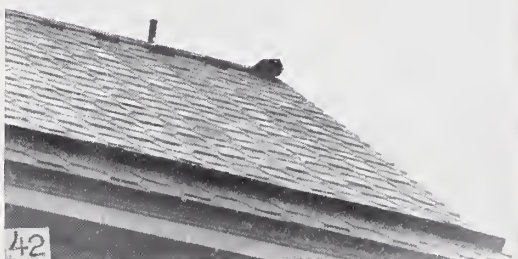
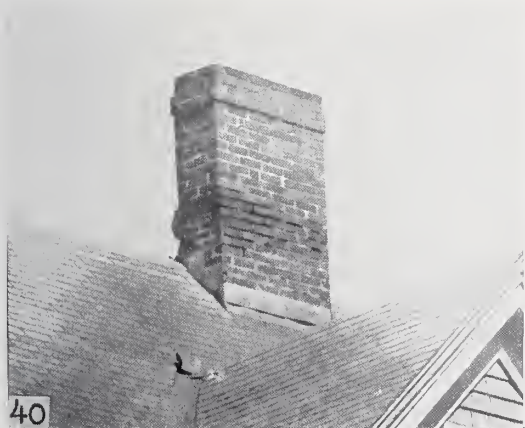
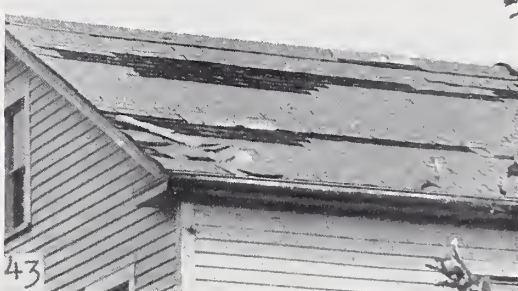
FIGURES 38 to 43.—*Metal roofs, flashings, and hurricane damage to asphalt shingles.*

Figure 38, dwellings with old standing-seam tin roofs in Wilmington, Del.; 39 and 40, typical chimney flashings; 41, combination valley, interlaced asphalt shingles, and wide metal strip; 42, tabs of asphalt-strip shingles blown up during hurricane; 43, hurricane damage to new asphalt shingles due to improper application.

The roof shown in figure 42 was photographed during the height of the storm. The only shingles that are affected in this roof are those in the course next to the ridge. Apparently these shingles were nailed very high in order that the ridge roll would cover the nail heads, as indicated by the shingle on the extreme right. Another roof that illustrates the improper application of asphalt shingles is shown in figure 43. These were square-tab strip shingles that were each fastened with three nails, one at the center and one at each end, about 1 in. from the top.

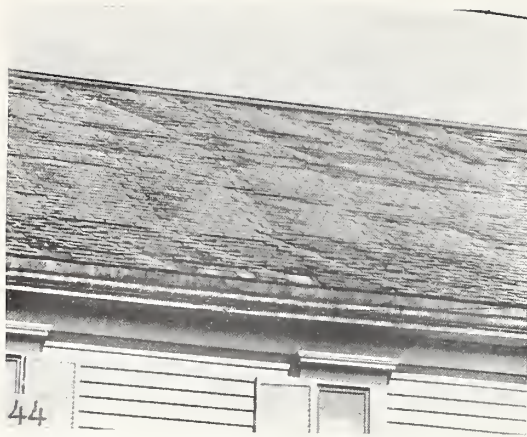
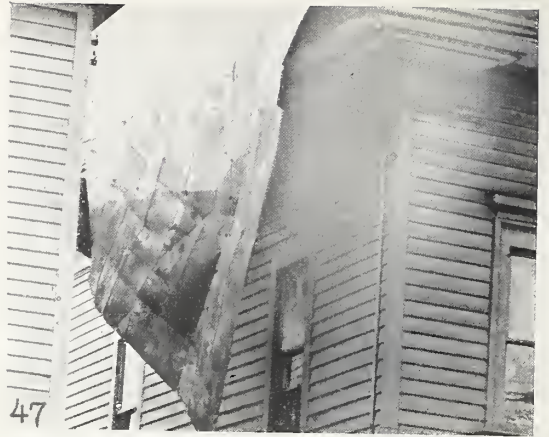
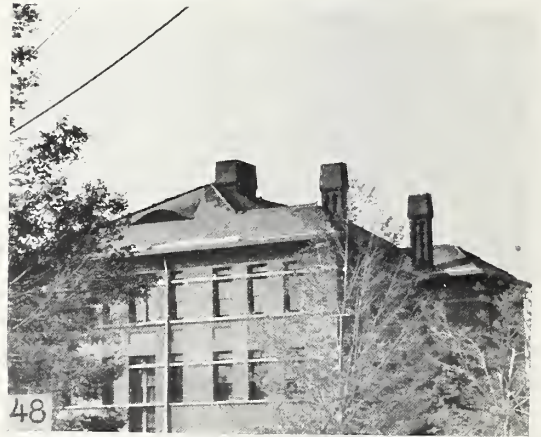
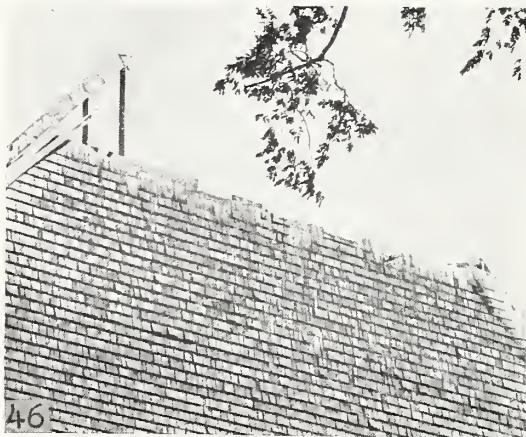
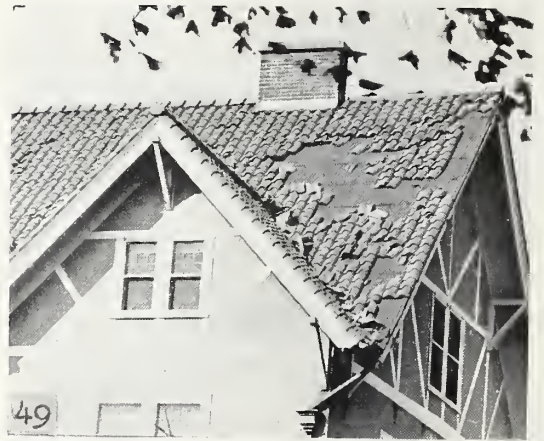
FIGURES 44 to 49.—Hurricane damage to roofs.

Figure 44, old asphalt-shingle roof; 45, damage to small section of comparatively new asphalt-shingle roof laid over wood shingles; 46, old wood-shingle roof; 47, old metal roof; 48, slate blown from hips; 49, damage to tile roof.

Figure 44 shows damage that was typical of badly weathered asphalt shingles. Figure 45 shows typical damage to a small section of a comparatively new asphalt-shingle roof laid over wood shingles. Numerous asphalt-shingle roofs in the immediate vicinity of that shown in figure 11 were badly damaged.

Figure 46 shows damage to a rather old wood-shingle roof. While only a few shingles were blown from one section of the roof, another whole section was blown off entirely. Very little damage was done to roofs of wood shingles that were not curled and weathered.

The metal roof in figure 47 is probably not typical of damage to roofs of this type, because generally, when these roofs were damaged, a section of the roof or the entire roof would be, rolled up and blown clear of the structure.

The roofs shown in figures 48 and 49 illustrate damage that may occur to slate and tile roofs. It was characteristic that damage to slate roofs was usually confined to small sections of the roof. Note that the felt underlay in figure 49 has not been disturbed. Very few tile roofs were observed in the hurricane area.
