REPORT BMS5

Structural Properties of  
Six Masonry Wall  
Constructions

by HERBERT L. WHITTEMORE  
AMBROSE H. STANG, and  
DOUGLAS E. PARSONS

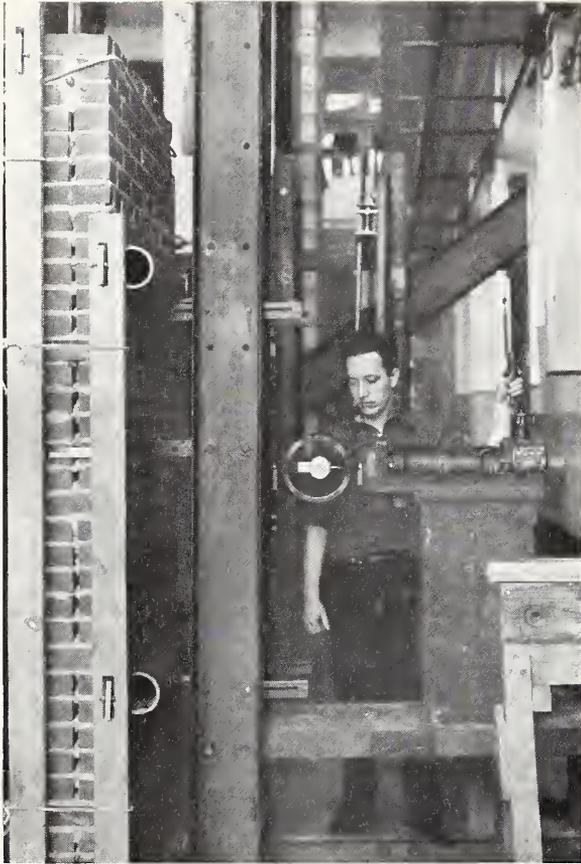
FIGURE 10.—Wall specimen *AB-T1* under transverse load.

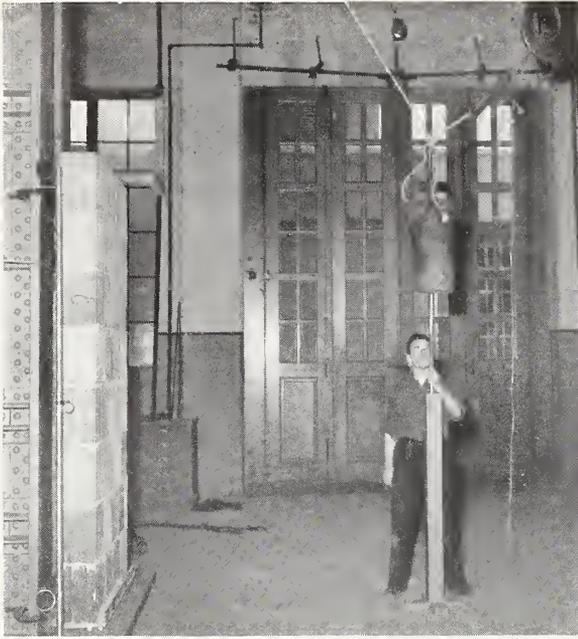
FIGURE 29.—Wall specimen AD-I1 during the impact test.

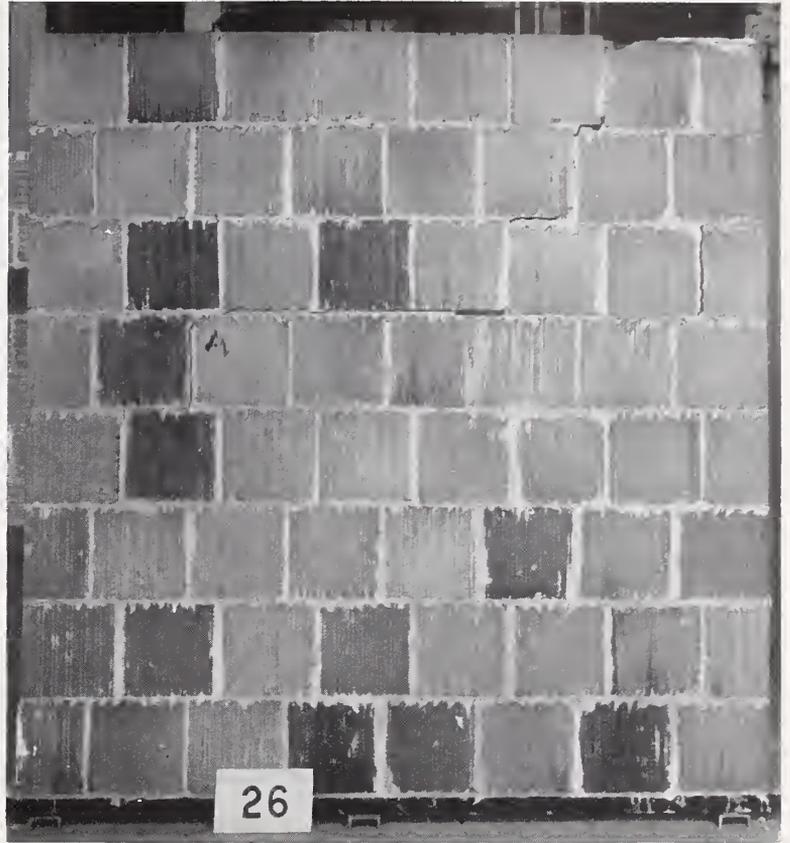
The load was applied to the right edge near the upper end of the specimen.

Specimen *R1* after the racking test is shown in figure 32. The failure by stepwise cracks through the joints is typical of the failure for both the *AD* and the *AE* racking wall specimens.
