REPORT BMS75

Survey of Roofing Materials
in the North Central States

Survey of Roofing Materials in the North Central States

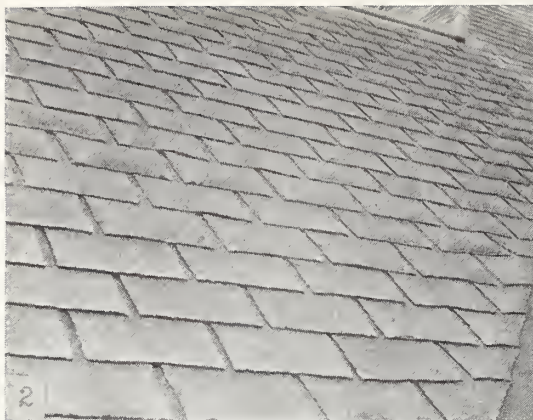
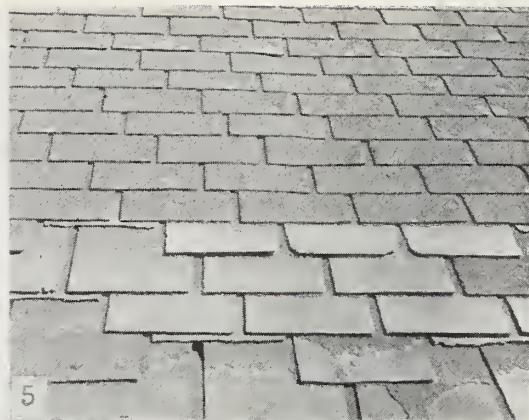
It should be noted in figures 2 and 3 that the shingles are laid so that the spaces between shingles in one course are placed in the center of the shingles in the next course below. This was the first method used for the application of individual shingles. Figures 4 and 5 illustrate a method that was developed later, in which the space between two adjacent shingles is placed to one side of the center of the shingle in the next course below. Shingles laid by both of these methods provide three layers of fabric over the greater part of the roof area. With those laid as in figures 2 and 3, a small part of the area is covered by only a single layer of fabric, whereas with the method illustrated in figures 4 and 5 no part is covered by fewer than two layers.

FIGURES 2 to 7.—*Asphalt shingles (individual shingles applied by the American method).*

Figures 2 and 3, exposed 29 years in Grand Rapids and Zeeland, Mich., respectively; 4 and 5, northern and southern sections, respectively, of a roof after approximately 27 years of exposure in Grand Rapids, Mich.; 6, exposed 20 years in Pittsburgh, Pa.; 7, exposed 24 years in Toledo, Ohio.

Figures 2 to 5, already discussed, are roofs in Grand Rapids and Zeeland, Mich., after 29 and 27 years of exposure. Other illustrations, with the location followed by the number of years of exposure are figure 6, Pittsburgh, Pa., 20 years; figure 7, Toledo, Ohio, 24 years; figures 8 and 9, northern and southern exposures, respectively, Milwaukee, Wis., 20 years; figure 10, Omaha, Nebr., 20 years; figure 11, St. Louis, Mo., 17 years; figure 12, India-

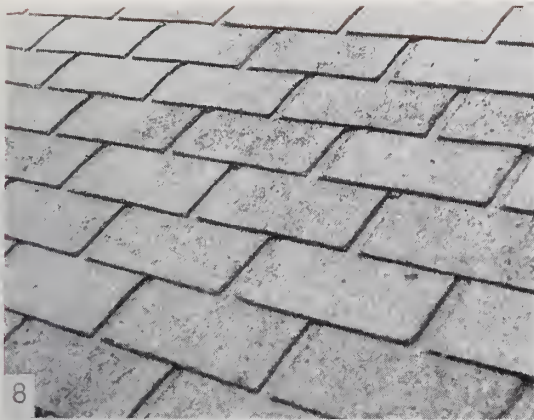
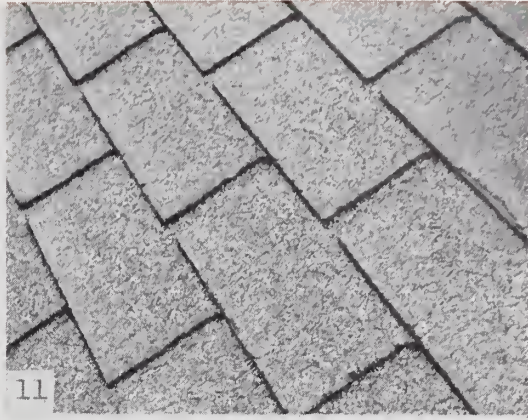
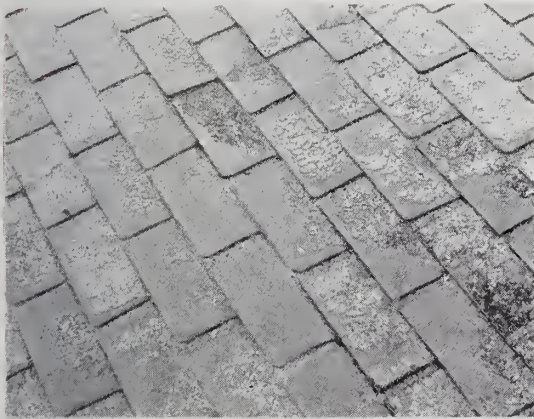
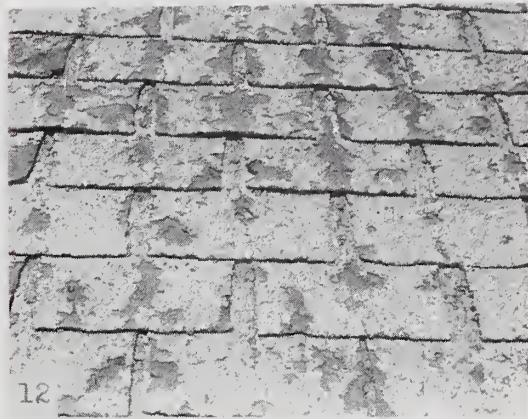
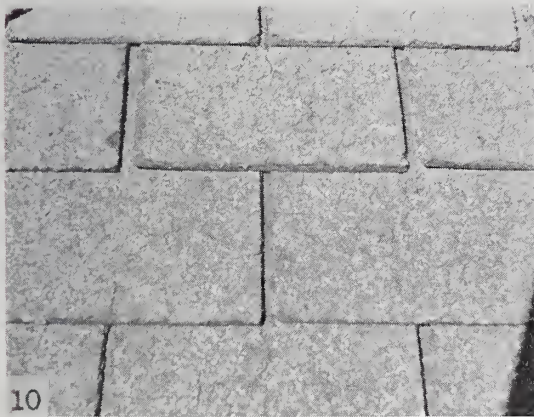
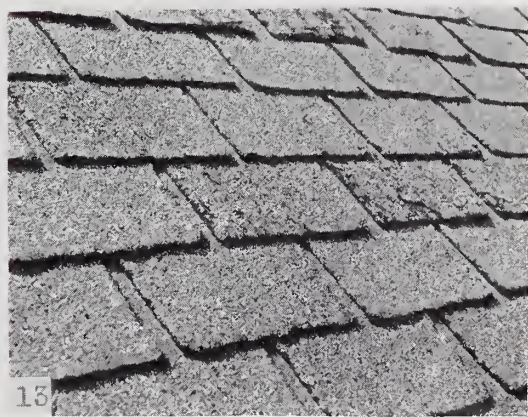
FIGURES 8 TO 13.—Asphalt shingles (individual shingles applied by the American method).

Figures 8 and 9, northern and southern sections, respectively, of a roof after 20 years of exposure in Milwaukee, Wis.; 10, exposed 20 years in Omaha, Nebr.; 11, exposed 17 years in St. Louis, Mo.; 12, exposed 18 years in Indianapolis, Ind.; 13, exposed 16 years in Cincinnati, Ohio.

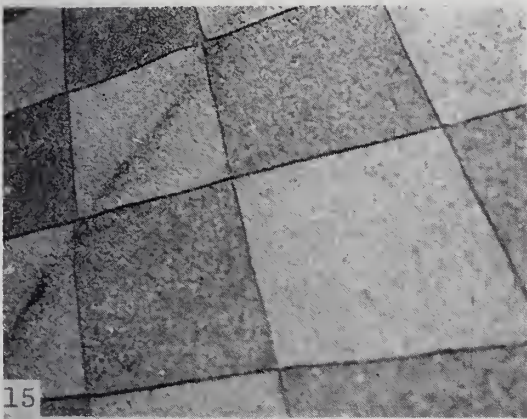
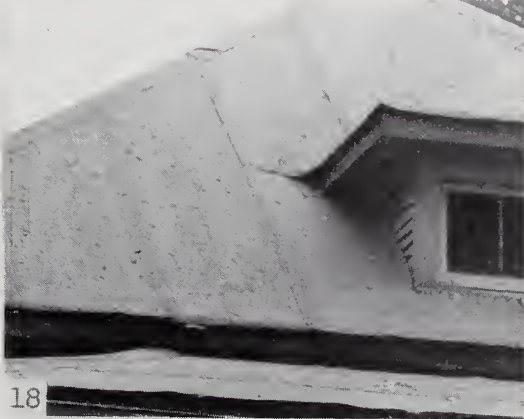
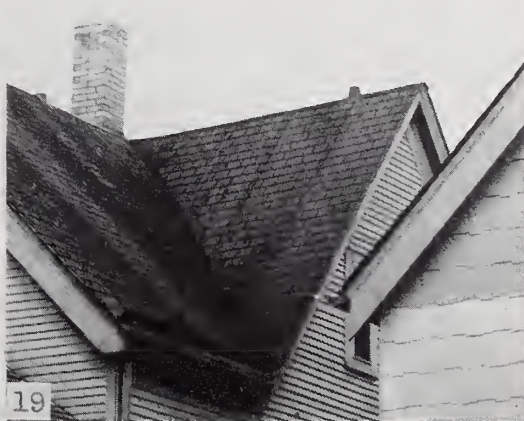
In general, mineral-surfaced roll roofings do not give as long service as asphalt shingles, mainly because they provide but a single layer of fabric over the greater part of the roof area. As with asphalt shingles, roll roofings older than any seen in the previous surveys were observed in this one. A few of these are illustrated in figures 15 to 18. These have also been chosen to illustrate an approach to the maximum service that may be expected: Figure 15, Toledo, Ohio, 20 years; figure 16, Milwaukee, Wis., 20 years; figure 17, Omaha, Nebr., 12 years; figure 18, Moberly, Mo., 12 years; figure 19, Milwaukee, Wis., 19 years. All of these were applied over wood shingles. The roofings in figures 16 and 18 show damage caused by hailstones.

FIGURES 14 to 19.—*Mineral-surfaced, asphalt-prepared roll roofings.*

Figure 14, diamond-point roofing; 15, exposed 15 years in Toledo, Ohio; 16 and 19, exposed 20 and 19 years, respectively, in Milwaukee, Wis.; 17, exposed 12 years in Omaha, Nebr.; 18, exposed 12 years in Moberly, Mo.

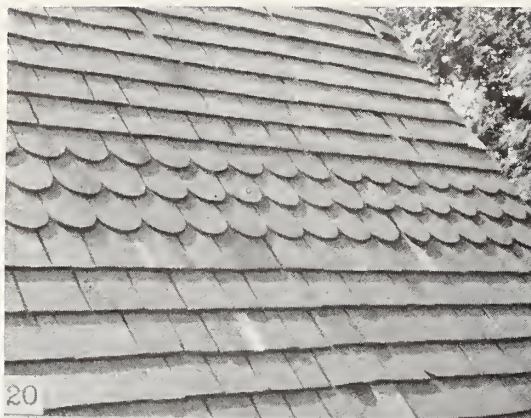
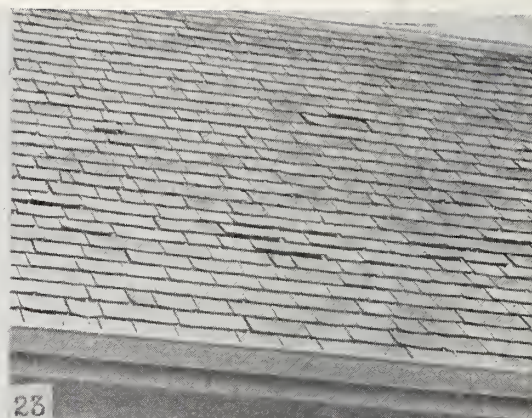
FIGURES 20 to 25.—Wood shingles.

Figures 20 and 21, northern and southern sections, respectively, of a roof after approximately 50 years of exposure in Bismarck, N. Dak.; 22, loose nails where butts of shingles had been nailed; 23, thin (6/2) shingles exposed 11 years in Sioux Falls, S. Dak.; 24 and 25, southern and northern sections, respectively, of a roof after approximately 30 years of exposure in Omaha, Nebr.

Figures 20 and 21 represent the northern and southern exposures, respectively, of a wood shingle roof in Bismarck, N. Dak., reported to be 50 years old. These were heavy, red cedar shingles of good grade, which showed considerable weathering, particularly on the southern exposure, but which were in a satisfactory condition when examined. A number of broken shingles had been replaced recently on the southern exposure, and on the northern exposure practically all of the butts had been nailed down. This practice is not generally recommended because of the tendency of the exposed nails to become loose, as illustrated in figure 22. These shingles were not weathered badly, after 15 years of exposure in Omaha, Nebr., but they had shown some tendency to warp and had been nailed through the butts. After further exposure, a number of these nails became loose and each nail hole became a potential leak.

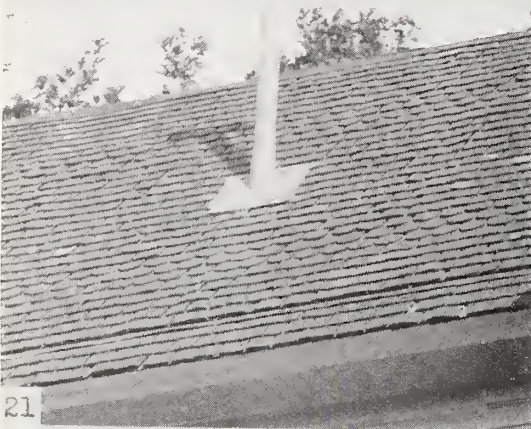
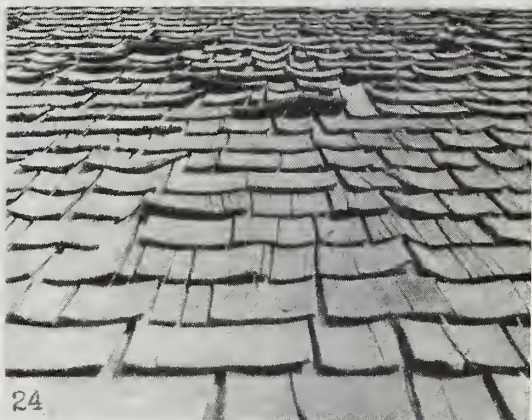
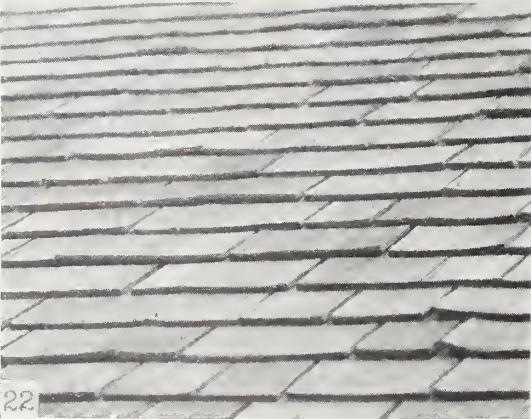
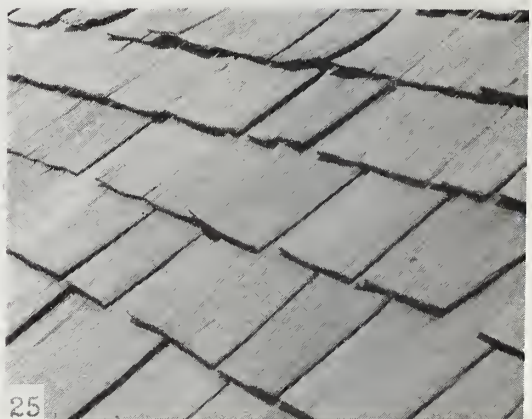
Figure 24 shows the southern exposure of a wood-shingle roof after approximately 30 years of service in Bismarck, N. Dak. The northern exposure of this roof, on which the shingles showed less curling, and with fewer of them cracked, is illustrated in figure 25. These shingles also show plainly the erosion caused by long exposure.

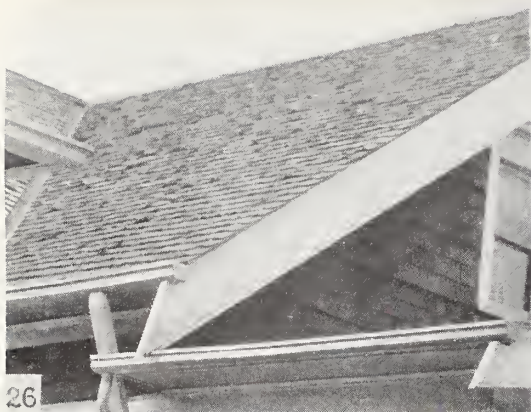
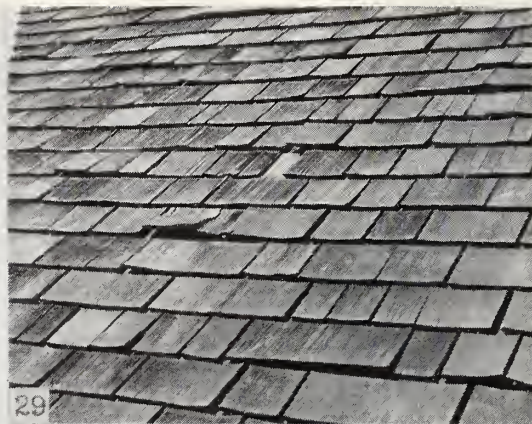
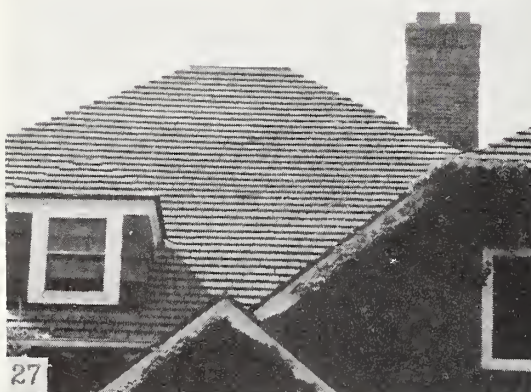
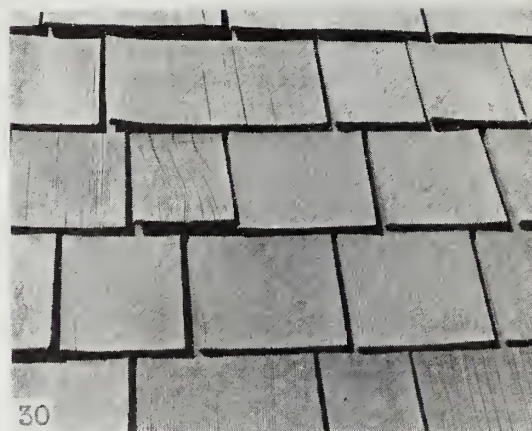
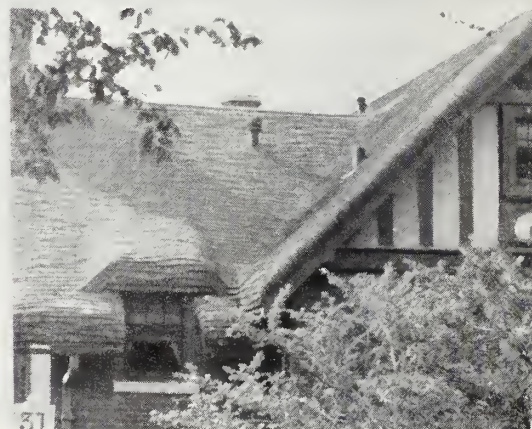
That the thickness of shingles is an important factor is further illustrated by figure 27, in which the shingles were almost 1 inch thick at the butts. They had been exposed for 15 years in Omaha, Nebr., yet the roof had the appearance of a new one. Shingles that remain flat after long exposure present a lesser fire hazard than those that are warped and curled.

FIGURES 26 to 31.—Wood shingles.

Figure 26, thin, poorly graded shingles, exposed 18 years in Milwaukee, Wis.; 27, heavy shingles exposed 15 years in Omaha, Nebr.; 28, poorly graded shingles; 29 and 30, first-grade shingles exposed 14 years in Cincinnati, Ohio; 31, shingles laid to simulate a thatched roof.

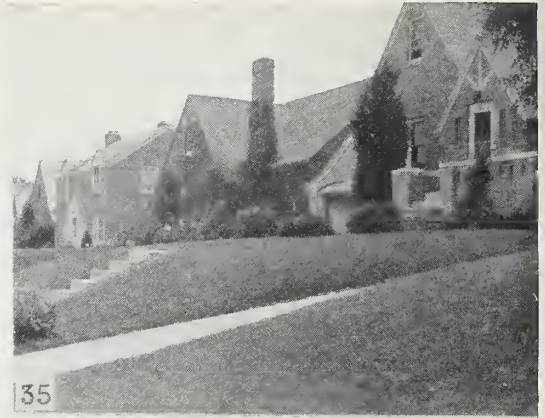
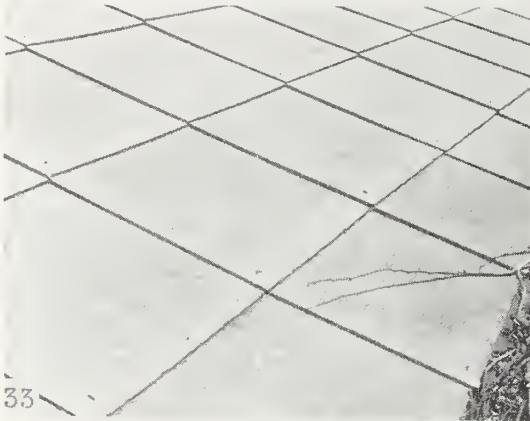
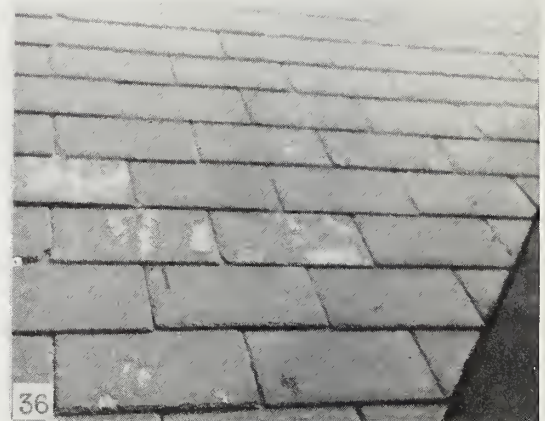
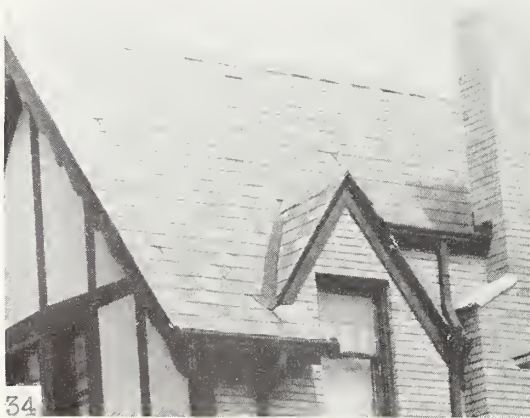
Figure 32 is a close-up of hexagonal pattern shingles after 15 years of exposure in Pittsburgh, Pa. These shingles showed considerable surface weathering, no doubt accentuated by the industrial atmosphere, but they were not badly discolored and appeared in good condition. The dark sections of these shingles were made by embedding mineral granules in the surface.

Figure 33 illustrates the oldest cement-asbestos shingles that were observed. They showed considerable surface weathering and discoloration after 30 years service in Toledo, Ohio. Several cities that had suffered severe hail storms during the past years were visited in this survey. Cement-asbestos shingles were reported in each case to have been damaged very little if at all.

Figure 34 illustrates cement-asbestos shingles laid by the American method after 10 years of exposure in Milwaukee, Wis. The corners of these shingles had been broken purposely when they were laid.

FIGURES 32 to 37.—Cement-asbestos shingles and slate.

Figures 32 to 35, inclusive, cement-asbestos shingles; 32, after 15 years in Pittsburgh, Pa.; 33, after 30 years in Toledo, Ohio; 34, after 10 years in Milwaukee, Wis.; 35, new dwellings in Omaha, Nebr., roofed with cement-asbestos shingles; 36 and 37, eastern Pennsylvania slate, 36, after more than 40 years in Pittsburgh, Pa.; 37, after 40 years in Omaha, Nebr.

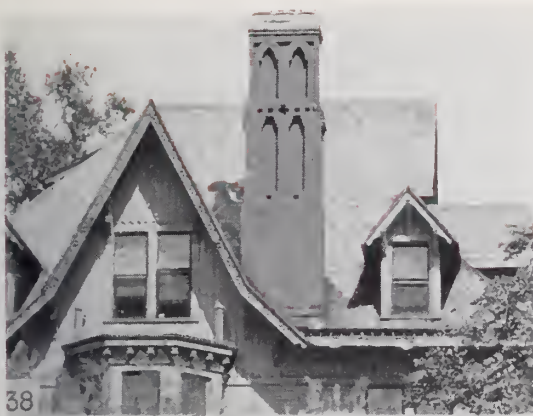
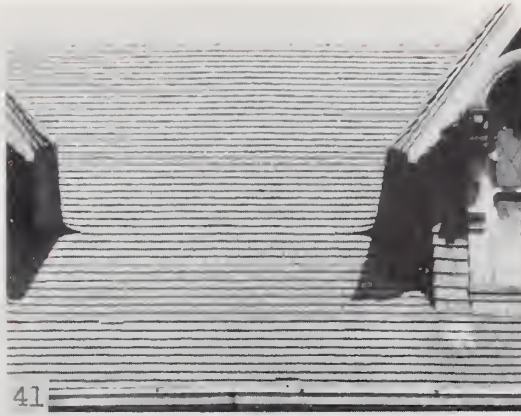
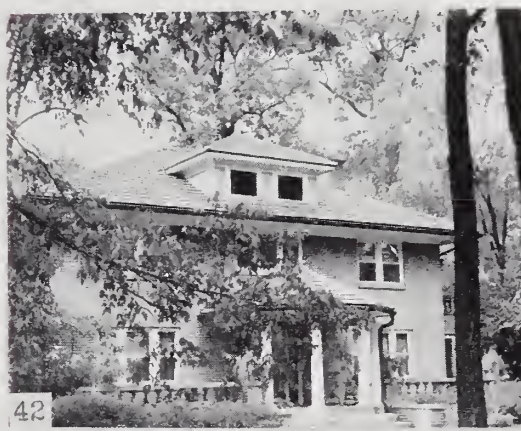
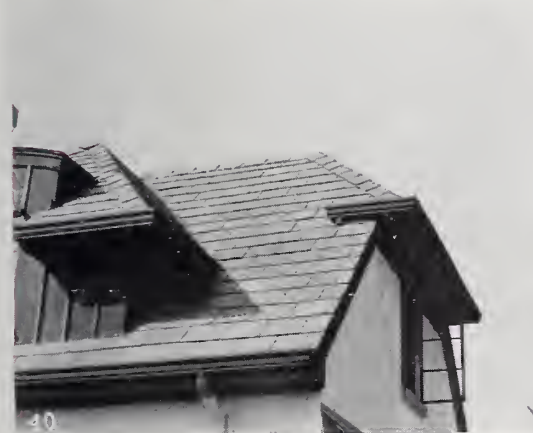
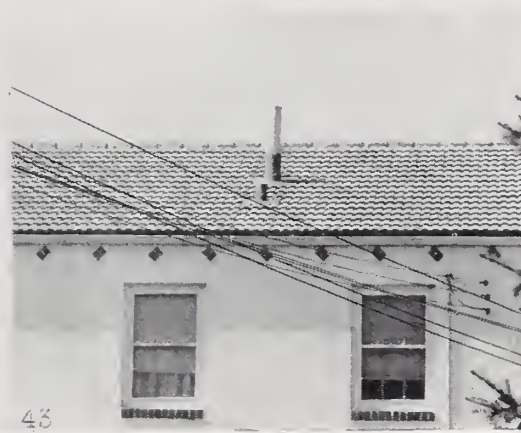
Figure 38 is a roof of colored slate from Vermont, also in Omaha, that was 40 to 45 years old. The slates on this roof were in excellent condition, but there had been some failure of the nails that were used to fasten them.

Variations in the conventional method of laying slate were observed in Cincinnati, Ohio, where they have been used to a considerable extent. By these methods the amount of slate per unit area of roof is reduced by substituting asphalt-prepared roofing for a part of the slate. Courses of asphalt-prepared roofing of the same width as the slate, or wider, are laid alternately with the courses of slate and the slates in one course are lapped at about 3 inches over those in the next course below. This method of laying is illustrated by the edge of the roof shown in figure 39. Figure 40 shows a roof laid by one of these methods, after 5 years of service. The owner of this roof shown in figure 40 reported that it had been entirely satisfactory.

FIGURES 38 to 43.—Slate and tile.

Figures 38 to 40, slate; 38, Vermont slate exposed 40–45 years in Omaha, Nebr.; 39 and 40, slate roofs in which asphalt-prepared roofing is substituted for part of the slate; 41, shingle-tile roof exposed 35 years in Omaha, Nebr.; 42, glazed tile 16 years old in Indianapolis, Ind.; 43, cement-tile roof in Sioux Falls, S. Dak.

Figure 43 illustrates a cement tile roof in Sioux Falls, S. Dak. The area of this roof was 16 squares. The owner reported that it had been necessary to replace 112 tiles in this roof after a severe hailstorm several years ago.

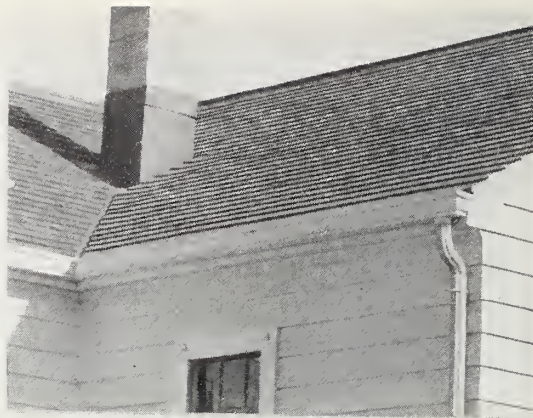
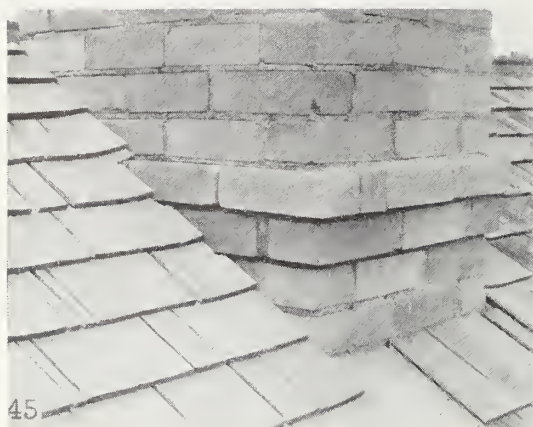
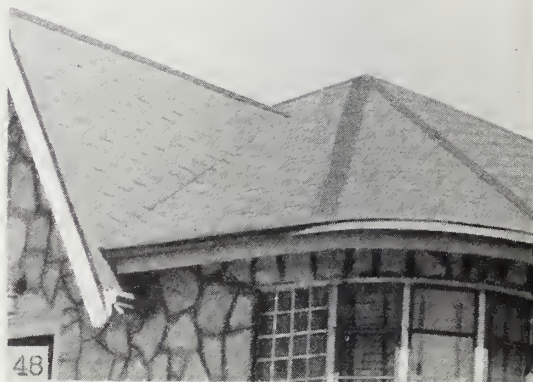
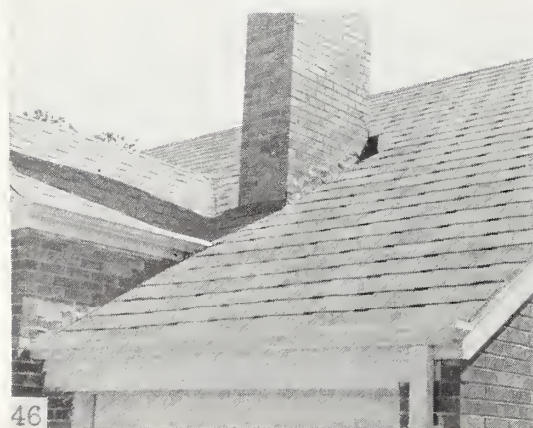
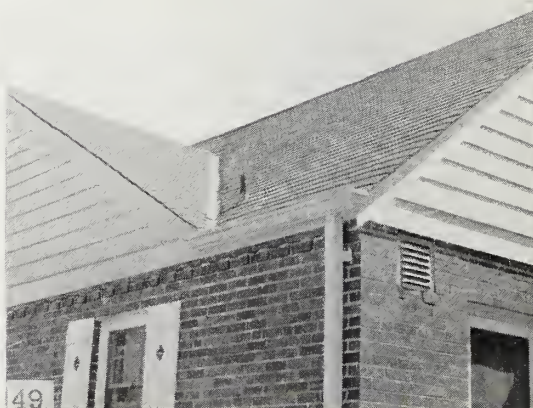
FIGURES 44 to 49.—*Metal roof, flashings, and valleys*

Figure 44, heavily galvanized roofing exposed 46 years in Southern Illinois; 45, absence of chimney flashing on wood-shingle roof; 46 and 47, respectively, low, step flashing and high metal flashing; 48, valley made by interlacing asphalt shingles; 49, divided metal valley.

The evidence obtained to date in this work indicates that suitably selected metallic roofing which is properly cared for, will render satisfactory service under normal conditions of exposure. Figure 44, of a heavily galvanized corrugated roof on a farm building in southern Illinois after 46 years of exposure, illustrates the long service that can be expected from galvanized metal with a heavy coating of zinc.

Copper, terne, and galvanized iron or steel are widely used for chimney and vent flashings. A few cases were observed of the use of roll roofing for chimney flashings; also where no flashings were used on either wood-shingle roofs (fig. 45) or asphalt-shingle roofs. This practice affords, generally, only temporary protection from leakage, particularly if plastic cement is utilized for sealing the shingles or roll roofing to the chimney.
