NBS BUILDING SCIENCE SERIES 105

Retrofitting an Existing Wood-Frame Residence for Energy Conservation— An Experimental Study

U.S. DEPARTMENT OF COMMERCE • NATIONAL BUREAU OF STANDARDS

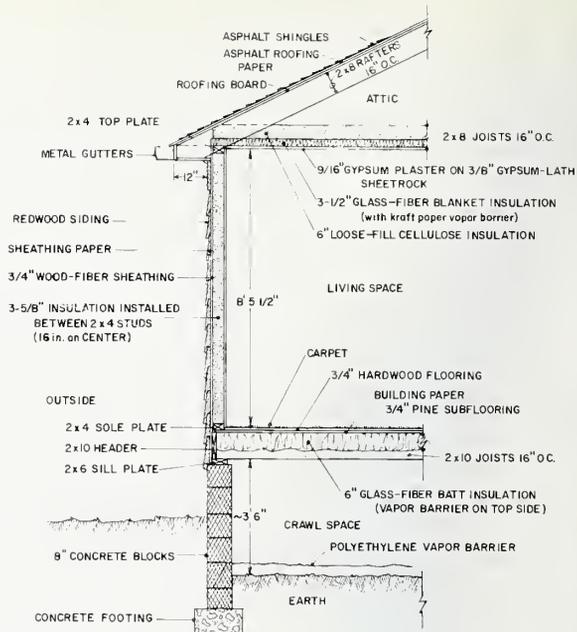
- 2 x 4 wood studs
- 3/4-in wood-fiber sheathing
- sheathing paper
- 7/16-in redwood siding

FIGURE 1. Typical cross-section of the house after retrofitting.

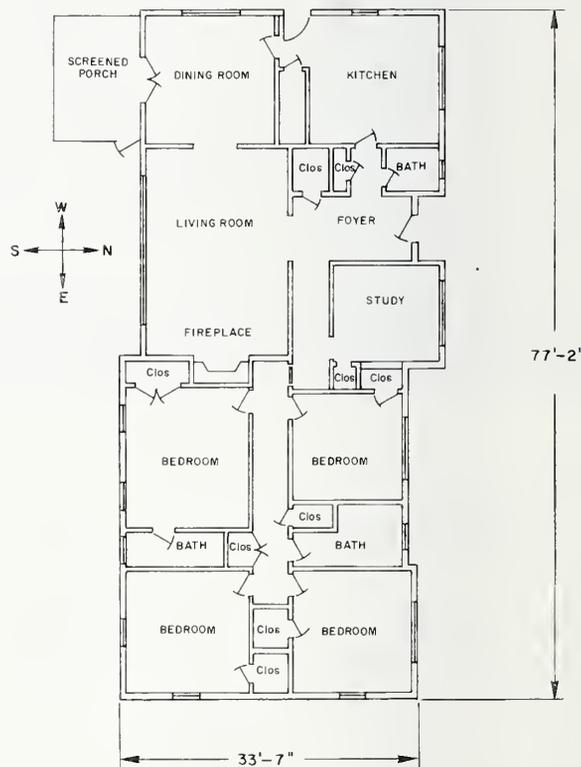
FIGURE 2. Floor plan of the test house.

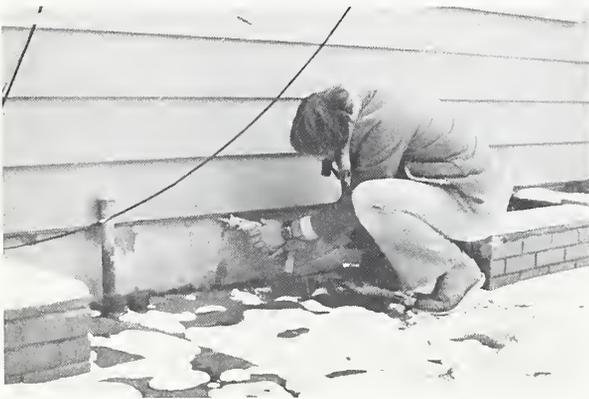
FIGURE 3. Caulking compound being applied to foundation sill.

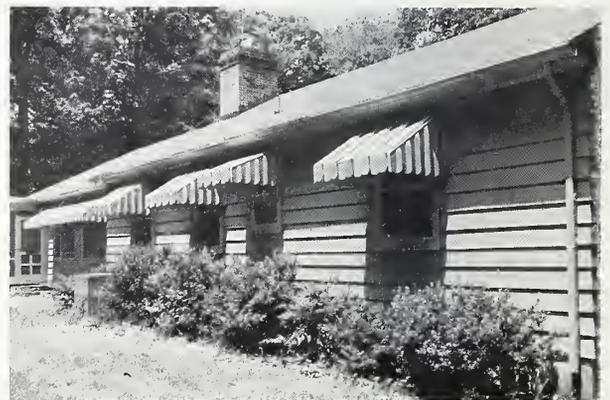
FIGURE 4. A photograph of the south side of the house showing the awnings.

Before the post-retrofit summer cooling energy measurements, aluminum awnings were installed above the windows on the south side of the test house. A photograph of the south side of the test house after the awnings were installed is given in figure 4.

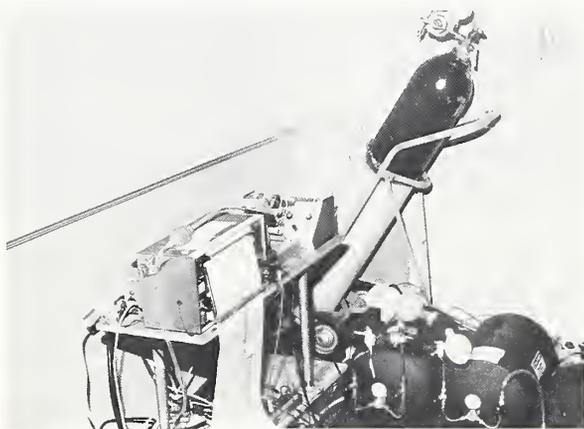
FIGURE 5. Apparatus used to measure air-leakage rates for the test house.

Sulfur-hexafluoride concentrations were measured with a gas chromatograph equipped with an electron-capture detector. A photograph of the measurement apparatus is shown in figure 5.

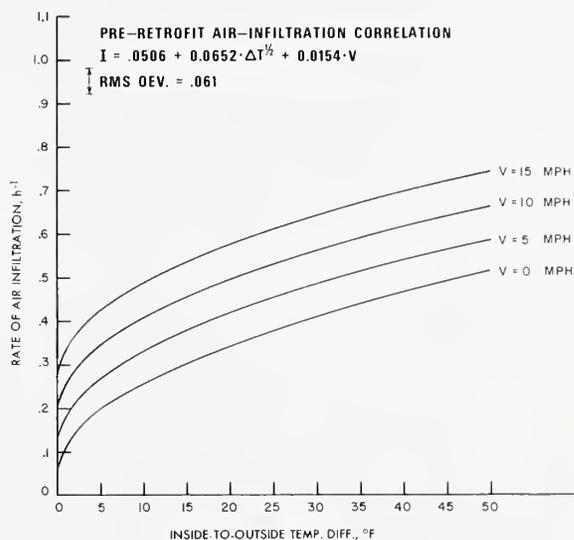
FIGURE 6. Pre-retrofit air-infiltration correlation.

A plot of eq (7) is given in figure 6. Under typical winter conditions, $\Delta T = 35^\circ\text{F}$ (19.4°C) and $V = 7$ mph (3.1 m/s), the rate of air infiltration is roughly 0.5 air changes per hour. At design conditions, $\Delta T = 55^\circ\text{F}$ (30.6°C) and $V = 15$ mph (6.71 m/s), the air-infiltration rate for the test house is 0.75 air changes per hour. These figures indicate that the test house in its original state had low air-leakage rates, due to good construction and good weather-stripping around the doors and windows.

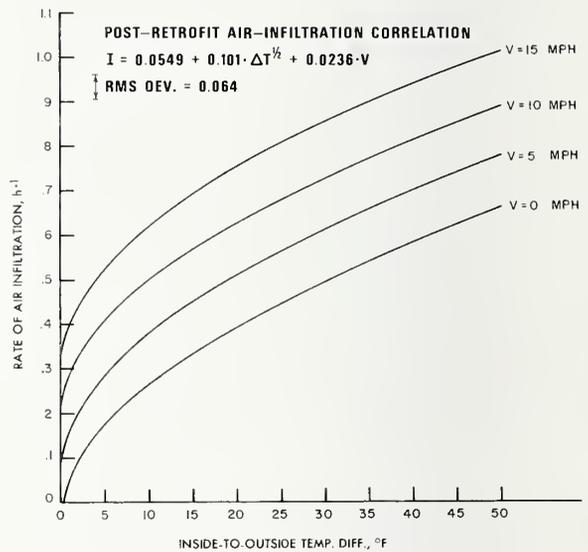
FIGURE 7. Post-retrofit air-infiltration correlation.

Eq (9) is plotted in figure 7.

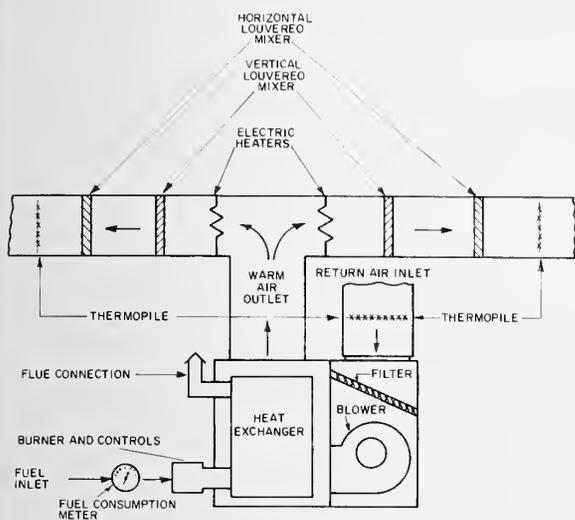
FIGURE 8. Schematic diagram of furnace system showing the location of measuring transducers.

In order to obtain meaningful duct velocity and temperature rise measurements, it is necessary that the measurements be made at a station in the duct having nearly uniform temperature profiles. A schematic diagram of the original oil-fired furnace system showing the location of the measurement transducers is shown in figure 8. Note that the air-delivery duct system has two major supply branches, one delivering conditioned air to rooms located over the basement, the other feeding the rooms located over the crawl space. For the pre-retrofit heating-energy measurements, uniform temperature profiles were created in each major supply branch by installing louvered air-mixing devices which were constructed according to specifications given in reference [18]. The heating

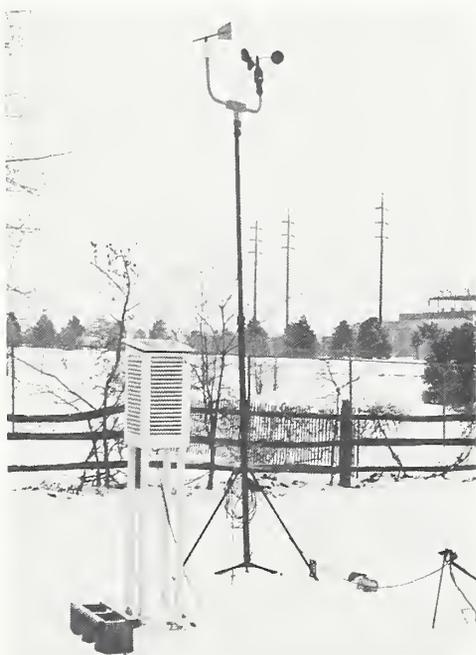
direction vane. The louvered enclosure shown in figure 9 contained a copper-constantan thermocouple for measuring outdoor temperature and a humidity-sensing element which produced a millivolt signal proportional to relative humidity. During the pre-retrofit heating energy measurements, the total solar radiation incident on a horizontal surface was measured with a pyranometer mounted on top of the louvered enclosure shown in figure 9. After the pre-retrofit heating energy measurements, the pyranometer was relocated on the roof of the test house. The outdoor ambient temperature was also measured with thermocouples installed on the north side of trees located behind the test house.

A photograph of the weather station used in the present study is shown in figure 9. This weather station was located approximately 60 ft (18.3 m) in front of and in line with the west end of the test house. This particular location was selected so that the wind direction and velocity sensors, mounted at the 18-ft (5.5 m) level, would be exposed to the prevailing winter northwest wind. Wind velocity was measured with a rotating-cup anemometer, and wind direction was measured with a wind-

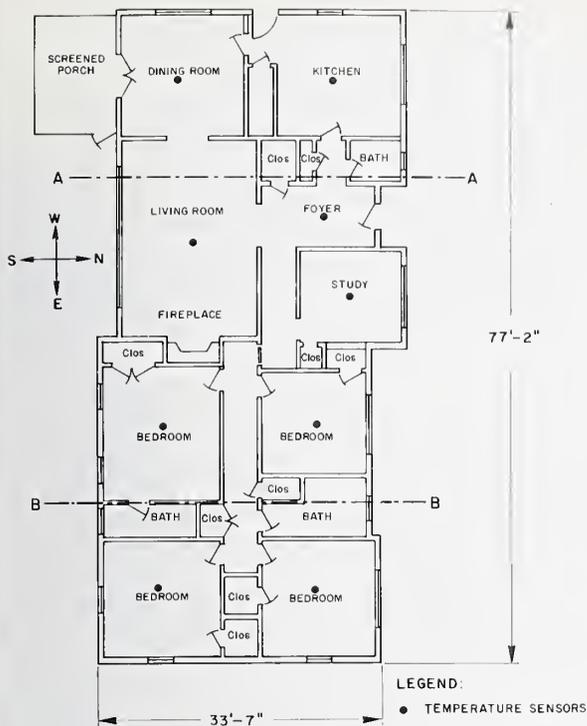
FIGURE 10. Floor plan of test house showing location of temperature sensors.

A relative humidity sensor (the same type that was used in the weather station) was placed indoors in the center of the living room next to the mid-height thermocouple. For the post-retrofit measurements, identical relative humidity sensors were installed in the crawl space, basement, and the attic. In all cases, an ambient air temperature thermocouple was placed next to each humidity sensor.

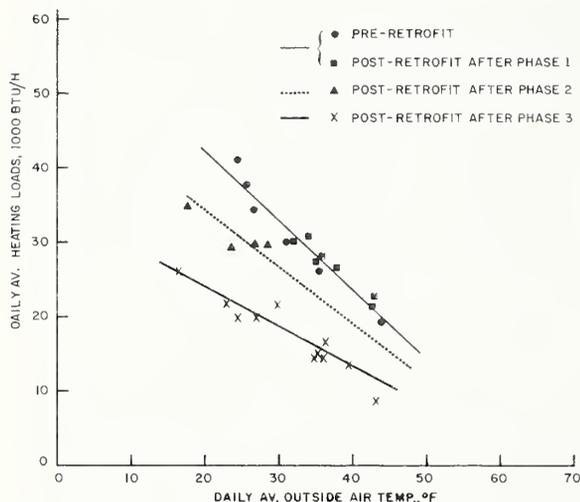
FIGURE 11. Measured heating loads for the unoccupied test house after various stages of the retrofit.

Since the measured daily-average heating loads for the unoccupied test house are approximately equivalent to heat-loss rates, relations (11) and (12) were used to normalize the measured heating loads for the unoccupied test house to the average wind velocity (4.2 mph (1.88 m/s)) and average indoor temperature (67.9 °F (19.9 °C)) of all the winter heating energy measurements. Normalized daily-average heating loads of the unoccupied house before and after the various stages of the retrofit are plotted as a function of daily-average outdoor air temperature in figure 11. The straight lines were obtained from a least-squares procedure.

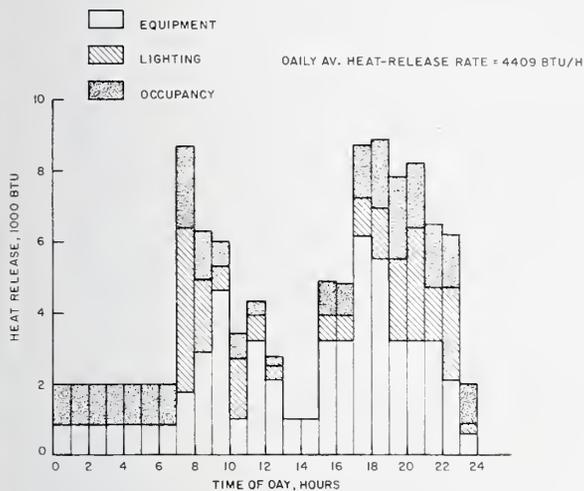
FIGURE 12. Energy-release rates for equipment, lighting, and occupancy.

plant during each hour of every test. If the test house had been occupied, the heat released by occupant-related activities would never have been sufficient to satisfy the heating load of the house over the conditions for which the house was tested. Therefore, the daily-average heating load for the test house, having an occupancy schedule of figure 12, would be equal to the heating load for the unoccupied test house (see fig. 11), less the daily-average heat-release rate for the occupancy schedule of figure 12.

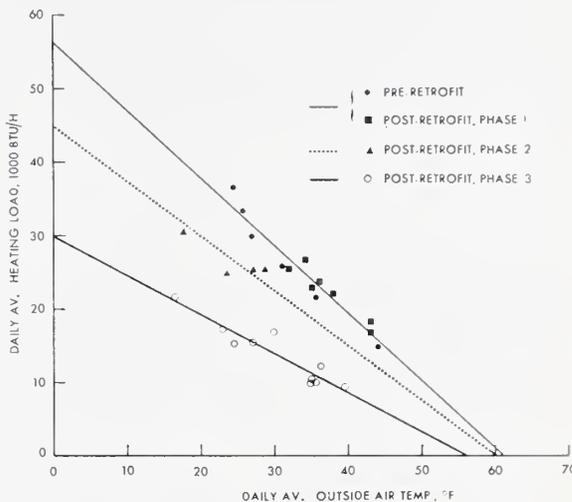
FIGURE 13. Heating-load correlations for the occupied test house after various stages of the retrofit.

The first term in the foregoing equations represents the heat-loss rate from the test house. The second term represents daily-average internal heat-release from occupancy, lighting, and equipment, and heat gain from solar radiation through the windows. Recalling that the daily-average heat-release rate for the occupancy schedule is 4,409 Btu/h (1,291 W), it is seen that the average solar load is calculated to be 1,971 (557 W) and 1,731 Btu/h (507 W), respectively, which are not unreasonable figures.

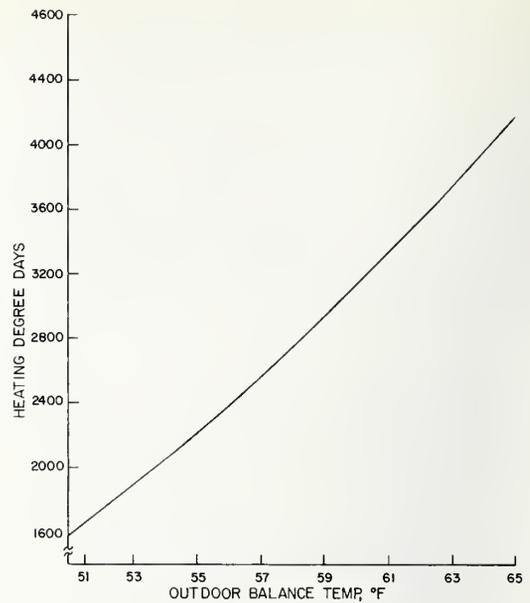
FIGURE 14. Heating degree days as a function of outdoor balance temperature for Washington, D.C.

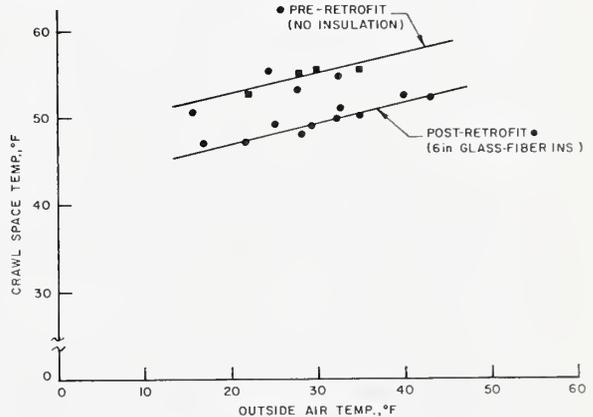
FIGURE 15. Pre- and post-retrofit winter crawl-space temperatures.

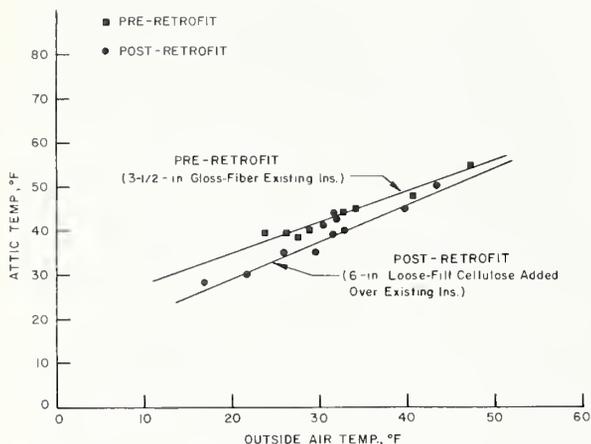
FIGURE 16. Pre- and post-retrofit winter attic temperatures.

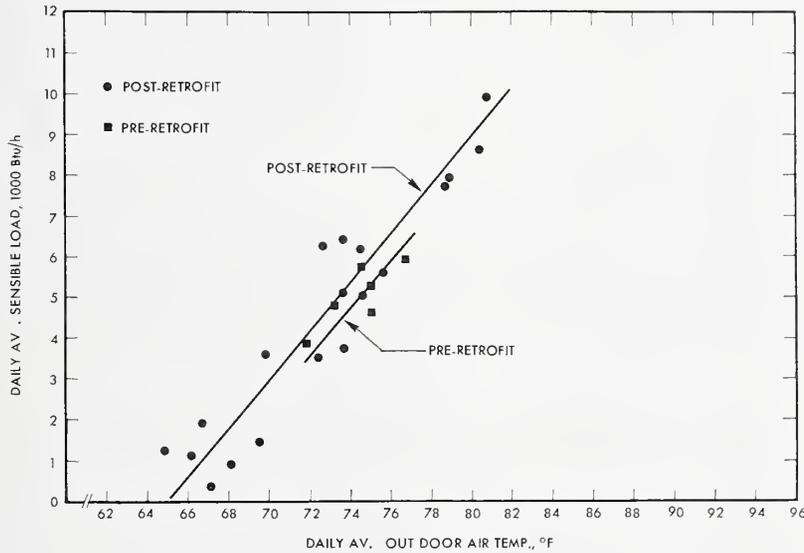
FIGURE 17. Pre- and post-retrofit sensible cooling loads.

FIGURE 18. Pre- and post-retrofit latent cooling loads.

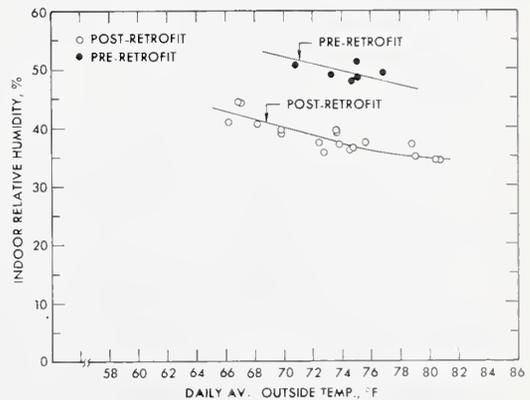
FIGURE 19. Pre- and post-retrofit summer indoor relative humidities.

The reductions in latent load were attributed to a change in the relative humidity levels in the living space. As shown in figure 19, the relative humidity in the first-floor living space was significantly reduced after the retrofit. The reduction in indoor

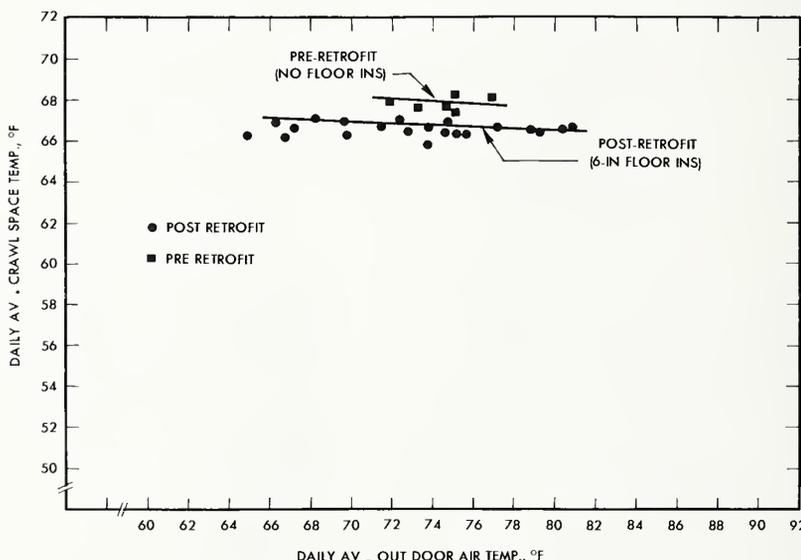
FIGURE 20. Pre- and post-retrofit daily average summer crawl space temperatures.

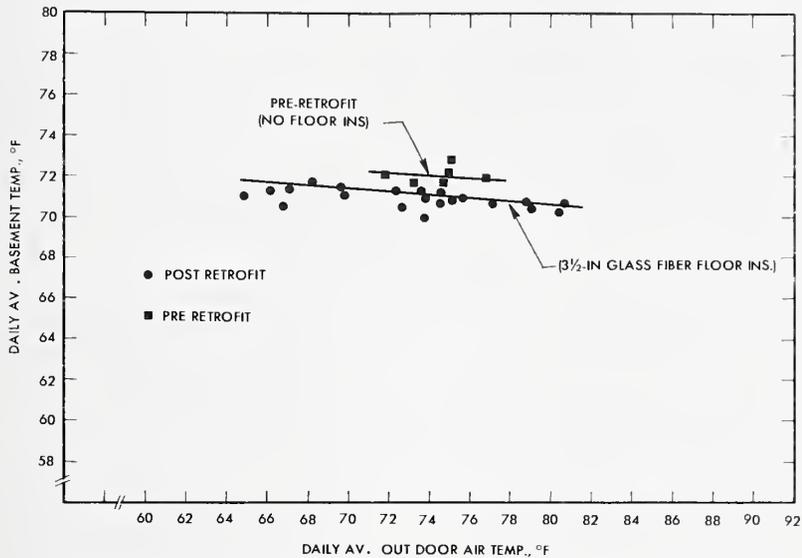
FIGURE 21. Pre- and post-retrofit daily average summer basement temperatures.

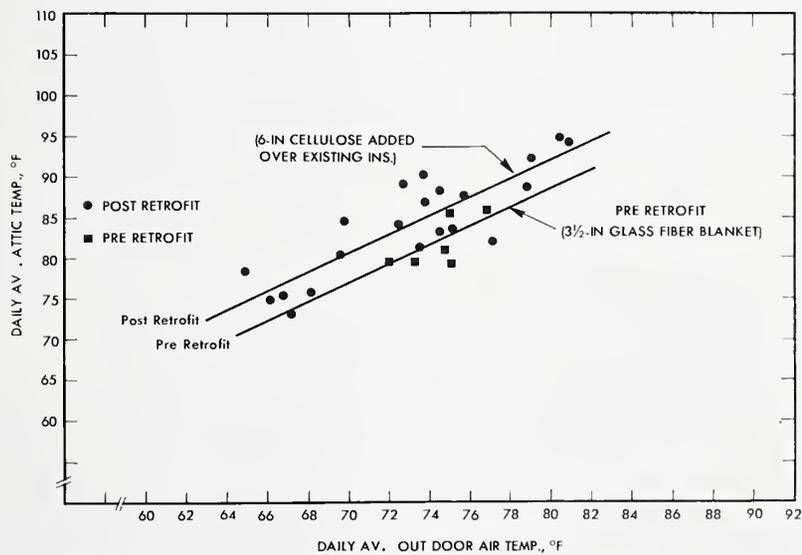
FIGURE 22. Pre- and post-retrofit daily average summer attic temperatures.

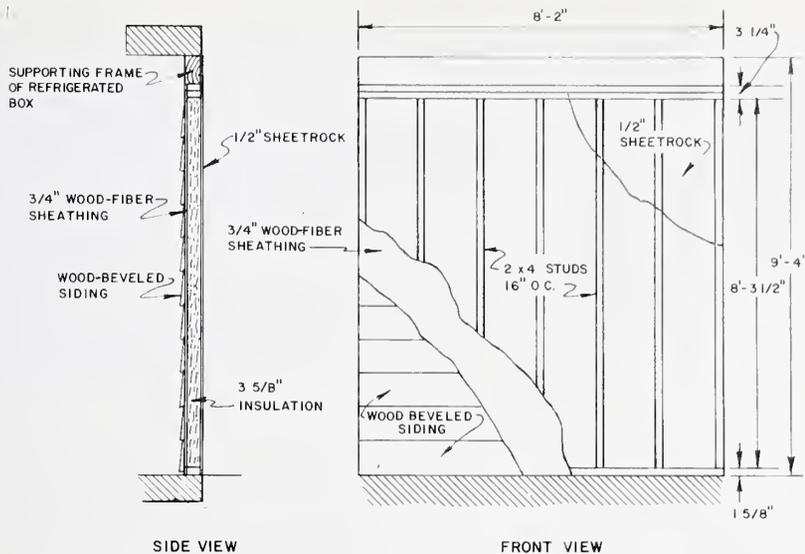
FIGURE 23. Construction details of laboratory test wall.

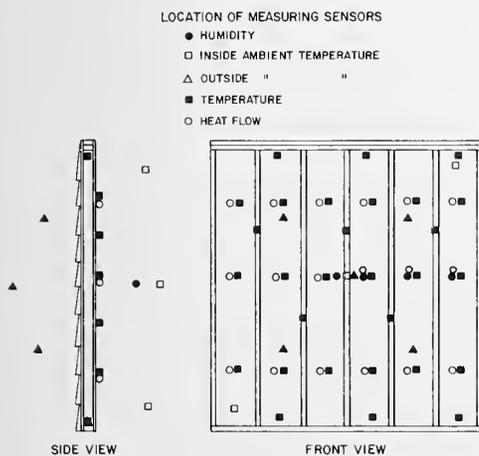
FIGURE 24. Location of measurement transducers on laboratory test wall.

Front and side views of the test wall showing the location of the measurement transducers are given in figure 24. Each pair of wall cavities insulated with different material was instrumented in a similar

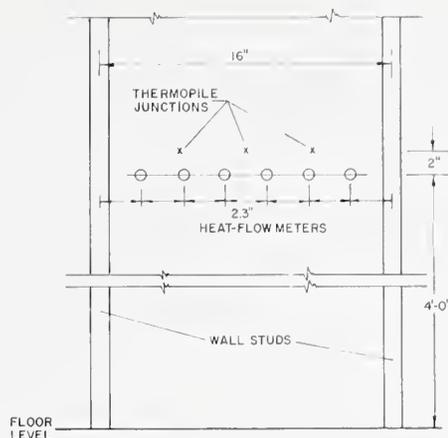
FIGURE 26. Elevation view of wall section of the test house showing heat-flow measuring station.

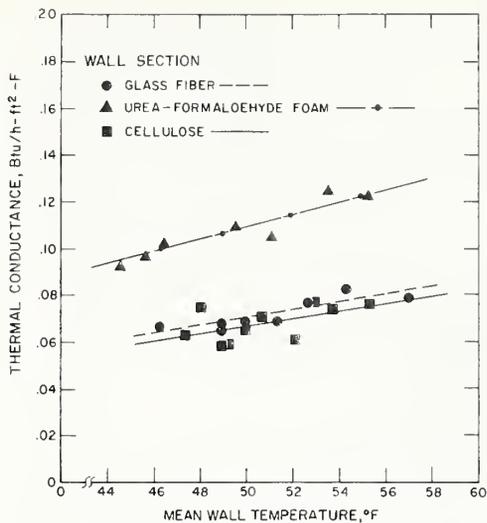
FIGURE 27. The effect of mean wall temperature on the thermal conductance of the three separate wall sections.

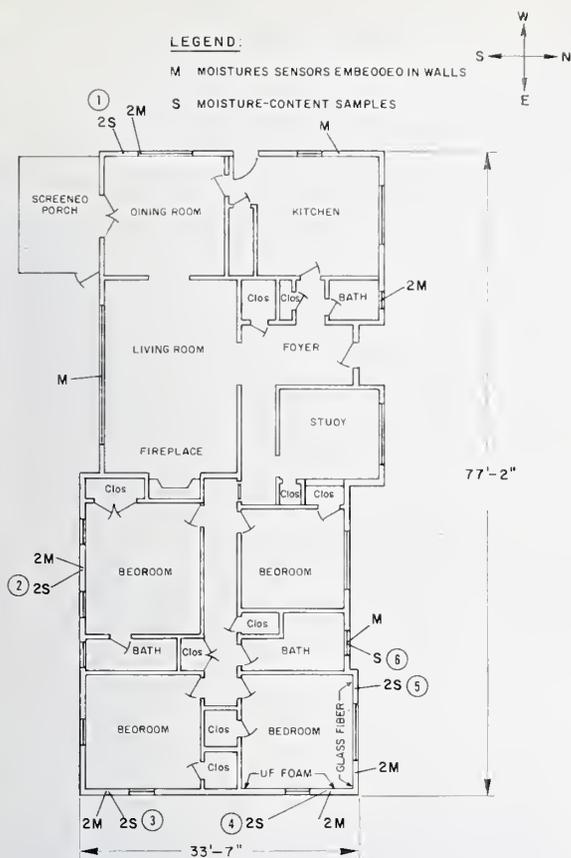
FIGURE 28. Floor plan of the test house showing location of humidity sensors and place where moisture content samples were cored out.

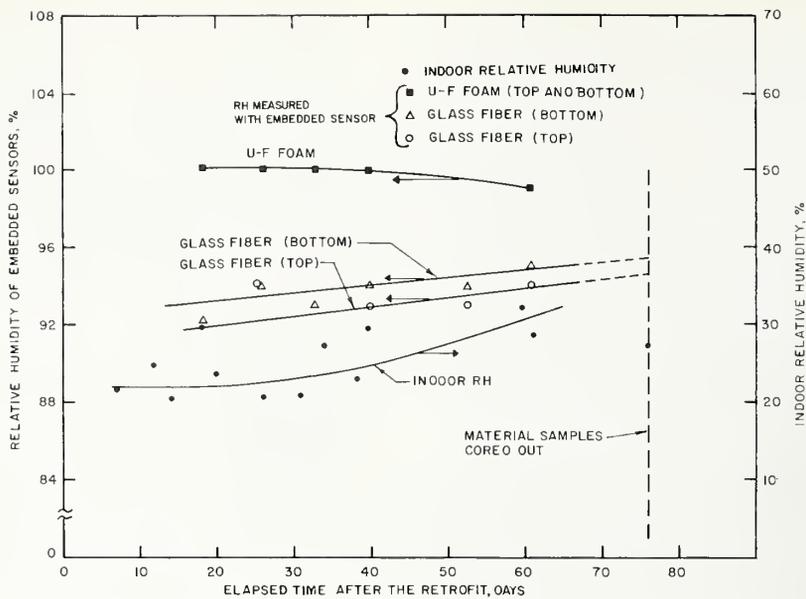
FIGURE 29. Variation of indoor relative humidity and relative humidities of embedded sensors.

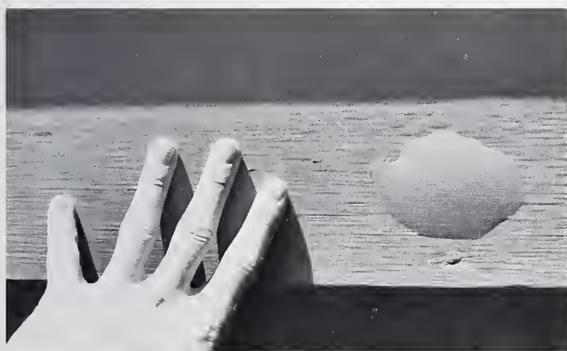
FIGURE 30. Water blister at exterior surface of U-F wall section.

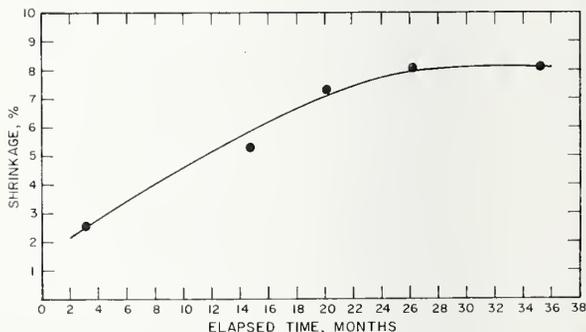
FIGURE 31. Percent linear shrinkage of urea-formaldehyde foam insulation as a function of elapsed time.

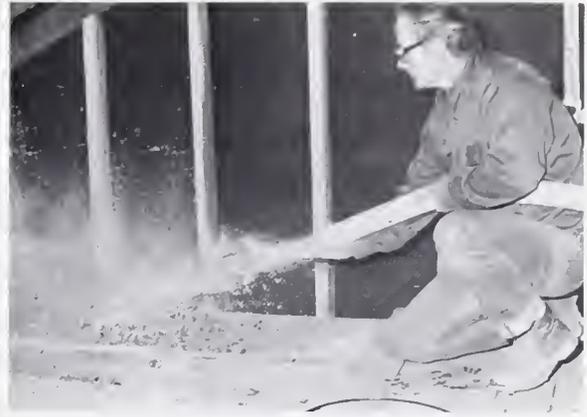
FIGURE A-2. Loose-fill cellulose being blown on top of the existing ceiling insulation.

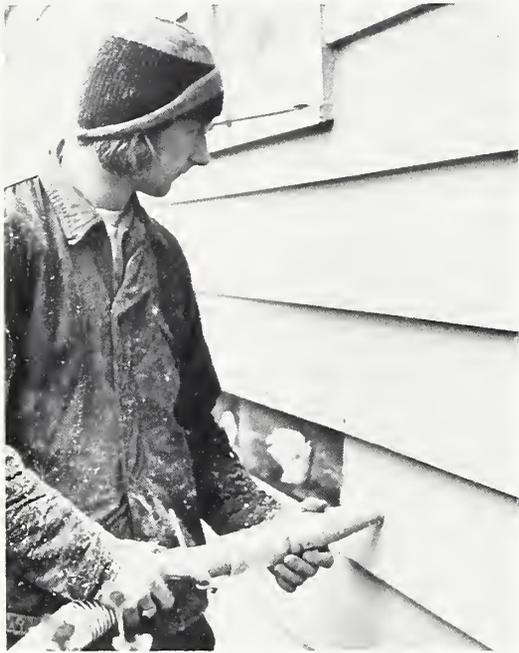
FIGURE A-3. Cellulosic fiber being blown into the walls of the test house.

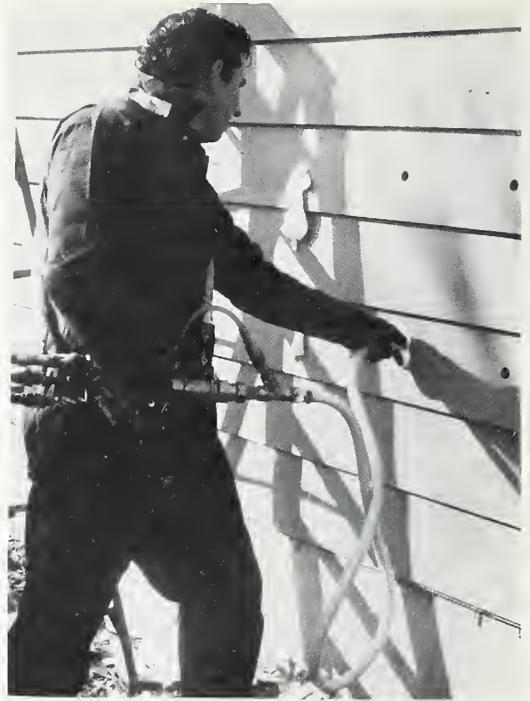
FIGURE A-5. Urea-formaldehyde foam being blown into a wall section.

The application technique was to drill four 1-in (2.54 cm) holes, approximately 2 ft (0.610 m) apart vertically, in each of the wall cavities. The U-F foam was successively applied from the bottom to the top holes, completely filling the wall cavity (see fig. A-5). When the foam was initially applied, its wet density was 2.5 lb/ft³ (40.1 kg/m³). Figure A-6 is a photograph of the technical representative for the U-F foam measuring the wet density of the U-F foam material. The technical representative

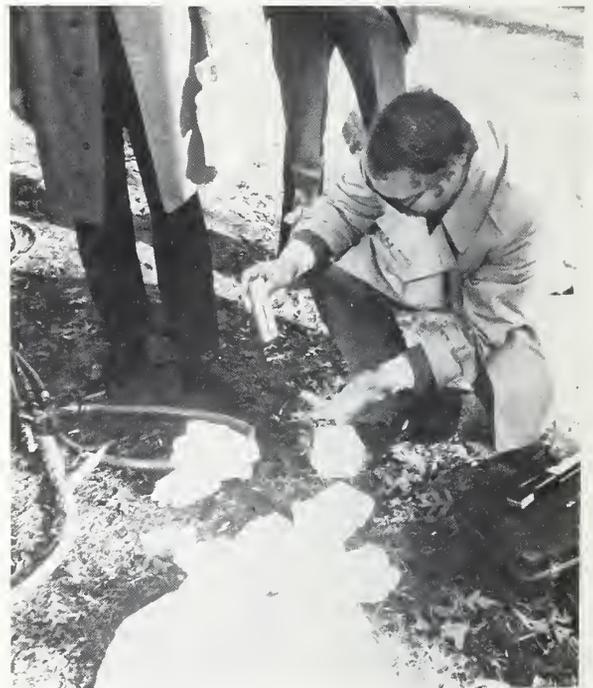
FIGURE A-6. Technical representative measuring wet density of the U-F foam.

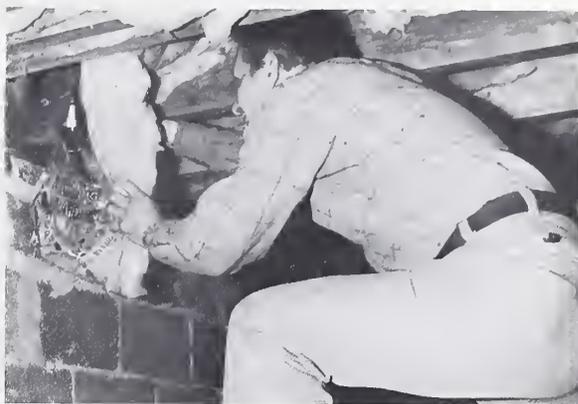
FIGURE A-7. Glass-fiber batts being installed under the floor in the crawl space.

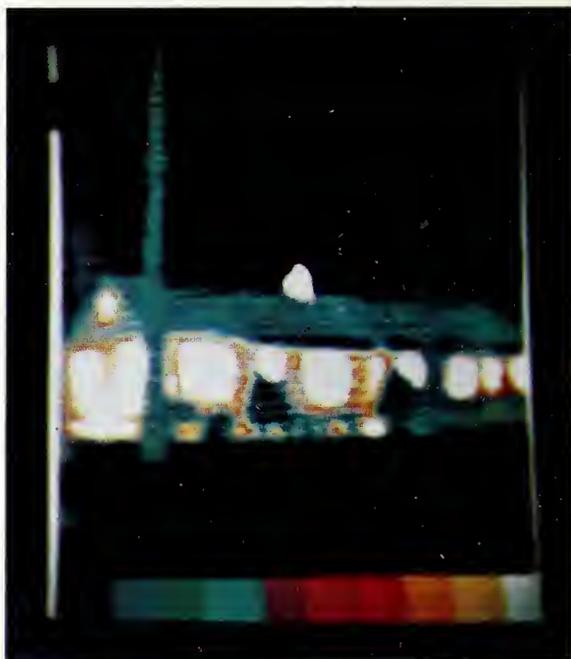
FIGURE B-2. Overall view of exterior surfaces of the test house. (b) Thermogram before retrofit.

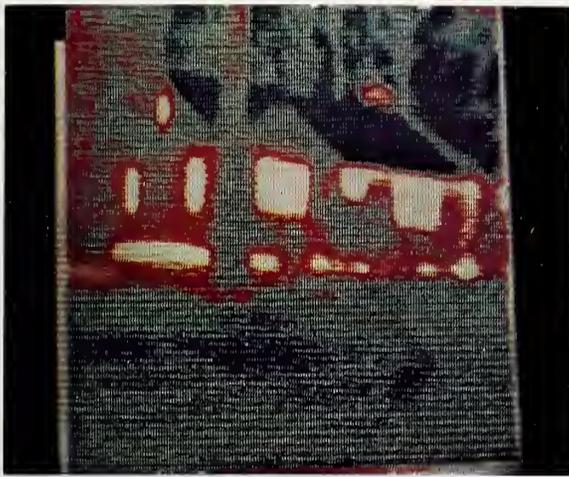
FIGURE B-2. Overall view of exterior surfaces of the test house.
(c) Thermogram after retrofit.

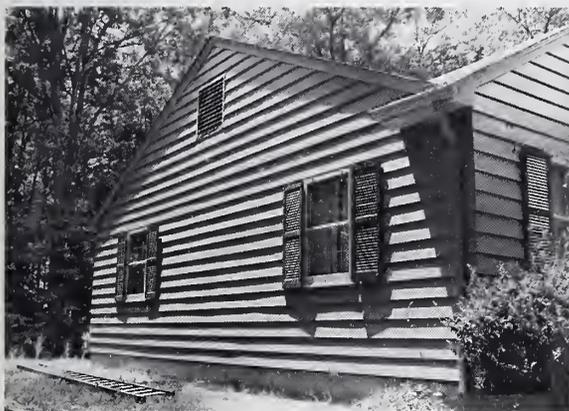
FIGURE B-3. East end of test house.
(a) Conventional photograph.

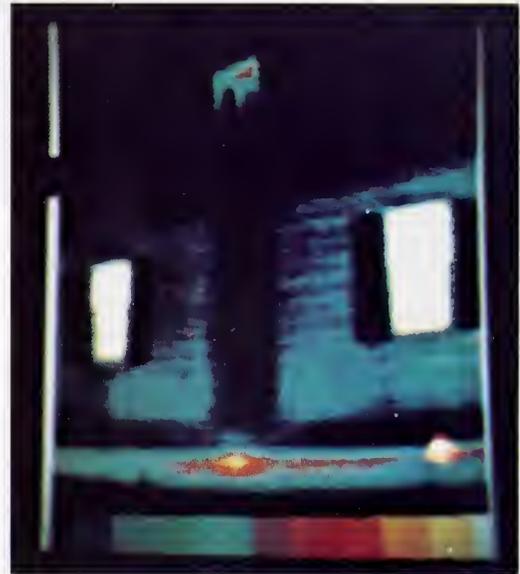
FIGURE B-3. East end of test house.
(b) Thermogram before retrofit.

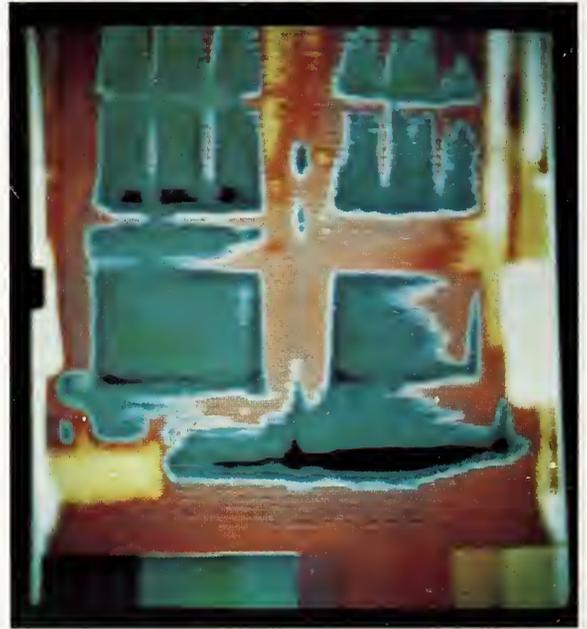
FIGURE B-4. Interior surface of dining room door.
(b) Thermogram before retrofit.

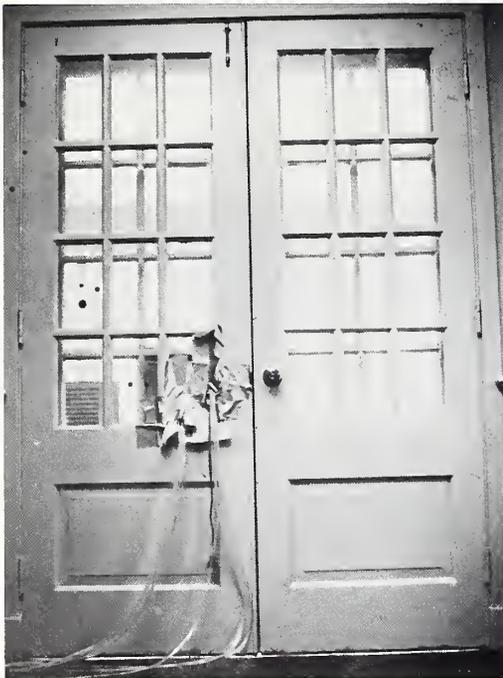
FIGURE B-4. Interior surface of dining room door.
(a) Conventional photograph.

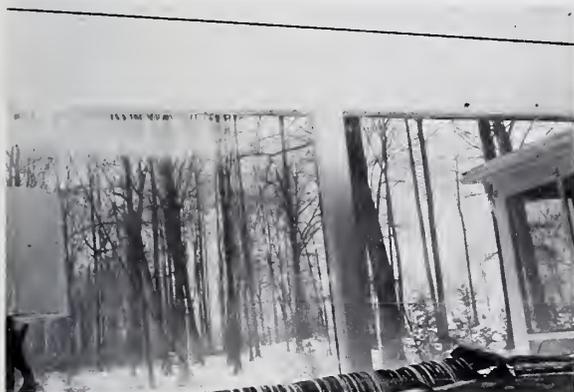
FIGURE B-5. Interior view of ceiling-wall interface above the bay window in living room.
(a) Conventional photograph.

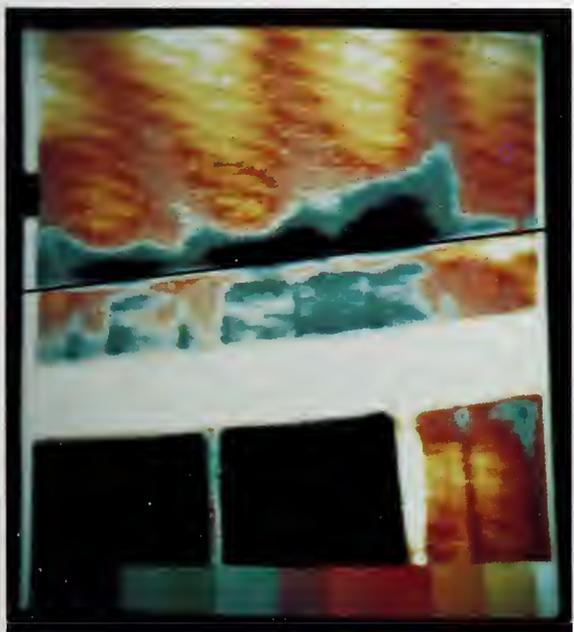
FIGURE B-5. Interior view of ceiling-wall interface above the bay window in living room.
(b) Thermogram before retrofit.

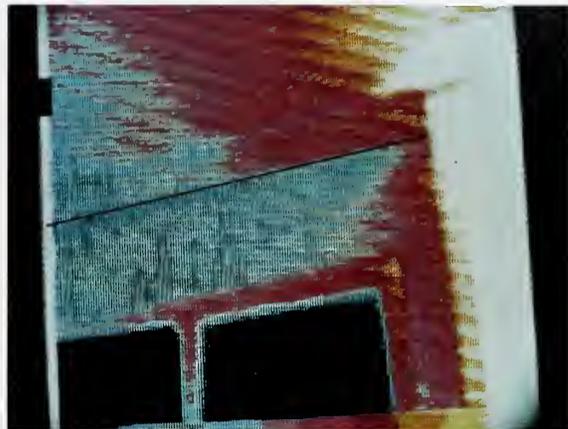
FIGURE B-5. Interior view of ceiling-wall interface above the bay window in living room.
(c) Thermogram after retrofit.

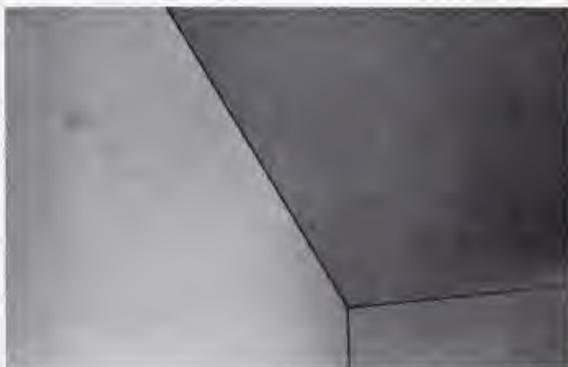
FIGURE B-6. Interior view of upper corner of northeast bedroom.
(a) Conventional photograph.

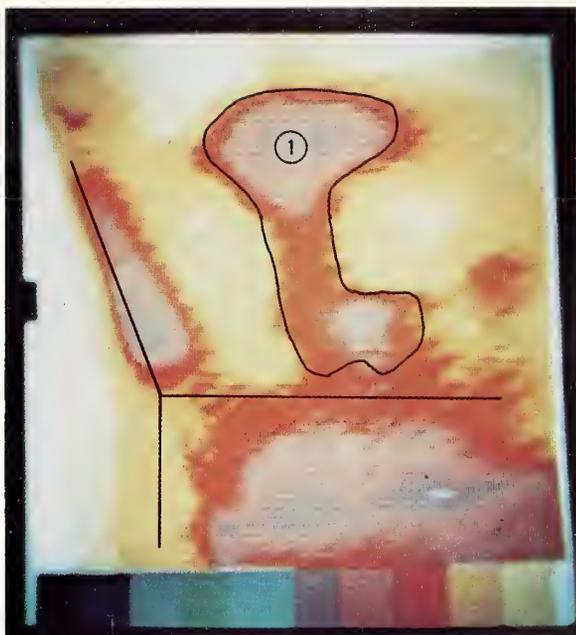
FIGURE B-6. Interior view of upper corner of northeast bedroom.
(b) Thermogram before retrofit.

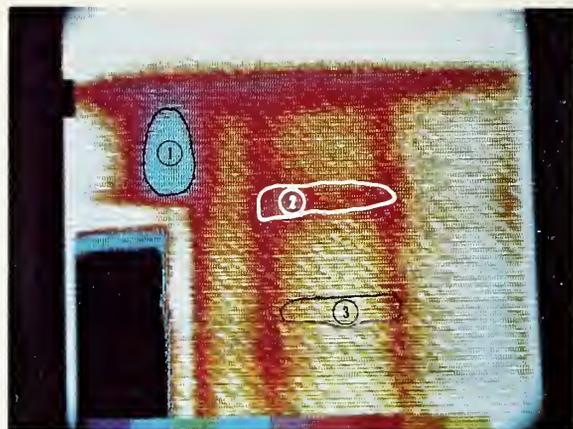
FIGURE B-7. Winter thermogram of inside surface of U-F wall section.

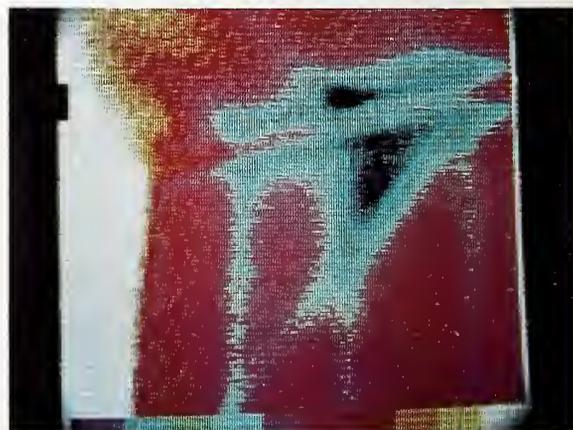
FIGURE B-8. Winter thermogram of inside surface of cellulose wall section in dining room.

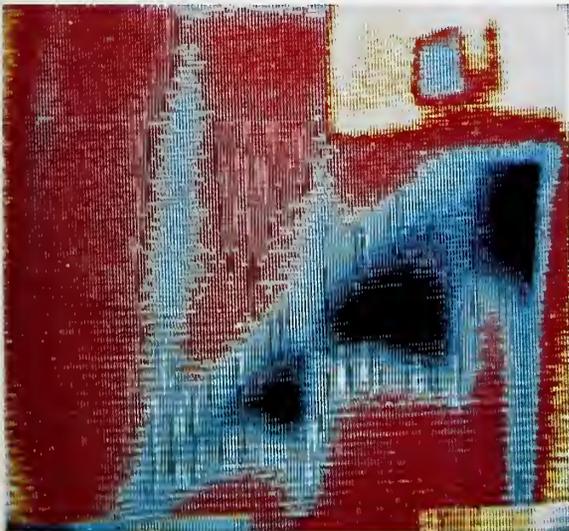
FIGURE B-9. Winter thermogram of inside surface of cellulose wall section in southeast bedroom.

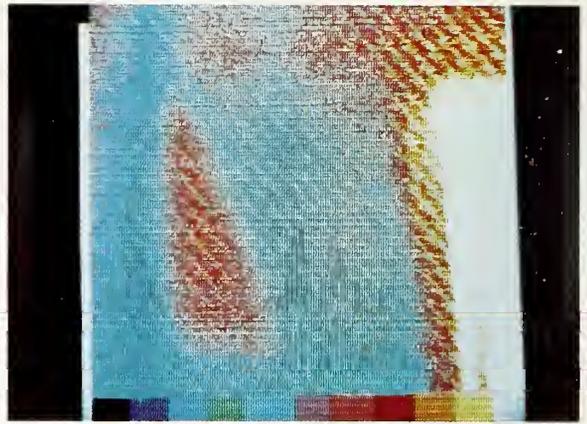
FIGURE B-12. Summer thermogram of the inside surface of the glass-fiber wall section in northeast bedroom.

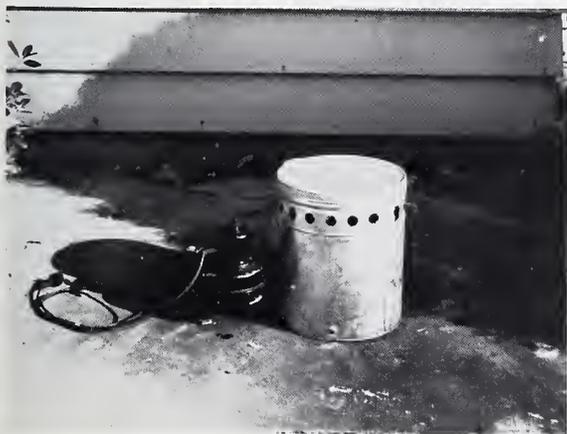
FIGURE C-1. *Drum-type smoke distributor.*

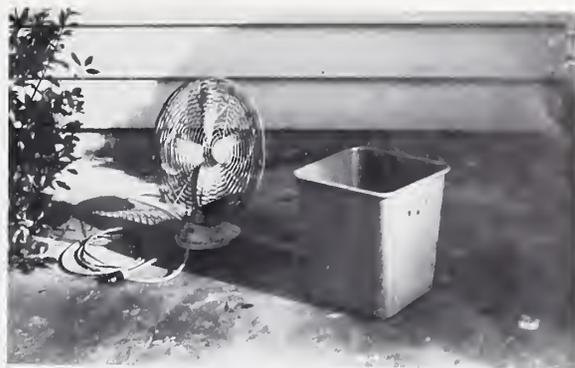
FIGURE C-2. *Fan and metal trash basket used to distribute white pyrotechnic smoke.*

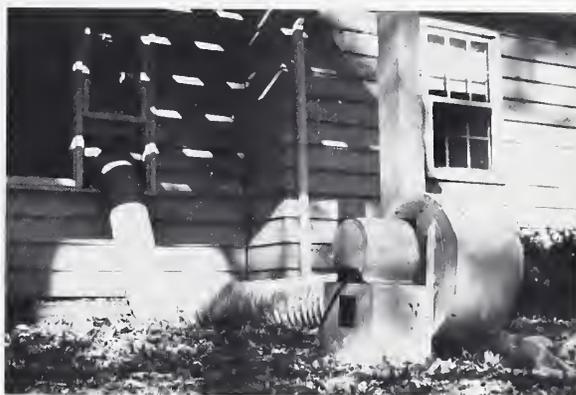
FIGURE C-3. *Centrifugal blower connected to the window panel with a flexible hose.*

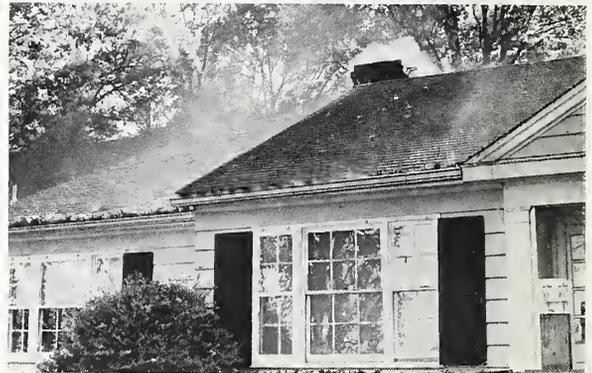
FIGURE C-4. Major air leakage path through the chimney.

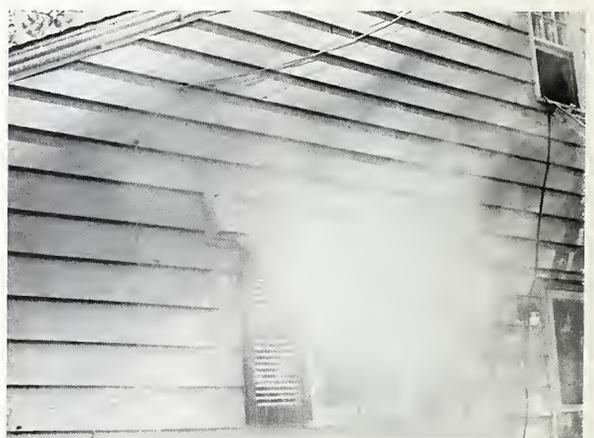
FIGURE C-5. Major air leakage path through kitchen exhaust opening.
