NORRIS COTTON
FEDERAL BUILDING

NBS BUILDING SCIENCE SERIES 133

Performance of the Norris Cotton Federal Office Building for the First 3 Years of Operation

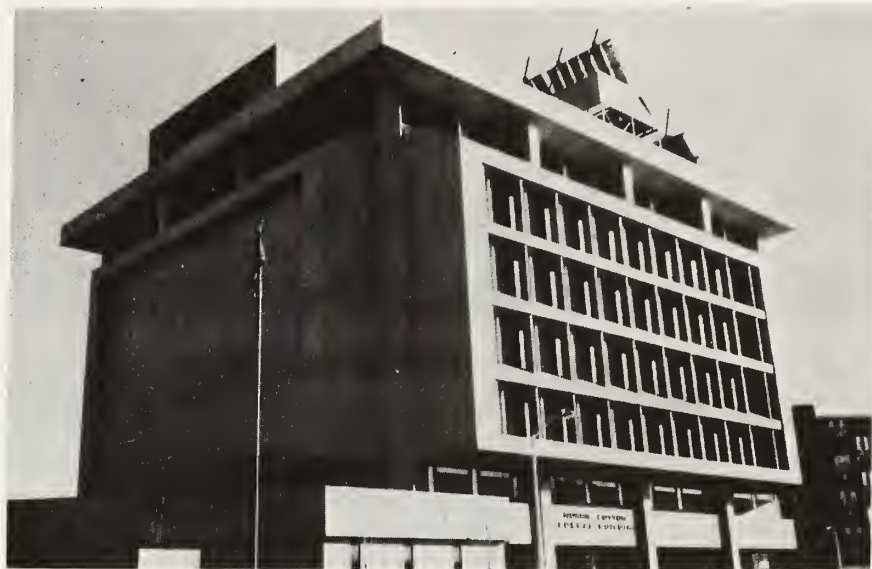
Figure 3. Norris Cotton Federal Office Building in Manchester, New Hampshire

The Norris Cotton building is shown in figure 3. The shell is nearly cubical in shape and thus has a low surface to volume ratio. Its exterior walls are constructed with relatively heavy, 30 cm (12 in) thick masonry blocks and are insulated on the outside rather than inside. The wall has an overall heat transfer coefficient (U value) of $0.34 \text{ W/m}^2\text{°C}$ ($.06 \text{ Btu/(h}\cdot\text{ft}^2\text{°F)}$). This "inside-outside" construction creates a thermal flywheel effect which reduces peak heating and cooling loads. Overall window area makes up only about 6 percent of the total exterior wall with the north wall being completely windowless. Each window is double-glazed and surrounded on the outside by granite fins that provide shading in summer and reduce convection heat losses due to wind. The air gap between glazings is 2-3 cm (approximately 1 in) and contains a set of adjustable louvers that control solar gain and reduce convection. The windows have a U value of $3.3 \text{ W/m}^2\text{°C}$ ($0.58 \text{ Btu/(h}\cdot\text{ft}^2\text{°F)}$).

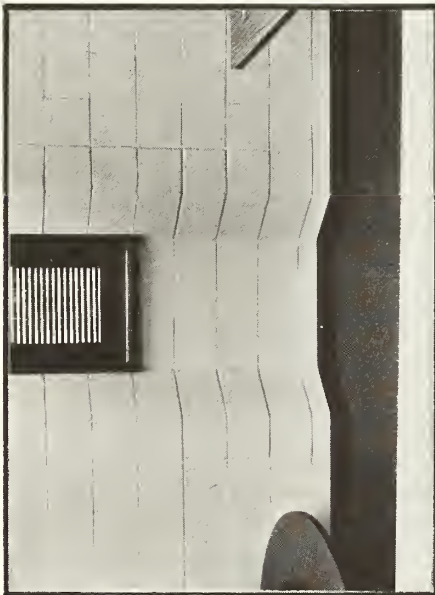
Figure 12. First floor east, interior wall of the Norris Cotton Federal Office Building

Figure 13. Results of the thermogram on the first floor east, interior wall of the Norris Cotton Federal Office Building (1 - coldest isotherm, 10 - warmest isotherm)

temperature and the design insulation values of the insulated concrete wall and double-glazed window, it was calculated that the wall should have been several degrees warmer than the window. However, it was observed that portions of the wall near the floor were at temperatures equal to the surface of the window (this phenomenon was found to exist at several locations throughout the building, often to a greater extent than is shown in figure 13). In order to obtain additional insight into this phenomenon, the thermographic equipment was moved outside the building and a thermogram was taken from the outside of the same section of the wall as shown in figures 12 and 13. It was felt that if the insulation in this space had been omitted or damaged so that heat loss here were purely a result of increased conduction and convection, the area under the window would have indicated a temperature as warm as the glass. However, the thermogram (figure 15) revealed this to be one of the coldest areas in the scan, much colder than the adjacent glass. Thus it appeared that thermal conduction through the insulation was not the cause of the cold inner surface since the outer surface would have been much warmer than it actually was.

A probable cause that explains why both the inner and outer wall surfaces were cold is the leakage of air into the building. Negative pressure within the building, created in part by a natural stack effect, causes cold air to be drawn in through window frames, cracks in the mortar and walls, breathing holes, and openings that may have inadvertently been left open during construction. As this cold air seeps into the building, it comes into direct contact with the inner masonry blocks and causes cooling. To test this theory, the suspended ceiling was removed near the wall on the second floor as shown in figure 16. Cold air was found to be leaking into the ceiling space at a location where a steel supporting structure extended through the insulation (circled area in figure 16). The corresponding thermogram, figure 17, shows the location as being quite cold. Subsequent examination of visual photographs taken during the building's construction showed that (1) steel struts extending through the insulation are used to support the granite facade overhangs on this floor and the glass fiber insulation was pieced together around the struts with no special precaution taken to seal against air leakage, and (2) several cracks existed in the exterior of the masonry wall before application of the insulation. These cracks appear to have resulted from either pipes built into the wall or defective mortar joints.

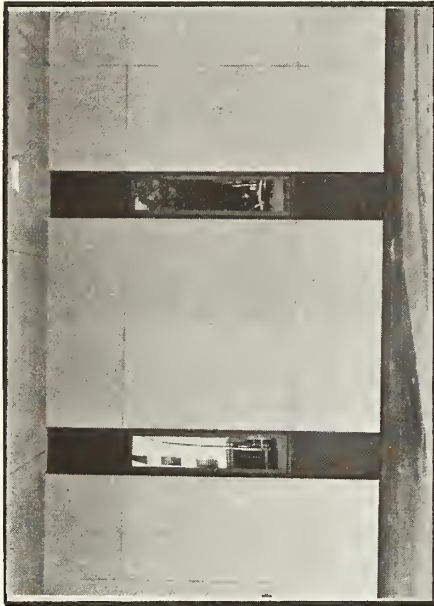
Figure 14. First floor east, exterior wall of the Norris Cotton Federal Office Building

Figure 15. Results of the thermogram on the first floor east, exterior wall of the Norris Cotton Federal Office Building (1 - coldest isotherm, 10 - warmest isotherm)

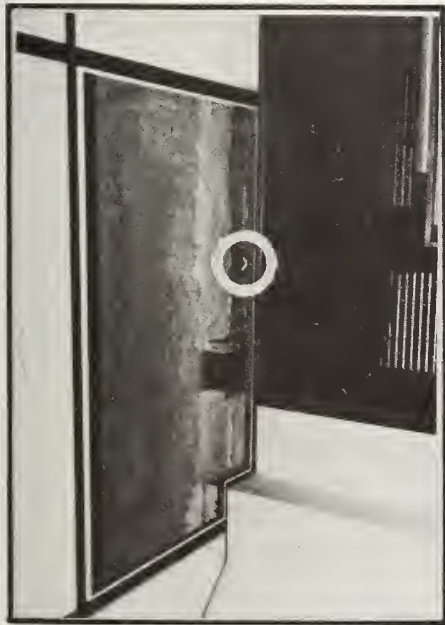
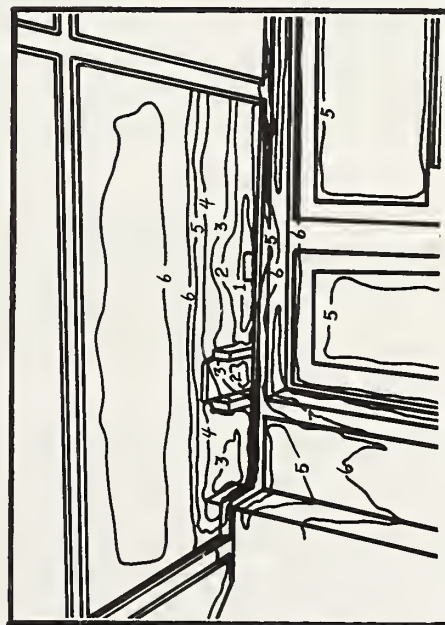
Figure 16. Ceiling with one tile removed on the second floor, west interior wall of the Norris Cotton Federal Office Building

Figure 17. Results of the thermogram on the second floor, west interior wall of the Norris Cotton Federal Office Building (1 = coldest isotherm, 10= warmest isotherm)

to some extent, the same problems found on the second floor. Even the north wall on the third floor was found to be substantially cool. This was surprising since there are no windows on the north wall and the construction is different than on the other three. Air must have been infiltrating the cavity space here along some path different than that on the other three walls.

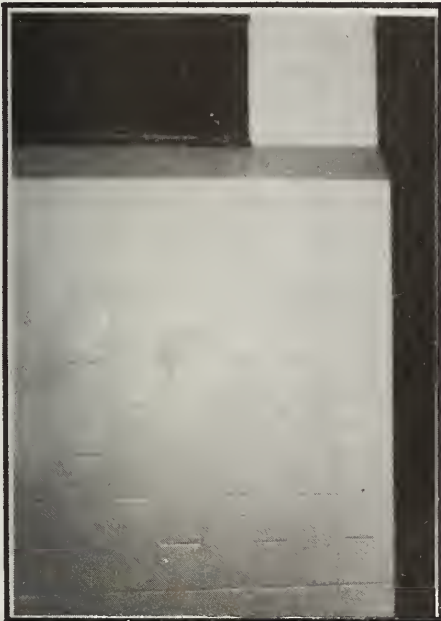
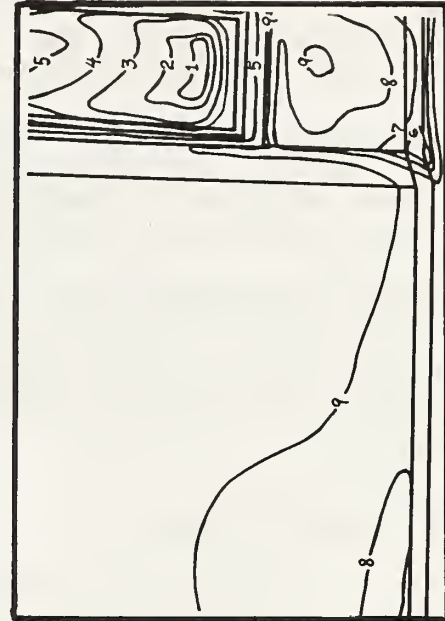
Figure 18. Properly insulated wall, sixth floor, east interior wall of the Norris Cotton Federal Office Building

Figure 19. Results of the thermogram on the sixth floor, east interior wall of the Norris Cotton Federal Office Building (1 = coldest isotherm, 10 = warmest isotherm)

There were some areas that were free of this air leakage problem. Figures 18 and 19 for example, were taken along the east wall of the sixth floor and the results were indicative of what should have existed throughout the building; a much warmer wall and floor surface than window surface.

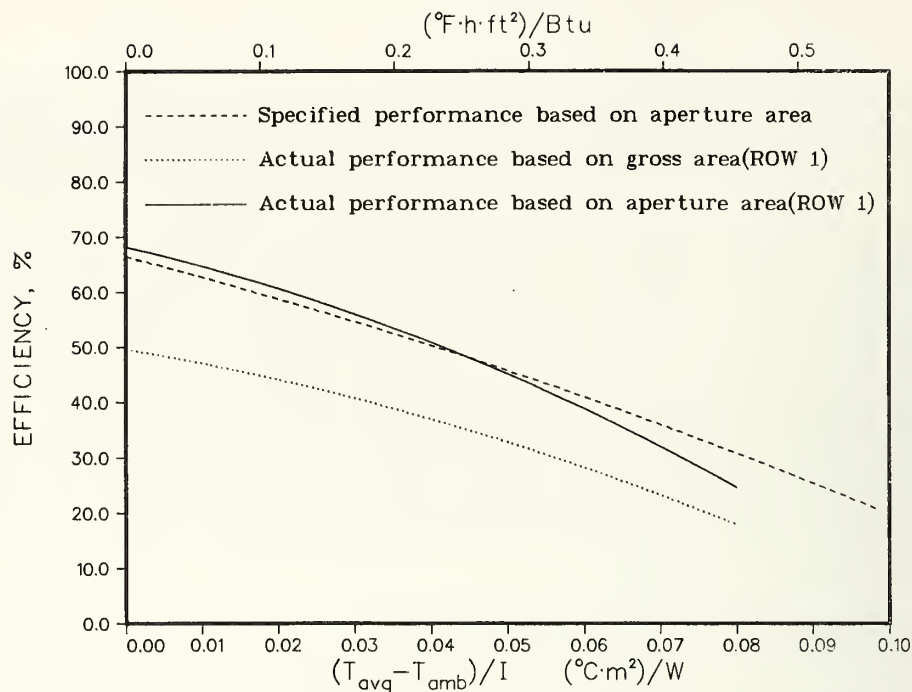
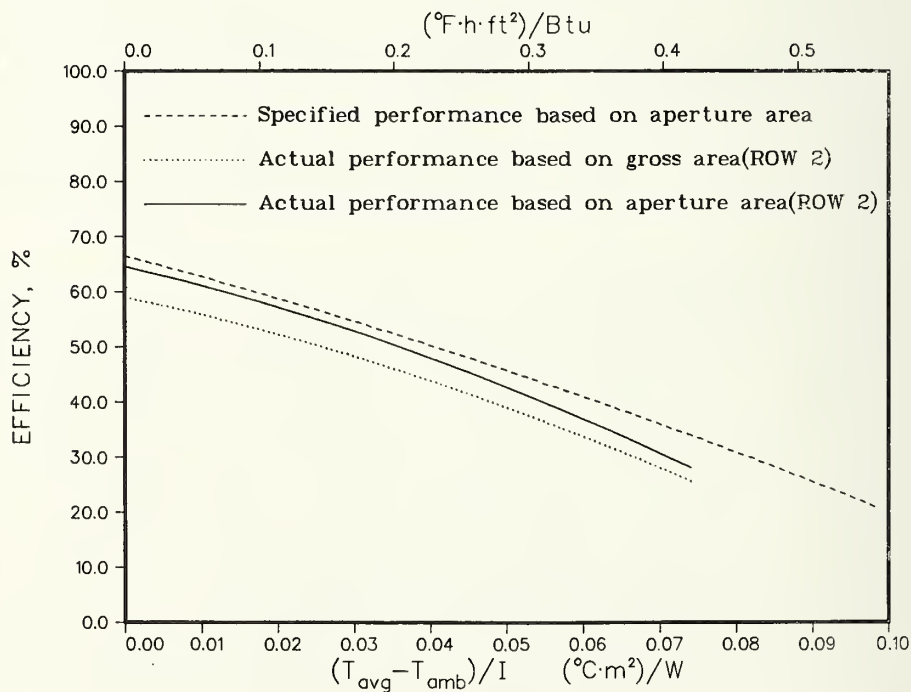
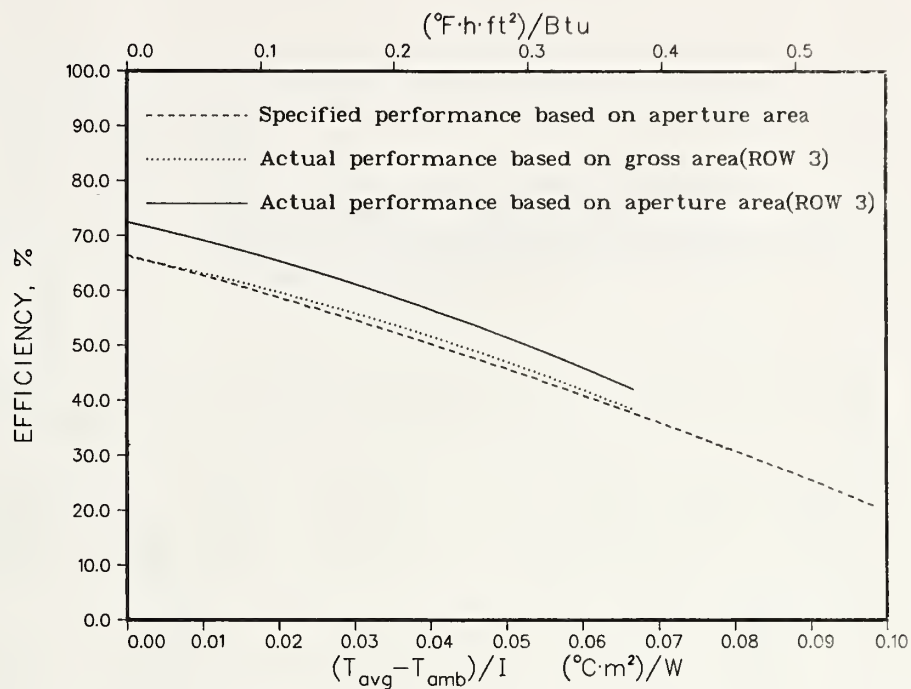
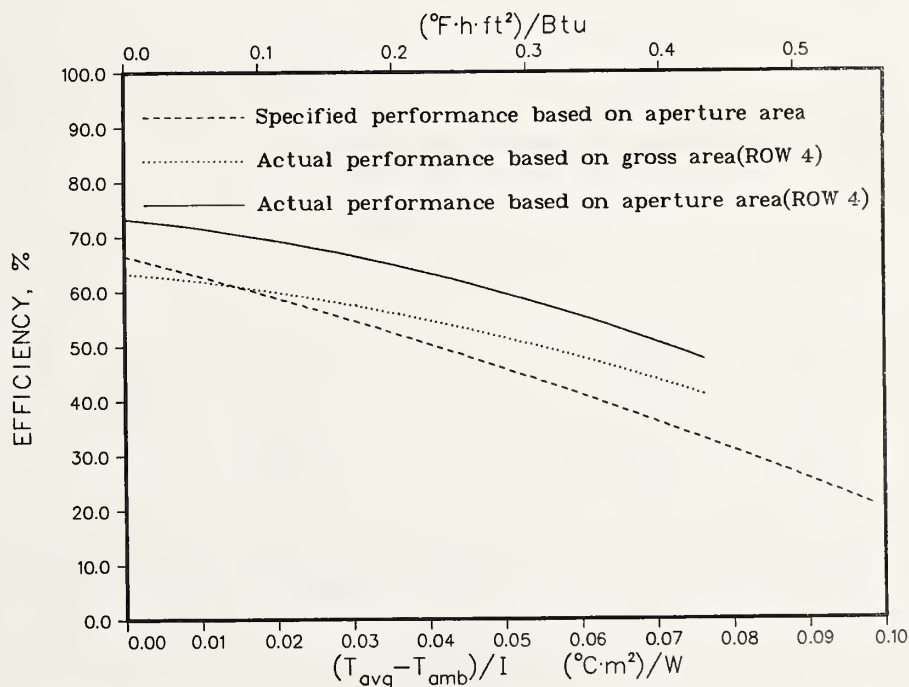
Figure 23. Collector performance for the modules in row 1 at Norris Cotton Federal Office Building as determined by a test of one module in a commercial testing laboratory

Figure 24. Collector performance for the modules in row 2 at the Norris Cotton Federal Office Building as determined by a test of one module in a commercial testing laboratory

Figure 25. Collector performance for the modules in row 3 at the Norris Cotton Federal Office Building as determined by a test of one module in a commercial testing laboratory

Figure 26. Collector performance for the modules in row 4 at the Norris Cotton Federal Office Building as determined by a test of one module in a commercial testing laboratory

- * Row 1: single-glazed, flat-black absorber, plastic convection suppressor
 Row 2: single-glazed, flat-black absorber
 Row 3: double-glazed, selective surface absorber
 Row 4: double-glazed, flat-black absorber
