NBS BUILDING SCIENCE SERIES 148

Investigation of Construction Failure of Reinforced Concrete Cooling Tower at Willow Island, WV

Issued September 1982

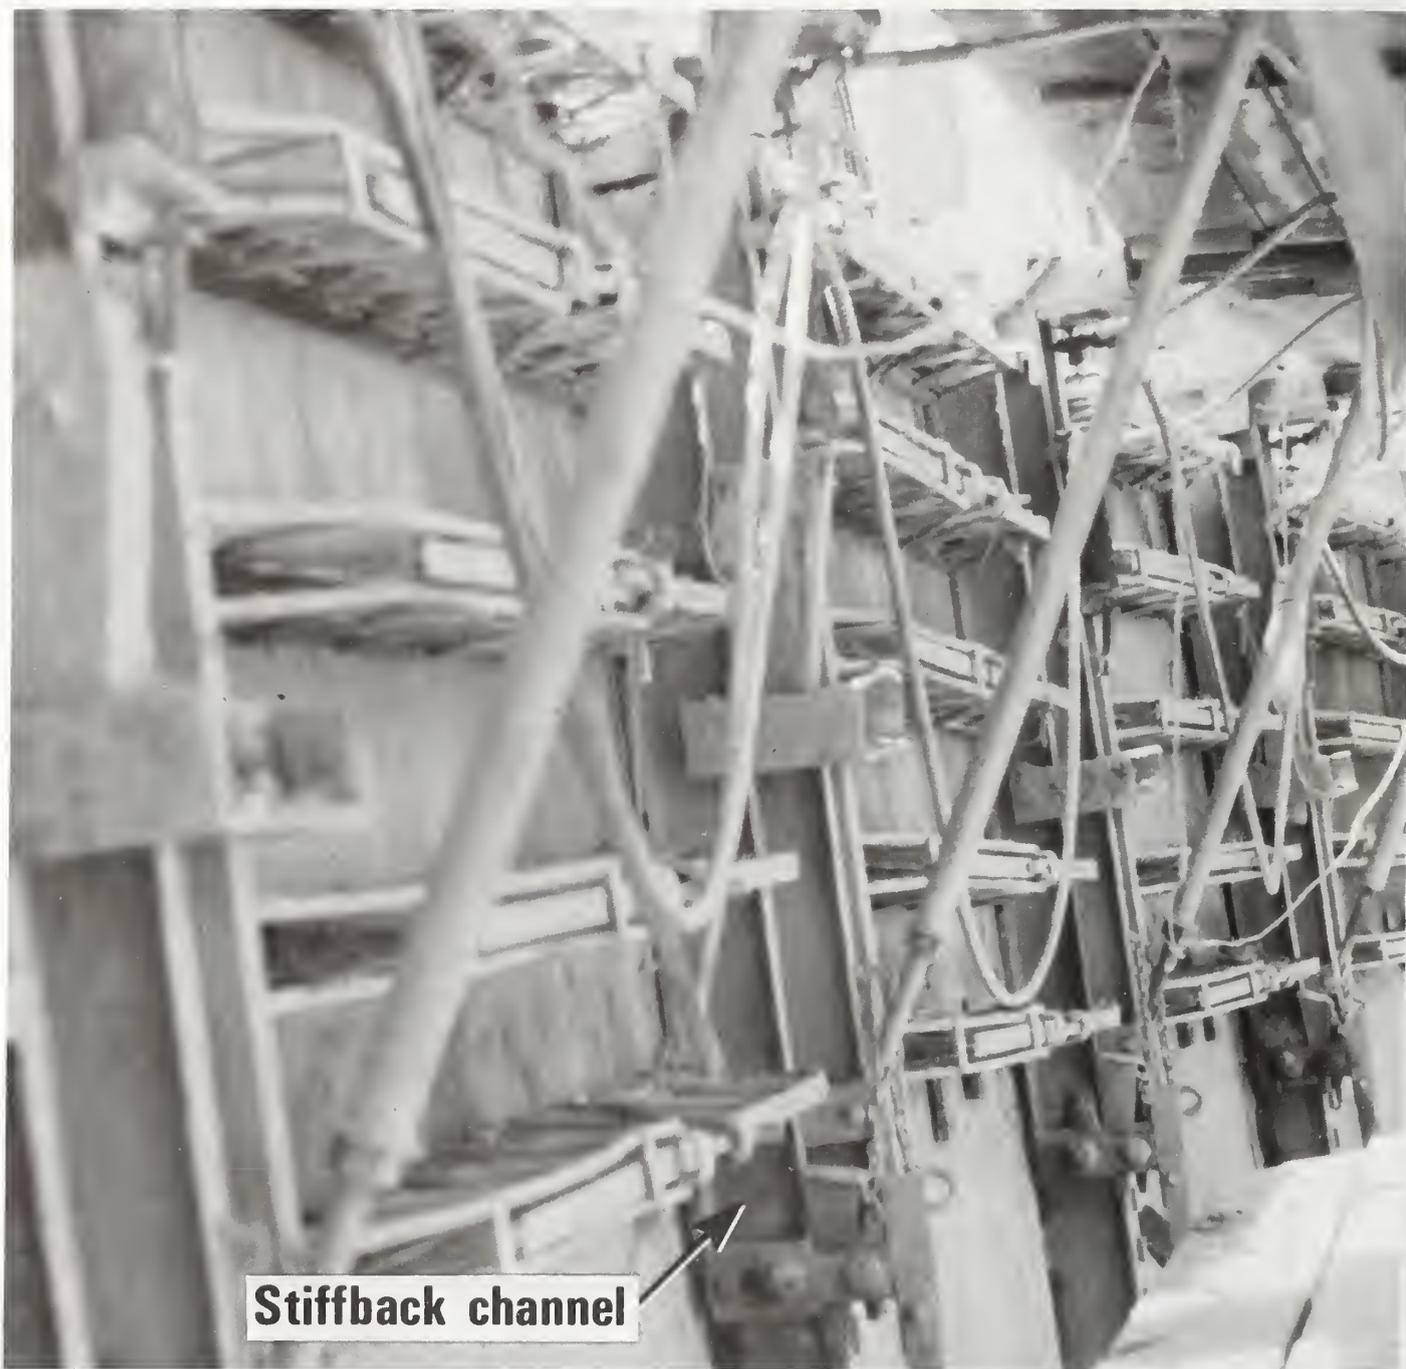
Figure 2.10 Formwork support system
(Note five levels of adjustable joists are used per lift.)

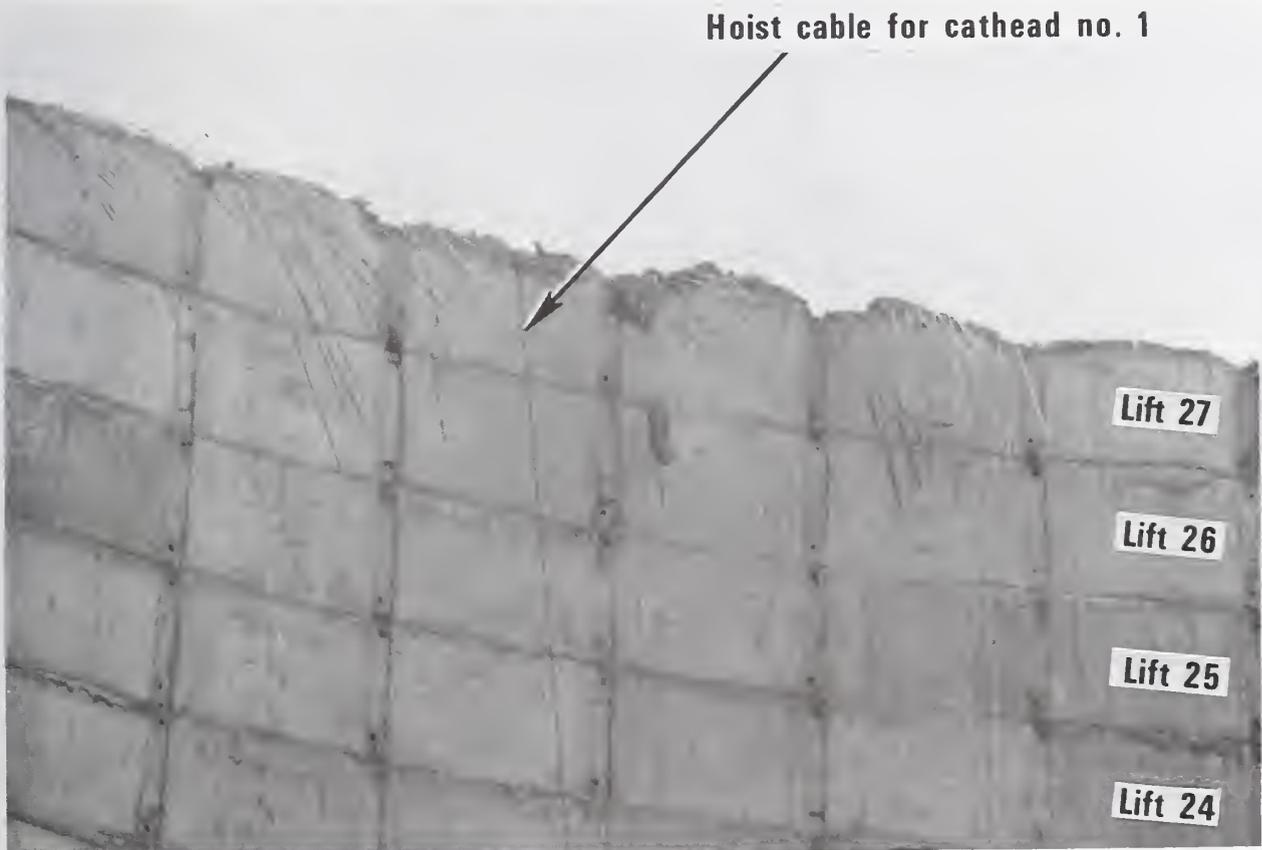
Figure 3.2 Top of Lift 27 Showing Jagged Edge

Figure 3.1 shows the exterior view of tower unit no. 2. Collapse occurred as concrete was being placed for lift 29. The top 5 ft (1.5 m) of the shell (lift 28) is missing in this photograph since the entire lift had fallen into the center of the tower leaving a jagged edge along the top of lift 27 (figure 3.2). Evenly spaced ribs on the exterior surface of the shell and 5 ft (1.5 m) lift lines may also be seen in figure 3.1. The exterior scaffolding-type stairs shown in the left part of the photograph were the only means of access to and from the top of the tower by the workers (figure 3.1).

As can be seen in figures 3.2 and 3.5, vertical bars at the top of lift 27 were bent toward the inside of the tower. None of the vertical bars examined at locations around the top perimeter of the tower showed any signs of fracture.

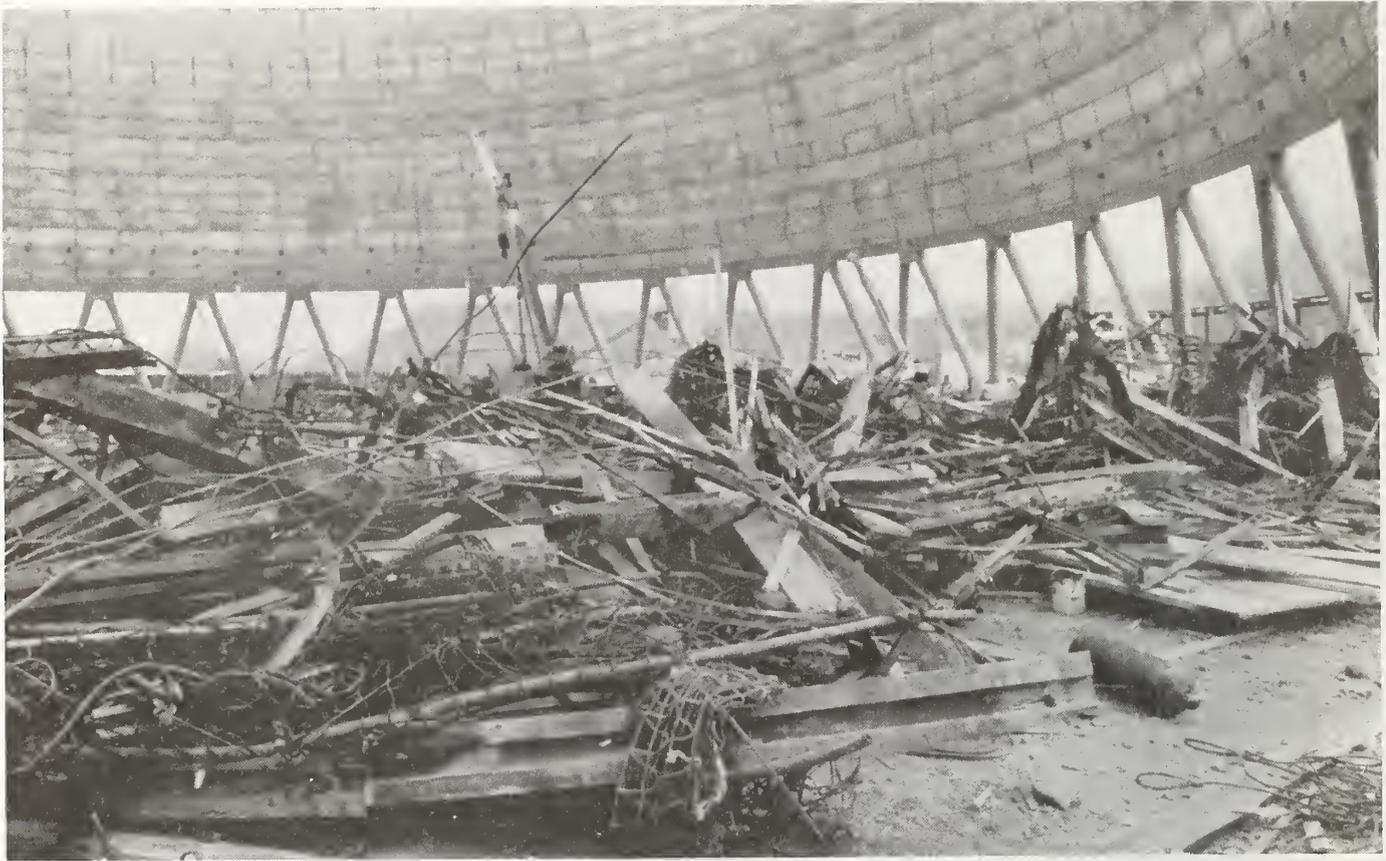
Figures 3.3 and 3.4 show debris piled upon the floor of the tower around the base perimeter. While the general positions of the debris inside the tower have not been drastically changed, it is known that the debris was lifted and moved to some extent during the rescue operations. The debris mainly consists of the cathead gantries, scaffolding and formwork systems, safety nets, and equipment. The concrete of lift 28 apparently pulverized upon impacting the tower floor since no large pieces of broken concrete were found.

Figure 3.3 Debris Piled up Inside the Tower

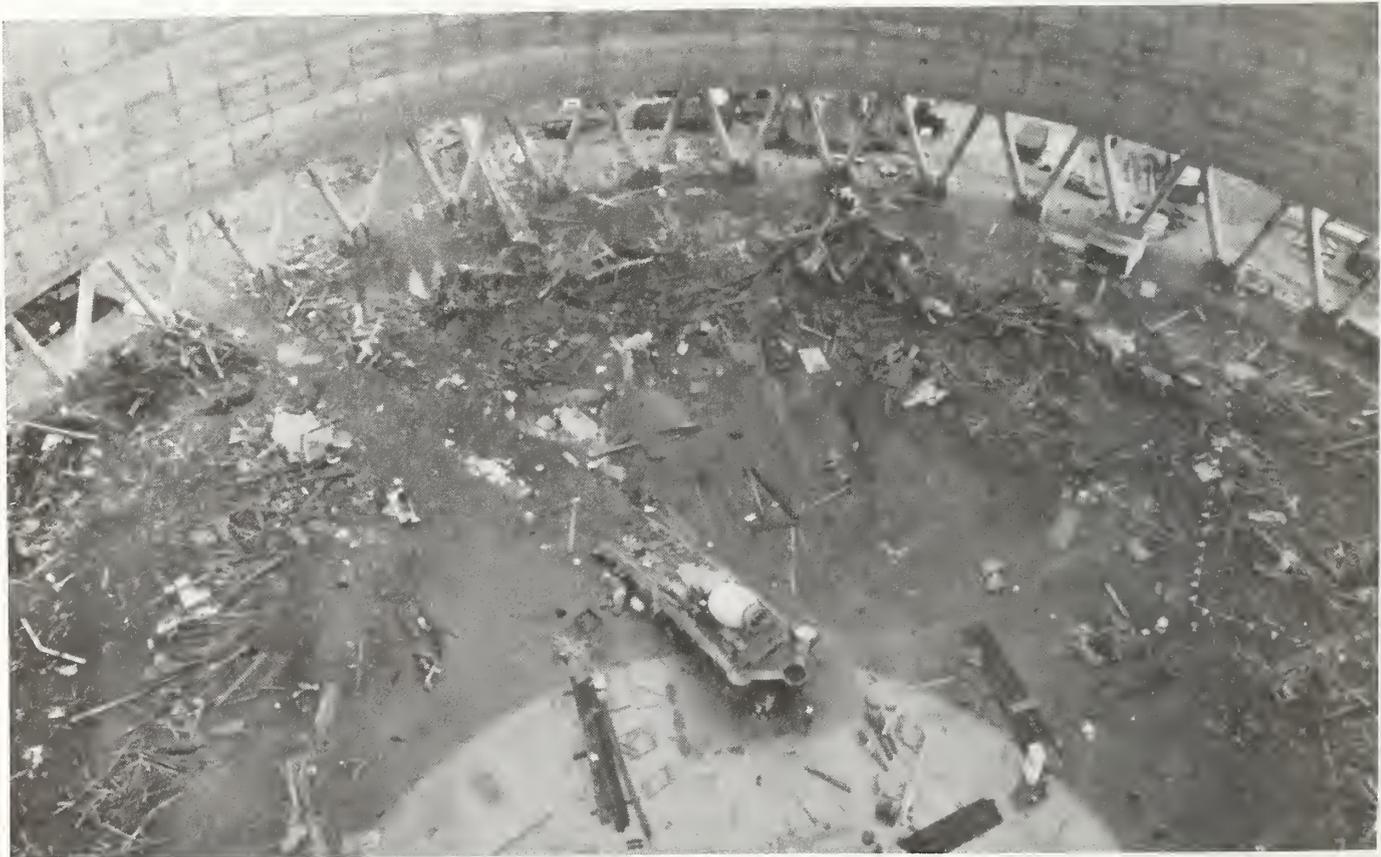
Figure 3.4 Distribution of Debris Around the Base of the Tower

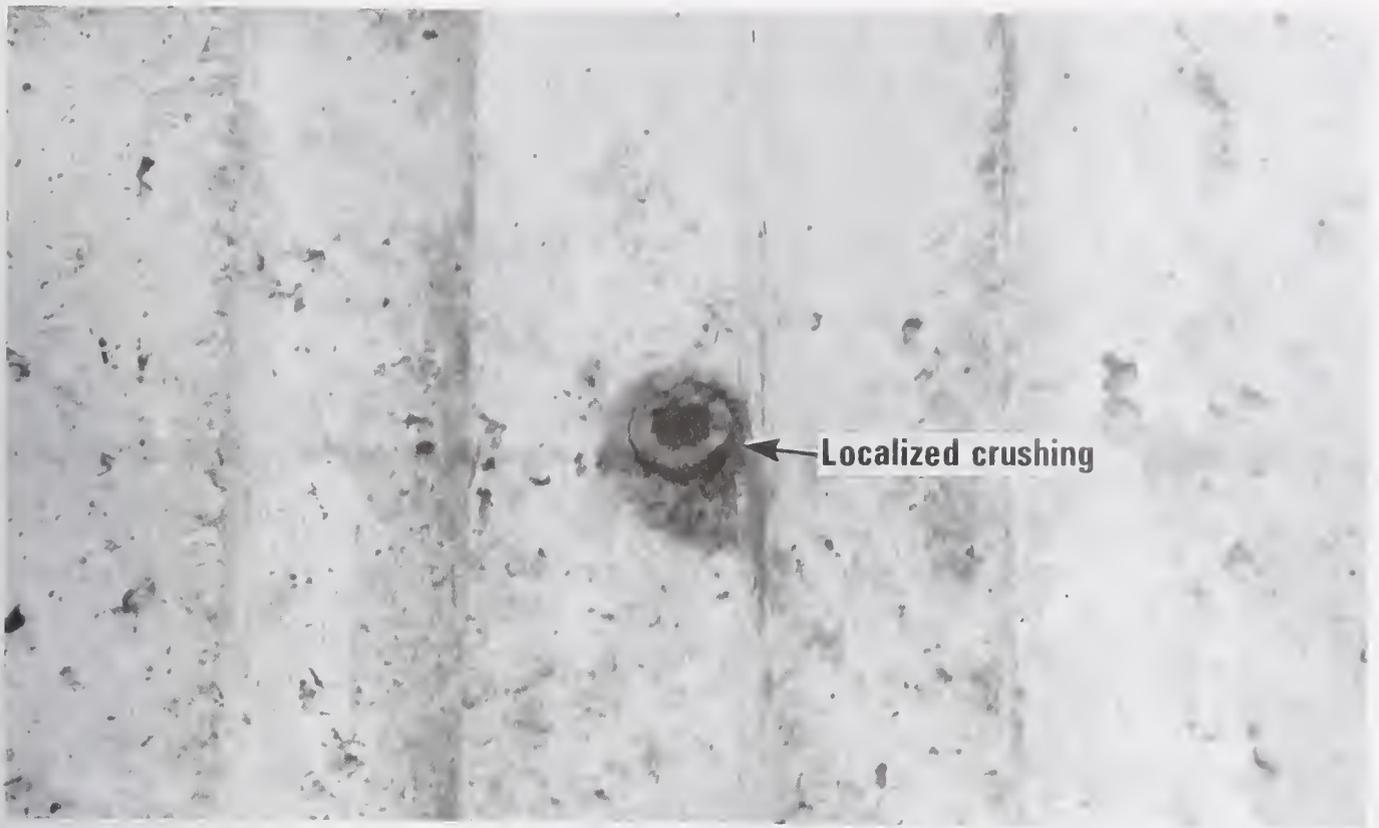
Figure 3.9 A Close-up View of the Bottom Bolt in Lift 27 Which Supported a Cathead Gantry

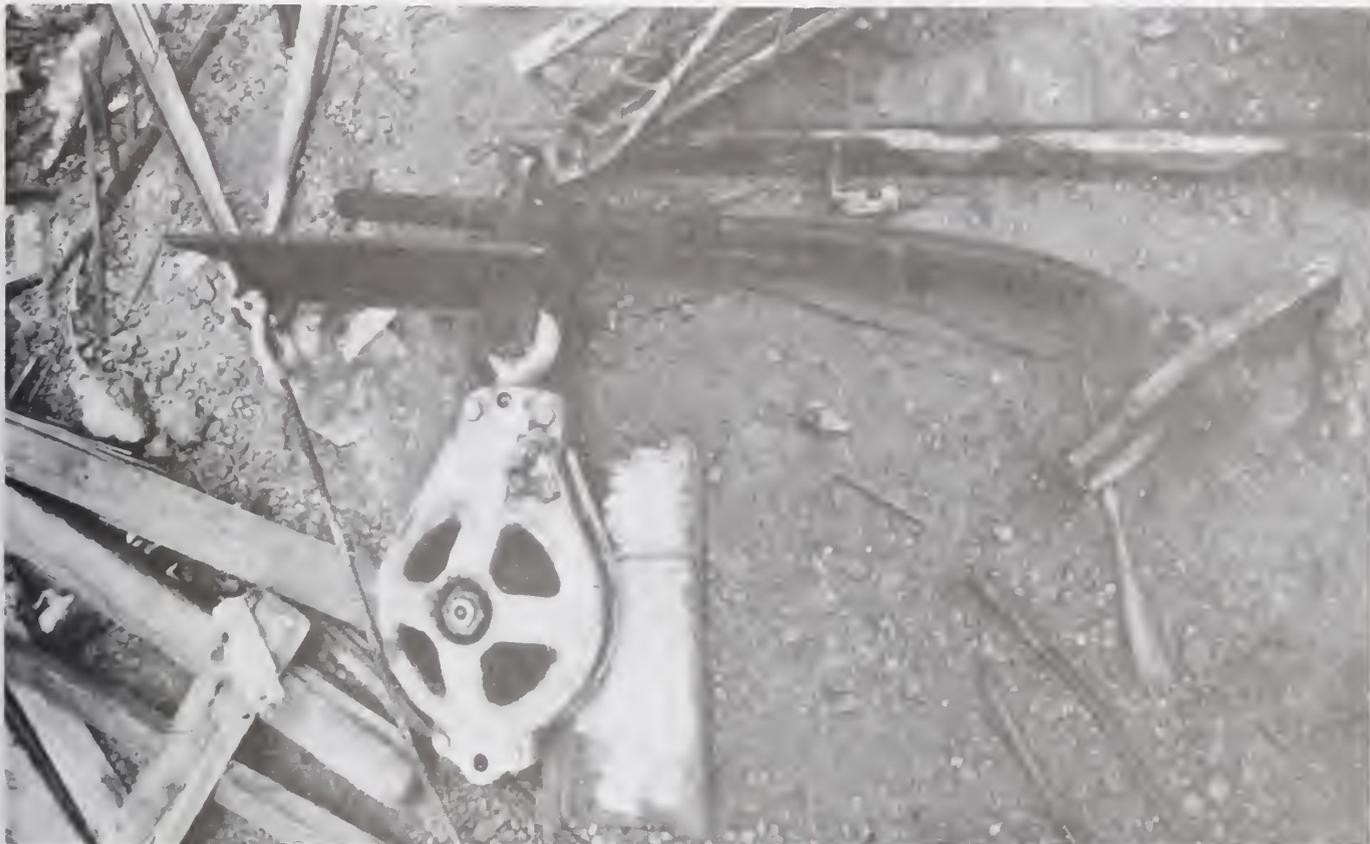
Figure 3.13 Slide Plate for Cathead Gantry No. 4

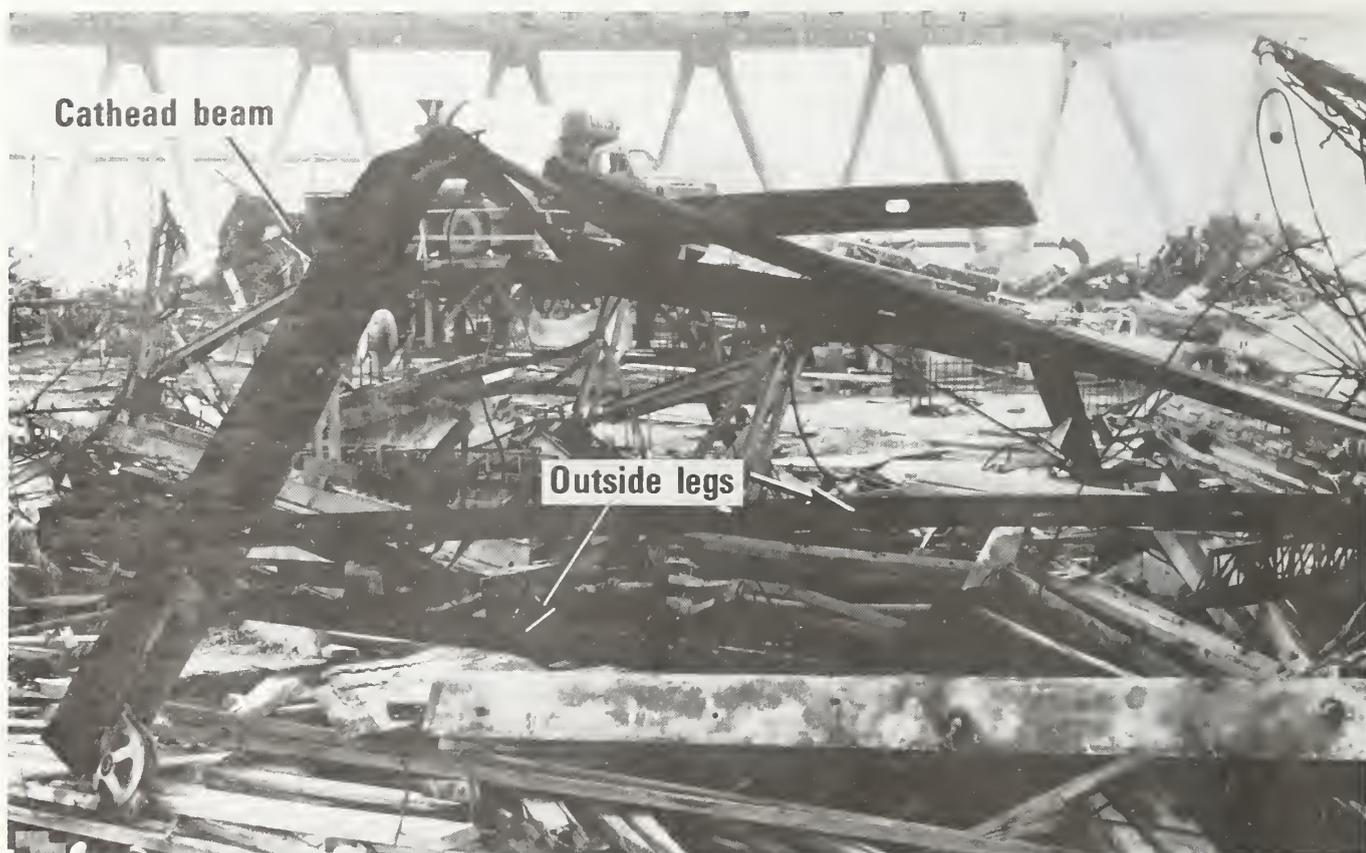
Figure 3.15 and 3.16 show the inside and outside legs of cathead no. 4. All four legs remained straight and showed no sign of damage. As is seen in figure 3.16 the cathead beam was severely bent. However, close examination showed no sign of buckling of the beam. It was concluded from this observation that the beam was bent after the collapse had initiated.

Figure 3.16 Outside Legs of Cathead Gantry No. 4

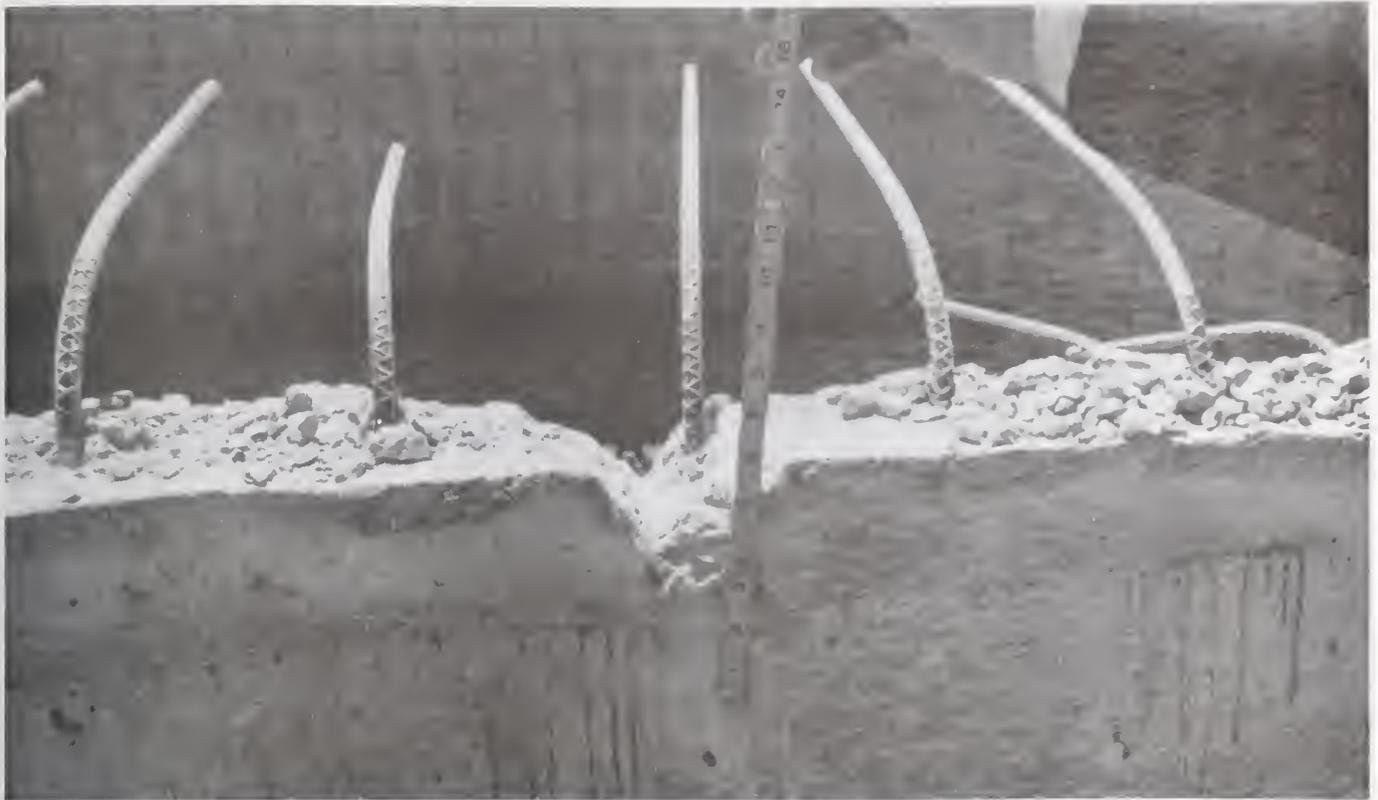
Figure 3.17 A Groove in the Shell Cut by the Hoist Line at Cathead Gantry No. 4

distance 408.5 ft (124.5 m) from the axis of the drum hoist, while the cable for cathead no. 5 was broken at the hoist end just above the dead-weight steel ball. The remaining four hoist lines were draped over the tower following the collapse. At both catheads no. 4 and 5 the hoist cable cut a deep groove in the shell. At cathead no. 4, the cable cut a 4 in (100 mm) groove (figure 3.17) and at cathead no. 5 a 5 in (125 mm) groove. The part of the cable from the bucket to the breakage point was still attached to the bucket. Close examination showed that the concrete bucket for cathead no. 4 fell to the ground with concrete in it. Figure 3.18 shows part of the concrete which remained inside the bucket. On the other hand, the concrete bucket for cathead no. 5 was found empty.

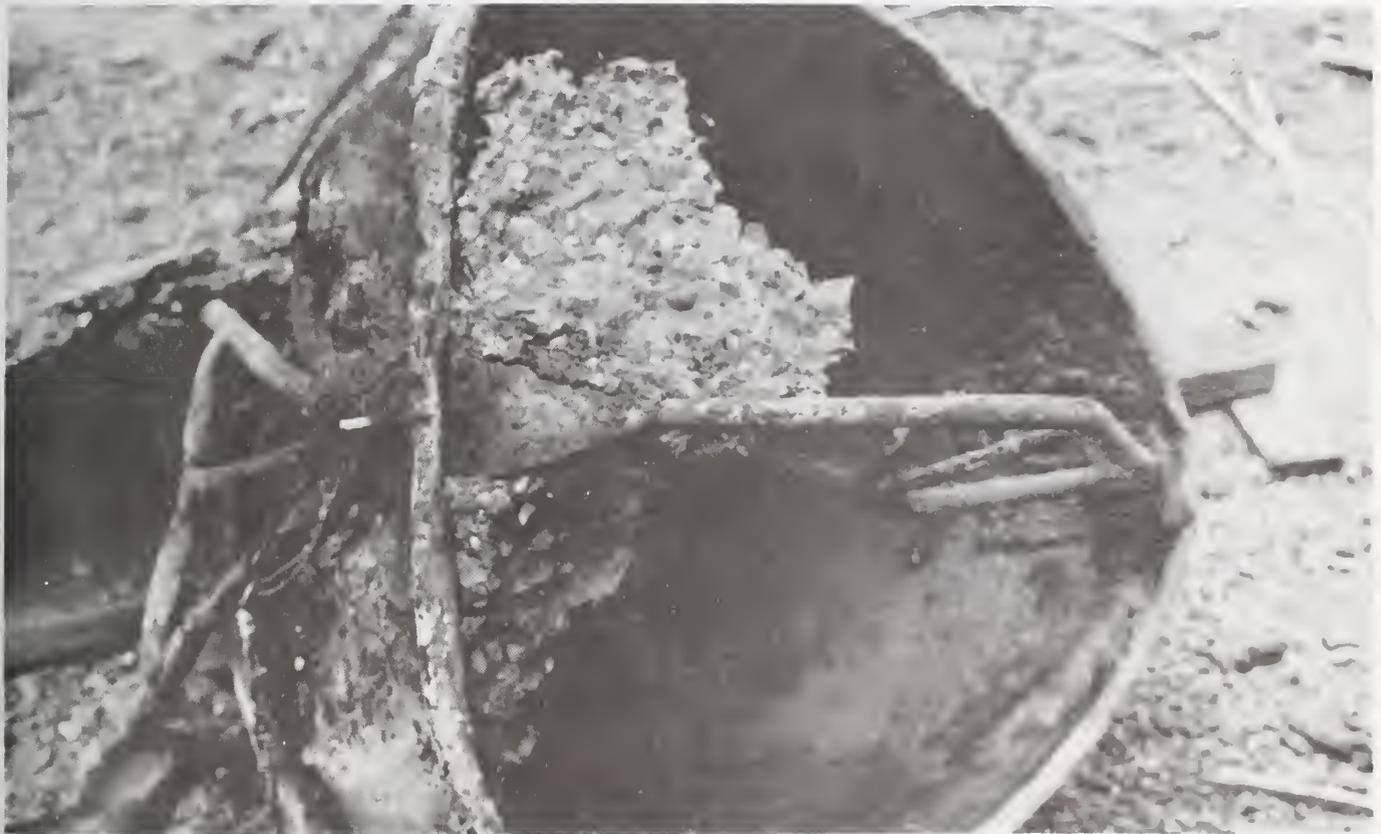
Figure 3.18 Concrete Basket Used for Cathead Gantry No. 4 Which Was Recovered from Wreckage

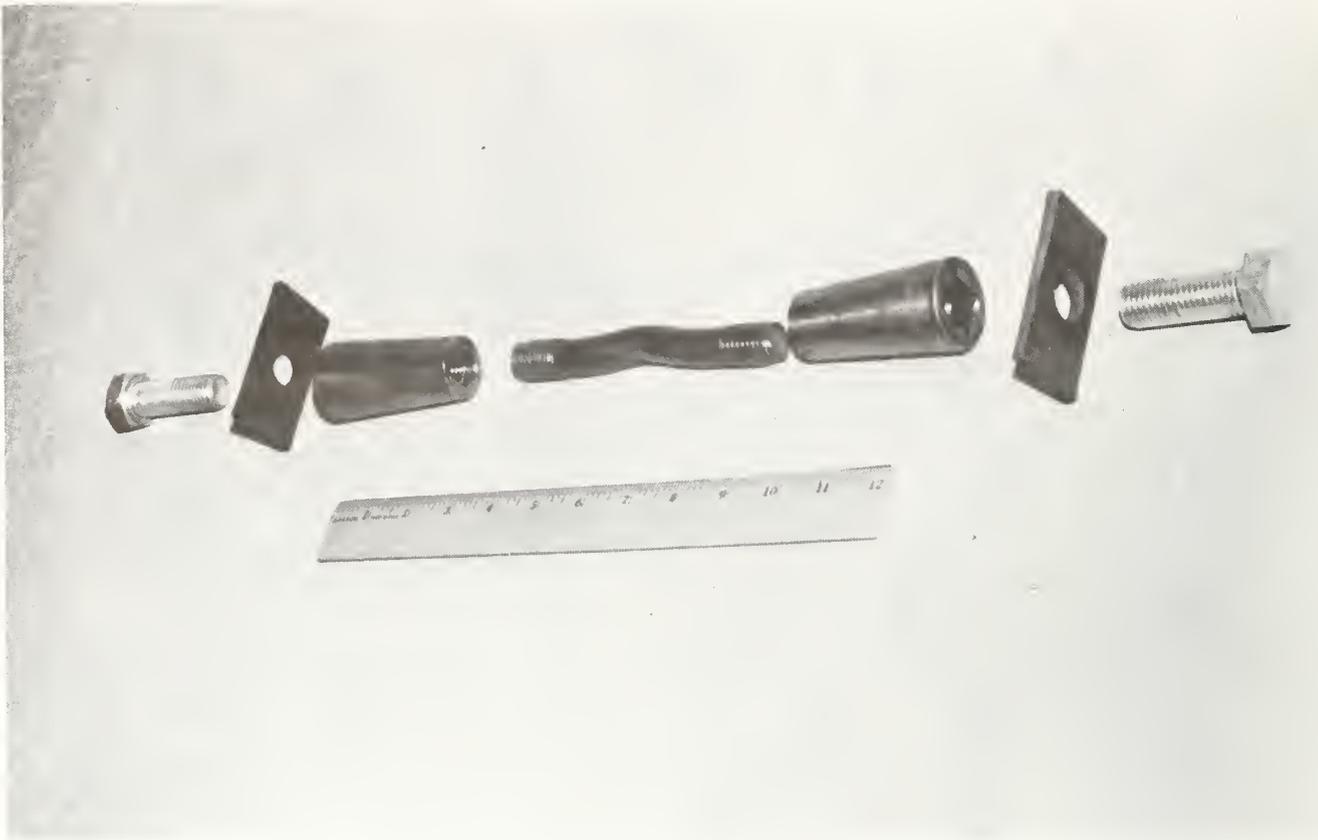
Figure 4.8 Williams Anchor Bolt Assembly

As described in chapter 3, special anchor bolts were used to hold the inside and outside jumpform beams together, separated by a constant distance, prior to casting of concrete. After the concrete had set, although friction existed between the flanges of inside and outside jumpform beams and the shell, the bolts served as the only positive means of transferring all construction loads to the shell. The components of the anchor assembly are shown in figure 4.8. The assembly consisted of two 3/4 in (19 mm) hexhead bolts (ASTM A 494), two rectangular washers, two tapered threaded couplings and a centerpiece threaded crimped rod. By adjusting the amount of insertion of the rod into the threaded couplings, the space between the two jumpform beams was adjusted.

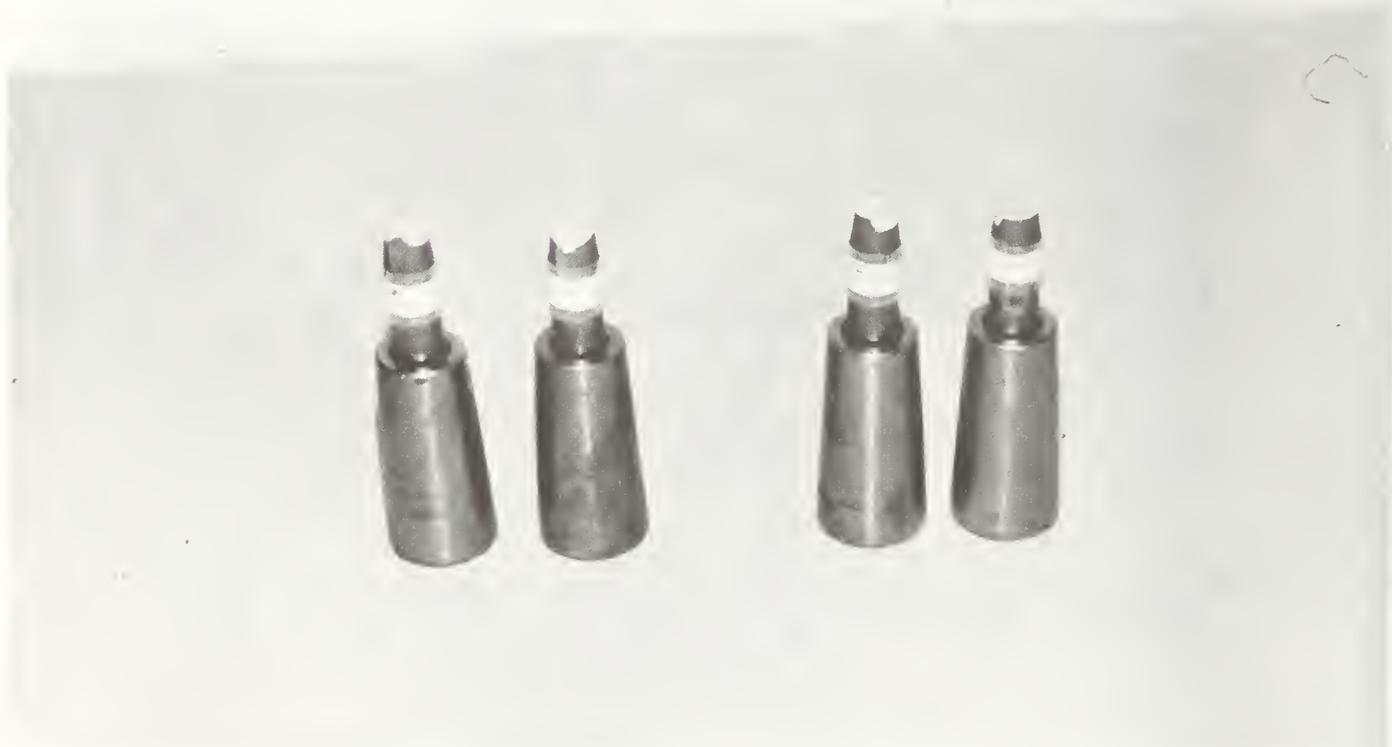
Figure 4.9 Appearance of Williams Anchor Bolts After Tension Test

Two anchor assemblies after tension testing to failure are shown in figure 4.9. In both cases the fracture took place at the middle where the crimp was present. The average of two anchor assembly tests was 40,350 lb (179.5 kN). Because it was observed in the field that in many cases the rod was fractured in the thread coupling through the net cross section at the first thread, a specimen was tested in tension with the anchor assembly embedded in a 12 x 12 x 12 in (305 x 305 x 305 mm) concrete cube. The purpose of this test was to see whether the failure mode would change if the anchor bolt were tested with concrete encasement. A photograph showing the fractured part is shown in figure 4.10. As can be seen, the male rod fractured through the net cross section at the first thread. The maximum test load was 43,200 lb (192.2 kN). This latter test load indicated that the strength of an unembedded anchor assembly would give a lower bound capacity.

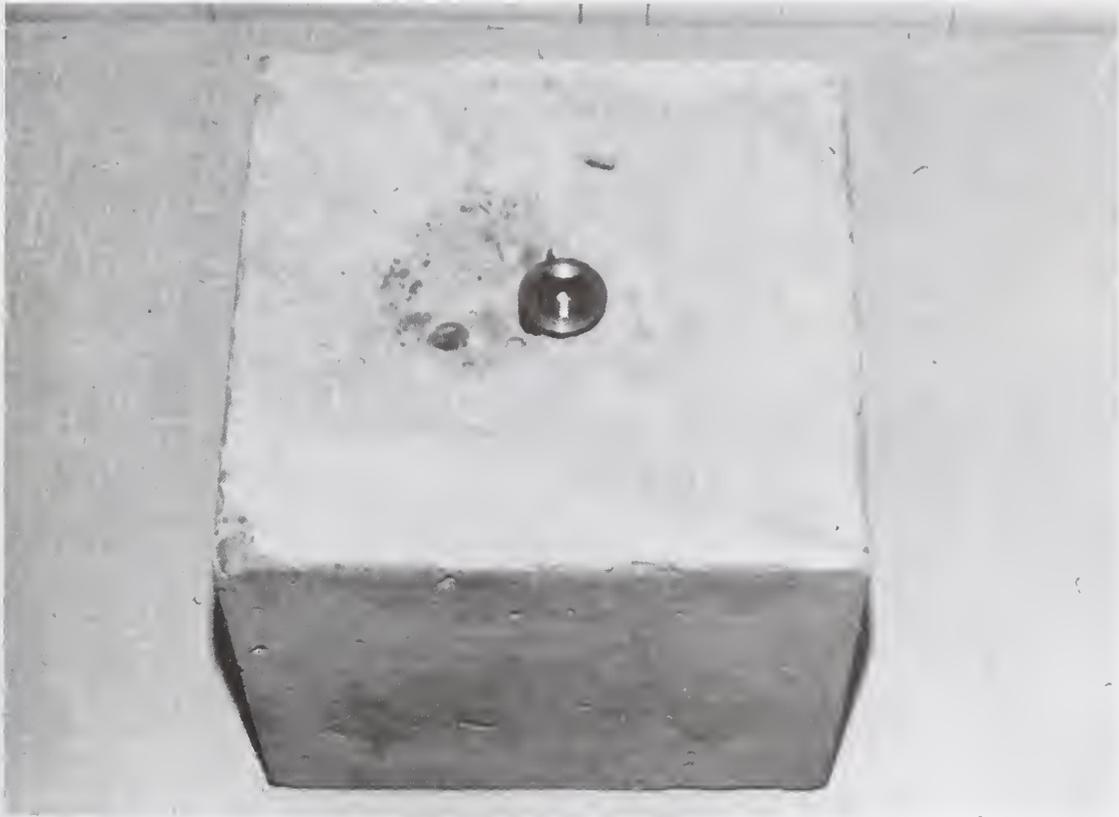
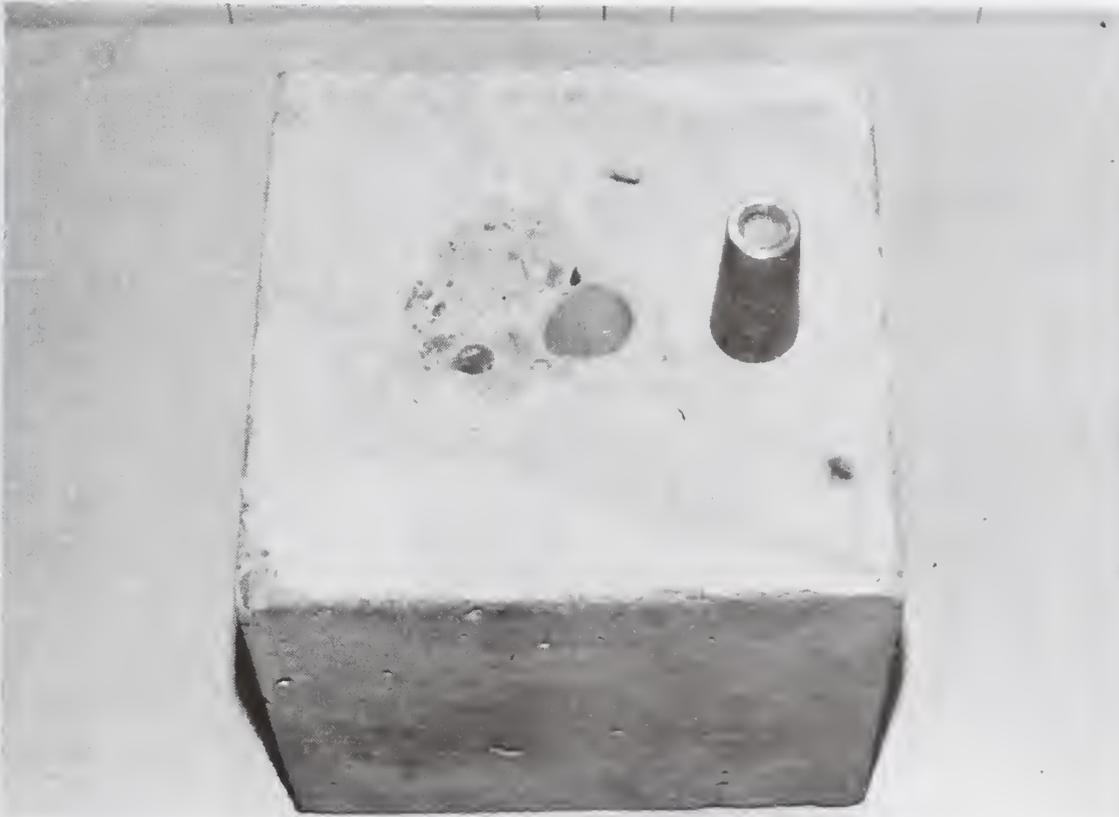
Figure 4.10 Fractured Williams Anchor Bolt Embedded in a Concrete Block

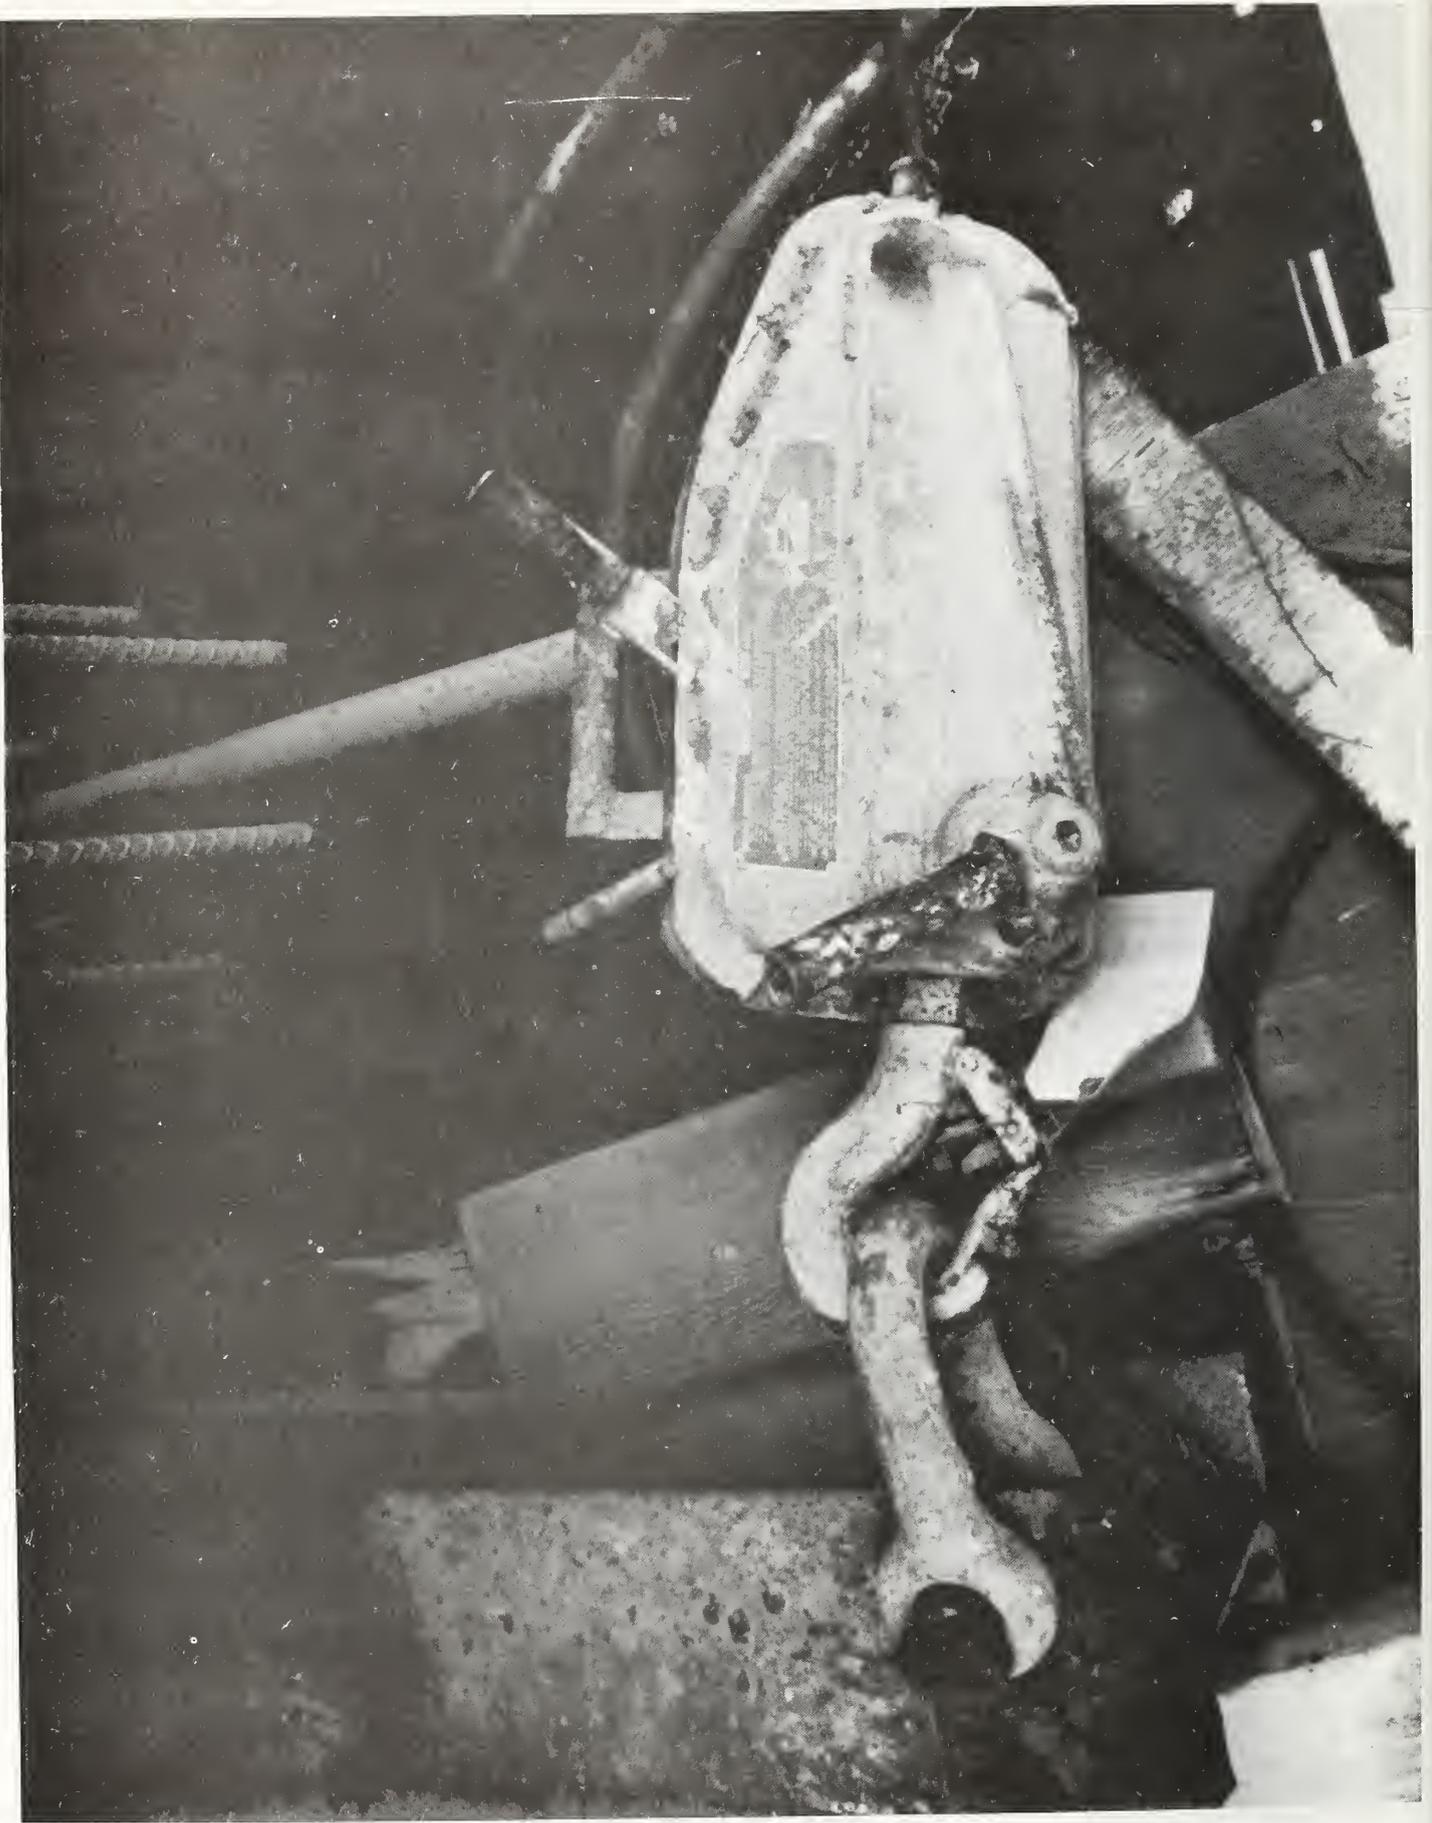
Figure 4.15 Anchorage of static line to ground through grip-hoist

As shown in figure 4.15, the static line was anchored to the ground by means of a grip-hoist. By jacking the hand lever on the grip-hoist, the static cable length and tension could be adjusted. Because any slippage of the static line through the grip-hoist could cause cathead no. 4 to become unstable the grip-hoist capacity needed to be determined.

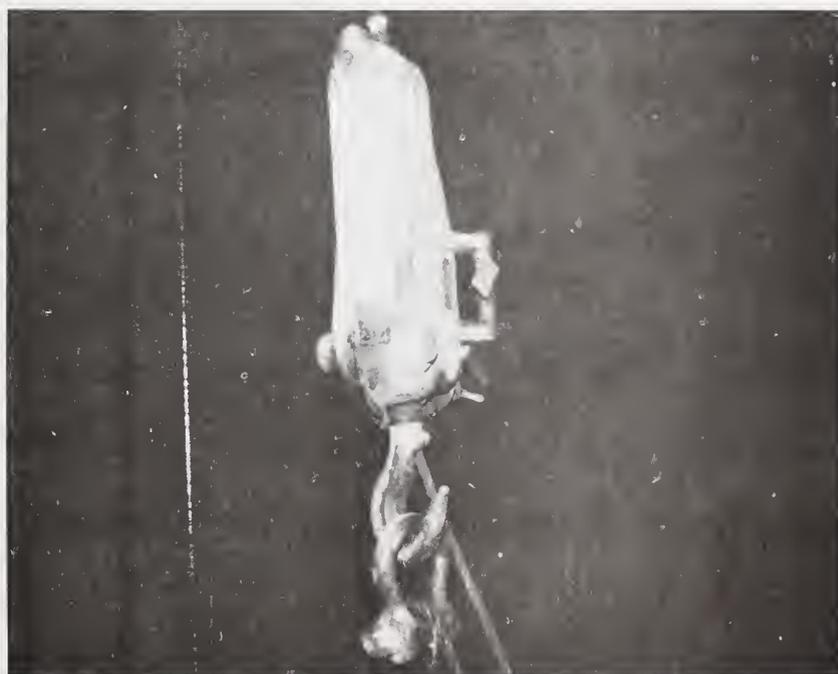
Figure 4.17 A Close-up View of Grip-Hoist After Tension Test.
The Hook Pulled Away from the Housing.

Figure 4.16 shows the tension test setup in which the grip-hoist was placed between the head and platen of the testing machine with the static cable attached to the lower end. At a maximum load of 19,100 lb (84.96 kN), the hook on the lower end broke away from the housing of the grip-hoist (figure 4.17). Throughout the entire range of test load, no slippage of the static line was observed.
