# BUILDING SCIENCE SERIES 48

Design, Siting, and Construction  
of Low-Cost Housing and  
Community Buildings  
to Better Withstand Earthquakes  
and Windstorms

Building Science Series

Center for Building Technology  
Institute for Applied Technology  
National Bureau of Standards  
Washington, D.C. 20234

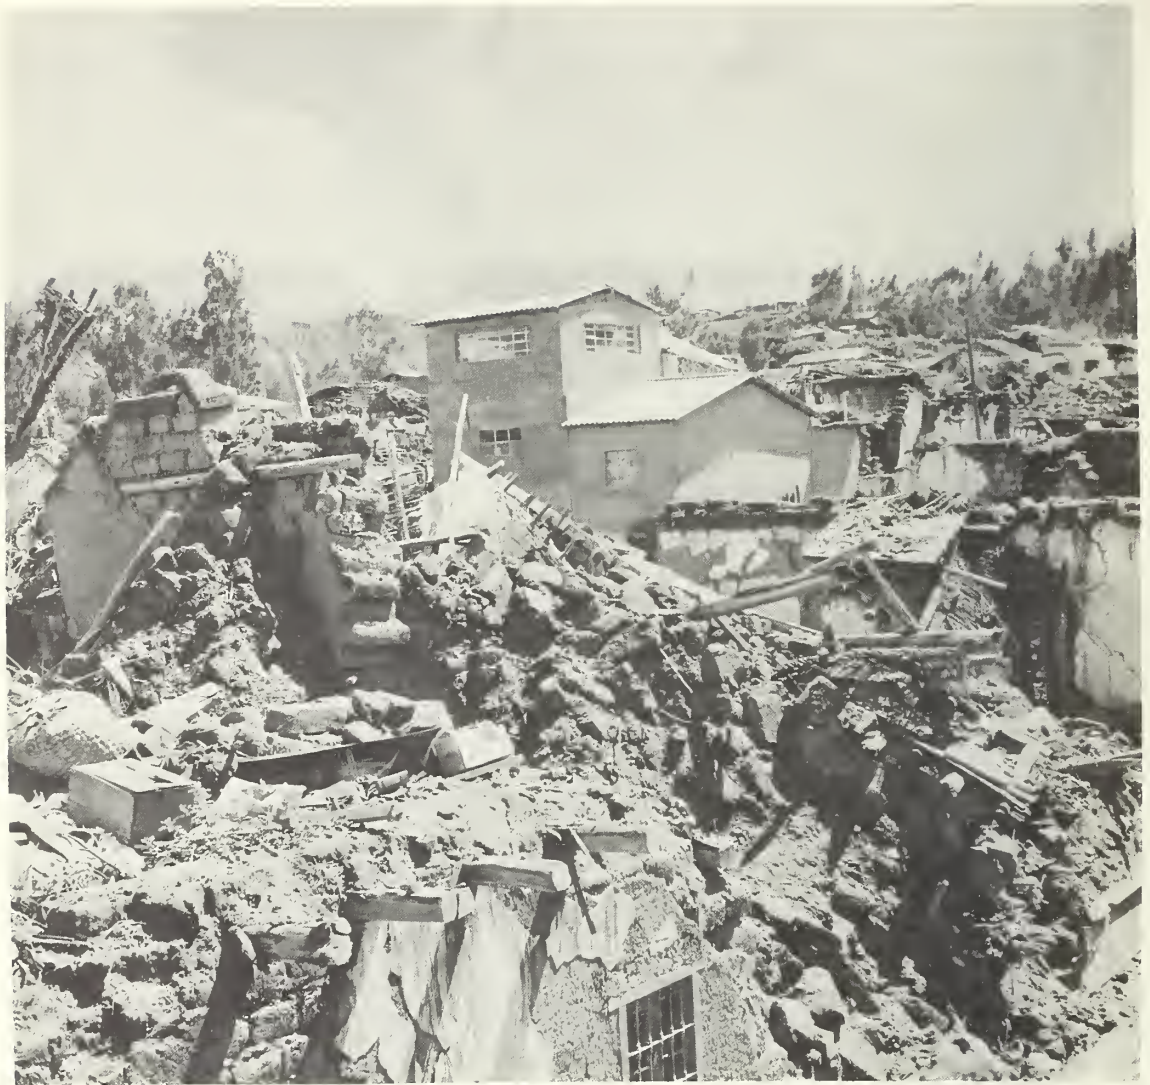
*Effects of earthquake in Huaraz, Peru. Thousands of people were buried under collapsed houses. (Courtesy of United States Geological Survey.)*

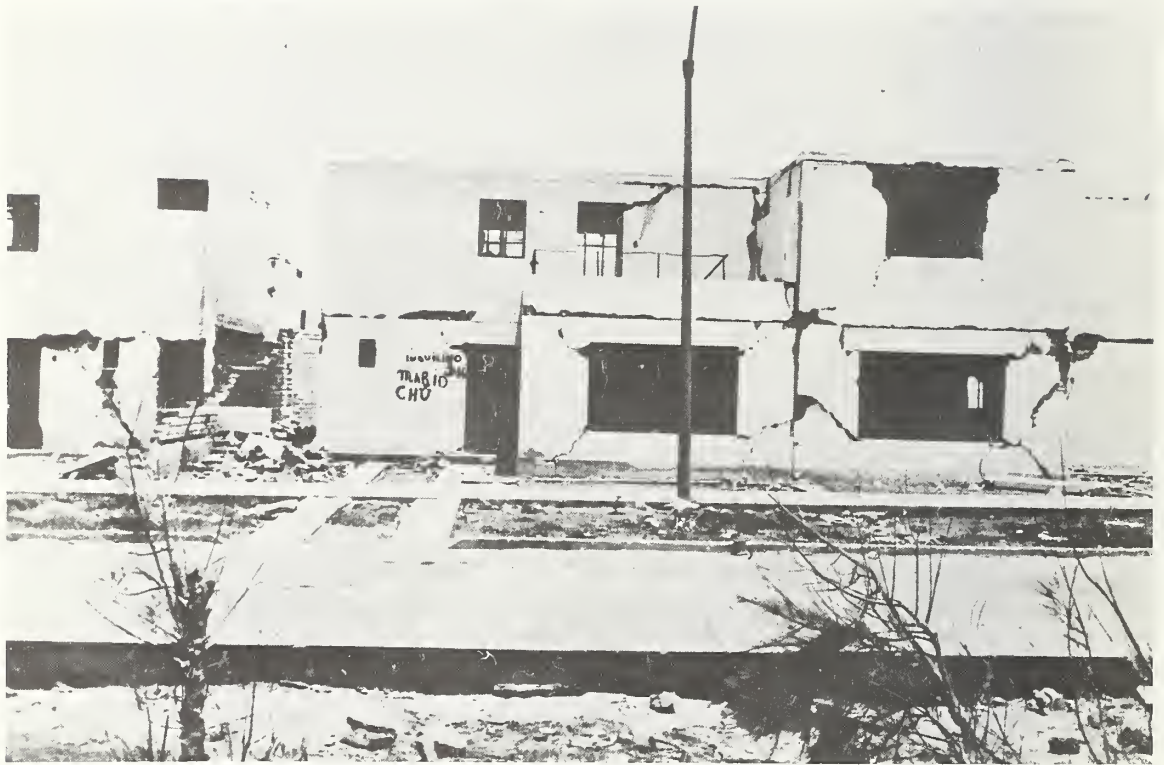
Figure 3.2 Damages sustained by residential units at Chimbote, Peru. Causes of damage: excessive size of openings in relation to area of walls (note the absence of cracks at the corners of the small openings); inadequate reinforcement at opening corners. Damage could have been prevented by reducing size of openings, providing adequate tie-beams and lintels sufficiently longer than the opening; strengthening the connections between roof to walls and floor to walls.

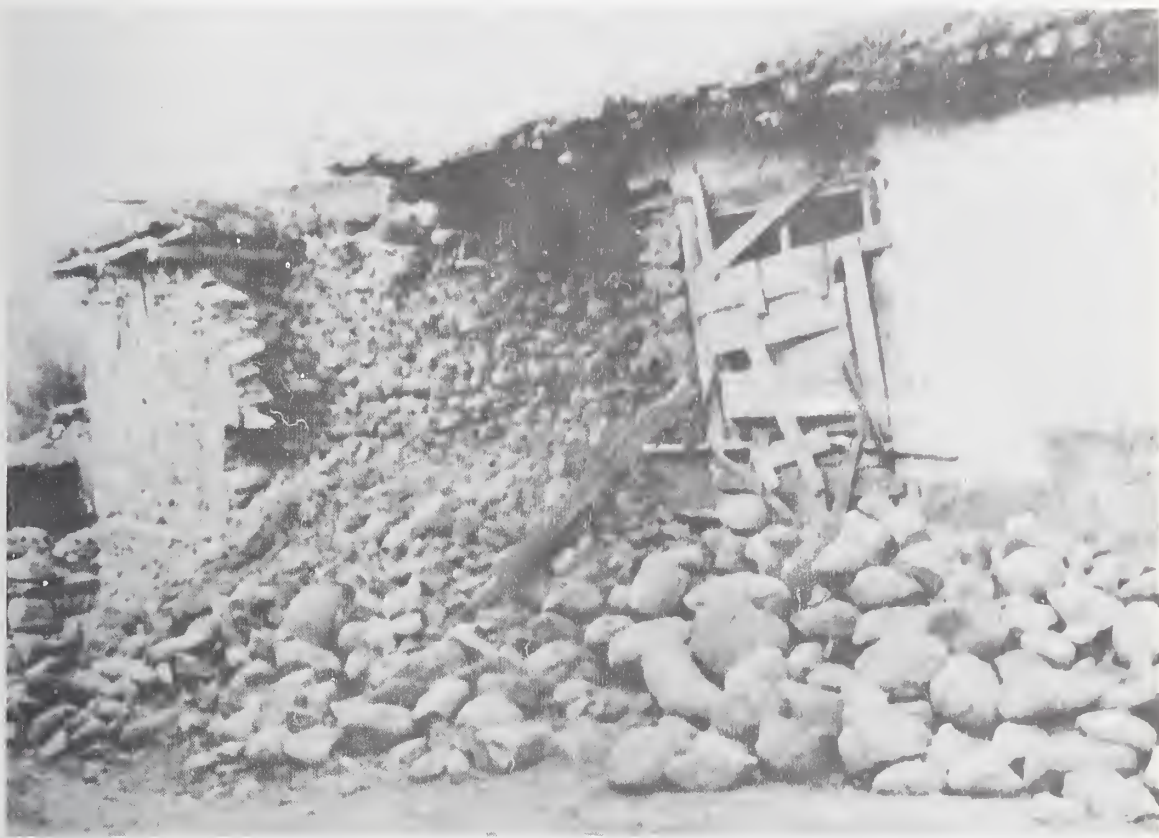
Figure 3.3 Field stone masonry house set in mud mortar, Turkey. Such construction is highly undesirable in earthquake-prone regions. Note, however, that wood ties have preserved the integrity of the wall at the corner. Field stone may be used in earthquake resistant construction provided that adequate tie-beams are used and that the mortar is of acceptable quality (see Figure 3.4).

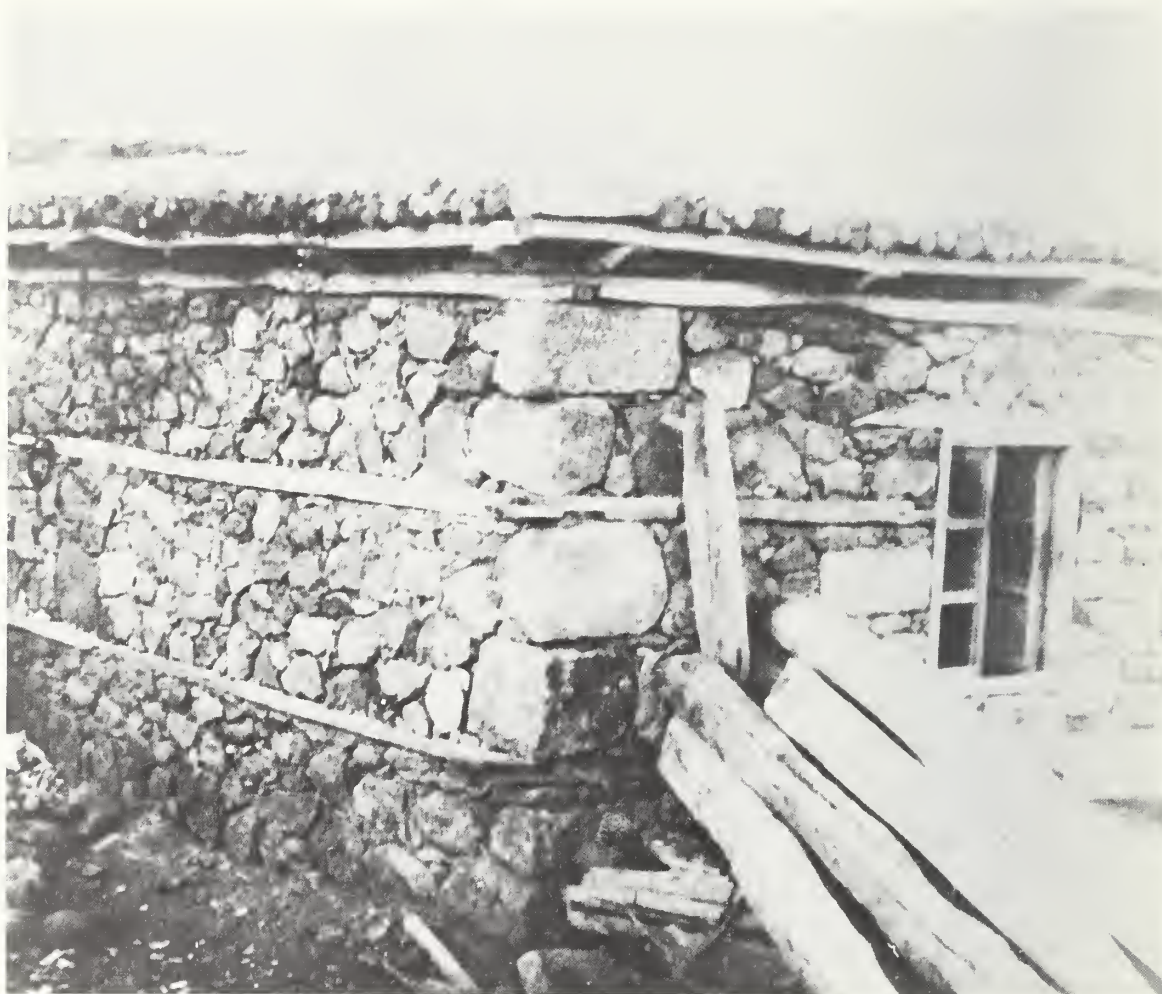
Figure 3.4 Stone dwelling with wood ties near Bingol, Turkey. The ability to withstand earthquakes is markedly improved in the case of this dwelling by the good quality of the workmanship and materials used (see Figure 3.6).

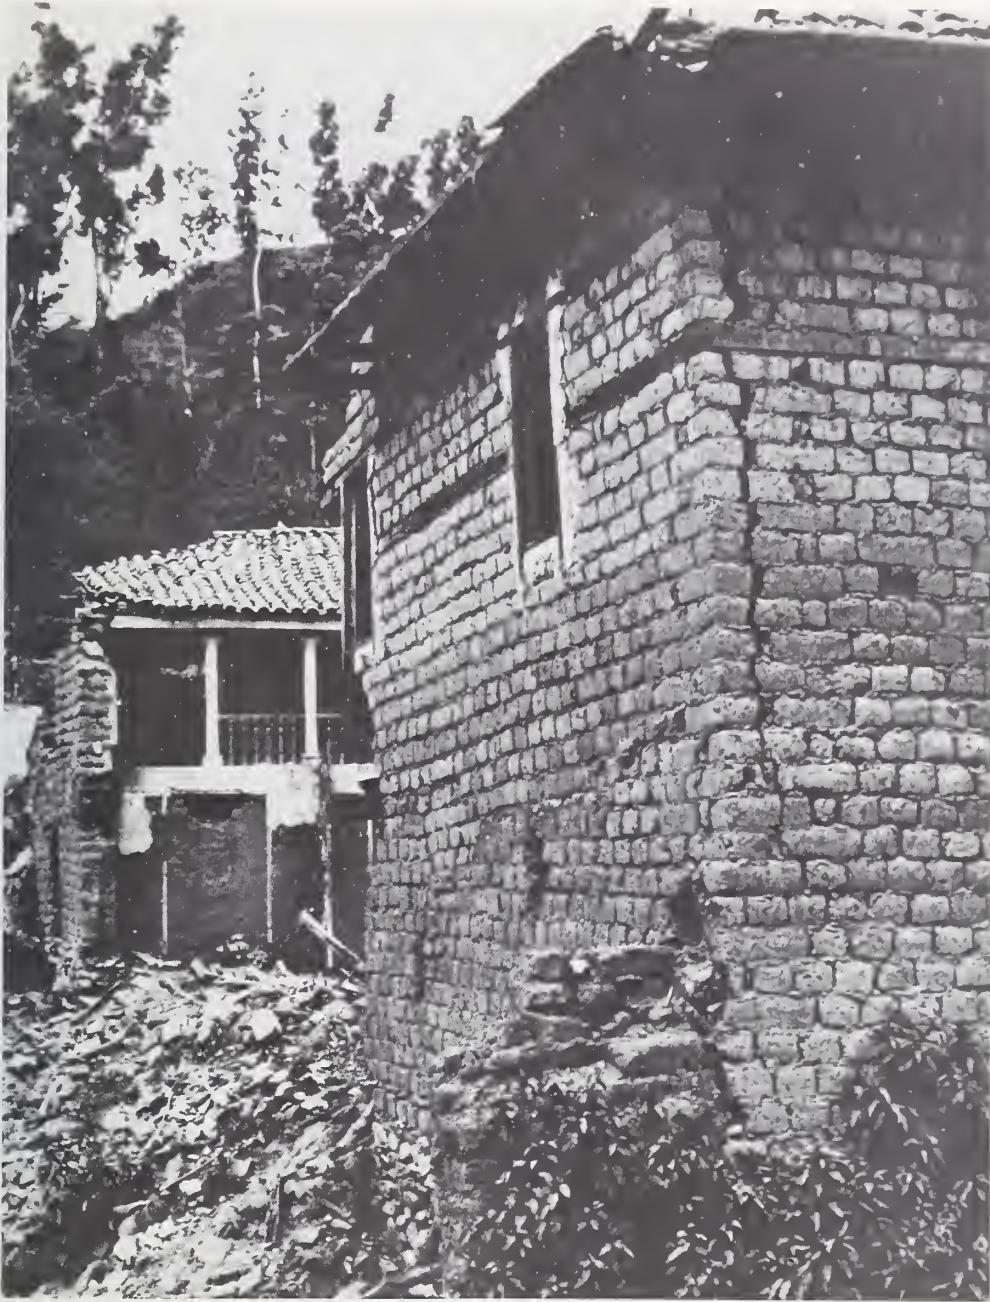
Figure 3.5 Corner failure of a two-story adobe wall with wood tie-beams (Peru). In this type of building, the roof does not act as a unit and thus does not transfer loads to the lateral walls (which would act in shear and thus easily sustain the loads). Instead, during the earthquake the roof exerts a thrust upon the frontal wall (the wall with openings in this picture) and detaches it from the lateral walls.

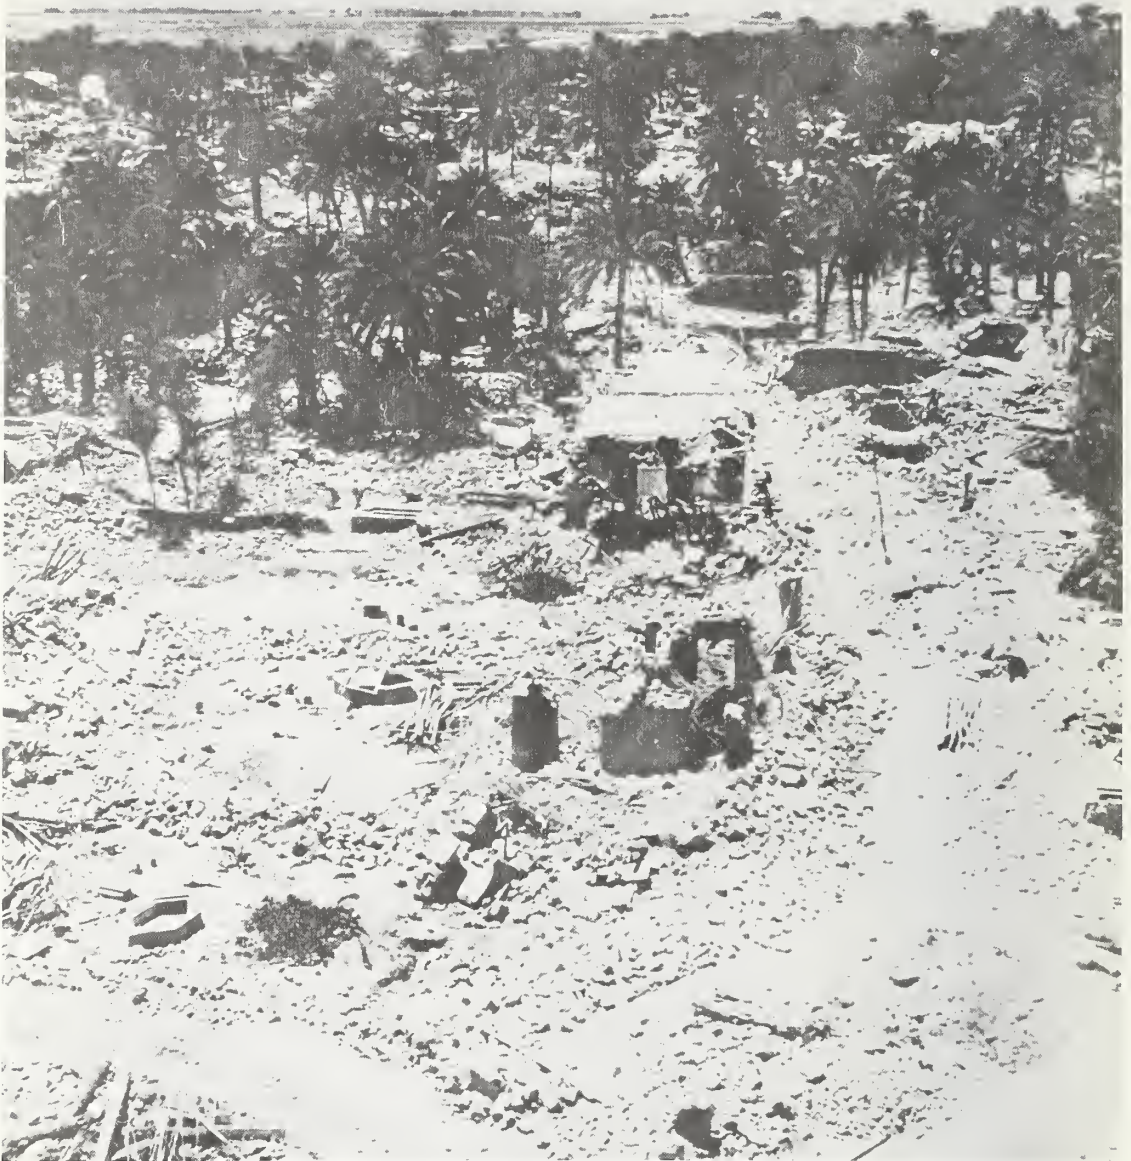
Figure 3.6 The town of Qir (Iran) after the 1972 earthquake. Most houses in Qir were built with sun-dried adobe blocks or rock rubble and adobe mortar, and had heavy roofs of logs first overlain by straw or burlap and then covered by adobe. Two-thirds of the people in Qir perished in the debris of their homes. Contributing factors to the magnitude of the disaster were the poor quality of the building blocks and of the mortar, the heavy roofs and the absence of adequate horizontal and vertical reinforcement and ties (courtesy of U.S.G.S.).

Bearing wall failures are characterized by sudden, partial or complete collapse of wall segments accompanied by collapse of roofs and upper floors (Figures 3.6, 3.7). Such collapse may be widespread and is a

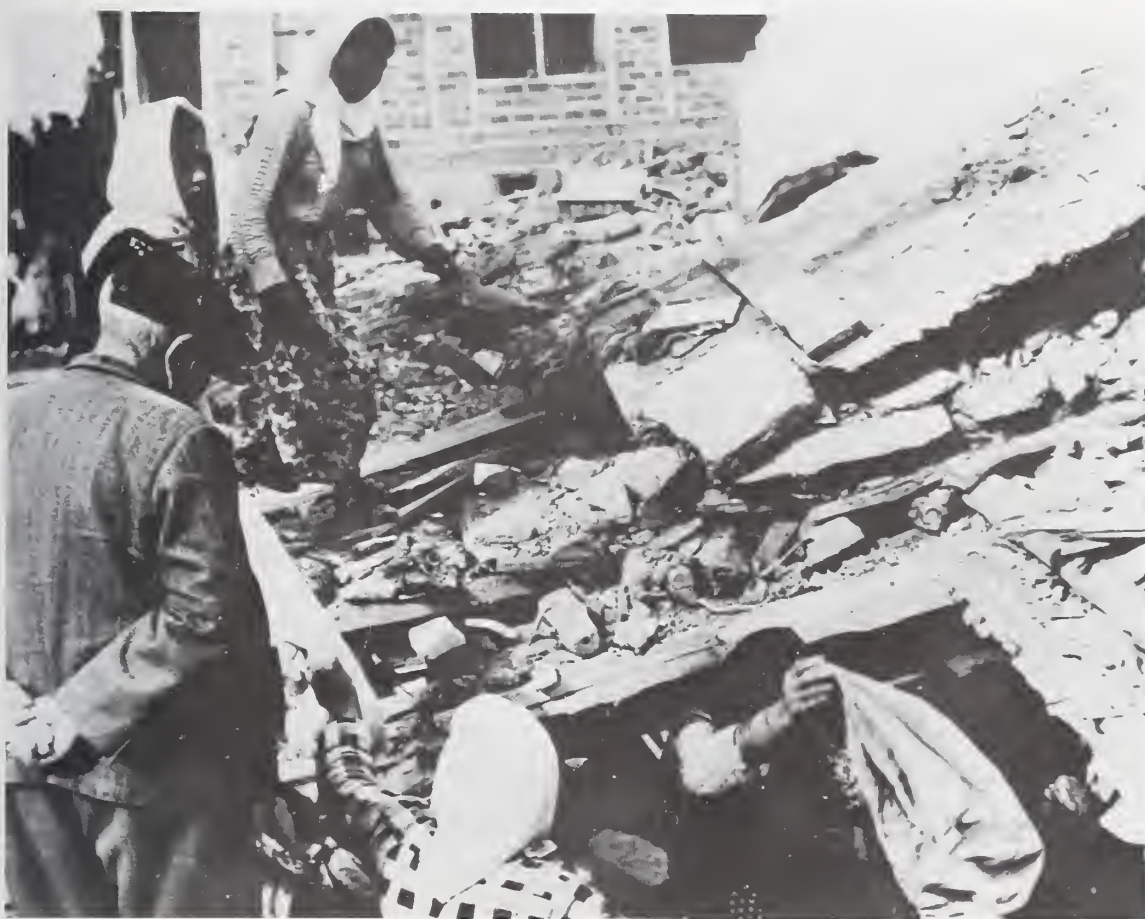
Figure 3.7 Collapsed two-story adobe building, Burdur, Turkey. The poor quality of the adobe blocks and mortar was a contributing factor in the collapse of this dwelling. Note the careful brickwork of the building standing in the background. Improved adobe block and mortar quality as well as the provision of adequate ties and connections substantially decreases the risk of failure under earthquake loads.

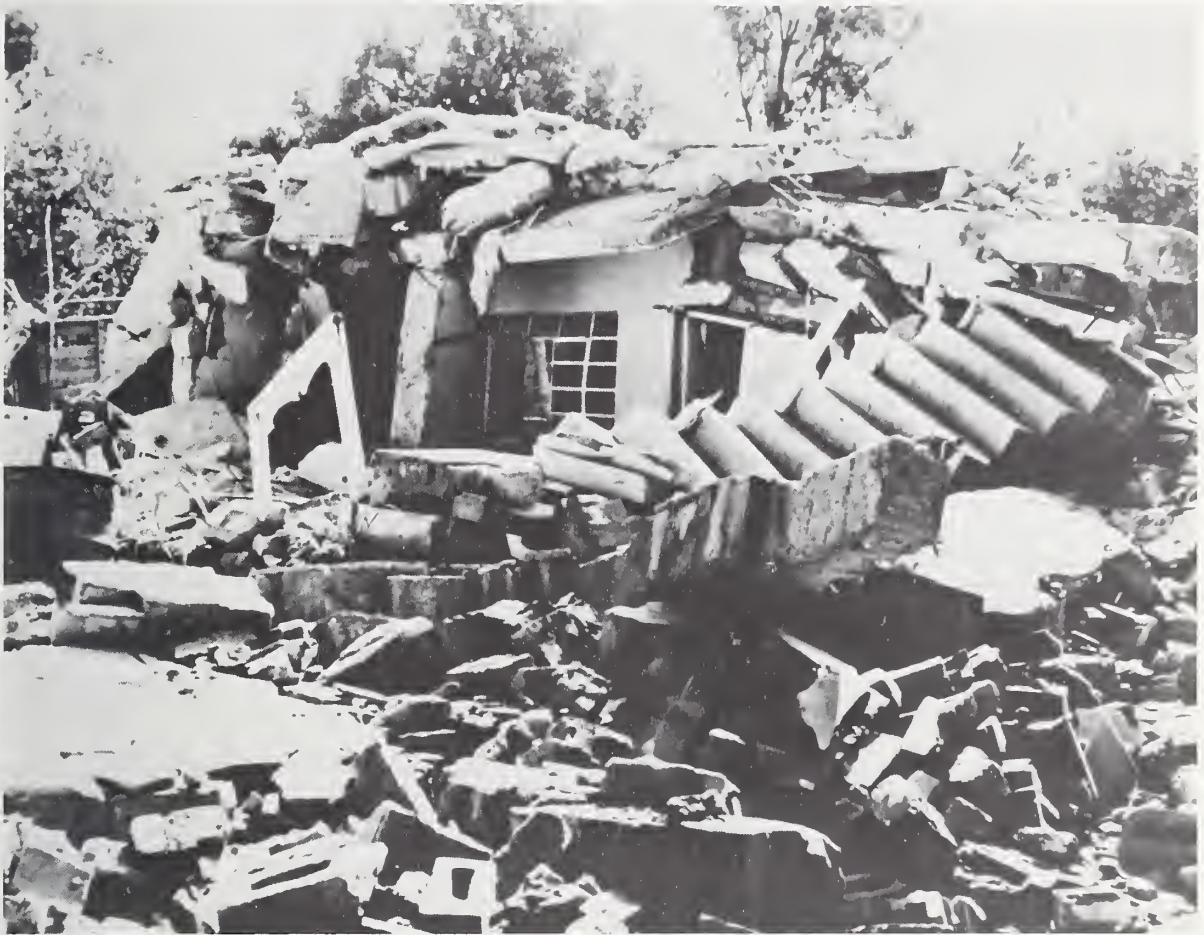
Figure 3.8 Collapse of a dwelling in Casma, Peru during 1970 earthquake. The collapse was due to inadequate arrangement of walls, leading to unbalanced stress distribution in building, poor connections between vertical and horizontal elements, and the absence of sound horizontal tie-beams

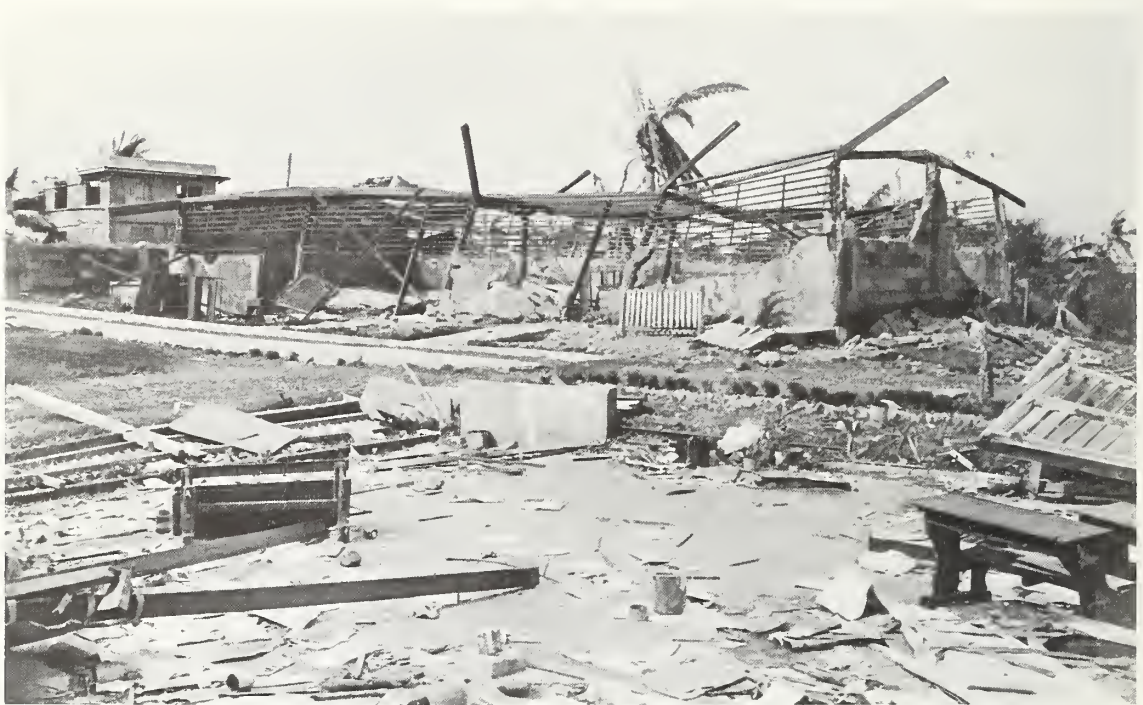
Figure 4.4 "Marcos" school destroyed by Typhoon Sening (Joan), October 1970, the Philippines. The inability of this structure to withstand wind loads was due to inadequate strength of the frame joints (particularly at the foundation level), of the roof connections, of cladding to building framing, of the end walls. Measures to improve behavior under wind loads would include provision of interior vertical bracing parallel to the short direction of the building (or a substantial increase of the bending capacity of the frames), improvement of roof and cladding connections, reinforcement of the end wall (or provision of in-plane bracing in end wall).

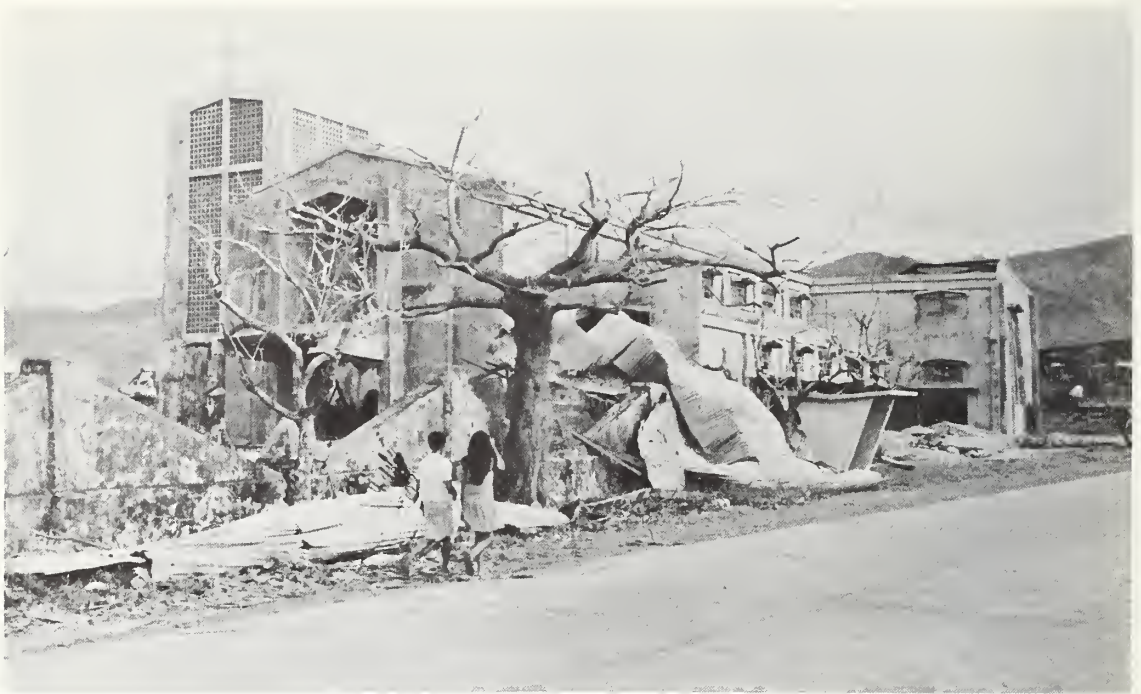
Figure 4.6 A church at Catanduanes, the Philippines, stripped of its roof by Typhoon Sening (Joan), October 1970.

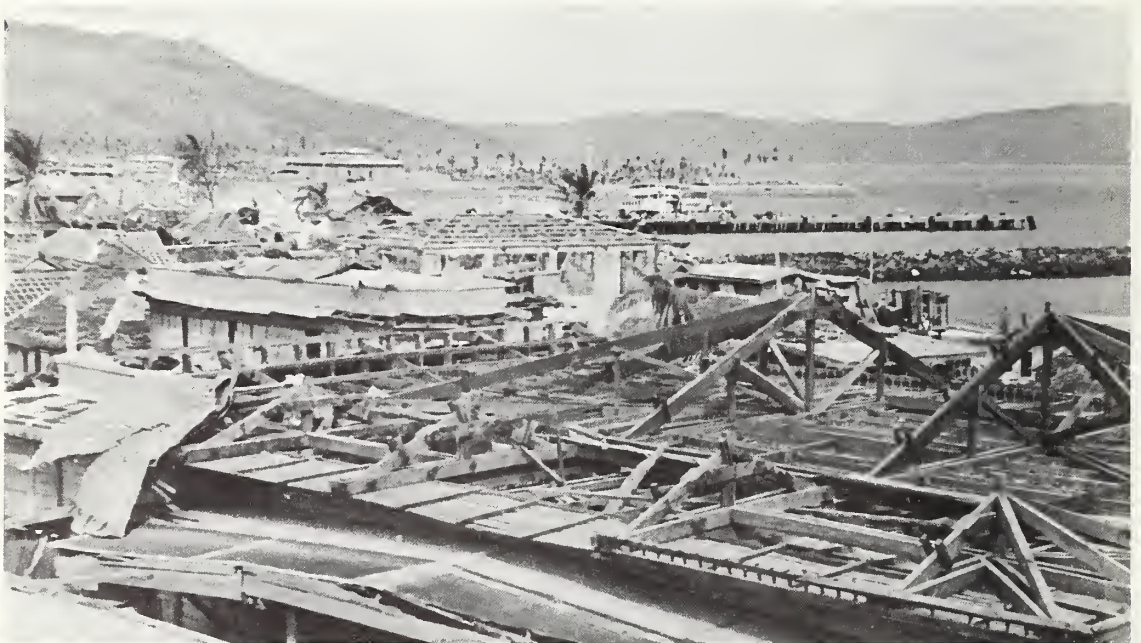
Figure 4.7 Roofing blown off by typhoon winds, the Philippines, October 1970. Sound attachment of roofing to roof members would have prevented damage to roof of buildings in the foreground and background of the picture.

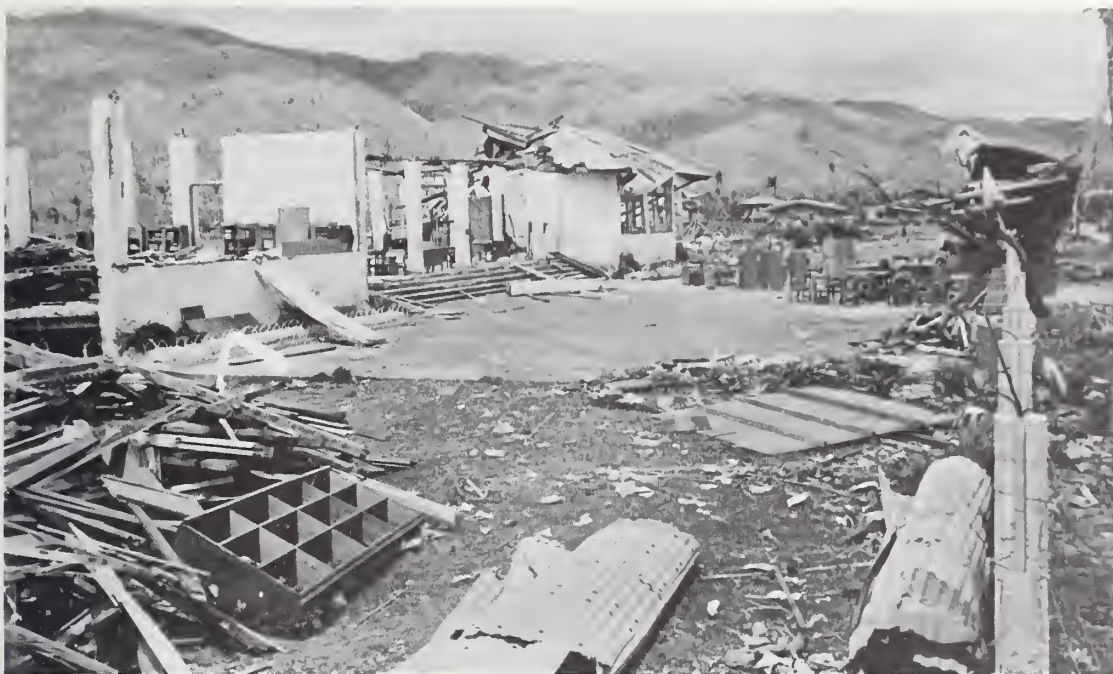
Figure 4.8 Destroyed homes and institutional building in the Bicol Region, the Philippines, October 1970. Cause of roof collapse: inadequate connections between roof members, inadequate anchorage of roof to walls.

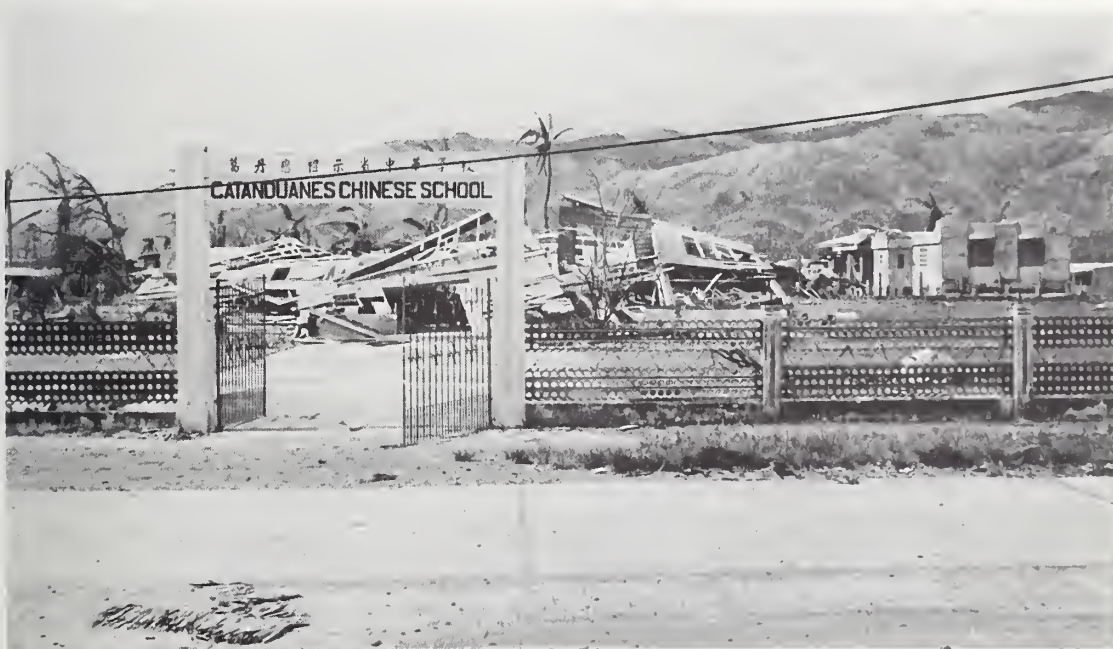
Figure 4.9 The Catanduanes school levelled to ground by Typhoon Sening (Joan). Poor vertical bracing was possibly responsible for the failure of this building.

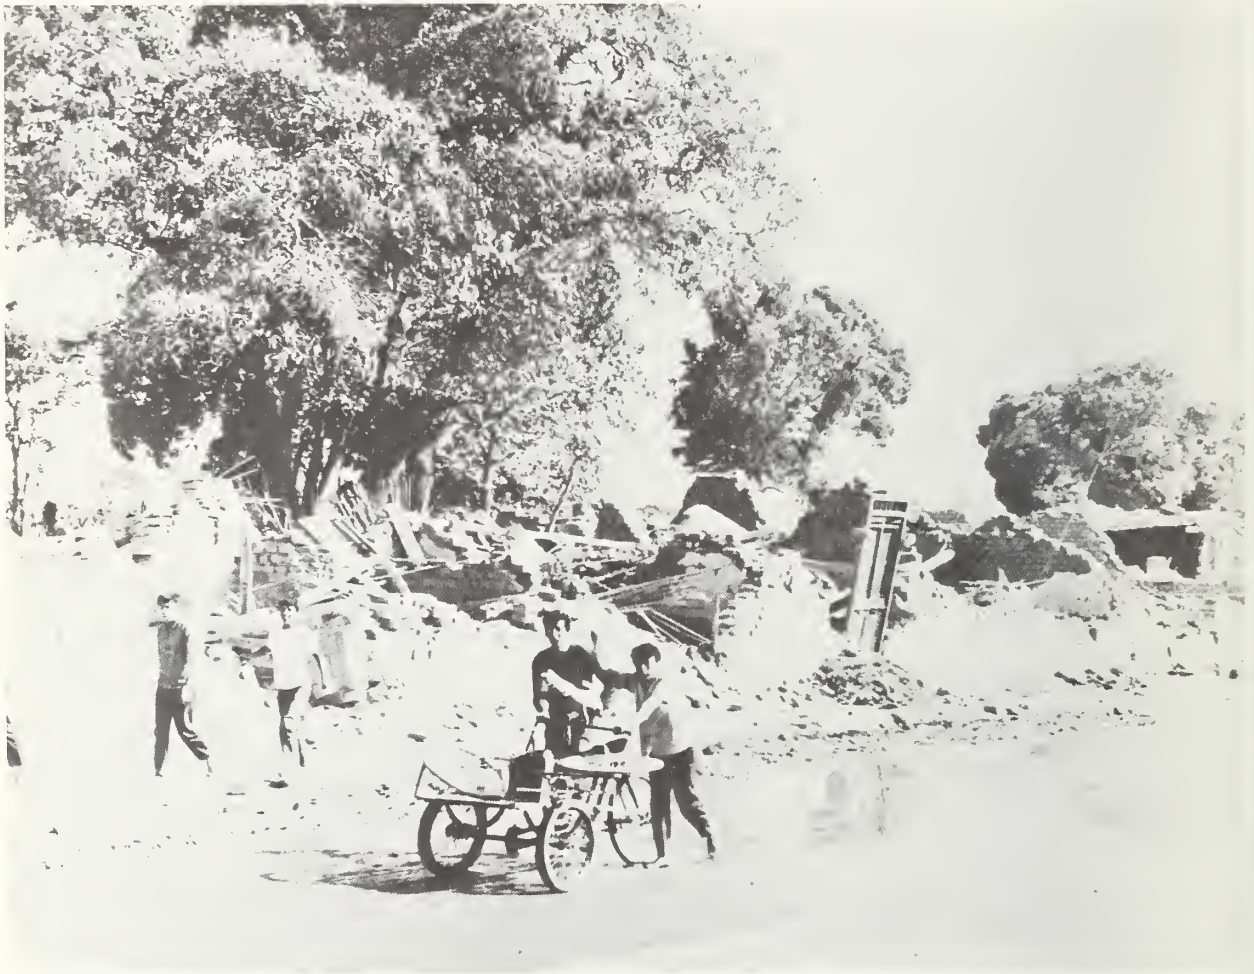
Figure 5.3 Residential street in Casma, Peru, where all adobe-block houses collapsed during the earthquake of May 31, 1970. Adobe used in construction here was of extremely poor quality, containing a high-percentage of silt and sand, with little or no straw binder. It crumbles easily in the hand. Casma, a town of about 15,000 inhabitants before the earthquake was almost totally destroyed during the earthquake.

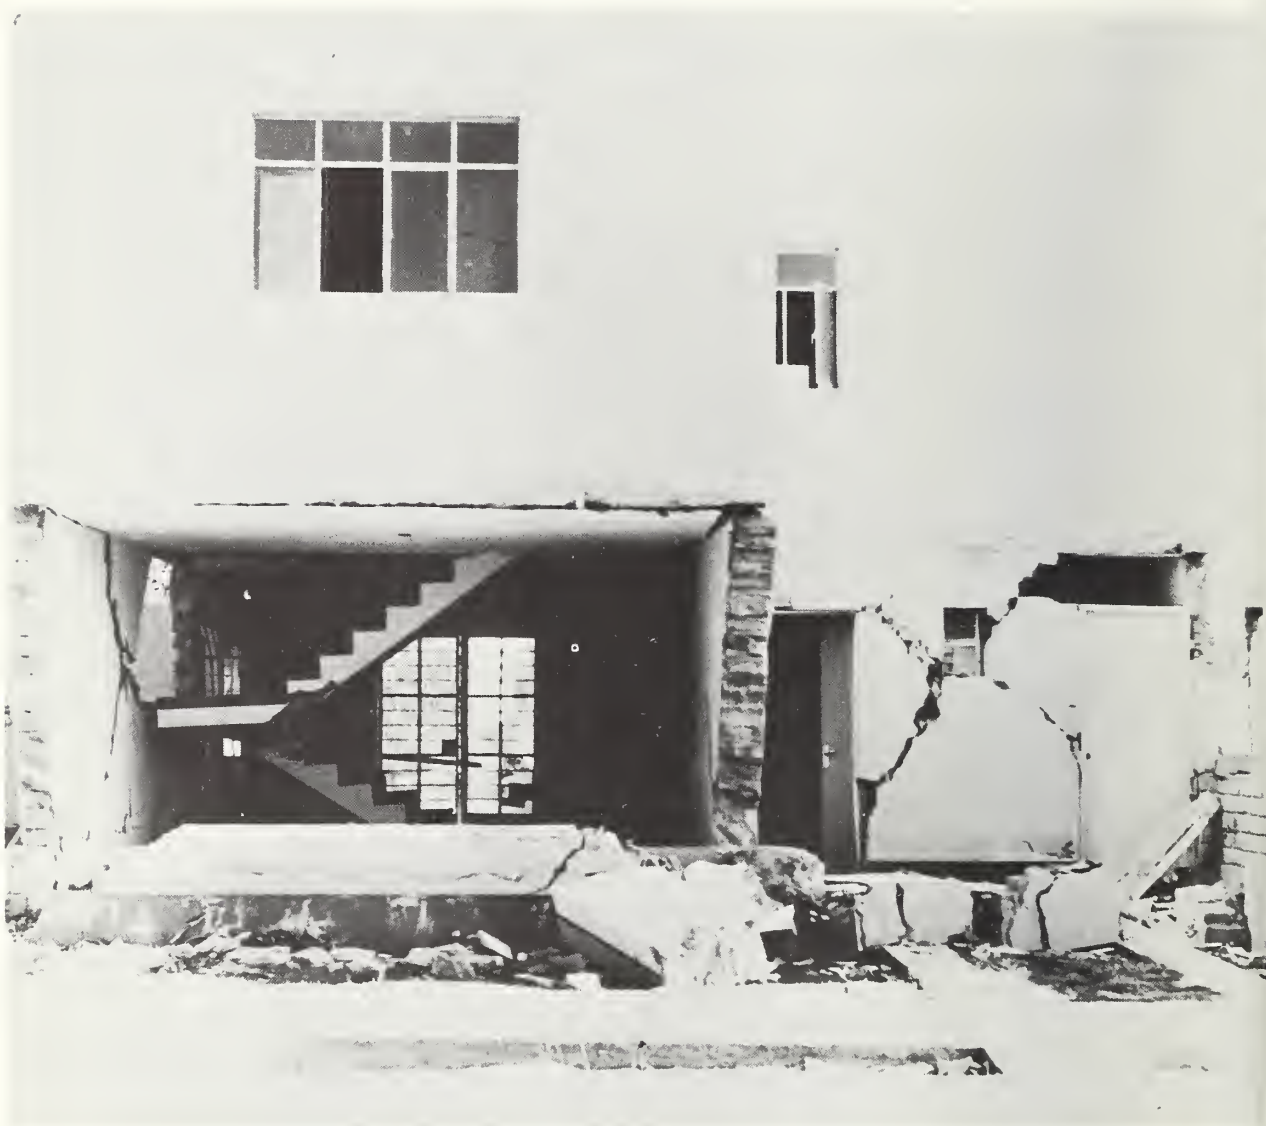
Figure 5.4 Destruction of new home of unreinforced brick construction in the Buenos Aires suburb of Chimbote, Peru; all buildings in this suburb were damaged beyond repair. None of the homes collapsed, probably because of the reinforced concrete stairway that connected concrete floor slabs.

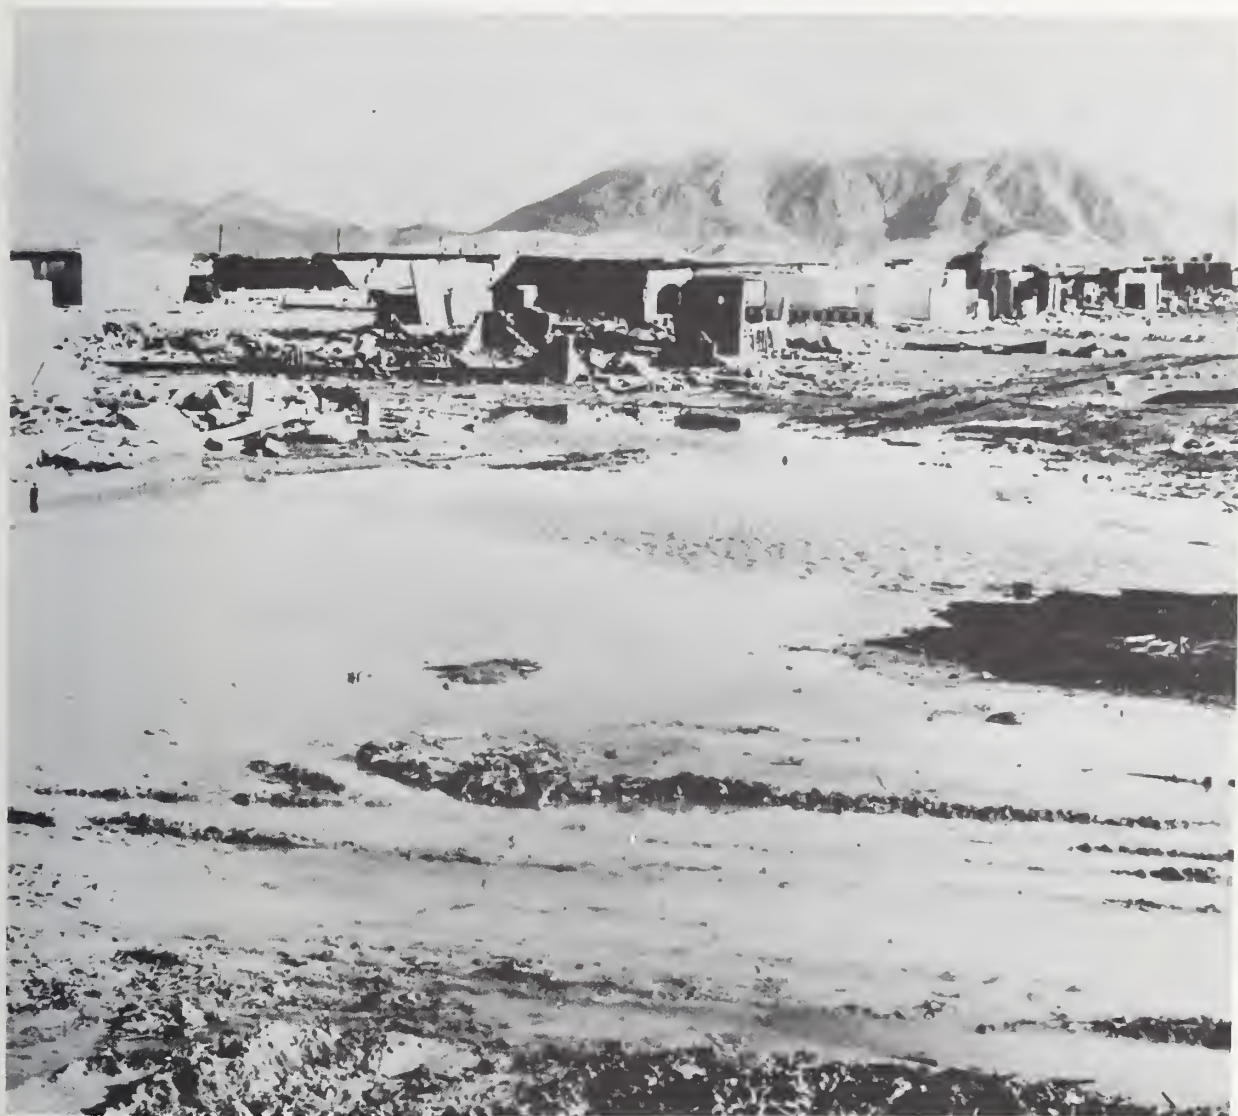
Figure 5.5 Compaction of foundation material and destruction of adobe, brick, and concrete block houses in low-lying area near the coast in southern Chimbote. Before the earthquake, the ground surface was dry, and the water table was reportedly at a depth of about 50 cm.

The most spectacular examples of compaction and landspreading of water-saturated sediments in Chimbote include: 1) settling and flooding of a residential area in the southern part of the city (Figure 5.5), where there was almost total destruction of unreinforced buildings; 2) differential compaction in the downtown business district (Figure 5.6); 3) compaction and landspreading near the steel plant dock, which caused subsidence of about a meter (Figure 5.7) and damaged roads and buildings; and 4) spreading of liquefied sand on a beach berm that resulted in opening of a fracture more than a block long, along which masonry houses were ripped apart (Figure 5.8).

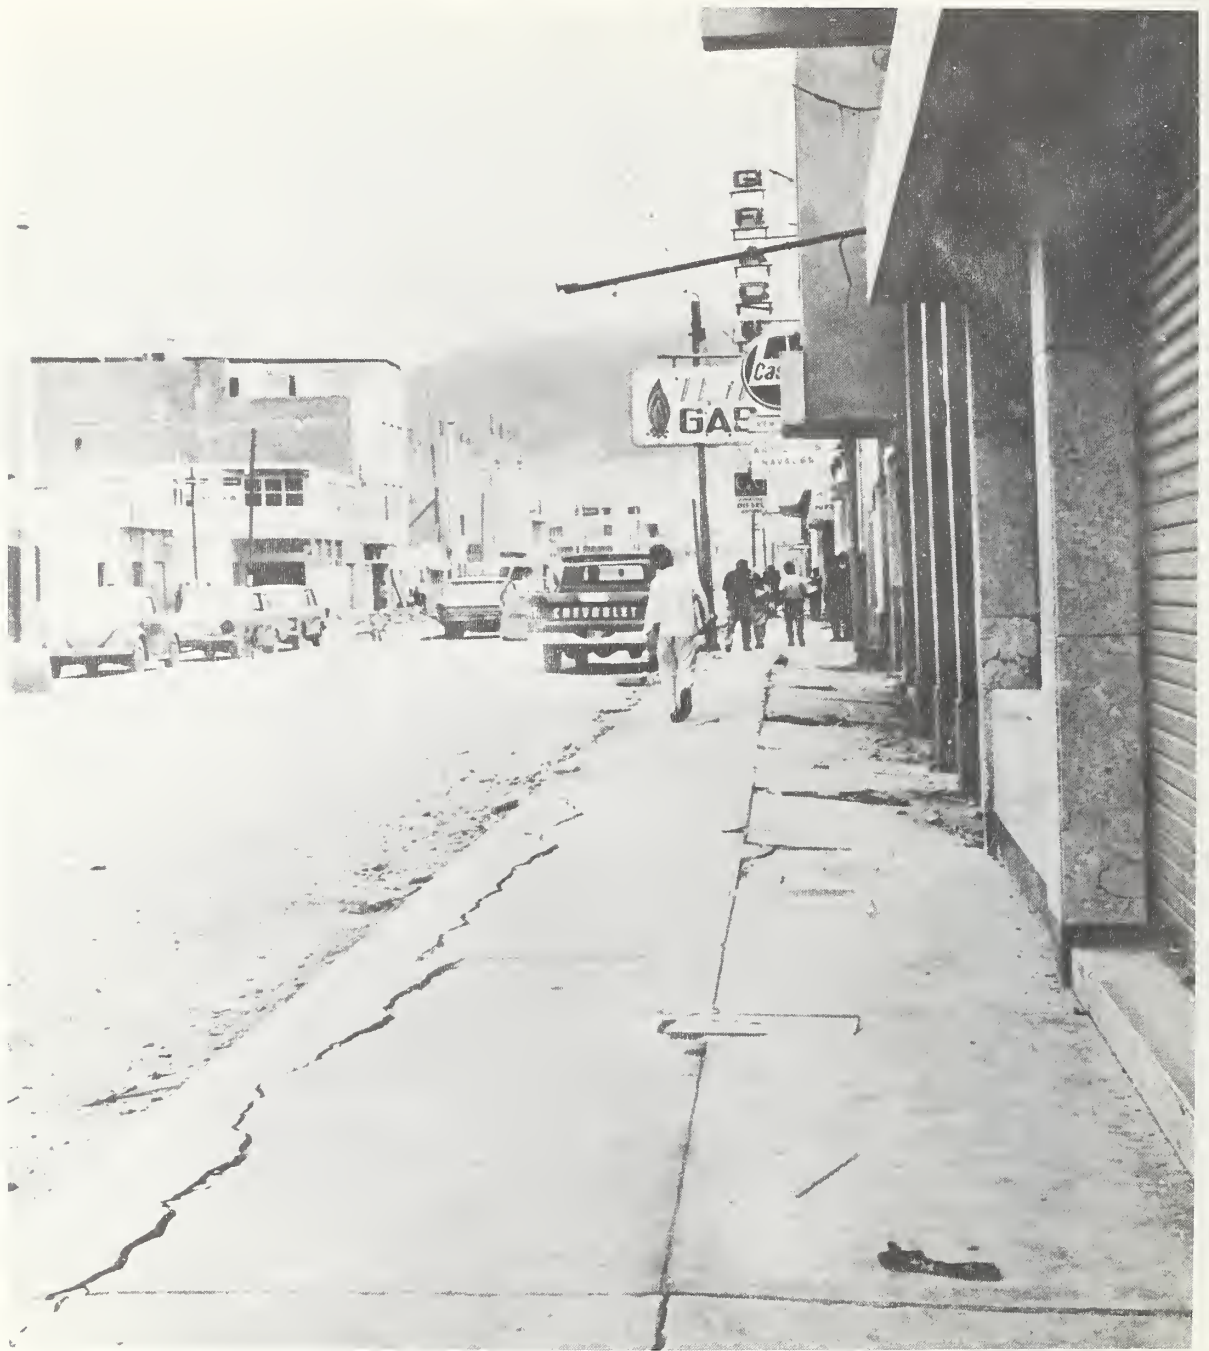
Figure 5.6 Street in downtown Chimbote where differential compaction of water-saturated beach deposits and manmade fill caused settling of buildings and cracking of concrete sidewalks. Here, 2-, 3-, and 4-story buildings settled 20-30 cm into the foundation material.

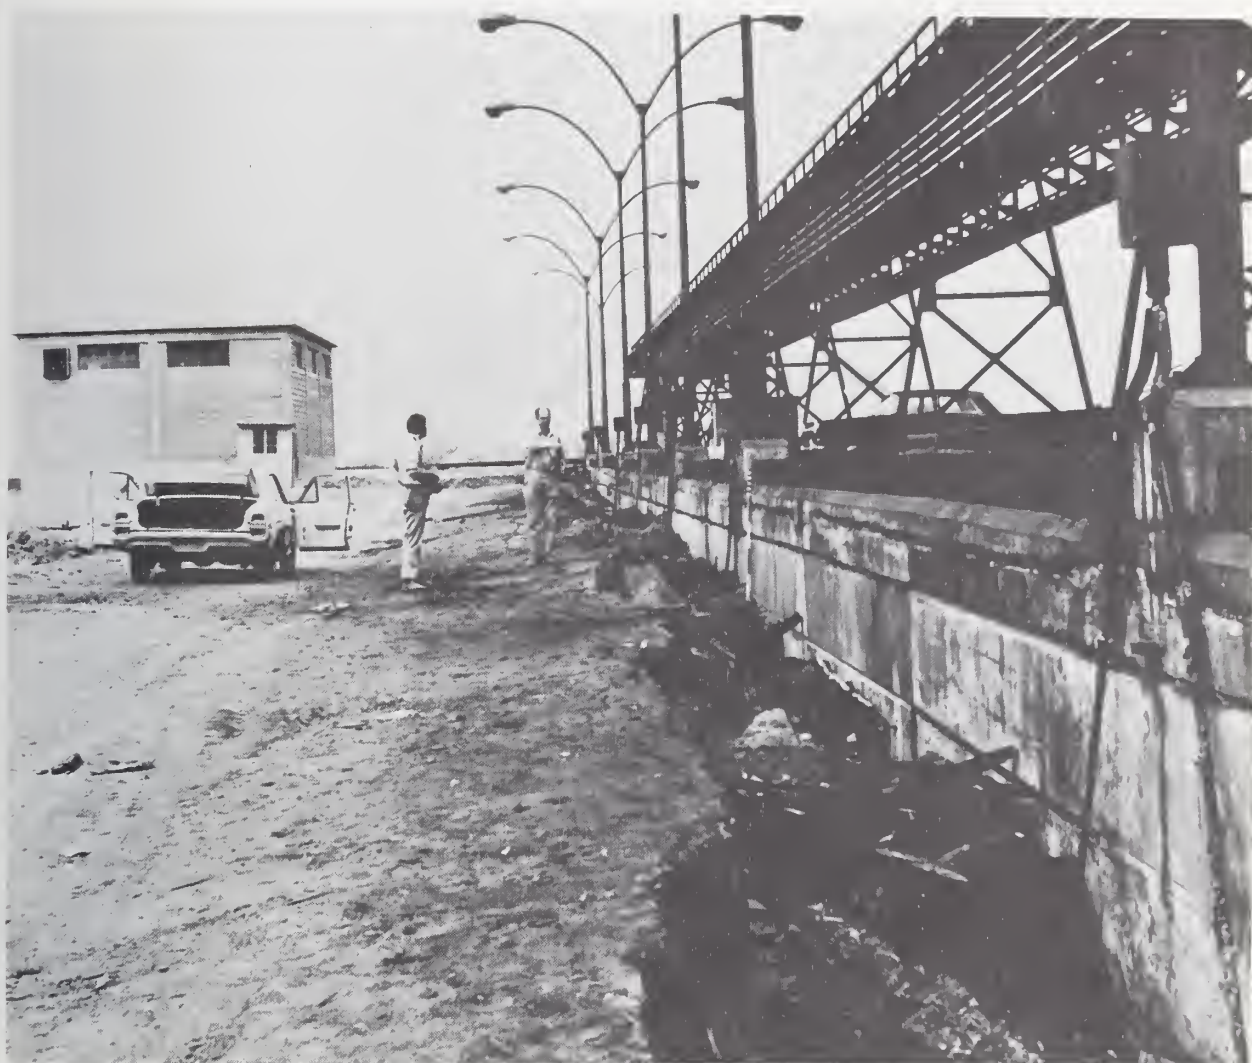
Figure 5.7 Subsidence of roadway fill at side of steel plant dock in northwestern Chimbote, resulting from compaction and seaward spreading of underlying water-saturated sediments. Roadway settled about 1.2 m here. The dock, which is on deep concrete piles, did not subside.
