# BUILDING SCIENCE SERIES 48

Design, Siting, and Construction  
of Low-Cost Housing and  
Community Buildings  
to Better Withstand Earthquakes  
and Windstorms

Building Science Series

Center for Building Technology  
Institute for Applied Technology  
National Bureau of Standards  
Washington, D.C. 20234

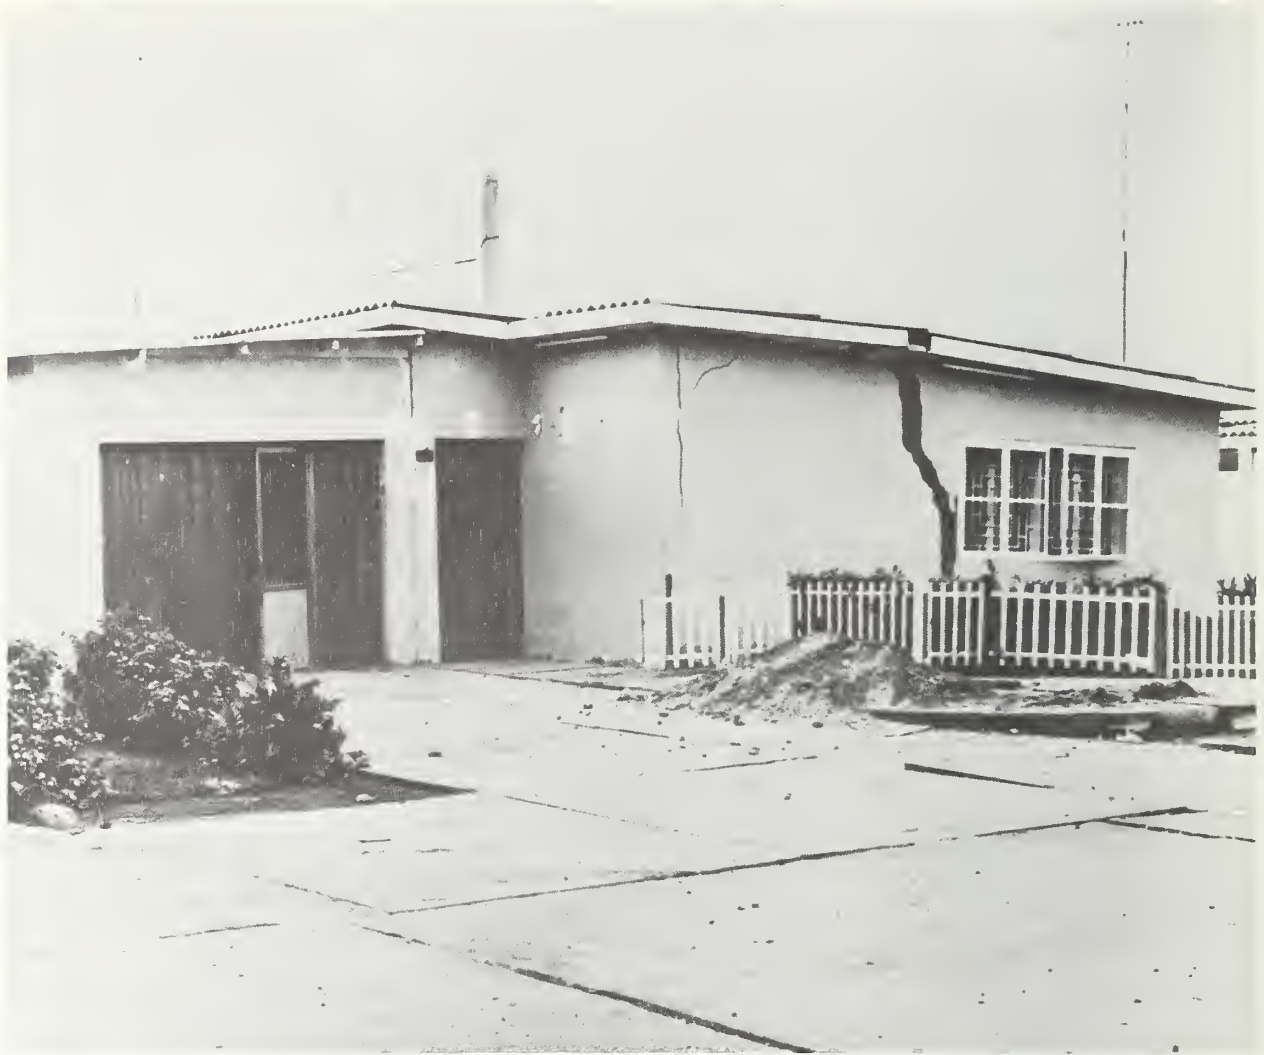
Figure 5.8 Concrete block house at the Corporacion Peruana del Santa housing development, northwestern Chimbote, torn apart by seaward spreading of the underlying beach sands that became liquefied during the earthquake.

The most spectacular examples of compaction and landspreading of water-saturated sediments in Chimbote include: 1) settling and flooding of a residential area in the southern part of the city (Figure 5.5), where there was almost total destruction of unreinforced buildings; 2) differential compaction in the downtown business district (Figure 5.6); 3) compaction and landspreading near the steel plant dock, which caused subsidence of about a meter (Figure 5.7) and damaged roads and buildings; and 4) spreading of liquefied sand on a beach berm that resulted in opening of a fracture more than a block long, along which masonry houses were ripped apart (Figure 5.8).

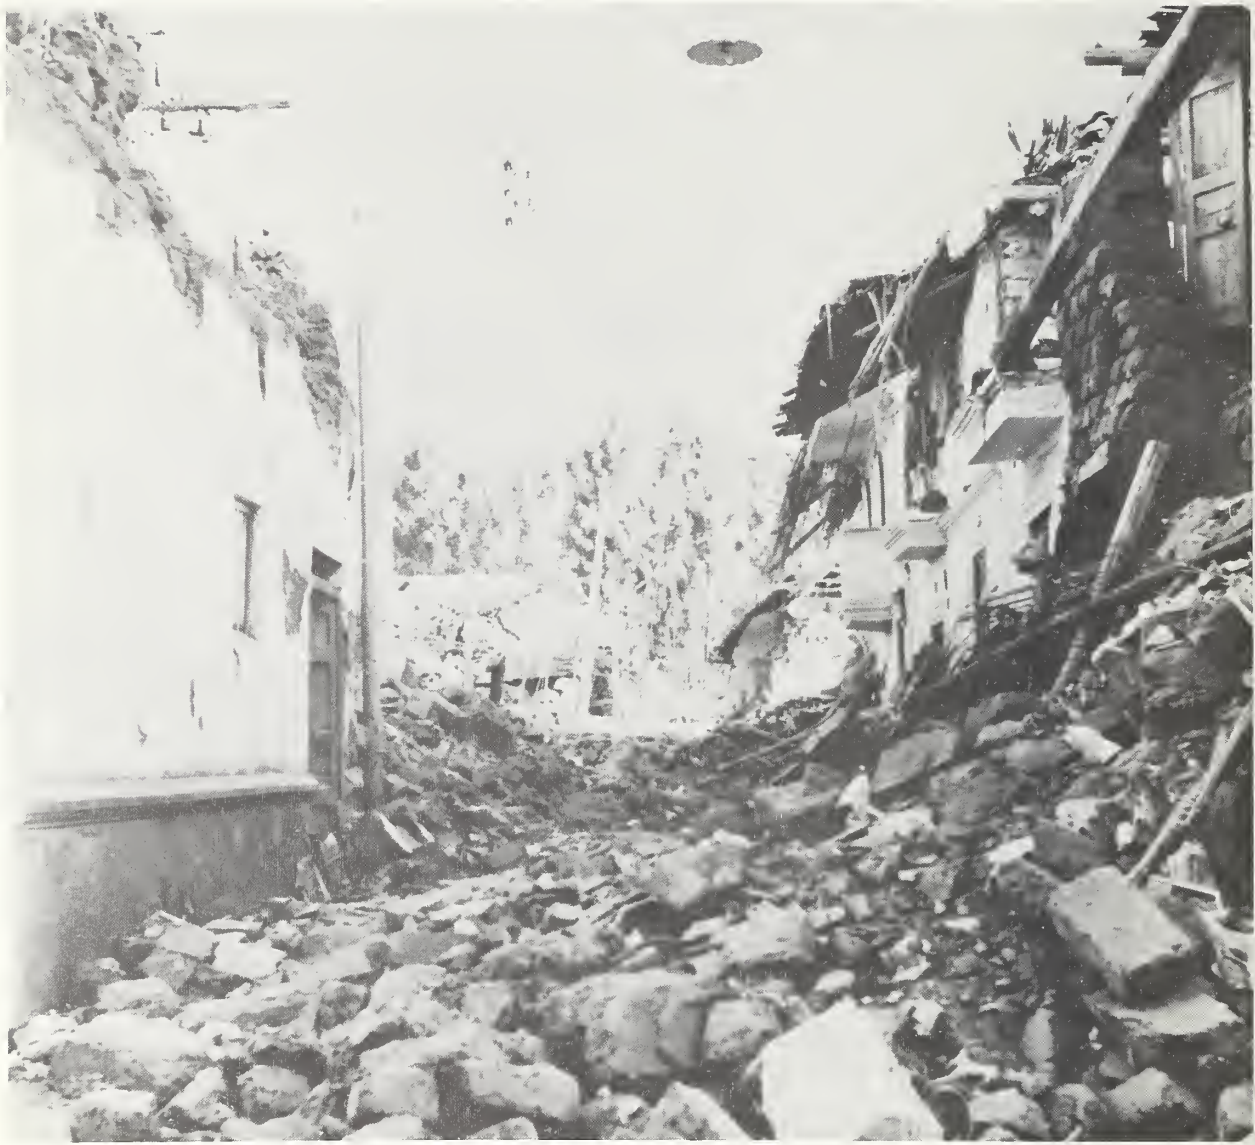
Figure 5.9 Typical street scene in a 100-block area of central Huaraz where nearly all adobe block buildings were destroyed. Most buildings were 2 or 3 stories high and had heavy tile roofs. Thousands of people were buried here in the narrow streets as well as in collapsed houses.

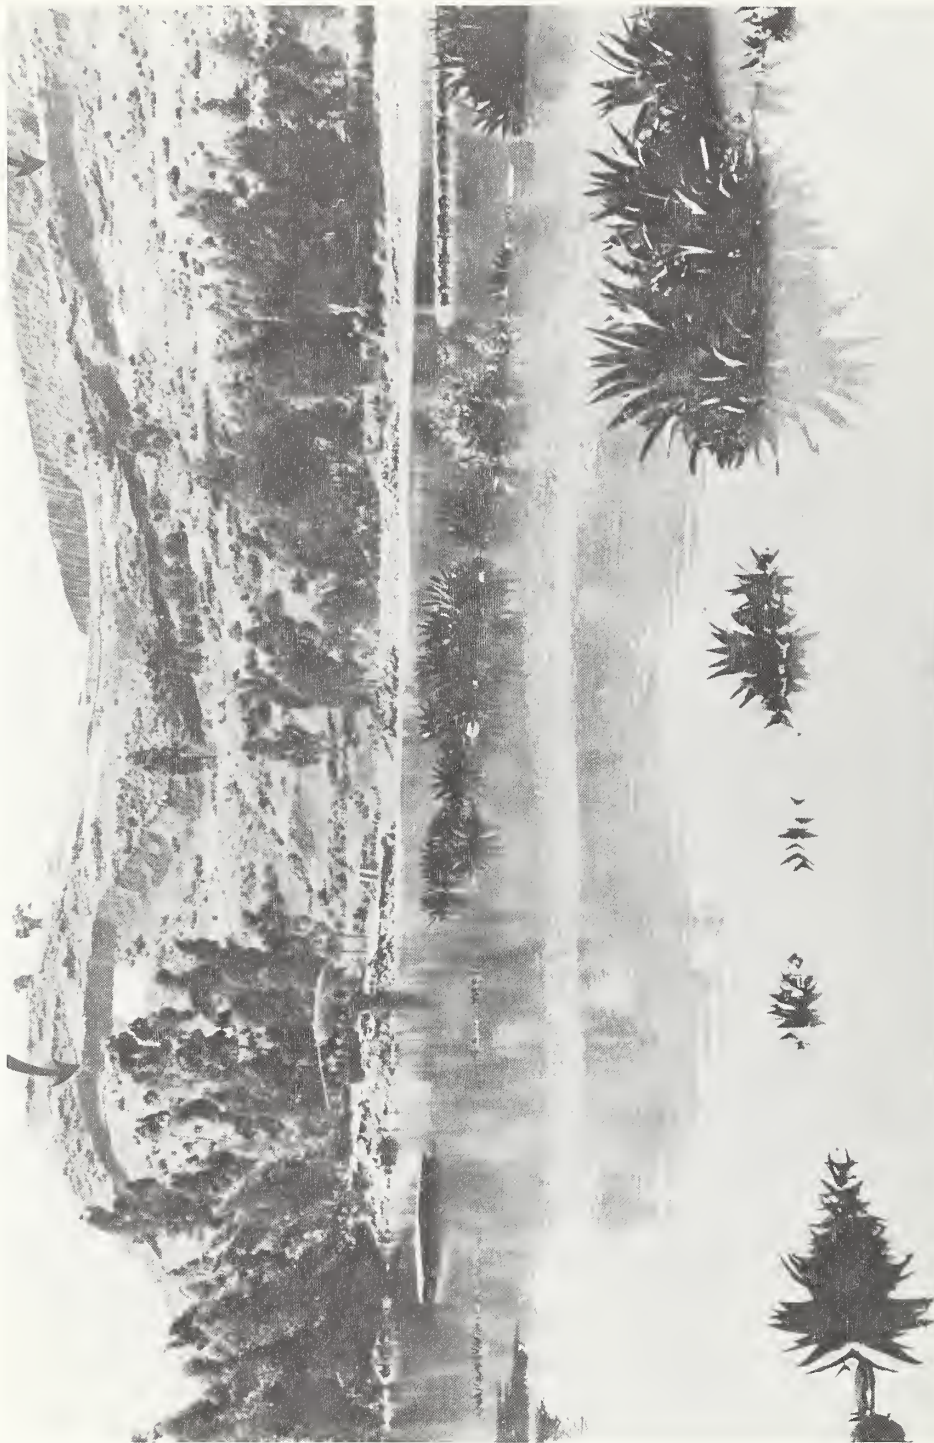
Figure 5.12 Rotational slide in glacial outwash and underlying thin-bedded sedimentary rocks at Recuay. Maximum height of headwall (arrows) is about 7 meters. The toe (arrows) is a 5-meter high ridge that blocked the Rio Santa and formed the small lake in foreground of photograph.

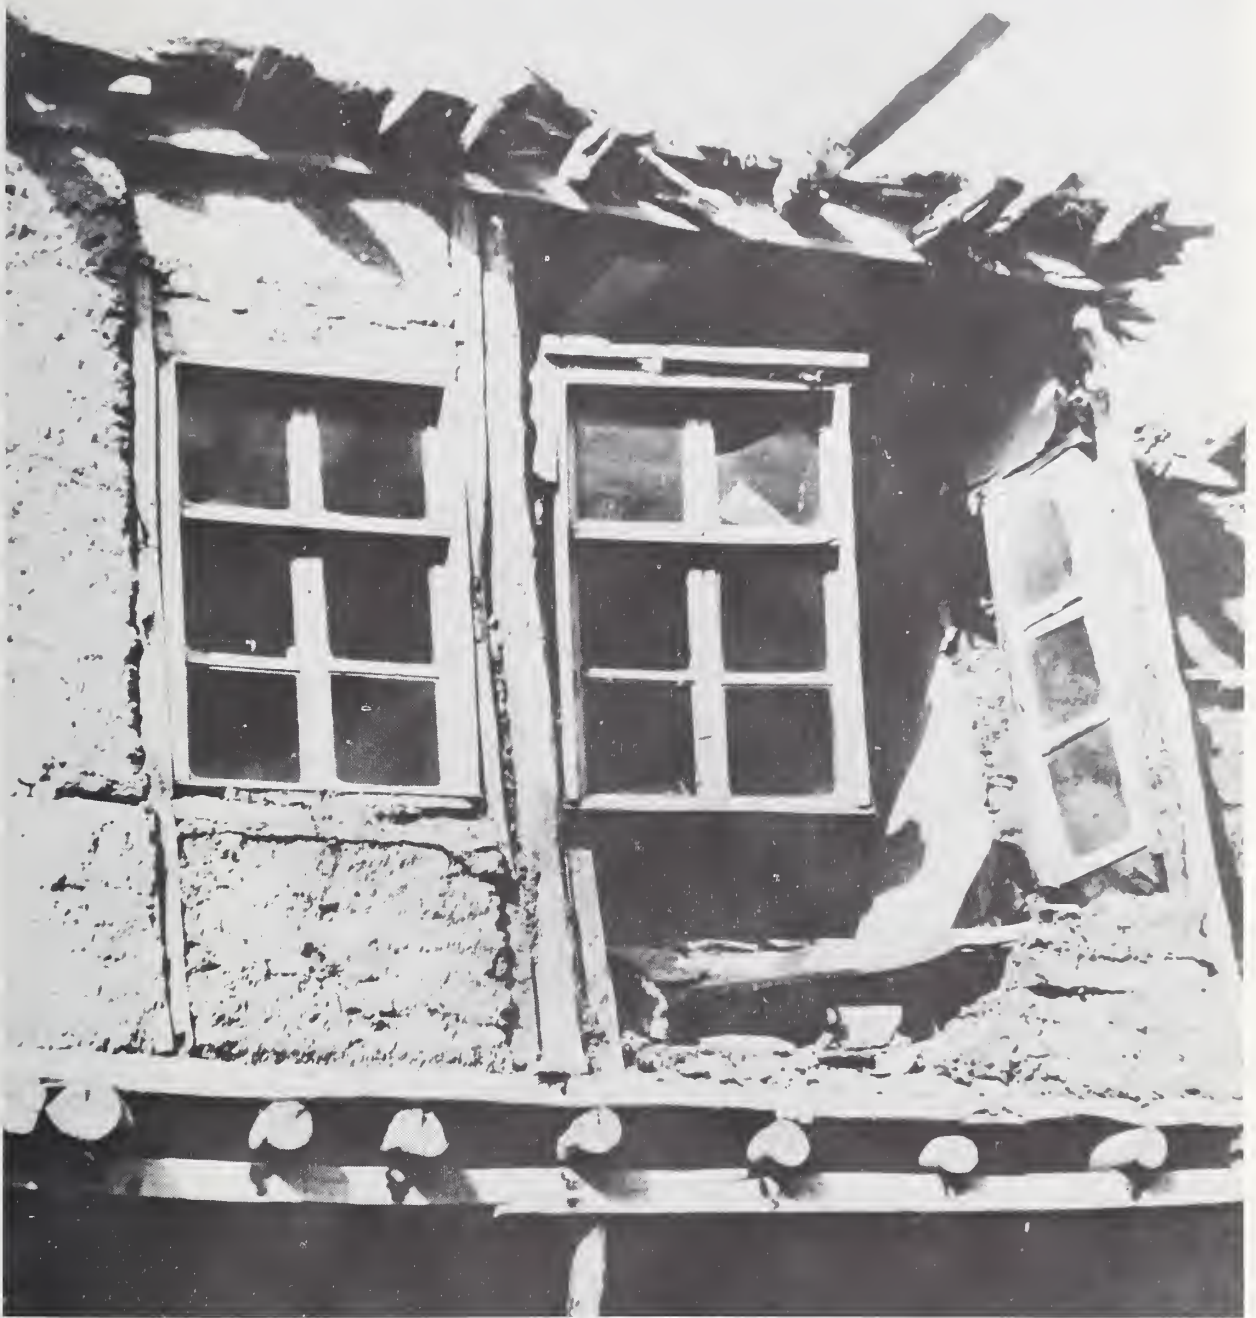
Figure 6.1 Two-story adobe-filled timber-framed structure in Turkey.  
Damage is due to poor quality of framing and connections.

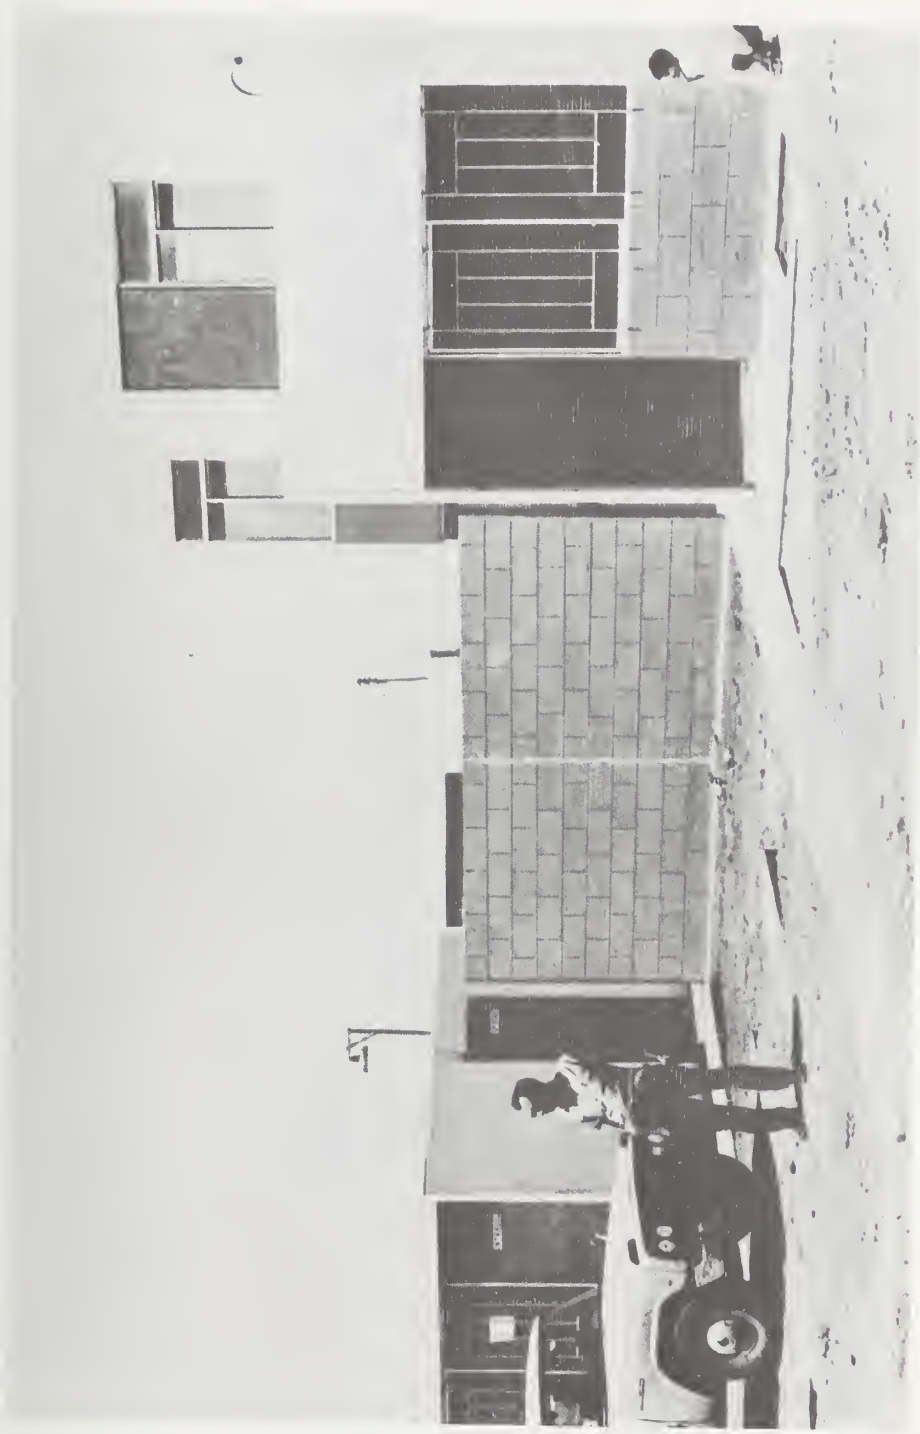
Figure 6.5 Unibrete precast concrete buildings, Chimbote, Peru. Very careful technical supervision of the erection of such buildings is necessary in regions subjected to earthquakes. Particular attention should be given to connection of components, both in design and in construction.

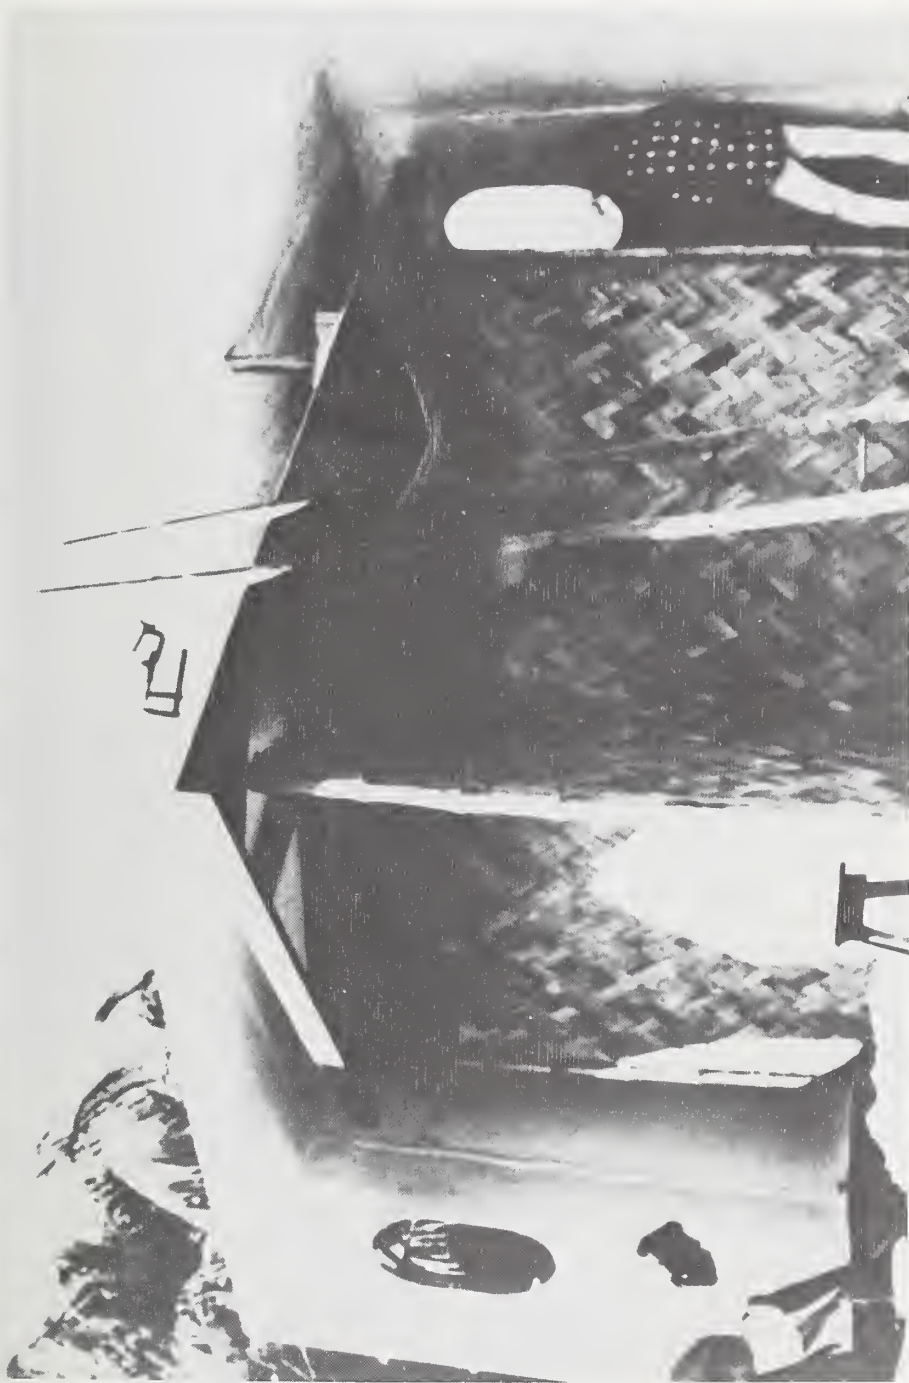
Figure 6.6 Plastic prototype house of CARE, Inc., Bangladesh. (1971). Interior view of three segments in place. Note variation in segments, one at extreme left does not use jute husk laminate but pure fiberglass with the necessary gusseting for this type of configuration. The other two sections are jute husk laminate each with some experimental variations.

A prototype house made from jute core laminated with fiberglass was designed, developed and constructed by CARE, Inc. in Bangladesh (Figures 6.6, 6.7). The reaction to the full size model in Dacca was highly favorable as the construction uses a high proportion of locally-available materials and appears to be of superior resistance and durability. The house is still in the experimental stage, both from the structural and the social acceptance standpoints.

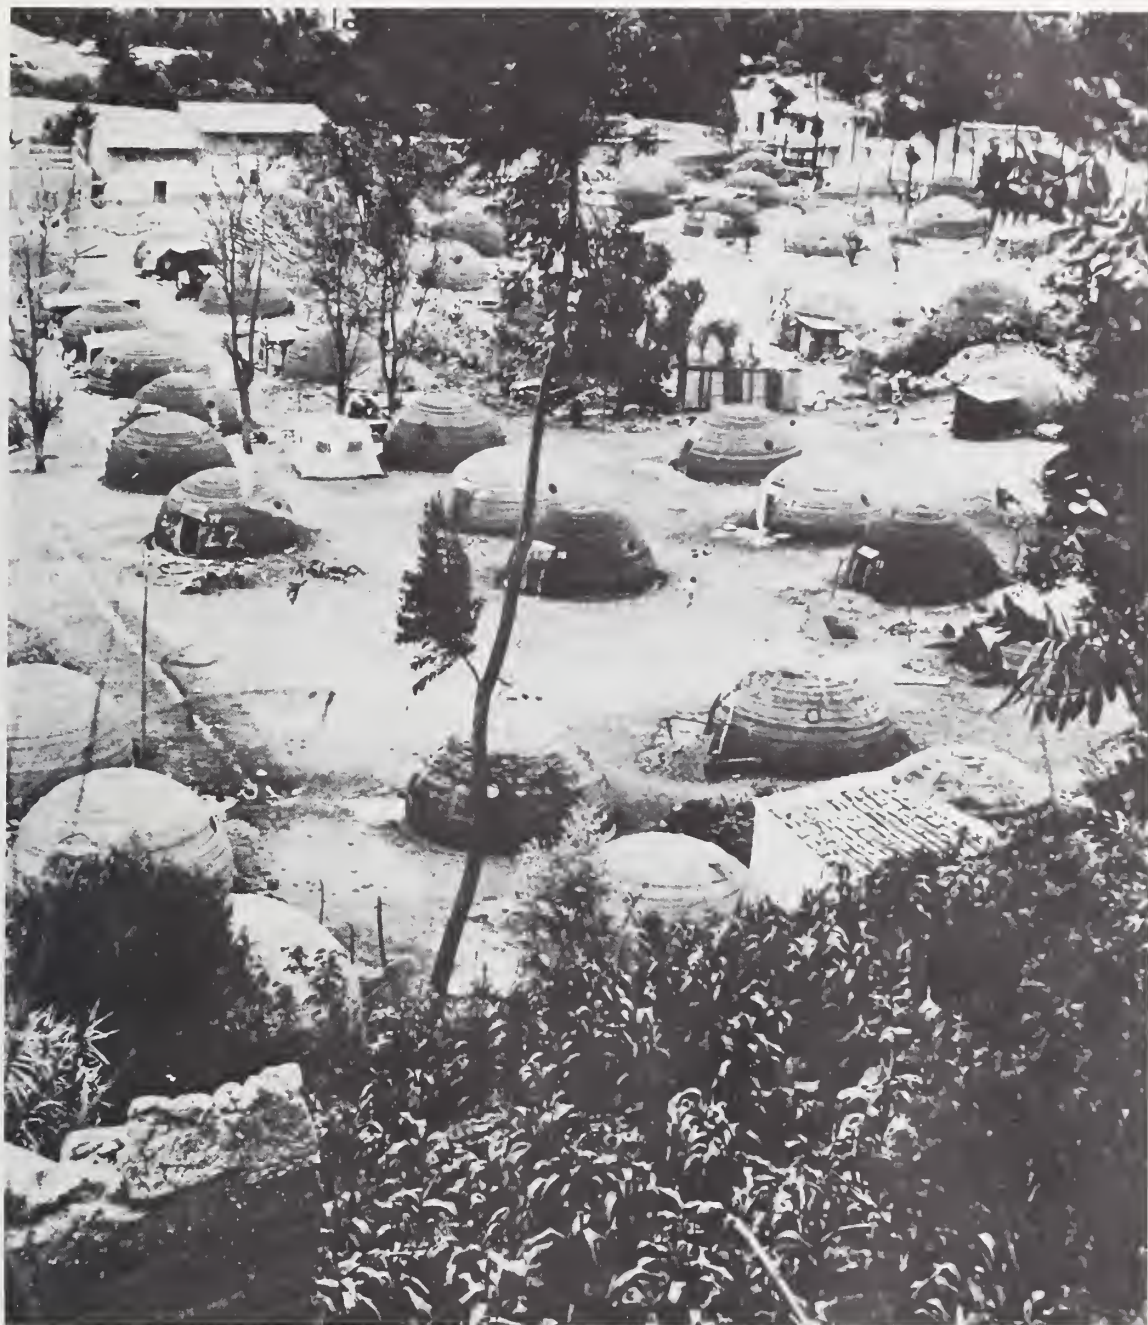
Figure 8.1 Polyurethane "igloo" homes at Caraz, Peru, built by the German firm Bayer, A. G. These homes failed to gain acceptance on the part of their users, who abandoned them after being adversely affected by
