## BUILDING SCIENCE SERIES 65

# Nonmetallic Coatings for Concrete Reinforcing Bars

James R. Clifton, Hugh F. Beehly,  
and Robert G. Mathley

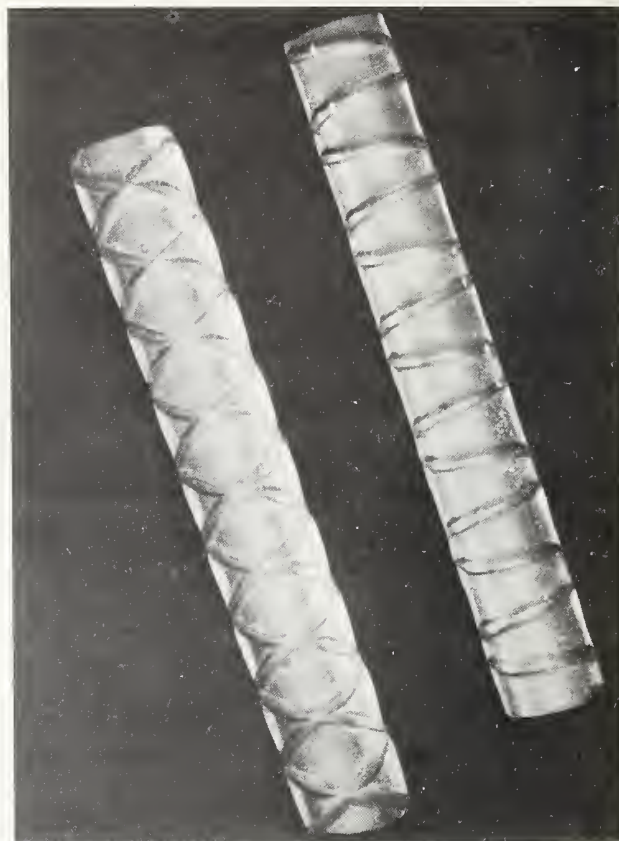
FIGURE 1. View of No. 6D (upper bar) and No. 6B (lower bar) reinforcing bars.  
D denotes diamond shaped deformation pattern and B indicates barrel pattern.

The tensile reinforcement in the pullout, creep, and corrosion tests consisted of No. 6 deformed bars having either a barrel (B) or diamond shaped (D) deformation pattern as shown in figure 1. The bars were randomly selected and may not all have been the same heat. A 4 foot length of each type of bar was tested to rupture in tension. The yield strengths determined by the "0.2 percent offset" method were 67,600 psi for No. 6 rebars (D), and 62,500 psi for No. 6 rebars (B). These bars did not exhibit a well-defined yield point, however, their stress-strain relationships (fig. 2) were linear up to a stress of about 64,000 psi for the (D) rebars and approximately 62,000 psi for the (B) rebars. Tensile properties of the bars are listed in table 2. The yield, tensile strengths and deformations of the bars met the requirements of ASTM A 615-72 [25] for Grade 60 bars. The properties of deformations were determined from three coupons of each type of bar and are given in table 3.

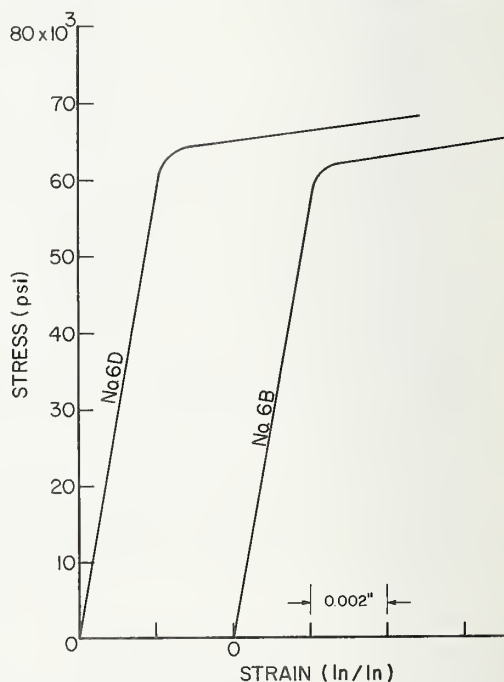
FIGURE 2. Typical stress-strain characteristics of reinforcing bars.

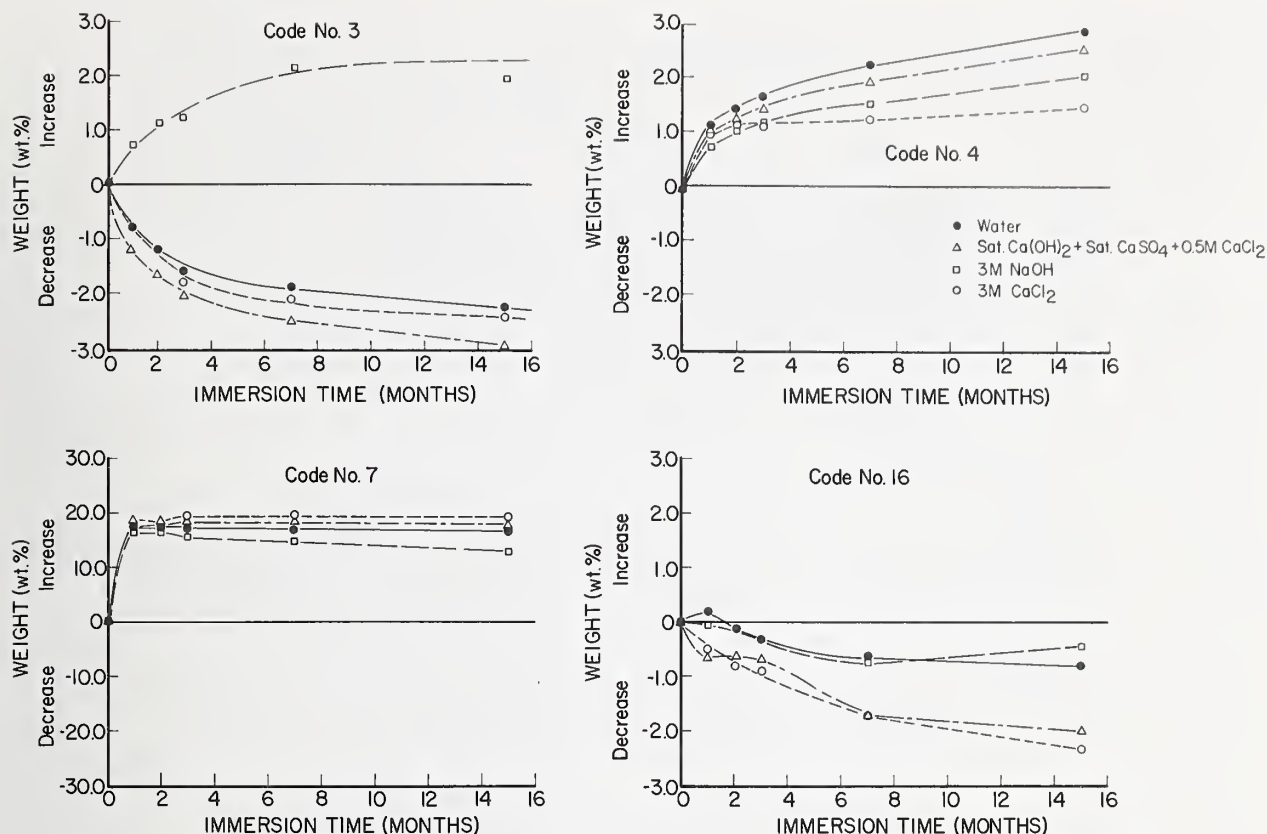
FIGURE 3. Weight stabilities of cured specimen disks, fabricated from four liquid epoxies, immersed in aqueous solutions.

The weight changes versus immersion times are plotted in figure 3 for epoxies Nos. 3, 4, 7, and 16, which represent the different behaviors of the epoxy specimens. No. 4 is typical of most of the specimens, with a modest weight increase irrespective of the test solution; in contrast No. 16 has a gradual loss of weight in all four test solutions. No. 7 had the largest weight change of all the epoxies tested with weight increases ranging from 13 to 19 percent; which essentially occurred during the first month of immersion. No. 3 experienced a gradual weight loss except when immersed in the NaOH solution.

A weight increase probably can be attributed to absorption of the test solution by the epoxy specimen; while loss in weight can be attributed to dissolution of the specimen in the test solution, or in the case of solvent-containing systems, the loss of entrapped solvent. It is felt that epoxies exhibiting minor weight changes, i.e., average under 4 percent, will not be degraded by long-term embedment in concrete.

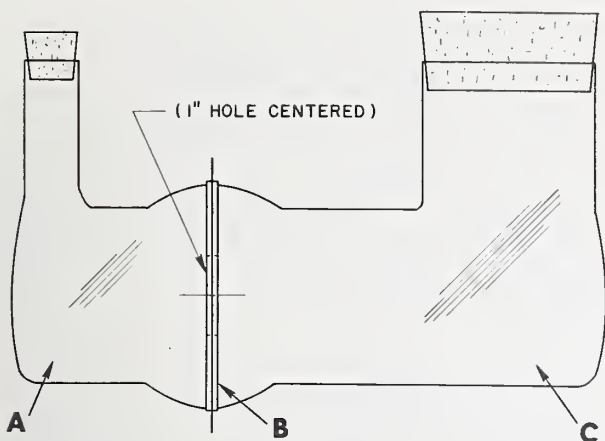
FIGURE 4. Permeability Cell.

Components: A. Compartment containing distilled water;  
B. Epoxy film sandwich between two glass plates each having centered one-inch diameter hole;  
C. Component containing 3M NaCl

The chloride permeability characteristics of thin films (3–7 mils) of cured epoxies were determined using permeability cells of the type shown in figure 4. Films selected for study were carefully handled, and examined for any defects prior to installation in the cell. The cell consisted of two glass compartments sepa-

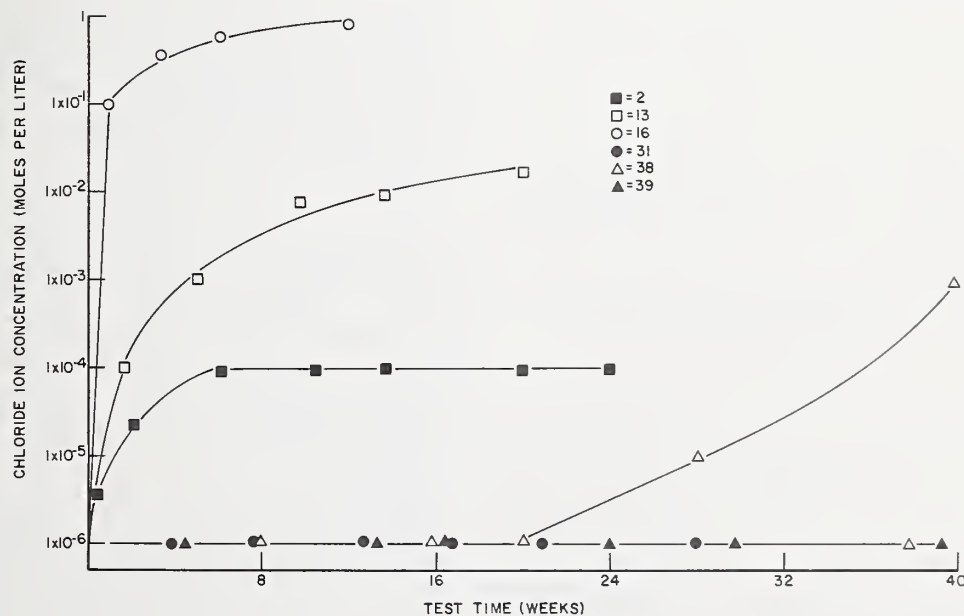
FIGURE 5. Concentration of chloride ions passing through epoxy films of materials Nos. 2, 13, 16, 31, 38, and 39.

Film thicknesses were 3 mils.

The data for 15 different epoxies are listed in table 6. Many of the epoxy films, Nos. 1, 3, 17, 19, 31, and 39, appear to be essentially impervious to chloride ions (at least during the listed exposure times). The accumulative concentrations of chloride ions passing through epoxy films are plotted versus time in figure 5 for

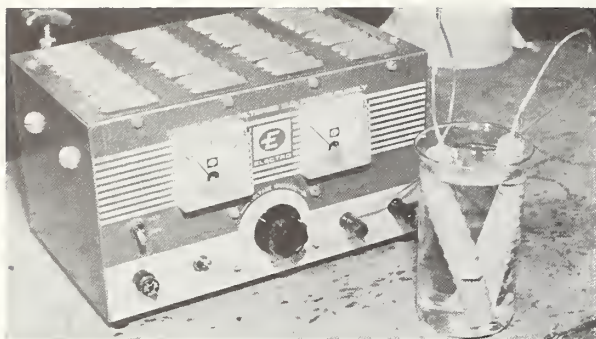
FIGURE 6.A. Applied voltage test at beginning of test.  
Anode and cathode coated with material No. 16.

The effects of electrochemical stresses on coatings on reinforcing bars were assessed by applied voltage studies. Such stresses can be induced in the field by cathodic protection devices, stray currents, or by corrosion processes. The cathode and anode were No. 6 reinforcing bars, 6 in long, both coated with the same material. The electrolyte was an aqueous solution of 7 percent NaCl. A potential of 2 V was applied and the electrodes were visually observed periodically for evolution of hydrogen gas at the cathode and for evidence of corrosion products of iron at the anode. Before immersion, any bare ends or obvious mechanically damaged areas on the electrodes were covered with a film of silicone rubber, and no intentional holidays were induced. The sources of any corrosion, therefore, were holidays in the films. The applied voltage method also serves as a sensitive holiday detector and can be used to ascertain whether holidays are developing in a film because of degradation of the coating. A typical experimental setup is shown in figure 6A. In this photograph, taken at the beginning of the test, the bars are coated with material No. 16. After 30 min of application of 2 V copious amounts of corrosion products were observed (fig. 6B).

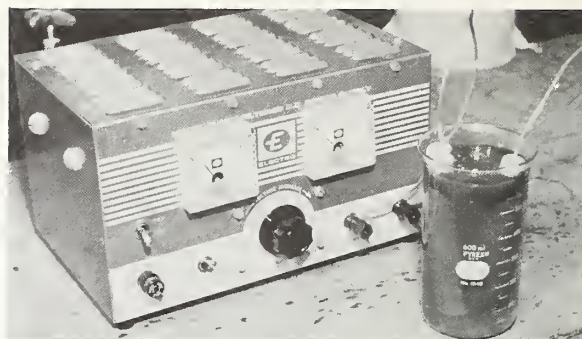
FIGURE 6.B. Results of application of 2 V for 30 min.

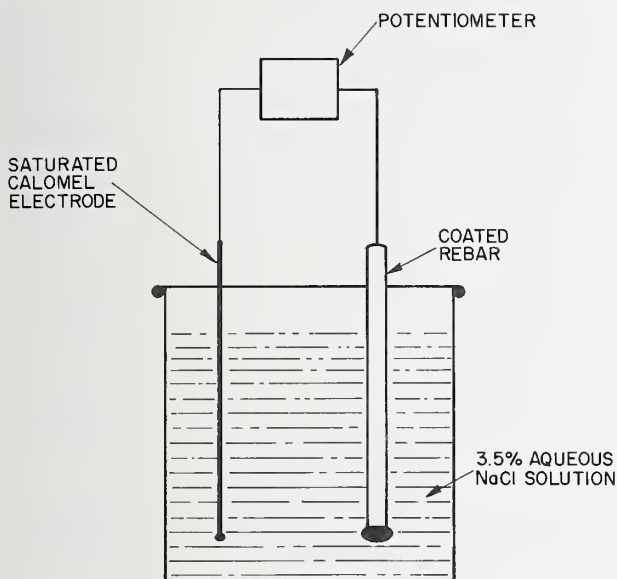
FIGURE 7. Measurement of electrical potentials of coated reinforcing bars immersed in 3.5 percent solution of NaCl.

Alternate means of assessing the protective qualities of barrier coatings are electrical potential measurements and the electrical resistance of the coating films. Such measurements were made on both coated reinforcing bars partially immersed in 3.5 percent aqueous solutions of NaCl and on coated bars embedded in

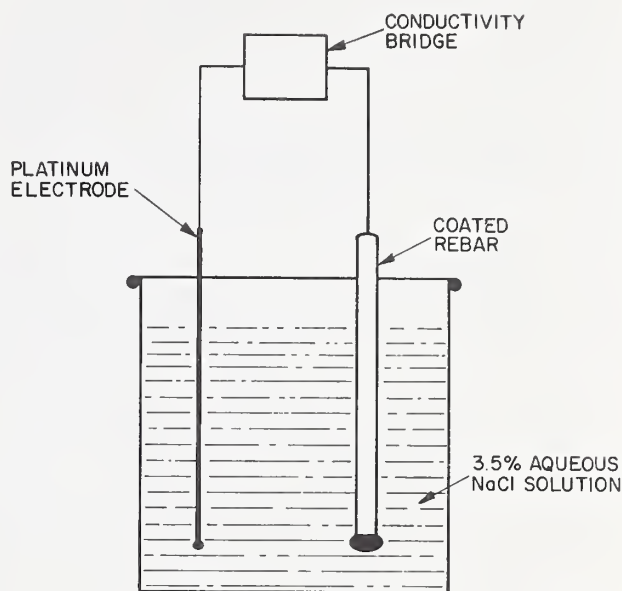
FIGURE 8. Measurement of electrical resistance of coatings on reinforcing bars immersed in 3.5 percent solution of NaCl.

concrete specimens partially immersed in 3.5 percent NaCl solution. The electrode potentials were measured using a Coleman Model 37A pH meter with a saturated calomel electrode (S.C.E.) as the reference electrode, as illustrated in figure 7. Measurements of electrical resistances were taken using a Yellow Springs Instrument Company Model 31 Conductivity Bridge along with a platinum electrode, figure 8.

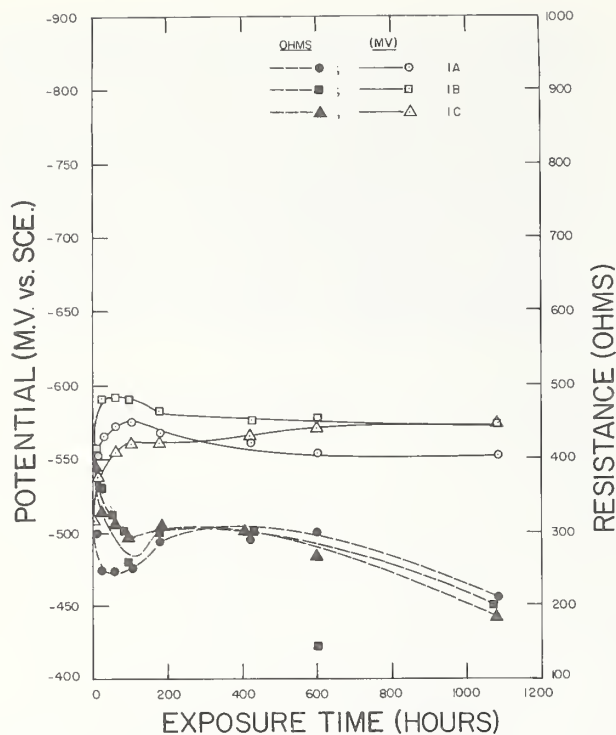
FIGURE 9. Electrical potential and resistance measurements of reinforcing bar coated with material No. 1 immersed in  $3\frac{1}{2}$  percent NaCl.

In the ordinate caption, M.V. versus S.C.E. denotes millivolt reading taken using a saturated calomel electrode as the reference.

Potential and resistance data for three sets of reinforcing bars, each set coated with a different epoxy (Nos. 1, 25, and 31) are plotted versus test time in figures 9, 10 and 11. The wide variance in the initial millivolt and ohmic readings of duplicate and triplicate specimens decreased rapidly during the first 200 h of testing and after 1000 hours good agreements were obtained for companion specimens. A rapid decrease in the resistance of a coating probably can be attributed to the emergence of holidays, while an increase in resistance is probably indicative of some type of healing mechanism.

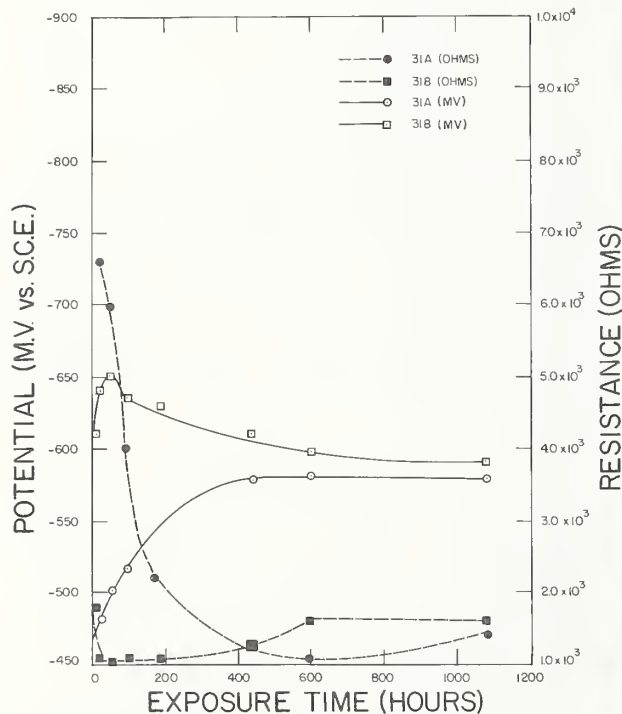
FIGURE 11. Electrical potential and resistance measurements of reinforcing bar coated with material No. 31 immersed in  $3\frac{1}{2}$  percent NaCl.

In the ordinate caption, M.V. versus S.C.E. denotes millivolt reading taken using a saturated calomel electrode as the reference.

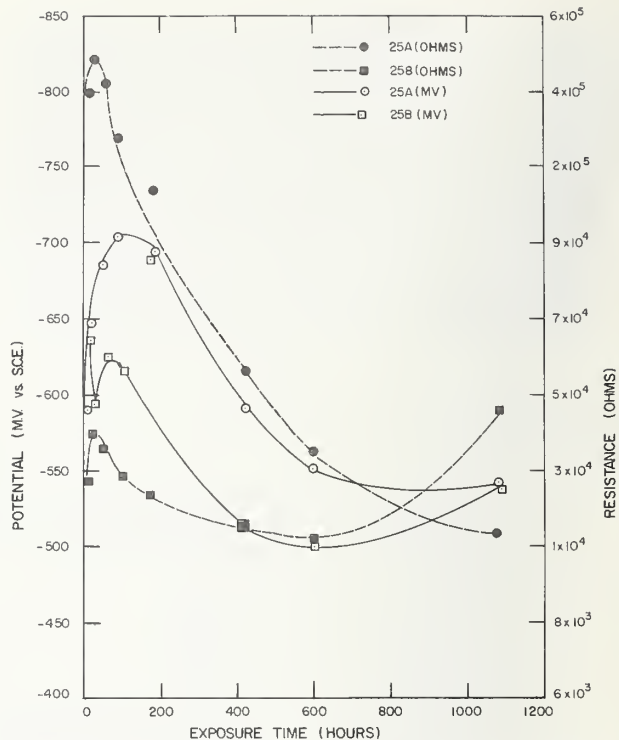
FIGURE 10. Electrical potential and resistance measurements of reinforcing bar coated with material No. 25 immersed in  $3\frac{1}{2}$  percent NaCl.

In the ordinate caption, M.V. versus S.C.E. denotes millivolt reading taken using a saturated calomel electrode as the reference.

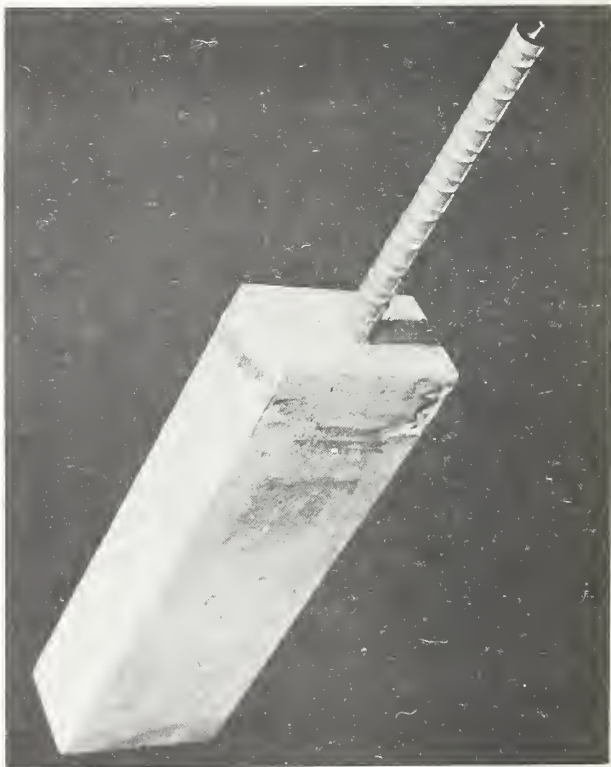
FIGURE 12. Corrosion-test specimen with coated reinforcing bar embedded in concrete block of dimensions  $2\frac{7}{8} \times 4\frac{7}{8} \times 15$  in.

The corrosion test specimens were concrete blocks  $2\frac{7}{8}$  x  $4\frac{7}{8}$  x 15 in in which were embedded a 24 in length of No. 6 reinforcing bar concentric with the longitudinal axis of the block. The bars protruded out of the concrete blocks with exposed ends of 1 in and 8 in. The end of the block with the 1 in of bar protruding which was to be immersed in the salt solution, was first coated with an "underwater" type of epoxy which bonded firmly to the concrete. Then the 1 in exposed end of the bar and the epoxy were coated completely with a heavy layer of silicone rubber. The bond of the rubber to steel and to the epoxy was very good, although its bond to concrete in a salt solution is poor. A terminal was inserted into the long end of each reinforcing bar so that electrical connections could be made to a voltmeter or conductivity bridge.

The corrosion-test specimens, figure 12, consisting of reinforcing bars embedded in  $27/8 \times 47/8 \times 15$  in concrete blocks were partially immersed in an aqueous solution of 3.5 percent NaCl. The solution was contained in a 105 gallon polyethylene-lined, fiberglass reinforced, polyester tank, 4 x 2 x 2 ft. The bars were in a vertical position with their lower ends, protected by silicone sealant, fitted into 1 in diam holes drilled in 1 ft x 1 ft spacing racks of  $3/4$ -in thick marine plywood. The racks rested on a sheet of marine plywood laid on the floor of the tank, and spacing racks were

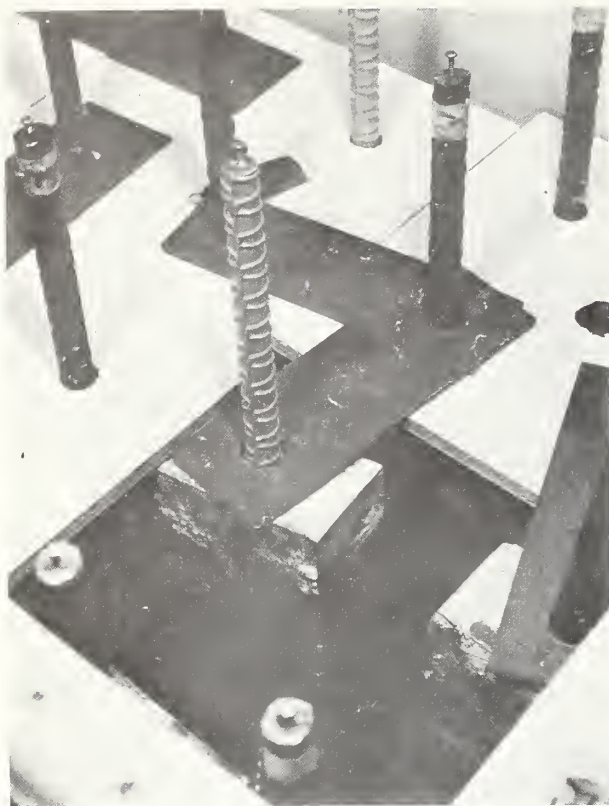
FIGURE 13. Corrosion-test specimens immersed in 3.5 percent solution of NaCl.

placed on top of the specimens (fig. 13). The lower 13 in of each specimen was immersed in the NaCl solution, with the upper 2 in of the concrete being above the level of the solution.

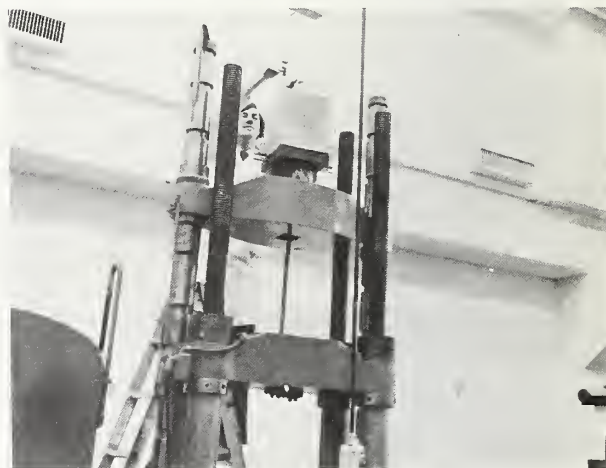
FIGURE 14. Pullout specimen on electromechanical testing machine being prepared for testing.

Pullout specimens were tested in a 200,000 lb capacity universal electromechanical testing machine 27 to 29 days after fabrication. A pullout specimen positioned on the testing machine is shown in figure 14. The pullout specimen shown in figure 15 is seated on leather cushions on two segments of a 2 in base plate attached to a spherical bearing block. Free- and loaded-end slips of the reinforcing bar were measured with  $1 \times 10^{-4}$  in micrometer dial gages and estimated to  $1 \times 10^{-5}$  in. At the loaded end of the specimen, two dial

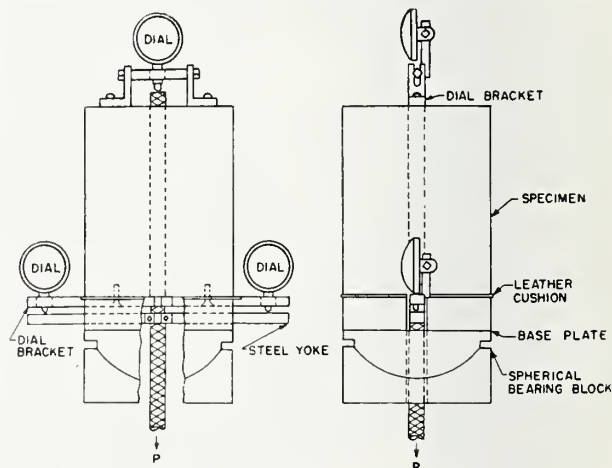
FIGURE 15. Schematic of pullout specimen.  
Size of concrete prism is 10 x 10 x 12 in.

gages were attached to a steel bar fastened to the face of the concrete by bolts secured into inserts cast in the concrete. The gages bore on a steel yoke fastened to the reinforcing bar about 1 in below the face of the concrete. The bar supporting the dial gages and the yoke was free to move in the recess in the base plate. The average of the two gage measurements gave the displacement of the point on the reinforcing bar where the yoke was attached, with reference to the face of the concrete. Slip at the free end was measured with a gage that bore on the exposed end of the reinforcing bar (any coating material on the exposed end of the reinforcing bar was removed prior to testing). The gage was mounted on a support attached to the top face of the concrete by bolts secured into inserts cast in the concrete.

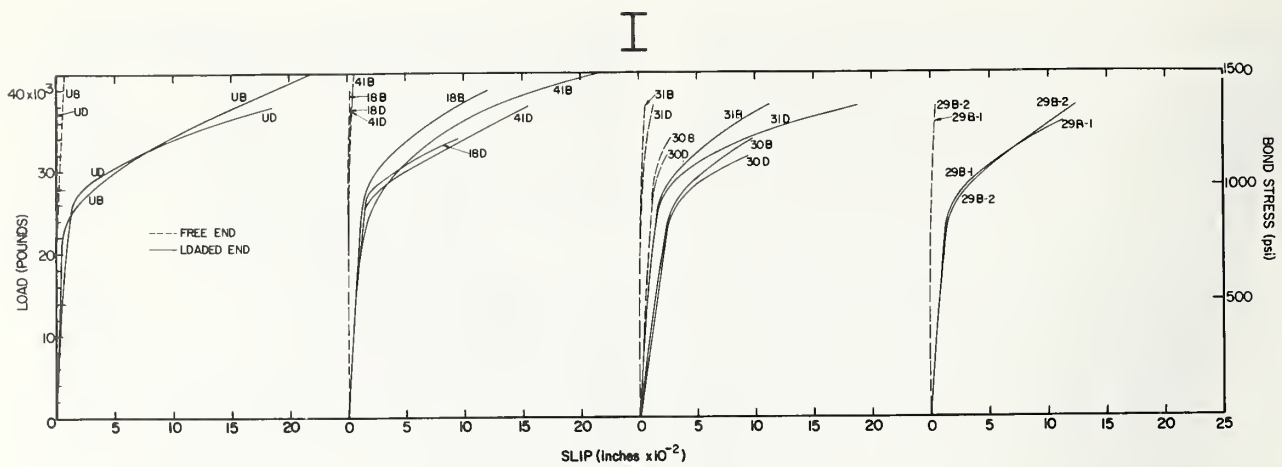
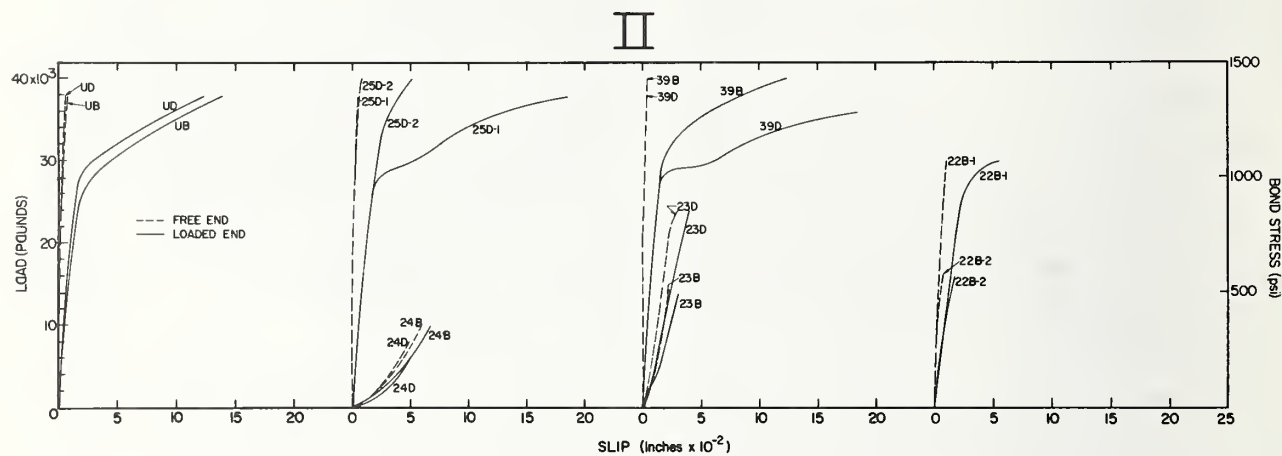
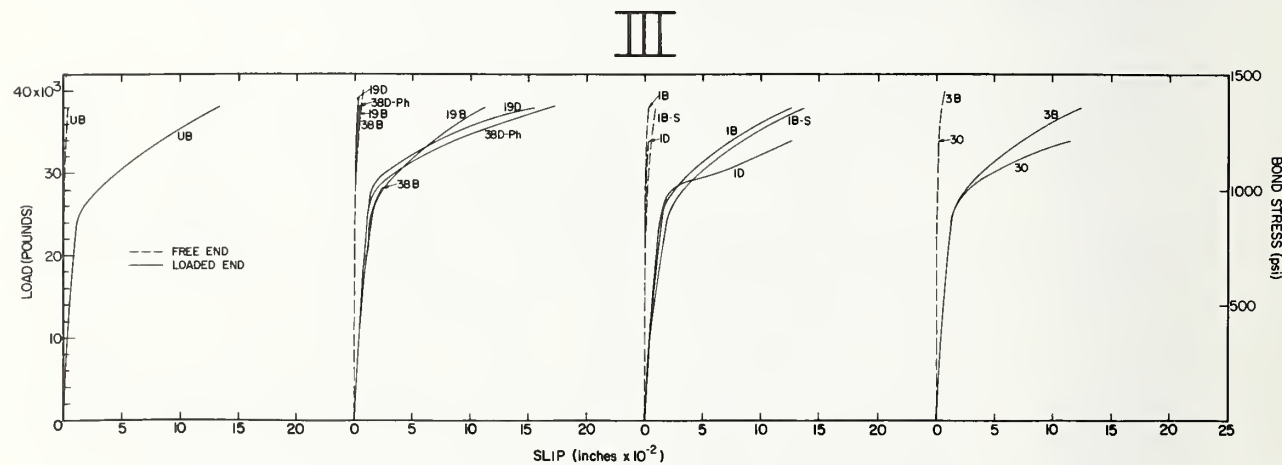
FIGURE 16. Applied load to reinforcing bar in pullout specimens versus free-end and loaded-end slip.  
Roman numbers indicate concrete batch number, while Arabic numbers identify the coating materials (table 1).

An evaluation of the pullout tests results indicates that epoxy-coated reinforcing bars have bond strengths essentially equal to uncoated bars when the film thicknesses are approximately 10 mils or less. Both liquid and powder epoxies performed equally well, and the application method did not significantly affect the bond strength of coated bars. The polyvinyl chloride coated bars had bond strengths considerably less than that for uncoated bars and bars with these coatings are not recommended for structural use. The lower bond strengths for polyvinyl coated bars are attributed in part to the thermoplastic nature of the polyvinyl chloride. The thickness of the polyvinyl chloride films was greater than most of the epoxy films but thicker films are normal for thermoplastics [39].

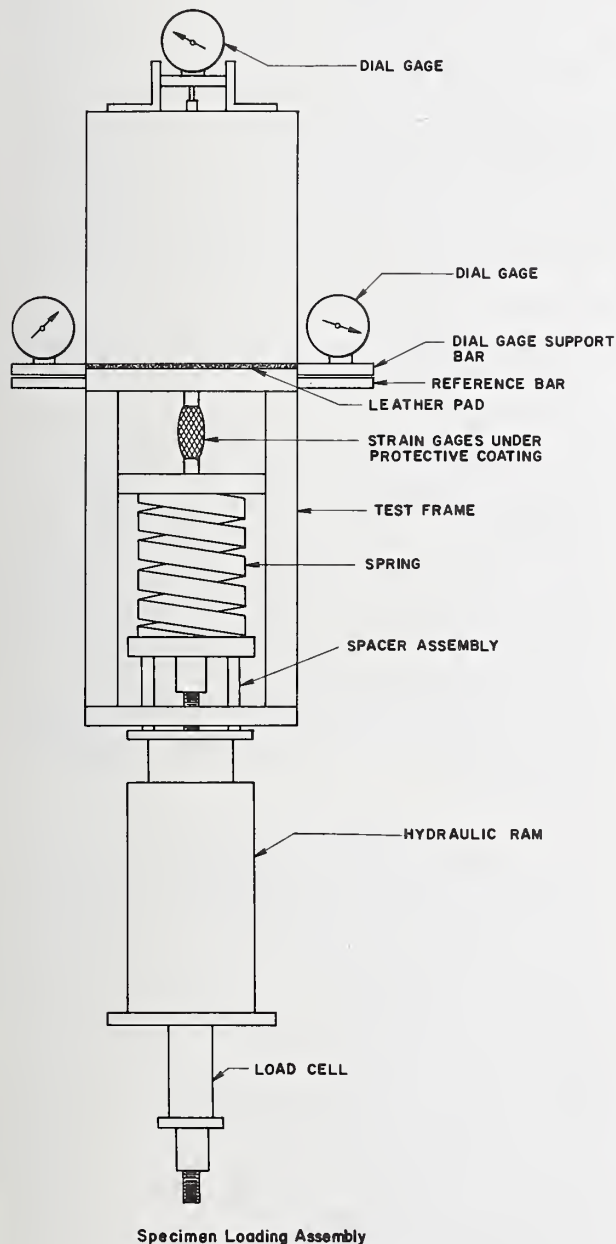
FIGURE 17. Schematic of creep specimen. Size of specimen is the same as the pullout specimen.

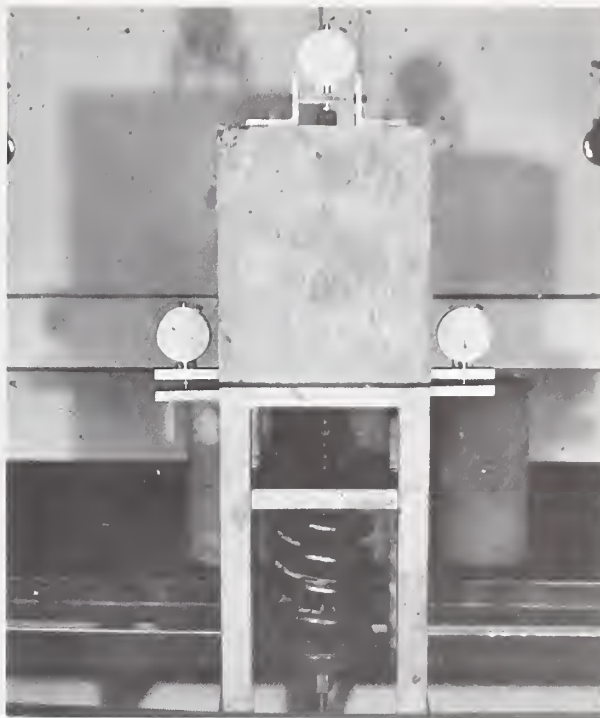
FIGURE 18. Creep specimen loaded to a tensile stress level of 30,000 psi (in the steel reinforcing bar).

The creep specimen in figure 18 was seated on leather cushions on two segments of the test frame (fig. 19). The dial gages were of the same type and attached in the same way as described for the pullout specimens. The free-end and loaded-end slip were also measured.

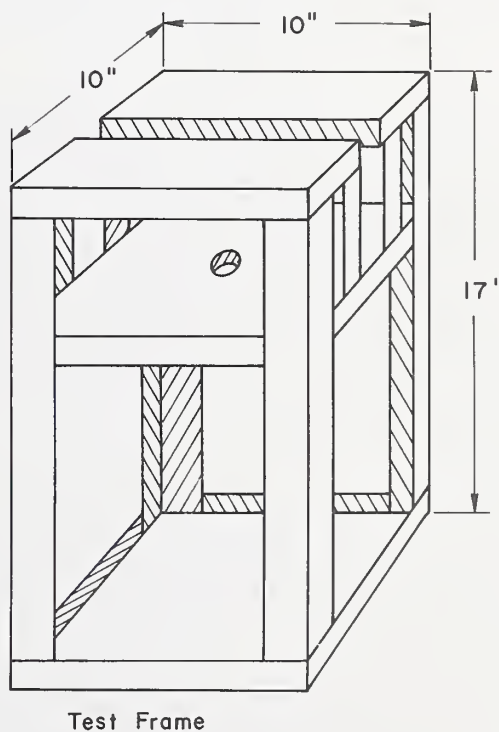
FIGURE 19. Schematic of creep test frame.

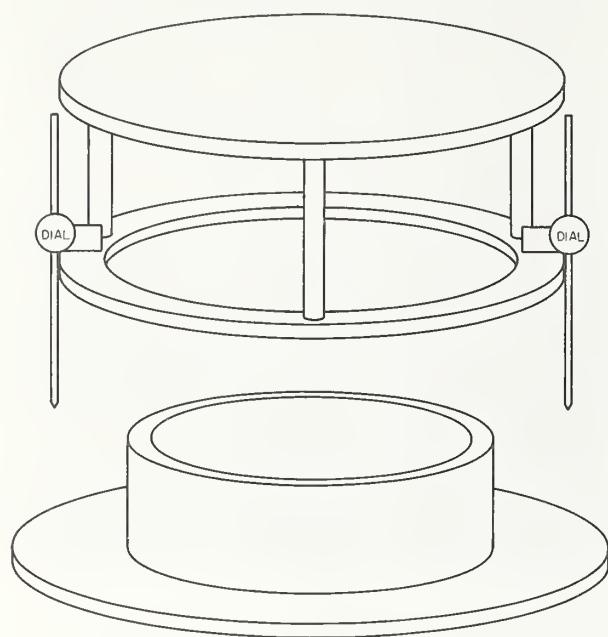
SPRING CALIBRATION APPARATUS

FIGURE 20. Apparatus for calibrating steel springs used to exert tensile stresses in the creep study.

diameter of  $1\frac{3}{16}$  in. The springs were calibrated (load versus displacement) using the device shown in figure 20. The compressive displacement of the springs was

measured with  $1 \times 10^{-4}$  in micrometer dial gages. The load was exerted on the springs with a 60,000 lb capacity hydraulic universal testing machine. Loads were in the range of 0 to 14,000 lb (14 kips) and dial gage readings of spring displacement were taken at intervals of 1 kip between 0 and 5 kips and 8 to 12 kips, while between 5 to 8 and 12 to 14 kips the intervals were 0.5 kips. Amounts of displacement were determined from the average values of the two dial gages located diametrically opposite on the calibration device. The 24 springs had nearly the same displacement response to loading as indicated by the plot in figure 21, which gives the range in displacement for corresponding load application.

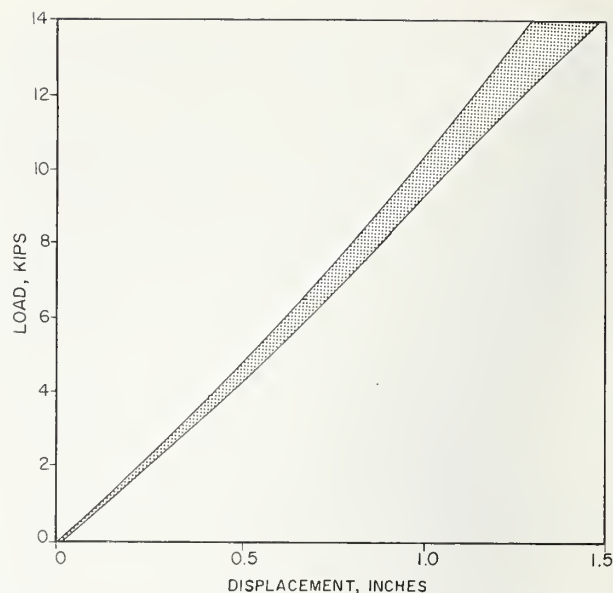
FIGURE 21. Range of displacement response of 24 steel springs used in the creep study.

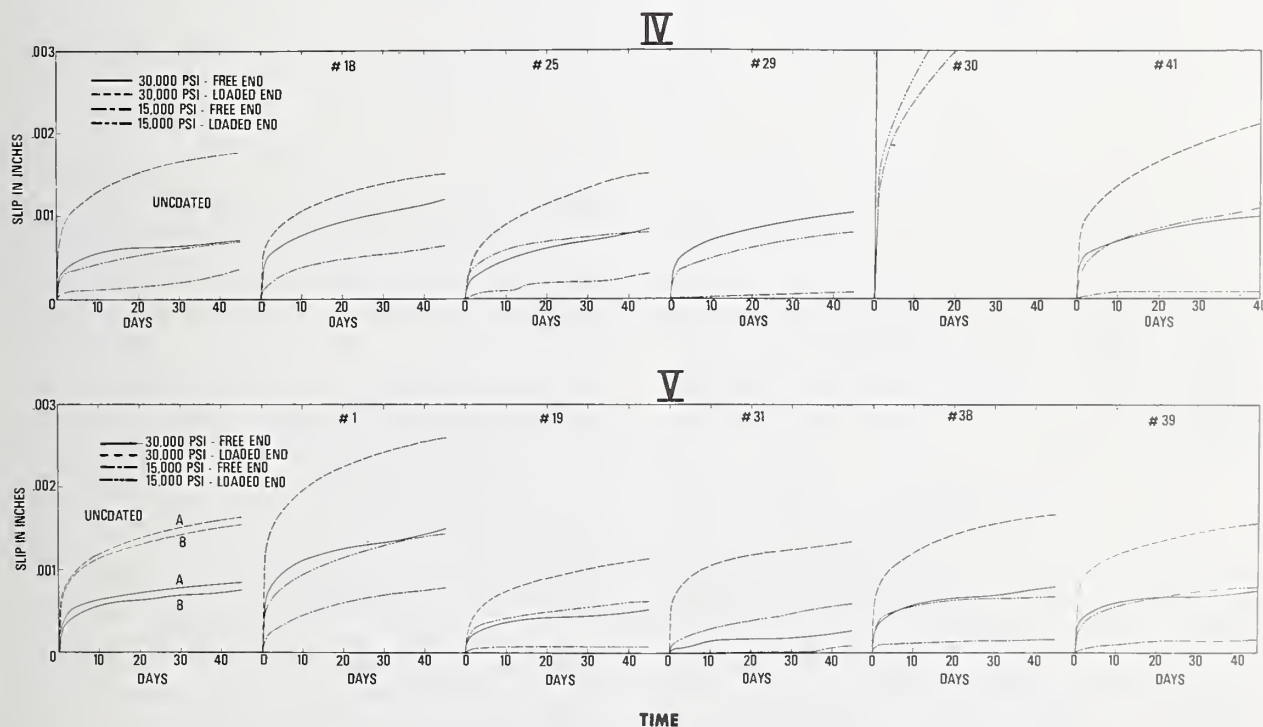
FIGURE 22. Free-end and loaded-end slips in creep specimens versus time.

Roman numbers indicate concrete batch number, while Arabic numbers identify the coating materials (table 1).

Free- and loaded-end slip data, at 45 days, of coated and uncoated bars are listed in table 15. The slip data obtained at the tensile stress level of 30,000 psi will be emphasized. The respective slip values for both the coated and uncoated bars attained at the tensile stress of 15,000 psi were about 10 to 50 percent of the values obtained at 30,000 psi stress level. Furthermore, the same conclusions are derived by analyzing either set of data.

Three creep specimens with uncoated bars were tested at the 30,000 psi stress level and average loaded-end slip was 0.00164 in and the average free-end slip was 0.00077 in, at 45 days. The agreement between the three loaded-end slip values and also the three free-end values was excellent for this type of experiment. The range and percent coefficient of variation for the loaded-end data was 0.00022 inch and 4.0 percent, and 0.00013 in and 7.1 percent for the free-end slip data. Because the variation in concrete strength was minor, no compensating adjustments were made in the slip values.
