Penetration Resistance Tests of Reinforced Concrete Barriers

December 1972

Interim Report for Period October 31 - November 3, 1972

Prepared for
Defense Nuclear Agency
Washington, D. C. 20305

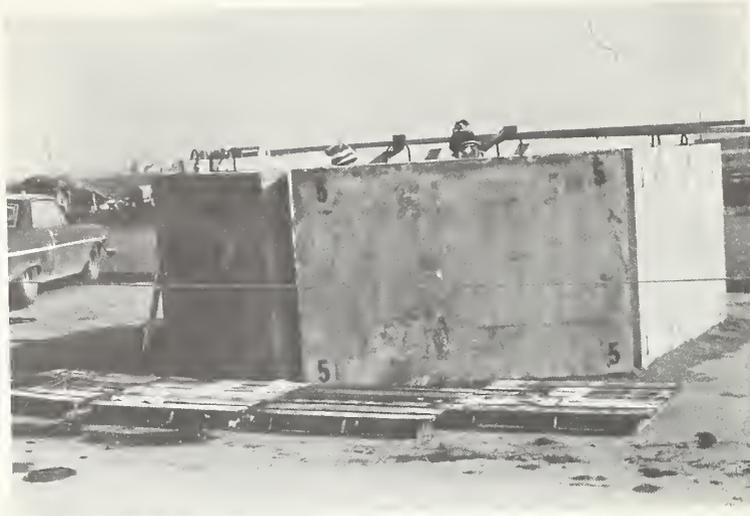
Figure 1. Configuration of Test Slabs

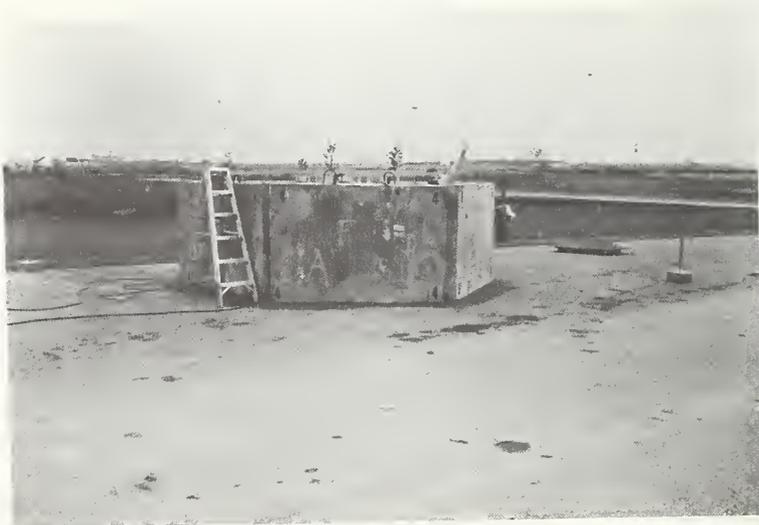
Figure 2. Slabs Prior to Beginning of Tests

A few days prior to the scheduled start of penetration testing the slabs and mix sample test pieces were removed from the curing room. The slabs were moved outside to a black top parking area at the east end of the building and placed on edge in a hexagonal configuration and wooden timbers were attached across their tops so as to provide bracing and support. (See fig. 1.) On the day prior to the start of testing, attack locations were laid out on the slabs and identified by spray paint lettering. The general arrangement is shown in figure 2.

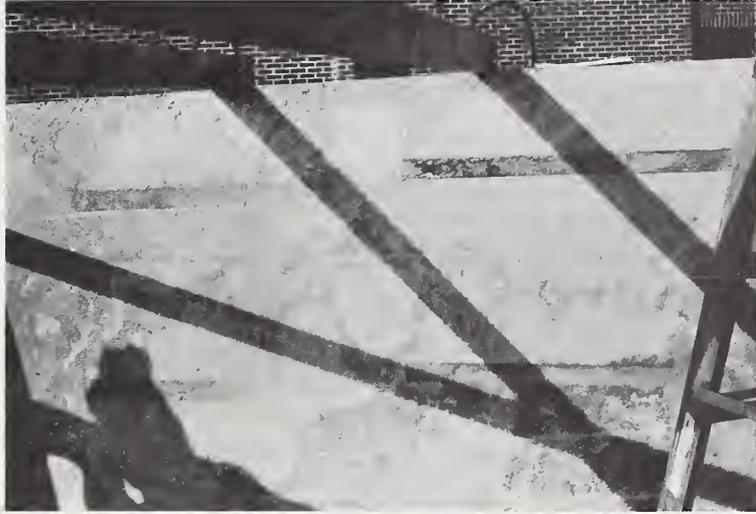
Figure 3. Vibration Transducer Location

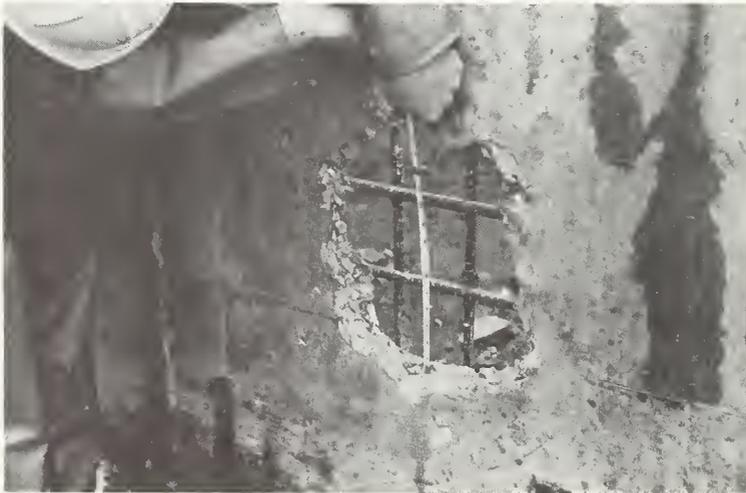
Figure 6. Exterior View of 1A

After 29 blows in 52 seconds, a depression was well developed on the front surface and a large circular crack could be observed on the rear surface. After 53 blows and 1:30 minutes, an opening of approximately 22 in.² was developed through the slab between the re-rods. A much larger area spalled away from the re-rod in the rear. After 2 minutes and 73 blows, the opening had been enlarged to approximately 75 in.² with maximum dimensions on the order of 10" X 8". At 90 blows and 2.43 minutes, the opening had maximum dimensions of 11" X 14" and a clear area of about 100 in.² and the sledgehammer portion of the attack was judged completed. (See figs. 6 and 7.)

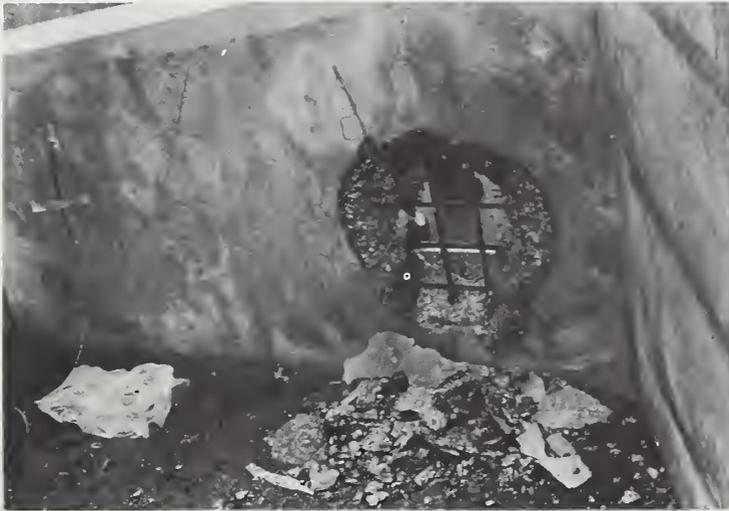
Figure 7. Interior View of 1A

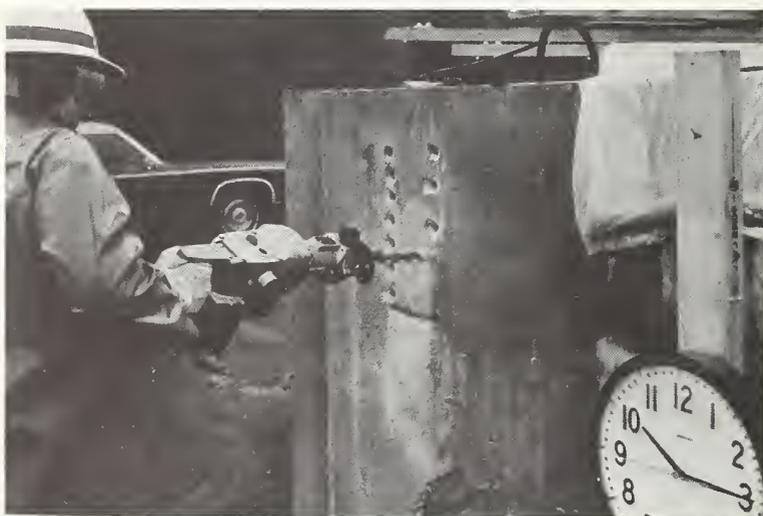
Drilling eighteen holes one inch in diameter required 7.125 minutes for an average time of 23.75 seconds per hole (see fig. 13).

Figure 13. Drilling with Rotohammer

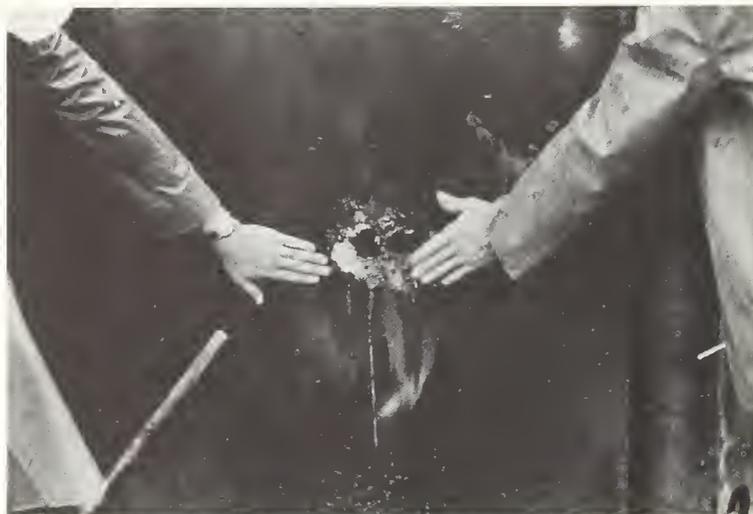
Figure 18 shows the exterior of the slab. This photograph was taken only a few moments after completion of the second burn. Figure 19 is an interior view of the slab.

Figure 18. 1D2, Front of Slab 1 after Burning Bar Attack

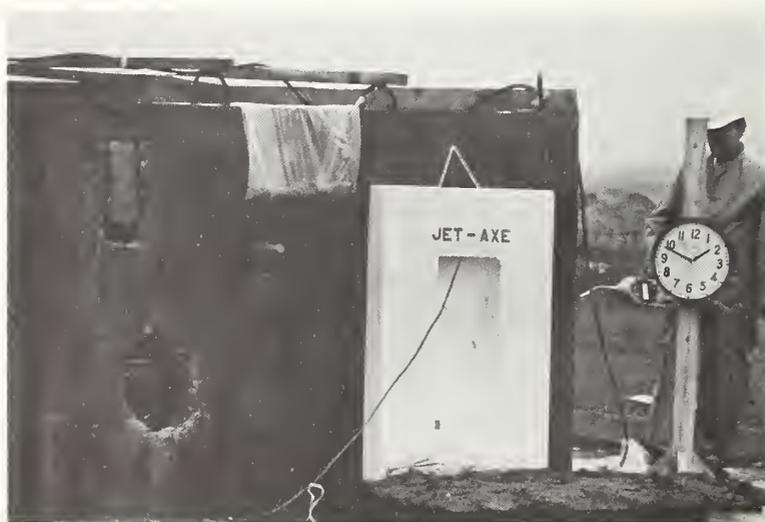
Figure 21 shows the Jet-Ax in place ready for firing and figures 22 and 23 show the results which it produced.

Figure 21. Jet-Ax Ready for Firing

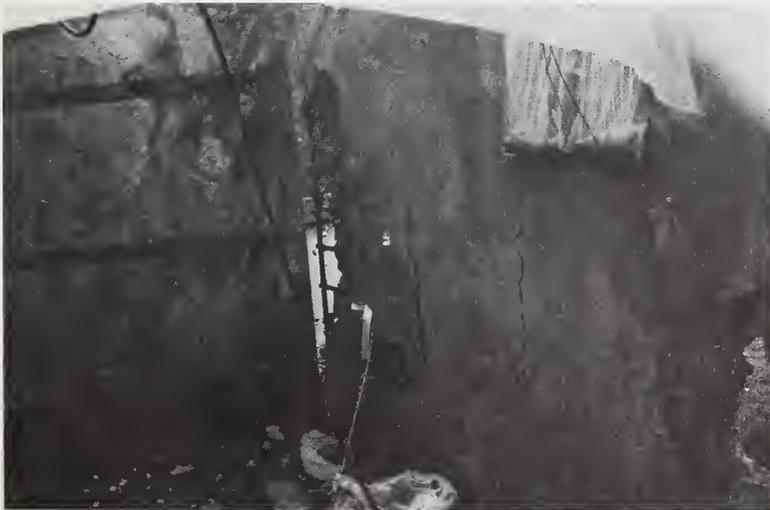
Figure 23. Effects of JA-3, Inside of Slab 1

The JA-3 caused partial penetration of the slab such that 22 blows of a 10-pound sledgehammer in 40 seconds time were adequate to completely expose the reinforcing rod in a 24" X 31" area. The Jet-Ax detonation also shifted end of the slab back approximately 1-1/2 inches and the other end was shifted, together with slab 3 which was against it, back 2-1/4 inches.

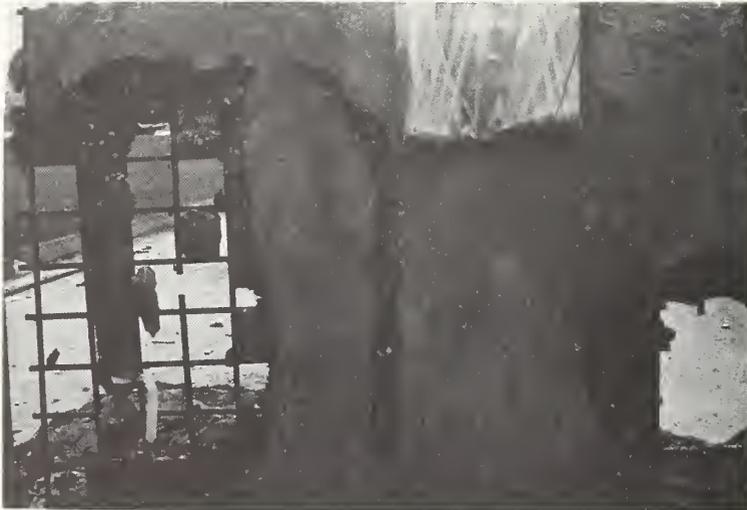
Figure 24 shows the interior view after the sledgehammer attack cleared most of the shattered concrete from the reinforcing bars.

Figure 24. Interior View of Slab 1 after Jet-Ax and Sledgehammer Attack

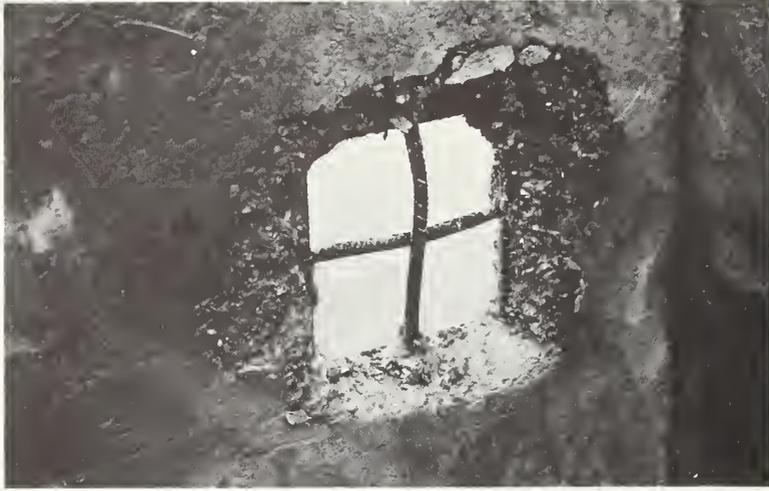
The first interior crack appeared after 110 blows and 2.93 minutes. Initial breakthrough occurred at 129 blows and 3.42 minutes. The reinforcing rod was exposed in an opening 9-1/4" X 10-1/4" at 288 blows and 8.0 minutes. The resulting opening is shown in figures 27 and 28. Note that the broken areas all occurred within the spaces between reinforcing bars. In the regular concrete of Slab 1, the extent of spalling and breakthrough was not constrained by the reinforcing bars in this way (see figs. 6 and 7).

Figure 28. Interior, Slab 2, Attack A1 after Breakthrough

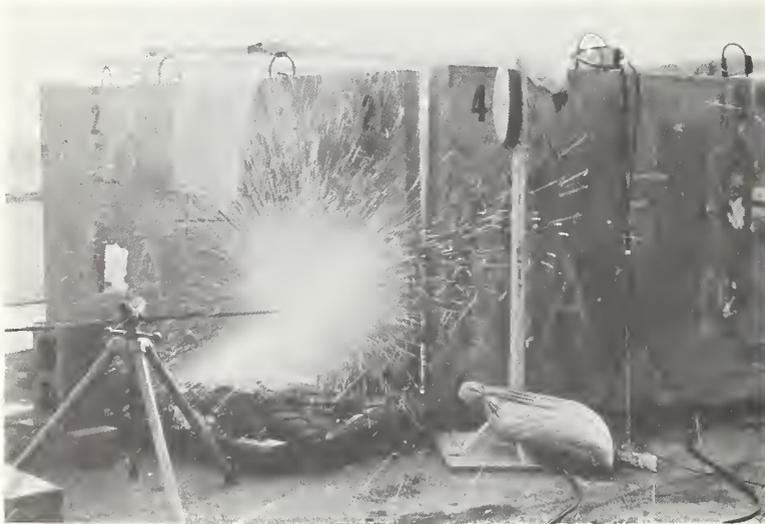
The burning bar was employed to make two holes; each required 24 seconds; one hole used 18-1/2" of bar and the other used 25" (see fig. 38).

Figure 38. Burning Bar Attack on Slab 2

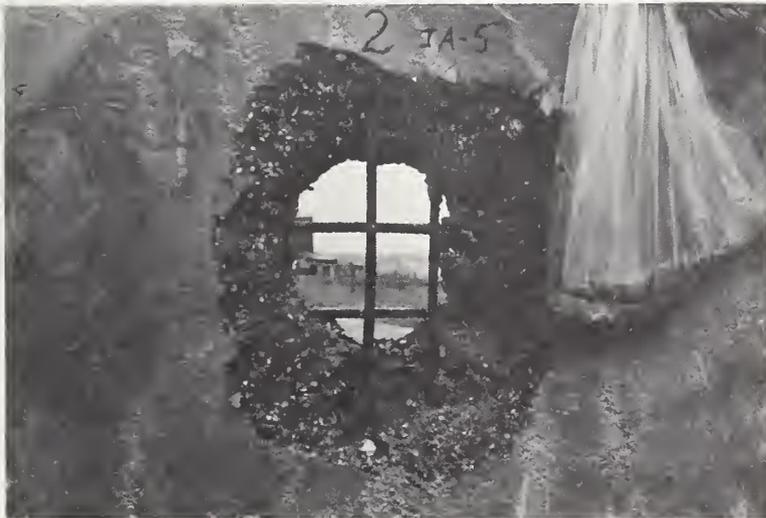
A size JA-5 Jet-Ax was tested against Slab 2 and produced a 10-1/2 inch diameter opening which was clear of all material except the reinforcing rods. These were slightly bowed but showed no evidence of any cutting action from the shaped charge. Exterior and interior views of the opening are shown in figures 45 and 46.

Figure 46. Interior after JA-5

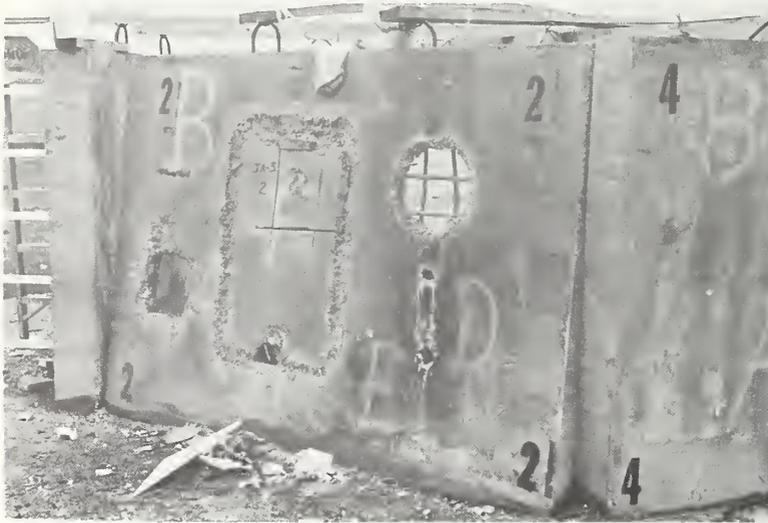
As shown in figure 47, a Jet-Ax, size JA-3, produced external spalling to a depth of 3/4" to 1" in a rectangular area having external dimensions of 27" X 39" and internal dimensions of 21" X 33", and produced a hairline interior crack, figure 48, along this perimeter. The JA-3 was judged to be relatively ineffective in marked contrast to its performance on Slab 1.

Figure 47. Exterior after JA-3 on Slab 2

Note in Figure 47 how the force of the Jet-Ax has driven the top of the slab back so that it is only restrained from falling by the bracing timbers which fastened all six slabs together.

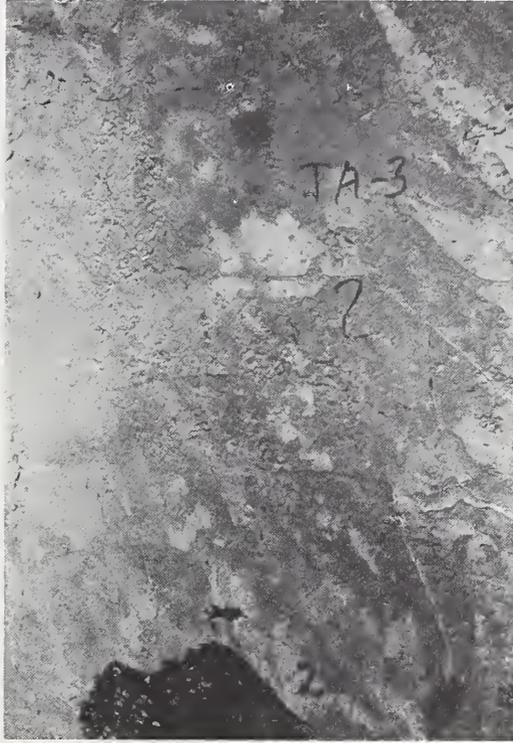
Figure 48. Interior after JA-3 on Slab 2

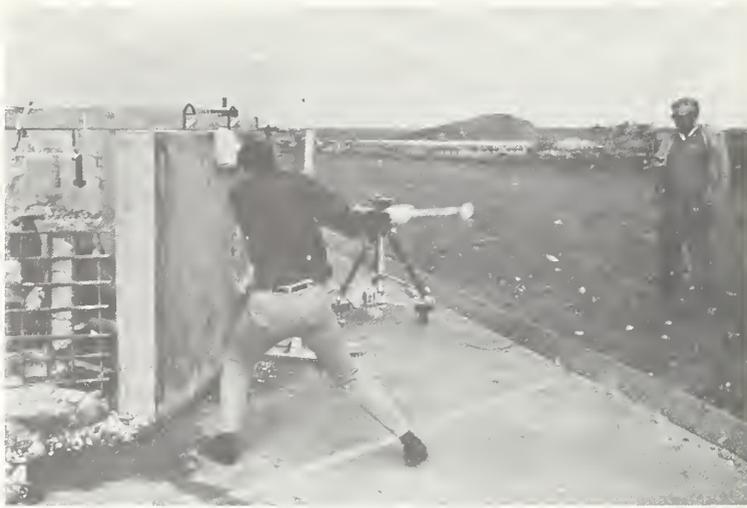
A 16-pound sledgehammer was used in an attempt to break through. The attack was conducted in a series of 30-second duration efforts each of which yielded 15 - 19 blows (see fig. 50).

Figure 50. 16 lb. Sledgehammer Attack on Slab 3

After 5.00 minutes and 162 blows, spalling had occurred sufficiently to yield a penetration depth of approximately 2". After 8.75 minutes and 298 blows, the penetration depth had been increased to 3" and a hairline crack was observed on the rear of the slab. Since a Jet-Ax attack had already been conducted on this slab, it is uncertain whether the hairline crack was initiated by that or by the sledgehammer attack.

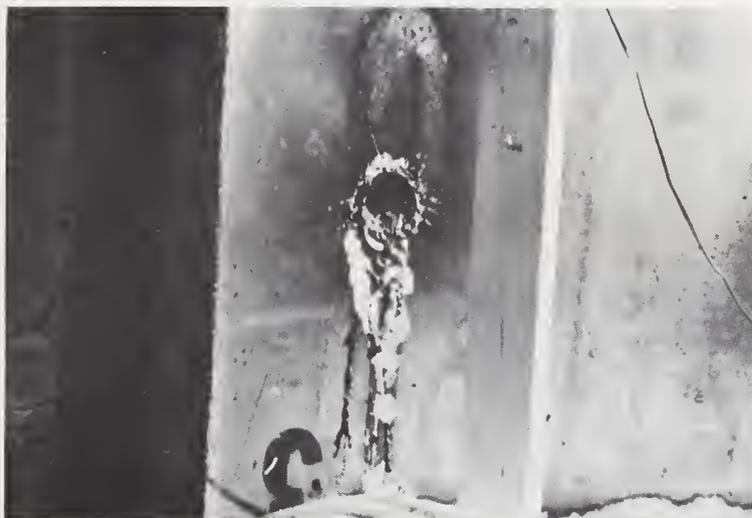
A single penetration was made with the burning bar. It took 52 seconds and burned 46" of bar. Oxygen pressure was again 200 p.s.i. Figure 52 shows the hole which was melted through.

Figure 52. Attack 3D, Burning Bar Hole

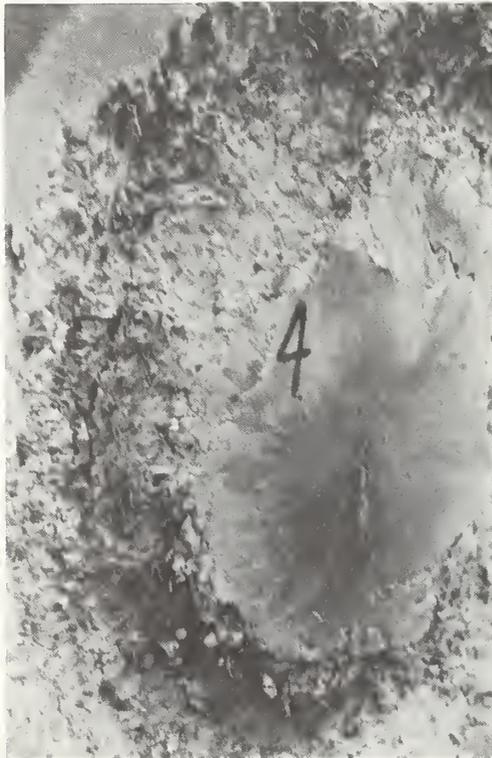
A size JA-4 Jet-Ax produced a 21" OD X 12" ID annulus of spalling to an approximate depth of 1-1/4". The central area inside the ring of spalling appeared to have been depressed about 1/16" inward. Cracks on the inside of the slab were less pronounced than on Slab 3. The detonation moved one end of the slab inward 3/8" and the other end 1-1/4".

Figure 59. Spalling Produced by Jet-Ax on Slab 4

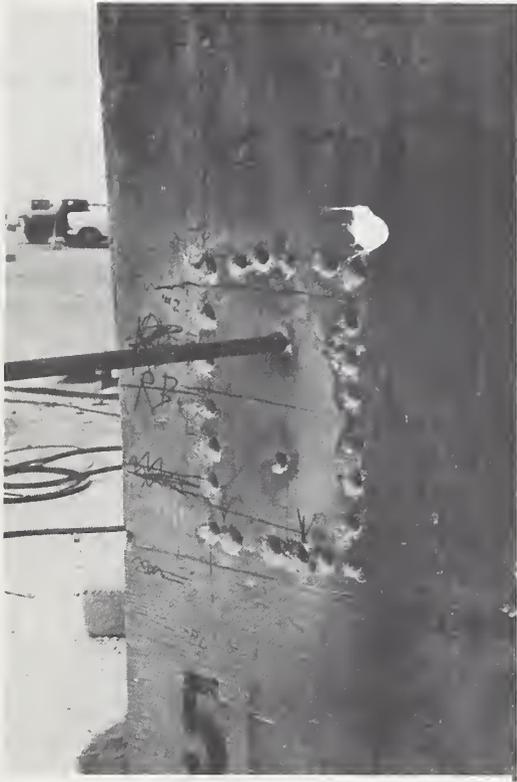
A couple of holes were then drilled half way through the slab near the central area of the central area of the plug and a superficial attempt was made to spall off the concrete on the interior (see fig. 61). A suitable bull point punch was not available however, and this approach was quickly abandoned.

Figure 61. Early in Multiple Tool Attack

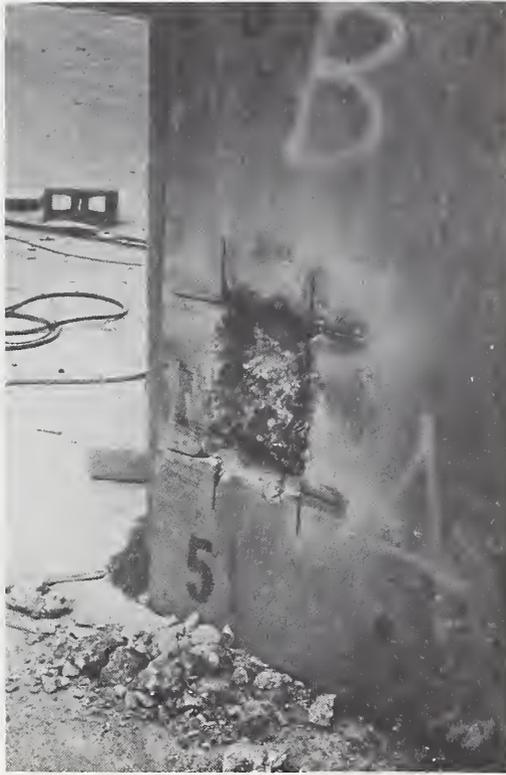
Figure 62. Material Chiseled Out of Plug
to Make Room for Saw Hub

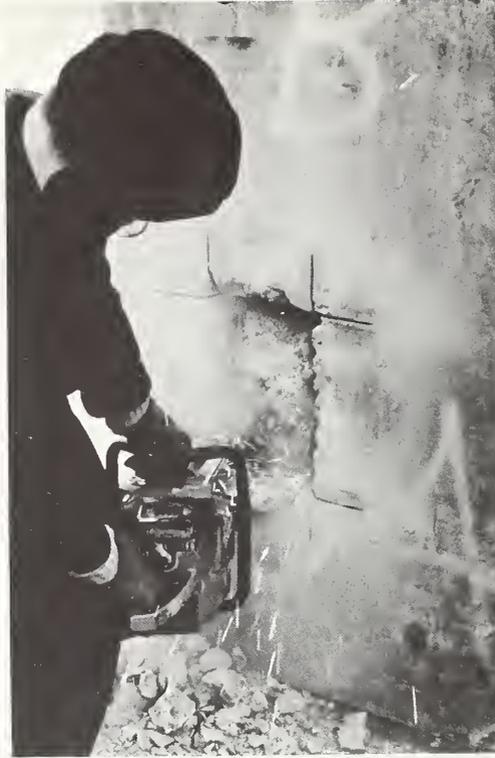
Figure 63. Sawing Reinforcing Rods

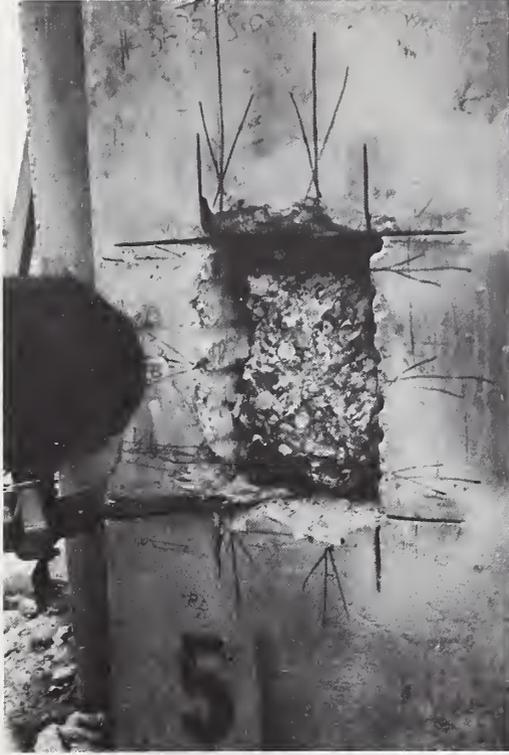
Chiseling was then resumed with the rotohammer and material was removed from most of the webs through the full thickness of the slab (see fig. 64). This required 5.52 minutes.

Figure 64. Chiseling Webs between Holes
on the Inner Half of the Opening

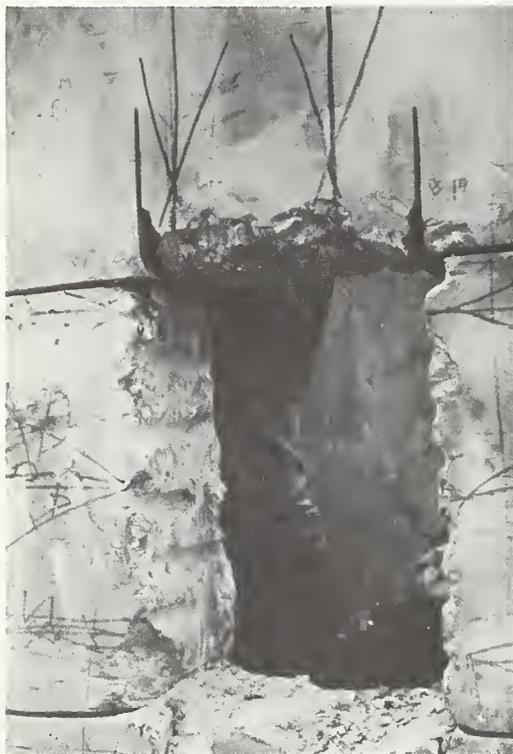
Finally, 15 more blows from the 16-pound sledgehammer knocked the plug out in 26 seconds (see fig. 65).

Figure 65. Final 9 X 14-inch Opening

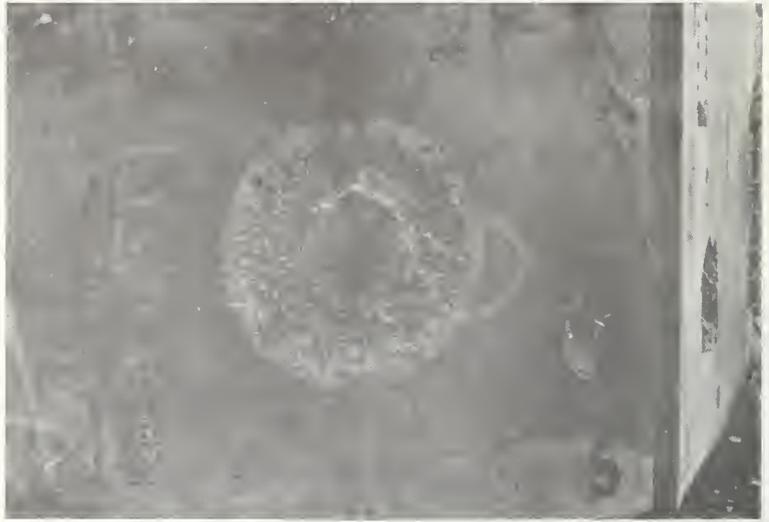
Two Jet-Axes were used against Slab 5. The JA-4 size produced a 22-1/2" OD by 11" ID annulus that was spalled to a depth of about 1-1/2". The center area within the annular ring was depressed approximately 1/32". One end of the slab was shifted back about 3" and the other end, resting against another slab, bounced forward about an inch. The cracking produced was significant but less extensive than Slab 3.

Figure 67. Results of JA-4 on Exterior of Slab 5

Figure 68. Close-up of Exterior Spalling

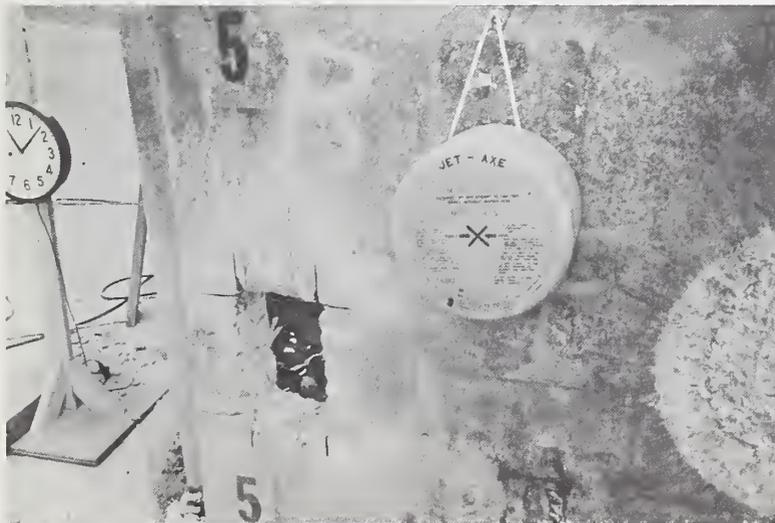
Figure 70 shows the Jet-Ax in place, figure 71 shows the exterior spalling it produced, and figure 72 shows the interior bulge and cracking.

Figure 70. JA-5 in Place

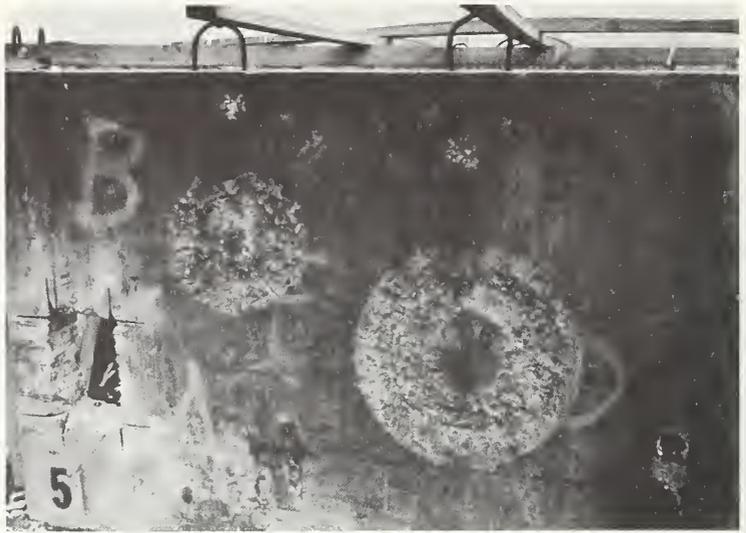
The size JA-5 produced a 15" OD X 4" ID annulus that was spalled to a depth of about 1-1/2", and a 1" bulge was produced on the interior of the slab.

Figure 71. External Spalling from JA-5

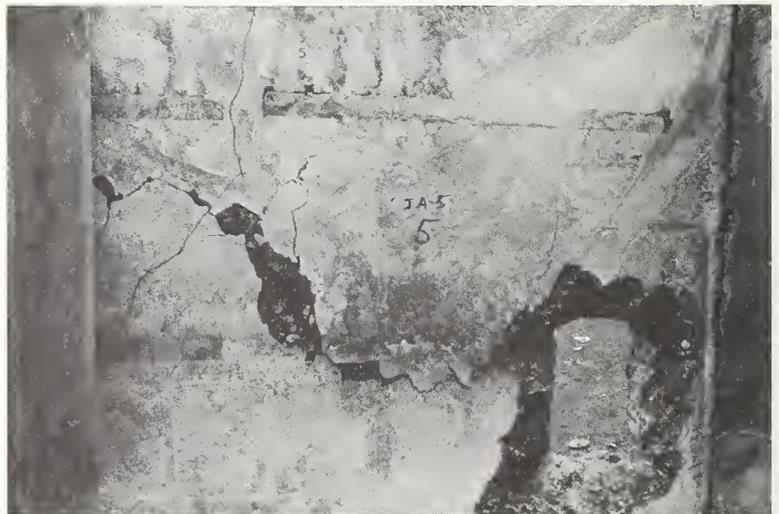
Figure 72. Interior Cracking Produced by JA-5

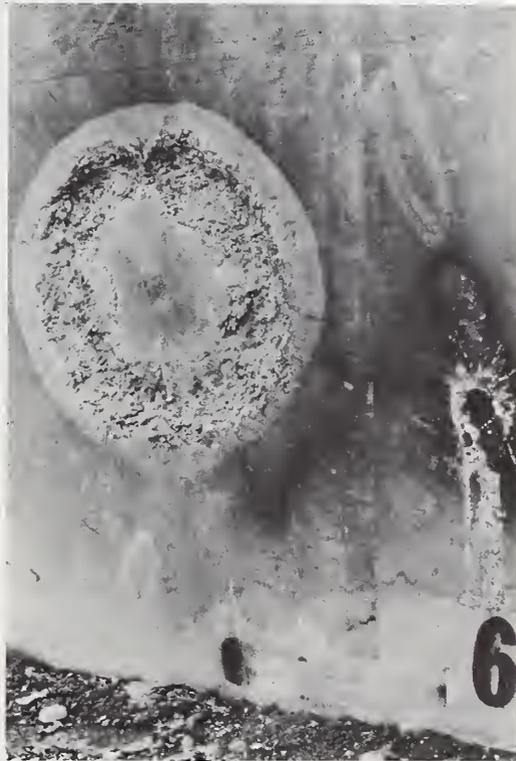
Figure 73. External View of Slab 6 after Burning Bar and Jet-Ax Attacks

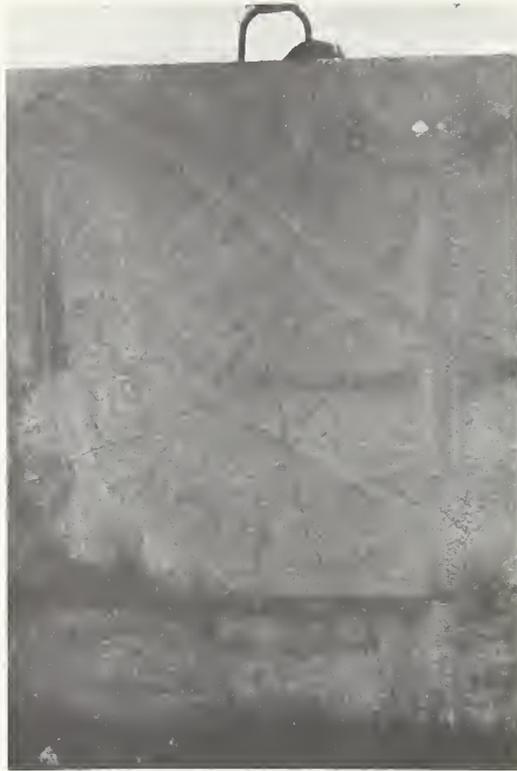
Figure 74. Interior View of Slab 6 after JA-4 Attack

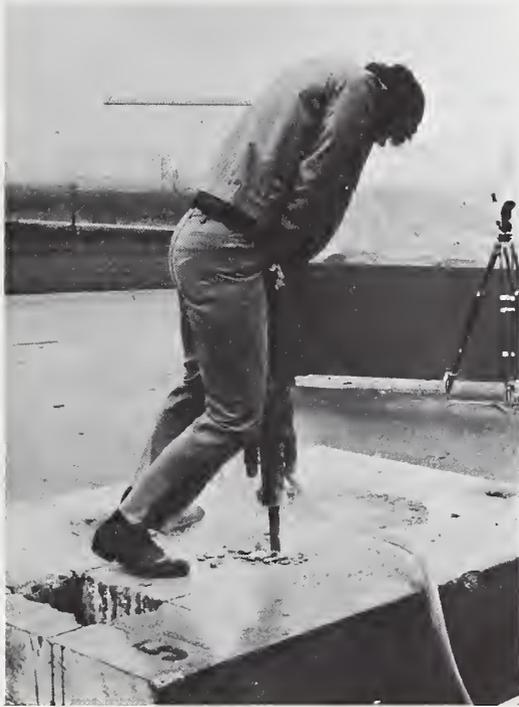
With the slab horizontal as described above, an attack was made with a pneumatic jackhammer (see fig. 75). The jackhammer was operated at 100 p.s.i. air pressure, and both spike point and 3" spade point tools were used. Initial breakthrough occurred in 2.55 minutes and by 5.55 minutes concrete had been cleared from an area 11" X 11". The reinforcing rods were not cut, see figure 76.

Figure 75. Pneumatic Jackhammer on Slab 5

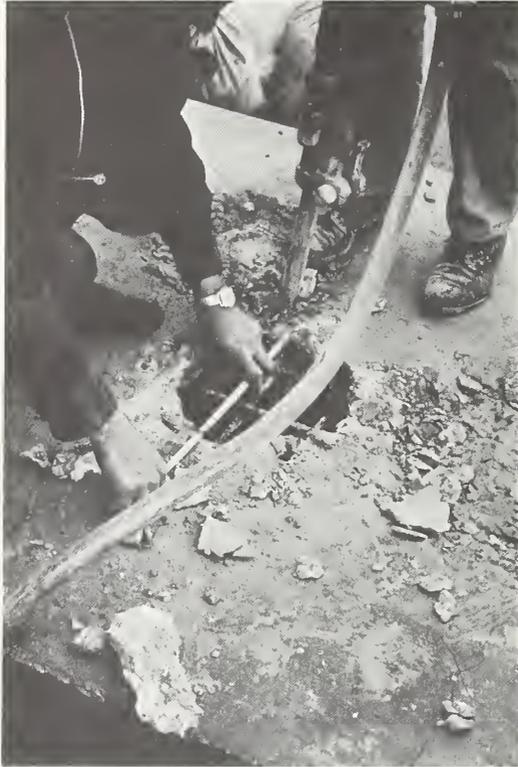
Figure 76. Opening Made by Jackhammer

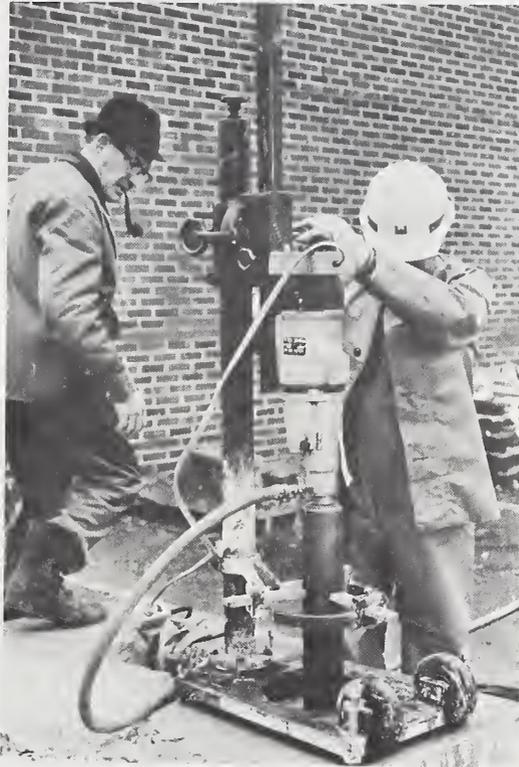
A 3-1/2" diameter water-cooled diamond core drill was run for 3.92 minutes and penetrated 3-5/8". The core drill was mounted in a semiportable drill press arrangement and was powered by a drill running at 900 RPM and operating at 7 - 7.5 amps. 110 Vac. (see figure 77).

Figure 77. Diamond Core Drill
