NBSIR 73-148

Evaluation of the Column Connections Used in a Precast Concrete Modular Housing System

Felix Y. Yokel and Thomas W. Reichard

Final Report

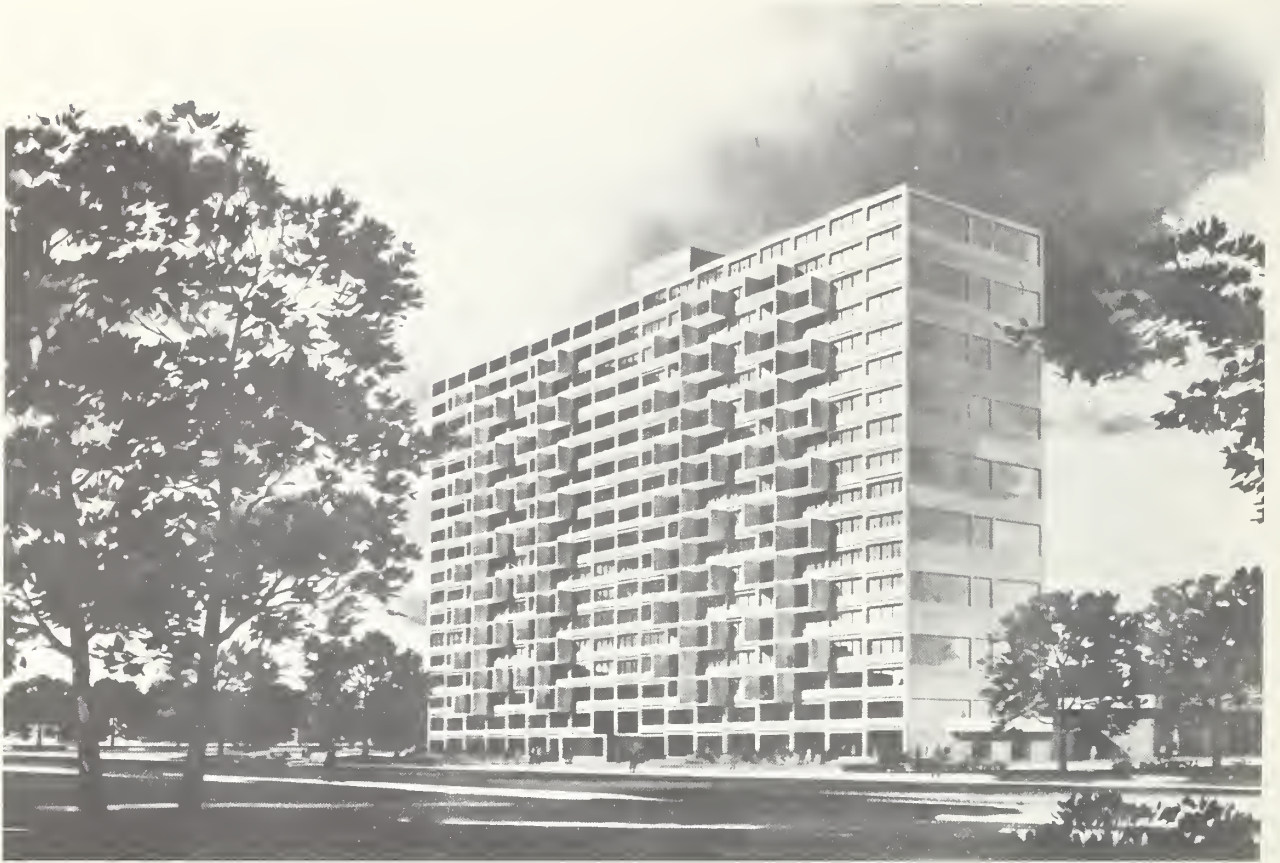
FIGURE 2.1 PROPOSED BUILDING

The proposed system consisted of precast reinforced light-weight concrete box modules, stacked in a checkerboard pattern. Figure 2.1 shows one of the buildings proposed for construction, a 19-story structure. Figure 2.2 shows the model of a complex of buildings which is under construction using the structural concepts and connection details evaluated in this report, however, the modules differ in size and configuration from those proposed for the structure shown in figure 2.1.

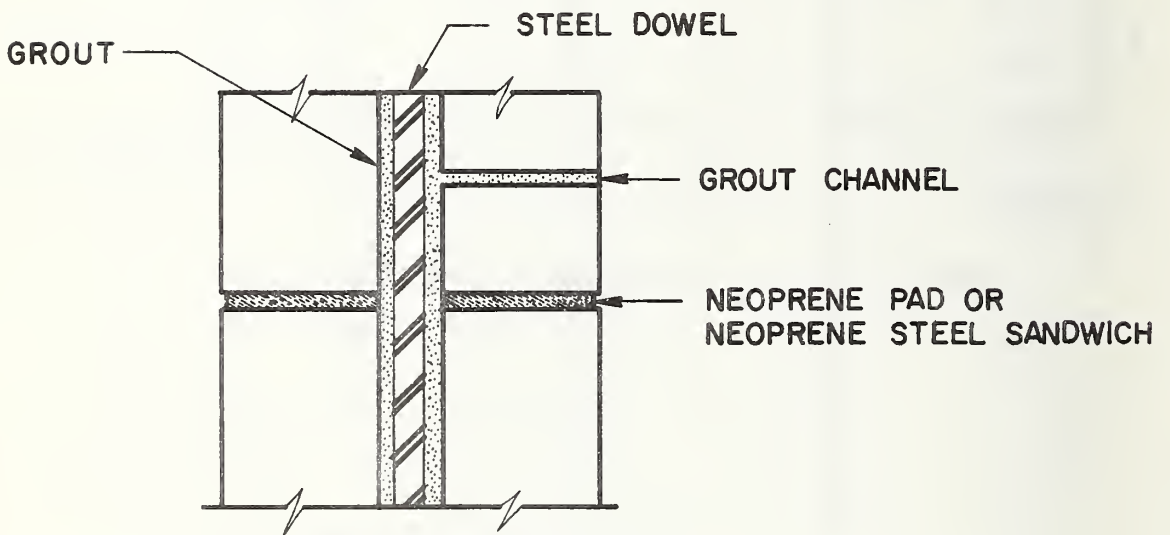
FIGURE 2.9 PROPOSED CONNECTION DETAIL

Details of the proposed column to column connection are shown in figures 2.8 and 2.9. Figure 2.8 shows the detail of an interior column joint. The heavy lines show the column and part of the floor slab of Module A, and column and part of the 8-in thick slab connecting the interior column bent in Module B. The dashed lines show the location of the roof and wall slabs. Note that the bottom of the floor slab extends $2 \frac{3}{8}$ in below the bottom of the column and that the column connection is located in a $2 \frac{3}{8}$ -in deep recessed pocket. The top of the ceiling in Module B is thereby located approximately at the same elevation as the top of the slab in Module A, thus eliminating the need for a stepped transition. It can also be seen that the wall of Module A does not bear on the wall of Module B. Thus all compressive and shear forces are transmitted through the bearing pad in the column connection. The joint between the boxes at locations other than the column connection contains a compressible filler material. Proposed connection details are shown in figure 2.9. Figure 2.9(a) shows the reinforcement near the column end where additional confinement ties are provided in the vicinity of the joint. Figure 2.9(b) shows a section through a connection.

(a) COLUMN REINFORCEMENT AT CONNECTION

(b) CONNECTION DETAIL

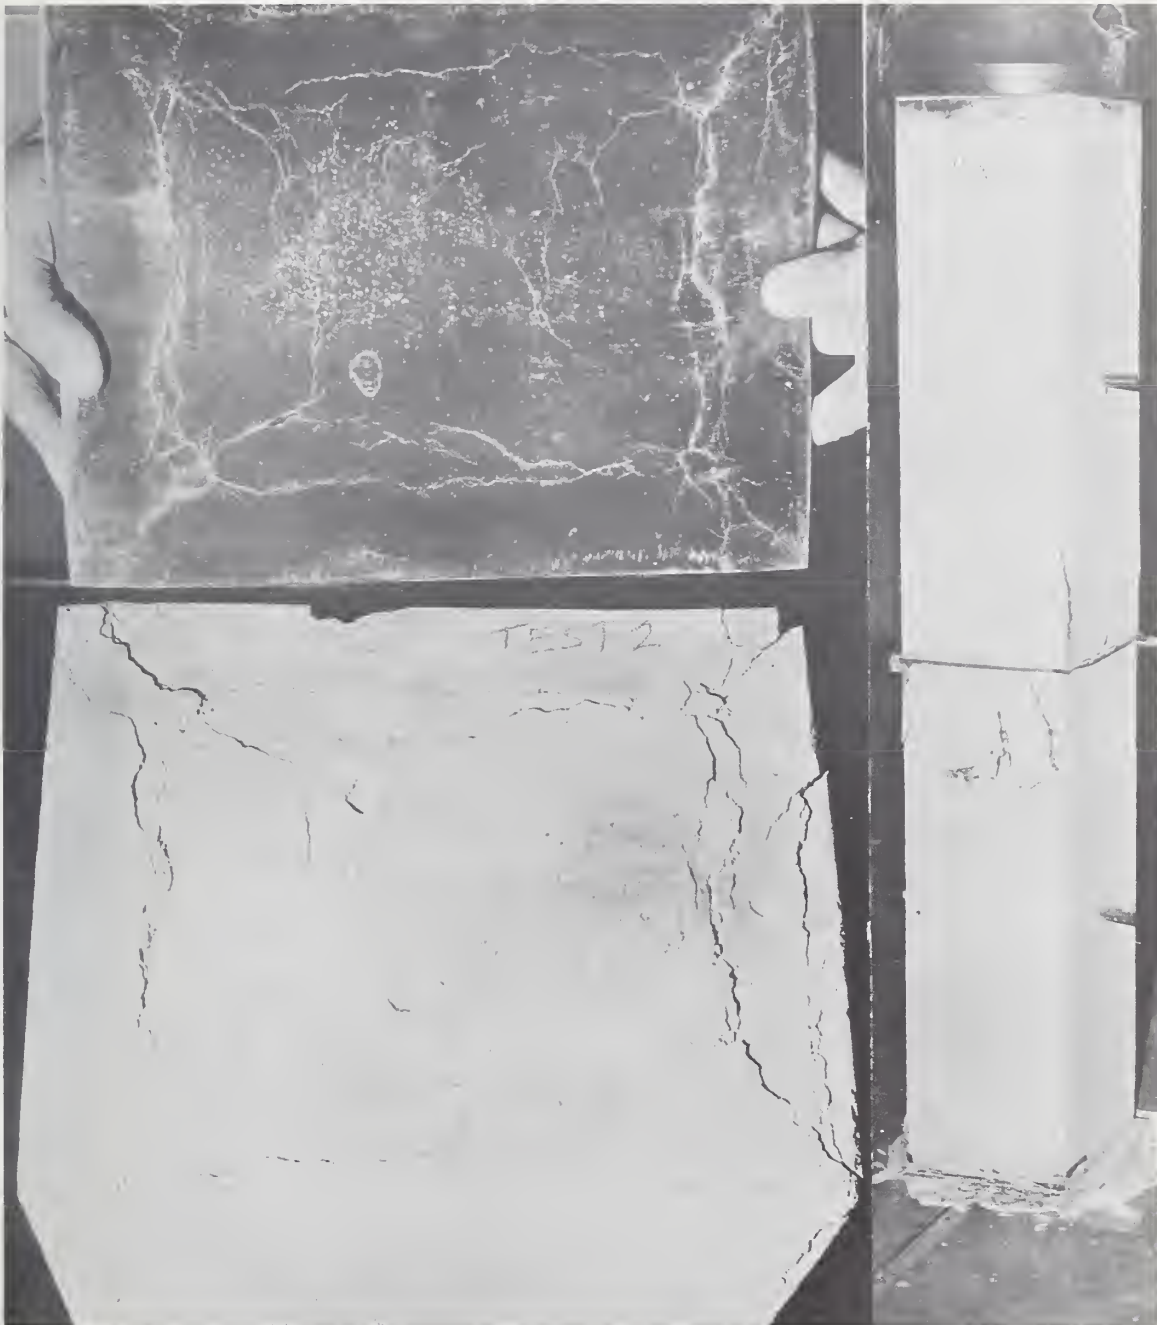
Figure 4.5 shows a typical failure of a connection using a neoprene pad. The spalling between the core inside the ties and the shell outside the ties is an indication that at ultimate load the core supported most of the load. The same observation can be made in figure 4.6 which shows the typical failure of a grouted connection.

FIGURE 4.5 TYPICAL FAILURE OF CONNECTION USING 1/4-IN NEOPRENE PAD

The effect of the type of bearing pad on the mode of failure can be observed in figures 4.5 to 4.9.

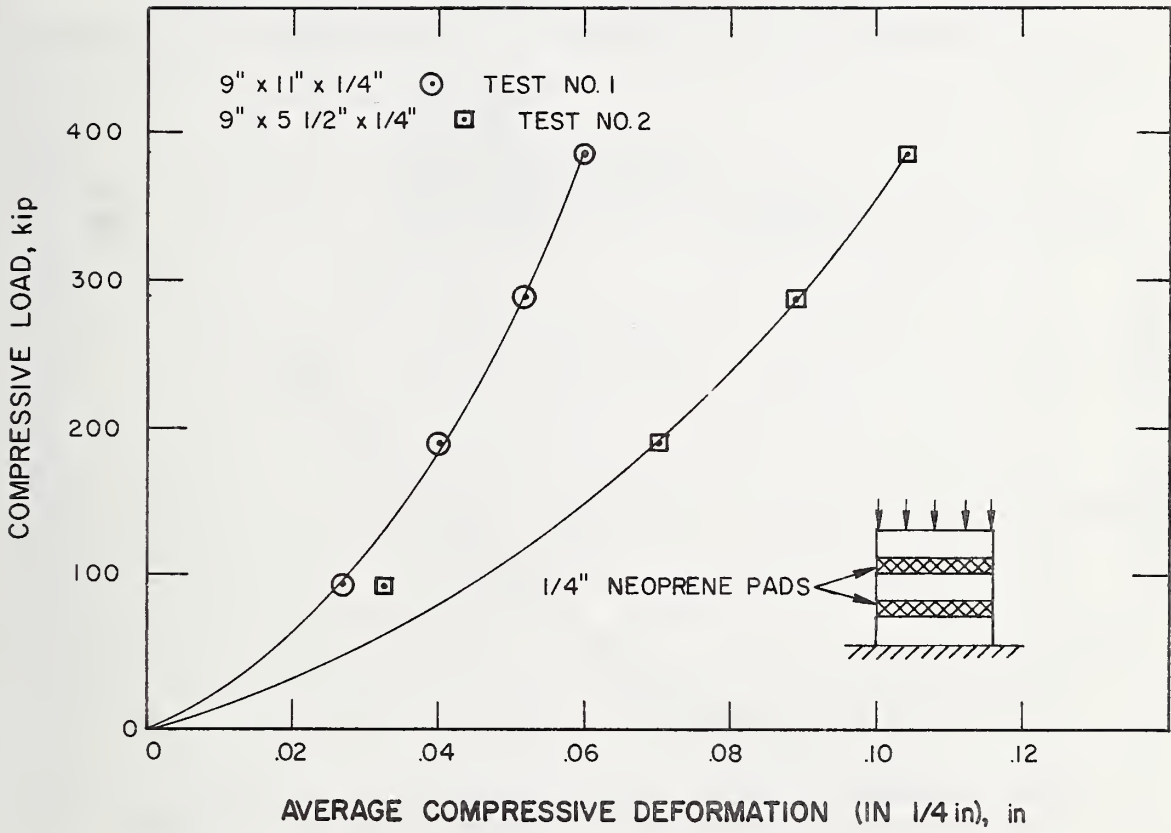
FIGURE 4.11 RELATIONSHIP BETWEEN COMPRESSIVE LOAD AND AVERAGE COMPRESSIVE DEFORMATION OF NEOPRENE PADS

(4) The load-deformation characteristics observed in the tests on the neoprene pads presented in figure 4.11 are reasonably consistent with joint compression measured in the bearing tests on column connections and presented in Table 4.1.4.
