NBSIR 73-223

Penetration Tests on J-SIIDS Barriers

Interim Report for Period March 13 – 16, 1973

Prepared for
Defense Nuclear Agency
Washington, D. C. 20305

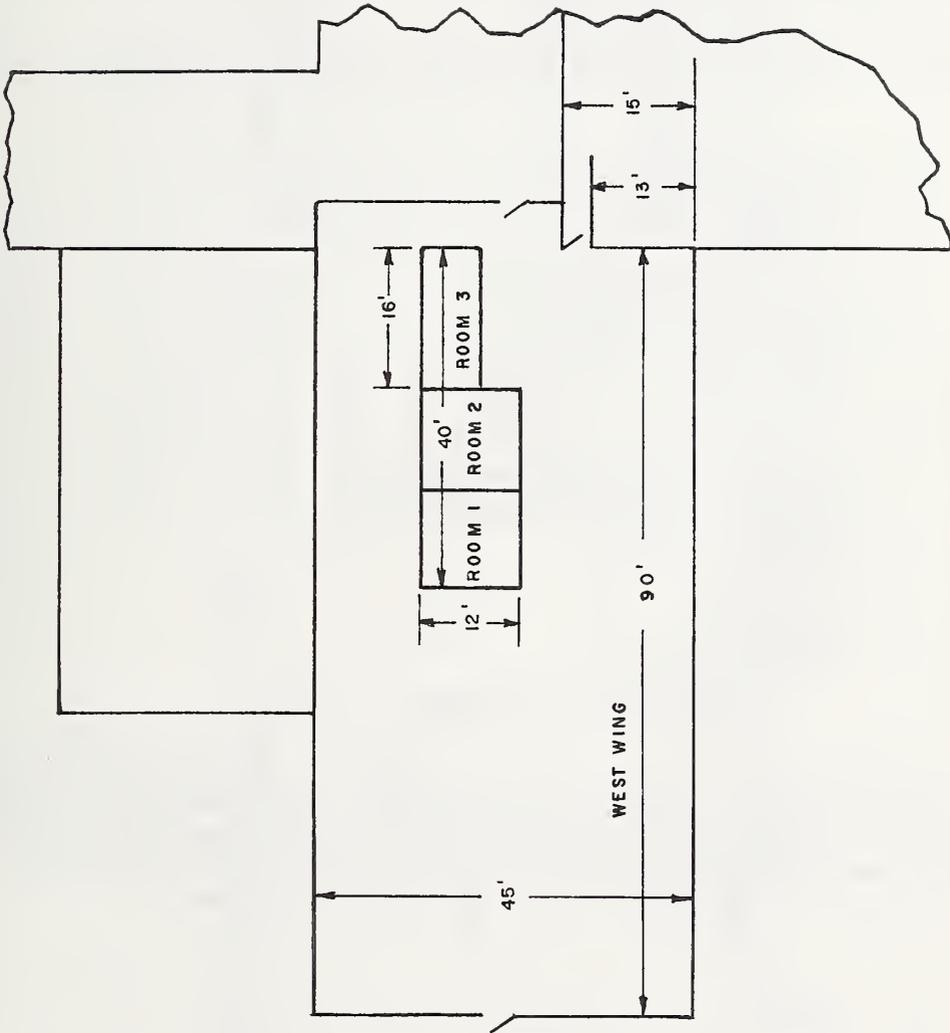
Figure 1. Layout for Simulated Arms Rooms

The simulated arms room facility consisted of a three-room structure located inside of the 45' X 90' west wing of one of the Harry Diamond Laboratories buildings at Woodbridge, Virginia. The general arrangement of the structure is shown in figure 1. Room 1 was fabricated of wood with a double planking of nominal one-inch thick wood siding over 2" X 4" studs and no interior finish. The flat roof was similarly planked over 2" X 6" rafters. The roof height was approximately 9' and was level with that of the other two rooms.

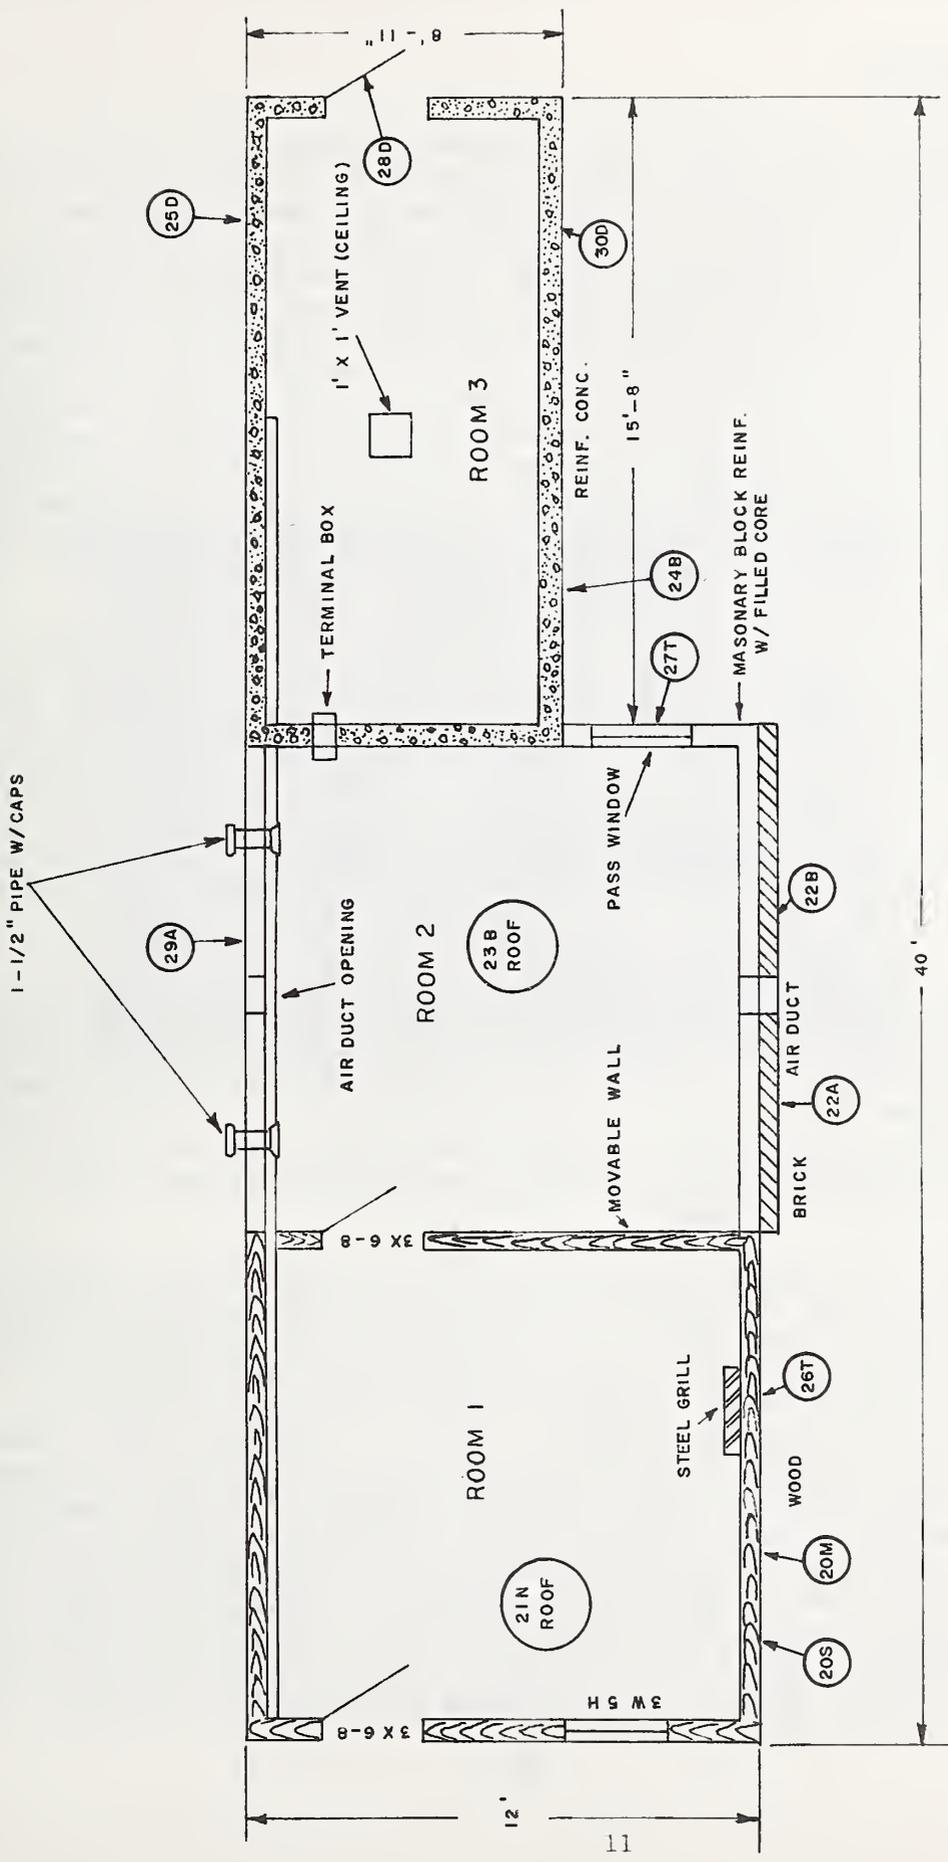
Figure 2. Locations of Attack Areas on Simulated Arms Room Test Facility

Some deviation from this list of designators occurred when changes in the test plan were occasionally made after the identifiers had been painted on the barrier. Rather than delay the test series to repaint the identifier, the testing proceeded using the original markings. Figure 2 shows the locations of all of the attack areas.

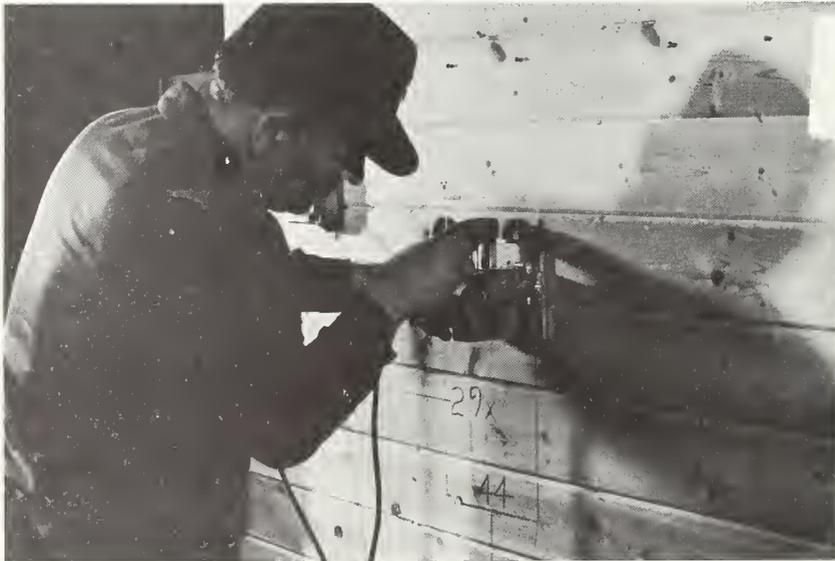
Figure 4. Attack 20S

The first hole required 19 seconds working time. The second hole was aborted after 28 seconds when the lead screw of the bit entered a crack between planks of the inner layer and the bit would not feed. A new hole was then started and was completed 16 seconds later. A sample of the acoustical disturbances is shown in figure 5. The vibrational disturbances were not noticeable above the ambient vibrational background. Sawing required 45 seconds with acoustical and vibrational spectra as shown in figures 6 and 7, respectively.

In this attack, the total working time was 1.33 minutes, the elapsed time was 1.55 minutes, and the first J-SIIDS alarm occurred 27 seconds after the attack was started.

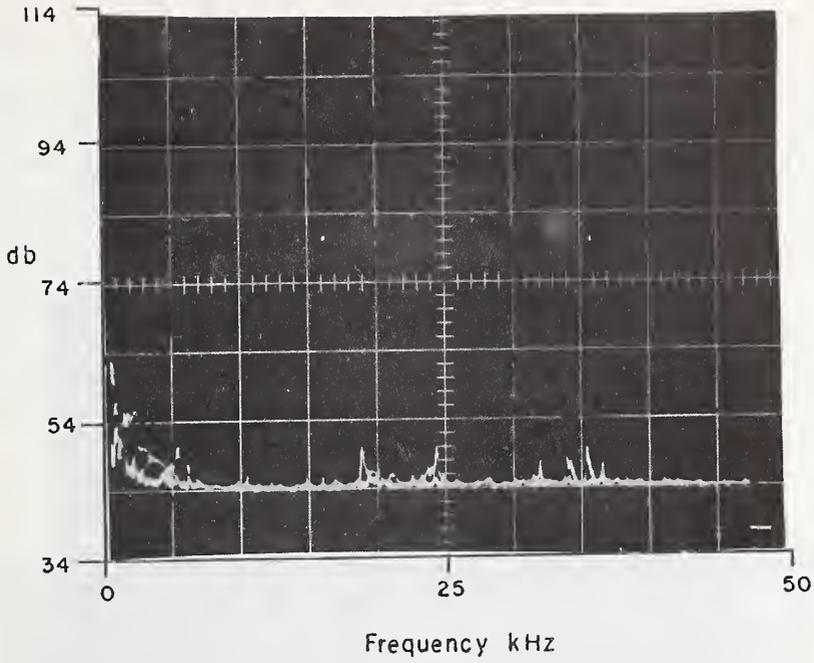
Figure 5. Acoustical Disturbances Made by Hand-operated Brace and Bit

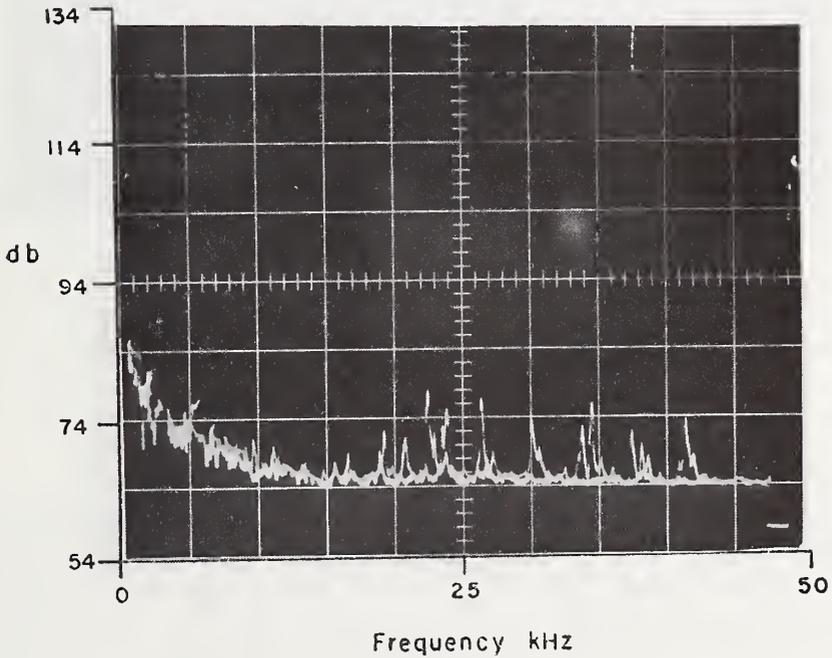
Figure 6. Acoustical Disturbances from Electric Saber Saw

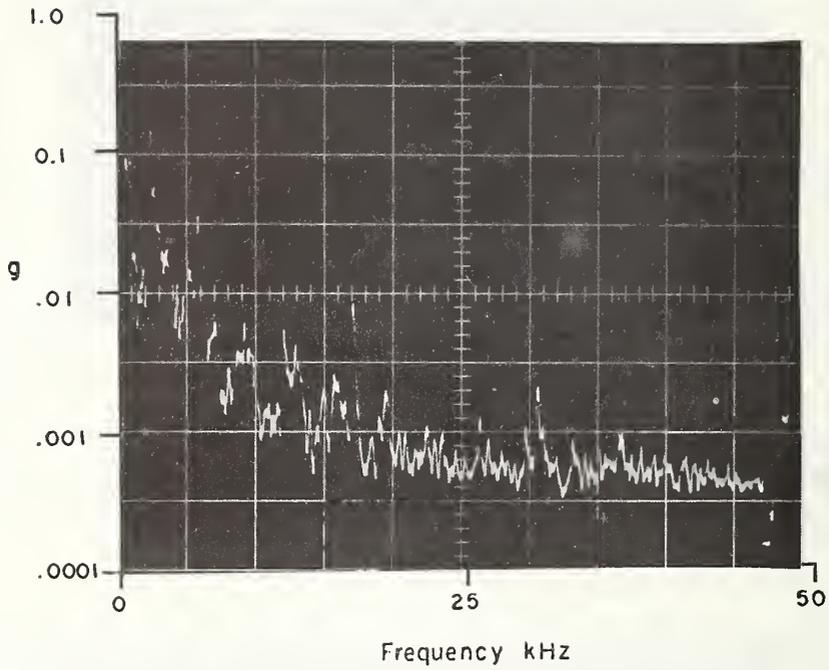
Figure 7. Vibrational Disturbances
from Electric Saber Saw

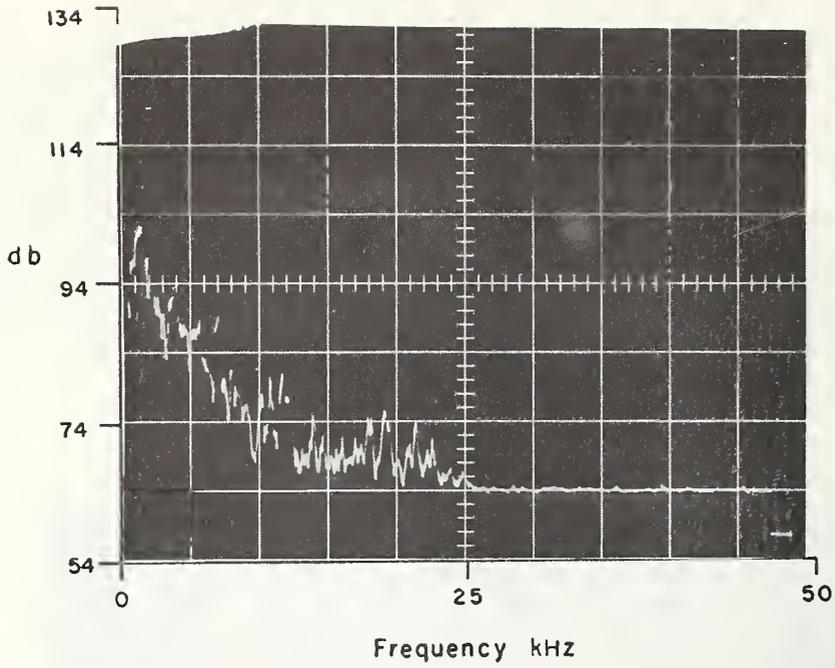
Figure 9. Acoustical Disturbances from Rotary Electric Saw.

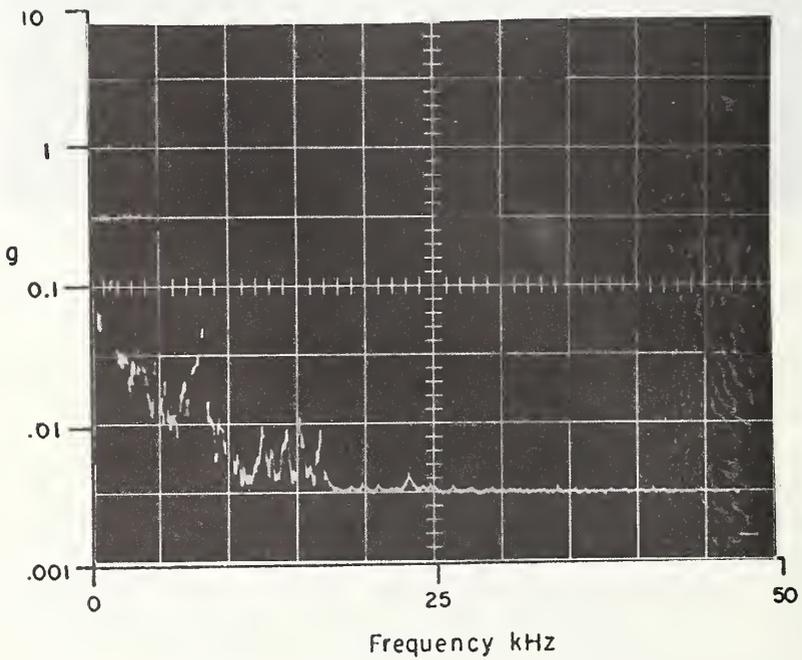
Figure 10. Vibrational Disturbances from Rotary Electric Saw

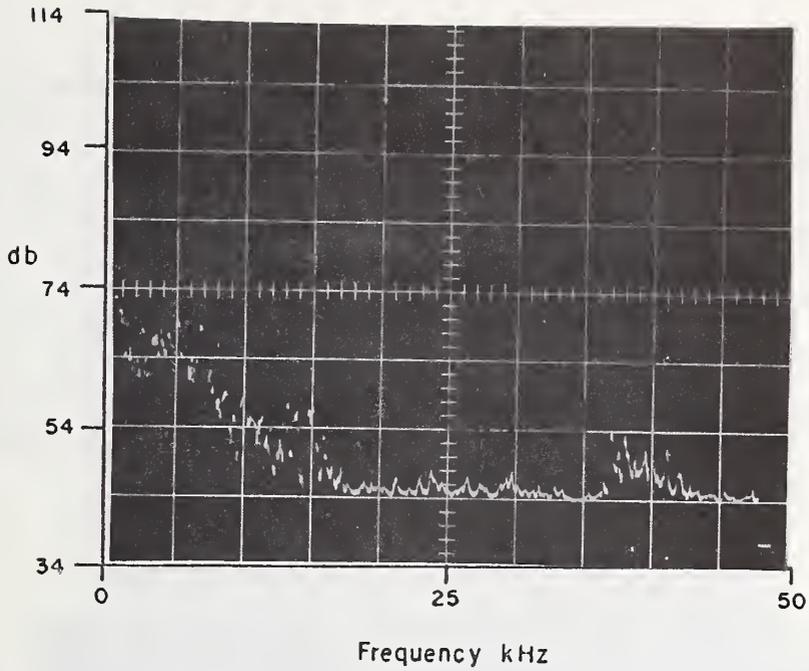
Figure 11. Acoustical Disturbances from
 3/4" Wood Bit Used with 3/8"
 Variable Speed Electric Drill

Following attack 20M, a brief test was made to estimate the disturbances likely to be produced by a power-driven wood bit. This was accomplished by drilling sample holes in the area between the previous two attacks. A 3/4" wood bit was used in a 3/8" variable speed electric drill. Acoustical disturbances are shown in figure 11 and vibrational disturbances in figure 12.

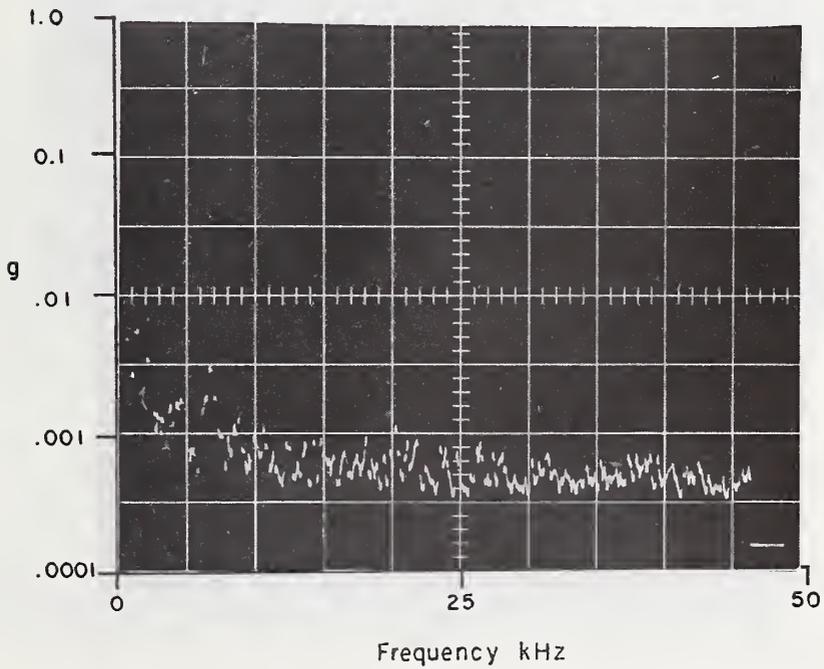
Figure 12. Vibrational Disturbances from 3/4"
 Wood Bit and Electric Drill

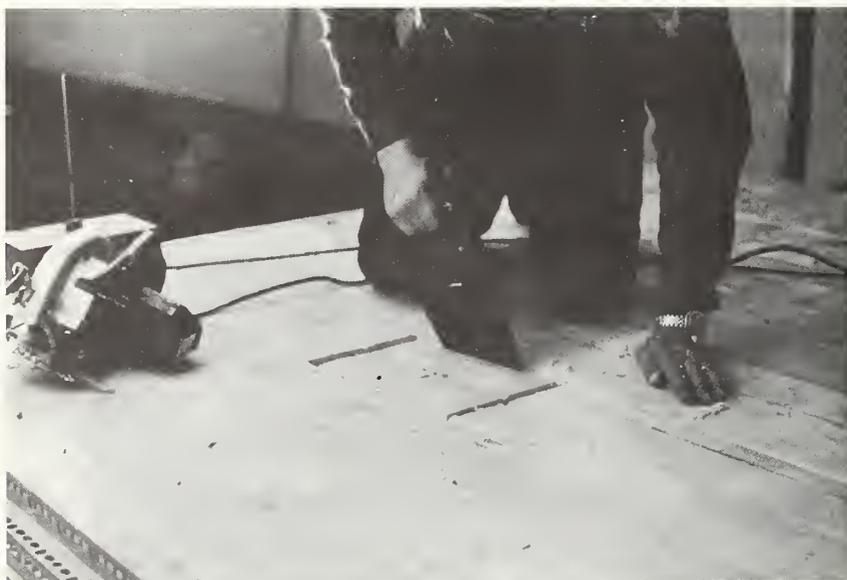
Figure 13. Attack 21N

Location 21N was centered on the roof of Room 1 at a distance of 8' from the vibration transducer. The vibration transducer was mounted on an interior wall of the room at a point 2' below the roof. Thus, the transmission path included 2' of wall and 6' of roof of the structure. The attack location was chosen so that the opening would straddle one of the 2" X 6" wooden rafters so that this would have to be cut in two places to complete the penetration. A 1-1/2 horsepower electric saw with a 7-1/4" combination blade was used to cut through the planking along the rectangular perimeter of the opening in 0.5 minute. The rafters were then cut with a carpenter's handsaw in 0.96 minute, as shown in figure 13. The total working time was 1.47 minutes with elapsed time of 1.73 minutes. The initial J-SIIDS alarm occurred 5 seconds after the attack began.

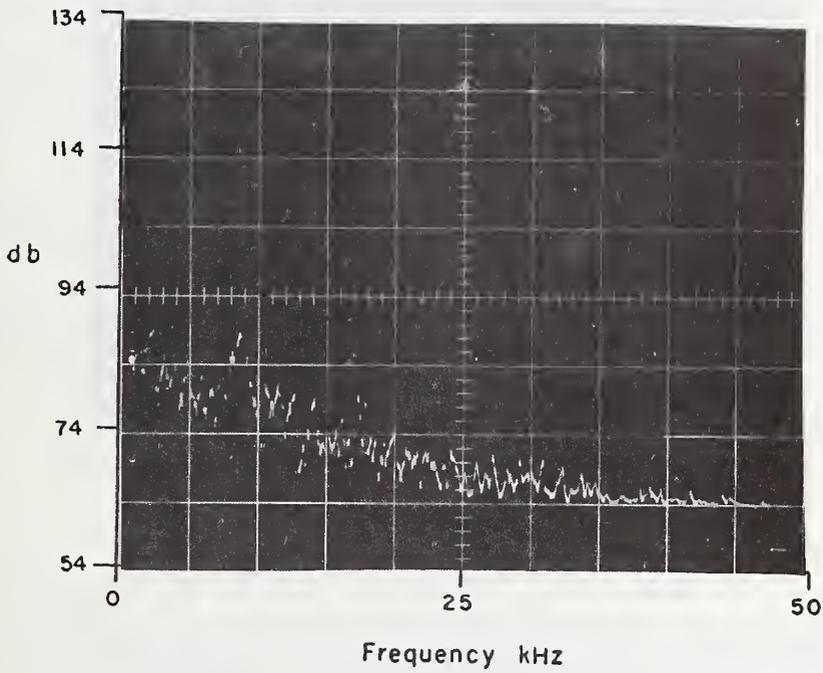
Figure 14. Rotary Electric Saw, Acoustical

Samples of the acoustical, figure 14 , and vibrational, figure 15 , disturbances from the electric saw were quite similar to those observed from the different electric saw and blade used in Attack 20M.

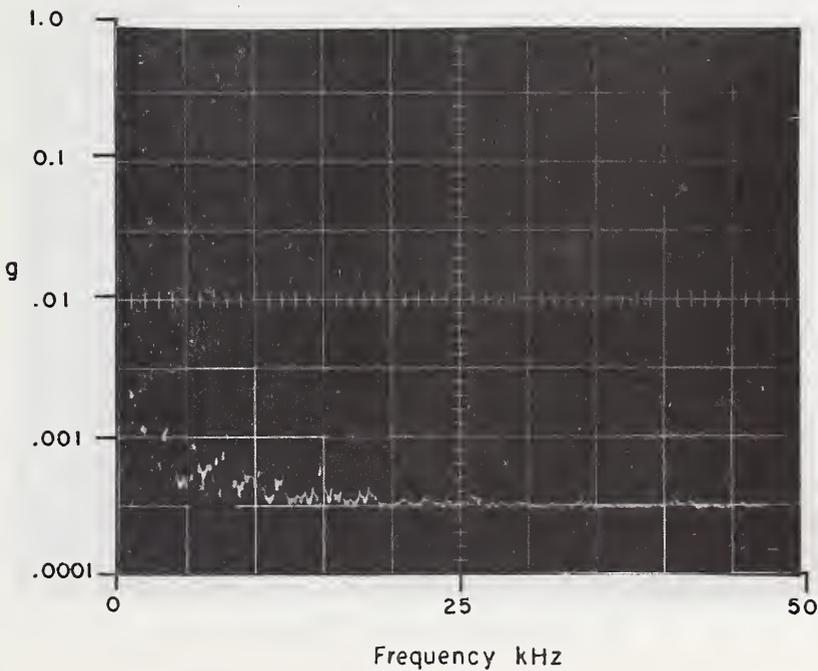
Figure 15. Rotary Electric Saw, Vibration through Eight-foot Transmission Path

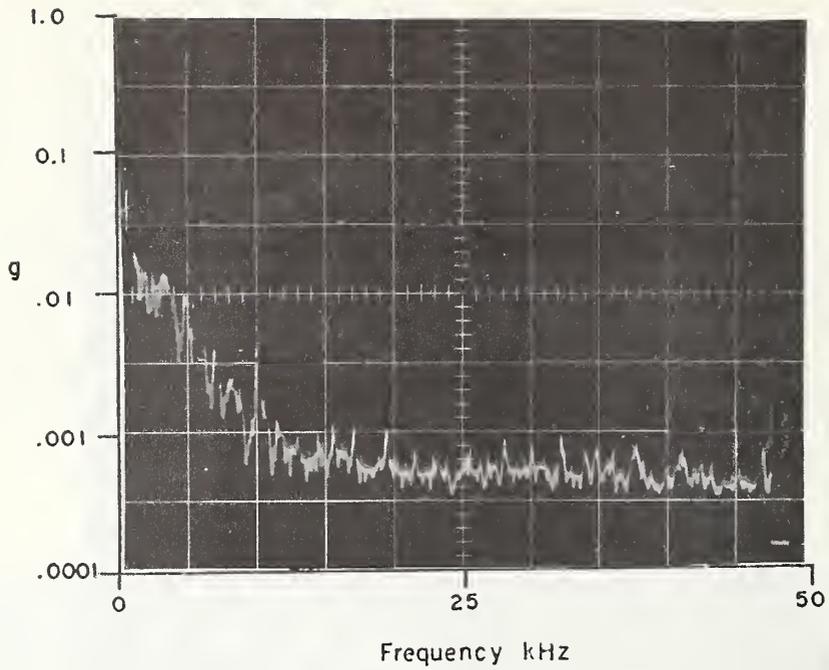
Figure 16. Vibration Produced by Handsaw Cutting Rafter

The vibrational disturbances produced by the handsaw are shown in figure 16. The handsaw produced a peak SPL of 98 dB observed at a distance of approximately 5'.

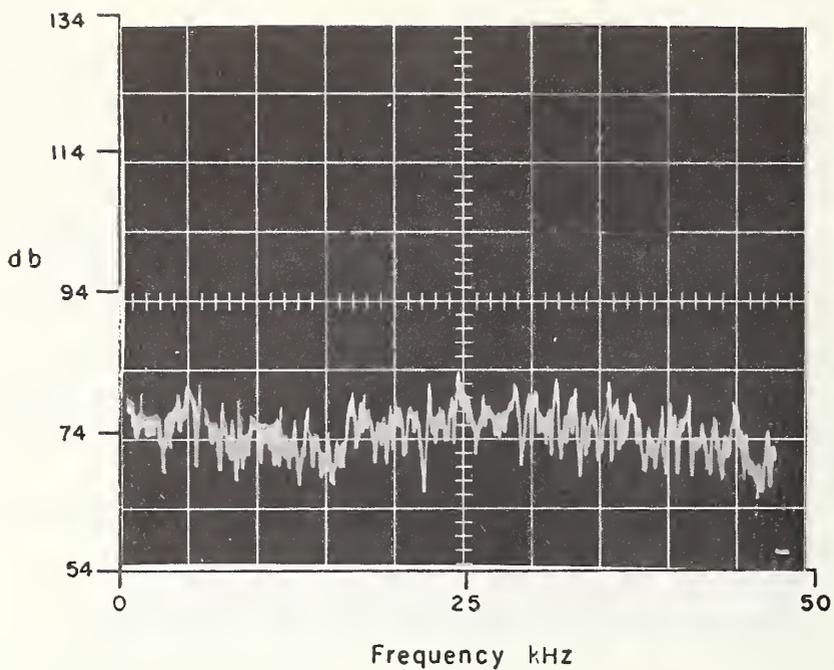
Figure 19. Acoustical Disturbances from Oxyacetylene Cutting Torch

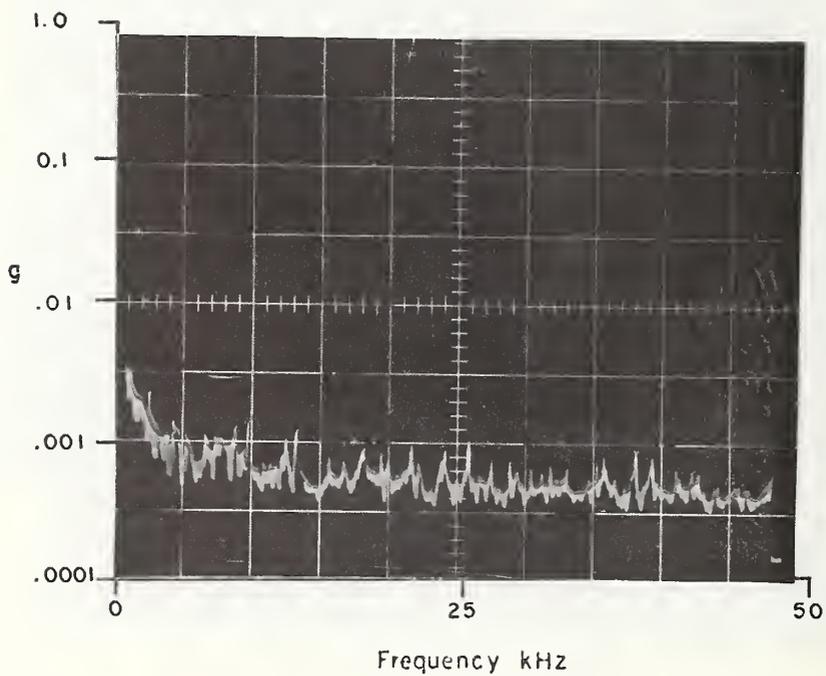
Figure 20. Vibration from Cutting Torch

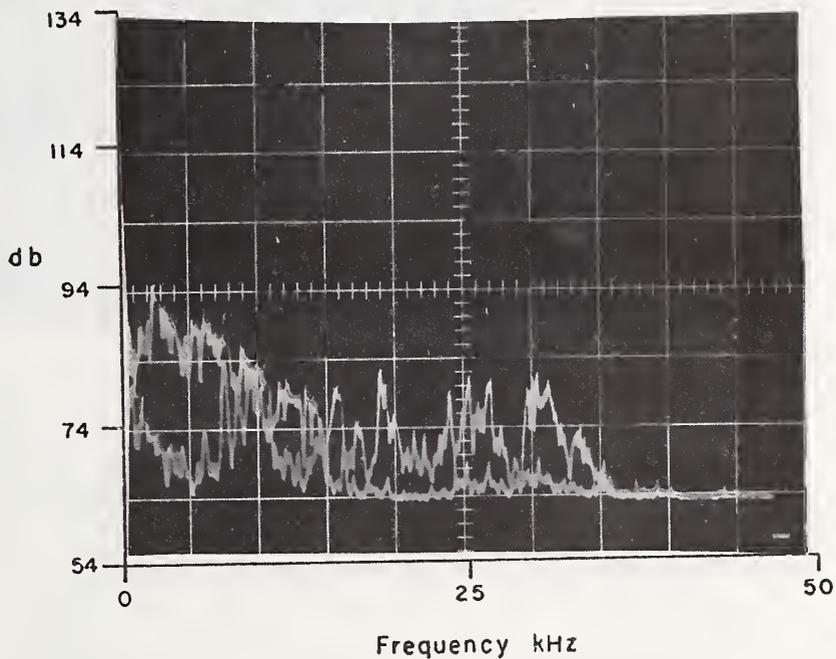
Figure 21. Multiple Sweep of Acoustical Disturbances from Breaking Glass Window

To conclude the activities in Room 1, another unscheduled test was performed. This involved breaking the glass in a window located at the west end of the room and cutting a coarse wire mesh attached rather flimsily to the inside of the window frame. The glass was quickly broken with a hammer and samples of the acoustic disturbances are shown in the multiple trace photograph of the spectrum analyzer output in figure 21. When a bolt cutter was used to cut the wire mesh, see figure 22, it fell off of the window frame on the second or third cut so no actual total times are available. It is estimated that this penetration could have been completed in less than 30 seconds if the mesh had remained in place.

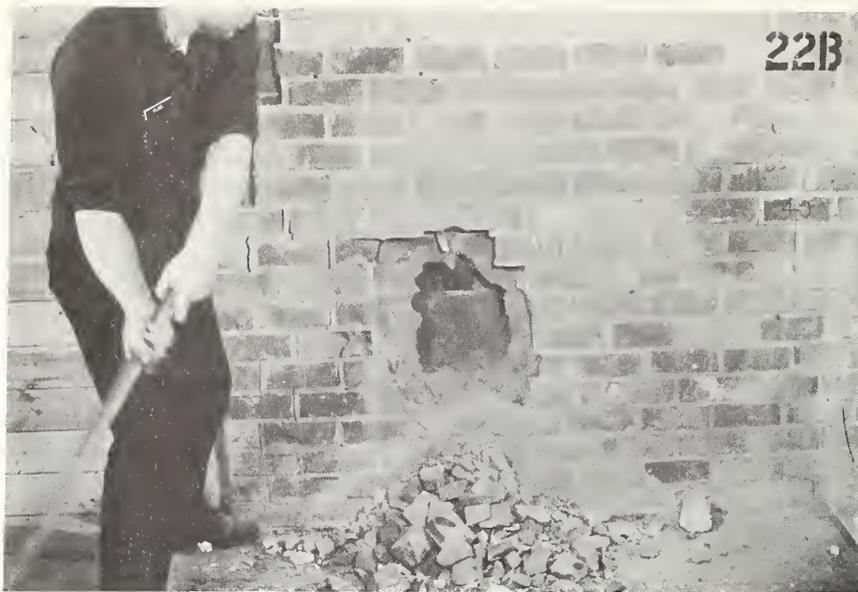
Figure 23. Attack 22A

Attack 22A was conducted on Room 2 on a wall made up of a layer of brick veneer over 8"-thick cinder block. The brick was spaced out from the cinder block 1" and tied to every second course of block by metal ties. The block was reinforced with 5/8" diameter rod inserted vertically in the cores on approximately 14" centers. The cores of the block were presumably to have been filled with mortar. After the attack, examination showed the mortar filling to be rather loose and crumbly with a large number of voids.

The attack was begun with a 10-pound sledgehammer and 28 blows produced an oversize opening through the brick veneer. These produced a peak SPL of 94 dB as observed at a distance of 10' outside of the room. This was followed by 16 blows with a 12-pound sledgehammer, see figure 23, and 28 blows with a 10-pound sledgehammer which produced a break measuring approximately 2" X 4" through the cinder block. Twelve more blows, with the end of the 10-pound sledgehammer being used as a ram, enlarged the opening to 10-1/2" X 11-1/4". This required a total of only 64 blows with a working time of only 2.12 minutes. By chance, the opening did not intercept one of the infrequent reinforcing bars so a cutting torch was not required. Samples of the acoustical disturbances prior to breakthrough are shown in figure 24 and of the vibrational disturbances in figure 25. Both of these figures show multiple sweeps of the spectrum analyzer.

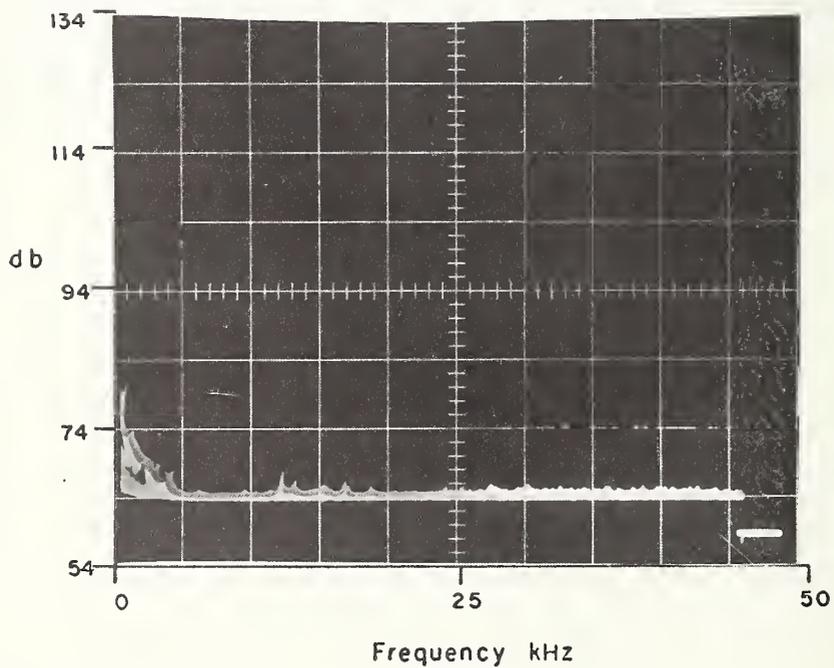
Figure 24. Acoustical Disturbance from Sledgehammer Prior to Breakthrough

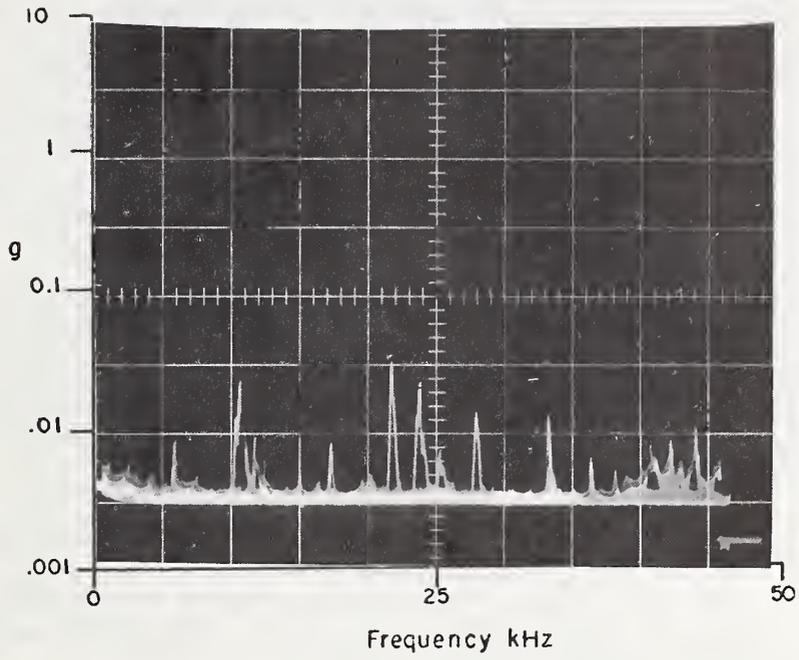
Figure 25. Vibrational disturbances
from Attack 22A

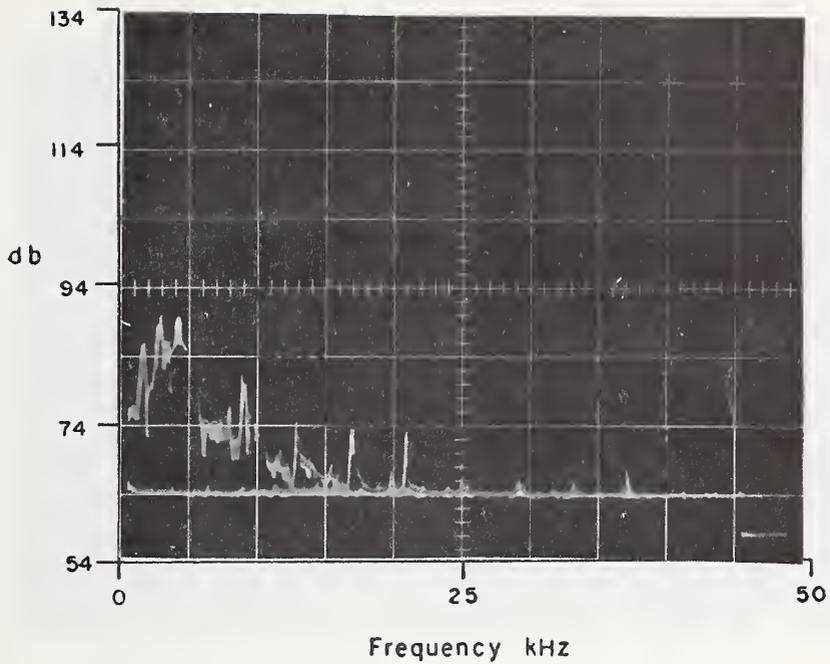
Figure 26. Acoustical Disturbance from Attack on Brick Veneer

Attack 22B occurred on the same wall as 22A and at a location centered 18" from the vibration transducers. This attack employed a rotohammer and 1-1/2" toothed-chisel to cut along the perimeter of the targeted opening. Mortar joints were prime targets to the extent that they reasonably corresponded with the perimeter. It required 4.87 minutes to clear a somewhat oversize opening through the brick veneer. This activity produced a SPL of 95 to 100 dB as observed at a distance of 12' and produced acoustical disturbances inside the room as shown in figure 26 . Vibrational disturbances are shown in figure 27 .

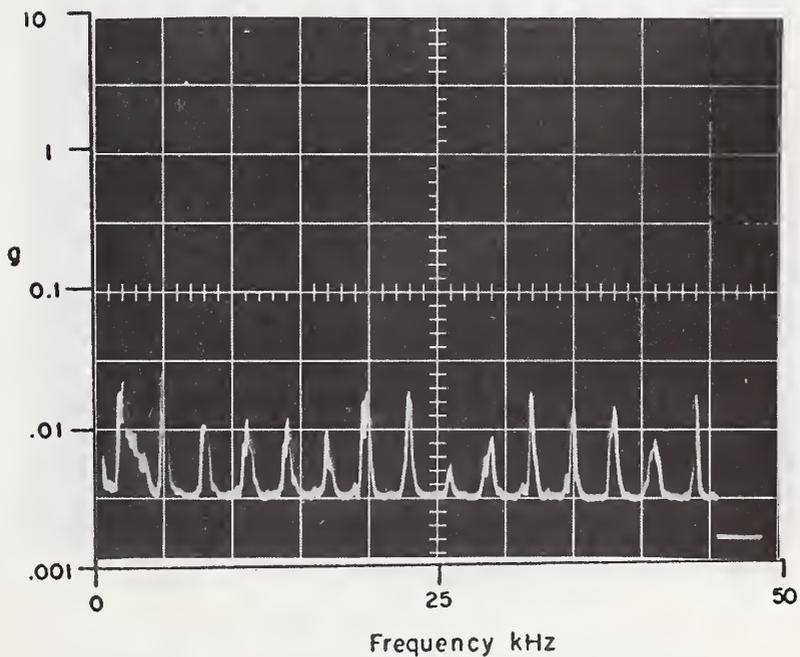
Figure 27. Vibration from Attack on Brick Veneer

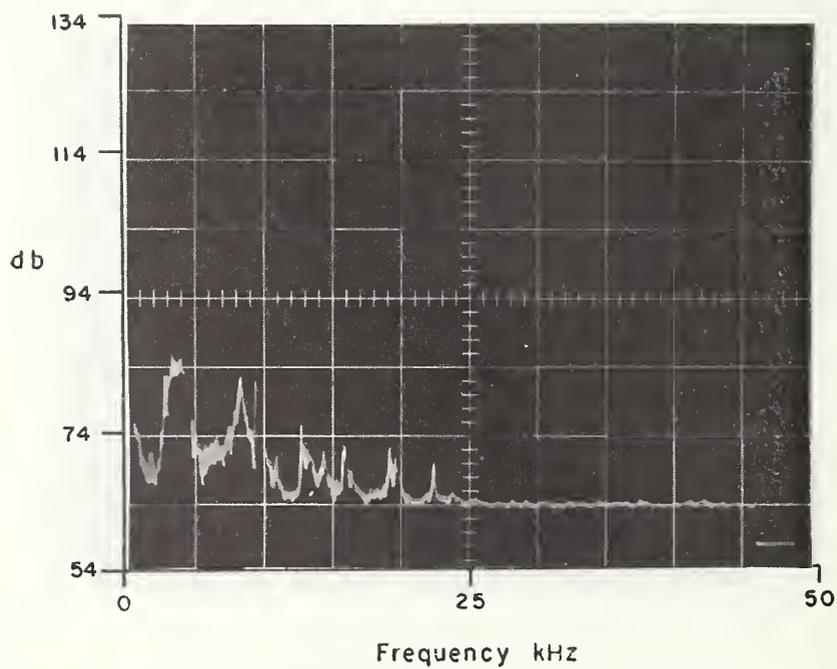
Figure 29. Acoustical Disturbance from Rotohammer Attack on Cinder Block

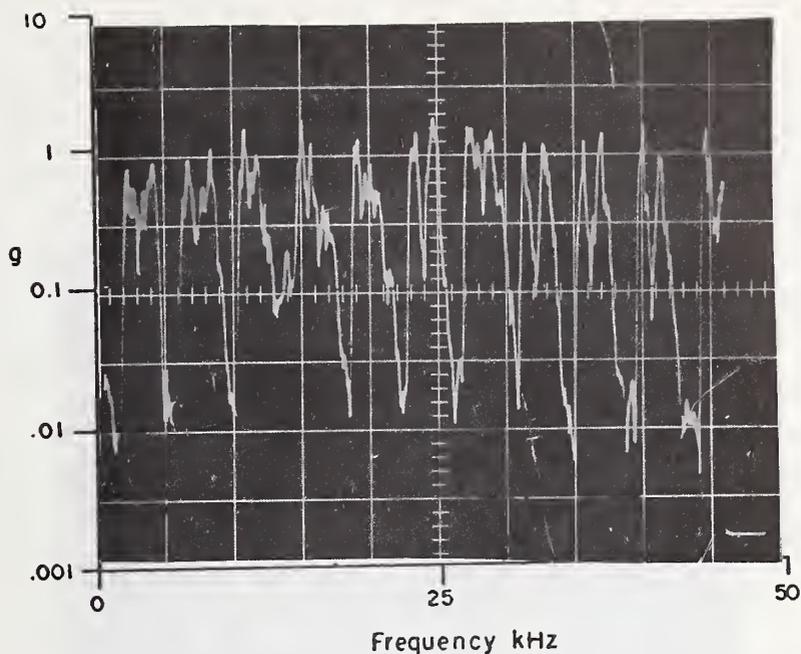
Figure 30. Vibration from Attack on Cinder Block

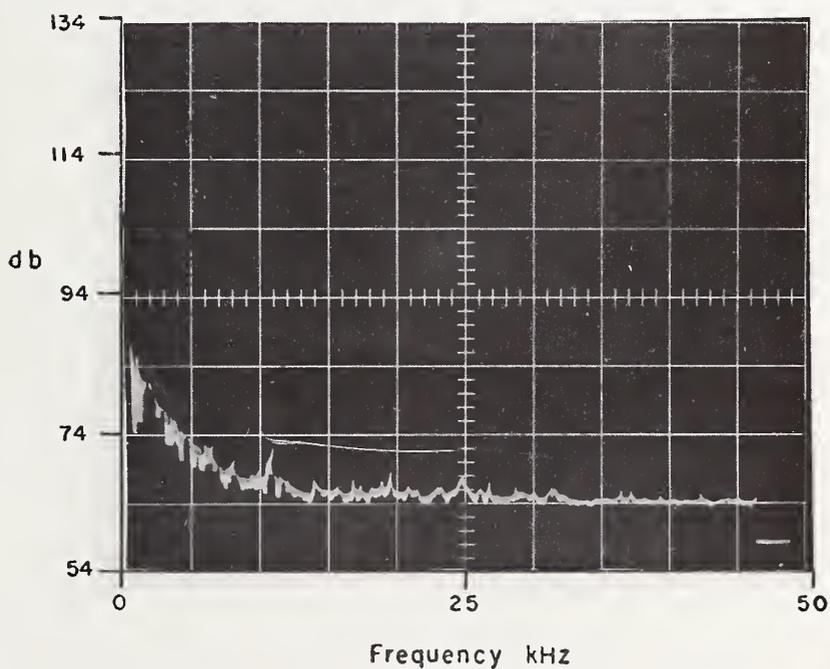
Figure 31. Acoustical Disturbances from Cutting Torch

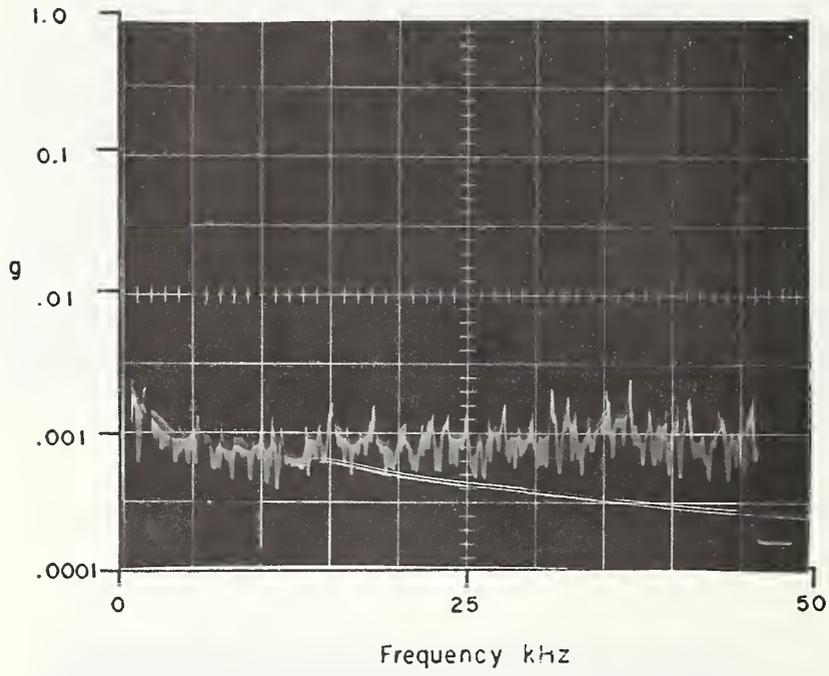
Figure 32. Vibrational Disturbances
from Cutting Torch

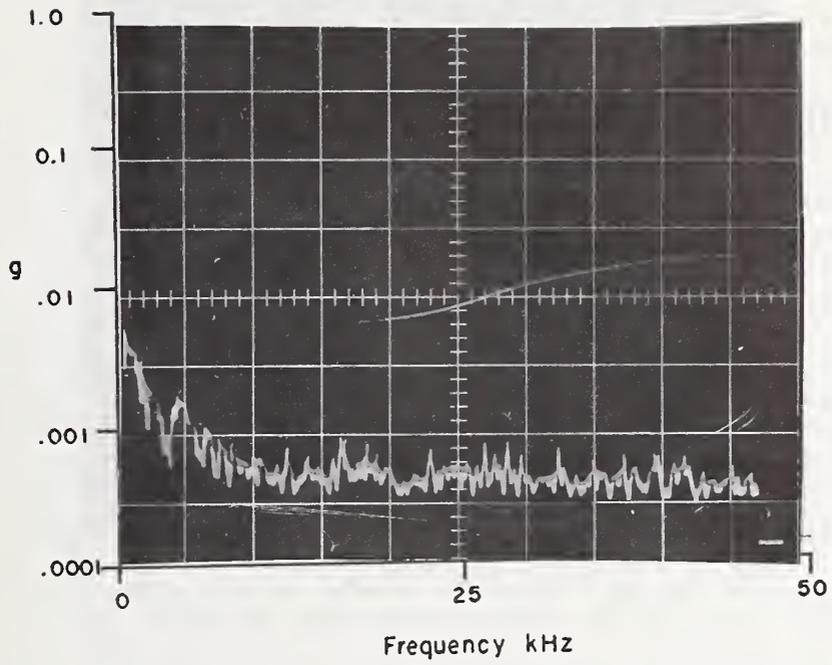
Figure 34. Vibration During Bolt Cutter Attack

During this attack, the vibration transducer was located in the same position as in Attacks 22A and 22B and at a distance approximately 8' away. Vibrational disturbances observed during the bolt cutter attack are shown in figure 34 which does not materially differ from the background disturbance level prior to the attack as shown in figure 35. A multiple sweep of acoustical disturbances produced by the bolt cutters is shown in figure 36. The vibrational disturbance from the sledgehammer breaking the draw bolt is shown in figure 37.

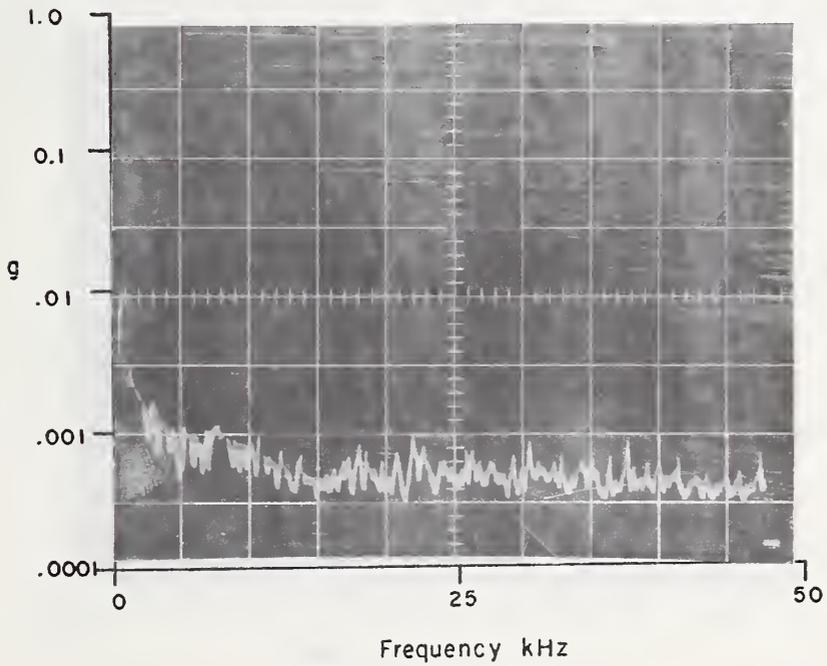
Figure 35. Ambient Vibrational Background at Location 27T

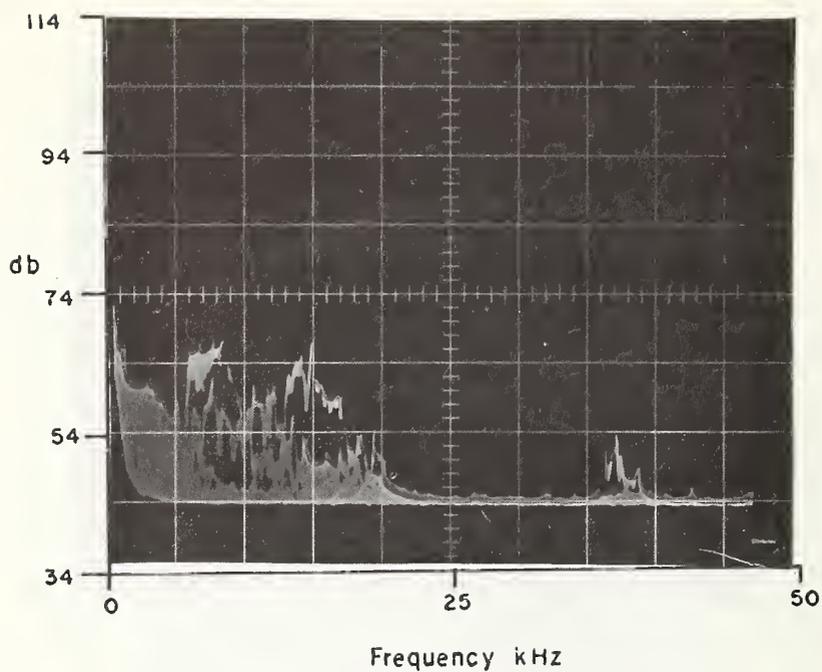
Figure 36. Multiple Sweep of Acoustical Disturbances Produced by Bolt Cutters

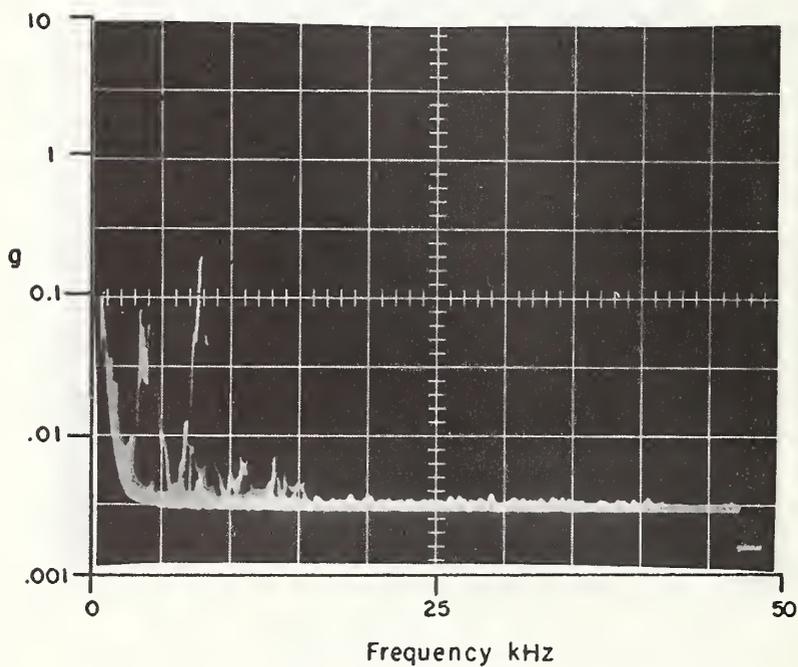
Figure 37. Vibration from Sledgehammer Attack on Draw Bolt

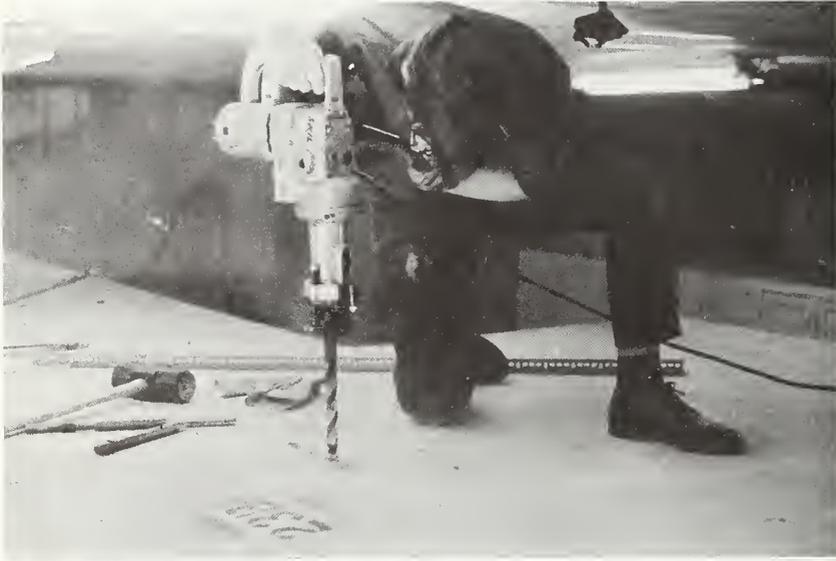
Figure 38. Attack 23B

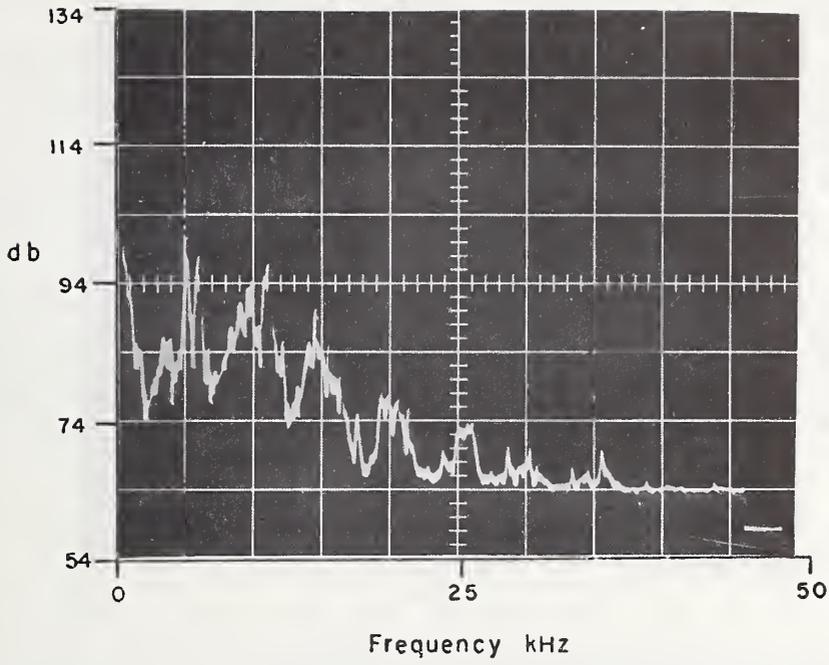
Figure 39. Acoustical Disturbance from Drilling

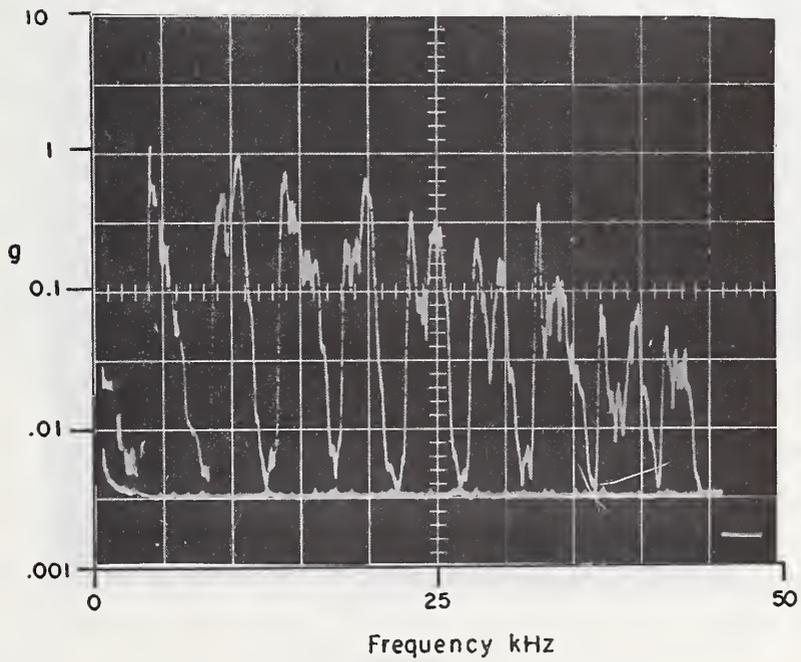
Figure 40. Vibrational Disturbance from Drilling

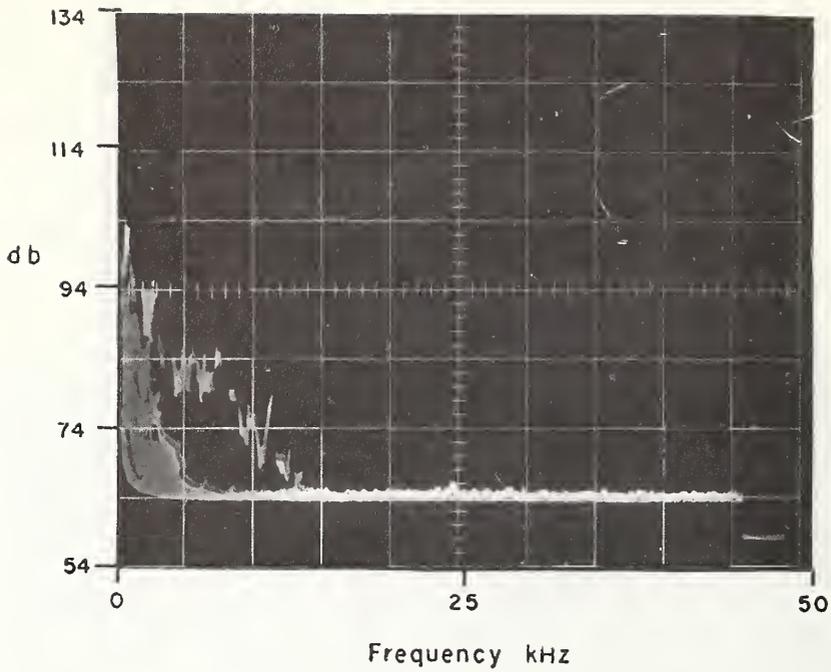
Figure 41. Acoustical Disturbance from Spalling

Spalling out the concrete below the bottoms of the holes required 2.92 minutes and produced a peak SPL of 91 dB observed 25' away from the attack location. Multiple sweep photographs of the acoustical spectra are shown in figure 41 and the vibrational spectra in figure 42.

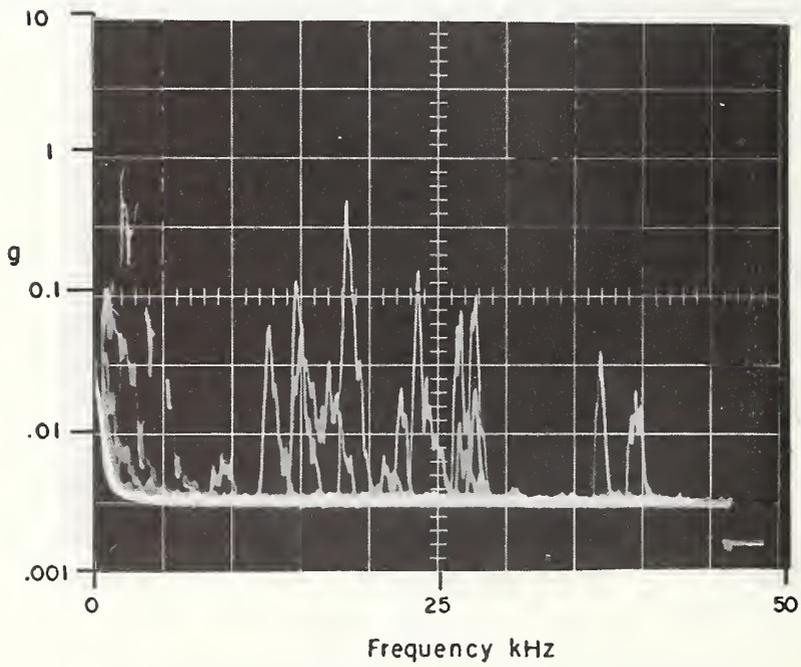
Figure 42. Vibration from Spalling
