NBSIR 73-223

Penetration Tests on J-SIIDS Barriers

Interim Report for Period March 13 – 16, 1973

Prepared for
Defense Nuclear Agency
Washington, D. C. 20305

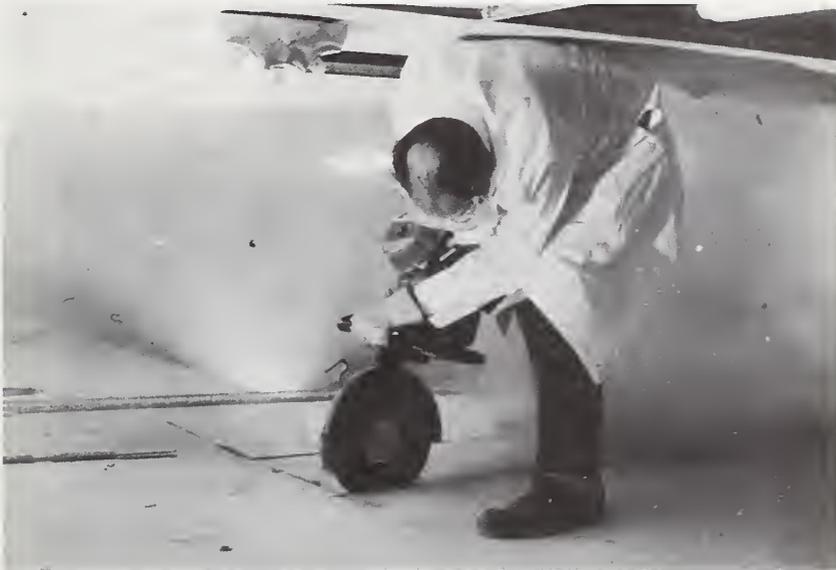
Figure 43. Abrasive Wheel Cutoff Saw
Used in Attack 23B

Next, as shown in figure 43, a 5-horsepower gasoline-powered saw equipped with a 12" diameter abrasive cutoff wheel was used to cut a groove around the perimeter of the relocated opening. This took 5.06 minutes working time and it was necessary to replace the cutoff wheel about midway through this activity because of wheel wear. In addition, it was necessary to vacate the wing of the building housing the arms rooms after each of the 4 perimeter cuts while the dust and exhaust fumes were cleared away by fans. These latter time intervals were not included in the calculation of elapsed time.

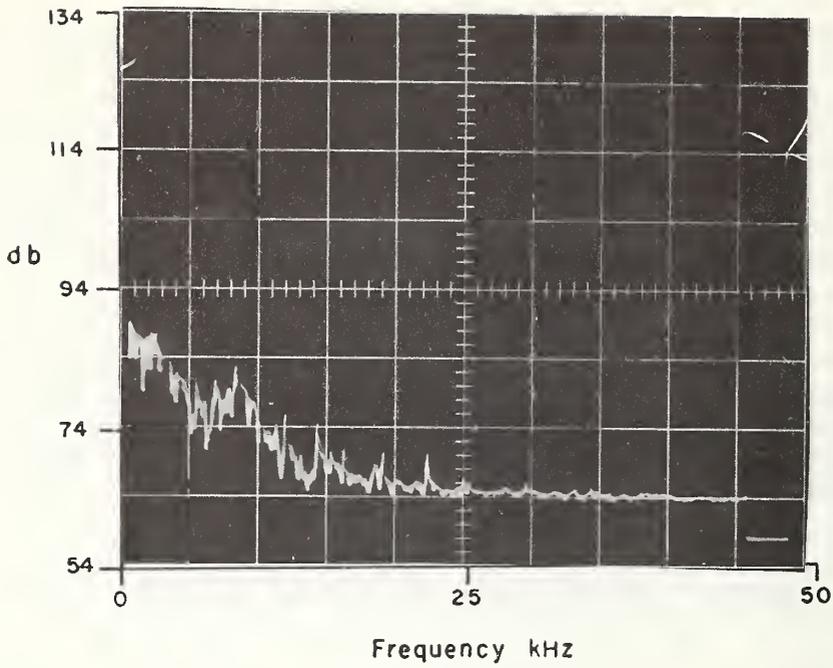
Figure 44. Acoustical Disturbances from Abrasive Wheel Cutoff Saw

Outside of the room the abrasive wheel cutoff saw produced 105 dB SPL at a distance of 25'. Samples of the acoustical spectrum within the room were lower and are shown in figure 44 and the vibrational spectrum are shown in figure 45 . Note how the latter peaks in the 15 to 35 kHz frequency range.

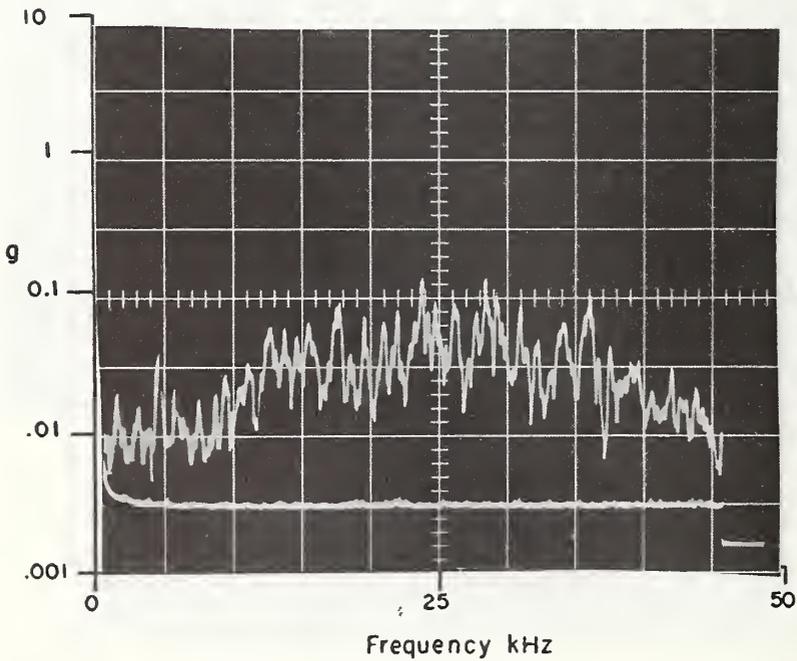
Figure 45. Vibration from Abrasive Wheel Cutoff Saw

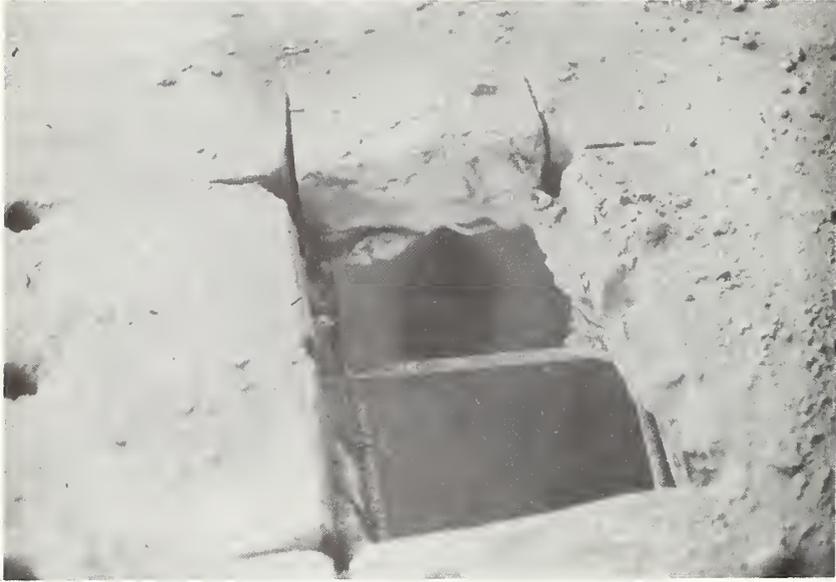
Figure 46. Opening Made by Attack 23B

The cut made by the abrasive wheel saw around the perimeter of the opening penetrated to a depth of between 2" and 3". This left about an inch of concrete between the bottom of the cut and the top of the previously spalled interior area. It was hoped that the remaining plug could be broken out by a direct sledgehammer assault, but, when 50 seconds of effort with this tool produced only moderate spalling on the surface, it was decided to drill two more holes with the rotohammer. These were made in 18 seconds and then the sledgehammer attack was resumed. This time it was quite successful and only 23 more seconds were required to clear the concrete from the opening exposing the reinforcing rods for cutting as shown in figure 46. Acoustic disturbances produced by the sledgehammer are shown in figure 47 and vibrational disturbances in figure 48. Both of these are photographs of multiple sweeps of the output of the spectrum analyzer.

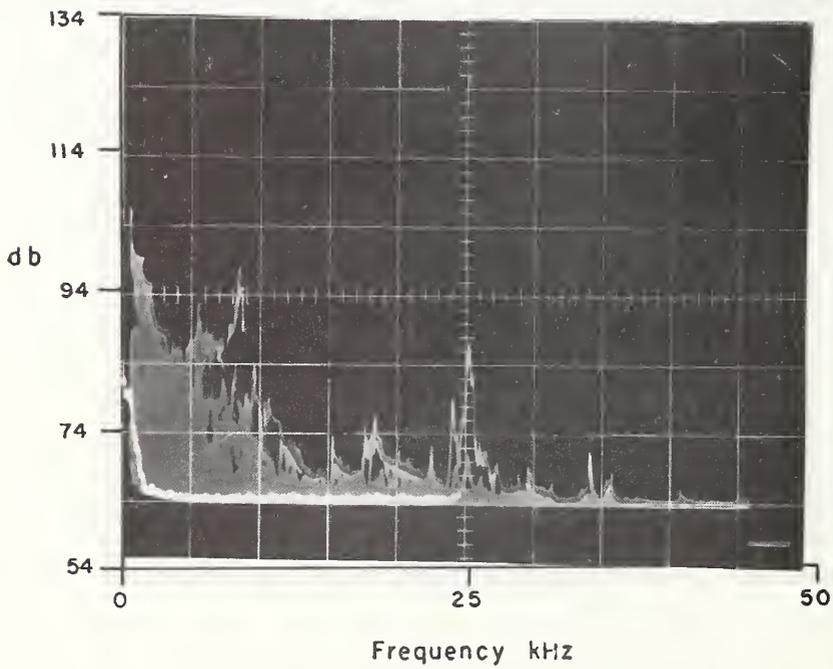
Figure 47. Acoustical Disturbances from Sledgehammer

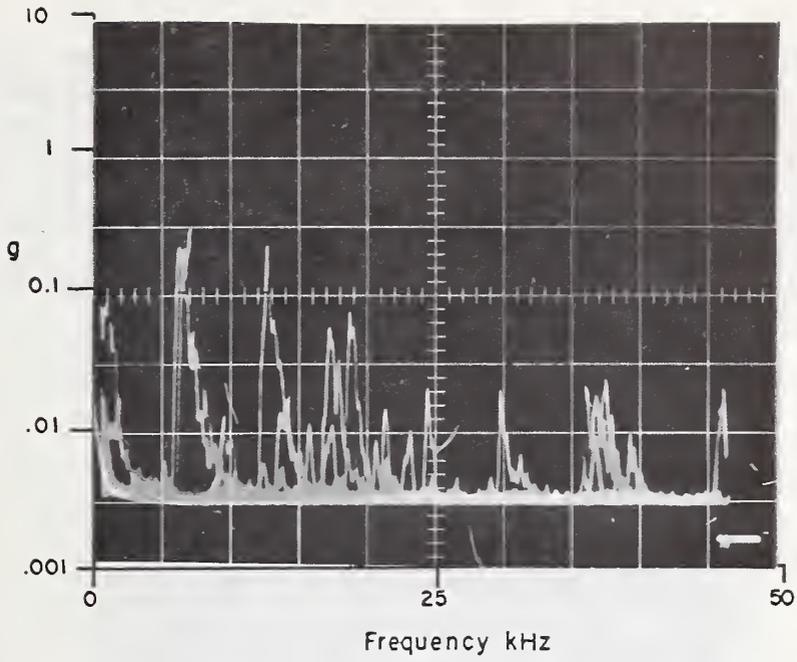
Figure 48. Vibration from Sledgehammer

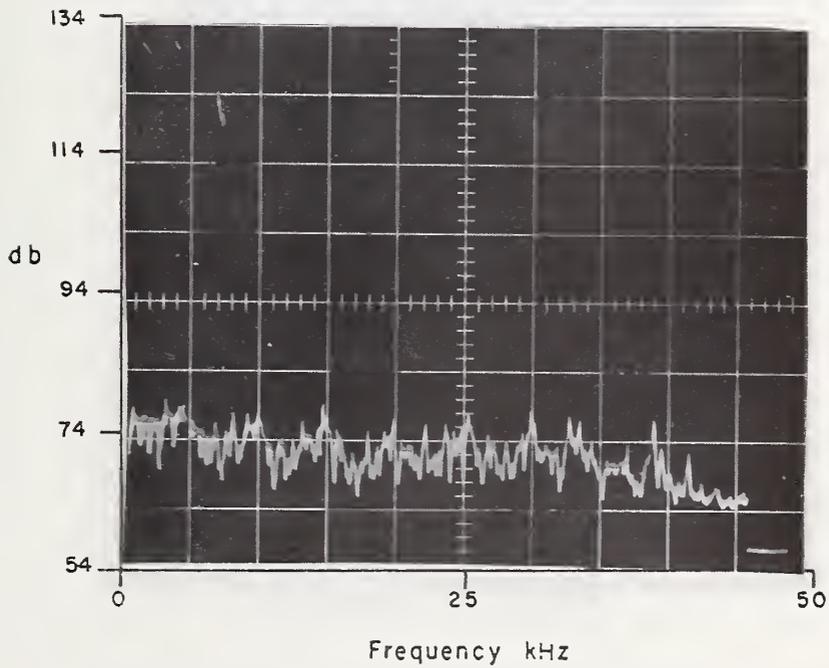
Figure 49. Acoustical Disturbances from the Cutting Torch

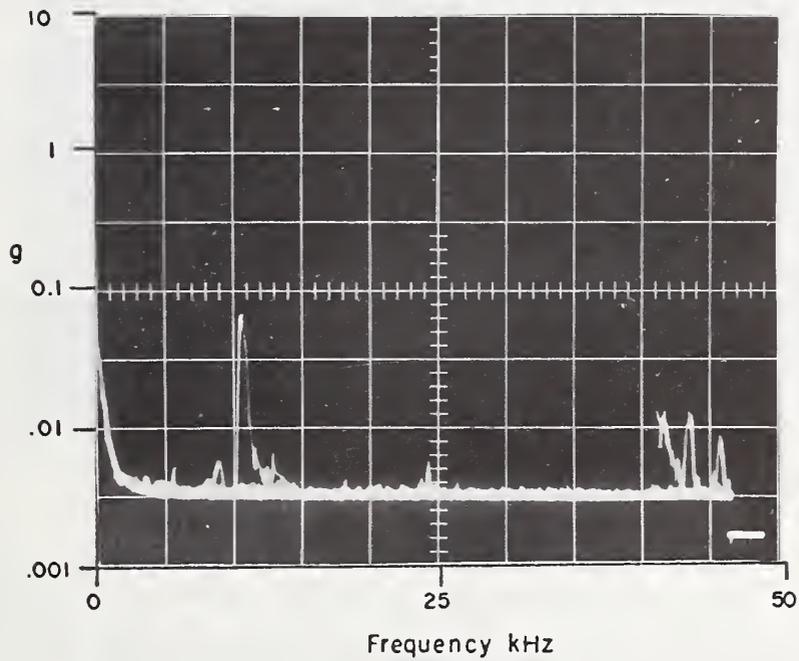
Figure 51. Vibration from
Sledgehammer on
Cinder-block Wall

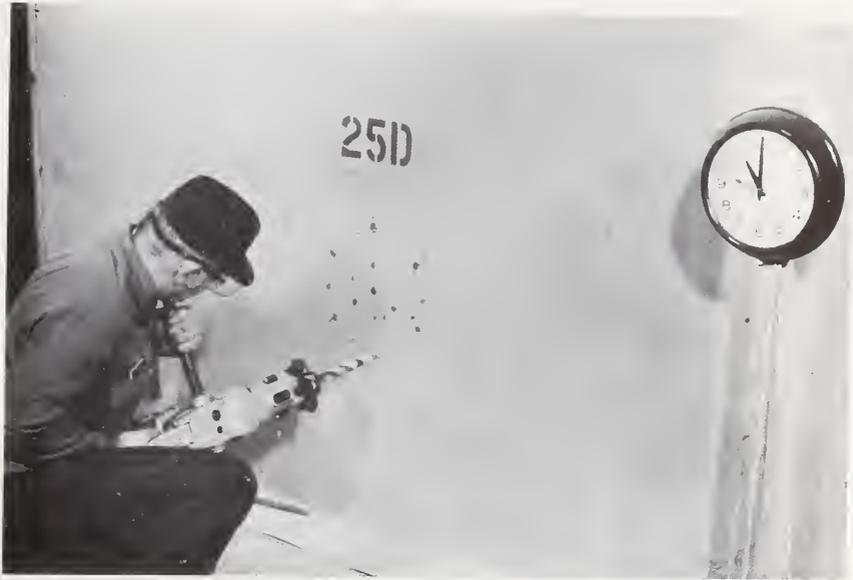
Figure 52. Attack 25D

This test was identified as 25B on the test plan but the physical location was stenciled as 25D and it will hereinafter be referenced by that identifier to be consistent with the photographic coverage. The attack was made on one of the 8" thick reinforced concrete walls of Room 3. It involved drilling a pattern of 1" diameter holes partially through the concrete to predetermined depths, then spalling out concrete on the interior using a 1" bull-point punch and sledgehammer. Initial spalling was from the deepest holes and after the material was cleared out behind them the attack shifted to the shallower holes and finally to the surface of the remaining plug. Finally, reinforcing would be cut if necessary. As developed, the opening exposed but did not straddle a reinforcing bar and cutting was not necessary in this attack.

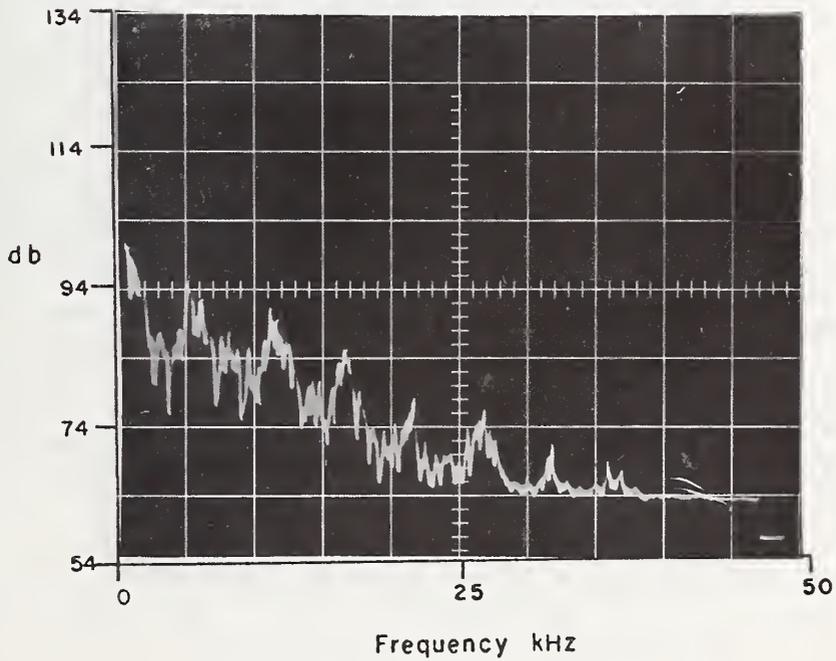
Figure 53. Acoustical Disturbances from Drilling Reinforced Concrete

Typical SPL values of 108 to 110 dB were observed at a distance of 7'. Acoustical disturbances inside Room 3 are shown in figure 53. Vibrational disturbances recorded from a transducer mounted on the wall 10' from the attack point are shown in figure 54 .

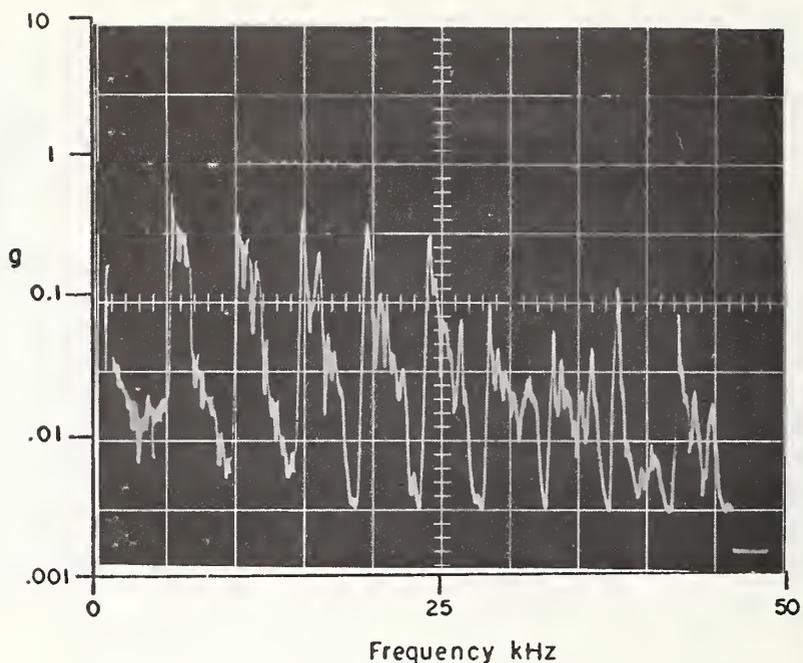
Figure 54. Vibration from Drilling Reinforced Concrete

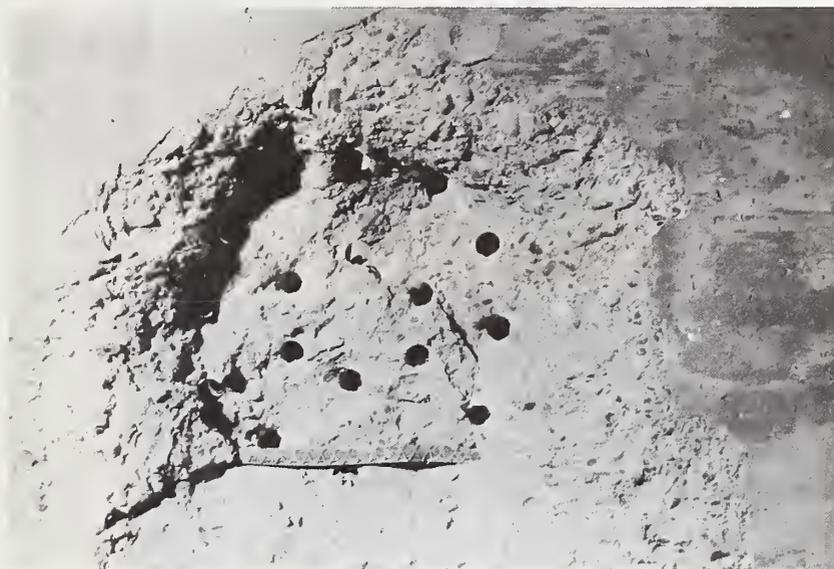
Figure 55. Interior of the Wall with Spalling Nearly Complete

Spalling the concrete from the interior beneath the holes was accomplished using a 10-pound sledgehammer and 1" diameter bull-point punch and required 6.98 minutes. Figure 55 shows the interior of the wall with spalling nearly complete. Figure 56 is a multiple sweep photograph of the acoustical disturbances which were produced within Room 3. Outside SPL readings 99 to 102 dB were observed at a distance of 8'. Typical vibrational disturbances observed with a transducer located on the same wall as the attack and at a distance of 10' are shown in figure 57. A second transducer mounted on the opposite wall of Room 3 with a transmission path length of approximately 20' yielded the spectrum shown in figure 58.

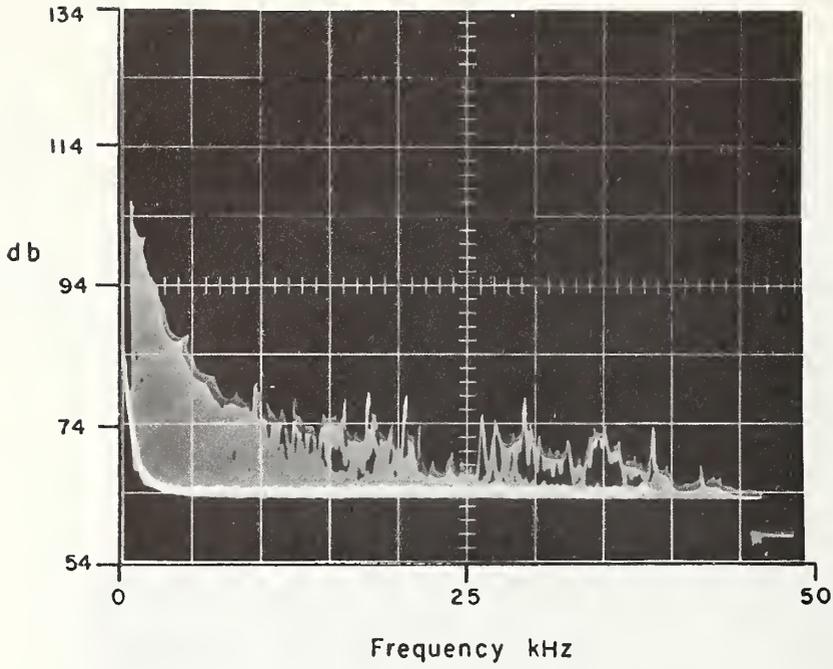
Figure 56. Multiple Sweep of Acoustical Disturbances Produced by Spalling

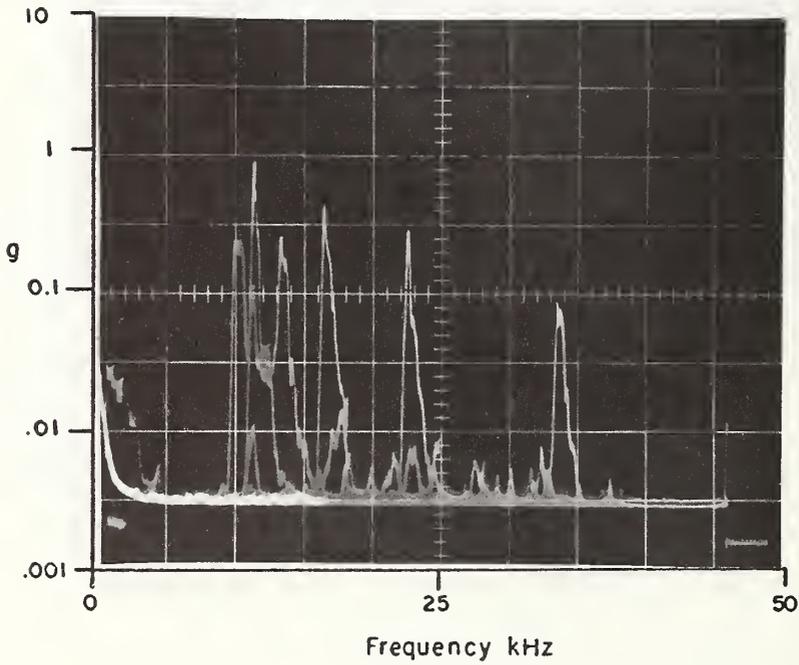
Figure 57. Vibration from Spalling with Transducer mounted 10' from Attack Point

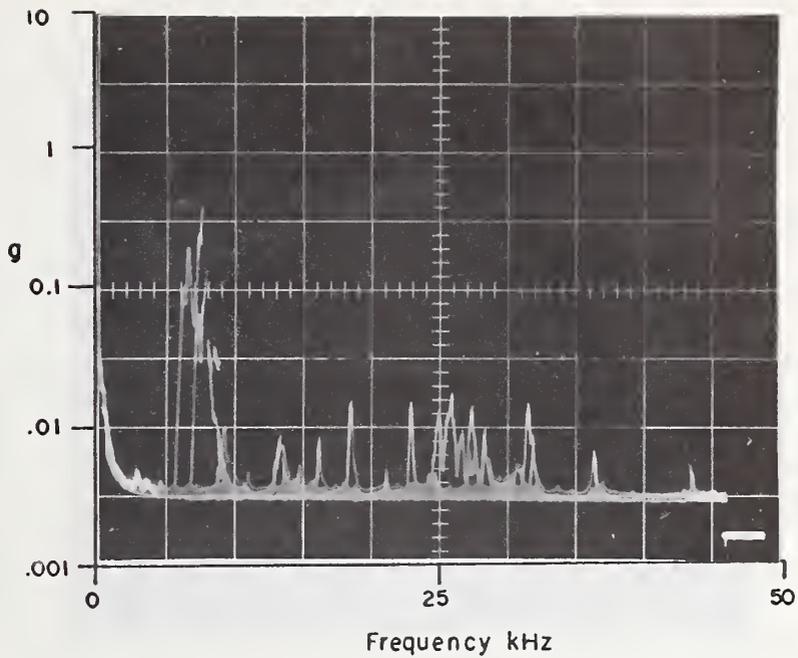
Figure 58. Vibration from Spalling with Transducer Mounted 20' from Attack Point

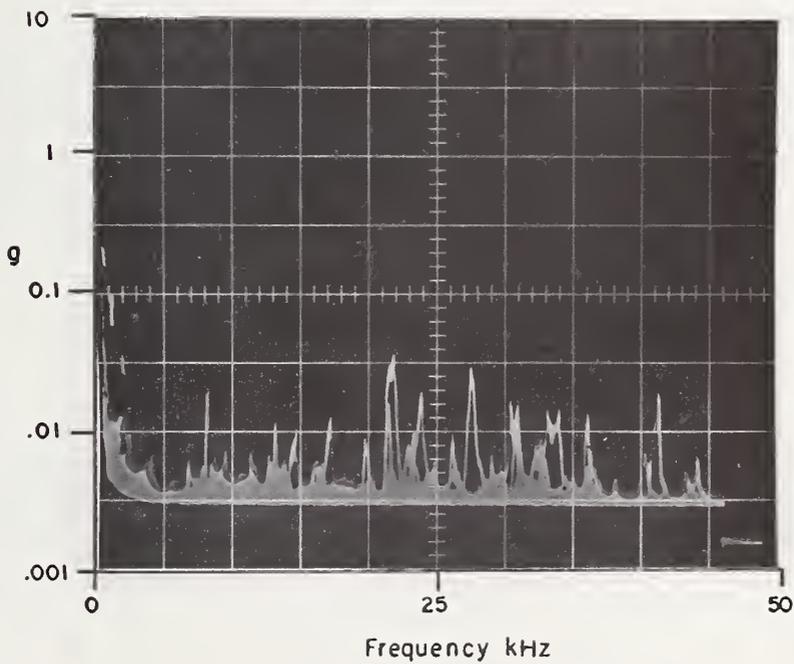
Figure 59. Vibration from 20-pound Sledgehammer

After the spalling was completed, the remaining plug was broken out using a 20-pound sledgehammer for 23 seconds and a 10-pound sledgehammer for 13 seconds. Multisweep vibrational data from the 20-pound hammer is shown in figure 59 and from the 10-pound hammer in figure 60. In both instances the transducer was 10' from the attack point. Note the higher g values developed by the 10-pound hammer. This is attributed to the higher velocity which could be developed in swinging this lighter hammer.

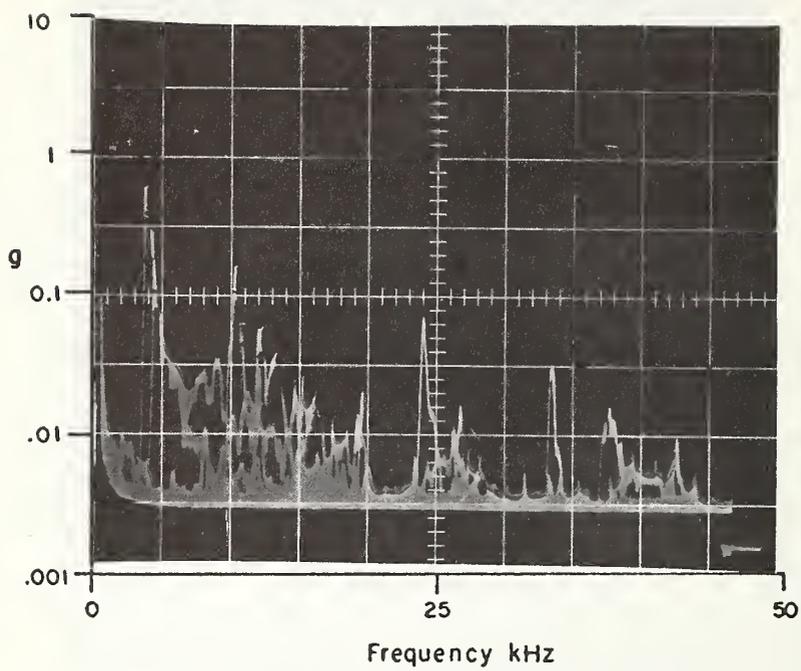
Figure 60. Vibration from 10-pound Sledgehammer

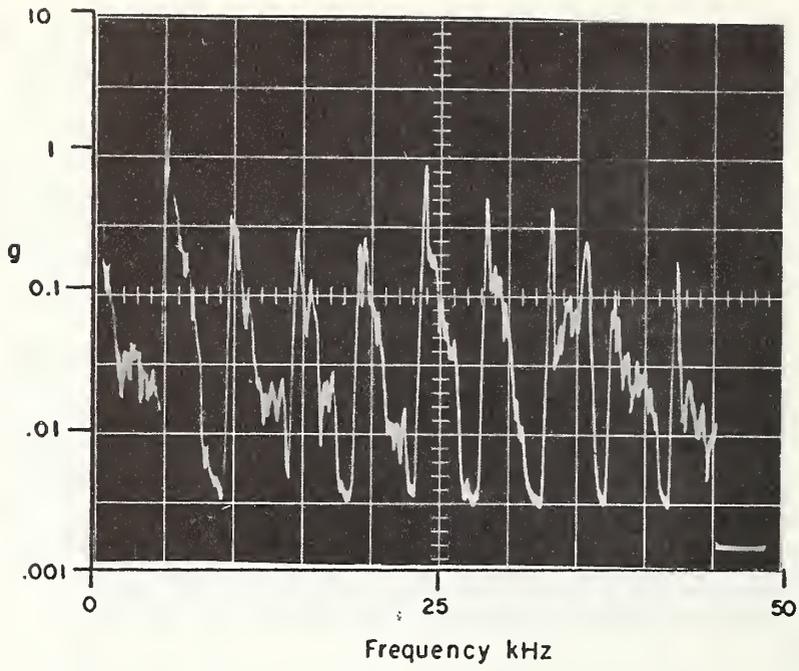
Figure 61. Vibration from Rotohammer

The hole pattern selected consisted of eight holes equispaced around the perimeter of a circle 11-1/2" in diameter. Alternate holes were drilled 5" and 3-1/2" deep. A single 4" deep hole was drilled at the center of the circle. The rotohammer with 3/4" bit completed this 38 linear inches of drilling in 2.62 minutes at an average rate of 4.13 seconds per inch. SPL values of 104 dB were observed at 8' and 112 dB at 2' distance. Vibrational disturbances as observed with the transducer mounted on the interior of the wall at a distance of 5' from the center of the opening are shown in figure 61 .

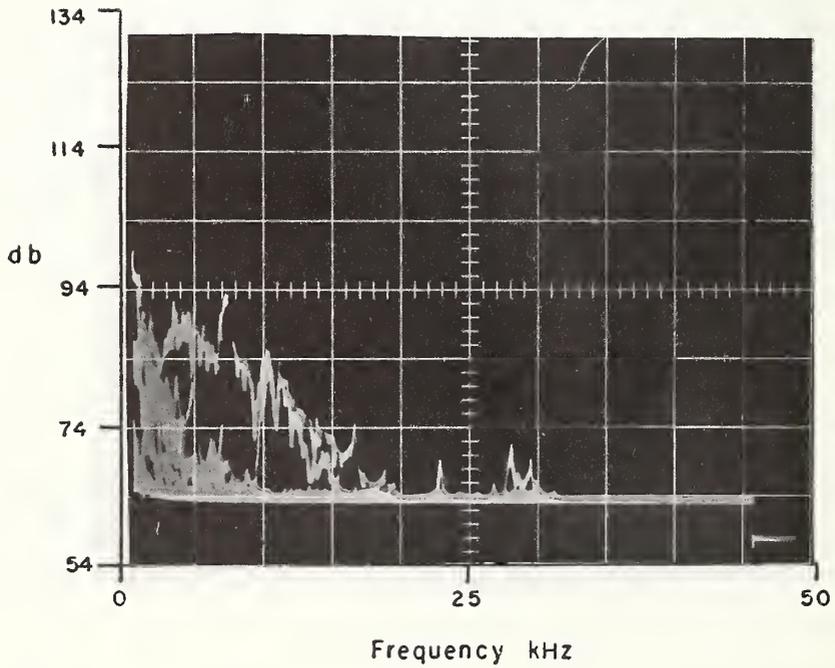
Figure 62. Acoustical Disturbances from Spalling

Spalling out the bottoms of the drilled holes was accomplished with the 3/4" diameter bull-point punch and 12-pound sledgehammer. It took 1.42 minutes and 63 hammer blows on the 5" deep holes followed by 1.26 minutes and 58 blows for the 3-1/2" deep holes and 0.2 minutes and 9 blows for the 4" deep center hole. Samples of acoustic disturbances are shown in figure 62 and vibrational disturbances in figure 63 .

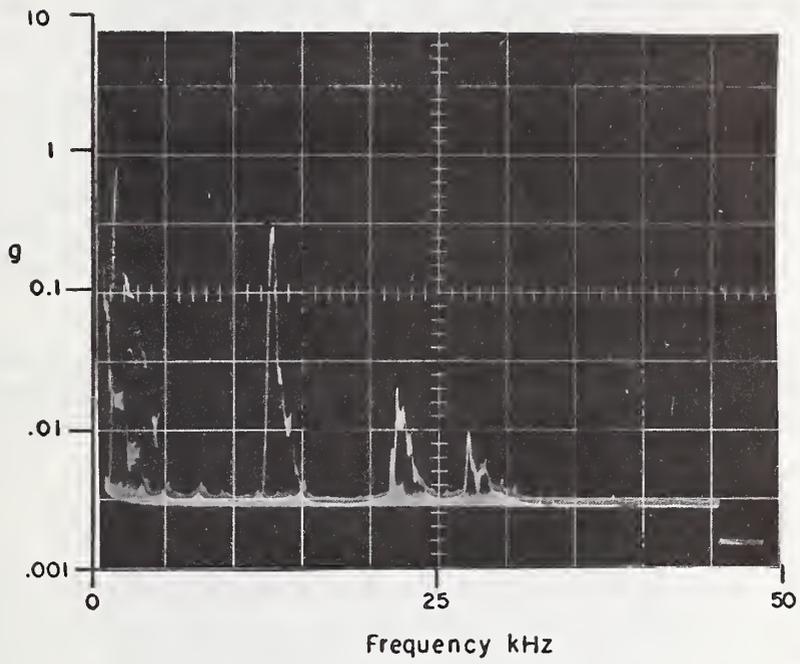
Figure 63. Vibration from Spalling

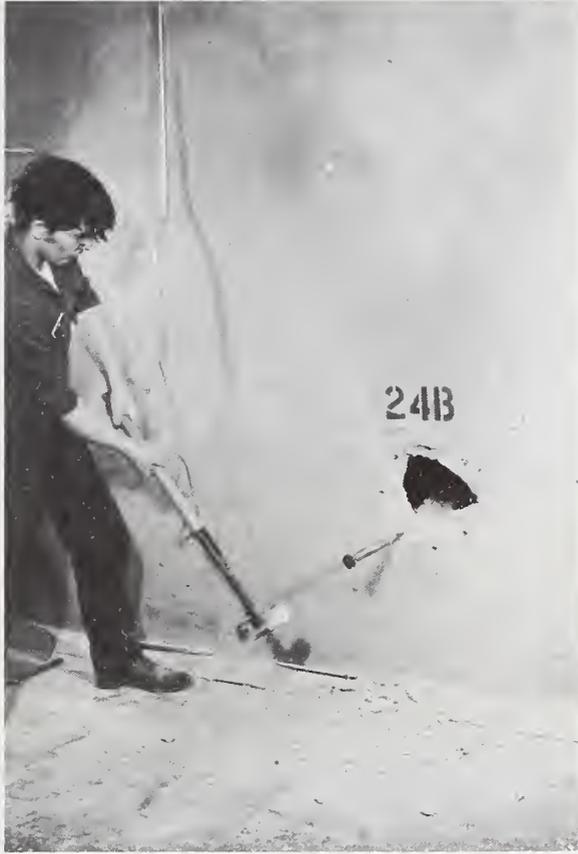
Figure 64. Use of Tapered Punch
in Attack 24B

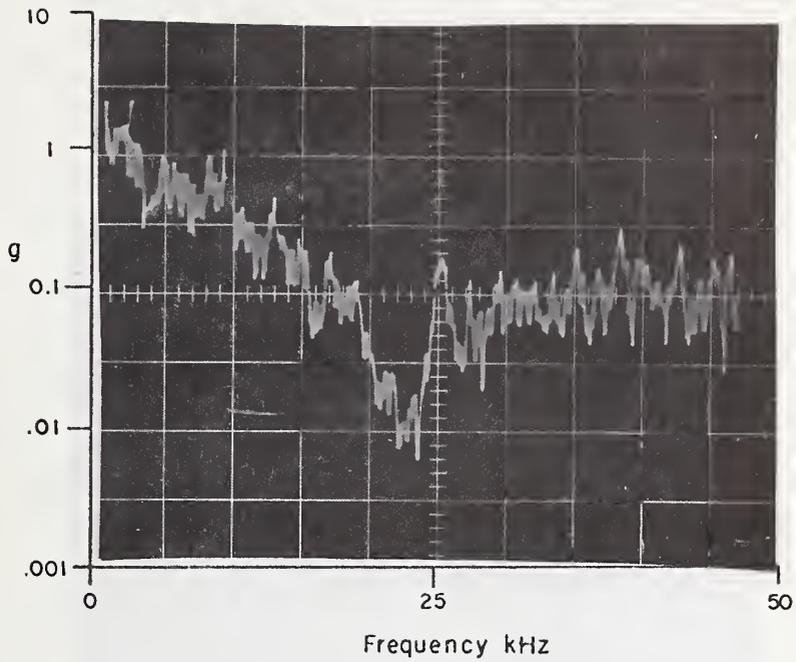
Figure 65. Vibration from File

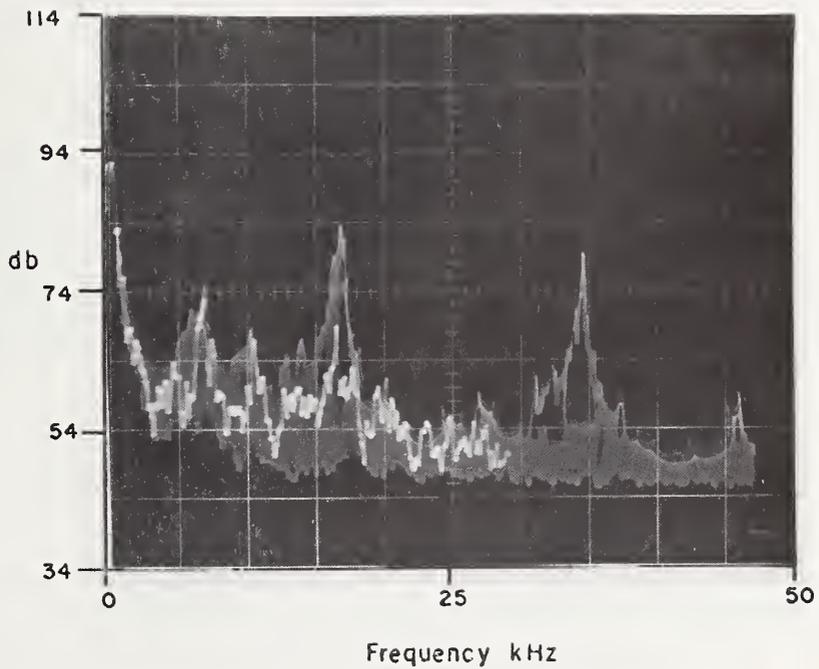
Figure 66. Acoustic Disturbance from Drilling on Vault Door

Next, because drilling could be used to attack the bolt-work blocking mechanism, a sample hole was started in the appropriate area to provide an opportunity to collect acoustical and vibrational disturbance data. A 9/32" high-speed steel bit was used in a 3/8" variable speed electric drill. Multiple sweeps of the resulting acoustical data appear in figure 66 and vibrational data in figure 67 . The vibrational transducer was on the inner frame of the vault door and the microphone was within the vault with the door closed, of course. On the outside, SPL values of 80 dB were observed with the drill running at low speed and 87 to 88 dB at high speed at a distance of 3'.

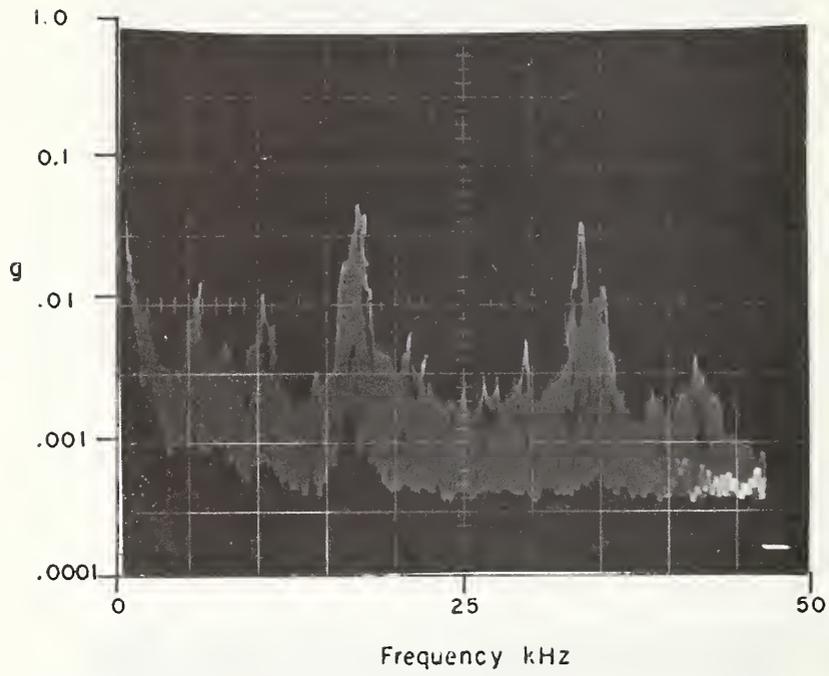
Figure 67. Vibration from Drilling
on Vault Door

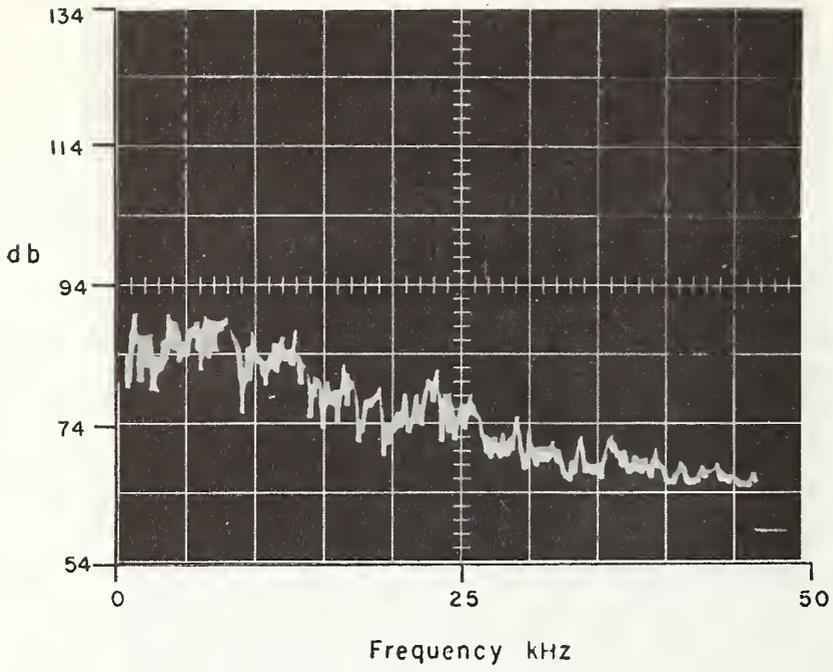
Figure 68. Acoustical Disturbances from Rocket Torch

Next, the portable cutting torch (rocket) was used to attack the area of the vault door over the bolt-work blocking mechanism. After 74 seconds it appeared unlikely that this attack could be successfully completed with the torch and a circular cut was immediately started in another area of the door. In the remaining 99 seconds, before the torch's fuel was consumed, an 80° arc of an 11.3" diameter circle was cut in the 1/4" thick mild steel plate. The total burning time of the torch was 2.88 minutes. Acoustical disturbances are shown in figure 68 and vibrational disturbances in figure 69 .

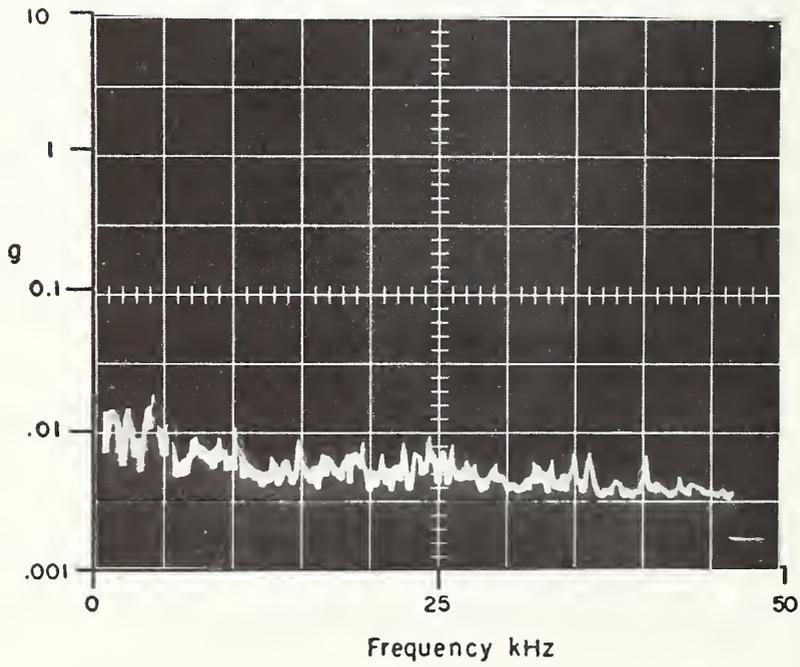
Figure 69. Vibration from Rocket Torch

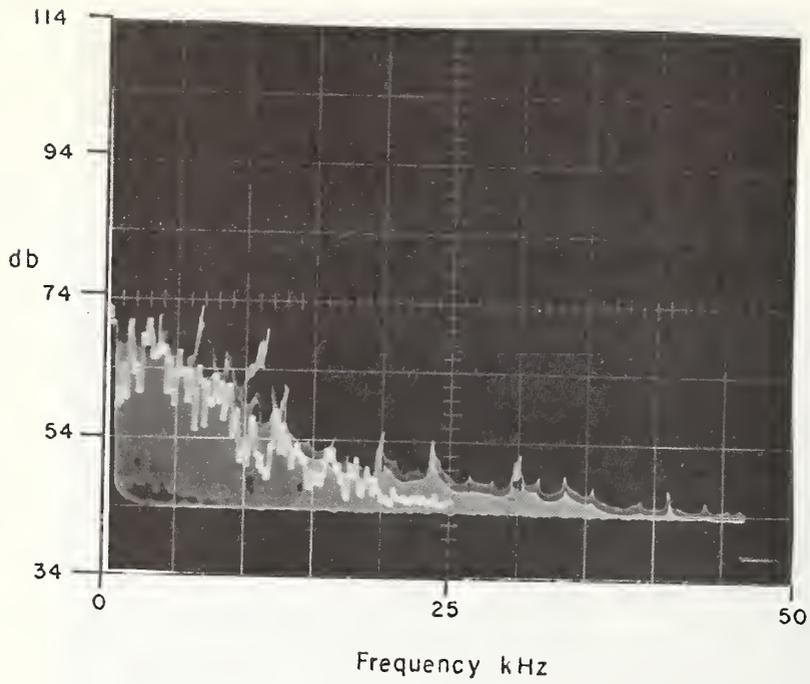
Figure 71. Acoustical Disturbances
from the Electric Arc Torch

On the assumption that the rocket torch might have annealed the drill-resistant plate, drilling was resumed after the door had cooled off to where it did not represent a burn hazard to the operator. This was continued for 3.55 minutes and then abandoned in favor of an oxygen-fed electric arc torch attack. The electric arc was used for 5.65 minutes to make a hole through which the bolt-work blocking mechanism could be accessed. Multiple sweeps of the acoustical disturbances produced by the arc are shown in figure 71 and the vibrational disturbances in figure 72 .

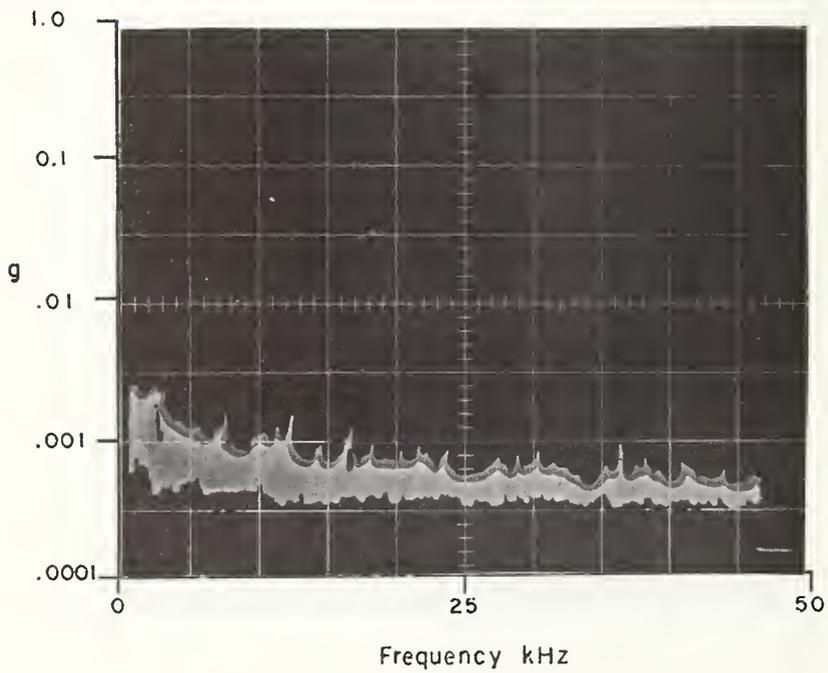
Figure 72. Vibration from the Electric Arc

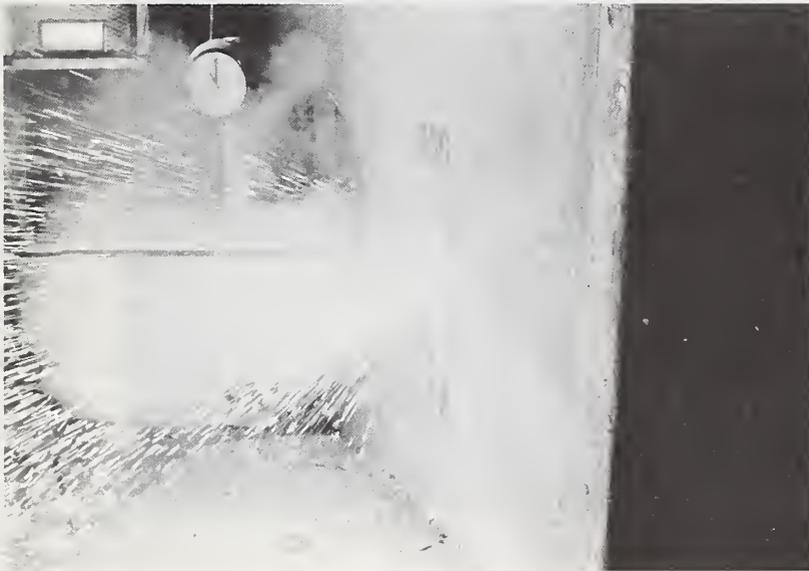
Figure 73. Burning Bar Melting a Hole through Concrete

A burning bar was used to make a single hole in the 8" thick concrete wall of Room 3 as shown in figure 73 . It took .73 minute and used 40" of bar with the oxygen pressure at 160 p.s.i. Acoustical disturbances are shown in figure 74 and vibrational disturbances in figure 75. The vibration transducer was mounted on the inner surface of the wall at a distance of two feet from the attack point.

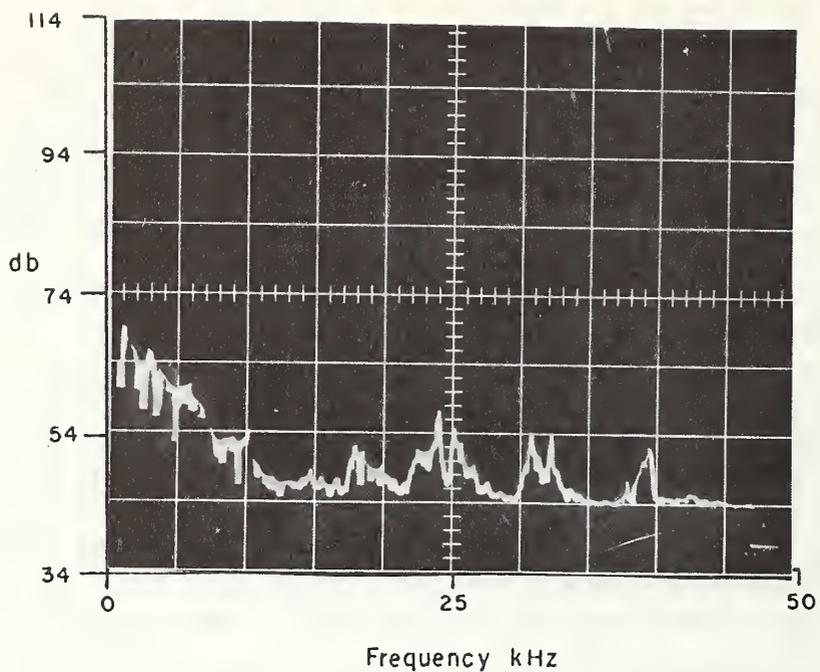
Figure 74. Acoustical Disturbance from Burning Bar Attack on Concrete

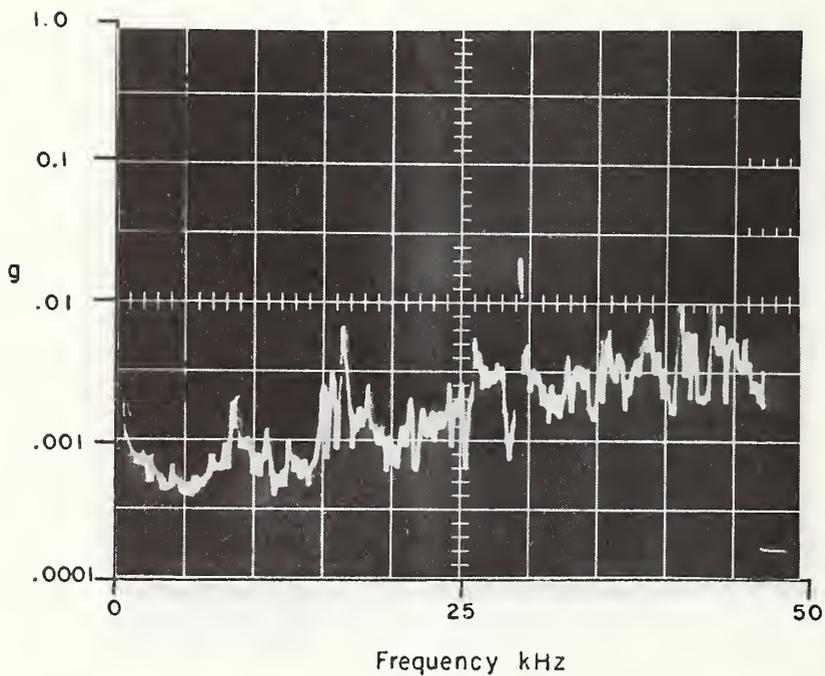
Figure 75. Vibration from Burning Bar Attack on Concrete

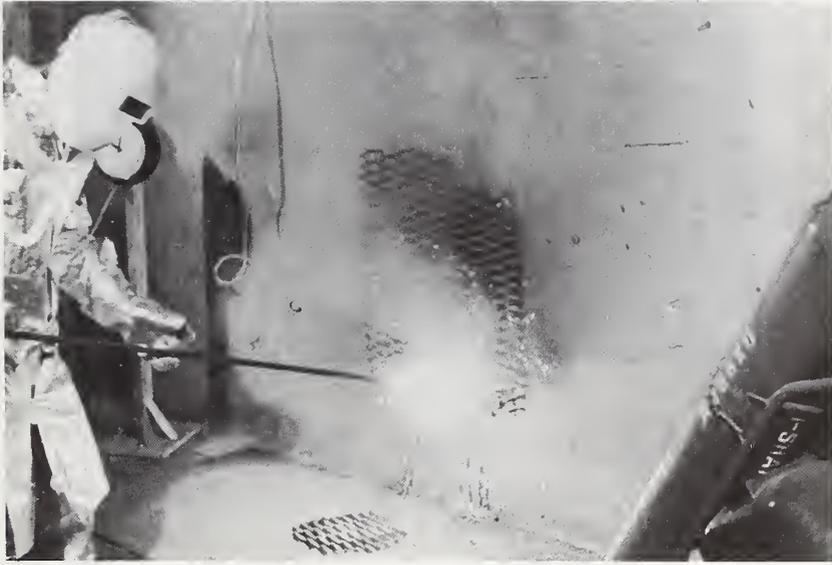
Figure 76. Burning Bar Cutting
Reinforcing Rod at
Location 24B

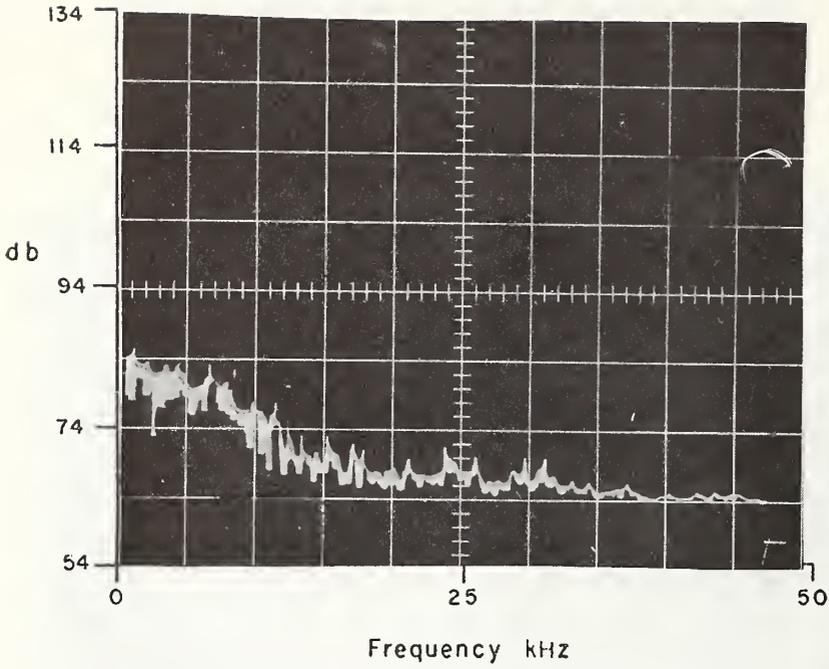
Figure 77. Acoustical Disturbance from Burning Bar Attack on Expanded Metal

Acoustic disturbances produced by the burning bar are shown in figure 77 and vibrational disturbances in figure 78 . The vibrational transducer was located on the inner wall of Room 3 five feet from the 24B opening.

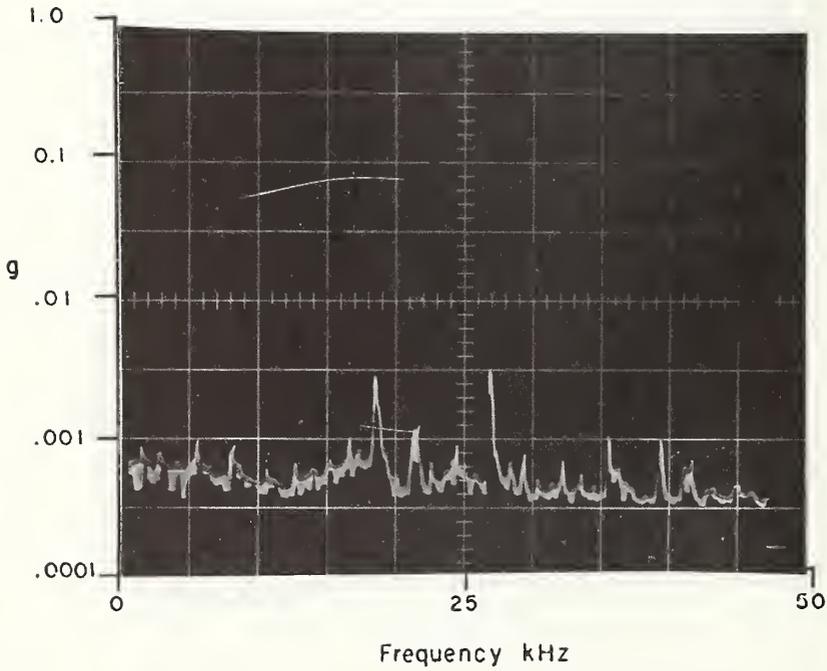
Figure 78. Vibration from Burning Bar Attack on Expanded Metal
