Report of Fire Tests on Flexible Connectors in HVAC Systems

July 1973

Final Report

**REPORT OF FIRE TESTS ON FLEXIBLE
CONNECTORS IN HVAC SYSTEMS**

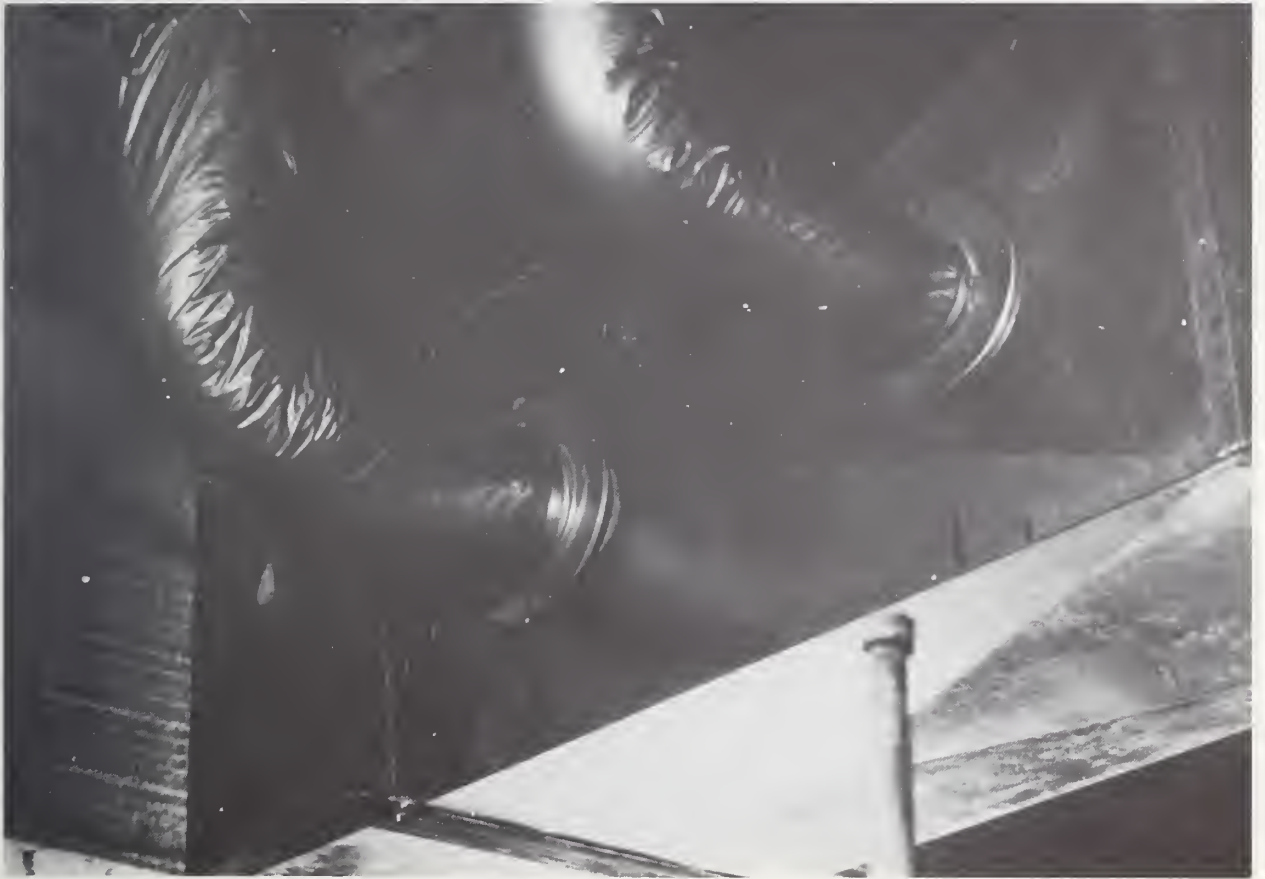
Figure 3 - View of Steel Connectors Showing the Vinyl Covering and the Method of Attaching to the Duct.

Figure 3 shows the two steel connectors attached to the main duct; Figure 4 shows the aluminum connector attached to the main duct; Figure 5 shows the steel connectors attached to the terminal units; Figure 6 shows the aluminum

The flexible connectors were attached with steel friction strips to a standard flange plate attached to the duct; the details can be seen in Figures 3 and 4.

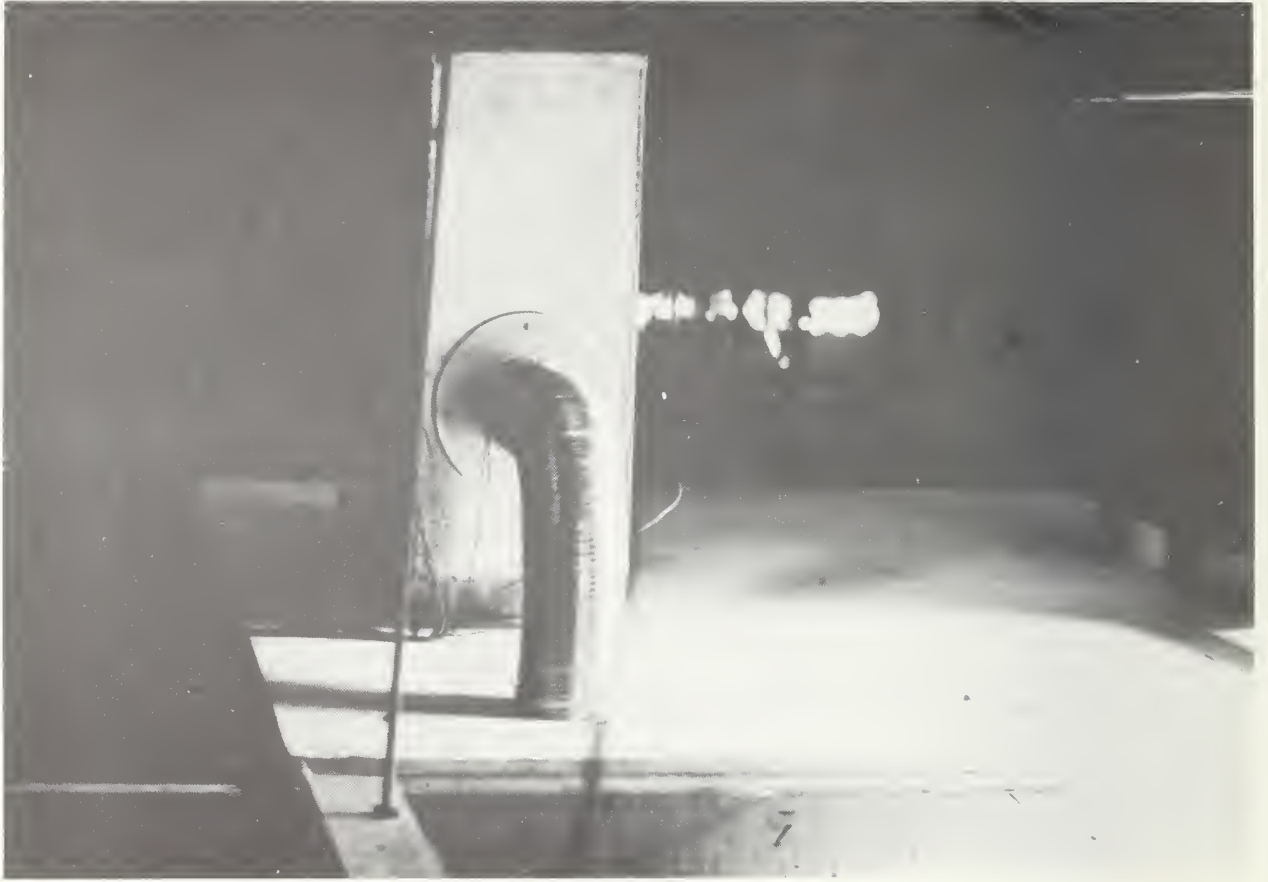
Figure 6 - Test 512 - View of Aluminum Flexible Connector at Terminal Unit

connector attached to the terminal unit; and Figure 7 shows the architectural enclosures in place.

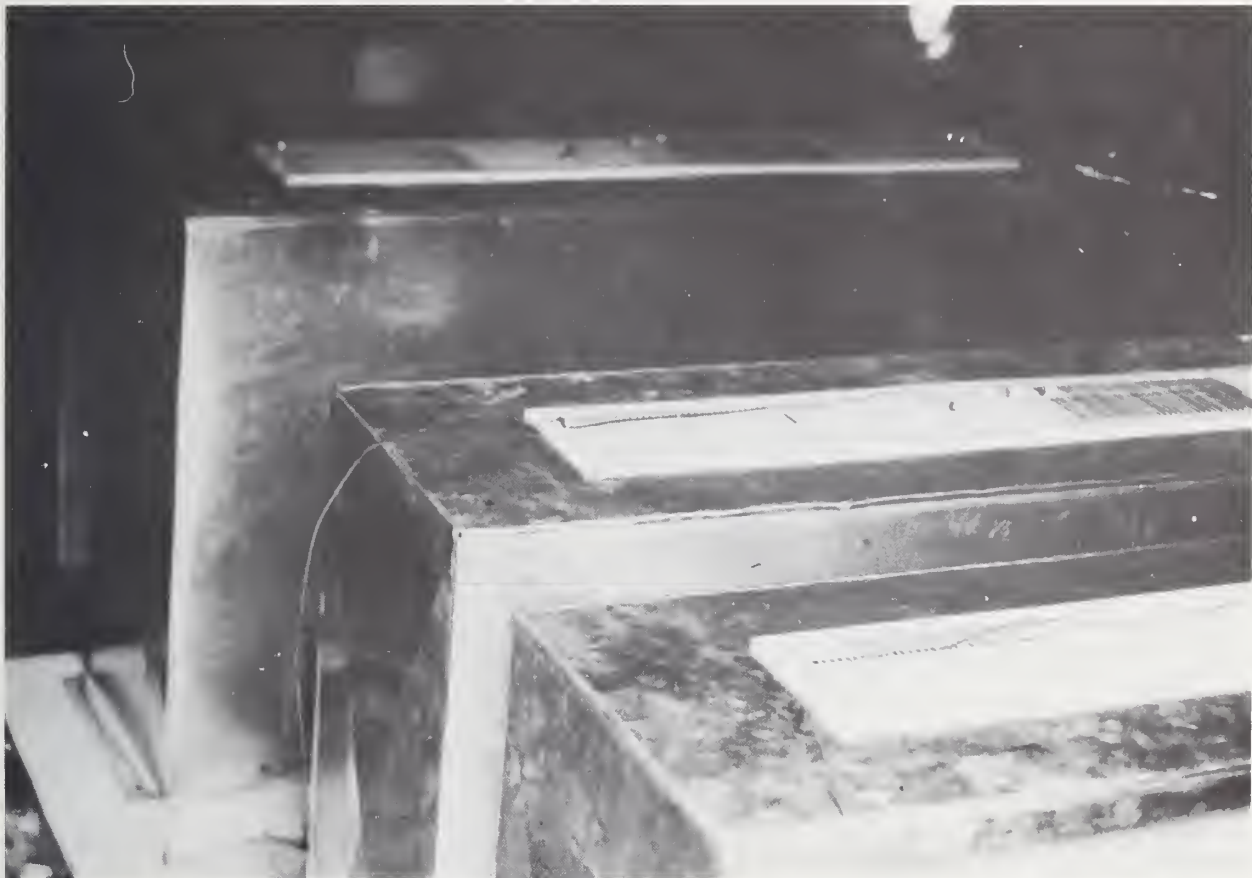
Figure 7 - Test 512 - Architectural Enclosure in Place

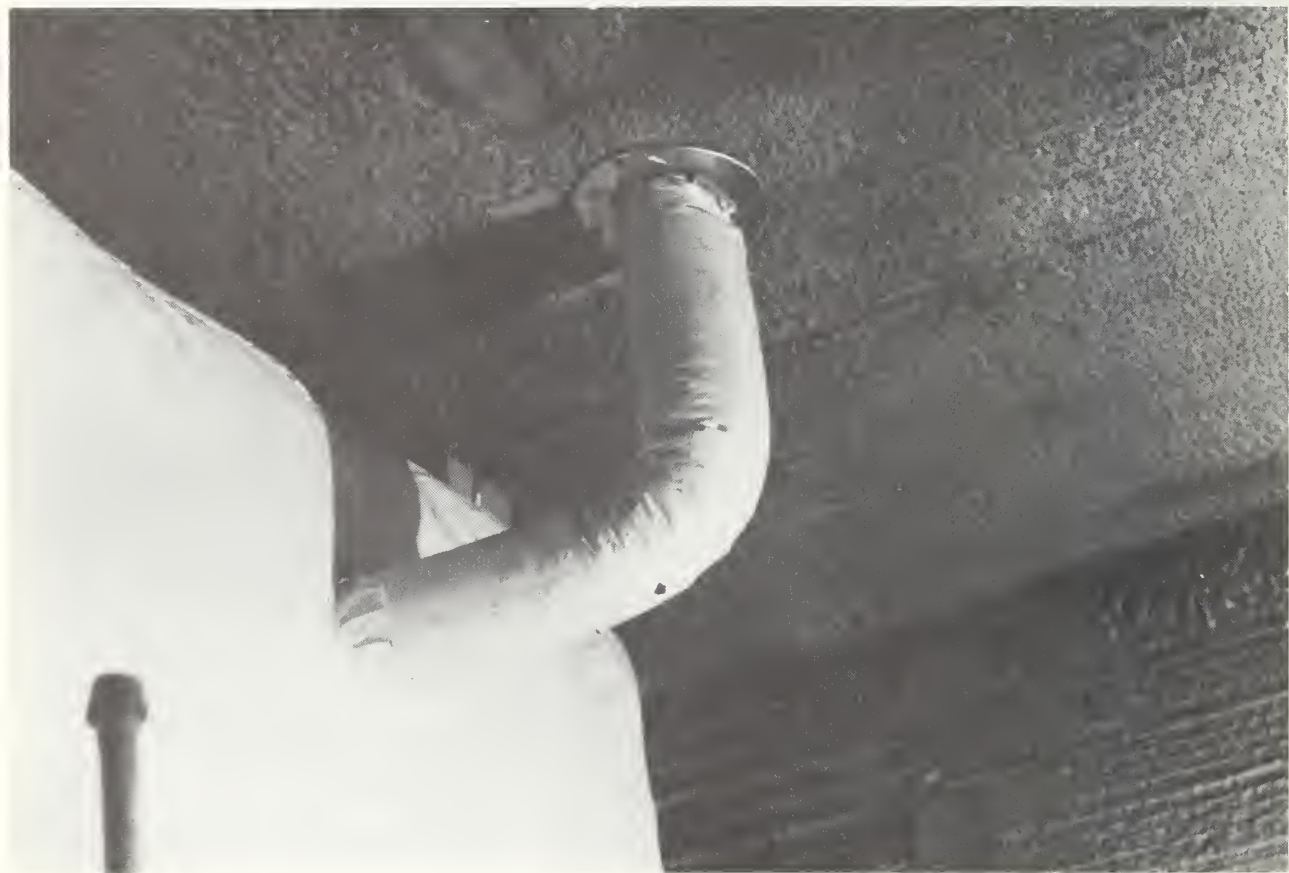
Figure 8 - Test 512 - Aluminum Flexible Connector. (Note method of blocking penetrations through closure)

The separations (gaps) between the flexible connectors and the hole through the furnace closure were packed with glass fiber, and were protected on the fire side with a steel flange plate. The steel flange plate was supplied by the manufacturer of the flexible connectors. Figure 8 shows the method of blocking the penetrations through the furnace closure.

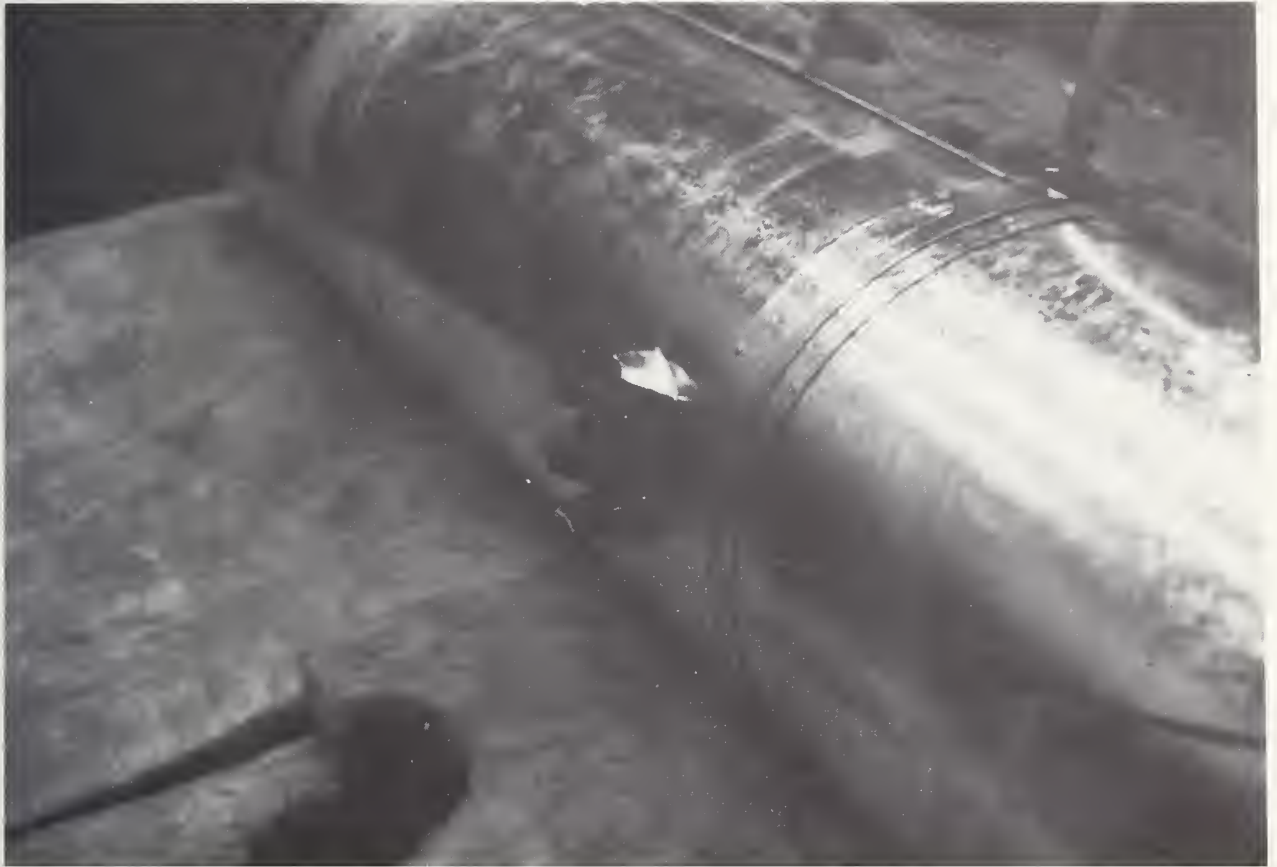
Figure 15 - Typical Duct Showing Glass Fiber Blanket and Connector
Junction Point

For this test the attachment of the steel connectors to the main ducts was changed to represent a common field type, as shown in Figures 12 and 15. Instead of using a flanged plate on the duct a small hole was cut in the duct and radial cuts were made from the edge of the hole out to the radius of the connector and the resultant strips were bent out to form ears. The connector was attached to the ears with a steel friction band. In addition to the bands, four self threading sheet metal screws were used to attach the connector to the bent out ears.

As in the pilot test, the main ducts were covered with a rated two inch thick aluminum foil-backed glass fiber blanket. This was attached with a rated adhesive and rated tape, see Figure 15.

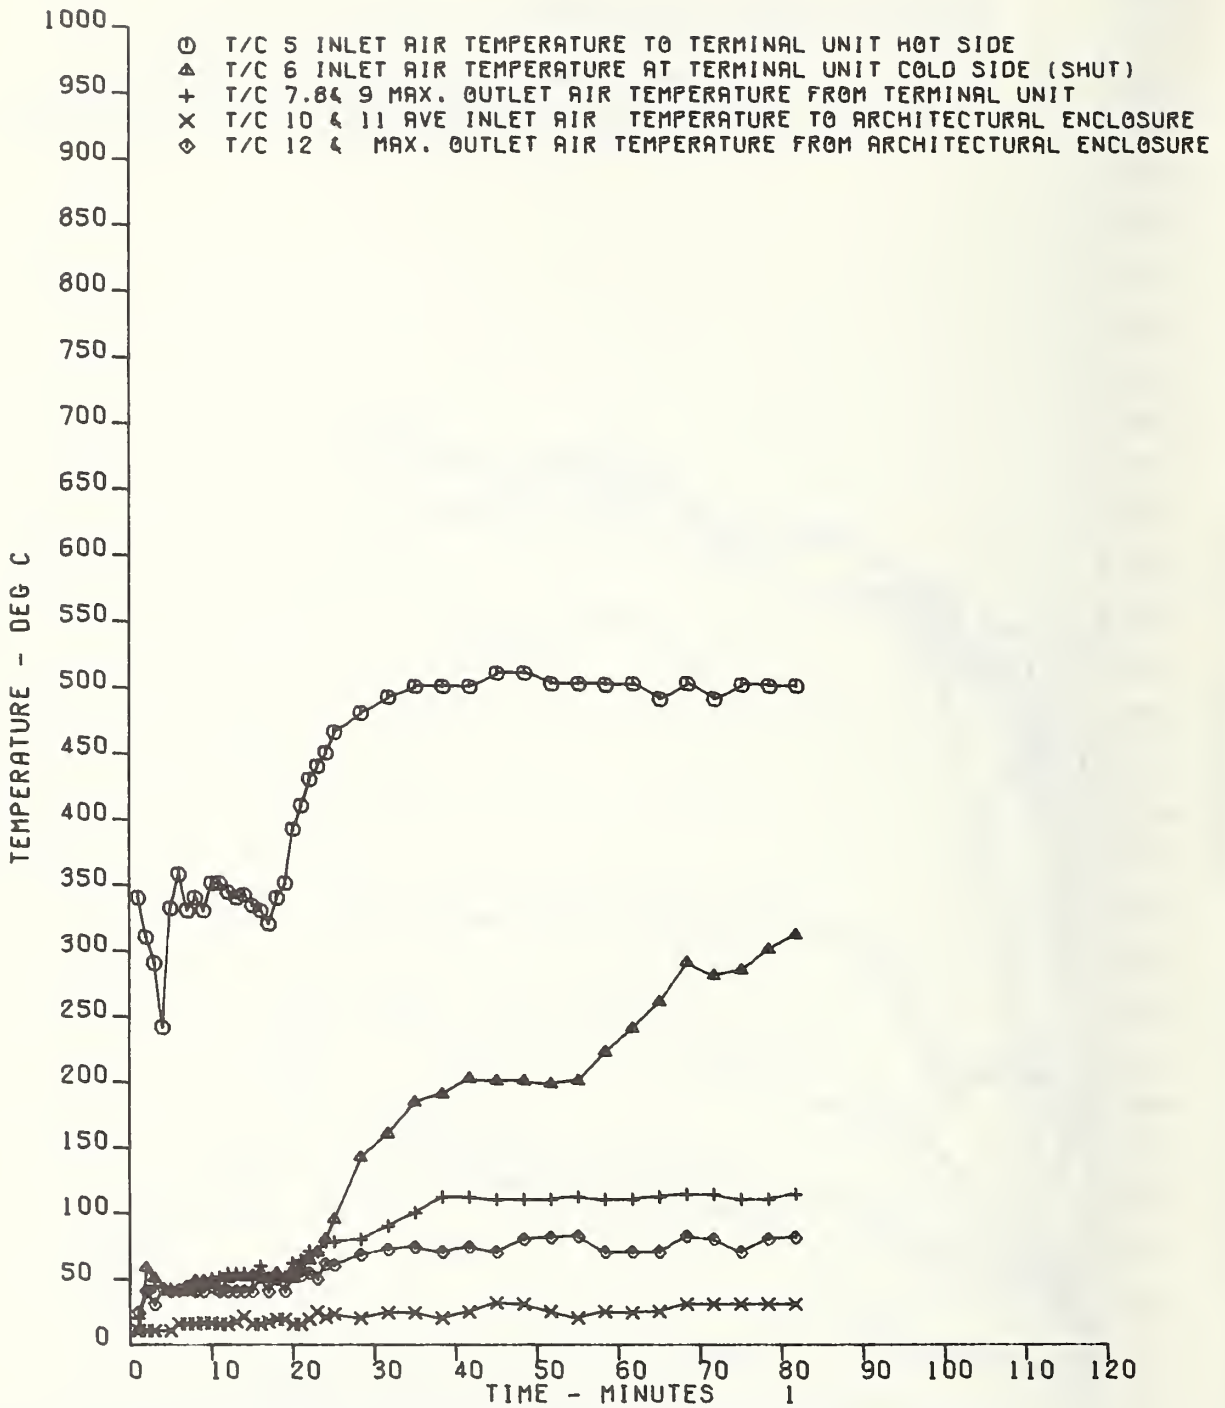
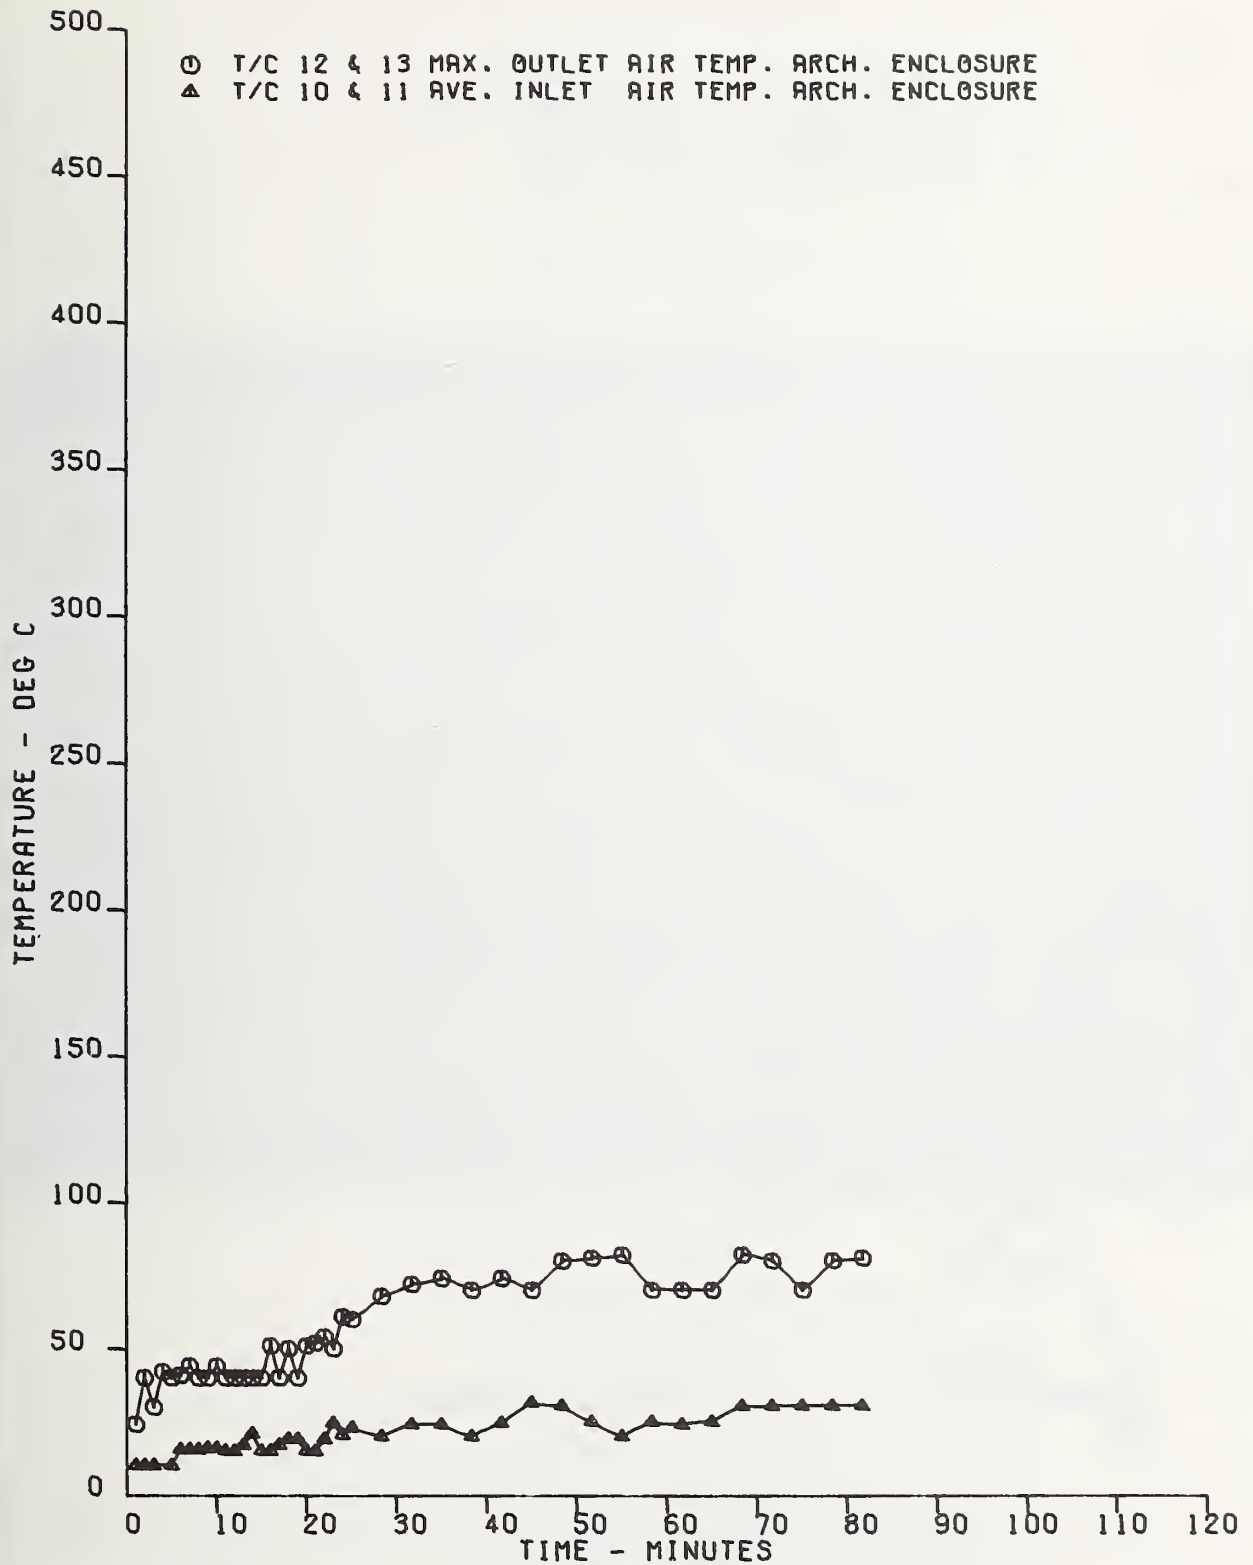
FIG 27 TEST 516 6 INCH GALV STEEL - TEMPERATURES ALONG CONNECTOR

FIG. 28 TEST 516 6 INCH GALV STEEL - TEMPERATURES ALONG TERMINAL UNIT AND ARCHITECTURAL ENCLOSURE

FIG. 29 TEST 516 6 IN GALV STEEL AIR TEMPERATURES ARCHITECTURAL ENCLOSURE

Comparing the temperatures of the two steel connector assemblies, in Figures 25 to 28, it is seen that from about 30 minutes to the end of the test the inlet temperatures to the terminal unit for the 5 inch connector are about 675°C while those for the 6 inch connector are about 500°C. During the test it was observed at 32 minutes that the 5 inch connector was separating from its duct. However, the abrupt rise in temperature at the outlet of the architectural enclosure would indicate that the separation probably occurred at about 20 to 25 minutes. This separation which is shown in Figure 31 allowed hot furnace gases to enter this assembly and so produce the higher observed temperatures in the 5 inch connector assembly.
