The Proof Testing of Porcelain Insulators and the Application of Acoustic Emission

A. G. Evans, S. M. Wiederhorn, M. Linzer and E. R. Fuller, Jr.

Inorganic Materials Division
Institute for Materials Research
National Bureau of Standards
Washington, D. C. 20234

Final Report

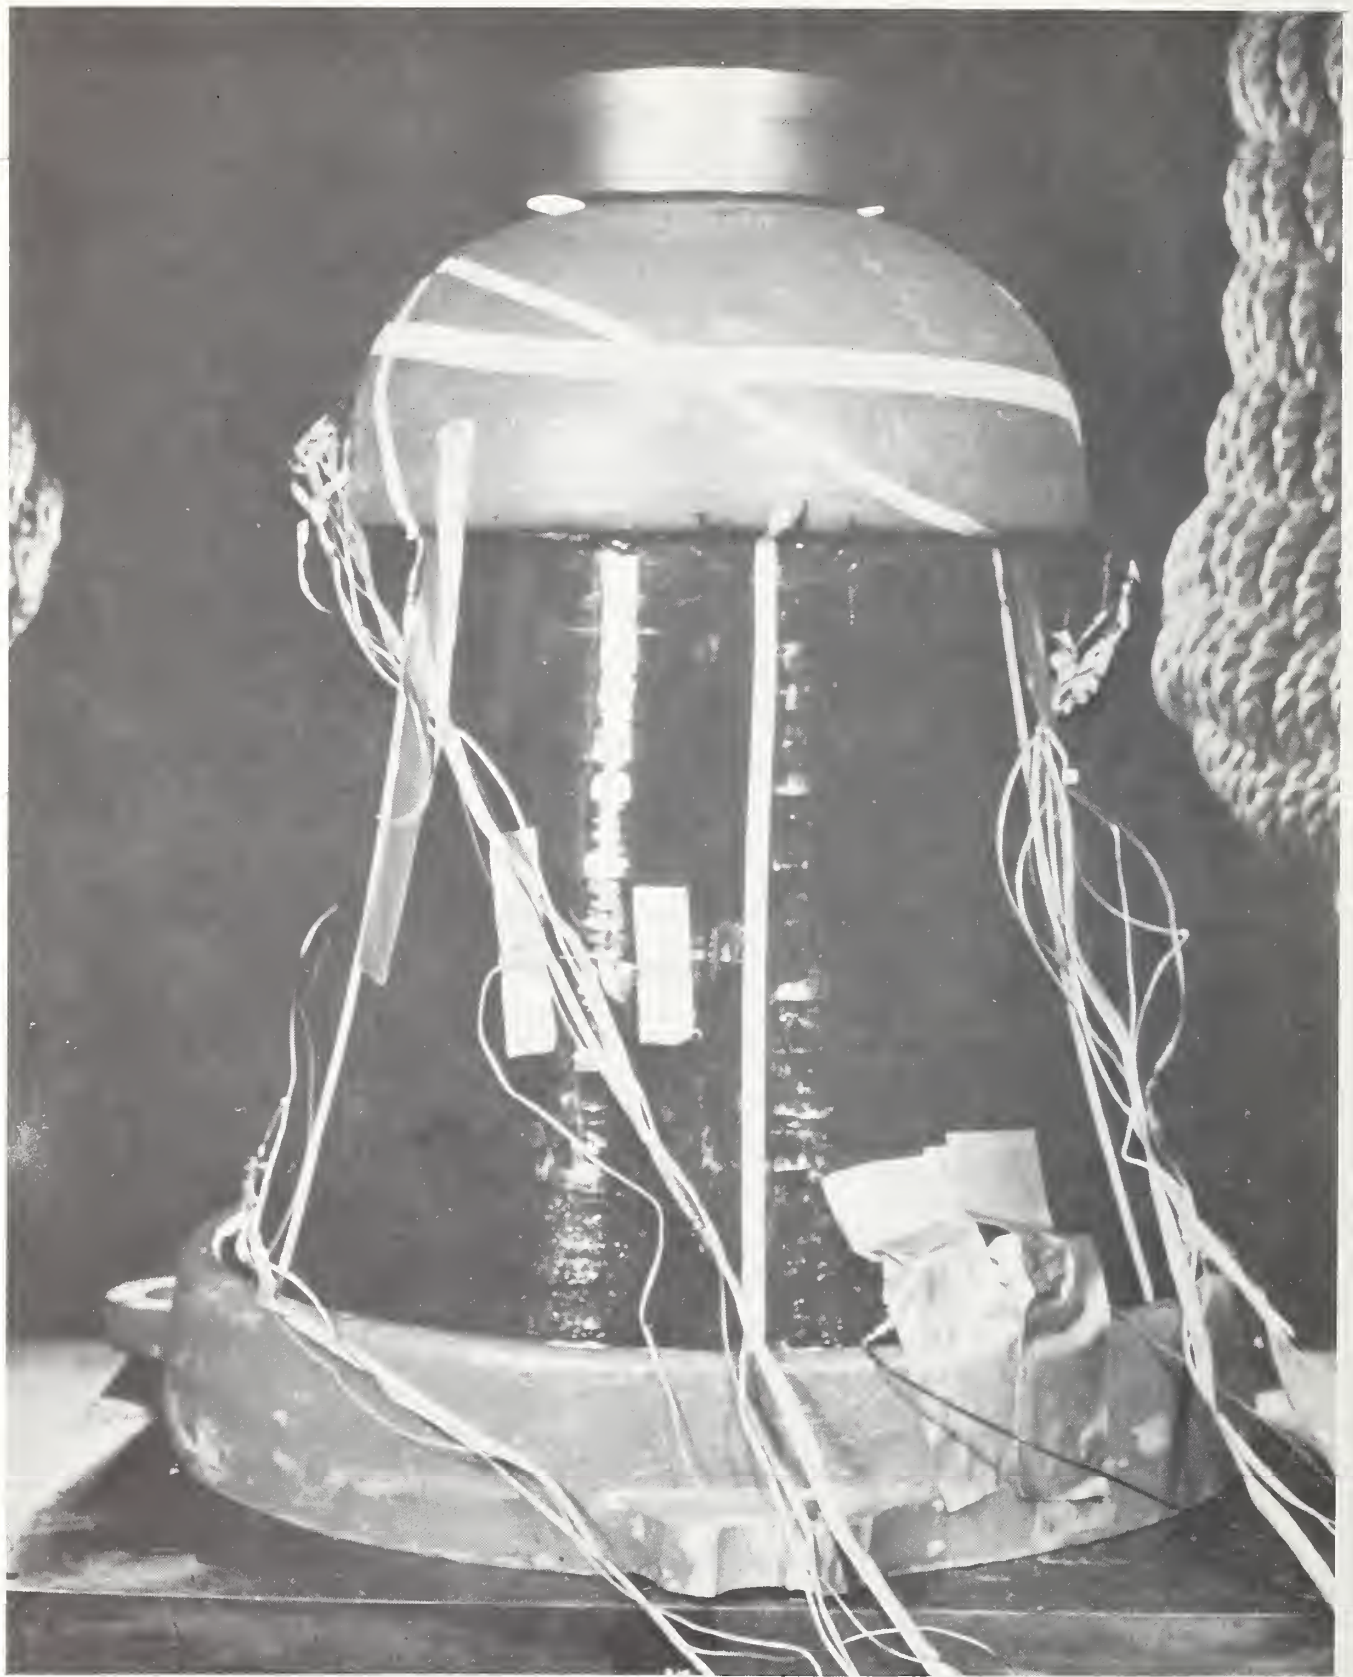
Fig. 1. A typical cone insulator used in this study.

The two types of insulators studied are shown in Figures 1 and 2. The bell-shaped "cone" insulators (Figure 1) were approximately one meter in height and one meter in diameter at the base. They were hollow, with a wall thickness at the base of approximately 0.08 m. The ends of the insulators were enclosed by steel end-caps, attached by Portland cement. The bottom bearing surface and the side surfaces of the porcelain were glazed, but the top bearing surface was not. The insulator was designed for a maximum compressive force of 13.5 MN.*

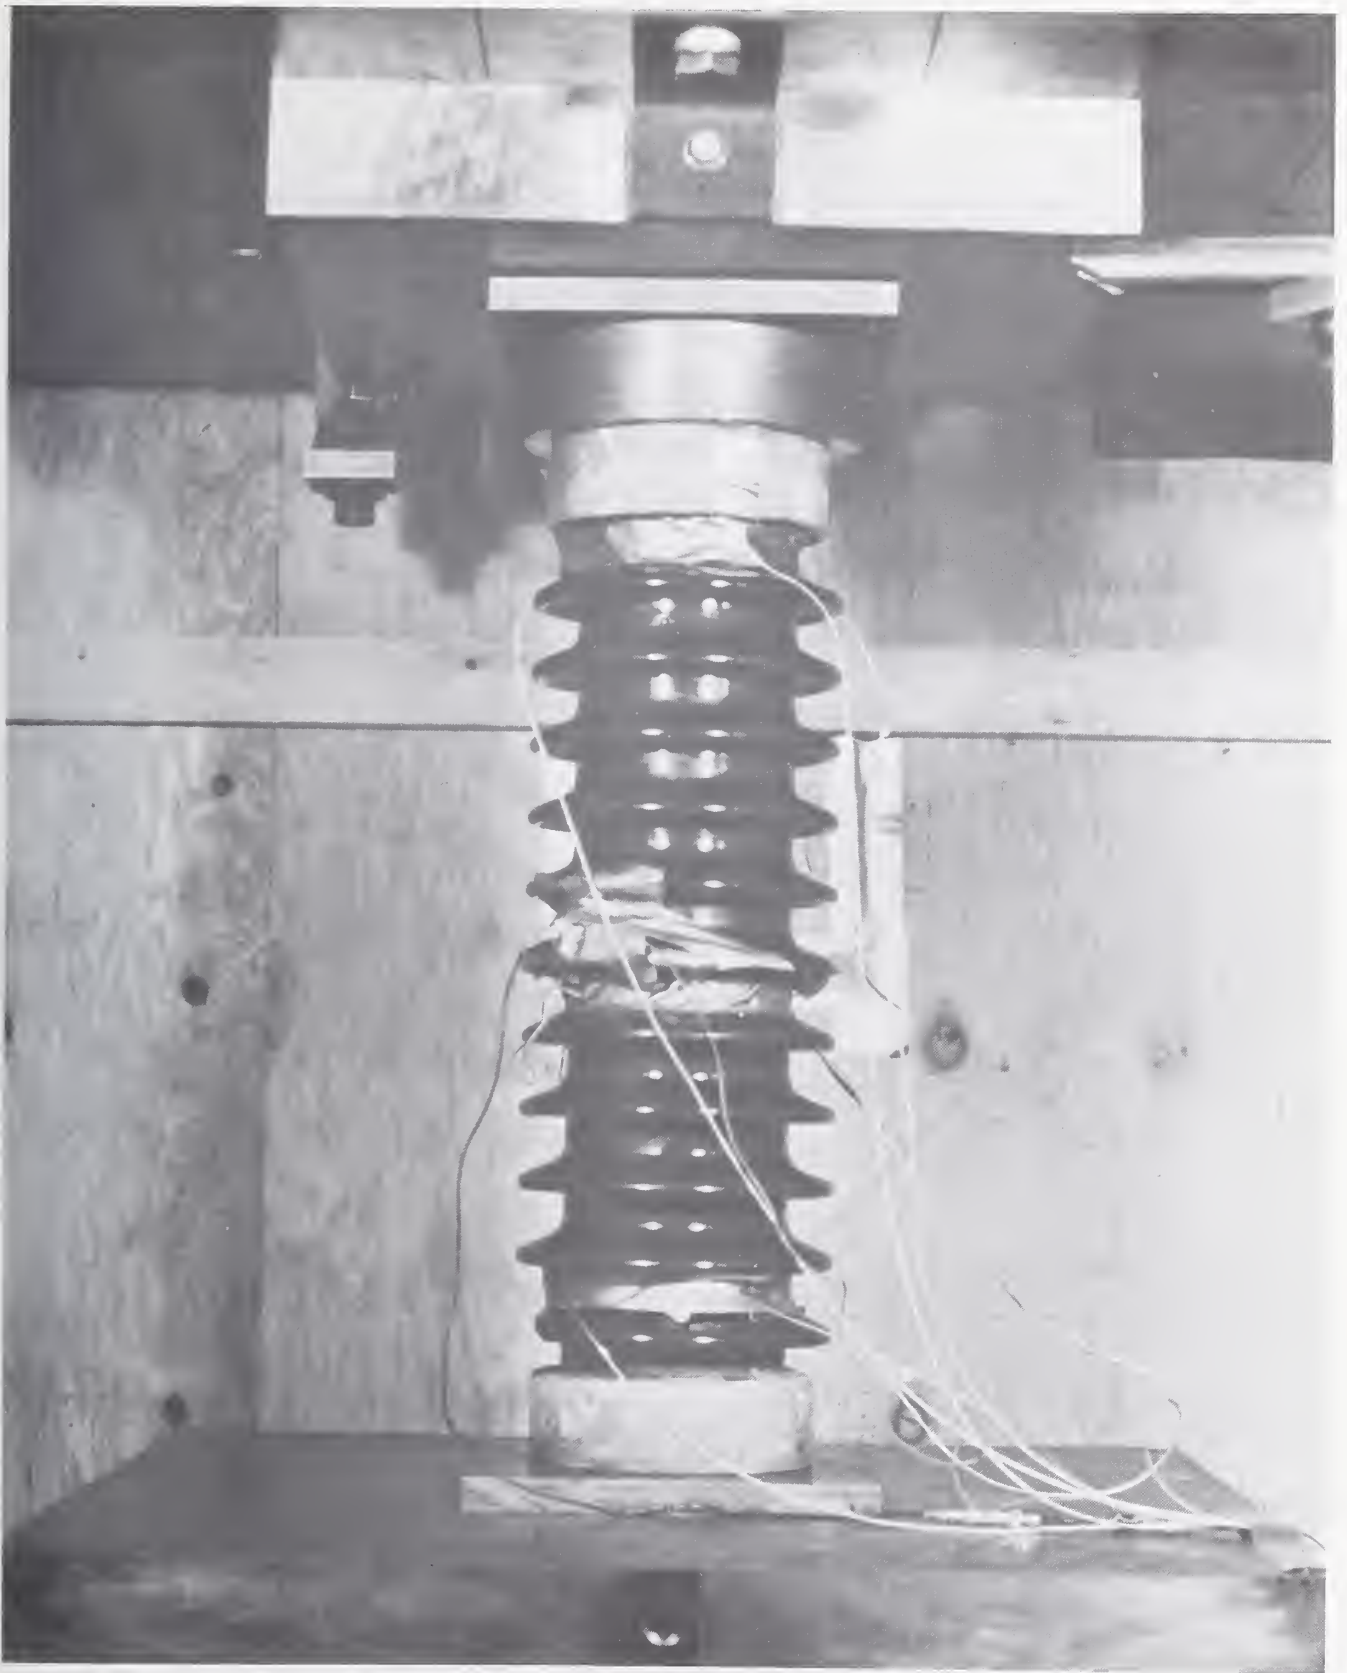
Fig. 2. A typical post insulator used in this study.

The "post" insulators (Fig. 2) were solid and cylindrical in shape, with circumferential skirts for improved electrical insulation. They too had steel caps at the top and bottom, attached by Portland cement. These insulators were designed for a maximum compressive force of 4.5 MN.

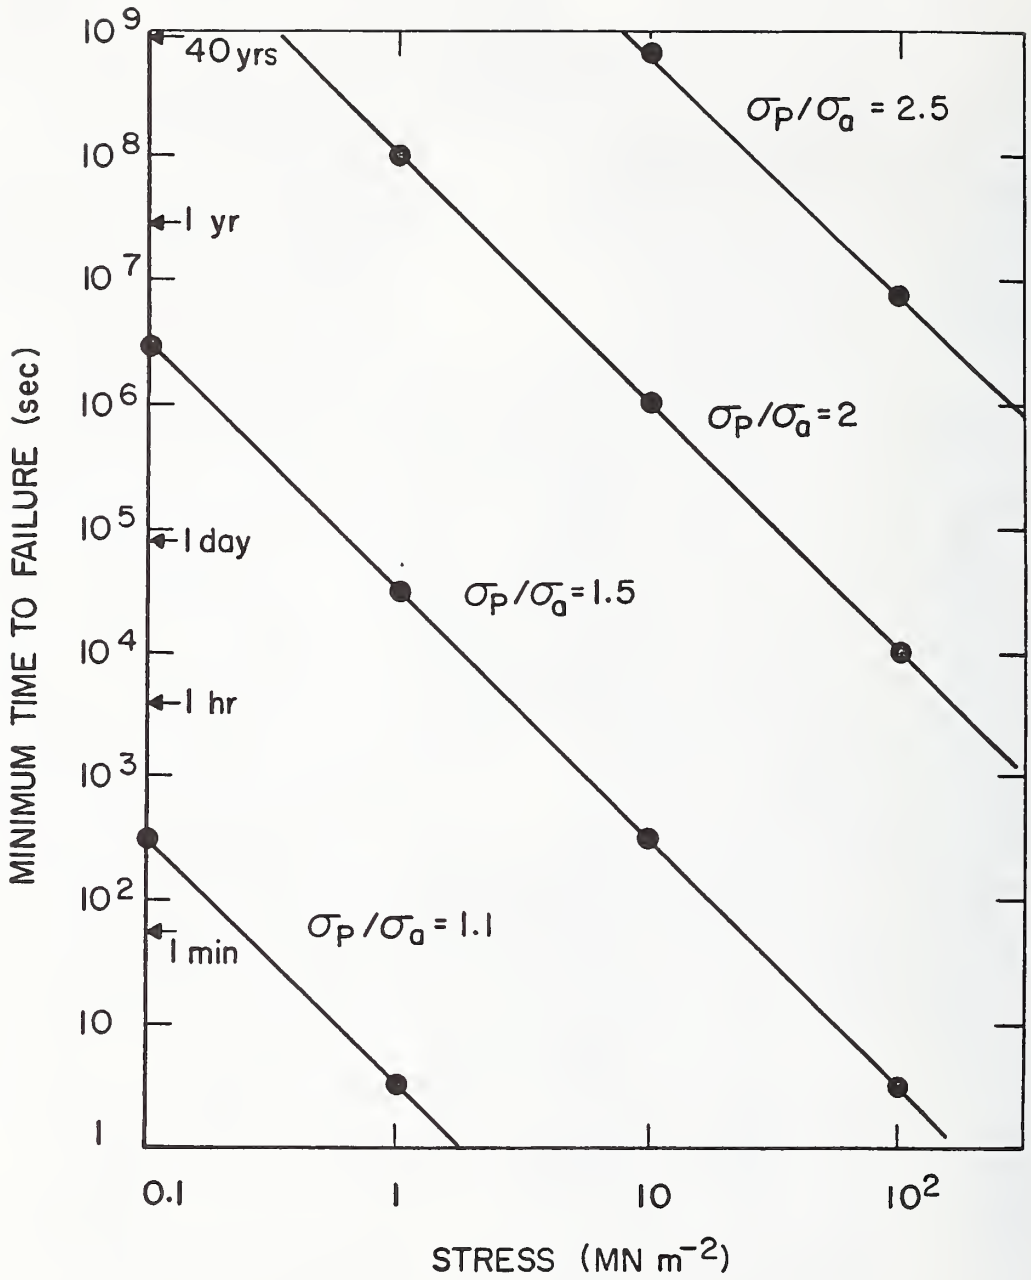
Fig. 3. A proof test diagram for porcelain in humid environments², giving the minimum service life time as a function of the service stress, σ_a , at various proof stress levels, σ_p .

The proof test load was established from a design diagram, developed earlier from subcritical crack growth studies on porcelain specimens cut from a similar cone insulator. [2] The design diagram (Fig. 3) gives a logarithmic plot of the minimum expected time to failure, t_{\min} , versus the service stress, σ_a . Each straight line on this figure relates σ_a to t_{\min} for a predetermined value of the proof ratio, i.e. the ratio of the proof stress (σ_p) to the service stress. Once a tentative determination is made of both the service stress and the minimum acceptable time to failure, the proof ratio can be determined from Fig. 3. For the cone insulators the maximum tensile stress at the service load (4.5 MN), as determined by finite element stress analysis, [5] is $\sim 30 \text{ MN m}^{-2}$.

Therefore, for a minimum service lifetime of 40 years, the requisite proof ratio obtained from Fig. 3 is 2.5, giving a proof load of 11.3 MN.

Quantitative lifetime predictions after proof testing require values for the maximum stress during the proof test, σ_p , and the maximum stress during service, σ_a . [1] The ratio σ_p/σ_a then gives the minimum failure time from Fig. 3, if the stress distributions are comparable. [1,4] For a system that exhibits reversible behavior, this ratio is given directly by the ratio of the proof load to the service load. But, for a system that exhibits some irreversibility, this load ratio does not suffice. Instead, a detailed stress analysis (for the complete proof cycle and the service condition) is needed to obtain values for the maximum stress in the proof test, and its distribution, and the maximum in-service stress. This analysis has not been performed, and hence, we cannot yet determine whether an effective proof test procedure for this system is a practical feasibility. We suggest that urgent attention is devoted to this stress analysis (both analytically using stress calculations and empirically using acoustic emission) to enable this issue to be resolved.

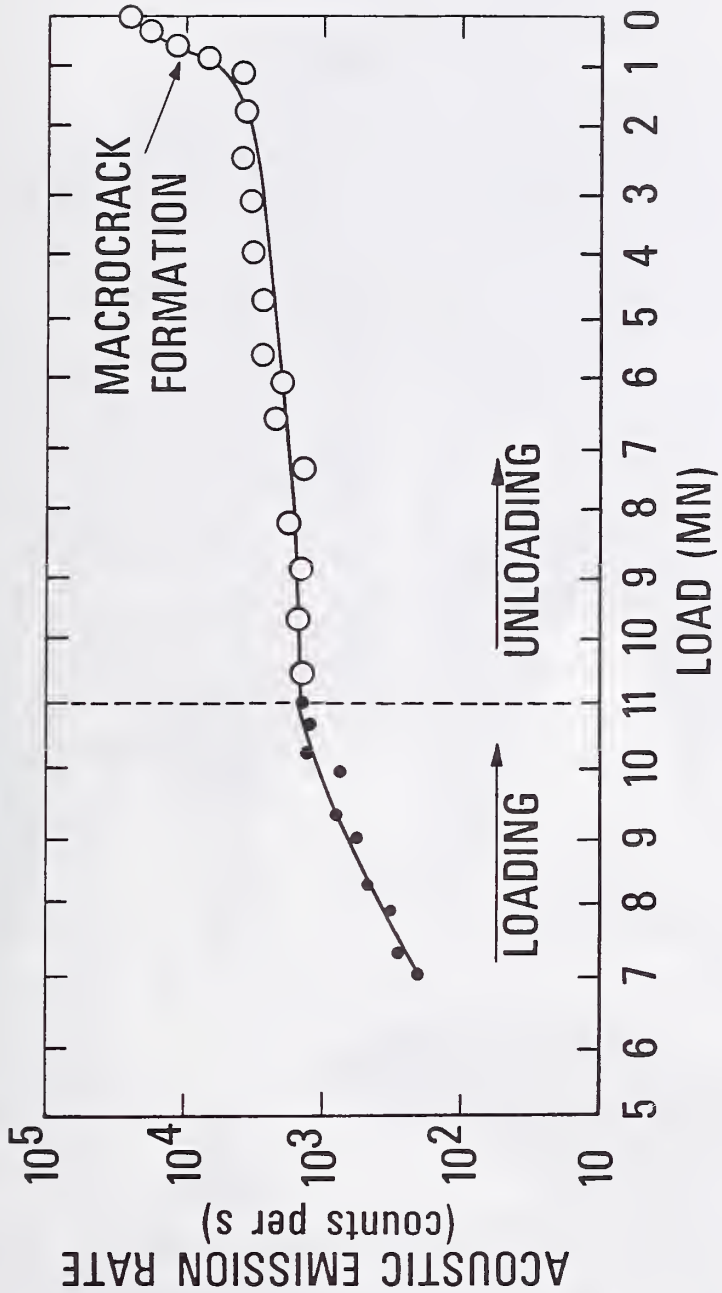
Fig. 4. The relation between acoustic emission rate and load obtained on a cone insulator loaded to 11 MN, and unloaded rapidly. The large rate increase during unloading (just prior to zero load) can be attributed to macrocrack formation.

Peaks of this sort were observed in the cone insulators (Figs. 4 and 8) and correlated with macrocrack formation. No significant peaks were observed during the simulation proof test in the post insulators.

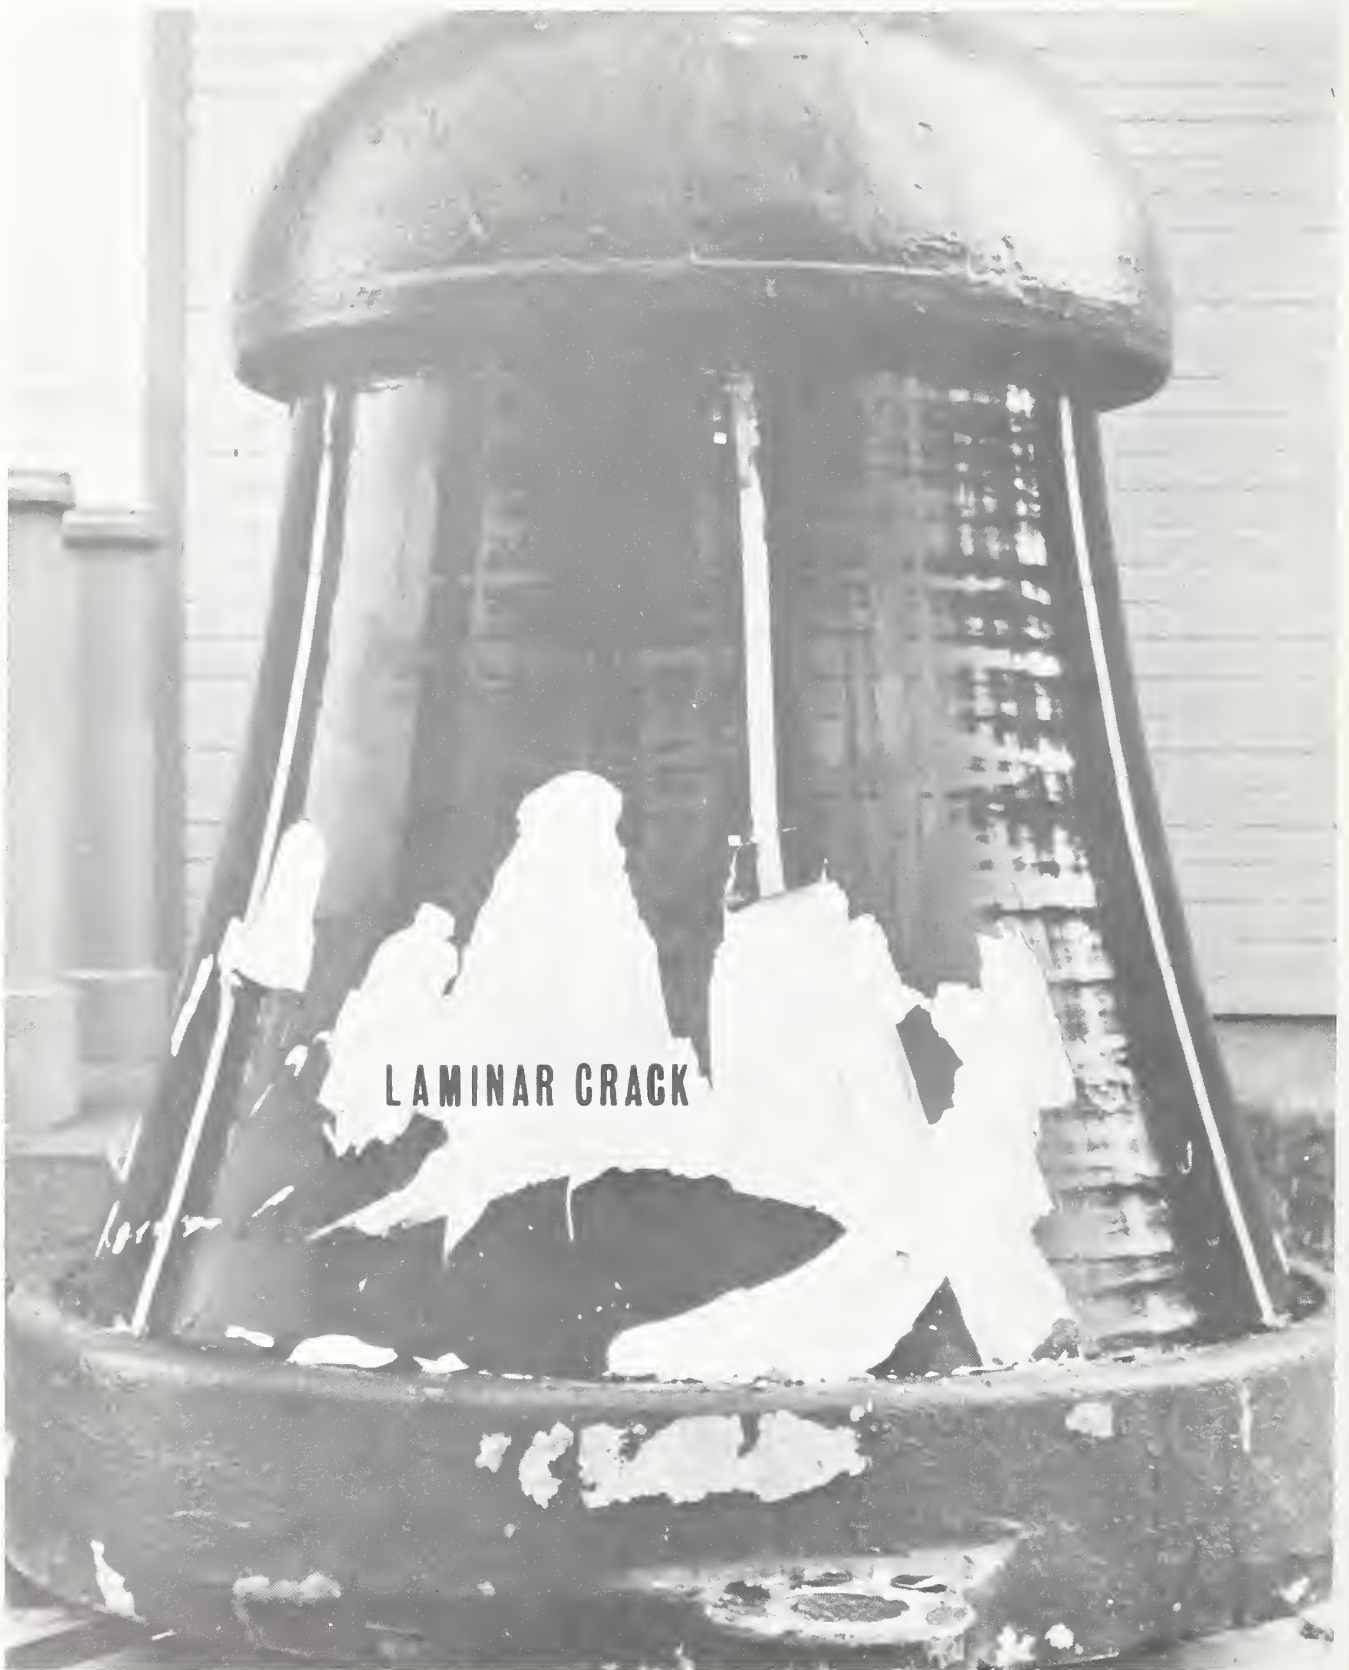
Fig. 5. An example of a laminar crack formed in a cone insulator.

The topology of the cracks was examined by ultrasonic and visual inspection after testing. Two principal types of crack were formed:^{*} laminar cracks that grew from the top and bottom end caps roughly parallel to the exterior surface, and orthogonal cracks that grew through the insulator wall perpendicular to the exterior surface. An example of a laminar crack that emerged at the exterior surface is shown in Fig. 5. By sectioning the insulator we were able to show that this type of crack grew from the sloped bearing surfaces at the base and top of the insulator (Fig. 6). The rough surfaces of the laminar cracks served as nucleating sites for the longitudinal through cracks, shown in Fig. 7.

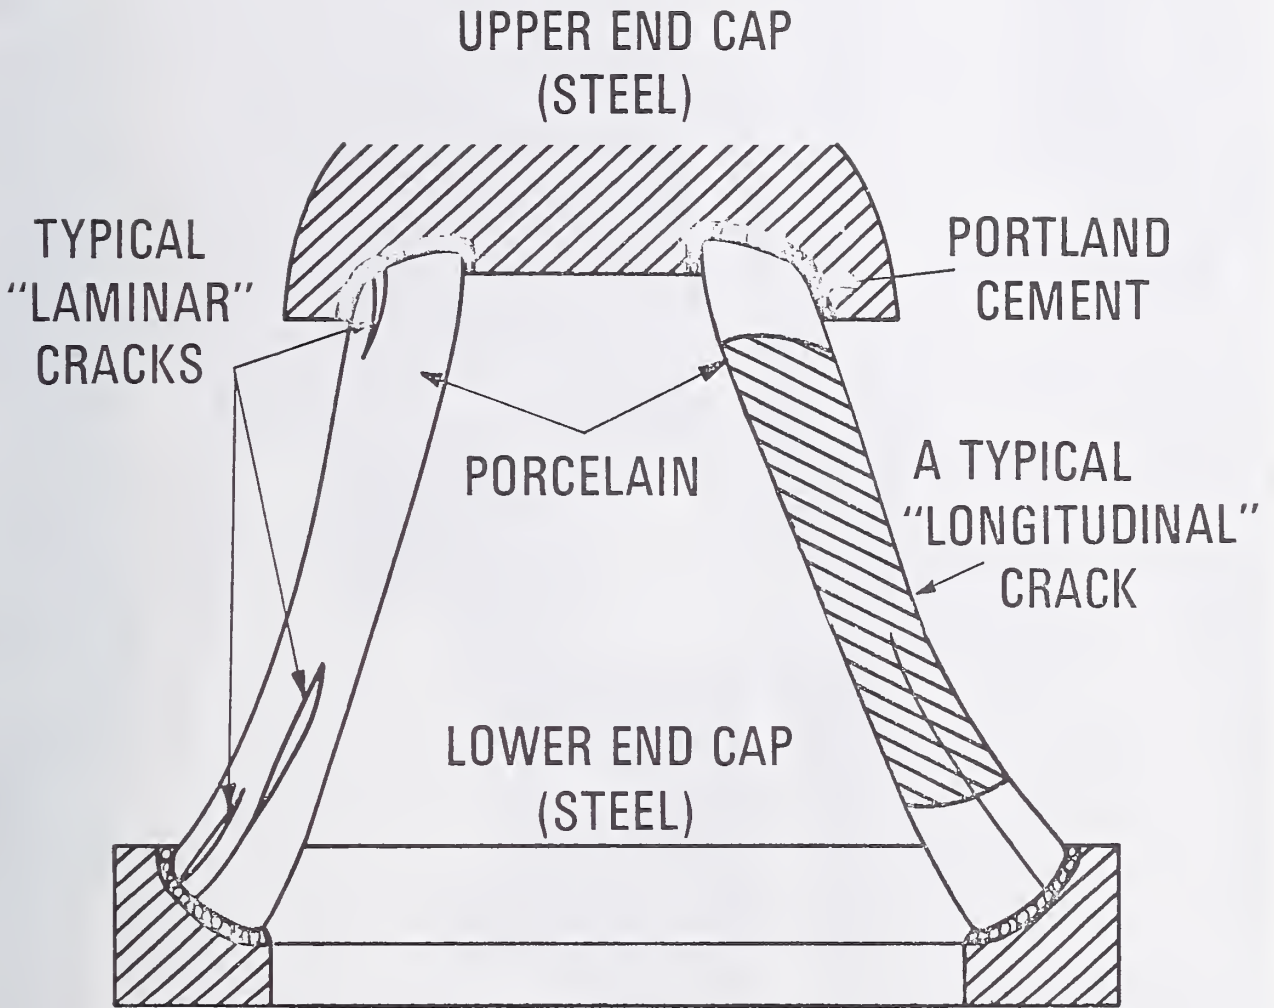
Fig. 6. A schematic of the laminar and orthogonal cracks that form in cone insulators.

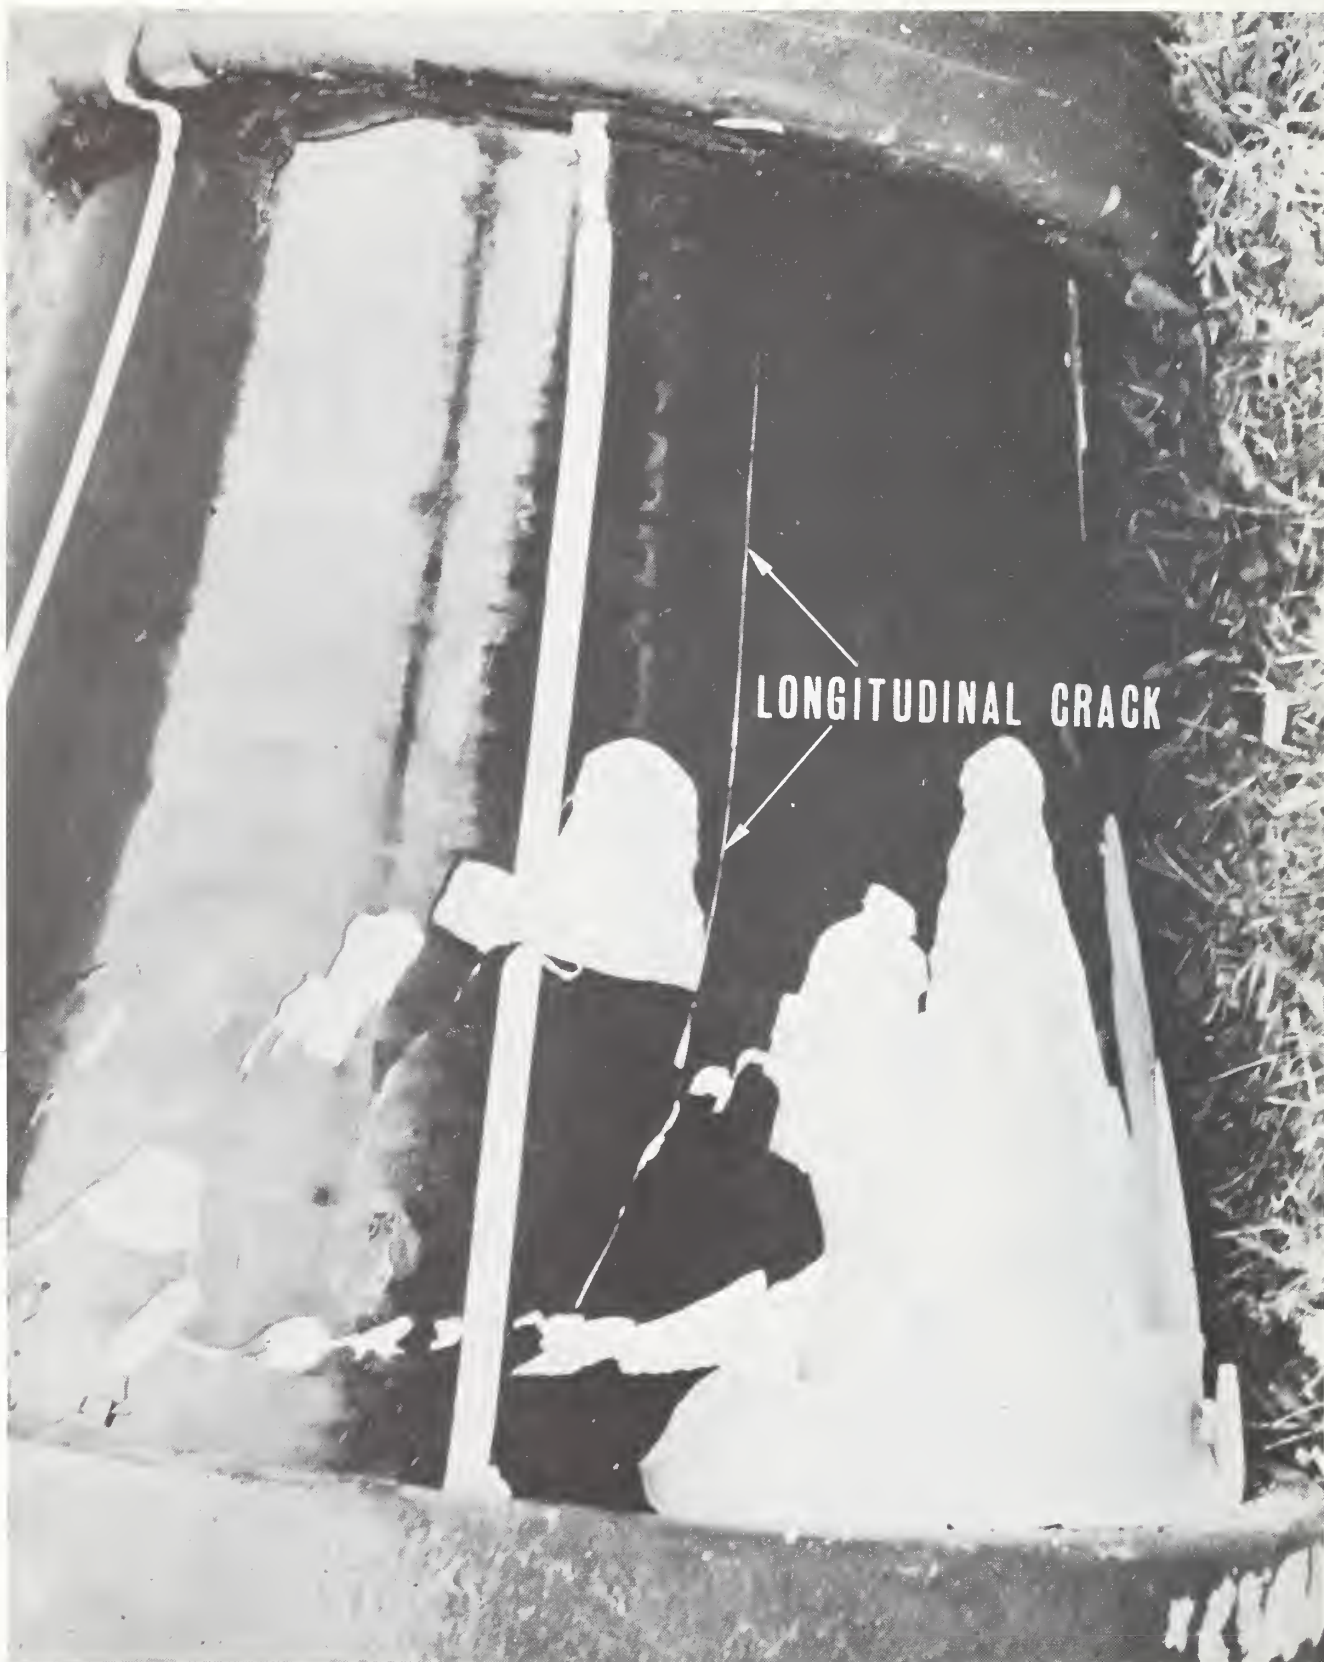
Fig. 7. An example of a longitudinal crack in a cone insulator.

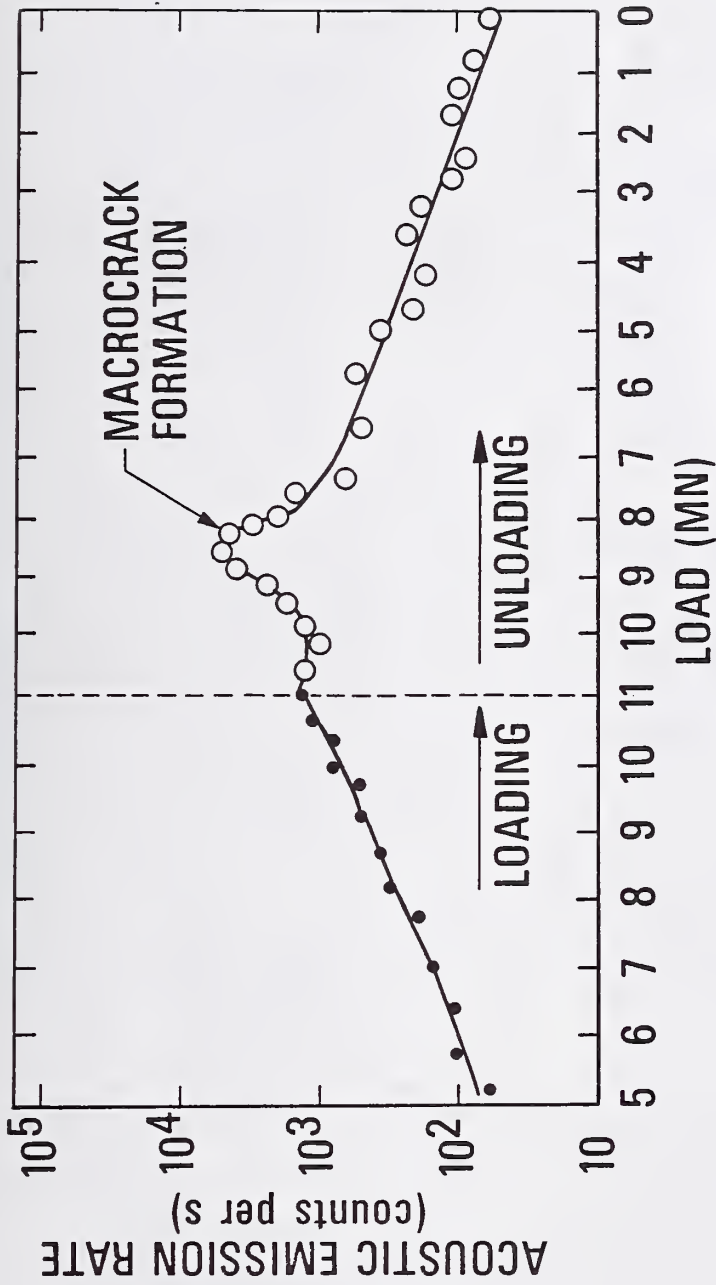
Fig. 8. The acoustic emission rate obtained on a second cone insulator loaded to 11 MN and unloaded slowly. An acoustic emission peak appears during unloading at 9 MN, and has been attributed to macrocracking.

The acoustic emission rate slowly increased as the insulator was loaded and further increased as the insulator was unloaded (Fig. 8). A large acoustic emission peak was observed at 9 MN during unloading. This peak was shown to correspond to macrocrack formation by an ultrasonic inspection during the proof test, in which the back surface reflection under one of the transducers slowly disappeared and was replaced by a reflection approximately one-half the distance between the interior and exterior surfaces. Additional ultrasonic inspection after the proof test confirmed the existence of this crack, which extended one-third of the way around the circumference and approximately 0.15 m below the upper end cap. The second proof test cycle resulted in saturation level acoustic emission rates ($>10^5$ counts/s) when the specimen was unloaded. Ultrasonic inspection of the cone insulator after testing detected no additional large cracks, but many small reflections were detected suggesting the nucleation and growth of many small cracks throughout the body of the insulator.

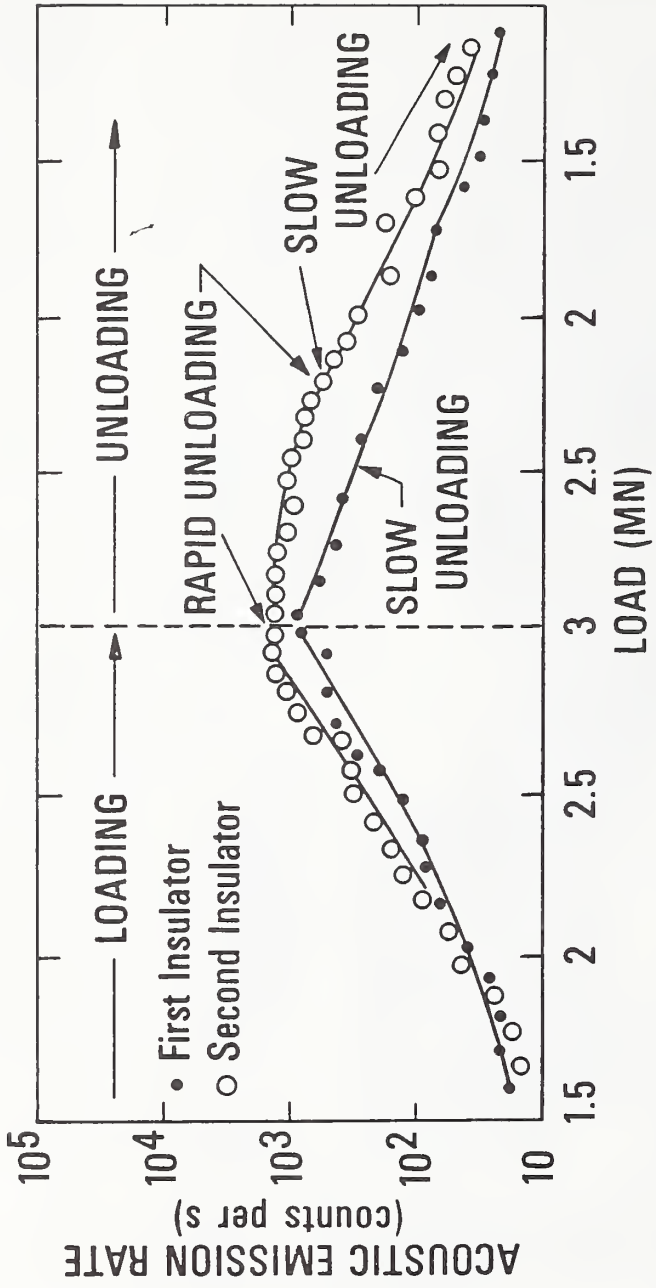
Fig. 9. The acoustic emission rates obtained on the post insulators during loading to 3 MN and unloading.

Some similarity between the predicted and observed emission rates (Figs. 13 and 9) is apparent for the post insulators, suggesting that acoustic emission in the post insulators is due mainly to microcrack formation (occurring in the porcelain and/or the cement). A more quantitative comparison can be made by using the acoustic emission test data to calculate m and n of Eqs. (1) through (3). The slopes of predicted curves in Fig. 13 are given by $x = [m(n+1)/(n-2)]-1$, for the constant loading rate portion of the curve and $y = [m/(n-2)]-1$ for the constant stress portion. By substituting for x and y (the measured values of these slopes), we find: $m \approx 5$ and $n \approx 10$. Similar values were obtained in the laboratory on flexural specimens cut from an equivalent insulator [2] ($m = 3$ to 4 ; $n = 10$ to 12), thus adding additional credence to our suggestion that microcracking (occurring mostly in the porcelain) is the primary source of acoustic emission in these insulators.

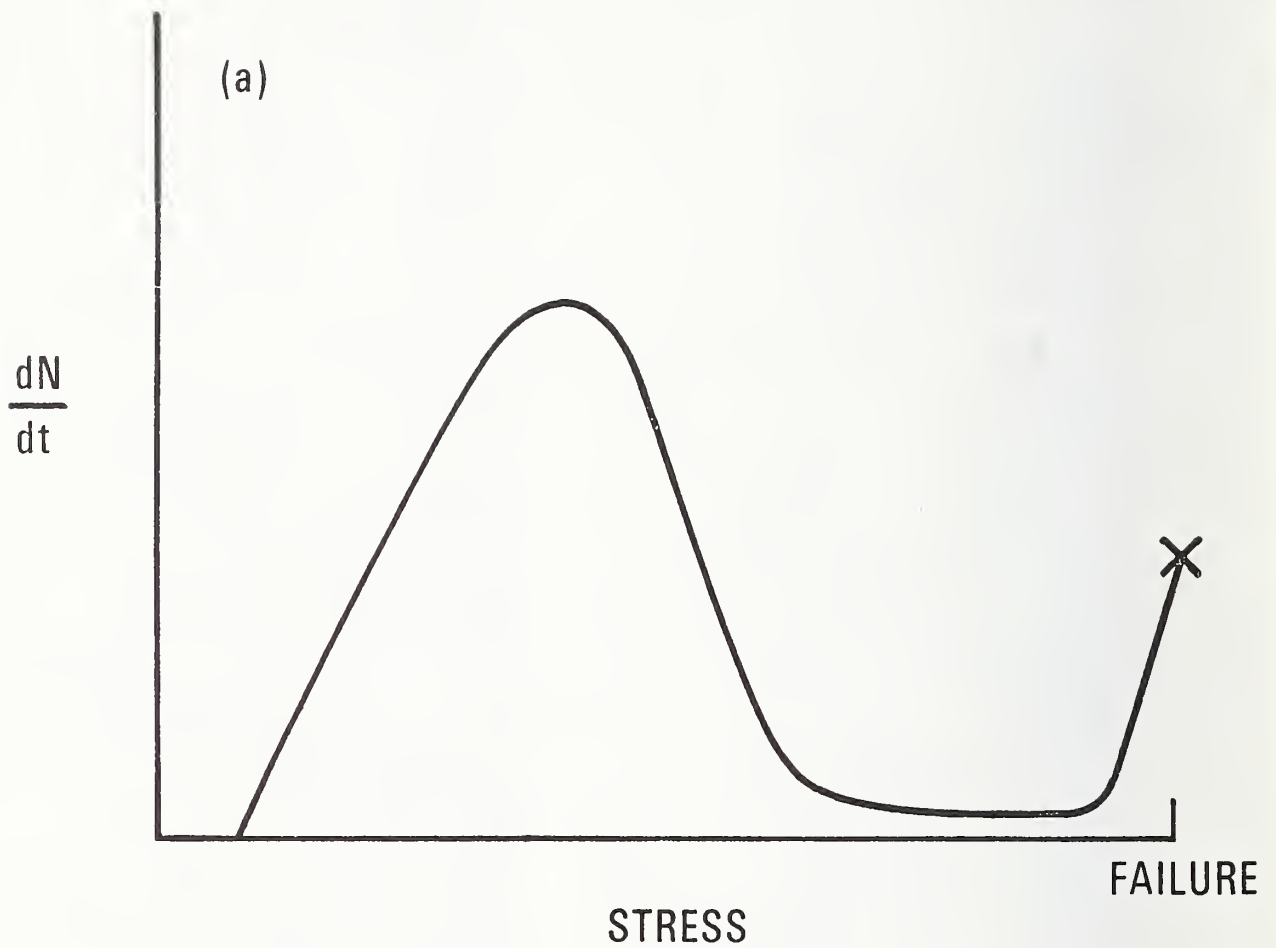
Fig. 11. The acoustic emission expected due to plastic deformation of the steel end caps.

Plastic deformation results in intense acoustic emission if the dislocations move in discrete glide "packets". [6] This occurs only during the initial loading period when new dislocation sources are being generated, and the acoustic emission due to a deforming part will typically exhibit the features shown in Fig. 11. Deformation of the steel end caps might, therefore, contribute to the emission during initial loading, but is unlikely to be a significant contribution during the constant load and unloading portions of a proof test cycle.

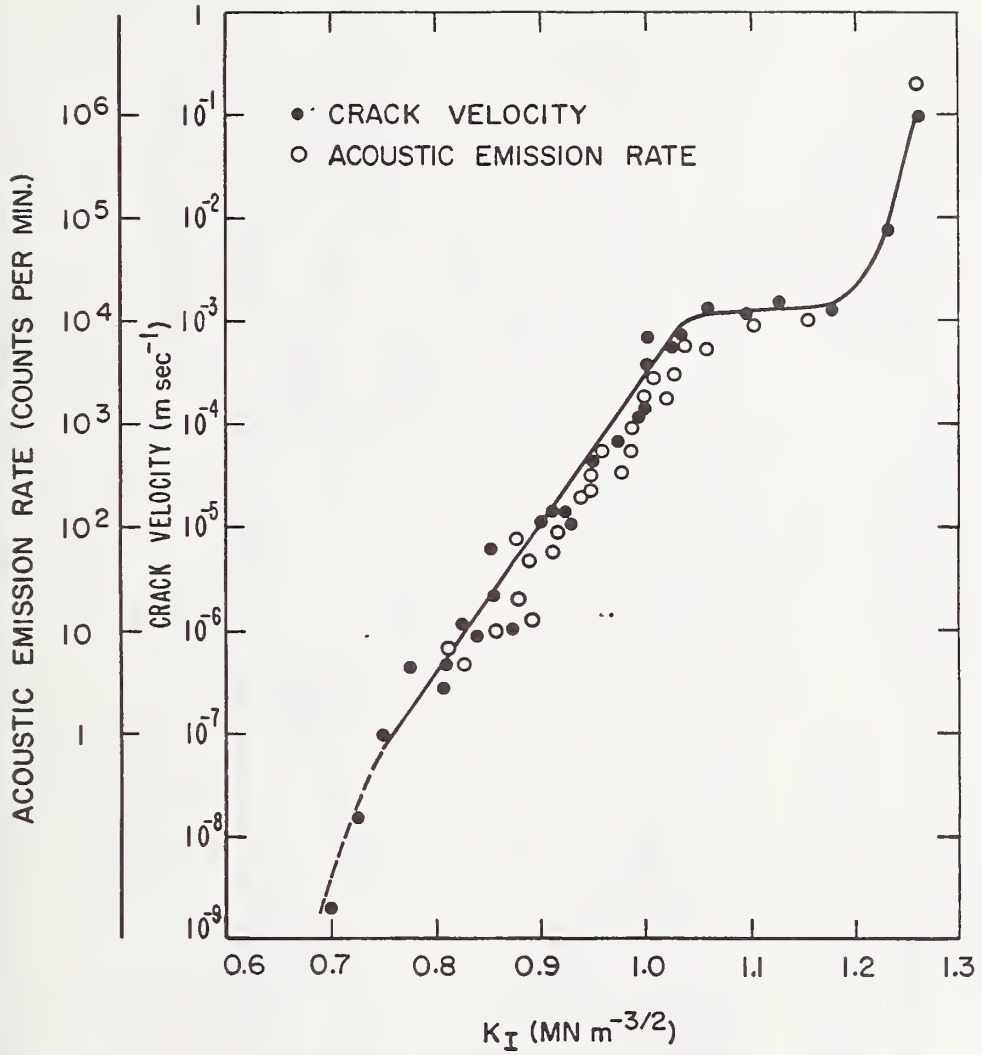
Fig. 12. The relation between acoustic emission rate and crack growth rate during slow crack growth in porcelain.²

Acoustic emission during macrocrack growth in porcelain has been investigated by Evans and Linzer. [2] They showed that the acoustic emission rate is approximately proportional to the crack velocity, (Fig. 12). A direct comparison between their acoustic emission data and the data in this paper is not possible, due to differences in specimen shape and size, the transducer location etc.; but their data illustrate the important trends needed for the qualitative analysis of macrocrack growth. A quantitative treatment can be performed and some objective conclusion reached with a modest amount of additional information (see Appendix).

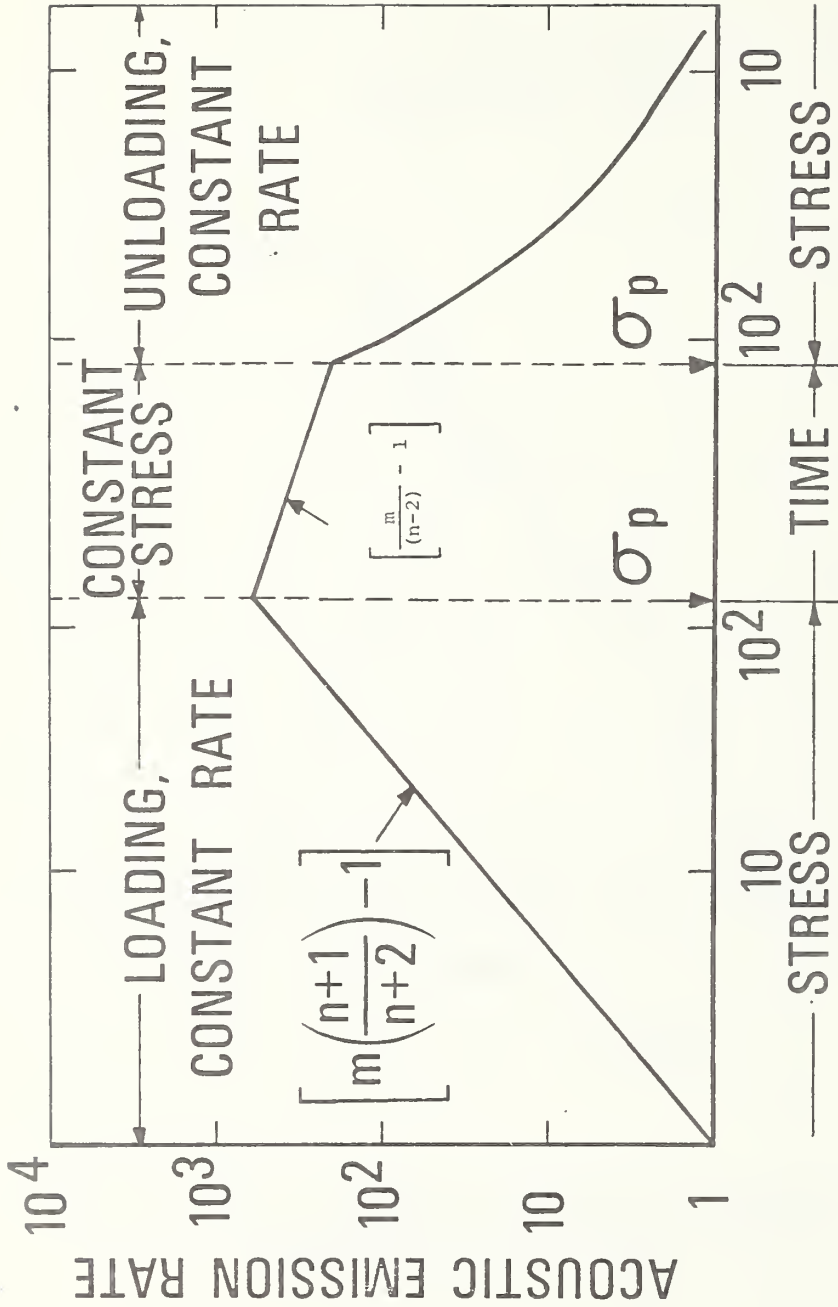
Fig. 13. The predicted acoustic emission rate from microcracking in an elastic, reversible system.

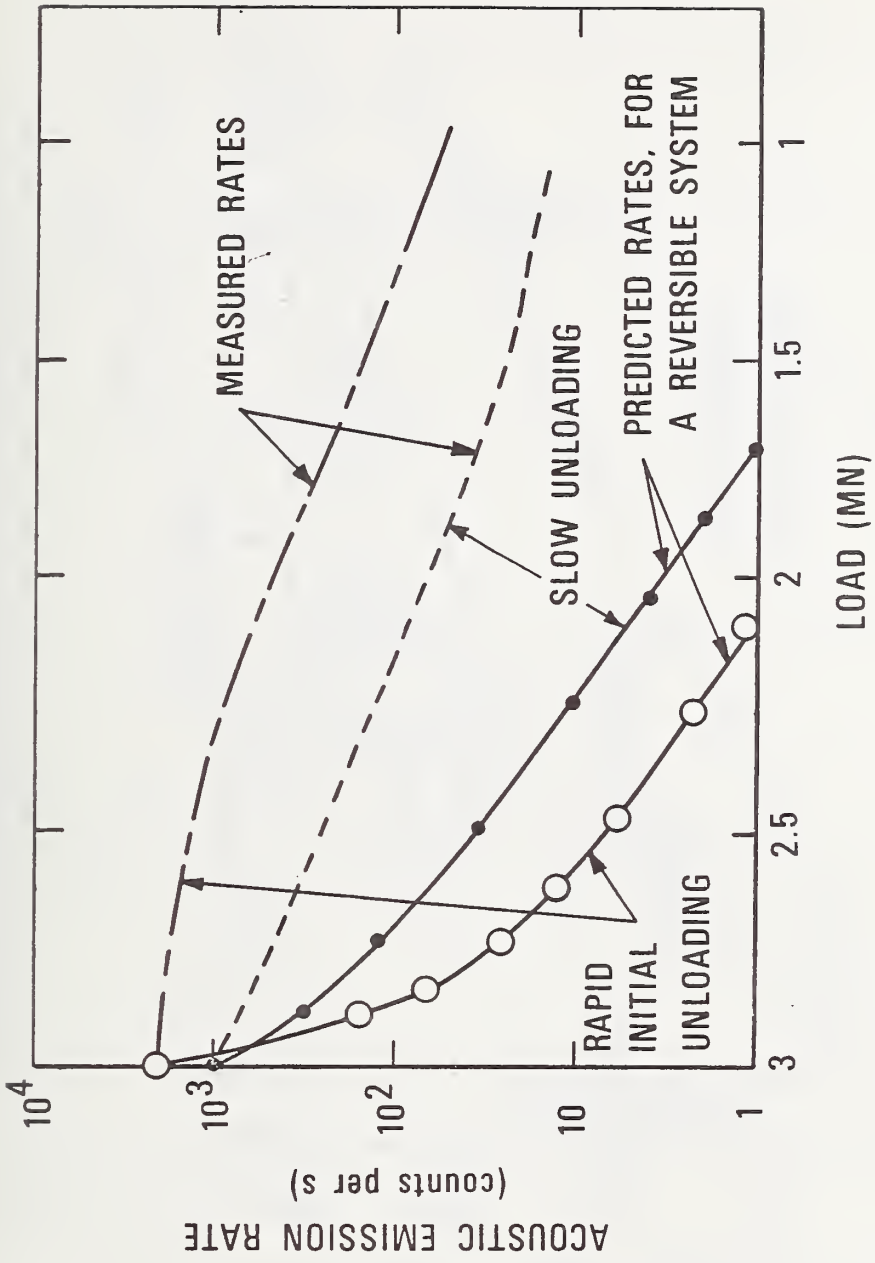
Fig. 14. A comparison of the acoustic emission rates measured during unloading with the rates predicted for a reversible, elastic system.

during unloading. [7] The results for the post insulator, shown in Fig. 14, indicate an acoustic emission rate exceeding that expected for a reversible system. A similar calculation for the cone insulators would indicate a much larger discrepancy. This additional acoustic emission is almost certainly due to residual stress development (resulting from some irreversible slip at the porcelain/cement interface), which causes additional microcracking; and, for the cone insulators, leads to macrocrack formation. A measure of the severity of the residual stress can be computed by substituting the observed acoustic emission rate on unloading into Eq. (3). [7] The result (Fig. 15) indicates a small, but significant, residual stress that persists to zero load.

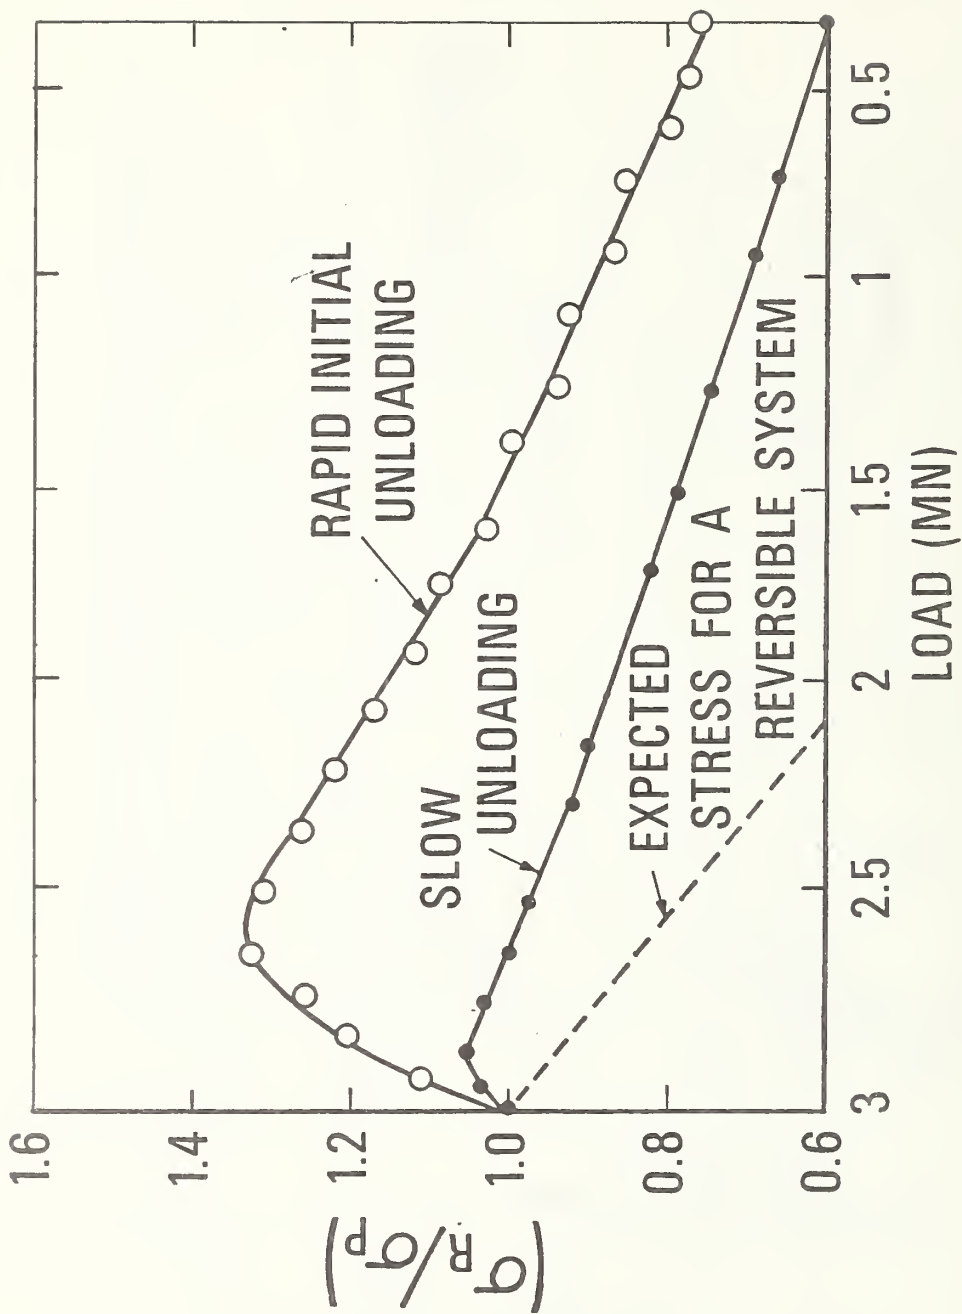
Fig. 15. The relative residual stress in the post insulators during unloading as predicted from the excess acoustic emission; σ_R is the residual stress and σ_P is the stress at the proof load.
