The Proof Testing of Porcelain Insulators and the Application of Acoustic Emission

A. G. Evans, S. M. Wiederhorn, M. Linzer and E. R. Fuller, Jr.

Inorganic Materials Division
Institute for Materials Research
National Bureau of Standards
Washington, D. C. 20234

Final Report

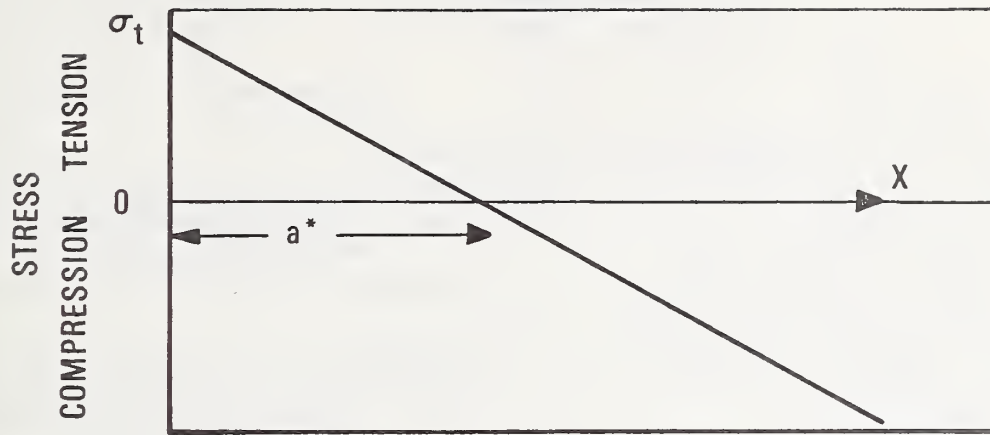
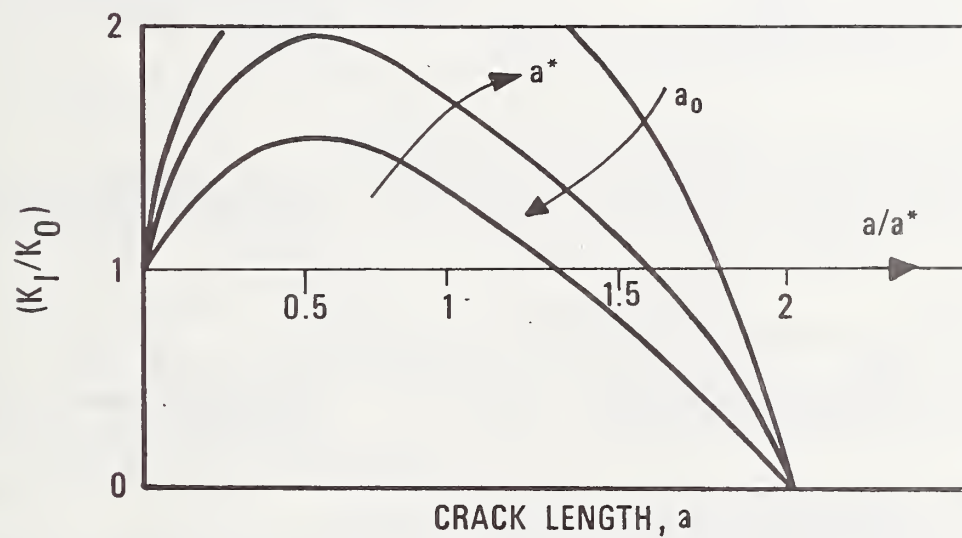
Fig. 16. (a) A schematic of a linearly decreasing stress field defining the parameters used in the text.
 (b) The relation between stress intensity factor, K_I , and crack length, a , for the stress field in Fig. 16 (a).

For illustration purposes we shall now consider an edge crack propagating in a linearly decreasing stress field (Fig1.16a):

Also, note that $K_I=0$, when $a=\pi a^*/2$. Hence, we can construct relatively simple (K_I, a) diagrams for this system, as depicted in Fig. 16b.
