NBSIR 74-528 (R)

DNA/NBS/Crane NAD Barrier Tests

Report for Period March 24 - 29, 1974

Prepared for
Defense Nuclear Agency
Washington, D. C. 20305

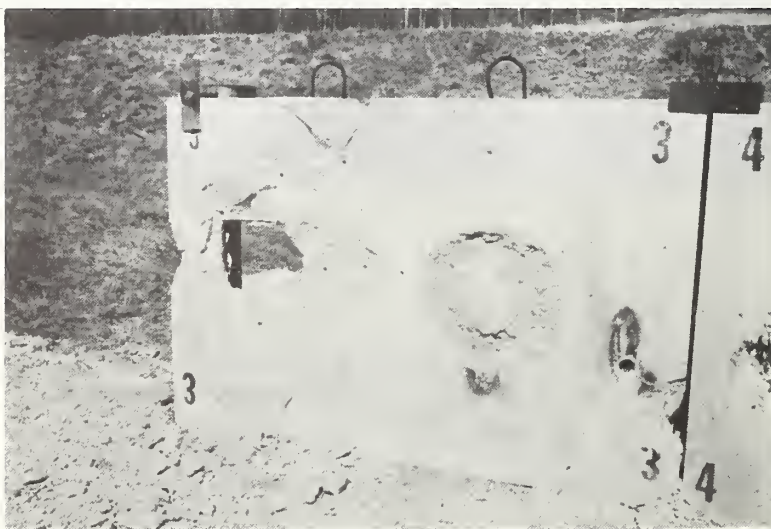
Figure 3. 3L1. Slab 3, front view of completed opening

A relatively undamaged area was selected on slab 3 and marked as a target area. Then a 16 round burst of 20 mm APT was fired from a distance of approximately 150 m . Figure 1 shows the front and figure 2 shows the rear of the slab after this burst. Damage was such that it required only five blows with a sledgehammer to clear away the shattered concrete and expose the reinforcing. This was cut with bolt cutters and in only 0.44 minute working time an opening measuring 348 mm X 292 mm (13-1/2" X 11-1/2") was cleared as shown in figure 3.

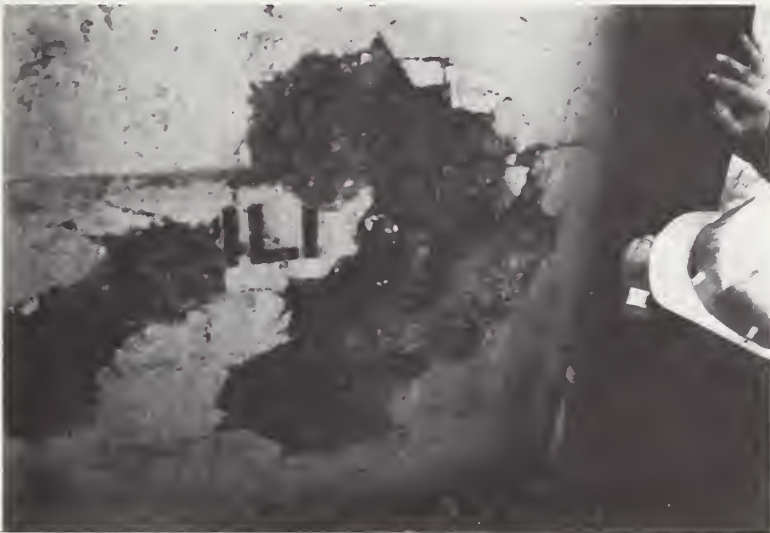
Figure 5. 4L1. Slab 4, rear view of results of 17-round burst of 20 mm APT

As in the preceding test, a target area was selected and then a 17 round burst of the 20 mm APT was fired at this target. Figures 4 and 5 show front and rear views of the resulting damage. The fibrous concrete in this slab was more difficult to clear away and 75 blows were required from a

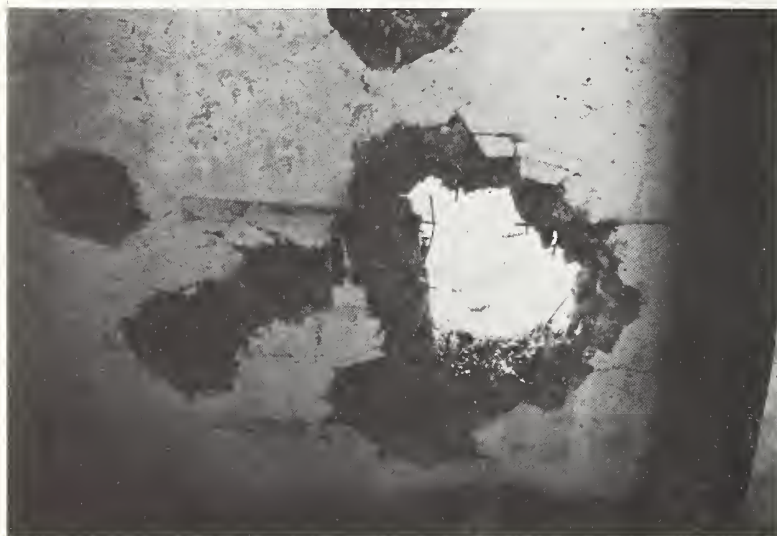
Figure 6. 4L1. Slab 4, completed opening

4.5 kg (10-lb.) sledgehammer. These were followed by 15 cuts with bolt cutters which produced an irregular shaped opening of approximately 305 mm X 330 mm (12" X 13"). The total working time was 2.18 minutes. Figure 6 shows the finished opening.

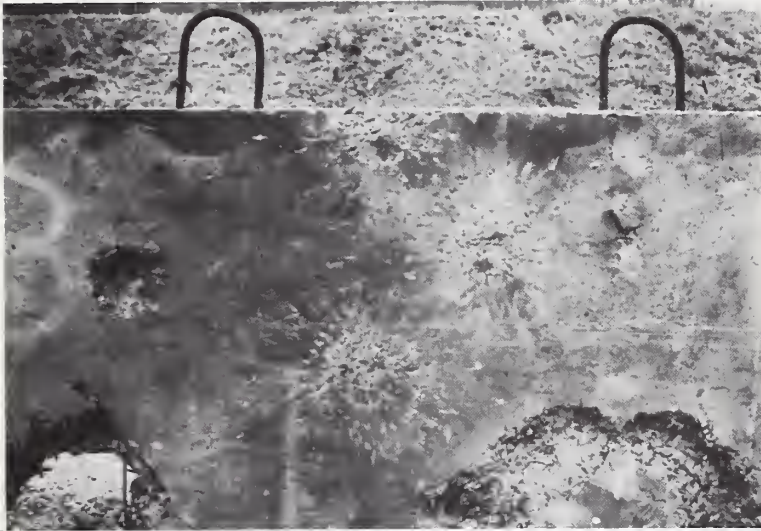
Figure 7. 4L1. Slab 4, impact marks
from 40 mm HE

A further unscheduled test was performed on slab 4. Three rounds of 40 mm HE were launched from a distance of about 75 m against the face of the slab. These exploded on impact leaving only the slight marks shown in figure 7.

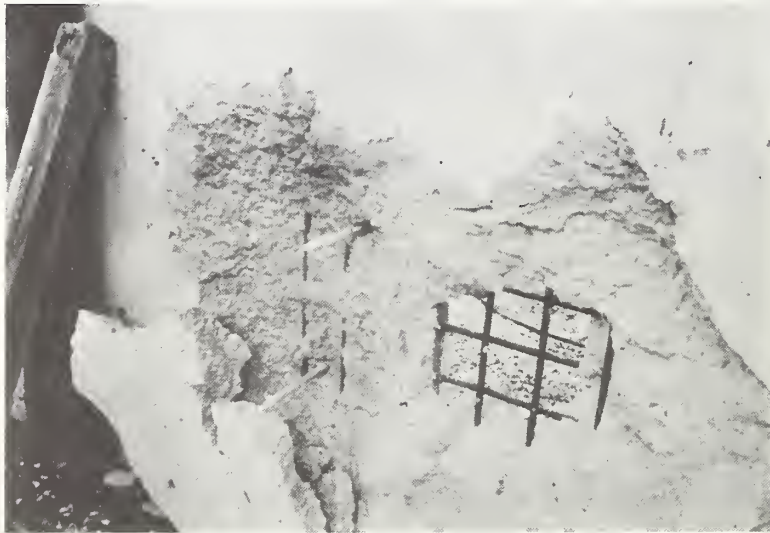
Figure 8. 5E3. Slab 5, rear view after reinforcing was exposed

Then, using a bull-point punch and a 4.5 kg sledgehammer, the bottoms of these holes were spalled out with 34 blows delivered in 0.78 minute. This produced a spalled area on the rear surface of the slab that extended to the depth of the centered reinforcing bars over an area approximately 864 mm (34") high and 520 mm (20-1/2") wide. Then, 68 blows with the sledgehammer delivered in 1.05 minutes cleared away the remaining concrete fully exposing the reinforcing as shown in figure 8. Ten cuts with bolt cutters required 2.18 minutes and produced a clear opening approximately 356 mm (14") in diameter. The total working time was 4.60 minutes.

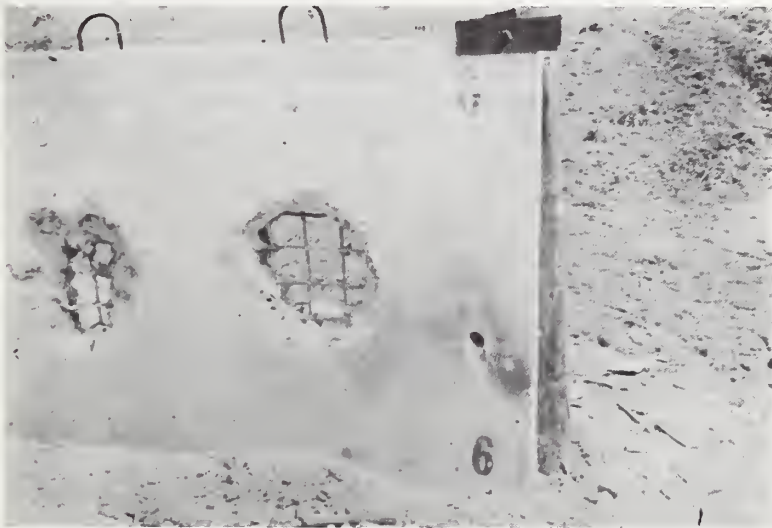
Figure 12. 6E2. Slab 6 after 44.45 minutes working time

Next, four more holes were drilled partially through the slab near the center of the annulus. These were spalled and then a direct sledgehammer attack eventually produced a small central initial breakthrough. Using a combination of tapered punches and direct sledgehammer attacks, the peripheral holes were enlarged and spalled into the central breakthrough region. It required a total of 44.45 minutes of working time to make the opening shown in figure 12. It is estimated that it would have required at least two more minutes to cut the reinforcing bars with bolt cutters.

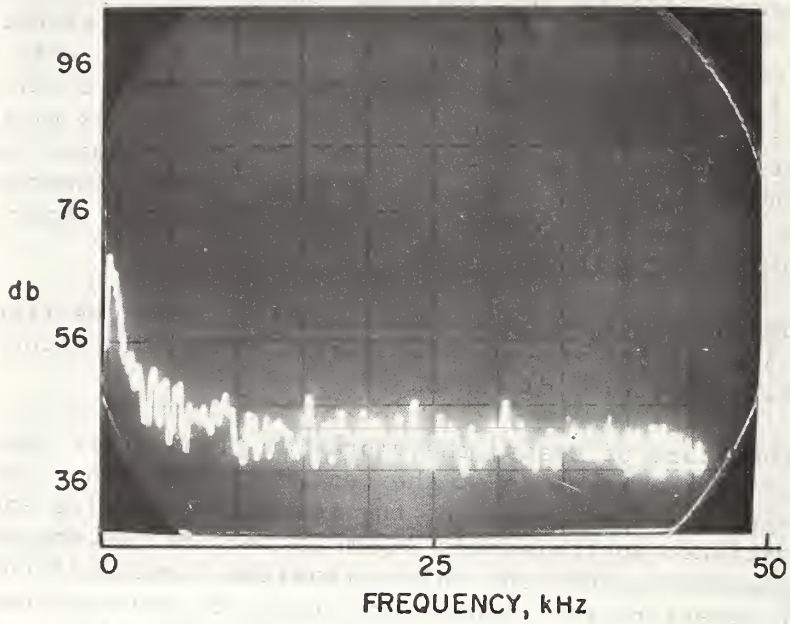
Figure 13. Typical ambient acoustical level inside magazine.

The typical ambient, acoustical level inside the magazine is shown in figure 13. The low frequency peaks around 70 dB were confirmed by SPL readings and resulted from the diesel-powered generator which was used to provide electric power at the test site. A recording of the ambient vibrational disturbances is shown in figure 14.

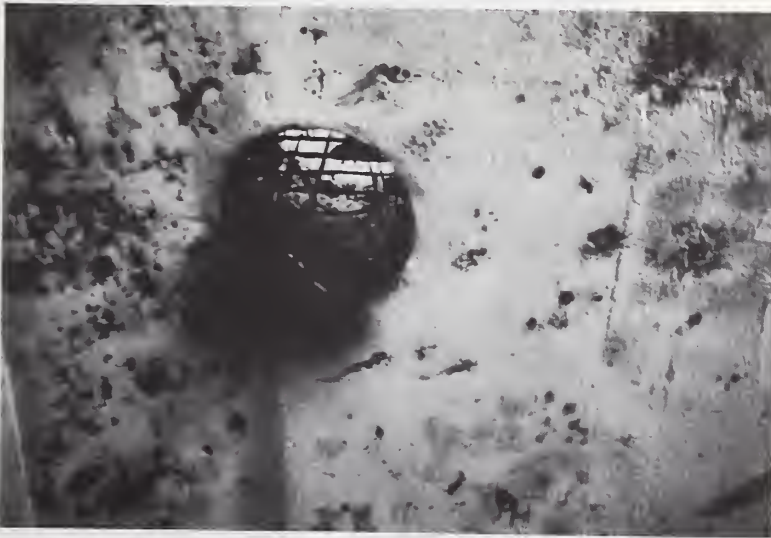
Figure 15. Test 1421X1. Interior view of grating

The battering ram broke through the grating bars and made a hole only about half the required diameter(see fig.15), so the ventilator cover was replaced and the test was restarted using an alternative approach.

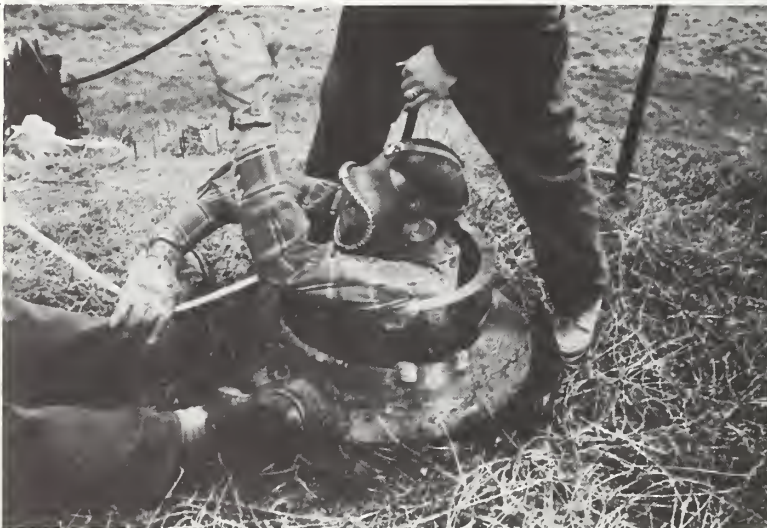
Figure 16. Test 1421X1. Attacker being lowered through ventilator shaft

The breathing apparatus was jury-rigged. A belt was volunteered by one of the attack team and used to try to strap the pressure regulator of the breathing apparatus in such a position that the semirigid air supply line would not kink the hose between the regulator and breathing mask. When this had been done, the intruder was lowered to the interior floor of the magazine using belaying techniques as shown in figure 16. The bottom was reached after 8.70 minutes of working time and 11 minutes elapsed time.

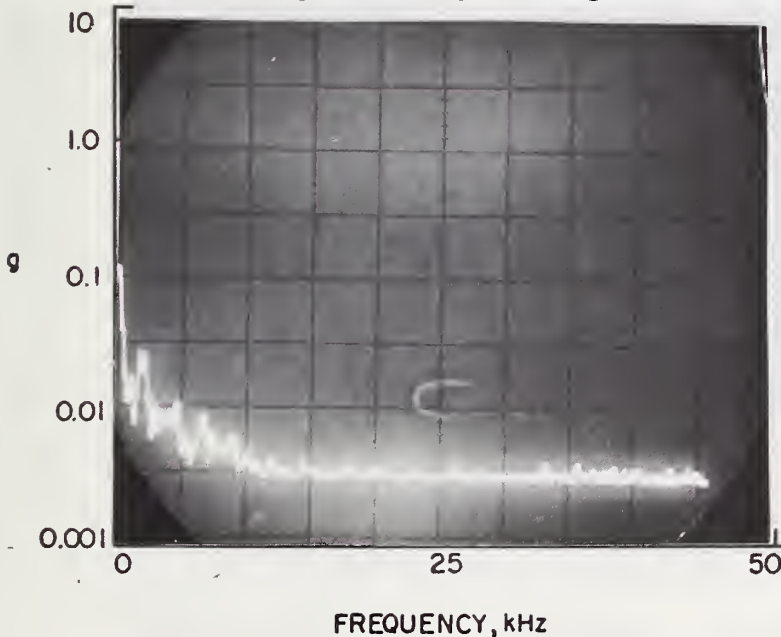
Figure 18. 1421X1. Vibrational disturbances produced by burning bar

Acoustical disturbances produced by the burning bar are shown in figure 17 and vibrational in figure 18. The latter were from the transducer mounted 1 m from the shaft, and, as previously noted, are of questionable validity.

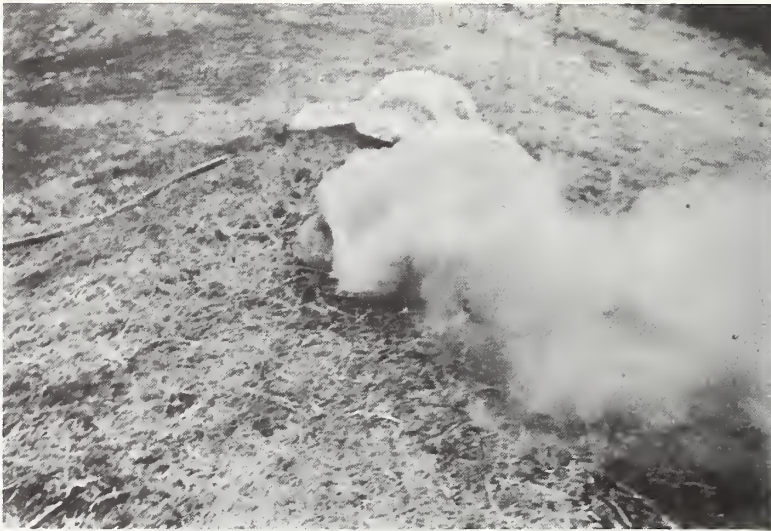
Figure 19. Test 1421X1. Smoke from ventilator after burning grid

After completion of test 1421X1, a grid work of plastic pipes was placed across the interior of the ventilator shaft and connected to a smoke generator. This was to simulate a proposed chemical forced entry deterrent system. The magazine was again closed and the pipe grids were cut with the burning bar. Smoke poured out of the ventilator, as shown in figure 19, and the interior of the magazine was filled with dense smoke. When the doors of the magazine were opened, it was several minutes before there was sufficient visibility to even find the fans which had been placed inside to facilitate forced ventilation and smoke removal. After they had finally been located and turned on, it took nearly half an hour to clear the magazine of smoke. It is believed that unless an invader had been trained to perform his mission in total darkness he could not have functioned in the environment of a closed magazine filled with such dense smoke even using breathing apparatus and portable lights.

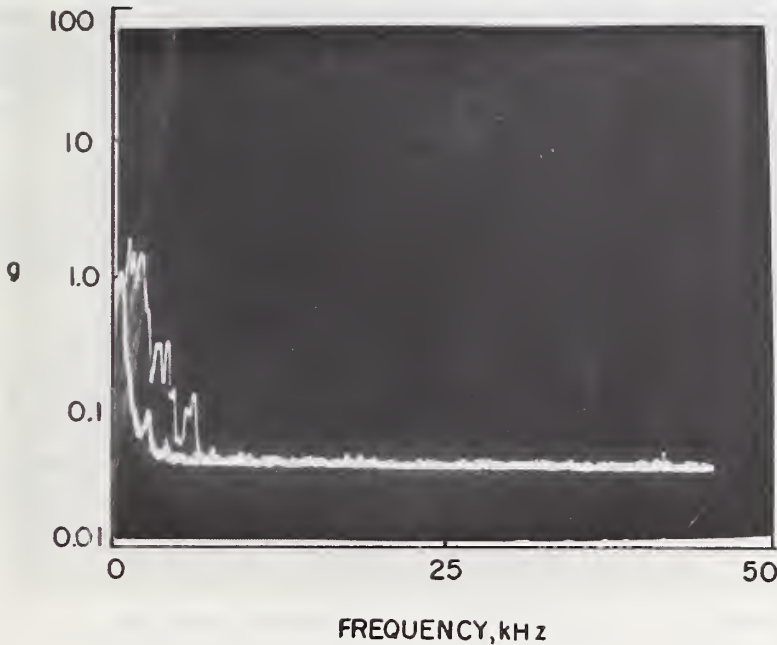
Figure 23. 1421N2. Vibrational disturbances produced by spalling

A bull-point punch was inserted in one of the drilled holes and 1.62 minutes of working time was expended in an unsuccessful attempt to spall out the bottom of the hole. The sledgehammering produced sound pressure levels of 78 to 95 dBc on the outside of the magazine at a distance of 3.0 m and 95 to 104 dBc inside the magazine at a similar distance from the attack point. Spectra of the acoustical and questionable vibrational disturbances are shown in figures 22 and 23.

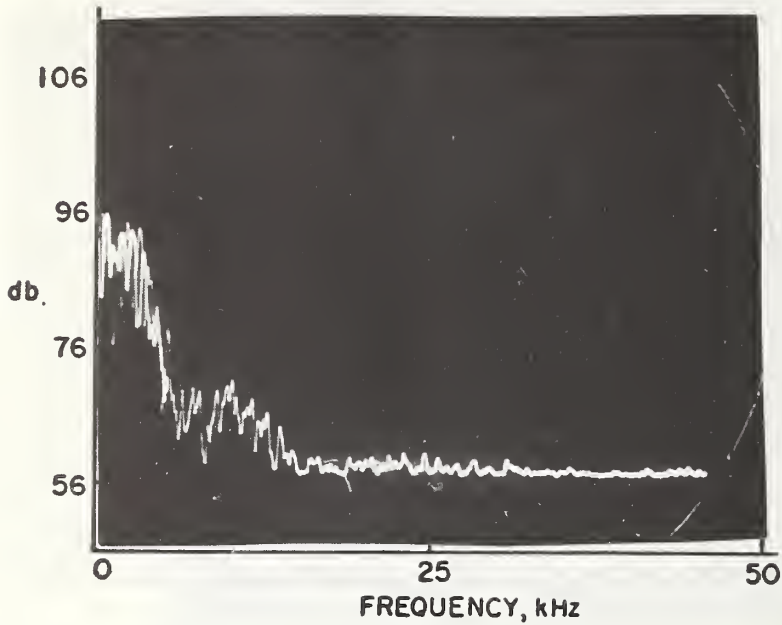
Figure 28. Test 1421W3. Acoustical disturbances from drilling

Next, four holes 22.2 mm (7/8") in diameter were drilled to a depth of 11.43 cm (4-1/2") in a row extending between the two slits near their midpoint. This required 1.42 minutes and produced the acoustical disturbances shown in figure 28 and the questionable vibrational disturbances shown in figure 29.

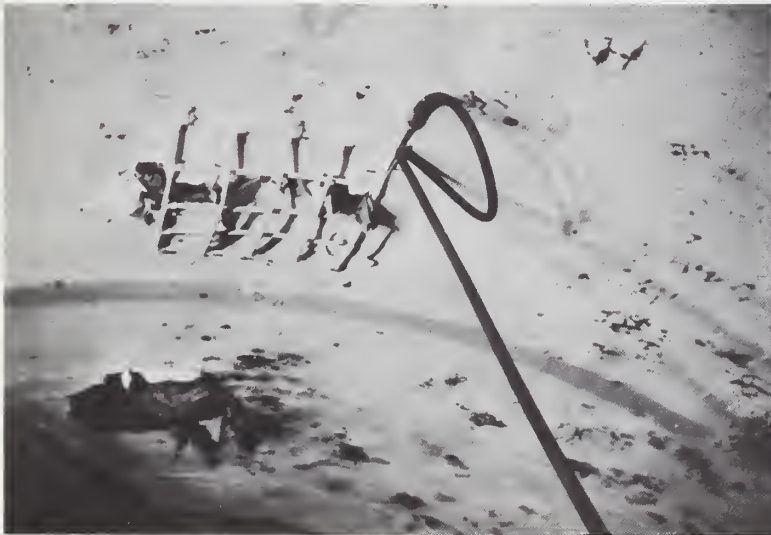
Figure 30. Test 1421W3. Interior grid work showing slight bowing

The following day, the testing was resumed with a fresh supply of sledgehammer handles. The 7.62 cm (3") deep holes were extended to 12.7 cm (5") in depth and were spalled out in 3.95 minutes. On several occasions, punches came through the concrete in positions which threatened to penetrate the pipe grid work attached to the interior of the arch but in each instance the grid was merely bowed or deflected as shown in figure 30.

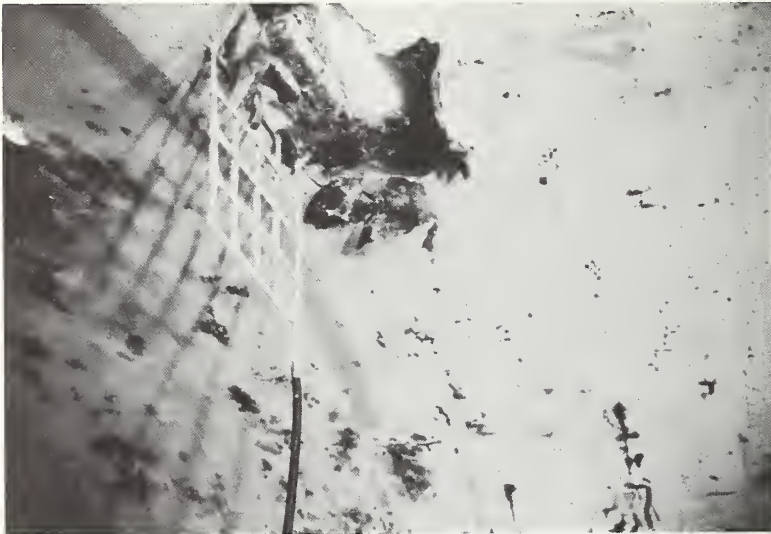
Figure 31. Test 1421W3. Unruptured pipe grid hanging loose from one side

Again the battering ram was dropped, and, on the tenth drop, after a working time of 1.17 minutes, about half of the concrete broke through. Then, 0.42 minute work with the sledgehammer cleared an opening 20.3 cm (8") wide and 54.6 cm (21-1/2") long. In the process, the pipe grid did not rupture but was torn loose from its hangars on one side and hung vertically as shown in figure 31. A final 0.57 minute of work with bolt cutters cleared the remaining reinforcing wires, completing the opening in a total working time of 33.15 minutes.
