NBSIR 74-559

Stress Corrosion Behavior of Die Forged 7049-T73 Aluminum Alloy

Final Report

Prepared for
Naval Air Systems Command
Department of the Navy
Washington, D. C. 20360

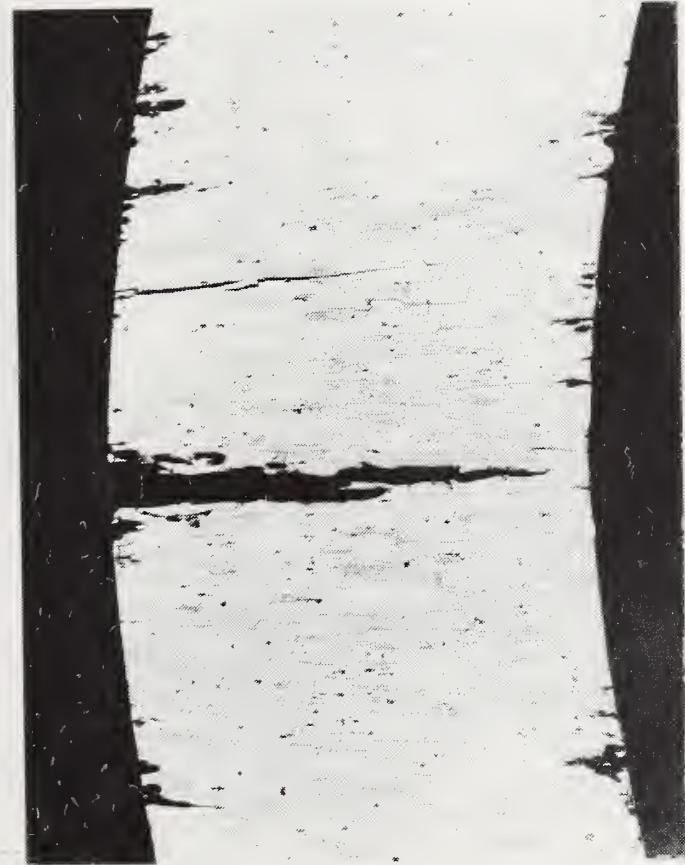
FIGURE 1. Corrosion attack of aluminum alloy 7049-T73 at areas of maximum stress on C-ring Type specimens.

(a) Intergranular corrosion on specimen stressed at 75% yield strength and exposed for 798 days in the marine atmosphere, Kure Beach, N. C. Etched, Keller's Etch. x40.

Results: The results summarized in Table 2, indicate that the alloy has good resistance to stress-corrosion cracking. However, C-ring specimens machined from parting line areas of the forging that had been stressed to 75% of the yield strength of the alloy and exposed in the marine atmosphere had failed after exposure for 798 days. Metallographic examination of sections obtained from areas where failure was noted revealed secondary intergranular cracking adjacent to the main crack. An example is shown in Figure 1a. Similar specimens exposed intermittently

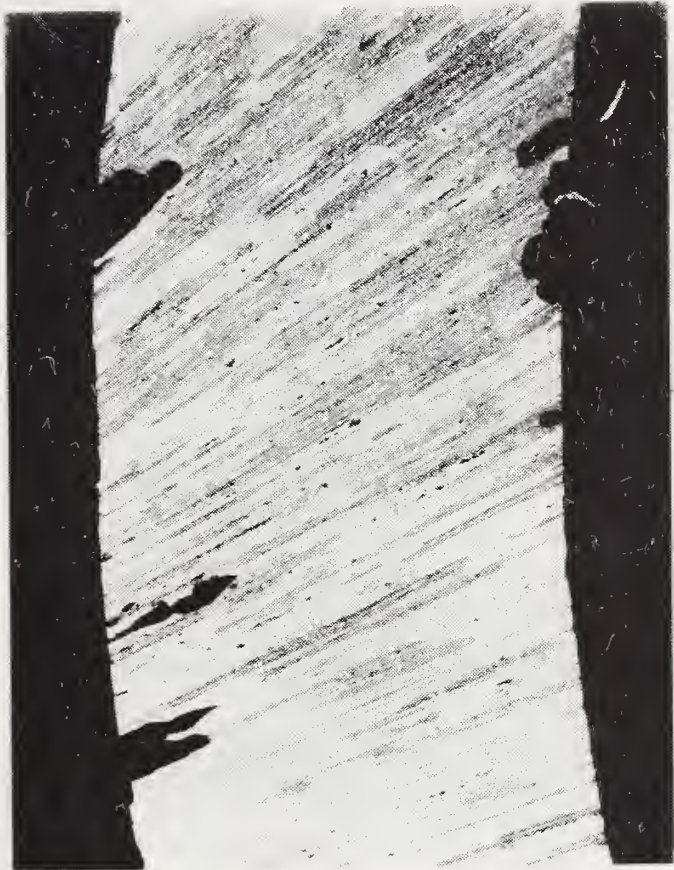
(b) Pitting corrosion observed on specimen stressed at 75% yield strength and exposed for 62 days in an artificial environment (3-1/2% sodium chloride solution). Etched, Keller's Etch. x40.

for 62 days in an aqueous 3.5% sodium chloride environment were found to be severely pitted by corrosion along the grain boundaries (Figure 1b), particularly in areas at and adjacent to the zone of maximum tensile stress on the specimens.
