NBSIR 74-560

# Stress Corrosion Behavior of Selected Types of Stainless Steels and Titanium Alloys in a Marine Environment

Corrosion and Electrodeposition Section  
Metallurgy Division  
Institute for Materials Research  
National Bureau of Standards  
Washington, D. C. 20234

Twelve Year Progress Report

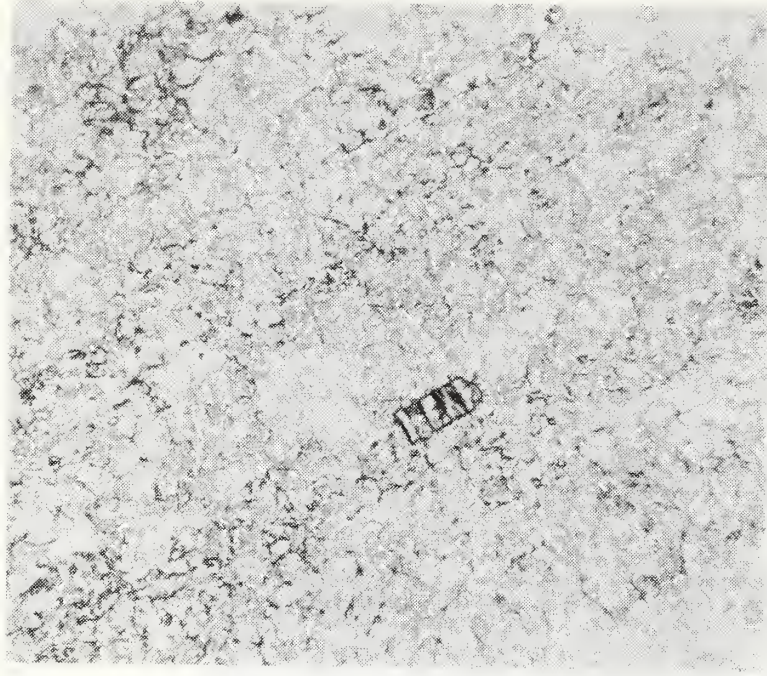
Figure 6 Microstructures of 17-7 PH alloy steel specimens.

- (a) 17-7 PH in the RH 950 condition. Crack shown is both intergranular and transgranular. Note ferrite phase. Etched, HF-HNO<sub>3</sub>.x500.
- (b) 17-7 PH in the RH 1075 condition. Note that for this alloy as the tempering temperature is increased from 950° F (as in 6a) to 1075° F that the ferrite phase reverts to austenite. Etched, HF-HNO<sub>3</sub>.x500.

17-7 PH in the RH 950 condition also revealed a mixed mode of fracture as seen in Figure 6a. The ferrite phase is visible in this micrograph. As the tempering temperature is increased to 1075°F this phase is no longer visible as shown in Figure 6b. The ferrite reverts to austenite as the tempering temperature is raised above 1050°F<sup>(10)</sup>. Also shown in this micrograph are cube shaped titanium nitride inclusions which were found distributed throughout the alloy.
